JESSE L. SOLES
1604 TERRACE VIEW DRIVE
WEST COLUMBIA, SOUTH CAROLINA 29169
POLICY NUMBER: SF00178142
DONAN PROJECT NUMBER: 21-15100537-0

NOVEMBER 10, 2015

RE: **Jesse L. Soles**
1604 Terrace View Drive
West Columbia, South Carolina 29169
Policy Number: SF00178142
Donan Project Number: 21-15100537-0

At your request, on October 24, 2015, a study was made on the house at the above-referenced address. The purpose of the study was to determine the extent of structural damage from a recent flood event. Mr. Jesse Soles was present to point out areas of concern and to provide firsthand information. This letter, with the attached photographs, is the report of my findings and conclusions.

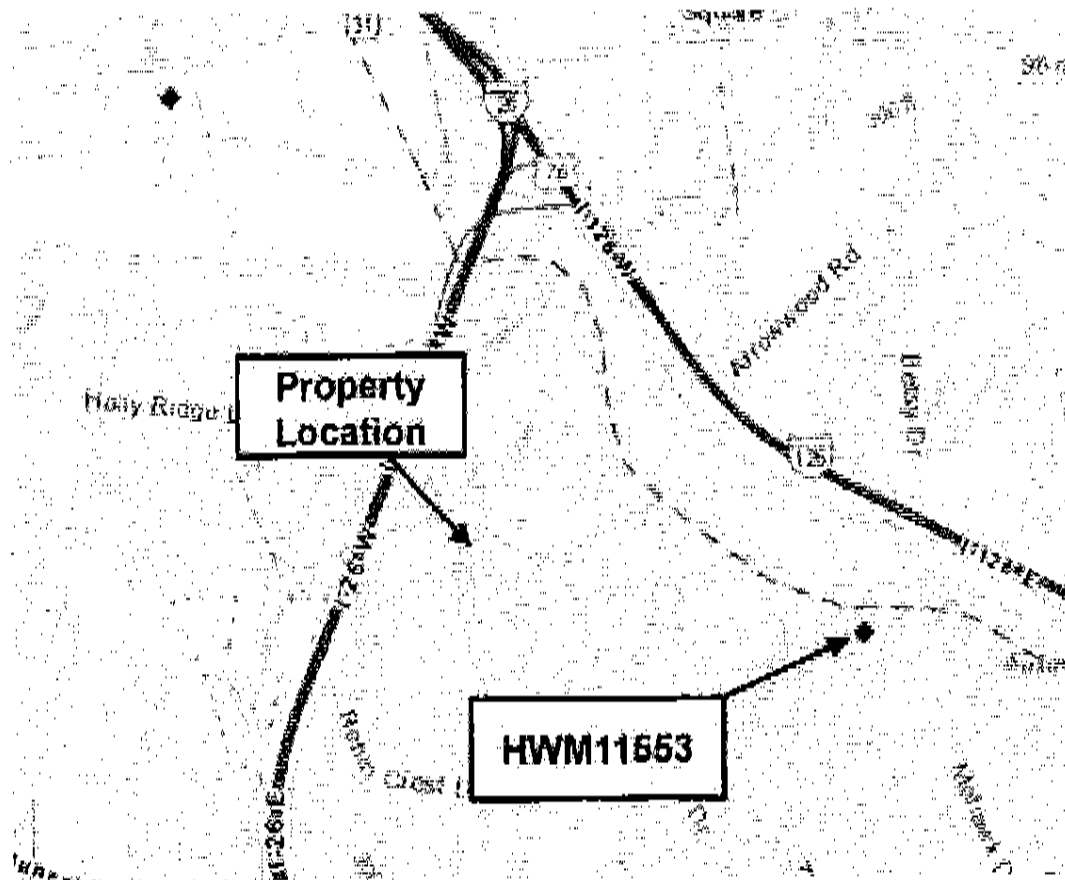
Figure 4: USGS Documented High Water Mark -- October 2015⁸

Rainfall totals in the Columbia area exceeded 21 inches in some areas, and the one-day, two-day, and three-day rainfall records were broken.⁶ Most river gages in the area ceased functioning during the flood event. The USGS surveyed high-water marks throughout the flood-affected areas. A survey point, located about 1300 feet east of this property, documented a high-water mark at 5.10 feet above the ground (Figure 4).⁷

The high-water marks indicate that floodwater up to about 39 inches deep inundated this property. The water depth filled the crawlspace and reached
