David's Mill Pond Historic District (Site Number 2737) Historical Overview and Resource Descriptions

Compiled by Tracy Martin and Bill Jurgelski
South Carolina Department of Transportation
January 2019

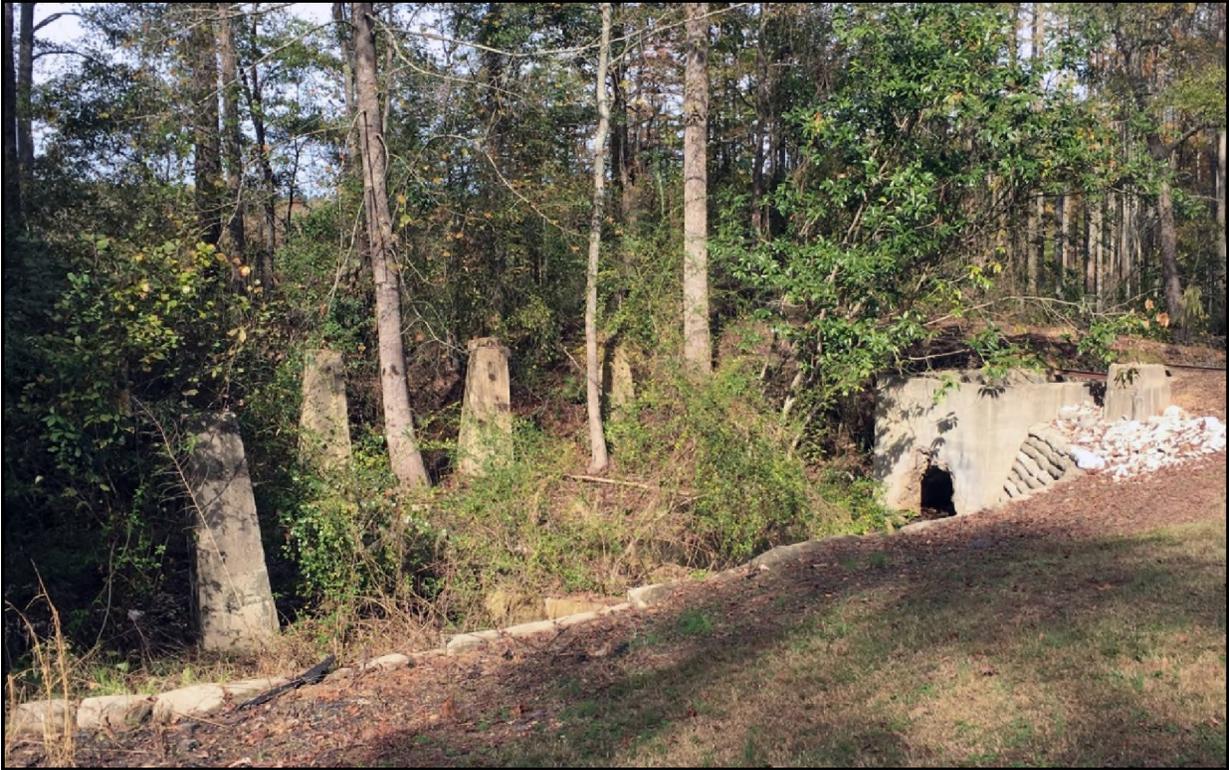
The remains of the mill building associated with David's Mill Pond are located in the southeastern corner of the district just to north of David's Pond Road. A millrace leading from the southeastern corner of the pond passes through the building remains. The mill building is visible on aerial photographs dating to 1950 and 1958. Highway plans dating to 1961 indicate that the structure was demolished when David's Pond Road was relocated in 1961 (see **Figure 7**). The road originally passed over the mill dam. Historical maps and aerial photographs indicate that the mill building was located just to the south of and adjacent to the road at that time (see **Figures 3 – 6**). Extant remains of the mill building include seven concrete pier supports, a concrete lined channel/sluiice, a rectangular concrete enclosure that appears to have housed a turbine, and a curved concrete retaining wall constructed of bags of concrete that were hardened while in the bags. It is not clear if this retaining wall was constructed when the mill was operational or if the wall postdates the mill. **Figures 10 and 11** show the mill remains at the time of survey.

Figure 10. View of 2737.01 [38ML373] Mill Building Remains, Showing Concrete Wall, Enclosure, and Piers, Facing North.

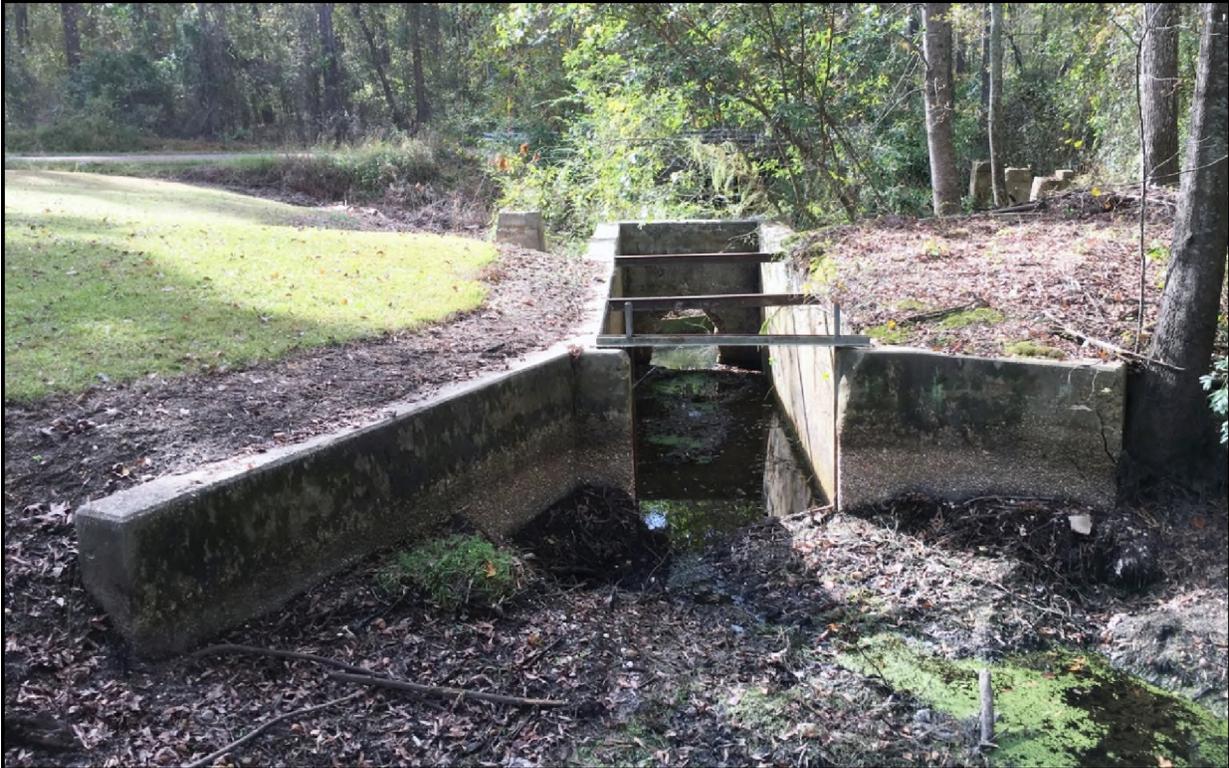
Figure 11. View of 2737.01 [38ML373] Mill Building Remains, Showing Concrete Channel and Possible Turbine Enclosure, Facing Southwest.

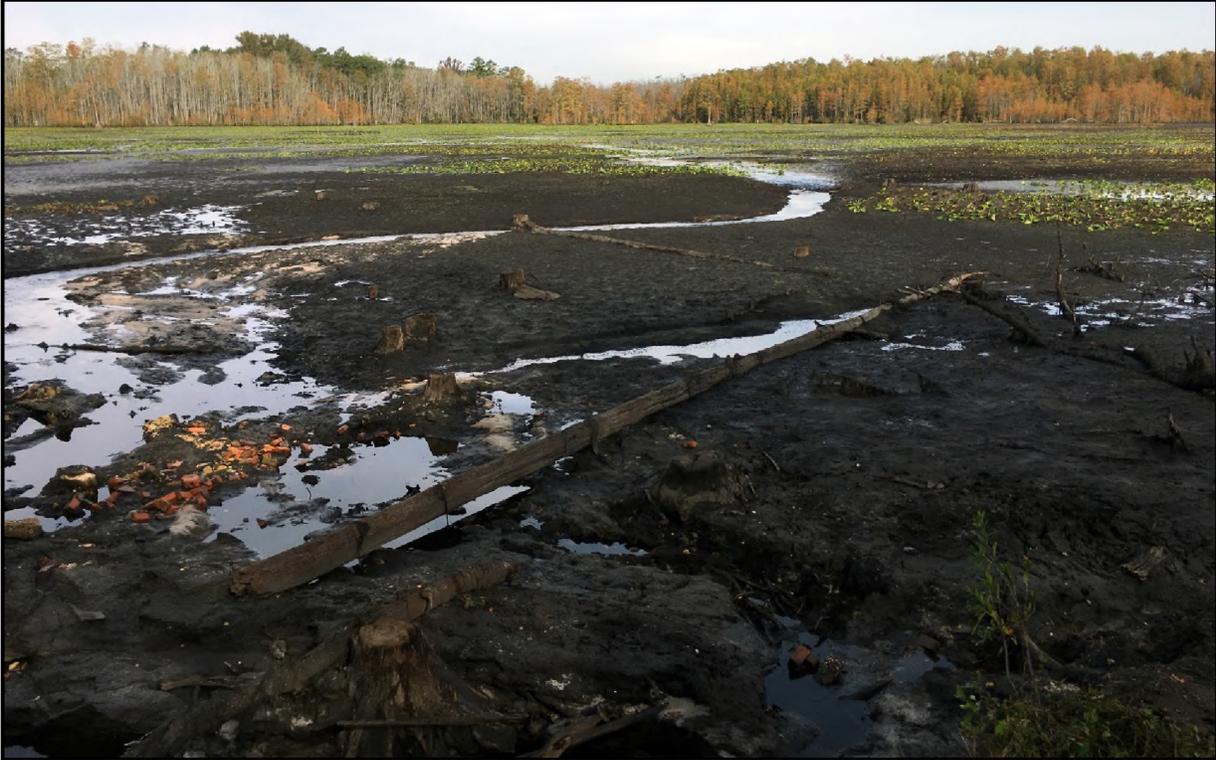
David's Mill Pond is a large shallow waterbody measuring approximately 1,860 feet by 1,470 feet (approximately 42 acres). The pond impounds a small stream called Naked Creek, and very probably covers an area that comprised natural wetlands prior to the time that the pond was constructed. At the time that the district was recorded in November 2018 flooding associated with Hurricane Florence had caused the mill dam to be breached and most of the water in the pond had drained out into the wetlands south of the district. **Figures 12 and 13** show the mill pond at the time that it was recorded.

Figure 12. View of 2737.02 (Mill Pond), Facing North.

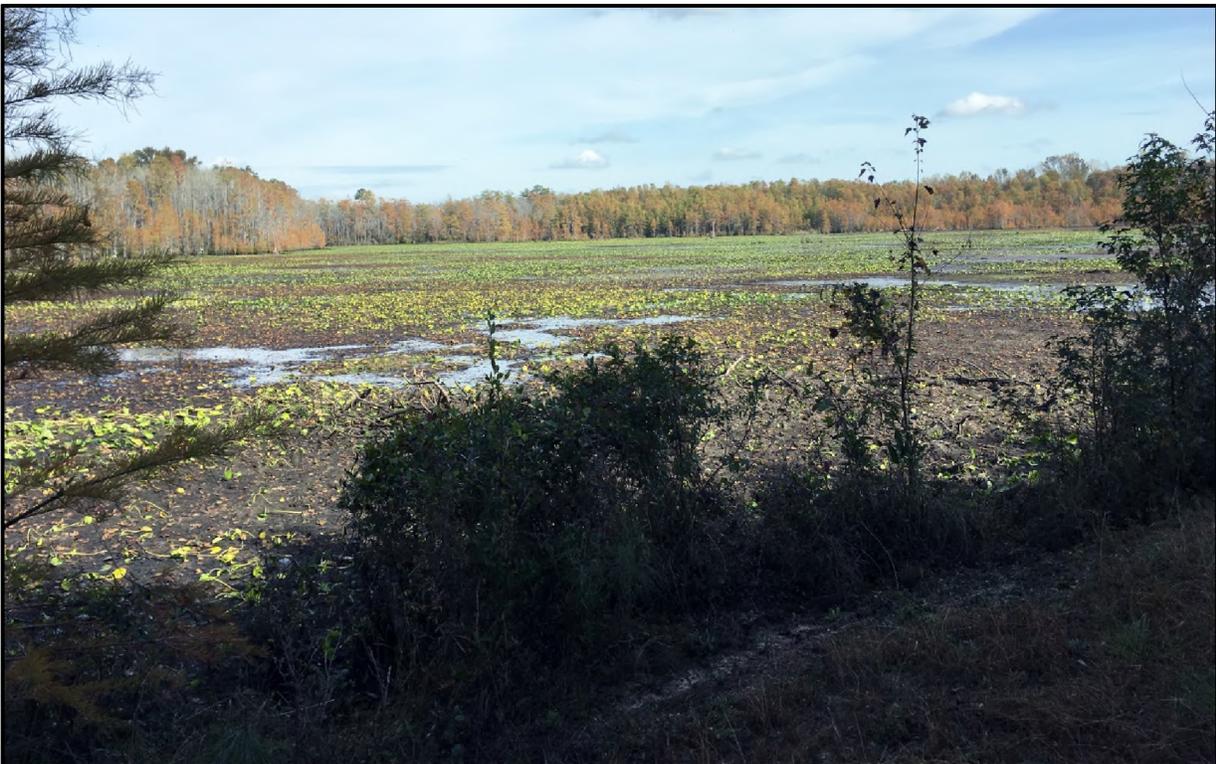
Figure 13. View of 2737.02 (Mill Pond), Facing Northeast.

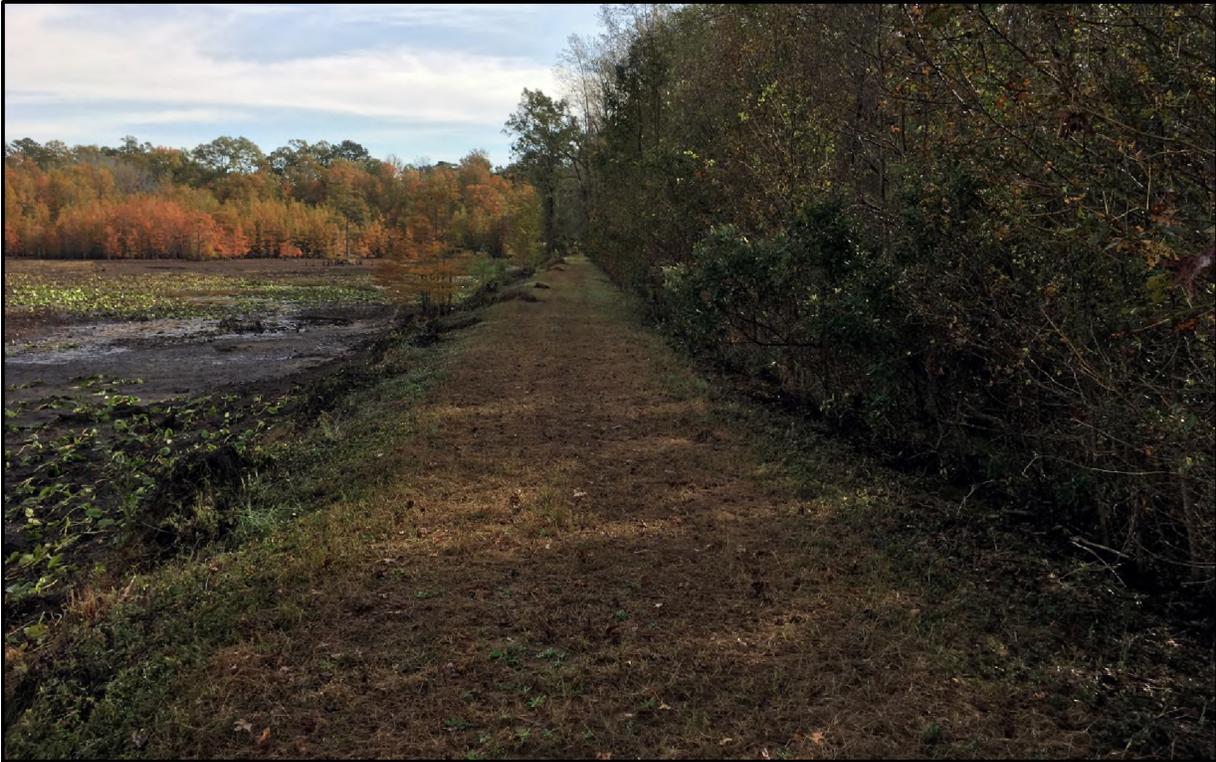
The earthen dam that impounds David's Mill Pond is located along the southern end of the pond. The dam is oriented roughly east to west and is approximately 1,630 feet long by about 40 feet wide. The dam appears to have been maintained and in use until the hurricane damaged it causing the pond to drain. David's Pond Road originally ran along the top of the earthen dam but was moved south onto its current alignment in the 1960s. **Figures 14 and 15** show the earthen dam at the time that it was recorded.

Figure 14. View of 2737.03 (Earthen Dam), Facing East.

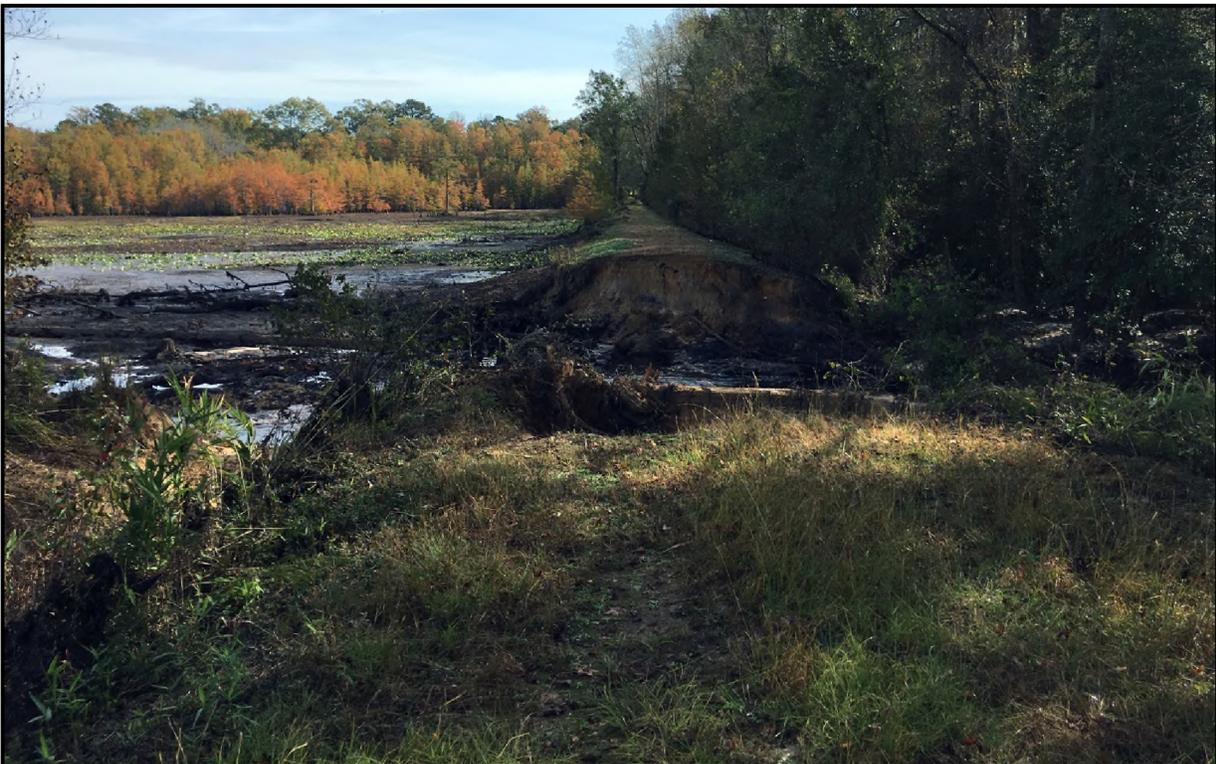
Figure 15. View of 2737.03 Showing Dam and Sluice Gate Breach, Facing East.

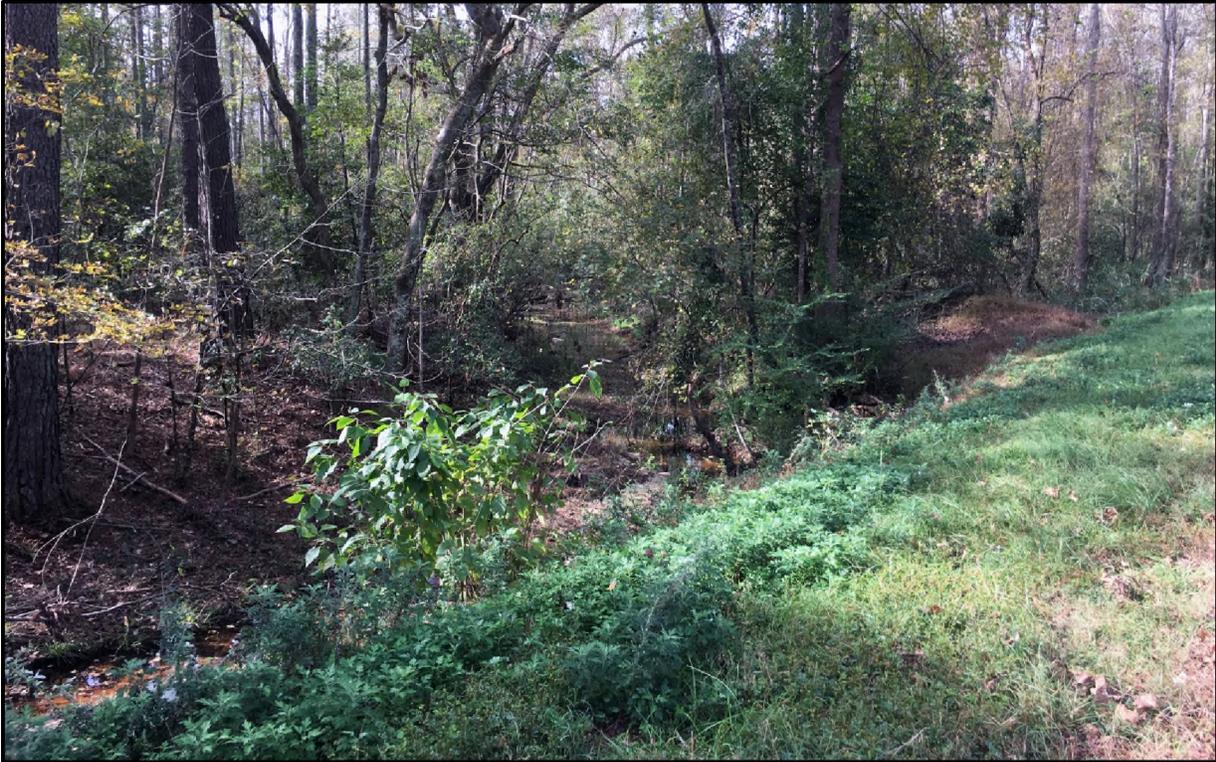
The mill race begins at the southeastern corner of David's Mill Pond, passes the mill building remains, and continues to the southwest, passing under David's Pond Road and eventually emptying into Naked Creek or the wetlands surrounding the creek. The mill race is approximately 1,200 feet in length and roughly 20 feet wide. At the time of the November 2018 cultural resources survey the race was heavily silted in and covered with thick vegetation for most of its length. **Figure 16** shows the mill race at the time of the survey.

Figure 16. View of 2737.04 (Mill Race), Facing Southwest.

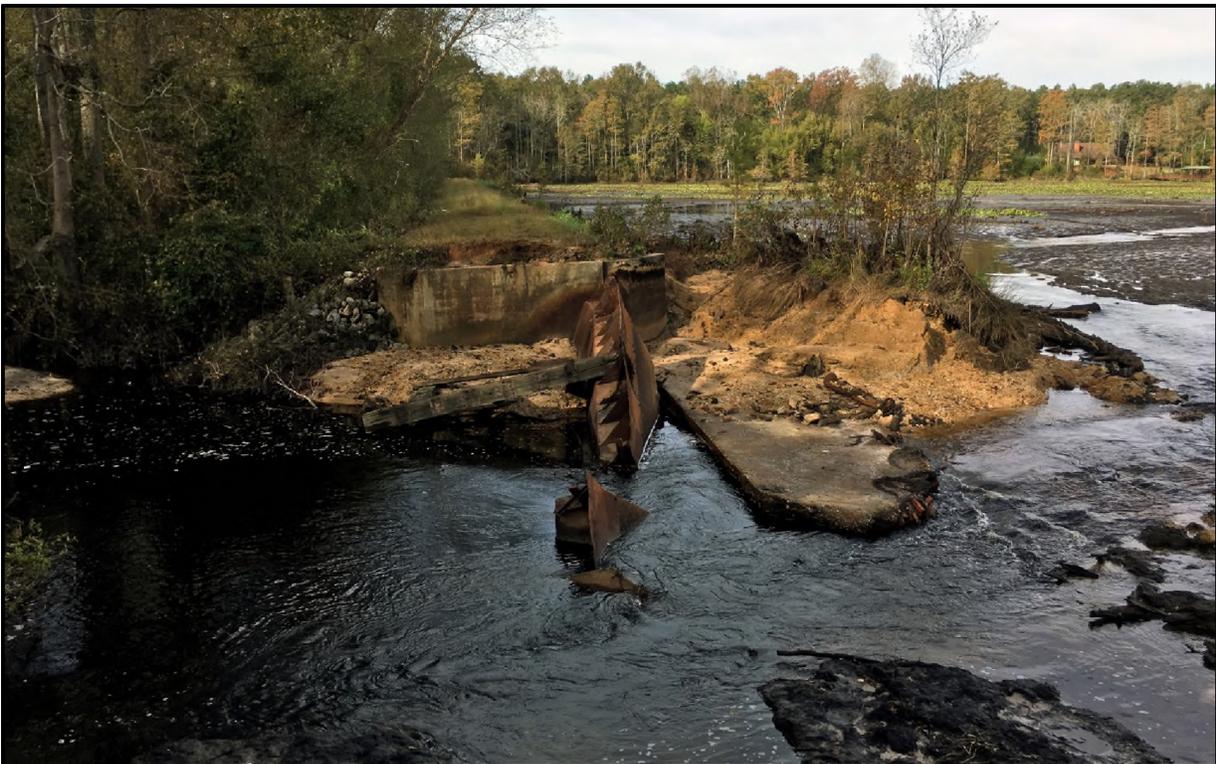
The sluice gate that once regulated water levels in David's Mill Pond is located centrally within the earthen dam that impounds the pond. The spillway leading from the sluice gate flows south from the dam, passing beneath David's Pond Road, and appears to follow the original course of Naked Creek. The sluice gate was heavily damaged during the flooding associated with Hurricane Florence, and remains of the feature are intermixed with the remains of the bridge that once carried David's Pond Road over the spillway when the road was located on top of the mill dam. **Figures 17 and 18** show the sluice gate and spillway at the time of survey.

Figure 17. View of 2737.05 Showing Damaged Sluice Gate and Spillway, Facing West.

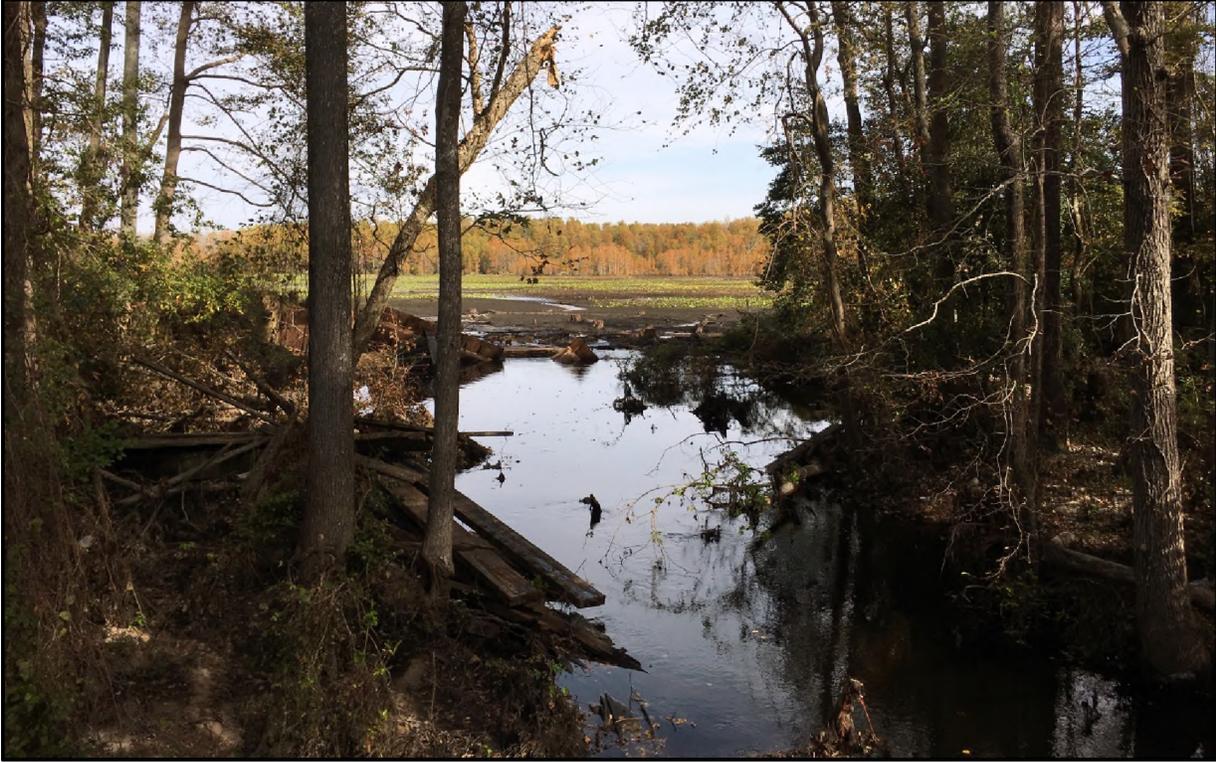
Figure 18. View of 2737.05 Showing Damaged Sluice Gate and Spillway, Facing North.
