Chicora Foundation, Inc.

Memo

Chicora Foundation conducted the November 2008 IMLS CAP assessment of the I.P. Stanback Museum and Planetarium. We were requested early last week to examine a space that is being proffered as a replacement for the museum building while it undergoes renovation. That inspection was conducted on October 2, 2015 by the authors and was *pro bono*. A second independent assessment was conducted at the same time by conservators Carol and Craig Crawford who are submitting their own assessment.

The Crawford Engineering Building, originally called the Mechanical Industries Hall, was a WPA project, built between 1938 and 1942. It had only minor renovations post-2006, but we cannot determine the overall impact. The building, based on aerial photographs, appears to have the same roof that was present in 1994 (putting the roof at or beyond its service life). The building is listed on the National Register of Historic Places, which places limitations on exterior modifications. The space proposed as a replacement for the Stanback Museum contains approximately 7,000 square feet of useable space.

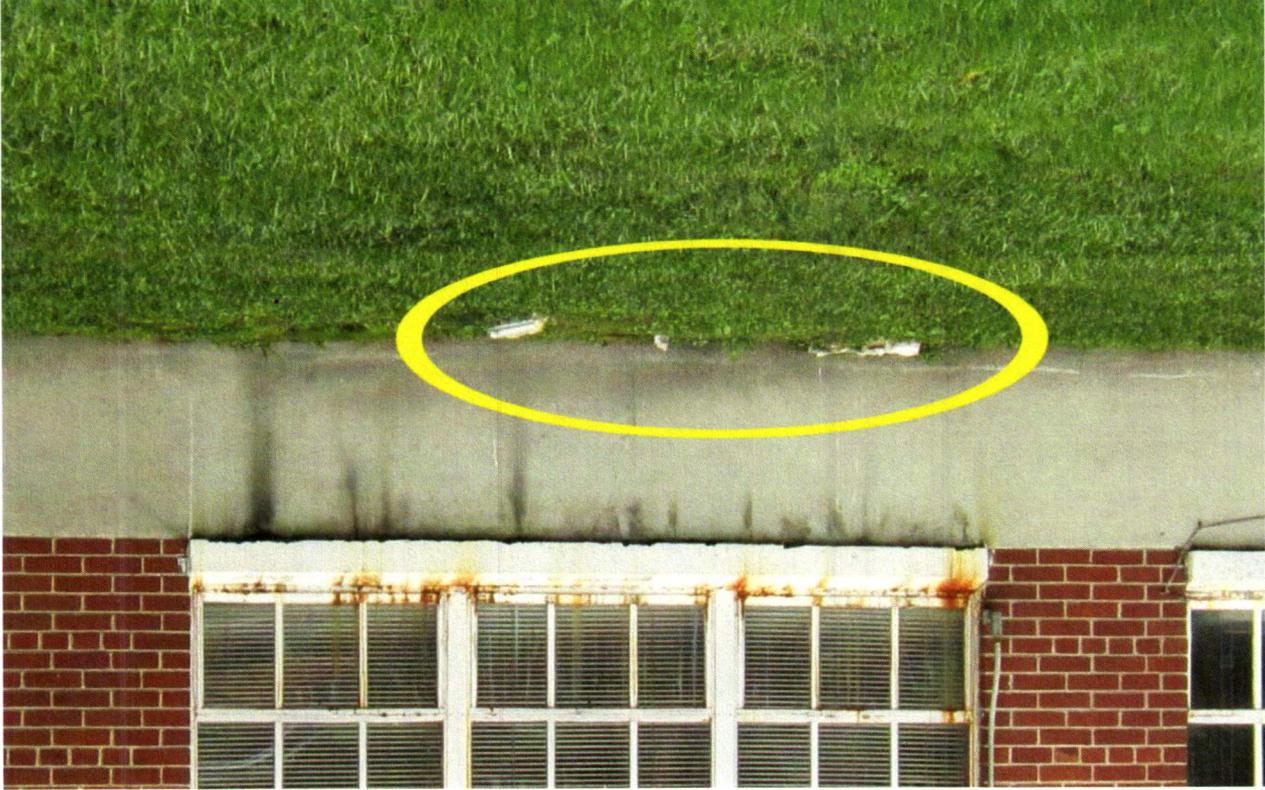
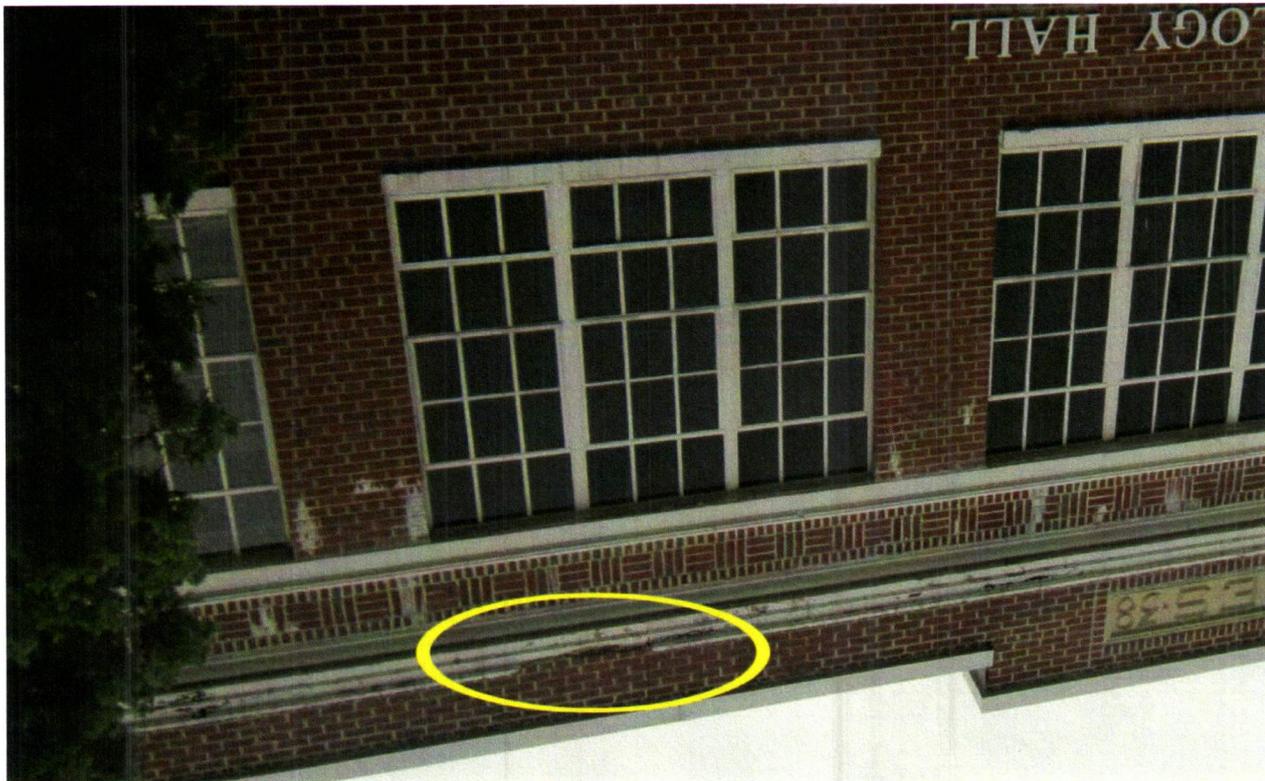
Deterioration of the building cornice, falling on the ground. This National Register listed building requires immediate maintenance attention and the deterioration presents a significant liability to the University.

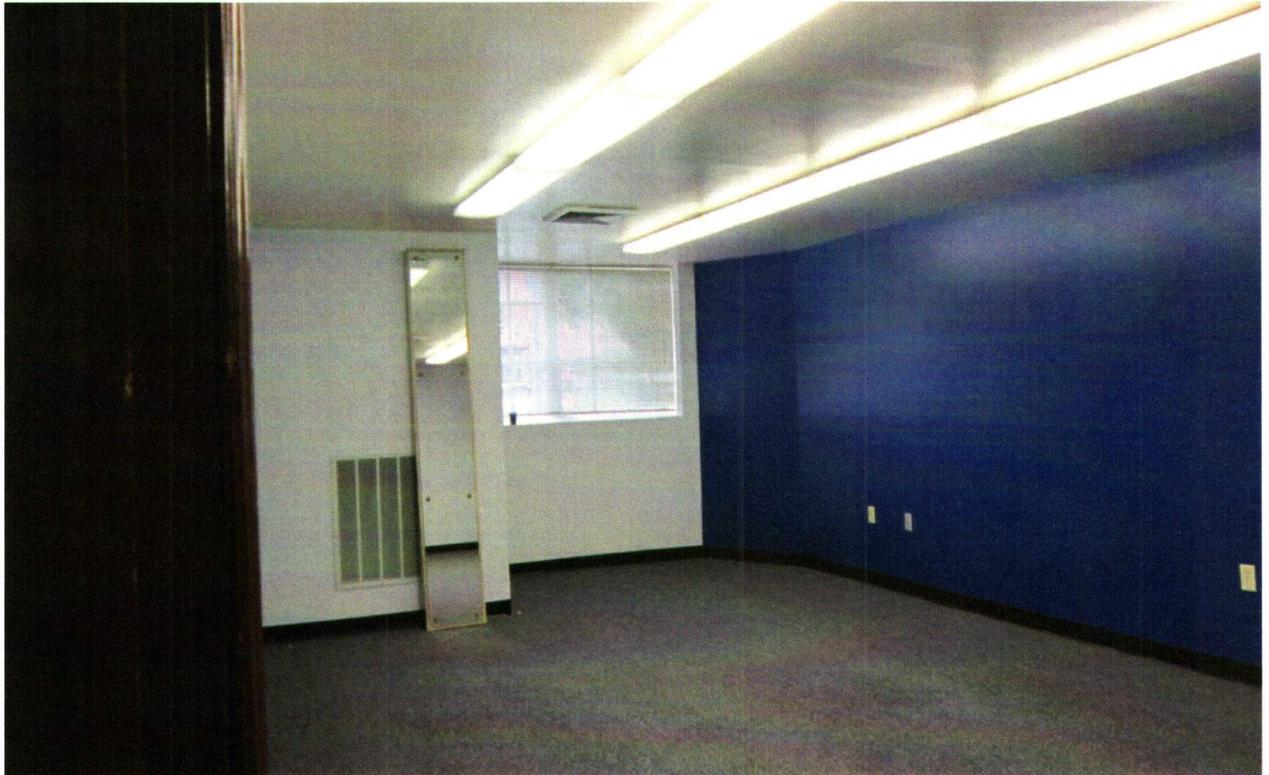
Dropped ceilings and carpet in the proposed space. Spaces are oddly shaped, minimizing their usefulness for the museum.

1. Significant repair of the building's windows;
2. Removal of all carpet and replacement with a suitable flooring, such as tile or cork;
3. Significant improvement in overall building maintenance, both interior and exterior, with additional housekeeping;

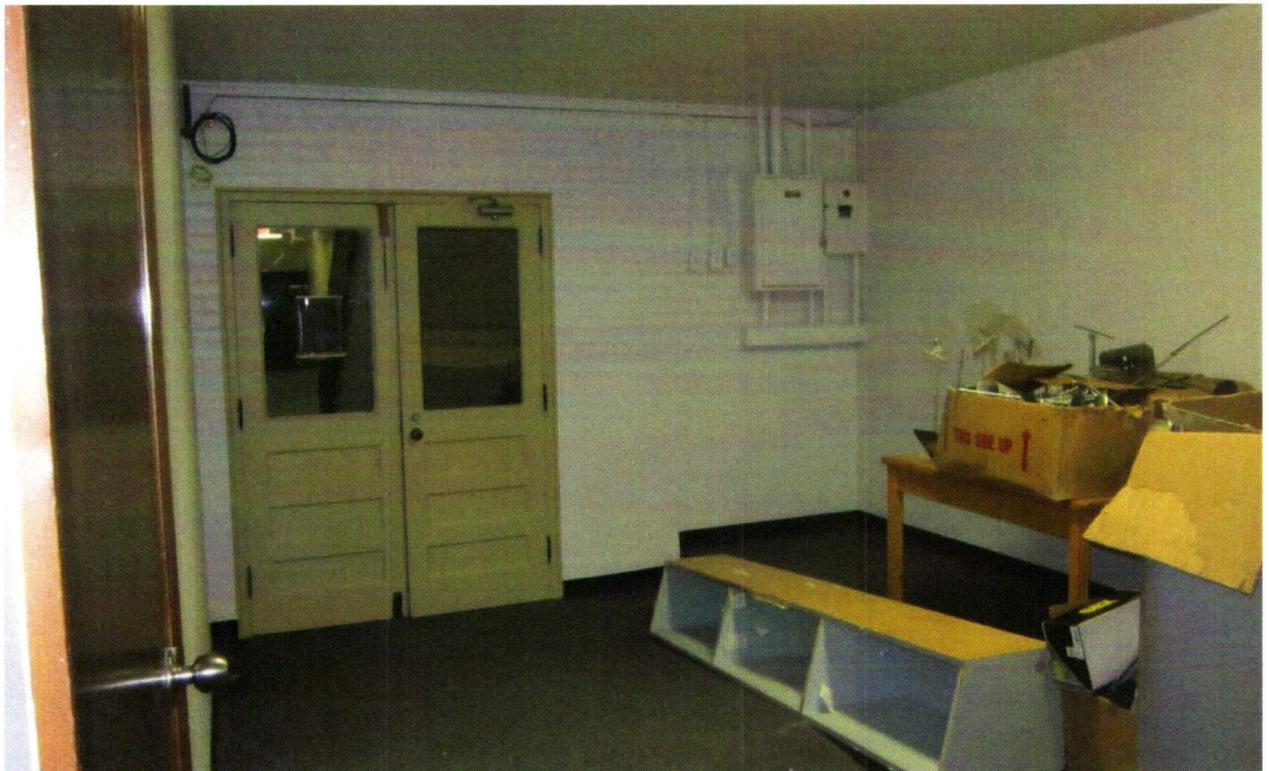
Double wood and glass entrance doors, not fire rated. They would need to be replaced. Electrical panel box to the right was locked and not available for inspection.

16. Replace all doors and assemblies with fire rated doors;
17. Ensure that there are no penetrations of fire walls; minimize or seal penetrations in other walls;

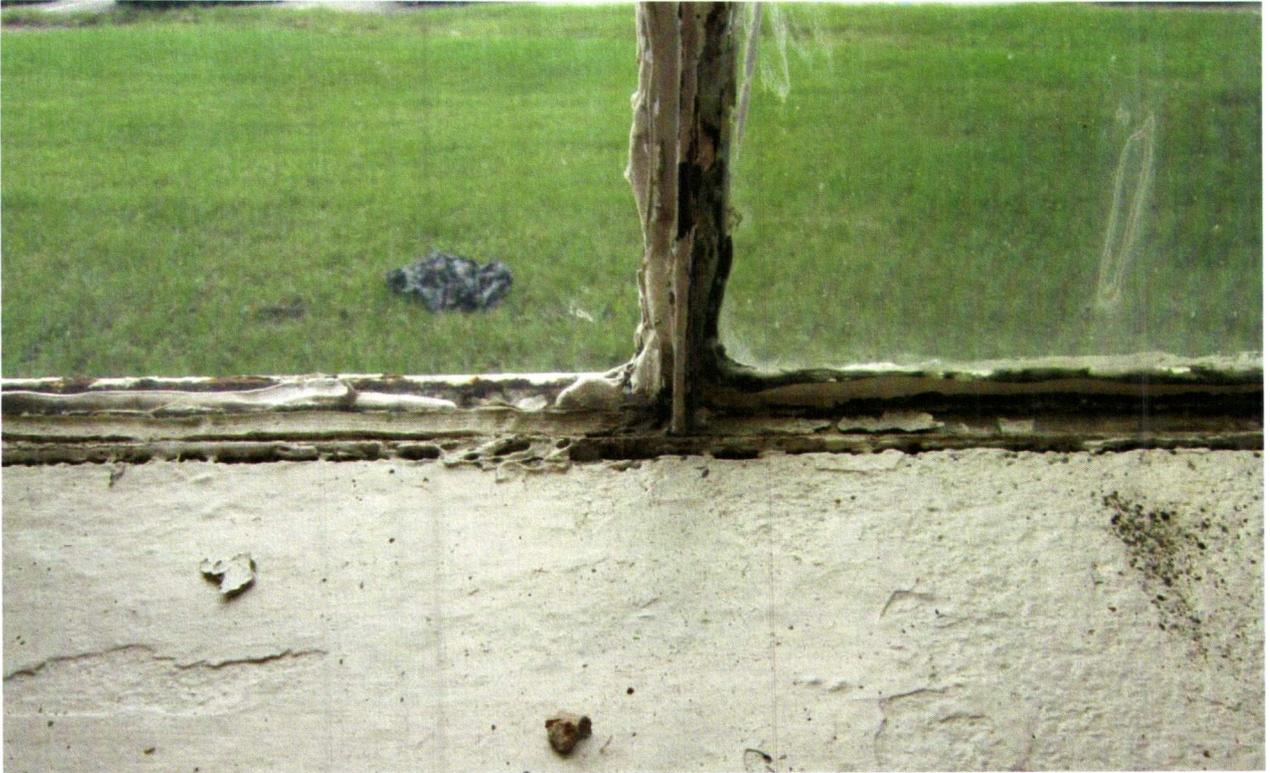
Windows are single pane metal casements. None are in operable condition. There is much damage, including failing window putty and corrosion. Several of the windows do not shut completely, allowing entry of pests, and air and moisture penetration. Several (perhaps all) have been modified by using drywall screws to secure them closed. These could be easily pried open. Extensive, and costly, repair of these windows is required to maintain historic integrity of the building, although these windows are entirely impractical for a museum.

Close-up of metal windows showing deterioration and poor fit. They all exhibit a significant lack of maintenance and require extensive repairs.

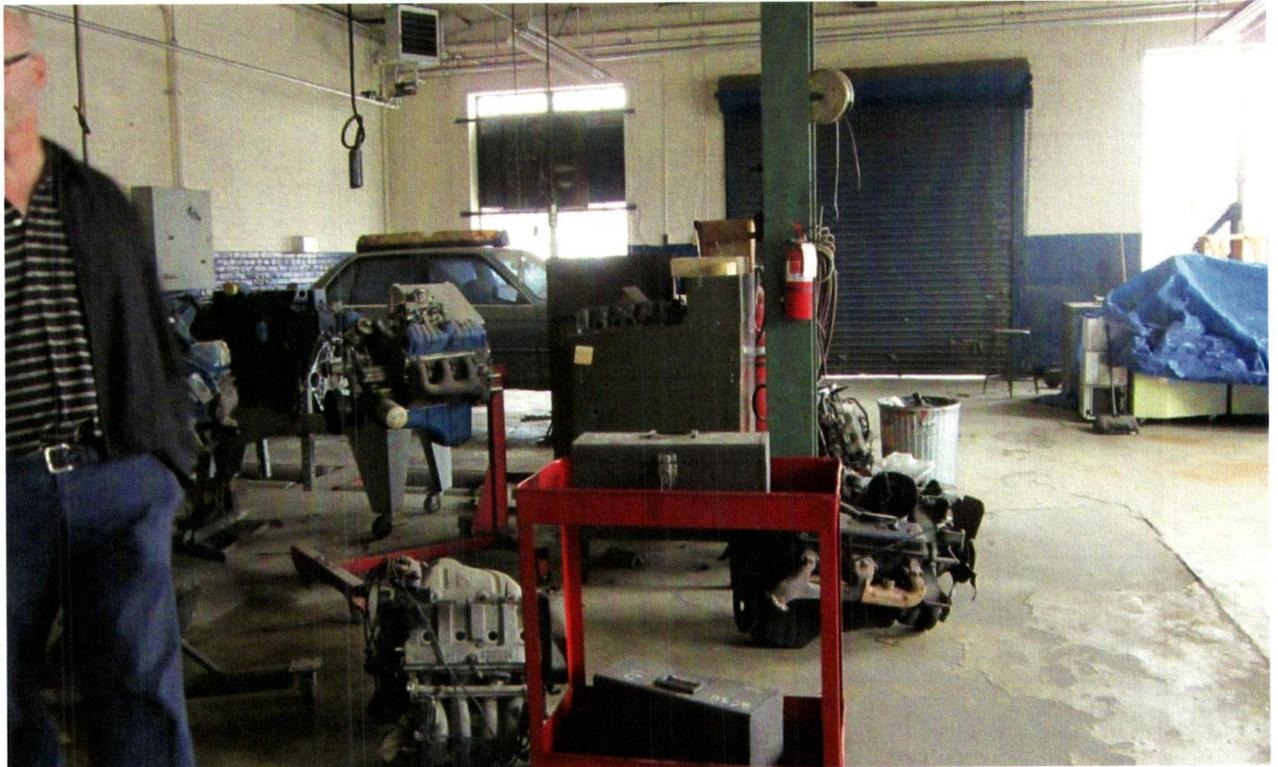
Garage space immediately adjacent to the proposed museum space. The area looks abandoned with significant deterioration to the floor, tools scattered, trash not collected.

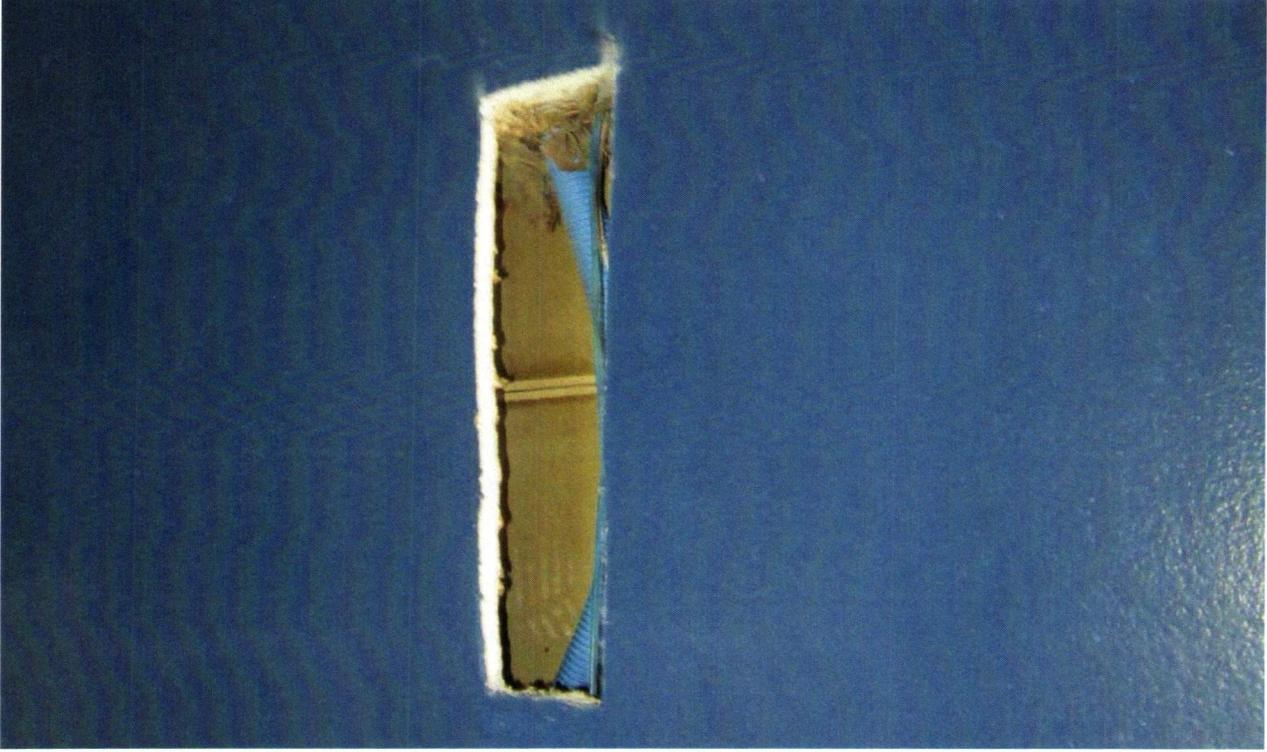
Hole in the garage side wall between the garage and proposed museum space showing that the wall is not fire rated. The penetration was never sealed, indicative of the overall poor maintenance of the campus building.

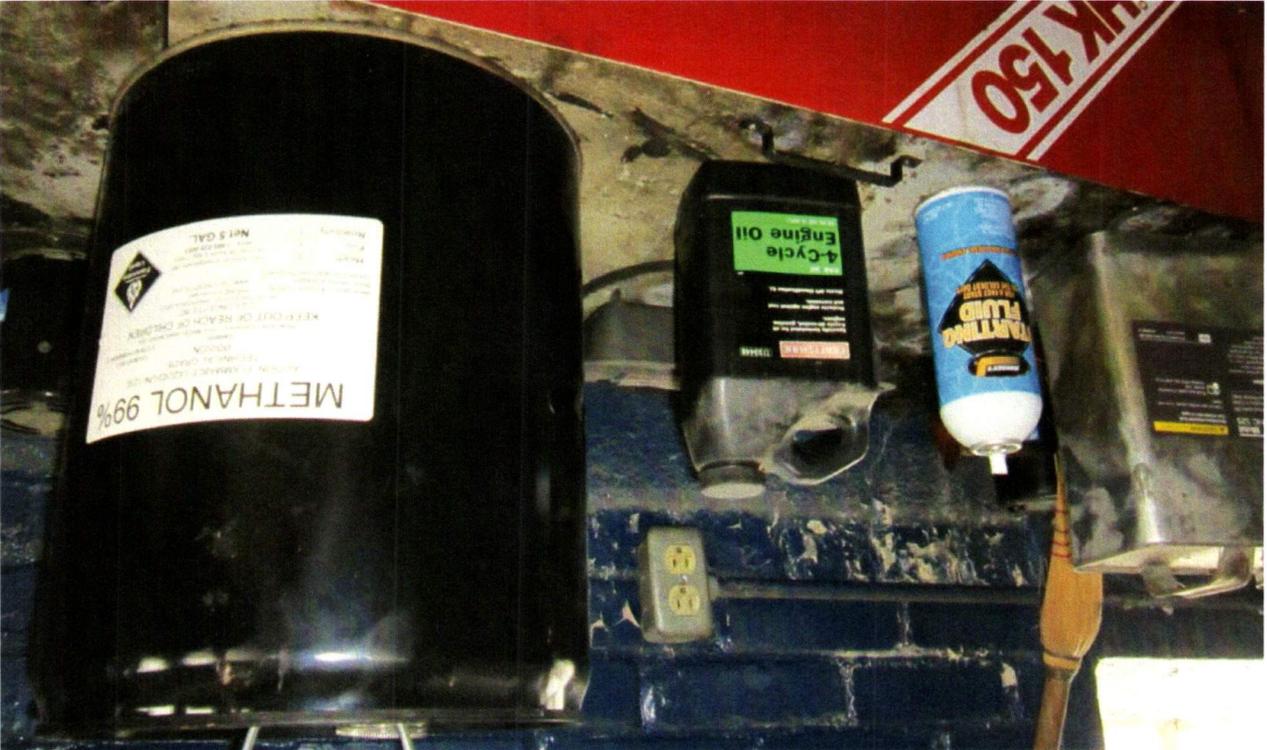
Remnant hazardous and flammable chemicals improperly stored in the garage adjacent to the proposed museum space.

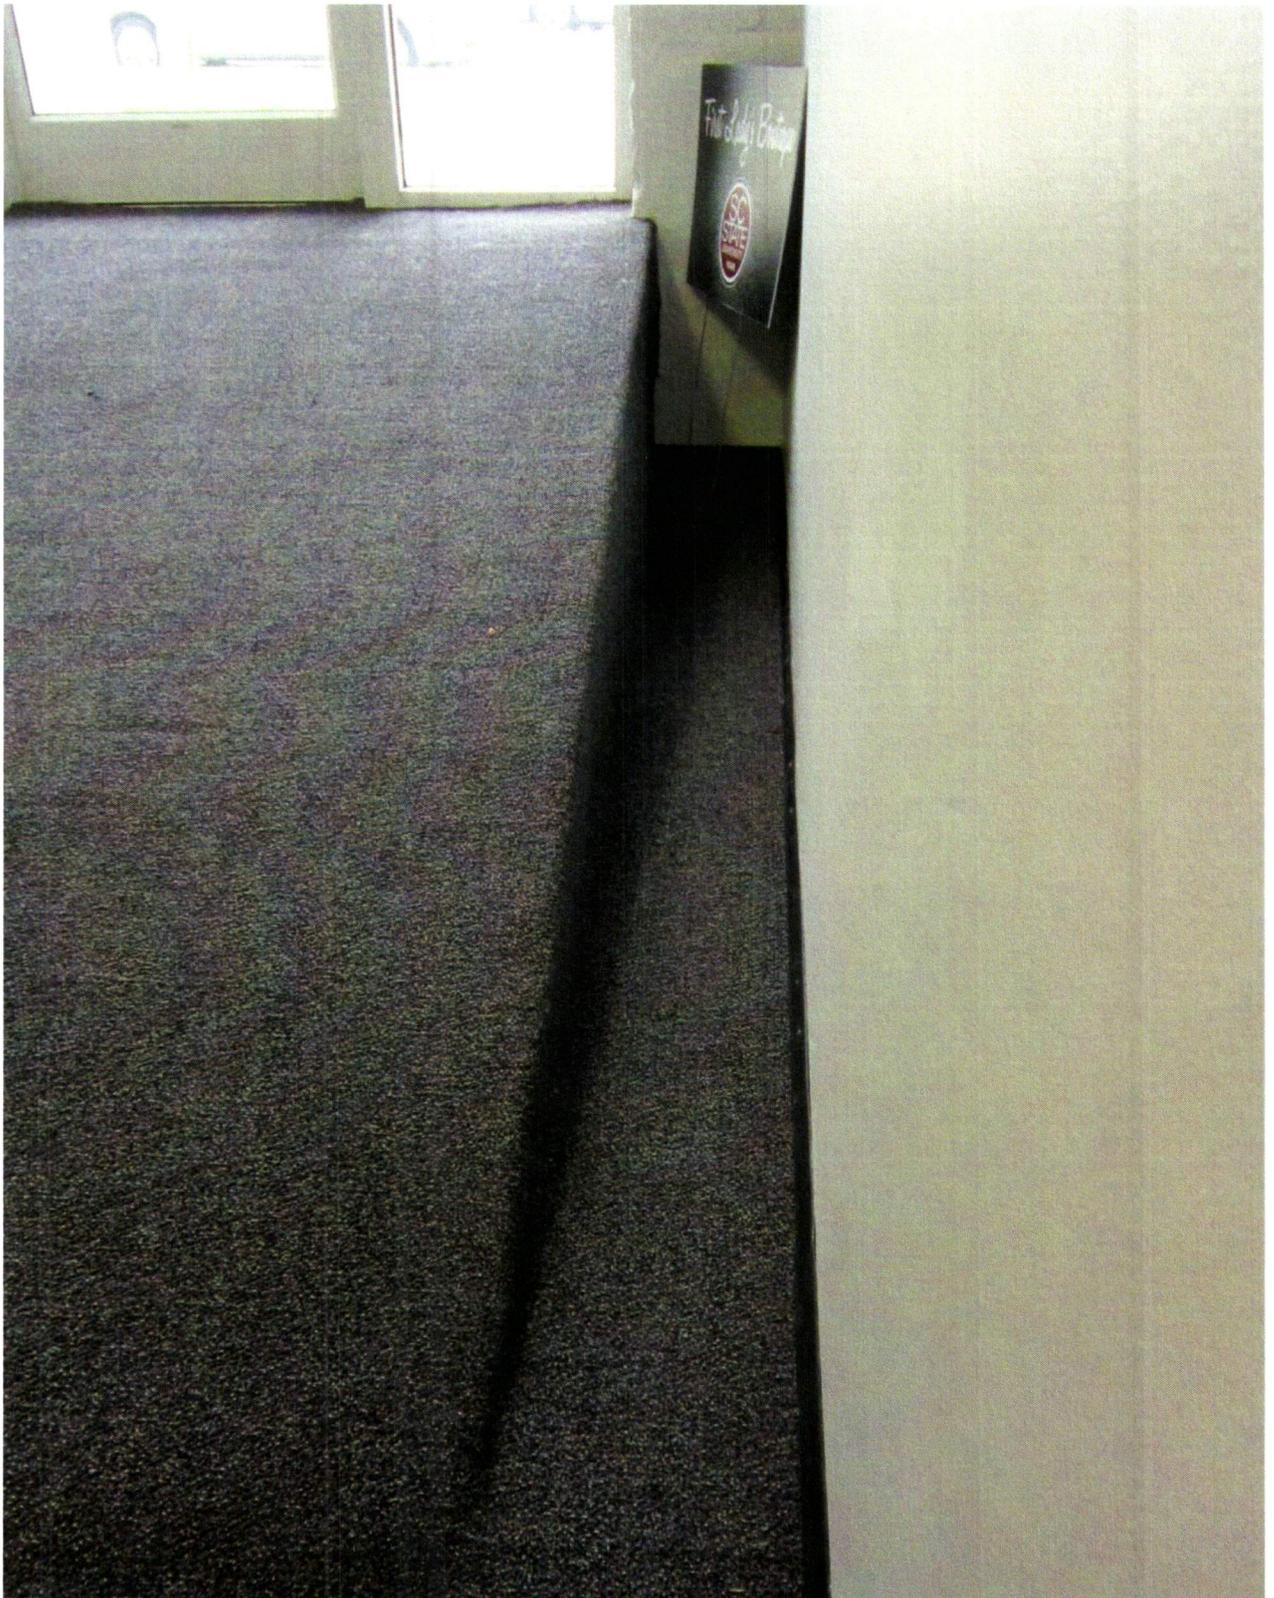
It is critical that museums be ADA compliant allowing unhindered and convenient access by the public. There is currently no ADA compliant entrance to building that we observed. The front entrance involves steps, although a ramp could be constructed. The egress through the single glass door is not ADA compliant. There is an exterior step and the interior ramp is too steep and lacks handrails (which is likely also a building code violation and is certainly a significant liability to the University). The

This ramp is not ADA compliant because of the steep slope. It does not meet building code since it lacks a handrail, and it is not compliant with fire codes since the door is at a different elevation than the interior and exterior. There is not ADA compliant entrance.

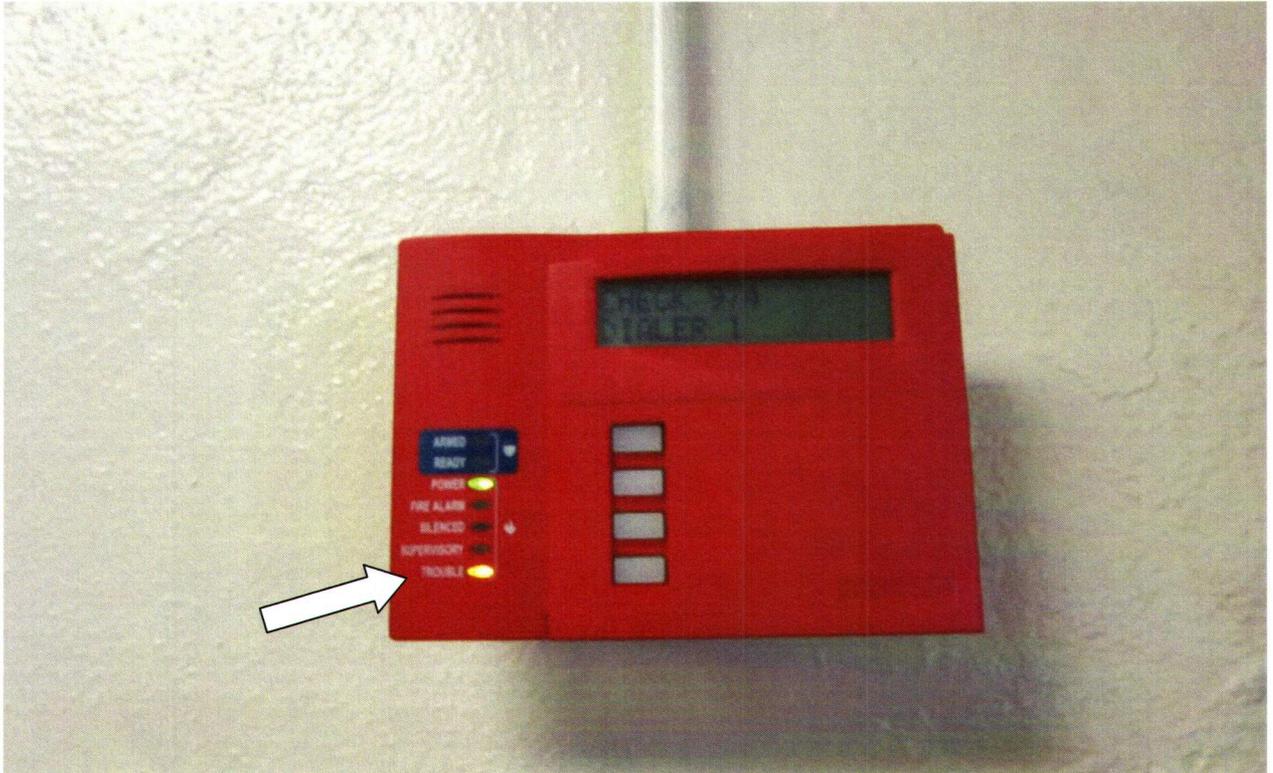
Alarm panel for the building on the day of the assessment showing a trouble or fault signal apparently related to the dialer. This suggests that the alarm may not be functioning.

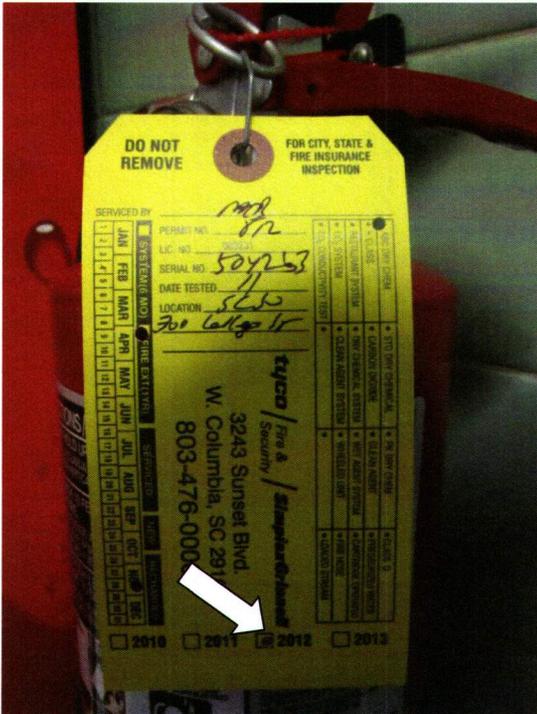
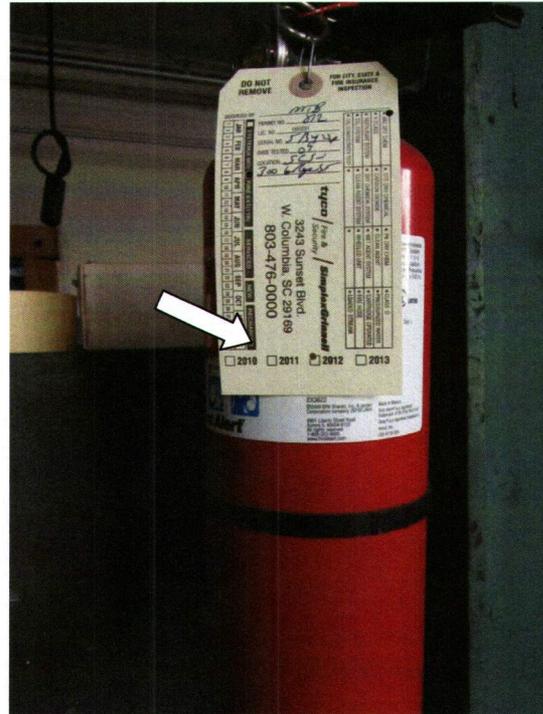
Two fire extinguishers in the building showing they have not been serviced since November 2012 – nearly 3 years ago. We did not check when hydrostatic testing was due.

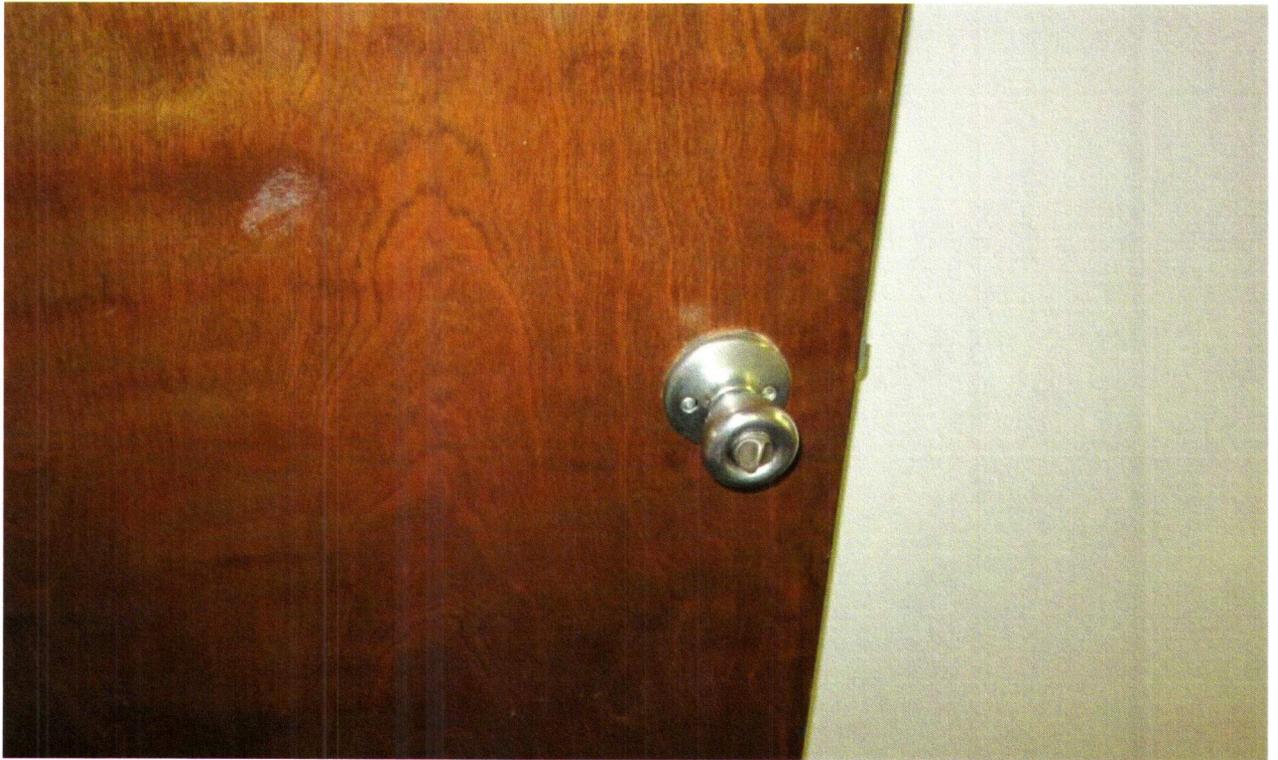
Flimsy knob locks are inadequate for a museum setting, as are the doors and door assemblies. All will require replacement.

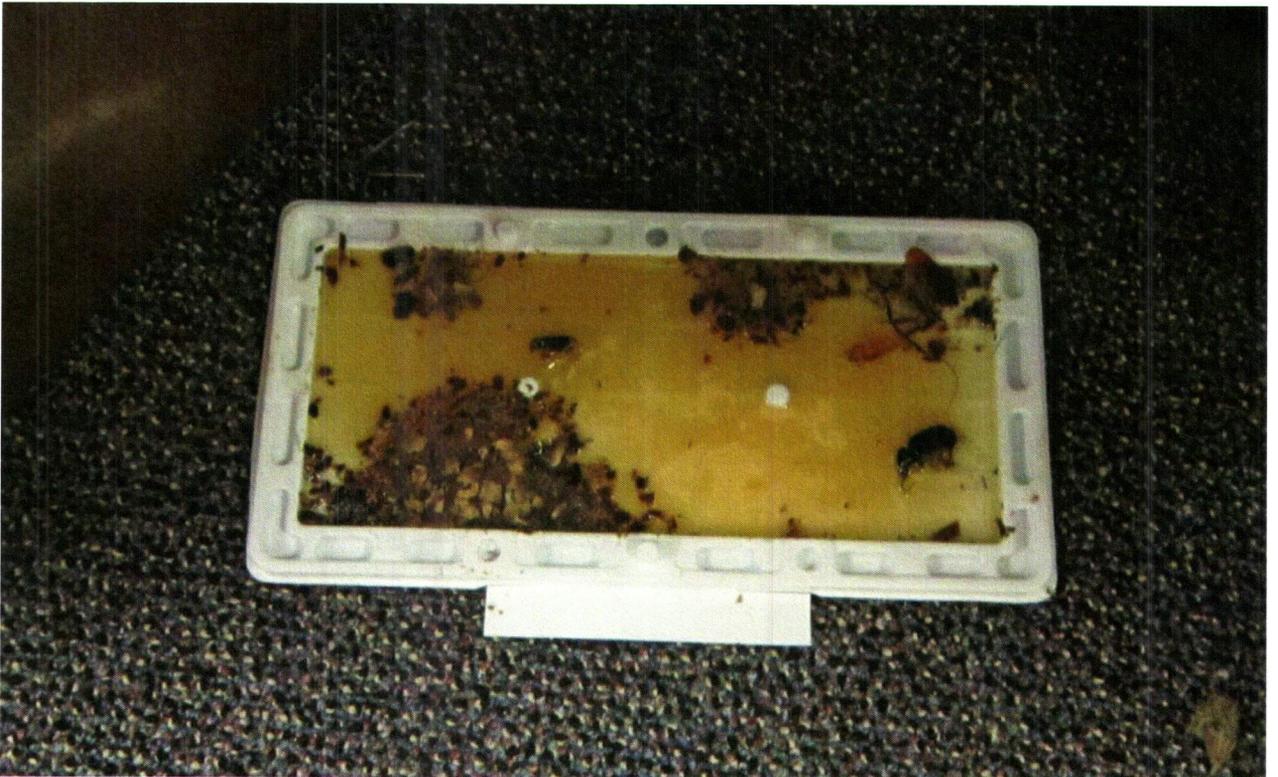
Sticky trap showing the capture of a variety of pests, some of which would damage museum collections. The trap has apparently not been checked in a very long time.

20. The entire building must be treated for pests;
21. The entire building must be inspected for rodent nests, travel, and damage, especially to electrical systems;

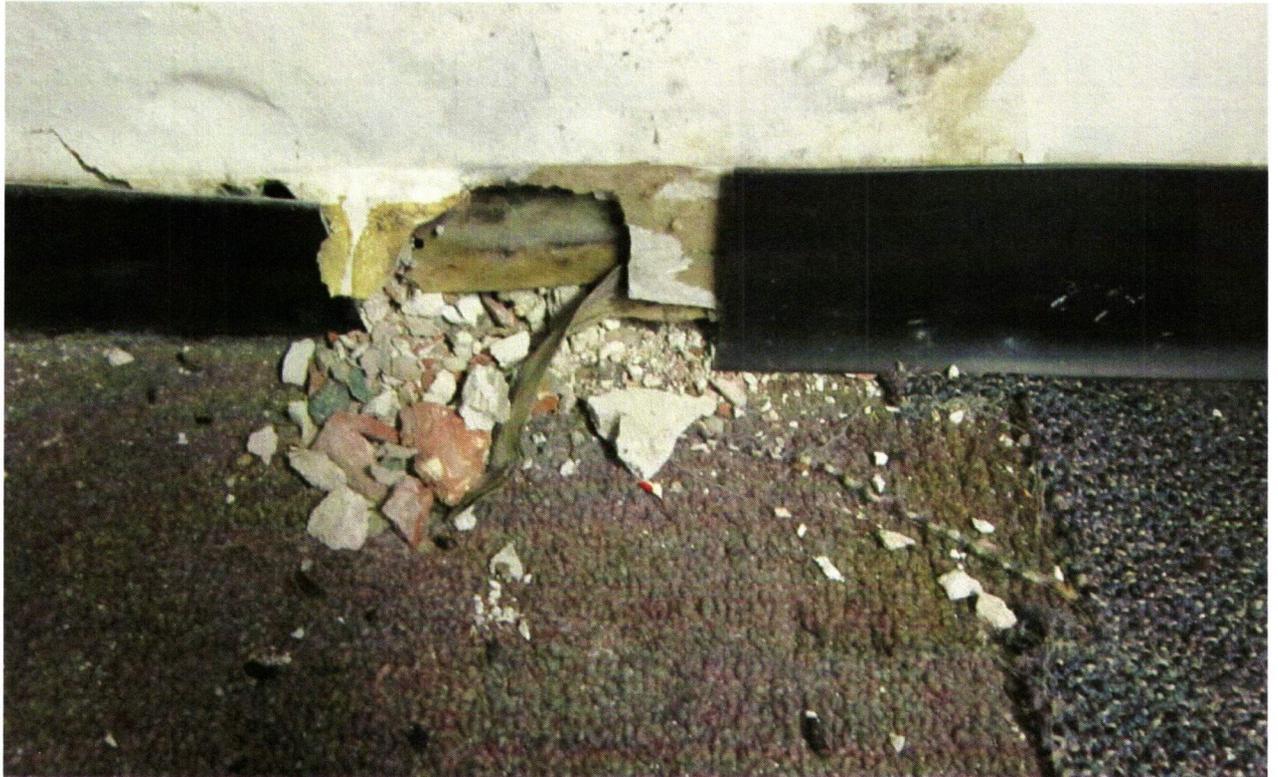
The third problem is of extraordinary consequence both the safety of the collections, as well as staff and visitors. We found rat droppings (fecal material) at multiple locations. In addition, we found a recently dead juvenile Norway rat on a sticky trap. Rodents will find the hollow walls and drop ceiling particularly attractive. Unlike mice they have a much larger (3-dimensional) range and are difficult to catch. In addition, the NFPA has noted that rodents are a leading cause of fire because they tend to gnaw and chew on electrical wires. Given the rodent problem, all interior walls and the dropped ceiling will need to be inspected to ensure that fecal remains are removed and wiring is inspected.

Rodent hole and rat droppings in the proposed museum space. Not also the mold and water damage to the wall board.

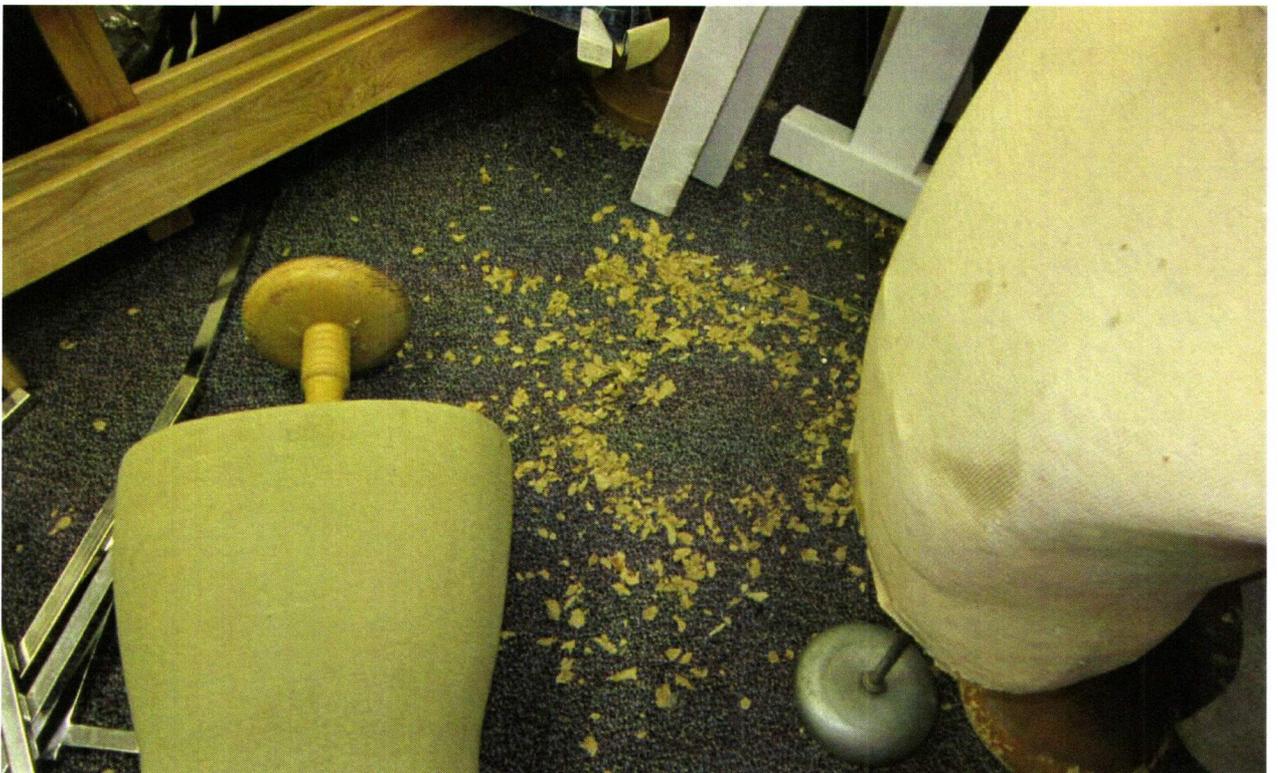
Debris from the interior of the mannequins, probably being used by rodents for nesting material.

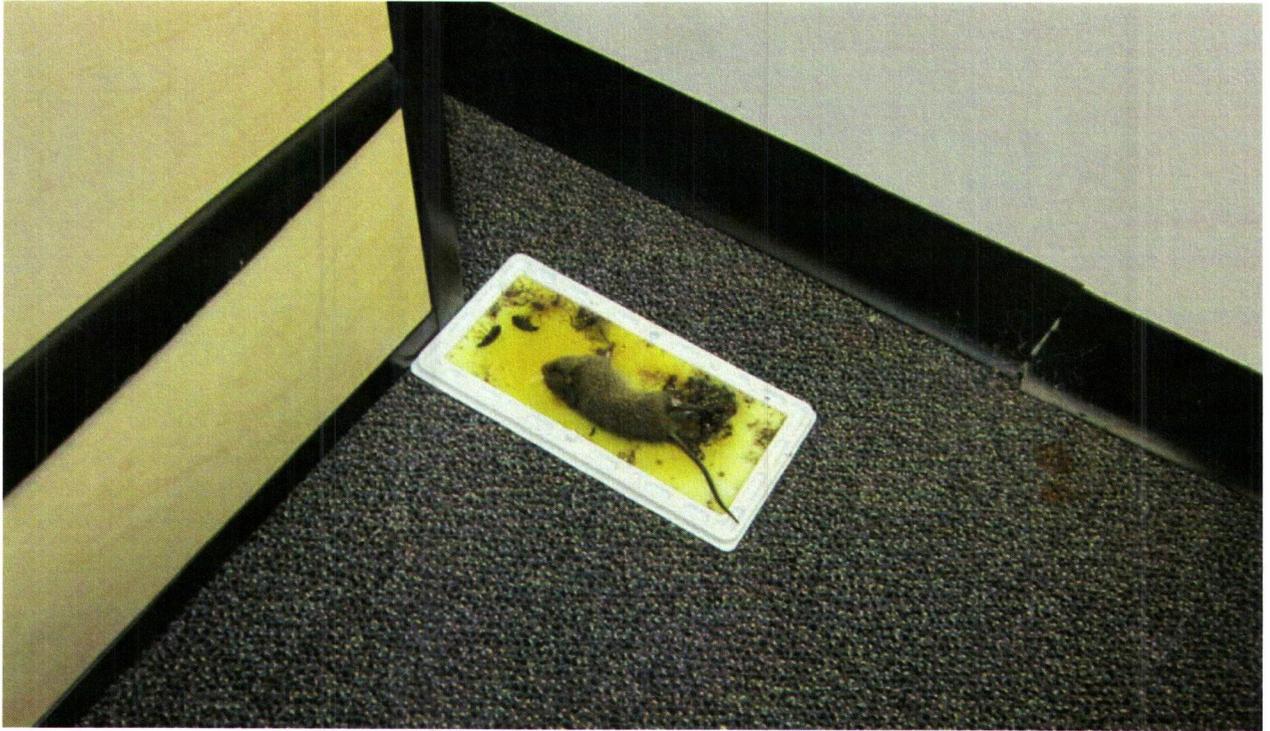
Rat on a sticky trap. This indicates that the traps, once set, have not been routinely checked. More importantly, it reveals that rodents are in the building. This is unacceptable for a museum setting and treatment must incorporate the placement of snap traps throughout the building. Treatment of this space alone is not appropriate.

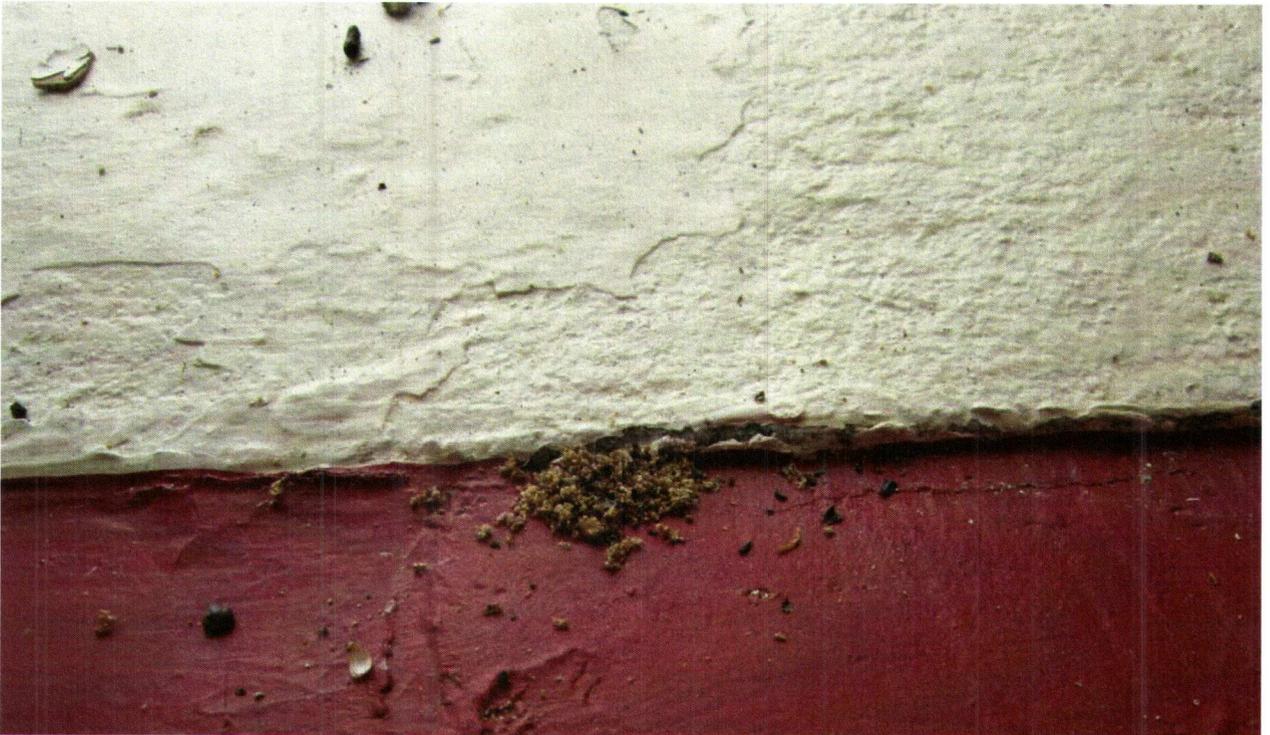
Accumulations of cast larval skins are found at virtually every window, suggesting the presence of dermestid beetles or carpet beetles. Both are major museum collection pests.

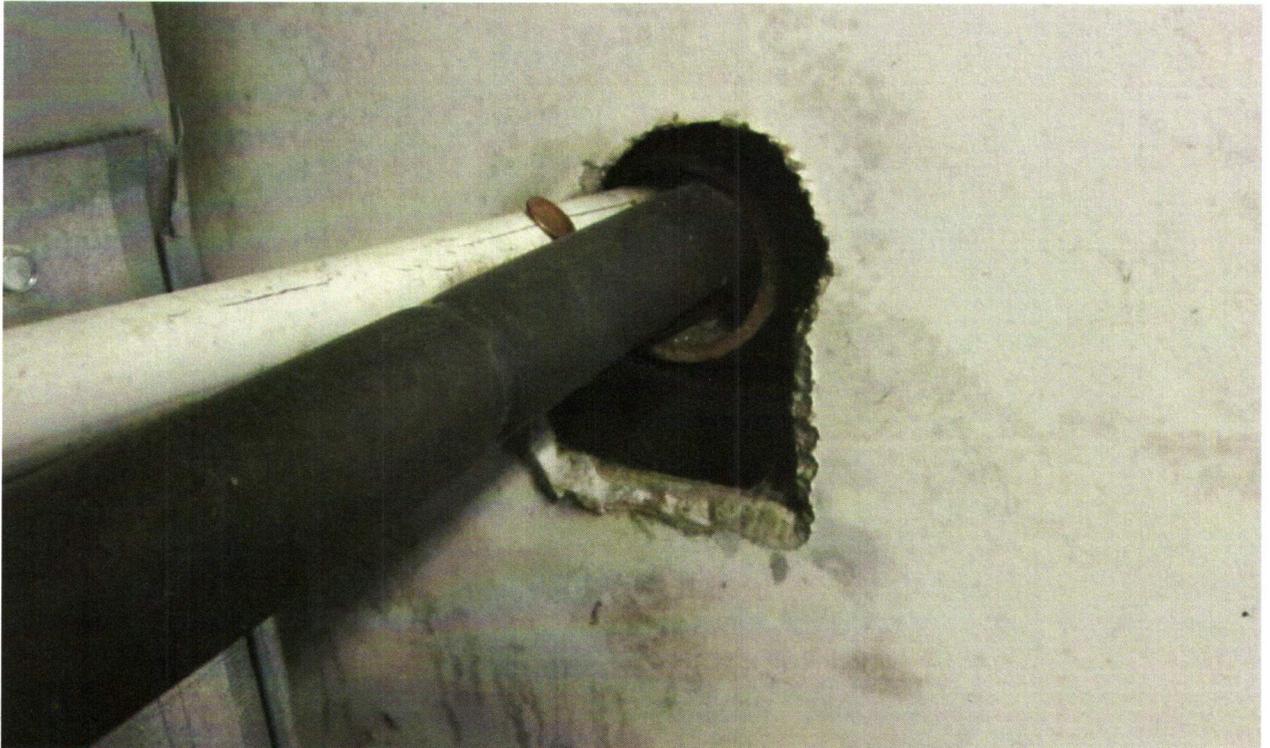
The pest problems will be difficult, perhaps impossible, to manage without extensive building envelop work. We observed numerous wall penetrations that, in addition to being a fire safety issue, also allow for ready access by pests. A rat, for example can enter through a hole the size of a quarter and other pests require entry points far smaller.

Multiple unsealed wall penetrations throughout the space promote pest problems and provide harborage in wall voids. They allow rodents access to electrical wires and that is a significant fire threat. The unsealed penetrations will also aid fire spread. Not also the presence of "black" mold on the wall board, indicating a moisture penetration problem.

22. The entire building must be caulked, thresholds improved, in order to seal pests out;
23. Visible and UV light from windows must be reduced; this will likely require installation of plexi panels with film to reduce visible light and eliminate UV light (this is in addition to the repair of the windows);

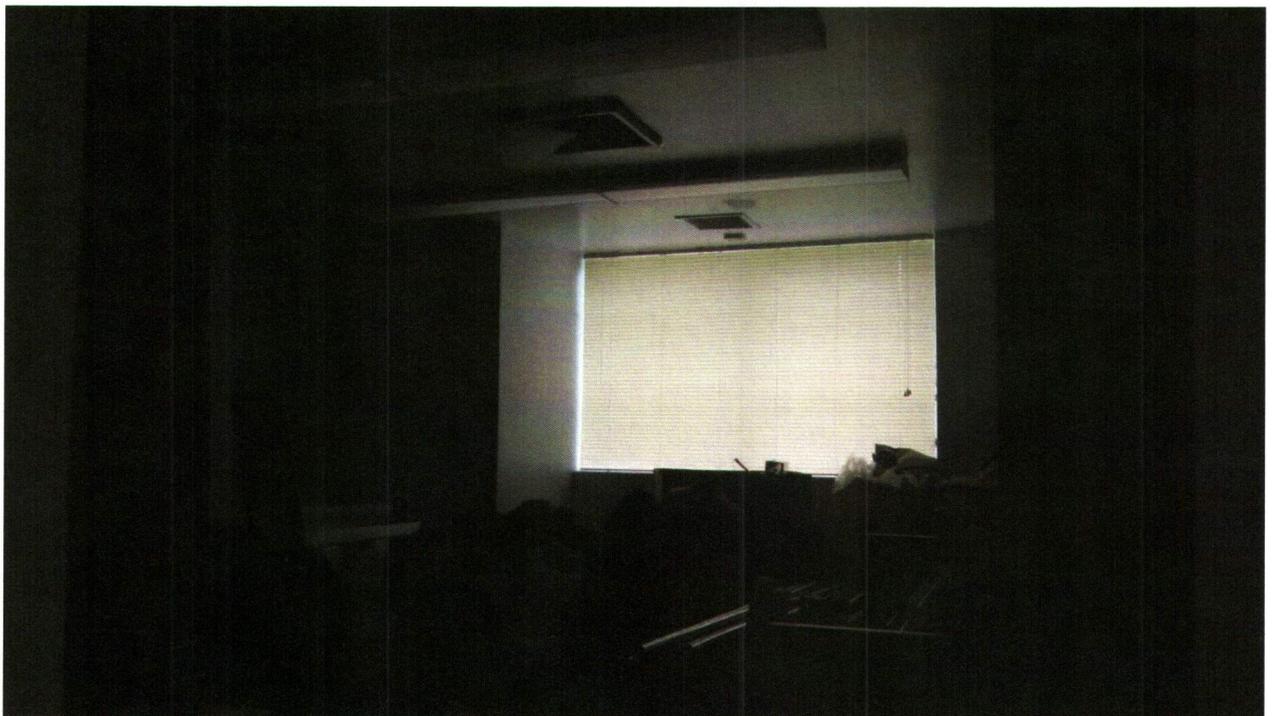
The windows allow significant levels of visible and UV light, even with blinds, that will damage museum collections.

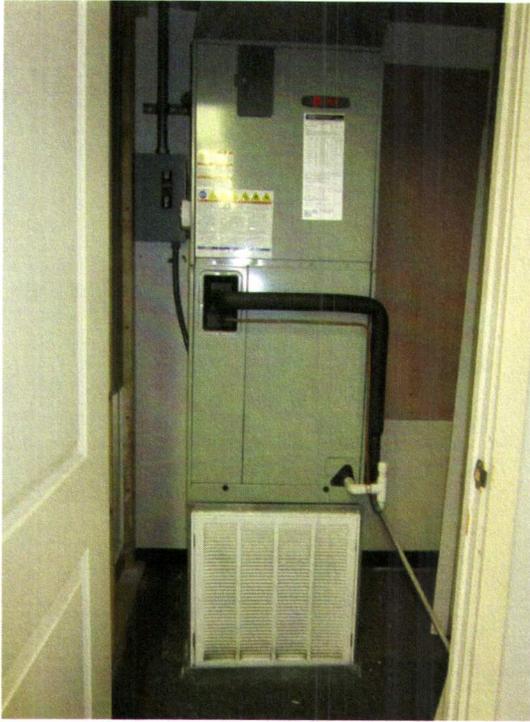
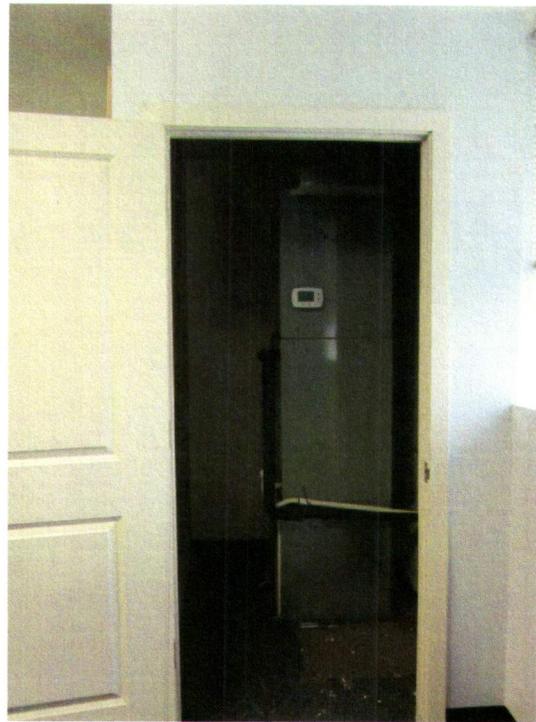
At the present time the entire space is serviced by two DX units, one on the east side of the hall and another on the west. Ductwork is of unknown type and condition. Thermostats are located in the small closets containing the units and therefore do not reasonably reflect space conditions where collections and exhibits will be located.

The two DX units in the space provide only cooling and cannot dehumidify the space. This will result in significant mold development – which has already begun in the space.

24. Replace all plastic shades on fluorescent lamps;
25. DX HVAC must either be replaced or significantly upgraded to provide better temperature control and, most importantly, the ability to control relative humidity;
