Chicora Foundation, Inc.

Memo

Chicora Foundation conducted the November 2008 IMLS CAP assessment of the I.P. Stanback Museum and Planetarium. We were requested early last week to examine a space that is being proffered as a replacement for the museum building while it undergoes renovation. That inspection was conducted on October 2, 2015 by the authors and was *pro bono*. A second independent assessment was conducted at the same time by conservators Carol and Craig Crawford who are submitting their own assessment.

The Crawford Engineering Building, originally called the Mechanical Industries Hall, was a WPA project, built between 1938 and 1942. It had only minor renovations post-2006, but we cannot determine the overall impact. The building, based on aerial photographs, appears to have the same roof that was present in 1994 (putting the roof at or beyond its service life). The building is listed on the National Register of Historic Places, which places limitations on exterior modifications. The space proposed as a replacement for the Stanback Museum contains approximately 7,000 square feet of useable space.

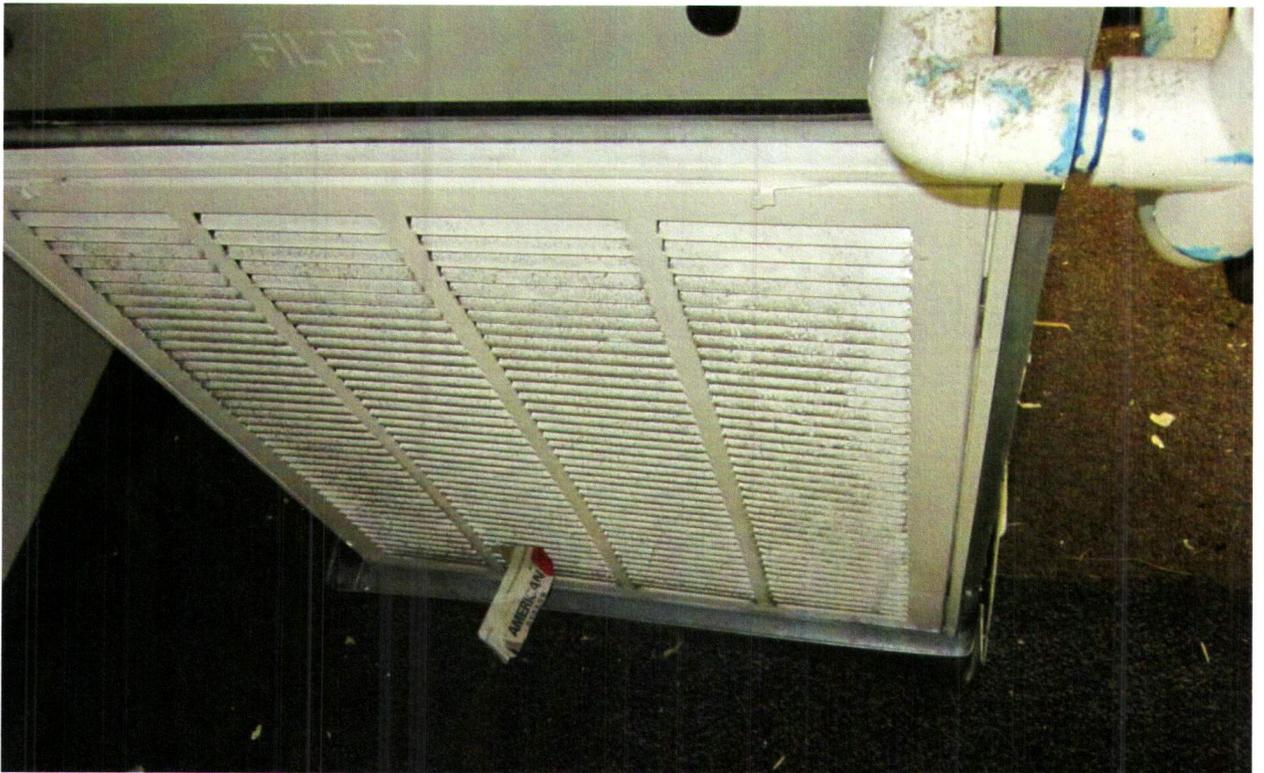
Note soiling and mold on the grill of the return.

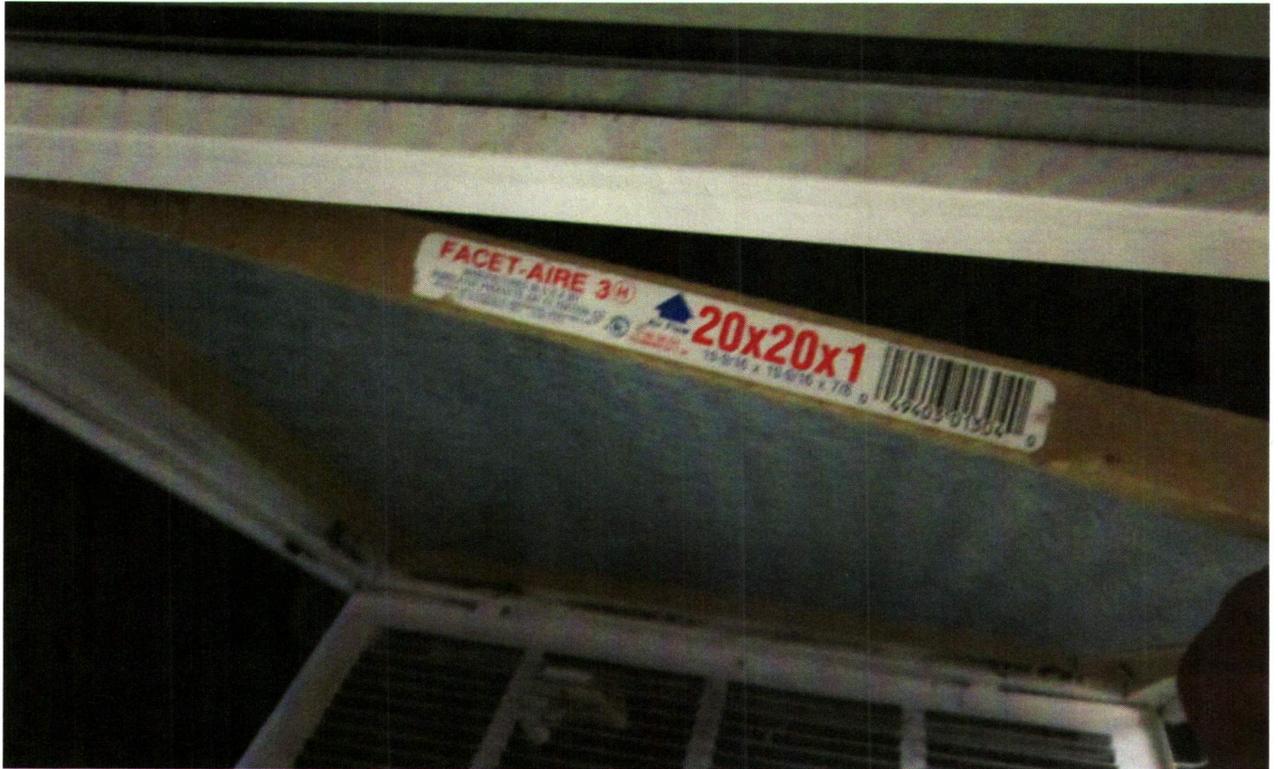
At the present time the two DX units have only 1-inch fiberglass filters installed. This provides less than 20% ASHRAE Dust Spot Efficiency, or roughly a MERV 4 rating. They offer “minimal” filtration and are capable of capturing under the best circumstances particles of greater than 10 microns. Minimal recommendations for a museum collection are MERV 10 or ASHRAE Dust Spot Efficiency of 50-55%. Better recommendations suggest MERV 11 or even MERV 13 filtration.

The filtration provided by these 1-inch spun fiberglass filters is inadequate for a museum setting.

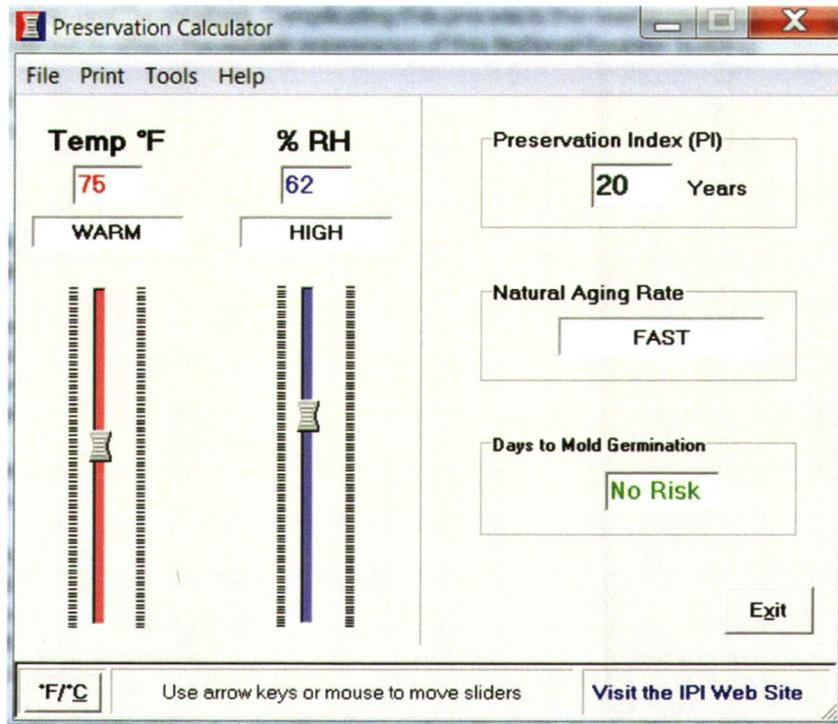
At the time of this assessment, the spaces were 75°F, with a relative humidity of 62%. We have no long-term data collection and must rely on this information at a general level.

To examine the suitability of these conditions we can use the *preservation index*. This reveals the combined effect of temperature and RH on the decay rate of vulnerable organic materials in collections and gives a general idea of how long it will take for them to become noticeably deteriorated. In the current situation, this space yields a preservation index of approximately 20 years (anything under 45 years is a clear risk to collections).

Likewise, readers may suggest simply reducing the temperature, adjusting the thermostat to perhaps 68°F. Temperature and relative humidity are interconnected. Adjusting one will affect the other. In this case, going from 75°F to 68°F, will increase the relative humidity from 62% to 78%. This "buys" us only one extra year – increasing the preservation index to 21 years. Moreover, it creates an environment that is so damp, mold will likely to be visible within 20 days.

IPI Preservation Calculator showing the current environmental conditions would lead to rapid deterioration of the museum collections. Lowering the temperature will only result in an increase of relative humidity, resulting in significant mold growth. The existing HVAC system is not adequate for museum collections.

24. Replace all plastic shades on fluorescent lamps;
25. DX HVAC must either be replaced or significantly upgraded to provide better temperature control and, most importantly, the ability to control relative humidity;
