The Saluda Canal Historic District (Site Number 7903) Historical Overview and Resource Descriptions

Compiled by Tracy Martin and Bill Jurgelski
South Carolina Department of Transportation
September, 2018

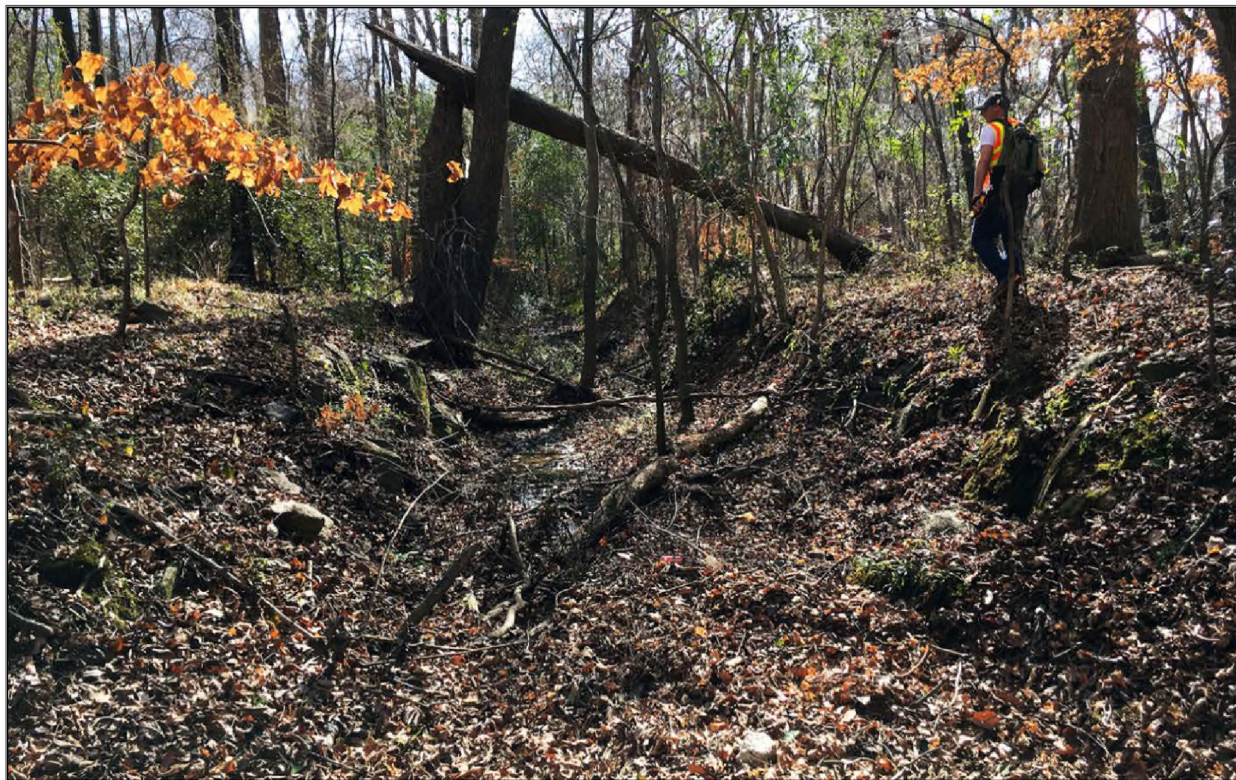
Segment A is the northwestern most section and is approximately 1,722 meters in length. It begins just a few meters from the Saluda River and wraps to the south southeast before ending at a wide powerline corridor. This section of the canal is very visible and reaches to between 5 – 10 meters in width with a

varying depth between 1 – 2.5 meters. **Figure 10** shows a typical view of this portion of the canal. A shallow earthen berm lines both sides of some of the deeper portions of this canal segment. The northernmost stretch of the segment is partially filled in with sediment and appears to have suffered damage from flooding. A modern drainage pipe empties into the canal near the northern end of the segment and water from the pipe flows through the old canal bed before emptying into the Saluda River near the southern end of the segment through a blowout in the canal wall. A large portion of the canal within this segment was excavated and/or blasted through granite bedrock. Within these portions of the canal there are visible drill marks inside the canal trench along the sheered stone wall (**Figure 11**). A considerable amount of stone debris is scattered around the canal bed in areas where it was excavated through bedrock. Many of these large scattered stones also show drill marks as seen in **Figure 12**. Approximately 150 meters south/southeast of the mouth of the canal is a large rubble pile, presumably leftover from blasting the bedrock out (**Figure 13**). Historical sources indicate that a dam crossed the Saluda River at the northern end of this segment, funneling water into the canal. However, no trace of this dam was found during the 2017 – 2018 survey.

Figure 10. General View of Site No. 7903.01, Canal Segment A, Facing North.

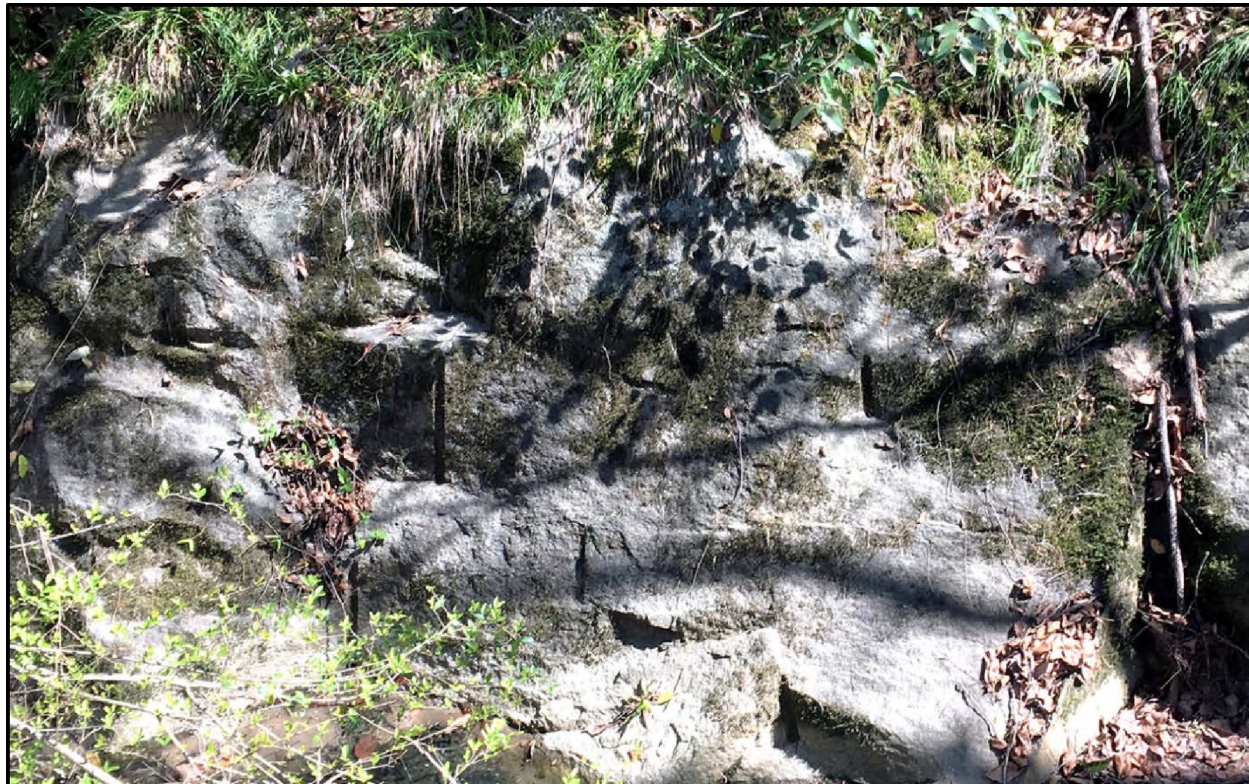
Figure 11. Example of Drill Marks in the Site No. 7903.01, Segment A, Canal Wall.

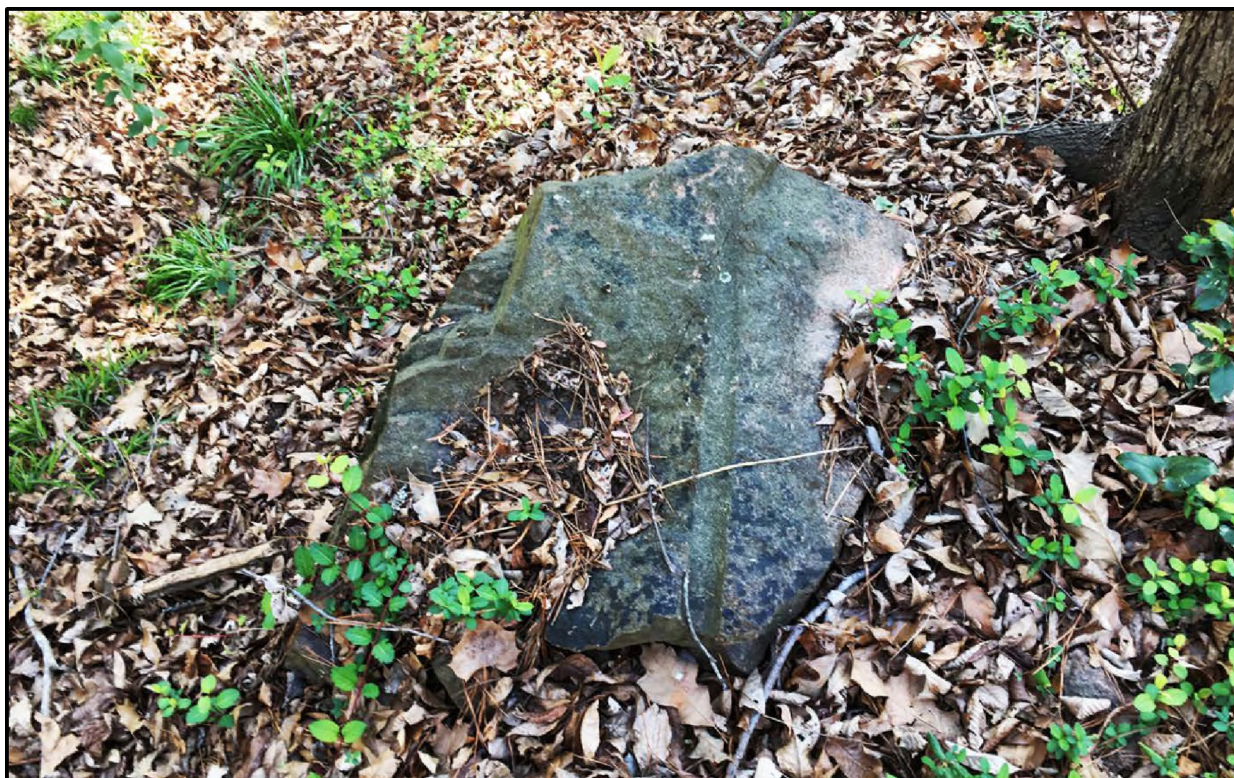
Figure 12. Example of Drilled Stone at Site No. 7903.01, Segment A.

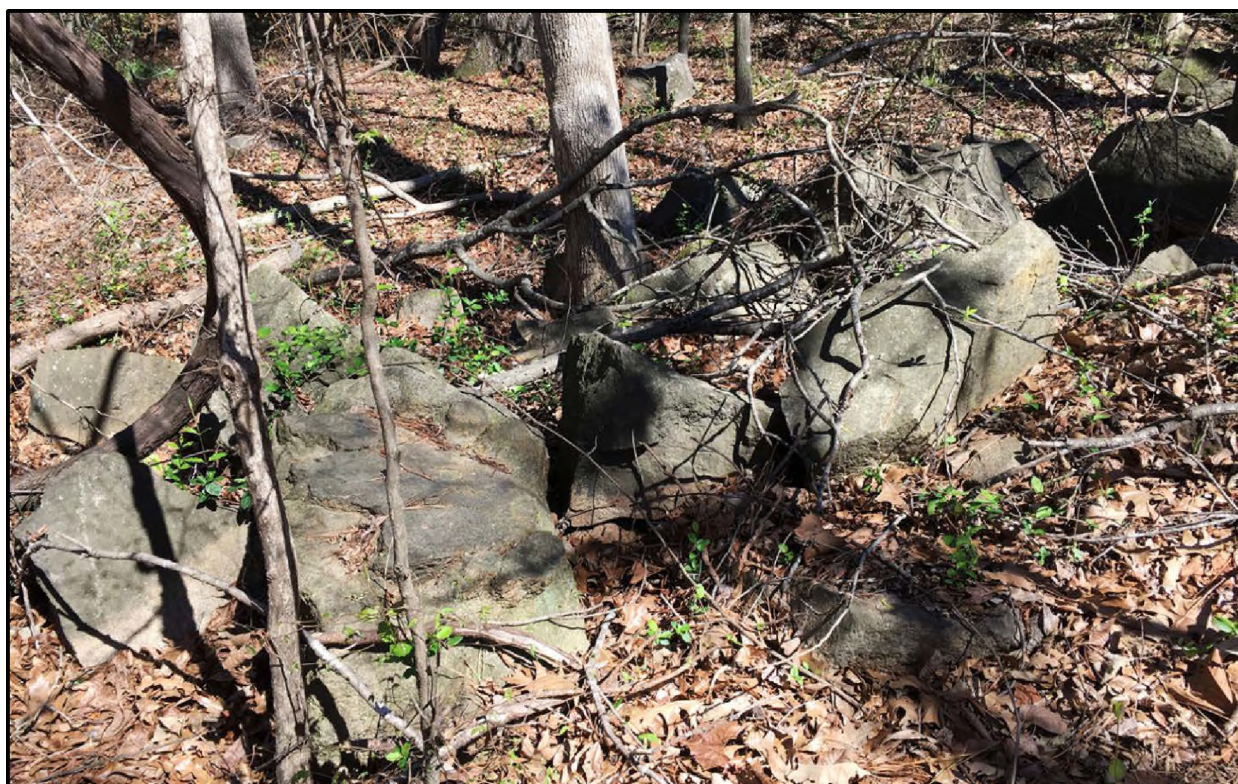
Figure 13. Stone Debris Pile near Site No. 7903.01, Segment A.

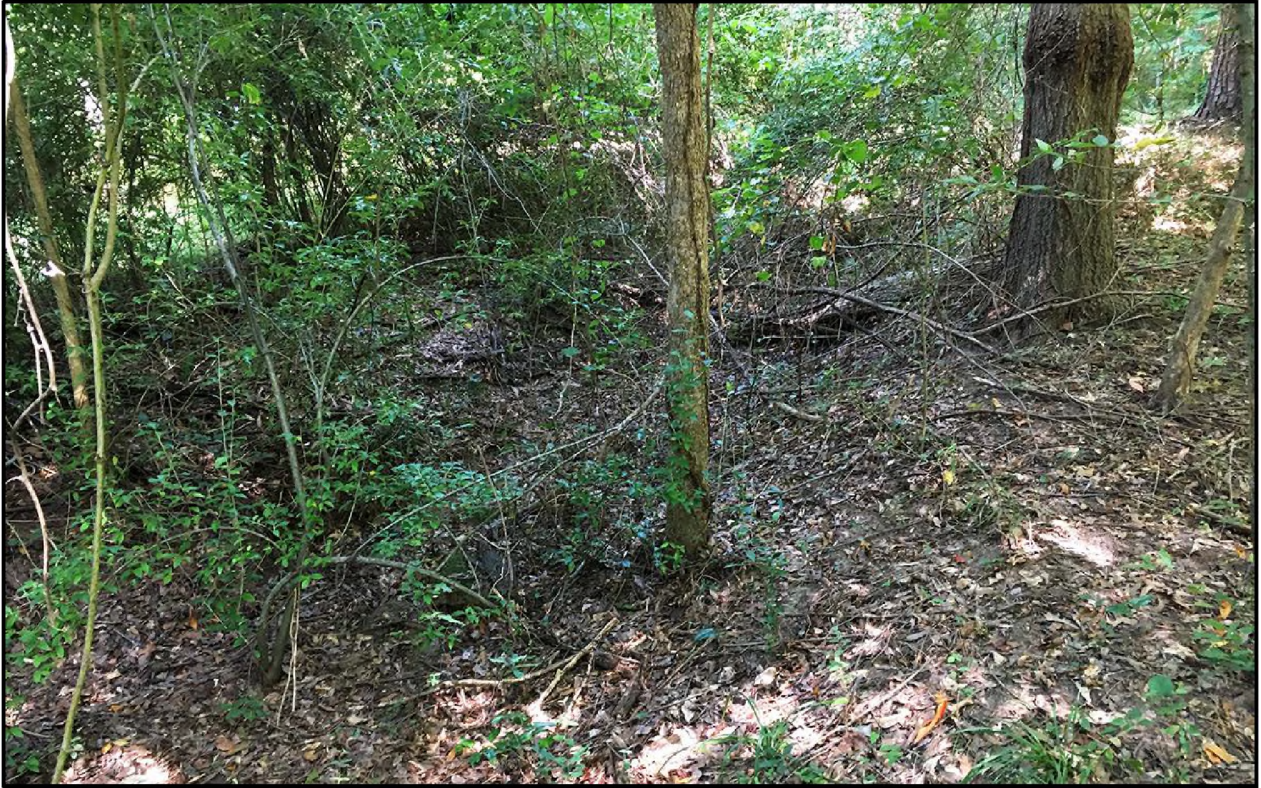
Segment B is a very short segment, just 22 meters in length. It was identified using historical aerial photographs as being a potential canal remnant and verified in the field. It is filled with sediment and barely visible. The width of this segment is just a few meters and it is less than a meter deep (**Figure 14**).

Figure 14. General View of Site No. 7903.01, Canal Segment B, Facing Northwest.

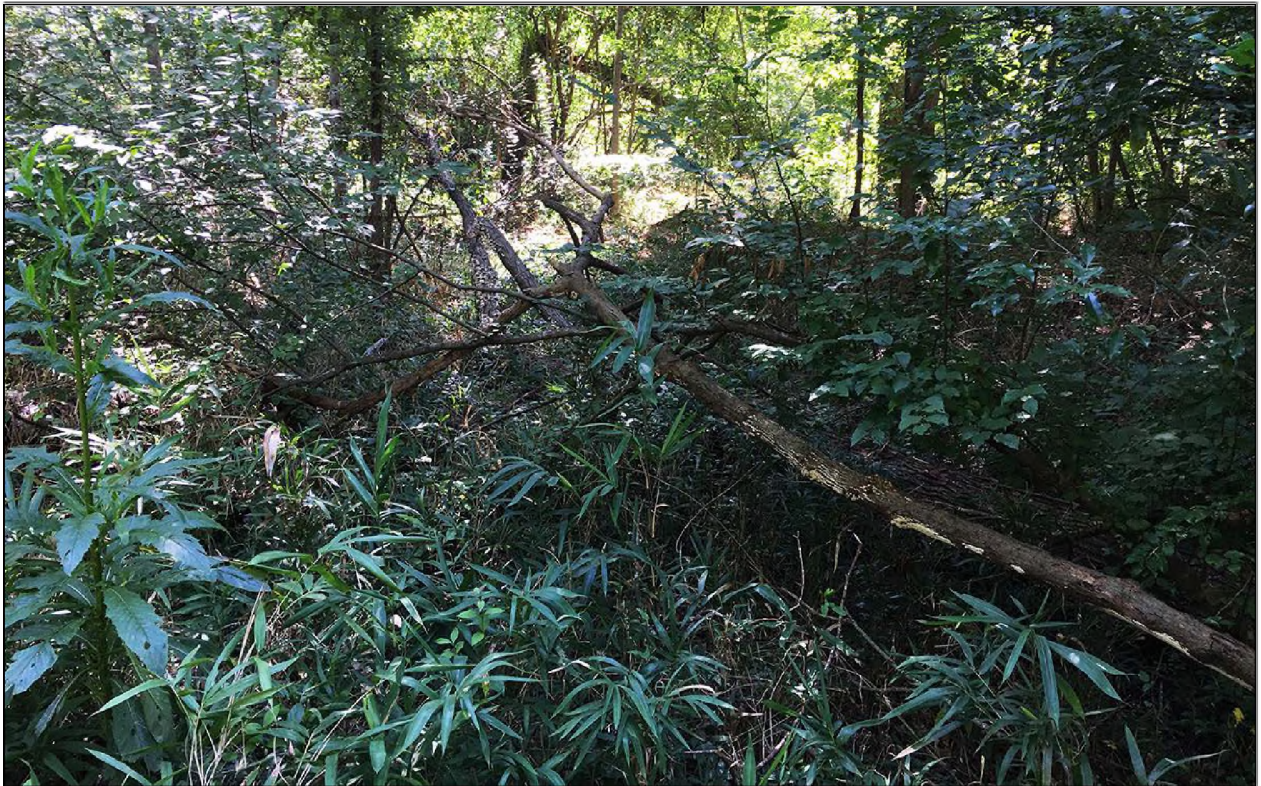
Segment C of the canal is approximately 63 meters in length. The segment is about 12 meters wide and less than a meter deep. It is associated with an intact stone culvert (7903.05) which was constructed to carry the canal over a natural drainage. **Figure 15** provides a view of Segment C.

Figure 15. General View of Site No. 7903.01, Canal Segment C, Facing West.

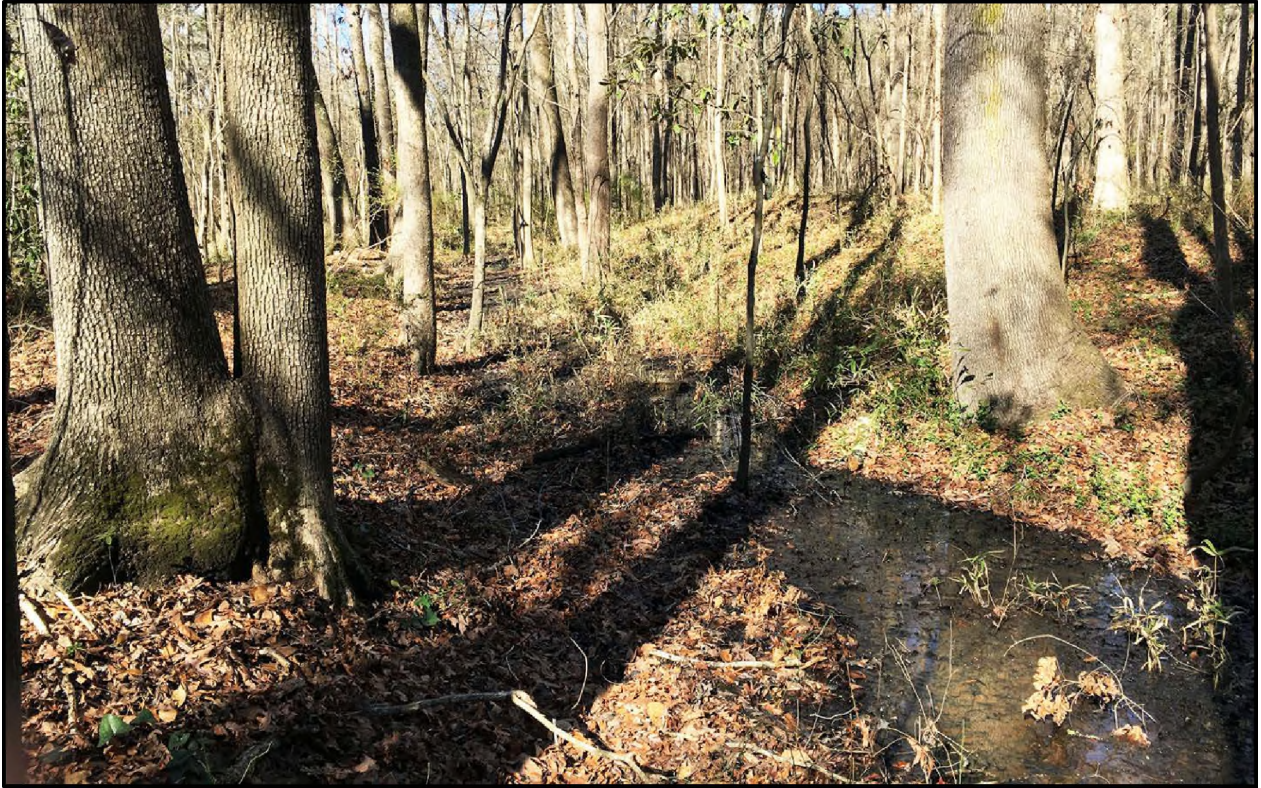
Segment D is approximately 530 meters long. It is highly visible on the landscape as a distinct excavation flanked by earthen berms. From berm to berm the canal measures about 13 meters across in this segment and it is up to two meters deep. **Figure 16** shows a typical view of this segment of the canal. This canal section is associated with two notable features, 7903.06 (stone bridge remains) and 7903.07 (the remains of a possible stone culvert). About 30 meters east of the stone bridge remains the canal in this segment gets noticeably wider, expanding to around 15 meters in width for a short distance (**Figure 17**). It is possible that the canal was widened in this location to provide a place where boats could turn around or moor to transfer cargo to or from wagons traveling along the road that passed over the bridge.

Figure 16. General View of Site No. 7903.01, Canal Segment D, Facing Northwest.

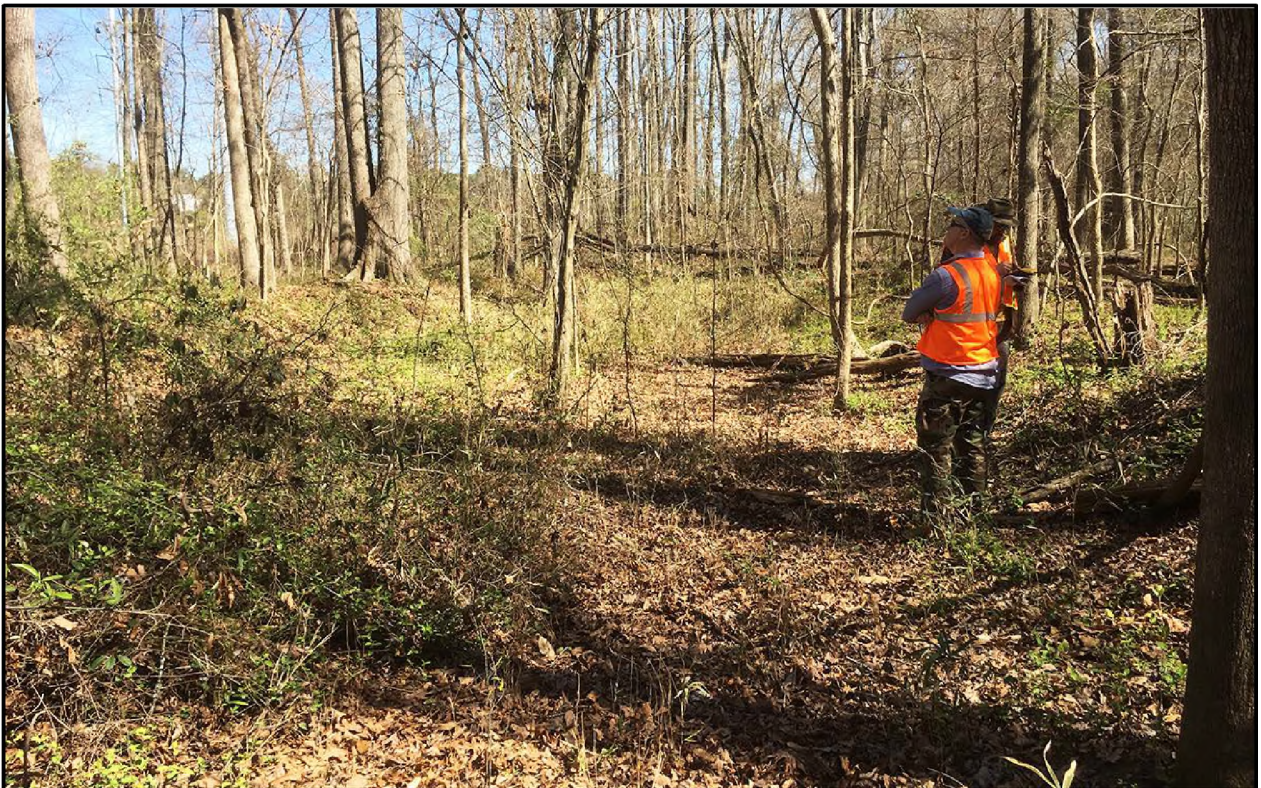
Figure 17. View Showing Wide Area in Site No. 7903.01, Canal Segment D, Facing East.

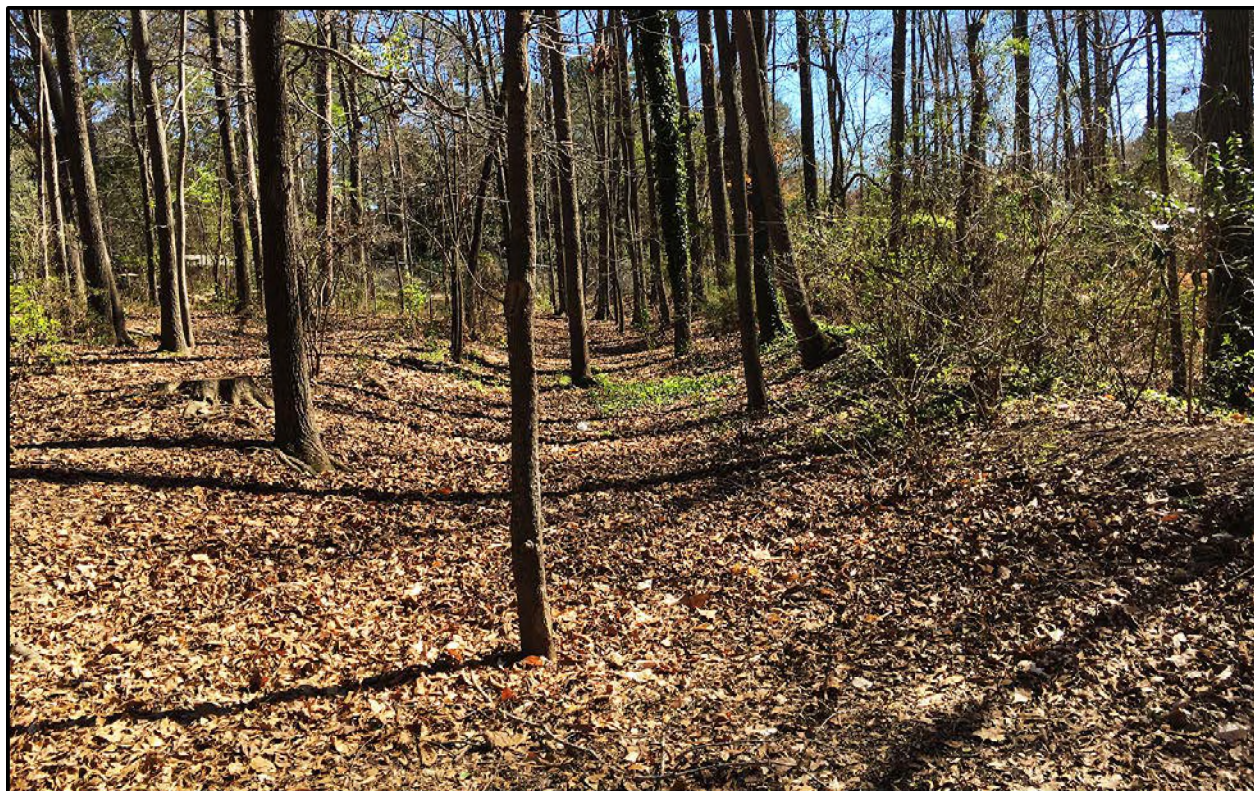
Segment E is located within the Riverbanks Zoo property in a wooded picnic area. This segment measures approximately 120 meters long and, having been filled in through sedimentation, is a meter or less deep. **Figure 18** provides a view of this segment.

Figure 18. General View of Site No. 7903.01, Canal Segment E, Facing Southeast.

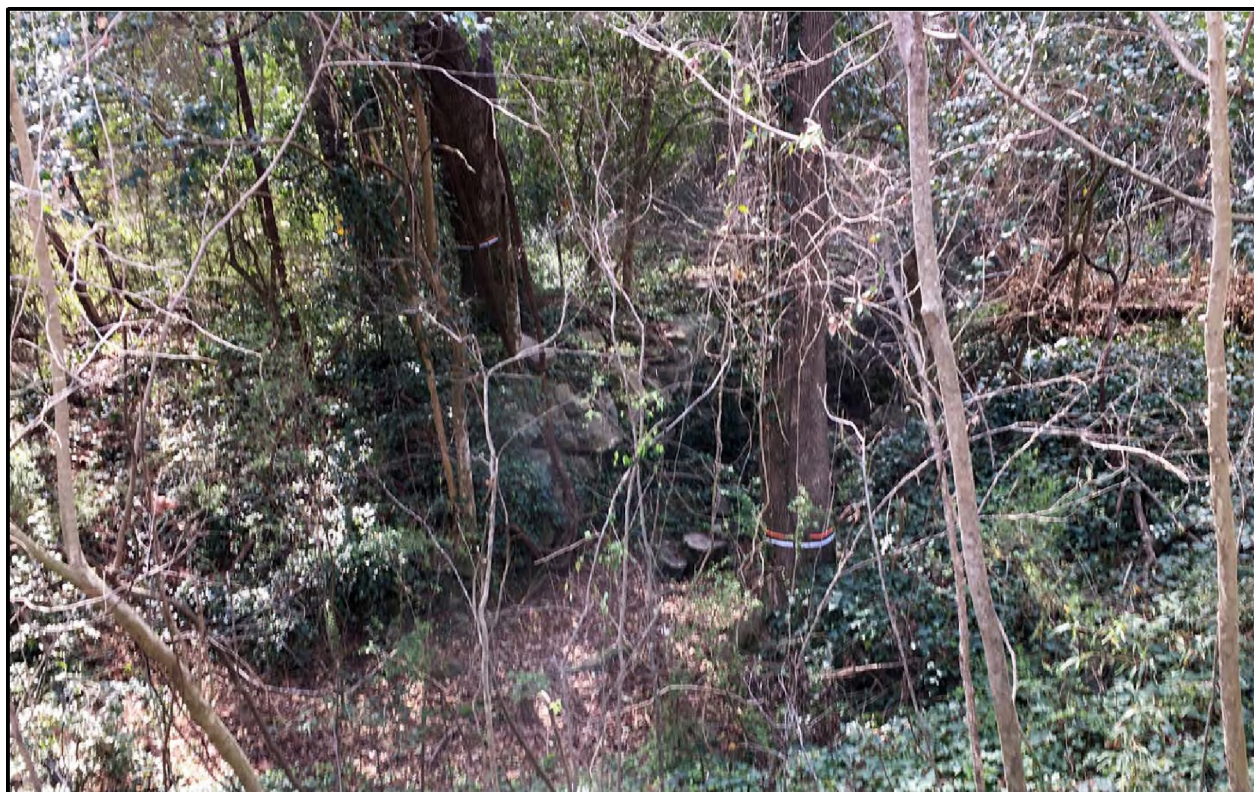
Segment F is a short section of canal, roughly 60 meters in length. It is currently inaccessible on the Riverbanks Zoo property, where it is located behind the elephant enclosure, but it is visible from the Ndoki Lodge special events building through one of the windows. This portion of the canal appears to be fairly deep and about 12 meters wide. Stone is visible in the canal walls so it is likely that part of this section was cut and/or blasted from bedrock (**Figure 19**).

Figure 19. General View of Site No. 7903.01, Canal Segment F, Facing Southwest.

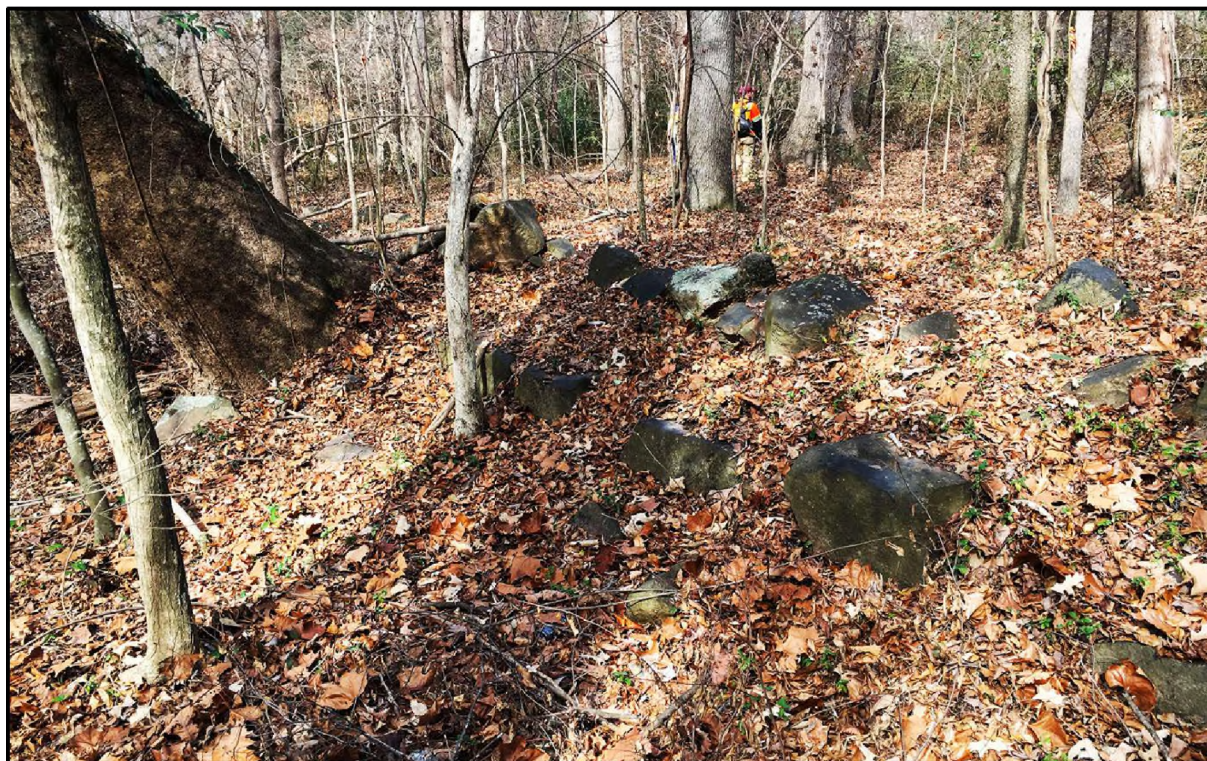
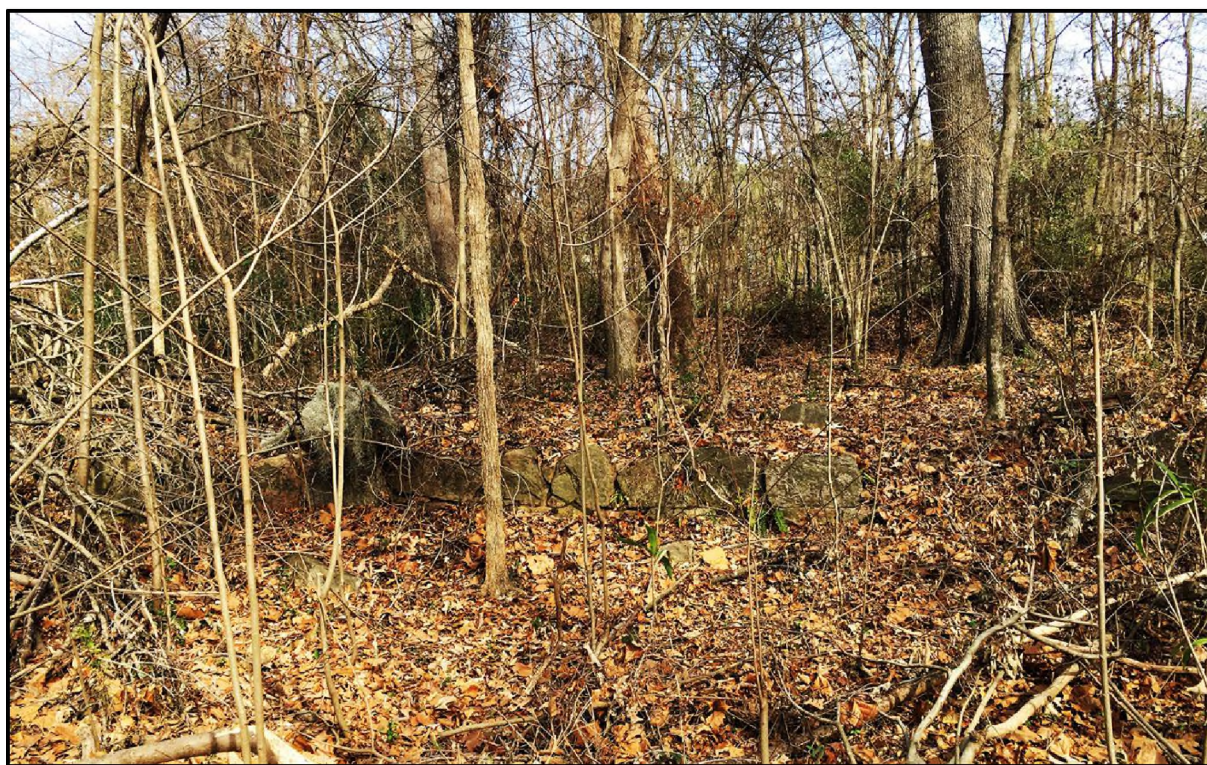
Site Number 7903.02 is a stacked stone wall/possible guard wall located near the northern end of Segment A of the canal (**Figures 20 – 21**). The wall measures approximately 61 meters northwest/southeast and fronts a slightly elevated area about 18 meters in width. The wall is only about a half meter high. If the feature served as a guard wall it would have helped protect the entrance of the canal from damage during high water events. The wall is not shown on the ca 1820 plan map for the canal indicating that it may have been constructed after this date.

Figure 20. View of Site No. 7903.02, Possible Guard Wall, Facing North.

Figure 21. View of Site No. 7903.02, Possible Guard Wall, Facing Northwest.

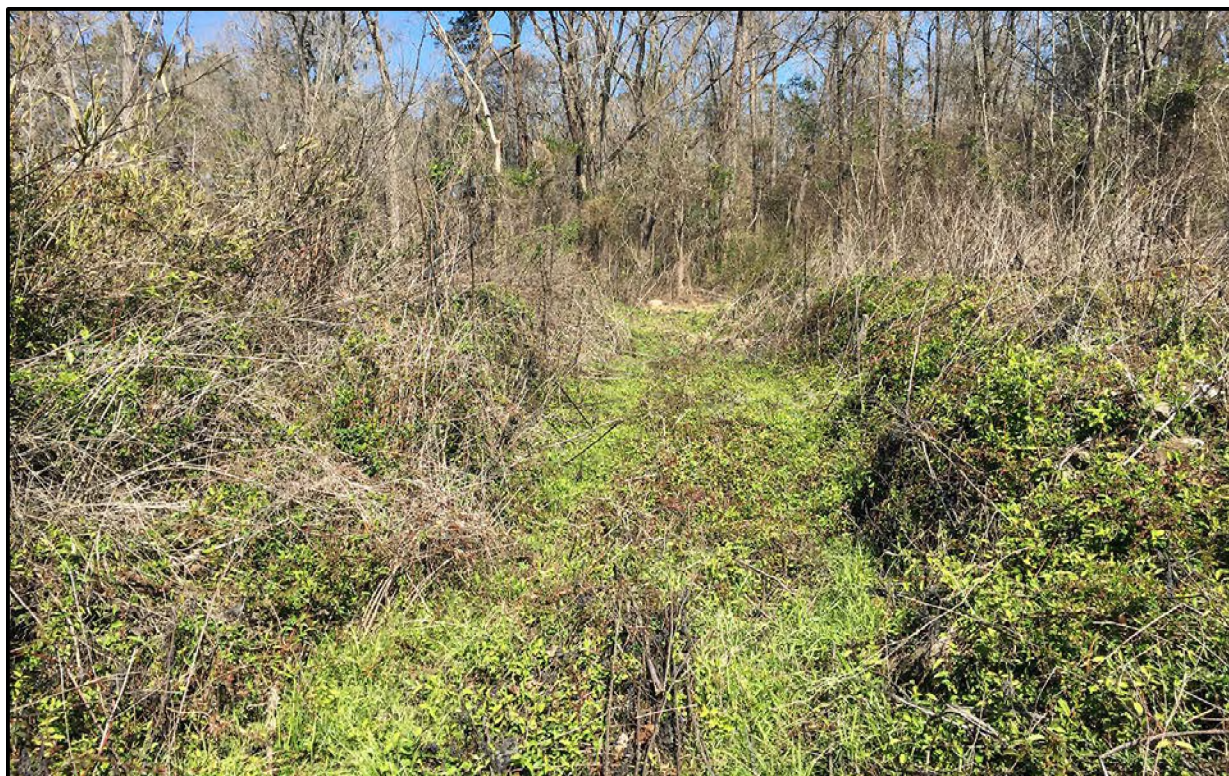
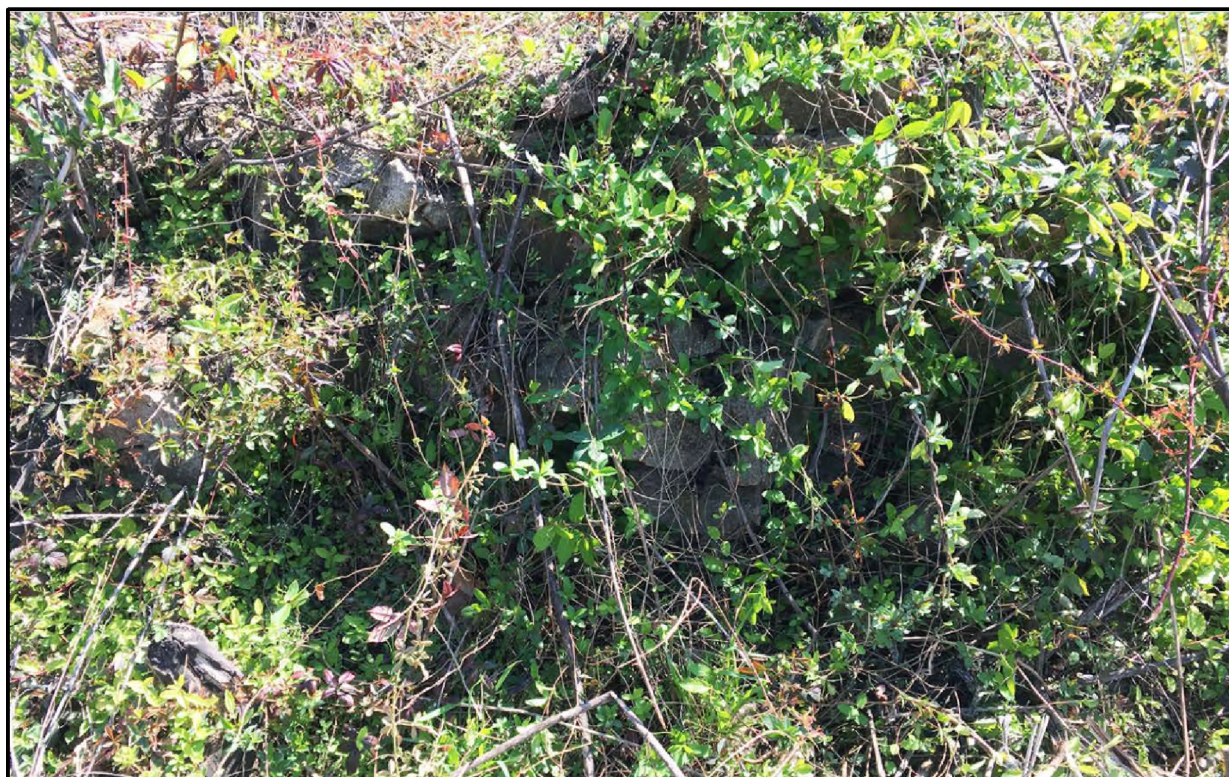
Site Number 7903.03 is located at the southern end of Segment A in a wide powerline corridor. It consists of stone walls lining either side of the canal (**Figures 22 – 23**). It is possible that these walls served as a guard lock, which would have helped control the flow of water through the canal and prevent flooding in times of high water. The feature is approximately 31 x 4 meters in size and about one meter in height. It was heavily overgrown in vegetation when it was recorded in 2018. There is no feature drawn on the ca 1820 plan map for the Saluda Canal that georeferences with the location of this feature, suggesting that it may be a later addition to the canal. A guard lock is specifically identified on the ca 1820 map but is shown to be located about 30 meters to the SE of Site No. 7903.03 (see discussion of Site No. 7903.04 below).

Figure 22. View of Site No. 7903.03, Possible Guard Lock, Facing North.

Figure 23. View of Stonework in Site No. 7903.03.

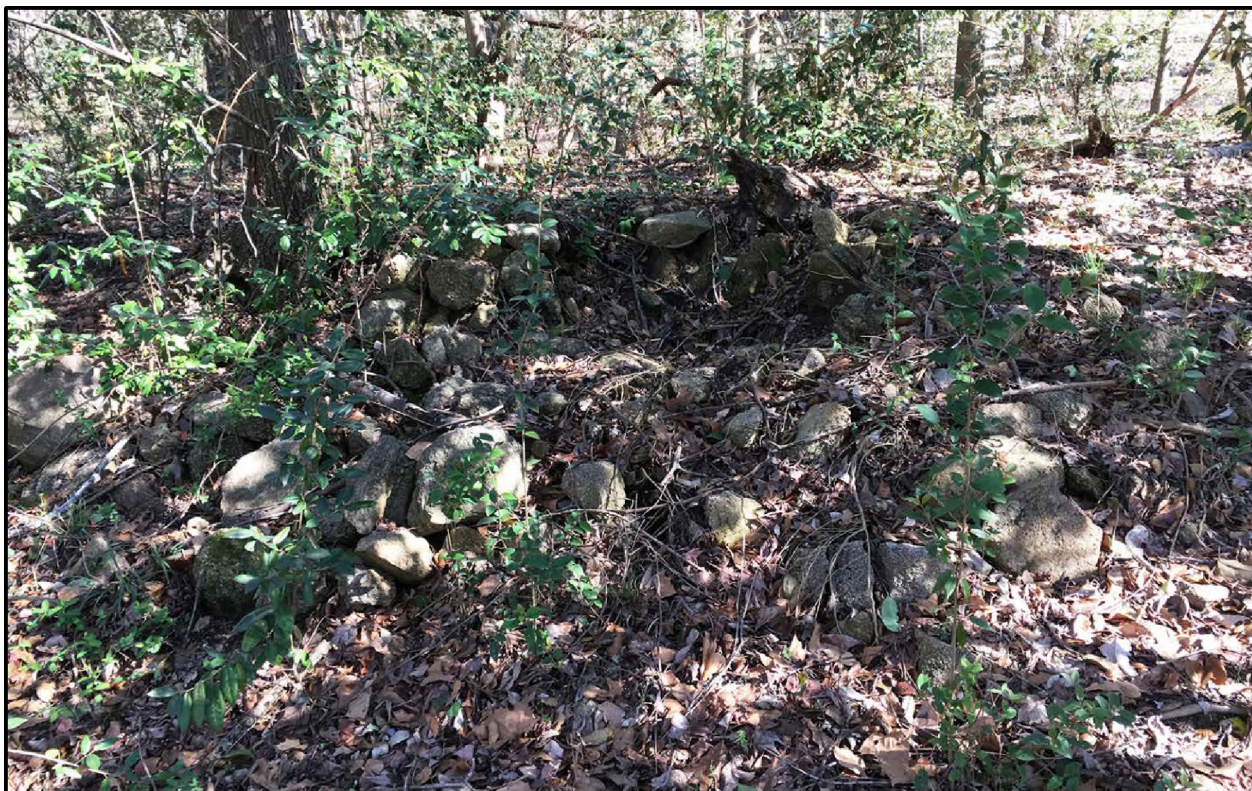
Site Number 7903.04 is about 30 meters southeast of 7903.03. It consists of a moderate sized cluster of stones situated in the approximate location where a guard lock is shown to have been on the ca 1820 canal plans. Some of the stones may form the remnants of parallel walls but the alignments are difficult to discern due to the heavy vegetation and leaf litter surrounding the feature, and may be illusory (**Figure 24**). It is possible Site No. 7903.4 comprises the remains of an initial guard lock that was subsequently rebuilt a short distance to the west (see the Site No. 7903.03 description, above).

Figure 24. View of Site No. 7903.04, Remains of Possible Guard Lock, Facing Northeast.

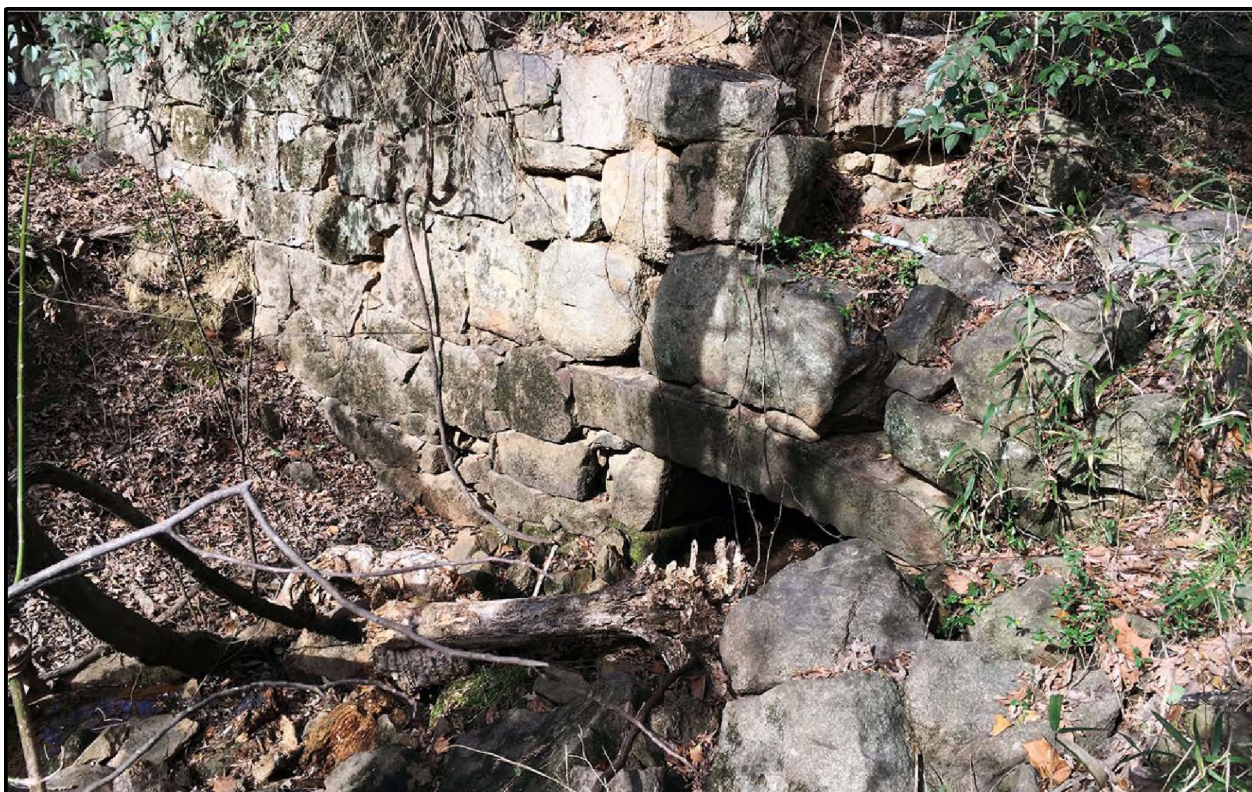
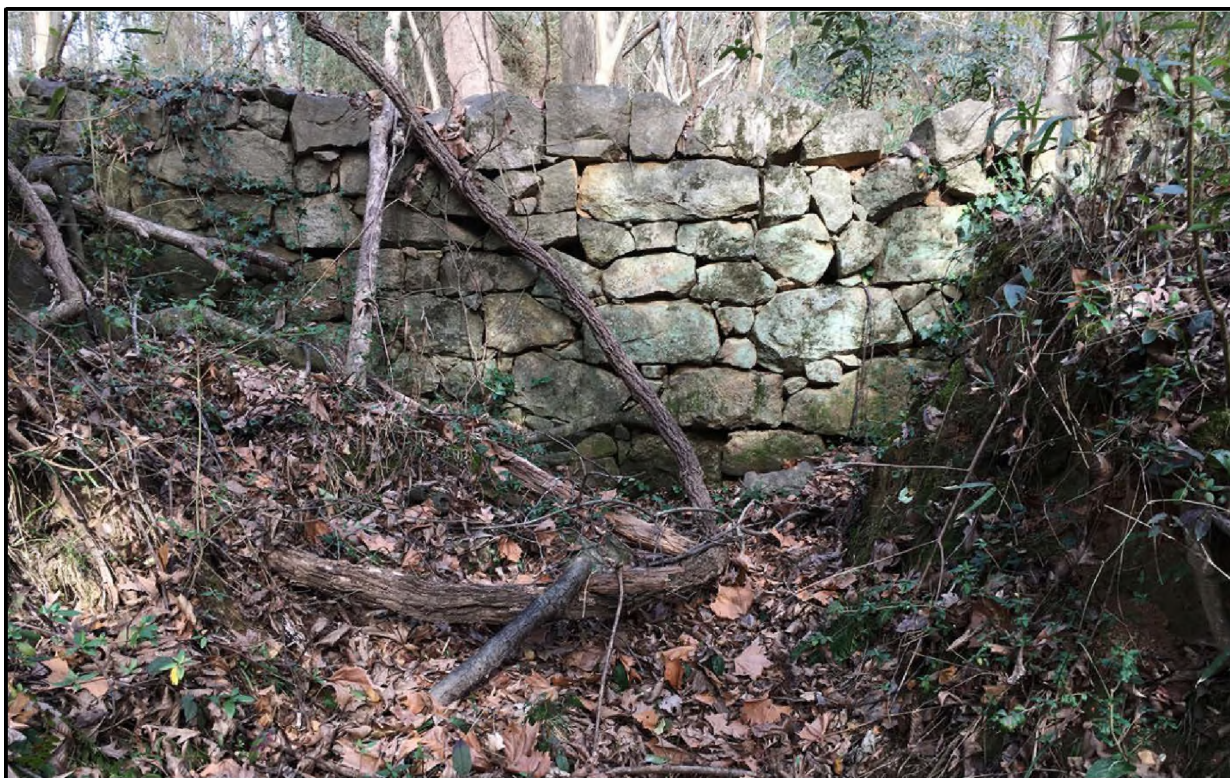
Site Number 7903.05 is a stone culvert located in Canal Segment C. The feature measures approximately 36 x 11 meters in size and is largely intact but appears to be partially buried in sediment (**Figures 25 – 26**). The location of the feature matches perfectly with the location where a culvert is shown on the ca 1820 canal plan.

Figure 25. View of Site No. 7903.05, Culvert, Facing North.

Figure 26. View of Site No. 7903.05, Culvert, Facing South.

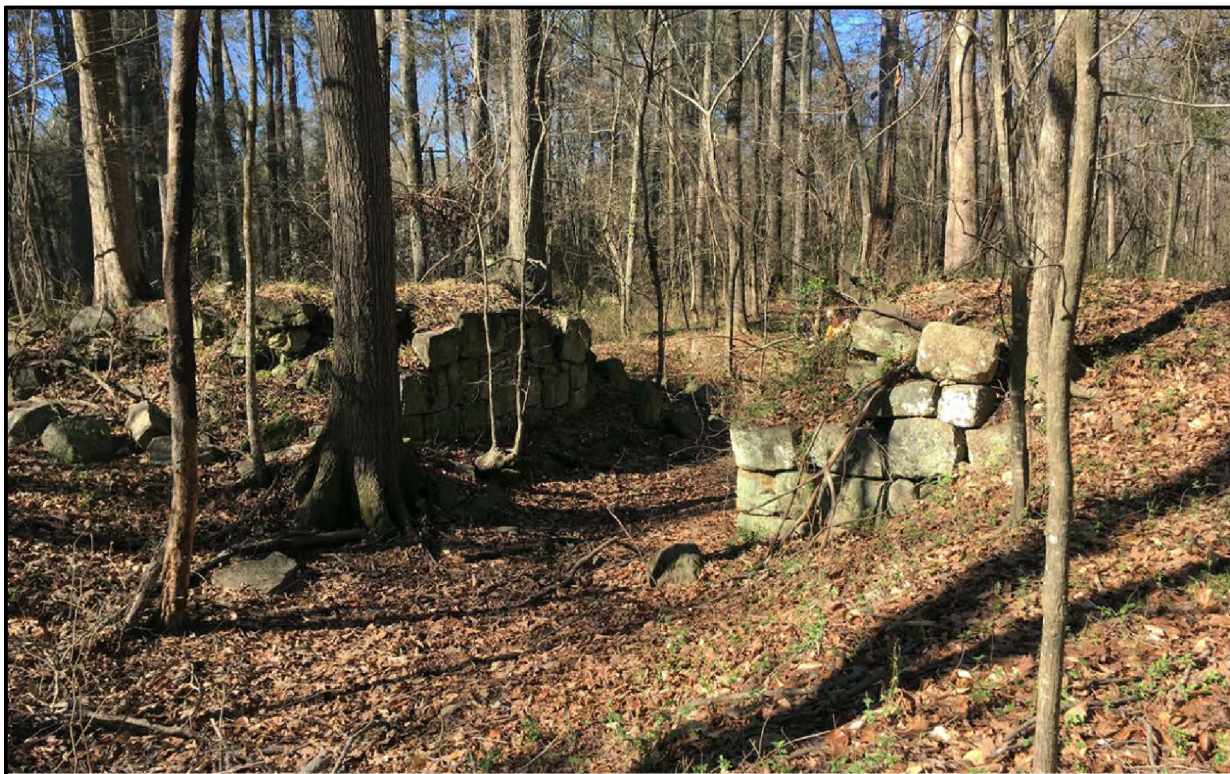
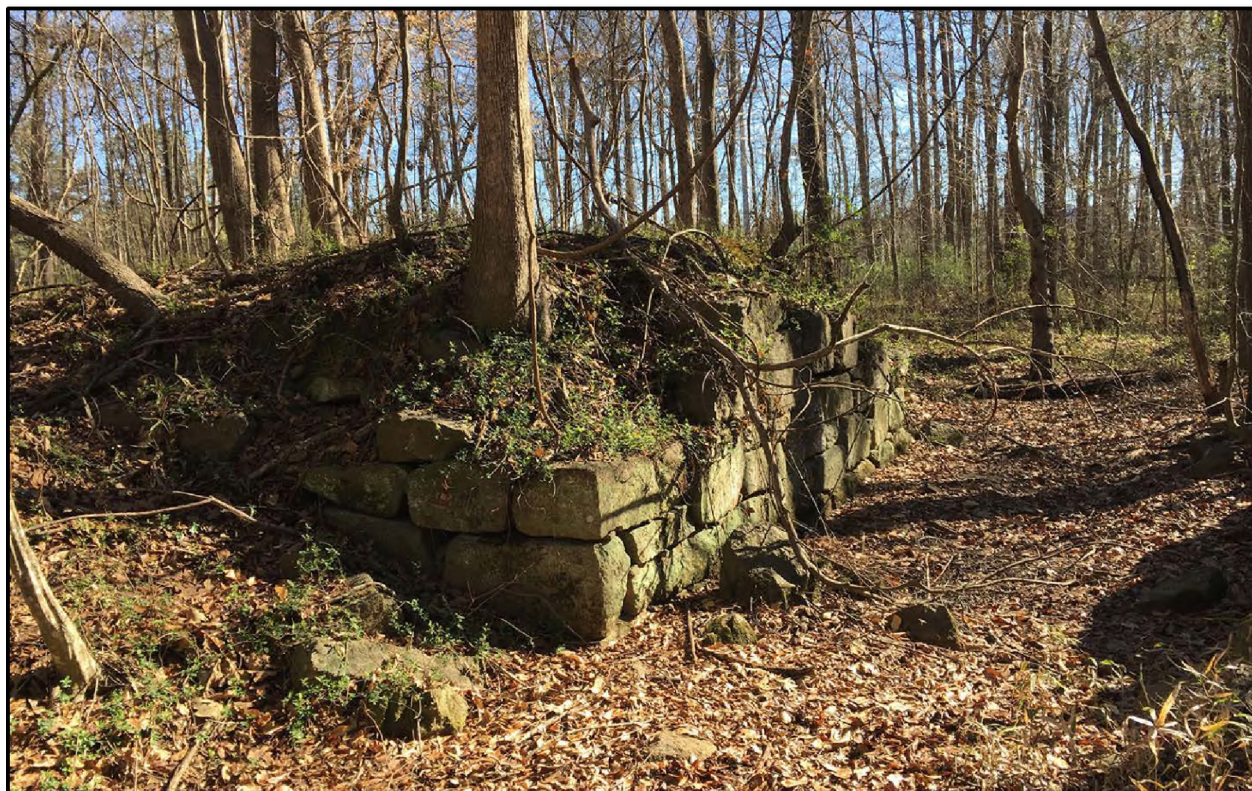
Site Number 7903.06 is located in Canal Segment D and consists of two intact bridge abutments that comprise the remains of a bridge that once spanned the canal. These abutments are about seven meters wide and are made of earth and stone (**Figures 27 – 28**). The bridge location is indicated on the ca 1820 canal plans and is also visible on the 1825 Mills Atlas map of the Lexington District, which shows the road crossing the Saluda Canal before reaching the Saluda River at Stark's Ferry.

Figure 27. View of Site No. 7903.06, Bridge Remains, Facing Southwest.

Figure 28. View of Site No. 7903.06, Bridge Remains, Facing East.

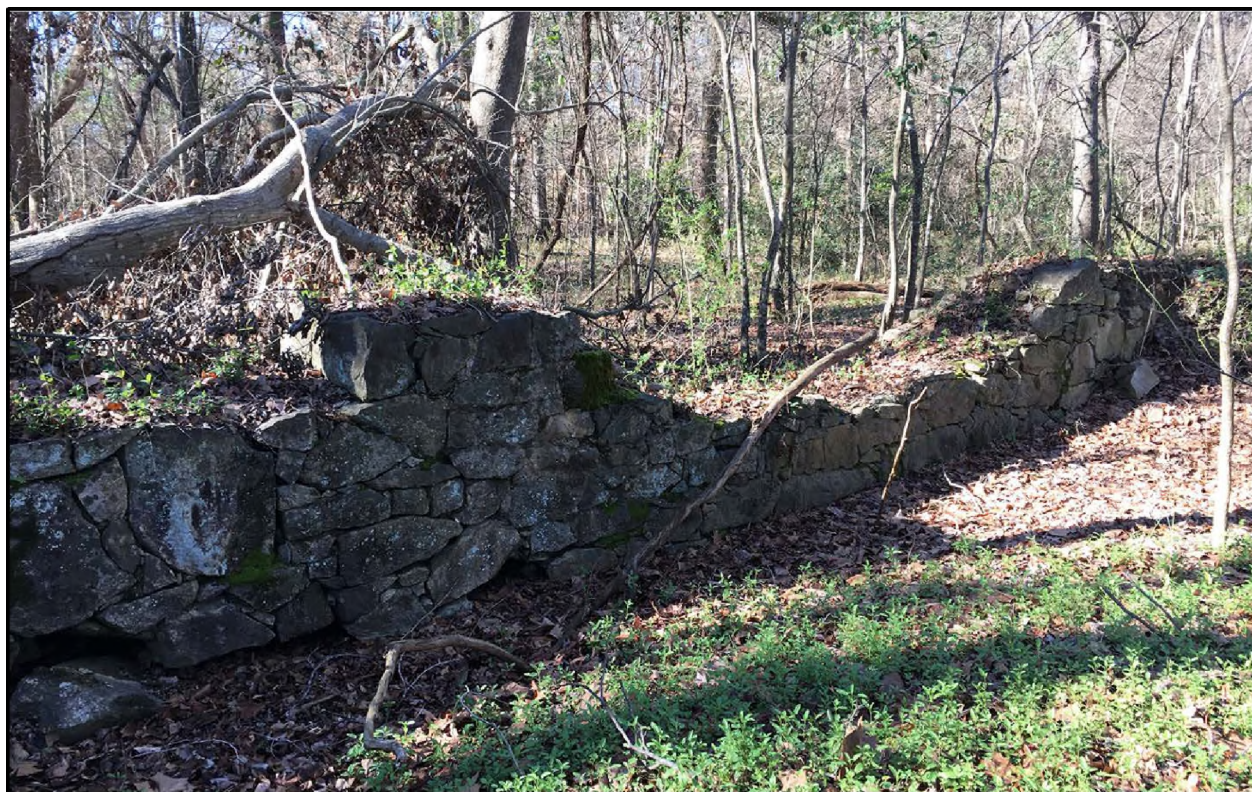
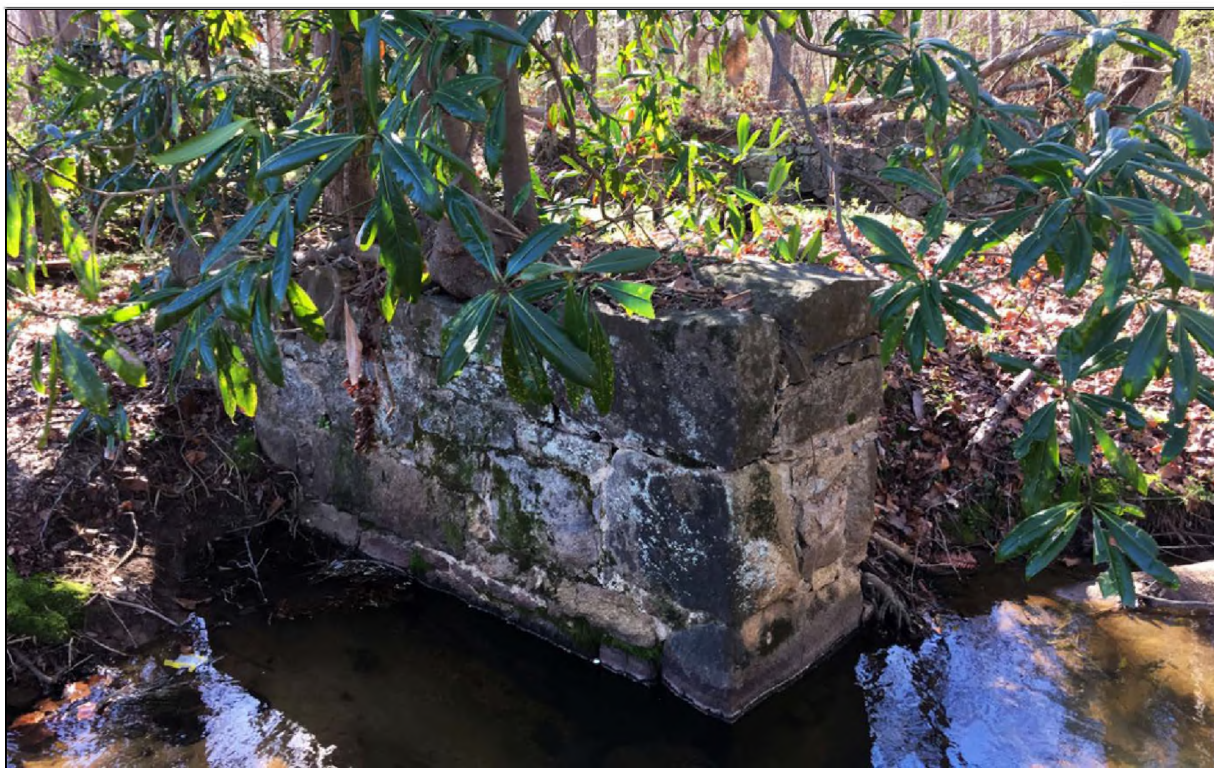
Site Number 7903.07 is located approximately 140 meters east of 7903.06 in Canal Segment D and consists of two intact stone walls (**Figures 29 – 30**). The southernmost wall is about 15 meters in length and between one to 1.5 meters in width. The wall to the north is much smaller at 4 meters long and less than a meter wide. Both walls are about one meter tall. It is possible that these walls comprise the remains of a culvert because they are located where a drainage intersects the canal. This feature is not depicted on the ca 1820 canal plans so it may have been constructed after this map was made.

Figure 29. View of Site No. 7903.07, Possible Culvert, South Wall, Facing Southwest.

Figure 30. View of Site No. 7903.07, Possible Culvert, North Wall, Facing Southeast.
