The Saluda Canal Historic District (Site Number 7903) Historical Overview and Resource Descriptions

Compiled by Tracy Martin and Bill Jurgelski
South Carolina Department of Transportation
September, 2018

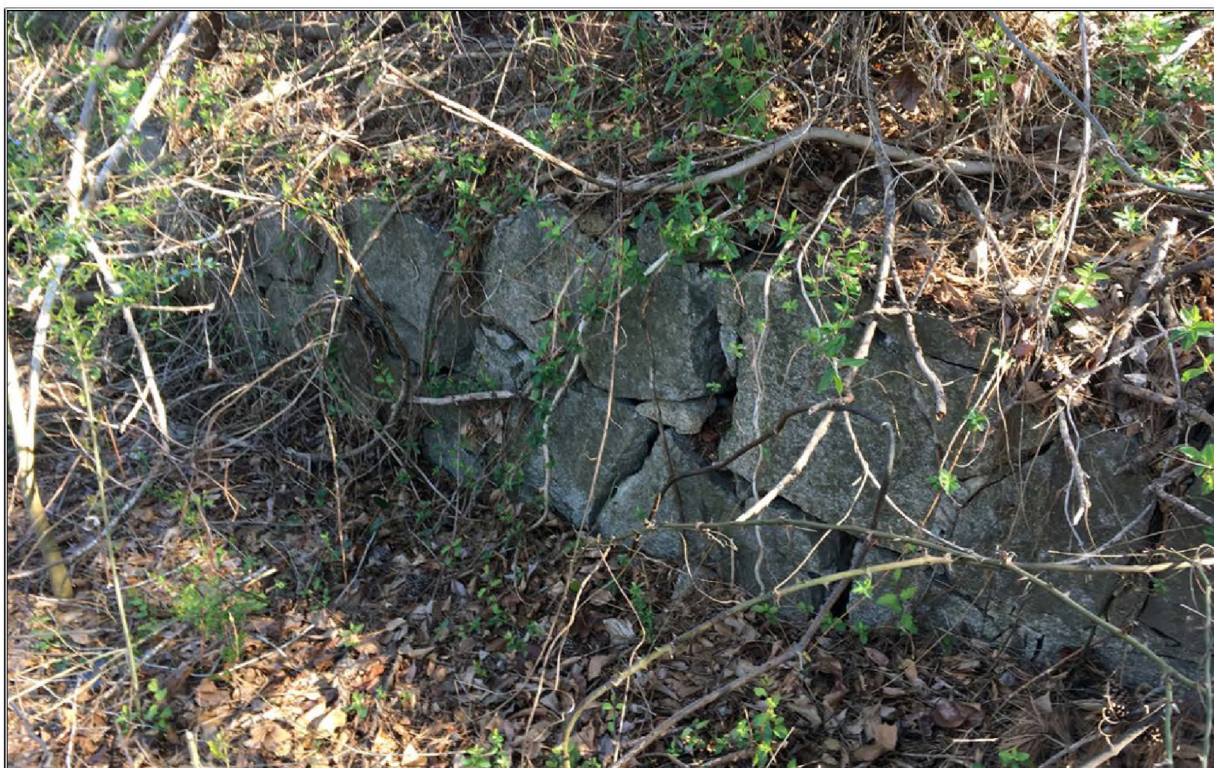
Site Number 7903.08 consists of a portion of intact stacked stone wall that is about 4 meters in length and less than a meter in height (**Figure 31**). Based on its location and the quality of its construction the

wall appears to be associated with the canal, very probably comprising the remnant of a lining or retaining wall. However, no visible portion of the canal excavation is located nearby, and there is no feature on the ca 1820 canal map that correlates to the wall. Any other traces of the canal in the vicinity of the wall appear to have been destroyed by the construction of the railroad corridor and nearby commercial development.

Figure 31. View of Site No. 7903.08, Stone Wall Remains, Facing Northeast.

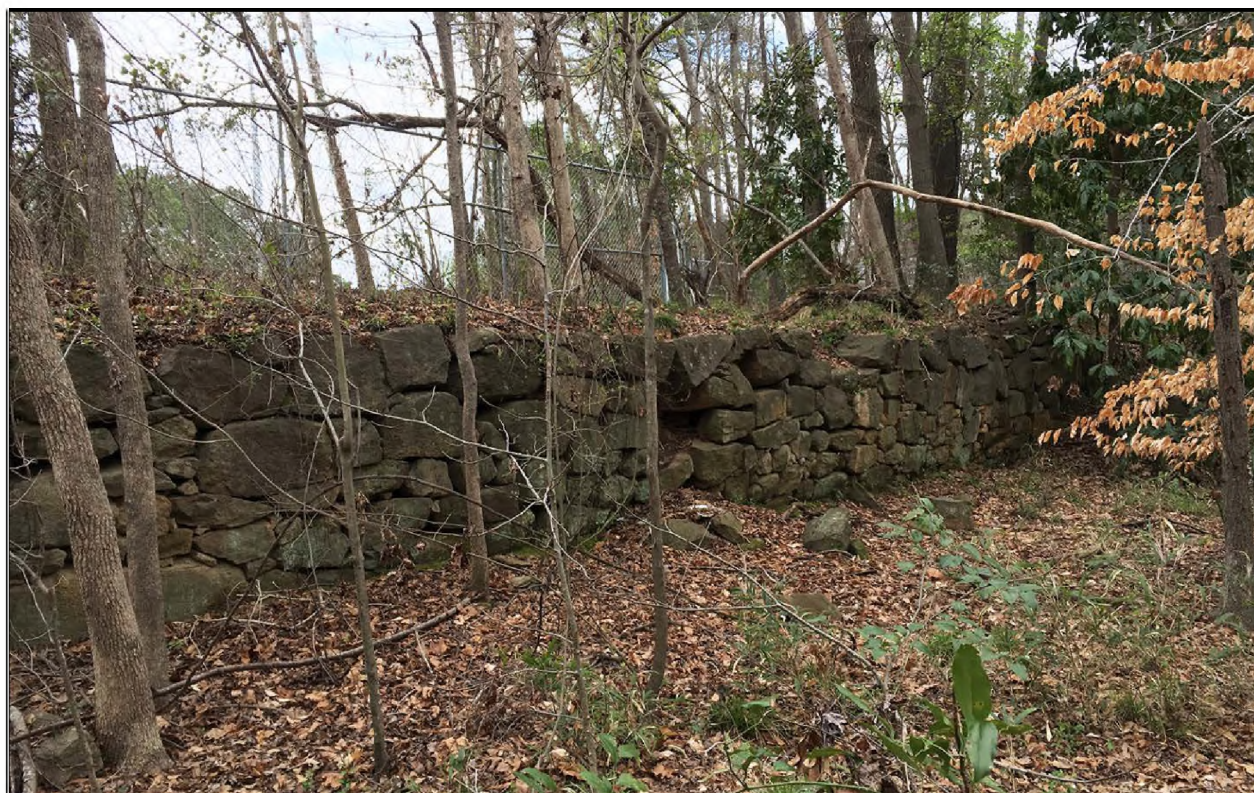
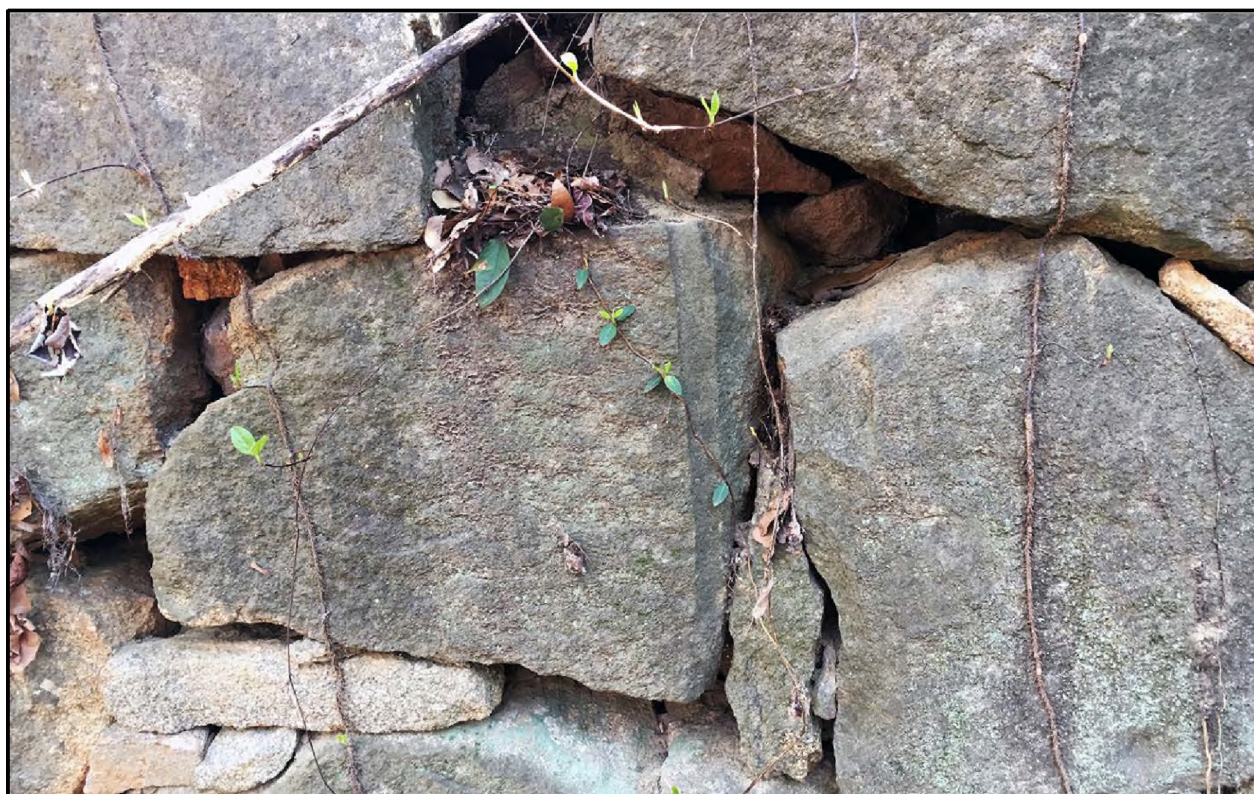
Site Number 7903.09 is a retaining wall located next to Canal Segment E. The wall is approximately 20 meters in length and up to 2 meters in height (**Figures 32 – 33**). There are drill marks on at least one of the stones making up the wall. There is no feature on the ca 1820 canal map that correlates to this wall.

Figure 32. View of Site No. 7903.09, Stone Retaining Wall, Facing Northeast.

Figure 33. Close-up View of Site No. 7903.09, Showing Details of Construction, Facing North.

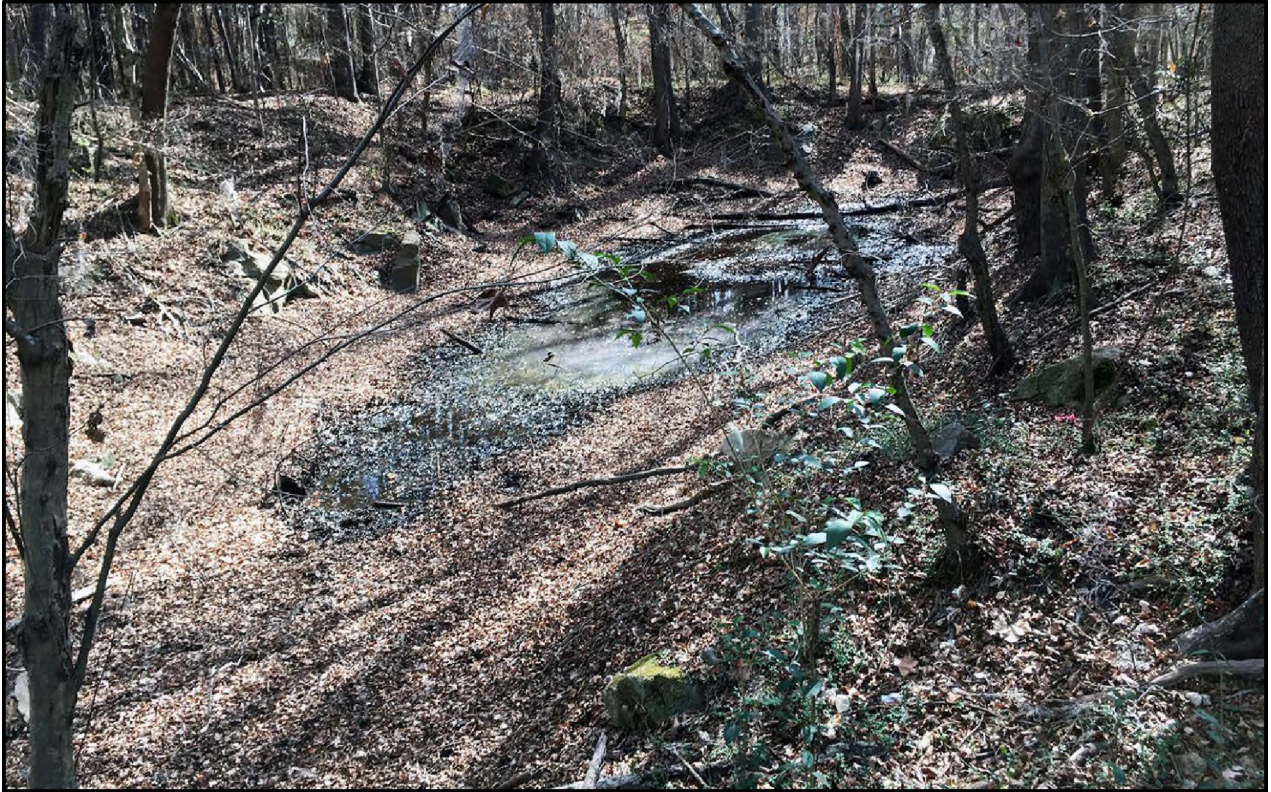
ERAR Number 1 is a deep depression or pit that measures approximately 45 x 20 meters in size (**Figure 34**). The feature is located on the east side of Canal Segment A near the southern end of this segment. ERAR 1 is interpreted to be an abandoned rock quarry that may have supplied stone for the locks, retaining walls, and other stone components of the canal, but this use is uncertain, as is the age of the feature. Even if the feature is a quarry it may have supplied stone for the construction of the nearby railroad or for some other purpose, rather than for the canal; thus, the association of the feature with the canal is unclear. The feature is not indicated on the ca 1820 map of the canal.

Figure 34. ERAR 1, Possible Quarry, Facing South.

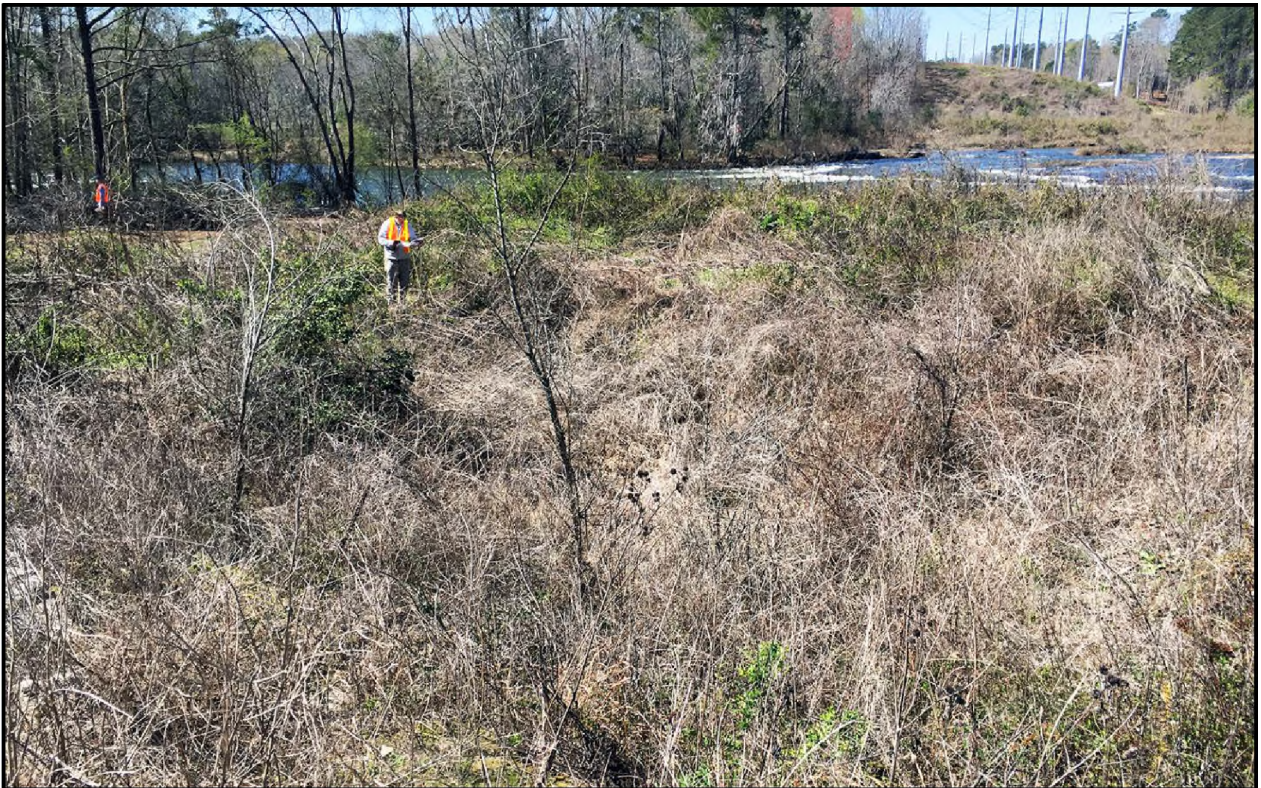
ERAR Number 2 is a second deep depression or pit that measures approximately 31 x 19 meters in size (**Figure 35**). The feature is located a few meters southeast of the southern end of Canal Segment A, in close proximity to Site No. 7903.03. ERAR 2 is interpreted to be an abandoned rock quarry that may have supplied stone for the locks, retaining walls, and other stone components of the canal, but this use is uncertain, as is the age of the feature. Even if the feature is a quarry it may have supplied stone for the construction of the nearby railroad or for some other purpose, rather than for the canal; thus, the association of the feature with the canal is unclear. The feature is not indicated on the ca 1820 map of the canal.

Figure 35. ERAR 2. Possible Quarry, Facing West.

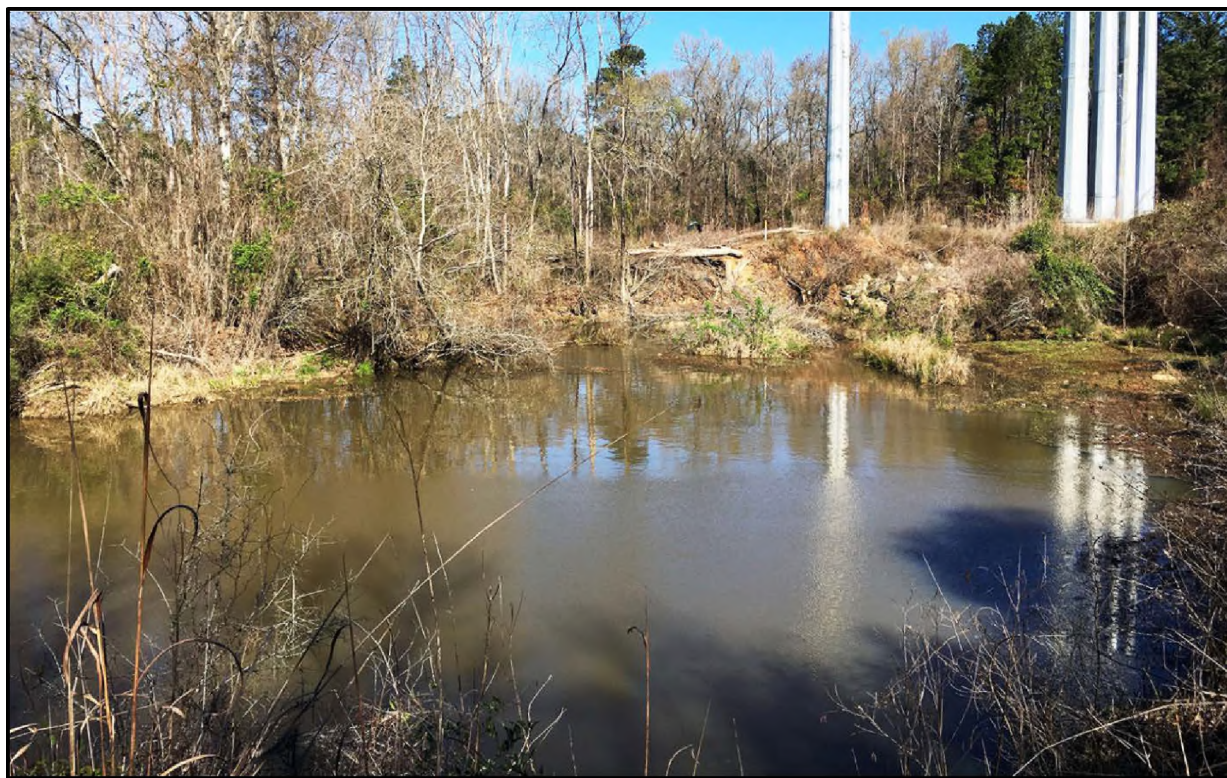
ERAR Number 3 is a third deep depression or pit that measures approximately 54 x 43 meters in size (**Figure 36**). The feature is located approximately 30 meters to the south of ERAR 2, in a location where no portion of the canal excavation is visible, but close to where the canal is projected to have been located. ERAR 3 is interpreted to be an abandoned rock quarry that may have supplied stone for the locks, retaining walls, and other stone elements of the canal, but this use is uncertain, as is the age of the feature. Even if the feature is a quarry it may have supplied stone for the construction of the nearby railroad or for some other purpose, rather than for the canal; thus, the association of the feature with the canal is unclear. The feature is not indicated on the ca 1820 map of the canal.

Figure 36. ERAR 3, Possible Quarry, Facing North.

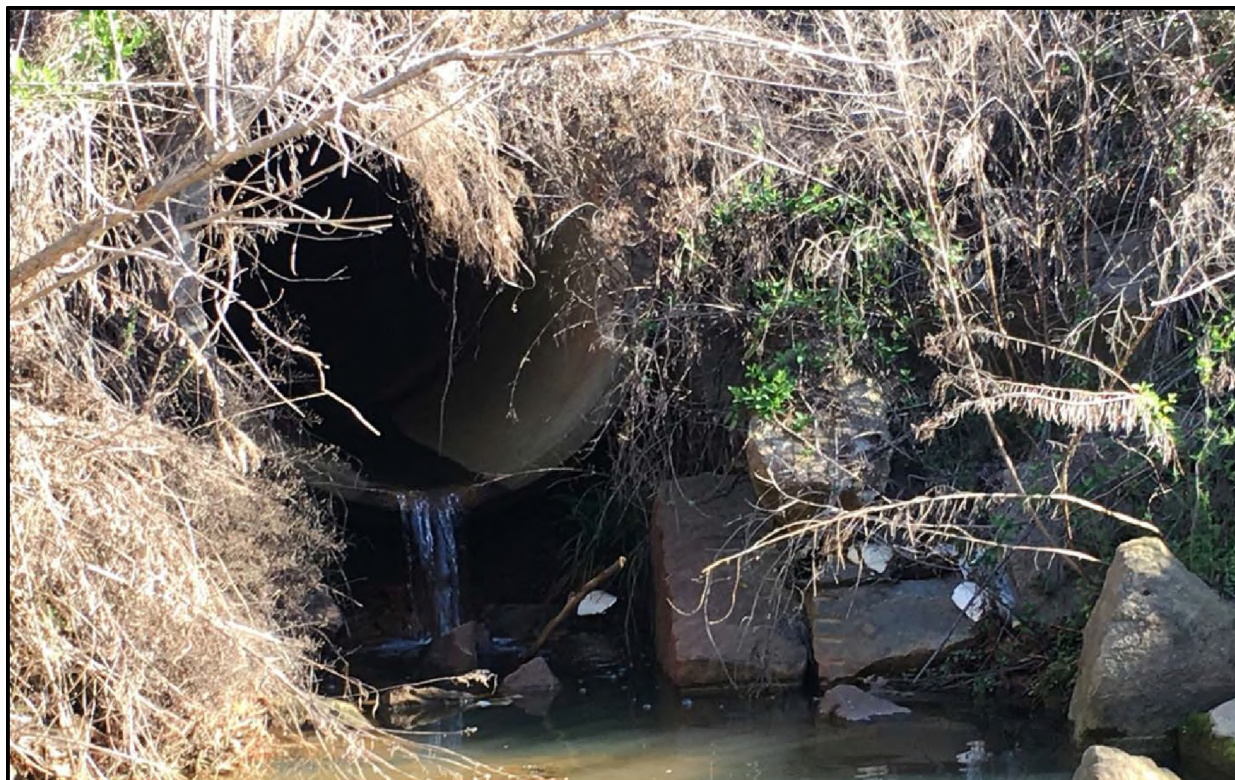
ERAR Number 4 is a small cluster of shaped or cut stone blocks and rock rubble that is visible in a drainage about 100 meters east of Site No. 7903.07, near the east end of Canal Segment D (**Figure 37**). The stones are not in a location where a canal feature is indicated on the ca 1820 canal map or in close association with any visible element of the canal, but may comprise the displaced remnants of a canal feature that has been destroyed.

Figure 37. ERAR 4, Cut Stone in Modern Drainage, Facing North.

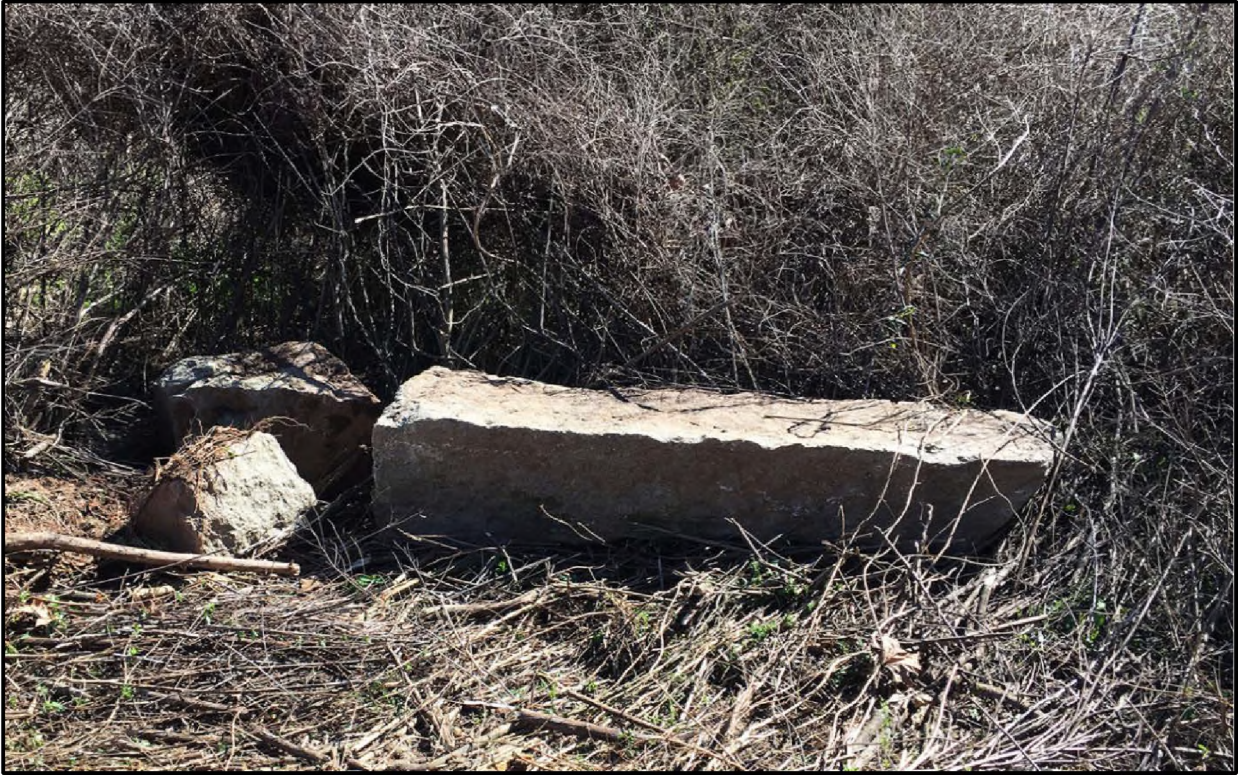
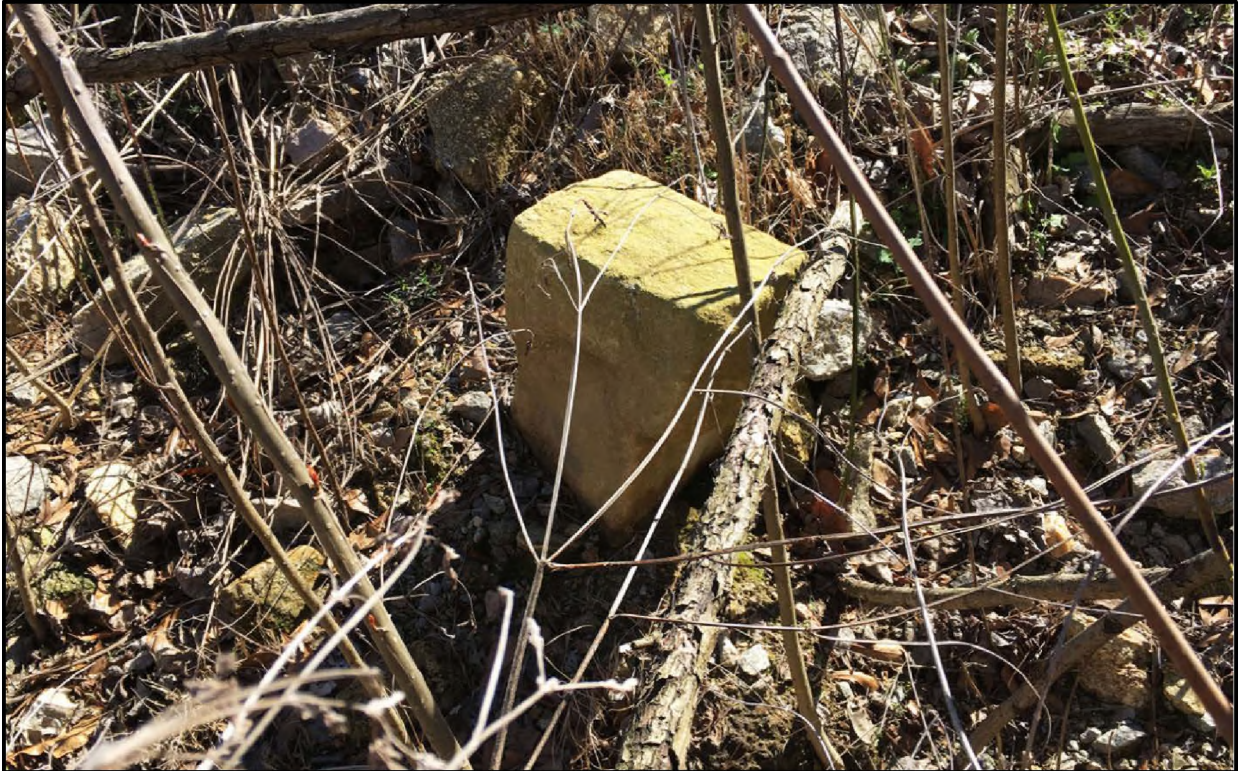
ERAR Number 5 consists of three rubble piles that contain cut or shaped stone blocks intermixed with undressed stone (**Figures 38 – 39**). The stone piles are located between approximately 120 meters and 240 meters east of ERAR No. 4. in an area where there is no visible canal excavation and the canal is believed to have been destroyed by modern development. However, the location of the stone piles corresponds to the location where a culvert is indicated on the ca 1820 canal plan, and it is possible that the stone rubble comprises the displaced remnants of this culvert.

Figure 38. ERAR 5, Cut or Shaped Stone in Powerline Corridor, Facing East.

Figure 39. ERAR 5, Cut or Shaped Stone in Powerline Corridor, Facing South.

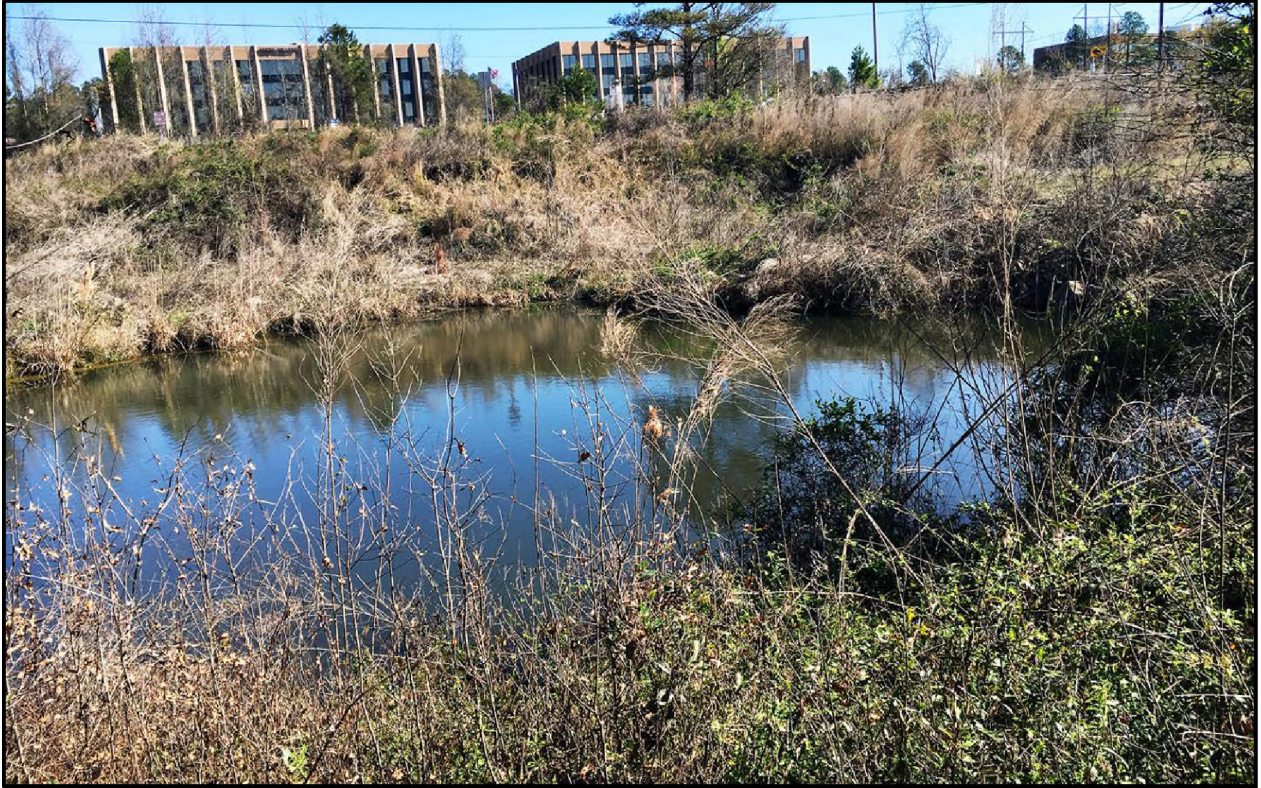
ERAR Number 6 is a fourth deep depression or pit that measures approximately 36 x 27 meters in size (**Figure 40**). The feature is located approximately 300 meters southeast of ERAR 5, in a location where no portion of the canal excavation is visible, but close to where the canal is projected to have been located. ERAR 6 is interpreted to be an abandoned rock quarry that may have supplied stone for the locks, retaining walls, and other stone elements of the canal, but this use is uncertain, as is the age of the feature. Even if the feature is a quarry it may have supplied stone for the construction of the nearby railroad or for some other purpose, rather than for the canal; thus, the association of the feature with the canal is unclear. The feature is not indicated on the ca 1820 map of the canal.

Figure 40. ERAR 6, Possible Quarry, Facing North.
