Phase I Cultural Resources Survey of a 26.5 acre tract on  
Ballenger Road, Spartanburg County, South Carolina

SHPO Project No. 18-KL0182

Apalachee Research Report No. 2019-13

Final Report December 2, 2019

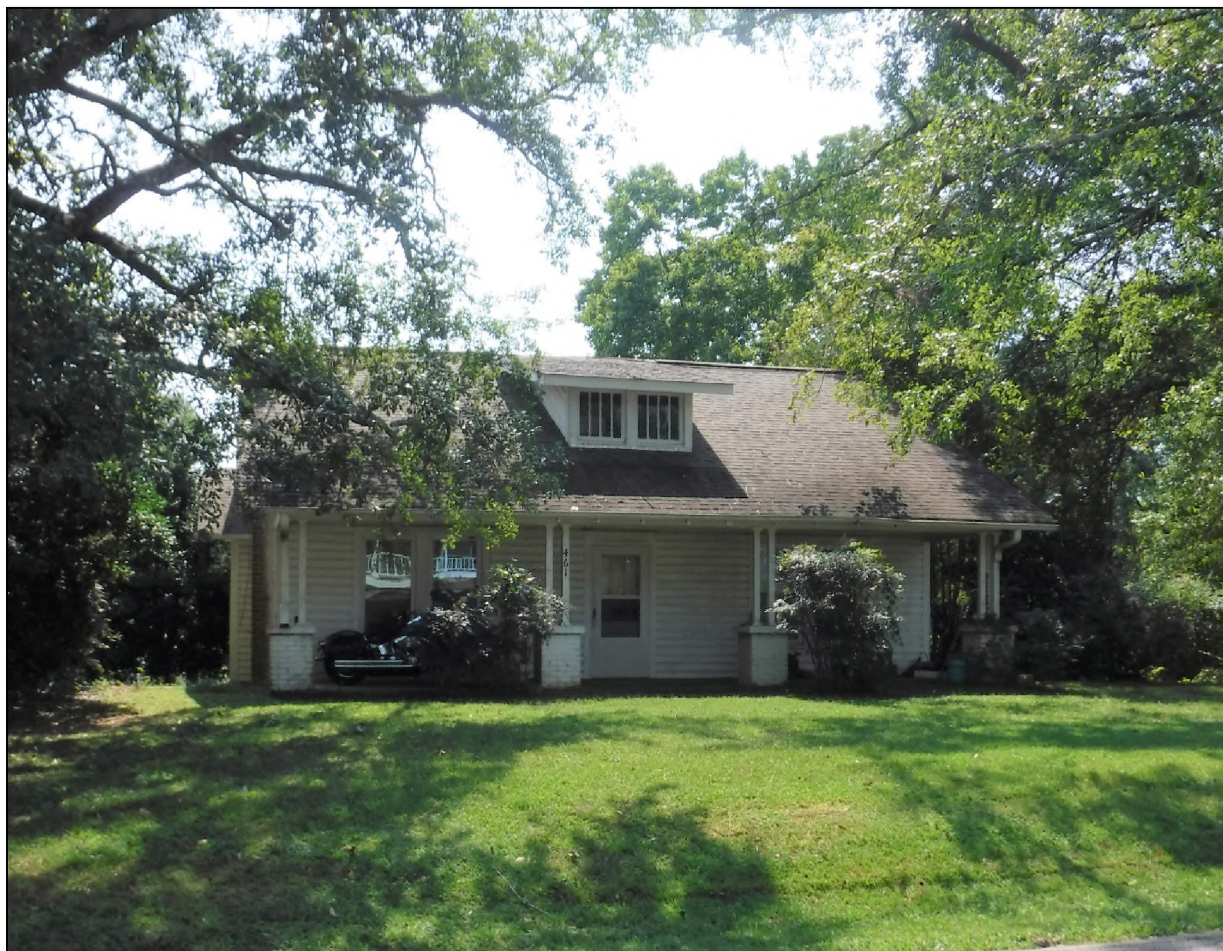
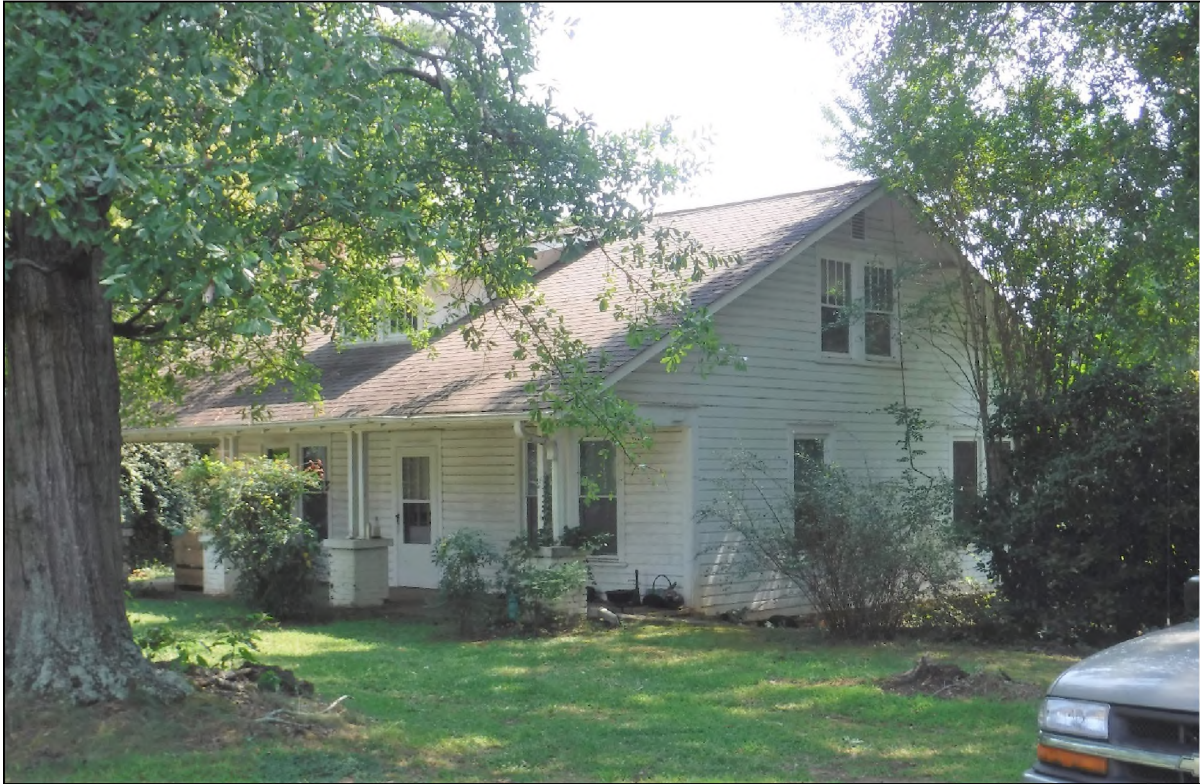
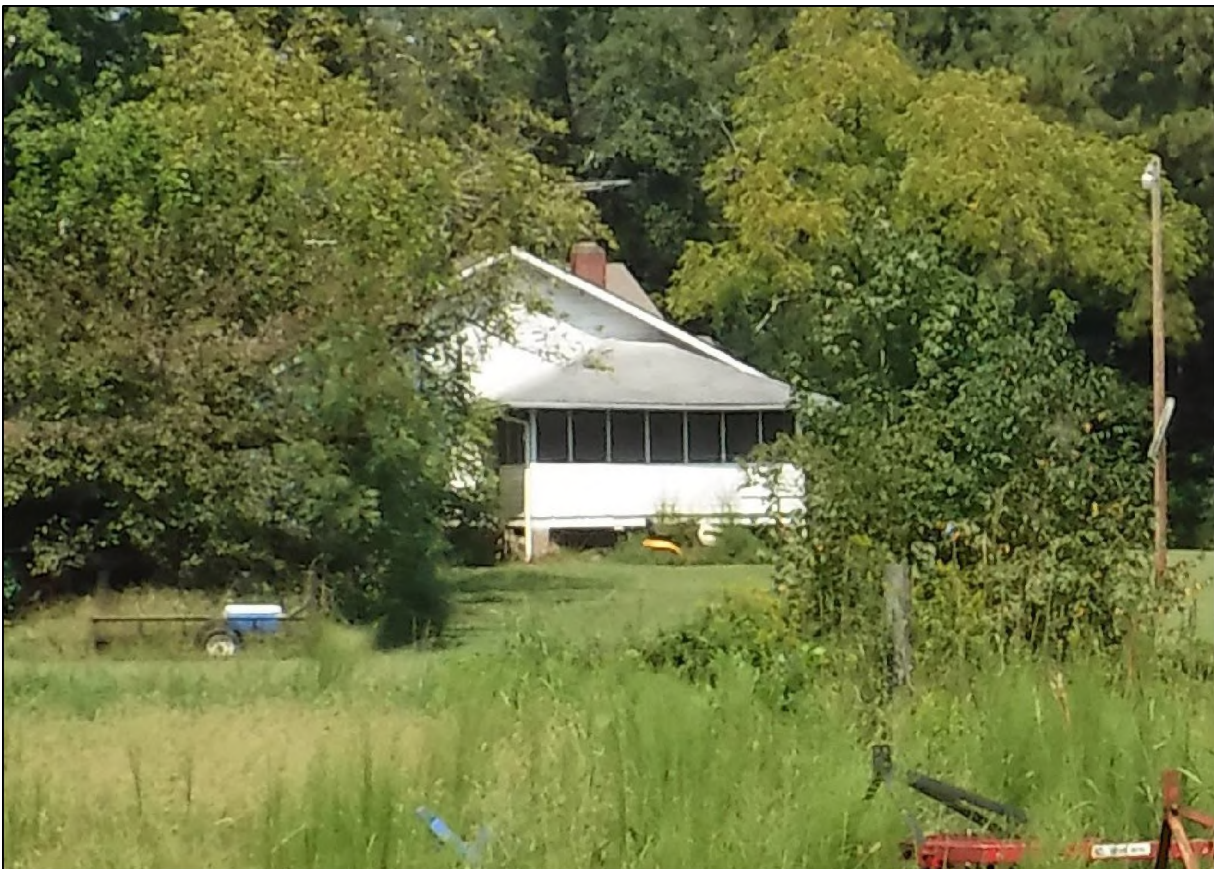
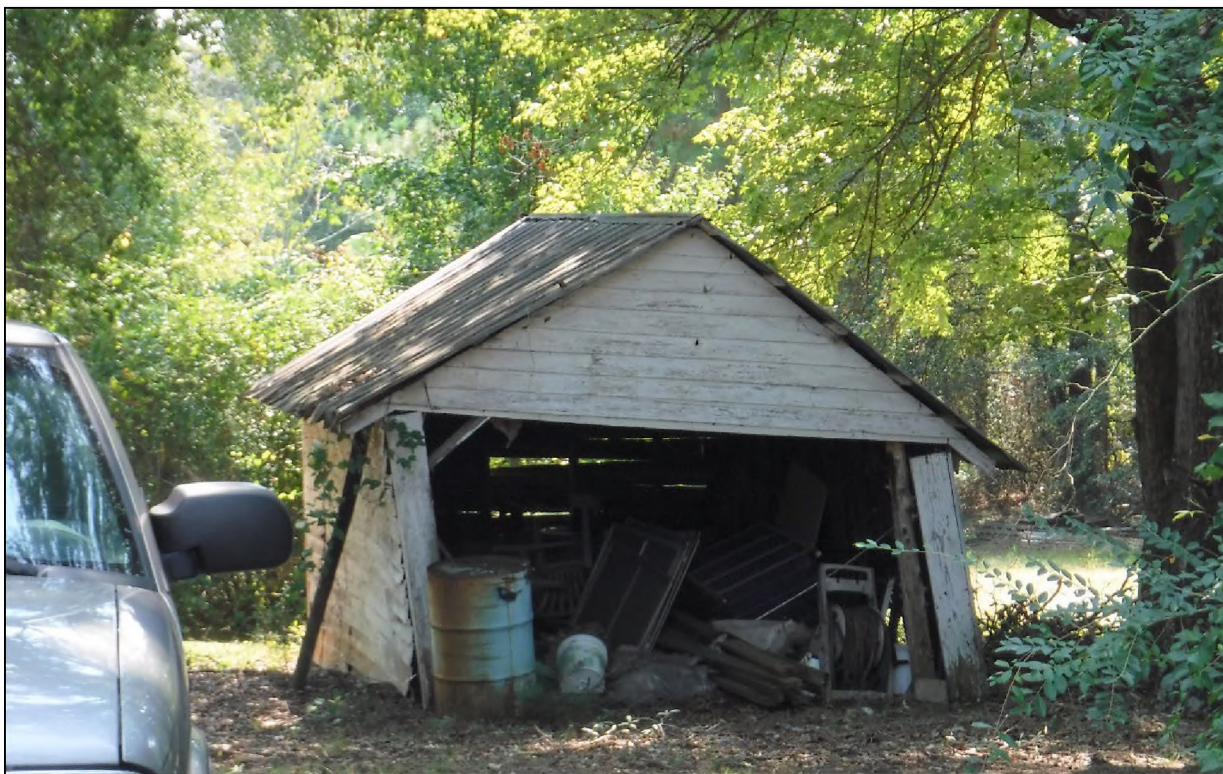
This is a circa 1935-1945 one story, side gabled bungalow fronting Ballenger Road (Figures 8-10). It is occupied and in good condition. It is on a five acre parcel bounded on the west and south by the proposed development tract. The house has a side gable asphalt shingle roof with front shed roof dormer. There is a rear wing with a rear facing gable and small east side projection with a side gable roof. Exterior cladding is weatherboard and the foundation is continuous brick. The asphalt shingle roof has exposed rafter ends. There is an exterior gable-end brick chimney on the east side and two interior brick chimneys within the roof slope of the rear wing. The integral front porch is full width, one story with twin wood posts on brick piers. The floor is poured concrete with no visible foundation. The central front door is wood panel with glass lights that appears to be original. A storm door has been added circa 1980-1990. The windows are wood, double hung, with one over one lights and flat arches. The dormer has two fixed wood windows, flat arched, with four vertical lights. The side gable attic windows are wood, double hung, flat arched, with four over one lights. The partial width rear porch may be a later addition or a circa 1980-1990 replacement. It is one story with a half hip roof and enclosed with wood apron and screening. The porch foundation is concrete block piers. The door and steps are not visible but are presumably on the east side. There is a circa 1935-45 one story garage west of the house (Figure 11). It has a front gable standing seam metal roof with exposed rafters. Exterior cladding is weatherboard and the floor may be dirt. The garage is in poor condition. The house was originally evaluated as eligible for the NRHP under Criterion C (Wilson-Martin 2019) however, upon SHPO review it was re-evaluated as not eligible for the NRHP (Appendix I).

Figure 8. 461 Ballenger Road (SHPO Site No 1465) front façade, view facing south

Figure 9. 461 Ballenger Road (SHPO Site No. 01465) view facing southeast

Figure 10. 461 Ballenger Road (SHPO Site No. 1465) rear façade, view facing north

Figure 11. 461 Ballenger Road (SHPO Site No. 1465) garage view facing south

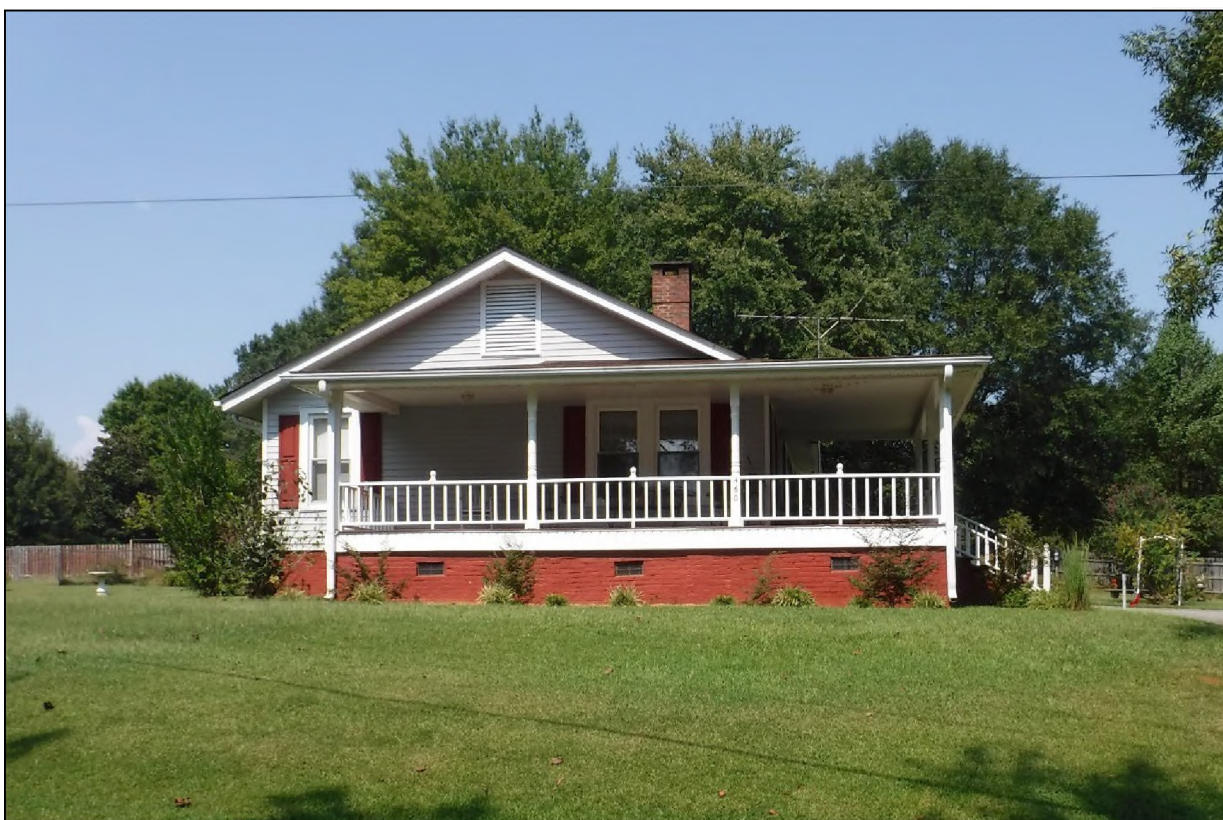
This is a circa 1935-1955 front gabled bungalow fronting Ballenger Road (Figure 12). It is occupied and in good condition. It on small parcel on the north side of the road opposite the development tract. The roof has asphalt shingles with boxed eaves enclosed with vinyl. There is a brick chimney with a chimney cap within the roof slope. Exterior cladding is vinyl siding and the foundation is continuous brick. The windows are modern replacements and are double hung with one over one lights. The front porch wraps around the north facade. The porch is one story, with a shed roof with wood posts, and a decorative railing. The main entry is on the north façade. The door is not full visible but appears to be a modern replacement. Architectural integrity is compromised by non-historic alterations including the vinyl siding and the porch therefore, it is recommended not eligible for the NRHP.

Figure 12. 460 Ballenger Road (SHPO Site No. 1466) view facing north

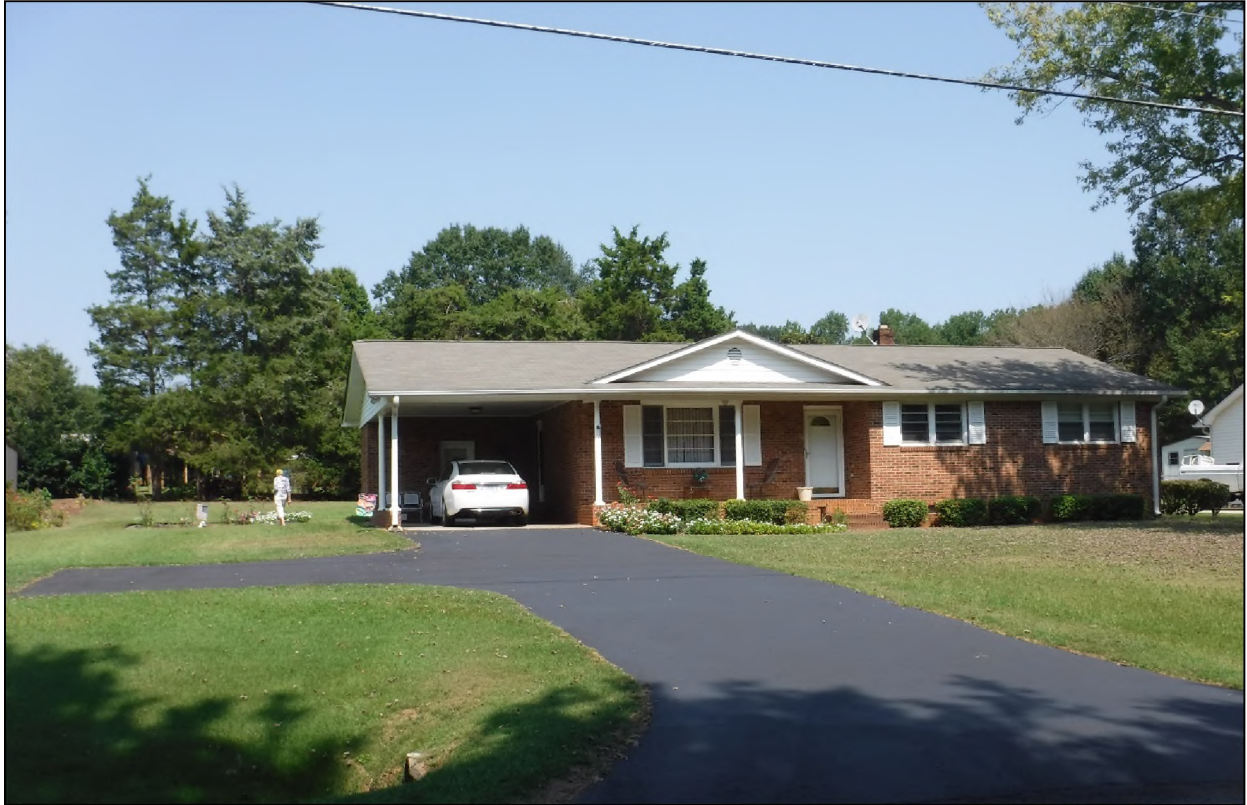
This is a 1970 one-story ranch house fronting Ballenger Road (Figure 13). It is occupied and in good condition. It is on small parcel on the north side of the road opposite the development tract. The parcel is maintained as lawn with foundation plantings, trees, and asphalt driveway. The foundation is continuous brick with a rectangular floor plan. The roof is crossed-gabled with asphalt shingles and boxed eaves. There is a brick chimney below the ridge line. Exterior cladding is brick veneer. Gables and eaves are covered in vinyl siding. The roof extends over an integral carport on the west elevation. The asymmetrical front façade has an integral, partial width porch with two turned post supports with a brick floor and brick steps. The offset entry is flanked by a fixed picture window with four lights. Other windows are double hung, with two over two lights that appear to be original. The front door is replaced otherwise alterations appear to be minimal however, this building is less than fifty years old and lacks enough distinctive characteristics to be considered a significant example of its type, period, or method of construction. Therefore it is recommended not eligible for the NRHP.

Figure 13. 480 Ballenger Road (SHPO Site No. 1467) view facing north

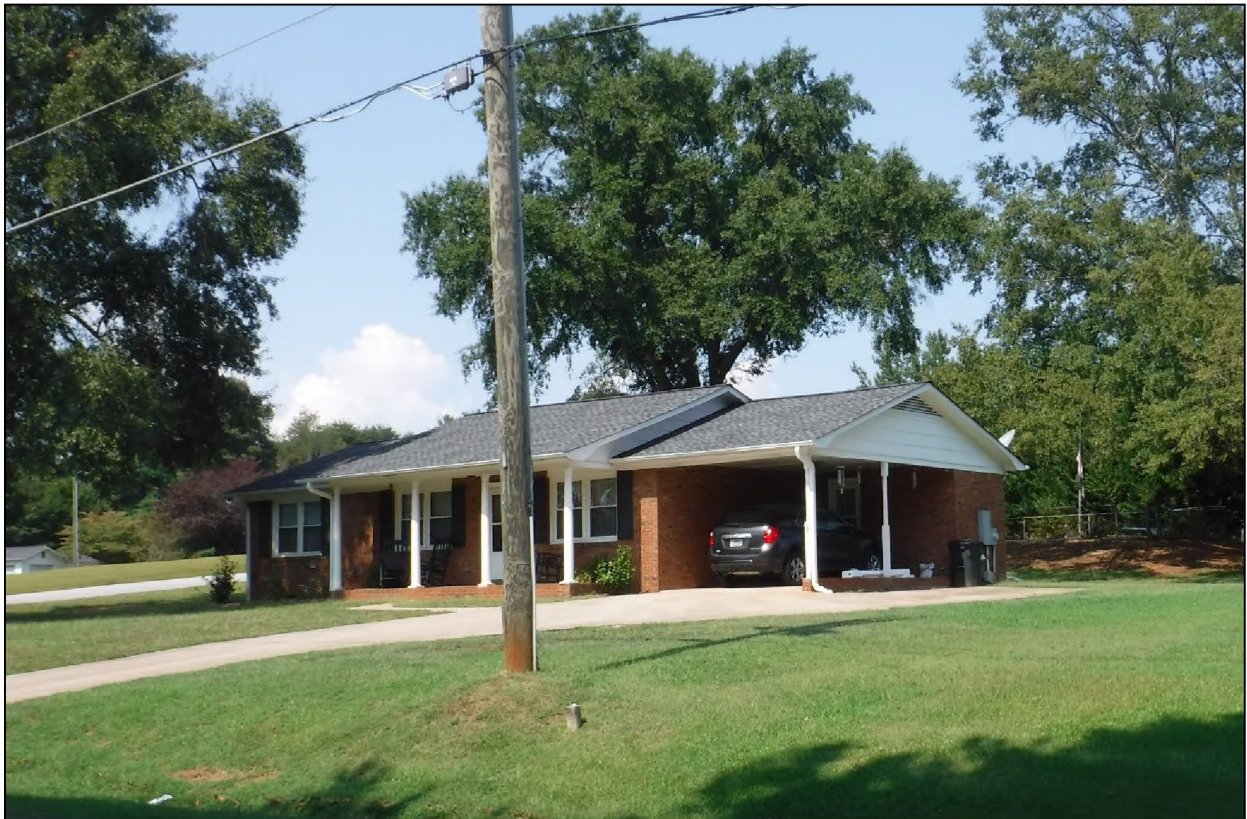
This is a circa 1968 one-story ranch house fronting Ballenger Road (Figure 14). It is occupied and in good condition. It is on a small parcel across the road from the proposed development tract. The parcel is maintained as lawn with foundation plantings, trees, a poured concrete paved driveway and in-ground swimming pool in the back yard added circa 1975. The house rests on a continuous masonry foundation with a rectangular floor plan. The roof is side-gabled with asphalt shingles and boxed eaves. Exterior cladding is brick veneer. Side gables and eaves are covered in vinyl siding. The roof extends over an integral carport on the east elevation. The symmetrical front façade has an integral, partial width porch, four turned post supports on a concrete floor. The central entry is flanked by paired, double-hung windows with one over one lights. Other windows include both paired and single double hung windows with one over one lights. Alterations include replaced doors and windows and removal of the original brick chimney. It lacks enough distinctive characteristics to be considered a significant example of its type, period, or method of construction. Therefore it is recommended not eligible for the NRHP.

Figure 14. 490 Ballenger Road (SHPO Site No. 1468) view facing northwest

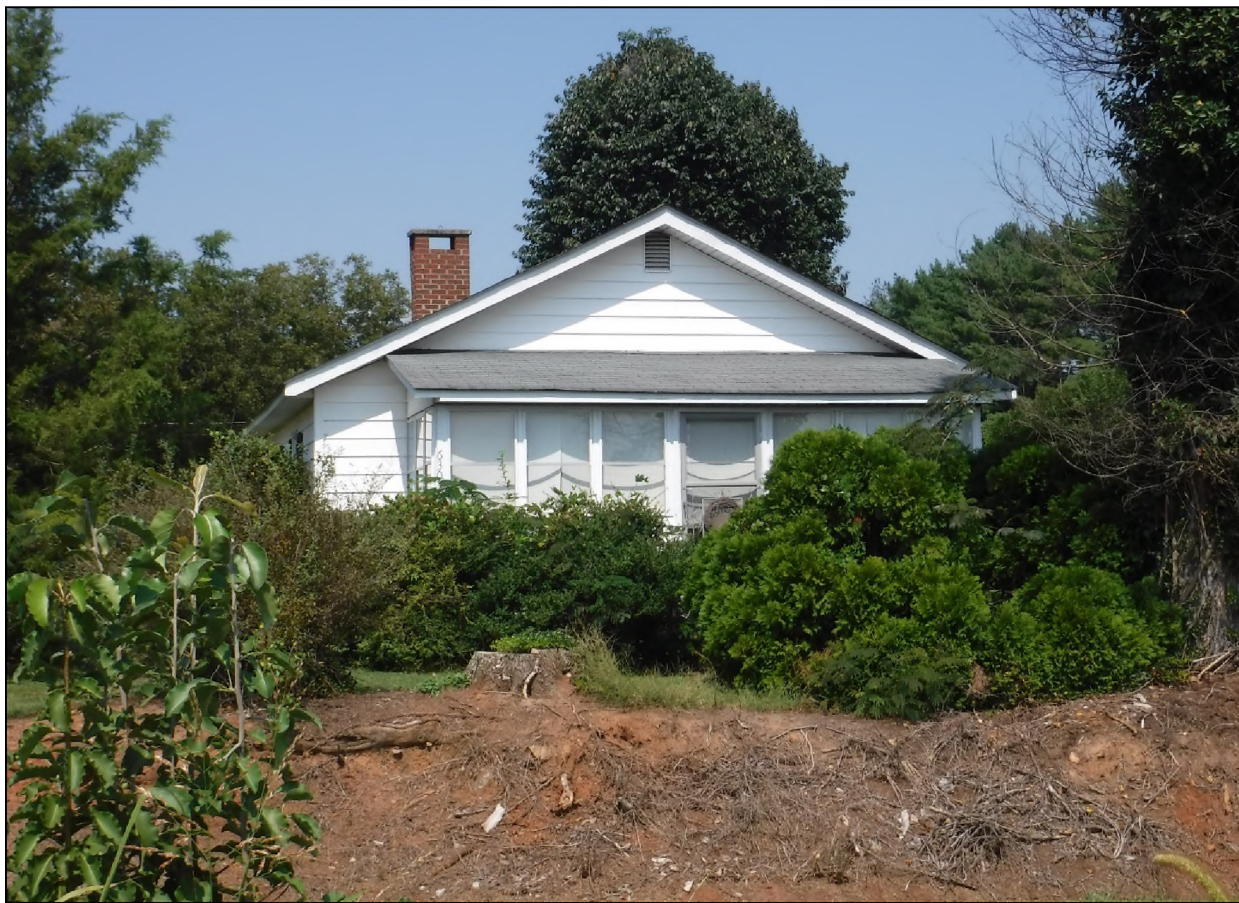
This is a circa 1945-1955 one story, front gabled bungalow fronting Ballenger Road (Figure 15). It is occupied and in good condition. It is on a 12.5 acre parcel across the road from the proposed development tract. The roof has asphalt shingles with boxed eaves enclosed with vinyl circa 2000-2010. There is a brick chimney with a chimney cap within the roof slope. There is a rear wing with a rear facing gable. Exterior cladding is vinyl siding added circa 2000-2010 and the foundation appears to be continuous concrete blocks. Windows are wood, flat arched, double-hung with one over one lights. The partial width front porch has been enclosed with metal windows circa 2000-2010, which may be storm windows. The porch is one story, with a shed roof, wood posts, wood brackets, and a wood apron. The porch

windows are flat arched, double-hung with one over one lights. The porch door is an asymmetrically placed storm door. The front door is not visible but may be asymmetrically placed to correspond with the porch door. The Tax Assessors sketch shows a northeast corner porch, which is not visible from the public road. Due to the alterations to the porch, and siding, the house has lost architectural integrity and would not be considered eligible for the National Register of Historic Places based on its architecture (Wilson-Martin 2019).

Figure 15. 630 Ballenger Road (SHPO Site No. 1469) view facing north
