# PHASE I CULTURAL RESOURCE SURVEY OF SC 557 FROM SC 55 TO WEST OF KINGSBURY ROAD PROJECT

YORK COUNTY, SOUTH CAROLINA

August 2, 2019 • **Final Report**  
New South Associates Technical Report 2928

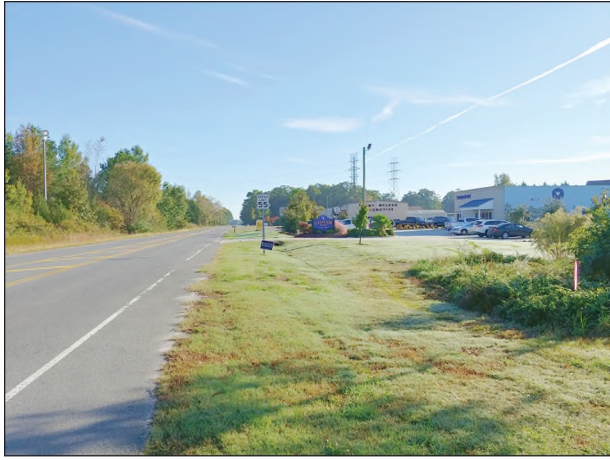
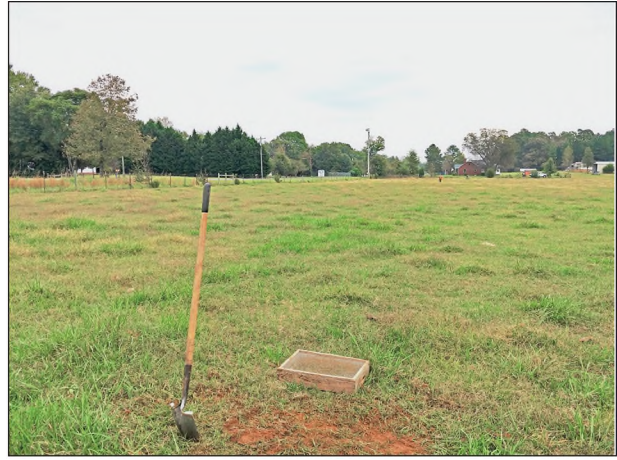
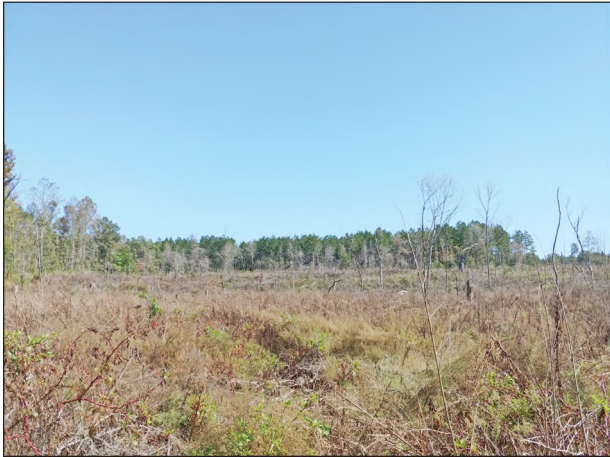
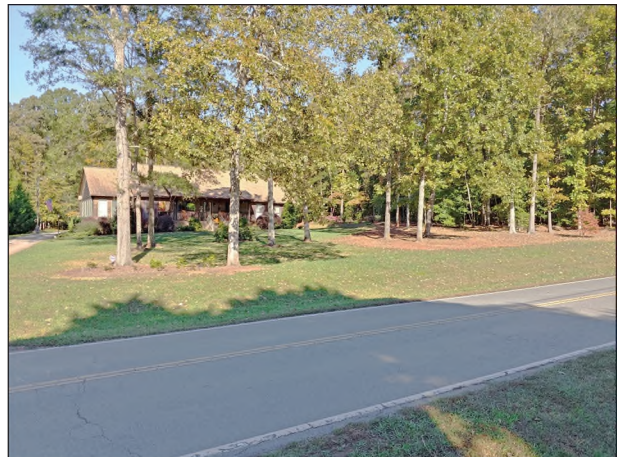
Figure 8.  
Typical Conditions Found in the Project Area

There were no previously identified archaeological sites found to be present within a half mile of the project area. The project area can be categorized into various landscape types, including residential, commercial, wooded, and agricultural (Figure 8). Multiple residential developments are scattered throughout the project area, and several small businesses are located around the western end of the project area, where SC 557 meets SC 55. The eastern end of the project area lies in planted pines, some of which had been recently harvested. Various smaller lots of planted pine trees are also present throughout the rest of the project area. Much of the central portion of the project area was agricultural land, including cattle fields, horse pastures, and cotton fields. These areas also contained scattered residences not associated with a singular development.

A. Commercial Development Along SC 557,  
View Northeast

B. Agricultural Field Along SC 557, View East

C. Recently Harvested Pine Stand Along SC 557,  
View Northeast

D. Residential Area in the Project Area, View West

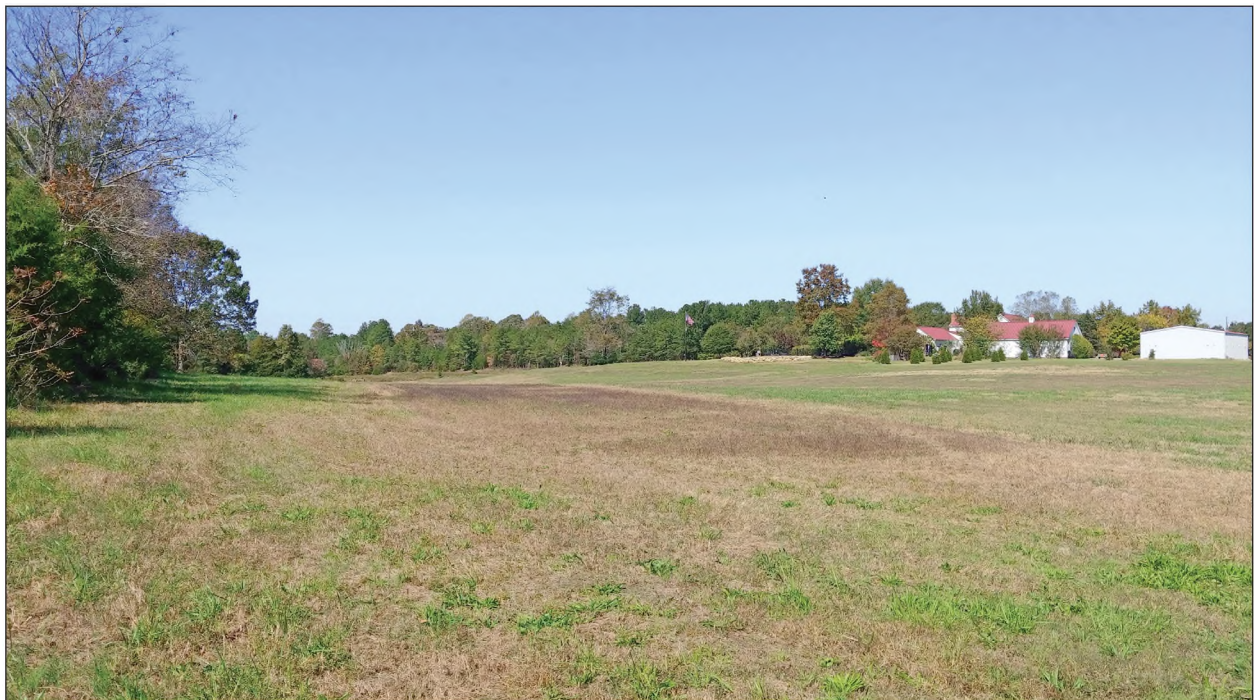
Figure 9.  
Map and Photograph of Site 38YK605

Site 38YK605 is a historic artifact scatter which spans roughly 2,600 square meters. It is located on the northwest side of SC 557, in a hay field just south of the intersection of SC 557 and Bate Harvey Road (Figure 9). Topographically, the field in which the site sits has a gentle slope downward from its northwest corner towards the southeast. At the time of survey, the field was recently harvested for hay and ground visibility was above 90 percent (see Figure 9b). The site was first identified during systematic shovel testing by observation of multiple artifacts on the surface.

A. Map Showing Site 38YK605

B. View North

At the time of survey, a discoloration was observed in the vegetation in the shape of a long strip roughly 25 meters wide and extending northward perpendicularly from SC 557 for several hundred meters (see Figure 9b). In talking to the landowner, it was revealed that this portion of the field had been leveled for the creation of a private landing strip suitable for a small, private airplane. This runway extended into the area of highest artifact concentration at the site. Based on the level of ground disturbance visible, it is likely that the alteration of this area pushed most of the artifacts out of context and into portions of the field with which they had no primary association.

The site has experienced significant disturbance due to cultivation and land alteration for a landing strip, and the only subsurface deposits of cultural material is within the plow zone. Local informants indicated that the site is located on what was once a much larger farm property, and may have been associated with a tenant farmer during the earlier part of its history. Historic research revealed a building, which first shows up on the 1947 USGS 7.5 minute quadrangle of Clover, South Carolina, at the location of the site (Figure 10). This building can also be seen on aerial photography from 1949 (Figure 11). Because the building is not on a 1939 county map nor is it seen on a later 1973 area photograph, it is likely that this building was constructed in the early 1940s and was demolished by the early 1970s.

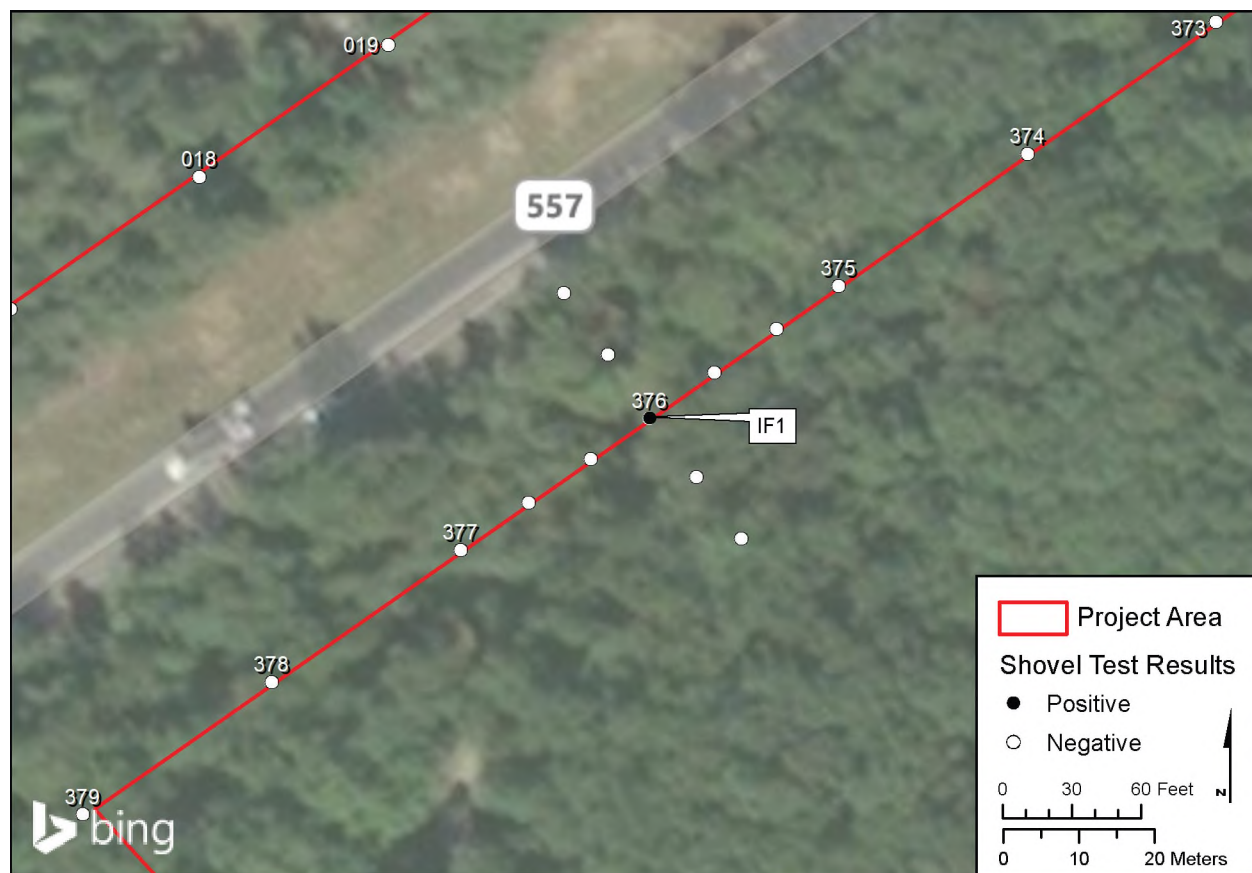
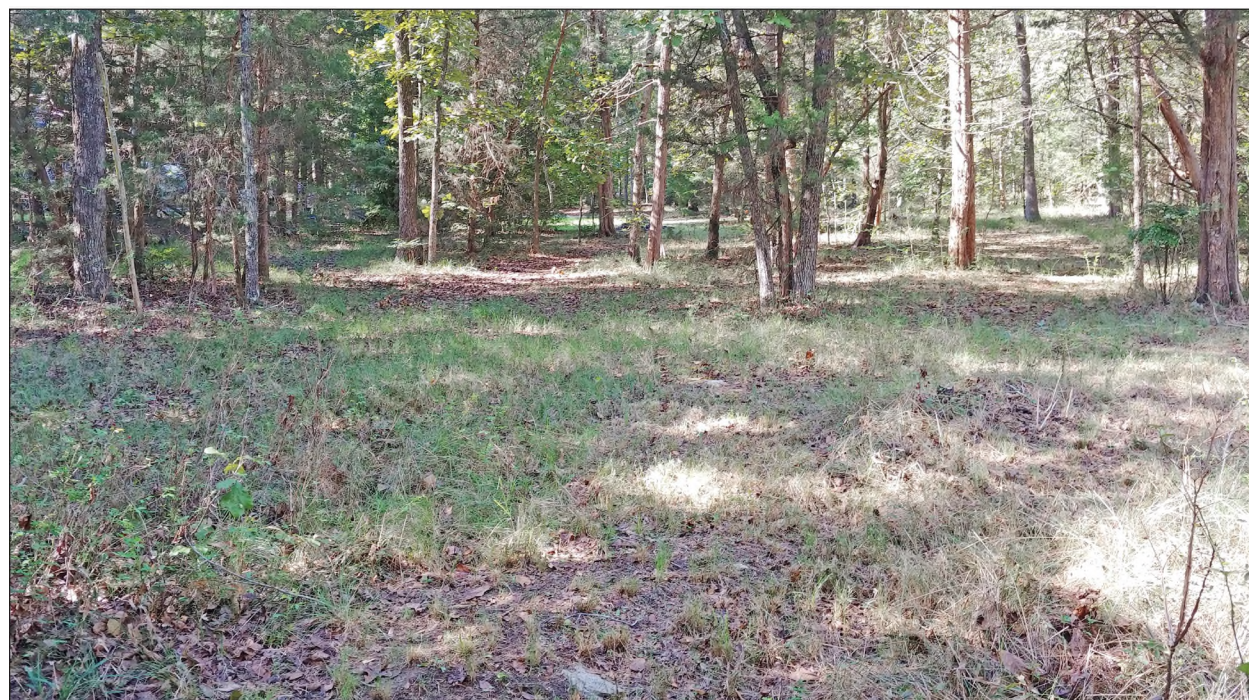
Figure 12.  
Map and Photograph of Isolated Find 1

Upon identification of cultural material, delineation tests were excavated in a cruciform pattern oriented along the project area axes. Soil profiles across the area are 0-15 cmbs of a light brown (7.5YR 6/3) sandy loam, followed by 15-30 cmbs of a dark yellowish brown (10YR 4/6) sand, followed by 30-40 cmbs of a yellow (10YR 5/4) clay. No additional cultural materials were identified during testing. As such, IF 1 fails to meet the standard for classification as a site.

A. Map Showing Isolated Find 1

B. View Northwest

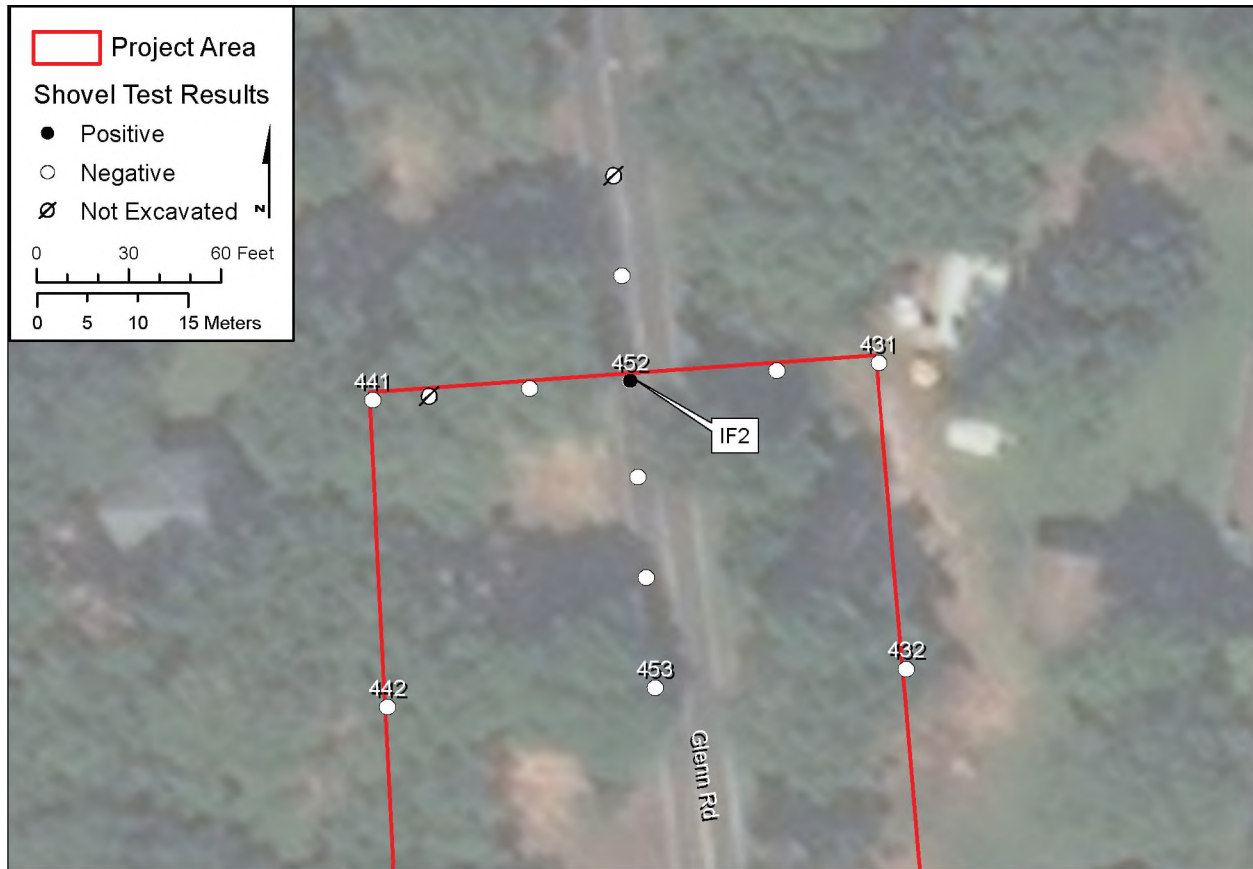
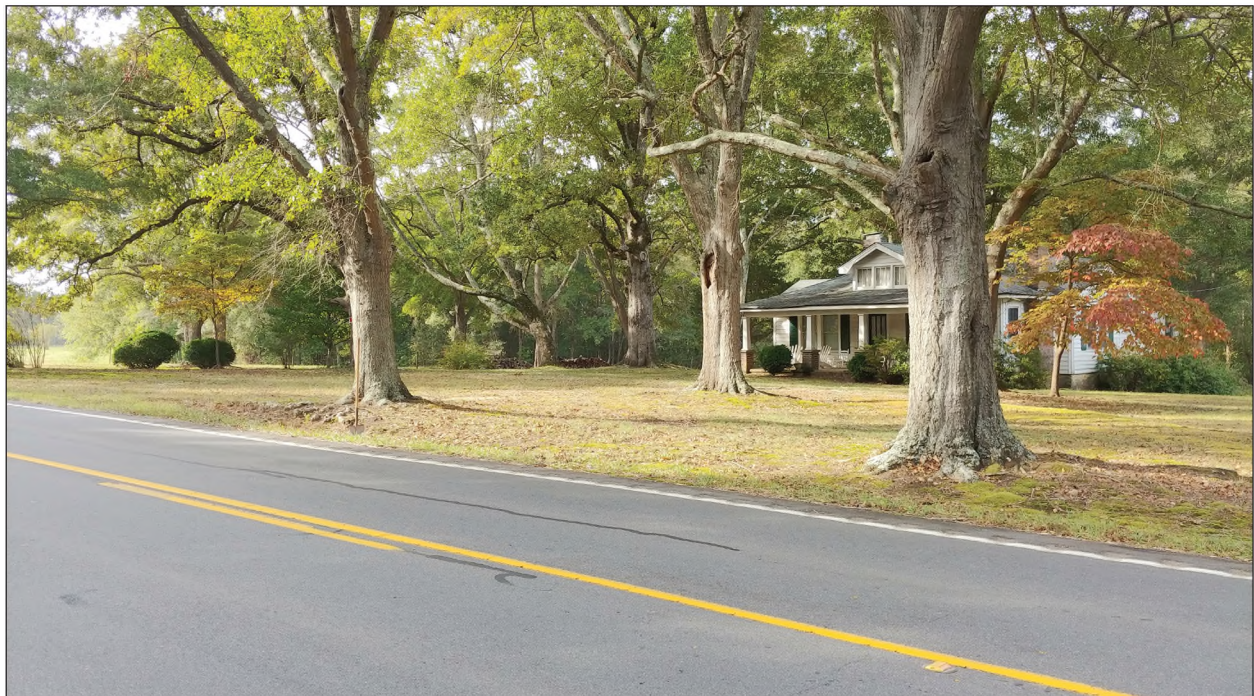
Figure 13.  
Map and Photograph of Isolated Find 2

Isolated Find 2 (IF 2) is comprised of a single shovel test within the project area along Glen Road/State Road 46-64 (Figure 13). Shovel test 452 produced one sherd of alkaline glazed stoneware and one piece of chimney glass from between 0 and 10 cmbs. The chimney glass was fractured into two at the time of excavation. This shovel test was located in a roadside gutter in front of a residence at the top of a hill. The surrounding terrain slopes gently to the north and south. Vegetation in the area is mature oak trees with exposed topsoil. Agricultural fields in the surrounding area showed evidence of recent harvest, but were recently planted in hay (see Figure 13b).

Upon identification of cultural material, delineation tests were excavated in a cardinal cruciform pattern to explore the bounds of the material deposit. Several of the tests were obstructed by the presence of a private driveway, and the eastern delineations were placed on the opposite side of the road from the initial positive. In some areas, the topsoil had eroded to the point that clay undersoil was visible. Generally, soils across the area were a light yellowish brown (10YR 6/4) clay loam from 0-10 cmbs, followed by a dusky red (10R 3/2) clay down to 20 centimeters. No other cultural material was recovered during delineation testing. Because the recovered material was identified in a roadside gutter, and the surrounding soils were heavily eroded, IF 2 was determined to be without sufficient context for classification as a site.

A. Map Showing Isolated Find 2

B. View West

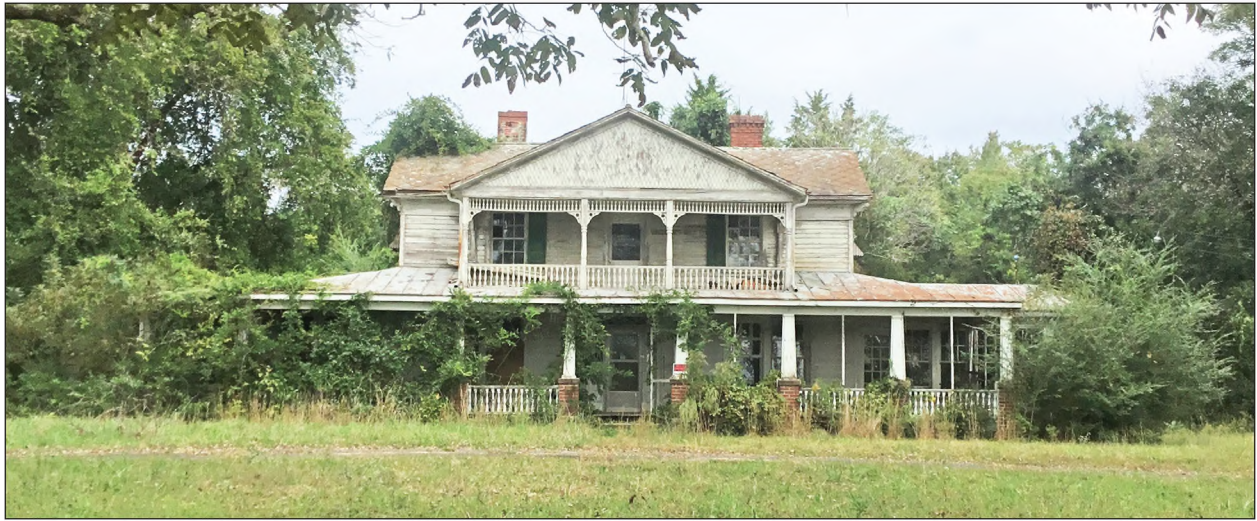
a. Resource 1371, Front Elevation

Resource 1371 is a Folk Victorian built in 1880 and has had recent alterations (see Figure 17a). The alterations include removal of the key Folk Victorian elements, replaced original wood windows with vinyl sashes and replaced original weatherboard with vinyl siding. It is also not known to be associated with any historic person or event.

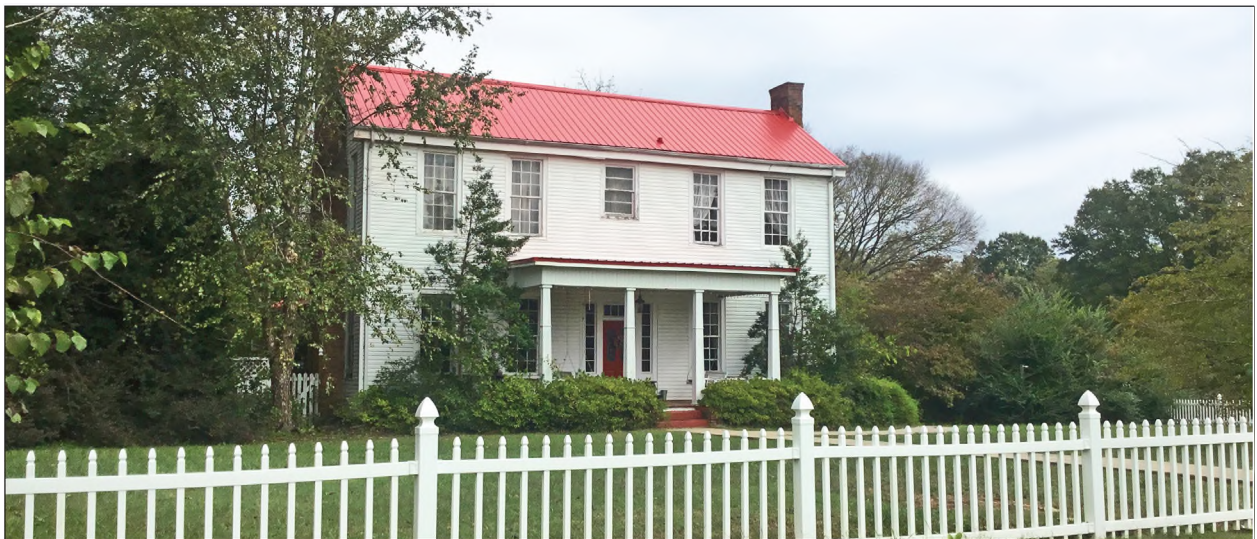
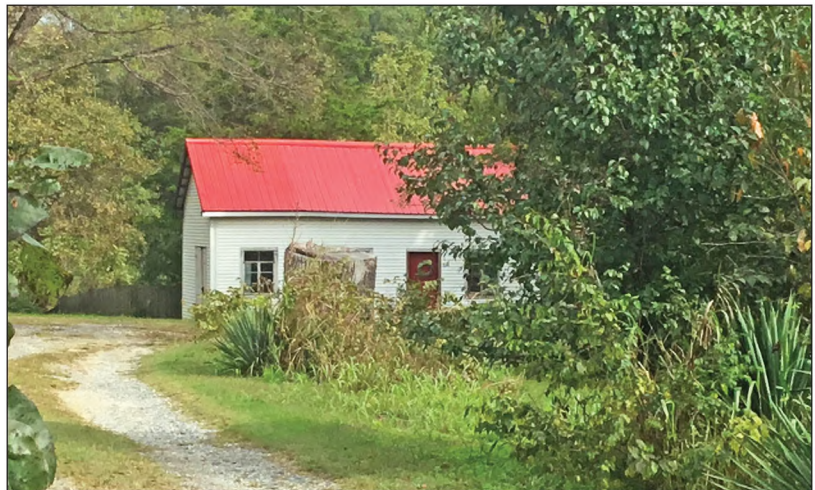
b. Resource 1577, Oblique

Resource 1577 is a standard two-story I-house built in 1820 that has had alterations since the 1992 survey (see Figure 17b). Alterations included additions that have altered the massing, replaced wood windows with vinyl sashes and replaced weatherboard with vinyl siding. It is also not known to be associated with any historic person or event.

b. Resource 1577's Outbuilding

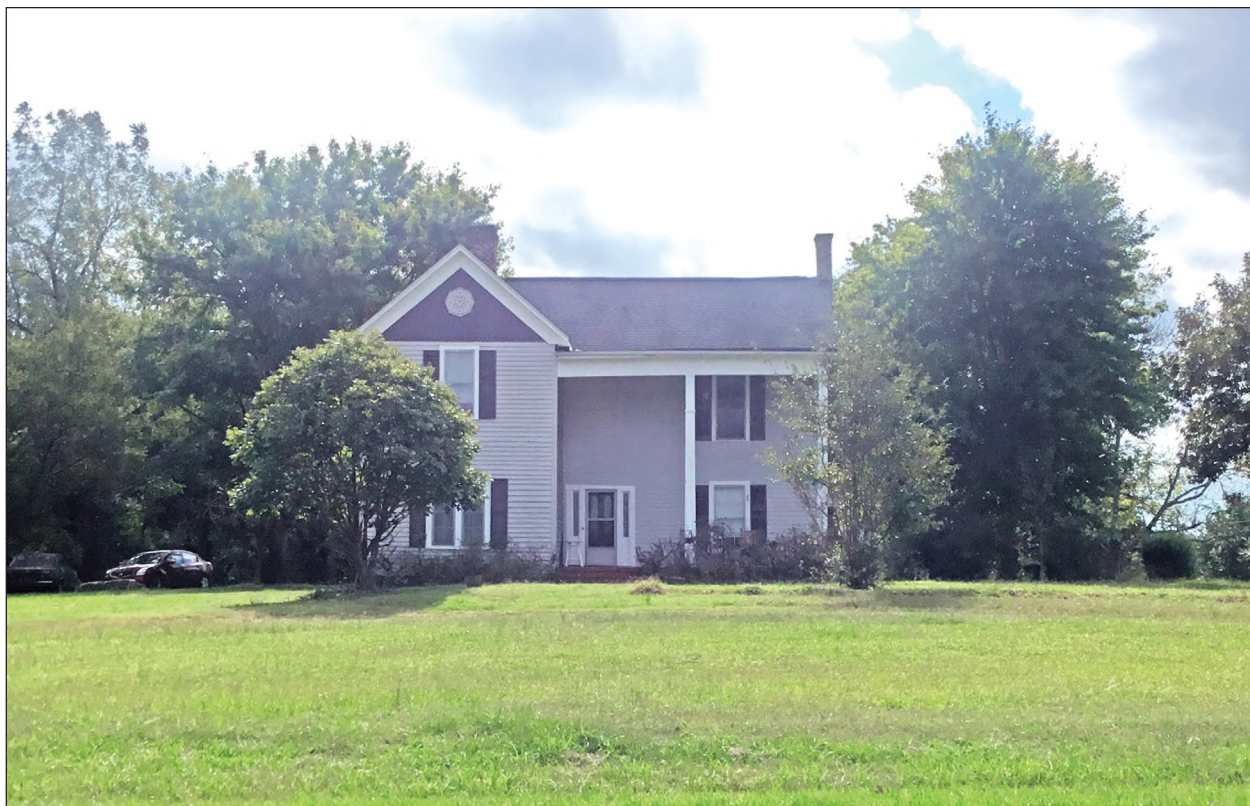
a. Resource 1578, Front Elevation

Resource 1578 is a Folk Victorian built in 1850 that has undergone alterations (see Figure 18a). These alterations include removal of the key Folk Victorian elements, replaced wood windows with vinyl sashes and replaced weatherboard with vinyl siding. It is also not known to be associated with any historic person or event.

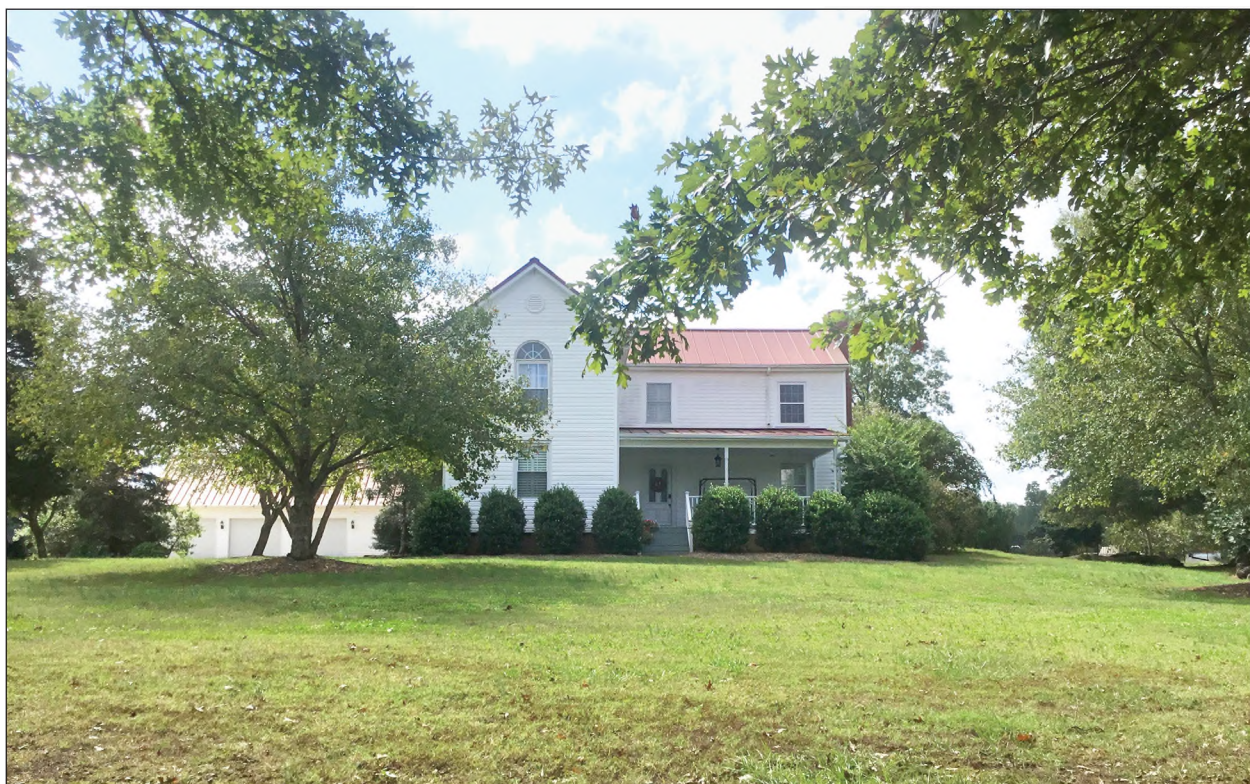
a. Resource 1580, Front Elevation

Resource 1580 was moved to its current location in 1983 and was found to not be eligible based on alterations and lack of setting integrity (see Figure 18b). Many of its Folk Victorian elements have been removed and only minimal characteristics of its original style remain.

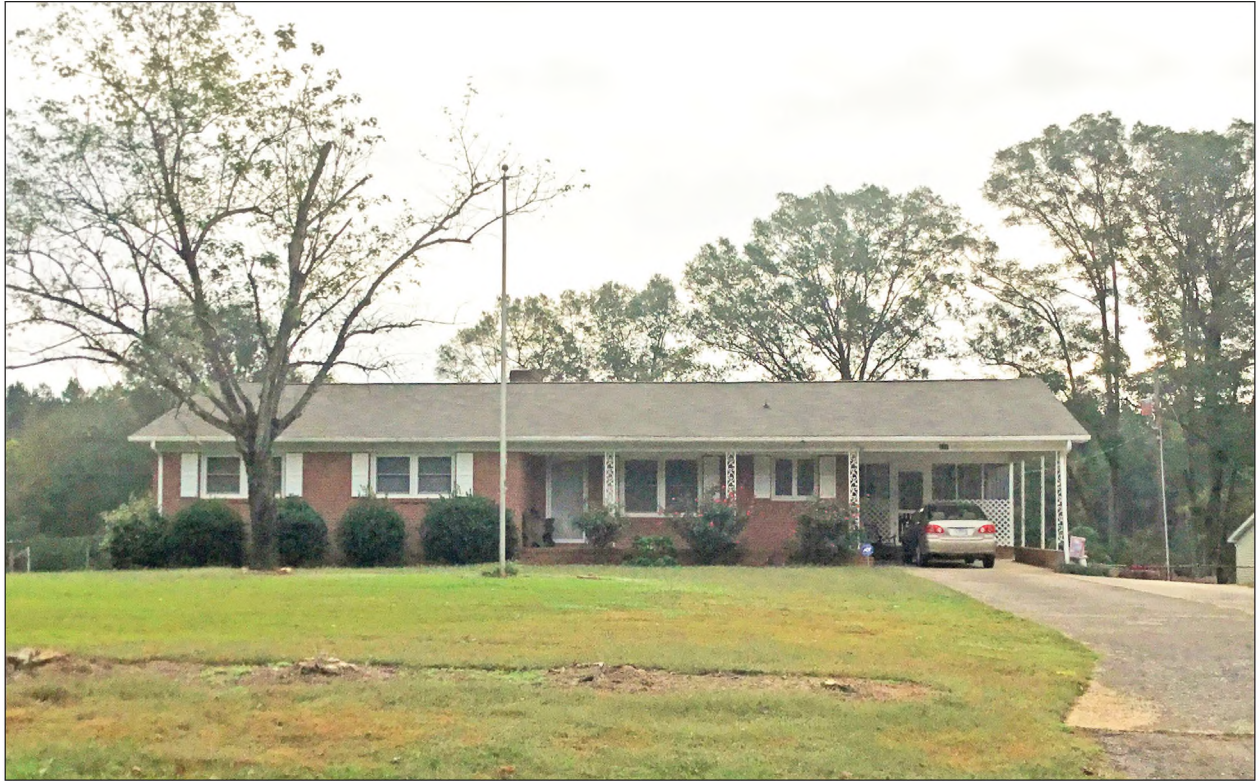
a. Resource 3891, Front Elevation

Resource 3891 is a Linear Ranch House built circa 1960 and is located at 176 Cross Road (Figure 19a). The resource is a one-story, rectangular residence clad in brick veneer with a lateral gable roof. The roof is covered in composition shingles and the gable ends are clad with pressboard. The engaged front porch is supported by decorative metal posts that extend to the

carport, which is located on the south elevation. The rear portion of the carport has been enclosed with screen and lattice. The resource also has an off-center interior brick chimney and the windows are vinyl replacement, one-over-one double hung sash windows.

The resource was not found to be significantly altered but does not embody a distinctive representation of its house type. It also does not represent the work of a master or possess high artistic value. It is not known to be associated with events or persons significant in the past. Therefore, the resource is recommended as not individually eligible for the NRHP under Criteria A, B, or C.

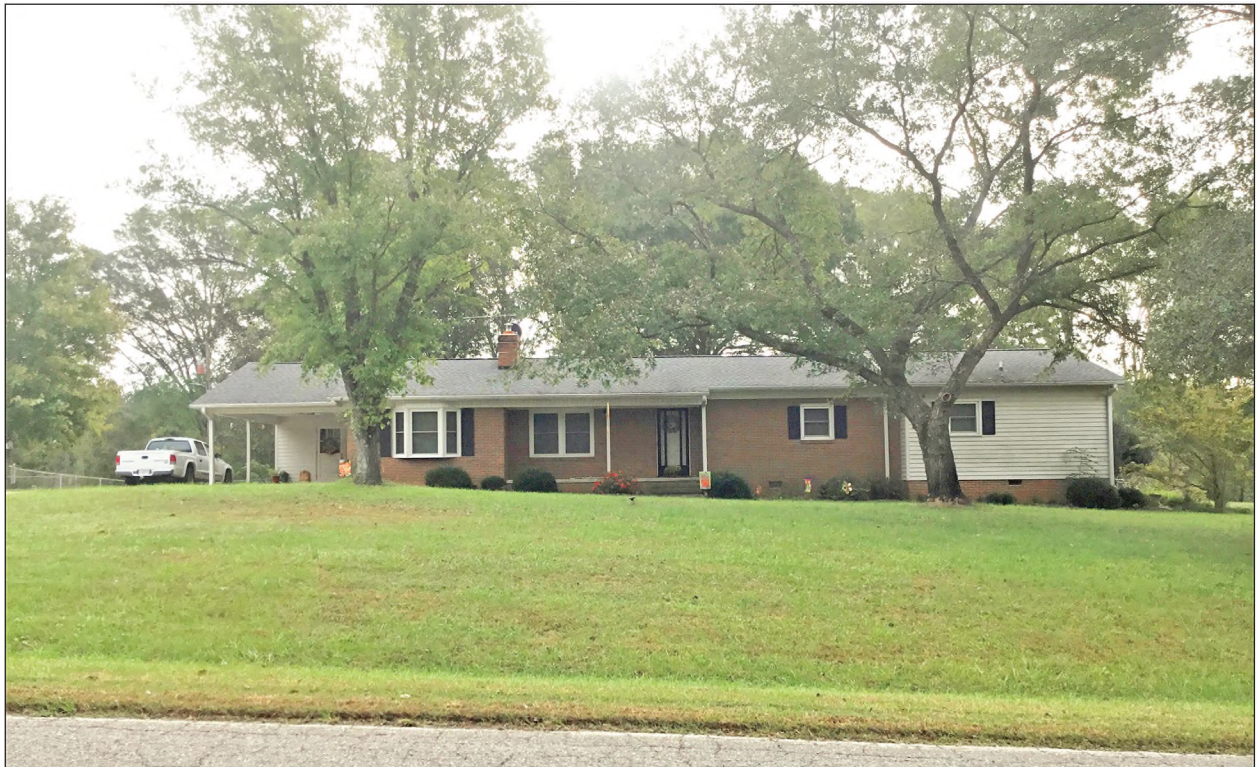
b. Resource 3892, Front Elevation

Resource 3892 has alterations that have slightly altered its appearance. The resource was not found to be significantly altered but does not embody a distinctive representation of its house type. It also does not represent the work of a master or possess high artistic value. It is not known to be associated with events or persons significant in the past. Therefore, the resource is recommended as not individually eligible for the NRHP under Criteria A, B, or C.

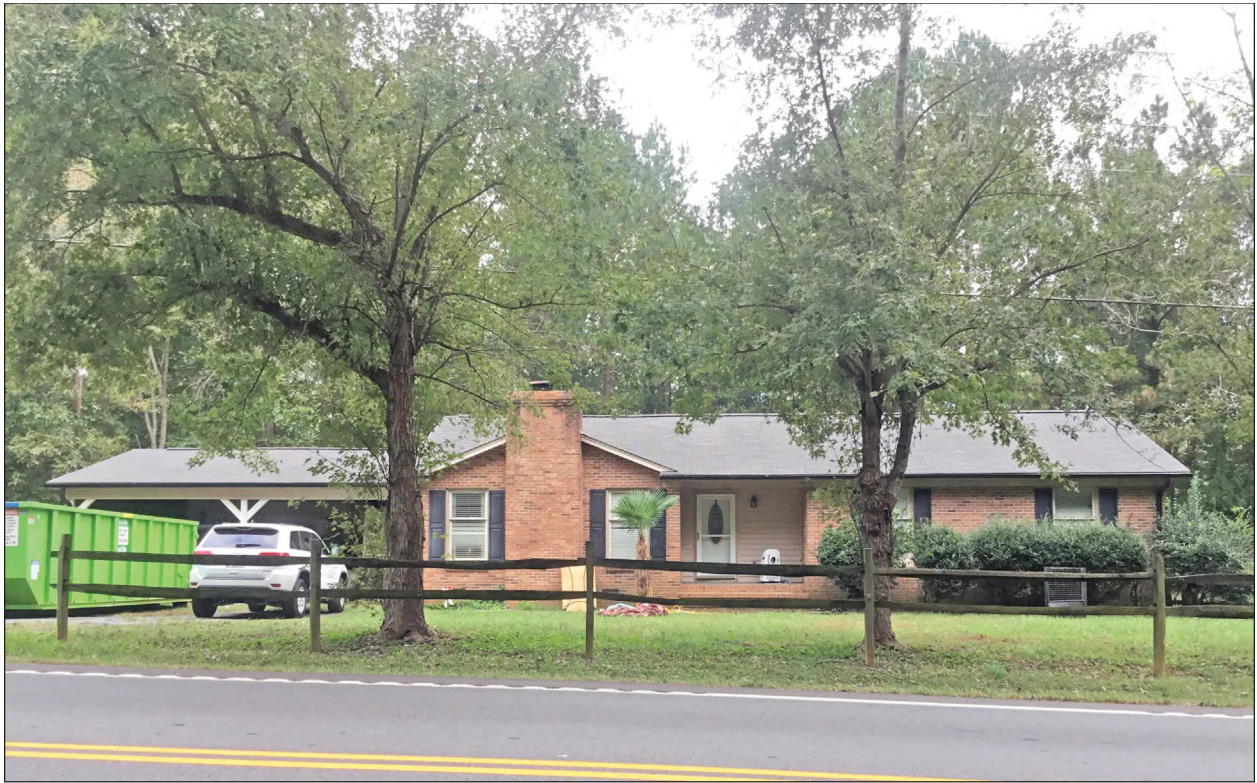
a. Resource 3893, Front Elevation

Resource 3893 is a Linear Ranch House, built circa 1960, located at 6728 SC 557 (Figure 20a). The resource is a rectangular, one-story residence, clad in brick veneer with a lateral gable roof. The roof is clad in composition shingles. The resource has a recessed porch that is clad with vinyl siding. On the south side of the front elevation is a front gable with a prominent exterior brick chimney.

The chimney is flanked by one-over-one double hung vinyl, sash windows which is common throughout elevations. The resource has an attached two-car carport on the south elevation that is clad in vinyl siding.

The resource was not found to be significantly altered but does not embody a distinctive representation of its house type. It also does not represent the work of a master or possess high artistic value. It is not known to be associated with events or persons significant in the past. Therefore, the resource is recommended as not individually eligible for the NRHP under Criteria A, B, or C.

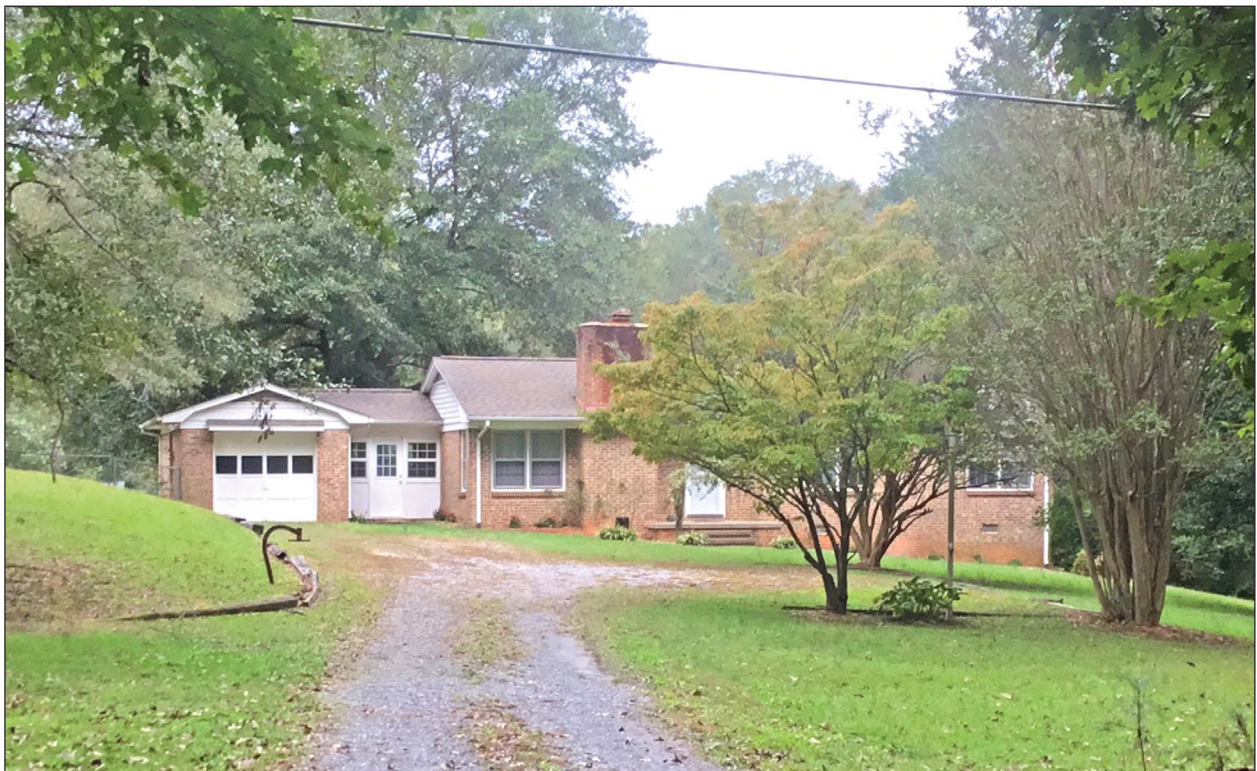
b. Resource 3894, Front Elevation

Resource 3894 is a one-story residence, built circa 1960, located at 6670 SC 557 (see Figure 20b). The resource is a linear building with a rectangular plan, clad in brick veneer, that has a lateral gable roof. The roof is covered in composition shingles and the gable ends are clad in vinyl siding. The front elevation features a prominent exterior slab brick chimney which is west of the recessed front entry. The windows are replacement six-over-six double hung vinyl sash windows. The resource has a one car garage attached to the west elevation of the resource via an enclosed walkway.

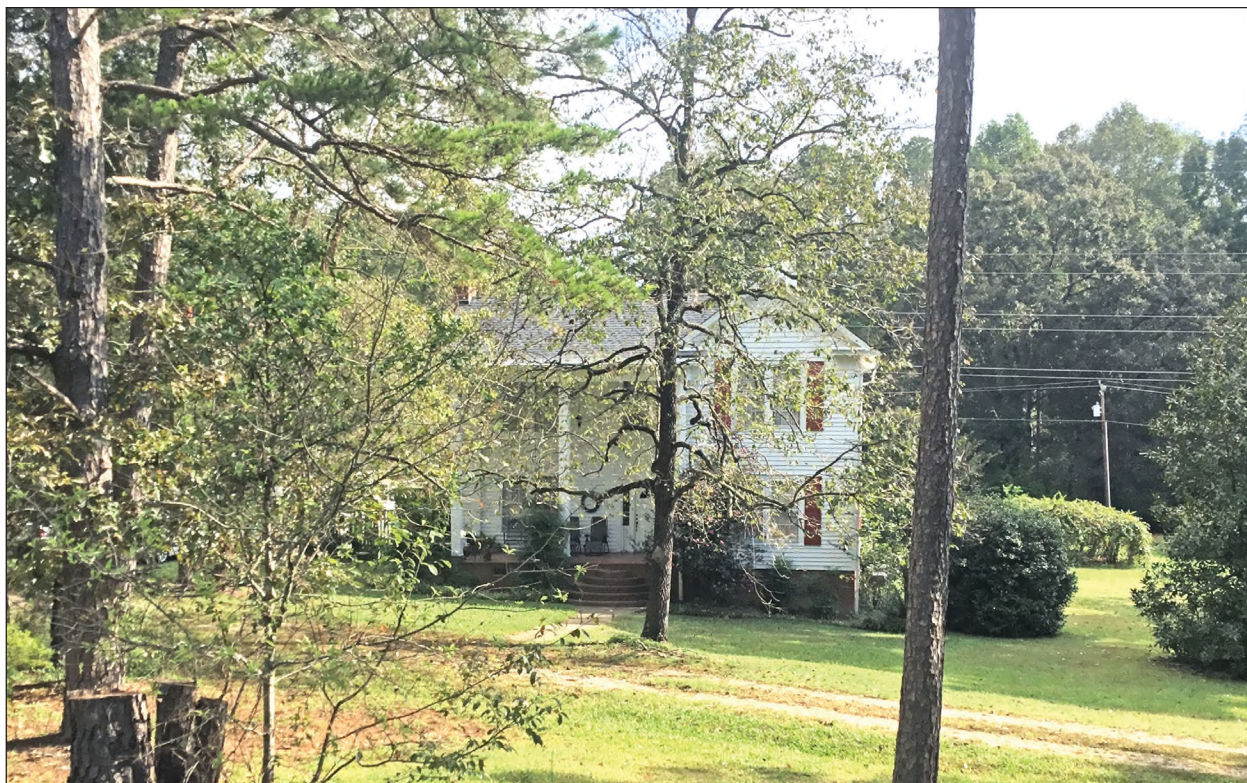
a. Resource 3895, Front Elevation

Resource 3895 is a two-story residence, built circa 1955, located at 162 Bethel Church Road (Figure 21a). The resource has an L-shape plan clad in vinyl siding with a gable front and side wing. The roof is clad in composition shingles. The front porch is full height with a shed rood supported by plain columns. The resource has two brick chimneys, one is located on the interior of the east elevation and the other is located on the exterior of the west elevation. The front entrance is flanked by single pane side lights with a half circle window in the center of the door.

The windows are non-historic, vinyl, six-over-six double hung sash windows. There is a detached double car garage located off the west elevation that is not historically associated with the main resource.

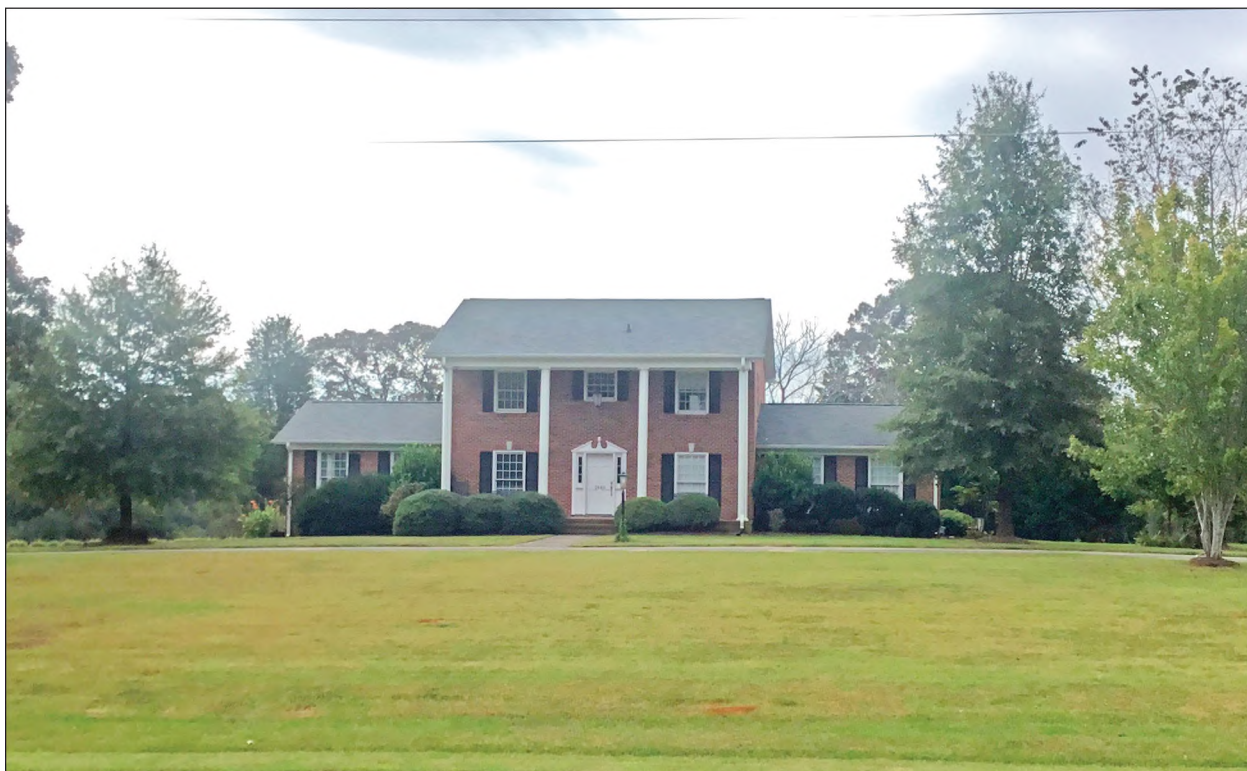
b. Resource 3896, Front Elevation

Resource 3896 is a Neoclassical Revival House, built circa 1950, located at 2445 SC 557 (see Figure 21b). The resource is a two-story rectangular house flanked by one-story side wings clad in brick veneer. It has a gable roof clad in composition shingles. It has a full-height portico which is supported by Greek revival columns. The front entrance has a Greek revival door surround with three-light side lights. The resource has large 12-over-12 vinyl windows throughout.

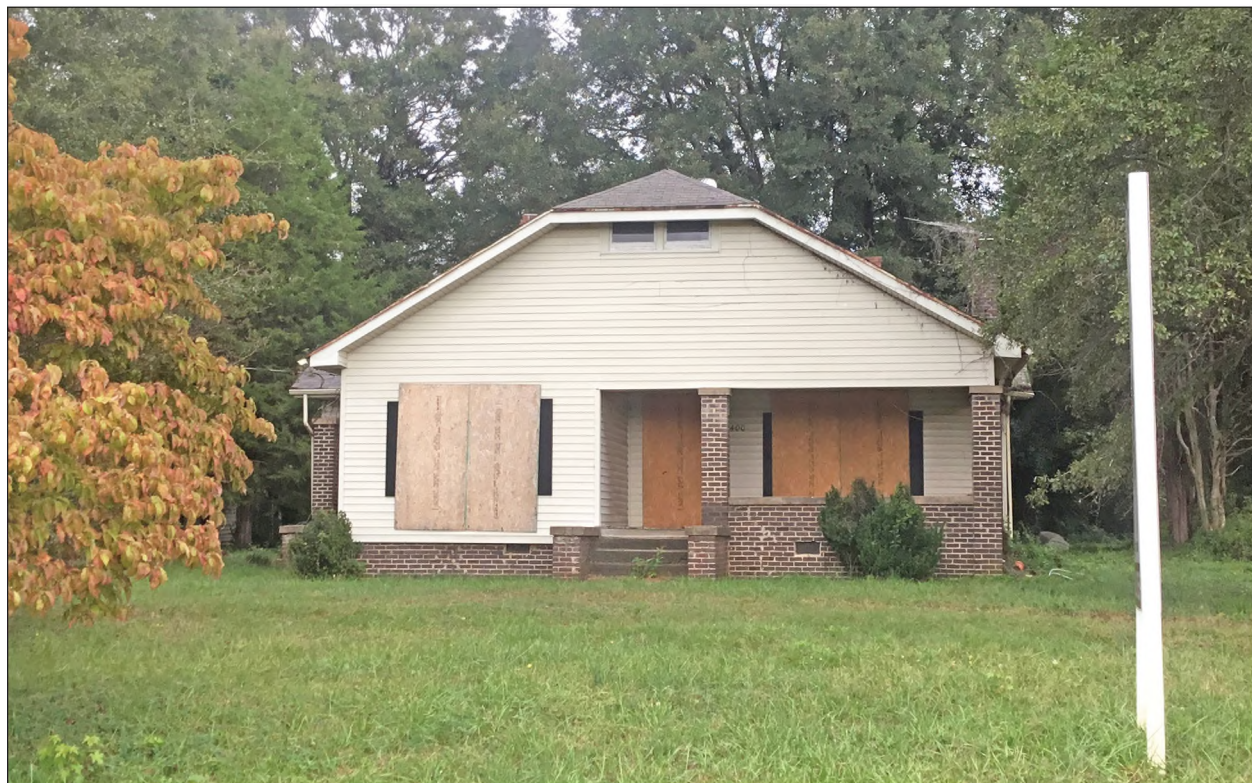
a. Resource 3897, Front Elevation

Resource 3897 is a Bungalow, built circa 1930, located at 2400 SC 557 (Figure 22). The resource is a one-story rectangular residence that sits on brick foundation and has a jerkinhead roof. The roof is clad in composition shingle and the exterior of the house is clad in vinyl siding. The partial front porch occupies the eastern side of the front elevation and is supported by brick columns. The east elevation has an exterior brick chimney and all of the windows and doors have been boarded over. An outbuilding was also located at the northwestern end of the house and was recorded as Resource 3897.01.

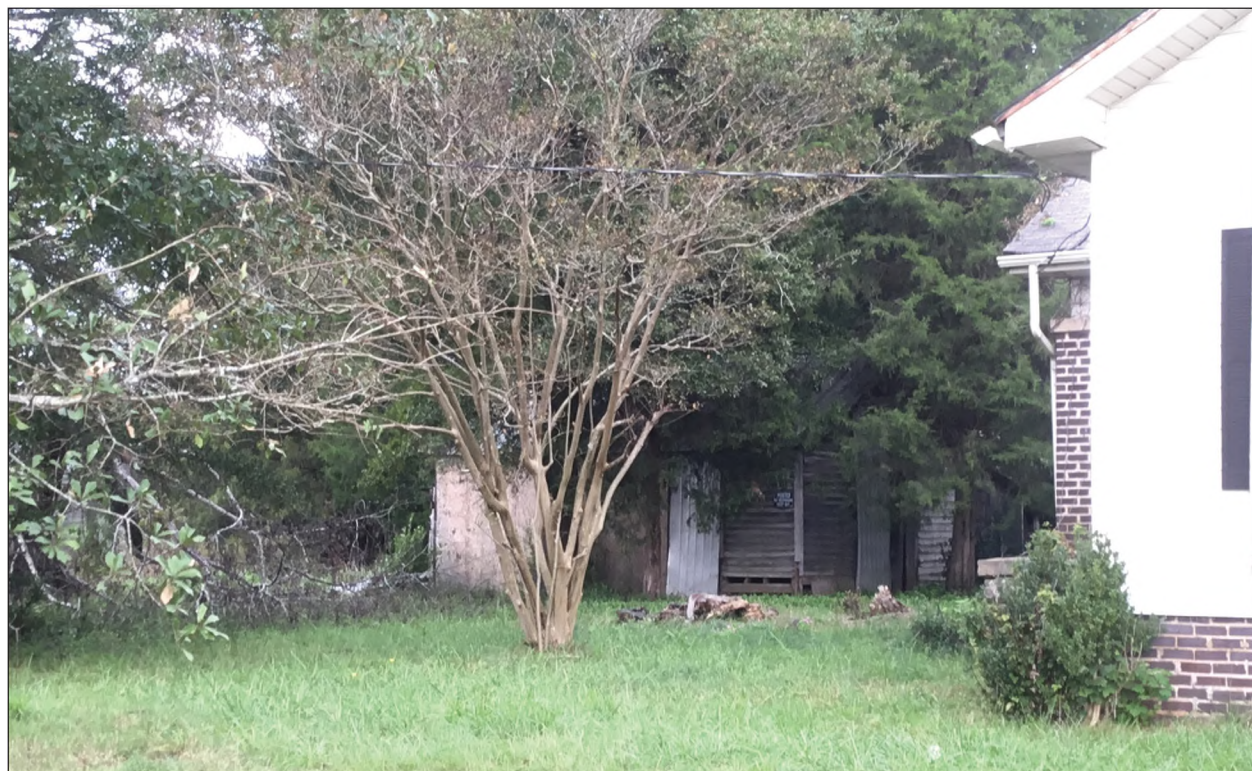
b. Resource 3897.01, Outbuilding

Resource 3897.01 is a small frame building located on the west rear portion of the lot. It has a rectangular plan with a gable roof. The roof is clad with metal and the exterior walls are encased with weatherboard. The building is non-historic and does not contribute to the main resource.

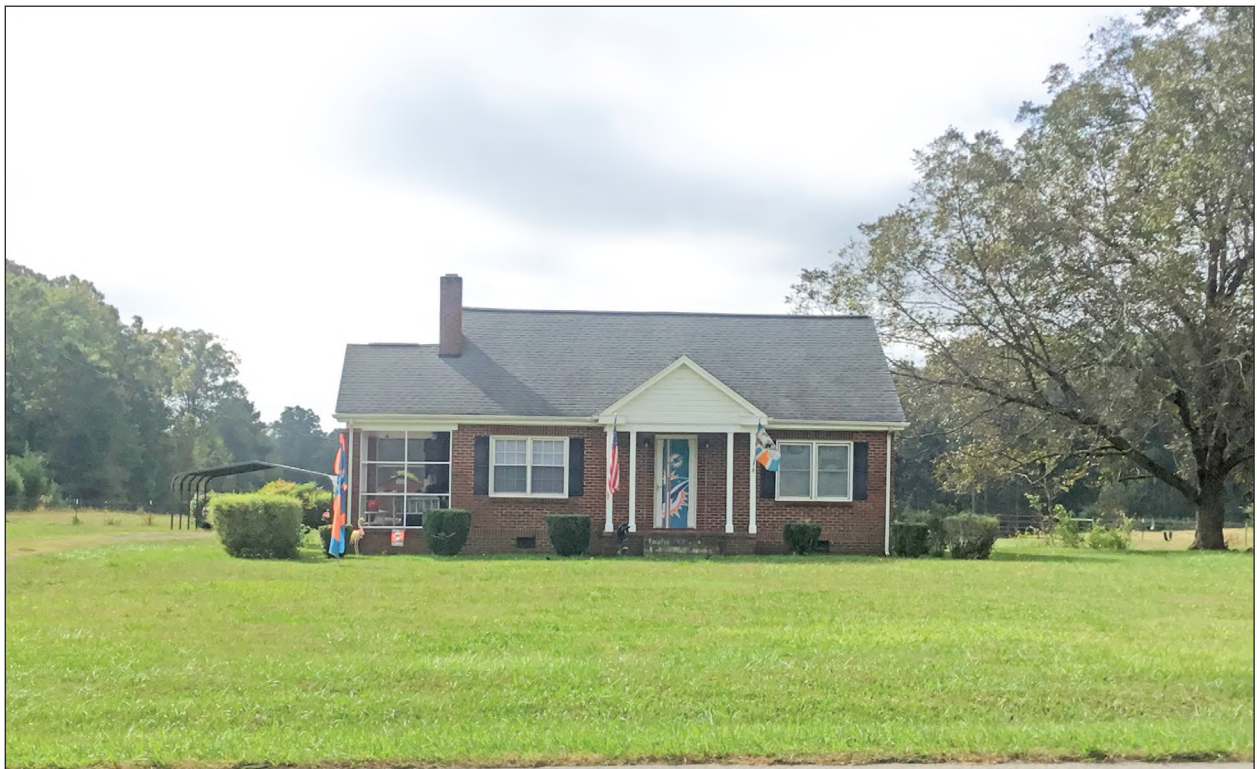
b. Resource 3899, Front Elevation

Resource 3899 is a Minimal Traditional house, built circa 1940, located at 2275 SC 557 (see Figure 23b). The resource is a one-story rectangular residence, clad in brick veneer, with a lateral gable roof. The roof is covered with composition shingles and the gable ends are clad in vinyl siding. The front entry porch has a gable roof supported by plain wood posts. The resource has an enclosed screen porch and an exterior brick chimney on the east elevation. The windows are non-historic six-over-six double hung sash windows.

The resource is located near rural residential development separated by open fields and the resource sits on a moderate size lot with some landscaping. There are planted bushes along the front façade and around the other elevations.
