# PHASE I CULTURAL RESOURCE SURVEY OF SC 557 FROM SC 55 TO WEST OF KINGSBURY ROAD PROJECT

YORK COUNTY, SOUTH CAROLINA

August 2, 2019 • **Final Report**  
New South Associates Technical Report 2928

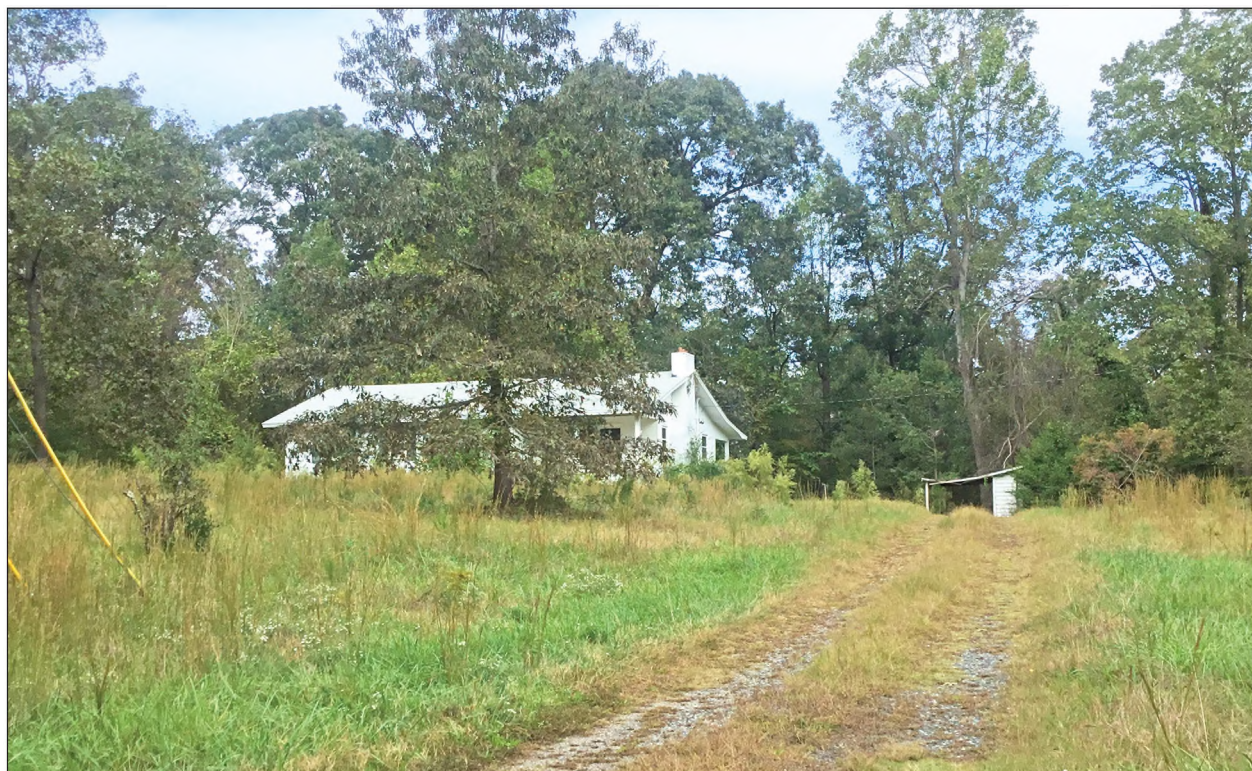
b. Resource 3901 and 3901.01

Resource 3901.01 is small shed located at the right rear corner of the property. It is a small rectangular frame building clad in weatherboard. It has a gable roof with an extended shed roof over the west elevation. The building is historic to the main resource.

The resources are located near rural residential development with fields and heavily wooded lots. The buildings sit on a moderate size lot that is overgrown with vegetation.

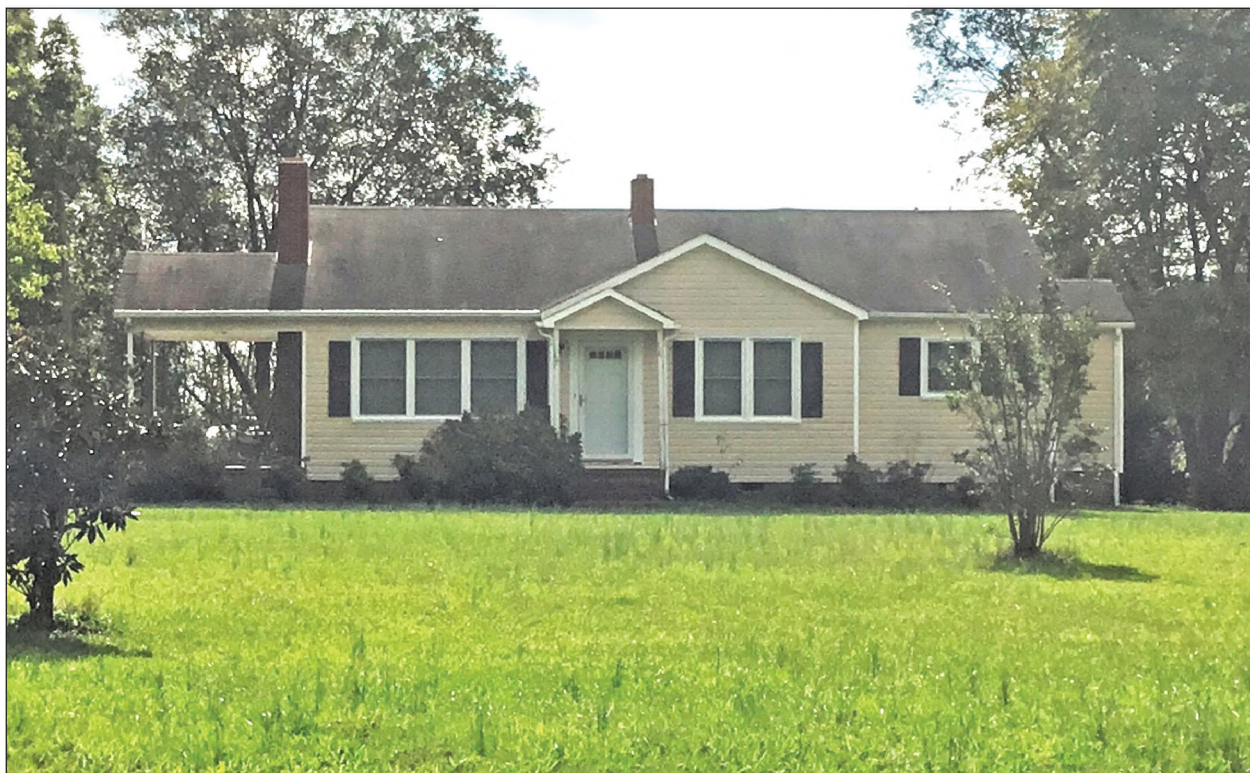
b. Resource 3903, Front Elevation

Resource 3903 is a Minimal Traditional, built circa 1940, located at 2091 SC 557 (see Figure 25b). The resource is a one-story residence with a rectangular plan, vinyl siding, and a lateral gable roof. The roof is clad in composition shingles and has a double gable on the front facade. The resource has two porches, the front porch has a front gable roof supported by plain posts while the east elevation porch has a lateral gable roof supported by decorative metal posts. There is one interior brick chimney and one brick chimney on the west elevation. The windows are vinyl replacement one-over-one double hung sash windows.

The building sits on a moderate size lot with some landscaping and sparse tree coverage. There are planted bushes along the front façade and around the other elevations. The driveway approaches from the west to the rear of the property. The resource is located near rural residential development with open fields. The viewshed of the resource has not been drastically compromised by commercial development and previous improvements to the road ways.

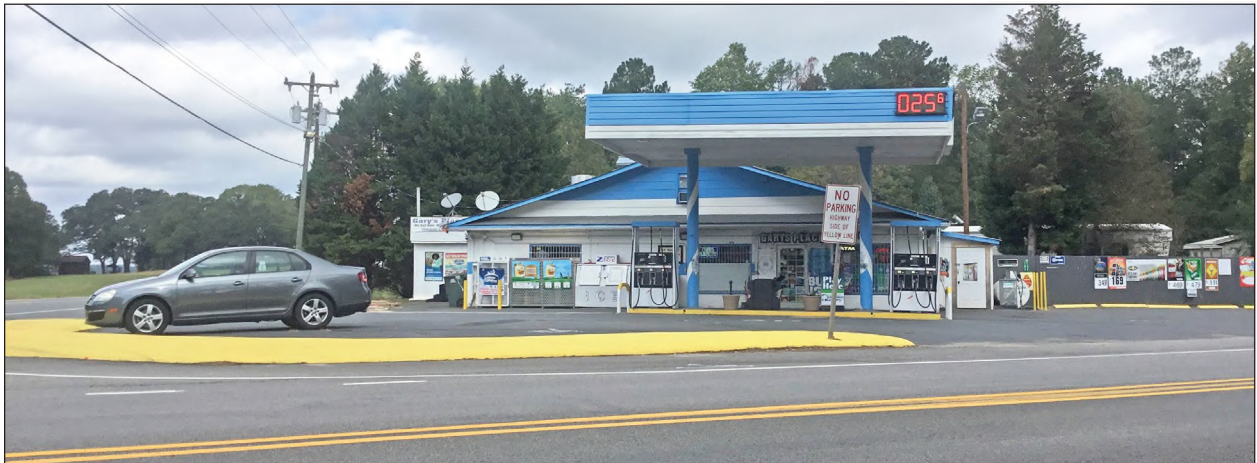
b. Resource 3905, Front Elevation

Resource 3905 is a commercial gas station, built circa 1960, located at 2045 SC 557 (see Figure 26b). The resource is a concrete block building with a front gable roof that extends slightly over the front façade. The gable end of the roof is clad in vinyl siding as is the canopy covering the gas pumps. The storefront features large, fixed sash windows in metal casing and the front entrance is a plain glass door reinforced with metal bars.

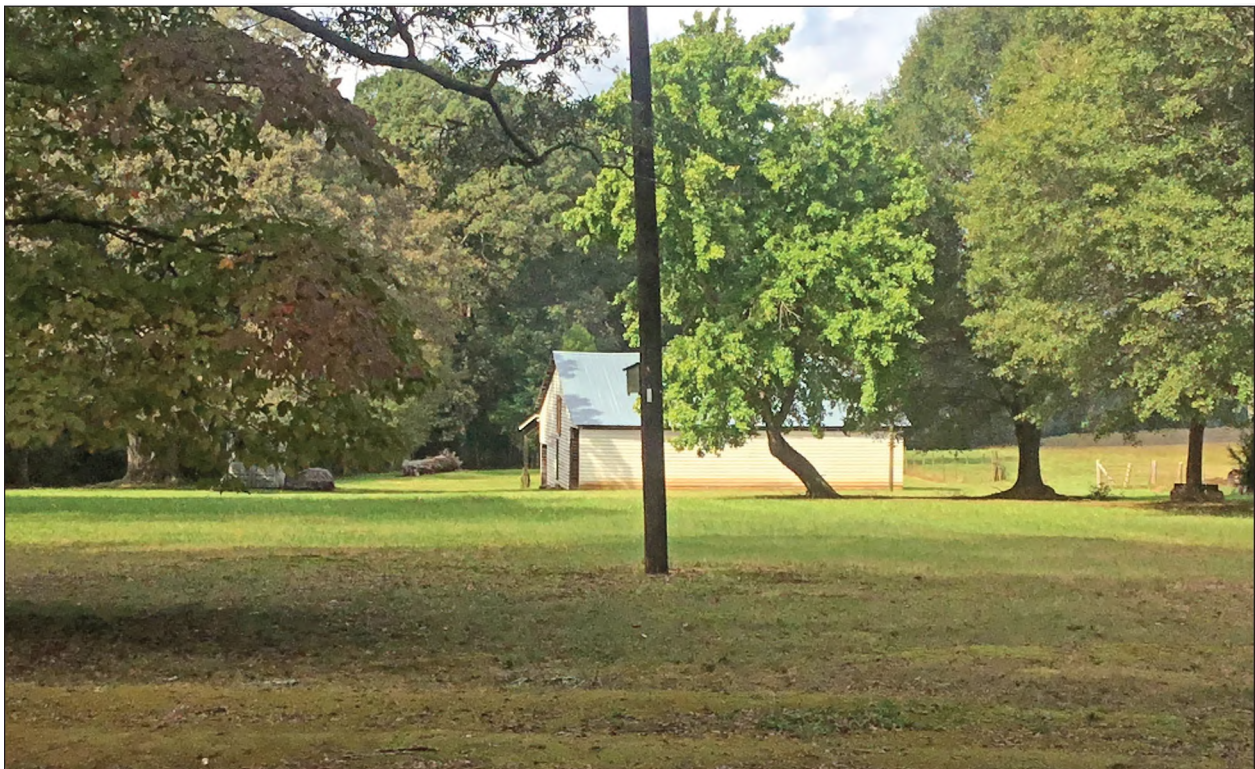
b. Resource 3907.01, Outbuilding, Oblique

Three agricultural outbuildings are located on the property. Resource 3907.01 is a front gable barn with metal roof. It is constructed of wood construction and clad in weatherboard (see Figure 27b). The resource is located at the north rear corner of the property.

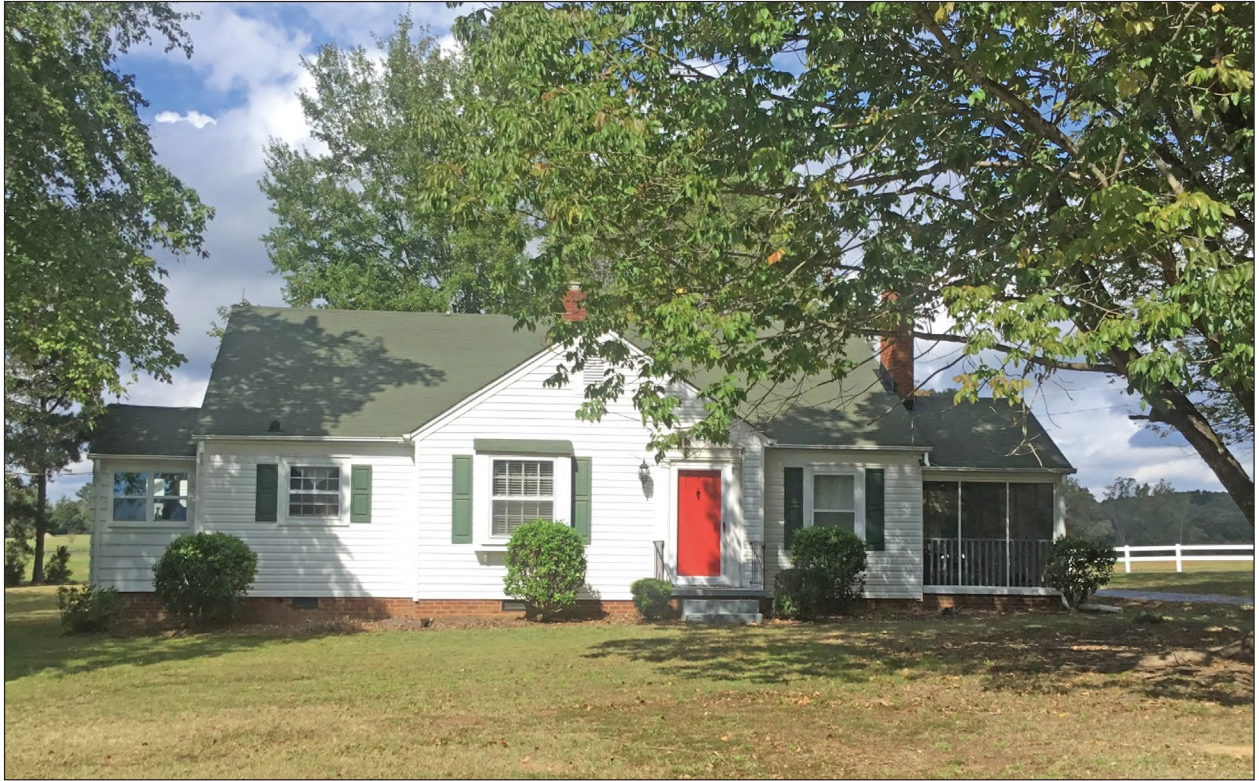
a. Resource 3908, Front Elevation

Resource 3908 is a Minimal Traditional house, built circa 1940, located at 1693 Bate Harvey Road (Figure 29a). The resource is a one-story residence with a rectangular plan that sits on a brick foundation and is clad in vinyl siding and has a central cross gable. The roof is clad in composition shingles. The front entry has a Greek revival surround and has concrete steps with

decorative metal railings as well as a side screened-in-porch on the east elevation. The windows on the central and west bays of the front elevation are non-historic eight-over-eight vinyl sashes and the east bay has non-historic six-over-six vinyl sash windows. The resource also has one interior brick chimney and a brick chimney on the east elevation.

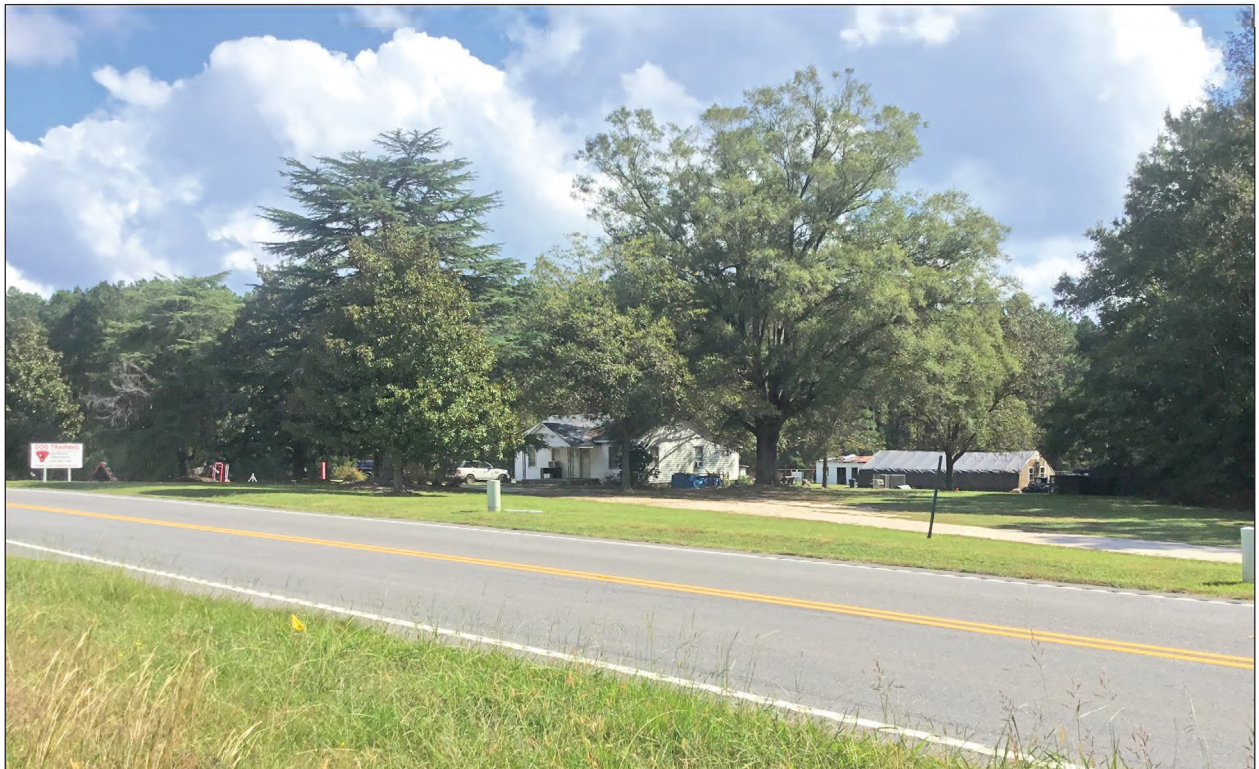
b. Resource 3909, Setting

Resource 3909 is a Minimal Traditional house, built circa 1950, located at 1849 SC 557 (see Figure 29b). The resource was built as a one-story residence but is currently used as a dog training facility. It has a rectangular plan that sits on a concrete slab foundation and has a lateral gable roof. The roof is clad in composition shingles and the exterior is clad in vinyl siding. The building has a front gable porch which is supported by decorative metal posts that lead to the front door. The windows are non-historic vinyl one-over-one double hung sashes.

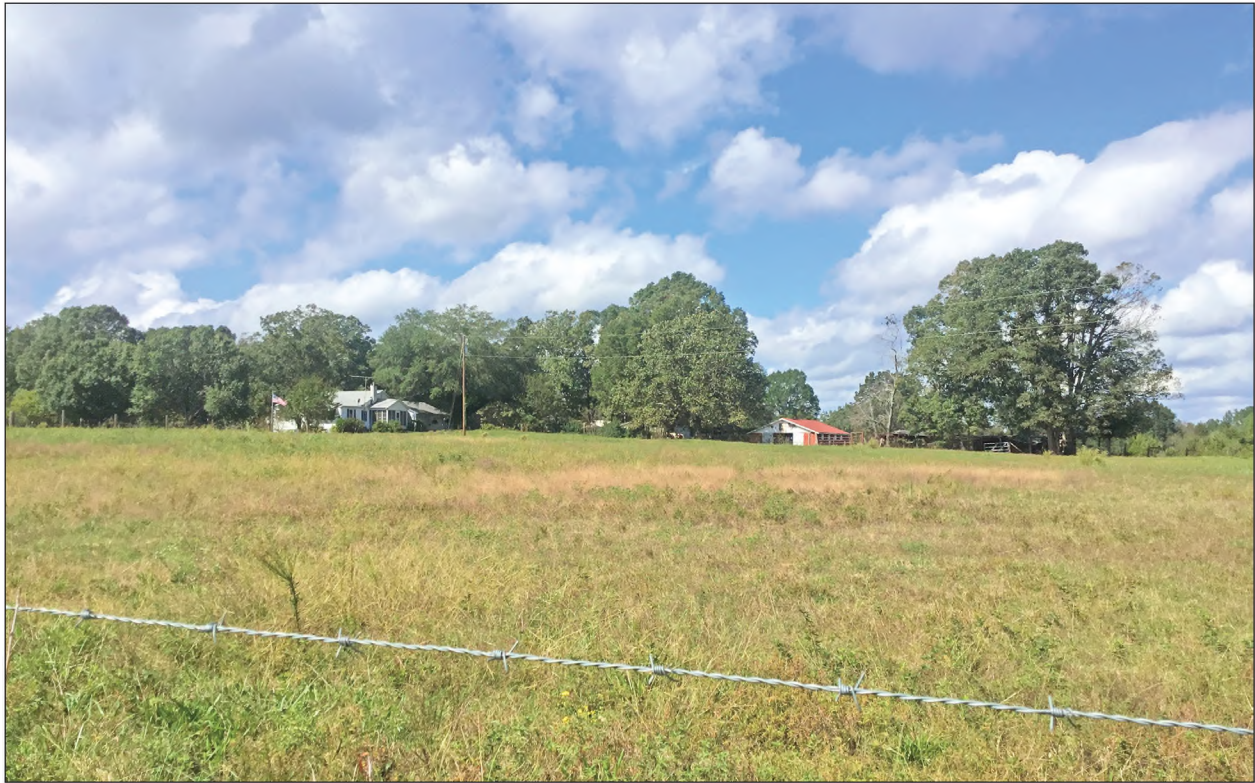
a. Resource 3910 and 3910.01, Setting

Resource 3910.01 is a barn located to the east of the house. The resource is a front gable barn that is constructed of wood framing and has a gable roof. The roof is clad in metal sheeting and the exterior walls are clad in vertical weatherboard. The resource has a central entrance with barn doors. Other outbuildings were located beyond the tree line out of vision.

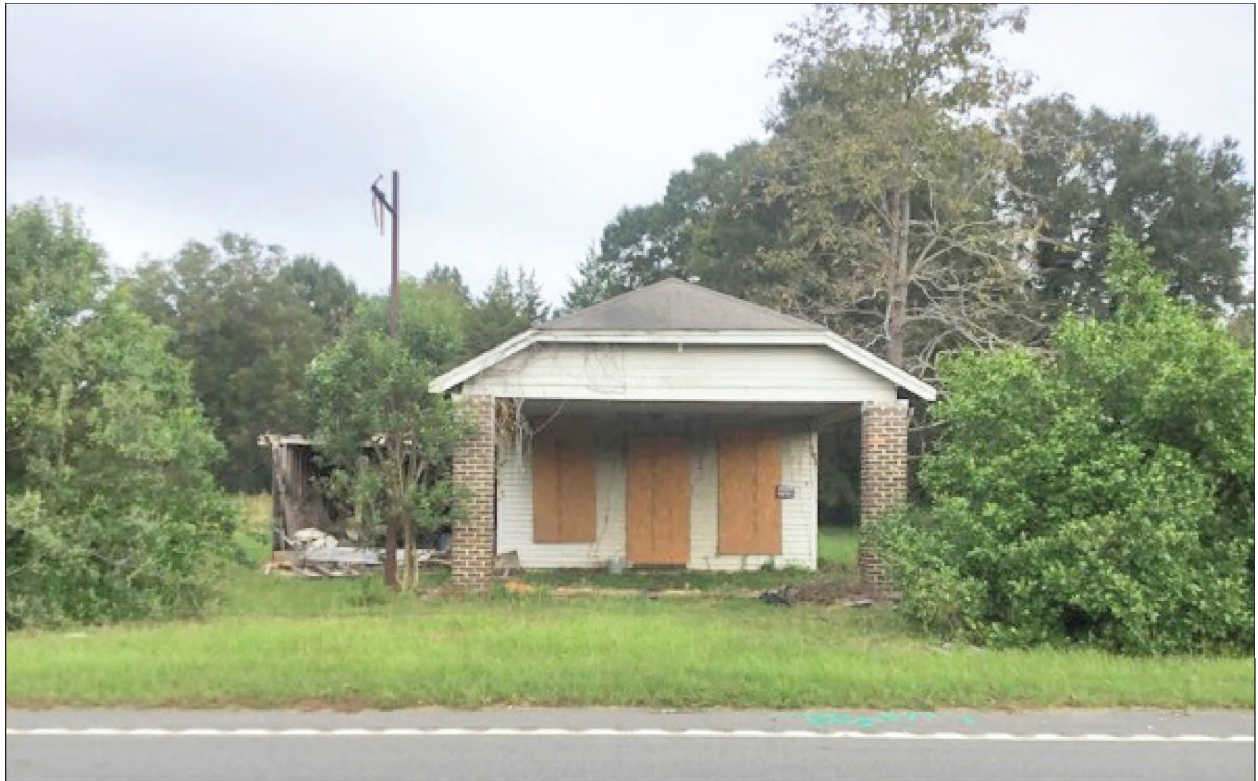
Figure 31.  
Resource 3912, Front Elevation

The resource is located on the same parcel as Resource 3894. The resource is located near rural residential development with fields and heavily wooded lots and sits on a heavily overgrown lot.

With its replacement siding and boarded windows, this resource has diminished integrity of design and materials. Therefore, this resource is not a significant example of a rural country stores found in South Carolina, nor does it represent the work of a master or possess high artistic value. It is not known to be associated with events or persons significant in the past. Therefore, the resource is recommended as not individually eligible for the NRHP under Criteria A, B, or C.

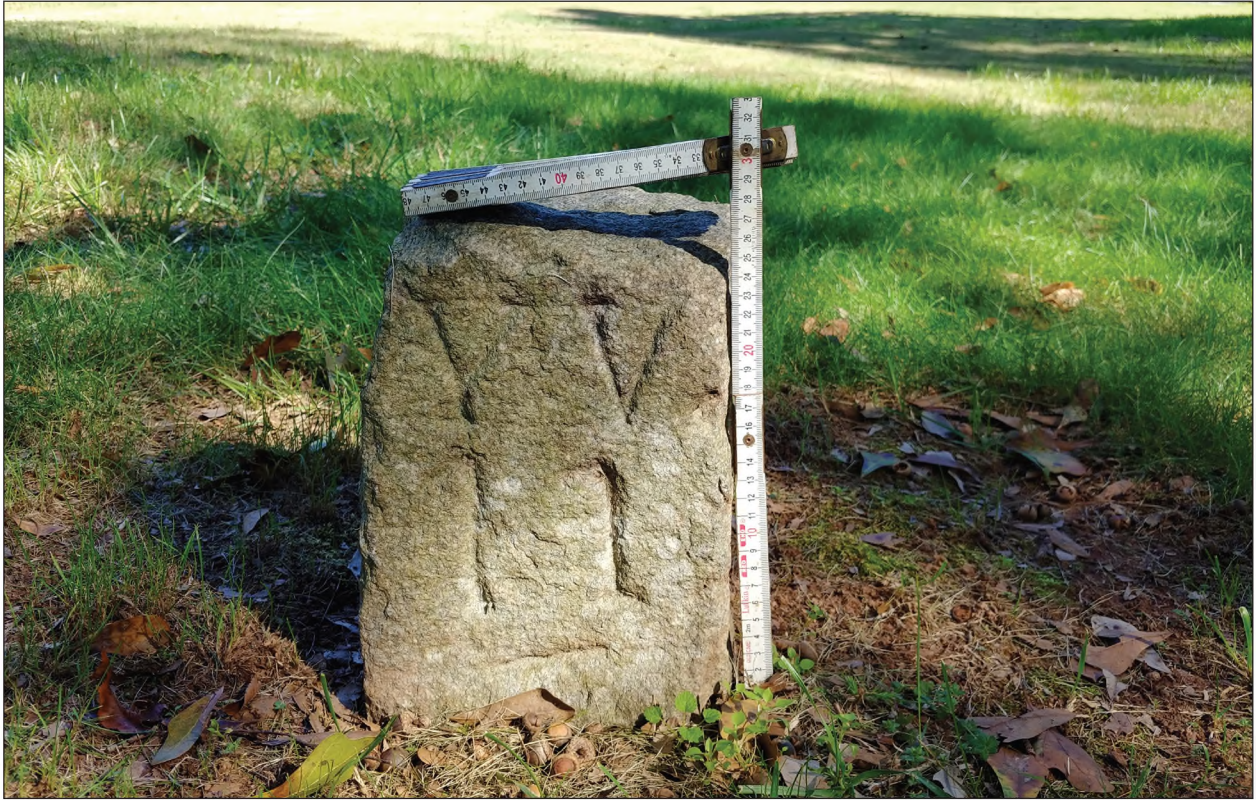
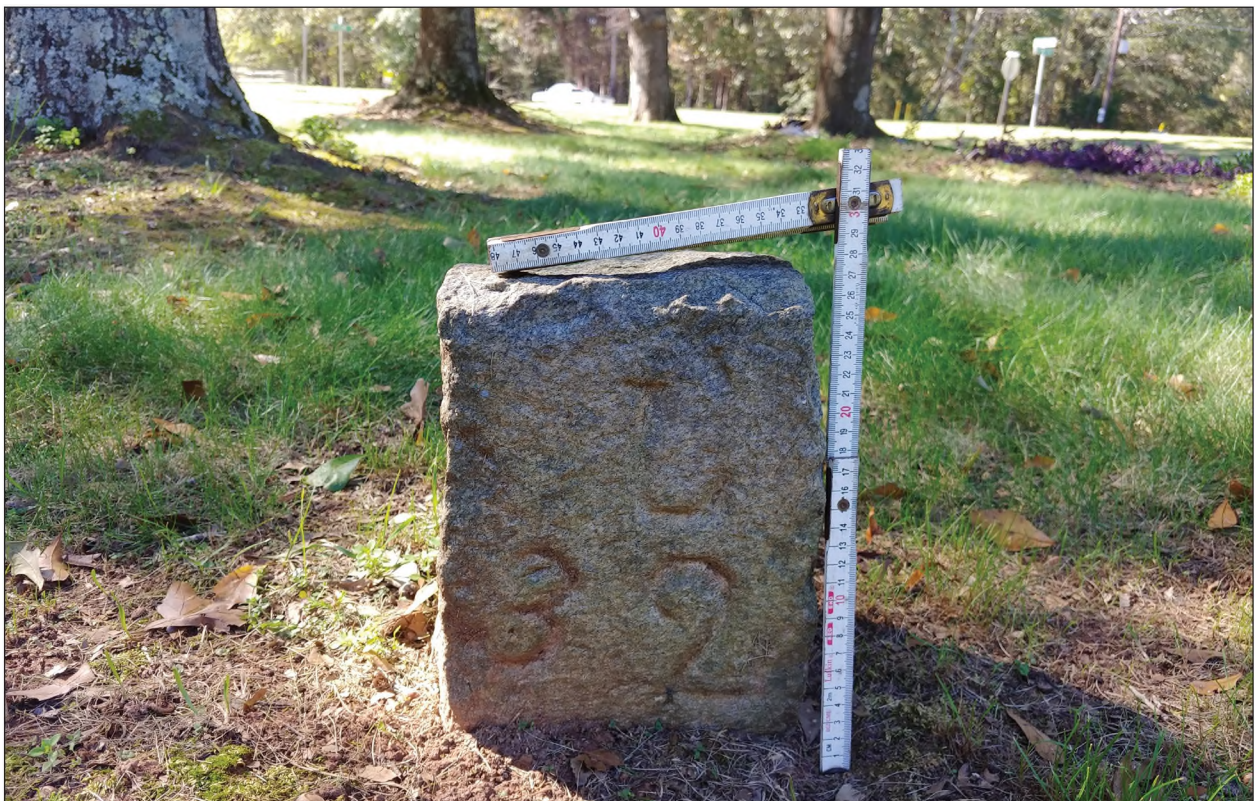
Figure 35.  
Resource 3913

The marker is carved granite stone which stands approximately 10.8 inches tall and 6.5 inches across (Figure 35). Etched into the eastern face is YV 11, representing the distance to Yorkville (now York). On the western face is etched L (Lincolnton) and 32. The marker appears to be in its original location and a road bed is not clearly discernible near the marker. In Figure 36, the old roadbed may have run from the north side of the road marker towards the existing power line visible in the picture. Also visible in Figure 36, the current road carrying SC 557 and North Parklane Road, respectively, has been built up and, therefore, altering the surrounding landscape. The lot containing the marker was drastically landscaped sometime after 1972 as evident in the 1972 aerial which shows a heavily wooded lot. The existing house on the lot is also not constructed at this time (Figure 37) but occurred sometime after 1972.

A. Eastern Face

B. Western Face
