June 13, 2019

**Re: FINAL REPORT**  
**Cultural Resources Reconnaissance Survey of Approximately**  
**21.5 Acres at the Proposed Greenway Square Retirement Community**  
**Lancaster County, South Carolina**  
**Terracon Project No. 73197085**  
**SHPO Project No. 19-KL0191**

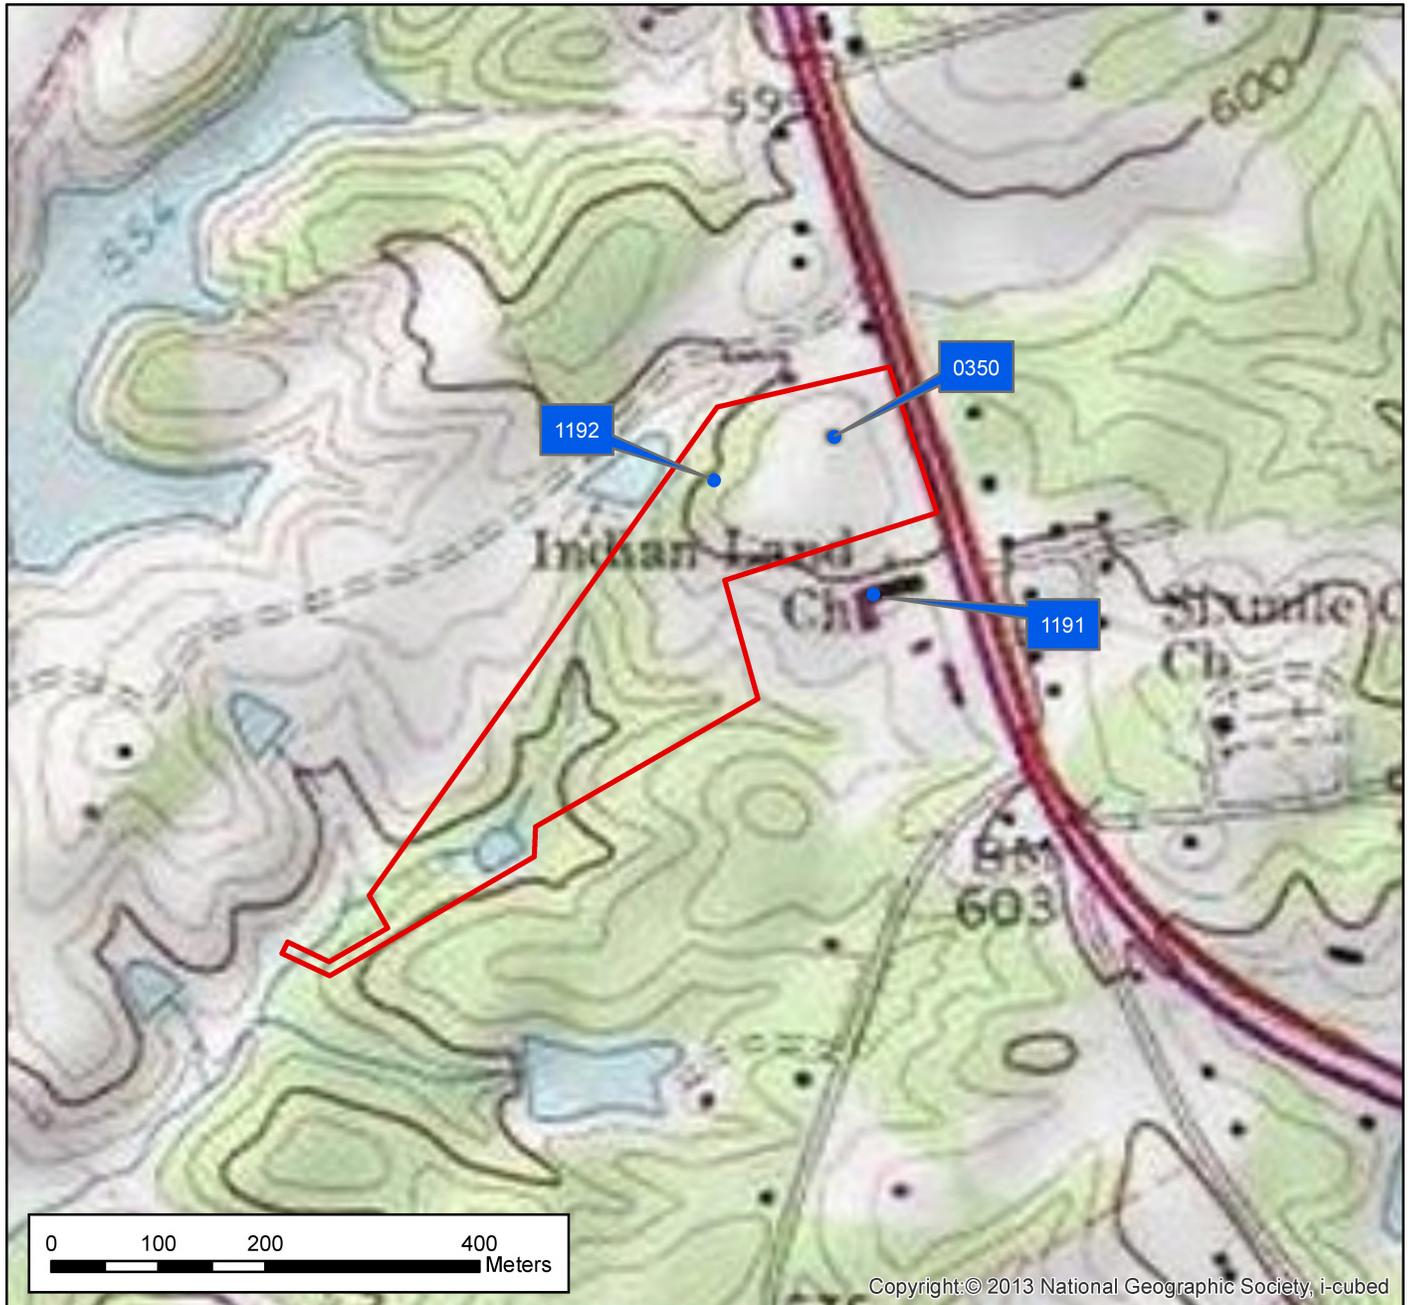
**1**

Figure 1. Cultural resources in and immediately adjacent to the project area.  
 Base Map: Catawba NE (1968, PR 1988) 7.5' USGS topographic quadrangle.

In addition to the records review, eighteenth through twentieth century maps of the project area were examined to determine whether historic resources were likely to be present within the proposed project area. Mouzon’s 1775 *An Accurate Map of North and South Carolina with their Indian Frontiers* shows the project area located within the area set aside for the Catawba Nation (Figure 7). Robert Mill’s 1825 map of the Lancaster District shows the project area north of the Indian Boundary in Catawba Indian Land. The project area itself is uninhabited, though Charlotte Highway and several unnamed roads are depicted in the vicinity (Figure 8). The 1939 South Carolina Department of Transportation county road map shows multiple roads and numerous buildings in the vicinity, with two structures within the project area itself (Figure 9). The setting remains rural until the late twentieth century, and the 1968 Catawba NE USGS topographic map places the roads in their current alignment. Unlike the 1939 county road map, there is only one structure indicated in the project area (Figure 1).

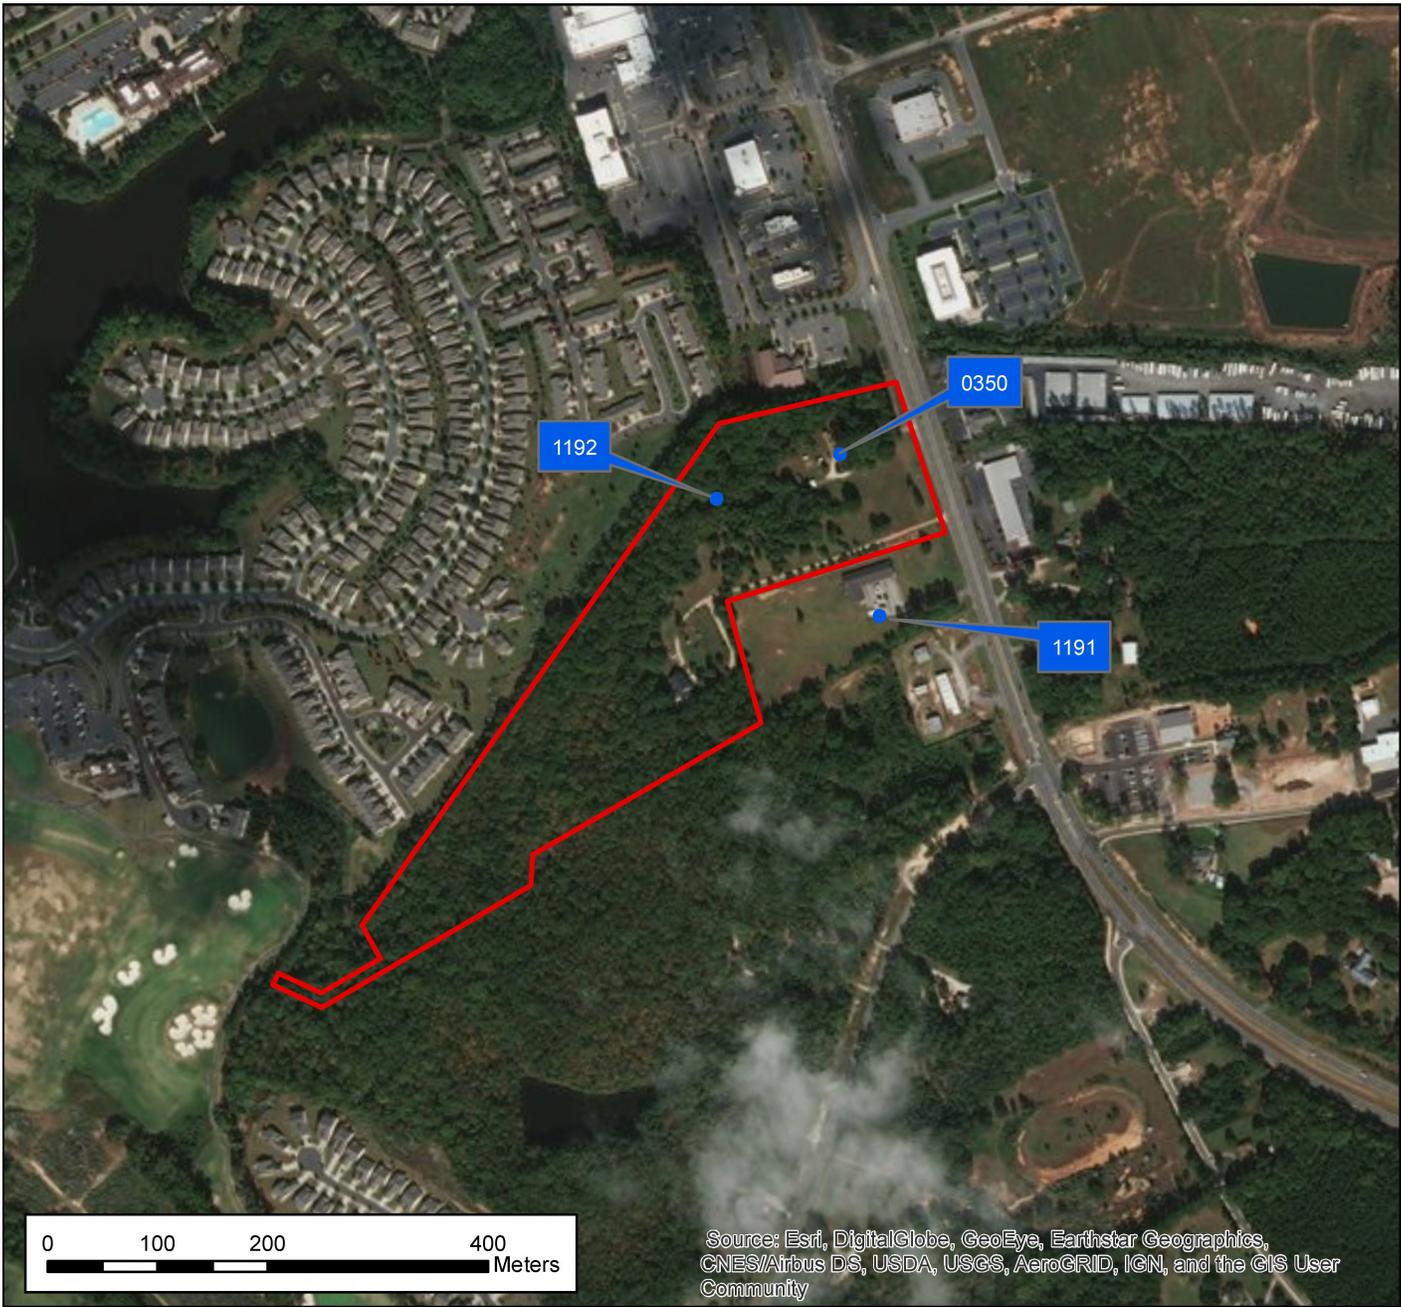
**2**

Figure 2. Aerial photograph depicting cultural resources in and immediately adjacent to the project area.  
Base Map: ESRI World Imagery.

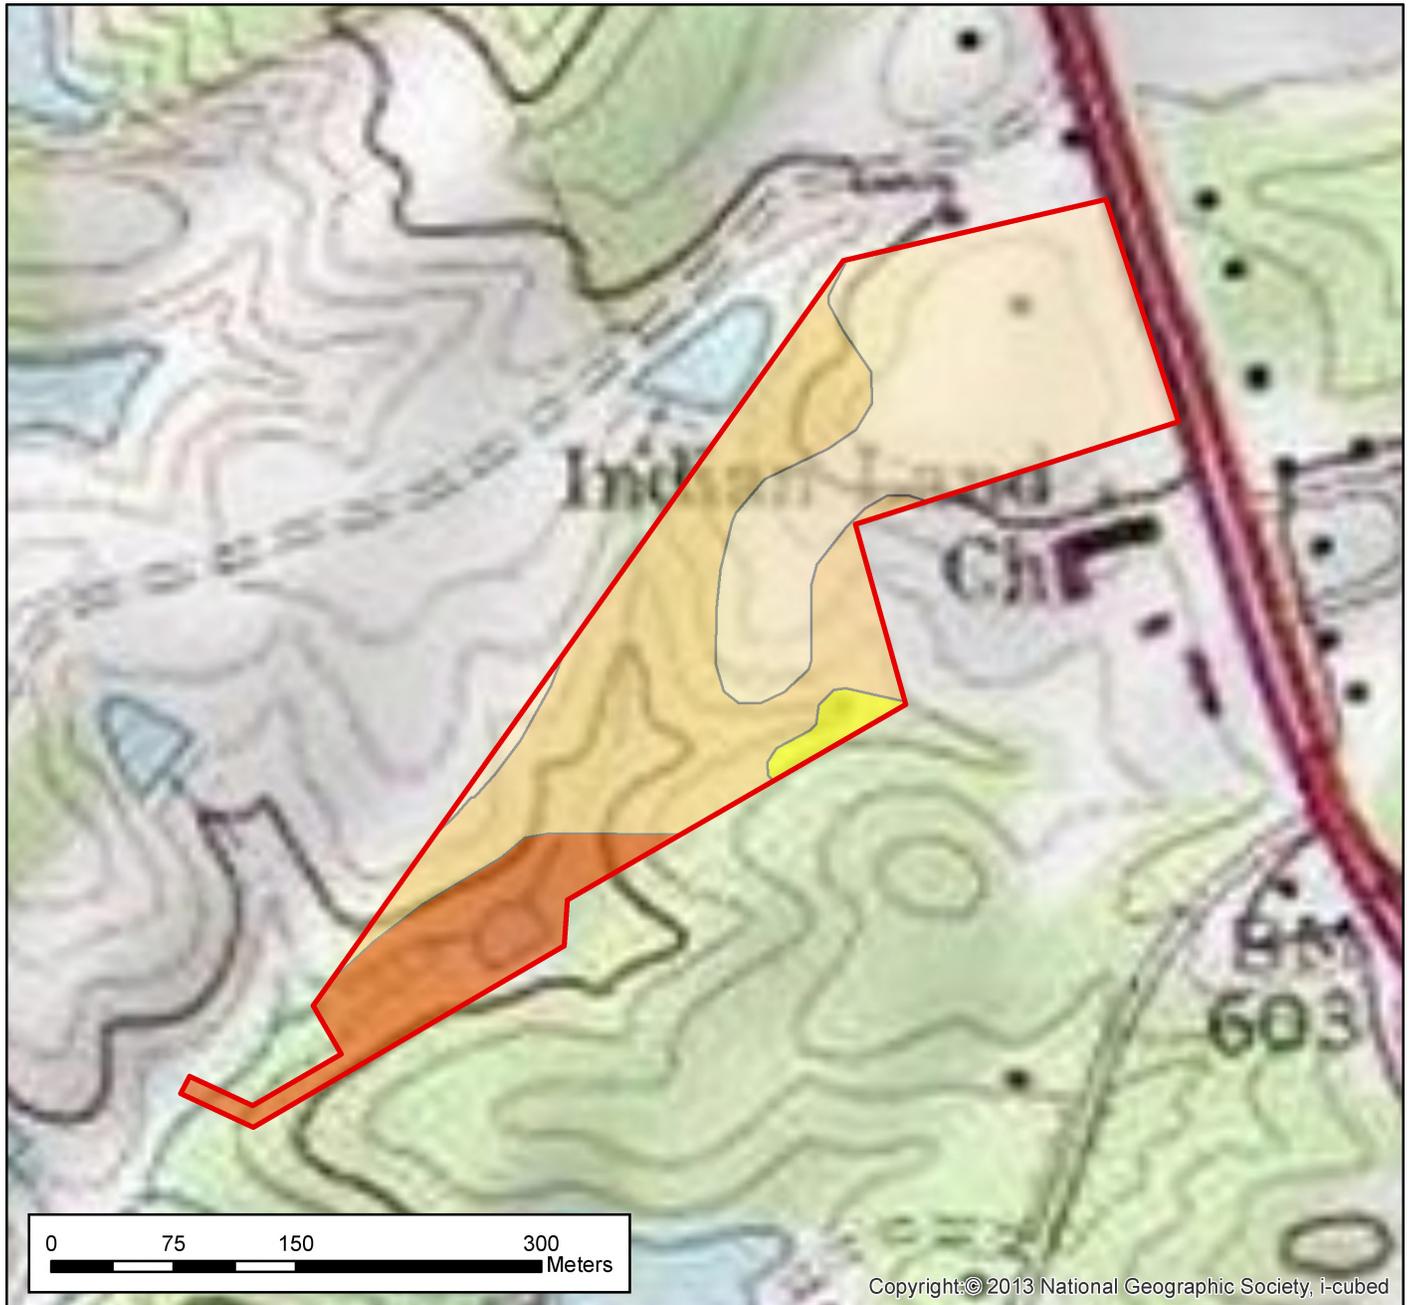
Figure
<b>3</b>

Soils in the project area are composed of silty and loamy soils formed from silty alluvium or clayey residuum weathered from argillite or sercite schist. Soil types include well drained Congaree soils, Herndon silt loam, and Nanford loam. Approximately 97 percent of the project area contains moderately eroded to eroded soils (Figure 3).

Figure 3. Soil types in the project area. Soil data obtained from NRCS Web Soil Survey. Base Map: Catawba NE (1968, PR 1988) 7.5' USGS topographic quadrangle.

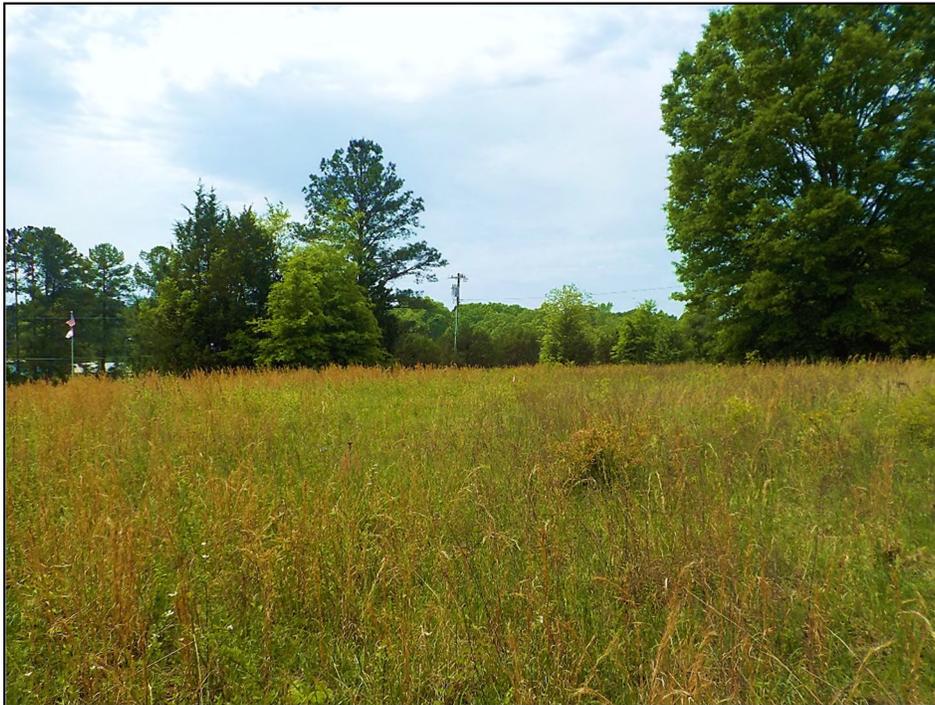
Figure 4. Overgrown field in the northeastern portion of the project area, facing southwest.

Topography in the project area slopes towards the drainage in the southwest portion of the tract and ranges from 550 feet above mean sea level (AMSL) in the southwest to 600 feet AMSL in the northeast portion of the project area. Vegetation consists of an overgrown field and mixed pines and hardwoods (Figures 4 and 5).

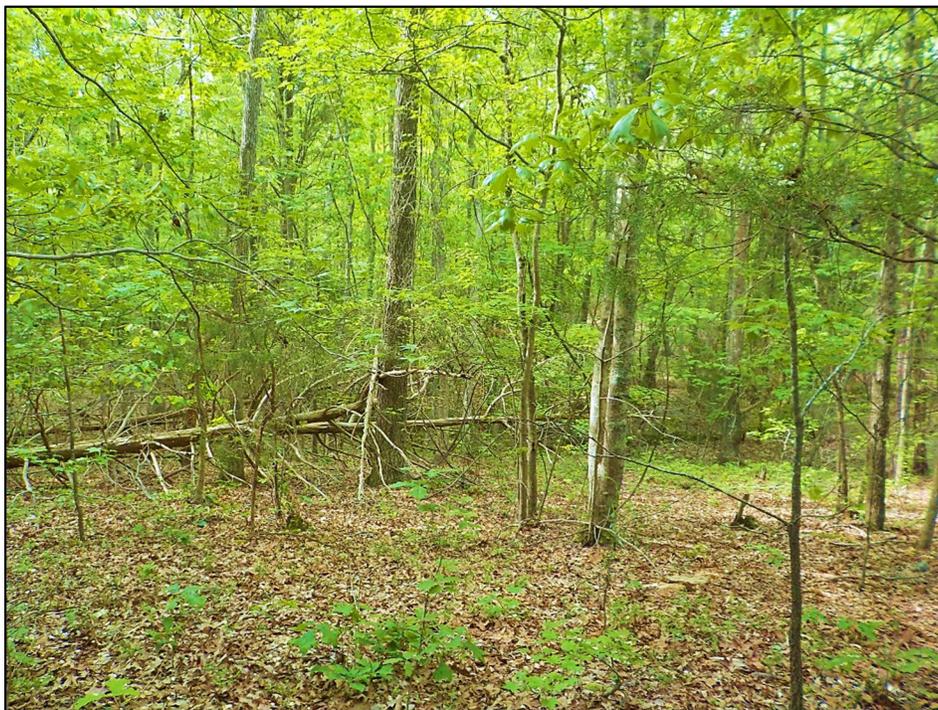
Figure 5. Vegetation and slope in the southern portion of the project area, facing south.

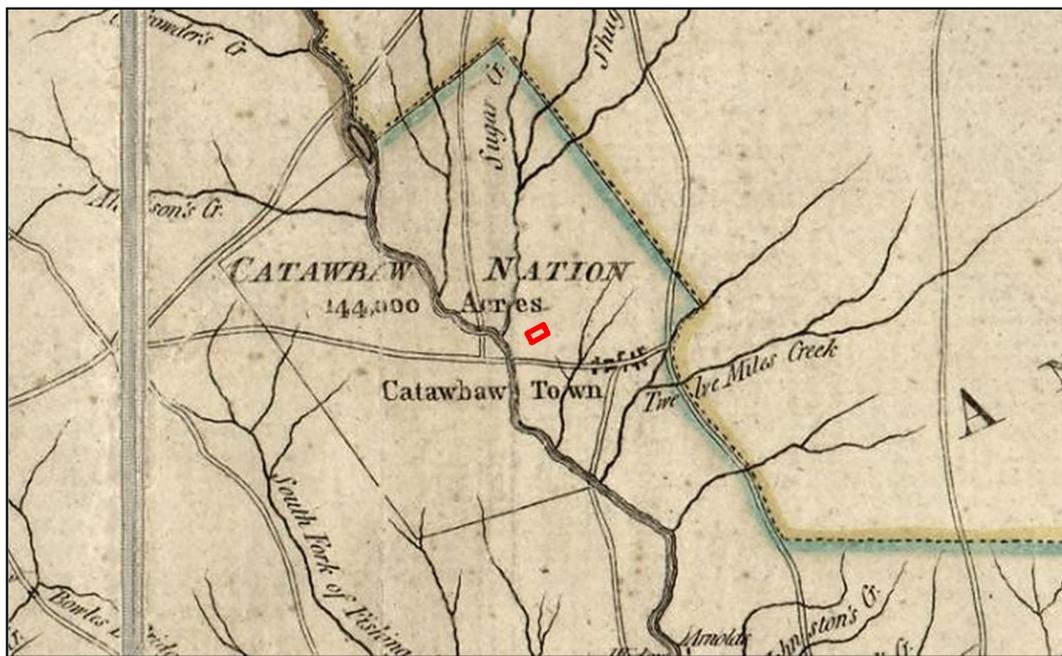
Figure 7. Mouzon's (1775) map of North and South Carolina showing the approximate location of the project area in red.

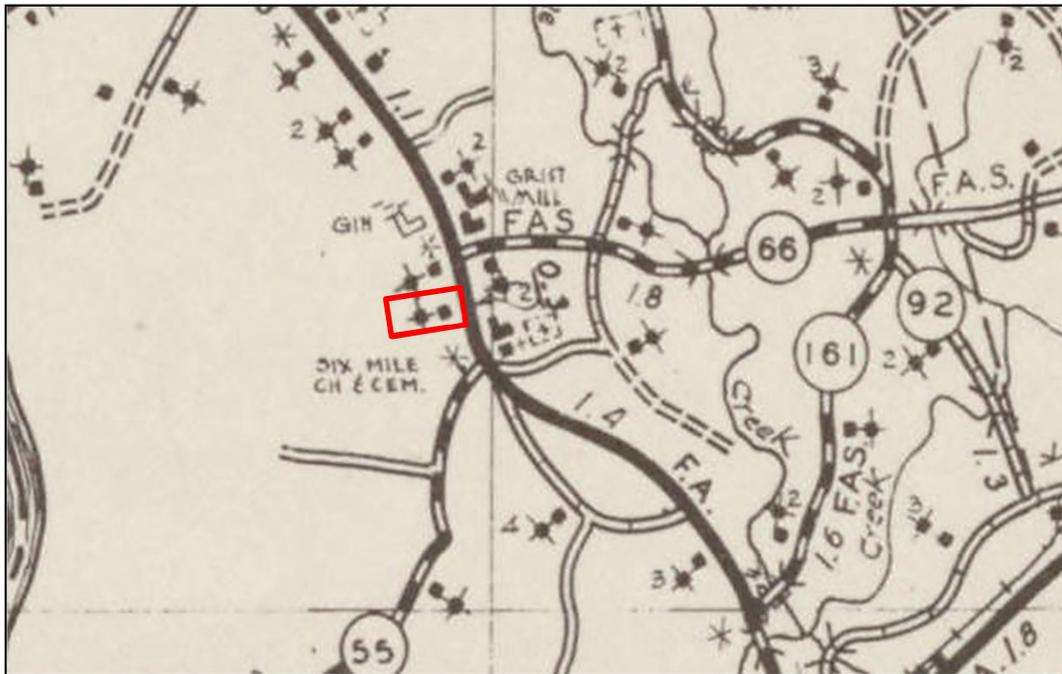
Figure 9. South Carolina Department of Transportation 1939 map of Lancaster County showing the project area in red.

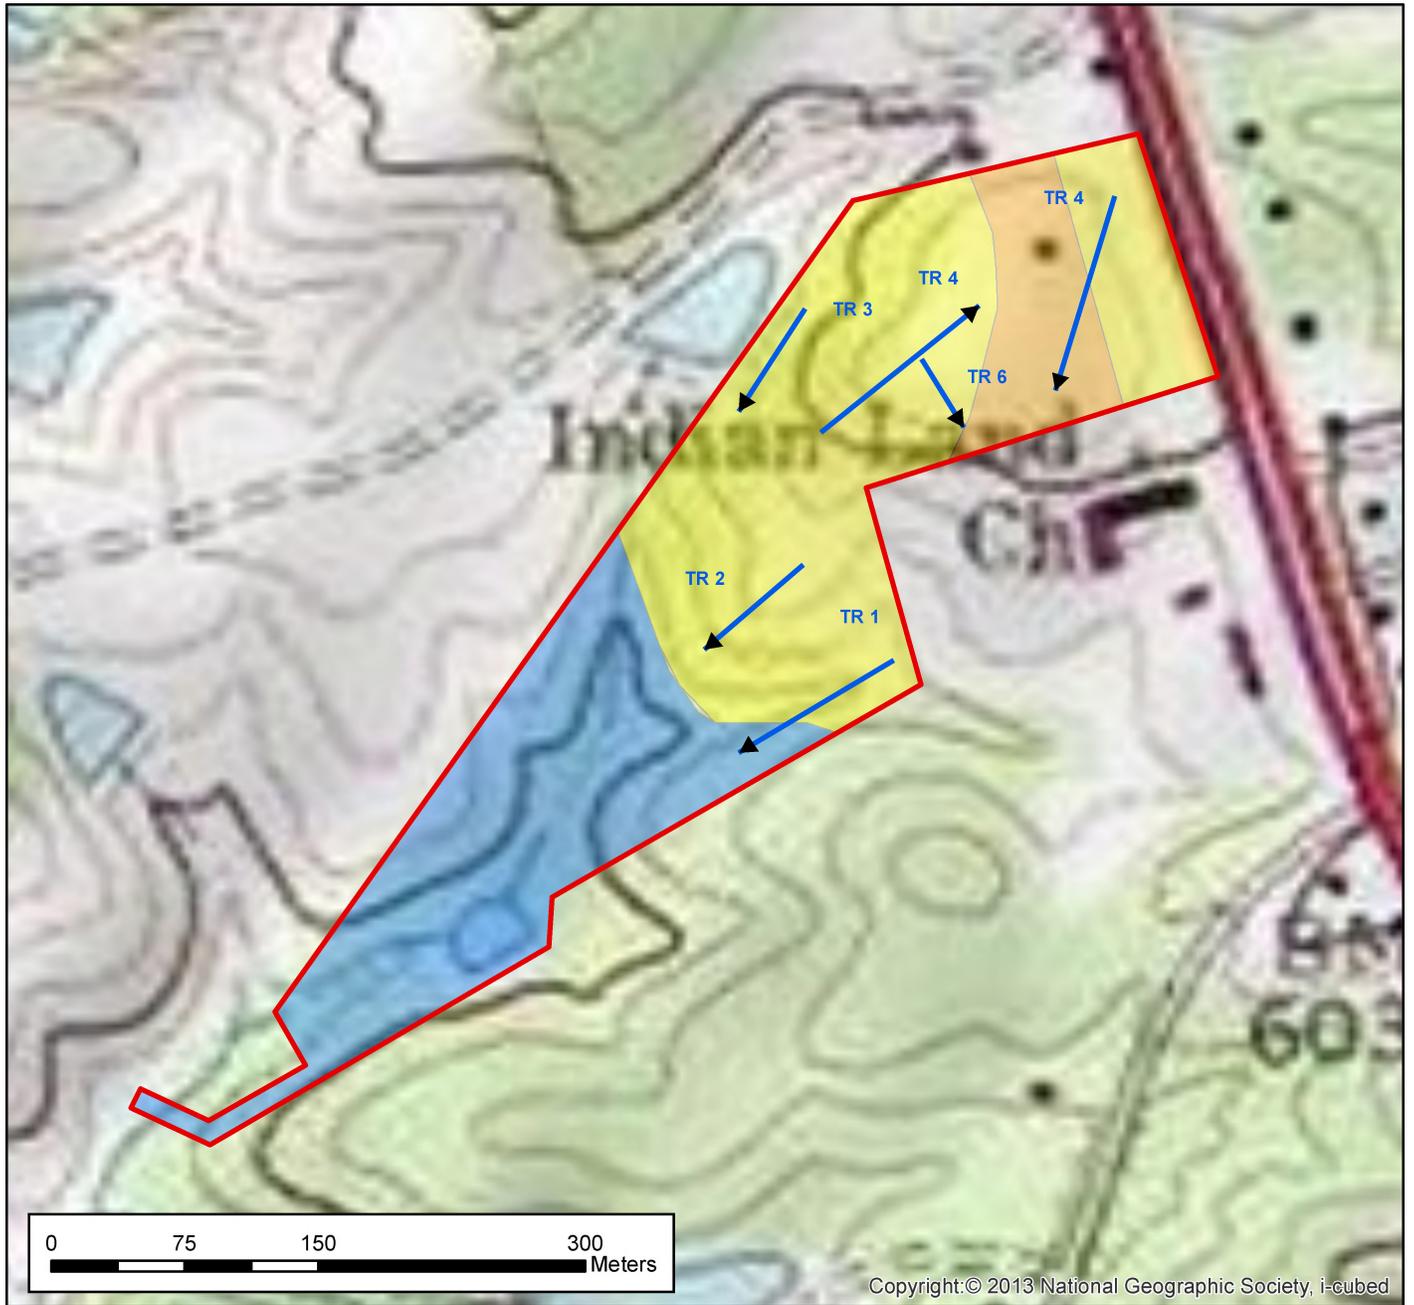
Figure  
**10**

probability areas include well-drained areas having slope of less than 10 percent that are located more than 150 meters from a water source. Low probability areas include ridge side slopes having slope greater than 10 percent, erosional gullies, and severely eroded areas. Based on these parameters, approximately 56 percent (n=12.1 acres) of the project area is considered to have a high probability for containing prehistoric and historic sites, as it lies within 150 meters of a water source, slopes are less than 10 percent and it lies within 50 meters of Charlotte Highway. Approximately 10 percent (n=2.1 acres) is considered moderate probability, as the property contains well drained soils and is more than 150 meters from the closest water source, while 34 percent (n=7.3 acres) of the project area is considered low probability, due to slopes greater than 10 percent (Figure 10).

On April 25, 2019, Archaeologist Kelly Higgins, M.A. conducted a reconnaissance survey of the project area. Shovel test pits (STPs) were excavated at 30-meter intervals along six transects in the project area (Figure 10, Table 2). Each shovel test was approximately 30 cm in diameter and excavated to culturally sterile subsoil. Surface visibility across the project area was negligible and a pedestrian survey was not conducted.

Figure 10. Probability areas and shovel test transects.  
 Base Map: Catawba NE (1968, PR 1988) 7.5' USGS topographic quadrangle.

As a result of the archaeological survey, no archaeological sites or isolated finds were identified. Although a predictive model based on the one used by the USFS at Sumter National Forest initially indicated that much of the tract had a high or moderate probability for containing archaeological resources (Figure 10), most of the soils on the property are highly eroded. Based

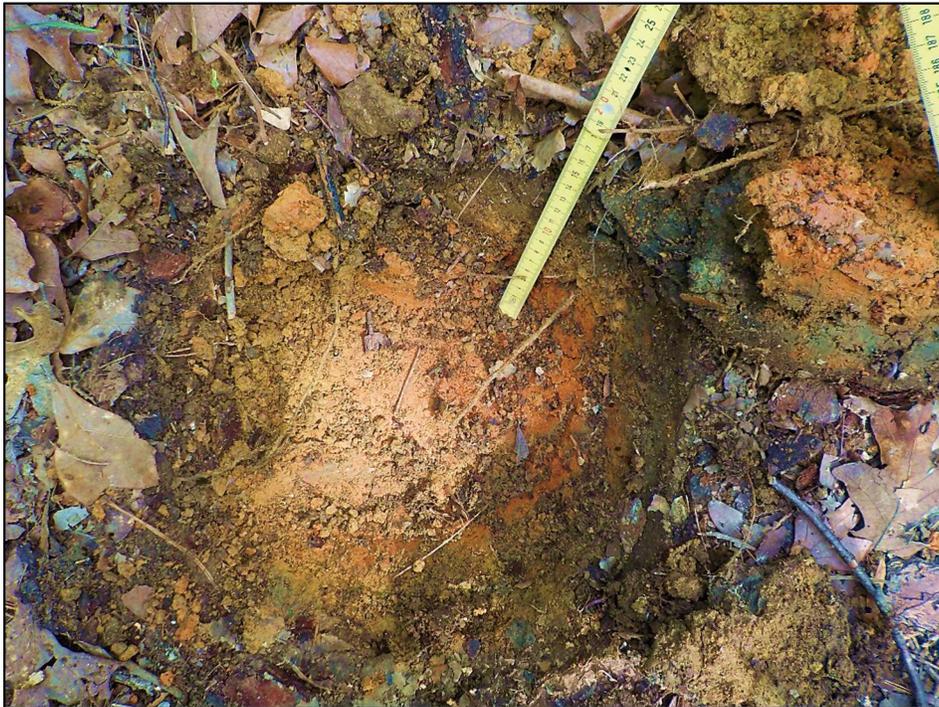
During the survey, 21 shovel tests were excavated to depths ranging from 15–25 cm below surface (cmbs). A typical soil profile consisted of approximately 5 cm of dark brown (10YR 3/3) loam, followed by 3 cm (5–8 cmbs) of yellow (10YR7/6) clayey loam (Ap horizon), followed by strong brown (7.5YR 5/8) clay subsoil (Bt horizon) (Figure 11). The majority of the shovel tests exhibited eroded soils, though soils near the creek were hydric and consisted of mottled yellow (10YR 7/6) and light gray (10YR 7/1) clay (Figure 12). As a result of the survey, no archaeological sites or isolated finds were identified.

Figure 11. Typical eroded soil profile (STP 3-1).

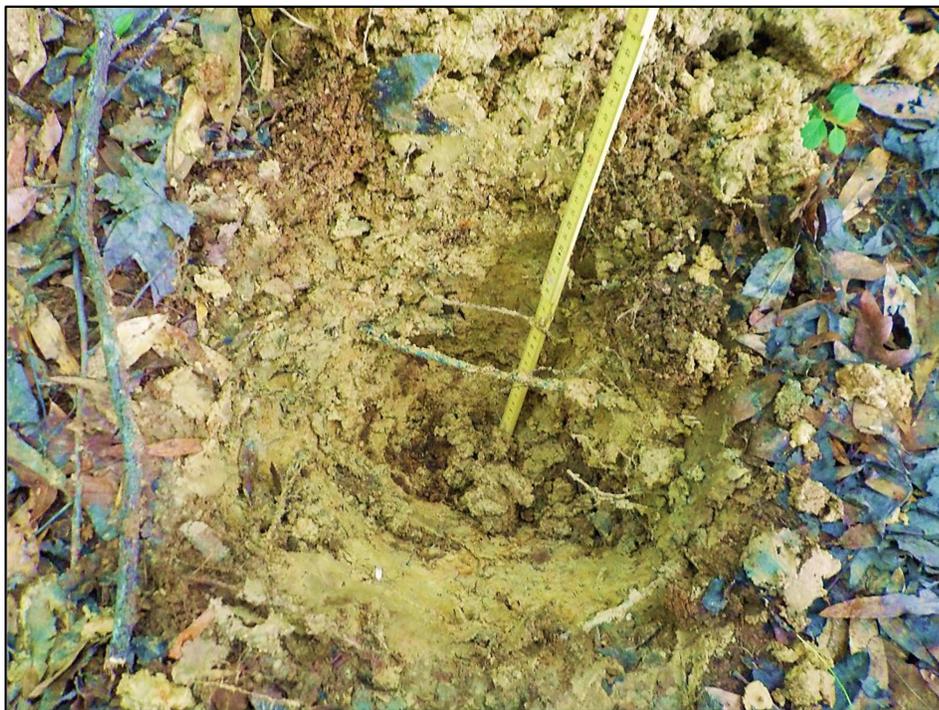
Figure 12. Hydric soils in the project area (STP 1-1).

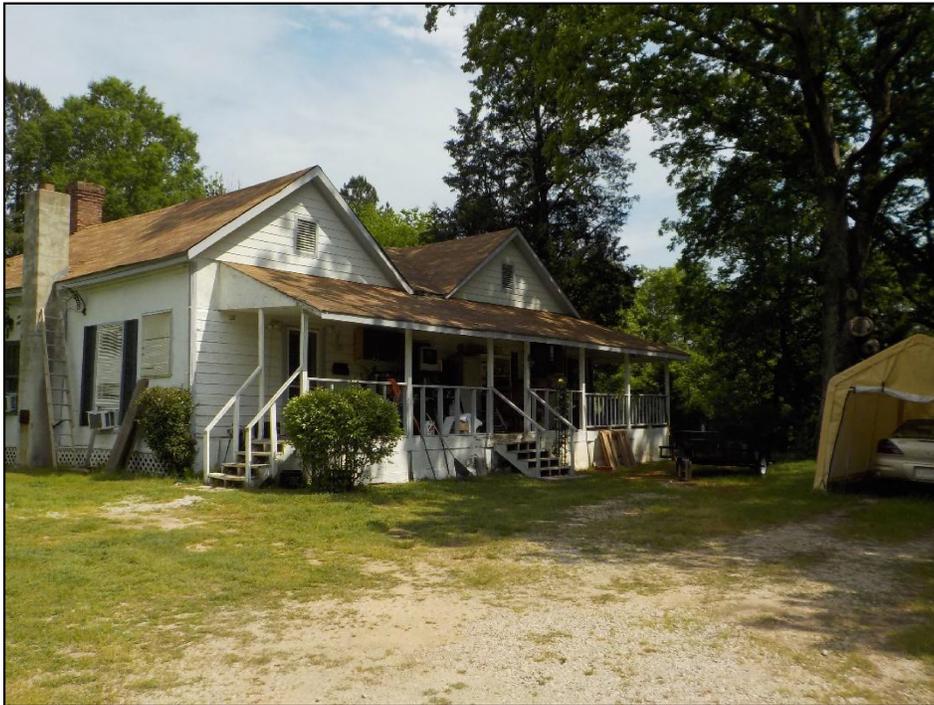
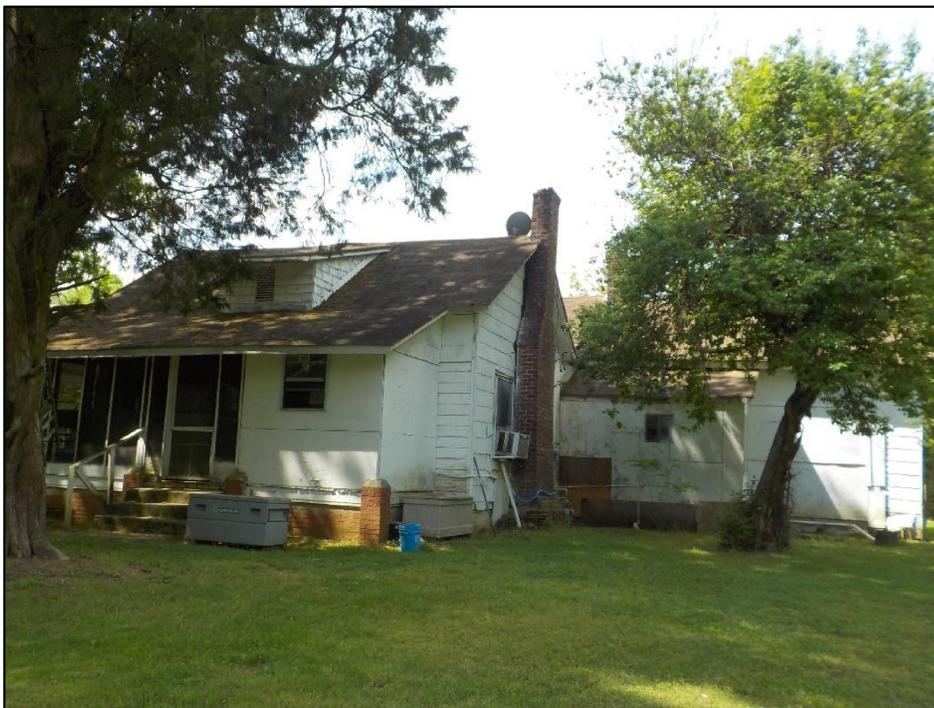
Resource No. 0350, located in the northeast portion of the project area, is a circa 1895 one-story frame residence, with weatherboard siding on the west façade facing the street, solid panel siding on the south façade, and asbestos shingles on the rear façade (Figures 13 and 14). The roof above the principal façade features two parallel front gables. A full-width one story open porch spans the façade, with a shed roof supported by seven slender square wooden columns. Clutter on the porch precludes a view of the fenestration, with the exception of a single door at the south end of the façade. An exterior brick chimney rises on the rear elevation. Three small sheds are located at the rear of the property. They are of frame construction with front gable roofs and are of indeterminate age (Figure 15).

Resource No. 0350 has remained on its original site of construction; therefore, it has retained integrity in location. However, it has not retained a majority of its original materials or vernacular workmanship style. The original setting has also changed due to heavy vehicular traffic along Charlotte Highway and suburban development in the area. Furthermore, there is no sense of a particular aesthetic, nor is there association with an important event or person.

Figure 13. Resource No. 0350 front façade, facing northeast.

Figure 14. Resource No. 0350 side and rear façade, facing southwest.

Resource No. 0350 does not display distinctive architectural features or characteristics and lacks significance through aesthetic features or association with an important person or historic context. Based on this evaluation, Resource No. 0350 is recommended ineligible for inclusion in the NRHP.

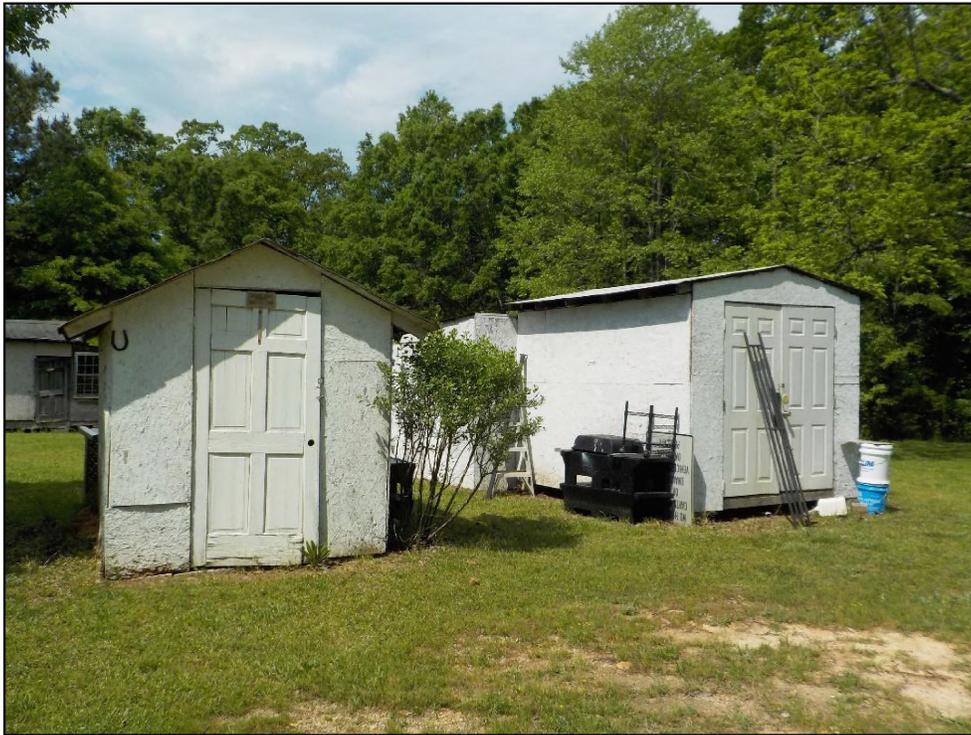
Figure 15. Resource No. 0350 outbuildings, facing south.

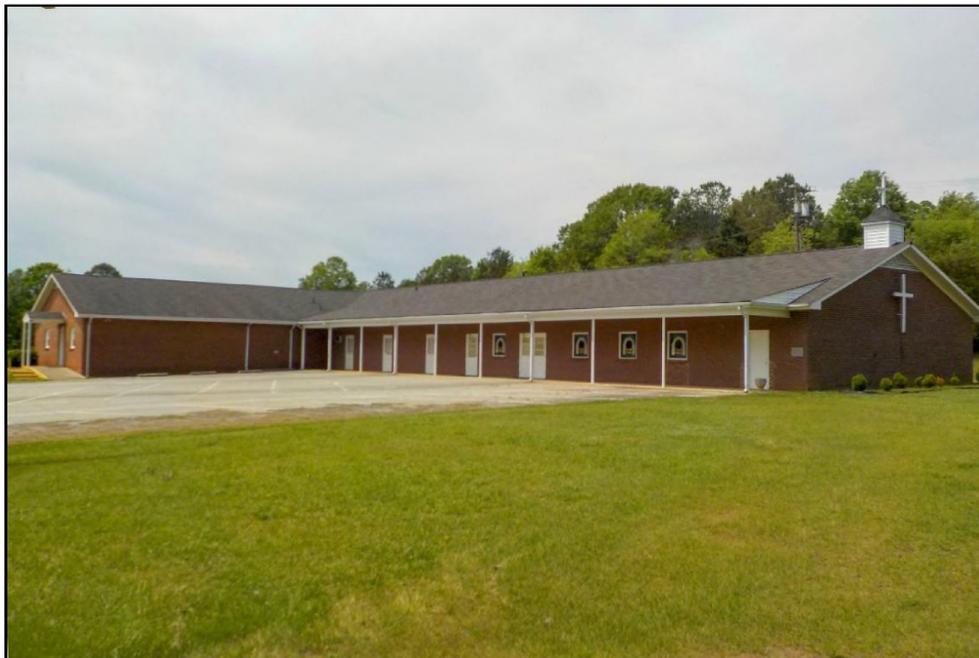
Resource No. 1191 (Indian Land Church), located approximately 50 meters south of the project area, is a circa 1967 one-story brick church with an L-shaped footprint (Figure 16). A front-gable section facing west toward the road features three bays, with a central single door flanked on each side by a small single double-hung window. The central entrance is protected by an open one-bay gabled porch supported by two square wooden columns. A cross gable section extends to the north from the rear of the front gable section, with an open full-width shed roof porch supported by 10 evenly-spaced slender wooden columns. Each of the four southernmost and the northernmost bay contains a single door, the fifth contains a double door, with four stained glass windows interspersed. A small cemetery is located to the west of the church and contains at least 50 graves, with the earliest interment dating to 1972. The cemetery is still in use and is not considered to be a historic resource.

This resource has remained on its original site of construction, retaining integrity in location. However, the original setting has changed due to heavy vehicular traffic along Charlotte Highway and increased development in the area. Furthermore, there is no sense of a particular aesthetic or historic feeling, nor is it associated with an important event or person.

Figure 16. Resource No. 1191, Indian Land Baptist Church, facing north.

This property displays no distinctive architectural features or characteristics and lacks significance through aesthetic features. Additionally, current research indicated no significant associations with an important person or historic context. Based on this evaluation, Resource No. 1191 is recommended ineligible for inclusion in the NRHP.

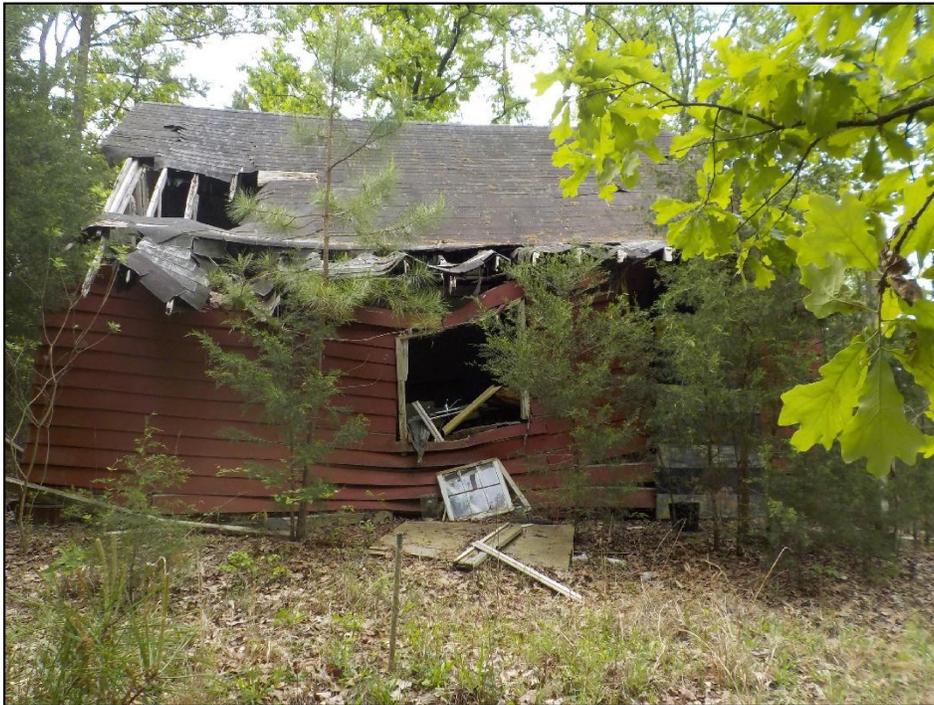
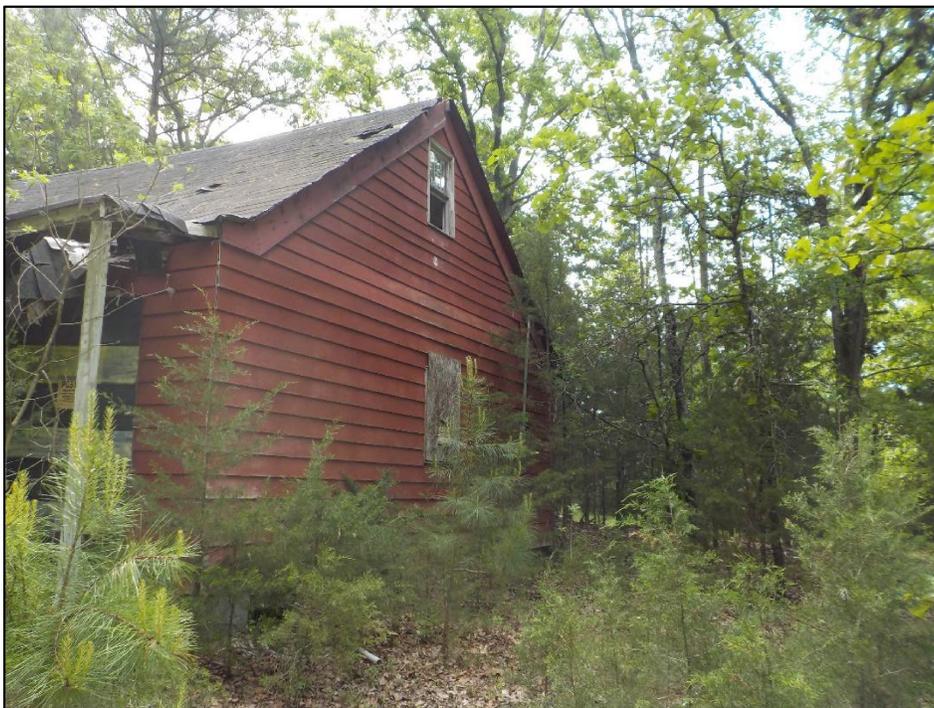
Resource No. 1192, located in the northern portion of the project area, is a ca. 1930 one-story frame house in a deteriorated condition surrounded by dense vegetation (Figures 17 and 18). The house appears to have been a front gable house, though the location of the entrance is not known with precision. The north façade is partially collapsed, with a large square window opening now disfigured by the sagging frame, with much of the roof cladding missing. The house is clad in weatherboard, while the roof featured exposed rafter tails. A frame enclosure surrounding a well pump is located in the yard a short distance from the house (Resource No. 1192.01) (Figure 19).

This structure has remained on its original site of construction; therefore, it has retained integrity in location. However, it is extremely dilapidated, the setting has changed to a built-up commercial and residential setting, there is no particular feeling or workmanship style, and there is no sense of a particular aesthetic. In addition, there is no known association with an important event or person.

Figure 17. Resource No. 1192 front façade, facing south.

Figure 18. Resource No. 1192 side façade, facing southeast.

Resource Nos. 1192 and 1192.01 do not display distinctive architectural features or characteristics, and lack significance through aesthetic features or association with an important person or historic context. Based on this evaluation, Resource Nos. 1192 and 1192.01 are recommended ineligible for inclusion in the NRHP.

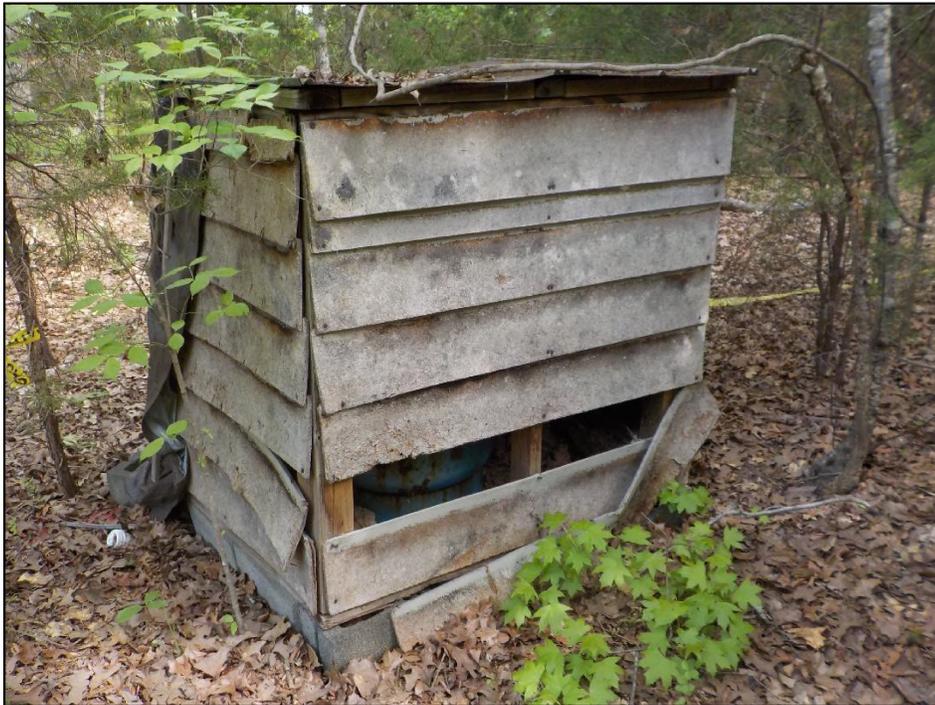
Figure 19. Resource No. 1192.01, outbuilding, facing north.
