# Cultural Resources Survey

US 701 Improvements Project

*Horry County, South Carolina*

February 2019

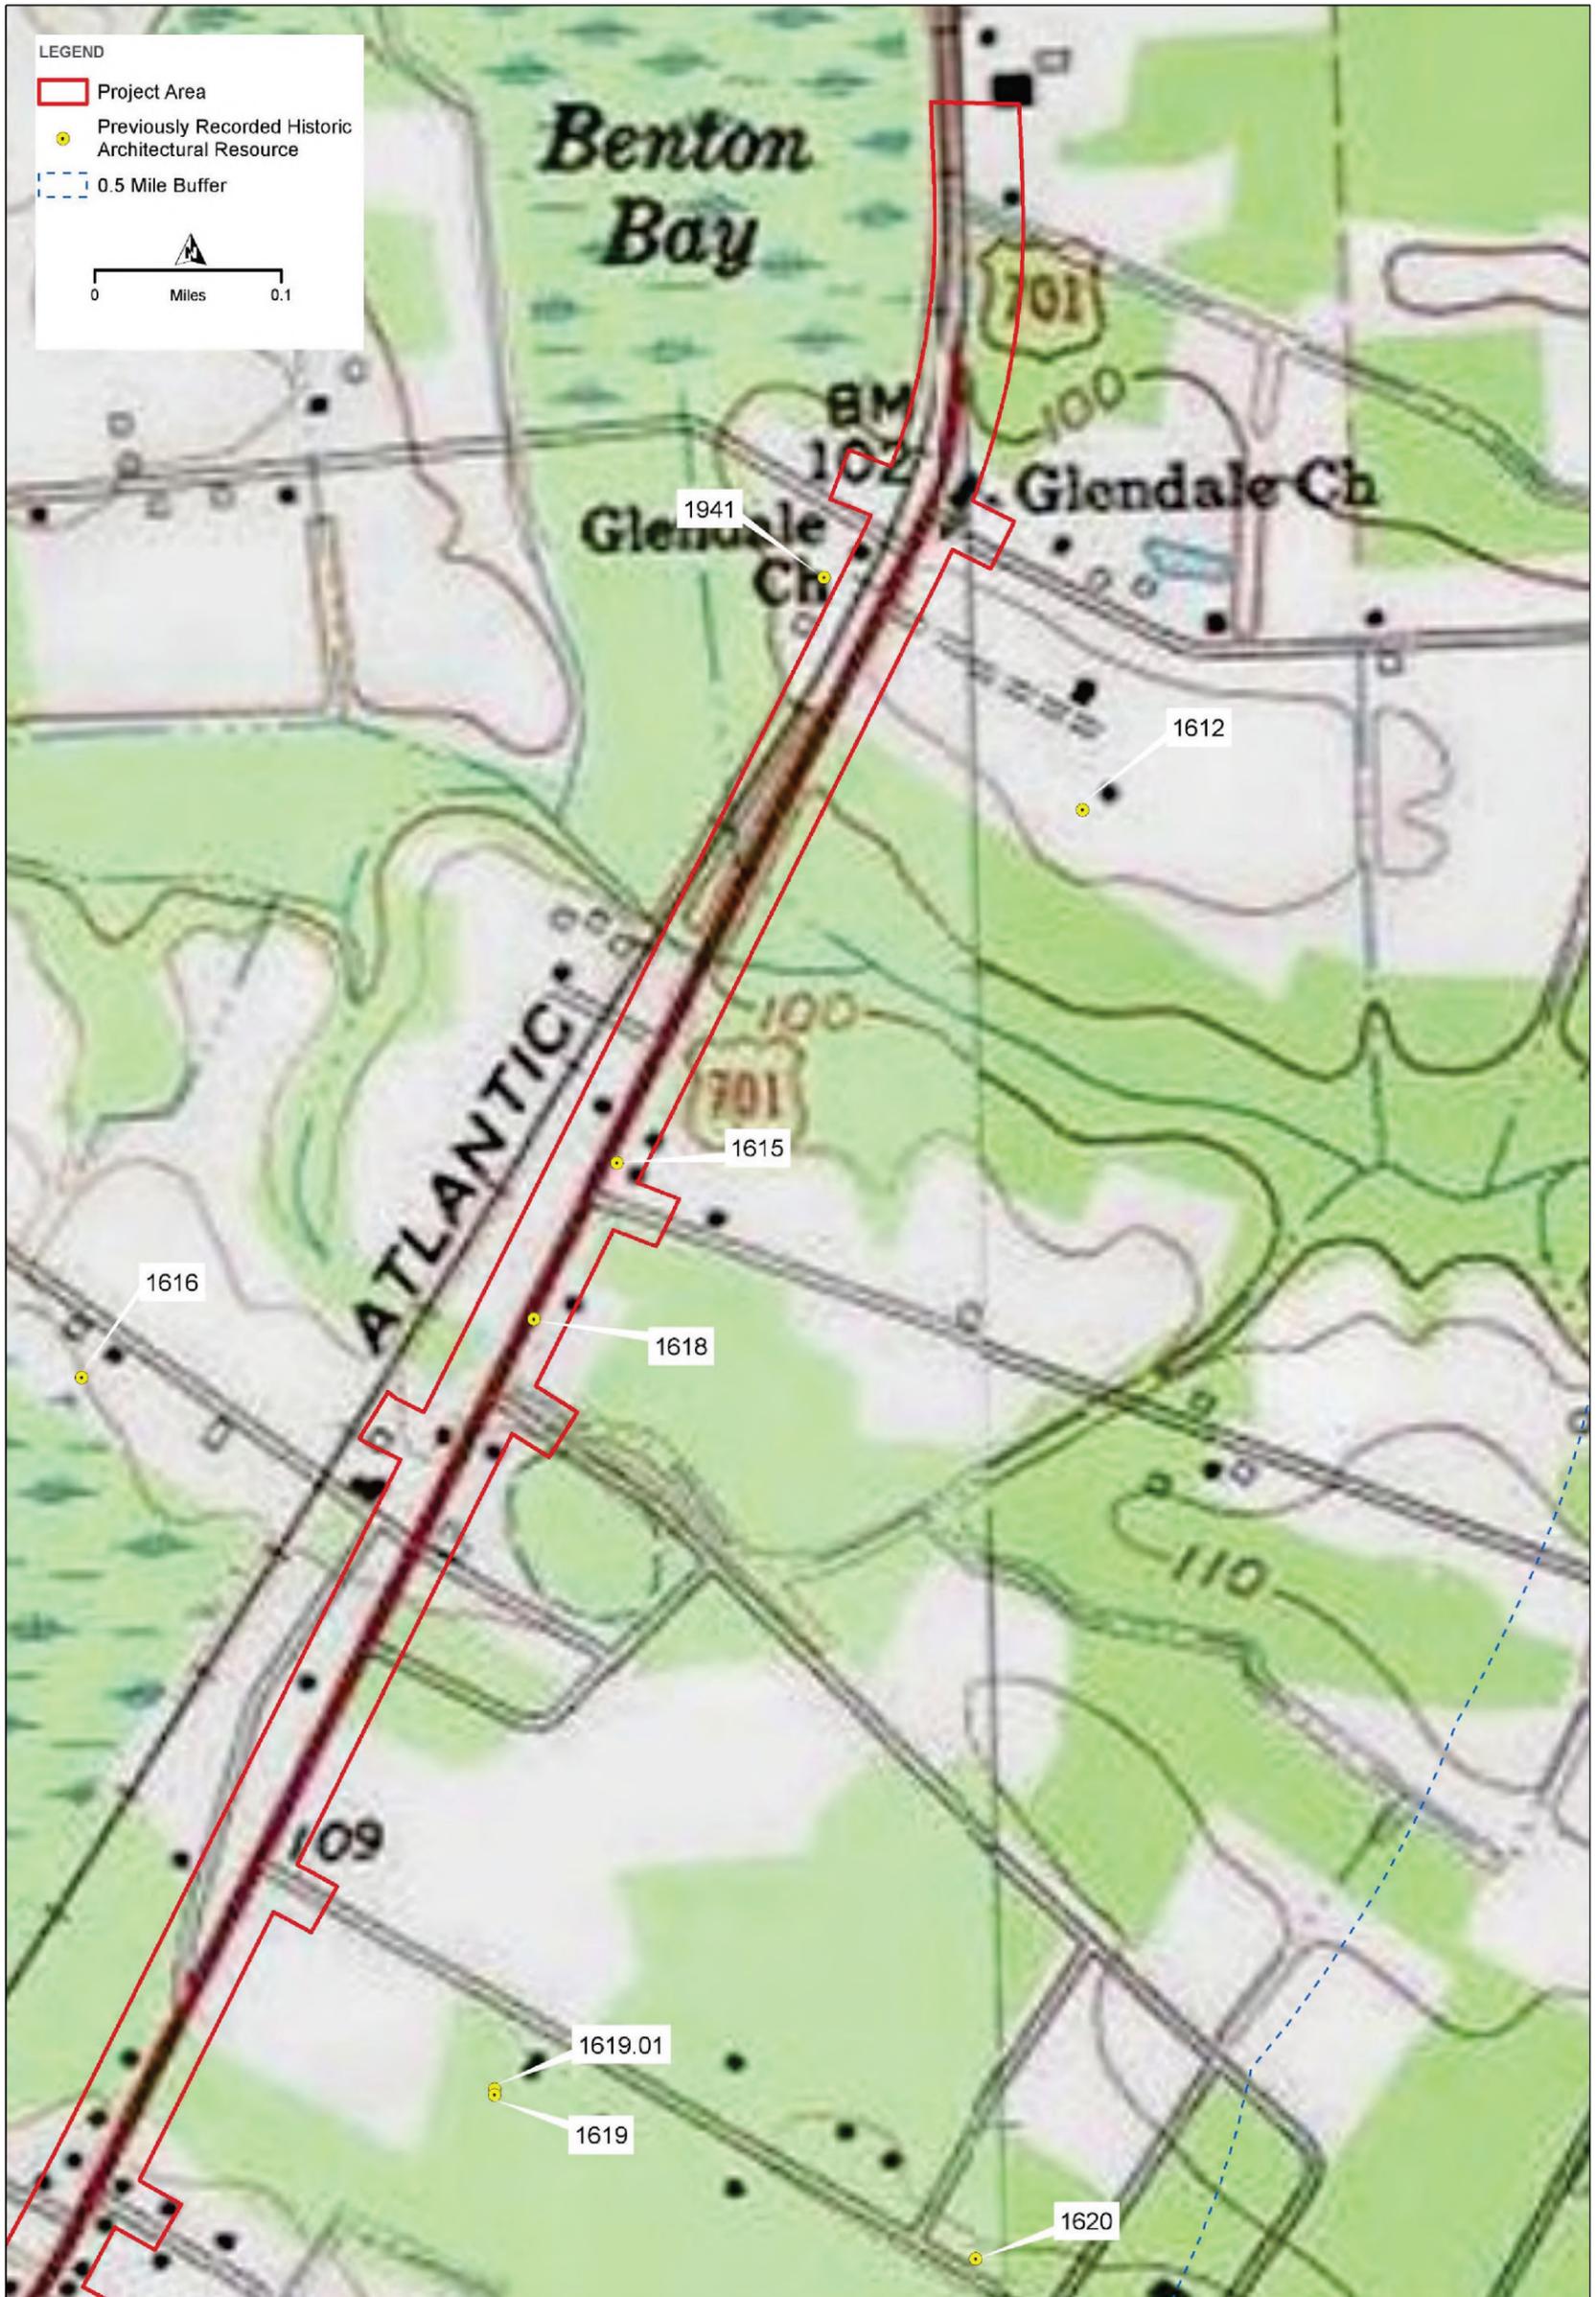
Figure 2B. Location of the US 701 Improvements Project and all previously identified cultural resources on the 1962 Loris, and 1962 Goretown, SC quadrangles.

The project archaeologist consulted ArchSite to obtain information regarding previous cultural resources investigations and to determine the locations of previously recorded cultural resources located within 0.5 mile of the Project (see Figures 2a-2c). The one relevant study was New South Associates' *Horry County Historic Resource Survey* (Richey et al. 2009), which resulted in the identification of 91 historic architectural resources within 0.5 mile of the Project. A total of 36 of these 91 resources are located within the Loris Historic District, which is located approximately 1,750 feet to the south of the proposed project. This NRHP-listed district contains early to middle twentieth-century historic architectural resources, with 34 contributing properties (Richey et al. 2009: 103-107). The 0.33-mile buffer that stands between the Project and the historic district is a heavily developed commercial zone. Thus, the historic district will not be visually impacted by proposed ground-disturbing activities associated with the US 701 Improvements Project.

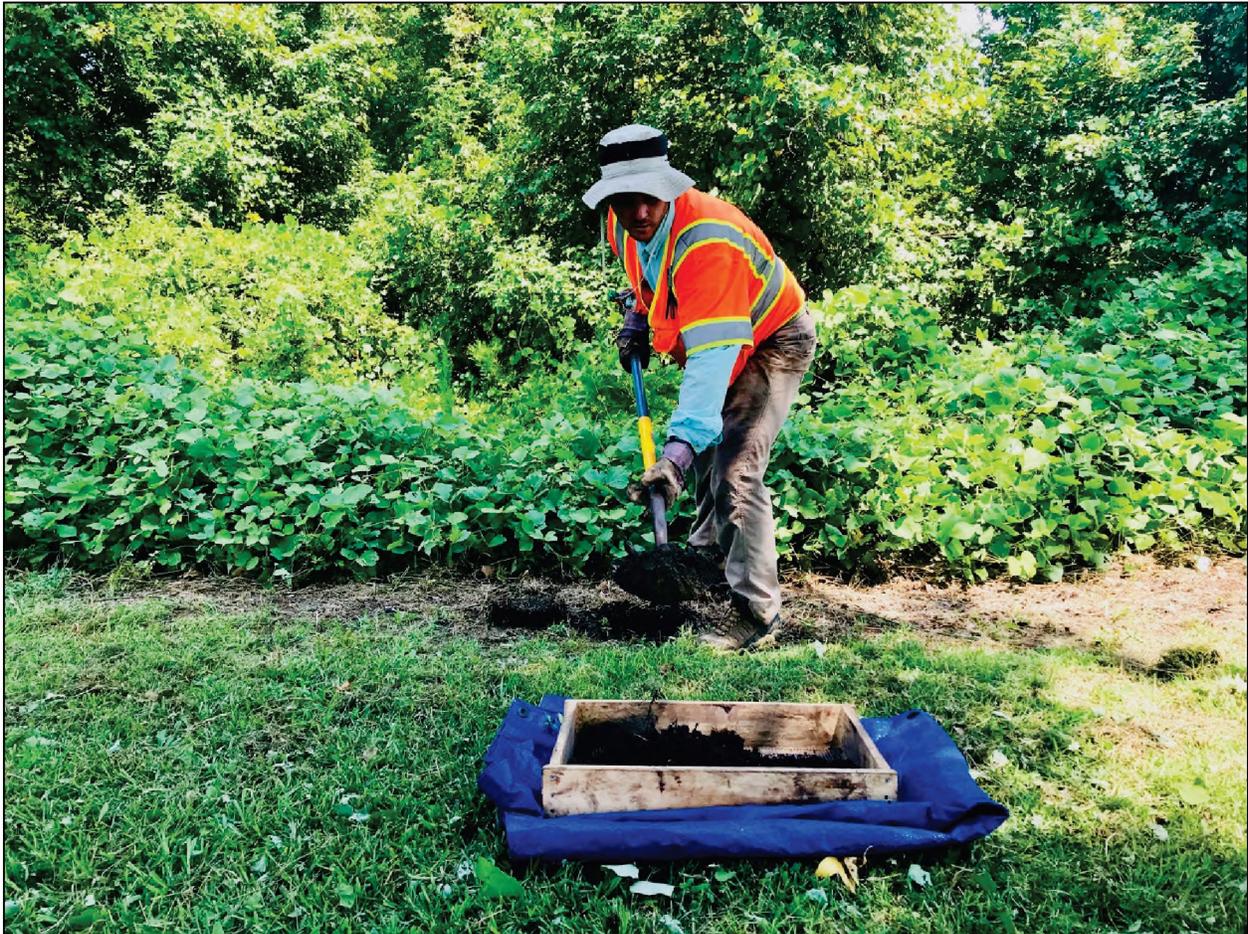
Figure 3. View of investigator excavating a shovel test

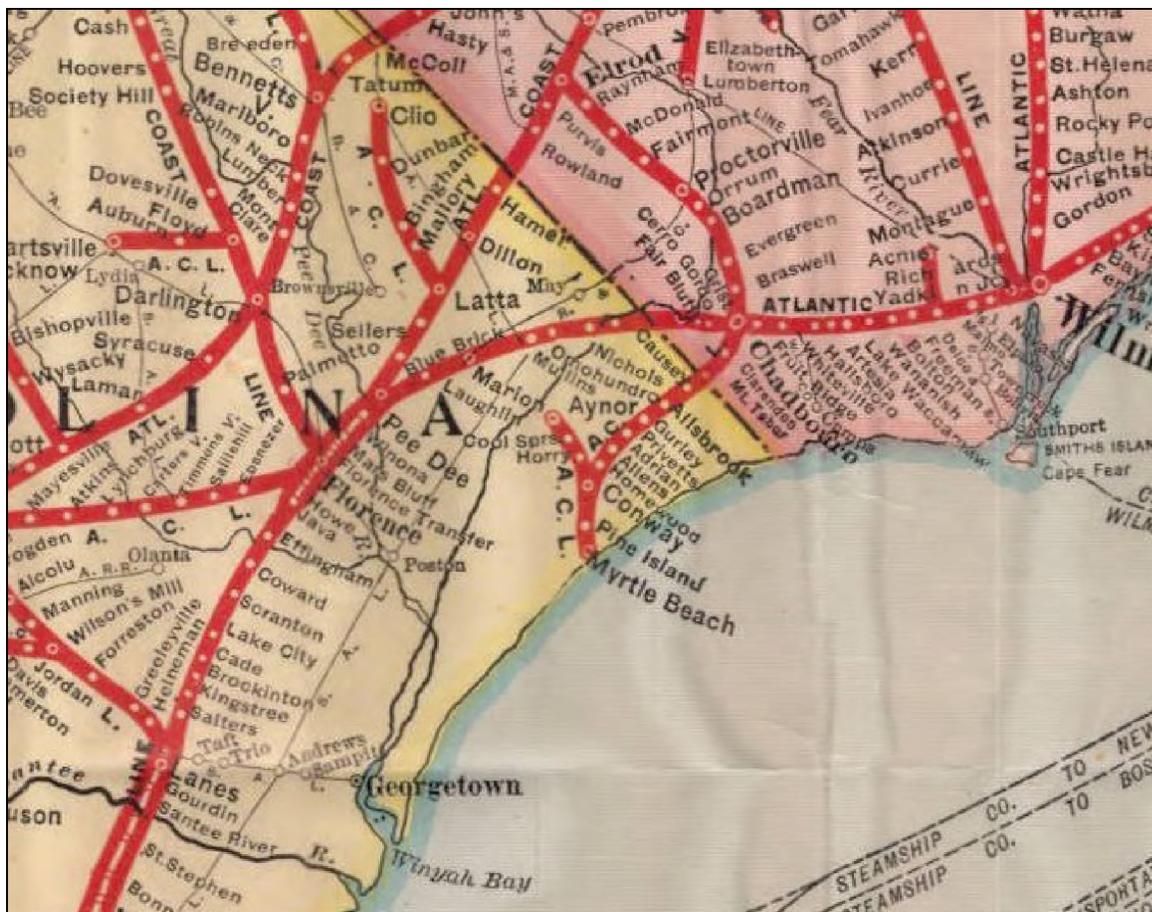
Figure 10. By 1923, the railroad spur had extended to Myrtle Beach, and a smaller spur connected the line to Aynor (Atlantic Coast Line Railroad Company 1923).

In 1909, the Conway Telephone Company installed a complete telephone system in Loris, strengthening its ties with the outside world. A new depot was constructed in the town in 1911 to accommodate the growing traffic of railroad freight. Figure 10 presents a 1923 map showing the extension of the railroad system that passed through Loris. The next two decades saw steady if slow growth in the town (Loris Chamber of Commerce 2013). The Horry Herald listed 25 businesses in Loris in August of 1915. These included the Loris Drug Company, Loris Hardware and Furniture, Prince Hotel, and multiple warehouses and banks. Methodist and Baptist churches were also established by this year, as well as a grade school and high school (Lewis 1987). Generally modest in scale and style, bungalows, Colonial Revivals, and gable-and-wing forms were built around the center of the town, and along the main thoroughfares. Farmhouses with barns were located further afield, and were accompanied by additional outbuildings. Both rural and town houses were typically frame-construction and clad in wood siding. Brick was commonly reserved for commercial and public buildings in Loris (Lewis 1987).

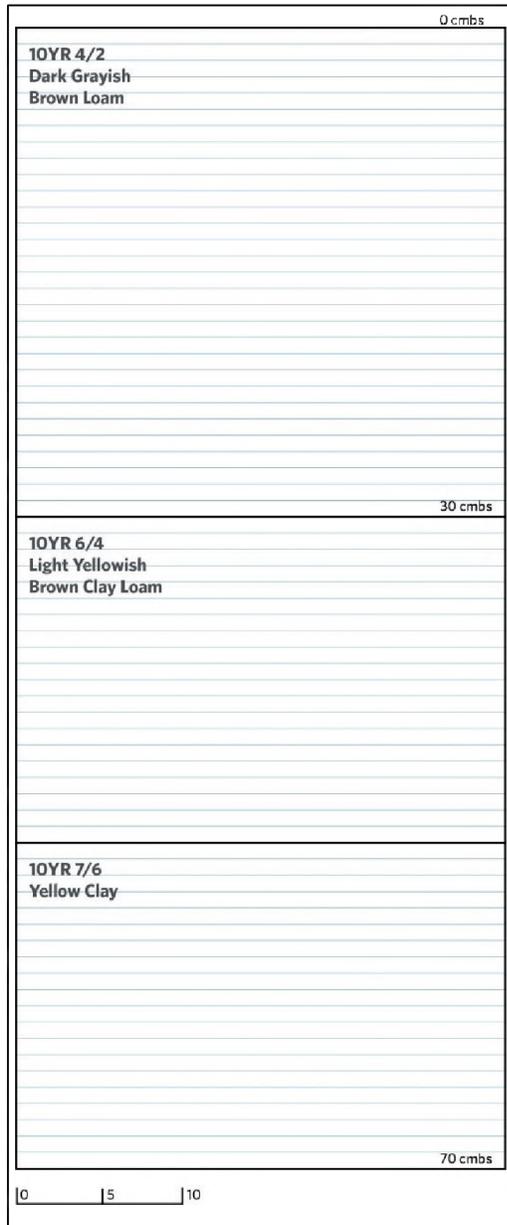
Shovel tests generally exposed a 10YR4/2 dark grayish brown loam from 0-30 cm bs, over a 10YR6/4 light yellowish brown clay loam at 30-50 cm bs, underlain by a 10YR7/6 yellow clay subsoil at 50-70+ cm bs. Figure 12 presents a typical soil profile. In several areas, the clay subsoil was reached as shallow as 15-30 cm bs. Generally, the upper 30 cm bs of the soil profile represents the current or former plow zone. No artifacts were recovered from any of the shovel tests excavated with the APE. Investigators also visually inspected the ground surface where possible; no artifacts were observed on the ground surface. Given the proximity of the shovel tests to US 701 and several intersecting side streets, modern bottle glass and other debris (litter) was recovered from a number of shovel tests, but was discarded in the field.

Figure 12. Typical soil profile.

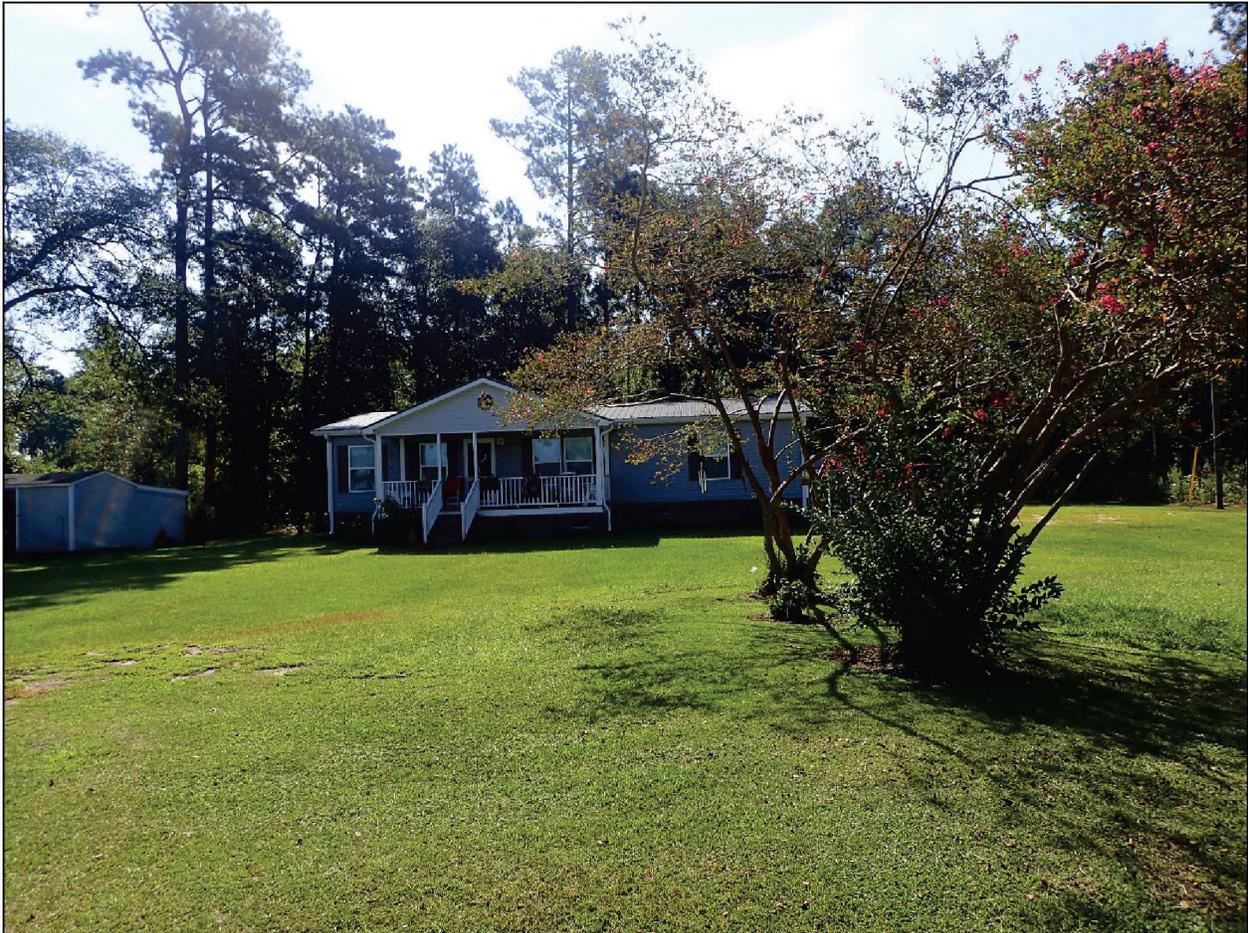
Figure 13. At an unknown date after 2014, the c. 1915 dwelling at 690 N. Hwy 701 was removed and replaced with this modern prefabricated home (HDR 2018).

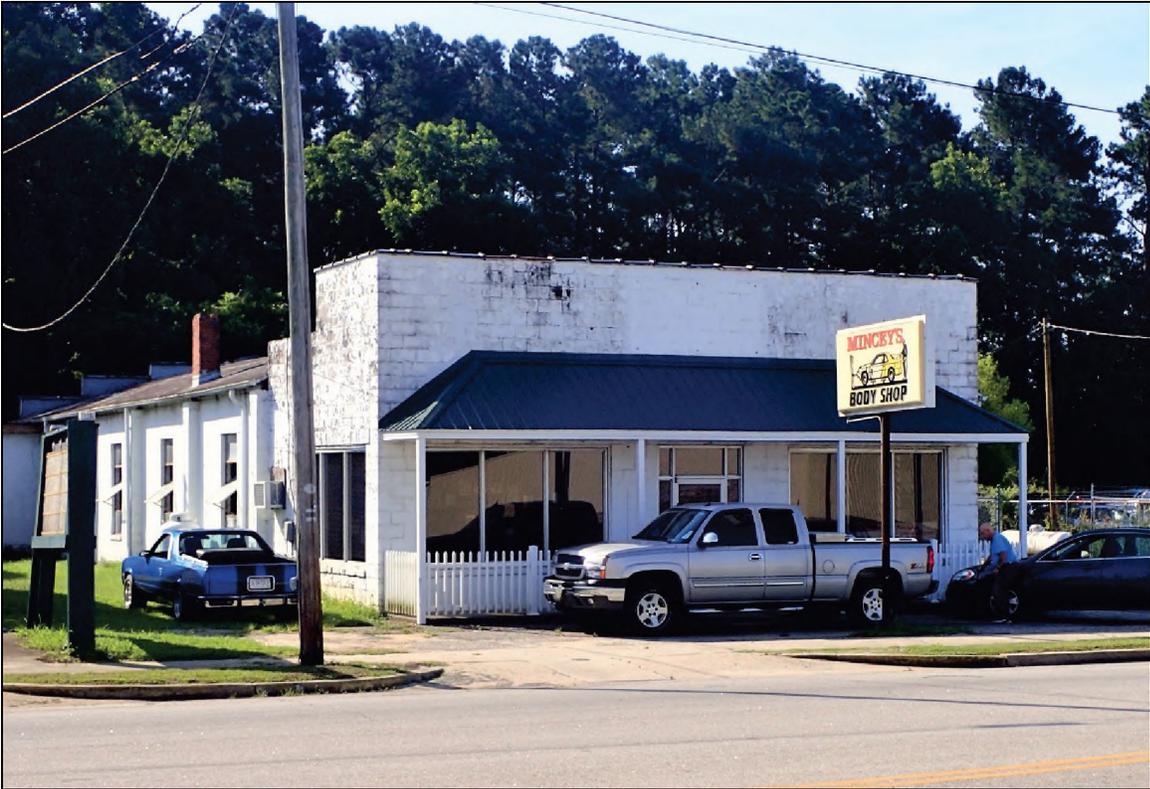
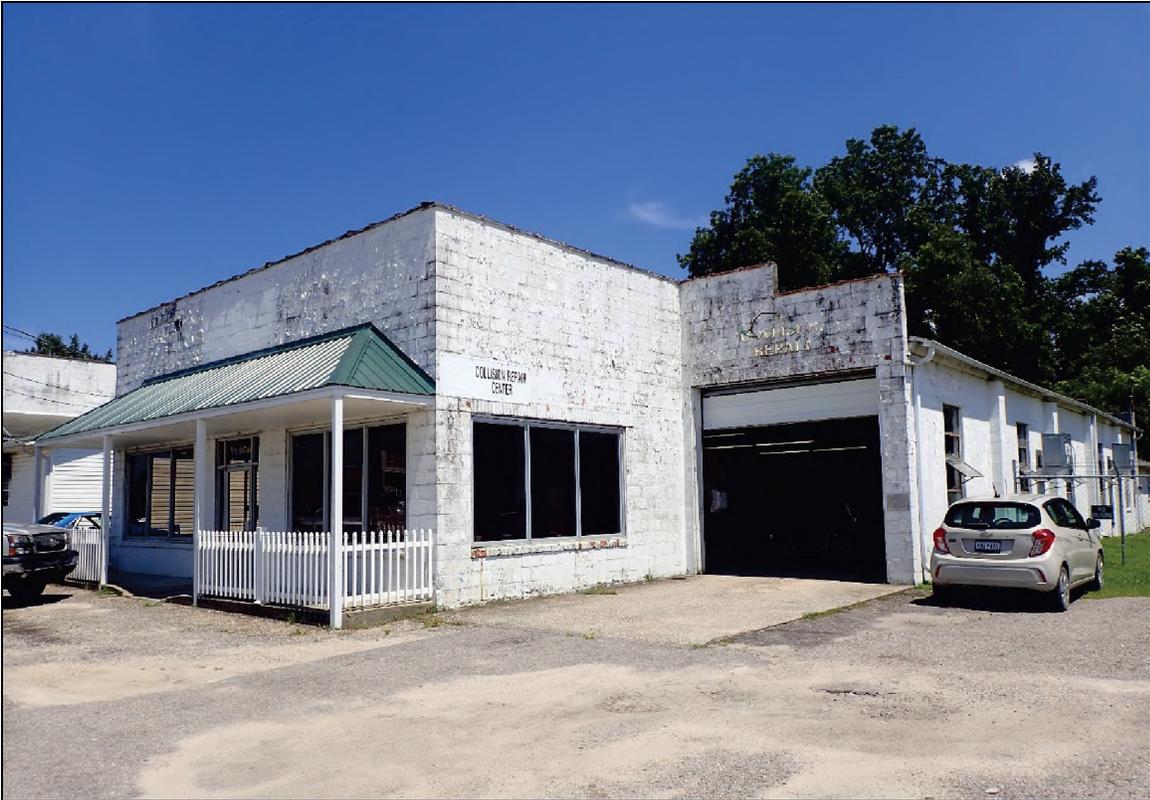
According to Horry County online tax assessor data, the commercial auto garage building was constructed in 1943. This date is supported by historic aerial imagery and maps. The building stands on the east side of N. Hwy 701, facing northwest. It is three bays wide by six bays deep, and rises a single story over an at-grade, concrete foundation. An additional, single auto bay extends off the south side of the building, recessed behind the rest of the façade wall, also facing northwest. The front (west) portion of the building is concrete block, and features a tall parapet across the façade that wraps around the front bay of each side (north and south) elevation. The building roof is barrel-shaped and covered in a rubber or asphalt material. An interior brick chimney rises near the center edge of the north roof slope.

A full-width front porch with a poured concrete floor, synthetic balustrade, and metal roof likely dates to c. 2010.

Figure 15. 4744 Broad St, view southeast (HDR 2018).

Figure 16. 4744 Broad St, view east (HDR 2018).

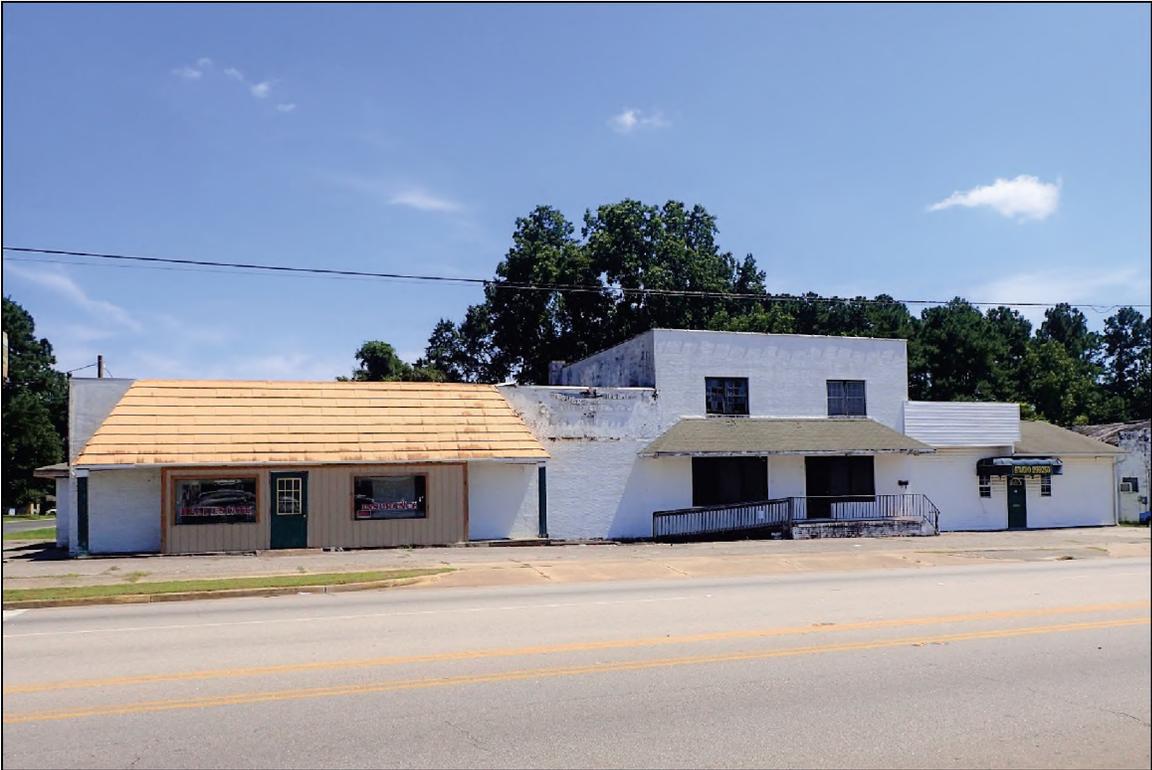
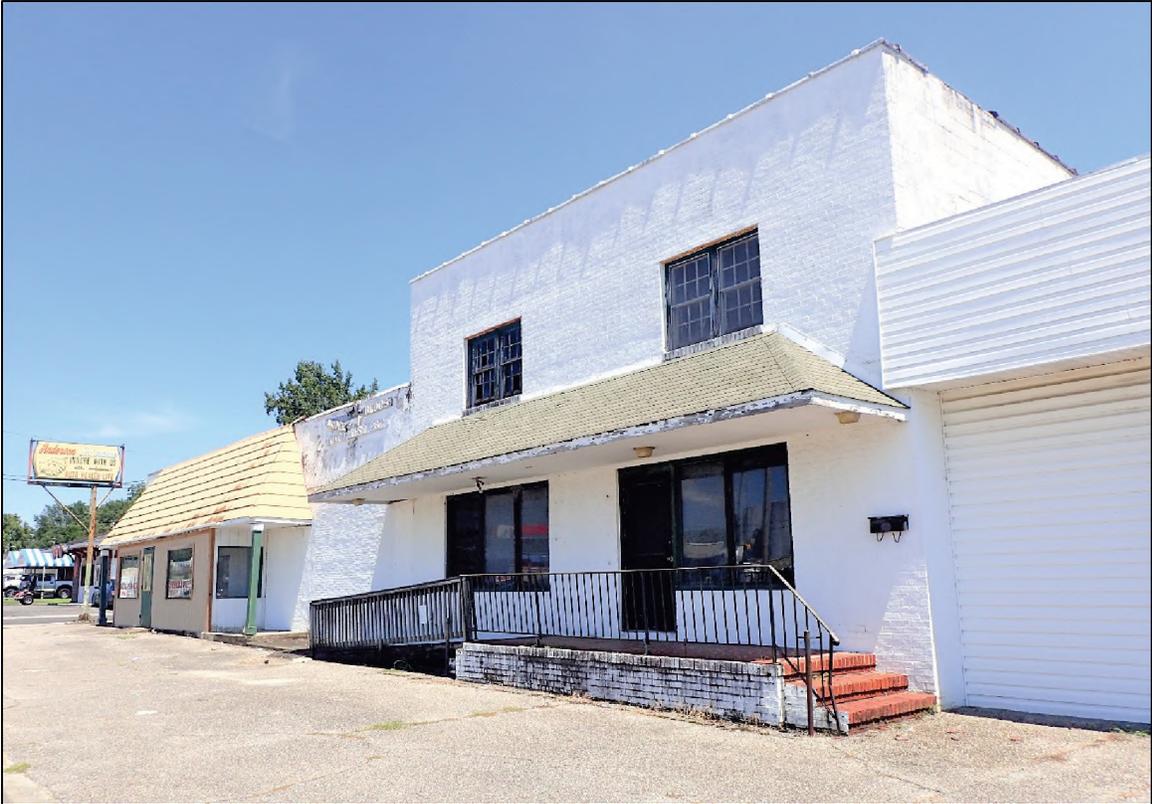
Figure 17. 4766 Broad St., view southeast. Original (1938) block stands at left (north) end (HDR 2018).

Figure 18. 4766 Broad St., view north: c. 1965 block at center (HDR 2018).

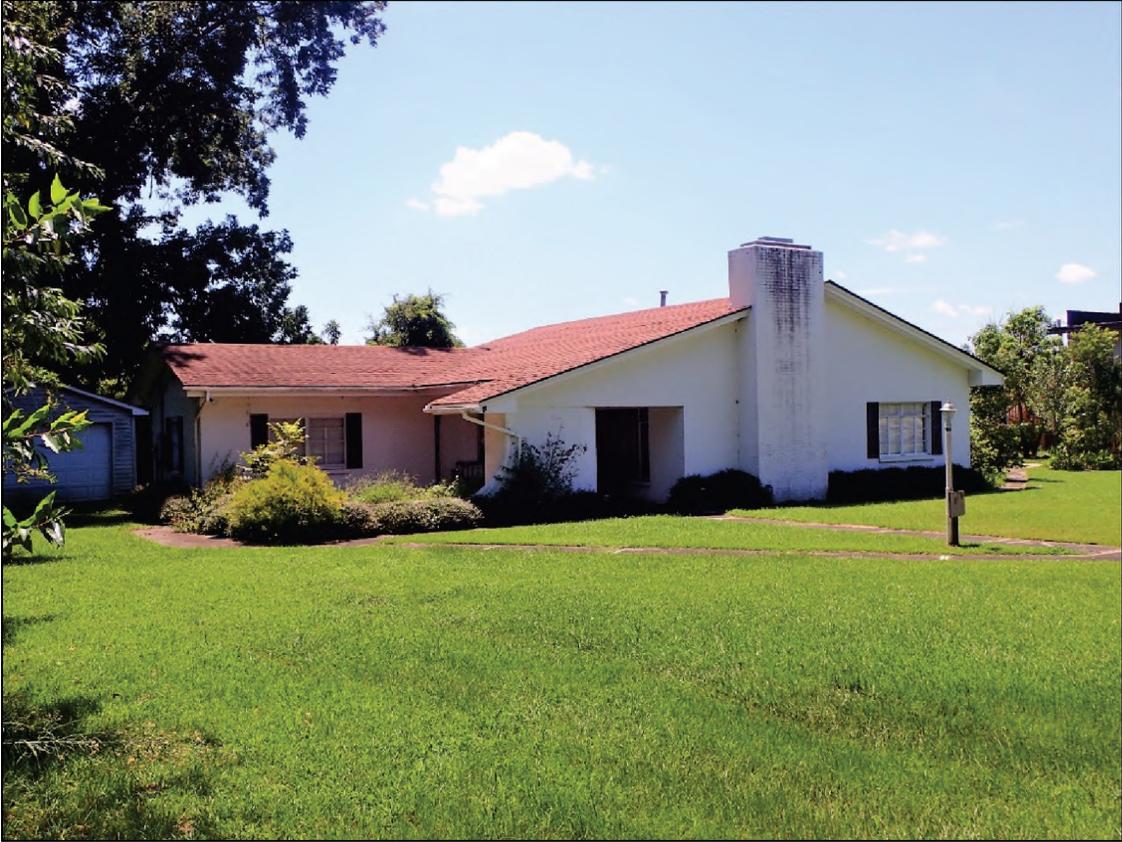
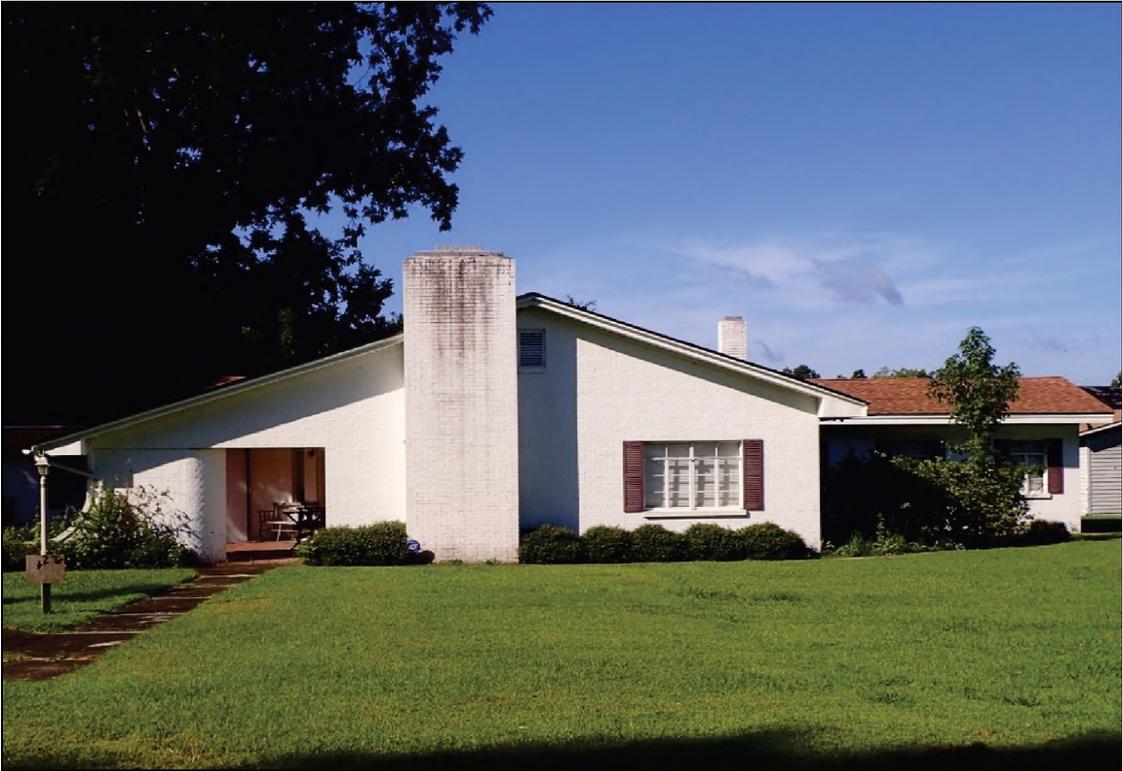
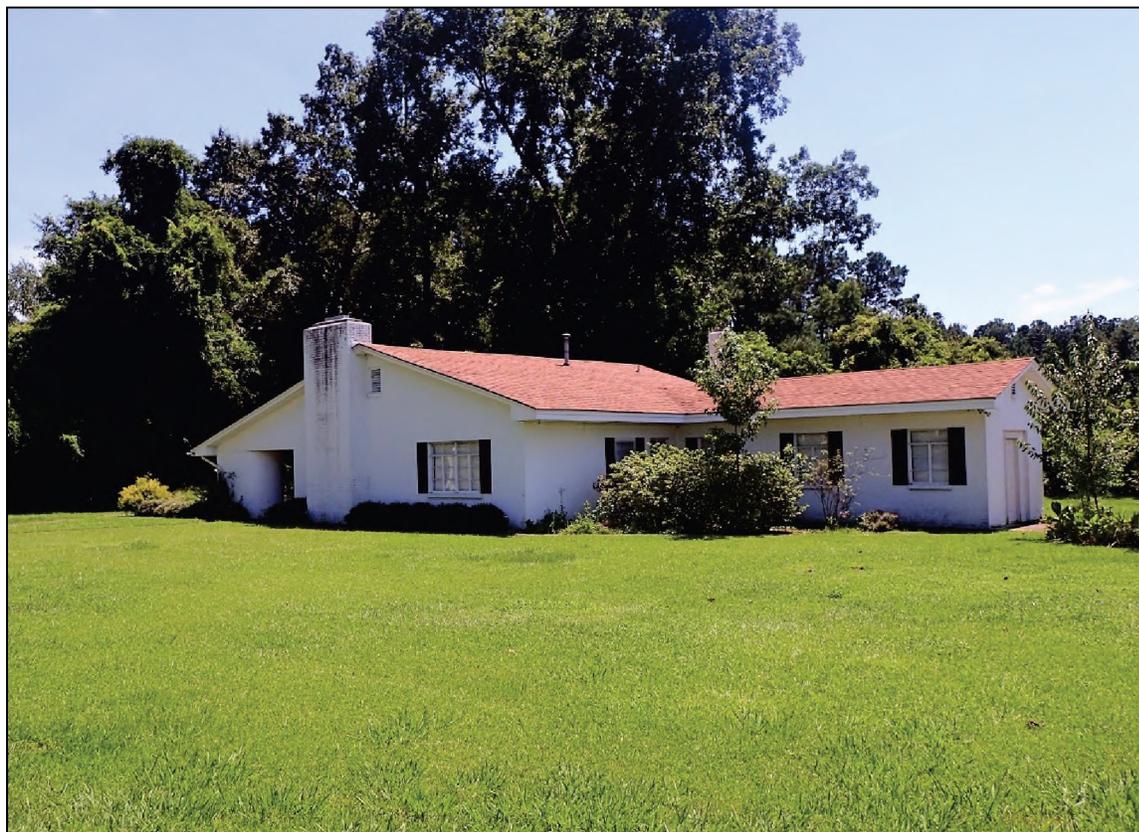
The main entrance of the home is situated on the engaged front porch located at the northeast corner of the house. The door, likely original, is located in a canted bay, flanked by a vertical band of lights on one side, and by a metal-frame picture window with sidelights on the other. The porch is supported by a single massive, curved brick pillar. Windows are single and paired 3x1 metal casement with fixed 2-light transoms. Windows have concrete sills and fixed louvered blinds. The north gable of the house is punctuated with an exterior, massive brick chimney. A second, smaller brick chimney protrudes from the roof ridge over the northwest wing of the T-plan building.

Figure 19. 4318 Holly St., view to southwest (HDR 2018).

Figure 20. 4318 Holly St., view to the south (HDR 2018).

Figure 21. 4318 Holly St., view to the southeast (HDR 2018).

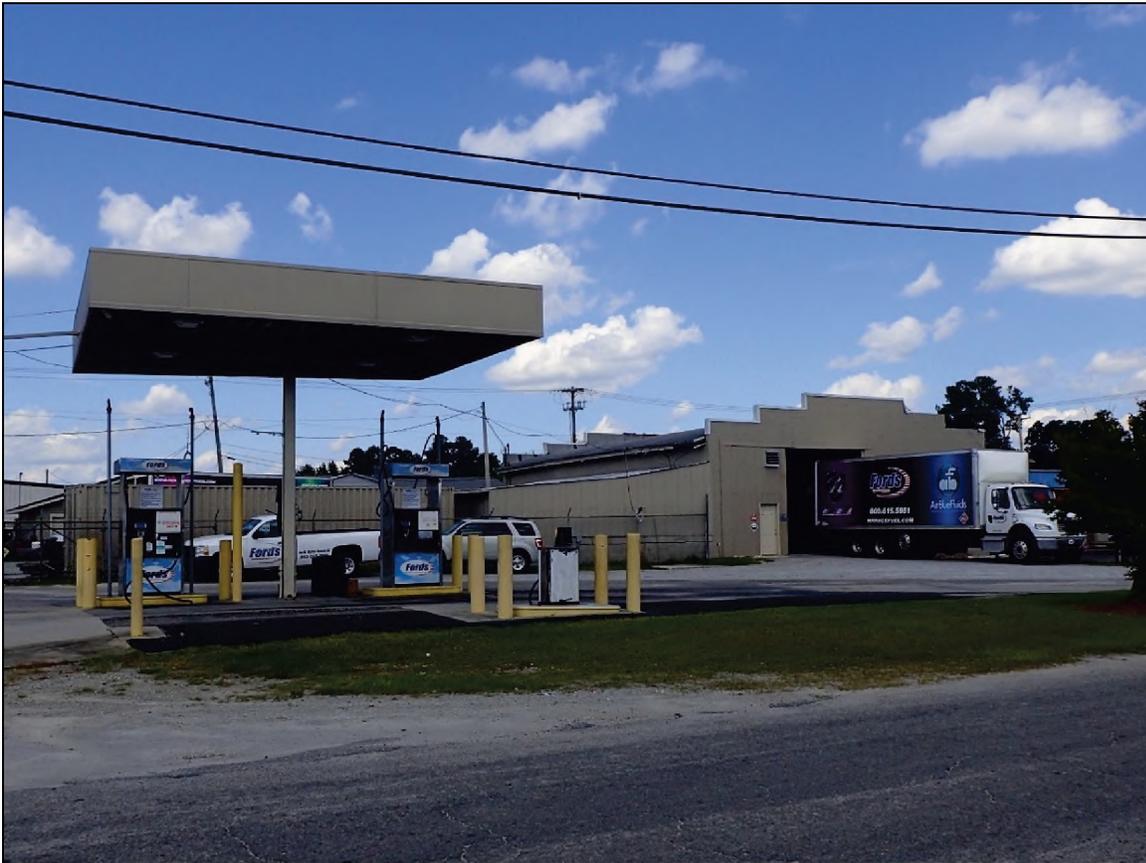
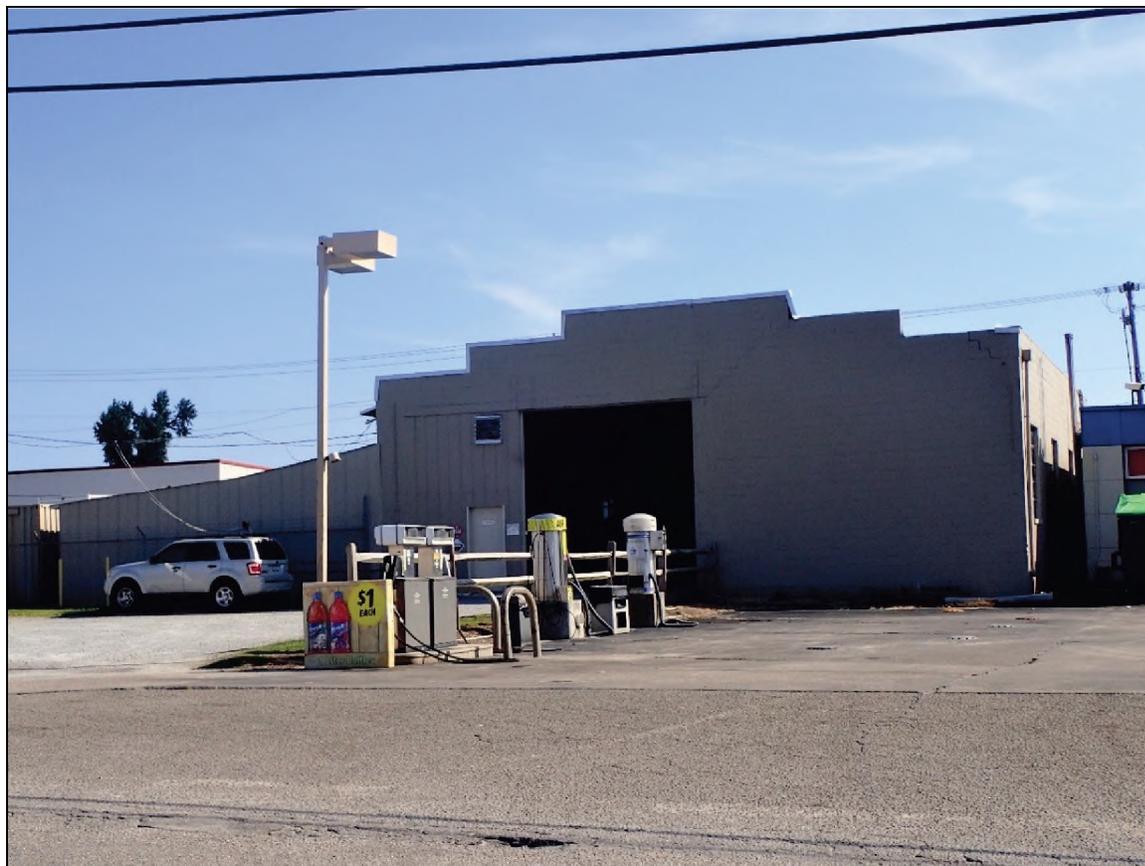
infilled with vertical wood siding, some brick, a modern composite pedestrian door, and a square metal fan vent. The building nearly abuts the commercial building located immediately on the east on the adjacent parcel, and the east elevation is therefore not fully visible. Discernable on the east wall are multi-light, metal-frame windows. Two additions are present: a west-side, shed-roof addition clad in ribbed metal (c. 2000), and a large, flat-roof addition on the rear (north) of the building (c. 1990). Two modern gas pumps are installed southeast of the garage building, sheltered under a square, metal flat-roof canopy.

Figure 22. 4115 Holly St, view to northeast (HDR 2018).

Figure 23. 4115 Holly St, view to north (HDR 2018).

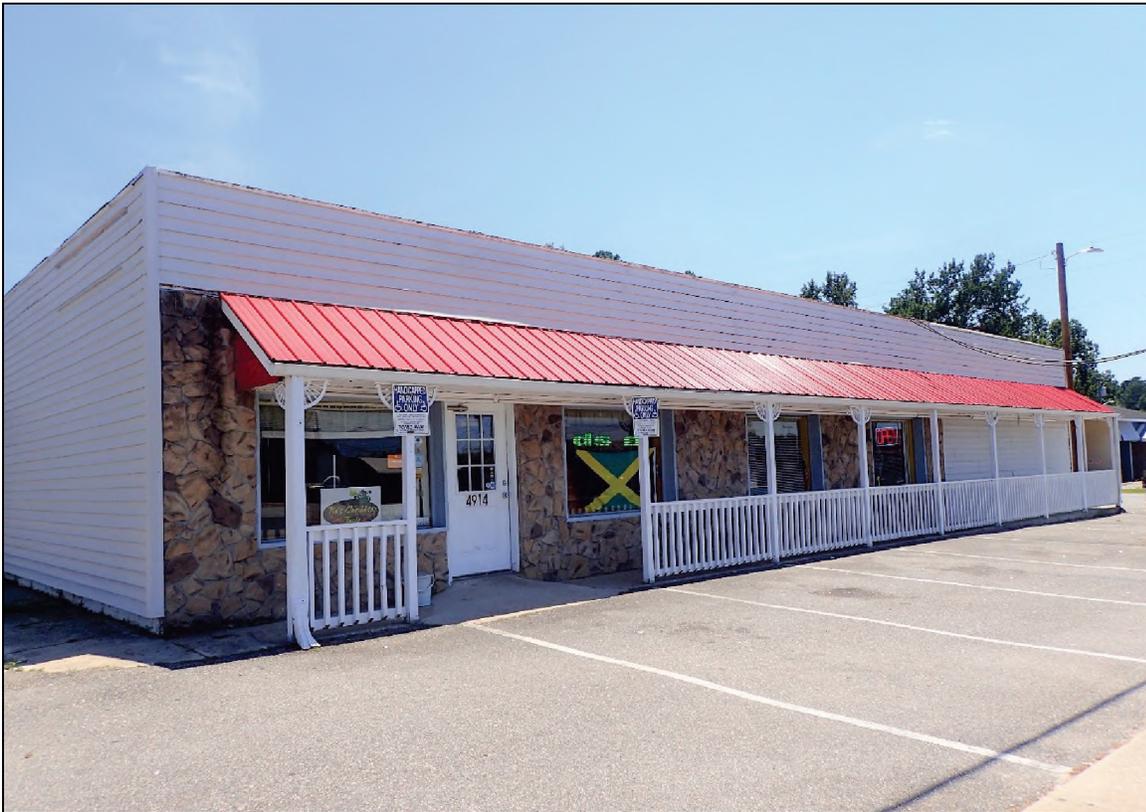
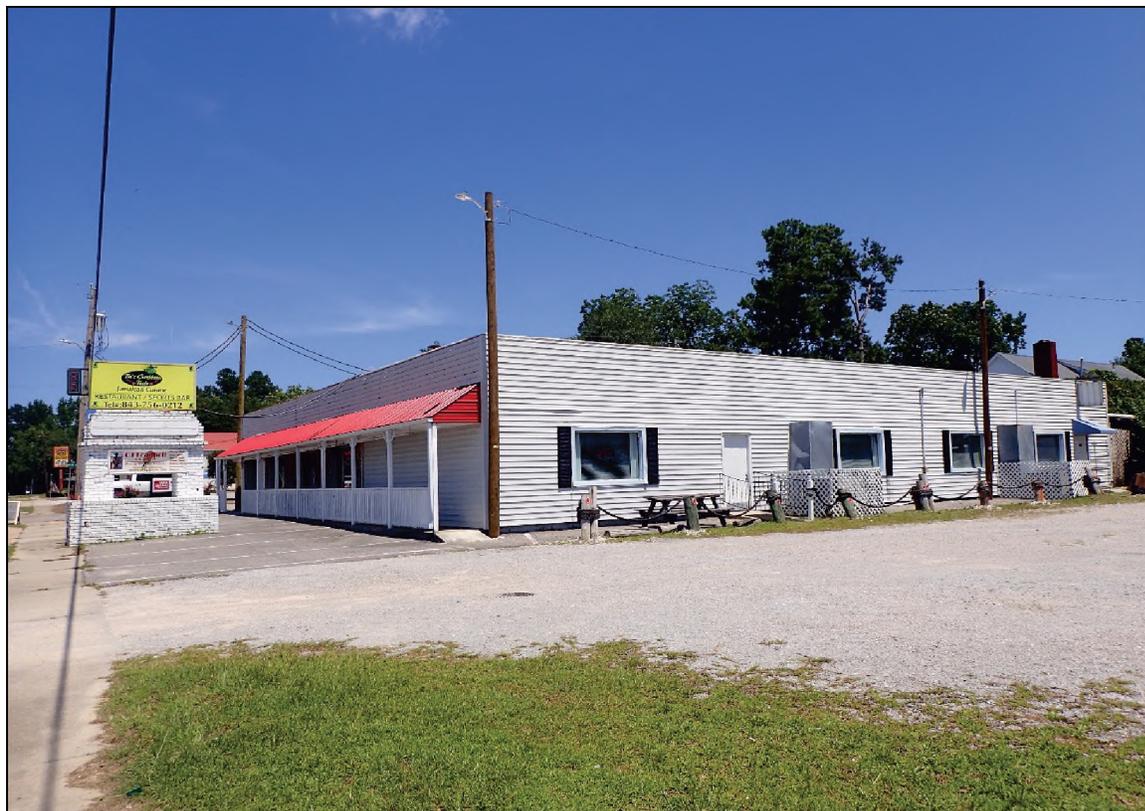
According to online Horry County assessor data, the commercial building at 4914 Broad St. was constructed in 1949. The rectangular building rises a single story above an at-grade foundation. The façade (west elevation) is six bays wide and is clad in vinyl and false stone veneer. Parapet walls obscure the flat roof of unknown material.

A brick sign post stands in the asphalt-paved parking area in front (west) of the building. The structure is composed of a three-foot-high brick wall, on top of which stand two brick piers, which are in turn capped by a corbelled brick lintel. A synthetic sign board sits on top of the lintel and reads “Tia’s Caribbean Taste, Jamaican Cuisine, Restaurant/Sports Bar.”

Figure 24. 4914 Broad St., view southeast (HDR 2018).

Figure 25. 4914 Broad St., view northeast (HDR 2018).

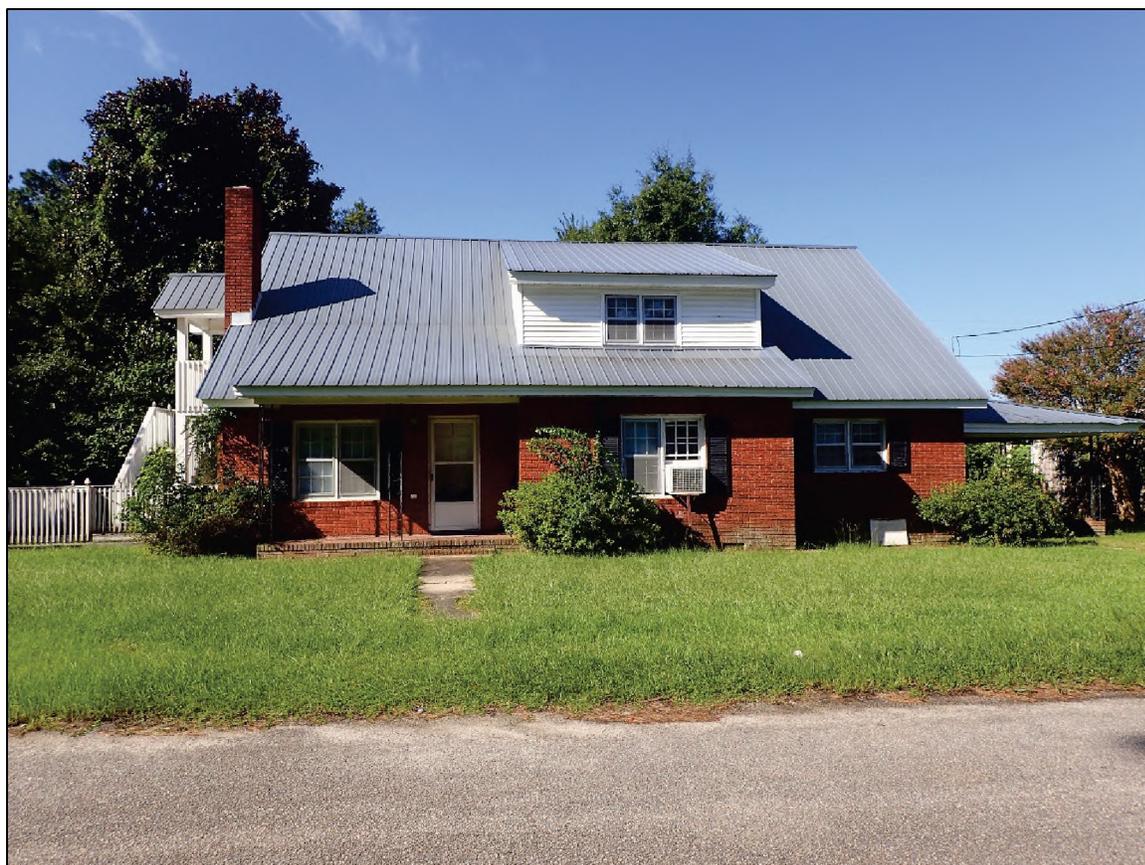
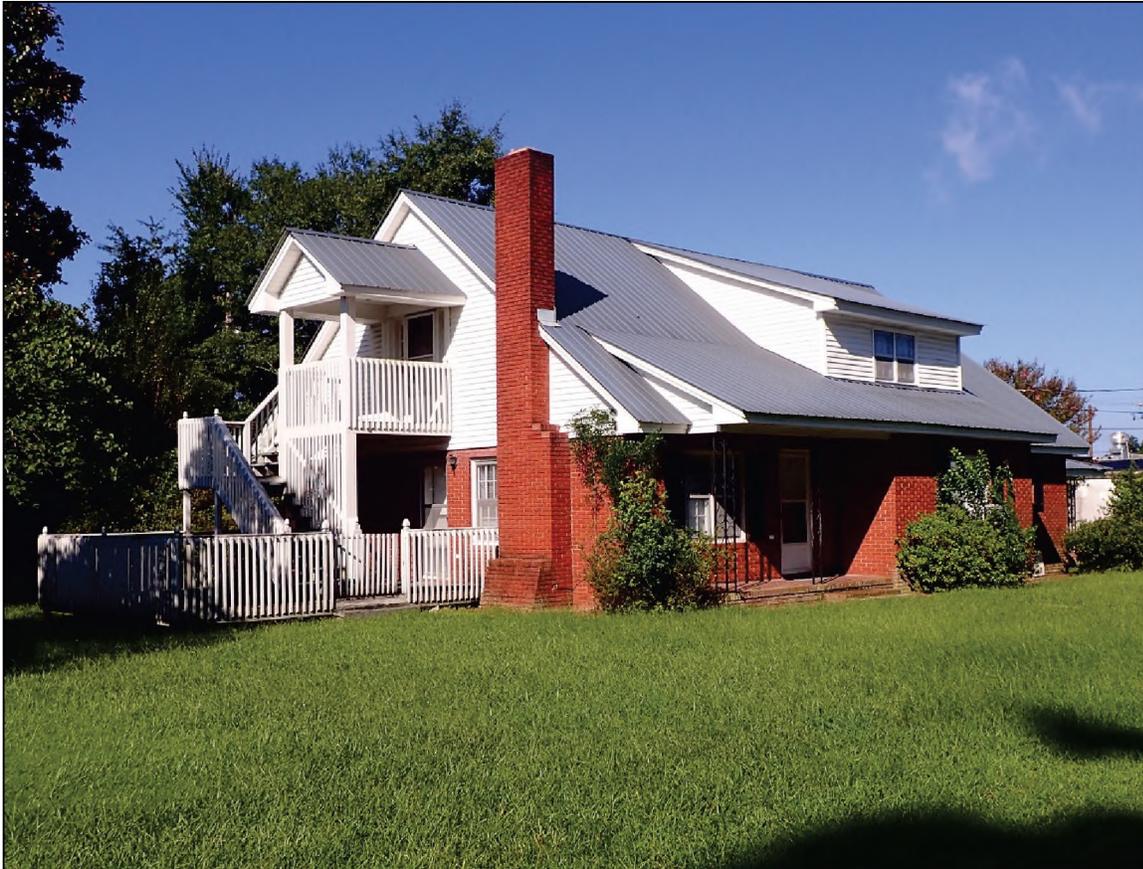
A detached single-bay garage with a gable front roof and raised seam metal siding stands southeast of the dwelling, facing the road. The building holds a vinyl roll top door with lights. It is likely a modern addition to the property.

Figure 26. 4220 Dogwood St., view south (HDR 2018).

Figure 27. 4220 Dogwood St., view southwest (HDR 2018).
