# Cultural Resources Survey

US 701 Improvements Project

*Horry County, South Carolina*

February 2019

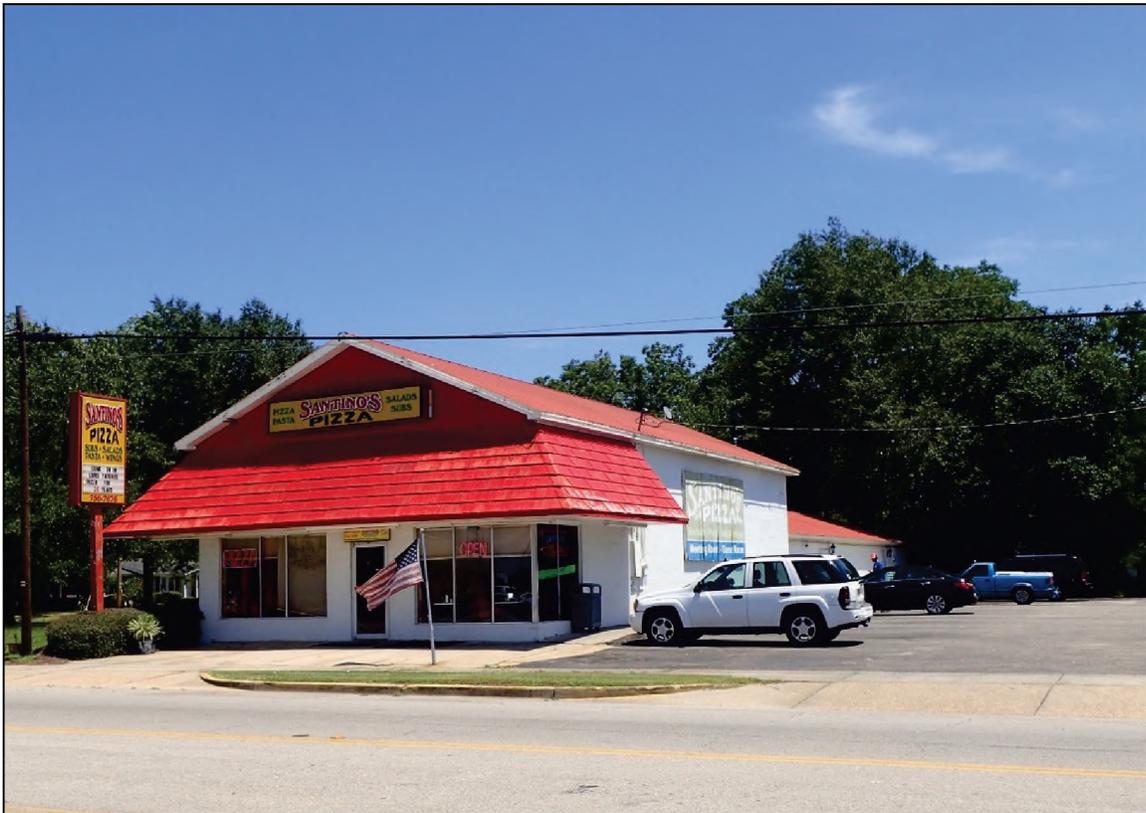
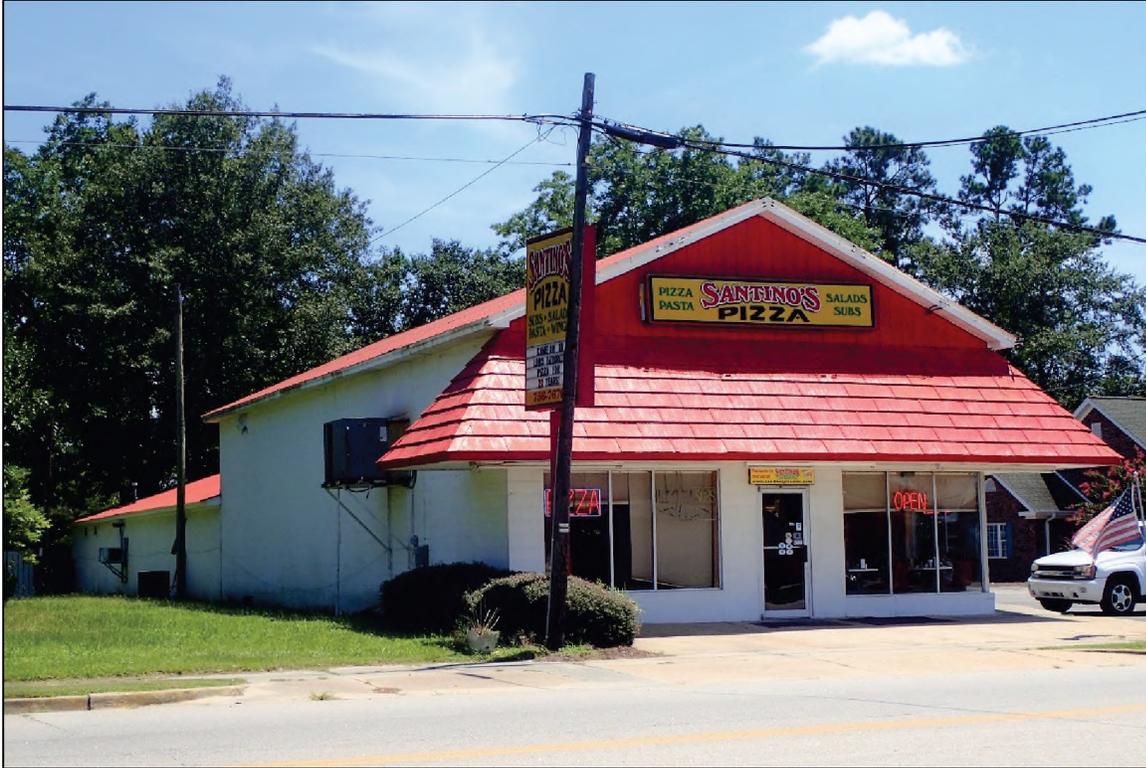
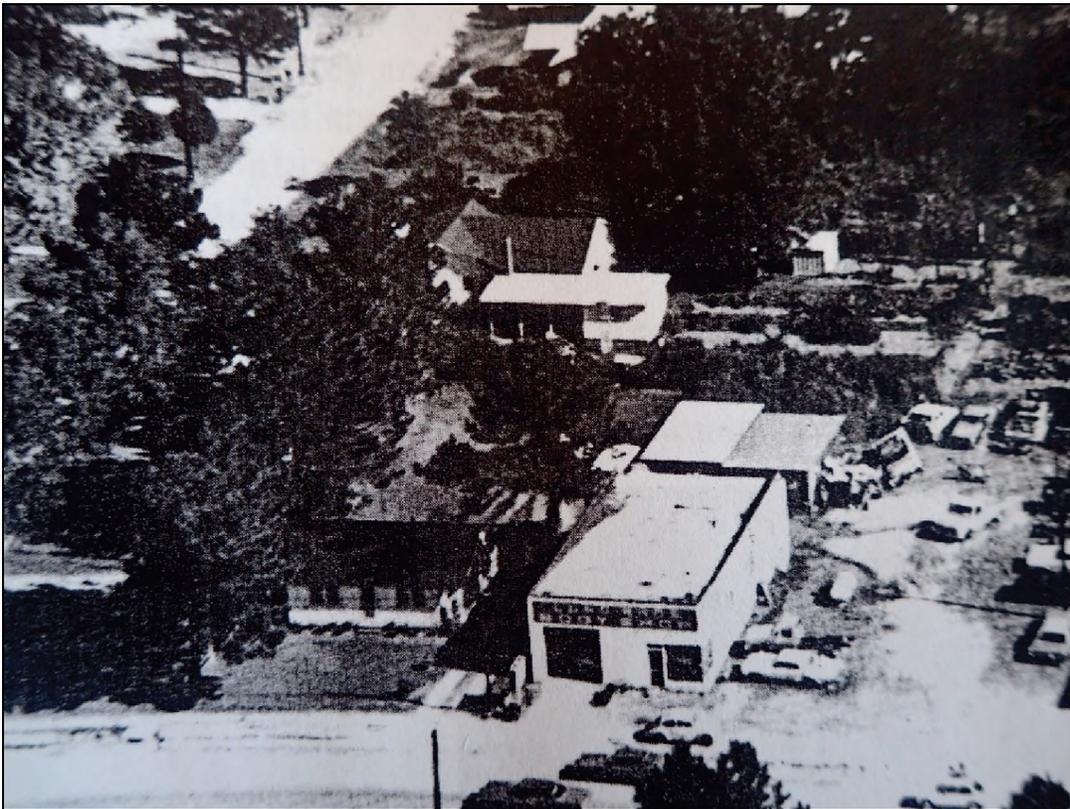
From at least 1969 to 1973, the Santino's Pizza building operated as an auto garage called Long Brothers' Body Shop (Figure 28). Though research was unable to confirm whether the building was originally constructed as a garage, the form of the building and historic photographs indicate that this was likely the case. When operating as a body shop, the building had a flat roof and no porch covering, and façade fenestration consisted of a single auto bay at the north end, and an office front door and window on the south end. Around the same time that the rear additions were built (c. 1985), and possibly coinciding with the purchase of the building by the current owners of Santino's Pizza in 1988, the building underwent several large modifications. The roof, formerly flat, was given a new front-gabled cap. The false mansard roof was installed on the façade, the auto bay was infilled with storefront windows, and a new doorway was cut out closer to the center of the façade.

Figure 28. 5102 Broad St, view to northeast (HDR 2018).

Figure 29. 5102 Broad St, view to southeast (HDR 2018).

Figure 30. 5102 Broad St at center, c. 1970, when operating as Long Brothers Body Shop. The parcel on the left/north is now vacant; visible in the background is 4226 Willow St. (Lewis 1987).

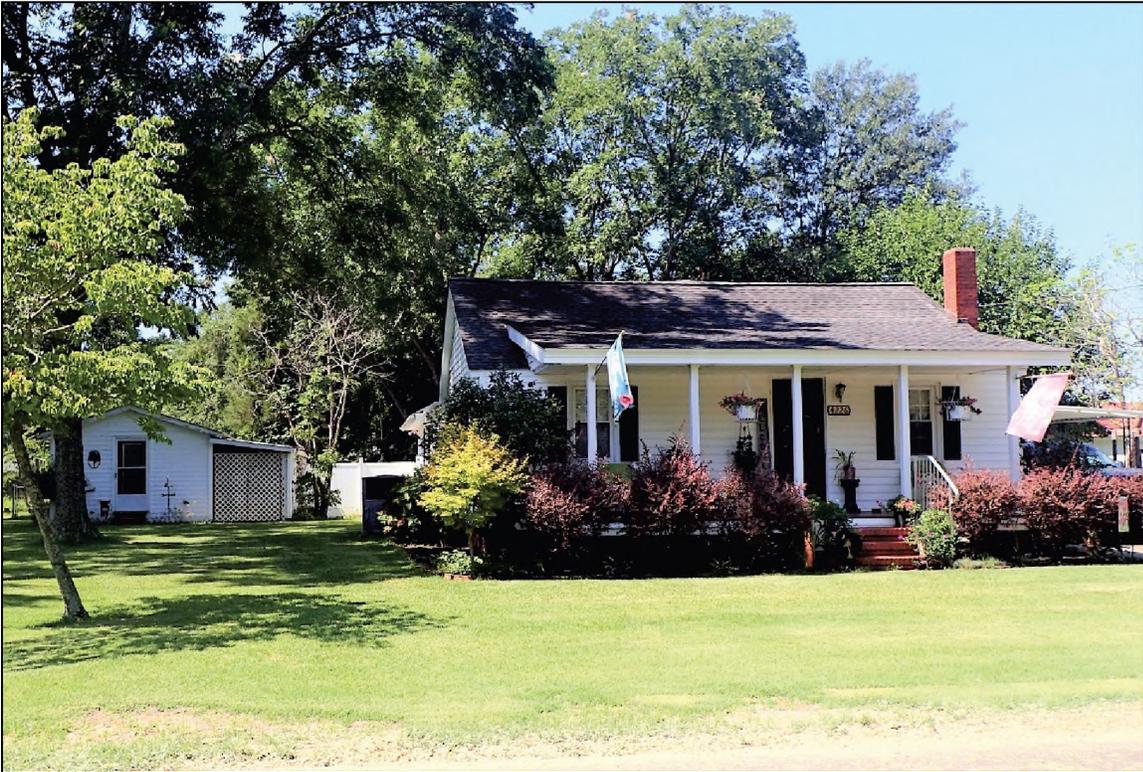
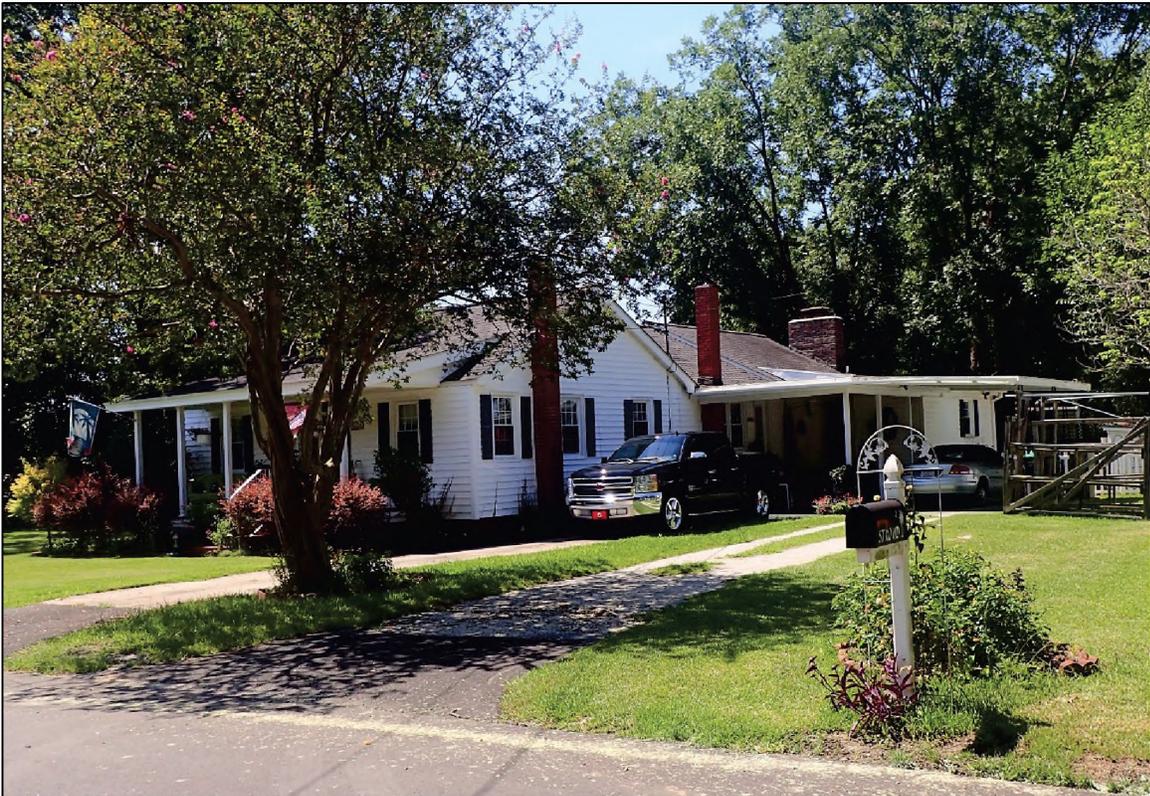
According to Horry County online tax assessor data, the dwelling at 4226 Willow St. was constructed in 1940. The small, one-story cottage sits on a raised concrete foundation and is capped by a side gable roof with narrow closed eaves. The building is clad in vinyl siding, and the roof is covered in asphalt shingles. A raised brick porch covers the façade (north elevation) and is covered by a shed roof supported on five narrow, square wood posts. A large gabled addition extends off of the rear (south) end of the building, and a flat-roof carport addition is attached at the southwest corner of the building.

A small gabled outbuilding (Site 3854.01) stands southeast of the dwelling. It is clad in vinyl siding and contains a single-leaf door fronted by a storm on the north elevation. A shed-roof extends off of the west side, covering a small bay enclosed with vinyl siding and wood lattice. The roof is covered by asphalt shingles and has closed eaves with wood rake trim.

Figure 31. 4226 Willow St., view southwest. Outbuilding on the left (HDR 2018).

Figure 32. 4226 Willow St., view southeast (HDR 2018).

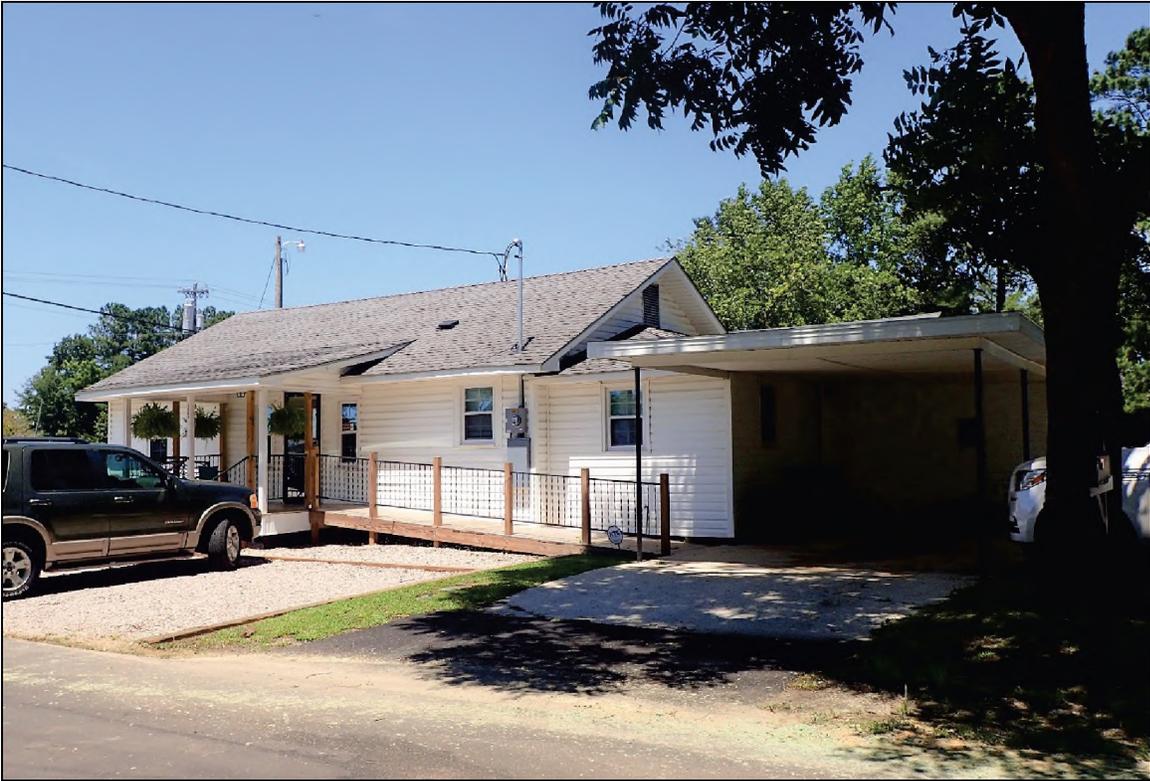
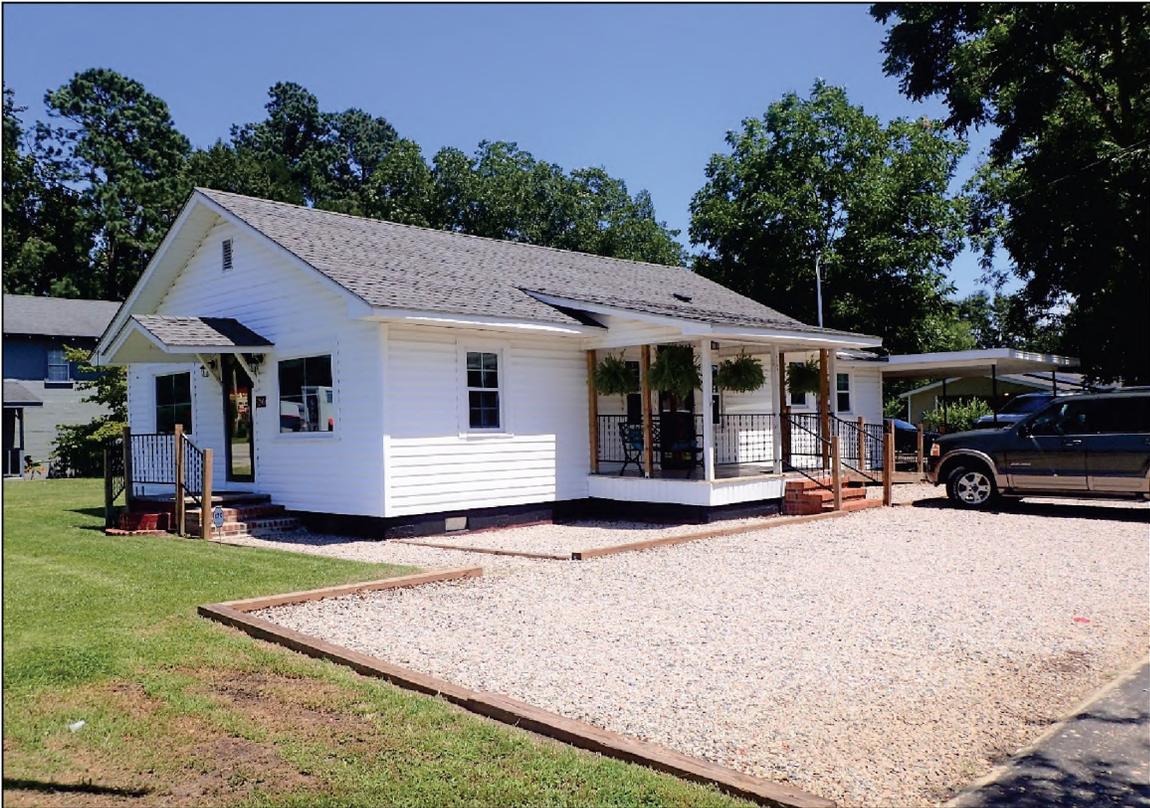
According to online Horry County tax assessor data, the dwelling at 5206 Broad St. was built in 1950; however, historic maps and aerial imagery indicate that the house was constructed at a slightly later date, c. 1955-1960. The Ranch-type dwelling doubles as a commercial store front: the dwelling faces south onto Willow St., and the commercial business (“That Salon”) faces west onto N. Hwy 701. The building rises a single story over a raised brick pier foundation with concrete block infill. The building is clad in vinyl siding and is capped by a side gable roof covered in asphalt shingles.

The commercial front (west elevation) of the building features symmetrical fenestration, with a single-leaf door centered beneath the gable peak. The door opens onto a brick stoop with a balustrade and is covered by a gable-front roof supported by wood braces. Two large square vinyl windows with simulated muntins flank the door. A rectangular vent is present in the west gable. Double and single vinyl sash are present on the north elevation.

Figure 33. 5206 Broad St., view northwest towards dwelling façade (HDR 2018).

Figure 34. 5206 Broad St., view northeast showing dwelling façade (right) and commercial front (left) (HDR 2018).

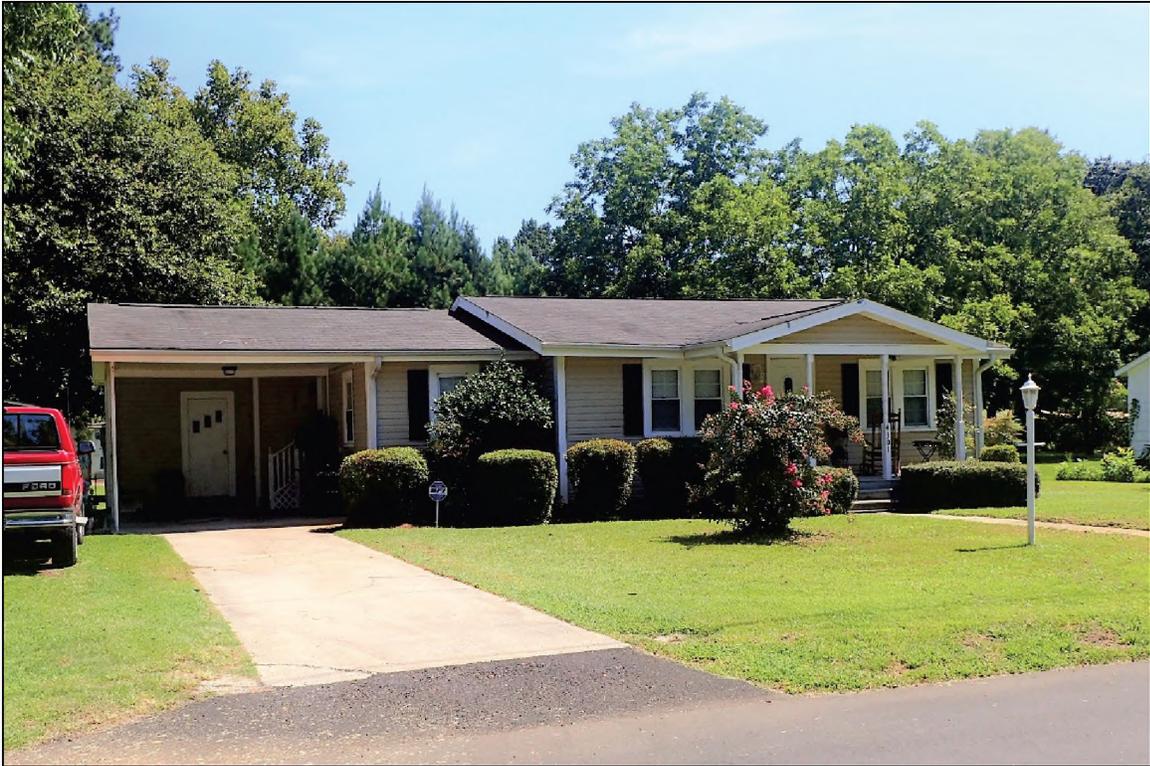
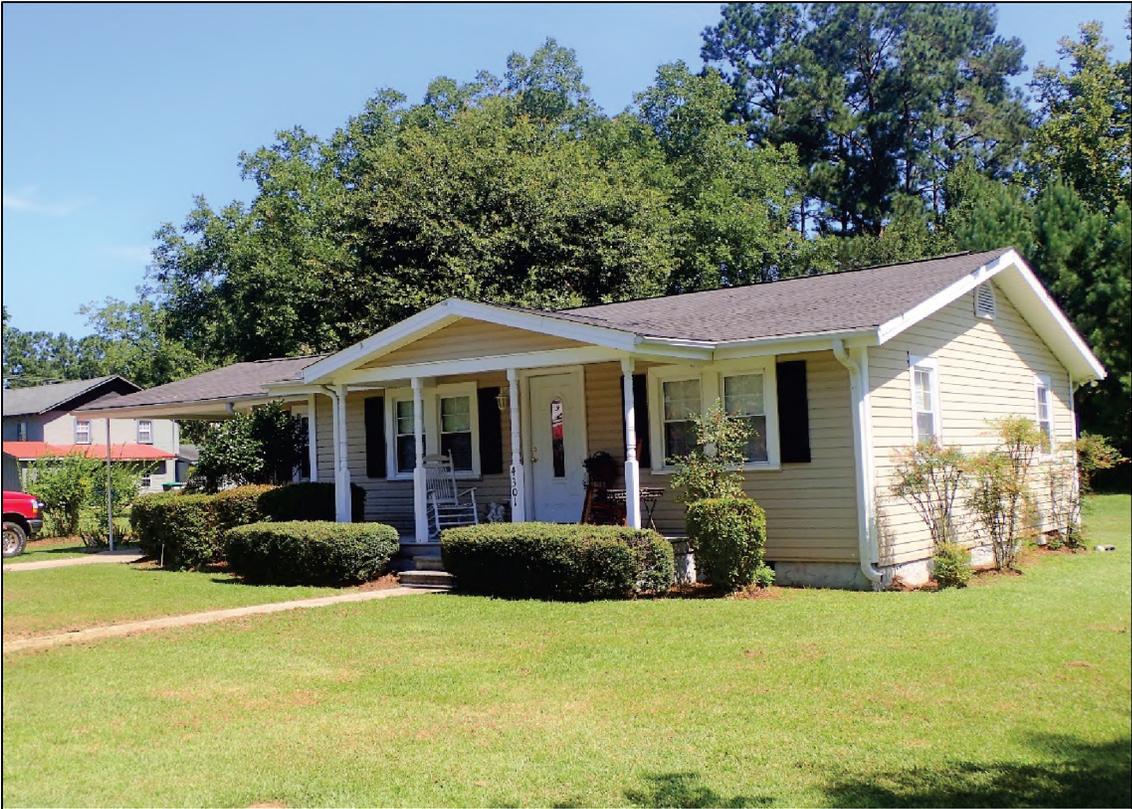
Online Horry County tax assessor data identifies a construction date of 1951 for the dwelling at 4301 Willow St. The building rises a single story over a raised, poured concrete foundation, facing south. It is clad in vinyl siding and capped by a side gable roof with closed overhanging eaves and covered in asphalt shingles. A gable-front porch projects off-center from the façade (south elevation). All windows are single and paired vinyl sash with simulated muntins.

The front porch rests on a raised concrete foundation and is capped by a wood deck. The porch gable is supported on four turned wood posts. Covered under the porch is a modern single-leaf door with central light, flanked by two pairs of vinyl sash with fixed shutters. The west wing of the façade is stepped down in height from the main gable roof line, and contains a single vinyl sash window and an open, single-bay carport. Sheltered under the carport are two pedestrian doors, one facing south and one facing west, as well as one vinyl window. The east (side) elevation of the building contains two single vinyl sash windows and a semi-circular gable vent.

Figure 35. 4301 Willow St, view north (HDR 2018).

Figure 36. 4301 Willow St, view northwest (HDR 2018).

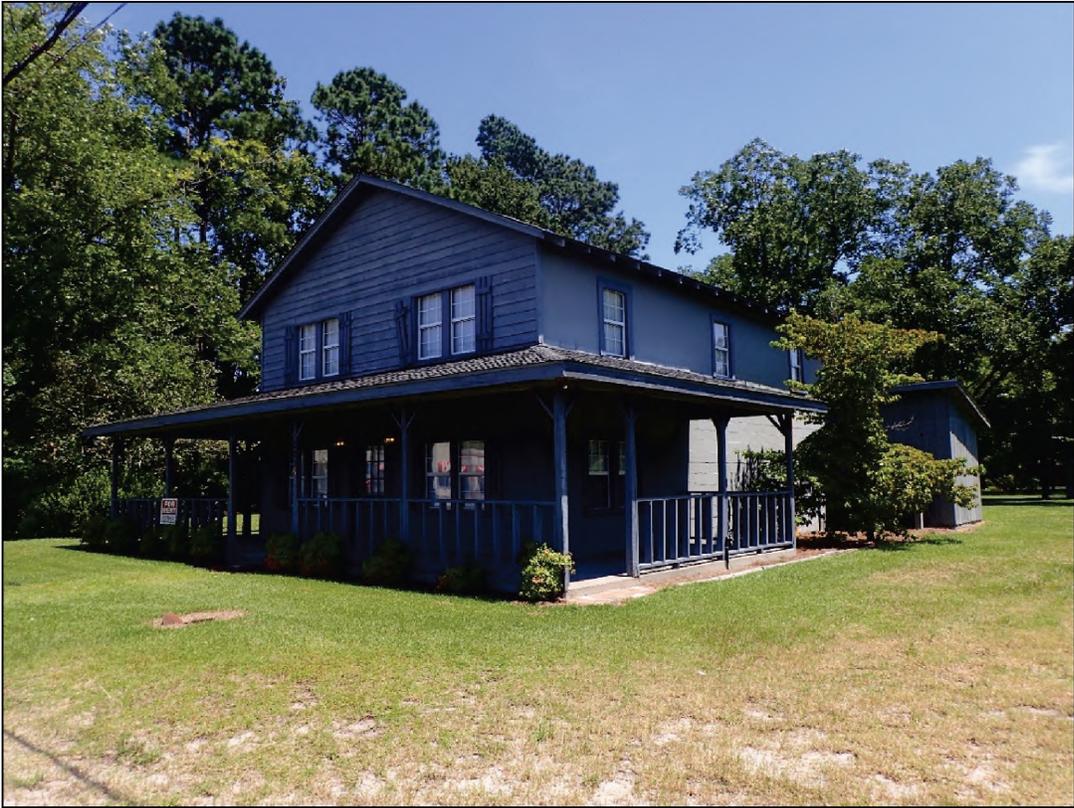
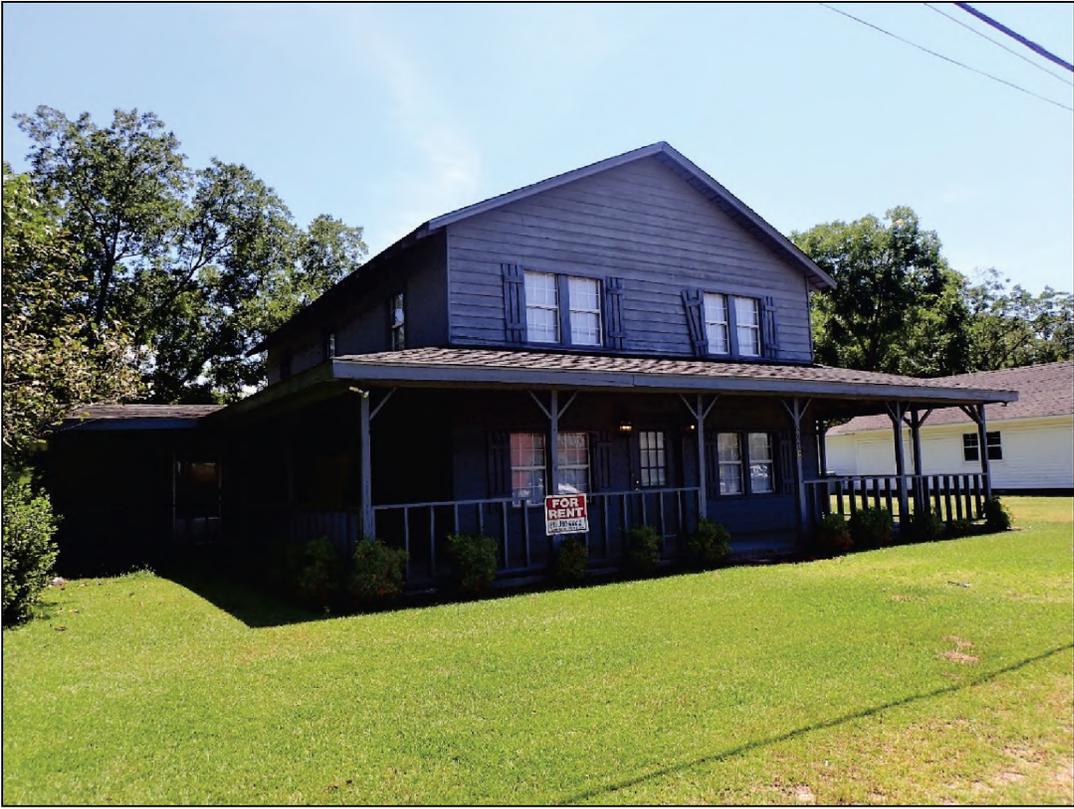
The two-story building is rectangular and front-gabled in form. It sits on a concrete foundation. The front of the building is clad in weatherboard, and side elevations are concrete block. A hipped-roof porch supported on narrow wood posts with braces wraps across the whole façade and around the side elevations. The porch floor is an at-grade, concrete slab, enclosed by a simple wood balustrade. The building façade (west) is symmetrical, with a single-leaf wood door flanked by two pairs of vinyl sash windows on the first floor, and two pairs of vinyl sash aligned above on the second floor. Façade windows are accented with fixed board-and-batten shutters. Side elevation windows are single vinyl sash. The roof is covered with asphalt shingles and finished with wood rake trim. Overhanging eaves are closed over the front gable, and have exposed rafter ends over the side elevations. Two additions are present: a one-story gable addition on the northeast corner, and a one-story shed-roof addition on the southeast corner, both built after 1951.

Figure 37. 5218 Broad St, view to the northeast (HDR 2018).

Figure 38. 5218 Broad St, view to the southeast (HDR 2018).

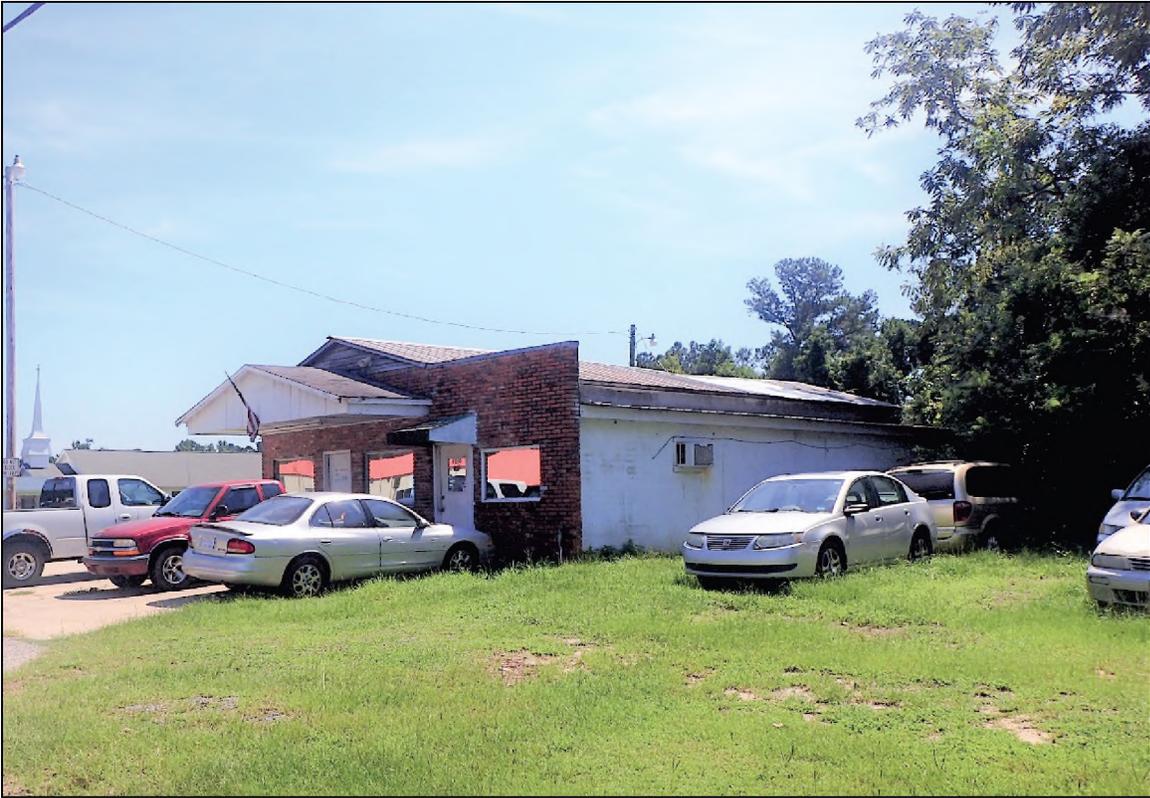
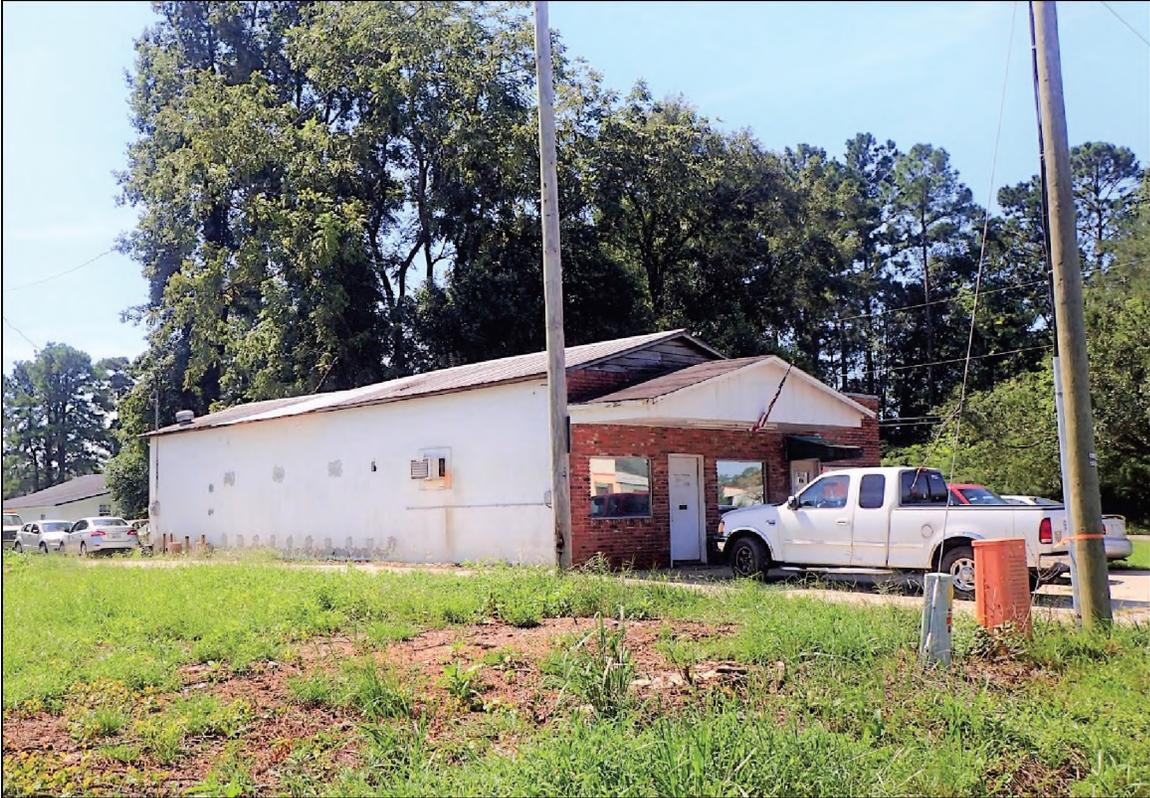
Each side elevation (north and south) contains a single window opening that has been infilled with an air conditioner unit. No other fenestration is visible on the sides of the building.

Figure 39. 5310 Broad St., view northeast (HDR 2018).

Figure 40. 5310 Broad St., view northeast (HDR 2018).

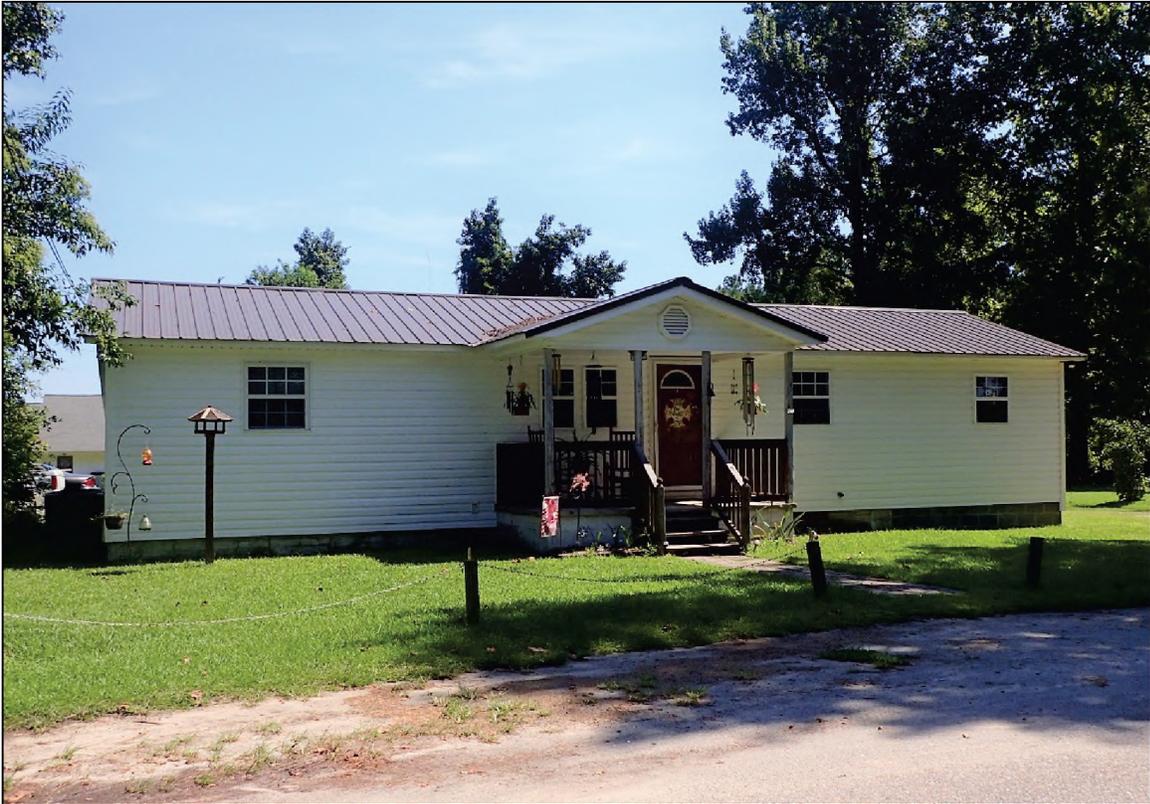
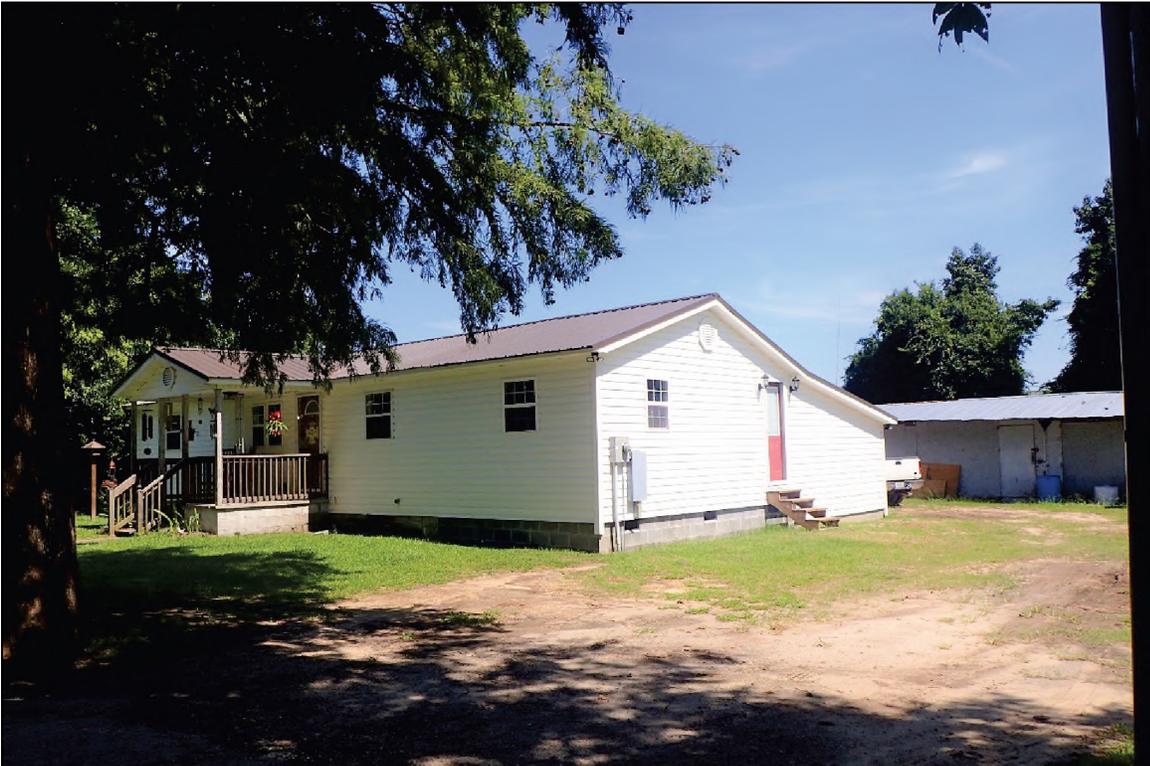
Online Horry County assessor data identifies a construction date of 1960 for the dwelling at 4301 Rose St. The rectangular, prefabricated house rises a single story over a raised concrete block foundation and is capped by a side gable roof with an off-center, gable-front porch projection. The building faces south. A full-width rear addition is covered under a lower-pitch extension of the gable roof. The building is clad in vinyl siding, and the roof is covered in raised metal seam. All windows are vinyl sash with simulated muntins.

The raised gable-front porch rests on a concrete block foundation capped by a wood balustrade and narrow wood posts. A set of wood steps gives access at center. Covered under the porch is a modern single-leaf door and a pair of vinyl sash windows. An octagonal vent is present in the porch gable. Bays east and west of the porch contain three single vinyl sash windows.

One wood-frame garage or shed stands behind (north of) the dwelling, facing south. The building is clad in panelized metal and capped by a side gable metal roof. Openings appear to include at least one auto bay and a single-leaf metal pedestrian door.

Figure 41. 4301 Rose St., view north (HDR 2018).

Figure 42. 4301 Rose St., view northwest (HDR 2018).

The property at 4301 Rose St. lacks associations with significant historic themes such as community or commercial development, and is not significant under Criterion A at the local, state, or national level. Nor is the property known to be owned, occupied, built by, or otherwise associated with historically significant individuals (Criterion B). The prefabricated dwelling lacks distinctive or noteworthy features of any style, form, or method of construction, and has furthermore sustained comprehensive replacement of materials (porch, siding, windows, and doors). The building is therefore not significant under Criterion C. The property is unlikely to yield information important to historical study (Criterion D). The property at 4301 Rose St. is recommended Not Eligible for listing in the NRHP.

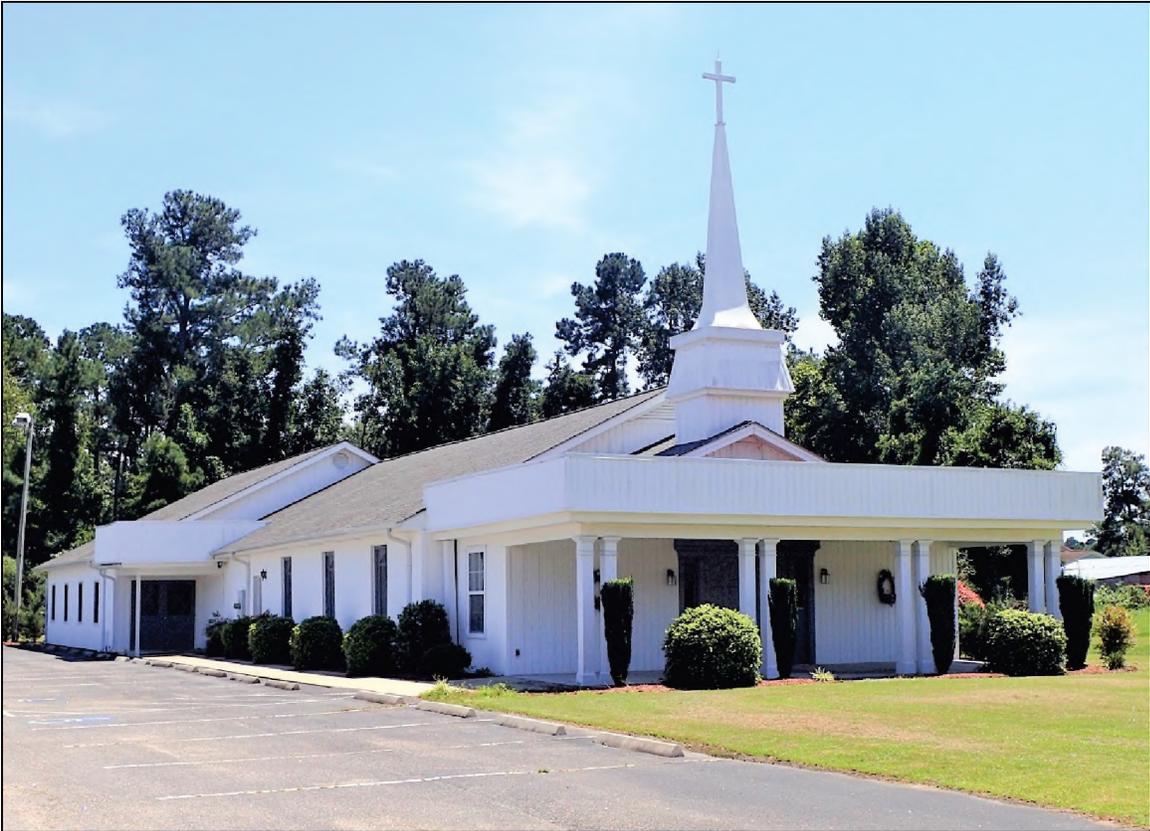
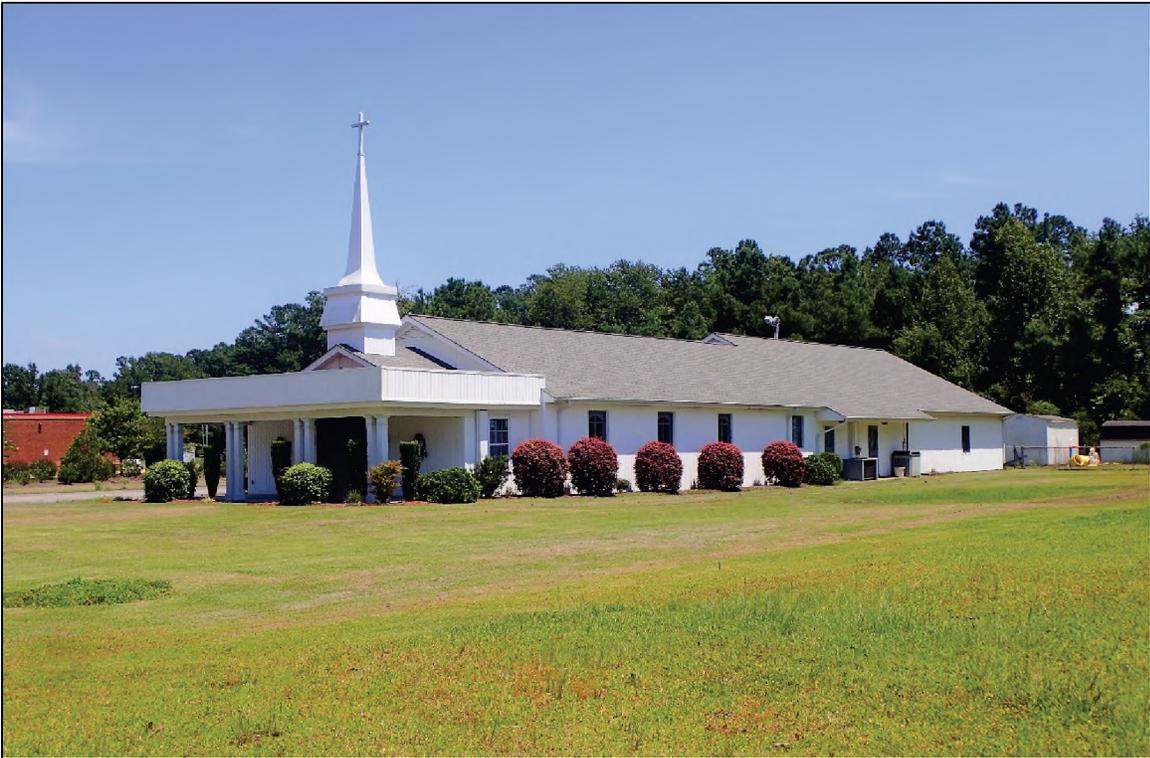
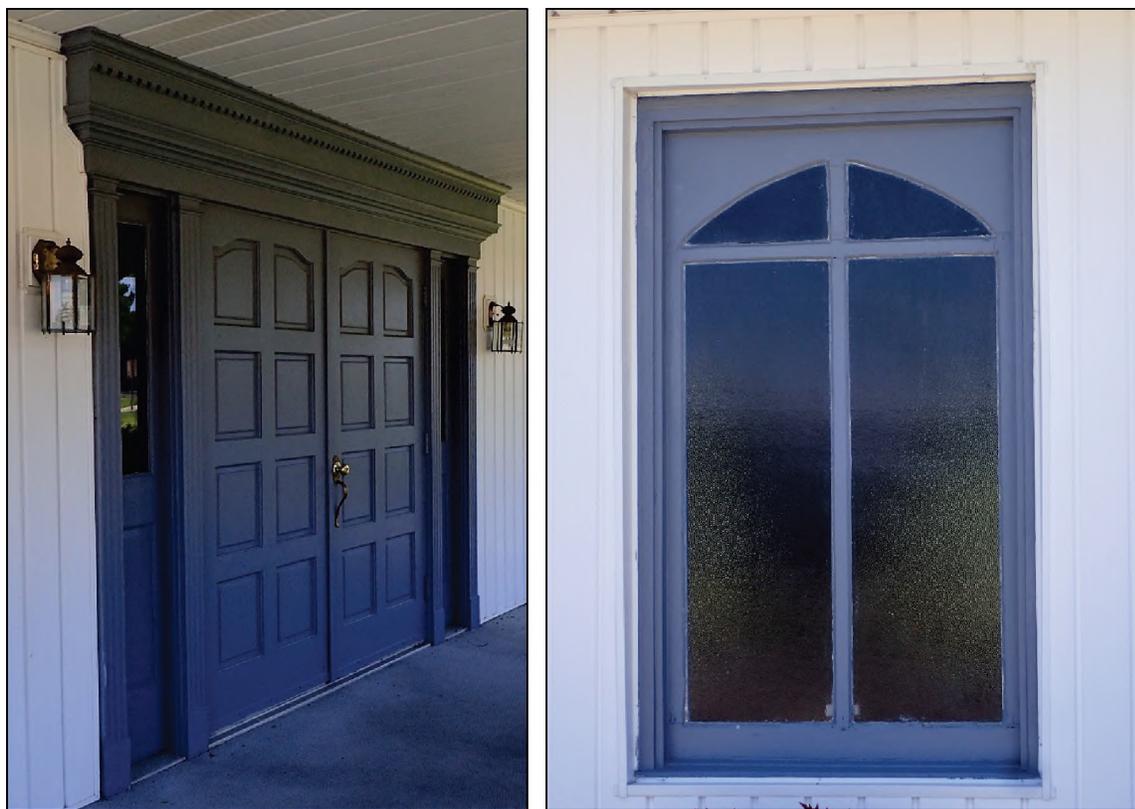
The stepped-down, gable-front bay contains a single vinyl sash window with simulated muntins on each side (north and south) elevation. Remaining windows on side elevations of the original, front portion of the building are single, wood-frame, 4-light windows with rounded upper lights and frosted glass. Windows appear to be fixed.

The rear addition, which appears to have been added between 1980 and 1990, is vinyl-clad and contains multiple secondary side entrances and vinyl windows.

Figure 43. Trinity Baptist Church at 5330 Broad St., view southeast (HDR 2018).

Figure 44. Trinity Baptist Church, view northeast (HDR 2018).

Figure 45. Trinity Baptist Church, front doors (left), view south; window detail (right) (HDR 2018).

Though constructed c. 1965, the church at 5330 Broad St. did not become affiliated with Trinity Baptist Church until 1984. The church and parish associated with 5330 Broad St. are not known to be associated with historic events, patterns, themes, or individuals significant locally or at the state or national levels (Criteria A and B). The church building exhibits elements common to the Neoclassical style found with frequency in ecclesiastical buildings throughout the region of the South and the U.S. Though the building possesses some distinctively Classical features such as its double leaf doors and temple front, it overall lacks architectural distinction and integrity, and is not a noteworthy example of a Neoclassical-style church. The building is therefore not significant under Criterion C. The property is unlikely to yield information important to historical study, and is not significant under Criterion D. Due to an overall lack of significance, Trinity Baptist Church at 5330 Broad St. is recommended Not Eligible for listing in the NRHP.

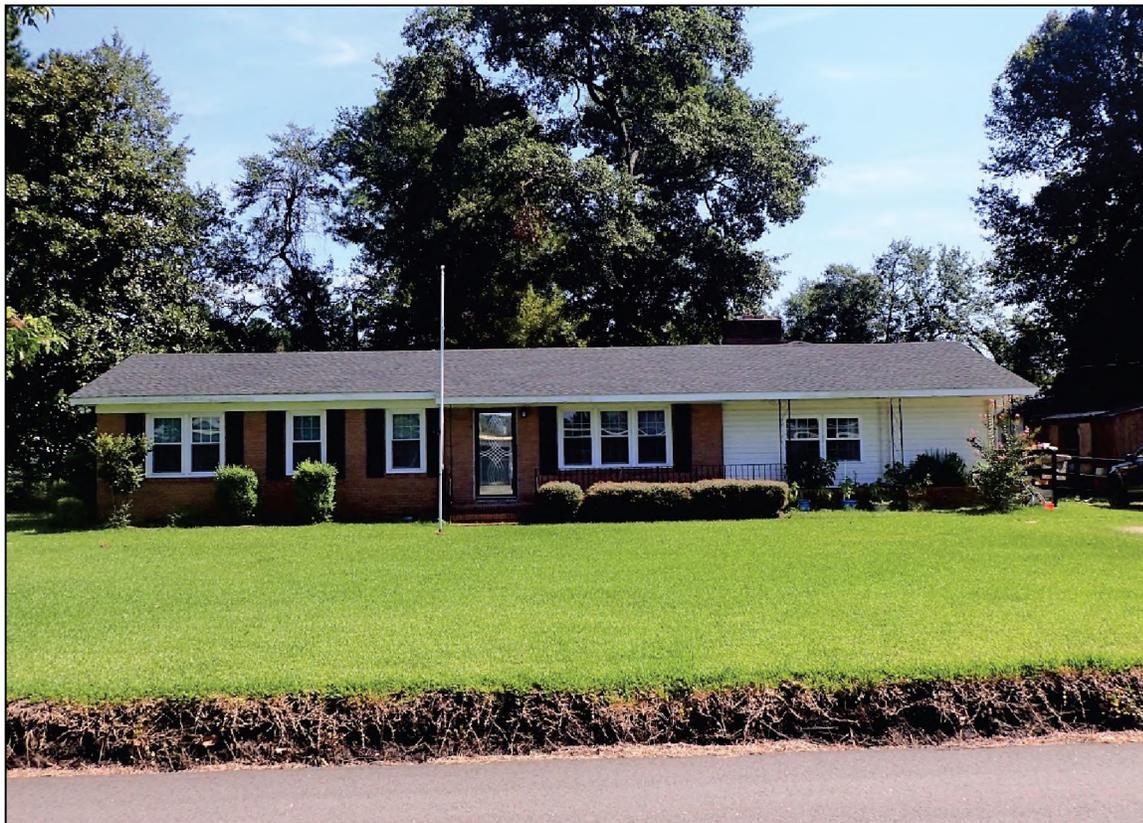
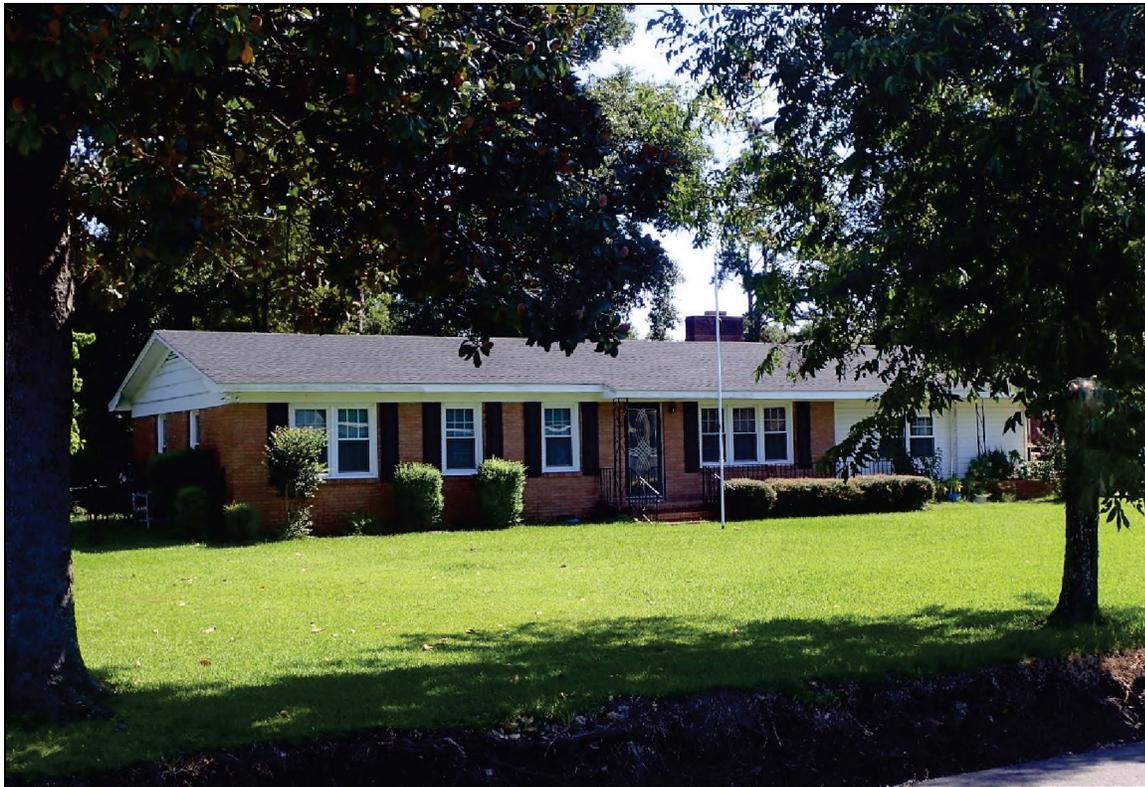
A wood drop-down shed with a side gable roof stands east of the house, and contains a pair of double-leaf sliding doors on its east elevation. The building was built c. 2000.

Figure 46. 135 Bay Circle Dr., view north (HDR 2018).

Figure 47. 135 Bay Circle Dr., view northeast (HDR 2018).
