# Cultural Resources Survey

US 701 Improvements Project

*Horry County, South Carolina*

February 2019

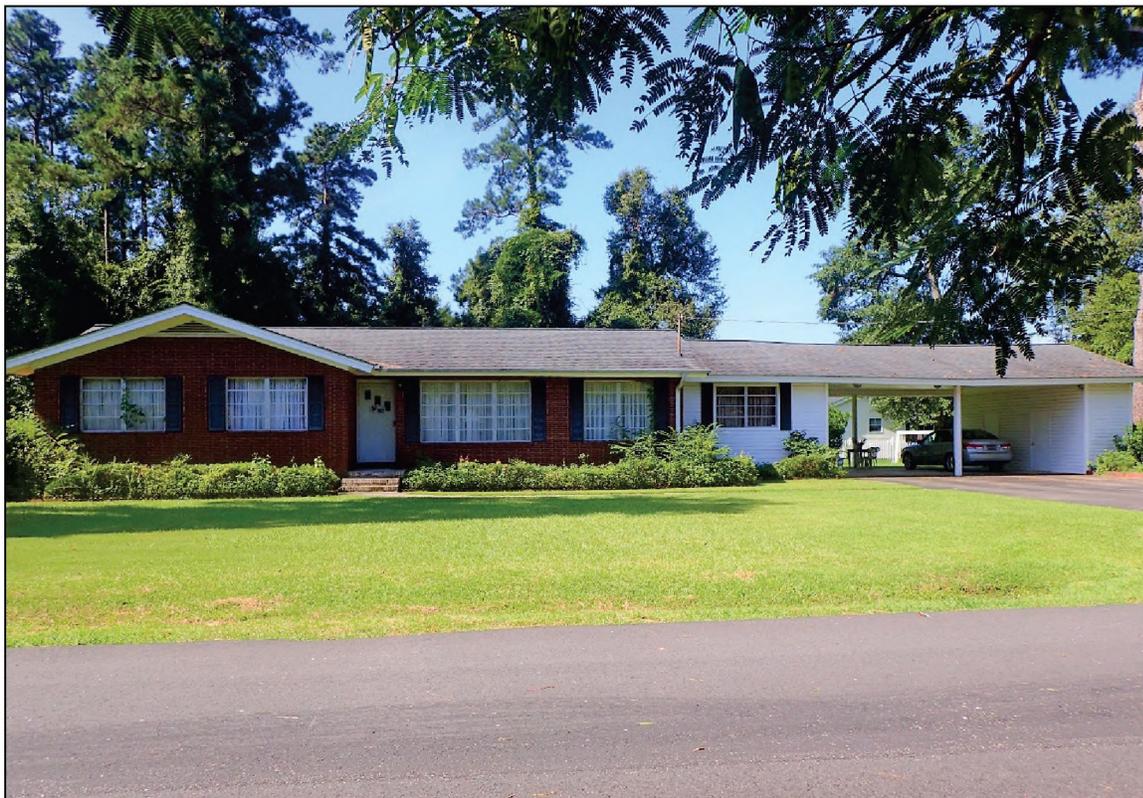
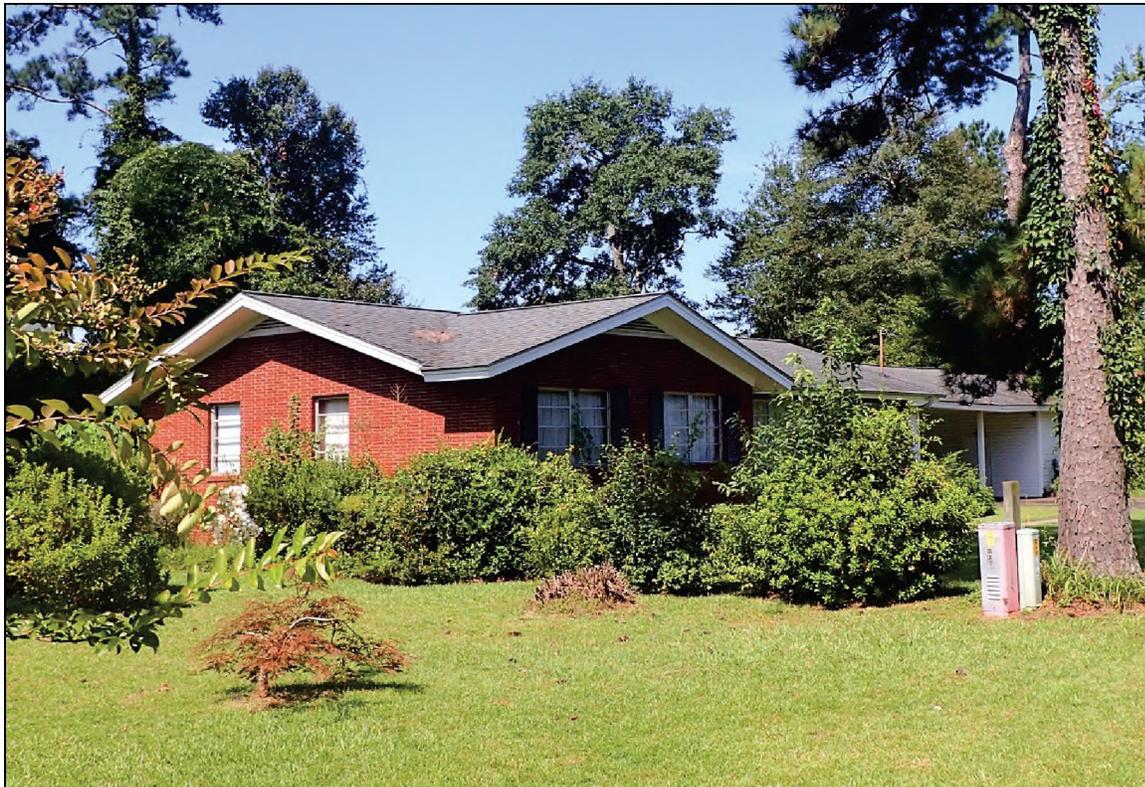
According to Horry County online assessor data, the Ranch-style dwelling at 167 Bay Circle Dr. was built in 1962. The building faces north. The rectangular-plan, one-story building sits on a raised foundation of brick or concrete, and is capped by a cross gable roof. The building is six bays wide, with an integral, two-bay carport extending off the west end. The building extends two bays deep. The primary exterior cladding is brick veneer, with vinyl siding on the west half of the building, which includes two enclosed bays flanking the open carport. The roof has deep, closed eaves and is covered in asphalt shingles.

triple set of metal jalousie windows with fixed louvered shutters. Triangular vents lie flush with the narrow frieze in front and side gable peaks. The east (side) elevation contains two single metal-frame jalousie windows. The west end of the building contains three pedestrian doors: one entering the house on the east side of the carport, and two entering a small enclosed garage bay at the west end of the carport.

Figure 48. 167 Bay Circle Dr., view south (HDR 2018).

Figure 49. 167 Bay Circle Dr., view southwest (HDR 2018).

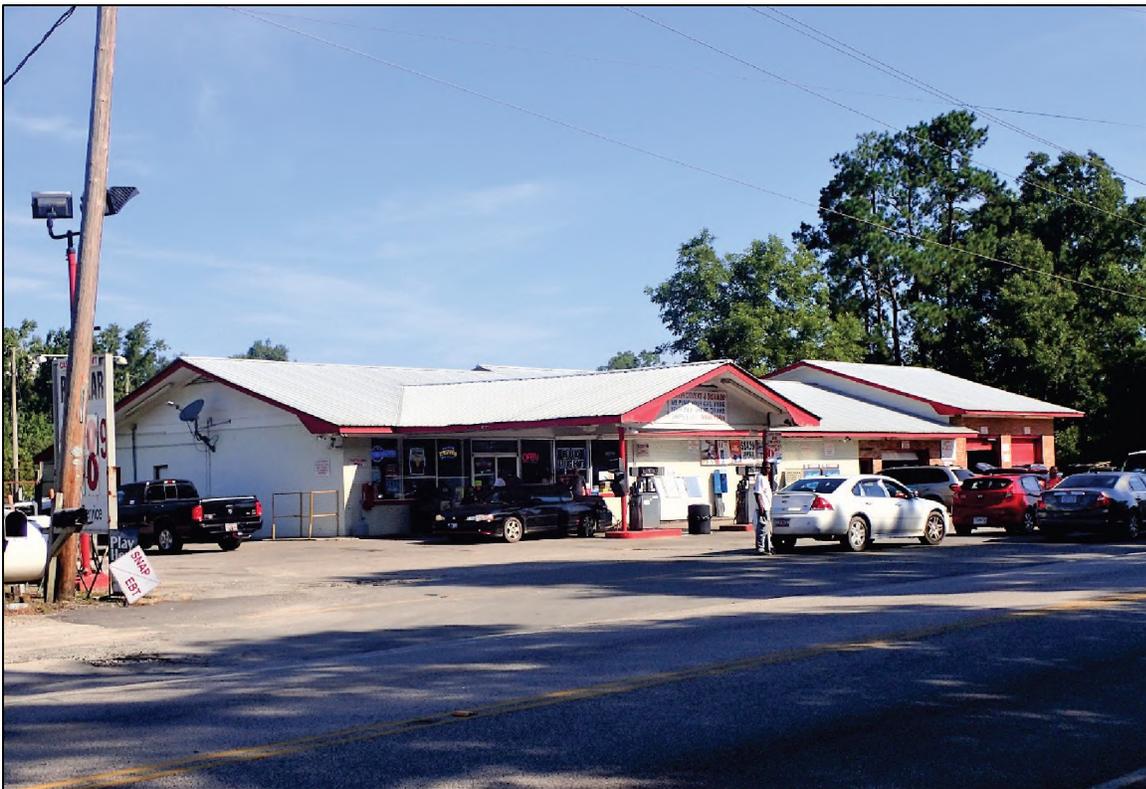
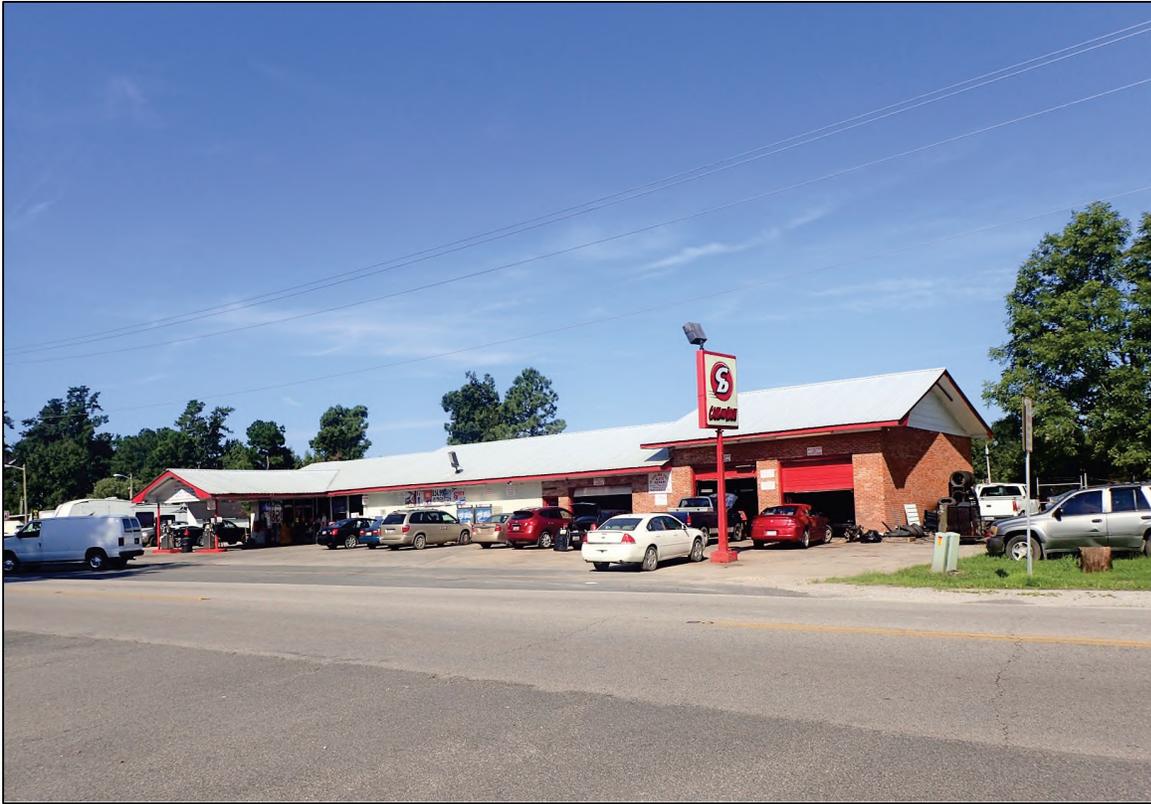
Suspended on a round metal pole at the northeast corner of the parcel is a square synthetic sign that reads “CD Cash and Dash.”

Figure 50. Cash and Dash at 701 Broad St., view northwest (HDR 2018)

Figure 51. Cash and Dash at 701 Broad St., view southwest (HDR 2018)

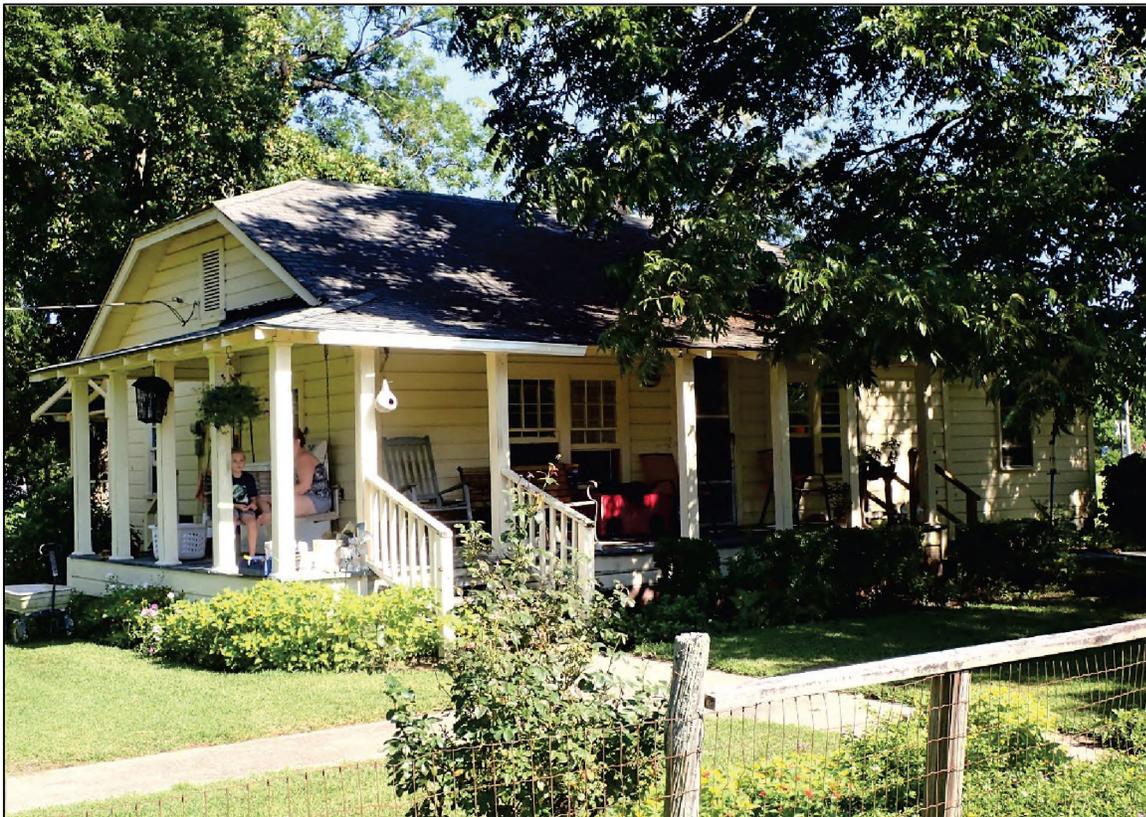
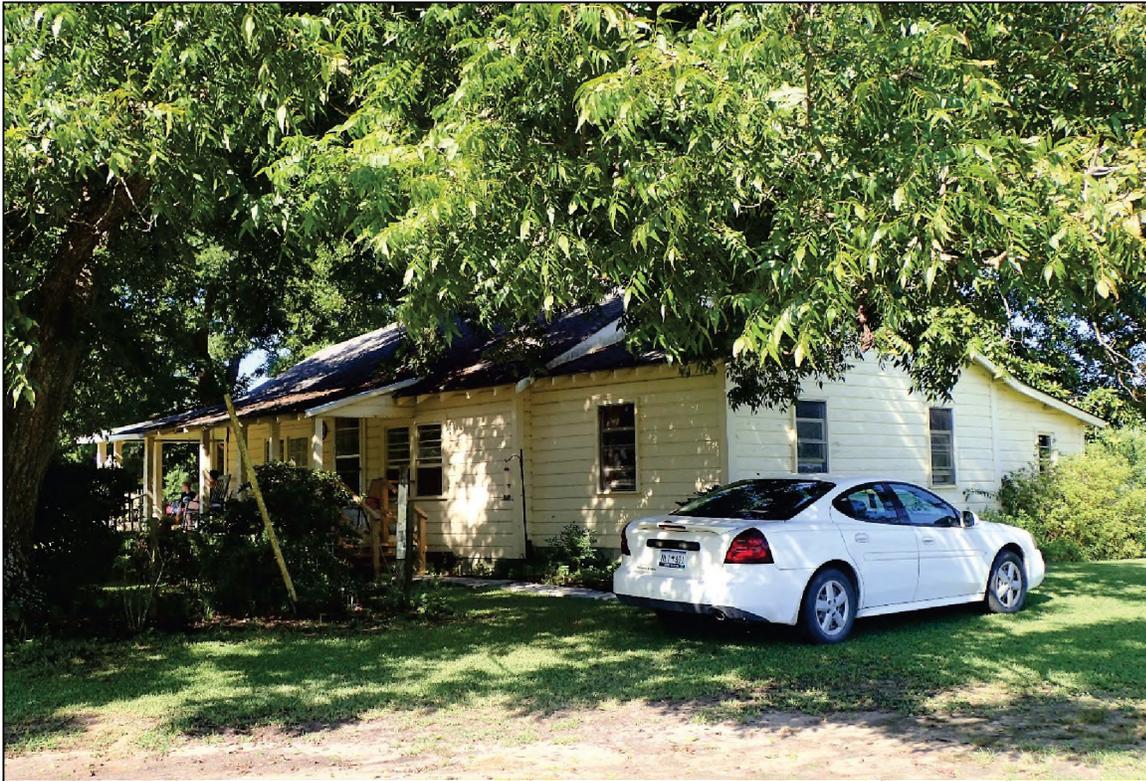
Two small outbuildings stand southwest of the house: a gable-roof shed (Site 3864.01) clad in weatherboard siding, with an open lean-to addition on the south side and a pedestrian door in the east gable end; and a small tool shed with a shed roof and plywood siding. The plywood shed is likely not historic in age.

Figure 52. 735 Broad St., view northwest (HDR 2018).

Figure 53. 735 Broad St., view southwest (HDR 2018).

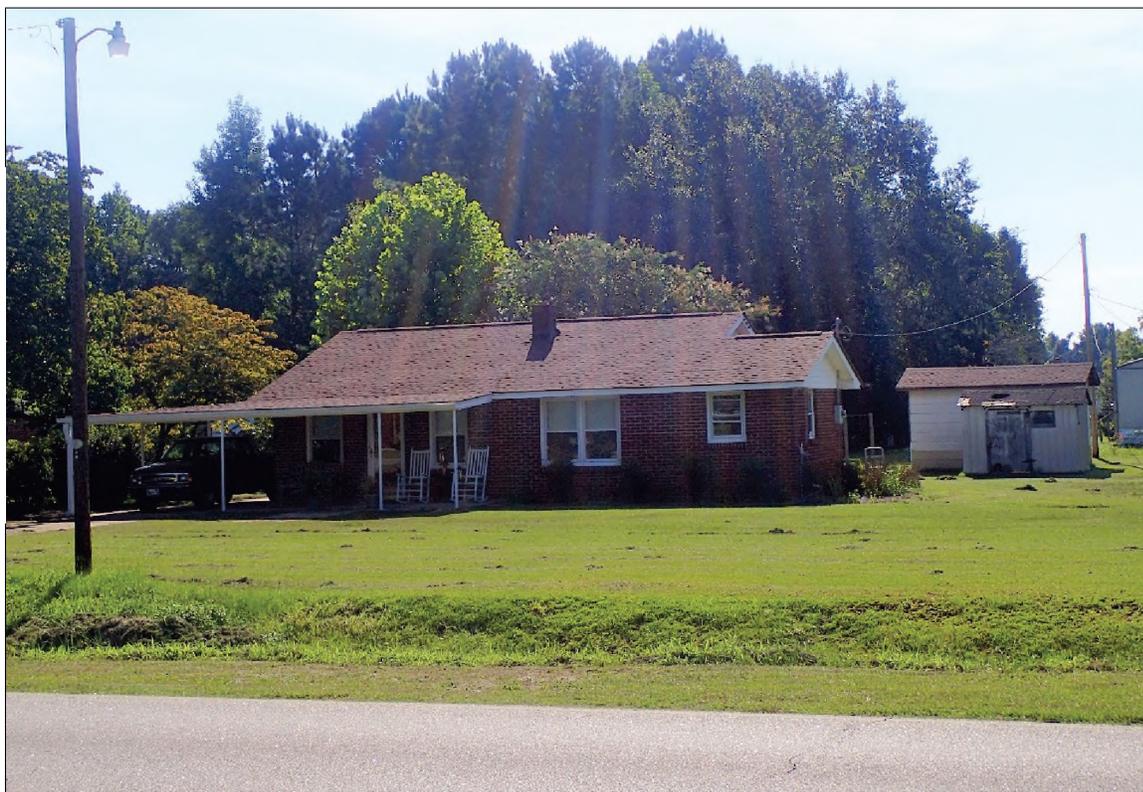
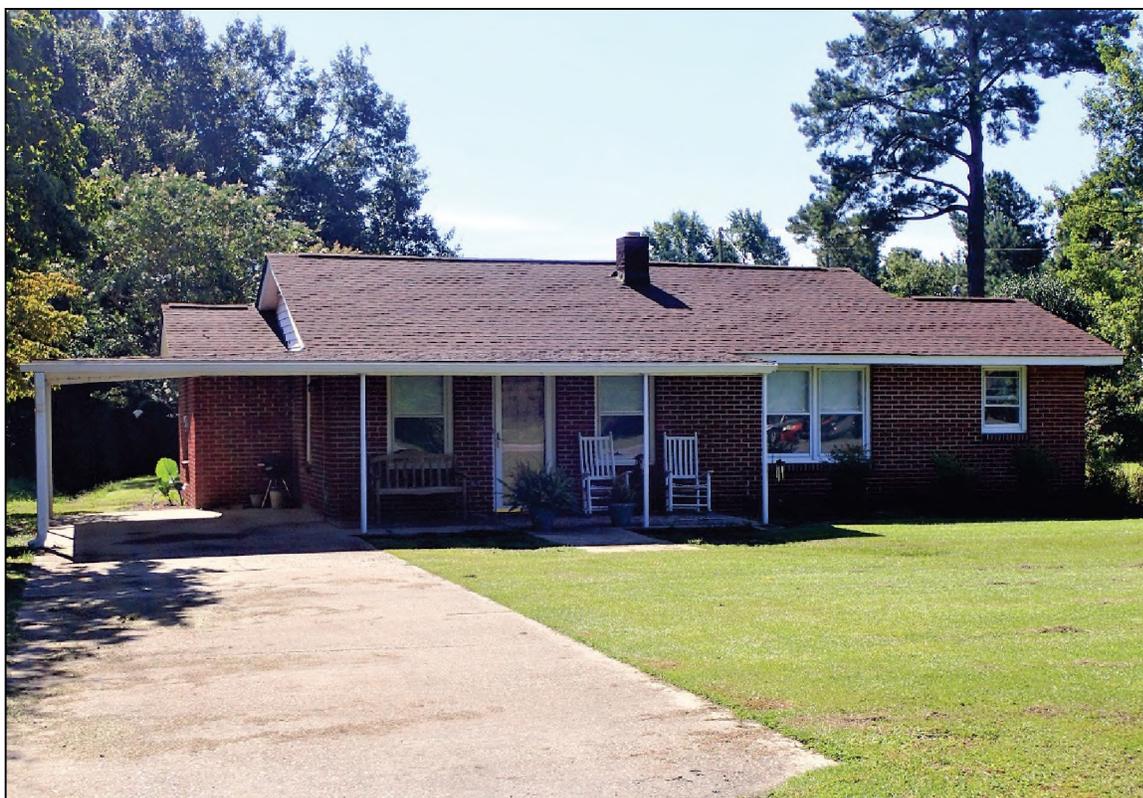
Two small outbuildings stand adjacent to one another and southeast of the dwelling. Both have gable roofs; one is clad in raised metal seam, with a hinged door on the west side, and one is clad in wood composite siding, with a door on the north gable end. Neither building appears to be historic in age.

Figure 54. 732 Broad St., view northeast; outbuildings on right (HDR 2018).

**Figure 55. 732 Broad St., view east (HDR 2018).**

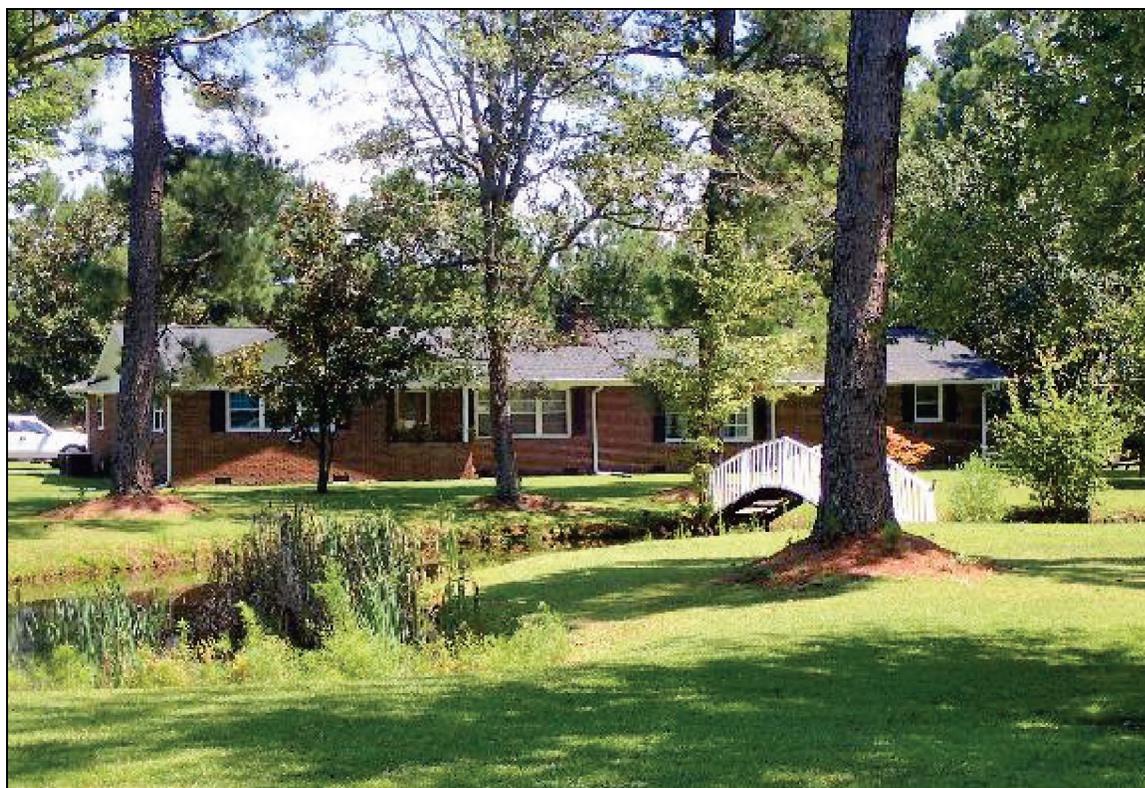
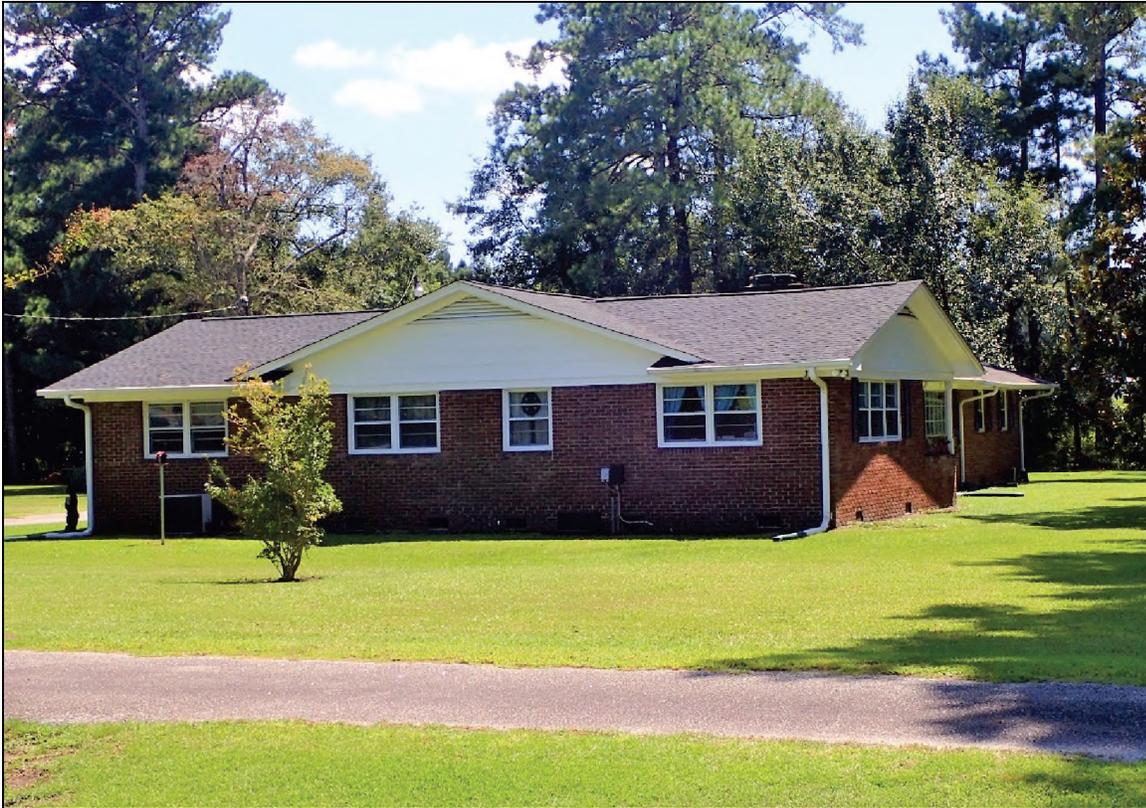
A semi-circular water feature lies west of the house, in the front yard. Evidently man-made, the small lake is traversed at center by a parabolic wood bridge with an open wood balustrade on each side. Building date of the bridge is unknown.

Figure 56. 850 N. Hwy 701, view southeast (HDR 2018).

Figure 57. 850 N. Hwy 701, view south (HDR 2018).

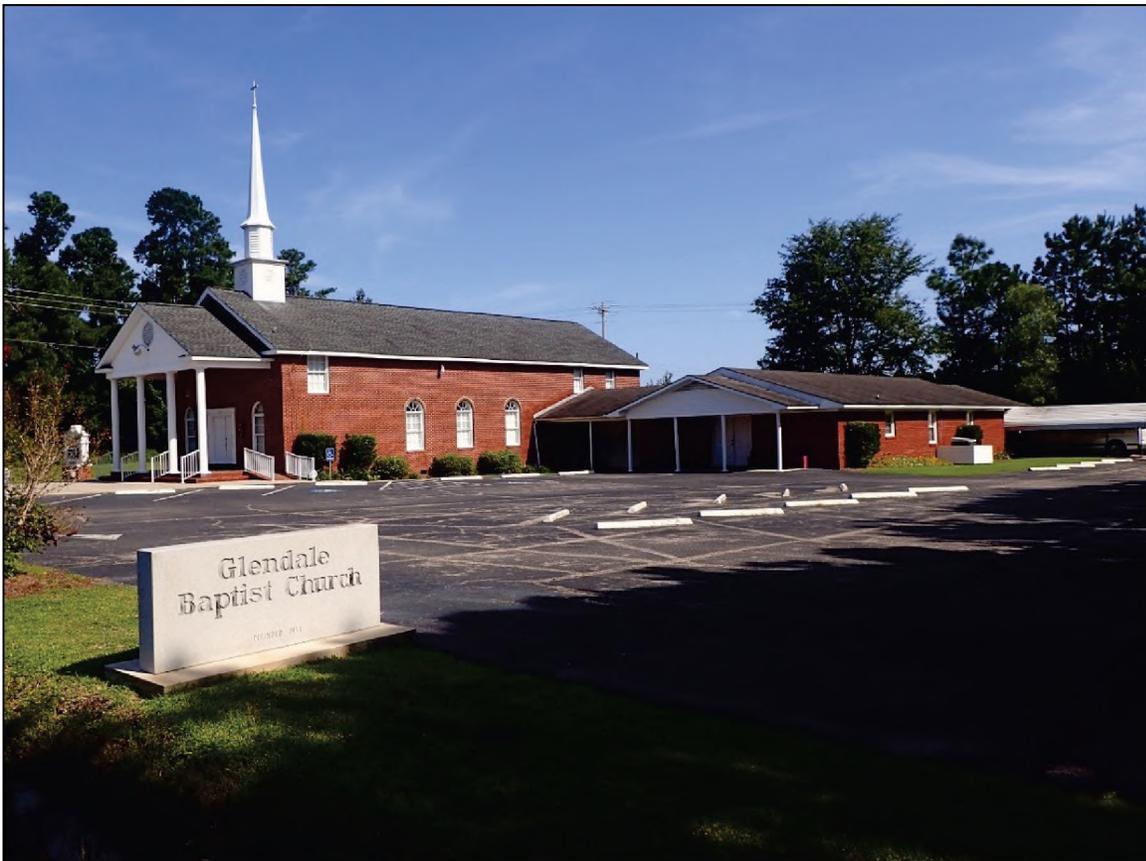
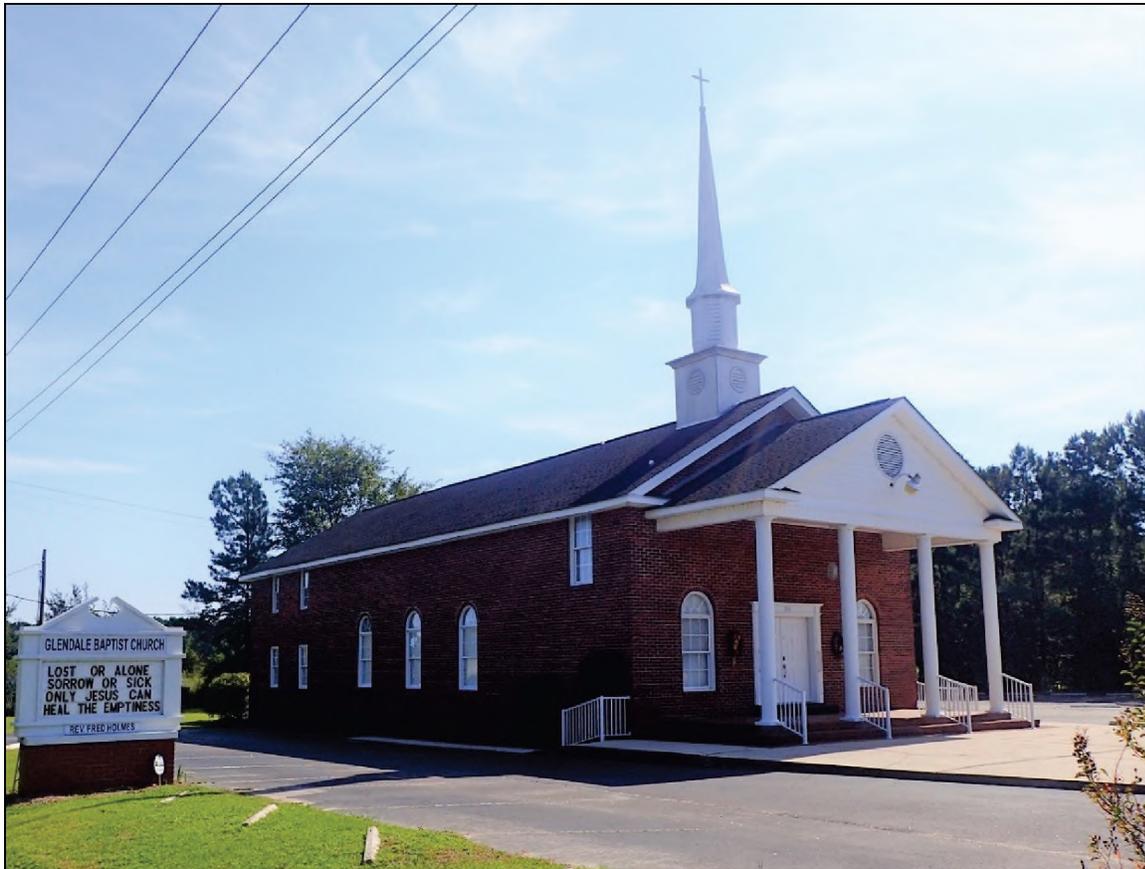
Figure 58. 950 N. Hwy 701, view to northwest (HDR 2018).

Figure 59. 950 N. Hwy 701, view to northwest (HDR 2018).

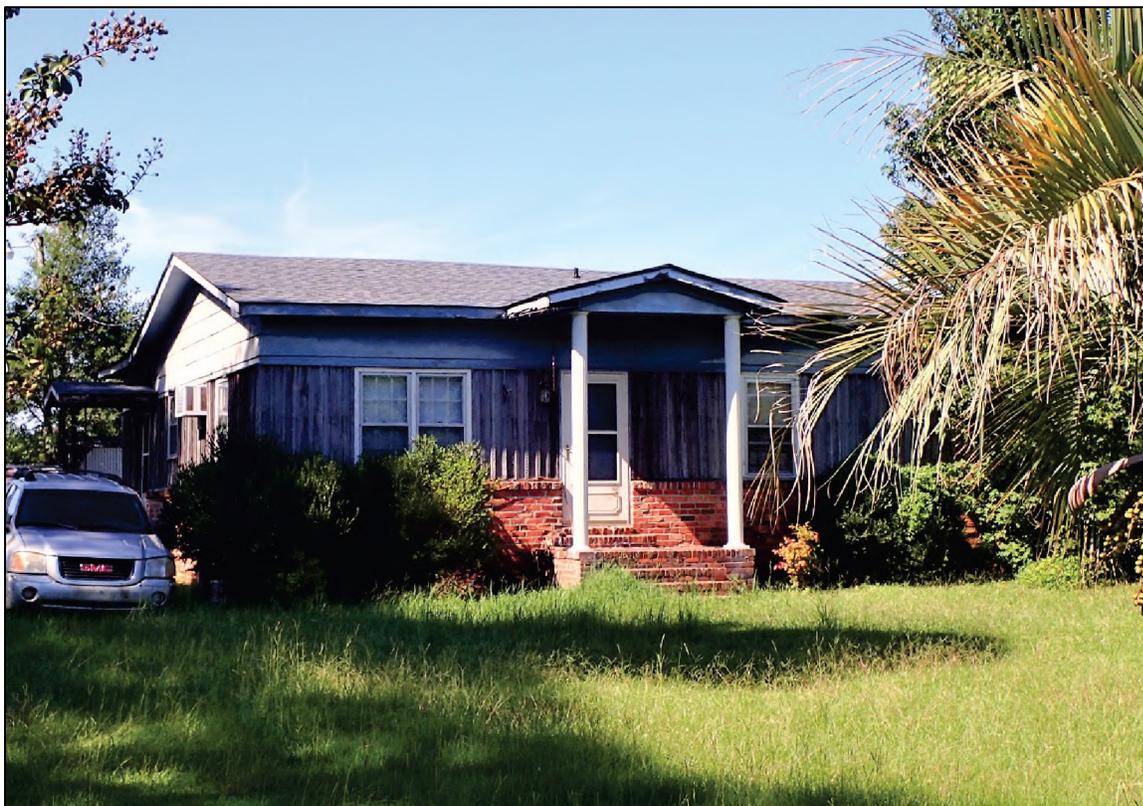
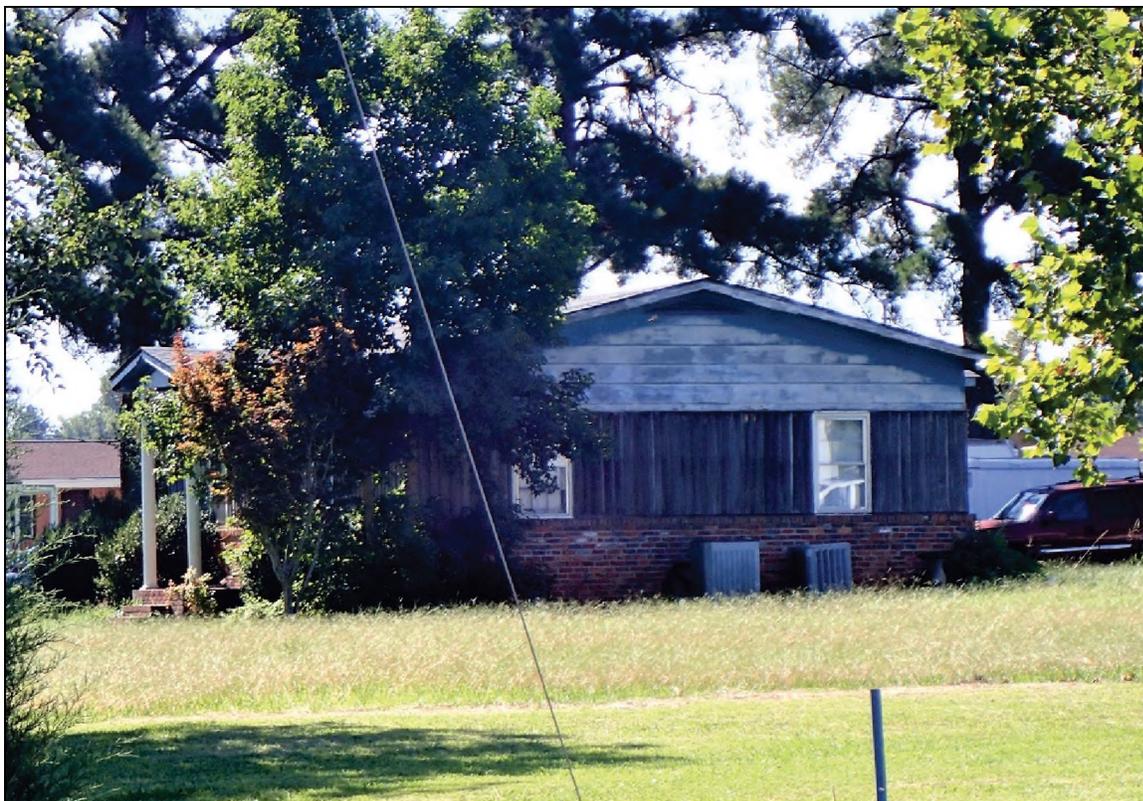
Figure 60. 134 Hwy 747, view southwest (HDR 2018).

Figure 61. 134 Hwy 747, view east (HDR 2018).

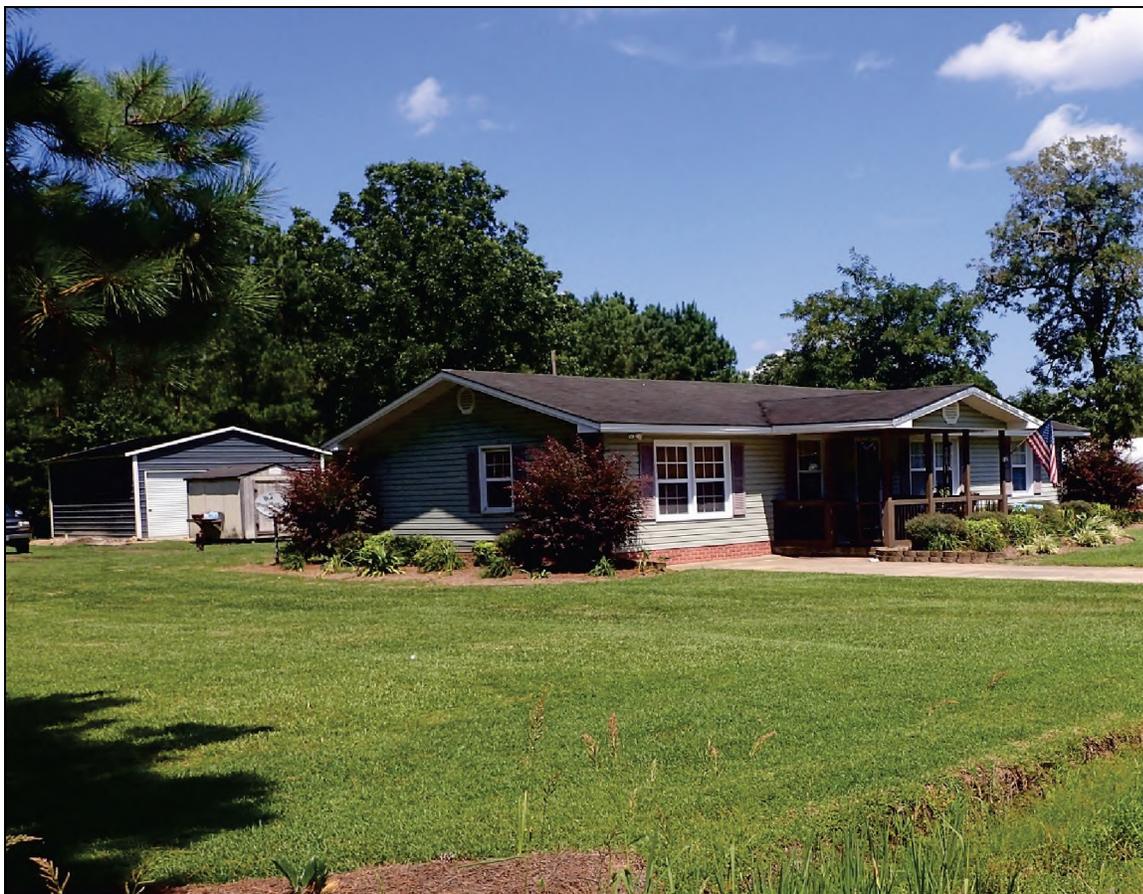
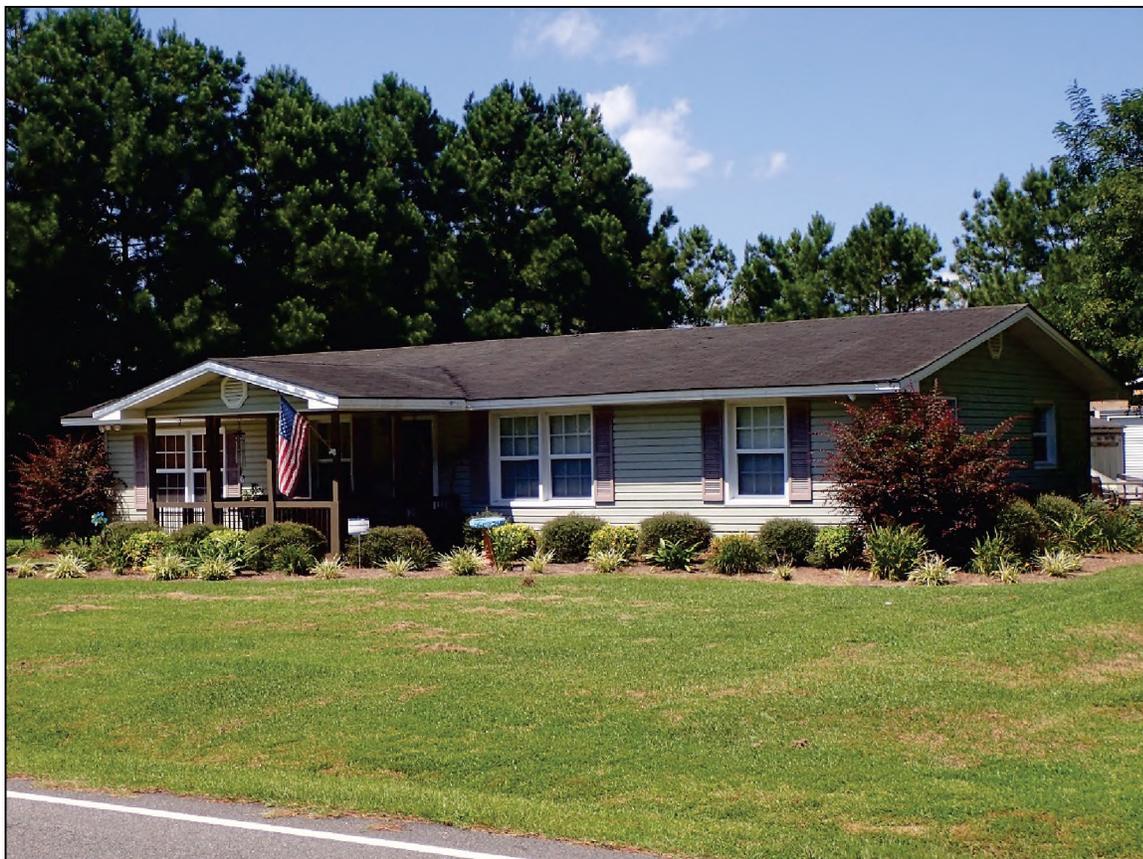
Figure 62. 131 Hwy 747, view northeast. Modern outbuildings visible behind house (HDR 2018).

Figure 63. 131 Hwy 747, view northwest (HDR 2018).

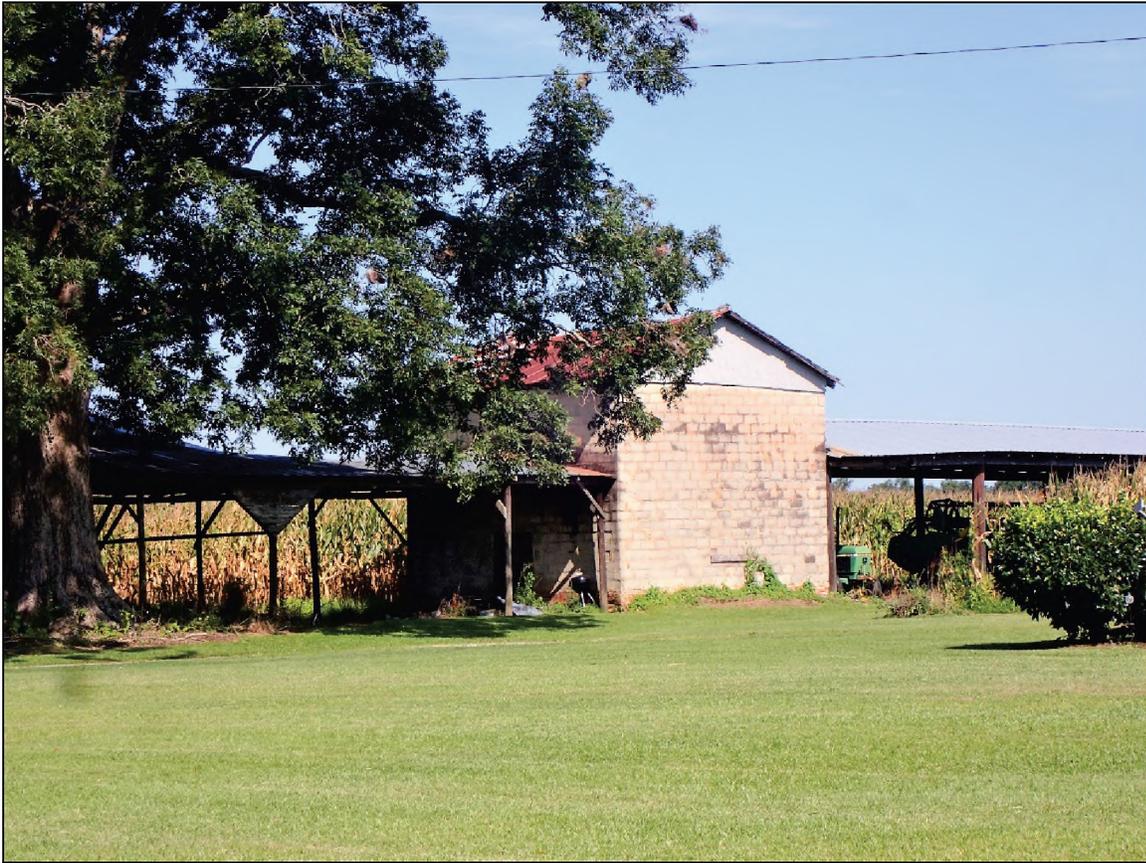
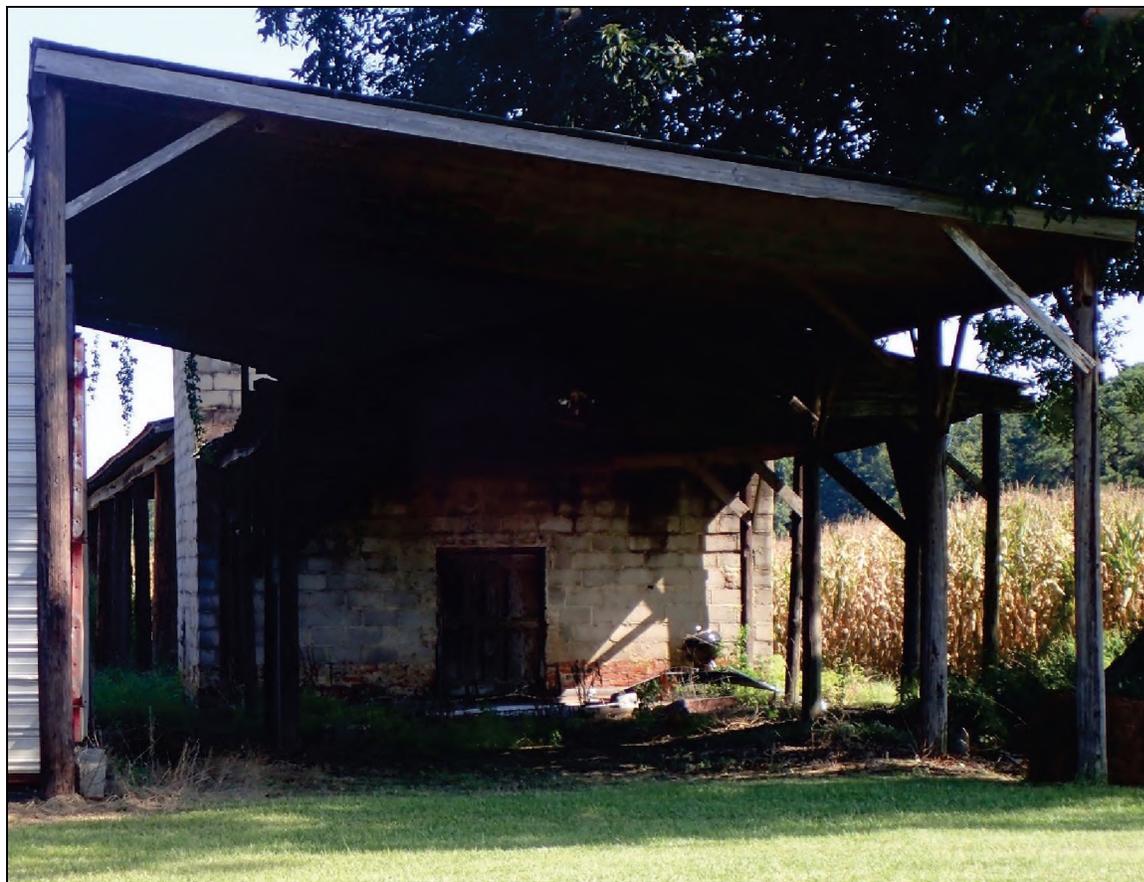
Figure 64. Barn at 360 Prospect Rd, view to northwest (HDR 2018).

Figure 65. Barn at 360 Prospect Rd, view to north (HDR 2018).

significant under Criterion D. Site 3870 is therefore recommended Not Eligible for listing in the NRHP.

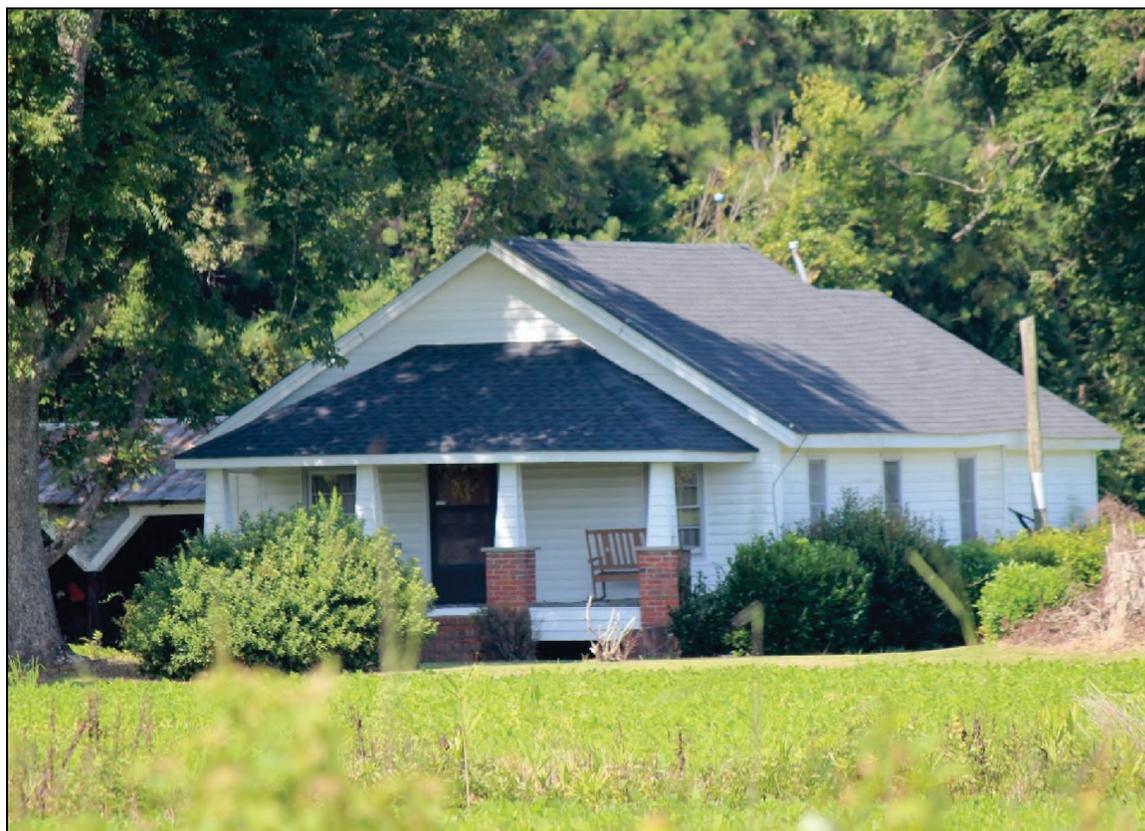
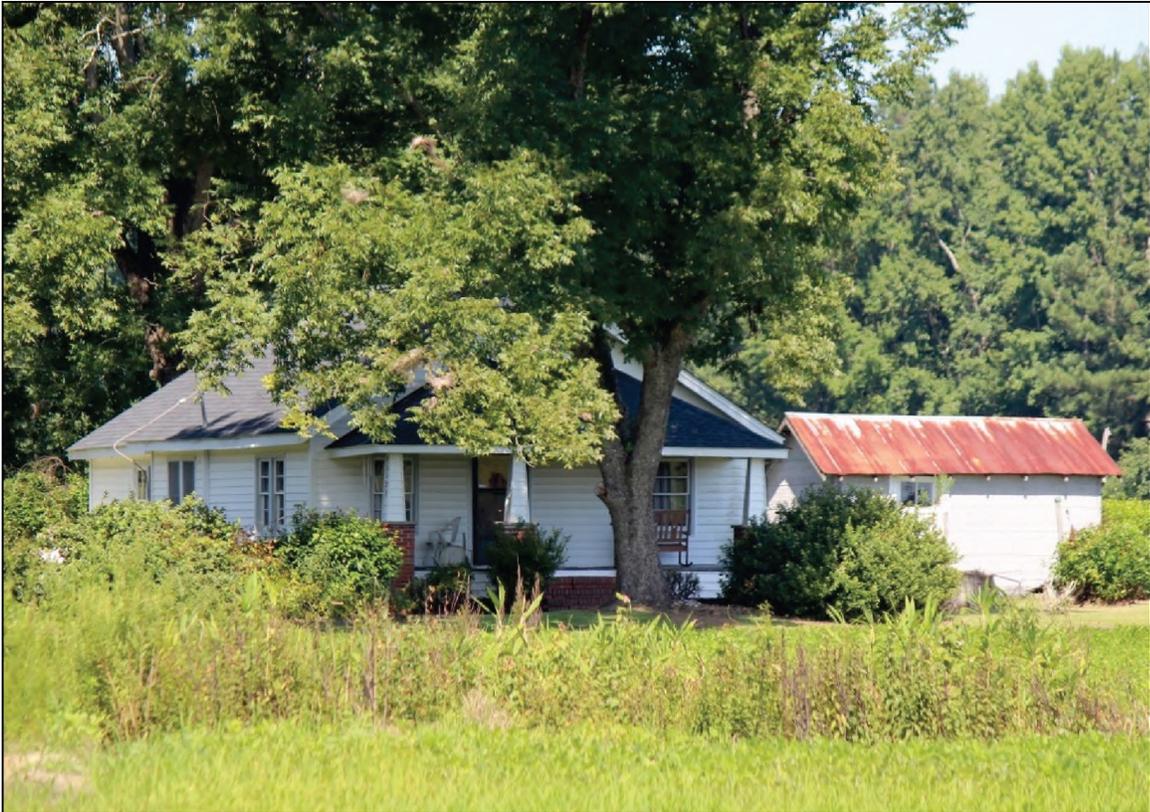
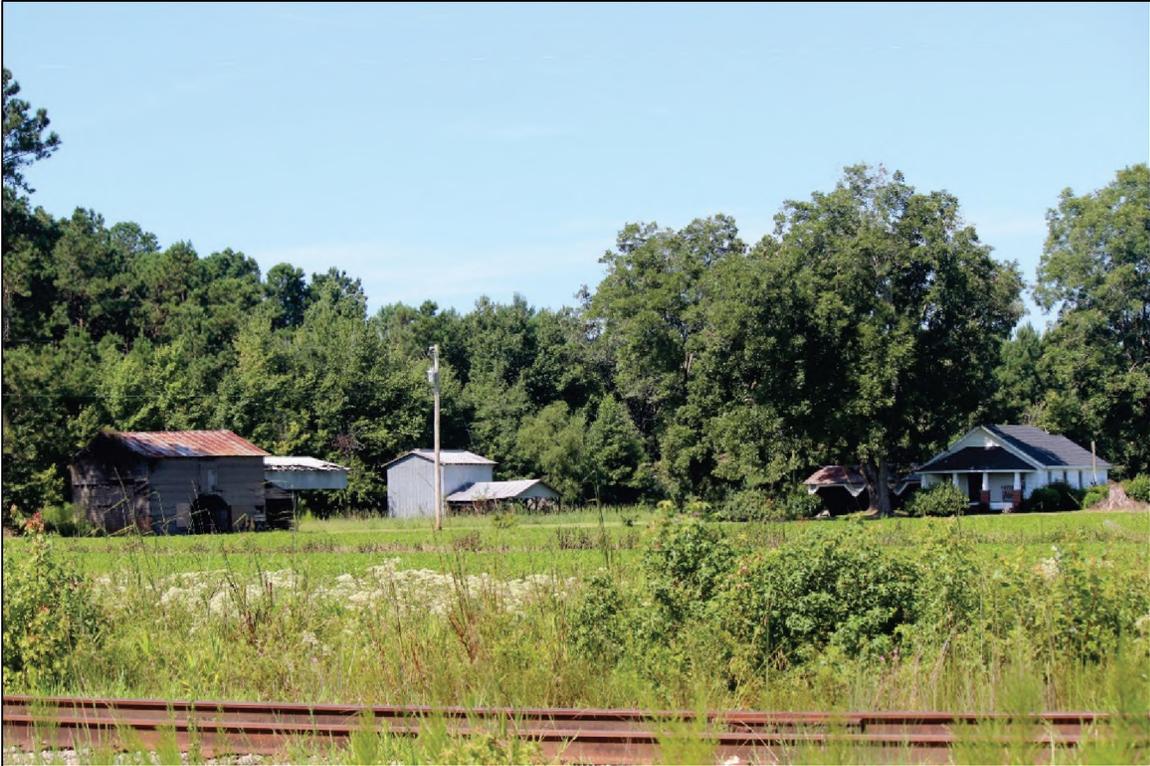
Figure 66. 1125 N. Hwy 701, view to southwest (HDR 2018).

Figure 67. 1125 N. Hwy 701, view to northwest (HDR 2018).

Figure 68. 1125 N. Hwy 701, view to southwest (HDR 2018).

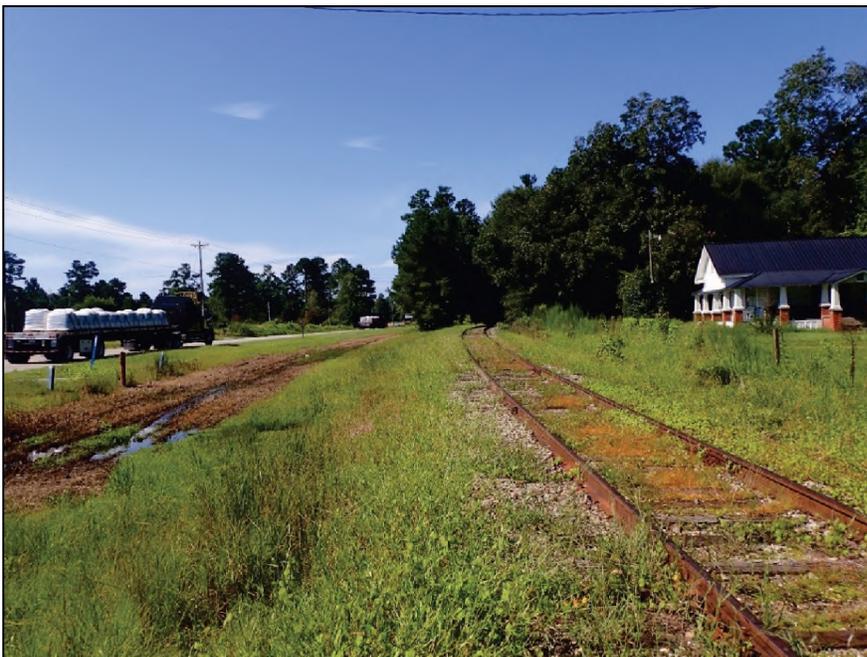
Figure 69. 3872, view south. 115 Prospect Rd (1941) visible on the right; Hwy 701 is on the left (HDR 2018).

The line continues through Loris on the west side, and upon entering town (outside of the Project APE), is flanked closely on the west by Meeting St, and on the east by Railroad Ave. Just southwest of the Project area and northwest of the town center, a segment of abandoned railroad siding extends alongside several industrial blocks, including Site 3850.

No railroad-related buildings or structures such as depots, signal towers, or bridges, were surveyed in association with 3872.
