# Cultural Resources Survey

US 701 Improvements Project

*Horry County, South Carolina*

February 2019

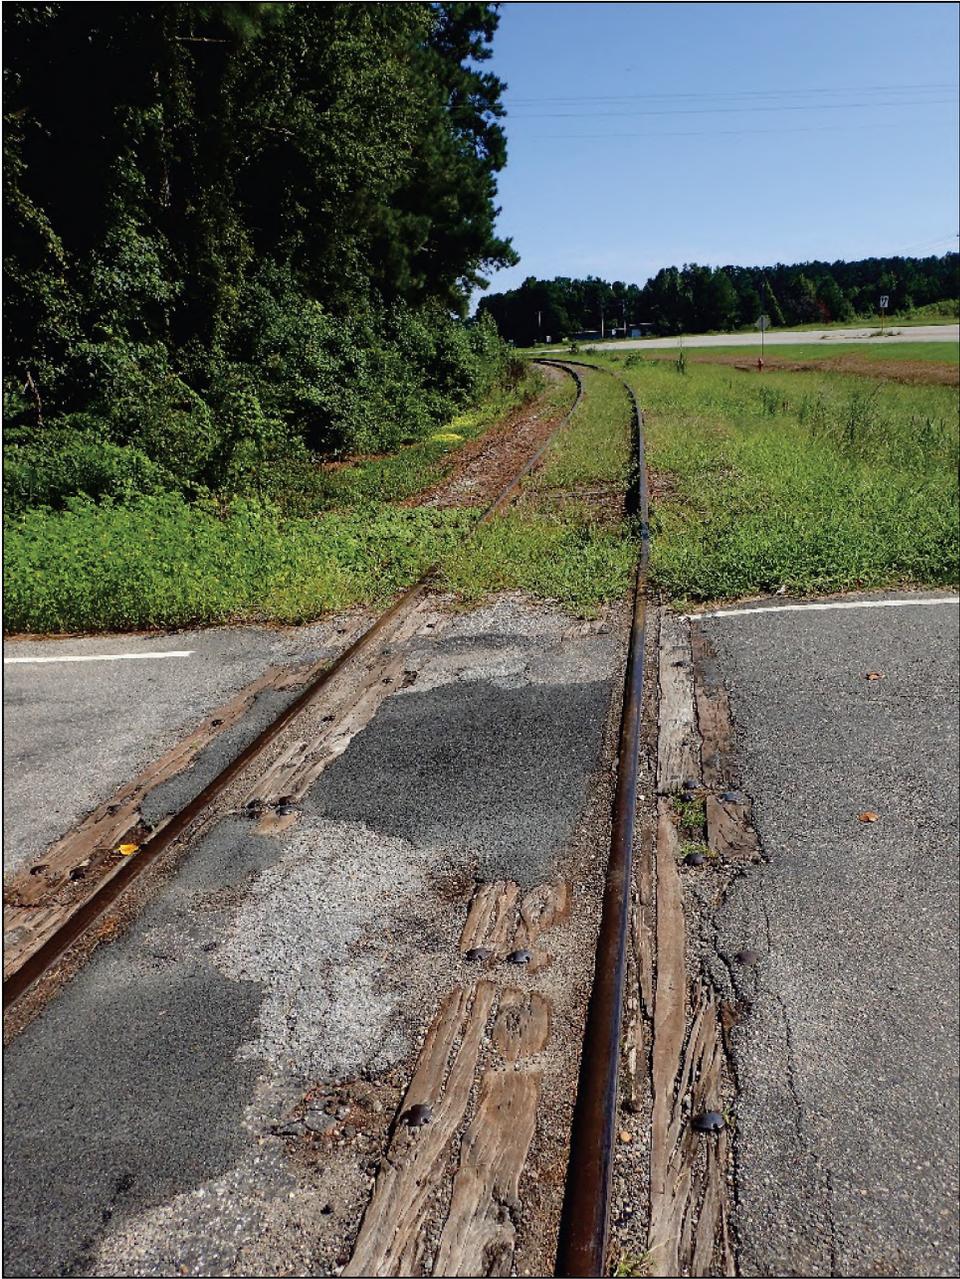
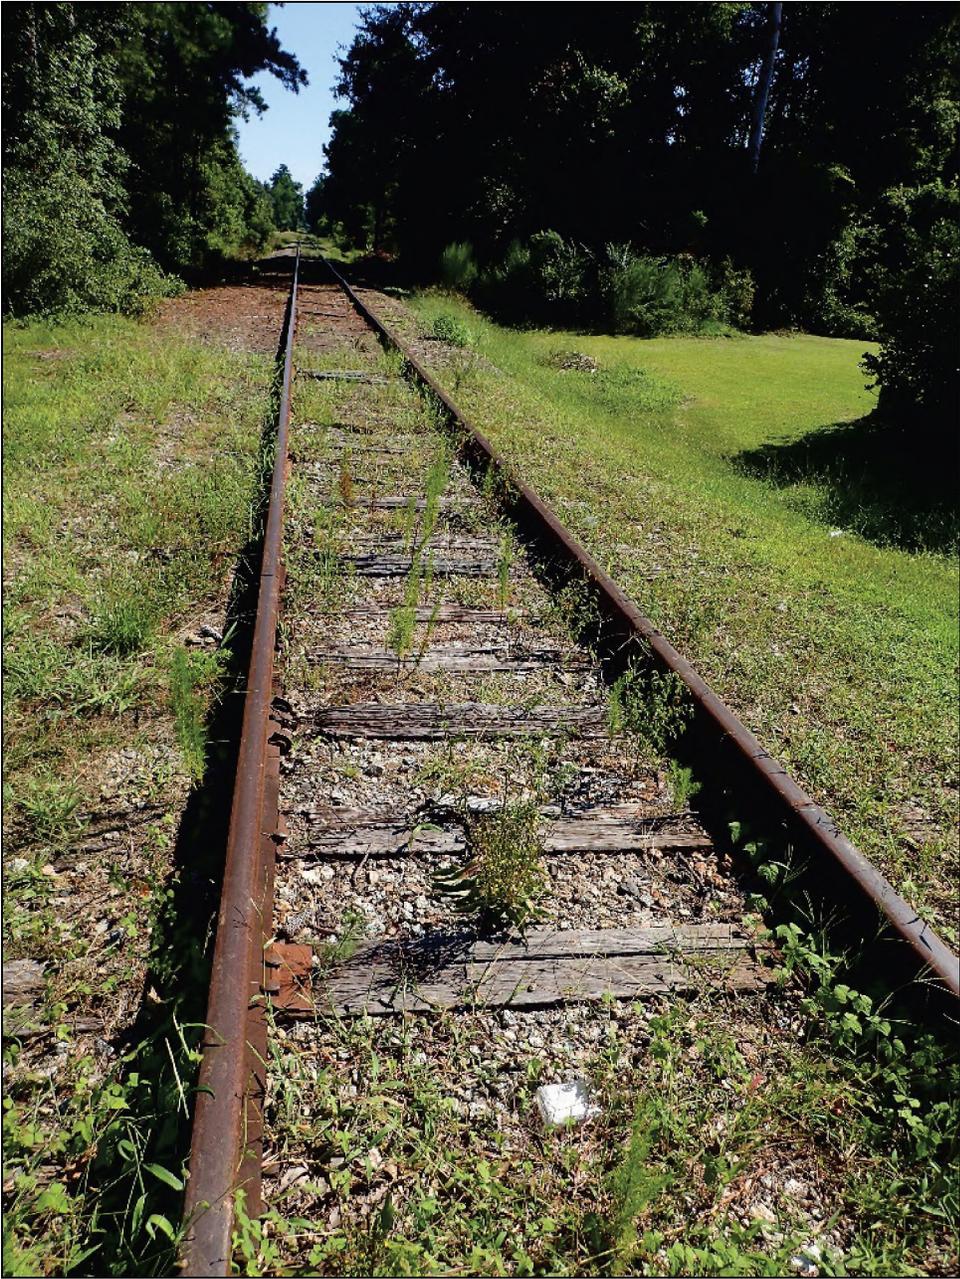
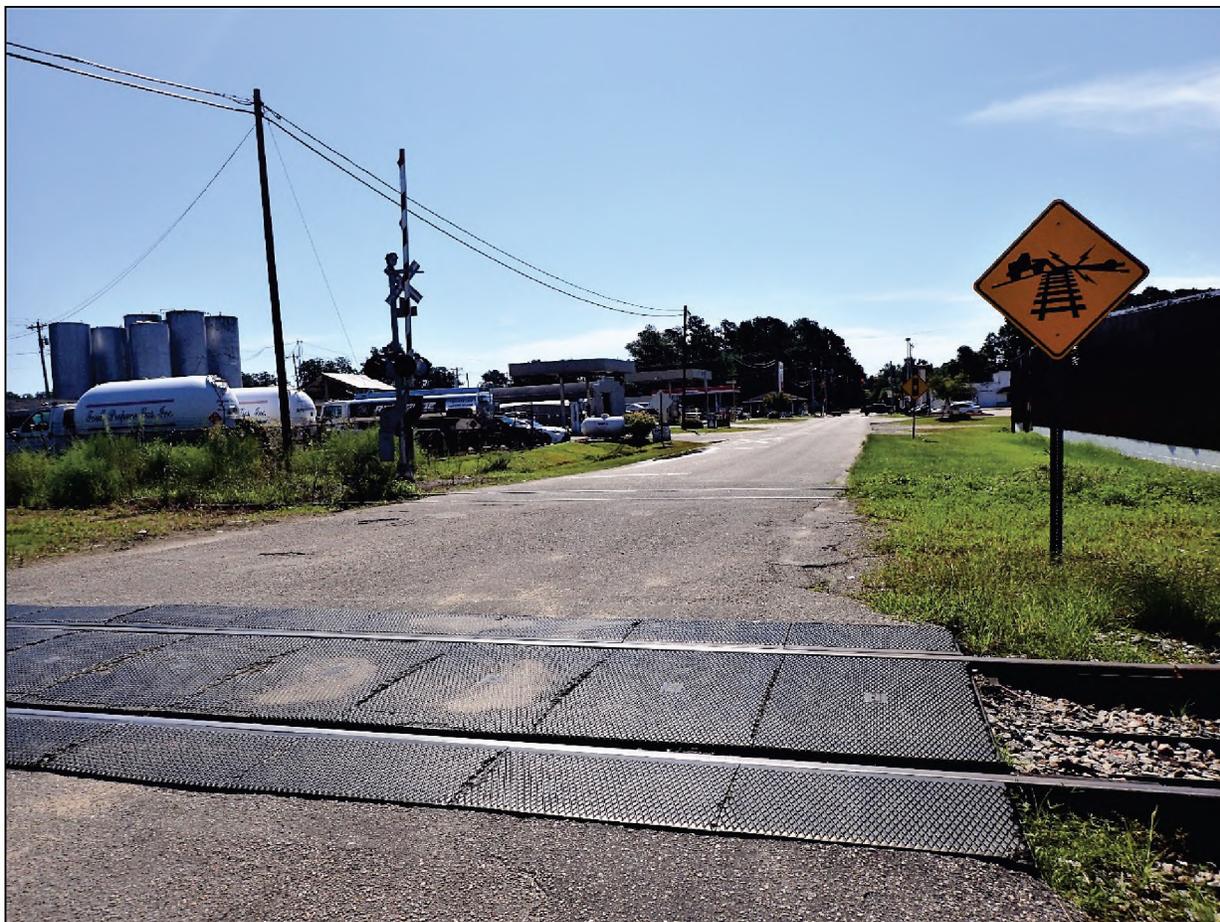
Figure 70. 3872, view north from Prospect Rd intersection. Hwy 701 is on the right (HDR 2018).

Figure 71. 3872, view north from Garden Dr intersection (HDR 2018).

**Figure 72. Carolina Lines south of the Project area, view east towards Site 3850 (4115 Holly St). Abandoned siding is visible just east of the active tracks (HDR 2018).**
