Re: FINAL REPORT
Cultural Resource Investigations of Approximately
48 Acres at the Proposed Richardson Solar Project
Barnwell County, South Carolina
Terracon Project No. 73187225
SHPO Project NO. 15-ED0126

Richardson Solar Project ■ Barnwell County, SC
February 1, 2019 ■ Terracon Project No. 73187225

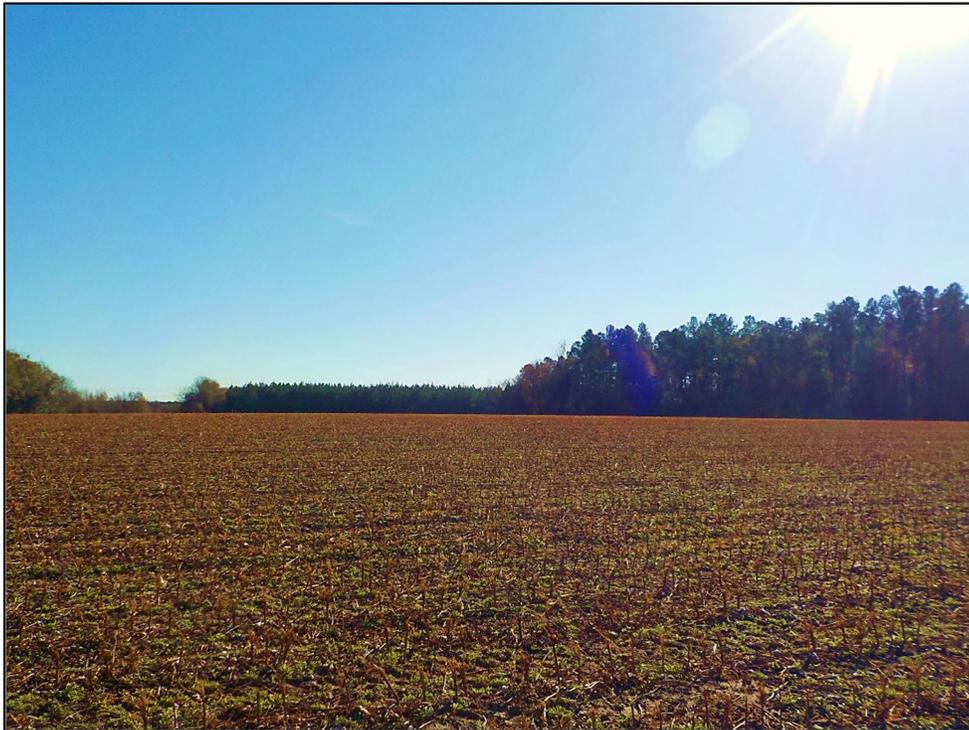
Soils in the project area are composed of loamy and sandy soils formed in loamy marine deposits. Soil types include well drained Wagram sand and Barnwell loamy sand (Figure 3). Topography in the project area is gently sloping, with elevations ranging from approximately 240 ft above mean sea level (AMSL) in the majority of the project area, with a rise to approximately 250 ft AMSL in the east-central portion of the project area. Vegetation consists primarily of fallow agricultural fields, with small stands of mixed hardwood and pine in the eastern portion of the project area (Figures 4–6).

Figure 4. Vegetation in the eastern portion project area, facing southeast.

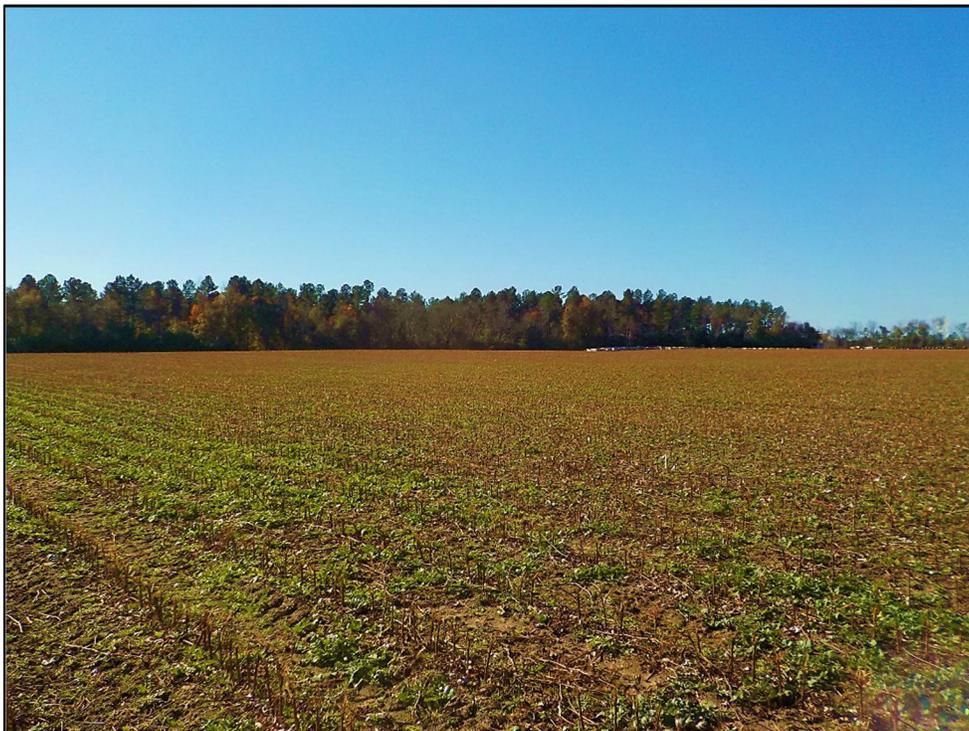
Figure 5. Vegetation in the central portion of the project area, facing southwest.

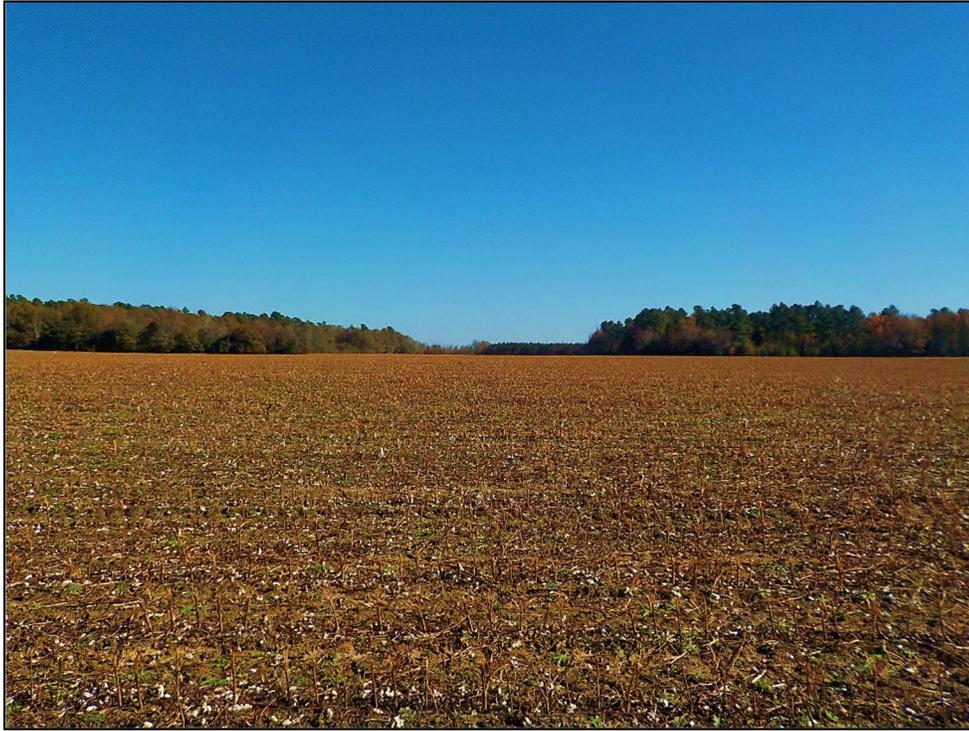
Figure 6. Vegetation in the western portion of the project area, facing east.

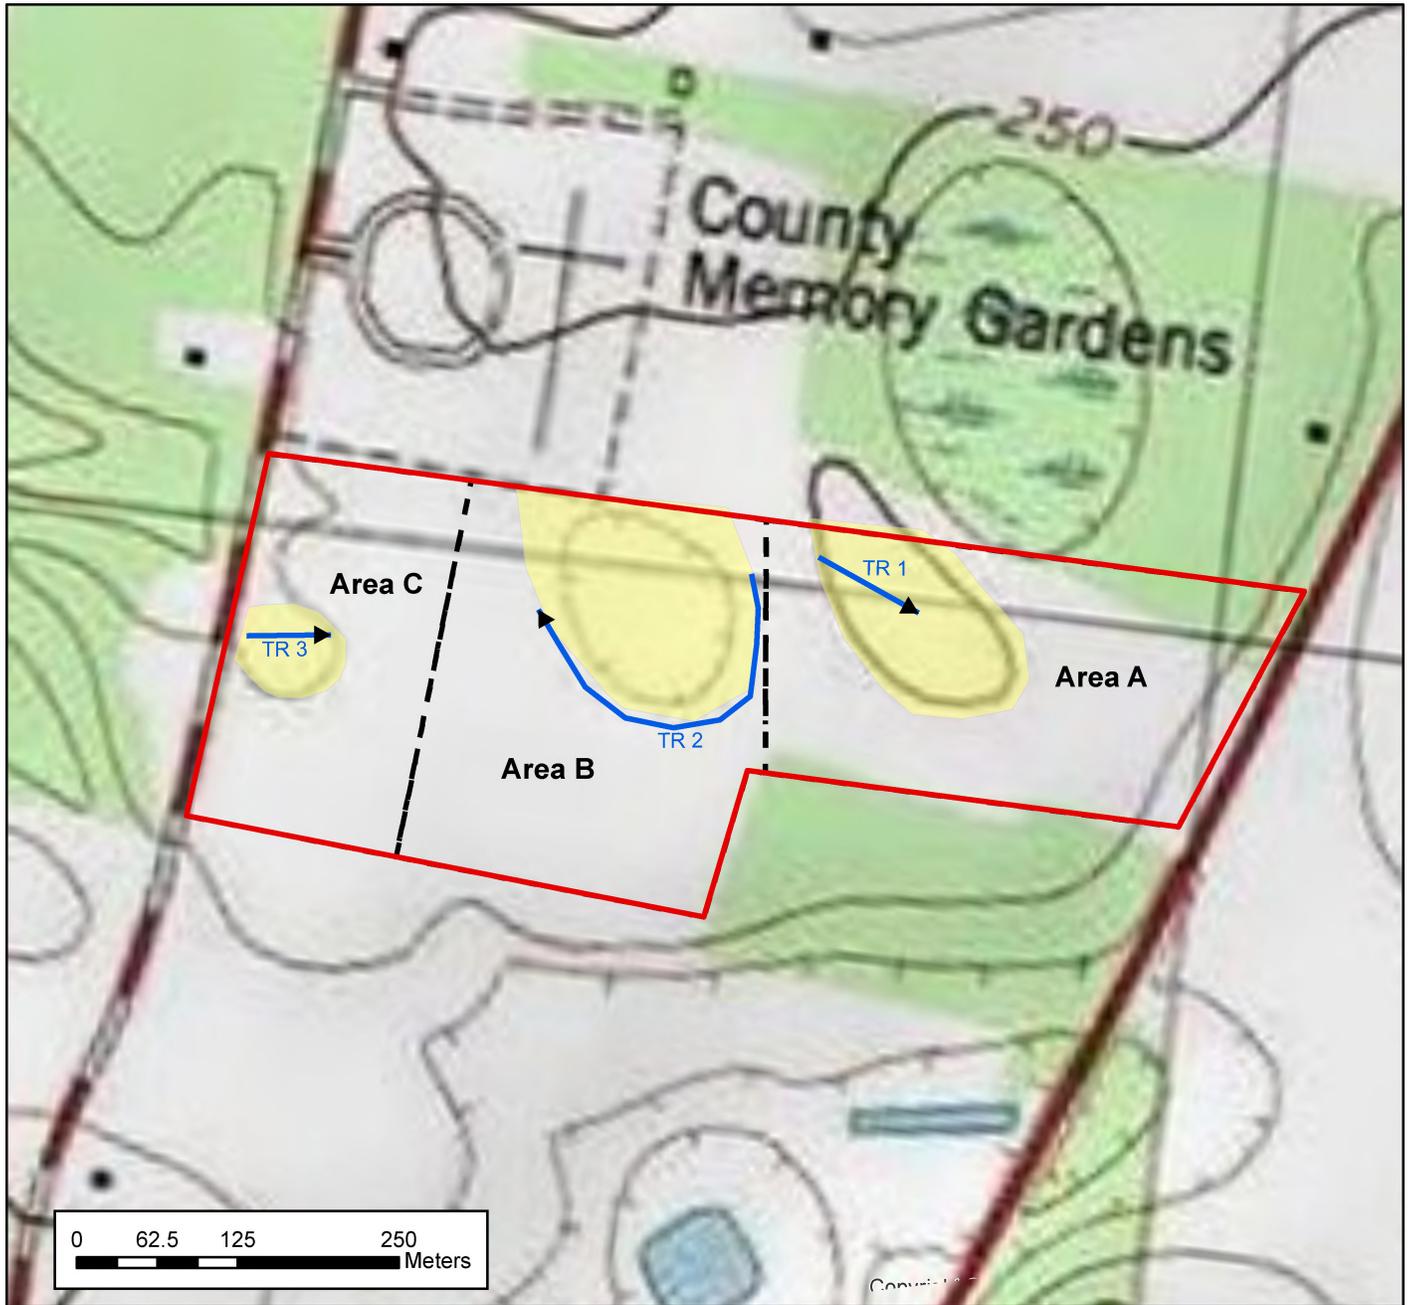
Based on these parameters, approximately 14.6 percent (seven acres) of the project area had a high potential for containing archaeological sites due to the presence of a structure indicated on historic maps and a ridge in the east-central portion of the project area. The remainder of the project area had a moderate potential for containing archaeological resources (Figure 11).

Area A, located in the eastern portion of the project area, is located on a rise just southwest of a small Carolina Bay (Figure 11). Vegetation consisted of a fallow field, with small stands of mixed hardwood and pine. Surface visibility is approximately 30 percent.

Figure 11. High probability areas and shovel test transects.
 Base Map: Blackville (1979) 7.5' USGS topographic quadrangle.

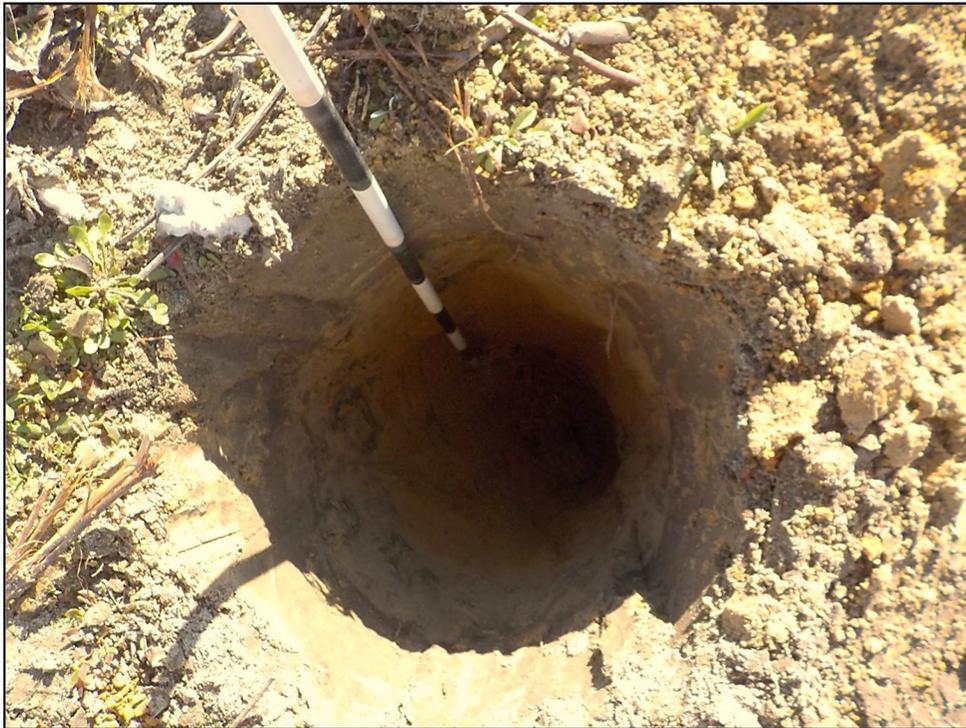
Four shovel tests, ranging from 50–80 cm deep, were excavated at 30-meter intervals along Transect 1 in Area A. A typical soil profile in this area consisted of approximately 15 cm of very dark grayish brown (10YR 3/2) sandy loam (Ap horizon), overlying approximately 25 cm (15–40 cmbs) of yellowish brown (10YR 5/6) sand (E horizon), followed by approximately 40 cm (40–80 cmbs) of reddish yellow (7.5YR 6/8) clayey sand (B horizon) (Figure 12). No archaeological sites or isolated finds were identified in Area A.

Figure 12. Typical soil profile in Area A (STP 1-1).

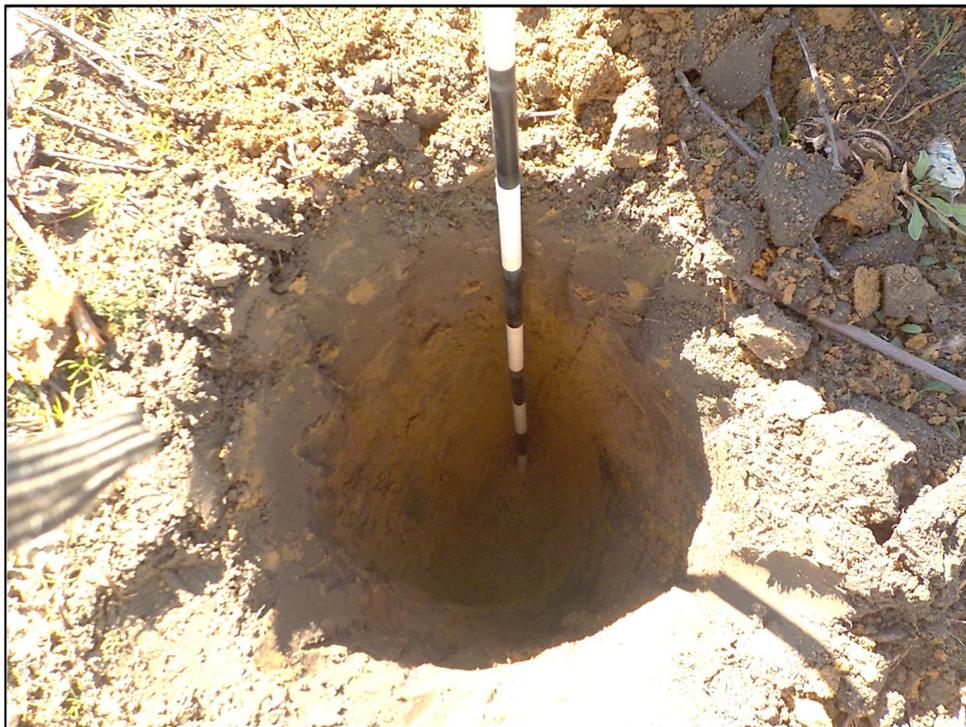
Area B is located in the north-central portion of the project area around a depression that at one time may have been a wetland (Figure 11). Vegetation consists primarily of fallow agricultural fields, while surface visibility was around 30 percent. Within Area B, three shovel tests, ranging from 45–80 cm deep, were excavated around the depression. A typical soil profile consisted of approximately 15 cm of very dark grayish brown (10YR 3/2) sandy loam (Ap horizon), overlying approximately 5 cm (15–20 cmbs) of yellowish brown (10YR 5/6) sand (E horizon), followed by approximately 20 cm (20–40 cmbs) of reddish yellow (7.5YR 6/8) clayey sand (B horizon), overlying 10+ cm (40–50+ cmbs) of reddish yellow (7.5YR 6/8) sandy clay subsoil (Bt horizon) (Figure 13). No archaeological sites or isolated finds were identified in Area B.

Figure 13. Typical soil profile in Area B (STP 2-1).

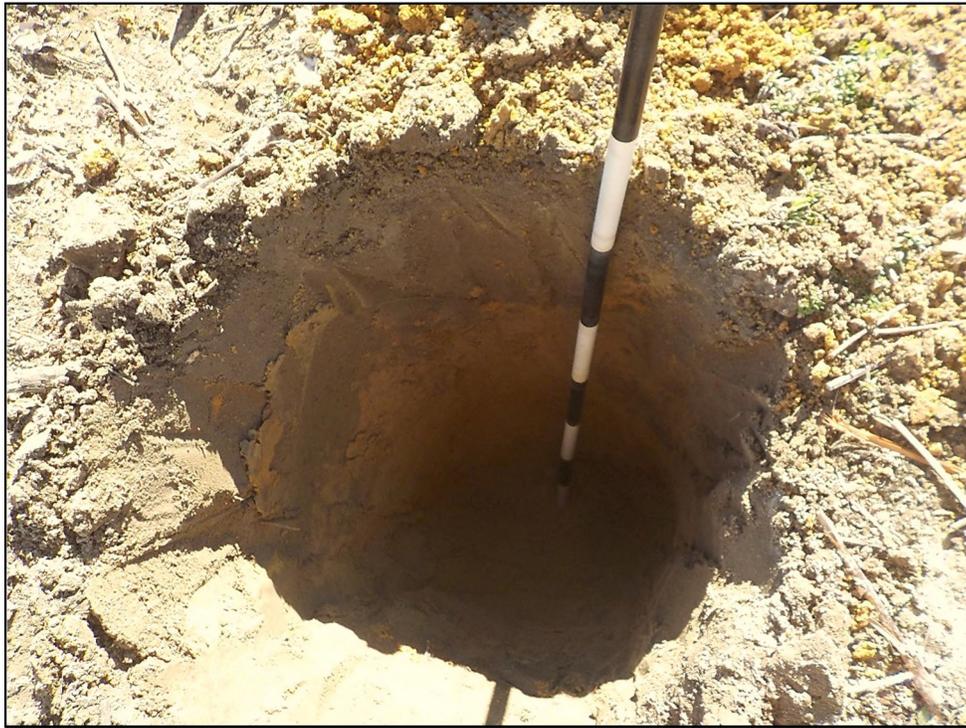
Area C is located in the western portion of the project area in an area where the 1943 Williston USGS quadrangle depicts a structure (Figure 11). Vegetation in this area consists of fallow agricultural fields and surface visibility was around 40 percent. Three shovel tests, ranging from 45–75 cm deep, were excavated at 30-meter intervals along Transect 3 in Area C. A typical soil profile consisted of approximately 30 cm of very dark grayish brown (10YR 3/2) sandy loam (Ap horizon), overlying approximately 10 cm (30–40 cmbs) of yellowish brown (10YR 5/6) sand (E horizon), followed by 10+ cm (40–50+ cmbs) of reddish yellow (7.5YR 6/8) sandy clay subsoil (Bt horizon) (Figure 14). No archaeological sites or isolated finds were identified in Area C and there was no evidence of the structure that was depicted on the 1943 map.

Figure 14. Typical soil profile in Area C (STP 3-1).

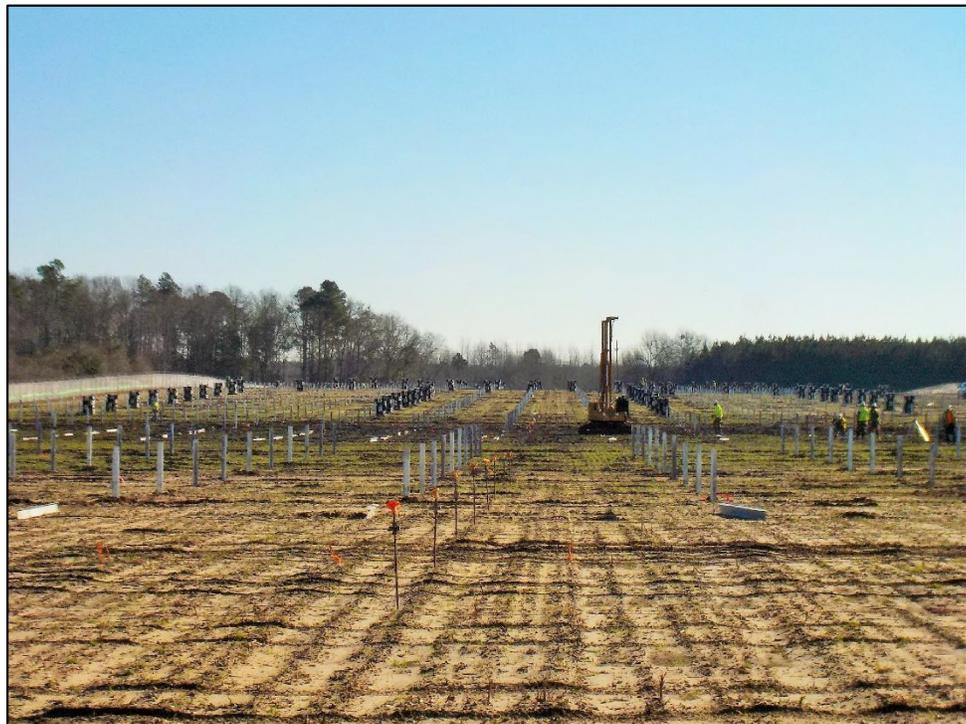
Sain Ph.D. and Crew Chief Samantha Hunt. No shovel tests were excavated in Areas A and B due to the recent construction in these portions of the project area (Figures 15 and 16). The excavation of one shovel test was attempted in the southwest corner of Area C, but it immediately filled with water. All of Area C was saturated (Figure 17) and the survey could not be completed in this area either.

Figure 15. Construction in Area A, facing east.

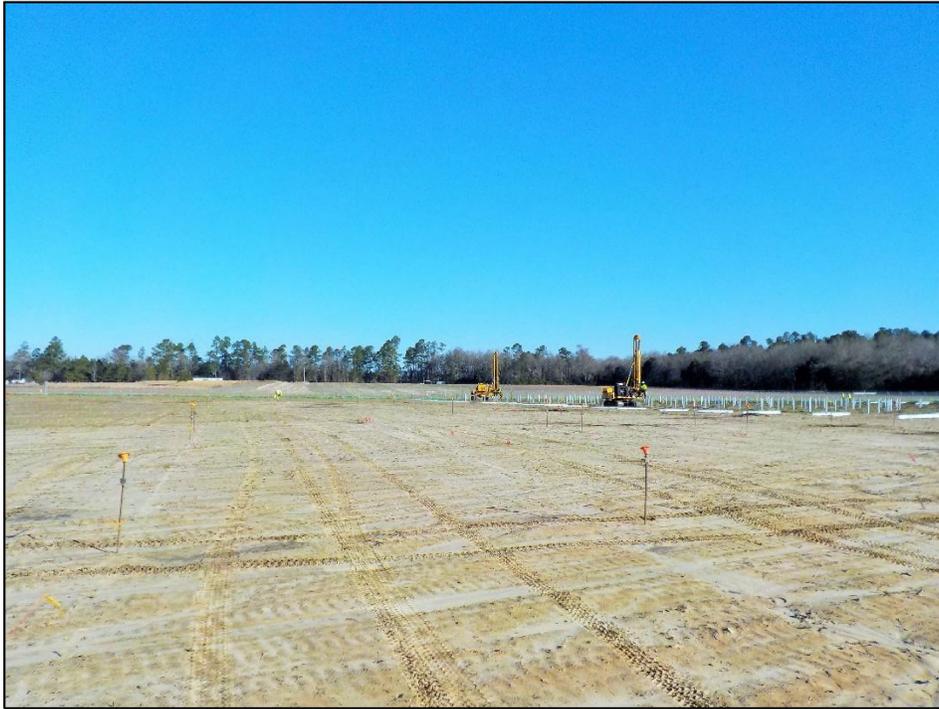
Figure 16. Construction in Area B, facing north.

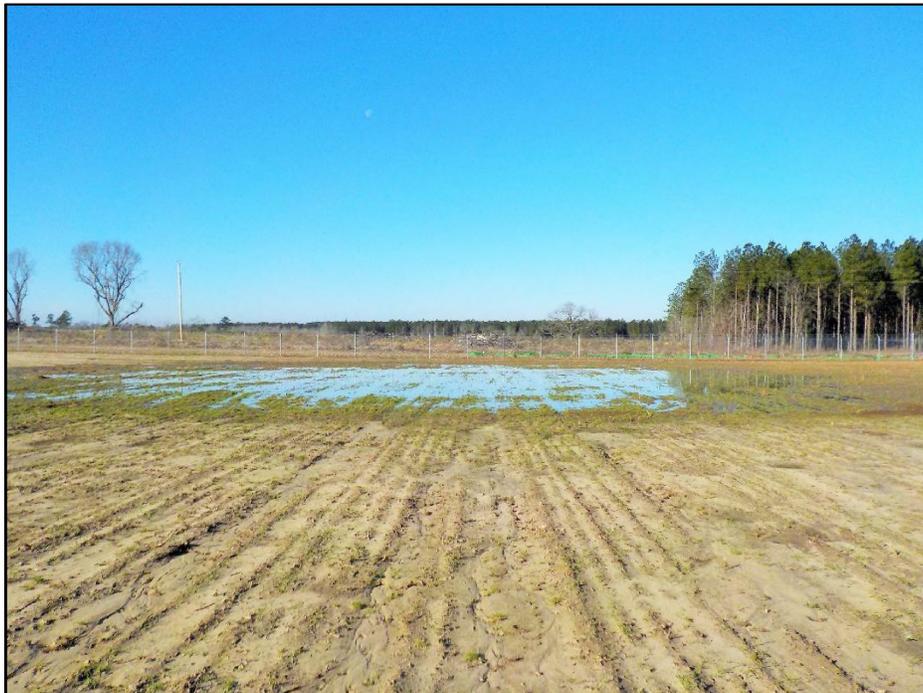
Figure 17. Area C showing saturated ground surface conditions, facing west.

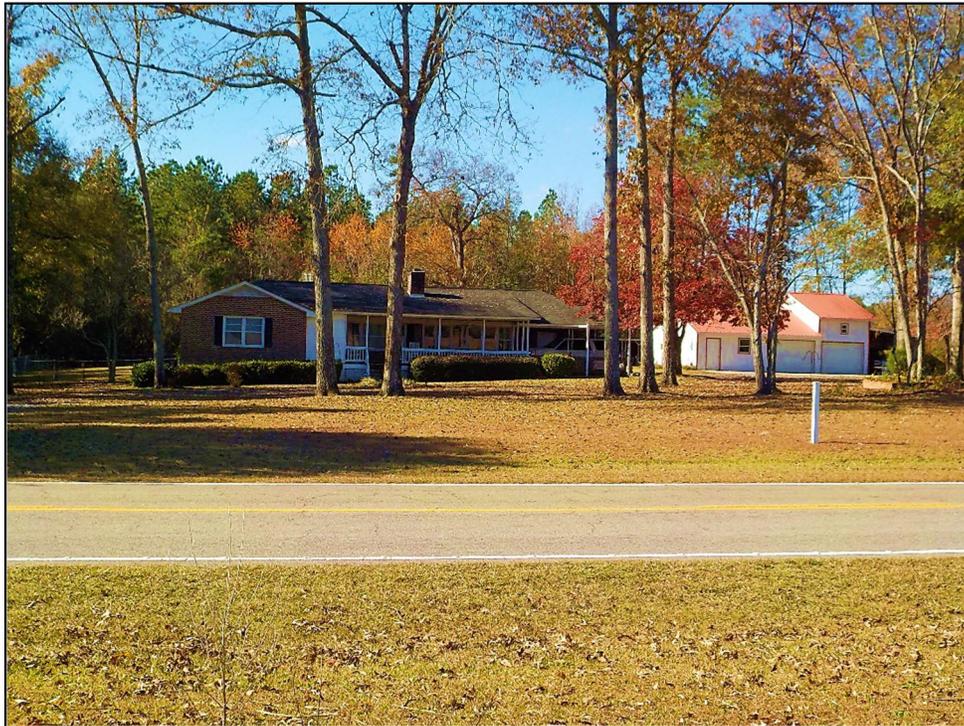
Resource No. 0496 is a circa 1970 one-story frame residence with brick siding (Figure 18). The house is rectangular in plan with the long side facing the street, surmounted by a lateral gable roof with a small front gable covering one bay on the left side. The façade to the right of the front porch gable section is recessed behind the overhanging roof, with an off-center single door flanked by large bay windows. A one-story open porch has a shed roof which projects from the middle of the lateral gable roof and is supported by slender metal columns. A brick chimney rises from the center of the front roof, while an open carport is located at the front on the right side. The lot also contains a modern two-story frame storage building.

Resource No. 0496 has remained on its original site of construction and has retained its original setting. However, Resource 0496 has not retained all of its vernacular workmanship style or original materials. Therefore, it has retained integrity in location and setting, but not in feeling, workmanship, or association. In addition, there is no sense of a particular aesthetic, nor is there association with an important event or person.

Figure 18. Resource No. 0496, facing west.

This resource does not retain its original workmanship, displays no distinctive architectural features or characteristics, and lacks significance through aesthetic features or association with an important person or historic context. Based on this evaluation, Resource No. 0496 is recommended ineligible for inclusion in the NRHP.

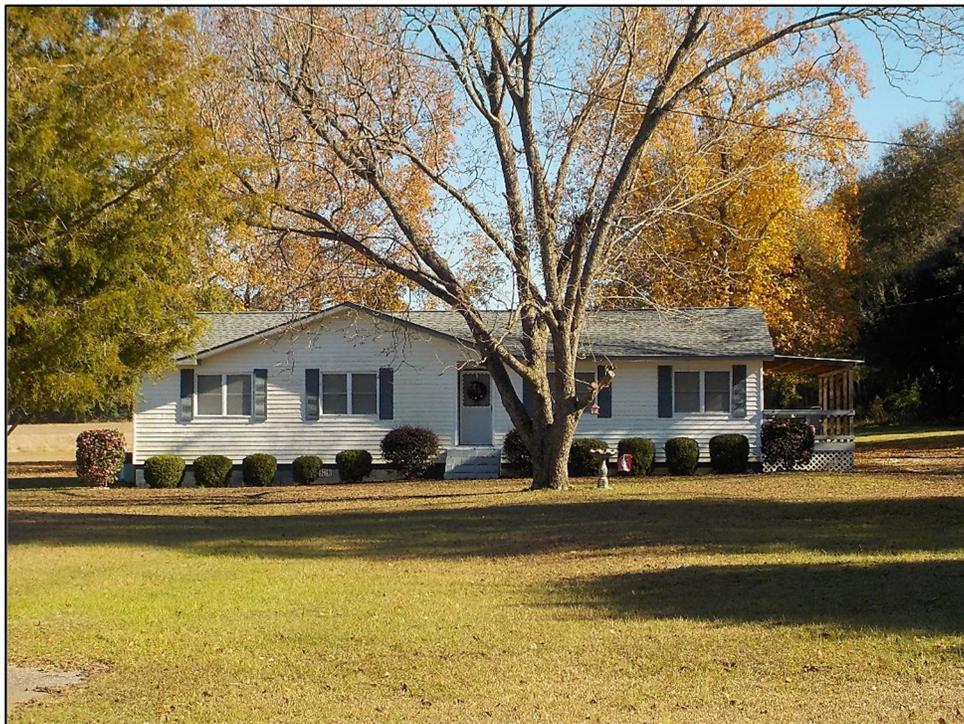
Resource No. 0497 is a circa 1970 one-story frame residence with vinyl siding (Figure 19). The house is rectangular in plan with the long side facing the street, surmounted by a lateral gable roof with a small front gable covering one bay on the left side. The asymmetrical 5-bay façade features an off-center single door flanked on each side by two double windows. The one-story open porch projects from the right side of the house and is protected by a shed roof and is supported by slender wooden posts.

Resource No. 0497 has remained on its original site of construction; therefore, it has retained integrity in location. However, it has not retained a majority of its original materials or vernacular workmanship style and there is no sense of a particular aesthetic, nor is there association with an important event or person.

Figure 19. Resource No. 0497, facing east.

Resource No. 0497 does not display distinctive architectural features or characteristics and lacks significance through aesthetic features or association with an important person or historic context. Based on this evaluation, Resource No. 0497 is recommended ineligible for inclusion in the NRHP.

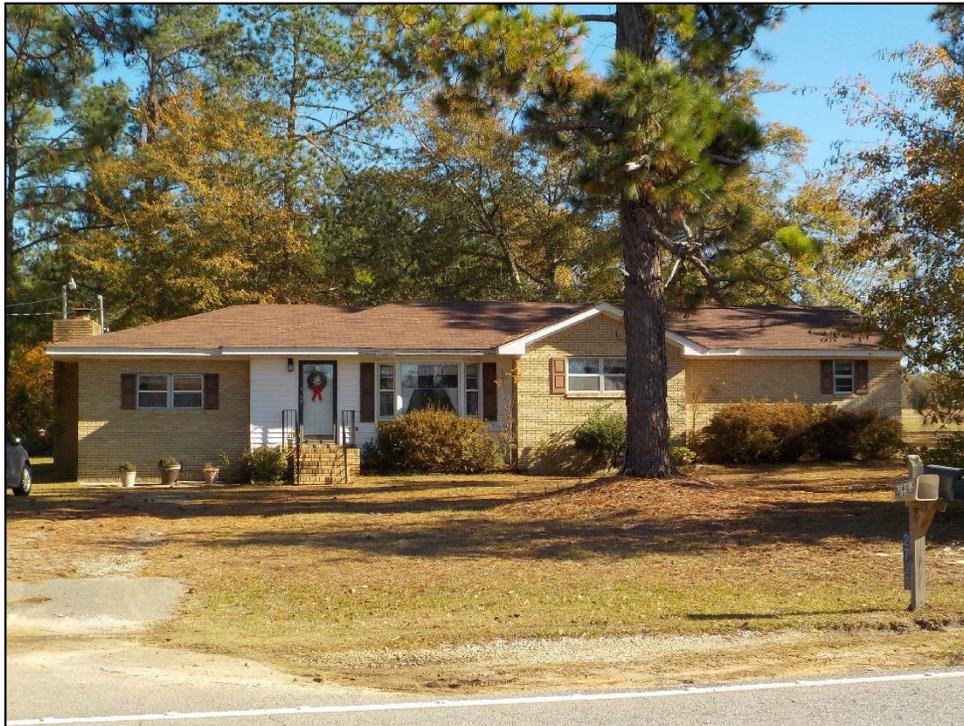
Resource No. 0498 is a circa 1970 one-story frame residence with primarily brick siding; the off-center entrance and bay window are surrounded by vinyl siding (Figure 20). The house is rectangular in plan with the long side facing the street, surmounted by a combination roof, hipped on the right leading to a lateral gable on the right, while a small front gable one-bay section projects from off-center on the façade. The asymmetrical façade features an off-center single door on the left with a tripartite window on the right and a double window on the left, while the projecting gabled section has a double window. There is an exterior and brick chimney on the left side.

Resource No. 0498 has remained on its original site of construction and remains in a rural setting; therefore, it has retained integrity in location and setting. However, a majority of its original materials are missing, there is no particular feeling, workmanship style or aesthetic. In addition, there is no known association with an important event or person.

Figure 20. Resource No. 0498, facing east.

This property has been modified and does not embody distinctive architectural features or characteristics and lacks significance through aesthetic features or association with an important person or historic context. Based on this evaluation, Resource No. 0498 is recommended ineligible for inclusion in the NRHP.

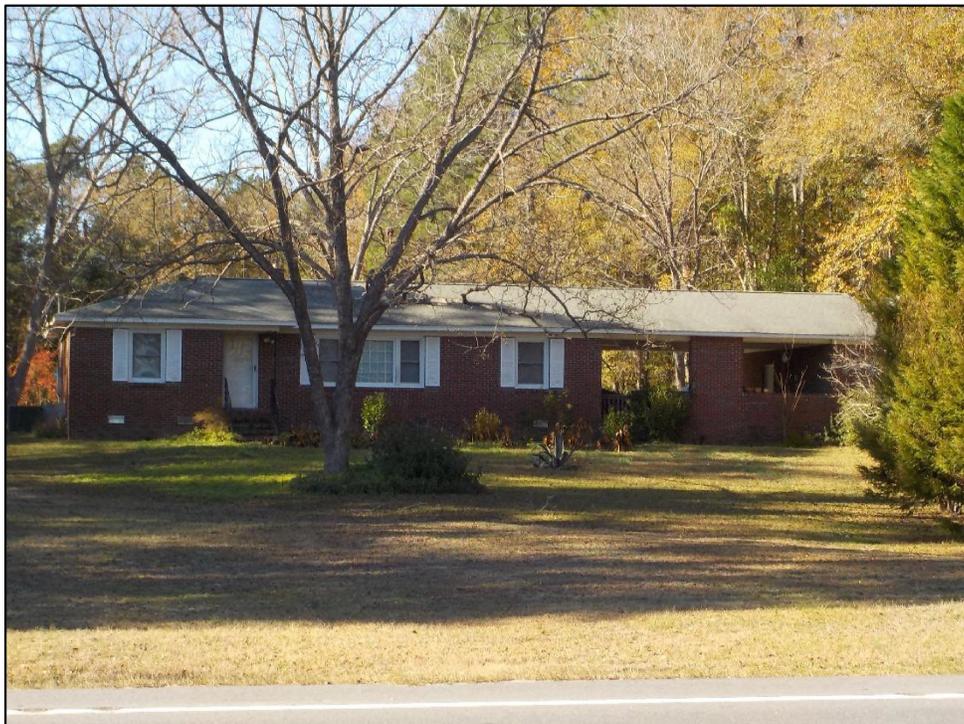
Resource No. 0499 is a circa 1970 one-story frame residence with brick siding (Figure 21). The house is rectangular in plan with the long side facing the street, surmounted by a lateral gable roof, with a small hipped section projecting from the left side. The four-bay façade has a recessed single entrance off-center on the left, flanked by a single window on the left and a tripartite bay window and a single window on the right. An open carport is on the right, beneath a continuation of the roof and separate from the house by an open walkway.

This structure has remained on its original site of construction and remains in a rural setting; therefore, it has retained integrity in location and setting. However, there is no particular feeling, workmanship style or aesthetic, nor is there a known association with an important event or person.

Figure 21. Resource No. 0499, facing west.

This property does not display distinctive architectural features or characteristics and lacks significance through aesthetic features or association with an important person or historic context. Based on this evaluation, Resource No. 0499 is recommended ineligible for inclusion in the NRHP.

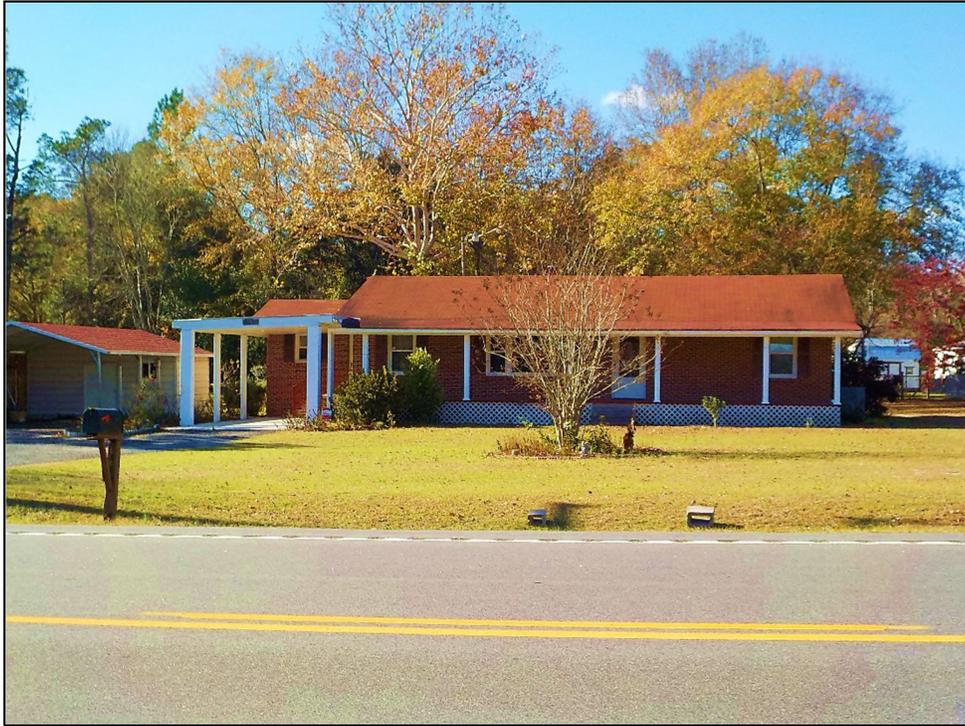
Resource No. 0500 is a circa 1970 one-story frame residence with brick siding (Figure 22). The house is rectangular in plan with the long side facing the street, surmounted by a lateral gable roof, with a small hipped section projecting from the left side. The four-bay façade has an off-center single entrance flanked by a single window on the right and a tripartite window and a single window to the left. A one-story open porch spans the façade, with a shed roof supported by slender metal posts. A lower one-story lateral gable enclosure projects from the left side of the house, recessed behind the façade, with an open flat-roof carport in front, supported by wide metal columns. The lot features a modern one-story detached garage.

This structure has remained on its original site of construction and remains in a rural setting; therefore, it has retained integrity in location and setting. However, a majority of its original materials are missing and there is no particular feeling, workmanship style, or aesthetic. In addition, there is no known association with an important event or person.

Figure 22. Resource No. 0500, facing west.

This property does not display distinctive architectural features or characteristics and lacks significance through aesthetic features or association with an important person or historic context. Based on this evaluation, Resource No. 0500 is recommended ineligible for inclusion in the NRHP.

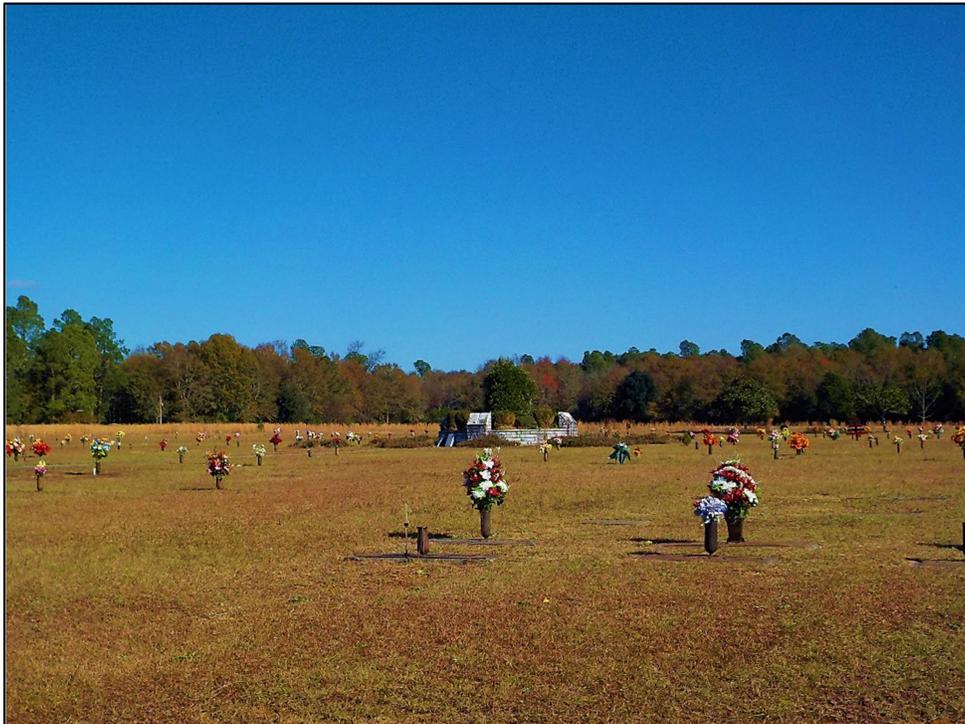
The Barnwell County Memory Gardens, established around 1969, is approximately 12 acres of flat land located on the east side of Reynolds Road. There are approximately 700 burials, with the earliest identified internment dated 1969 (Figure 23). One headstone for a person who died in 1934 appears to be a reburial. The cemetery has only flat grass markers to denote the burials.

The lot is rectangular, but the cemetery features a circular drive, with a low stone circular memorial structure in the center.

The Barnwell County Memory Gardens has remained on its original site and retains its rural setting; therefore, it has retained integrity in location and setting. However, there is no particular feeling as the markers are of common twentieth century design and material. In addition, the cemetery has no known association with an important person or event.

Figure 23. Resource No. 0501, Barnwell County Memory Gardens, facing north.

Barnwell County Memory Gardens displays no distinctive architectural features or characteristics and lacks significance through aesthetic features or association with an important person or historic context. Based on this evaluation, Barnwell County Memory Gardens is recommended ineligible for inclusion in the NRHP.
