**ARCHAEOLOGICAL FIELD REPORT
SCDOT ENVIRONMENTAL SECTION**

TITLE: Cultural Resources Survey of US 1 over SCLRR

PROJECT: US 1 over SCLRR

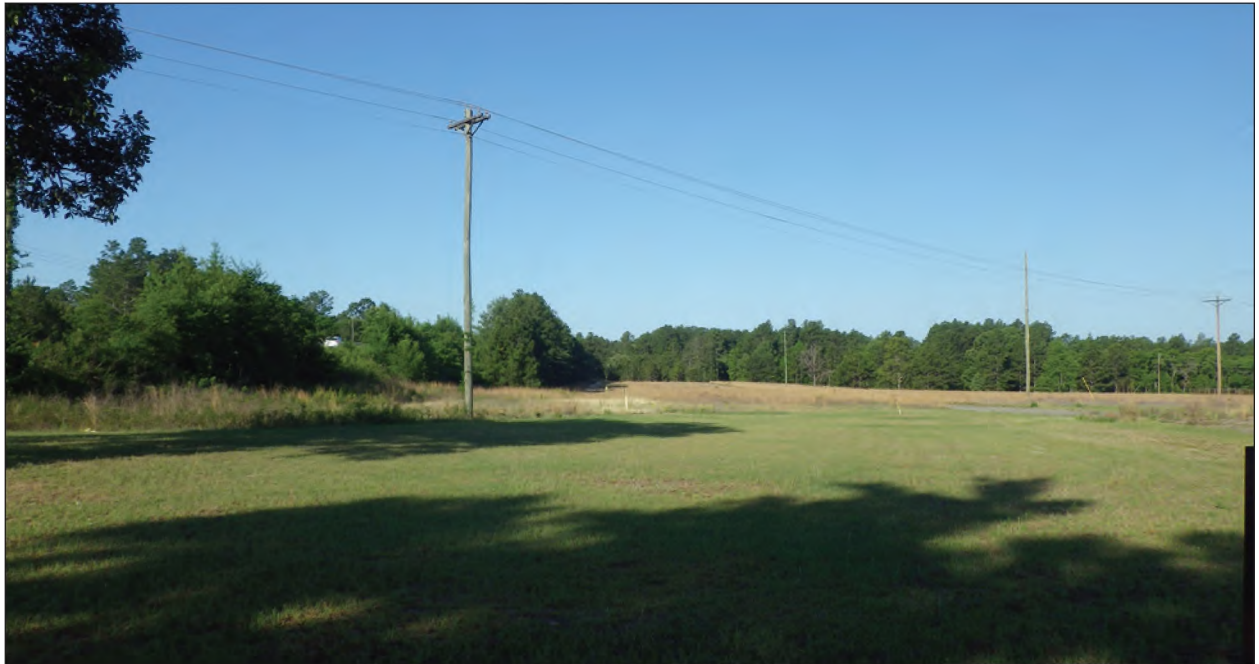
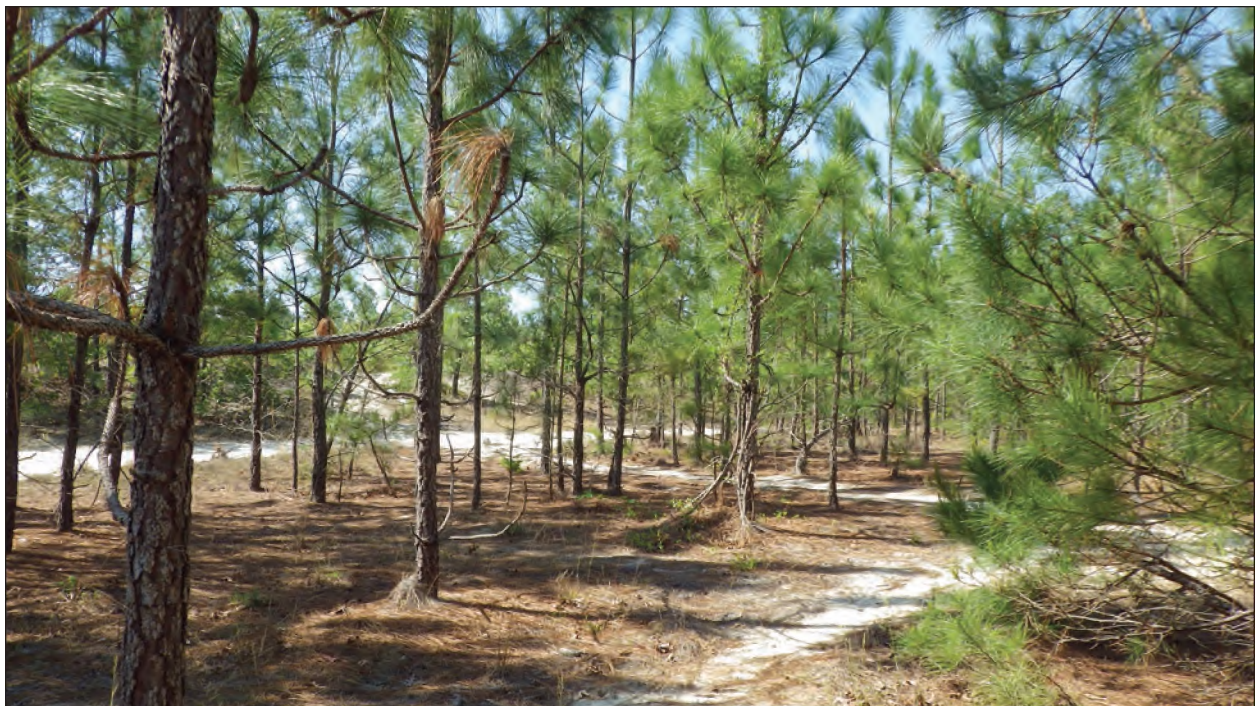
Figure 2.
Typical Vegetation Within the APE

A. Grassy Field to the Northeast of the Bridge

B. Pine Forest to the Southeast of the Bridge

Vegetation within the northeastern half of project area consists of areas of open canopy pine forests and grassy fields (Figure 2). A gas pipeline parallels the north side of the road on the eastern side of the bridge, and this section of the project area exhibited disturbance from both the pipeline and the road berm. The southeastern side of the road exhibited less disturbance and is wooded.

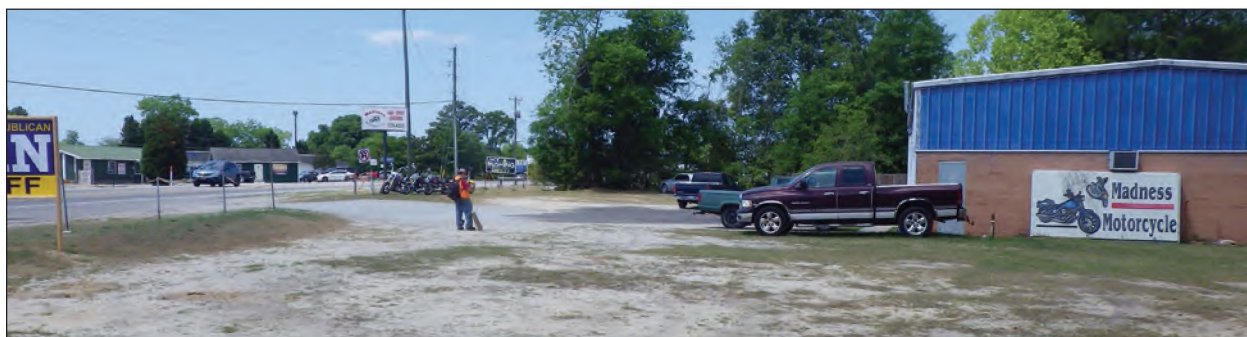
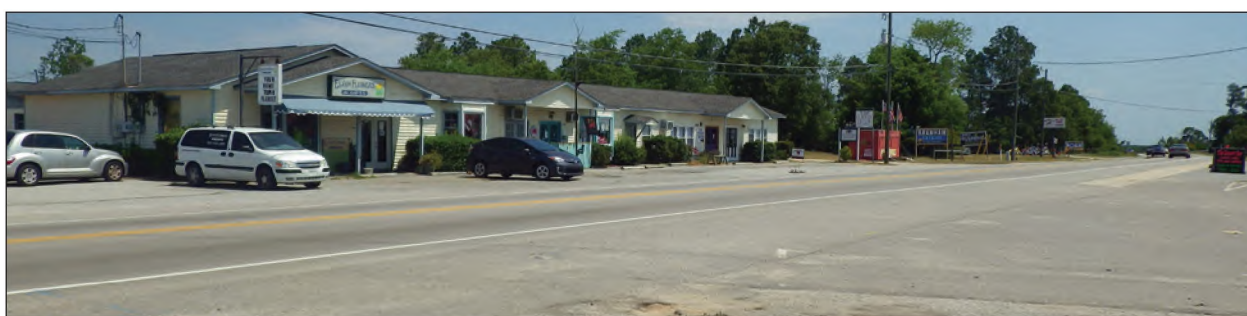
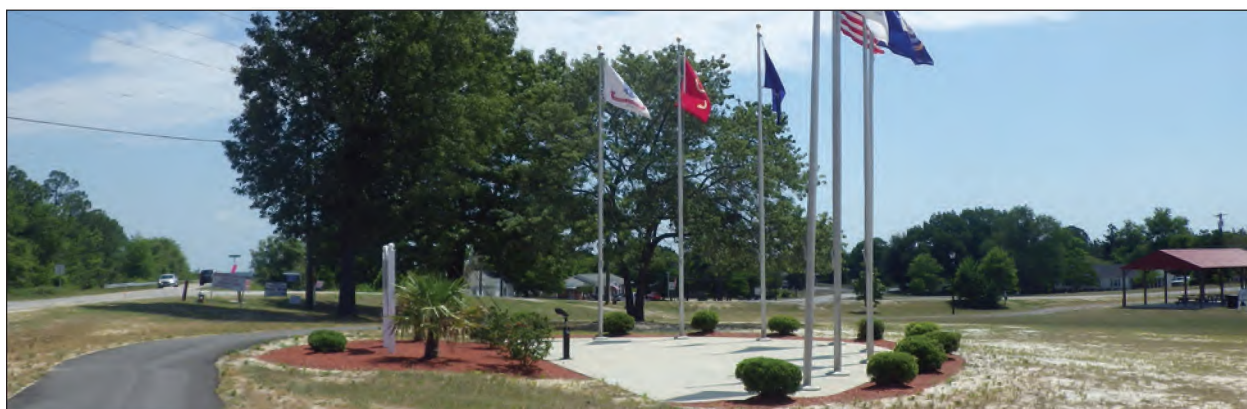
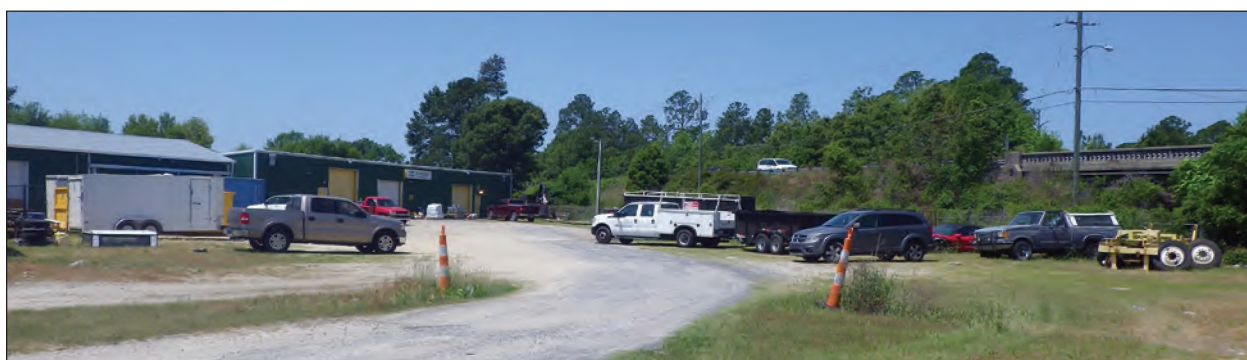
Figure 3.
Disturbance Within the APE

A. Looking Southwest Along the North Side of U.S. 1

B. Looking Northwest Along the South Side of U.S. 1

C. Potter Community Park on the Southwest Side of U.S. 1

D. Parking Lots Just Southwest of the Bridge

The southwestern half of the project area contains both residential and commercial development, including houses with graded lawns, paved and gravel parking lots, and a landscaped park (Figure 3). Surface visibility within the project area varied, but in some areas, visibility was as much as 50 to 75 percent.
