SCDOT Investigations at the Meekins Cemetery (38ML213), May-June 2018

GROUND-PENETRATING RADAR SURVEY OF THE **MEEKINS CEMETERY** **(38ML213)**

at the Right of Way of
Hebron Dunbar Road

July 9, 2018 • **Draft Report**
New South Associates Technical Report 2856

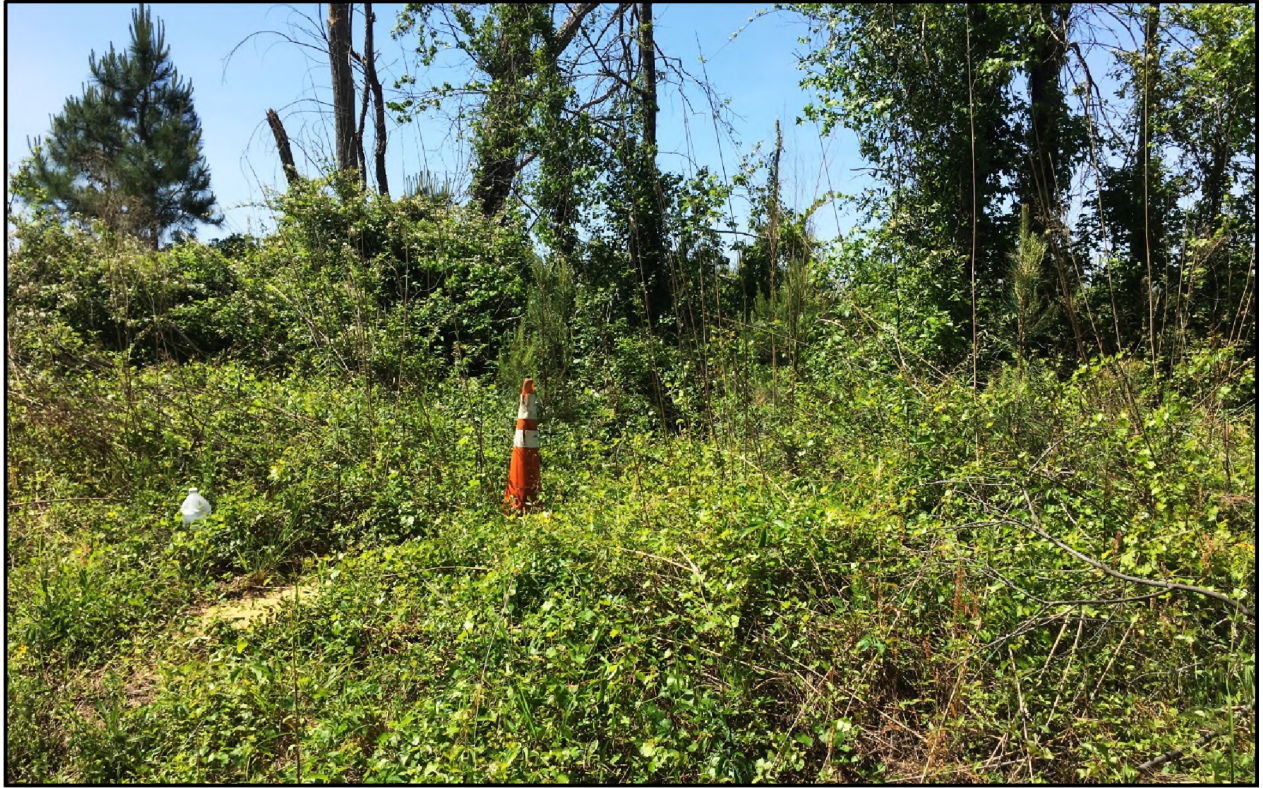
Figure 1 - Condition of the Meekins Cemetery on May 3, 2018.

Following an initial investigation by members of the Marlboro County SCDOT Maintenance Office SCDOT archaeologists visited the site on May 3, 2018 to assess the potential for graves to be present within the ROW (33 feet from centerline). During this initial visit the cemetery was found to be heavily overgrown with briars and vines, but portions of three stone grave markers and a scattering of brick fragments apparently associated with a collapsed brick burial vault were partially exposed on the ground surface. At least one of the stone markers was confirmed to be within the ROW **(Figure 1)**.

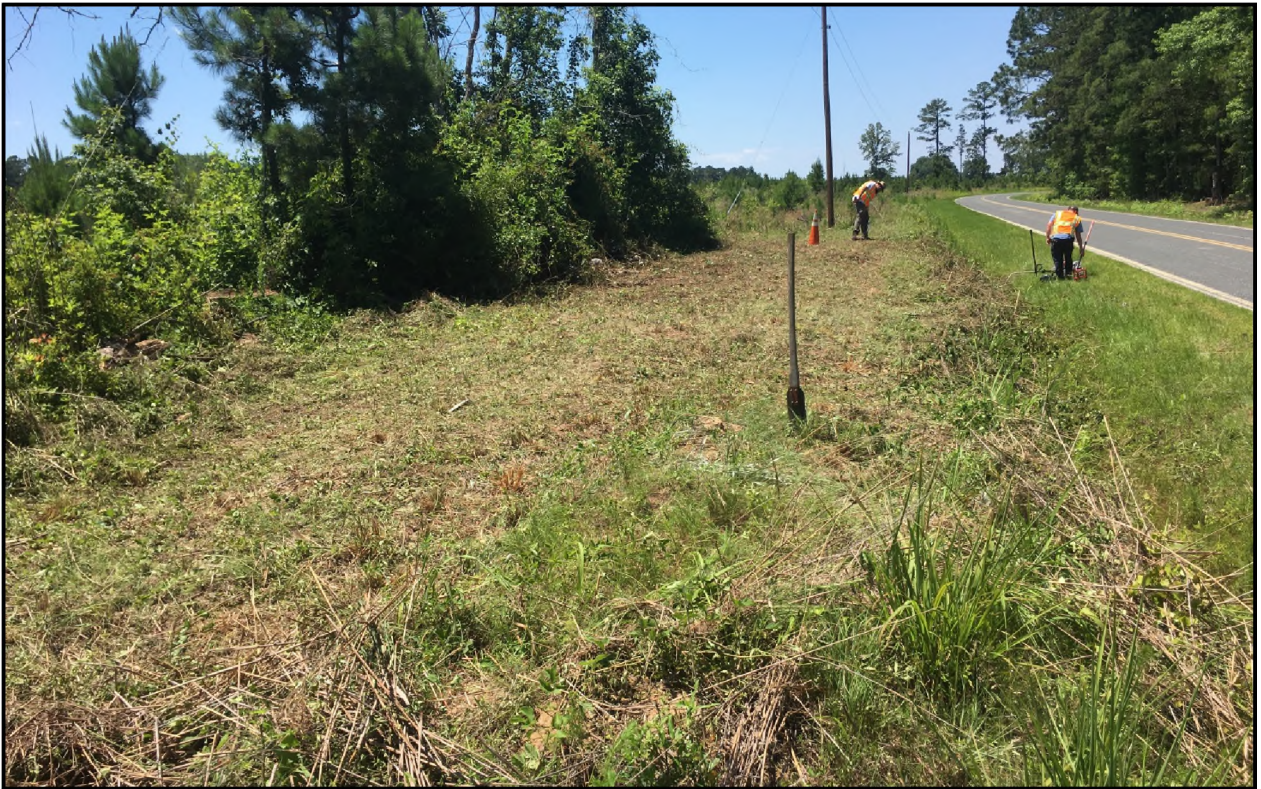
Figure 4 – GPR study area after clearing on June 6, 2018.

On June 6, 2018, SCDOT archaeologists and Marlboro County DOT employees met at the cemetery to clear vegetation prior to the GPR survey **(Figure 2)**. An area measuring approximately 16x120 feet was chosen for the survey. The SW to NE dimensions of the survey area were determined by the edge of the roadway cut bank on the NE and edge of the ROW on the SW, with the addition of an approximately two meter buffer to the SW. The NW and SE edges of the survey area were situated so as to extend beyond the estimated limits of the cemetery as determined based on local topography, vegetation, and the extent of brick rubble and fill surrounding the extant markers. Historical aerial photographs of the cemetery vicinity were also utilized to postulate the boundaries of the site by measuring the extent of the area around the cemetery that was left unplowed and forested from year to year **(Figure 3)**. Vegetation within the GPR survey grid was hand cut to less than 4 inches above ground surface. This was done in order to ensure that the accuracy of the GPR equipment would not be impeded by above-ground obstructions **(Figure 4)**.

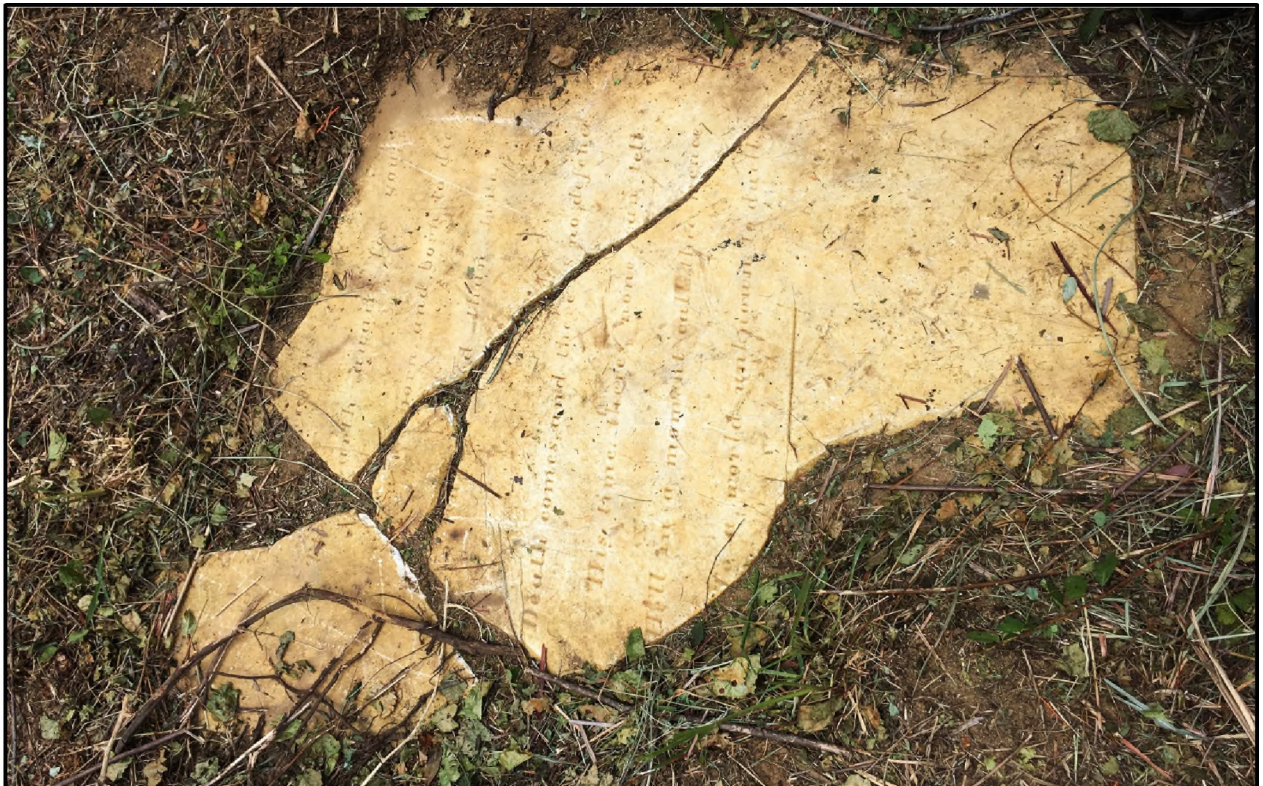
Figure 6 - Unidentified Grave Marker within the SCDOT Right of Way.

At least three partially intact markers remain in the cemetery (**Figures 6-8**). These markers lie flush to the ground but appear to be flat slabs or grave covers, rather than toppled over tombstones. Based on the fact that they retain an E-W orientation the markers appear to be on or near their original locations. This being said, the results of the GPR survey suggested that the markers may have been displaced slightly from their original spots. At least one of the markers extends into the Hebron Dunbar Road ROW.

Additional protective measures anticipated include the placement of signs within the roadway right of way denoting the presence of the cemetery, and developing a protocol to ensure that the cemetery isn't damaged during ditch clearing operations or other roadway maintenance actions.

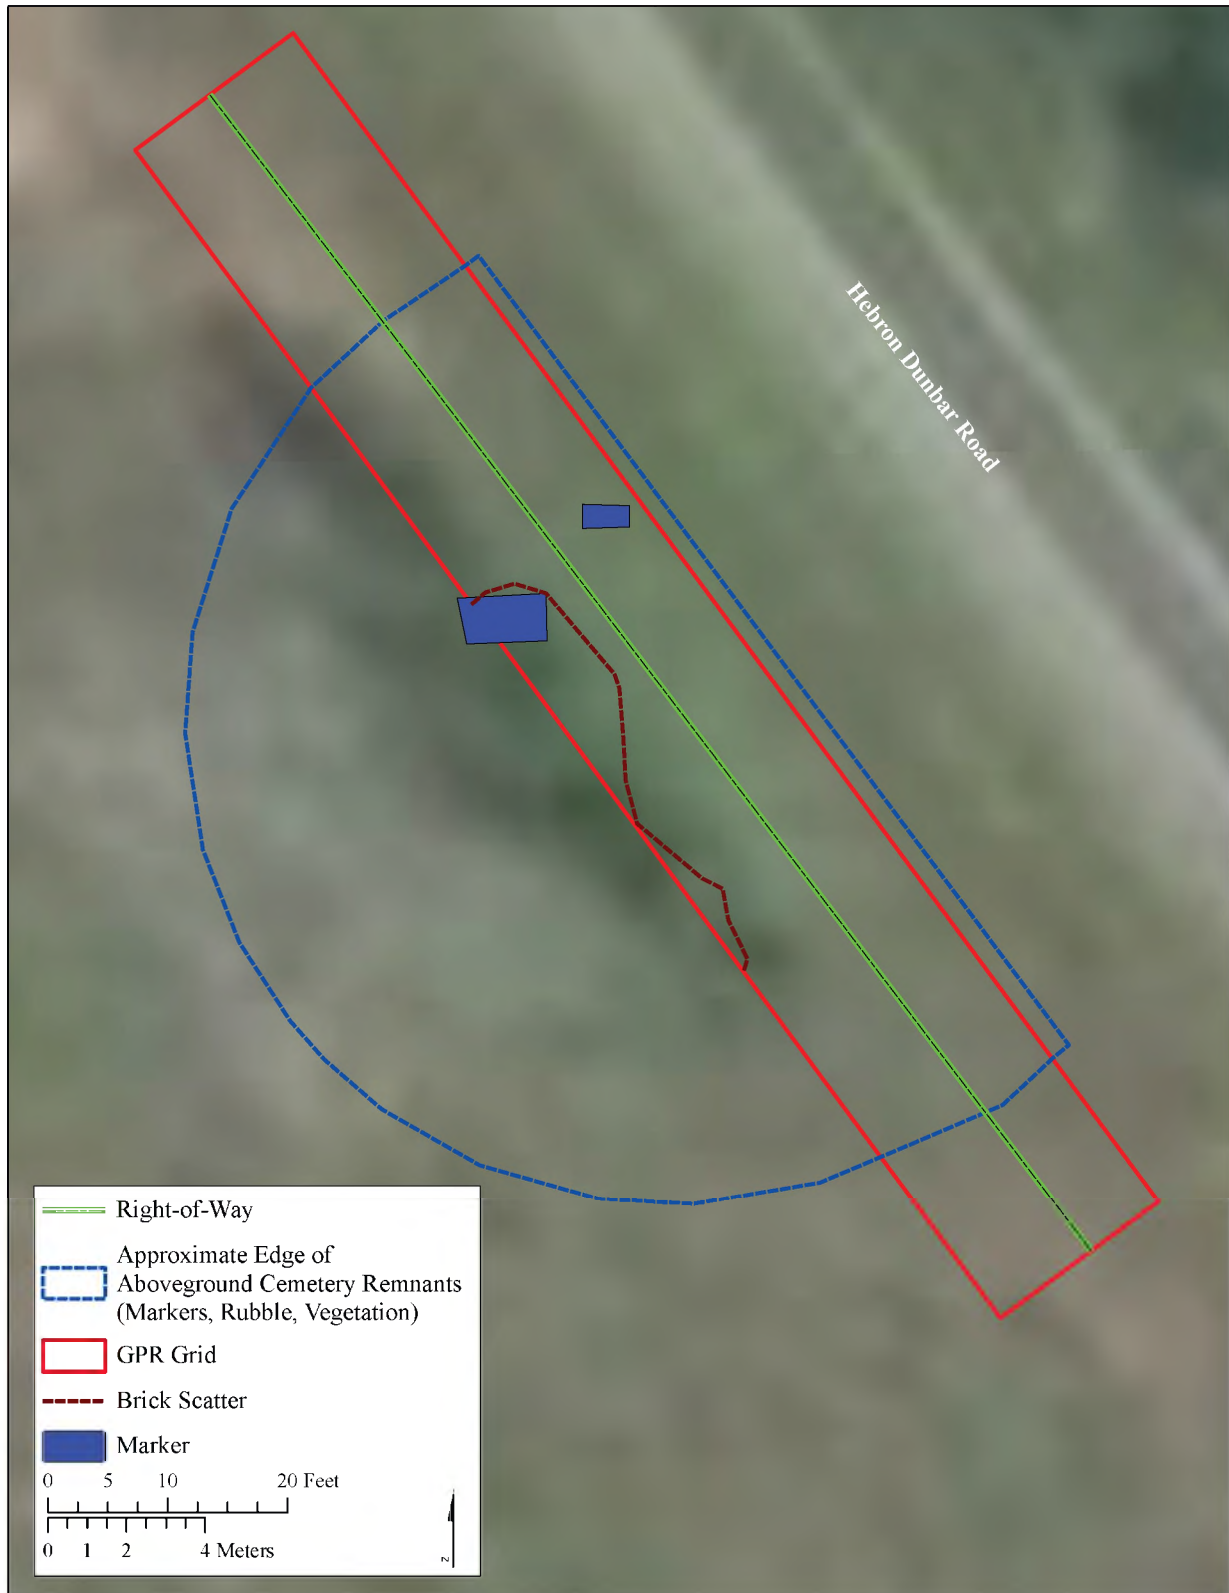
Figure 4.
Map of Survey Area and Approximate Cemetery Boundary

Source: Adams and Trinkley (1992:3); ESRI world Imagery (2018)

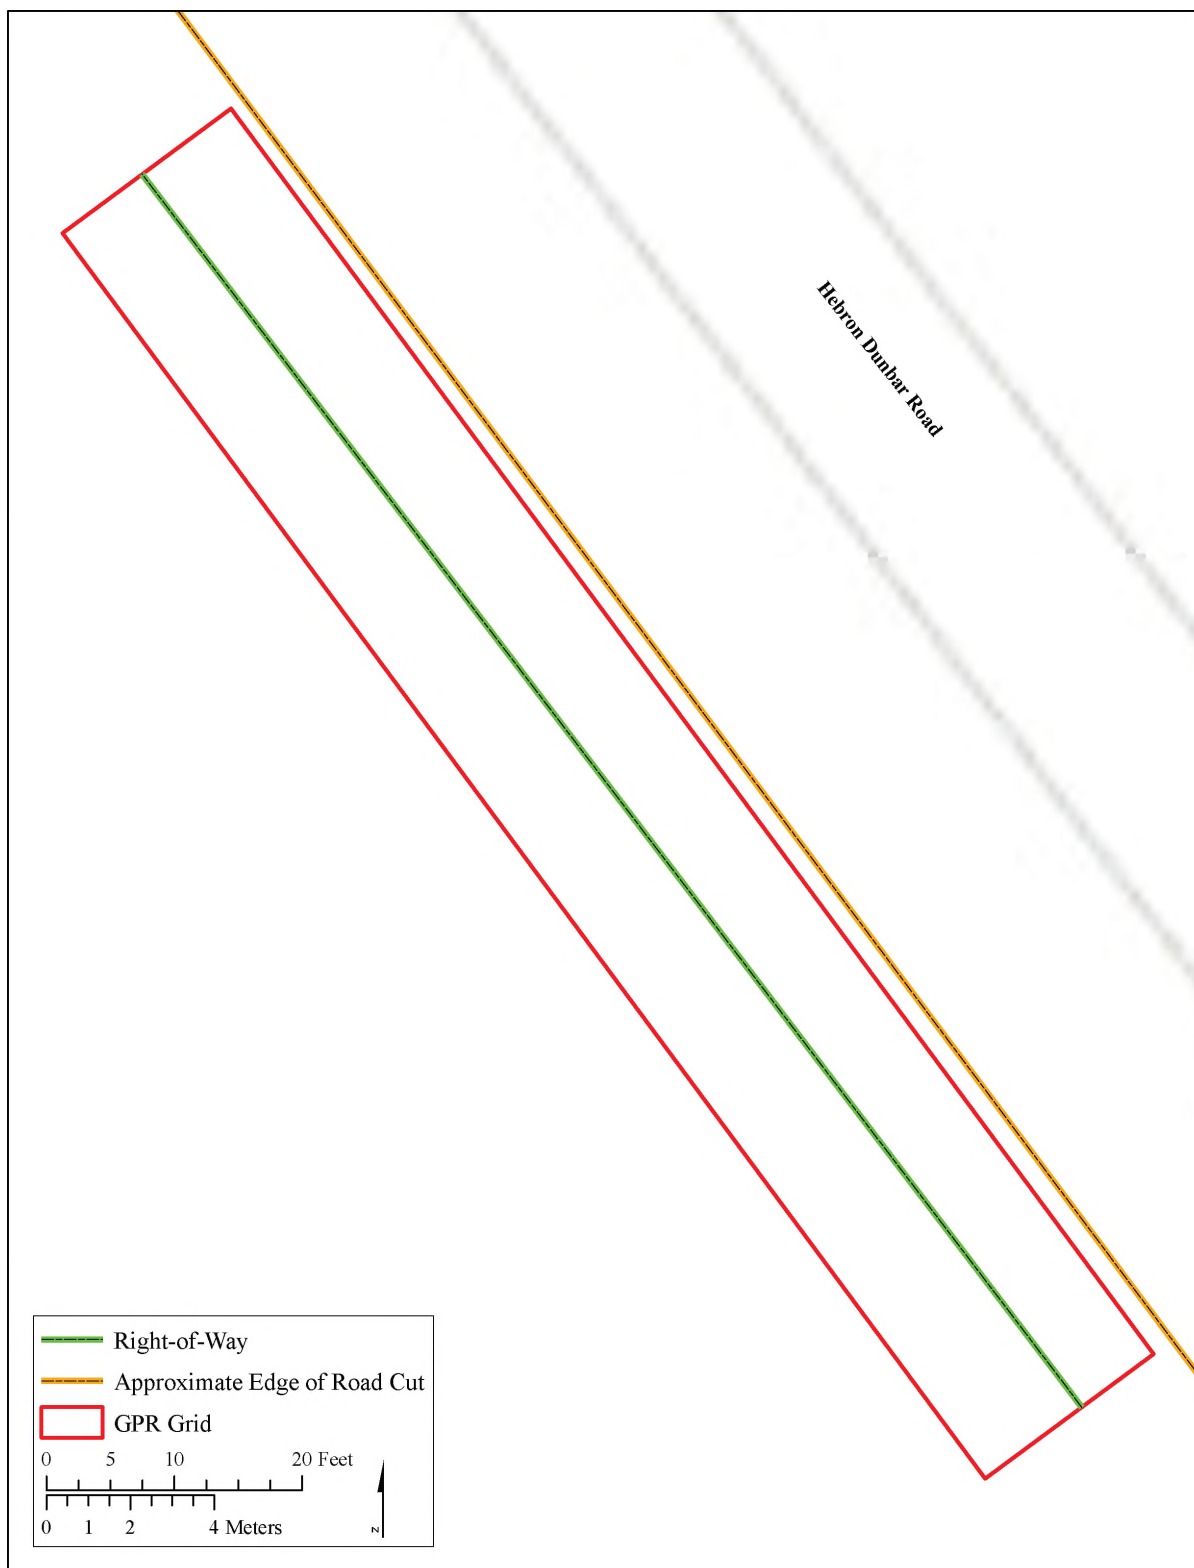
Figure 5.
GPR Survey Grid

The field survey was conducted using a GSSI SIR-4000 using a 350 MHz HS antenna over the entire project area. The survey area was defined to cover an approximately 0.05-acre section of the cemetery that intersects the right of way (Figure 5). It is generally standard practice to orient transects perpendicular to the long axis of suspected features. In this case, data were collected roughly north to south, as Christian burials are generally oriented east to west. Transect spacing was 50 centimeters, an interval that has been demonstrated to generate the best resolution while maintaining fieldwork efficiency (Pomfret 2005). Transects were collected in a zig-zag pattern, alternating starting direction, along the y-axis (north-south).

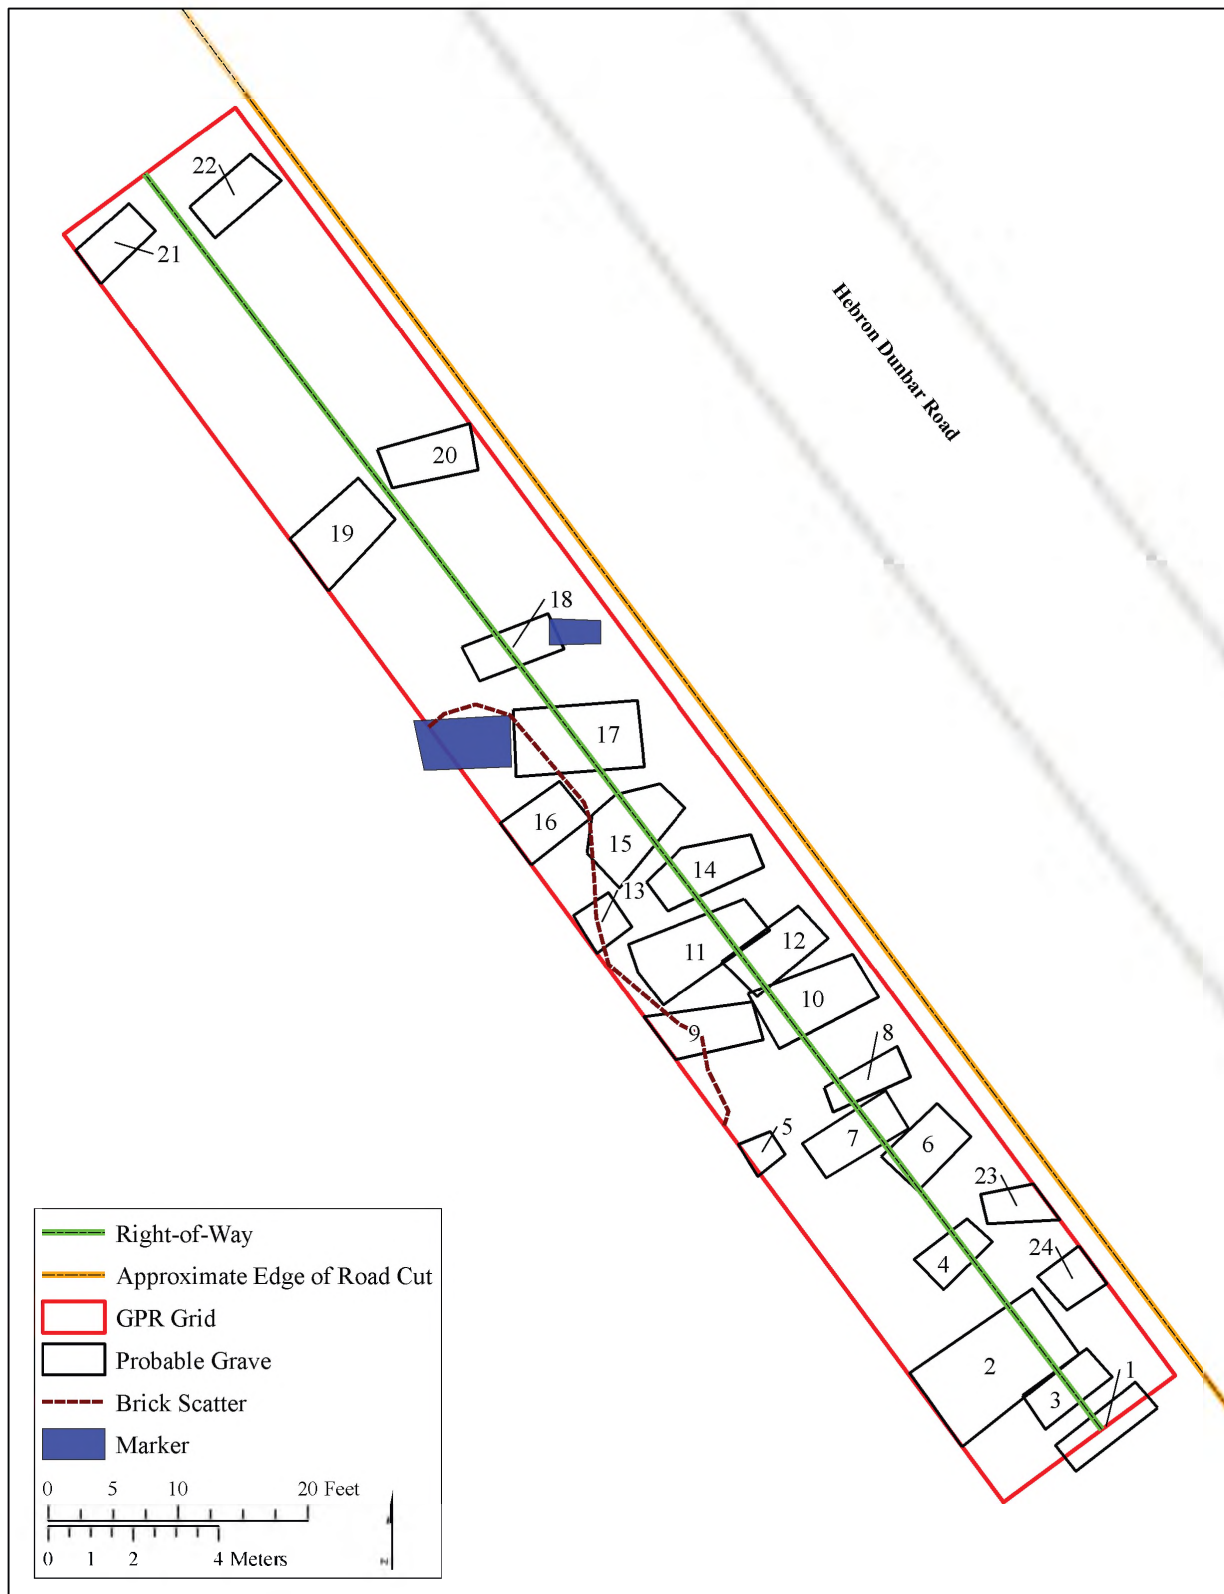
Figure 6.
Map of Surveyed Area Showing Identified Probable Graves and Right-of-Way

Of 24 probable individual graves identified, 17 were partially or completely within the ROW (Table 1, see Figure 6). Two markers and a scattering of brick were also recorded on the surface. It is likely that the markers correlate with anomalies 17 and 18, but as they have been damaged they may not be in situ (Figure 6).

New South recommends that the 24 GPR anomalies identified as probable graves should be treated as such. Additionally, care should be taken if any ground is to be disturbed within the cemetery to avoid damaging any graves that might be present but that were not detected because of poor preservation. If avoidance of graves is not possible, then additional steps should be taken to relocate the graves in compliance with the relevant South Carolina statutes. It is New South's understanding that no disturbances are currently planned within the cemetery, but that the cemetery has been damaged. The anomalies identified as probable graves should be protected from further damage.

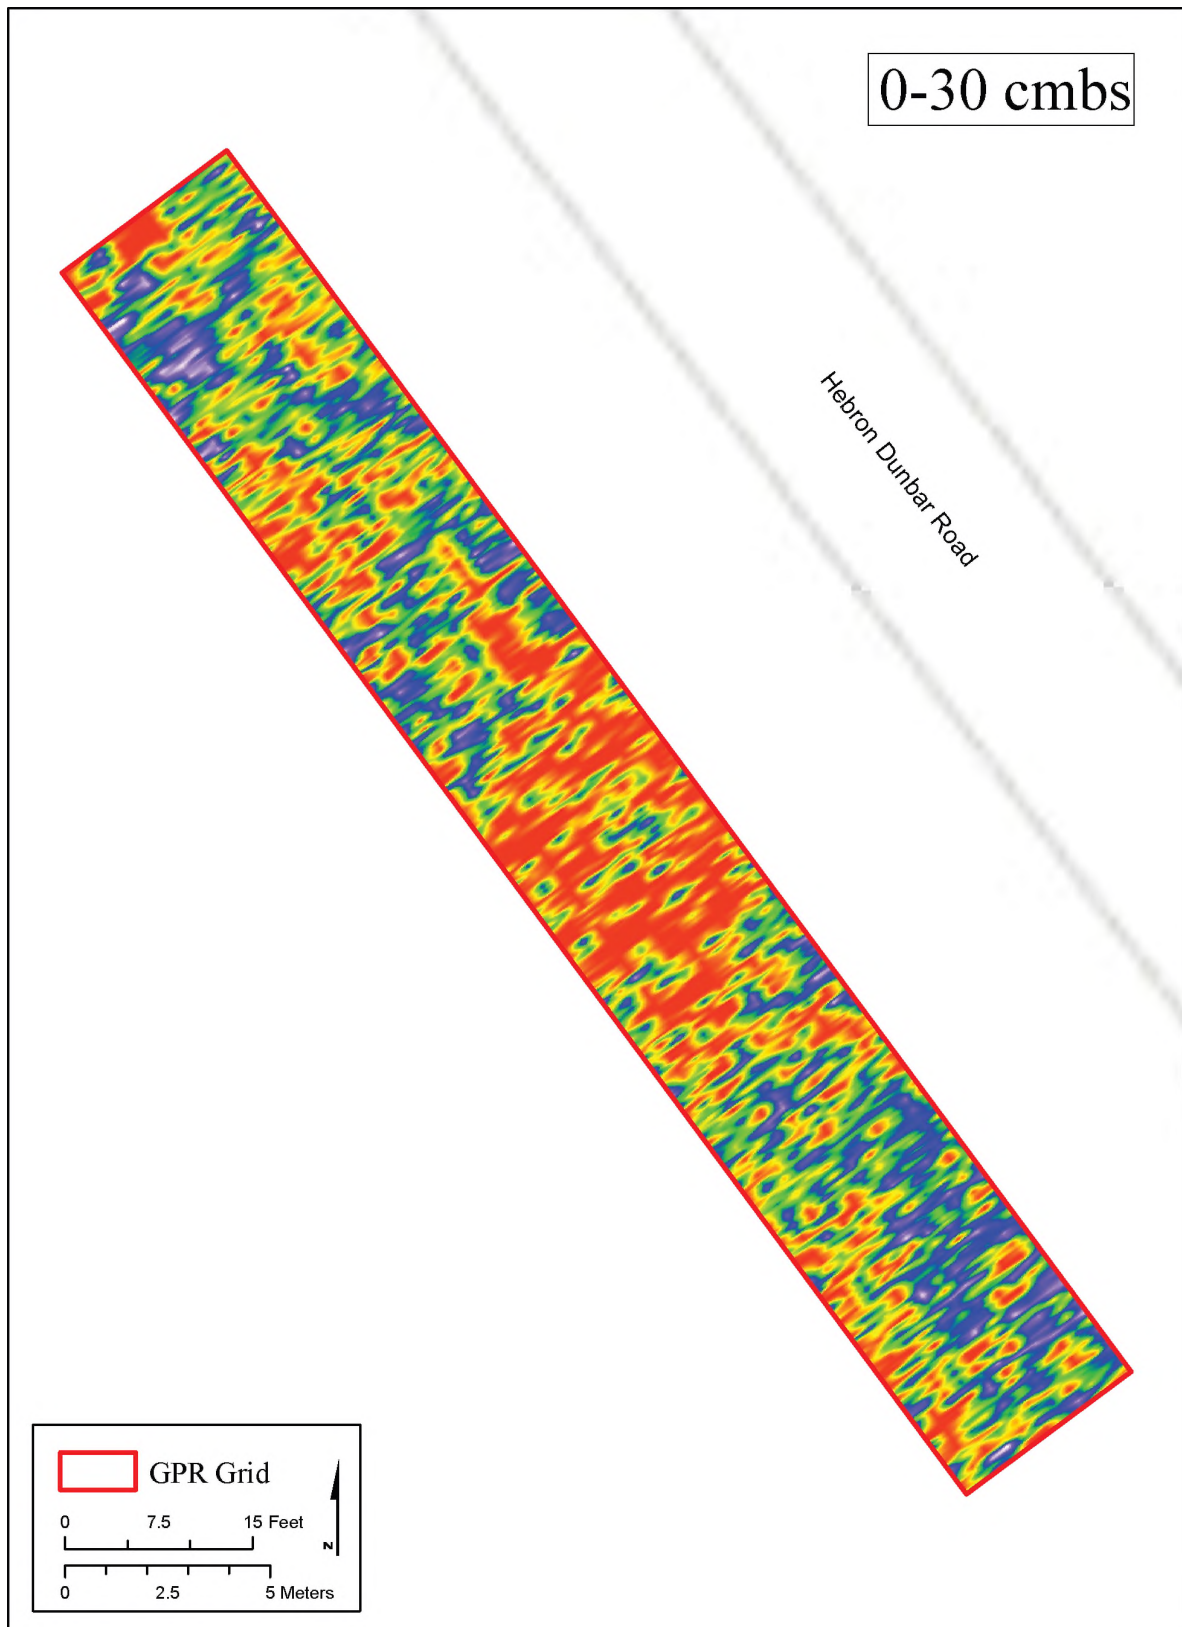
The next data processing step involved the generation of amplitude slice-maps (Conyers 2004b), which illustrate differences in reflected radar amplitudes across a given surface at various depths. Reflected amplitudes measure the degree of physical and chemical differences in the buried materials. Strong or high amplitude reflections often indicate denser (or different) buried materials. They can be generated from pockets of air, such as within collapsed graves, or from slumping sediments. The slice-maps are developed through comparison of reflected amplitudes recorded in vertical profiles. Variations in amplitude, recorded as digital values, are analyzed at each location in a grid containing many profiles where reflections were recorded. The amplitudes of all reflection traces are compared to the amplitudes of all nearby traces along each profile. This database can then be “sliced” horizontally and displayed to show the variation in reflection amplitudes at a sequence of depths in the ground. The result is a map showing amplitudes in plan view at varying depths.

Slicing of the data was done using the mapping program Surfer 8. Slice maps are a series of x, y, z values, with x (east) and y (north) representing the horizontal location on the surface within each grid and z representing the amplitude of the reflected waves. All data were interpolated using the Kriging method and then image maps were generated from the resulting files.

Figure 7.
Amplitude Slice Map from 0-30 Centimeters Below Surface (cmbs)

Figure 8.
Amplitude Slice Map from 30-60 cmbs

Figure 9.
Amplitude Slice Map from 60-90 cmbs

Figure 10.
Amplitude Slice Map from 90-120 cmbs

Figure 11.
Amplitude Slice Map from 120-150 cmbs

Figure 12.
Amplitude Slice Map from 150-180 cmbs

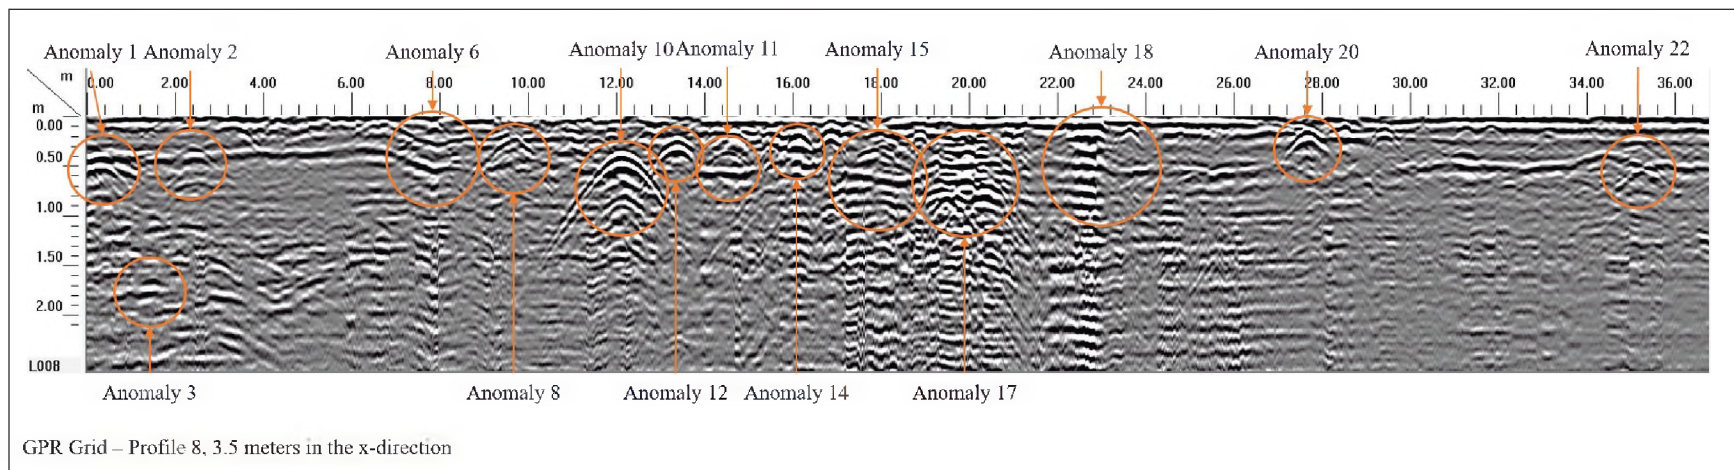
Figure 14.
Example of Probable Graves in Profile

The purpose of this survey was to identify geophysical anomalies consistent with the expected signature for graves. GPR results were based on analysis of the 350 MHz HS data, including individual reflection profiles and amplitude slice maps (Figures 6-13). The anomalies represented distinct contrasts with the adjacent soils and were visible in both plan and profile (Figure 14).
