# **Addendum Report for the Phase I Cultural Resources Survey of Approximately 12 Miles of IMPROVEMENTS ALONG I-85**

CHEROKEE COUNTY, SOUTH CAROLINA

August 8, 2018 • **Revised Draft Report**  
New South Associates Technical Report #2866

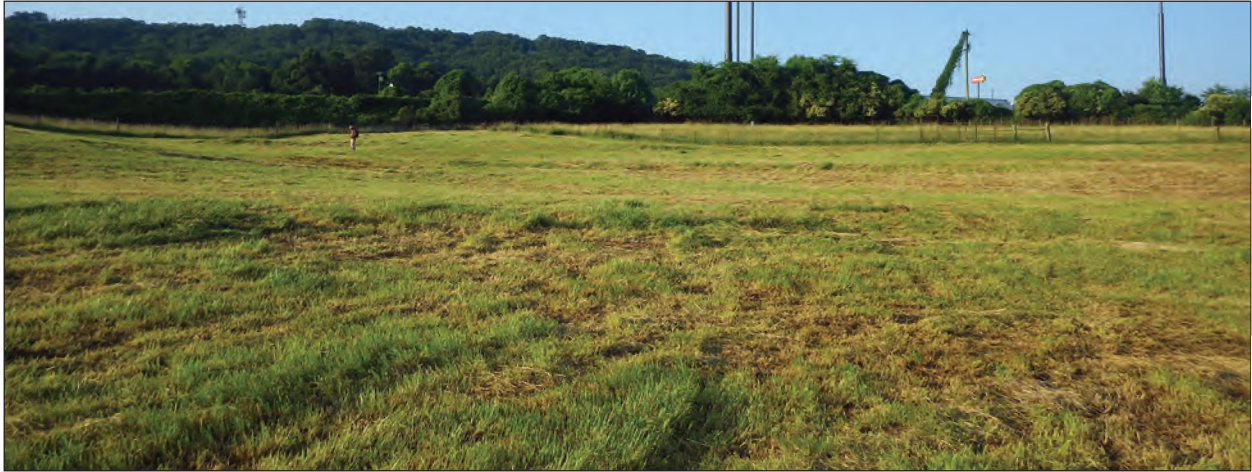
At the SC 83 interchange, the area between White Farm Road and I-85 was a mix of residential development and an undeveloped field. Shovel tests were excavated at 30-meter intervals in areas that were not disturbed by the residential development. There were two shovel test locations placed on either side of Holly Grove Road. However, one was not excavated due to the presence of bulls in the field.

A. Project Area Overview Facing South, Showing Level Grass Pasture near White Farm Road

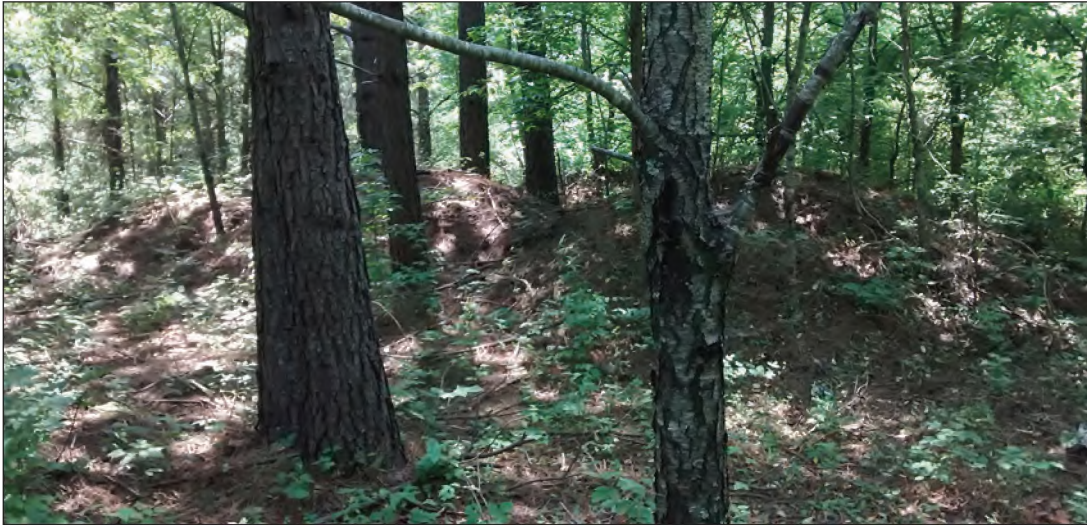
Finally, at the U.S. 29/East Cherokee Street interchange the wooded areas on the northwest and southwest sides of the interchange were sloped and eroded and had visible subsoil at the surface. The area along Wendy Drive was severely eroded and had visible subsoil at the surface. Judgmental shovel testing was performed here.

B. Project Area Overview Facing Southwest, Showing Wooded Area near U.S. 29

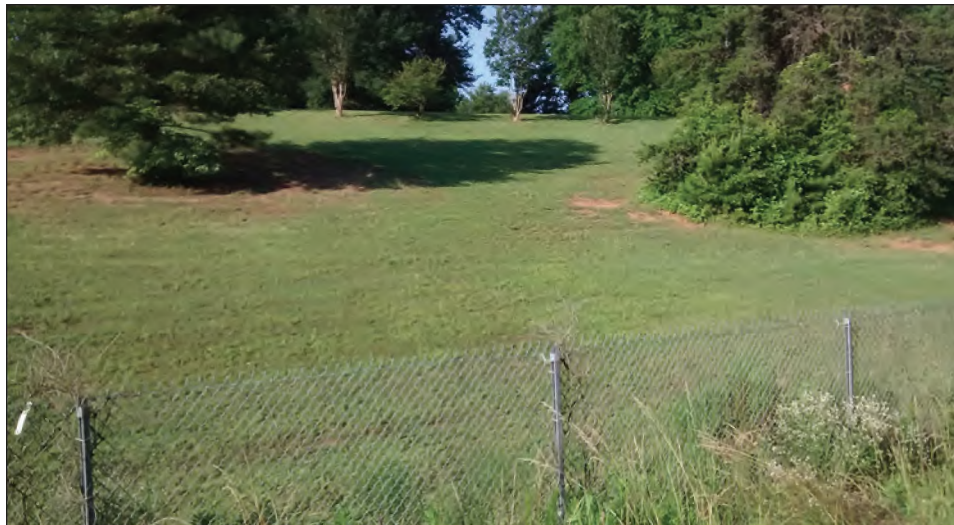
At the area along SC-S-11-73/White Farm Road near the Blacksburg Welcome Center, most of the area along the north side of the road was steeply sloped, eroded, and gullied. The southern side of the road was severely eroded and had subsoil visible at the surface. Judgmental shovel testing was performed here.

C. Project Area  
Overview Showing  
Exposed Subsoil and  
Graded Area near  
Blacksburg Welcome  
Center

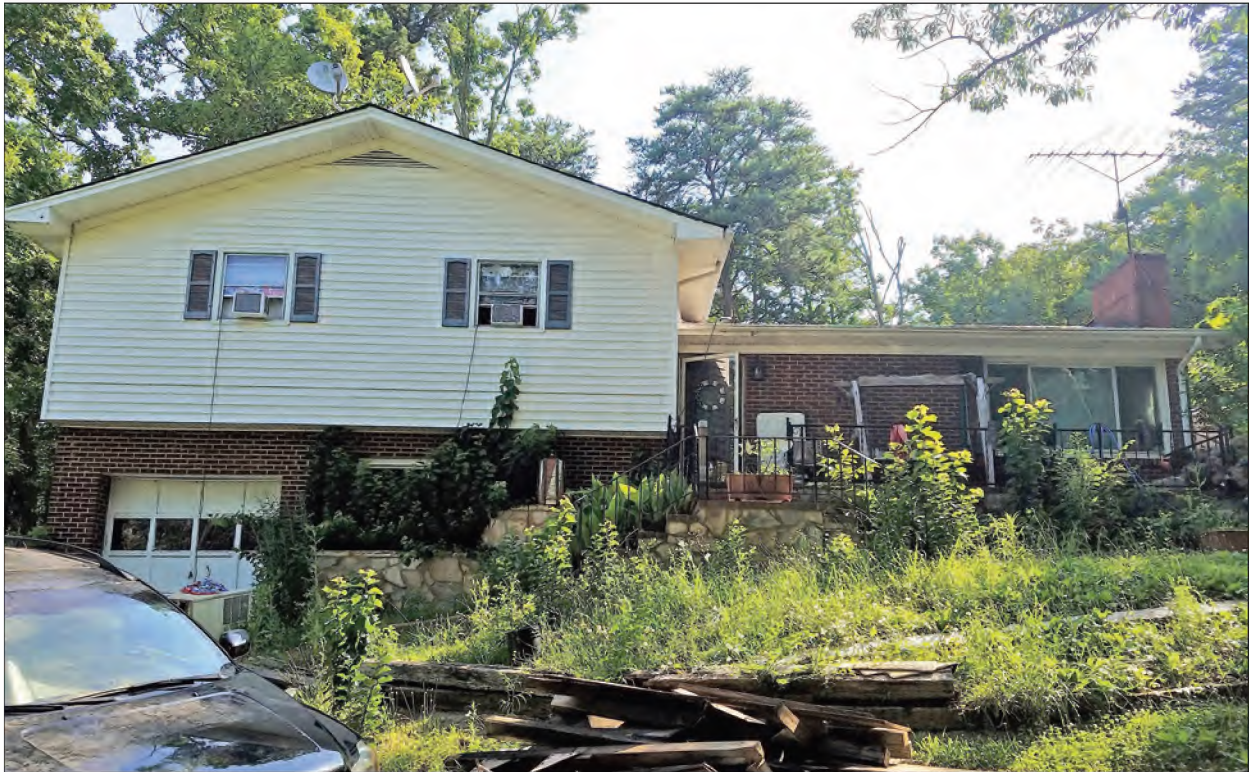
Resource 0272 is located at 856 N. Mountain Street in Blacksburg, South Carolina (Figure 3). It is a split-level house built in 1965. The exterior is clad in brick veneer with vinyl siding located on the upper level façade. The resource has a cross gable with the main roof line running parallel to the street. It has a raised basement on the lower level with a street-facing garage. There is a large brick chimney located on the exterior of the right elevation. The dual front steps, leading to the entry porch, is faced with stone veneer. The porch is partially engaged with decorative metal railings along the perimeter. There is a partial retaining wall in front of the lower level that is also faced with stone veneer. The windows are two-over-two double hung sash windows with aluminum casing. There is a large picture window flanked by two large single pane windows on the right bay.

A. Front Elevation

The resource was not found to embody a distinctive characteristic of a type, period, or method of construction. It also does not represent the work of a master or possess high artistic value. The resource has also been slightly altered which has changed the appearance of the building. It is not known to be associated with events or persons significant in the past. Therefore, the resource is recommended as not individually eligible for the NRHP under Criteria A, B, or C.

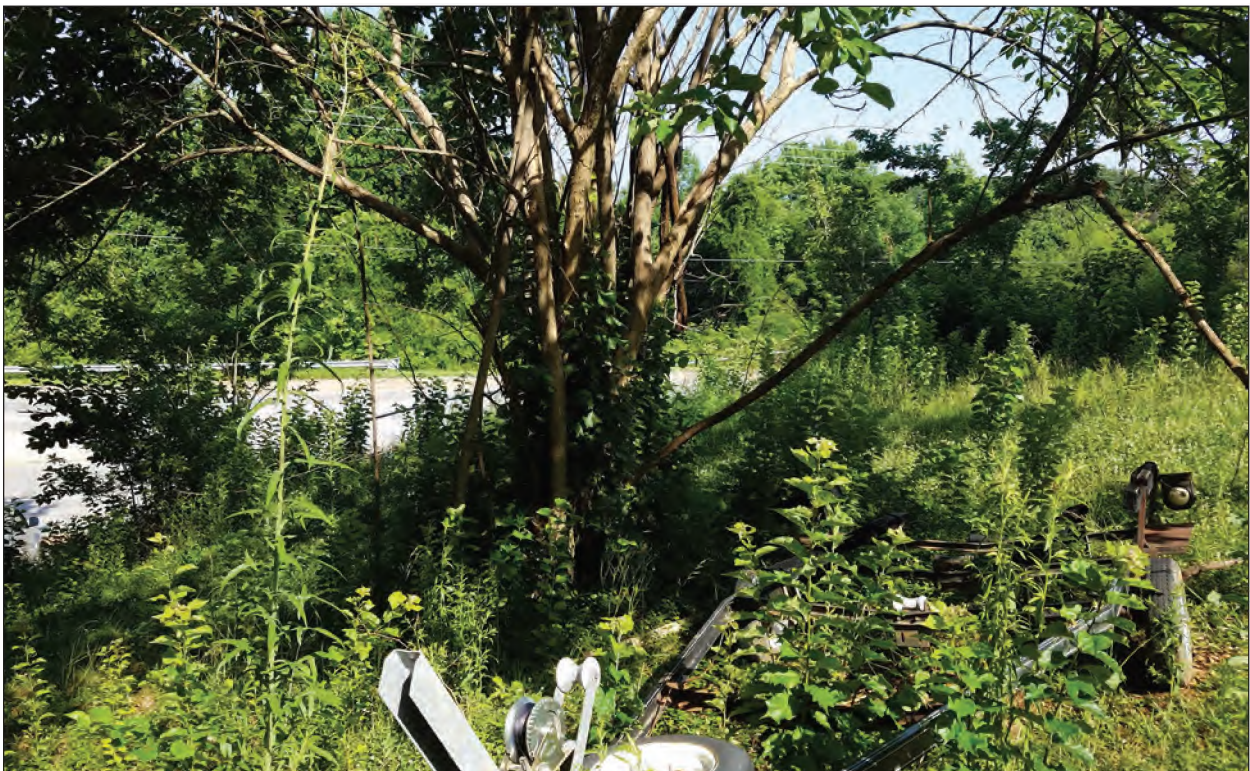
The resource is located within the APE on a small rise and faces southwest along N. Mountain Street (Figure 3). The lot is partially wooded and has an unmaintained landscape. There is a small cement block shed located on the property that is not historic and therefore not considered a contributing part to this resource.

B. View West towards North Mountain Street
