**PHASE I CULTURAL RESOURCE SURVEY OF THE PROPOSED  
US 1 BRIDGE REPLACEMENT OVER I-20 AND INTERCHANGE  
IMPROVEMENTS, LEXINGTON COUNTY, SOUTH CAROLINA**

**REVISED DRAFT REPORT**

**JUNE 2019**

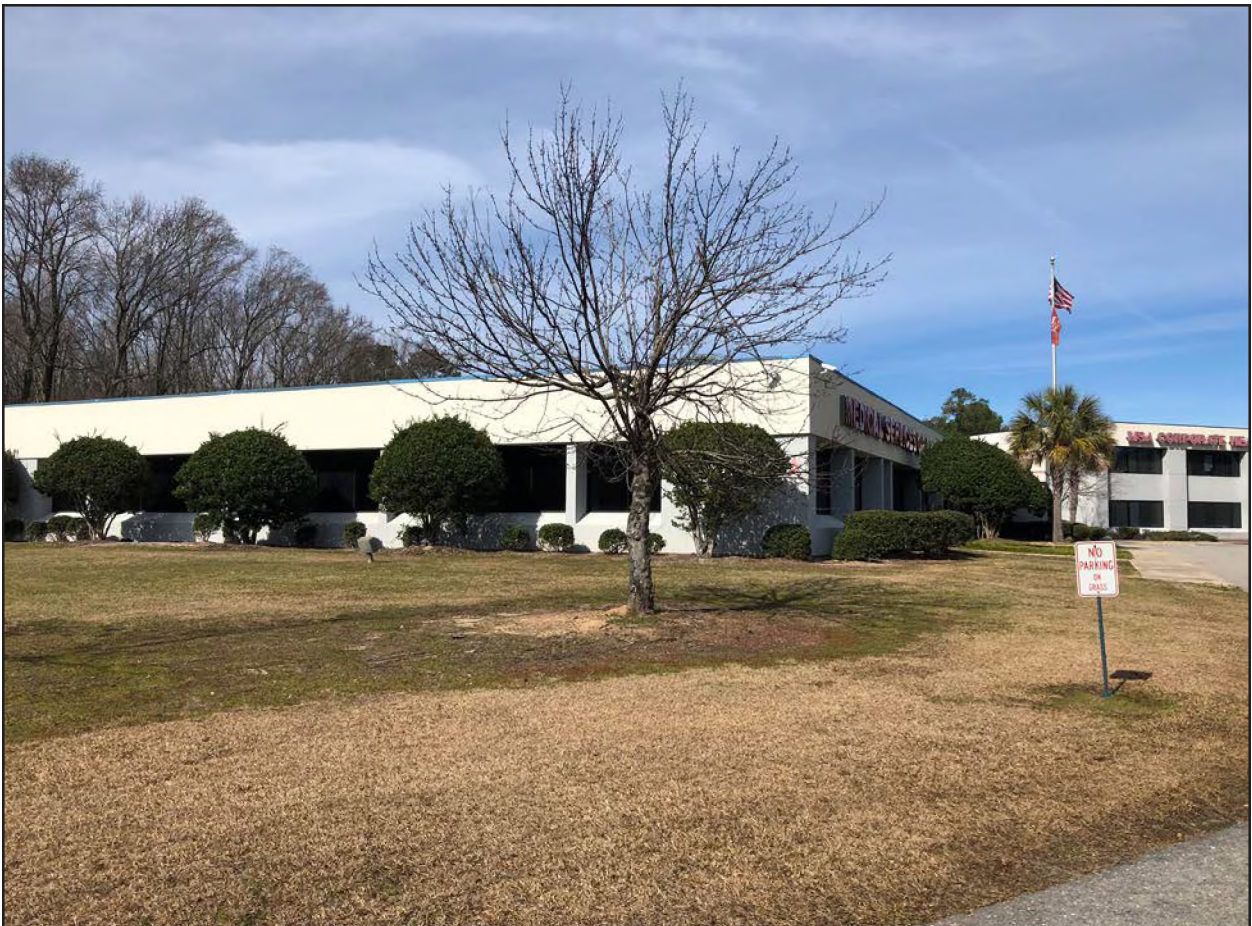
**Figure 4.2.** Photograph of 38LX198, facing northwest.

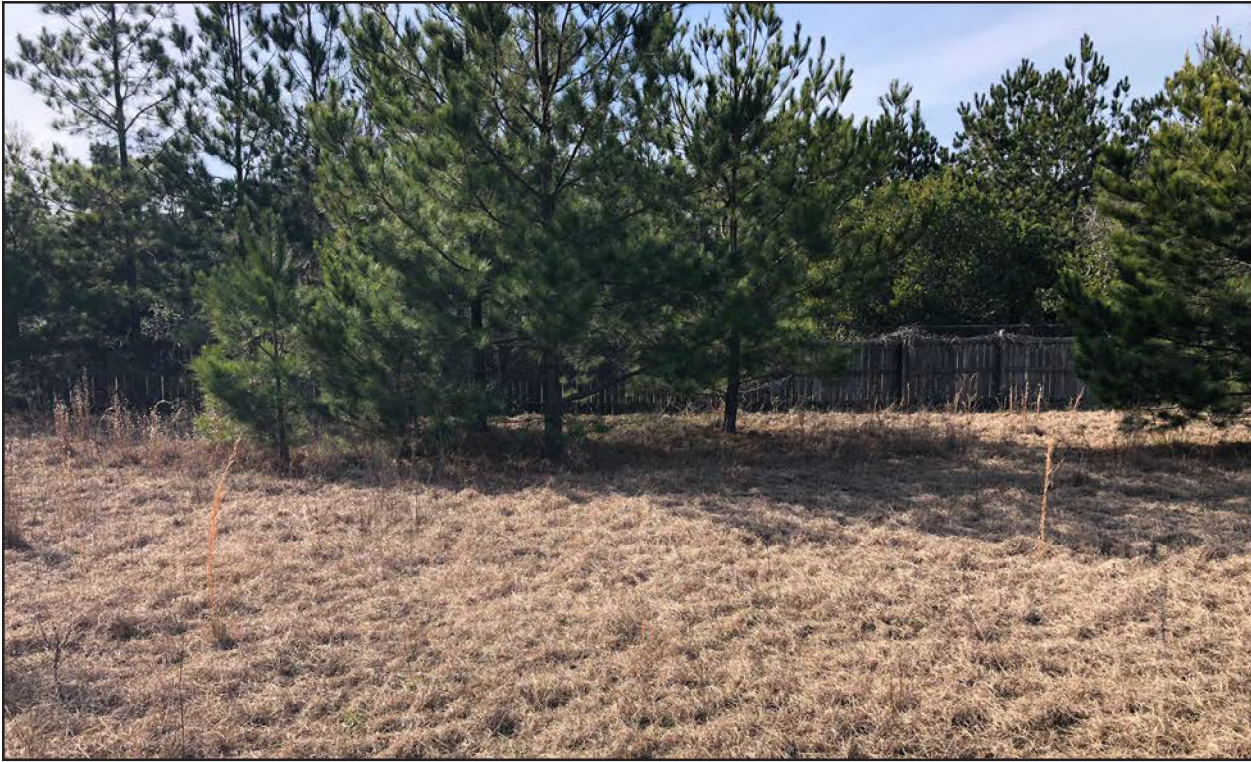
**Figure 4.3.** Photograph of 38LX644, facing west.

additional deposits or features that would change that evaluation. Figure 4.3 shows the current state of 38LX644.

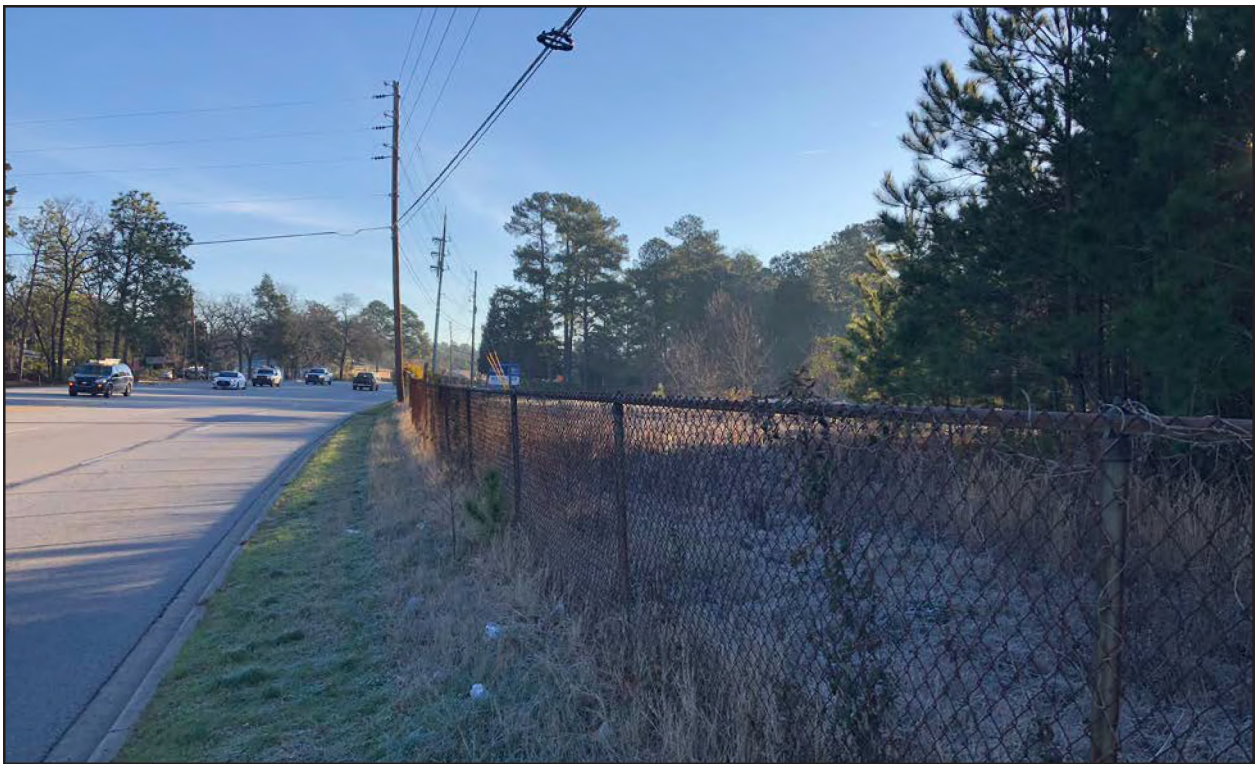
**Figure 4.4.** Photograph of 38LX671, facing east.

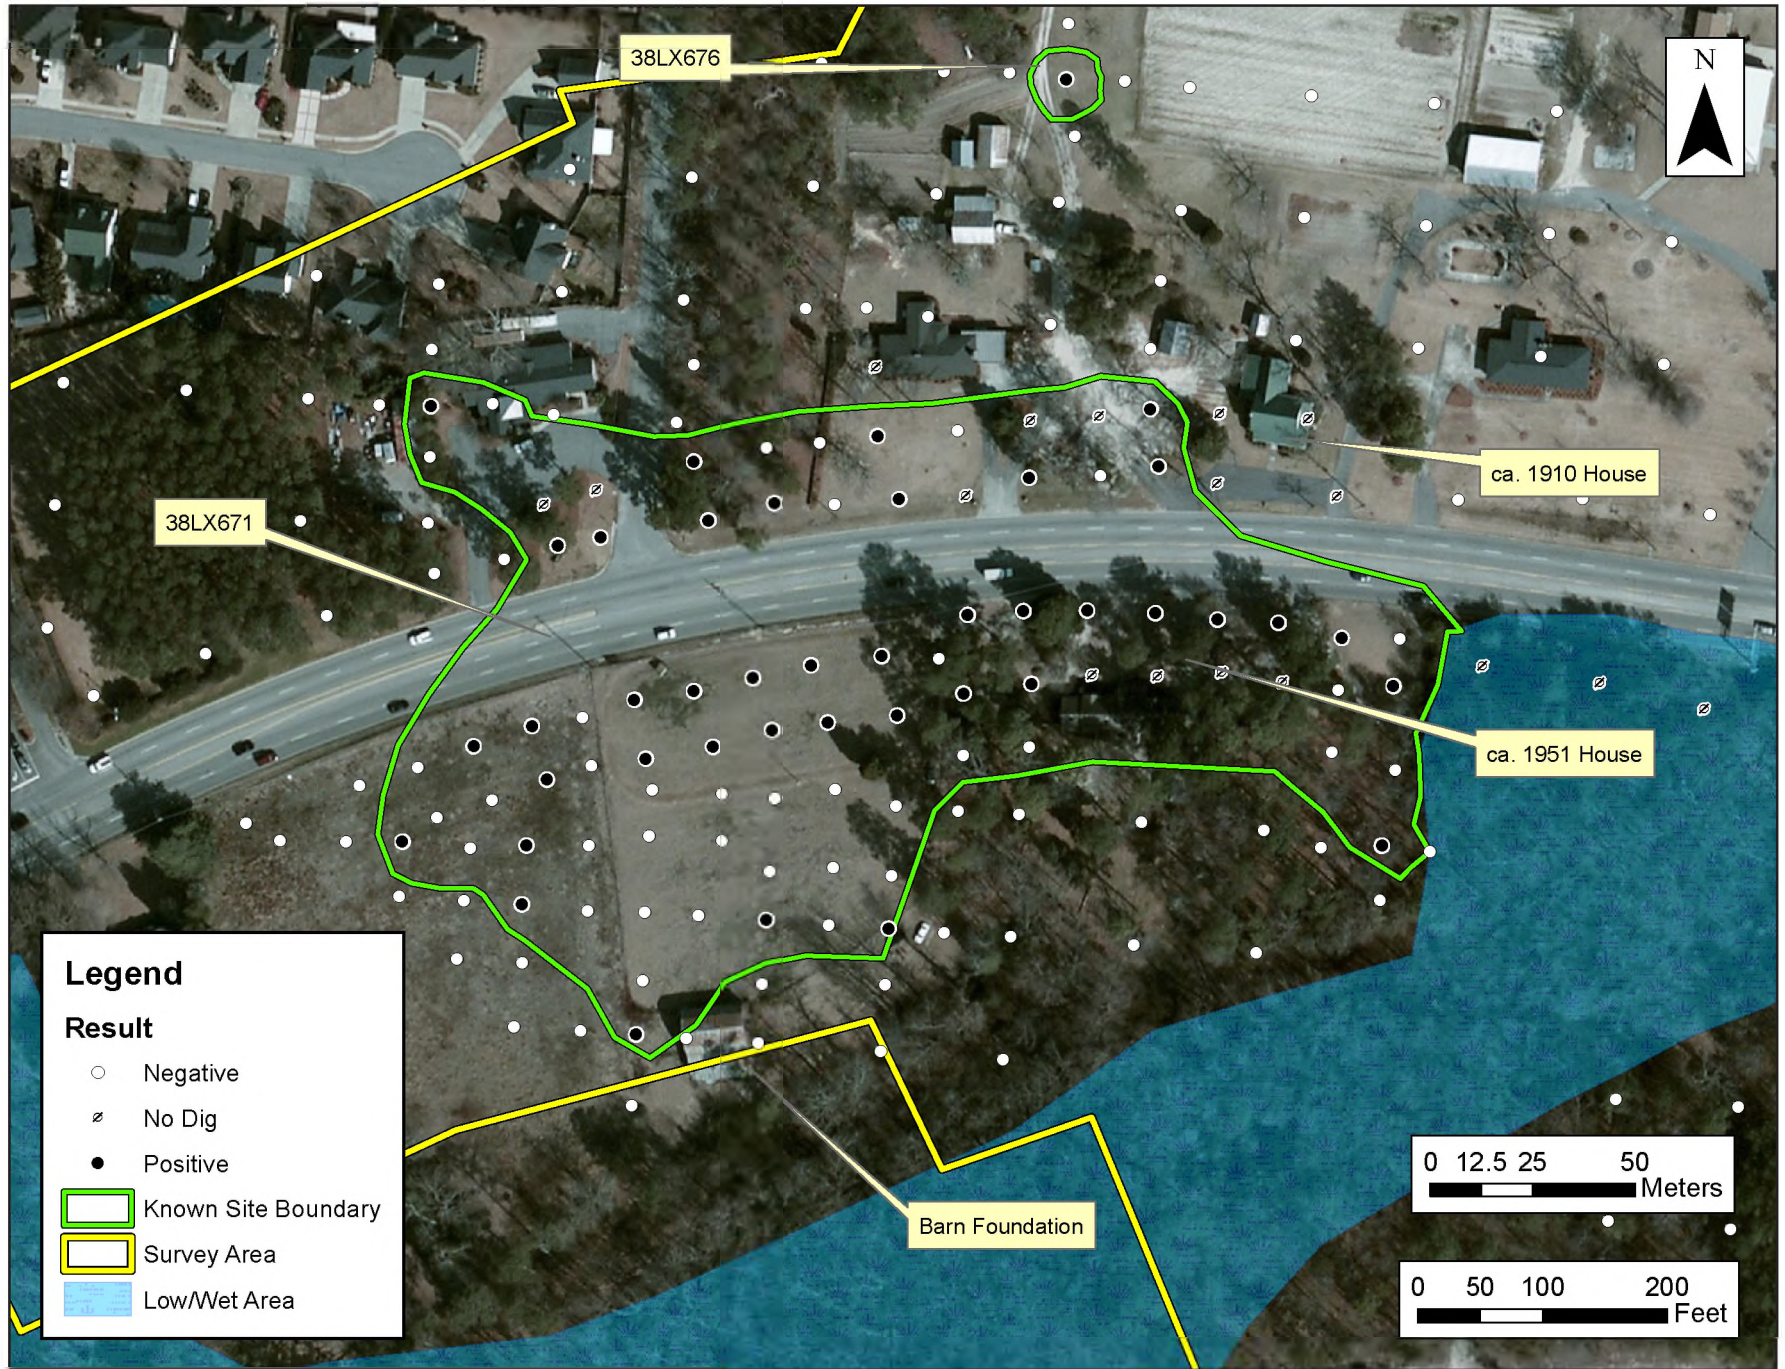
Figure 4.5. 38LX671 site map.

There were 286 artifacts recovered from shovel tests at 38LX671 (see Appendix A). The assemblage included both historic (n=31) and precontact (n=255) material. The historic assemblage was limited to five shovel tests and a small surface scatter within the extreme eastern, western, and southern portions of the site. The vast majority of this historic assemblage was concentrated in the eastern portion and corresponds with two residential lots on either side of US 1. Twelve historic artifacts were identified within TR0.5ST11.5 and a small surface scatter at 5070 Augusta Road (Figure 4.6). These artifacts included a fragment of an aqua glass mason jar from within the shovel test and aqua glass (n=2), clear bottle glass (n=1), light green bottle glass (n=1), and light pink table glass (n=1), and a milk glass lid liner was recovered from the ground surface. There were also several historic ceramics discovered in the surface scatter including unglazed earthen ware (n=1), a whiteware strap handle, undecorated porcelain (n=1), undecorated whiteware (n=2), and undecorated ironstone (n=1). This lot corresponds with a ca. 1910 structure that is currently used as office space. This structure is discussed in greater detail in Chapter 5. The clear bottle glass fragment identified within the surface scatter was determined to be a fragment of a possible cork top bottle type typically associated with the early twentieth century (SHA 2013). Furthermore, the aqua glass mason jar fragments were of a style of jar made between the 1890s and 1937 (SHA 2013). Based on this assemblage, it seems that the historic material within this portion of 38LX671 is representative of the early occupation of the structure at 5070 Augusta Road.

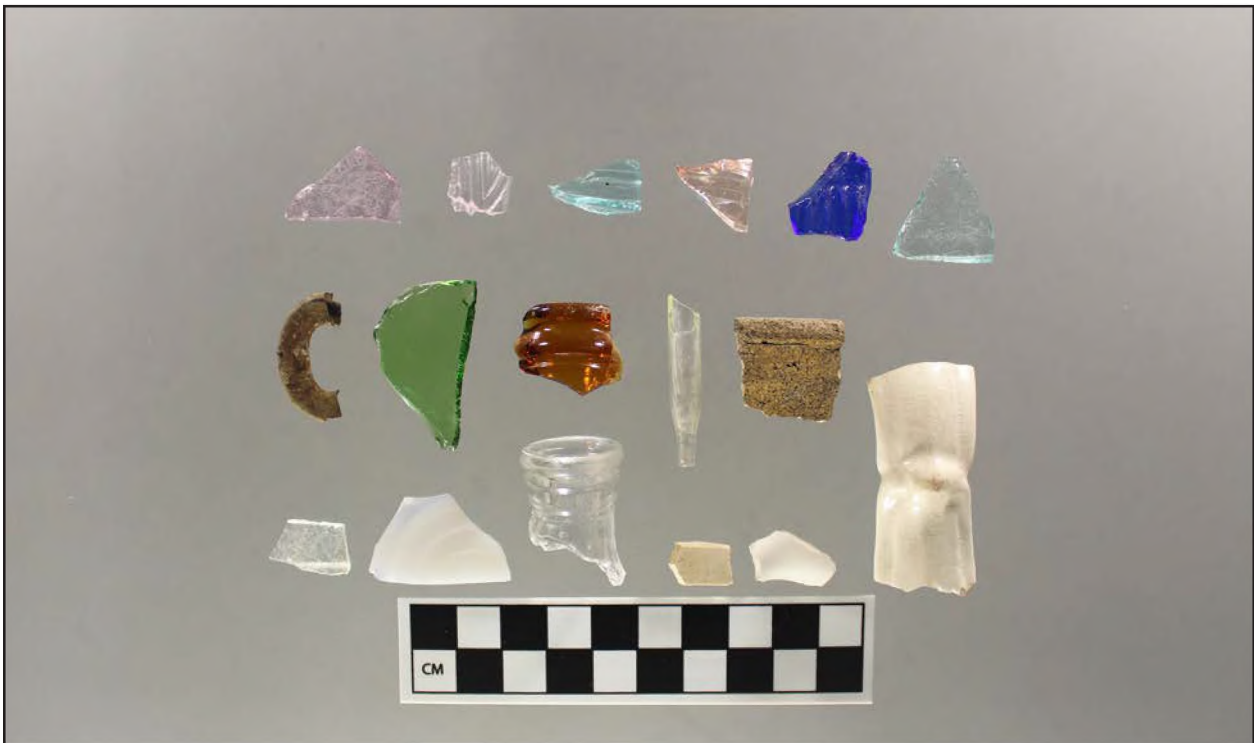
**Figure 4.6.** Top, left to right - amethyst (solarized) bottle glass (TR1ST11.5-4), amethyst (solarized) container glass (TR4ST4-4), aqua jar glass (TR0.5ST11.5-3), light pink table glass (GSC2-9), cobalt blue container glass (TR1ST11.5-5), light green bottle glass (GSC2-8); Middle, left to right - unclassified alloy unclassified object (TR1ST11.5-7), green bottle glass (TR4.5ST4-6), amber bottle glass (TR4.5ST4-7), light green glass dropper (TR4.5ST4-3), coarse unglazed earthenware (GSC2-2); Bottom, left to right - clear window glass (TR1ST11.5-6), milk glass lid liner (GSC2-5), clear bottle glass finish (GSC2-6), undecorated ironstone (TR1ST11.5-3), undecorated porcelain fragment (GSC2-4), whiteware strap handle (GSC2-3).

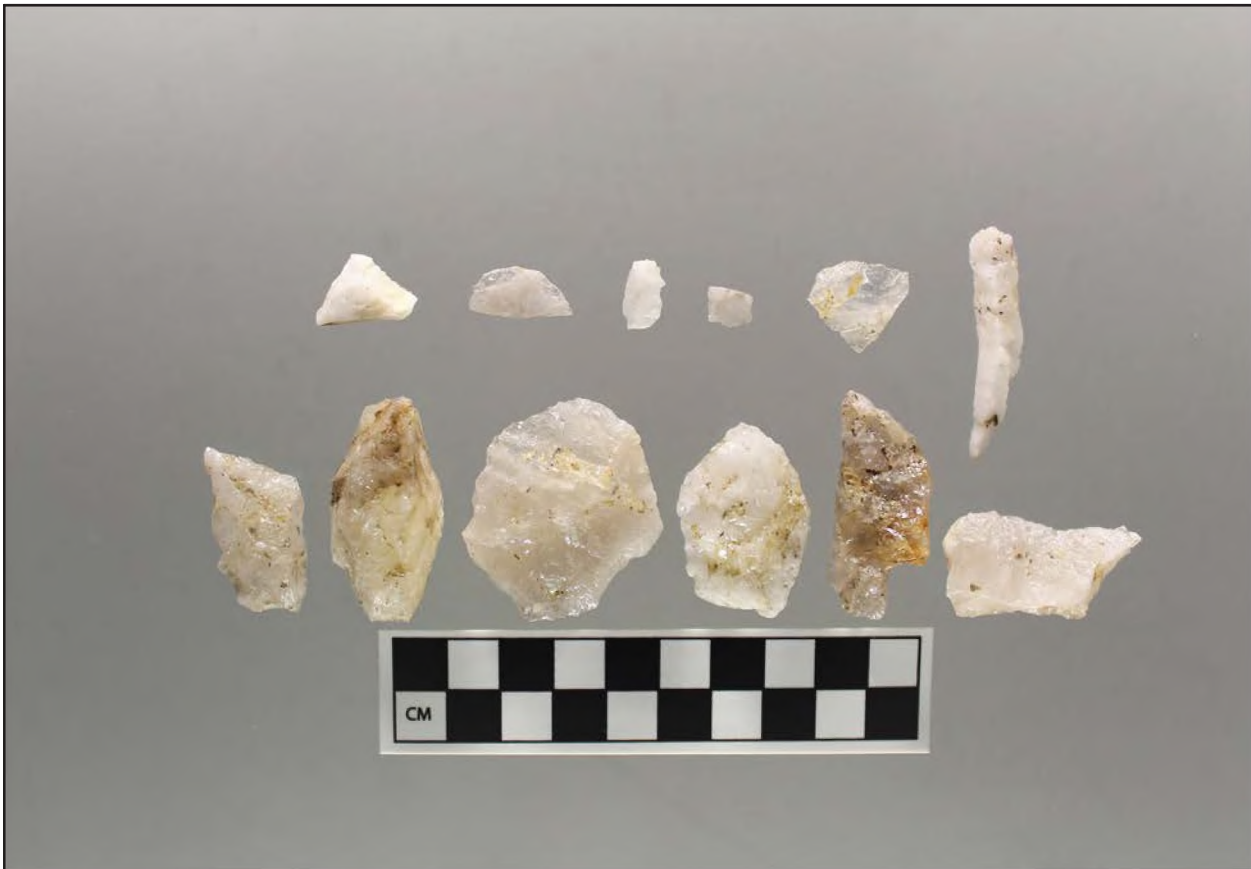
The vast majority of the assemblage (n=255) at 38LX671 was associated with precontact occupation of the site. This material consisted entirely of lithic artifacts of quartz (Figure 4.7). Most of

**Figure 4.7.** Top, left to right - quartz shatter (TR3.5ST5-3), quartz thinning flake (TR4ST0.5-4), quartz flake fragment (TR3.5ST5-2), quartz pressure flake (TR4ST0.5-3), quartz retouched flake (TR4ST0.5-2), quartz blade flake (TR4ST1-1); Bottom, left to right - quartz biface fragment (TR3.5ST7-1), quartz biface fragment (TR3.5ST4.5-1), quartz stage II biface (TR3.5ST7.5-1), quartz stage II biface (TR4ST0.5-1), quartz biface fragment (TR3.5ST5-1), quartz biface fragment (TR3ST6.5-1).

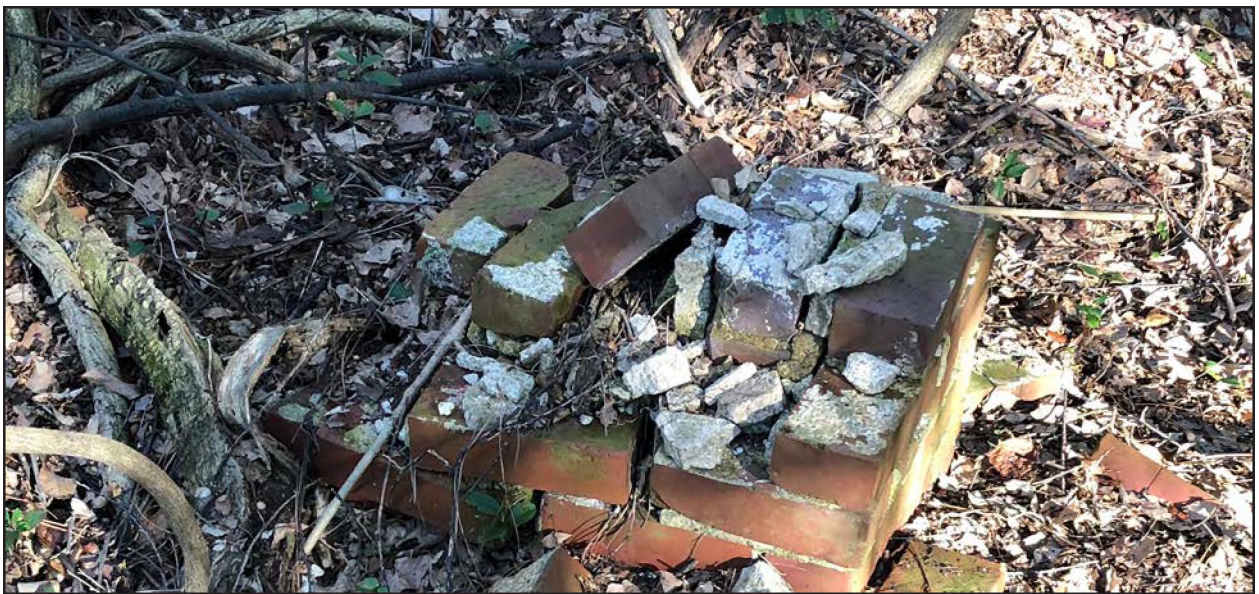
Site 38LX672 was encountered within the northwestern quadrant of the US 1/I-20 interchange, immediately north of the service road (see Figure 4.1). The site represents the location of a house that once stood at the corner of US 1 and Monroe Lane. Extant remains of the house are still present at 38LX672 and include several brick and stone piers, concrete steps, and the remains of a collapsed roof (Figures 4.8 and 4.9). There was also a brick-lined, rectangular septic tank located just west of the remains of the structure (Figure 4.10). The current site setting is characterized by dense forest, which has grown around the collapsed structure.

**Figure 4.8.** Photograph of structural piers at 38LX672, facing north.

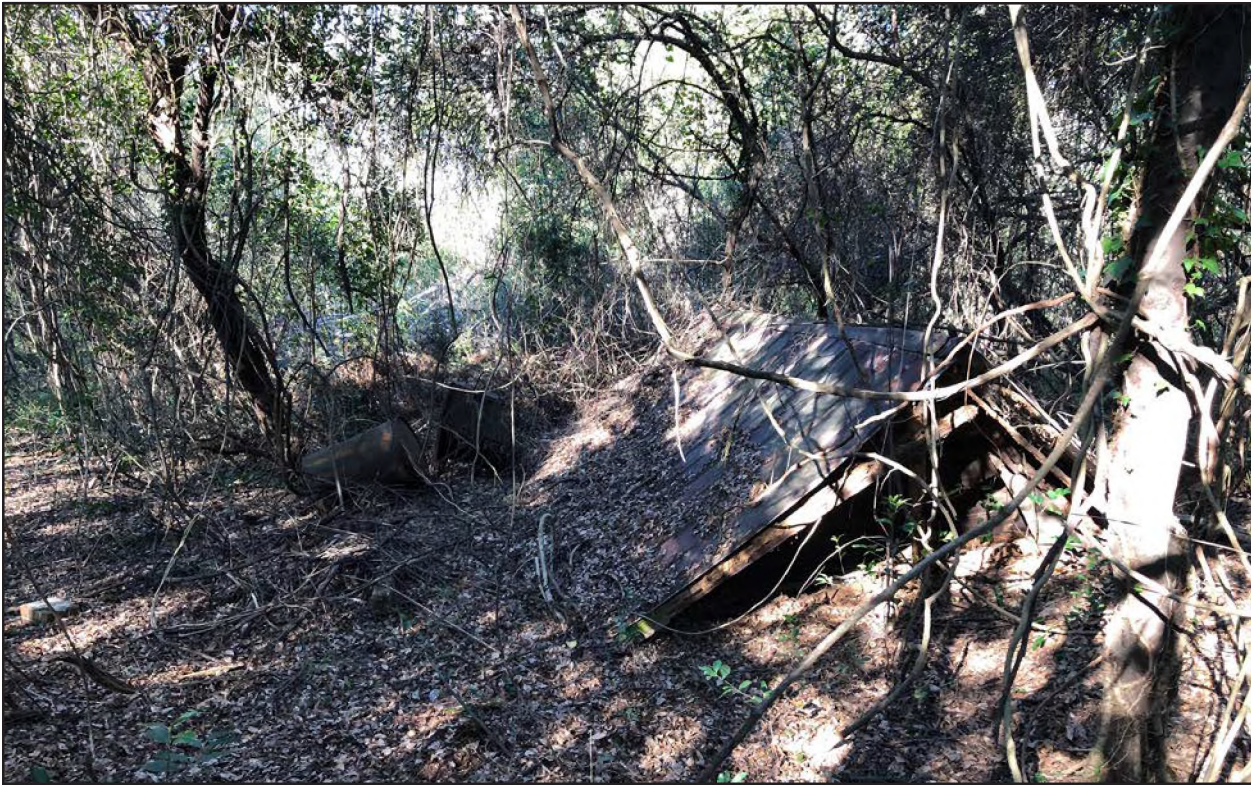
**Figure 4.9.** Photograph of collapsed roof at 38LX672, facing north.

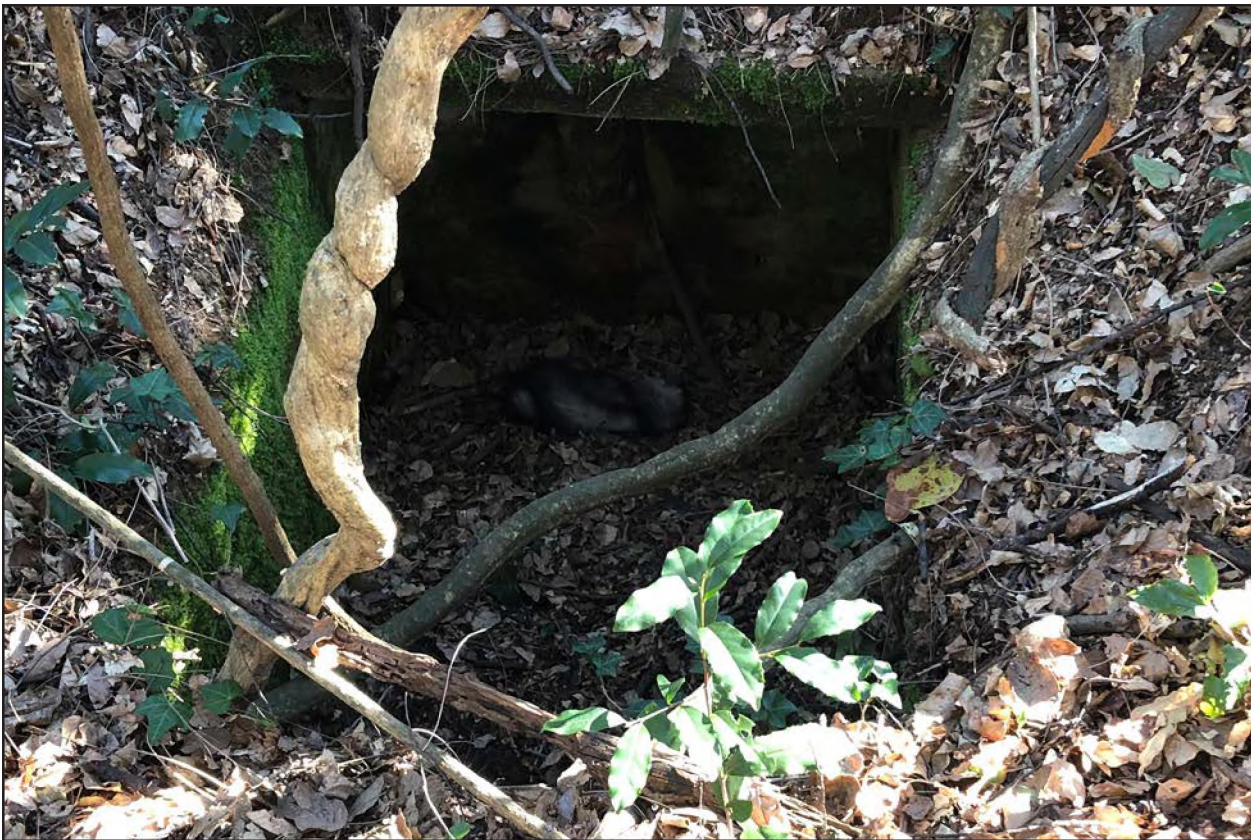
**Figure 4.10.** Photograph of brick lined septic tank at 38LX672, facing east.

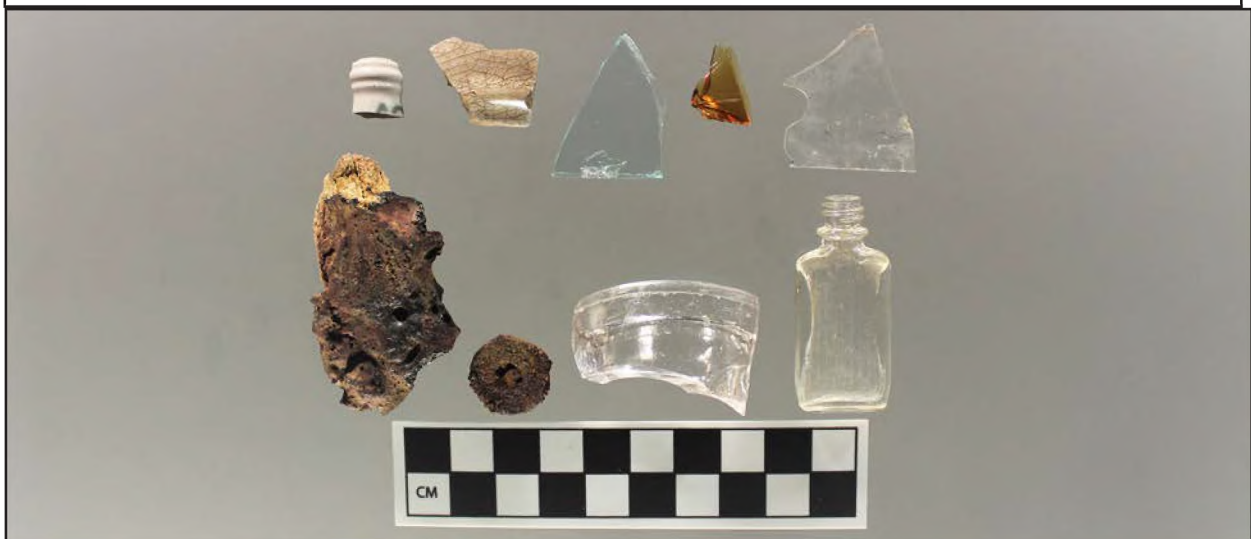
**Figure 4.12.** Top, left to right - porcelain spark plug insulator (TR2ST5-4), undecorated whiteware (TR2ST5-1), aqua container glass (TR2.5ST3-4), amber container glass (TR2.5ST3-5), clear window glass (TR2ST5-2); Bottom, left to right - burned/melted brick (TR2ST3-3), iron button (TR2.5ST4.5-2), clear milk bottle glass (TR2ST3-2), clear perfume bottle glass (TR2ST3-1), amethyst (solarized) container glass (TR32ST1-1).

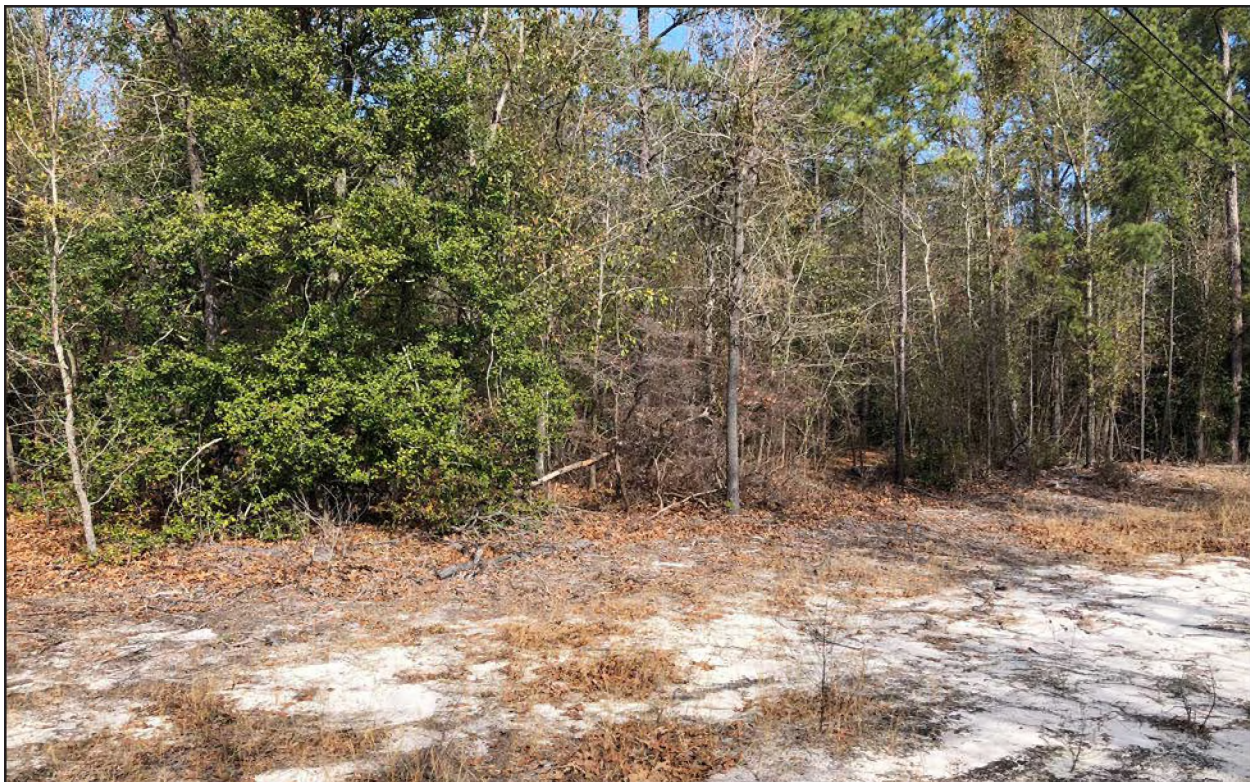
Site 38LX673 was identified in the northwestern quadrant of the US 1/I-20 interchange on the eastern slope of a broad landform overlooking the headwaters of an unnamed tributary of Twelvemile Creek (see Figure 4.1). The site is located in an undeveloped wooded lot, characterized by mixed pine and oak canopy with an understory of blackberry and briars (Figure 4.13).

**Figure 4.13.** Photograph of 38LX673, facing west.

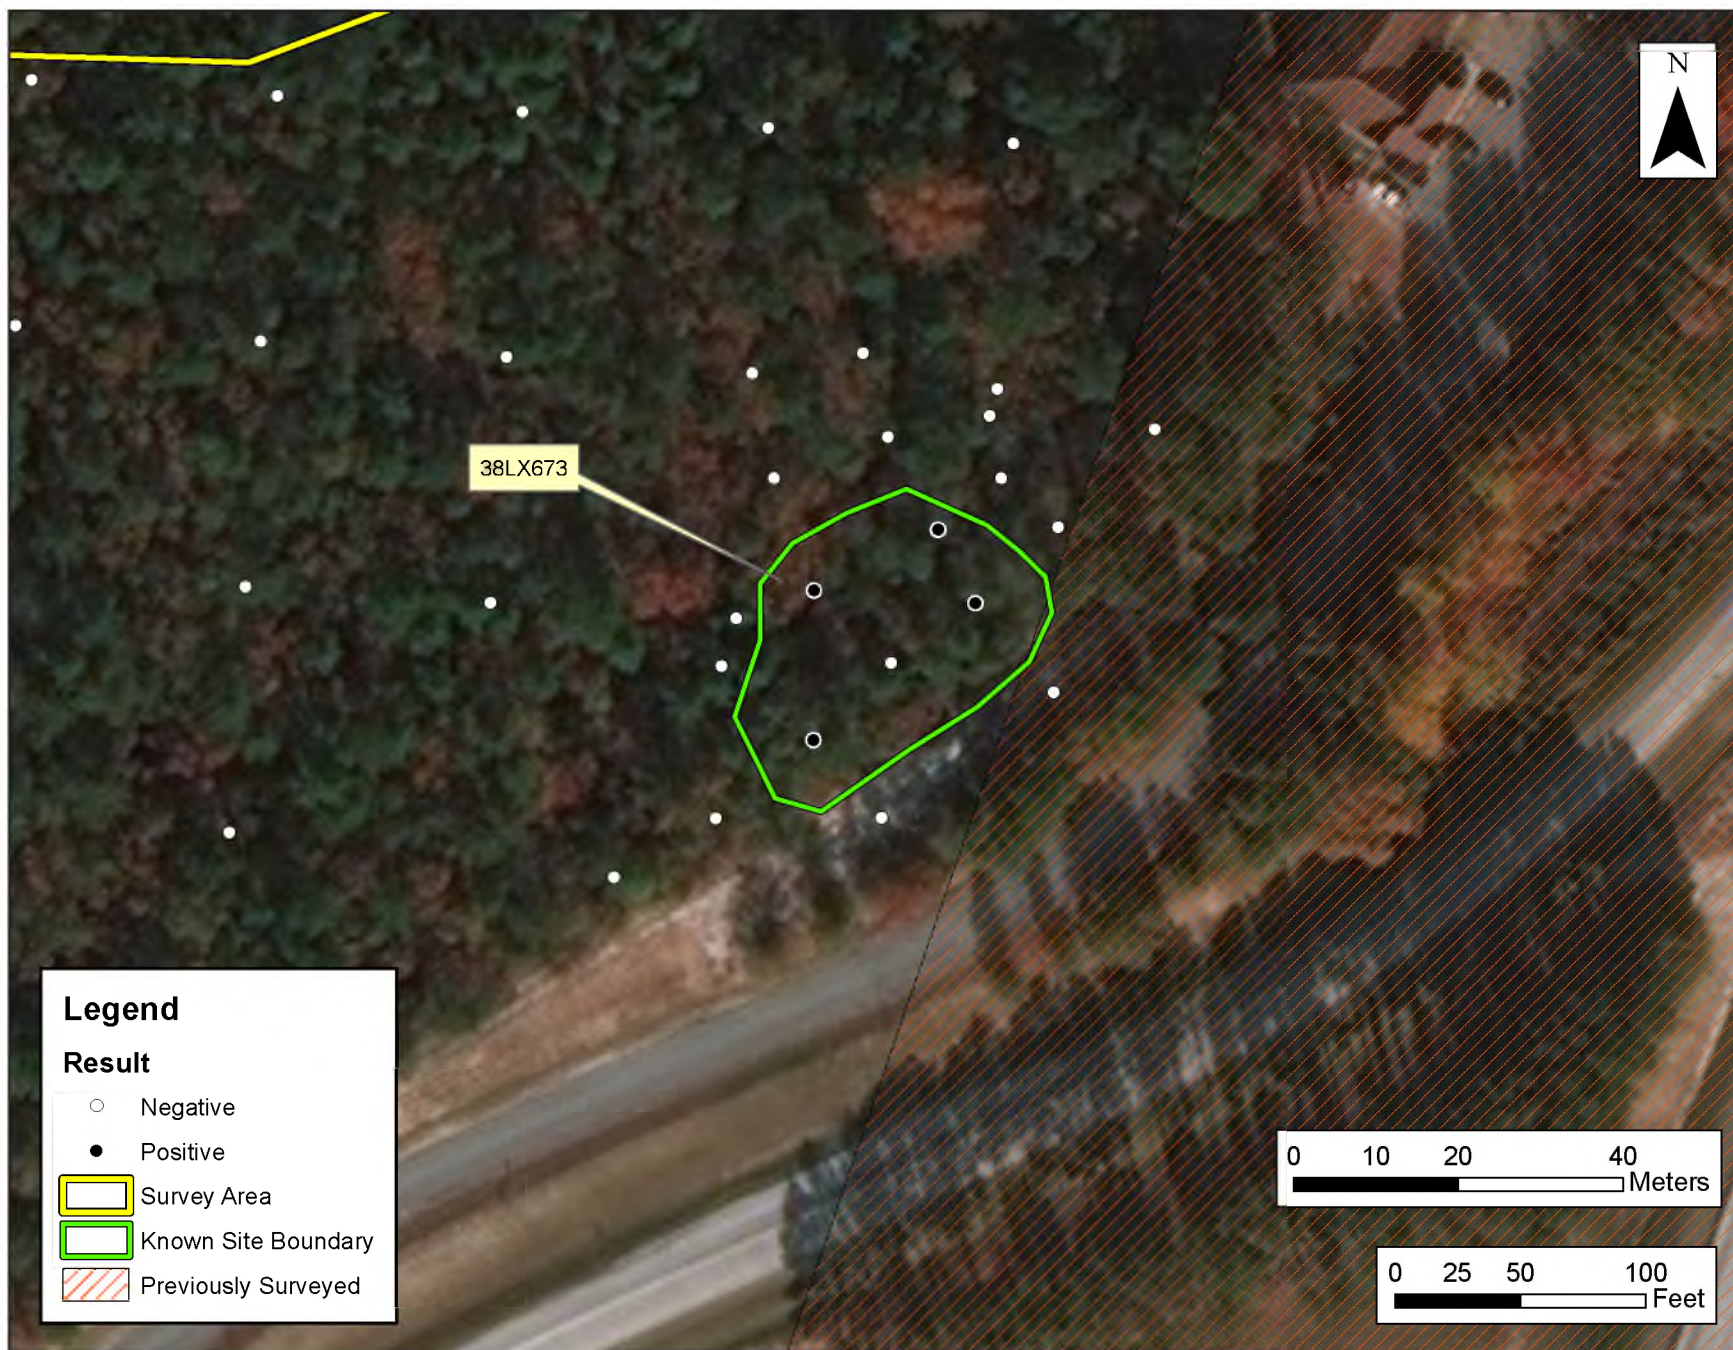
Figure 4.14. 38LX673 site map.

Site 38LX673 measures 41-x-13 meters and is oriented along a roughly northeast to southwest axis. Twelve shovel tests were dug to determine the boundaries of 38LX673, including four that were positive and eight that were negative (Figure 4.14). The typical soil profile at 38LX673 was made up of two strata: Stratum I (0 to 10 centimeters), a grayish brown (10YR 5/2) humic sand and Stratum II (10 to 80 centimeters), a yellowish brown (10YR 5/6) fine sand. Artifacts were recovered between 0 and 60 centimeters below surface and there were between 1 and 7 artifacts per positive shovel test.

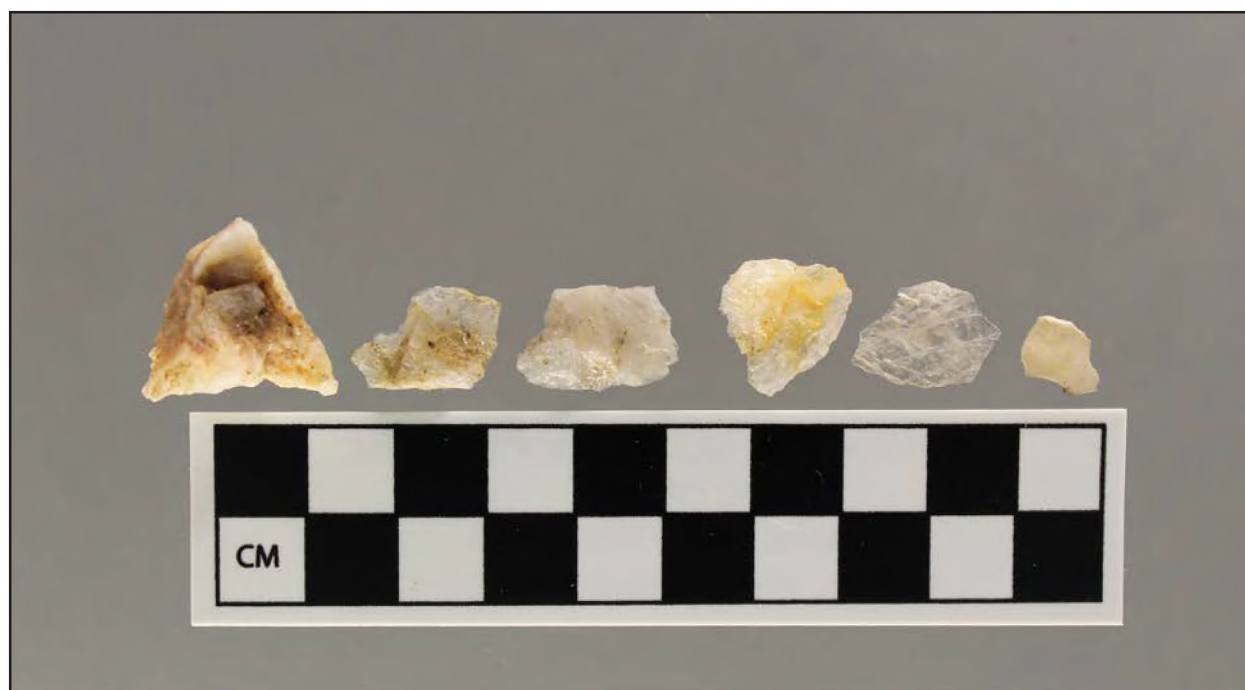
**Figure 4.15.** Left to right - quartz flake fragment (TR2ST12-1), quartz flake fragment (TR2ST3-2), quartz flake fragment (TRAST13-3), quartz thinning flake (TR2ST3-1), quartz thinning flake (TRAST13-2), CPC pressure flake (TRAST13-1).

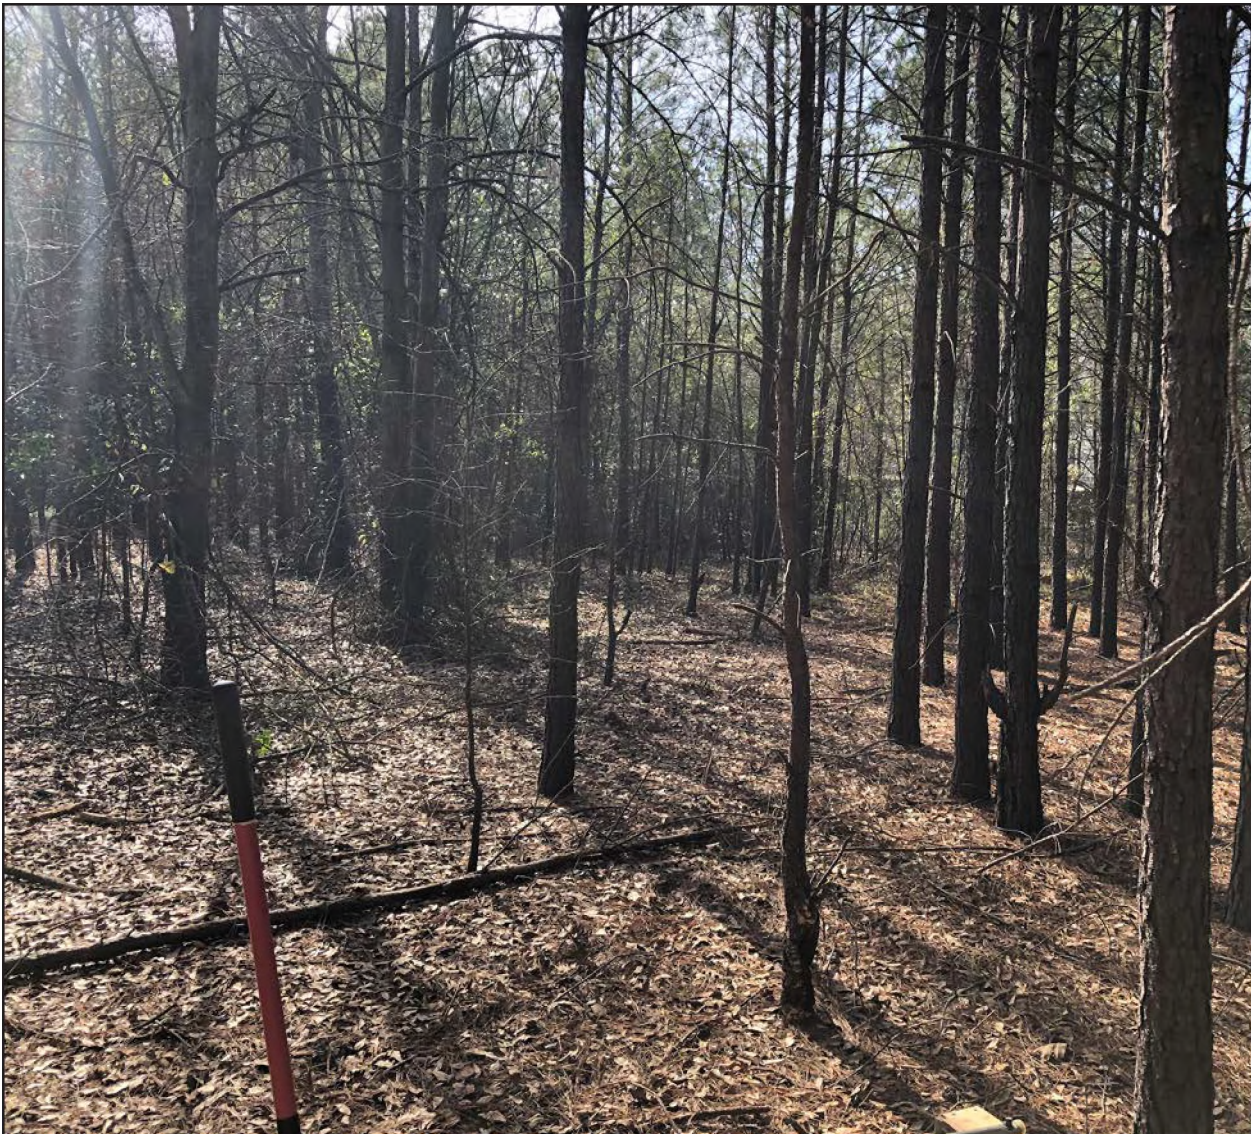
**Figure 4.16.** Photograph of 38LX674.

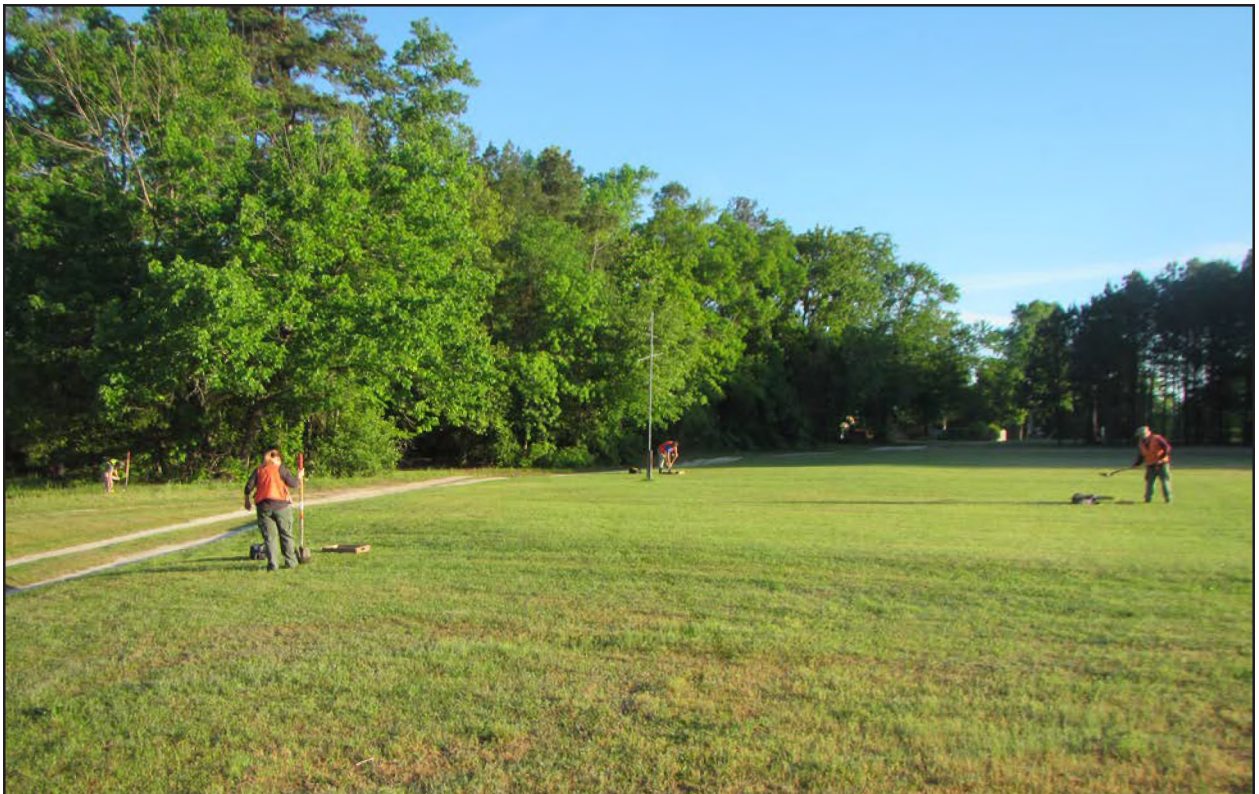
Site 38LX676 was identified in the northwestern quadrant of the US 1/I-20 interchange on the southwest slope of a large landform overlooking an unnamed drainage of Twelvemile Creek (Figure 4.1). The site was identified in a fallow field that appears to be seasonally used as a garden plot (Figure 4.19). 38LX676 is located within the residential lot at 5084 Augusta Road, which features a house that was built in 1951 and associated outbuildings.

**Figure 4.19.** Photograph of 38LX676.

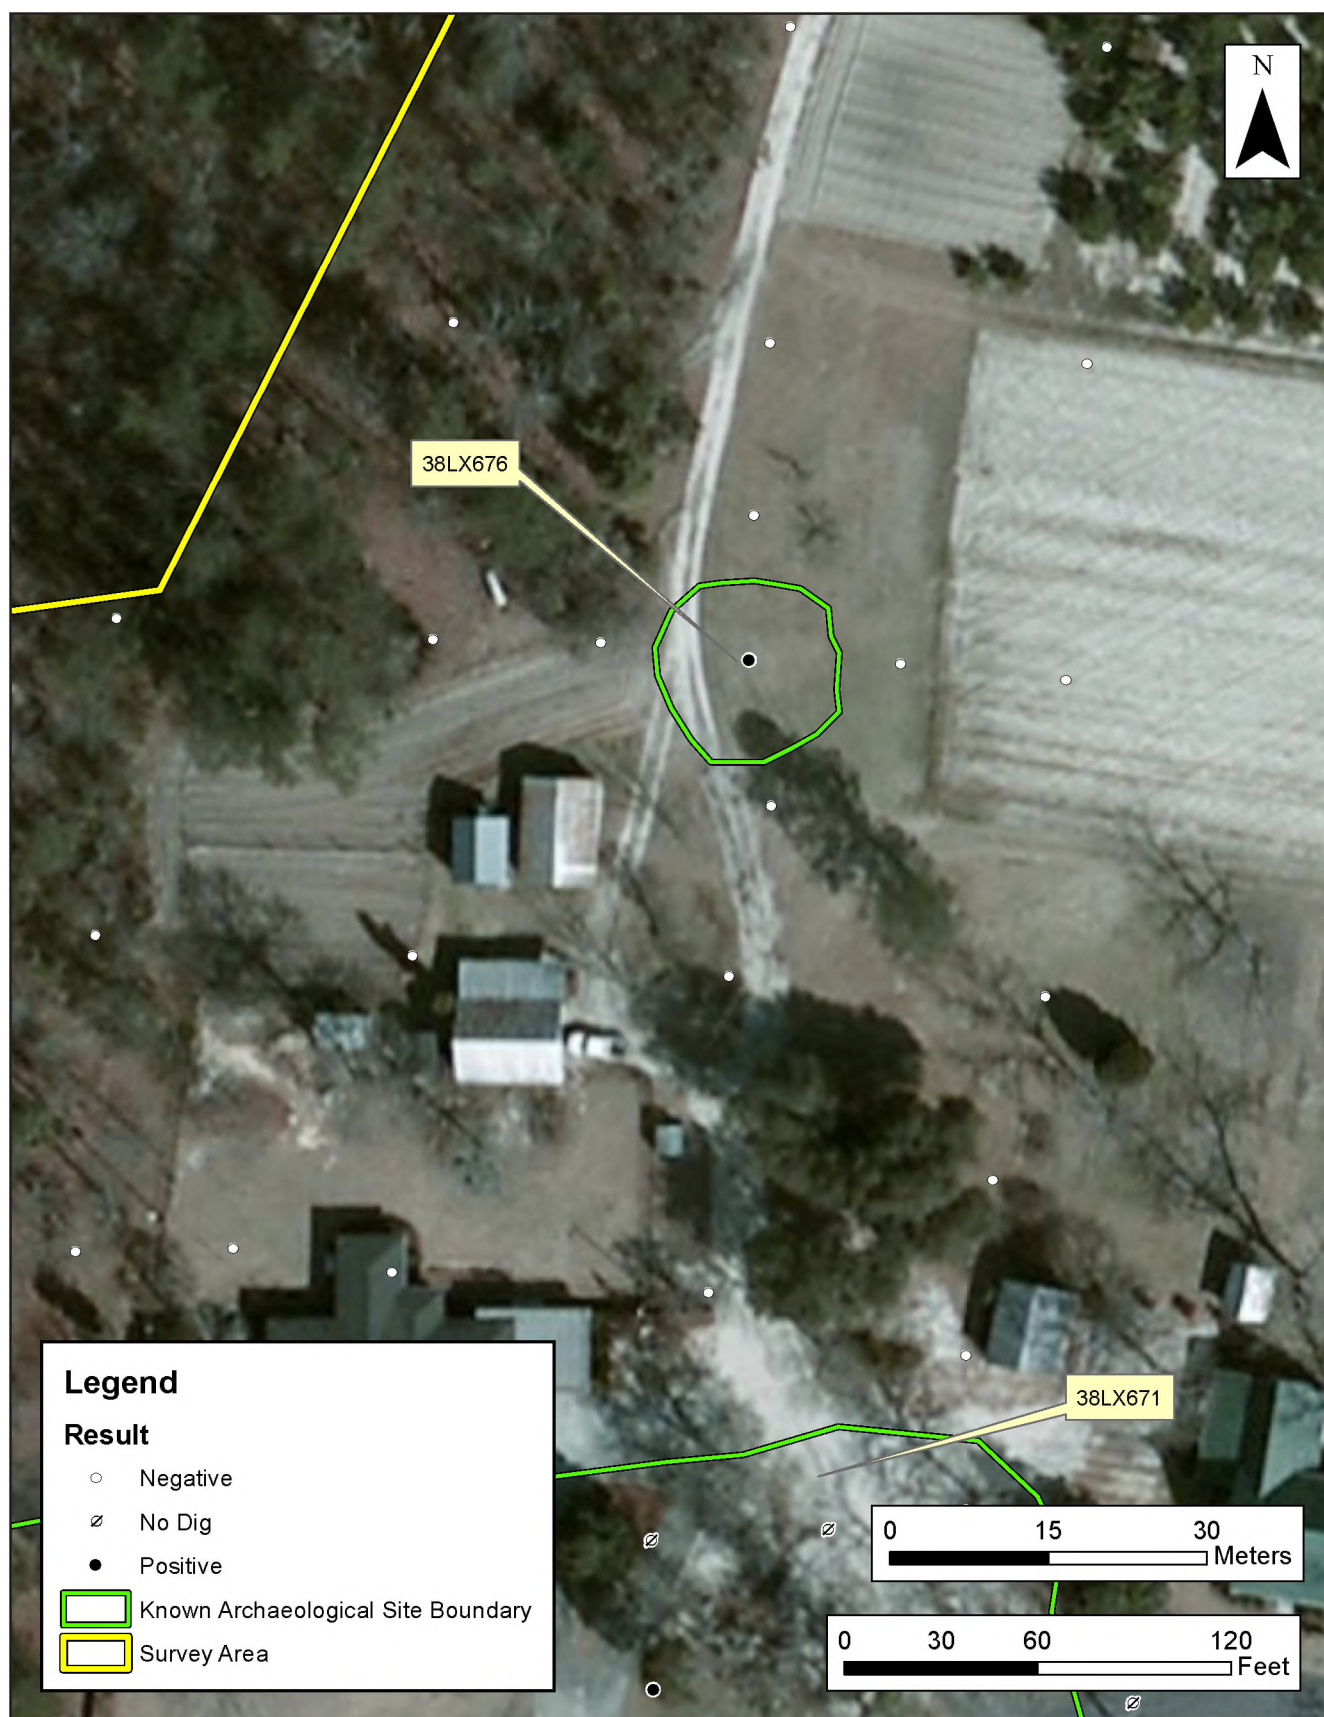
Figure 4.20. 38LX676 site map.

The boundaries of 38LX676 measure 15-x-15 meters in size around a single positive shovel test. Nine shovel tests were dug to determine the boundaries of 38LX676, including one positive and eight negatives (Figure 4.20). The stratigraphic sequence at 38LX676 consisted of three strata: Stratum I (0 to 20 centimeters), a grayish brown (10YR 5/2) humic sand; Stratum II (20 to 60 centimeters), a yellowish brown (10YR 5/6) fine sand; and Stratum III (60 to 80 centimeters), a pale brown (10YR 6/3) fine sand. Artifacts were recovered from between 10 and 20 centimeters below ground surface, a zone which corresponds with Stratum I, which was interpreted as the plow zone.

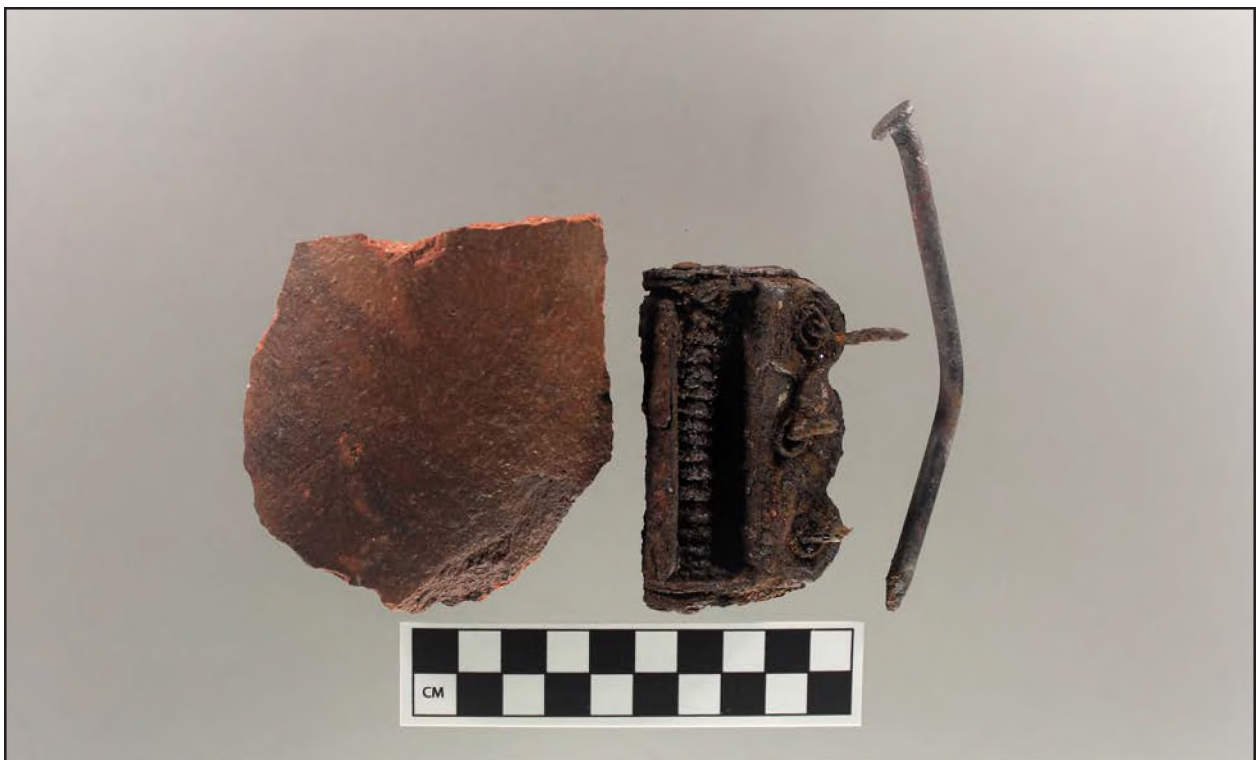
**Figure 4.21.** Left to right - terra cotta sewer pipe (TR19ST3-3), iron spring hinge (TR19ST3-1), iron wire nail (TR19ST3-2).
