**PHASE I CULTURAL RESOURCE SURVEY OF THE PROPOSED  
US 1 BRIDGE REPLACEMENT OVER I-20 AND INTERCHANGE  
IMPROVEMENTS, LEXINGTON COUNTY, SOUTH CAROLINA**

**REVISED DRAFT REPORT**

**JUNE 2019**

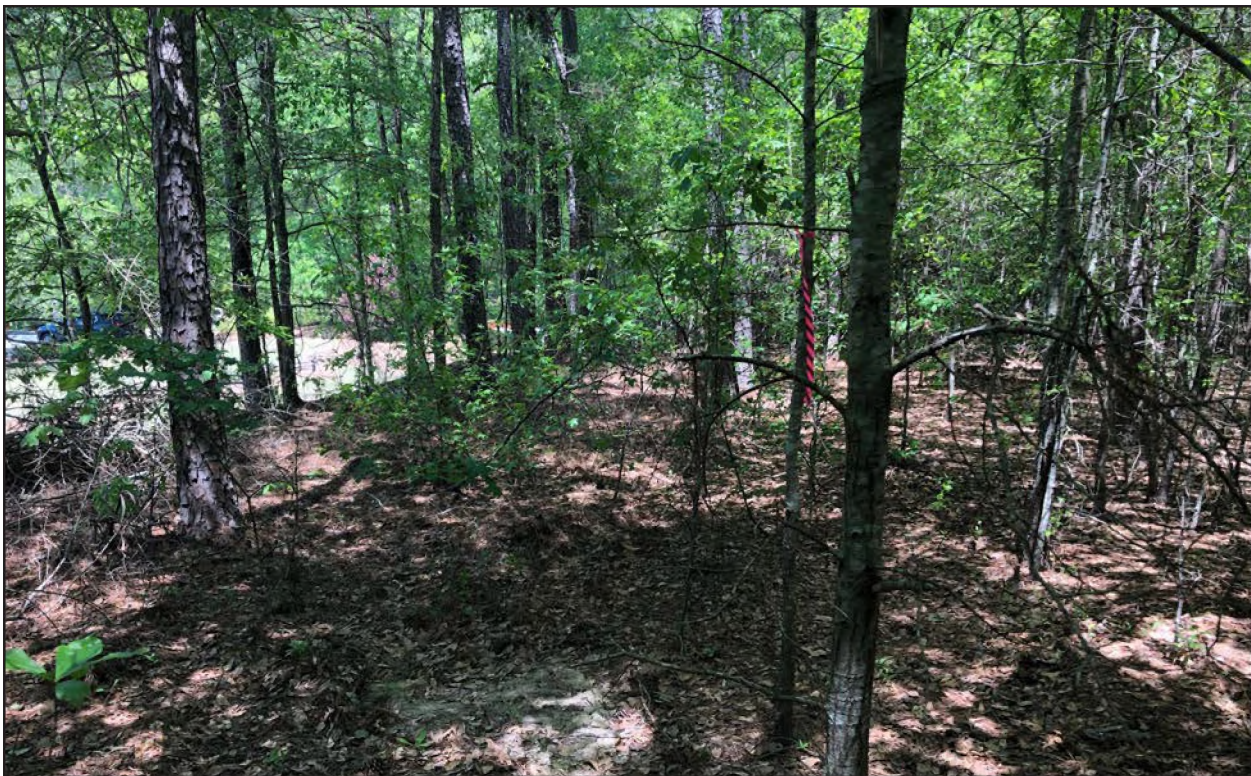
**Figure 4.22.** Photograph of 38LX677.

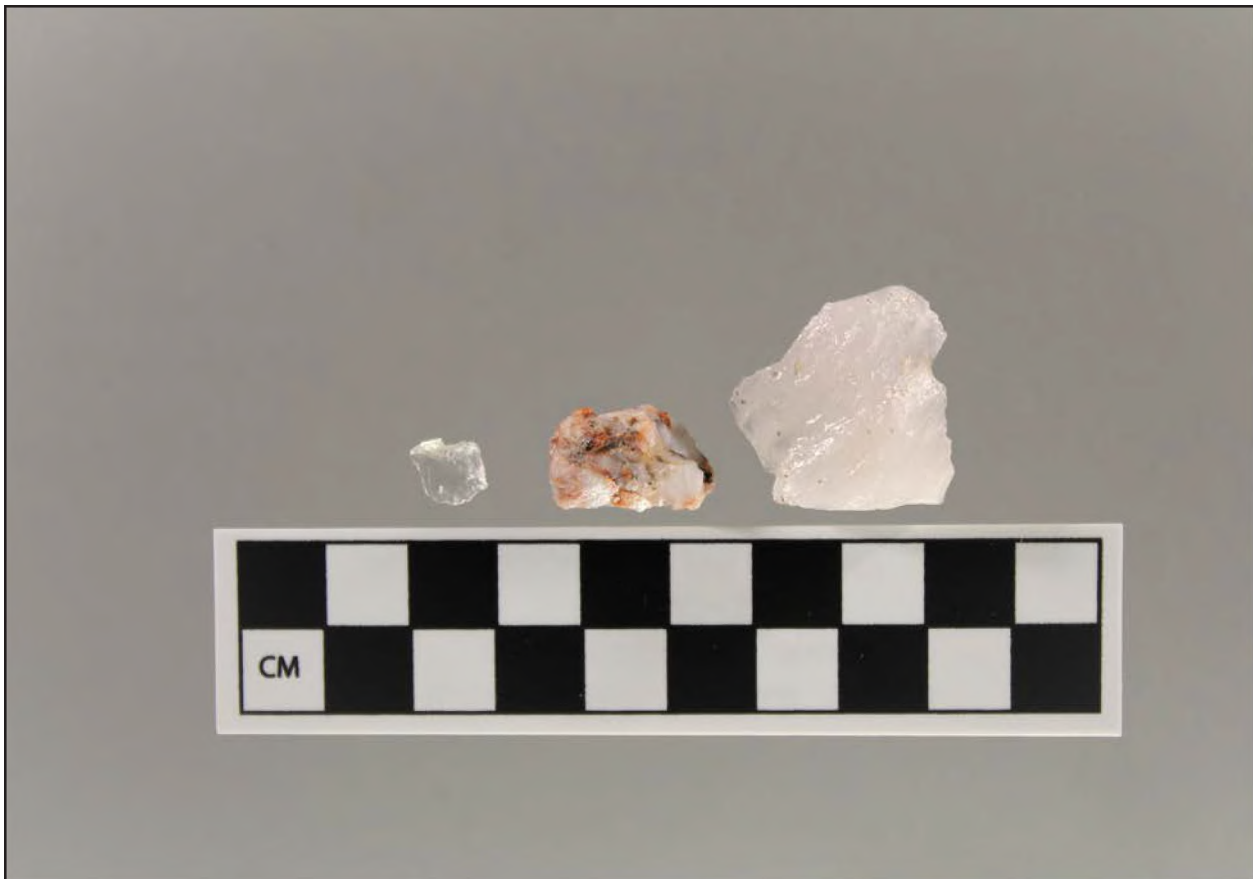
**Figure 4.24.** Left to right - quartz flake fragment (TR89ST2-1), quartz shatter (TR89ST1-1), quartz shatter (TR89ST1.5-1).

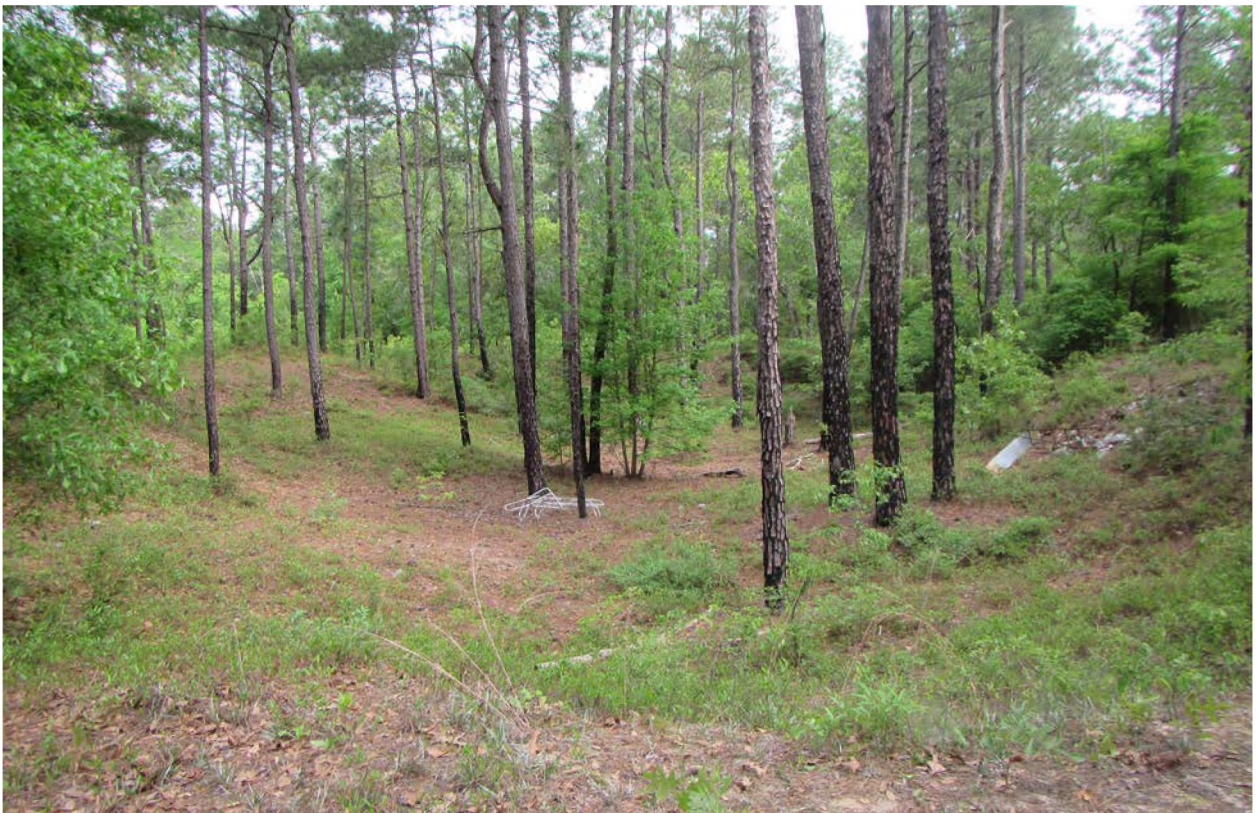
Site 38LX678 represents the remains of a borrow pit that provided fine white sand to be used to create the façade of the historic Lexington County Courthouse, which was constructed in 1939. The borrow pit was identified in the northwestern quadrant of the survey area at the apex of a large sandy terrace that is dissected by unnamed drainages of Twelvemile Creek (see Figure 4.1). This landform was owned by the Shull family in 1939 and was later inherited by Mrs. Elizabeth Busbee, who owns it now (Figure 4.25). Mrs. Busbee grew up on the property and was told by her family that the site was selected because it was only place one could find sand that white in close proximity to the town of Lexington. The sand was used to make the white stucco that adorns the entrance to the 1939 courthouse.

**Figure 4.25.** Photograph of 38LX678.

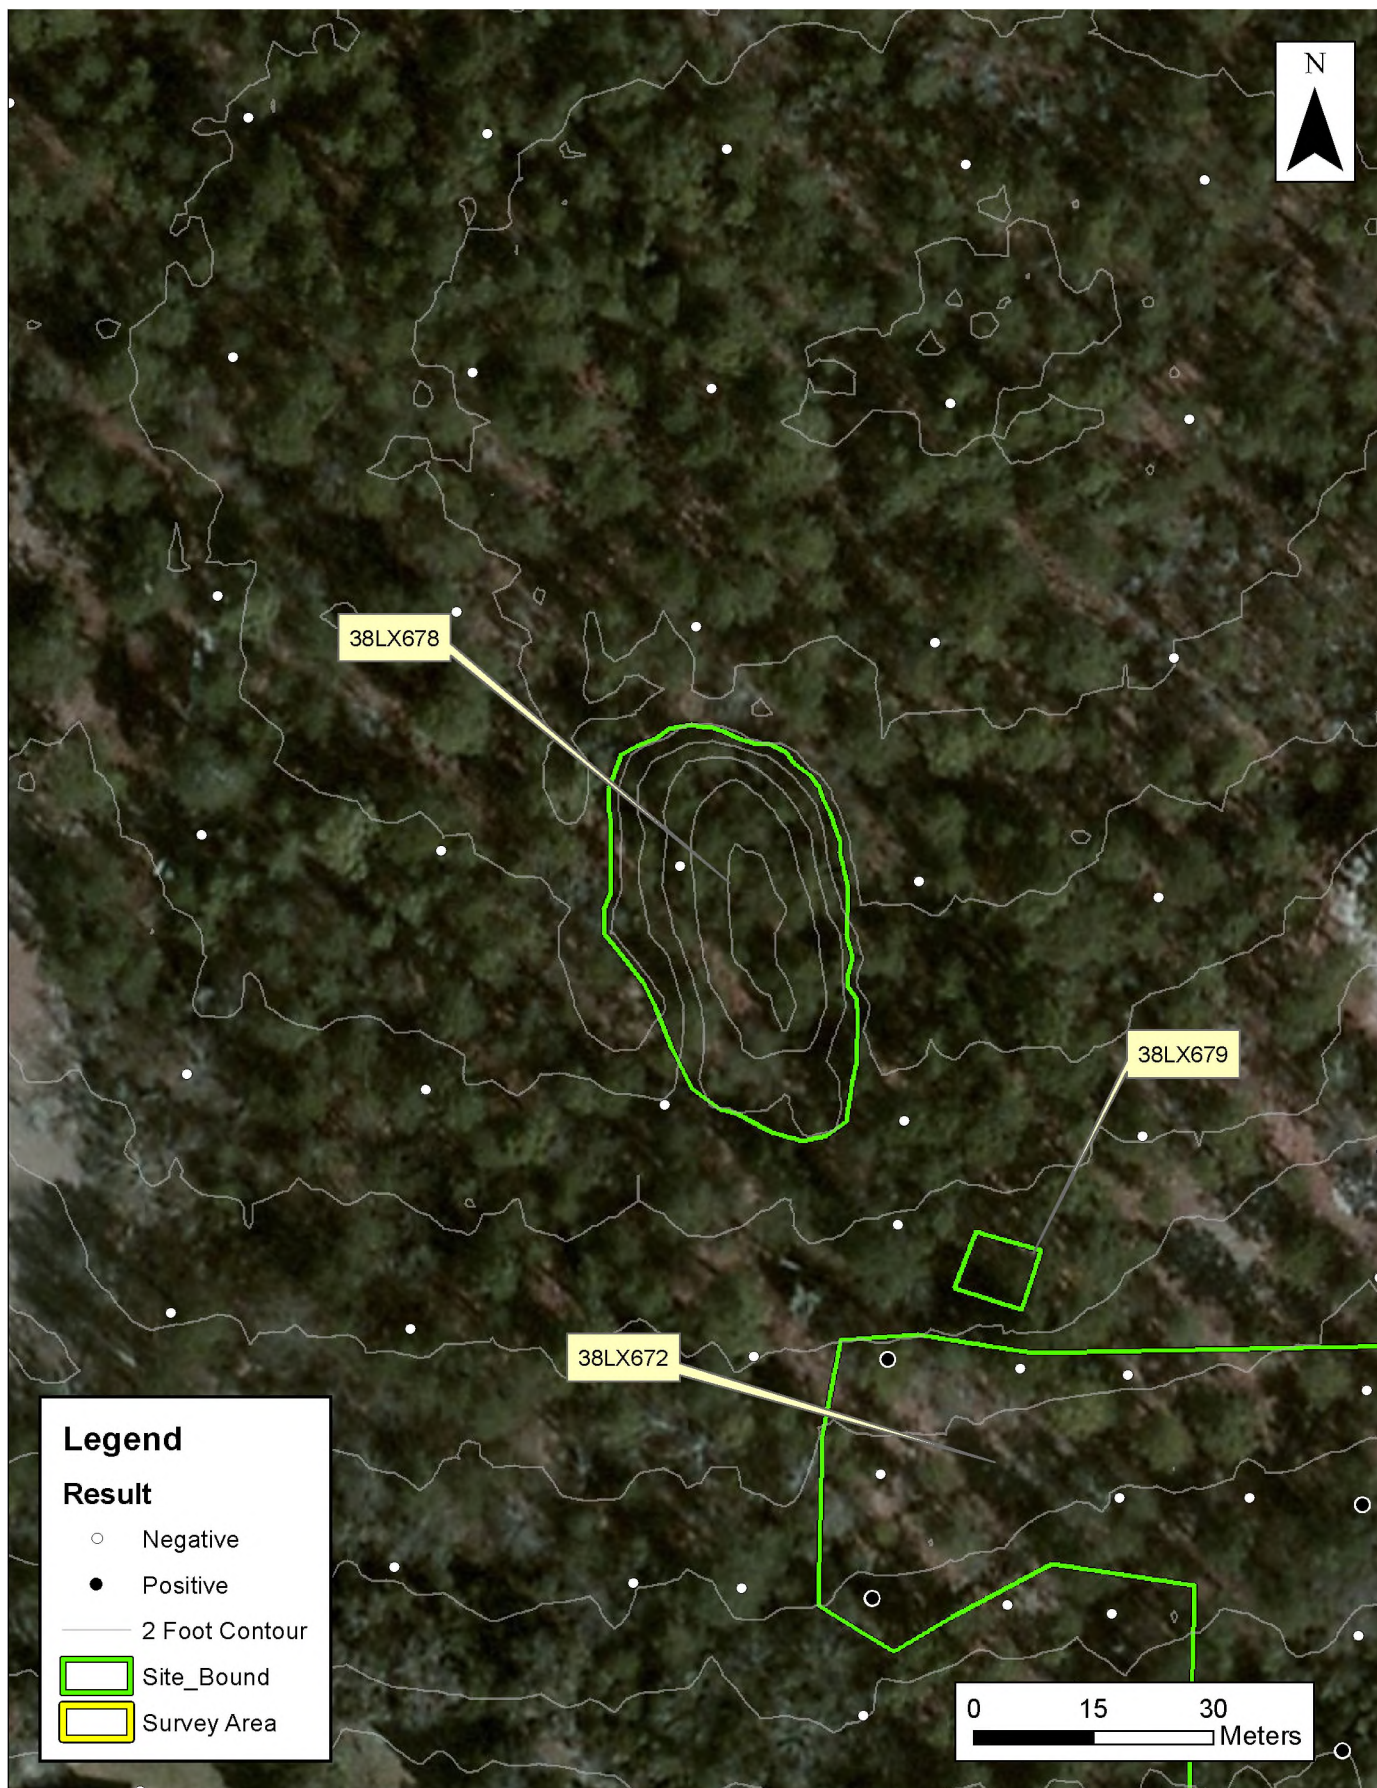
Figure 4.26. 38LX678 site map.

Four shovel tests were dug in the vicinity of 38LX678 in order to identify any artifacts that may be associated with the historic borrow pit (Figure 4.26). These tests were all negative for cultural

material. A representative soil profile at 38LX678 consisted of two strata: Stratum I (0 to 20 centimeters), a grayish brown (10YR 5/2) humic sand and Stratum II (20 to 80 centimeters), a yellowish brown (10YR 5/6) fine sand.

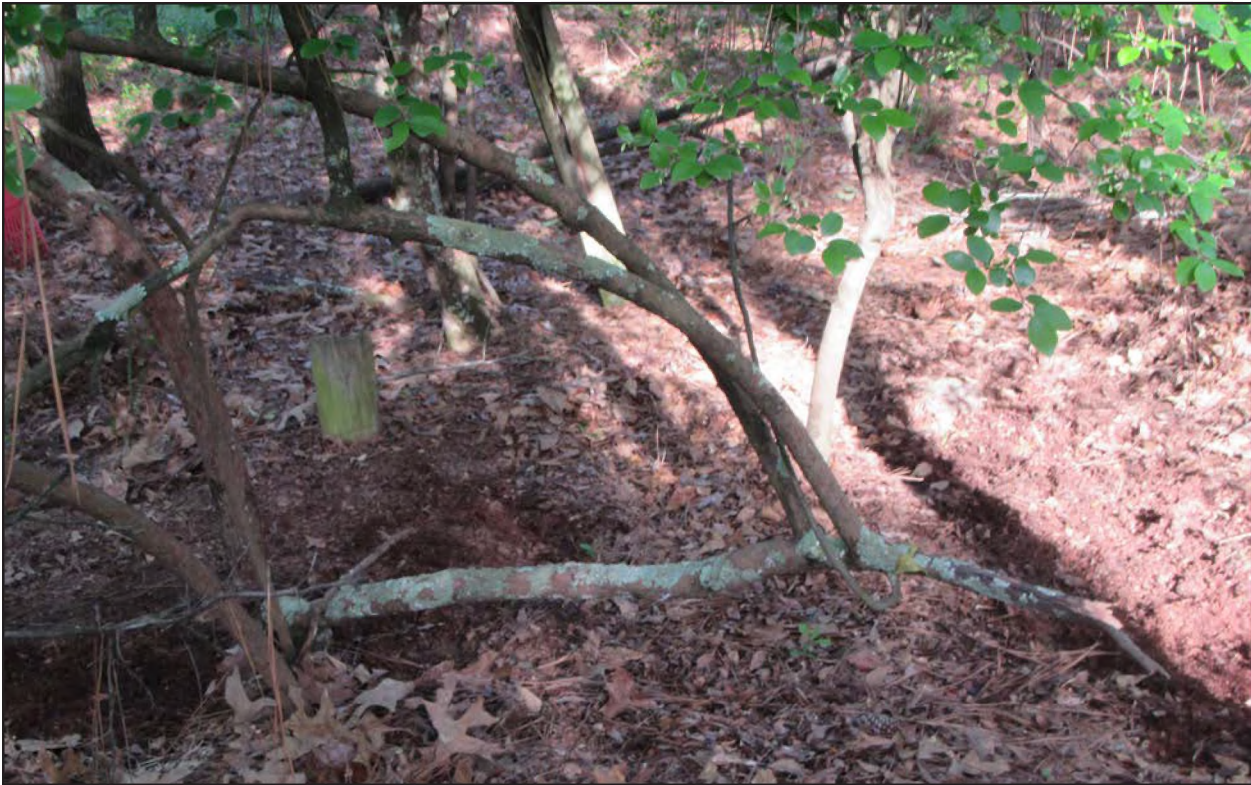
**Figure 4.27.** Photograph of 38LX679.

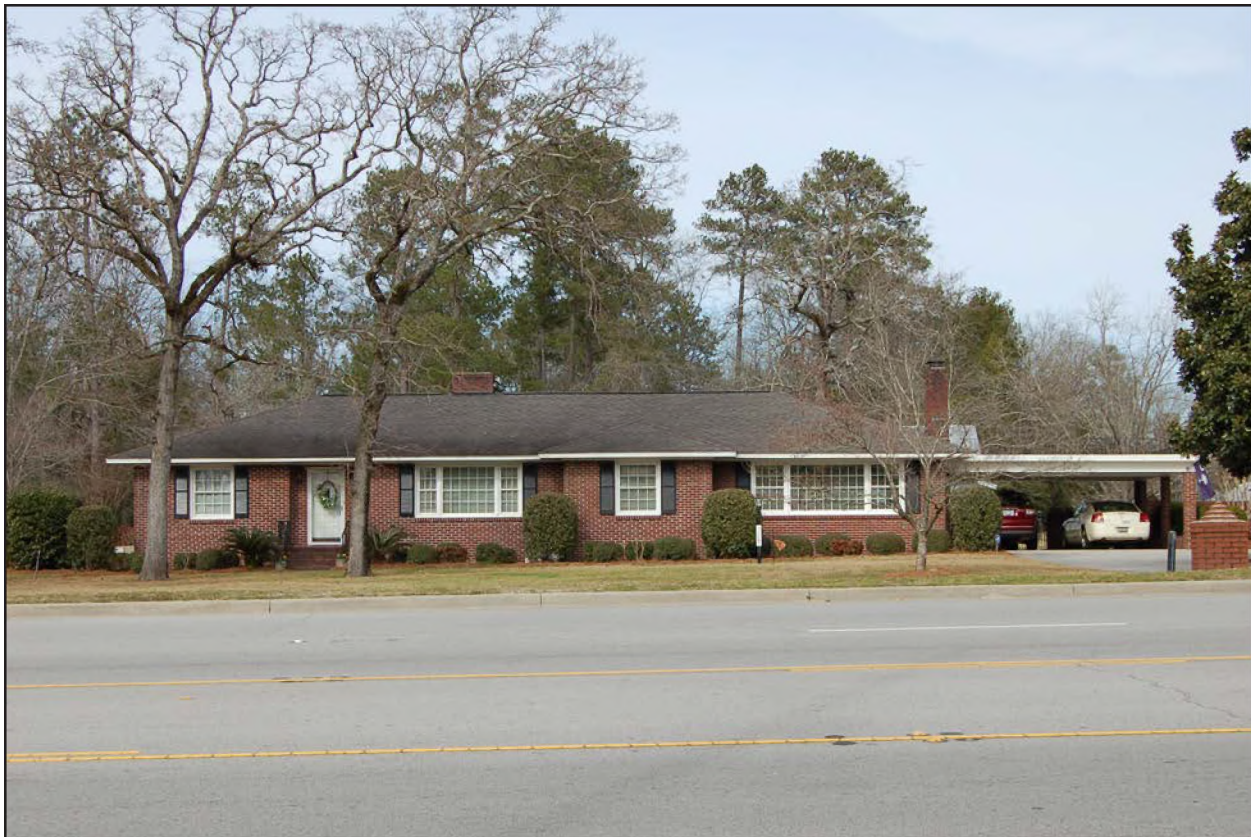
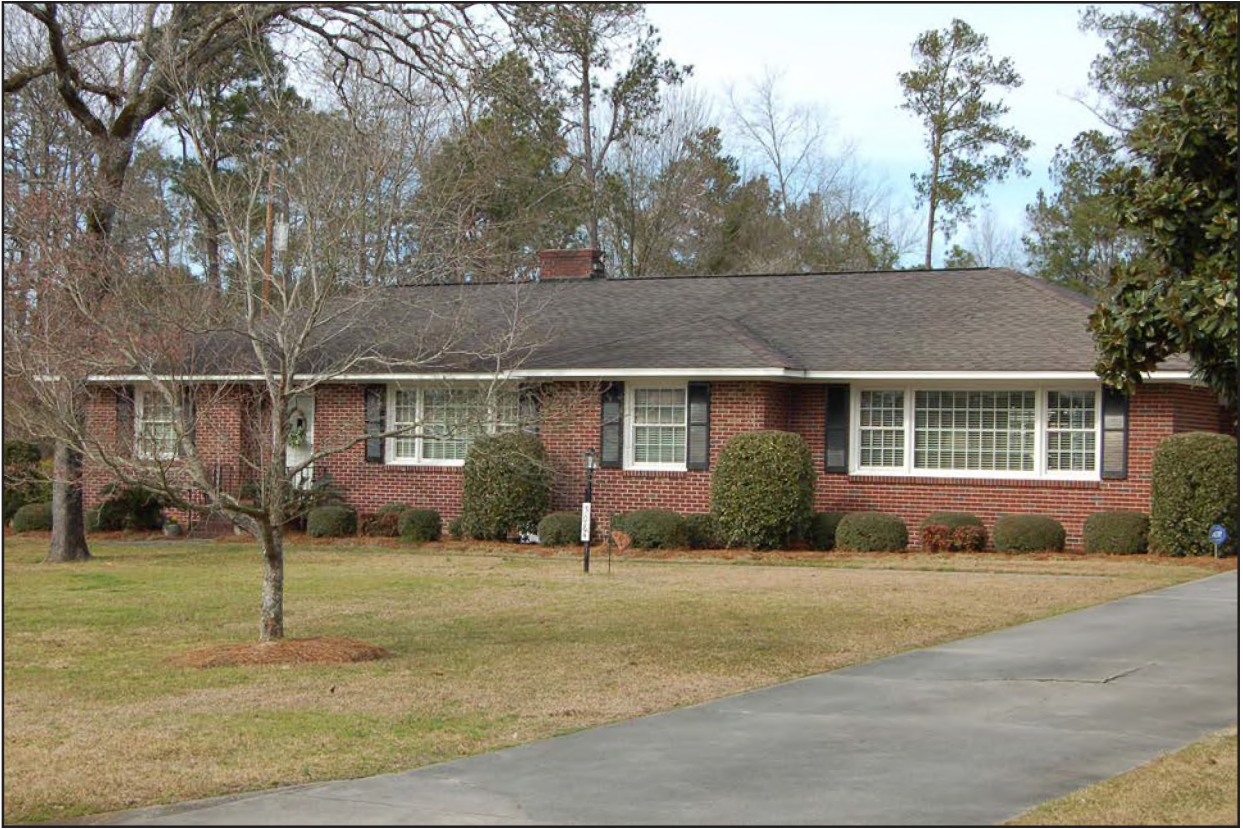
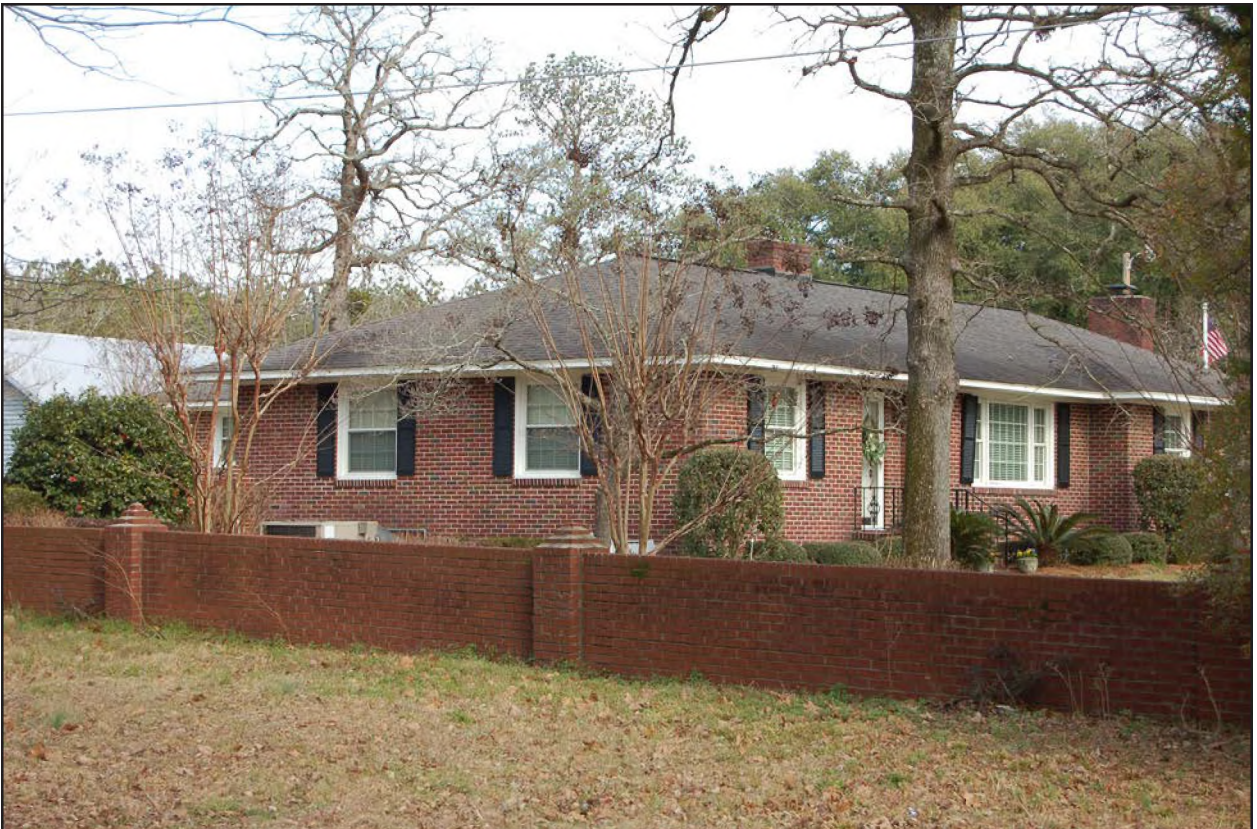
**Figure 5.5.** Resource 0983 - Façade view of house, facing north.

**Figure 5.6.** Resource 0983 - Oblique view of façade, facing northwest

**Figure 5.7.** Resource 0983 - Southwest oblique view of house, facing northeast.

smaller lots. House designs were based on a catalog of standard plans. The resource is a hipped-roof Ranch with a carport at one side (see Figures 5.5 – 5.7). It has two brick chimneys, one on an exterior wall and one near the center of the house. There are two multi-pane tripartite windows at the facade. There are low brick walls at the western edge of the property. The house has a large rear addition and a non-historic paved driveway. Both of these changes were made between 1971 and 1994. The resource is situated along a busy highway. It has a wide lawn, paved drive and variety of shrubs along the facade.

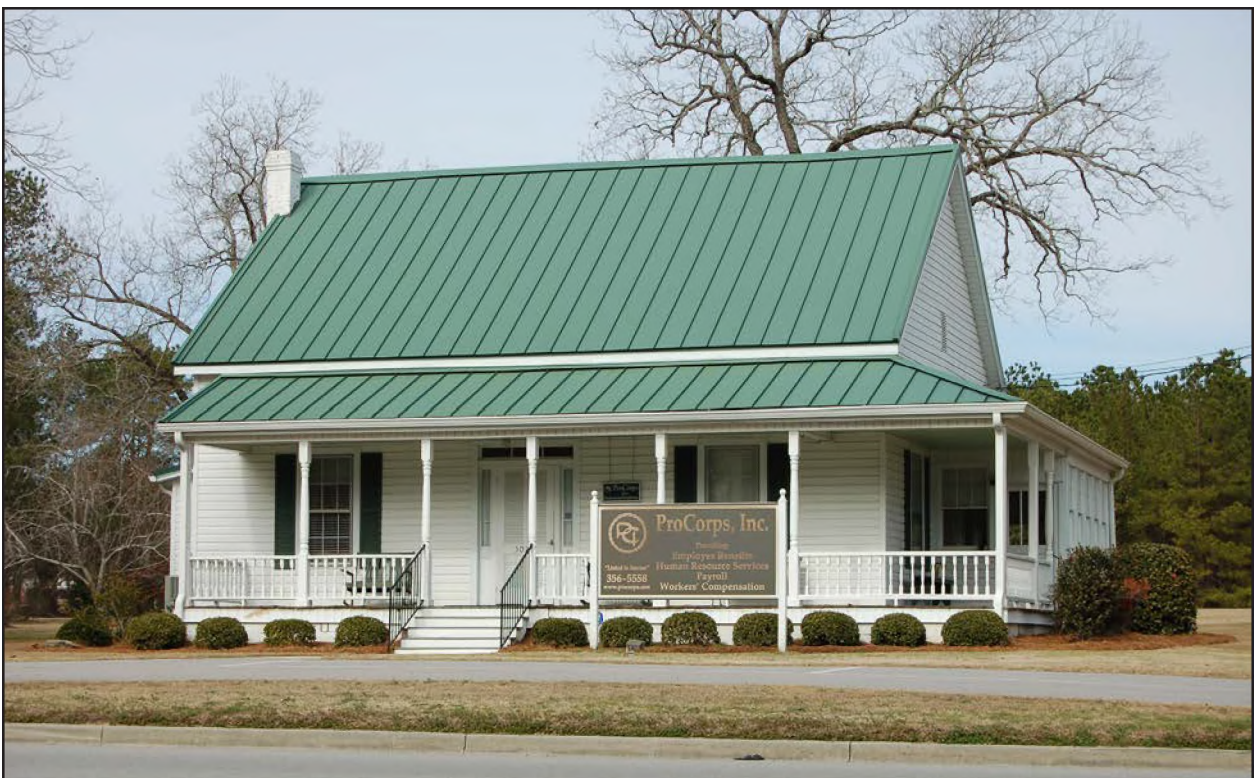
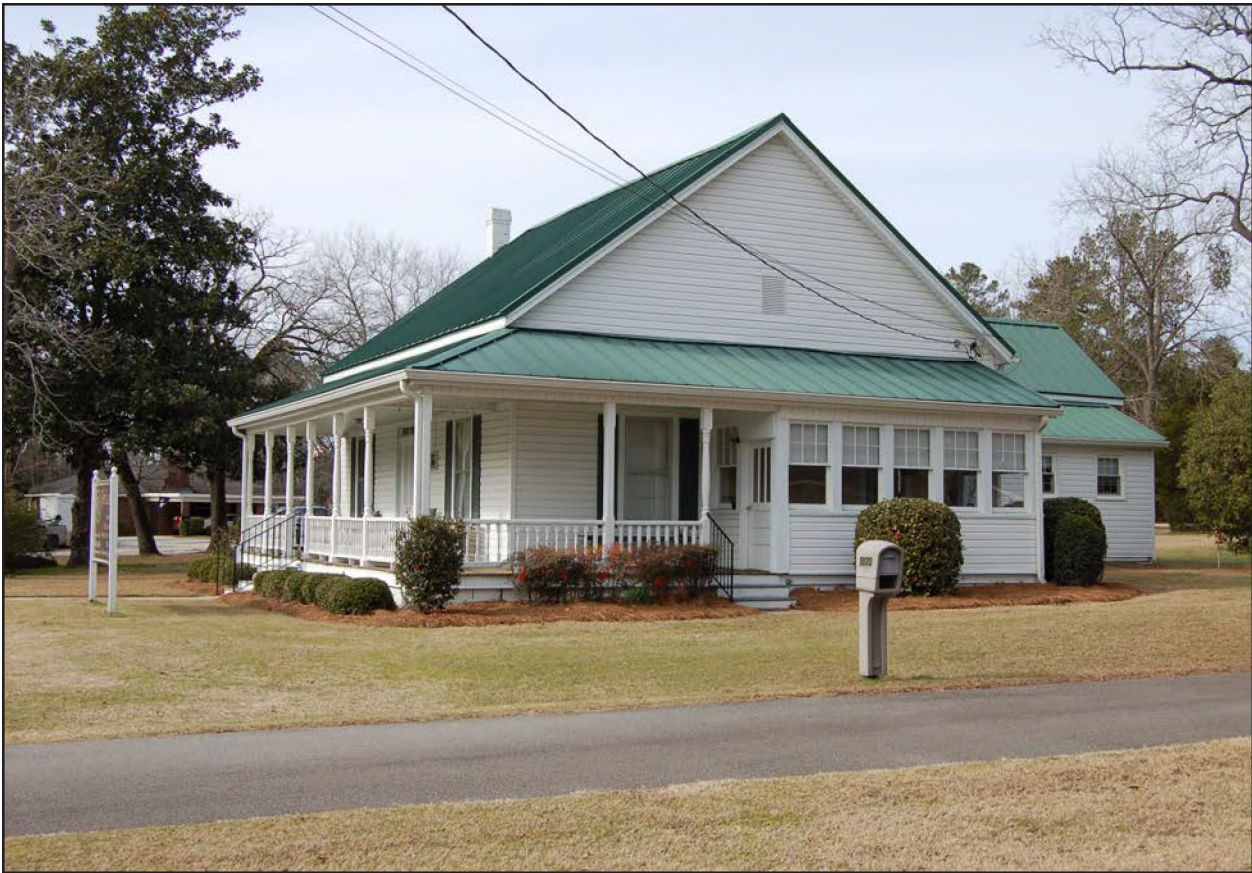
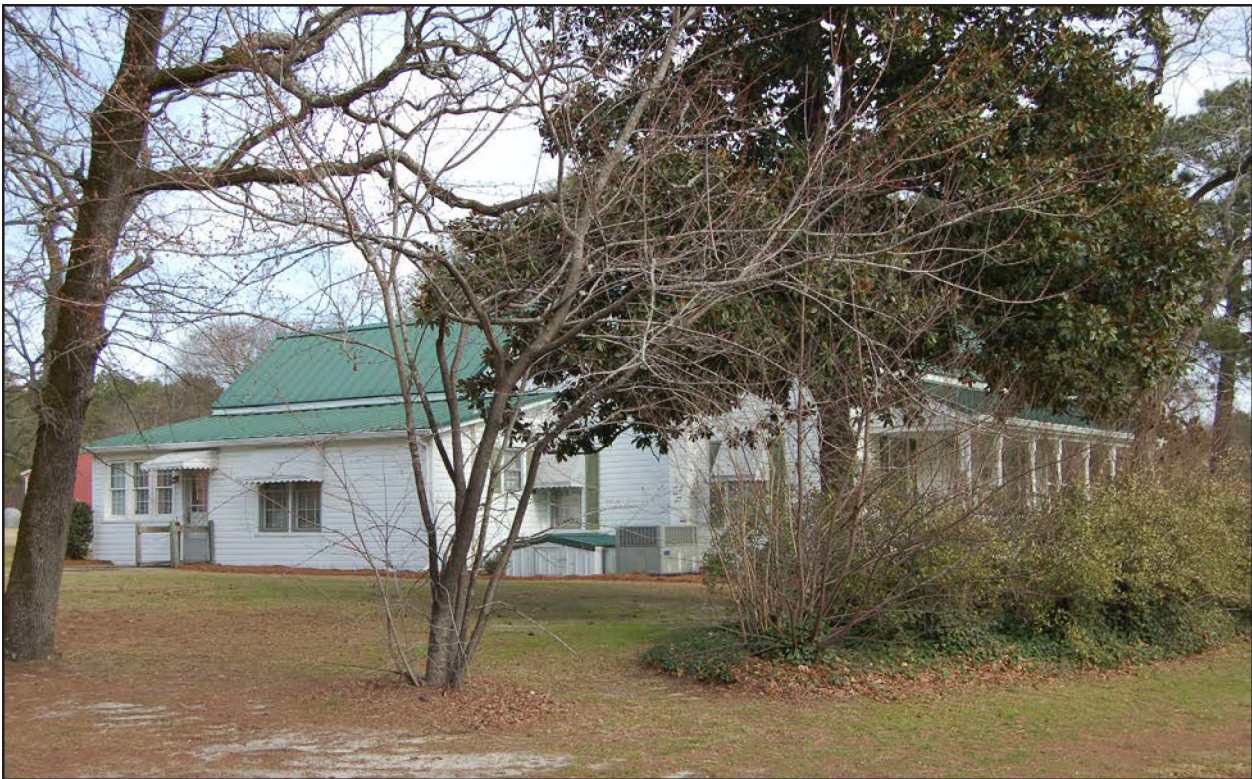
these smaller lots. This house predates the time of the land sales and would likely have been associated with the original, larger parcel. This resource is a gable-roof Colonial Revival house with a wraparound porch (see Figures 5.8 – 5.10). It has a central front door with sidelights and transom. One corbeled brick chimney is on the west elevation. Exterior materials have been altered, including the addition of a metal roof and synthetic siding. There are additions at the sides and rear of the building. The dates of these changes are unknown, but may have occurred in the 1950s. The house has been converted to commercial use. This resource is situated along a busy highway. It sits close to the roadway and has a lawn, foundation plantings, and mature trees on the property.

**Figure 5.8.** Resource 0984 - Façade view of house, facing north.

**Figure 5.9.** Resource 0984 - Southeast oblique view of house, facing northwest.

**Figure 5.10.** Resource 0984 - Southwest oblique view of house, facing northeast.

example. The house does not otherwise appear to represent a significant trend in South Carolina's architectural history. Additionally, due to the additions, replacement of historic siding and roofing, and conversion to commercial use, it has lost integrity in the areas of design, setting, materials, workmanship, feeling, and association and can no longer convey significance in the area of architecture. Therefore, Resource 0984 is recommended **Not Eligible** for listing in the NRHP under Criterion C.

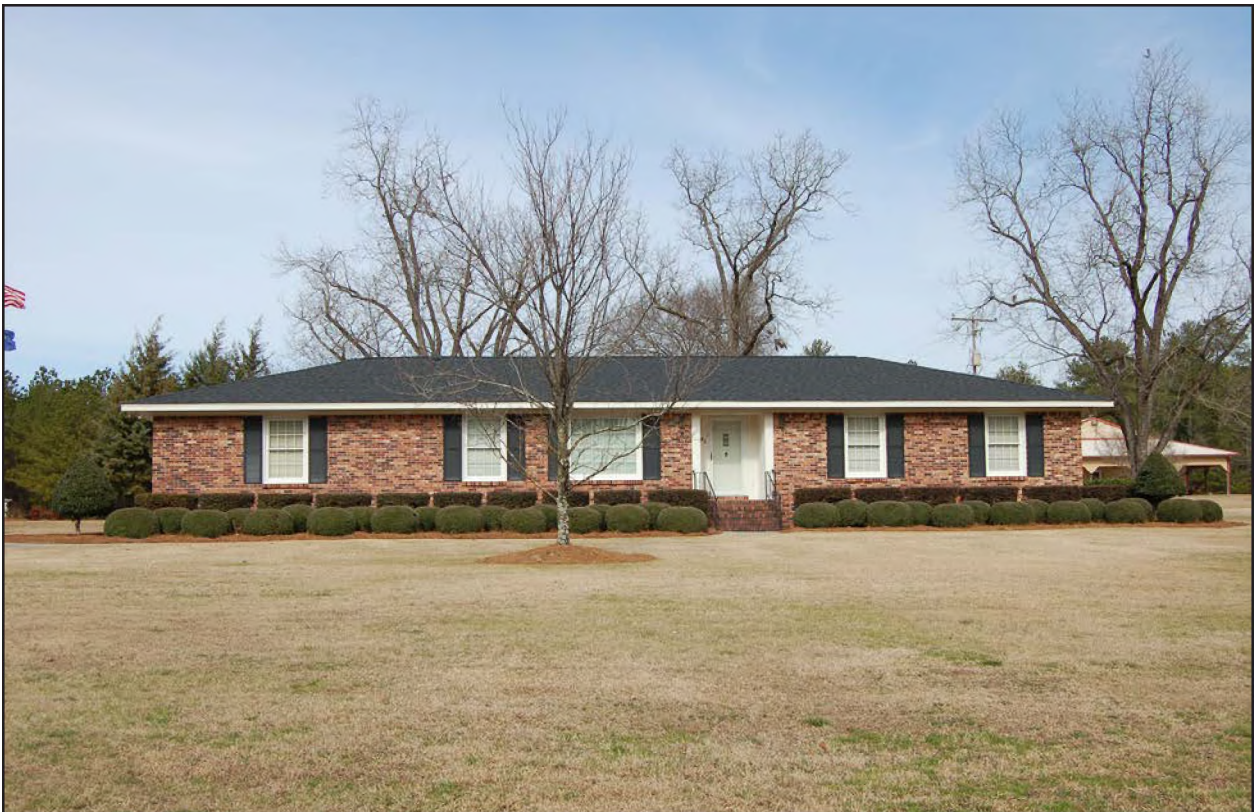
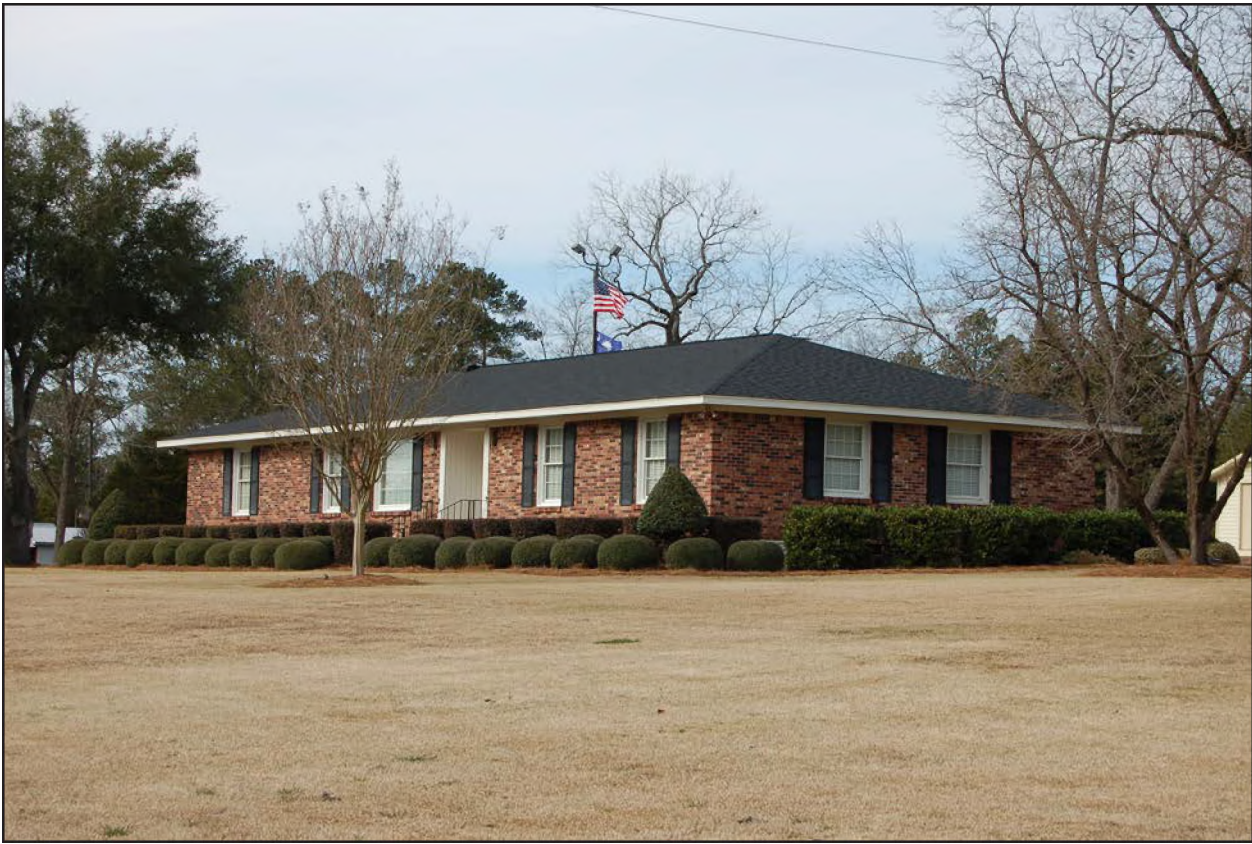
Resource 0985, the Boozer House, is located at 5062 Augusta Road on the north side of the roadway just east of Morgan Drive in Lexington County (refer to Figure 5.1). The Lexington County tax assessor record indicates the date of construction was 1960. This resource is a hipped-roof Ranch (see Figures 5.11 - 5.13). It has a central front door that is slightly recessed. It has one larger picture window and several single windows across the facade. An integral carport is on the west elevation. The house has a large rear addition and several non-historic outbuildings, which appear to have been constructed between 1971 and 1994. The house is situated along a busy highway. It has an open lawn and manicured shrubs planted across the facade.

**Figure 5.11.** Resource 0985 - Façade view of house, facing north.

**Figure 5.12.** Resource 0985 - Southeast oblique view of house, facing northwest.

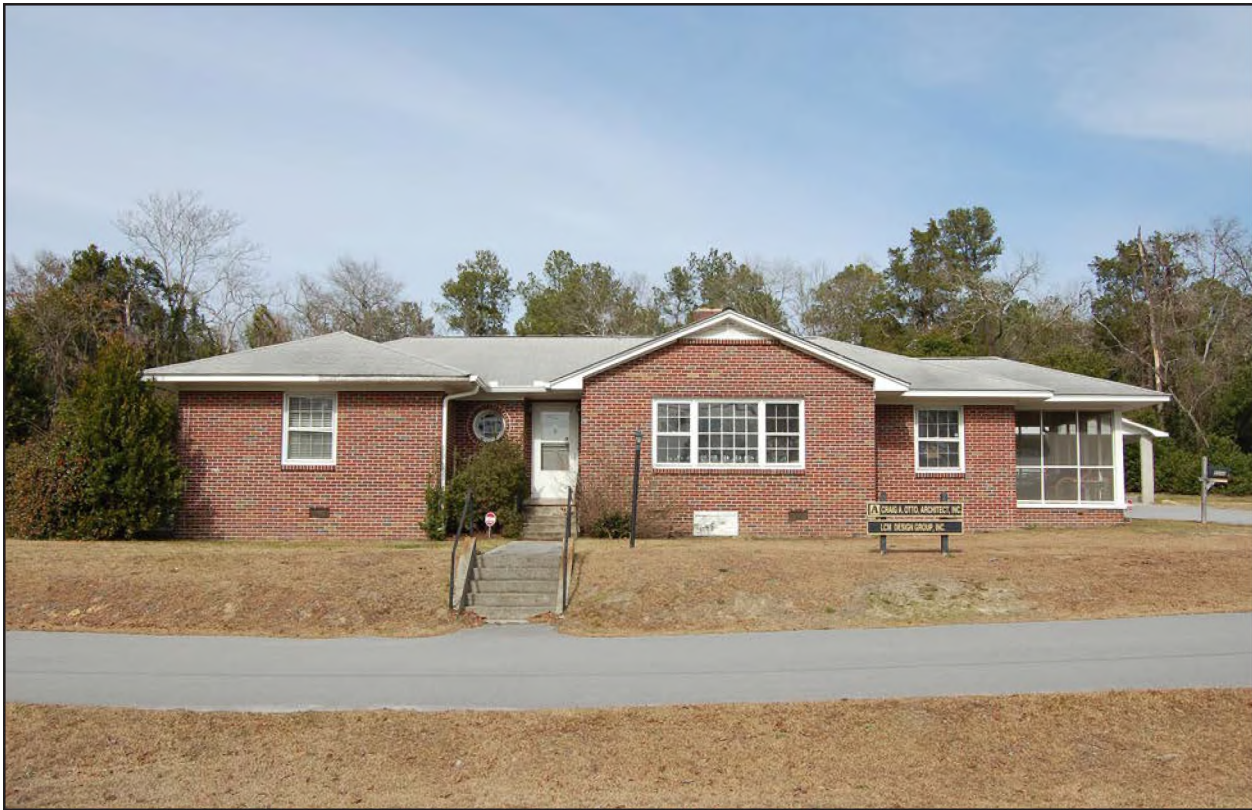
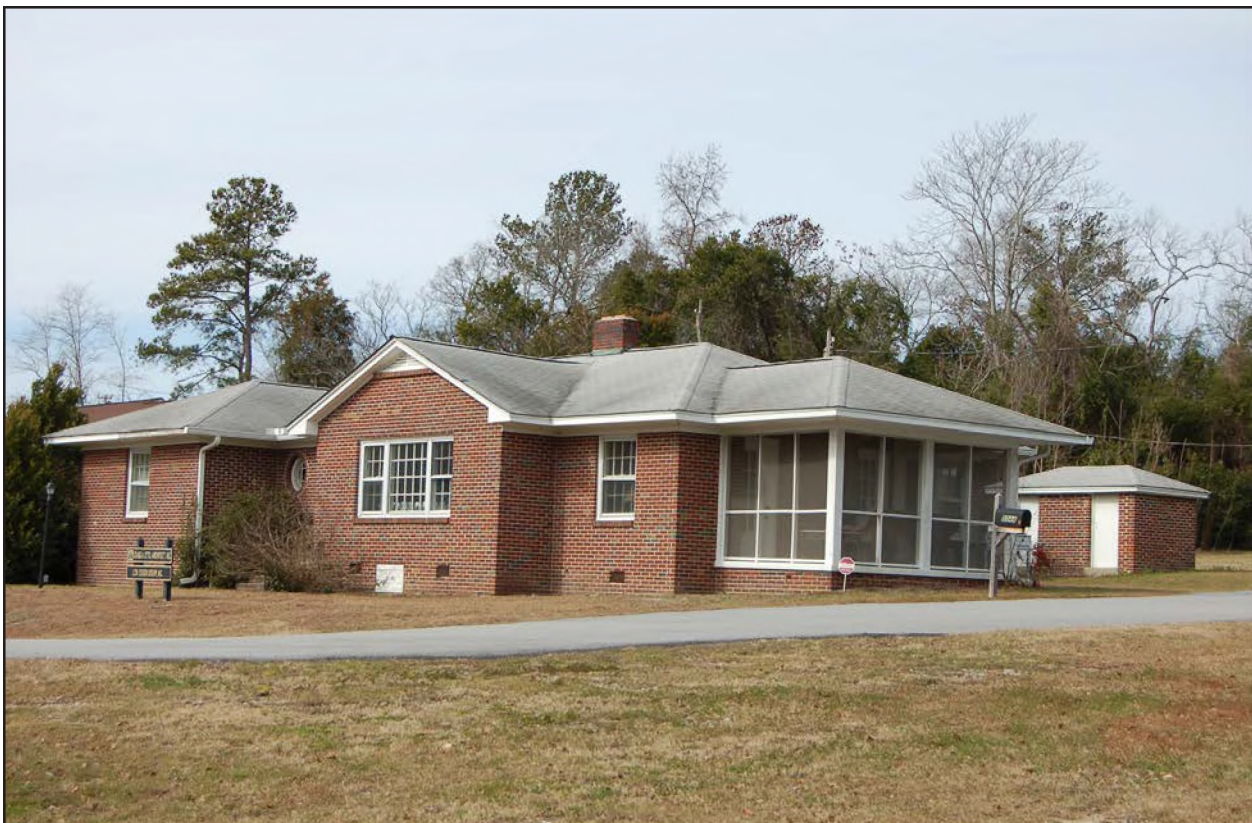
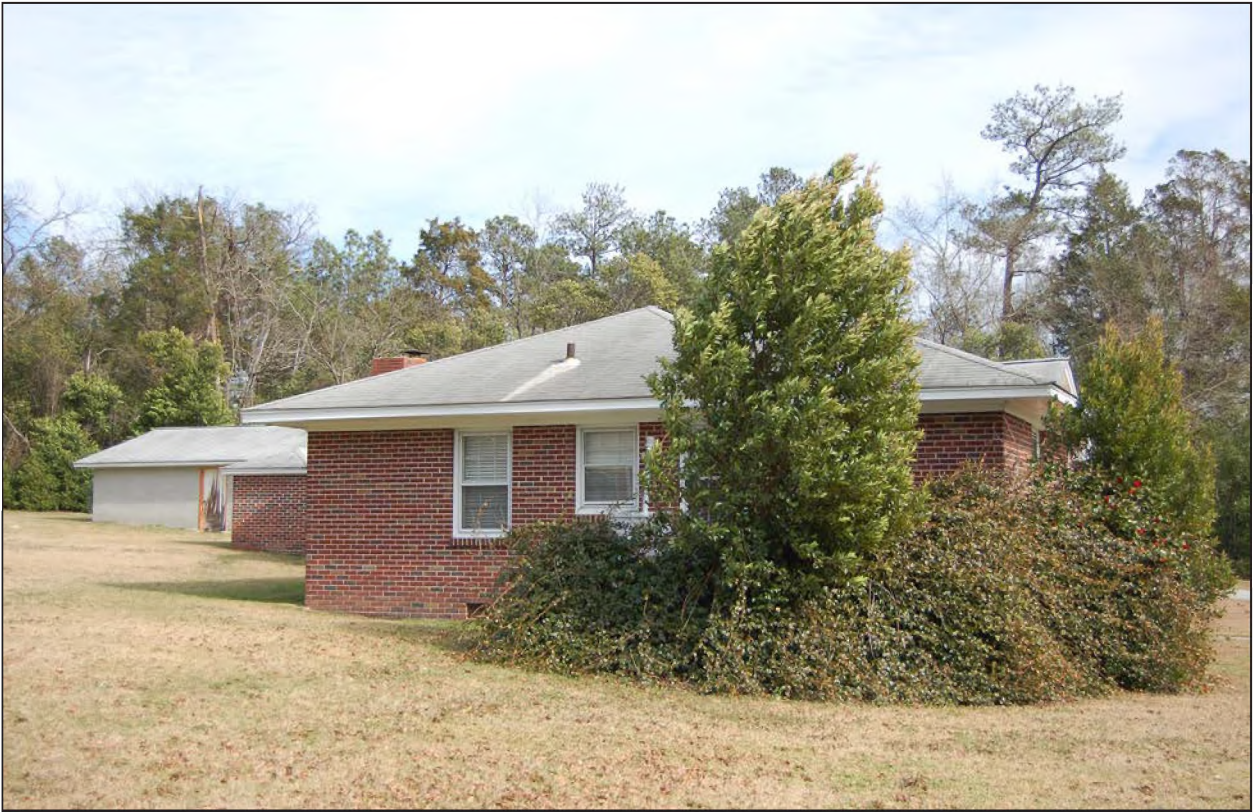
Resource 0986, the Frye House, is located at 5044 Augusta Road on the north side of the roadway just west of Monroe Lane in Lexington County (refer to Figure 5.1). The Lexington County tax assessor record indicates the date of construction was 1960. This resource is a hipped-roof Ranch (see Figures 5.14 – 5.16). It has a central front door that is slightly recessed between a front projecting hip at one side and front projecting gable on the other. A circular window is next to the front door. It has one larger picture window at the center of the front projecting gable. A rear facing gable is an addition, as is an outbuilding in the rear yard. A screened porch is on the east elevation. The house is situated along a busy highway and has been converted to commercial use. It has an open lawn and a paved driveway.

**Figure 5.14.** Resource 0986 - Façade view of house, facing north.

**Figure 5.15.** Resource 0986 - Southeast oblique view, facing northwest.

**Figure 5.16.** Resource 0986 - West elevation of house, facing east.

elements required to convey significance as a good example of a Ranch; however, it lacks a carport or garage, a prominent chimney, as well as the steel or aluminum casement or sliding windows that are characteristic of South Carolina Ranches. It has also had changes that have impacted the integrity of design and setting. These include a rear addition, which has changed the original, rectilinear footprint as well as the addition of a non-historic outbuilding. Because it lacks several Ranch features and because it has lost integrity in several areas it cannot convey significance in the area of architecture. Therefore, Resource 0986 is recommended **Not Eligible** for listing in the NRHP under Criterion C.
