**PHASE I CULTURAL RESOURCE SURVEY OF THE PROPOSED  
US 1 BRIDGE REPLACEMENT OVER I-20 AND INTERCHANGE  
IMPROVEMENTS, LEXINGTON COUNTY, SOUTH CAROLINA**

**REVISED DRAFT REPORT**

**JUNE 2019**

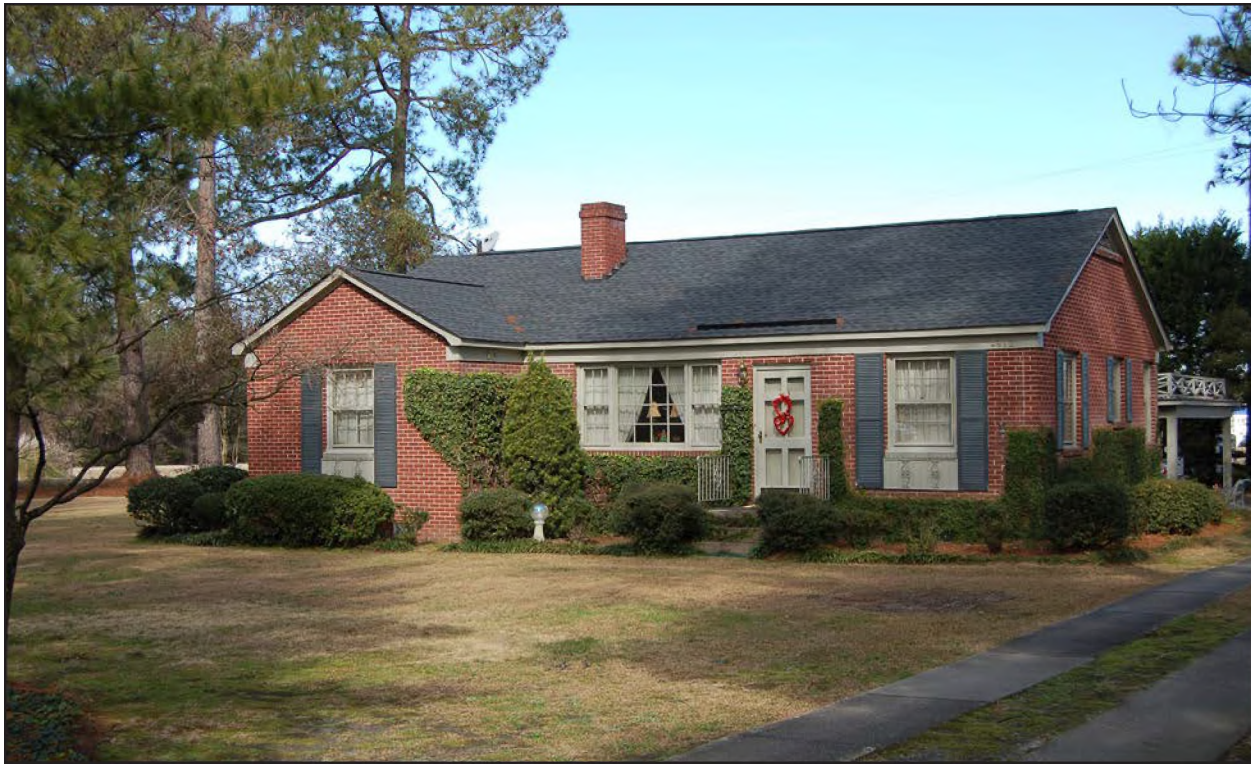
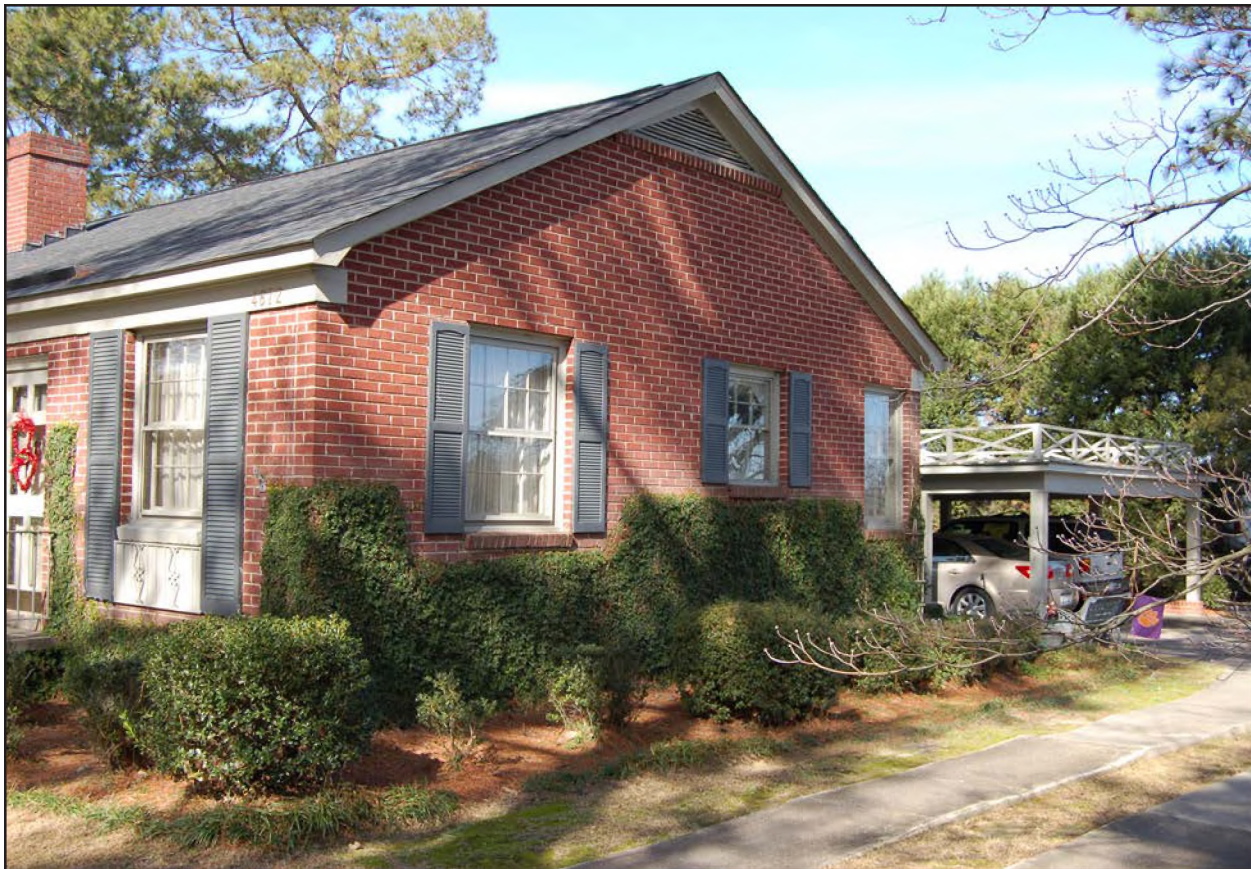
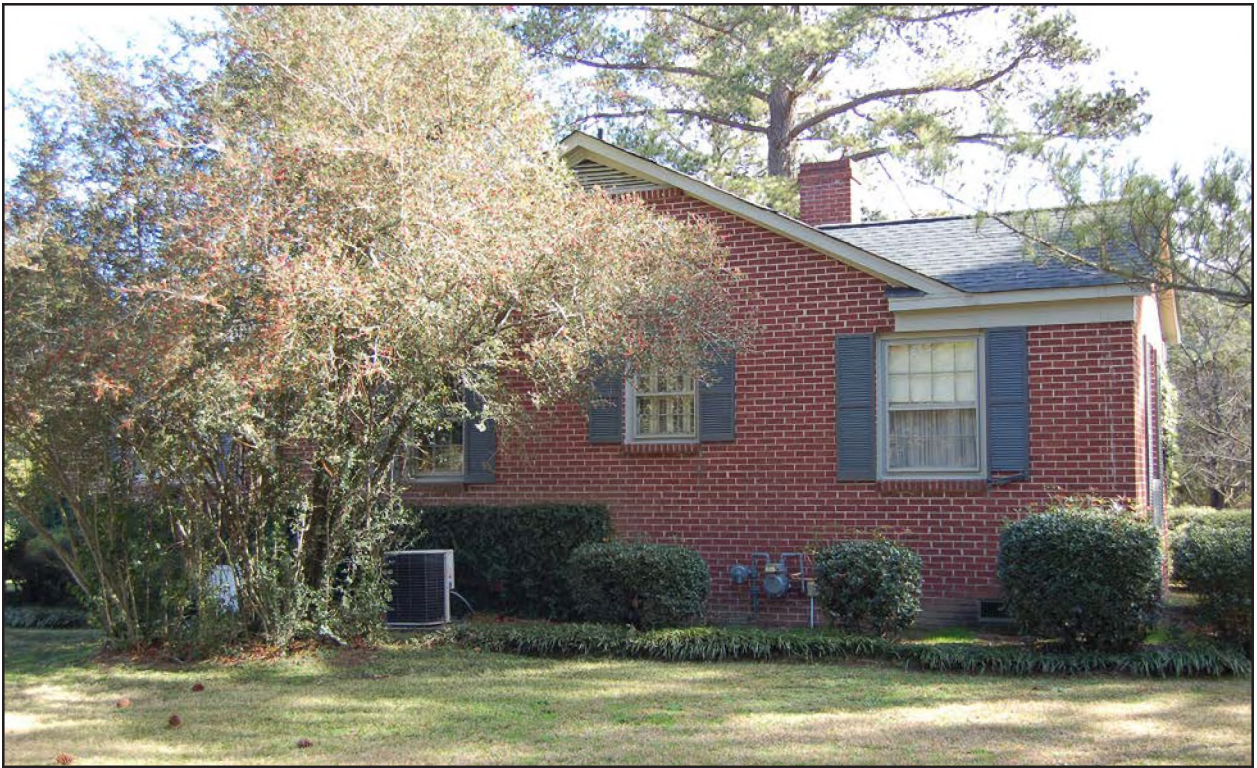
Resource 0987, the Sox House, is located at 4872 Augusta Road on the northeast corner of the intersection with Cedar Road in Lexington County (refer to Figure 5.1). The Lexington County tax assessor record indicates the date of construction was 1951. This resource is a Minimal Traditional house with a brick exterior (see Figures 5.17 – 5.19). There is a small front projecting gable at one side of the facade and a larger gable projection at the rear. There is an off-center front door that has a small concrete stoop in front. A tripartite window is to one side of the door. A brick chimney is near the center of the roof. The carport is a non-historic addition, constructed between 1971 and 1994. The house is situated along a busy highway. It has an open lawn, paved driveway, and a variety of bushes and trees on the property.

**Figure 5.17.** Resource 0987 - Southeast oblique view, facing northwest.

**Figure 5.18.** Resource 0987 - Oblique view of east elevation, facing northwest.

**Figure 5.19.** Resource 0987 - West elevation of house, facing east.

The resource is not known to be associated with a significant activity or event and there is not a known connection between the resource and any individual whose activities or achievements are historically significant. Therefore, there was no basis for evaluating the resource under Criterion A or B. Also, there are no indications that the resource is likely to yield information on important research questions in history or prehistory. The resource does not appear to have the potential to be the principal source of important information. Therefore, there was no basis for evaluating the resource under Criterion D. The resource, a Minimal Traditional house, does represent a recognized architectural type. However, it is not a significant illustration of that type. Because Minimal Traditional houses are a ubiquitous type with an overwhelming number of extant examples, they should possess clear significance and excellent integrity to be considered eligible for listing in the NRHP. The resource has most of the elements required to convey significance as a good example of this type. However, has a brick exterior, which is not a characteristic of South Carolina Minimal Traditional houses. It also has a carport addition, which has impacted the integrity of design and setting. Because it does not exhibit the typical exterior materials of its type, and because it has lost integrity of design and setting, it cannot convey significance in the area of architecture. Therefore, Resource 0987 is recommended Not Eligible for listing in the NRHP under Criterion C.

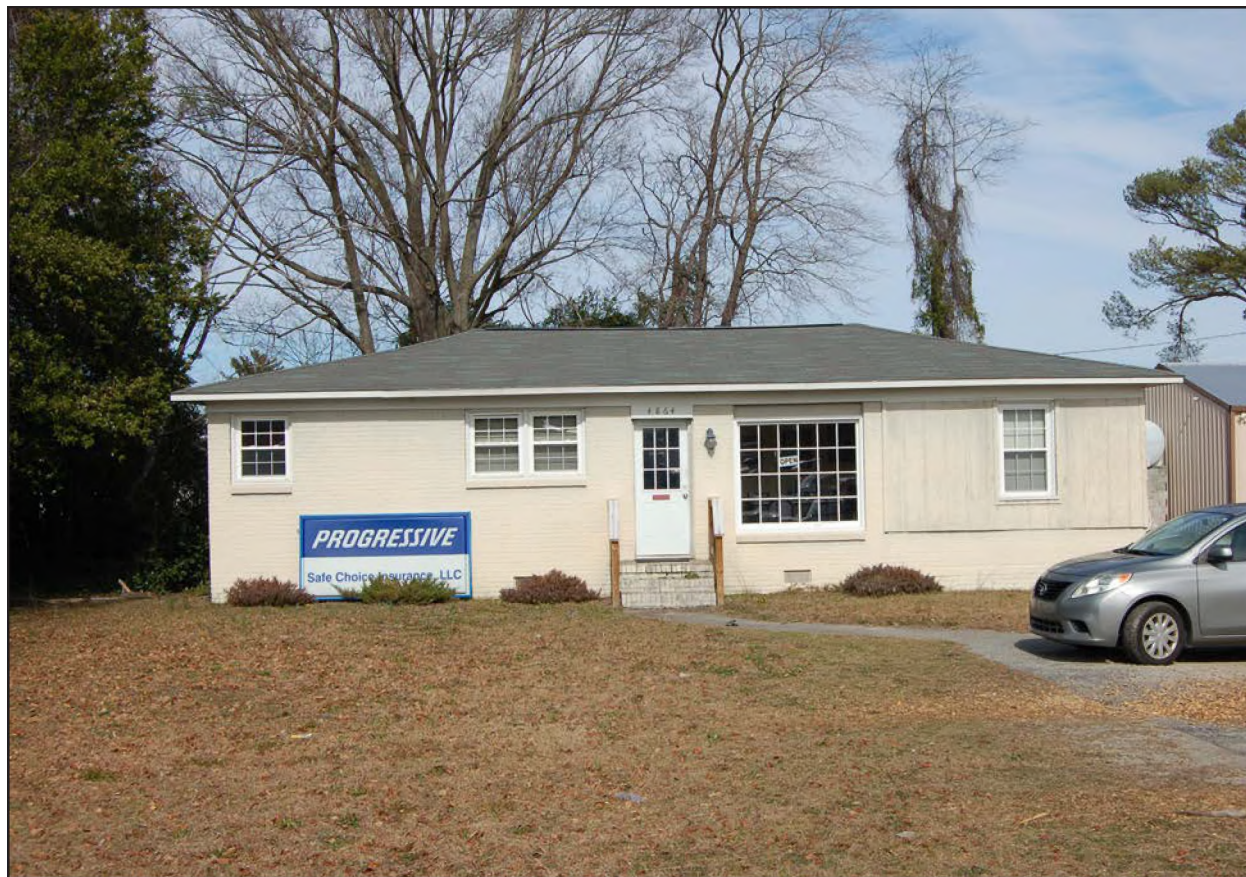
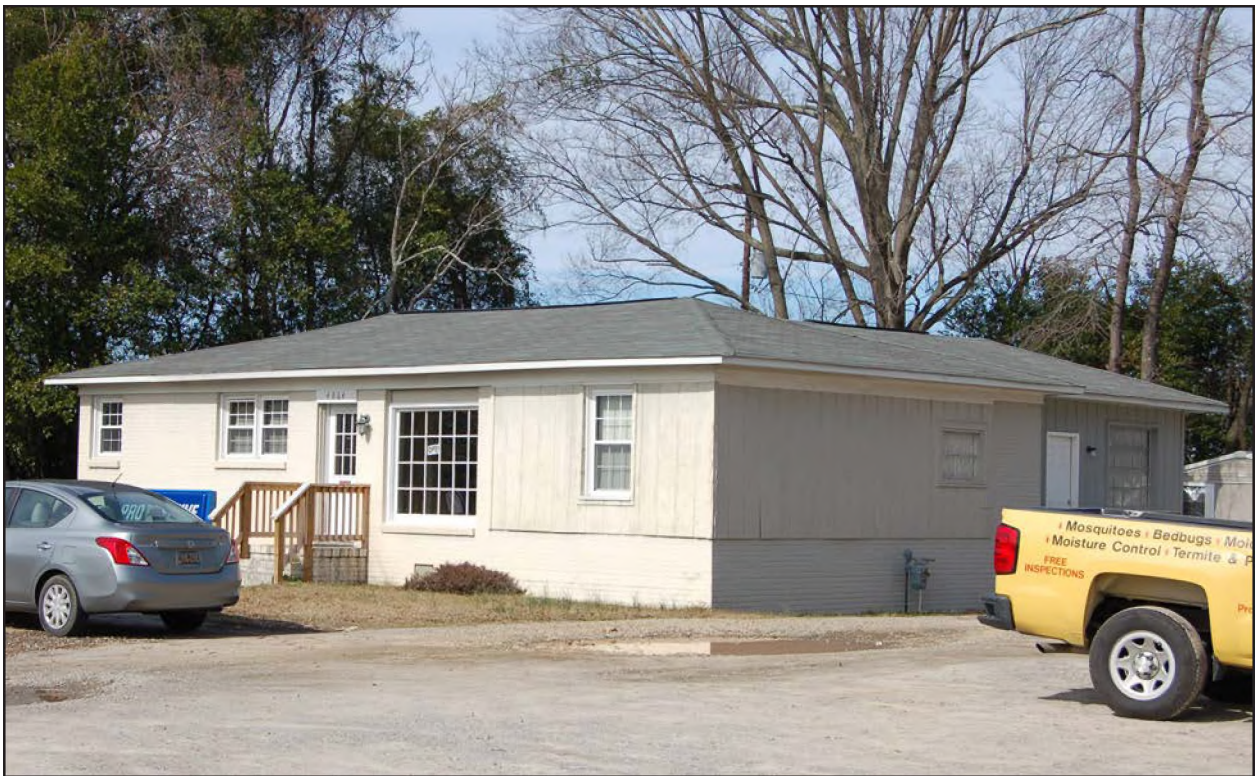
Resource 0988, the Wingard House, is located at 4864 Augusta Road on the north side of the roadway just east of Cedar Road in Lexington County (refer to Figure 5.1). The Lexington County tax assessor record does not have an estimated date of construction for the resource. Based on a review of historic aerial photographs and an evaluation of the resource's form and construction materials, this resource appears to have been constructed ca. 1969. This resource is a simple Ranch house with a rear hip addition (see Figures 5.20 and 5.21). The exterior is clad with a combination of brick and vertical panel siding. The paneled area appears to be an enclosed porch. It has a central front entry door with a brick stoop and wood railings. The door and railings are non-historic replacements. A multi-light picture window is to one side of the door, but this window does not appear to be original, and likely represents an alteration of the historic façade design. There is a large non-historic outbuilding next to the house. The property has been converted to commercial use and is situated along a busy highway. It has an open lawn, paved driveway and parking, and mature trees at the rear of the property.

**Figure 5.20.** Resource 0988 - Façade view of house, facing north.

**Figure 5.21.** Resource 0988 - Southeast oblique view of house, facing northwest.

historically significant. Therefore, there was no basis for evaluating the resource under Criterion A or B. Also, there are no indications that the resource is likely to yield information on important research questions in history or prehistory. The resource does not appear to have the potential to be the principal source of important information. Therefore, there was no basis for evaluating the resource under Criterion D. The resource, a Ranch, does represent a recognized architectural type. However, it is not a significant illustration of that type. Because Ranch houses are a ubiquitous type with an overwhelming number of extant examples, they should possess clear significance and excellent integrity to be considered eligible for listing in the NRHP. The resource has some of the elements required to convey significance as a good example of a Ranch; however, it lacks a carport or garage, a prominent chimney, as well as the steel or aluminum casement or sliding windows that are characteristic of South Carolina Ranches. It has also had changes that have impacted the integrity of design, setting, materials, workmanship, feeling, and association. These include changes to the façade and exterior materials, rear addition, and addition of a large non-historic outbuilding. Because it lacks key Ranch house features and has lost integrity in several areas it cannot convey significance in the area of architecture. Therefore, Resource 0988 is recommended Not Eligible for listing in the NRHP under Criterion C.

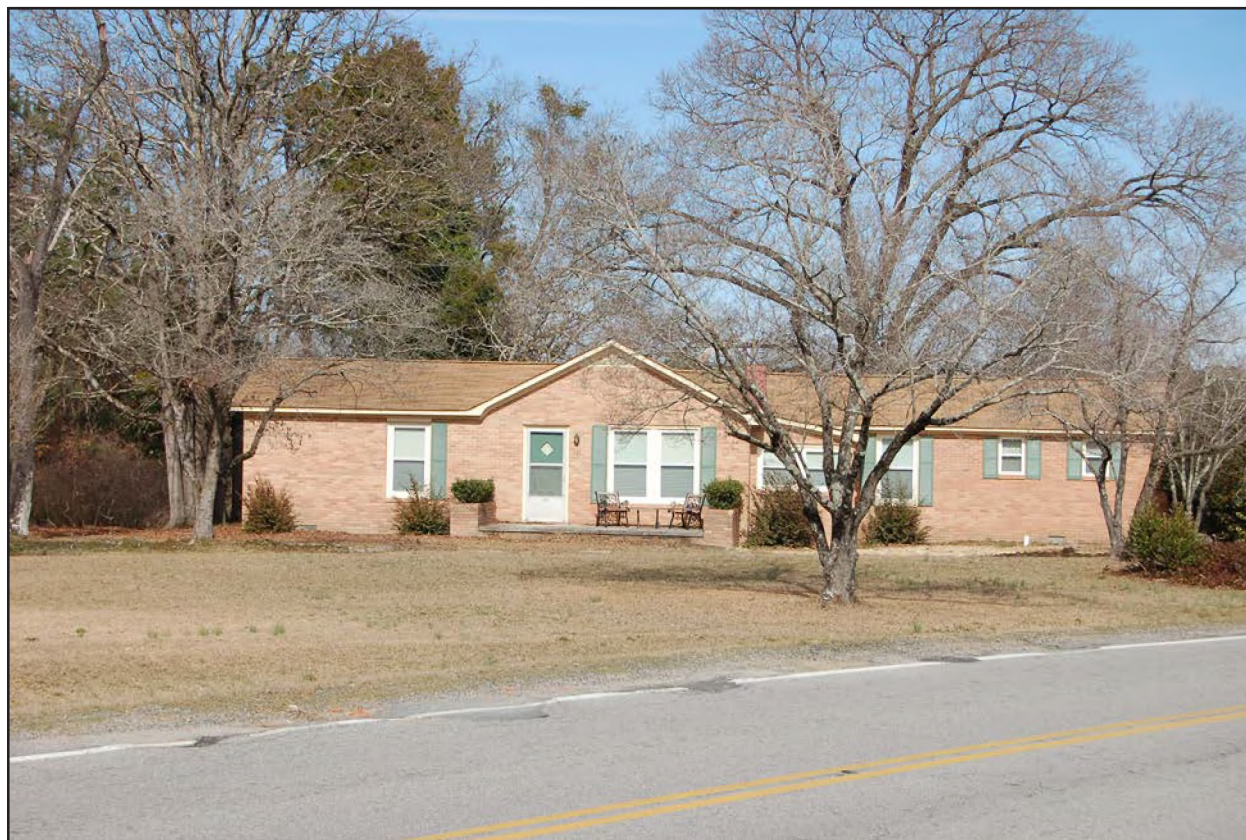
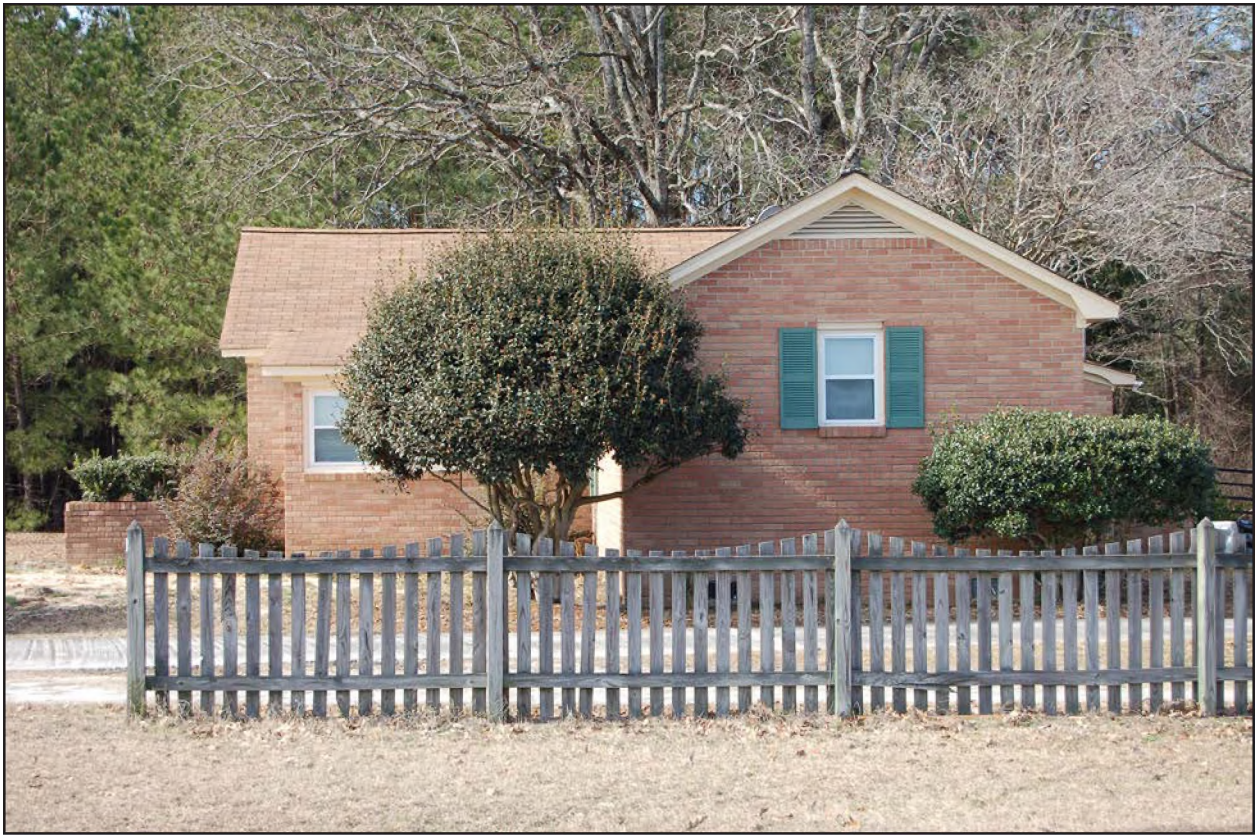
Resource 0989, the Mathias House, is located at 127 Cedar Road, north of Augusta Road and east of I-20 in Lexington County (refer to Figure 5.1). The Lexington County tax assessor record indicates the date of construction was 1957. This resource is a Ranch house (see Figures 5.22 and 5.23). It appears to have historically had a T-shaped footprint, but now has a gable projection added to the east side. The exterior is clad with brick, but this may have been added at the time of the side gable addition. It has an off-center front door that leads to a concrete patio lined with brick planters. Windows are single and paired and are non-historic vinyl replacements. The house is situated along a secondary road but is adjacent to an interstate. It has an open lawn, paved driveway, and mature trees at the rear and side of the property.

**Figure 5.22.** Resource 0989 - Façade view of house, facing north.

**Figure 5.23.** Resource 0989 - East elevation of house, facing west.

However, it is not a significant illustration of that type. Because Ranch houses are a ubiquitous type with an overwhelming number of extant examples, they should possess clear significance and excellent integrity to be considered eligible for listing in the NRHP. The resource has some of the elements required to convey significance as a good example of a Ranch; however, it lacks a carport or garage, a prominent chimney, decorative windows, and the steel or aluminum casement or sliding windows that are characteristic of South Carolina Ranches. It has also had changes that have impacted the integrity of design, setting, materials, workmanship, feeling, and association. These include the large side addition, likely alteration of exterior materials, and addition of two non-historic outbuildings. Because it lacks key Ranch house features and has lost integrity in several areas it cannot convey significance in the area of architecture. Therefore, Resource 0989 is recommended **Not Eligible** for listing in the NRHP under Criterion C.

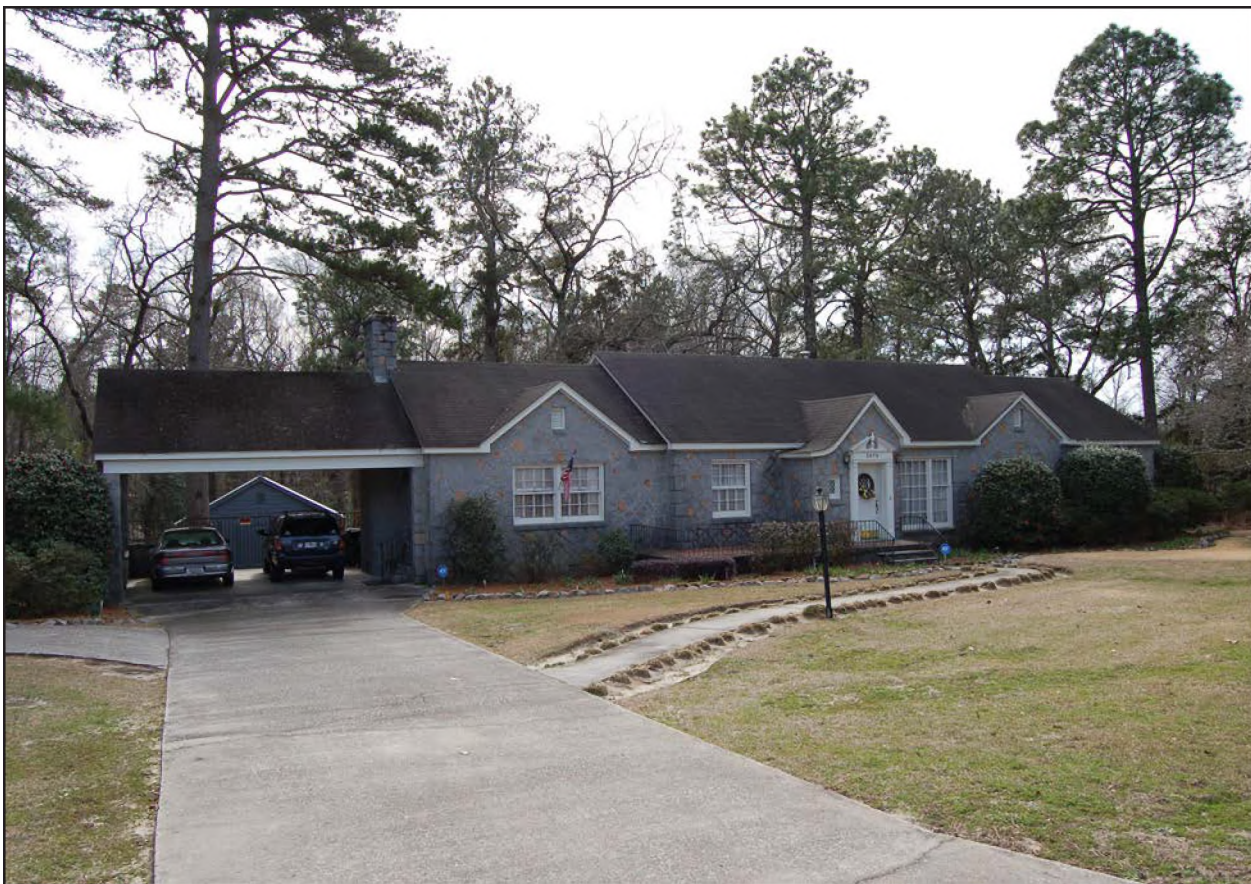
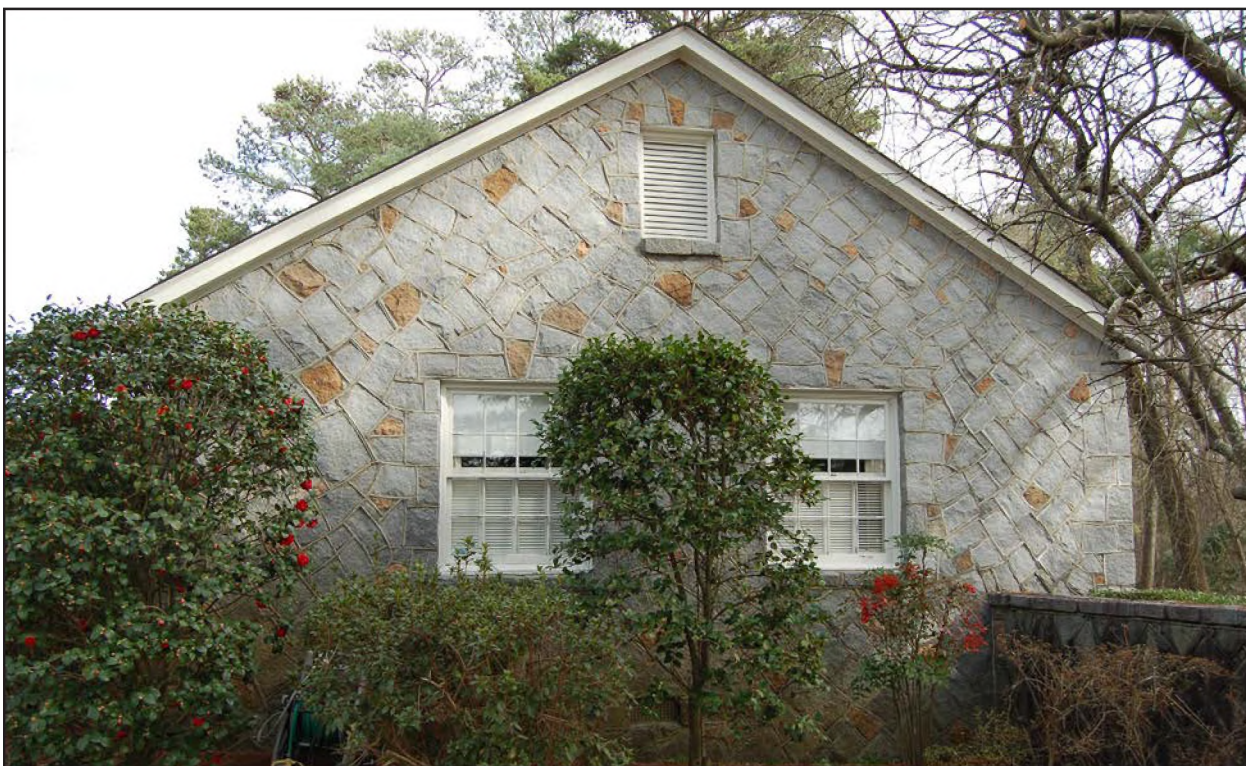
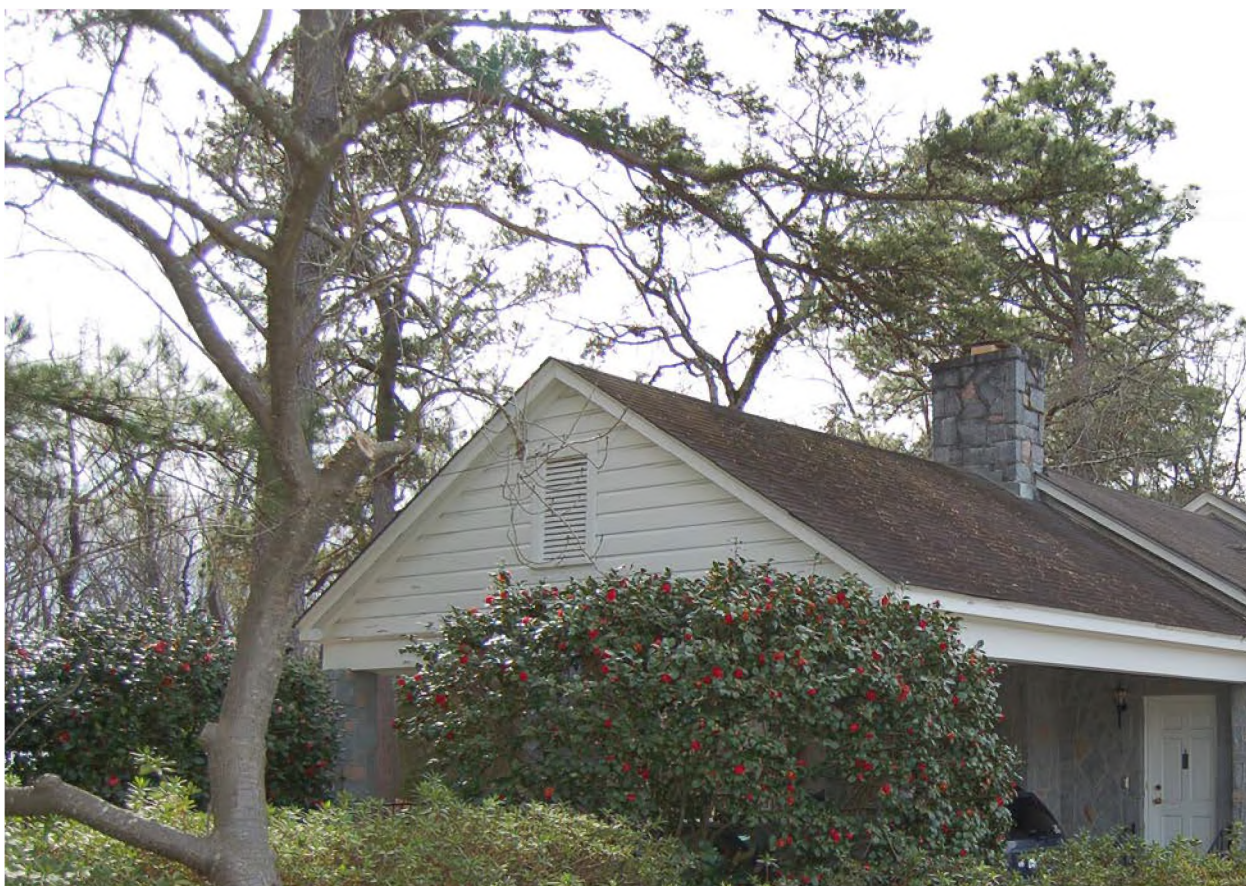
Resource 0990, the Caughman Sr. House, is located at 5079 Augusta Road on the south side of the roadway just east of the intersection with Morgan Drive in Lexington County (refer to Figure 5.1). The Lexington County tax assessor record indicates the date of construction was 1951. This house is one of several in the vicinity associated with the Caughman family. A larger parcel of land was previously owned by the family, but between the 1950s and 1960s most of the land was sold. Smaller parcels along the highway were purchased and/or retained by family members. During this time, members of the family and their associates employed a local builder, Parnell Cannon, to erect houses on these smaller lots. House designs were based on a catalog of standard plans. This resource is single-story linear house with a stone exterior and side gabled roof (see Figures 5.27 – 5.29). It has a double carport at one side. It has a stone chimney between the exterior wall and carport. There are several multi-light wood windows at the facade, including a tripartite window near the front door. A low porch with metal railings leads to a single front entry door with

**Figure 5.27.** Resource 0991 - Façade view of house, facing south.

**Figure 5.28.** Resource 0991 - West elevation, facing east.

**Figure 5.29.** Resource 0991 - Northeast oblique view of house, facing southwest.

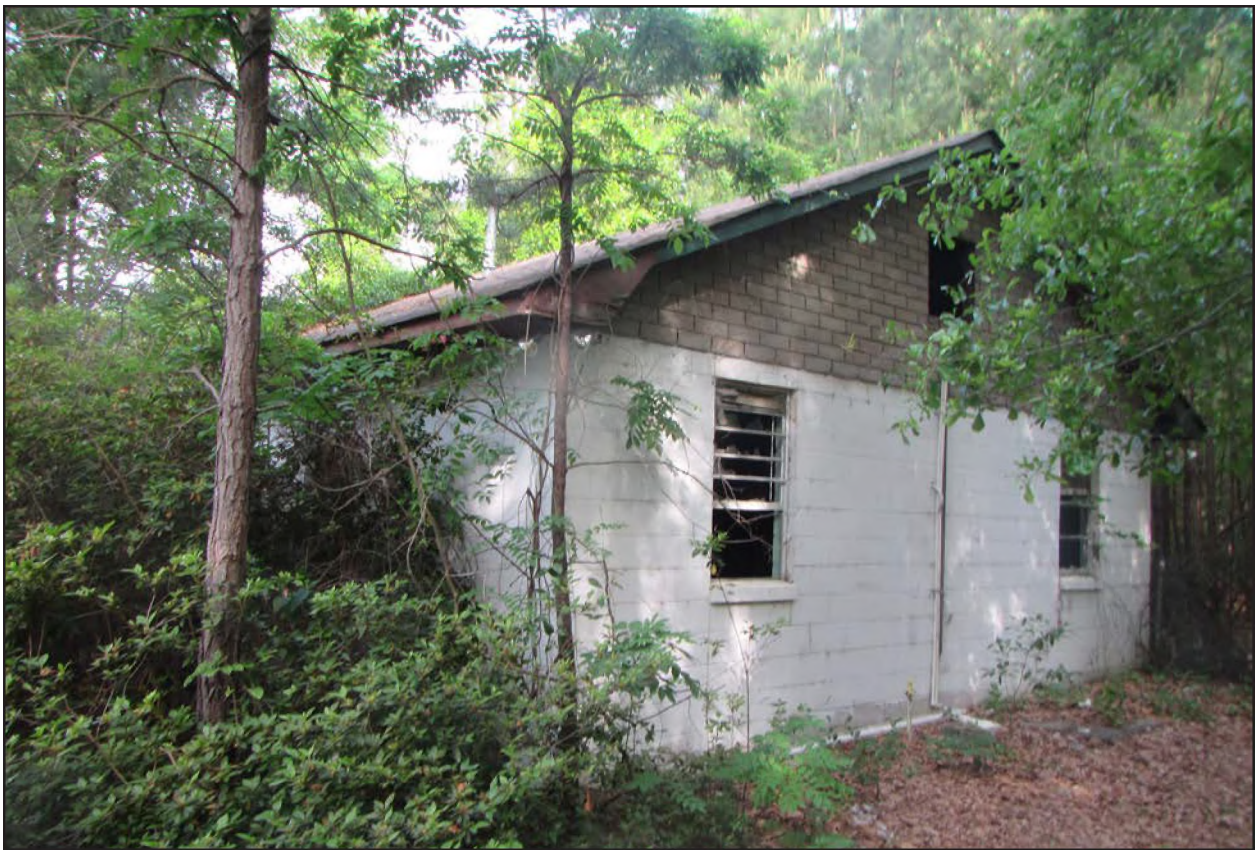
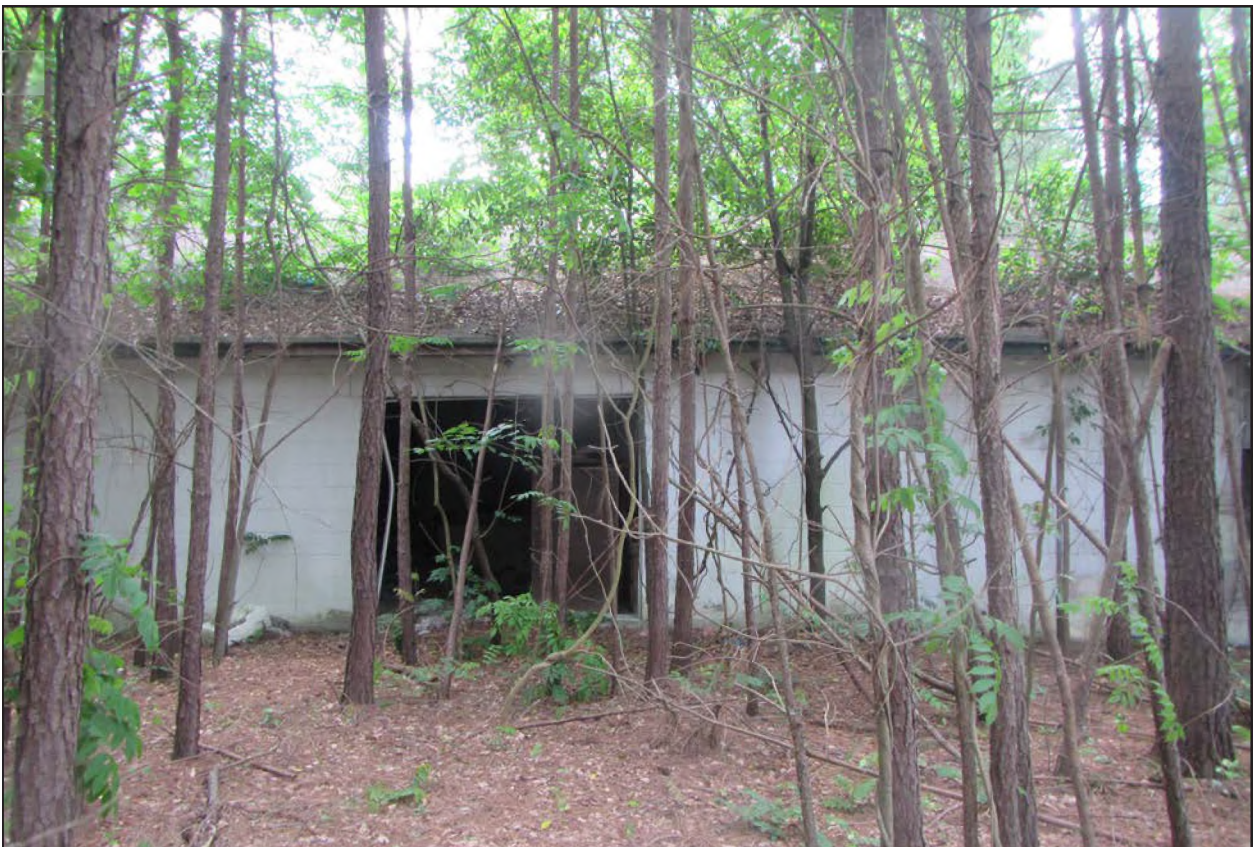
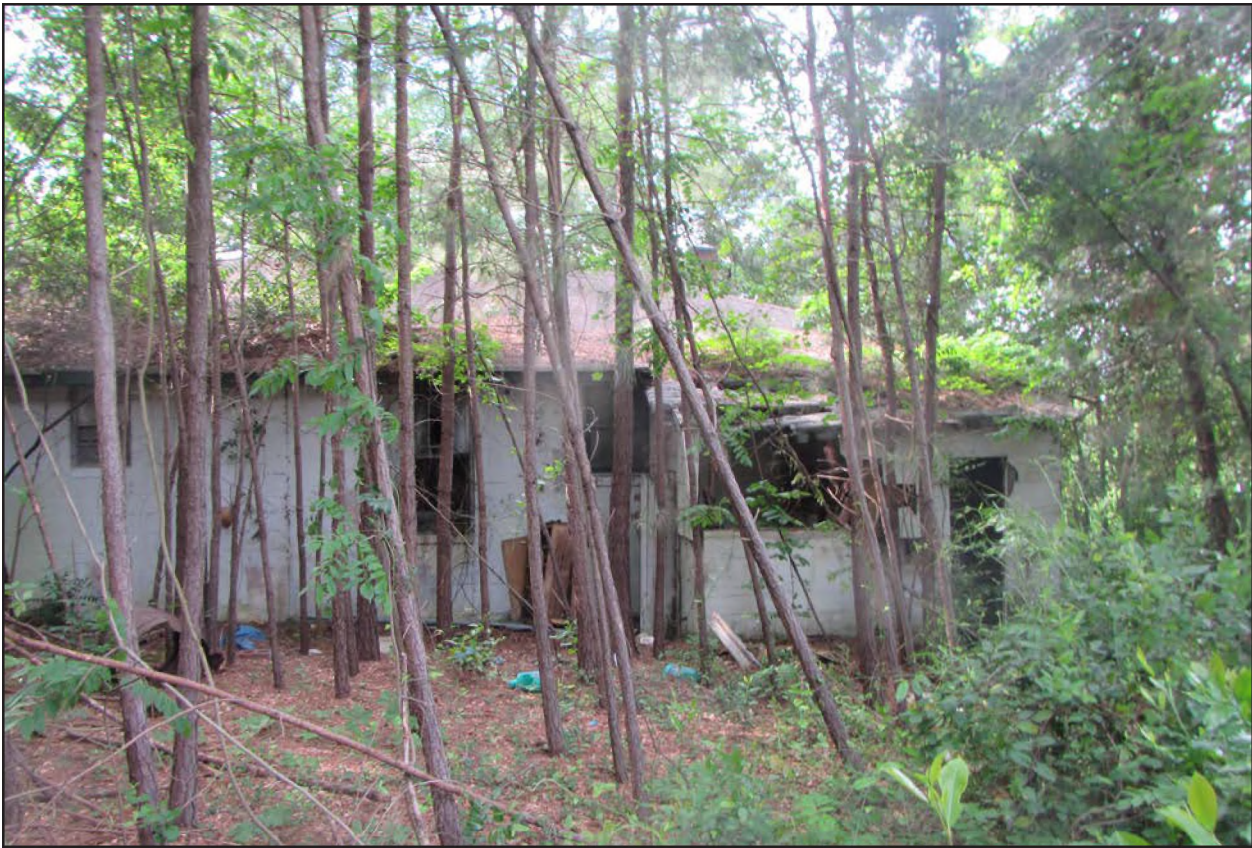
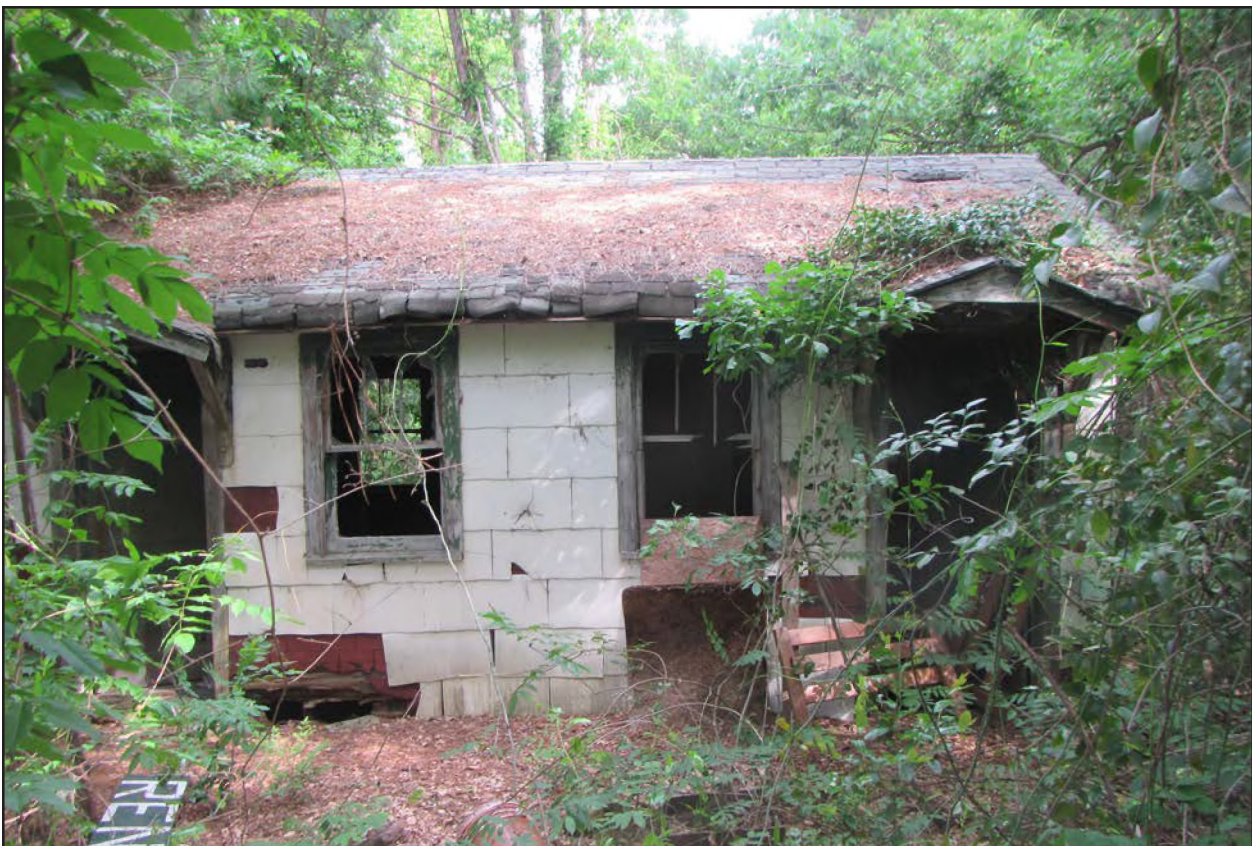
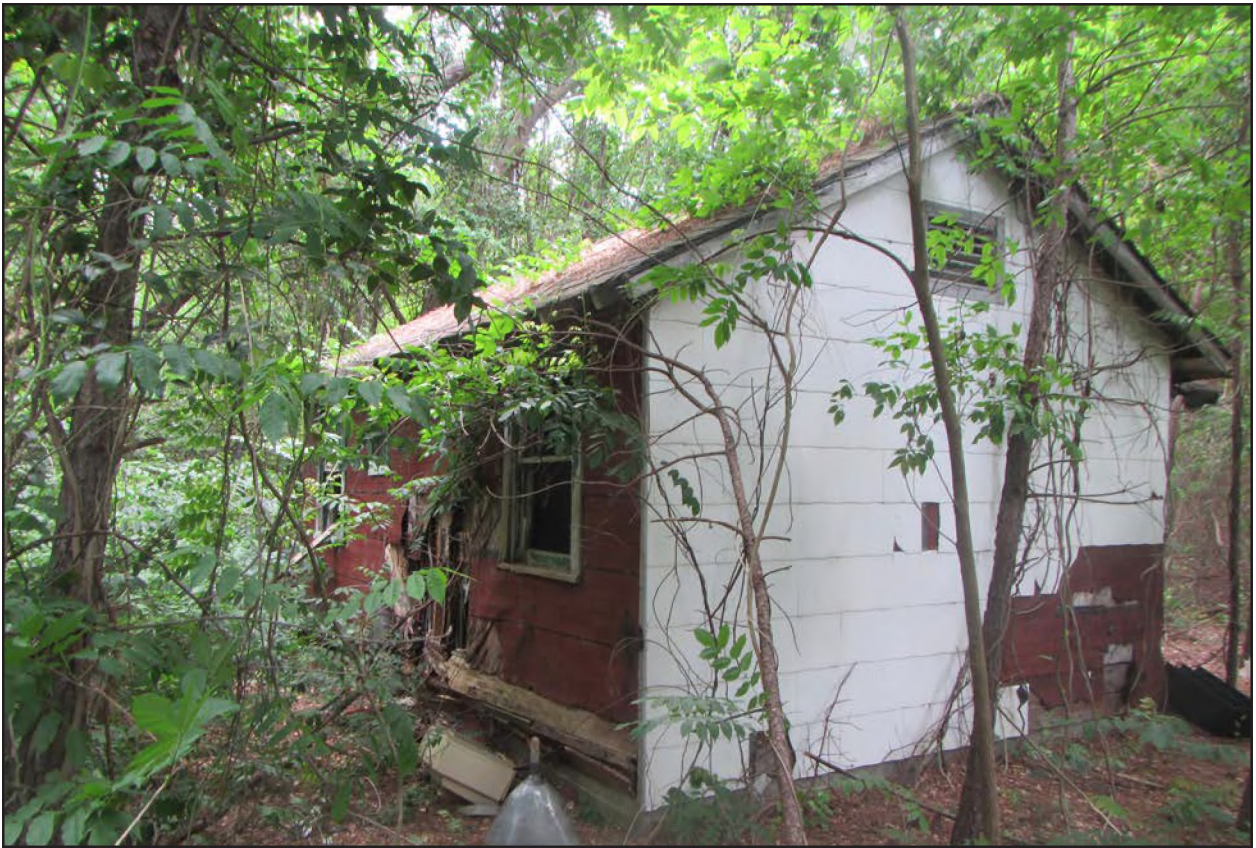
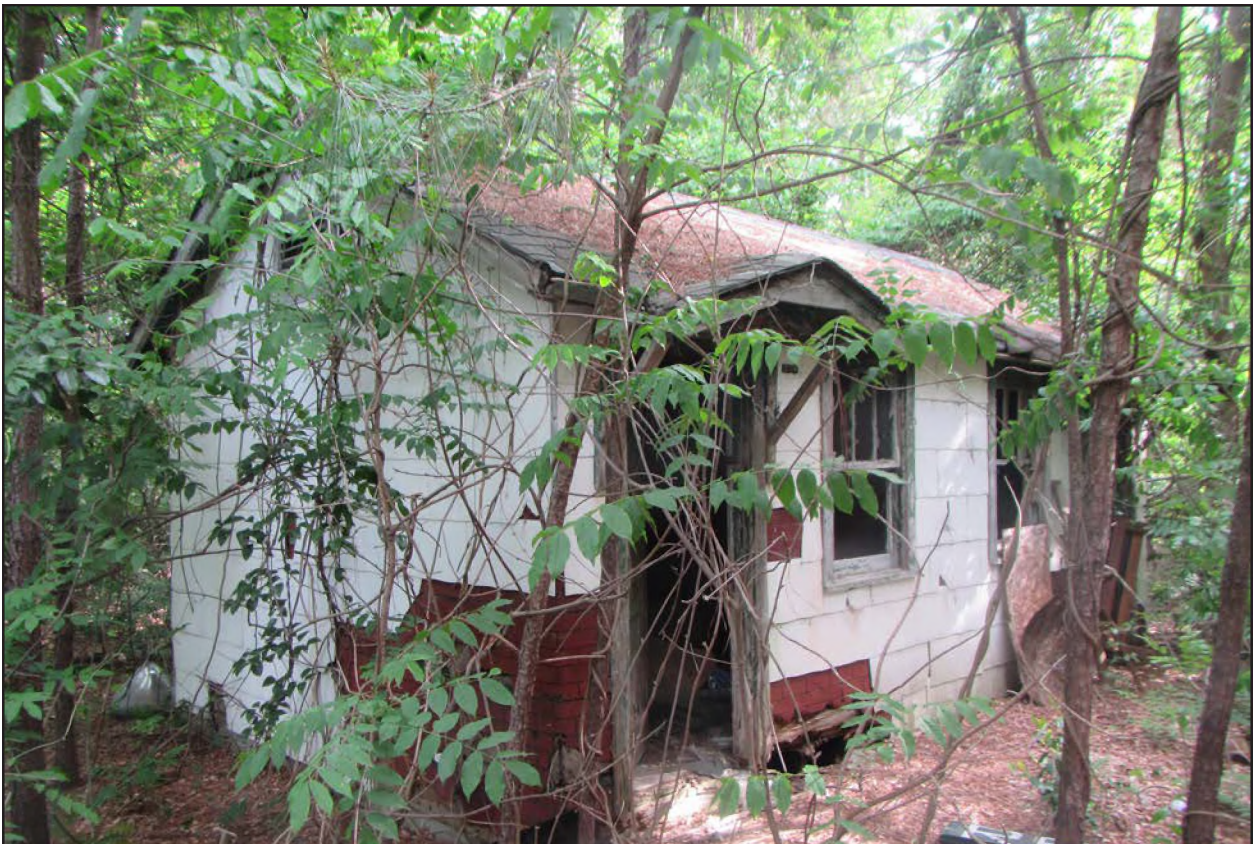
Resource 0992, a commercial property, is located at 5140 Augusta Road on the north side of the roadway just east of the intersection with Carlen Avenue in Lexington County (refer to Figure 5.1). The Lexington County tax assessor record indicates the date of construction was 1950. This property appears to have been used as a hotel (cabin camp) or rental units, and originally included at least four buildings, based on a 1974 topographic map of the area. There are two structures on the property currently. These include a larger concrete block building and a smaller frame structure (Resource 0992.1) (see Figures 5.30 – 5.35). The larger building sits close to the roadway and is a single-story concrete block structure with a side gabled roof. Asphalt shingle siding is at the gable ends. Windows, where present, have single, 2/2 aluminum sashes. A small shed projection is on the rear elevation as is a garage door opening. The smaller building appears to contain rental units. It is a single-story frame structure with a side gabled roof. Asbestos shingle siding is over asphalt shingle siding on the exterior. The building has a symmetrical facade with two windows at the center and doors on either end. Windows are 3/1 wood sashes, doors have been removed. Small gable projections with wood bracket supports shelter each doorway. The resource property is overgrown with trees and other vegetation and is situated along a busy highway.

**Figure 5.30.** Southeast oblique view of commercial building, facing northwest.

**Figure 5.31.** North elevation of commercial building, facing south.

**Figure 5.32.** North elevation of commercial building, facing south.

**Figure 5.33.** North elevation of smaller commercial building, facing southeast.

**Figure 5.34.** Northwest oblique of smaller commercial building, facing east.

**Figure 5.35.** Southwest oblique of smaller commercial building, facing northeast.

historically significant. Despite the apparent historical use of this property as hotel or rental units, there is no evidence that this use was significant to the development or social history of the area. Therefore, there was no basis for evaluating the resource under Criterion A or B. Also, there are no indications that the resource is likely to yield information on important research questions in history or prehistory. The resource does not appear to have the potential to be the principal source of important information. Therefore, there was no basis for evaluating the resource under Criterion D. The resource does appear to have been a type of lodging popular in the early-to-mid twentieth century, the cabin camp. These were typically groupings of individual structures with convenient access for automobiles which were rented under short term arrangements. Although this property appears to have served this purpose, it is not a good representation of this type of lodging. There were historically several buildings on the property similar to the remaining frame structure. The function of the larger, concrete block building is unclear, but it may have been the main office and/or lodging for the proprietor. The integrity of the property is poor, with the concrete block building of indeterminate function, the loss of several rental units, and the deterioration and material loss of the remaining rental unit. Without its historic arrangement of multiple units, this property is not a good illustration of the cabin camp type of lodging. Because it does not retain architectural integrity in the areas of design, setting, materials, workmanship, feeling, or association, it cannot convey significance in the area of architecture. Therefore, Resource 0992 is recommended **Not Eligible** for listing in the NRHP under Criterion C.
