**PHASE I CULTURAL RESOURCE SURVEY OF THE PROPOSED  
US 1 BRIDGE REPLACEMENT OVER I-20 AND INTERCHANGE  
IMPROVEMENTS, LEXINGTON COUNTY, SOUTH CAROLINA**

**REVISED DRAFT REPORT**

**JUNE 2019**

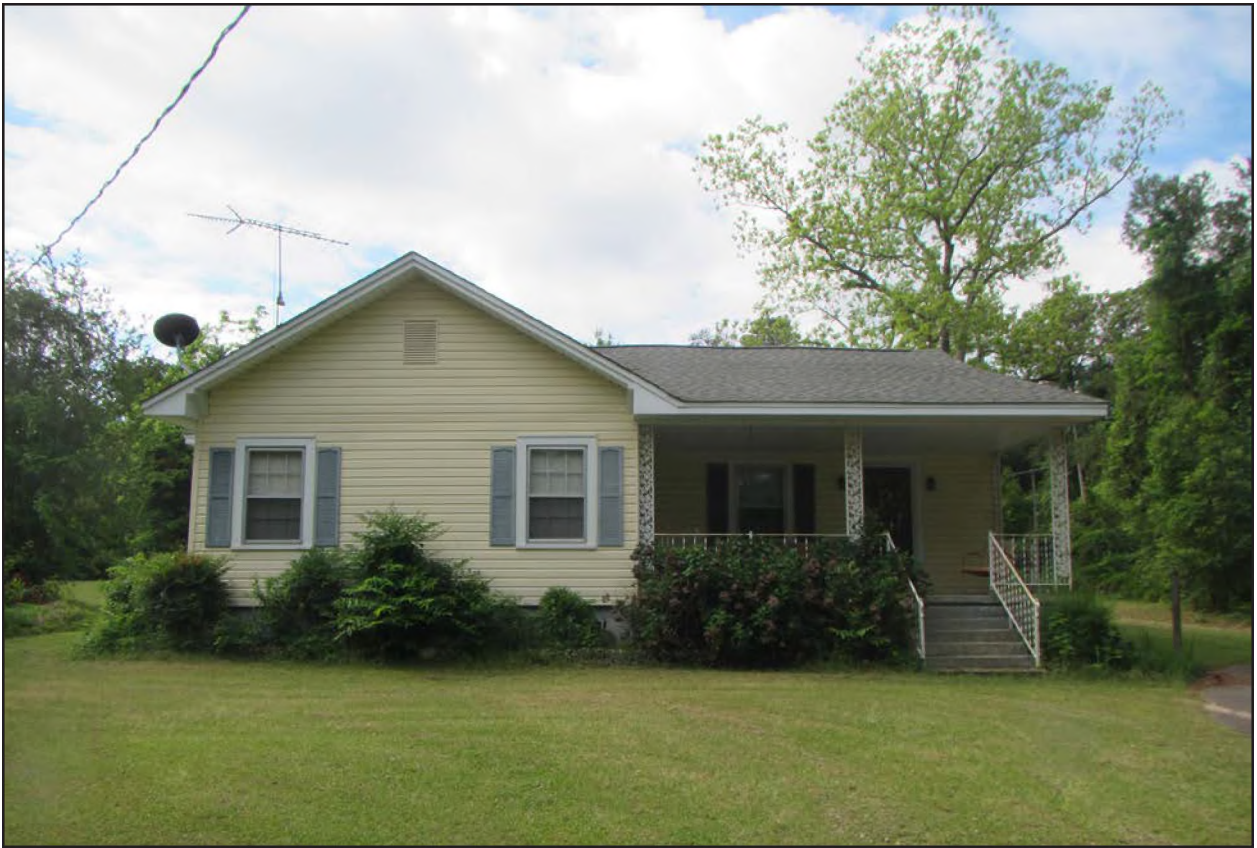
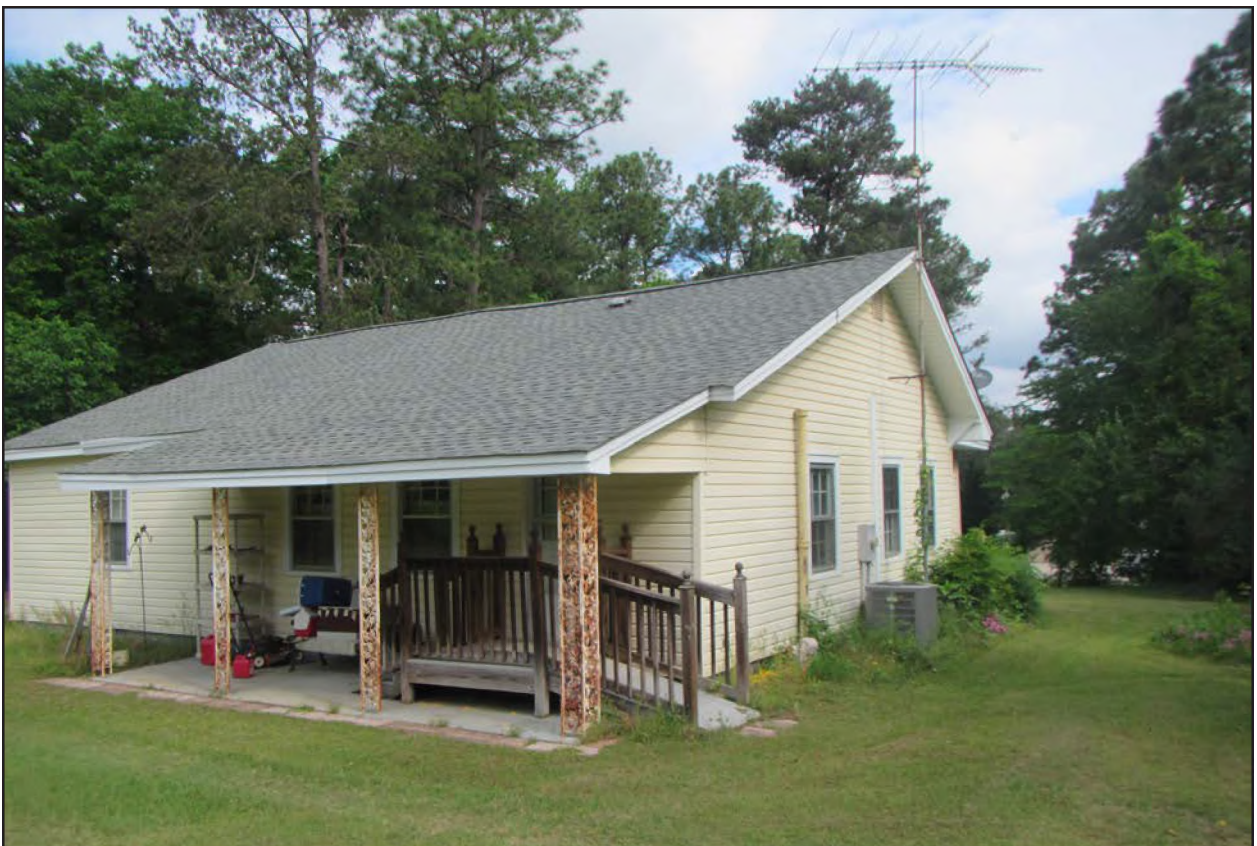
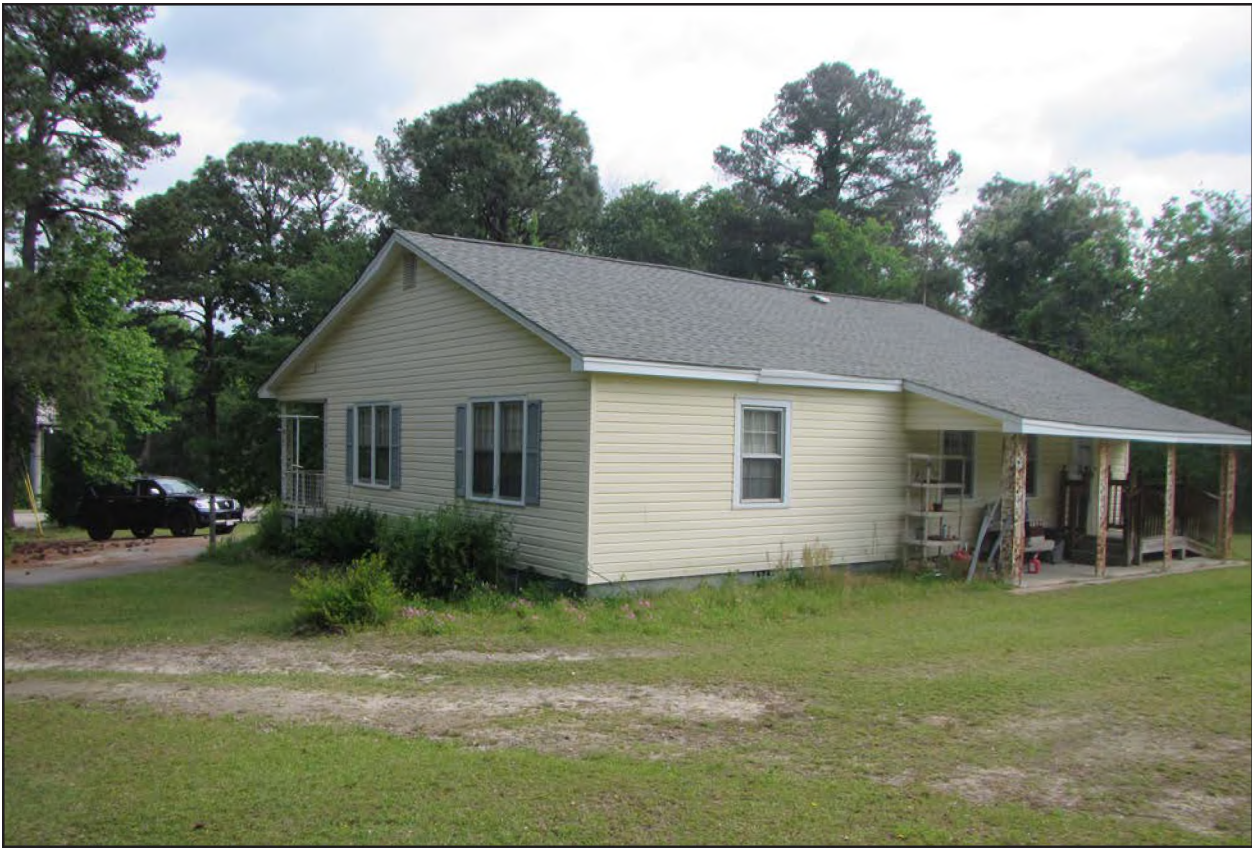
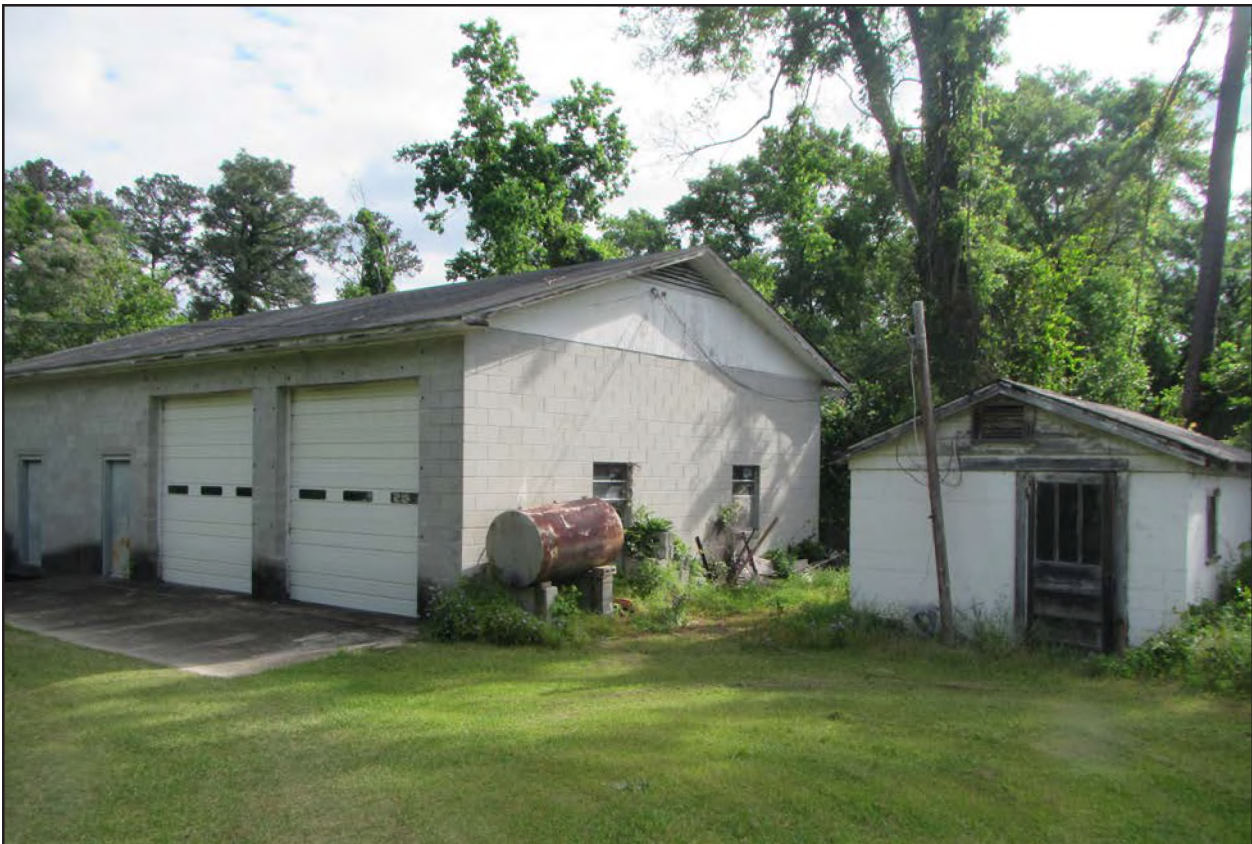
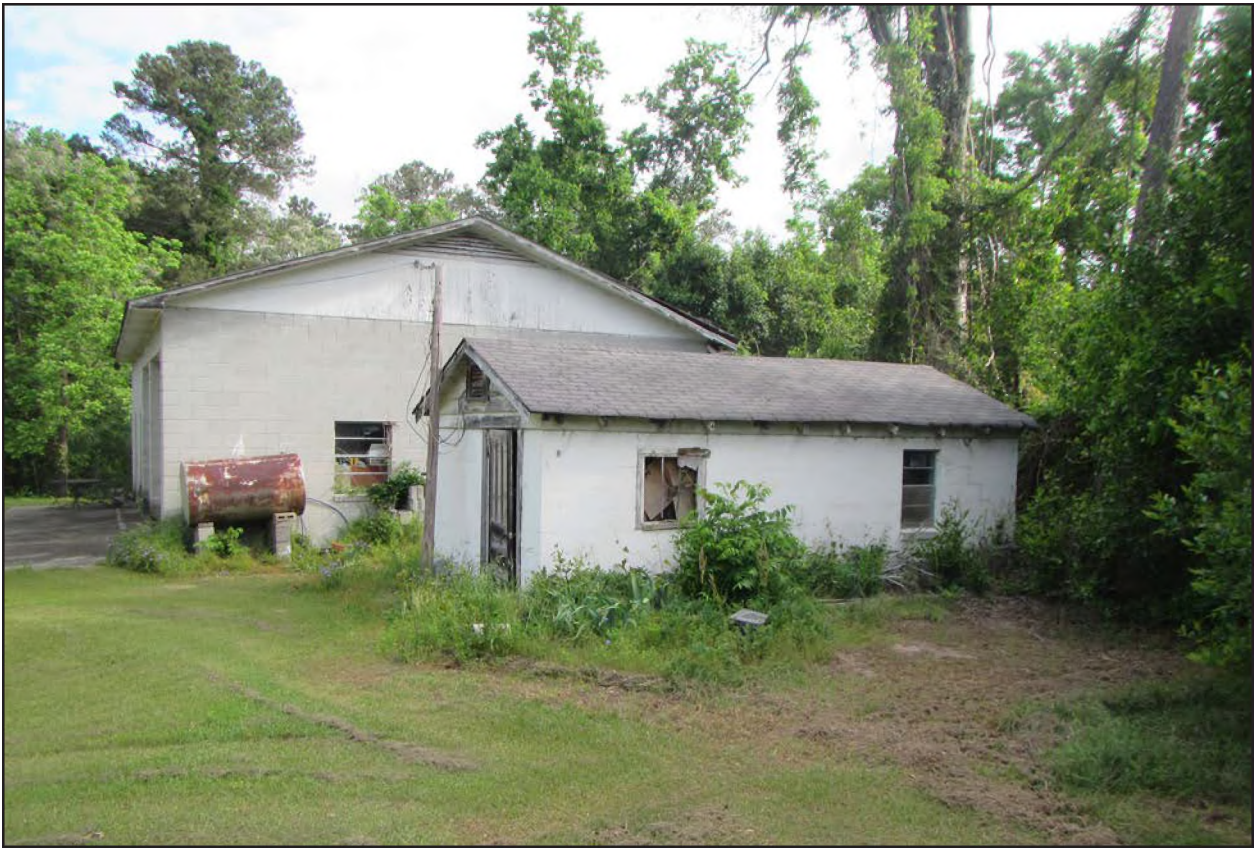
Resource 0993, the Enlow House, is located at 4801 Augusta Road on the south side of the roadway approximately 0.3 miles east of Cedar Road in Lexington County (refer to Figure 5.1). The Lexington County tax assessor record indicates the date of construction was 1940. The house has non-historic vinyl siding and non-historic vinyl windows. The date of these replacements is unknown (see Figures 5.36 – 5.40). This resource is a single-story house with a vinyl clad exterior and side gable roof. A front gable projection is on the eastern end of the facade. There is a shed porch on the western end of the facade and a shed porch at the rear. Both porches have scrolled metal supports. Windows are single, 6/6 non-historic vinyl units on all elevations except the west, where there are two pairs of similar non-historic windows. A small historic building is south of the house. It has a concrete block exterior and a gable roof. Two non-historic buildings are also on the lot. Landscaping includes a partially paved driveway and an assortment of shrubs and trees. The resource is situated along a busy highway.

**Figure 5.36.** Façade view of house, facing south.

**Figure 5.37.** Southeast oblique view of house, facing northwest.

**Figure 5.38.** Southwest oblique view of house, facing northeast.

**Figure 5.39.** South elevation of outbuilding with non-historic outbuilding at left, facing east.

**Figure 5.40.** Southwest oblique view of outbuilding with non-historic outbuilding at left, facing northeast.

A or B. Also, there are no indications that the resource is likely to yield information on important research questions in history or prehistory. The resource does not appear to have the potential to be the principal source of important information. Therefore, there was no basis for evaluating the resource under Criterion D. The resource does not represent a recognized architectural type. Therefore, the house does not appear to represent a significant trend in South Carolina's architectural history. Additionally, due to the replacement of historic siding and windows, it has lost integrity in the areas of design, setting, materials, workmanship, feeling, and association and cannot convey significance in the area of architecture. Therefore, Resource 0993 is recommended **Not Eligible** for listing in the NRHP under Criterion C.

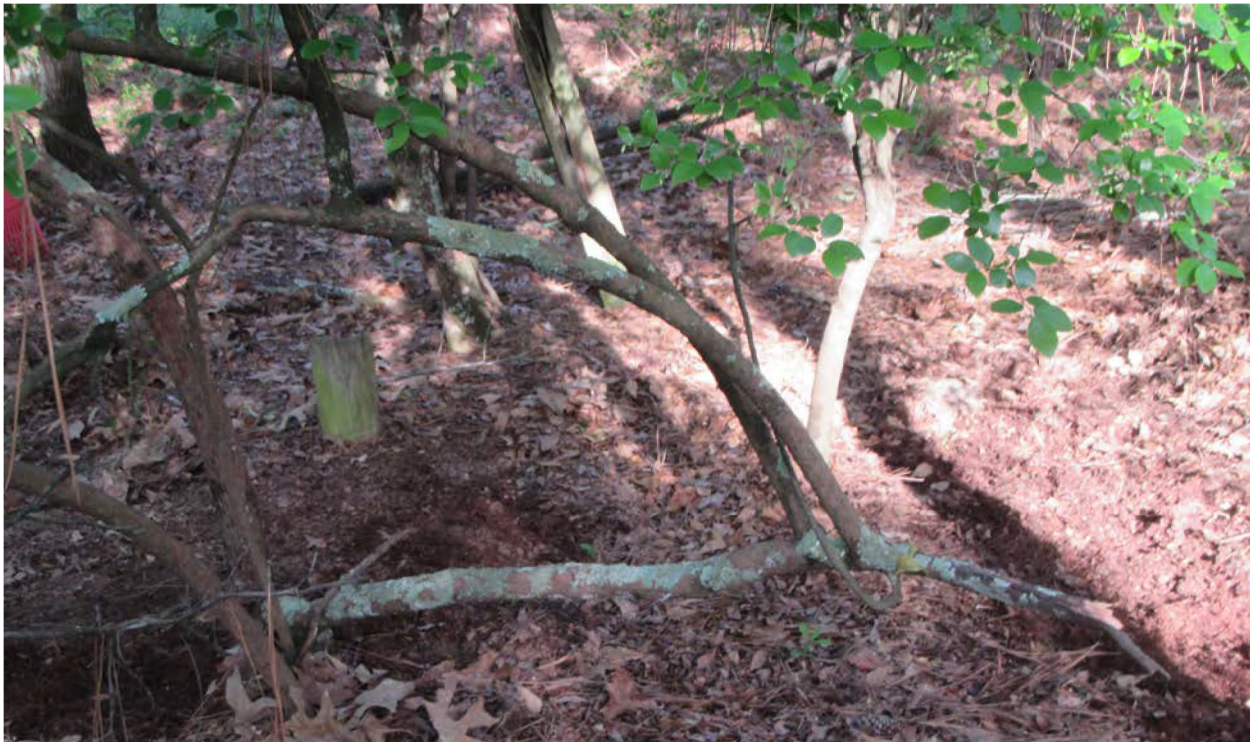
Resource 0994, the Busbee Property Cemetery, was also recorded as archaeological site 38LX679, as discussed in Chapter 4. This resource was identified within the large residential property at 184 Morgan Drive. The above ground aspects of the cemetery include an undecorated wooden marker and two improvised fieldstone grave markers (Figure 5.41). There were also several faint depressions visible near the known markers. The resource is described in greater detail as an archaeological site in Chapter 4. Based on the current investigation, it seems likely that Resource 0994 represents a small family cemetery associated with a tenant family that worked the fields on

**Figure 5.41.** Photograph of Resource 0994, facing northwest.

a farm belonging to Joel Corley. The cemetery is not associated with persons or events significant to the development of Lexington County and the improvised markers do not possess significance in design. Based on this, Resource 0994 is recommended as **Not Eligible** for NRHP listing under Criteria A, B, and C. As discussed in Chapter 4, the resource is considered of **Unknown** eligibility under Criterion D as it has not yielded data significant to the culture history of the study area thus far; however, no excavation or intensive historic investigation has yet been conducted. It is recommended that a 30-meter buffer be established around this resource and all impacts to the cemetery and buffer should be avoided. This boundary (see Figure 4.29) should be marked on all project plans and in the field during construction.
