ARCHAEOLOGICAL FIELD REPORT
SCDOT ENVIRONMENTAL SECTION

TITLE: Cultural Resources Survey for SC 72 (Saluda Road) and S-329 (McCandless Road) Intersection Improvement, Chester County, South Carolina (Revised Alignment)

PROJECT: SC 72 and S-329 Intersection Improvement

TITLE: Cultural Resources Survey – SC 72 (Saluda Rd) and S-329 (McCandless Rd) Intersection Improvement, Chester County, South Carolina.

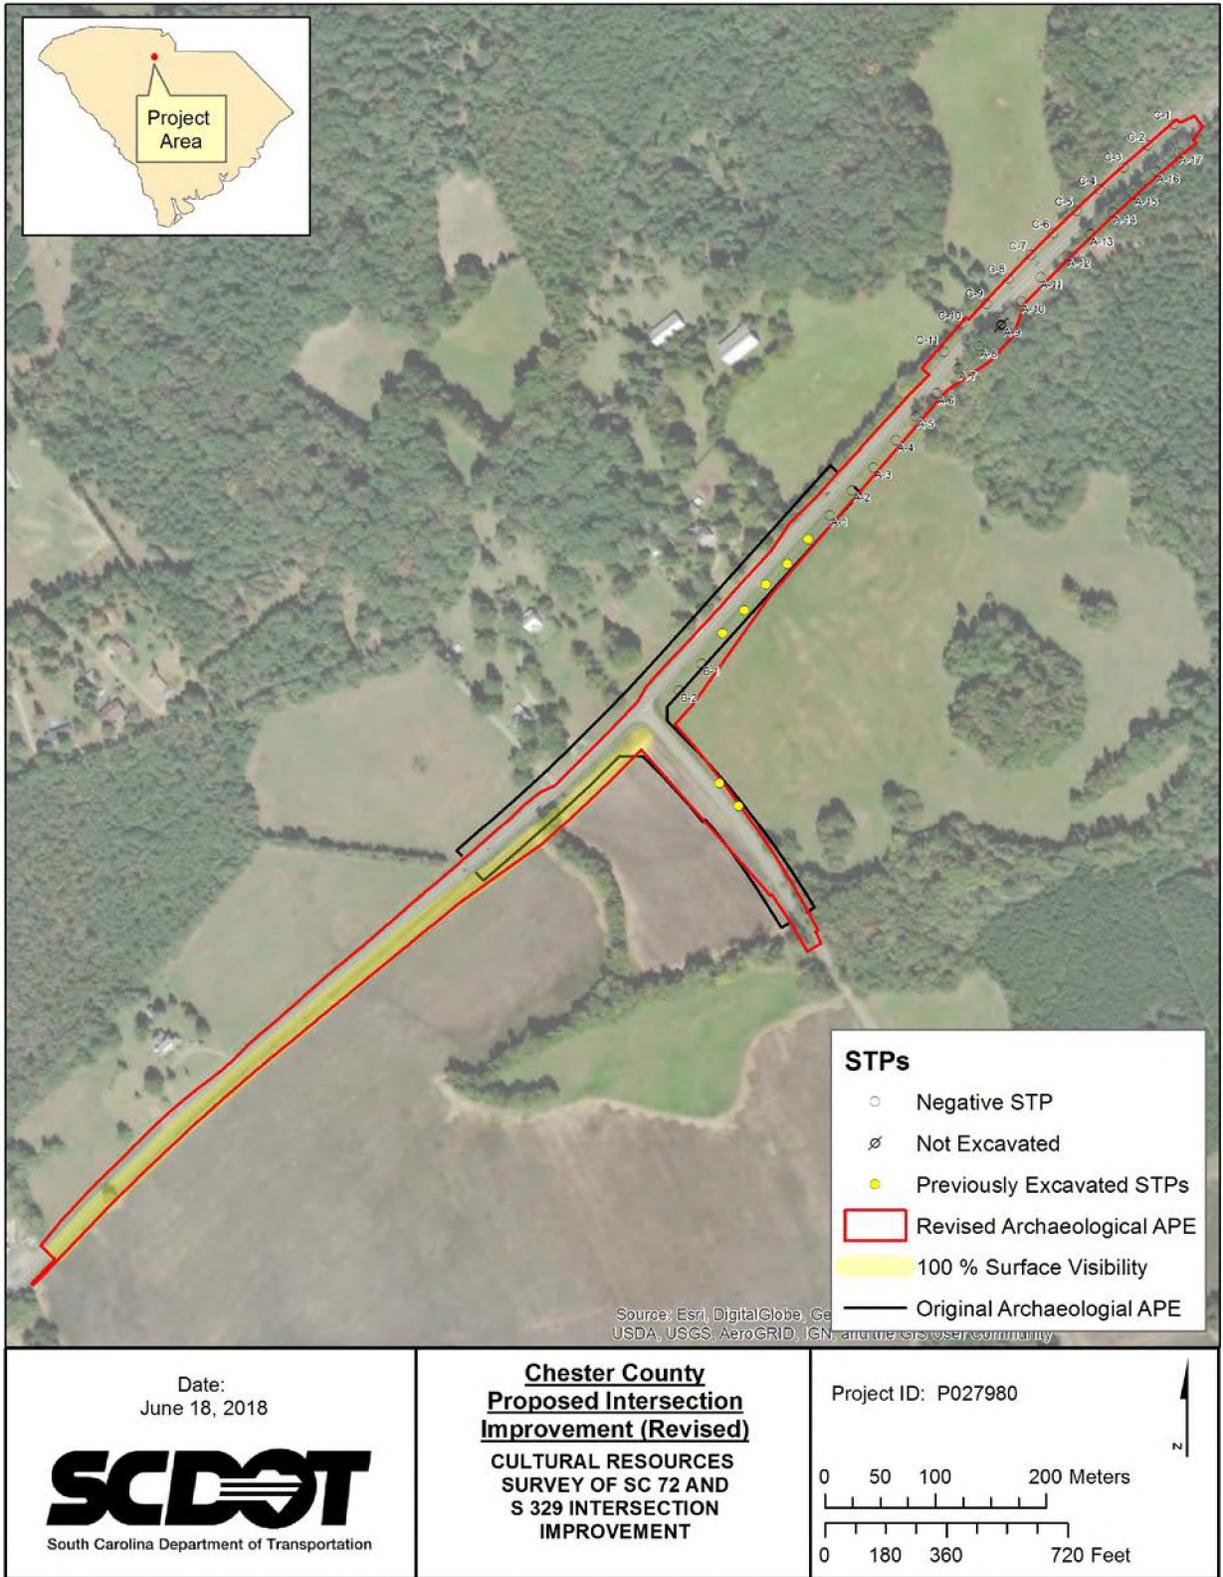
Figure 10. Map Showing Shovel Test Locations and Original and Revised Project Areas.

ARCHAEOLOGICAL SURVEY RESULTS: A total of 29 STPs were excavated on the northwest and southeast sides of SC 72 northeast of the intersection. This included 18 on the southeast side (not including one that was unexcavated due to slope) and 11 along the northwest side. Both original STPs and new STPs are shown on **Figure 10**. The portion of the new project area on the southeast side of SC 72 southwest of the SC 72 and S-329 intersection was a cultivated agricultural field with 80 – 100 percent surface visibility (**Figure 11a**). This area was visually inspected for artifacts. The portions of the revised project area on the northwest side of SC 72 southwest of the intersection and along McCandless Road were found to be heavily disturbed, most notably by underground utility lines, including a buried telephone line and a buried high pressure gas line (**Figures 11b – 12a**). Steep road berms and cut banks were also present in portions of project area, most notably in the area northwest of the intersection (**Figure 12b**). No artifacts or surface-level archaeological features were noted during the survey.

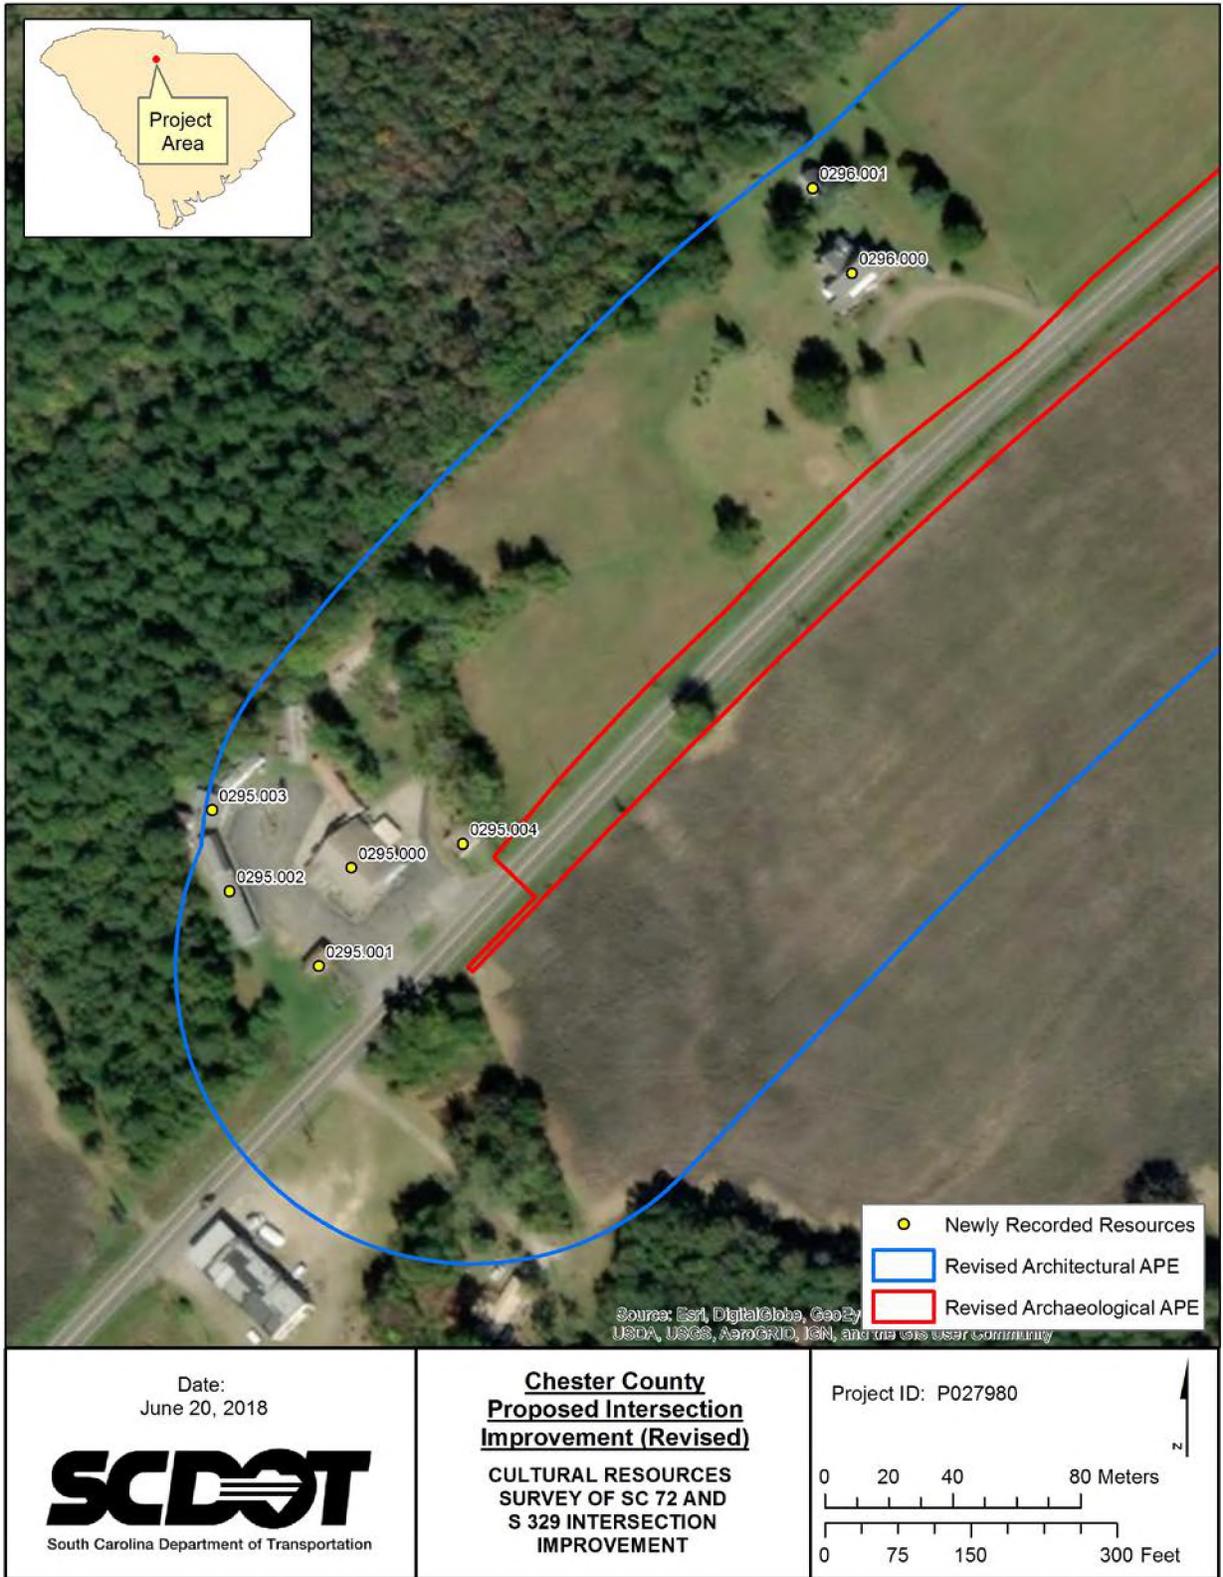
Figure 13. Map Showing Newly Recorded Historic Resources.

ARCHITECTURAL SURVEY: A historical resources survey of the project area was conducted on June 14, 2018. Site survey methods consisted of a visual examination of all buildings within the Architectural APE that were not recorded during the original survey. Two (2) resources (site #s 0295 and 0296) within the Architectural APE were evaluated to be survey-eligible. **Figure 13** shows the location of the two newly recorded architectural resources.

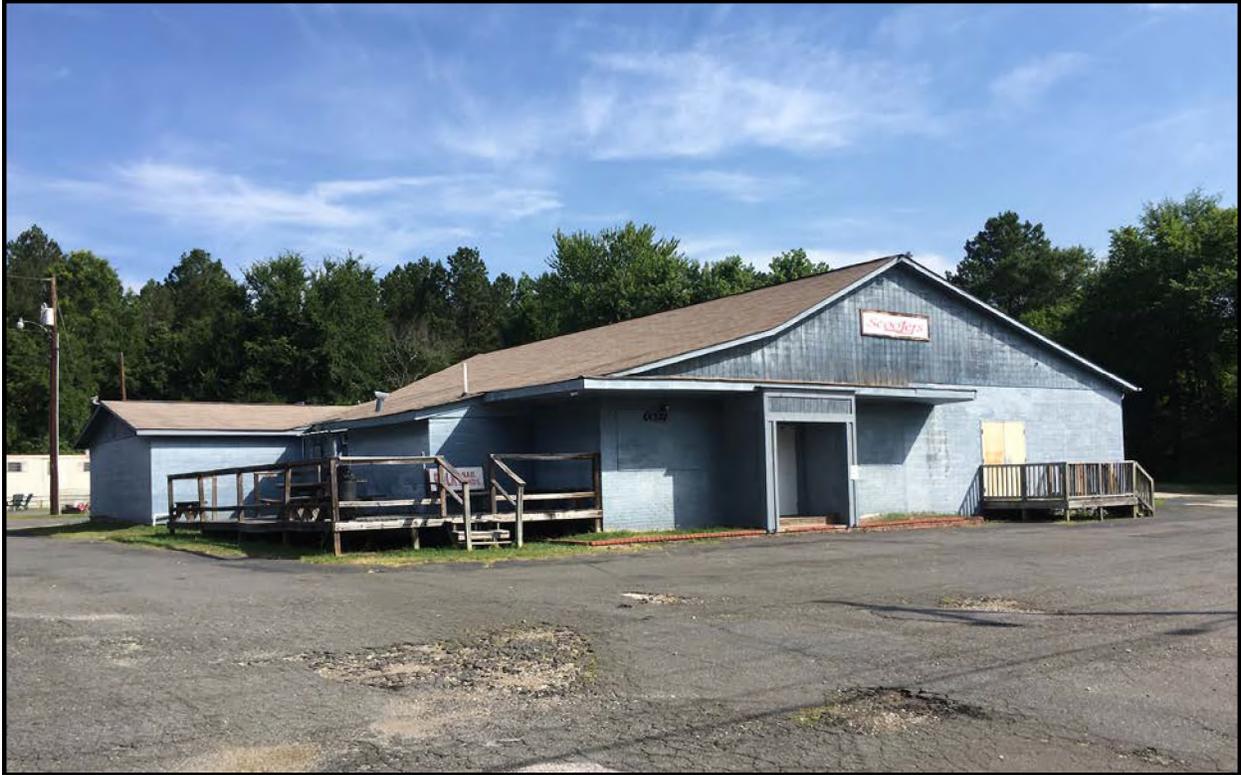
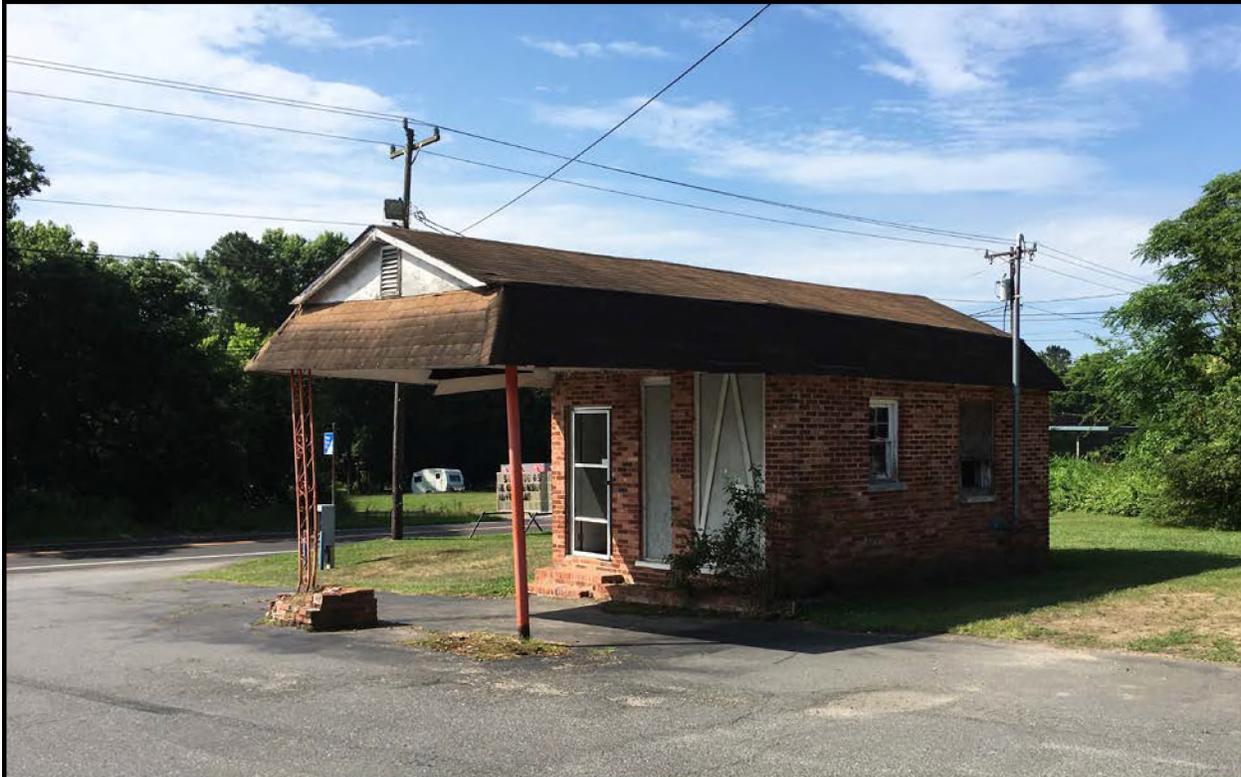
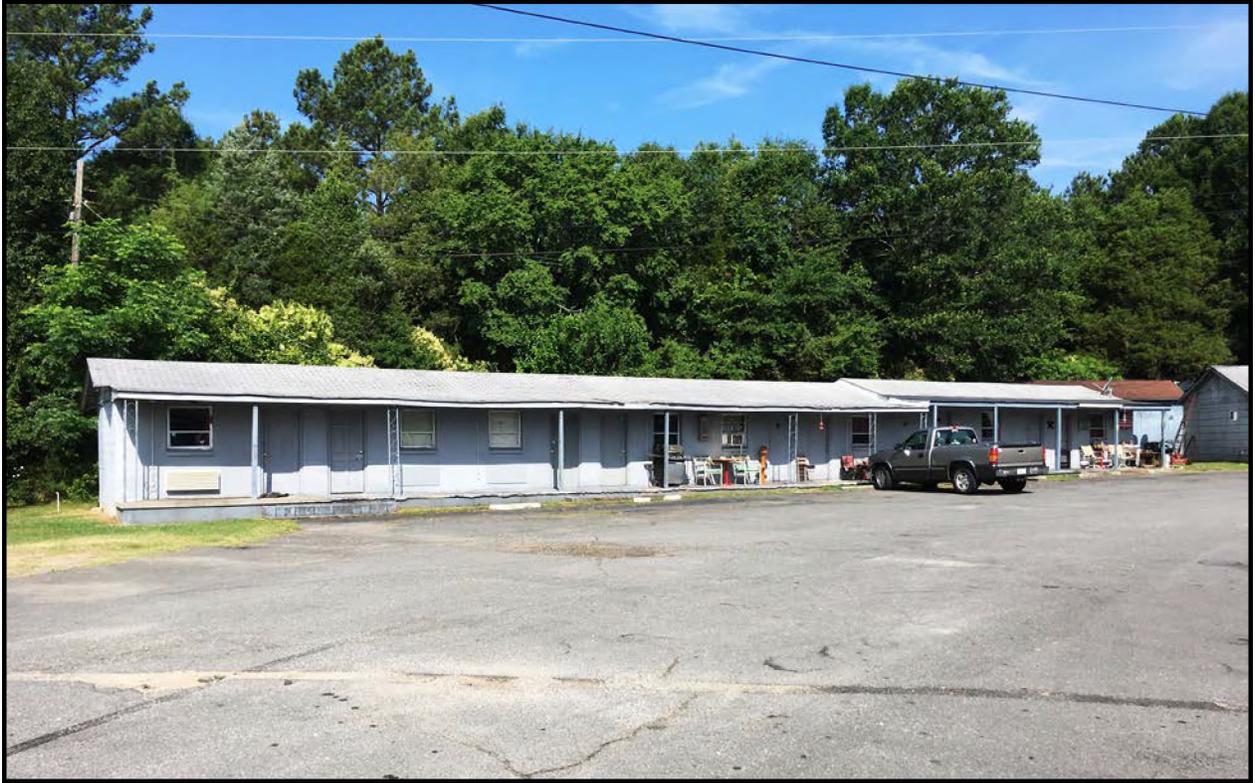
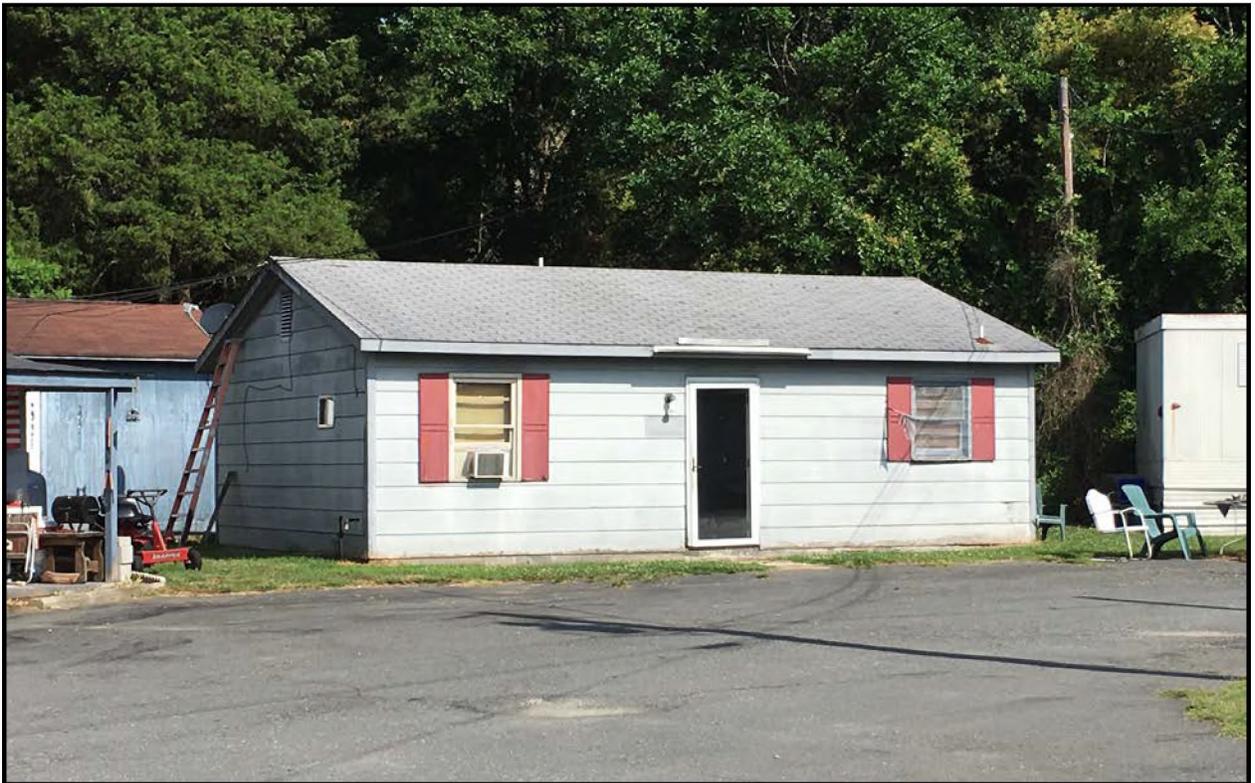
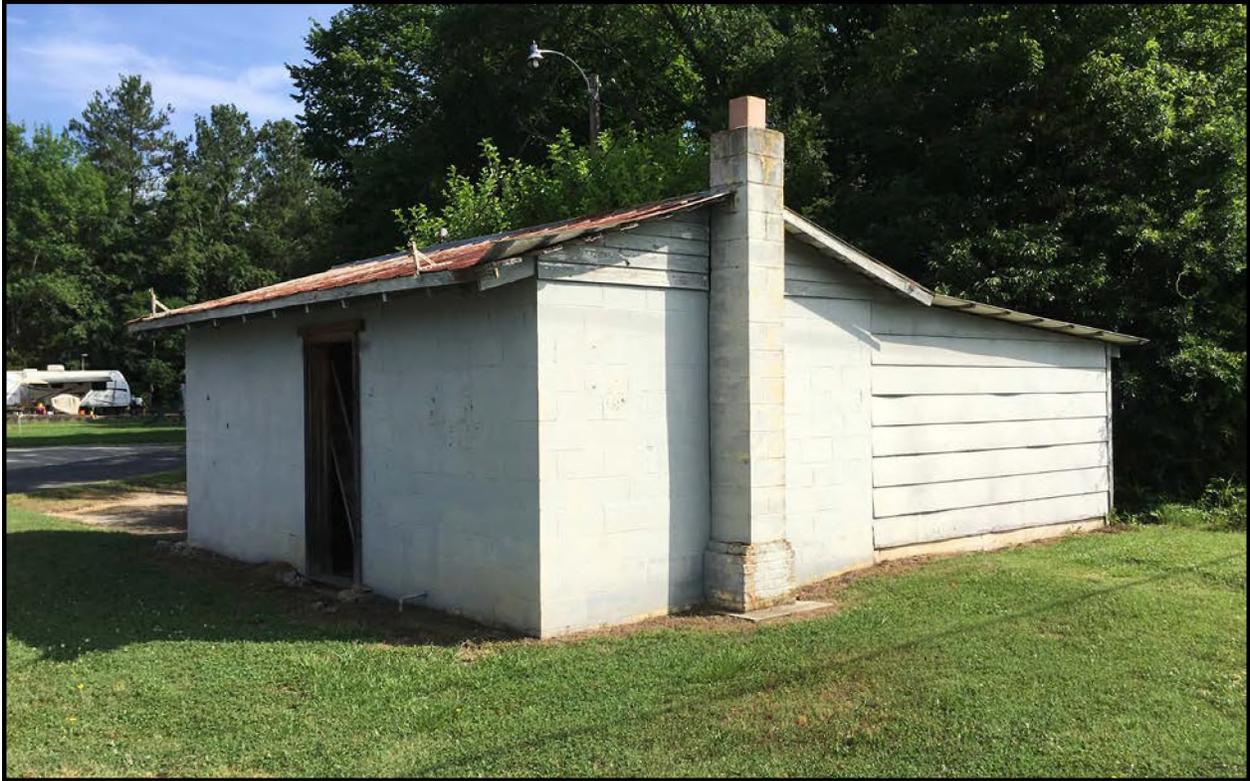
ARCHITECTURAL SURVEY RESULTS: Two (2) newly-identified resources (site #s 0295 and 0296) were identified within the Architectural APE. Site # 0295 is a circa 1950 motor court or lodging and entertainment complex with assorted buildings that appear to have contained lodging facilities, an office, management/owner lodging, and a bar/restaurant building (**Figures 14 – 16a**). Site # 0296 is a circa 1940 residence (**Figures 16b – 17**). After consideration under all the criteria of the National Register of Historic Places (NRHP) neither site is

recommended eligible for the NRHP. Site # 0295 appears to lack integrity and does not currently convey a sense of an intact or significant motor court facility. Site # 0296 has had minor alterations (vinyl siding, etc.) but still conveys its historic appearance. However, it does not appear to have sufficient merit under the most likely criterion (Criterion C for architecture) to be considered NRHP eligible, as it is a good but otherwise unexceptional example of a colonial revival house.

REMARKS AND RECOMMENDATIONS: The cultural resources survey for the proposed revised improvements to the intersection of SC 72 (Saluda Road) and S-329 (McCandless Road) in Chester County resulted in the identification of two additional architectural resources. Both of the architectural resources are recommended ineligible for the NRHP. No historic properties will be affected by the proposed undertaking. No additional cultural resources investigations are recommended.

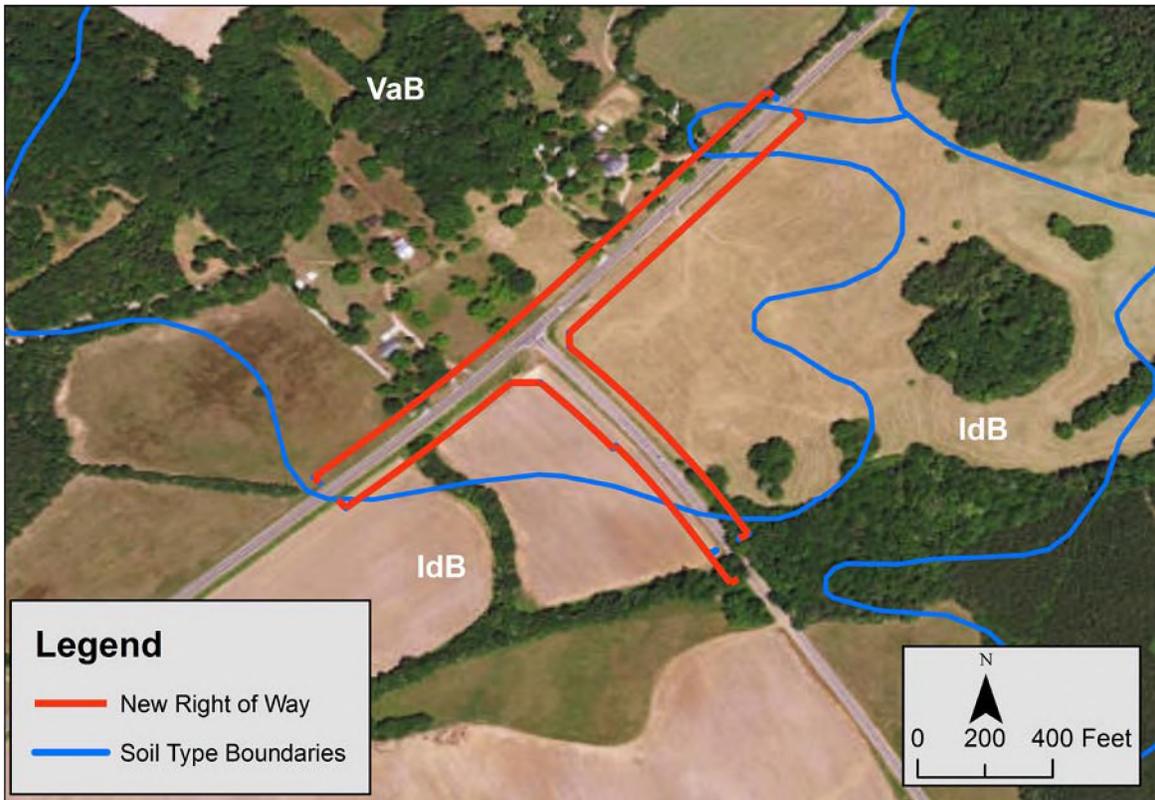
Figure 4 – Soils in the Project Area.

In general, soils in the project area consist of a shallow well drained to somewhat poorly drained sandy loam Ap horizon overlying clay (**Figure 4**).

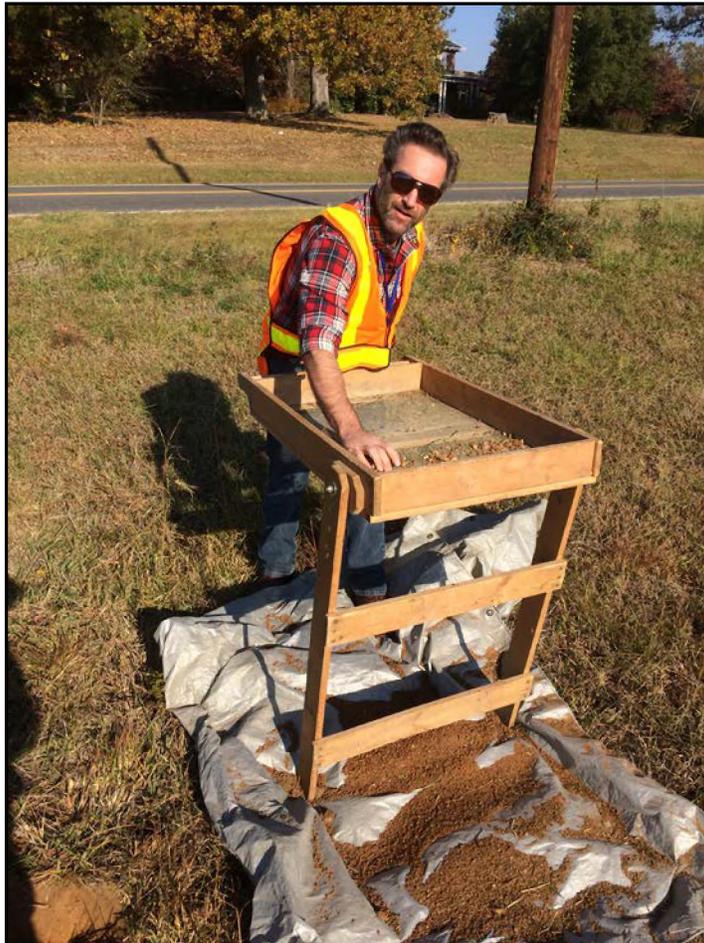
ARCHAEOLOGICAL SURVEY: An archaeological survey of the project area was conducted on November 18, 2016. Survey methods consisted of a pedestrian reconnaissance of the entire project area augmented by the excavation of shovel test pits (STPs) in areas of poor ground visibility. Shovel tests were not excavated in areas that were heavily disturbed, steeply sloping, or within obvious wetlands. Shovel tests averaged about 30 centimeters in diameter, and were excavated until sterile subsoil was encountered or further excavation was impractical due to the presence of rocks or large roots. All of the fill from the STPs was screened through 0.25-inch mesh hardware cloth to facilitate the recovery of any artifacts that might be present (**Figure 9**).

Figure 9 – Screening a shovel test pit within the SC 72 - S-329 project area.

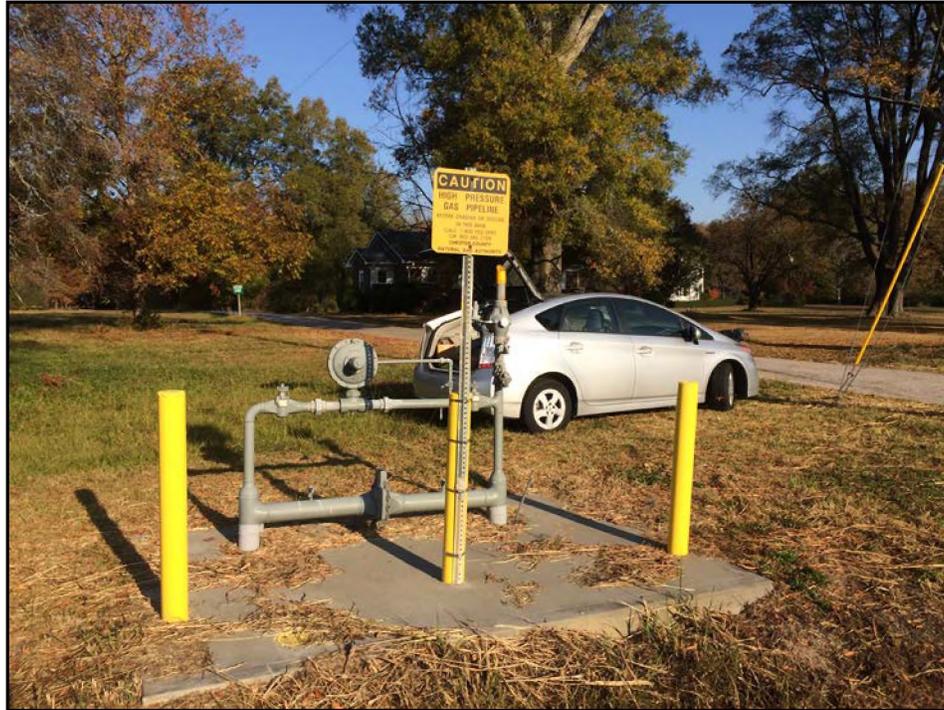
Figure 10 – High pressure gas pipeline located on the northwest side of SC 72 within the SC 72 - S-329 project area.

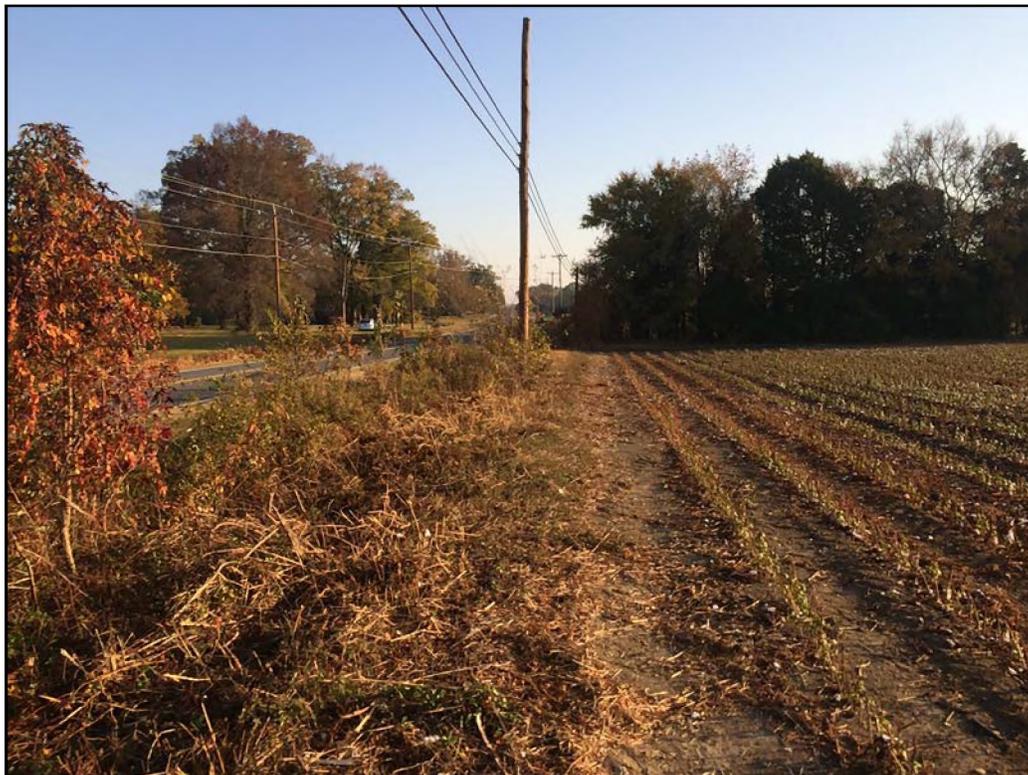
ARCHAEOLOGICAL SURVEY RESULTS: No artifacts or surface-level archaeological features were noted during the pedestrian reconnaissance of the project area. Throughout the project area the ground immediately adjacent to the existing road, within the current right of way, was found to be heavily disturbed by grading and roadside ditches. The portion of the APE along the north side of SC 72 was found to be heavily disturbed by underground utility lines, including a buried telephone line and most notably a buried high pressure gas line (**Figure 10**). For this reason shovel testing was not conducted in this part of the project area. The APE on the southeast side of SC 72 southwest of the SC 72 and S-329 intersection and the APE on the southwest side of S-329 southeast of the intersection was under cultivation at the time of the survey. The crop had recently been gleaned, affording excellent surface visibility in these areas. This obviated the need for subsurface testing in these areas (**Figure 11**). The APE on the northeast side of S-329 and the southeast side of SC 72 was not cultivated at the time of the survey, and ground surface visibility was generally poor due to a thick growth of grass. Portions of the APE in the area are too steeply sloping to be the likely locus of buried cultural resources, and the southeastern portion of the APE on northeast side of S-329 passes into a low lying area adjacent to an intermittent drainage. STPs were excavated at 30 meter intervals in the remaining areas. A total of five shovel tests were excavated on the southeast side of SC 72 northeast of the SC 72 and S-329 intersection, and two additional STPs were excavated on the northeast side of S-329 southeast of the intersection (**Figure 12**). Soils in the STPs typically consisted of an approximately 15 centimeter thick layer of 10YR4/4 (dark yellowish brown) compact sandy loam overlying very compact 5YR5/6 (yellowish red) to 10YR4/6 (dark yellowish brown) sandy clay (**Figure 13**). In general, soils in the STPs conformed to the mapped soil types for the project area. All of the STPs were negative for cultural resources.

Figure 11– Project APE on the southeast side of SC 72 southwest of the SC 72 - S-329 intersection. Photograph shows the roadside disturbance within the existing right of way and the cleared agricultural field at the southeastern edge of the APE in this portion of the project area.

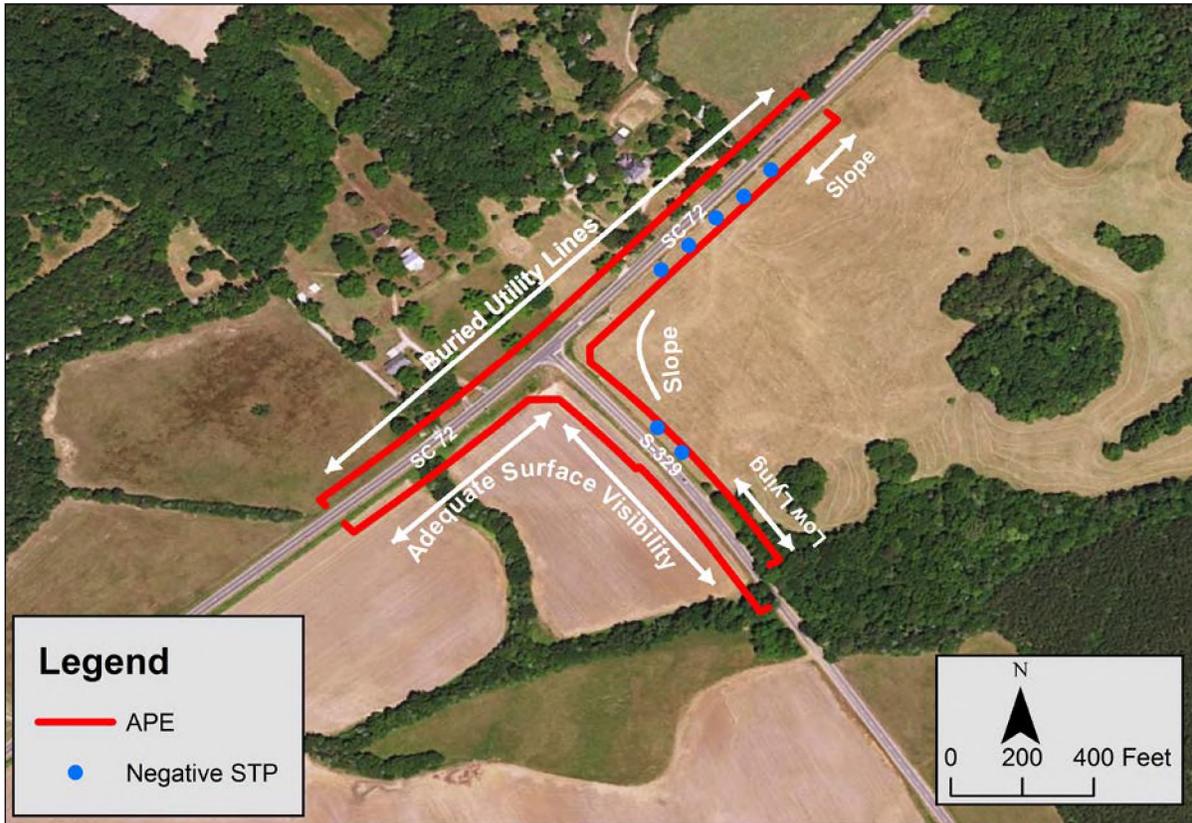
Figure 12 – Schematic of survey strategies employed and location of shovel test pits excavated within the SC 72 - S-329 project area.

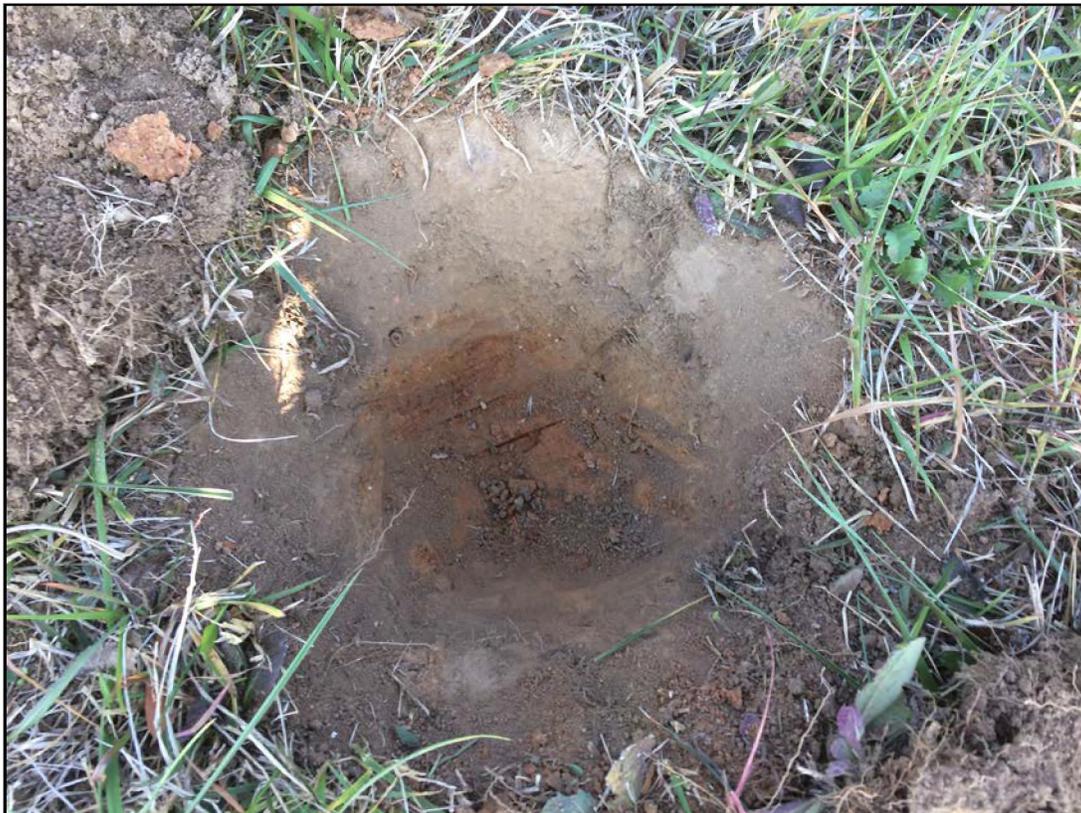
Figure 13 – Typical shovel test pit within the SC 72 - S-329 project area.

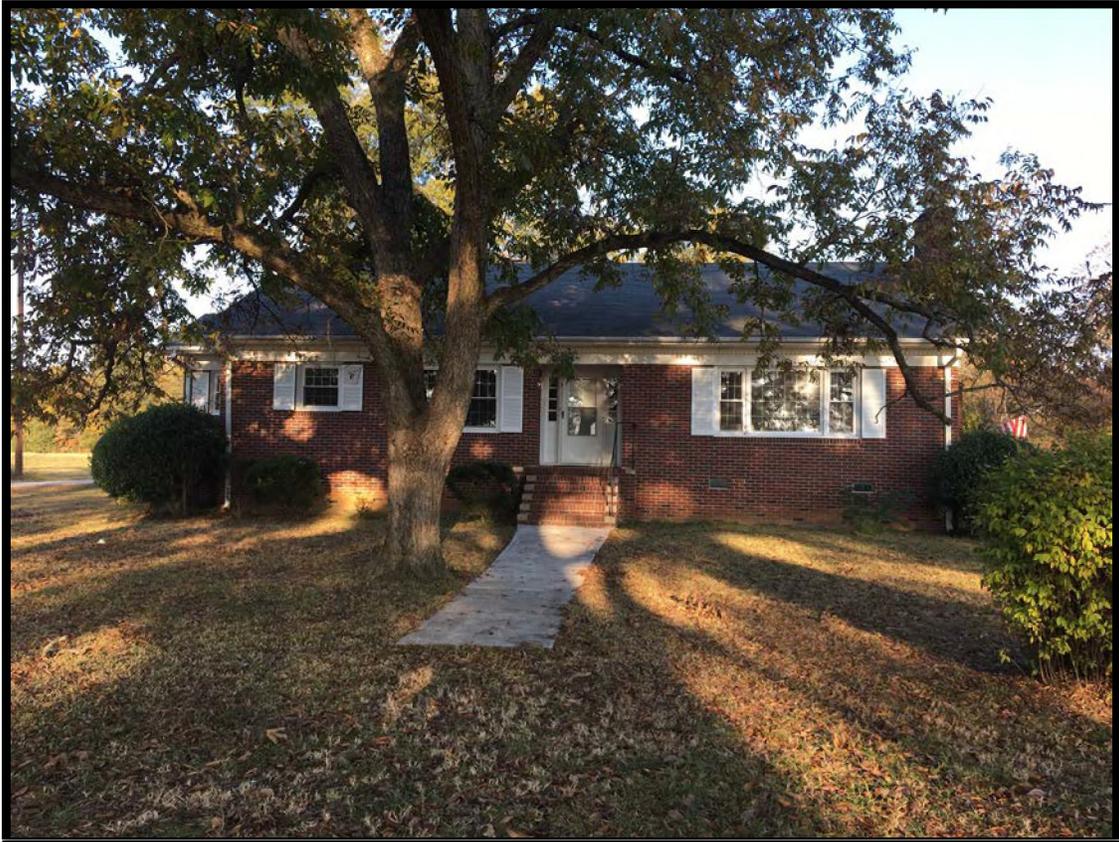
Figure 15 – Site # 0292

ARCHITECTURAL RESOURCES SURVEY RESULTS: Three newly-identified structures (site #s 0292 – 0294) were identified within the APE. **Site # 0292 (Figure 15)**, a mid-20th century residence of no historic or architectural significance, was determined to be ineligible for the NRHP. Both sites 0293 and 0294 are recommended eligible for the NRHP. **Site # 0293 (Figure 16)** is the “Spence House” (named after longtime owner—information provided Gina White, Winthrop University Archivist) and is recommended eligible for the NRHP under Criteria C as an example of the Early Classical Revival style. Although the accepted date range for Early Classical Revival would suggest this is an antebellum house, this report recommends that the house was built

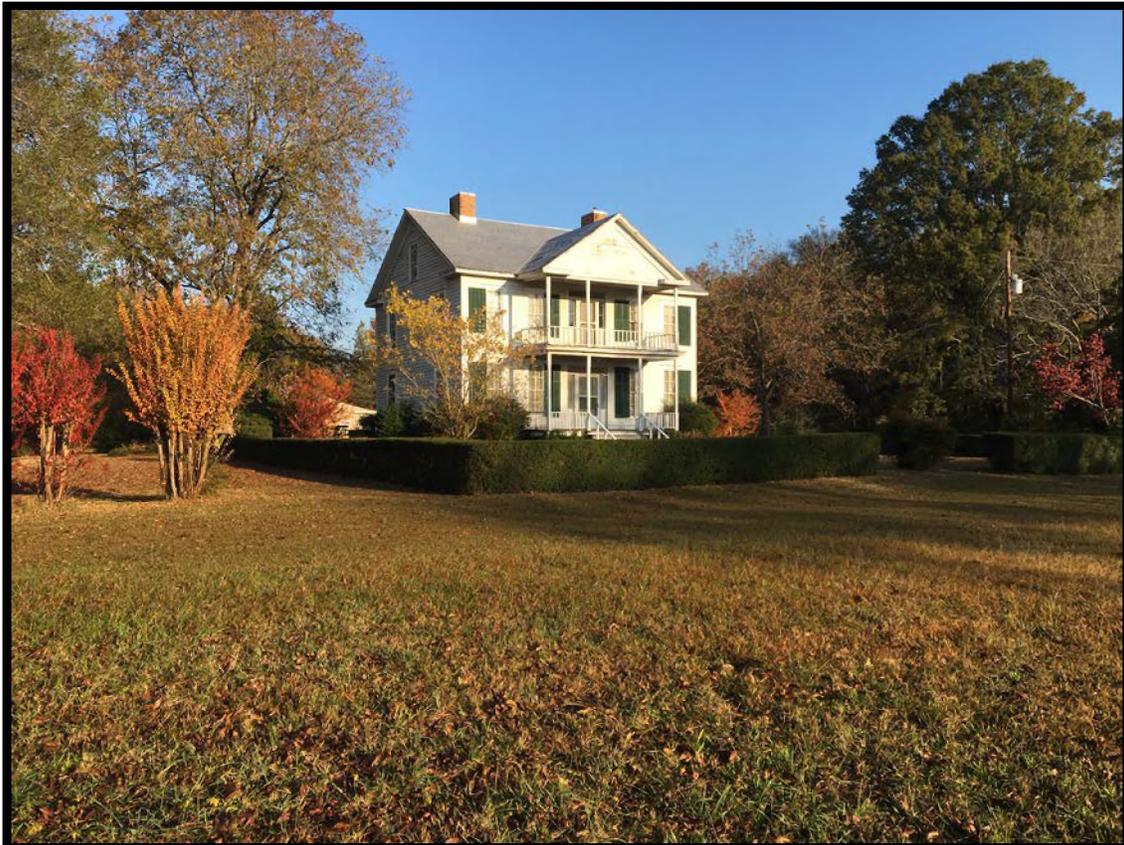
Figure 16 – Site # 0293, “The Spence House”

circa 1890. Many buildings in the upstate regions of South Carolina were built in styles that were anachronistic at the time of their construction. That trend, and the presence of brick rather than stone piers on this building, suggests that the building is late- rather than mid-19th century in origin. **Site # 0294 (Figure 17)** is the McCandless House (Gina White, Winthrop University Archivist) and is recommended eligible for the NRHP under Criteria A for Agriculture and Criteria C for Architecture. This house is a mixture of styles with elements of Italianate, Colonial, and Craftsman styles in prominence. The house was designed by local architect Alfred Gilchrist and is a replica of his design for the remodeled President's House at Winthrop University. The surrounding property includes a massive barn (site # 0294.01, see **Figure 18**) that predates the house by roughly a decade and was associated with the original McCandless House on this property (now ruins). Both sites 0293 and 0294 include outbuildings (all of which are considered to contribute to the eligibility of their associated primary resource) and surrounding landscape area in their recommended eligible boundary areas (see **Figure 14**) as both resources were related to agriculture and the outbuildings and open land around them adds to their "sense of place" and helps establish a proper physical context for their historical significance

REMARKS AND RECOMMENDATIONS: No new archaeological sites were discovered during the cultural resources survey. No additional archaeological investigations are recommended for this project. Three (3) new aboveground resources were documented during project investigations. Two of these resources (sites 0293 & 0294) are recommended eligible for the NRHP. The proposed project will require small amounts of right-of-way from the street-front (abutting SC 72) eligible boundary areas of both resources. However, the amount and area of the right-of-way to be acquired will not affect the eligible resources to an extent that diminishes the qualities which make them eligible (which are largely based on the architecture of the structures). The effects of the proposed project to sites 0293 and 0294 will be to the landscape of these resources. However, that effect is not considered adverse as it is minimal and does not substantially diminish the character, feel, setting, or association that the landscape of these resources provides. It is therefore recommended that the proposed project will have no adverse effect to historic resources. Based on SHPO concurrence with the proposed project's effect determination the Federal Highway Administration (FHWA) intends to make a de minimis finding regarding impacts to these resources, thus satisfying the requirements of Section 4(f).
