Intensive Documentation Form

Historic Name: _____
Common Name: BB&T Bank
Address/Location: 214 N Main St
City: Sumter County: Sumter
Vicinity of: _____ Quadrangle Name: Sumter East
Ownership: Private Category: Building
Historical Use: Commerical
Current Use: Commerical

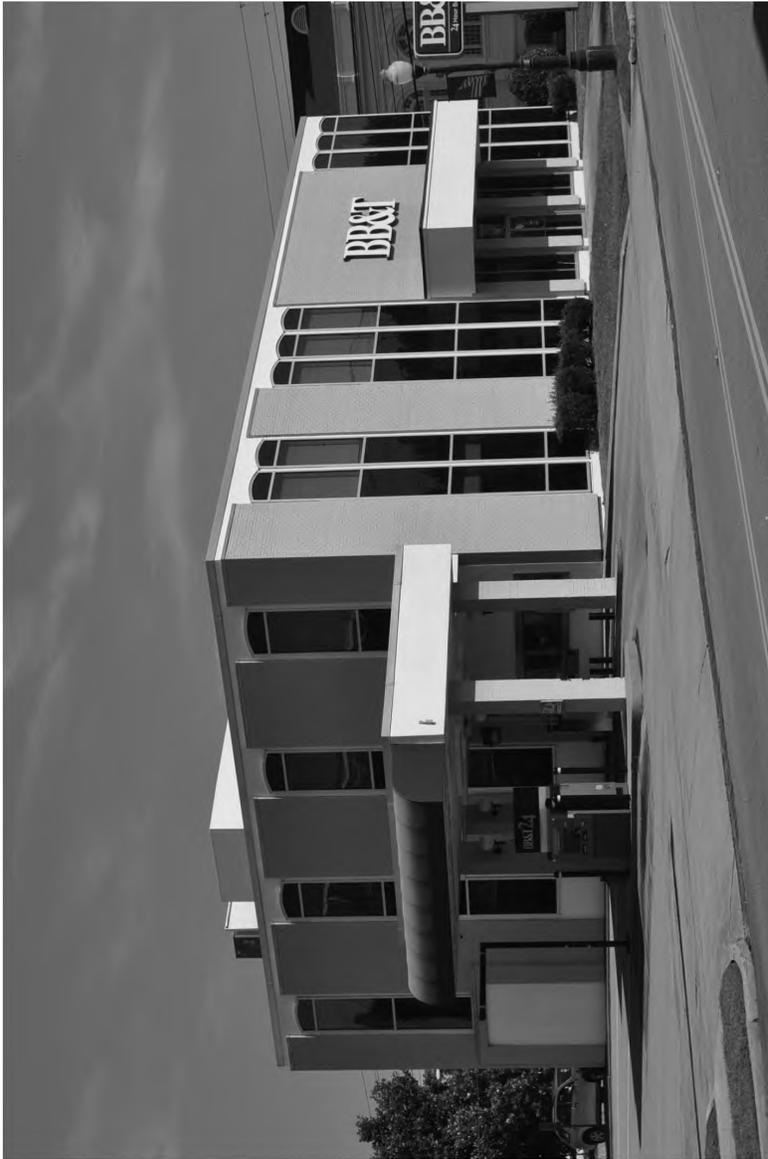
Main entrance on N Main St with cantilevered porch overhang, entrance composed of double metal and glass doors with sidelights and transom, bands of metal frame windows extend from ground to roof level with arched tops, asymmetrical front elevation

Cantilevered porch overhang and drive-through canopy have alterations; window glass looks replaced
