Addendum Report
Cultural Resources Reconnaissance Survey
Gaskins Tract
Kershaw County, South Carolina
S&ME Project No. 4261-19-041A
SHPO Project No. 19-KL0174

**Addendum Report
Cultural Resources Reconnaissance Survey
Gaskins Tract
Kershaw County, South Carolina**

S&ME Project No. 4261-19-041A
SHPO Project No. 19-KL0174

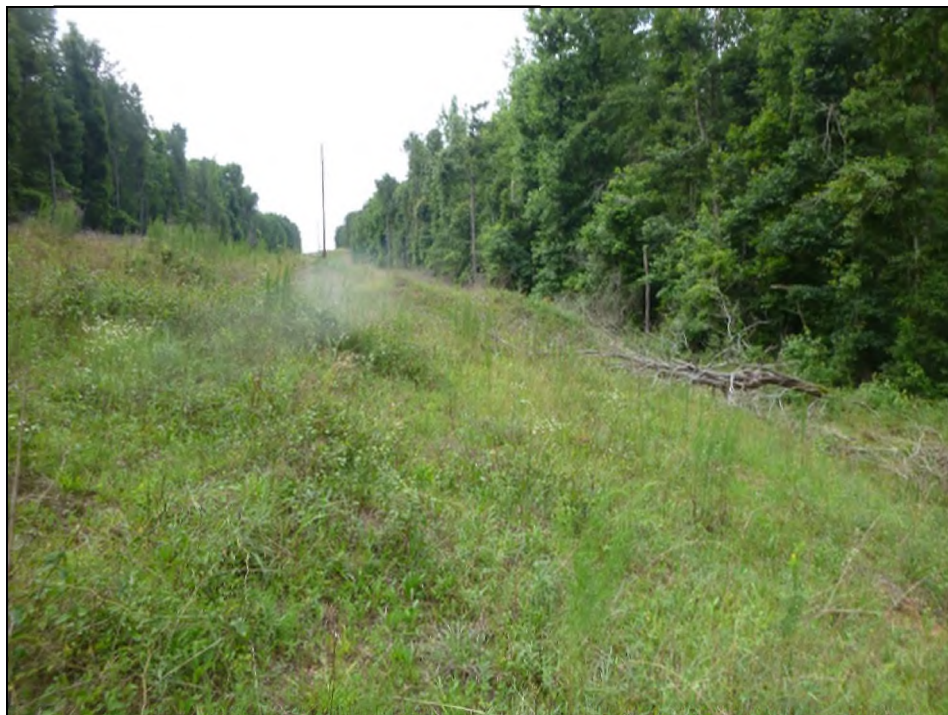
Vegetation within the project area consists predominately of hardwood forest with areas of secondary growth (Figure 2.4). The primary disturbance within the project area is the transmission line corridor (Figures 2.5–2.6).

Figure 2.5. Transmission line corridor in the project area, facing south.

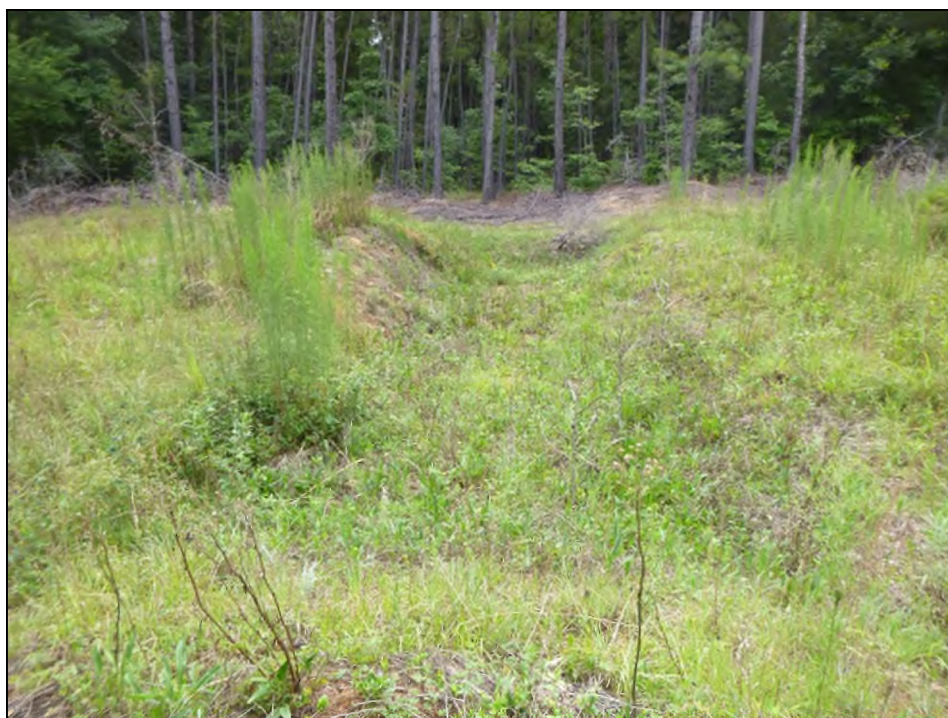
Figure 2.6. Area of ground disturbance within transmission line corridor, facing east.

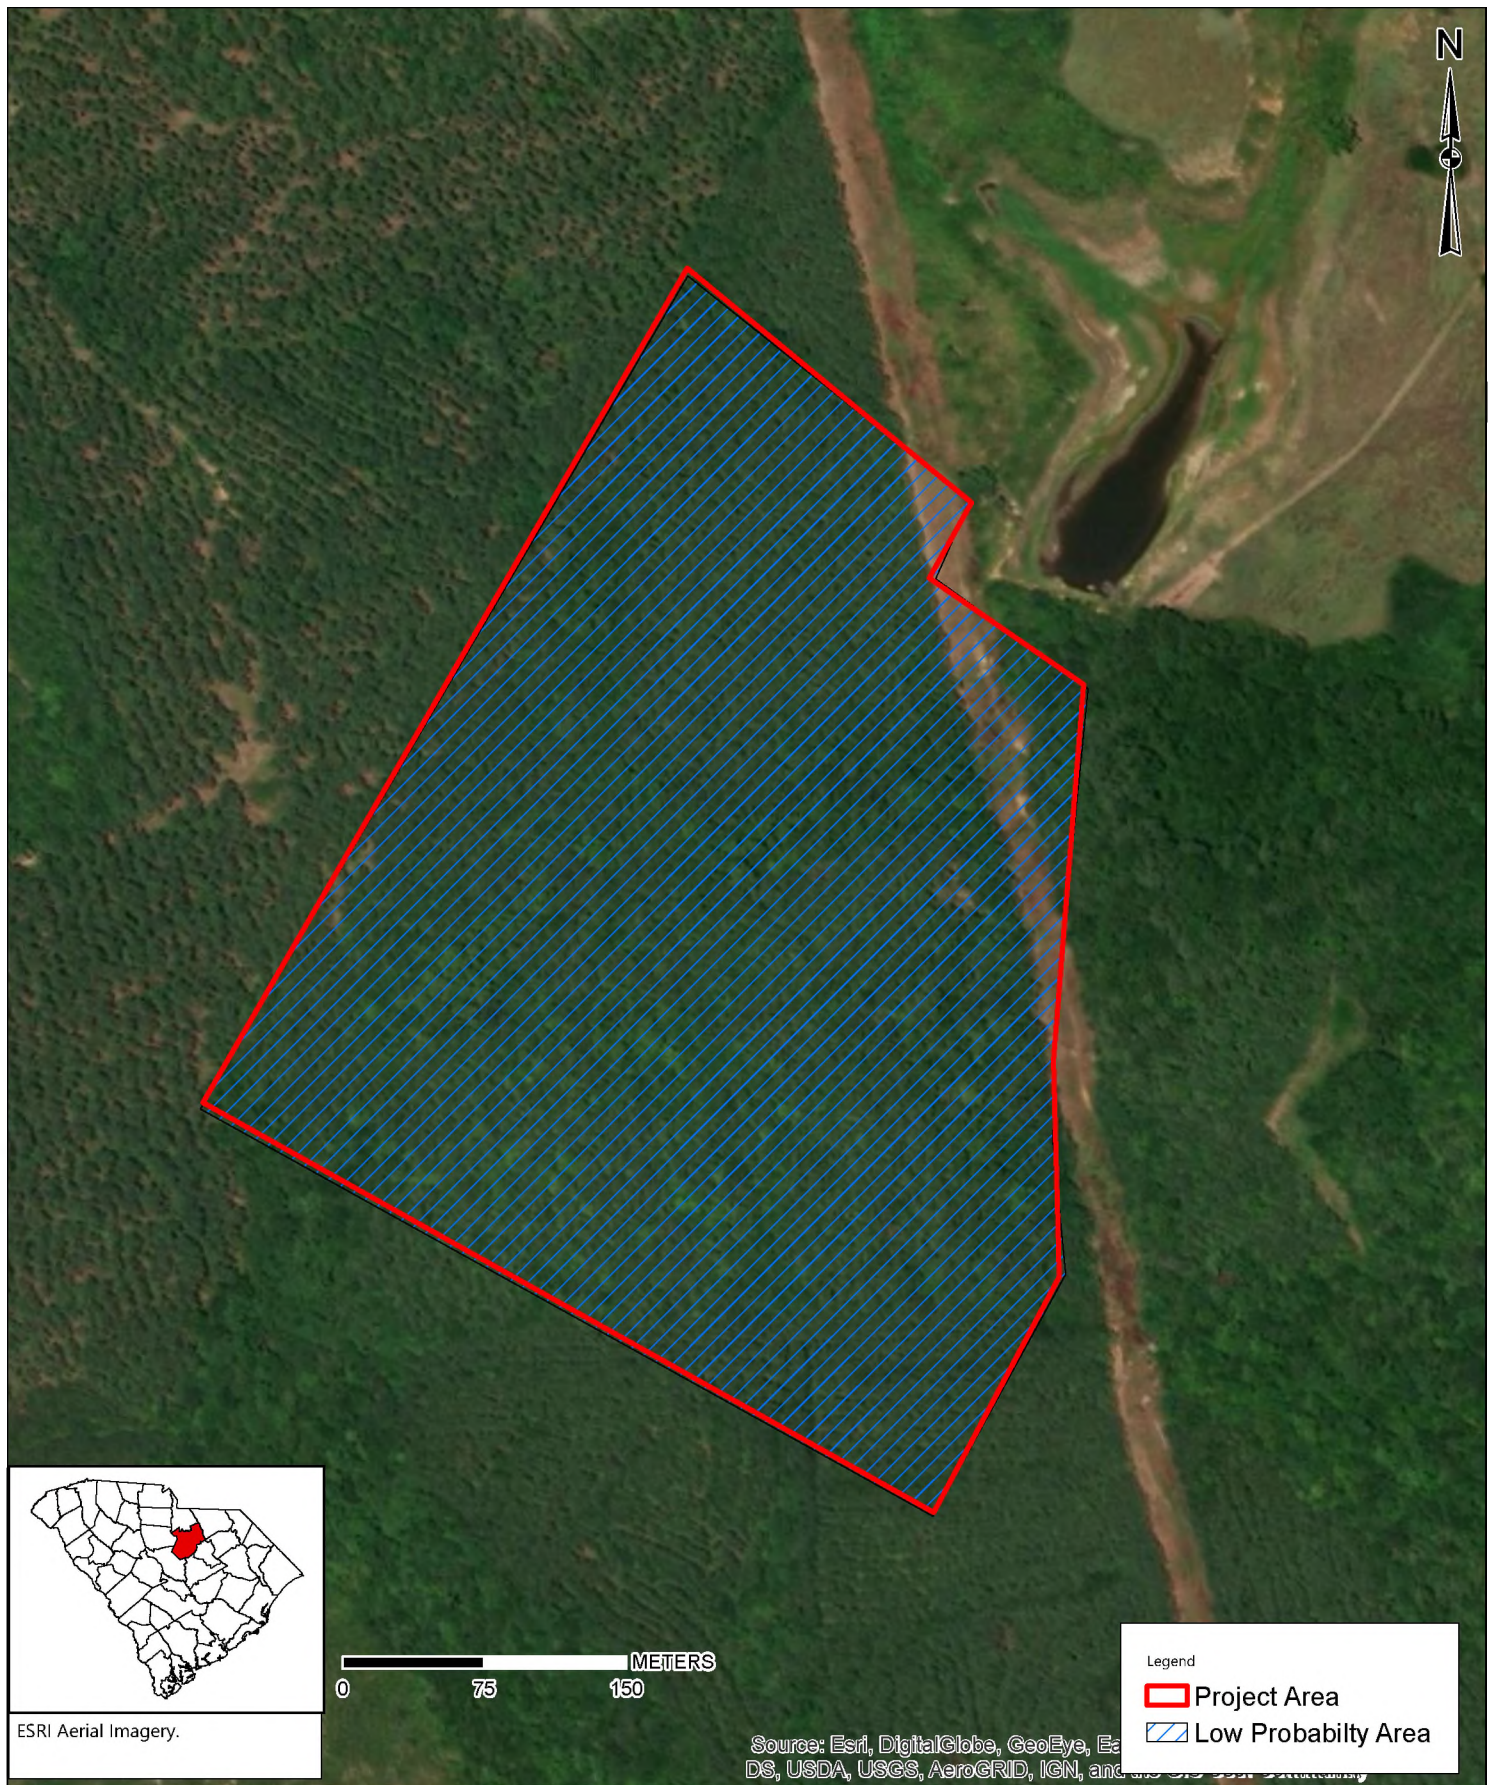
SCALE:	1:4,000	Aerial Map showing Probability Areas Gaskins Tract Additional Parcel Kershaw County, South Carolina	FIGURE NO. 3.11
	PROJECT NO:	4261-19-041A		
	DRAWN BY:	PAC		
	DATE:	7/5/2019

It is S&ME's opinion that based on the desktop review and fieldwork completed within the project area, although historic maps show structures and a dirt road traversing the project area, no evidence of the structures remain within the project area, and the project area contains eroded soils and a lack of intact soil horizons throughout. As a result, the project area should be considered low probability for containing significant archaeological resources (Figure 3.11).

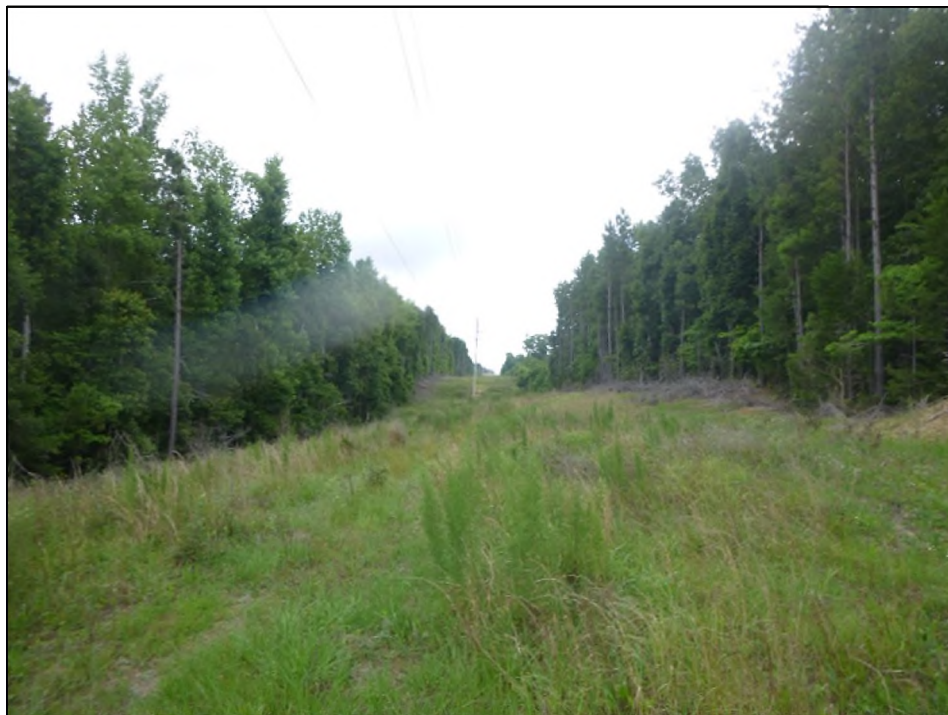
Figure 5.4. View of transmission line corridor, facing north.

A total of 18 shovel tests (ten shovel tests and eight radials) were excavated within the project area along four transects (Figure 5.1; Table 5.1). The project area contains steep slopes (Figure 5.2) and vegetation consists predominately of hardwoods with areas of thick understory (Figure 5.3). Disturbances in the project area include a transmission line corridor running approximately north to south along the eastern boundary, as well as ground disturbances within the transmission line corridor (Figures 5.4–5.5). An attempt was made to re-locate the three structures shown on the 1935 USGS Camden 30-minute topographic map (Figure 3.5). No evidence of the structures was found within the project area (Figure 5.6–5.8).

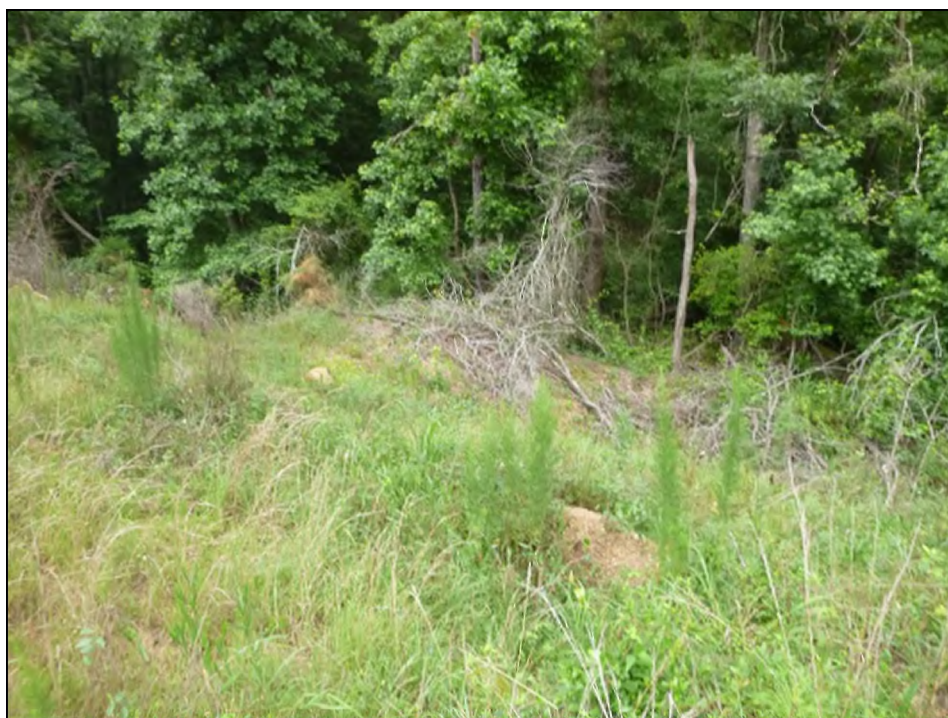
Figure 5.5. View of ground disturbance within transmission line corridor, facing west.

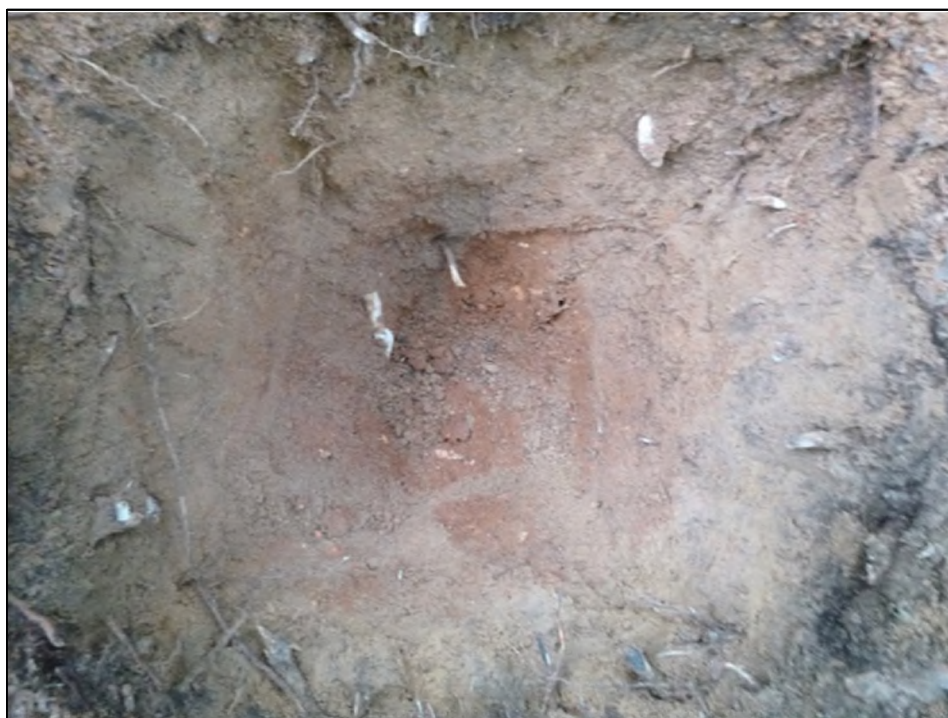
Figure 5.9. Typical shovel test profile of plow zone transitioning directly to subsoil.

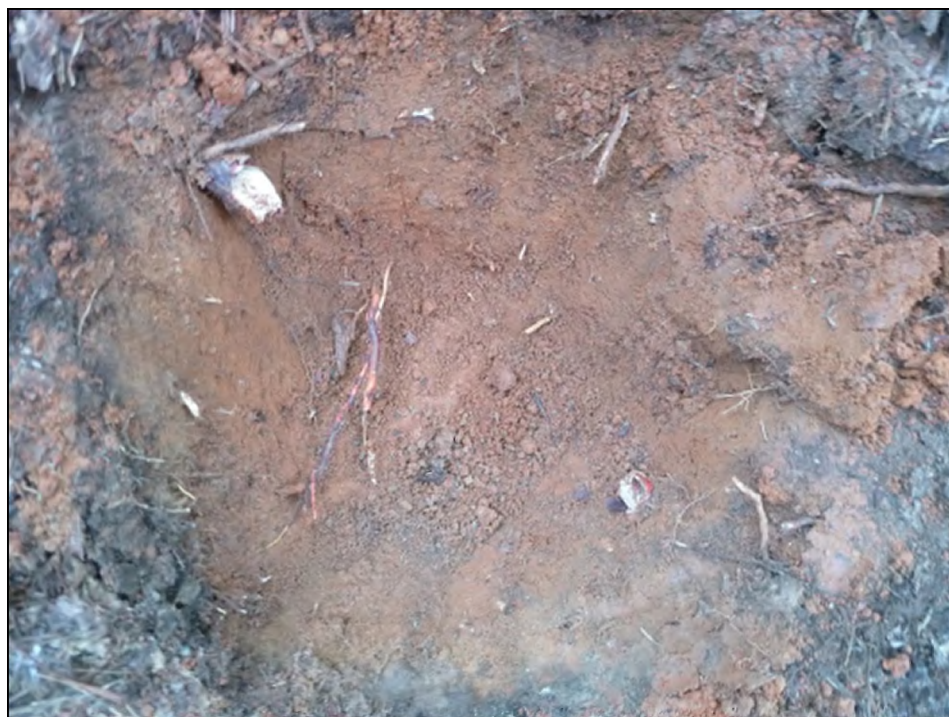
Figure 5.10. Typical shovel test profile when subsoil was encountered at surface.

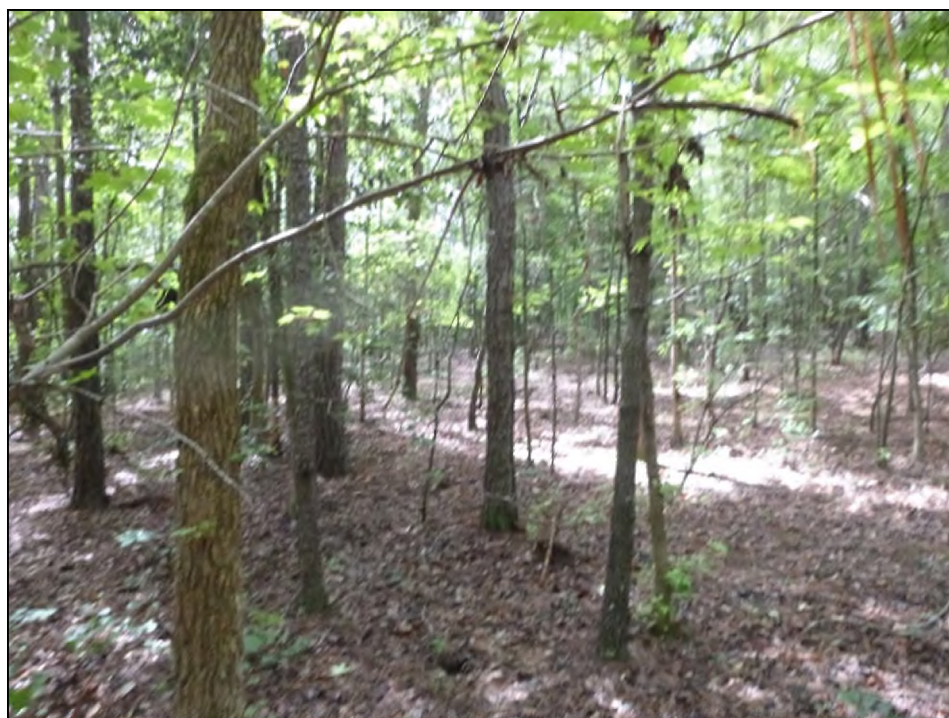
Isolated Find 1 (IF-1) consists of a single piece of rhyolite debitage found in a single shovel test between 0 and 24 cmbs in an area of hardwoods in the central portion of the project area, at UTM coordinates E534480 N3814625 (NAD 83) (Figures 1.1, 1.2, and 5.11). A total of eight shovel tests were excavated around the initial positive shovel test at 15- and 30-m intervals in each of the cardinal directions. None of the additional shovel tests contained artifacts. Based on the information presented, it is S&ME's opinion that the site is not associated with events that have made a significant contribution to the broad patterns of history (Criterion A), is not associated with the lives of significant persons in the past (Criterion B), does not embody the distinctive characteristics of a type, period, or methods of construction; represent the work of a master; possess high artistic values; or represent a significant and distinguishable entity whose components may lack individual distinction (Criterion C), and is unlikely to yield significant information on the prehistory of the area (Criterion D). As such, IF-1 is recommended ineligible for inclusion in the NRHP.

Figure 5.11. Overview of Isolated Find 1, facing east.

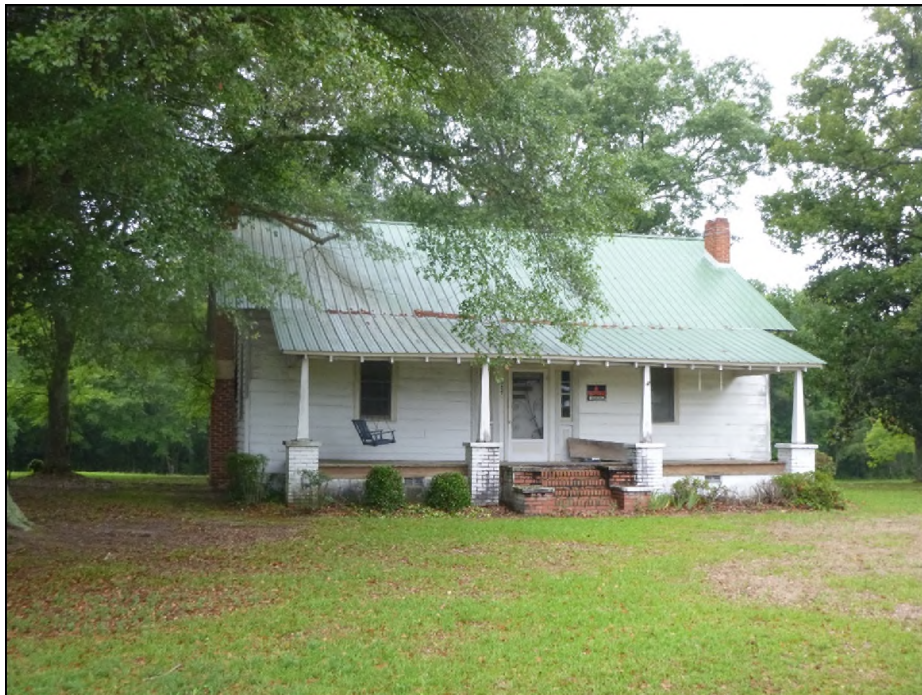
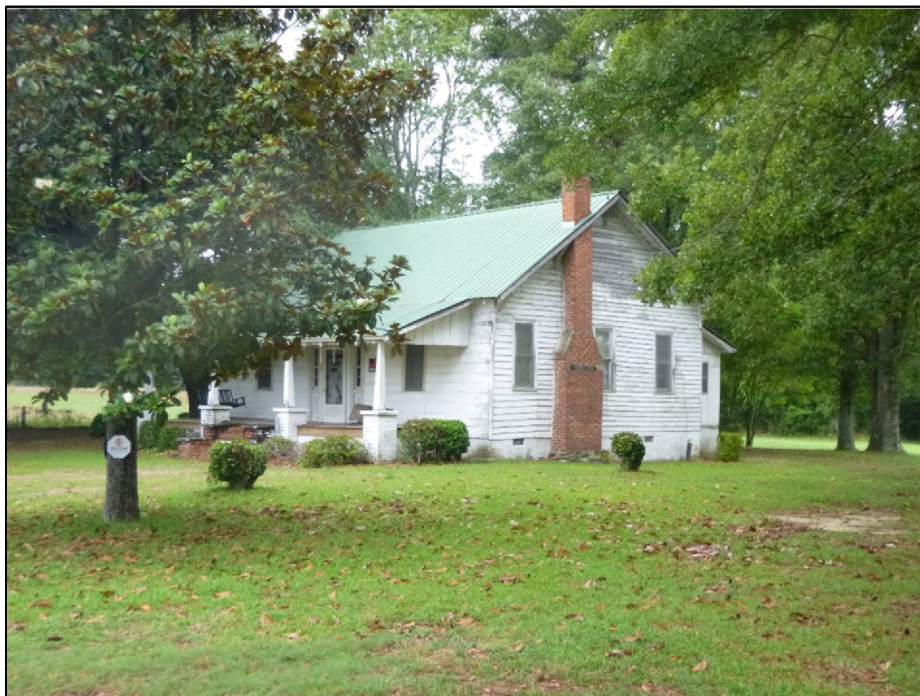
Structure 1195 is a circa-1900 residence that is located at 3627 Flat Rock Road, approximately 0.4-mile west of the proposed project area (Figures 1.1 and 1.2). The house and two associated outbuildings were identified during the 2002 survey of Kershaw County (Reed 2002). During the current survey, S&ME revisited Structure 1195, which remains extant, as well as its recorded outbuildings (1195.01 and 1195.02). The house is a single story, side-gabled structure with a three-bay front elevation; a central entry door, with a fluted pilaster surround and four-pane sidelights, is flanked by a single two-over-one, double-hung, wooden sash window on either side (Figure 5.12). A full-width, shed-roofed porch, which is supported by slender tapered square columns on brick piers and has visible rafter tails, spans the front elevation, which likely postdates the original construction of the house. The northern elevation of the house has three evenly spaced two-over-two, double-hung, wooden sash windows and an exterior brick chimney, with stone base; triangular brackets, which also likely postdate the original building construction period, are located in the gable end (Figure 5.13). The southern elevation of the house has the same configuration as the northern elevation. A shed-roofed rear addition, which may be an enclosed porch structure, is visible along the eastern elevation. The foundation of the house is brick piers, with concrete block infill; the exterior of the structure is covered with wooden weatherboard and the roof is standing-seam metal. The two

Figure 5.12. Structure 1195, facing west.

Figure 5.13. Structure 1195, facing southwest.

The house and outbuildings are a good example of an early twentieth century farmstead and the property retains five acres of land that were likely originally associated with the farm. The house and outbuildings retain integrity of location, design, materials, workmanship, setting, and feeling; the specific historical associations of the property are unknown, but it potentially retains an association with rural farming in Kershaw County during the early twentieth-century. Therefore, S&ME recommends that additional research be conducted on Structure 1195 and its associated outbuildings and property to make a definitive determination of NRHP eligibility under Criterion A, for its association with farming in the area. However, based on the distance of the property from the proposed project area, and the topography and vegetation of the intervening landscape, development of the Gaskins Tract will not have an adverse effect on the resource.

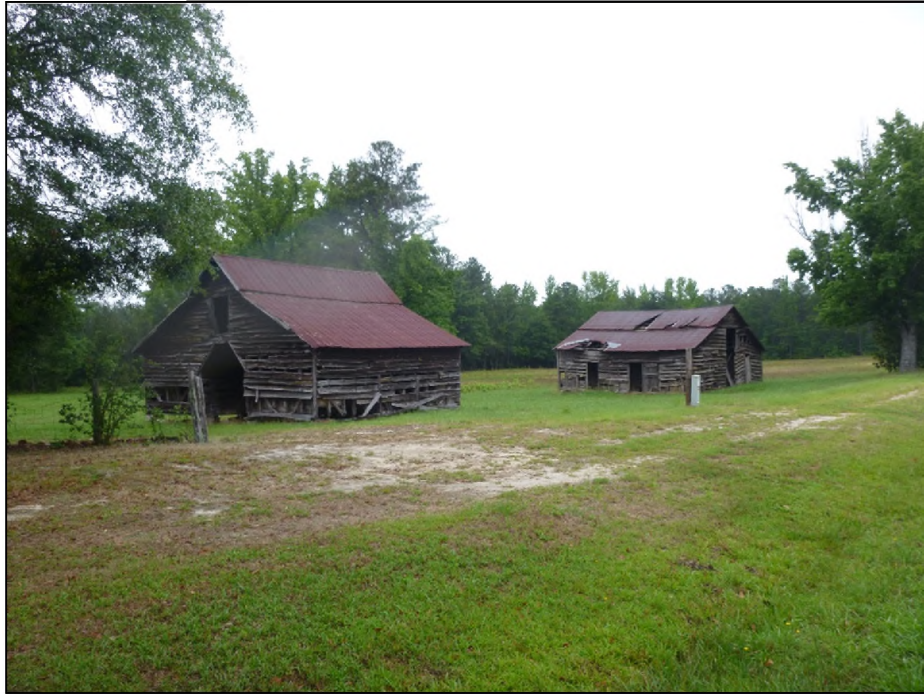
previously recorded agricultural outbuildings (1195.01 and 1195.02) are located to the north of the house (Figure 5.14). The southern barn (1195.01) is a one and one-half story, frame structure that rests on a stone and concrete block pier foundation (Figure 5.15). It has a broken gable roof, with its long access oriented toward the road; there is a large central opening on the lower story that spans the length of the barn and an upper hayloft opening. The barn's exterior is covered with horizontal wooden siding and the roof is standing-seam metal. The northern barn (1195.02) is oriented with its gable end toward the road (Figure 5.16). It is a one-story structure with horizontal wooden siding. The tall, off-center opening on the eastern elevation appears to be collapsing; the roof of the barn is covered with standing-seam metal. Both barns probably date to the early twentieth century. Northeast of the house is a small, concrete block wellhouse with a gabled roof and visible rafter tails (1195.03); it likely dates to the 1930s and appears to have been constructed around the time when additional details, such as the brackets and porch supports, were added to the house (Figure 5.17).

Figure 5.14. Structures 1195.01 and 1195.02, facing northwest.

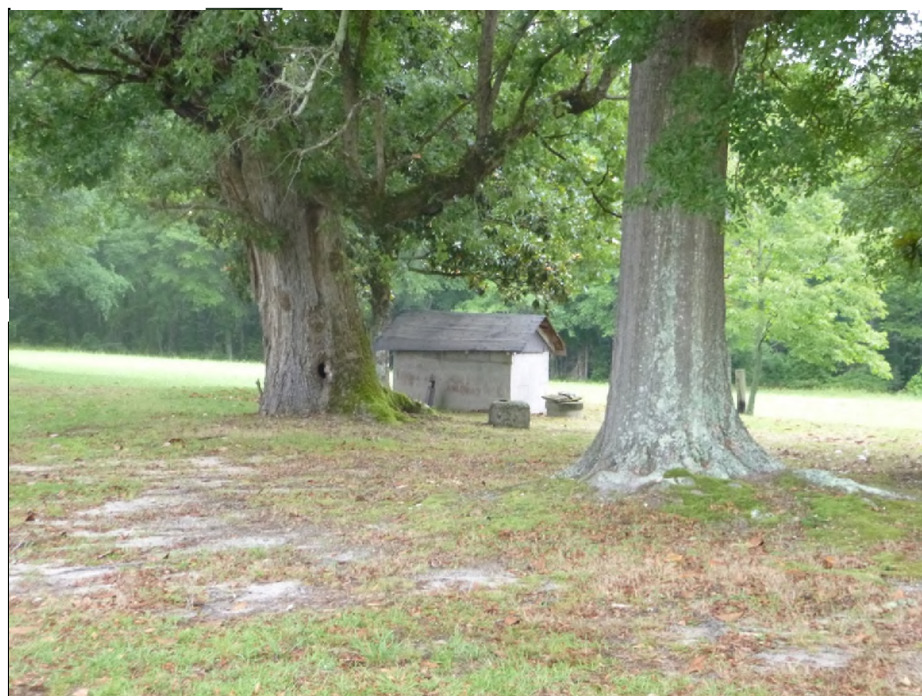
Figure 5.17. Structure 1195.03, facing west.

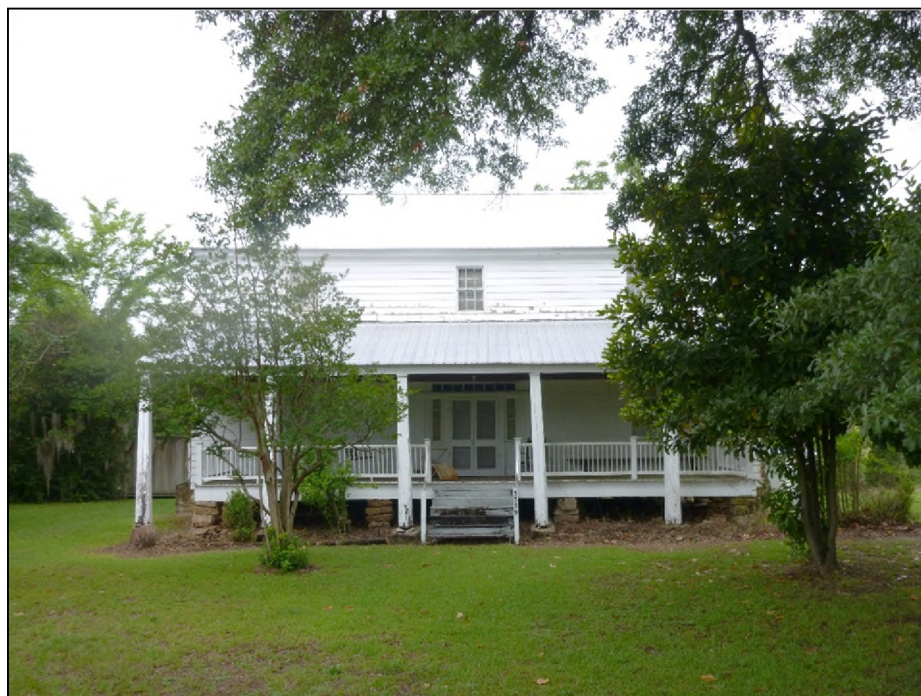
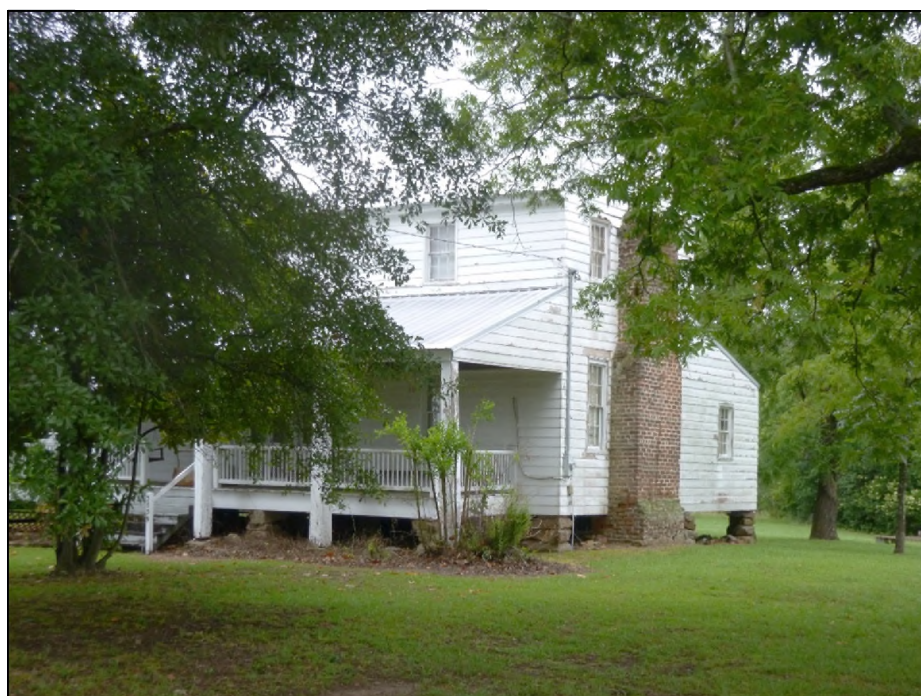
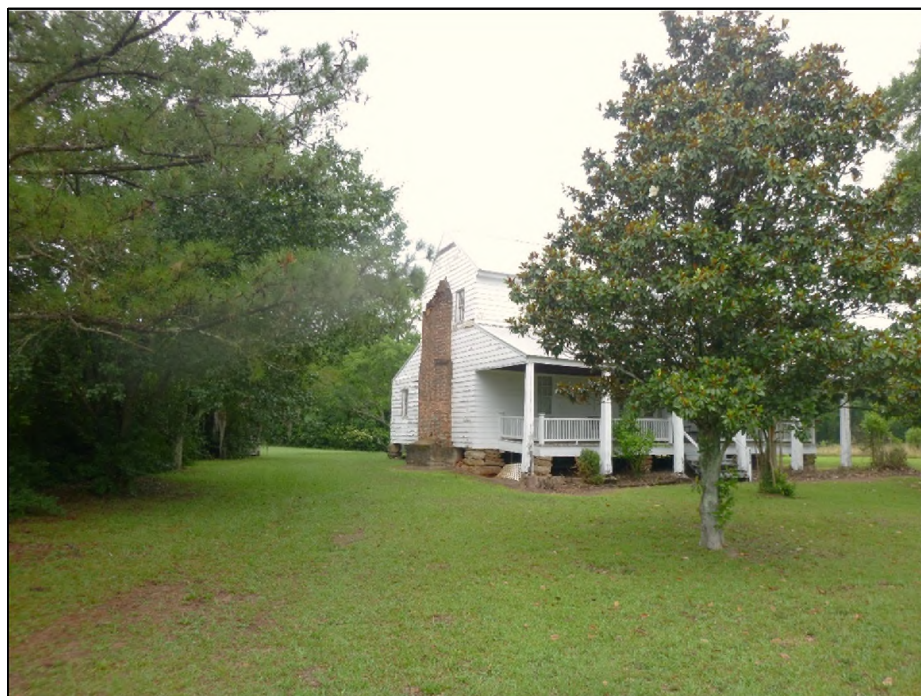
A shed-roofed addition, which may be an enclosed porch structure, is visible along the rear elevation. The southern elevation of the house also has an exterior brick chimney, although the bottom of this chimney is covered with concrete stucco and the portion above the second story has crumbled; to the west of the chimney there is a single six-over-six, double-hung, wooden sash window on the upper story only (Figure 5.20). The house rests on a stacked stone pier foundation; it has wooden weatherboard siding and a standing-seam metal roof. The smaller upper story windows may be an indication that the second story, or the current porch roof, may be a later addition that necessitated changes to the window size and structure of the house. To the south of the house is a single story, wooden frame barn structure that has been overgrown by vegetation (Figure 5.21). To the northwest of the house is a concrete block wellhouse with a gabled roof, that likely dates to the early twentieth century (Figure 5.22). Survey information from the 2002 survey indicates that a family cemetery is located on the property, north of the house, but it was not identifiable from the public right-of-way.

Figure 5.18. Jesse Truesdale House (1196), facing west.

Figure 5.19. Jesse Truesdale House (1196), facing southwest.

Figure 5.20. Jesse Truesdale House (1196), facing west.

The house and outbuildings are a good example of an early mid-nineteenth century farmstead and the property retains nearly 340 acres of land that were likely originally associated with the farm. The house and outbuildings retain integrity of location, setting, and feeling; although changes to the design, materials, workmanship of the house have been made, they occurred greater than 50 years ago and are part of the evolution of the house and farm property during the late-nineteenth and early twentieth centuries. The house and farm also retain their historical associations with Jesse Truesdale, the original owner, as well as their association with rural farming in Kershaw County during the nineteenth through early-twentieth-centuries. However, the strength of these connections and the role of Jesse Truesdale in the local community history are currently unknown and require additional information to evaluate; therefore, S&ME recommends additional research on the Jesse Truesdale House (1196) and its associated outbuildings and property to make a definitive determination of the property's NRHP under Criterion A, for its association with farming in the area. Based on the distance of the property from the proposed project area, and the topography and vegetation of the intervening landscape, development of the Gaskins Tract will not have an adverse effect on the Jesse Truesdale House.
