Addendum Report  
Cultural Resources Reconnaissance Survey  
Enoree Development Site  
Spartanburg County, South Carolina  
S&ME Project No. 210009  
SHPO Project No. 19-KL0371

## Addendum Report, Cultural Resources Reconnaissance Survey

### Enoree Development Site

S&ME Project No. 210009; SHPO Project No. 19-KL0371

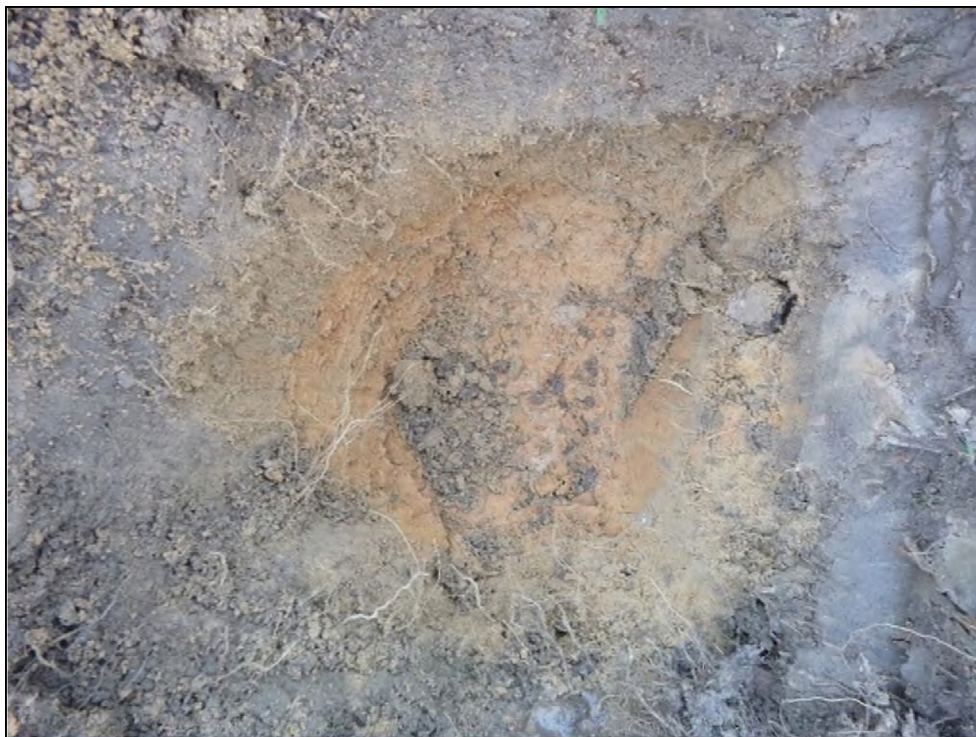
**Figure 5.5. Typical shovel test profile in southern parcel.**

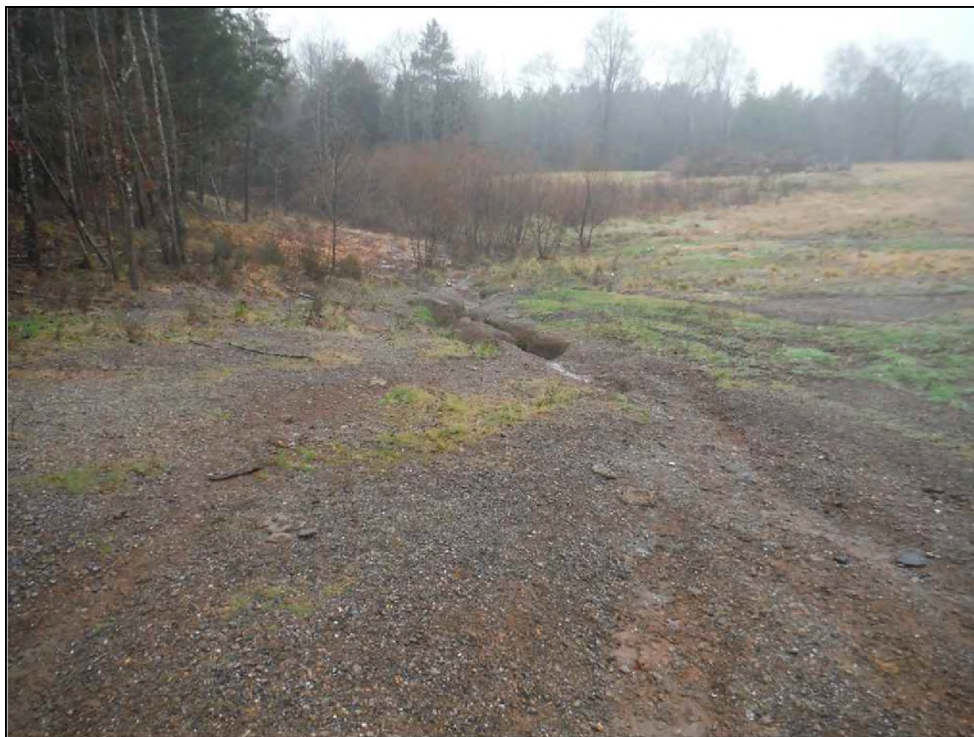
**Figure 5.9. Erosion in the northern parcel, facing west.**

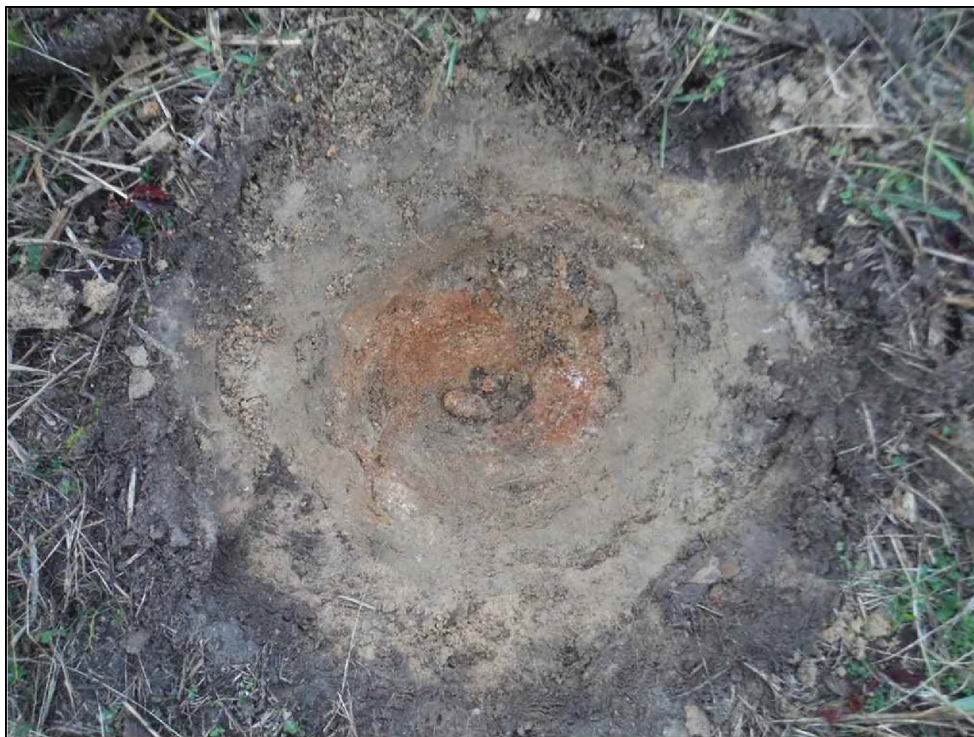
**Figure 5.13.** Typical shovel test profile within the northern parcel.

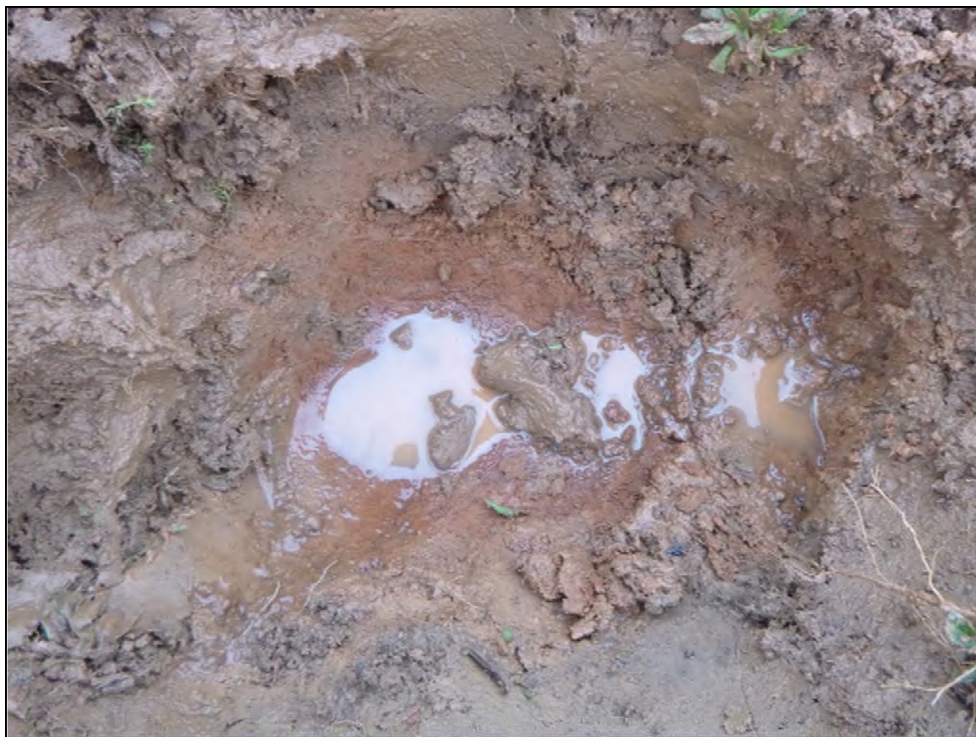
**Figure 5.16. Typical shovel test profile at 38SP470.**

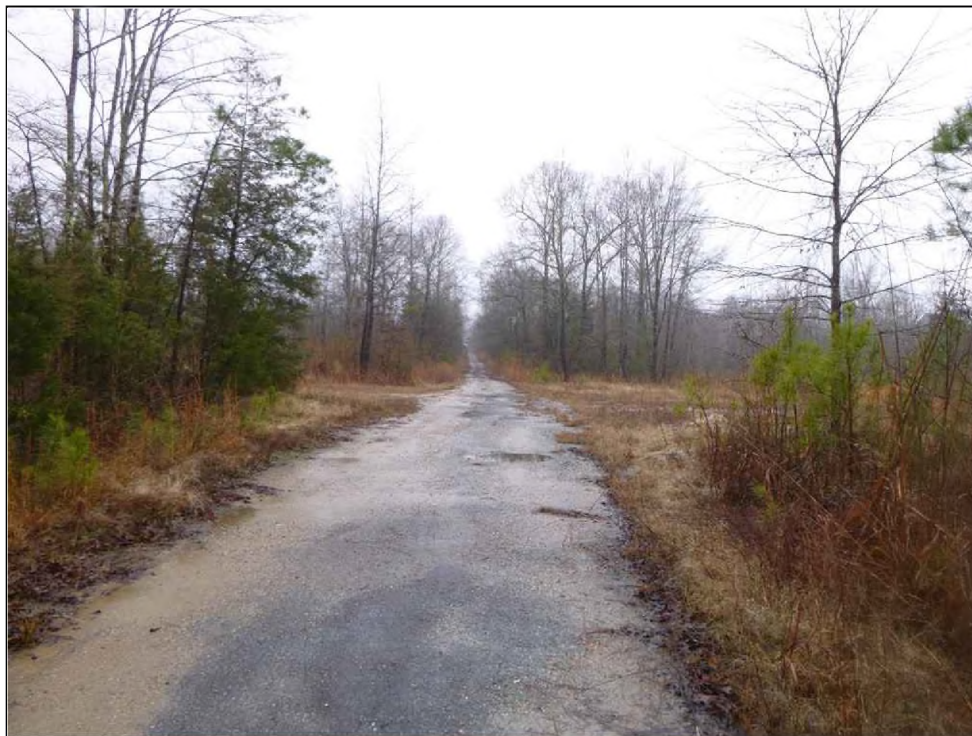
**Figure 5.19. Hanna Vermiculite Mine (SHPO Survey Number 1455), facing west along Old Rock Quarry Road.**

The Hanna Vermiculite Mine (SHPO Site Number 1455) is the remnants of a mid-to late twentieth century mineral mining enterprise that operated north and west of the proposed project parcels (Figures 1.1 and 1.2). It was recorded in 2019 and was recommended as ineligible for the National Register. The Hanna Vermiculite Mine has seven recorded aboveground structures and features, including a bridge abutment, concrete mining structures, and Old Rock Quarry Road (Figure 5.19) Outside of the structure remnants, the majority of the mining lands have been allowed to reforest. The structures and landscape features associated with the Hanna Vermiculite Mine (SHPO Site Number 1455) are a physical remnant of the vermiculite mining operated on the site from the 1950s through 1980. Although the mining remnants generally retain integrity of location, materials, and workmanship, only Old Rock Quarry Road retains its design and feeling and each other element has suffered some loss of design, feeling, and association. There have been no major changes to the Hanna Vermiculite Mine (SHPO Survey Number 1455) since it was recorded in 2019. S&ME concurs with the previous recommendation that the Hanna Vermiculite Mine (SHPO Survey Number 1455) is not eligible for the NRHP.

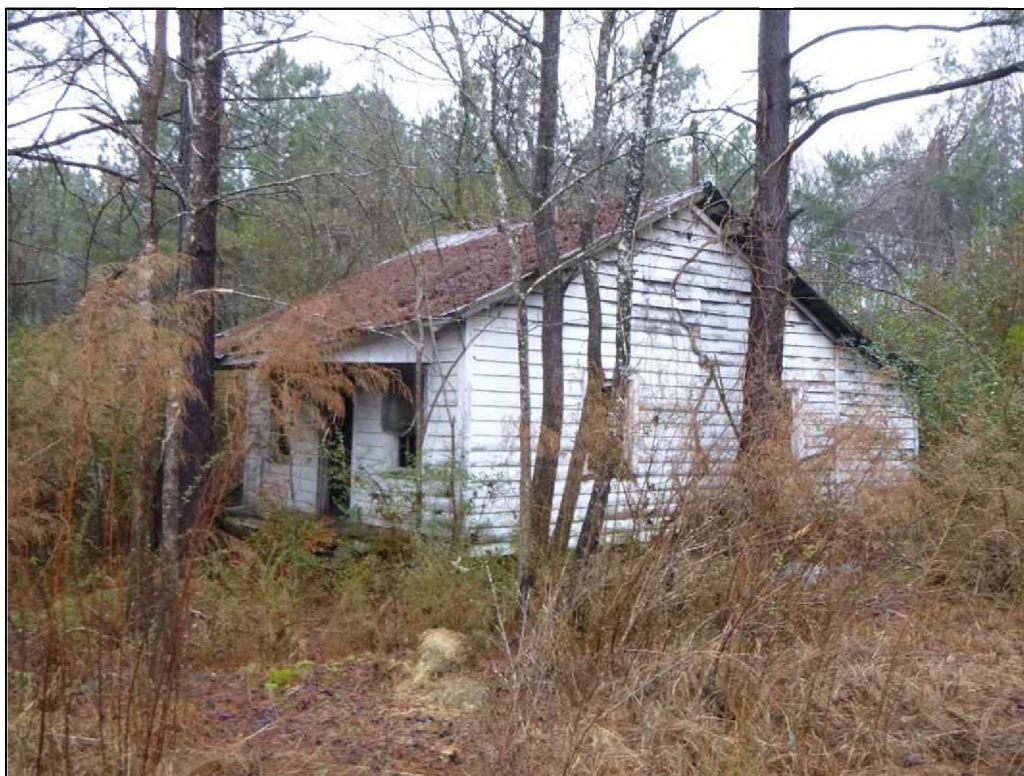
**Figure 5.20. SHPO Survey Number 1456, facing west.**

SHPO Survey Number 1456 is a circa-1920s frame residence that is located north of the intersection of Old Rock Quarry Road and Charles Street, west of the proposed project area (Figures 1.1 and 1.2). The house was recorded in 2019 and was recommended as ineligible for the NRHP. It is a one-story, frame residence with a side-gabled roof, which is currently abandoned and has fallen into disrepair (Figure 5.20). The front elevation is three bays wide, with a central door flanked by a single window opening on either side; a shed-roofed porch with no visible supports spans the front elevation. No structure appears at this location on the 1921 USDA soil survey map, although a structure at this location does appear on the 1940, 1951, and 1964 SCDOT maps and the 1969 USGS topographic quadrangle (Figures 3.5 through 3.9). Although the house retains its integrity of location, setting, and design, its materials, workmanship, feeling, and association, it is a common form and design of early-twentieth century vernacular residence and is not associated with a significant historical event or period. No major changes have occurred to SHPO Survey Number 1456 since it was recorded in 2019; S&ME concurs with the previous recommendation that SHPO Survey Number 1456 is ineligible for inclusion in the NRHP.

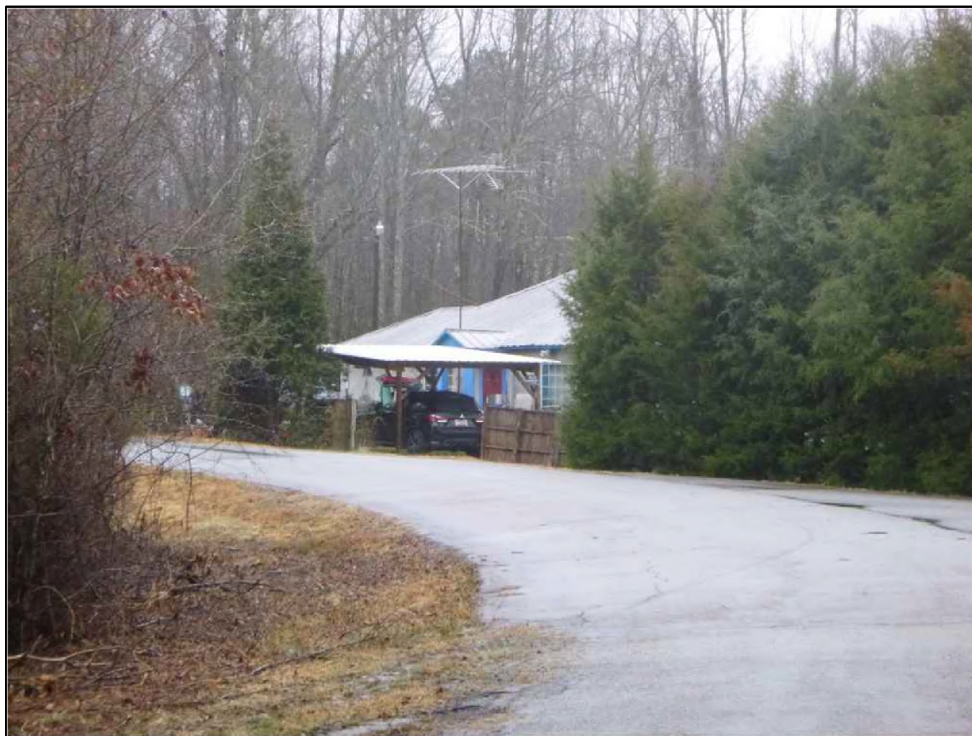
**Figure 5.21. SHPO Survey Number 1459, facing southwest.**

SHPO Survey Number 1459 is a circa-1950 residence that is located at 311 Charles Street, west of the southern parcel (Figures 1.1 and 1.2). The house was recorded in 2019 and was recommended as ineligible for the NRHP. The house is a one-story, frame Ranch-style residence with a stucco exterior and hipped roof (Figure 5.21). The front elevation is four bays wide, with an off-center door located beneath a gabled portico that is supported by square posts; flanking the doorway is a single 16-pane, vinyl frame, picture window on either side and a small, semi-circular window opening in a hipped-roof extension on the south elevation, which may have originally been an open carport. The roof, which is standing-seam metal, has two, symmetrical interior chimneys, covered in stucco, visible along the ridge line. A structure at this location appears on the 1964 SCDOT map and the 1969 USGS topographic quadrangle (Figures 3.8 and 3.9). Although the house retains its integrity of location, setting, feeling, and association, its design, materials, and workmanship have been altered by modern changes, including replacement windows and the enclosure of an original carport. The house is a common form and design of mid-twentieth century residence and is not associated with a significant historical event or period. No major changes have occurred to SHPO Survey Number 1459 since it was recorded in 2019; S&ME concurs with the previous recommendation that SHPO Survey Number 1459 is ineligible for inclusion in the NRHP.

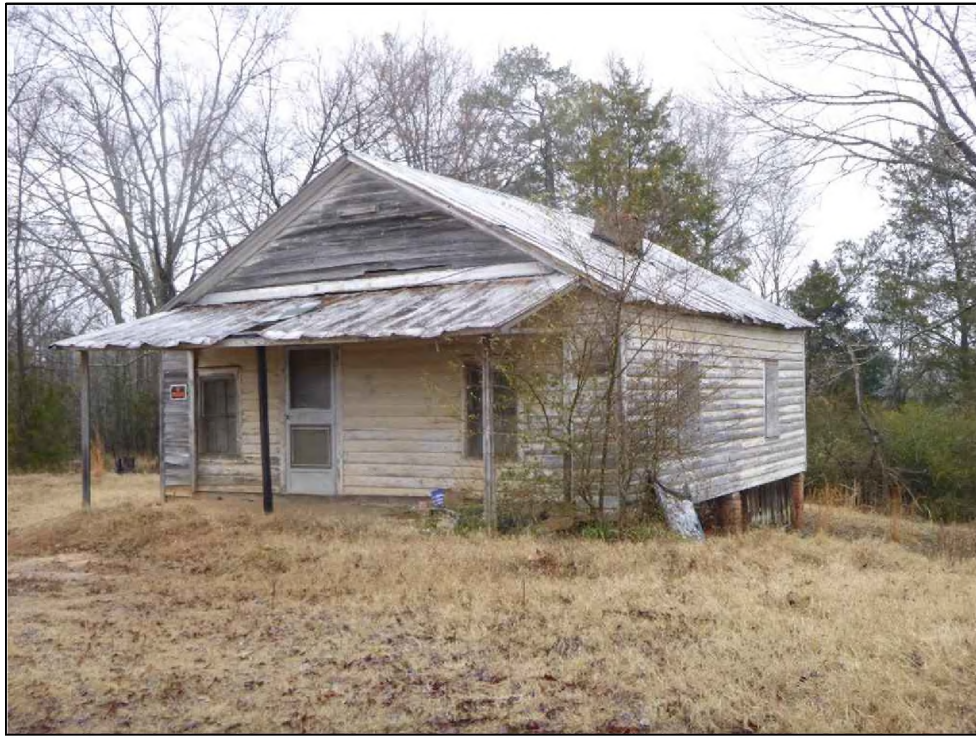
**Figure 5.22. SHPO Survey Number 1460, facing north.**

SHPO Survey Number 1460 is a circa-1910 residence that is located north of Charles Street, approximately 0.5-mile east of its intersection with Rock Quarry Road, west of the southern parcel (Figures 1.1 and 1.2). The house was recorded in 2019 and was recommended as ineligible for the NRHP. The house is a one-story, frame residence, resting on a brick pier foundation, with a front-gabled roof (Figure 5.22). The front elevation is three bays wide, with an off-center door that is flanked by a single six-over-six, double-hung, wooden sash window on either side. A shed-roofed porch, supported by square posts, spans the width of the front elevation. The east and west elevations each have two single six-over-six, double-hung, wooden sash windows evenly spaced along the façade. The house is covered with wooden weatherboard siding and the roof is standing-seam metal. A structure is shown at this location on the 1921 USDA soil survey map and on subsequent historic maps (Figures 3.5 through 3.9). Although the house retains its integrity of location, setting, materials, workmanship, feeling, and design, it is a common form and design of early-twentieth century vernacular residence and is not associated with a significant historical event or period. No major changes have occurred to SHPO Survey Number 1460 since it was recorded in 2019; S&ME concurs with the previous recommendation that SHPO Survey Number 1460 is ineligible for inclusion in the NRHP.

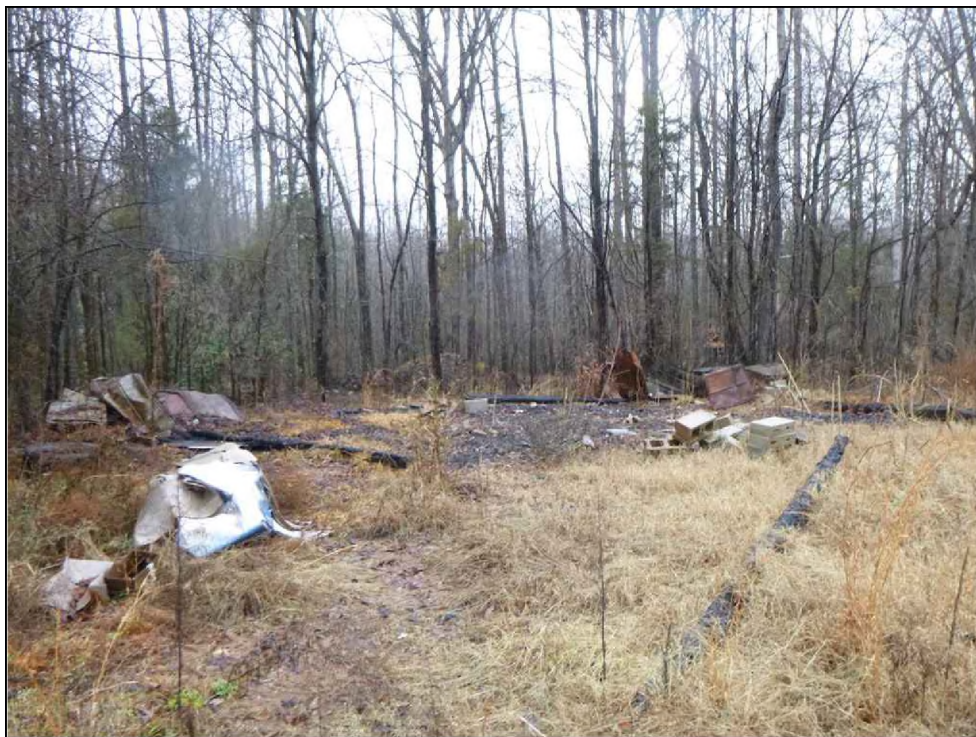
Full Salvation Baptist Church (SHPO Survey Number 1461) was recorded in 2019 as a circa-1950s church structure, located at the northeast corner of Charles Street and Ice House Road, west of the southern parcel (Figures 1.1 and 1.2). In addition to the church structure, there was also a wooden storage shed on the property (SHPO Survey Number 1461.01). A revisit to the site found that neither structure on the property remains extant and the church building appears to have been destroyed by a fire (Figure 5.23).

**Figure 5.23. Location of Full Salvation Baptist Church (SHPO Survey Number 1461), facing east.**

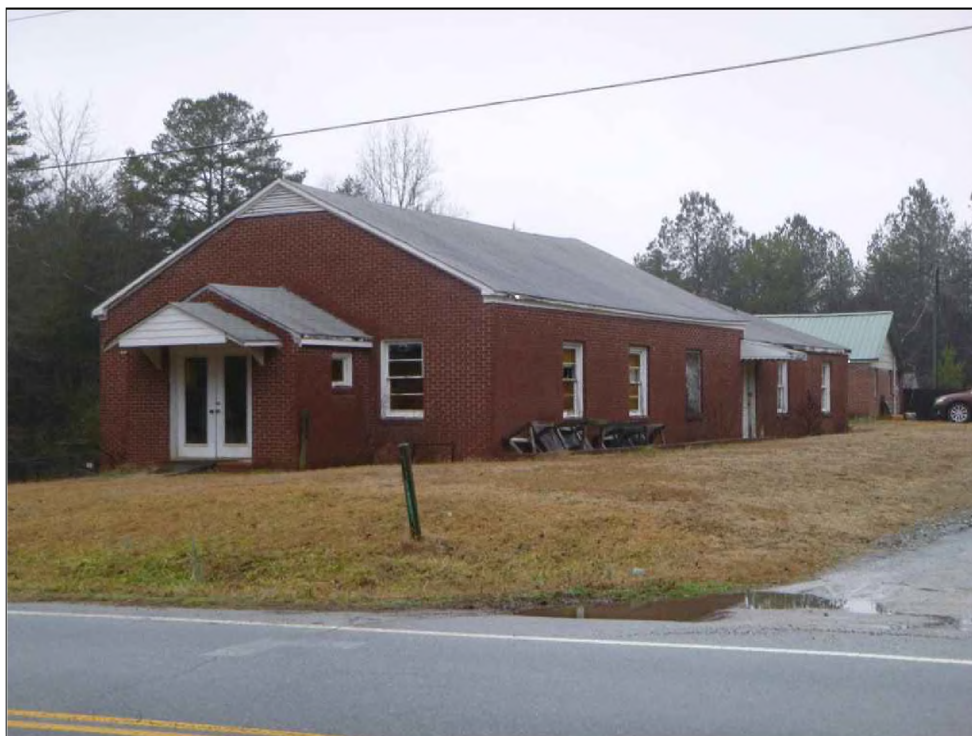
SHPO Survey Number 1462 is a circa-1950s church building that has been converted into a residence; it is located at 1891 Highway 92, east of the southern parcel (Figures 1.1 and 1.2). The structure was recorded in 2019 and was recommended as ineligible for the NRHP. The building is a single story, front-gabled, frame structure with a brick veneer exterior (Figure 5.24). The front elevation has an enclosed gabled entry portico, that has a gabled hood supported by brackets that shades the double front entry door; on either side of the portico is a single two-over-two, double-hung, wooden sash window. Both the east and west elevations of the main structure have three evenly-spaced, two-over-two, double-hung, wooden sash windows. Along the north elevation is a gabled rear addition, with a secondary entry door and two single six-over-six, double-hung, wooden sash windows on the east elevation and three six-over-six, double-hung, wooden sash windows along the west elevation. The roof of the residence is covered with composition shingles. Located behind the church building is a mid-twentieth century, one-story, side-gabled house with a brick veneer exterior (SHPO Survey Number 1462.01). The house is a Ranch-style residence, with a slightly off-center door that is located beneath a gabled porch that is supported by decorative metal posts. To the west of the door are paired and a single six-over-six, double-hung, vinyl sash windows; to the east of the door are two single six-over six, double-hung, vinyl sash windows. Each gable end has two evenly spaced six-over-six, double-hung, vinyl sash windows and the attic level of each side is covered with vinyl siding. The roof of the house is standing-seam metal. Structures are shown near the location of SHPO Survey Number 1462 on the SCDOT maps, but none is labeled as a church; on the 1969 USGS topographic quadrangle, a structure at this location is labeled as Freewill Church (Figures 3.6 through 3.9).

Although SHPO Survey Number 1462 retains its integrity of location, setting, materials, and workmanship, its design, feeling, and association have been altered by its conversion from a church to a residence. The structure is a common form and design for mid-twentieth century religious buildings that has undergone recent changes; it is not associated with a significant historical event or period. Additionally, SHPO Survey Number 1462.01 is a common type of mid-twentieth century residence that has lost its integrity of materials and workmanship through the replacement of the windows and the siding in the gable ends. No major changes have occurred to SHPO Survey Numbers 1462 and 1462.01 since they were recorded in 2019; S&ME concurs with the previous recommendation that SHPO Survey Numbers 1462 and 1462.01 are ineligible for inclusion in the NRHP.

**Figure 5.24. Freewill Church/House (SHPO Survey Number 1462), facing northwest.**

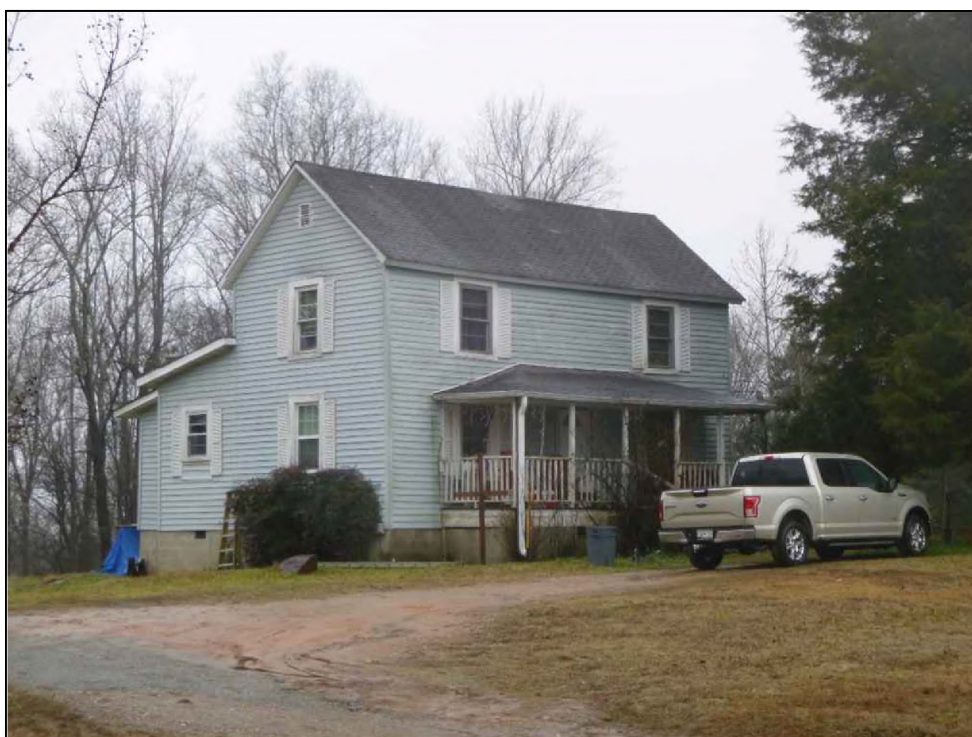
SHPO Survey Number 1463 is a circa-1910 residence that is located at 2030 Highway 92, east of the southern parcel (Figures 1.1 and 1.2). The structure was recorded in 2019 and was recommended as ineligible for the NRHP. The house is a two-story, frame residence, resting on concrete, with a side-gabled roof (Figure 5.25). The front elevation is three bays wide, with a central door that is flanked by a single two-over-two, double-hung, wooden sash window on either side. A hip-roofed porch, supported by square posts, spans most of the width of the front elevation. The east and west elevations each have a single two-over-two, double-hung, wooden sash window on each story. A shed-roofed rear addition is visible along the north elevation of the house. The house is covered with vinyl siding and the roof is composition shingles. A structure is shown at this location on the 1921 USDA soil survey map and on subsequent historic maps (Figures 3.5 through 3.9). Although the house retains its integrity of location, setting, feeling, and design, its materials and workmanship have been compromised by replacement siding and changes to its porch supports; it is a common form and design of early-twentieth century vernacular residence and is not associated with a significant historical event or period. No major changes have occurred to SHPO Survey Number 1463 since it was recorded in 2019; S&ME concurs with the previous recommendation that SHPO Survey Number 1463 is ineligible for inclusion in the NRHP.

**Figure 5.25. SHPO Survey Number 1463, facing southwest.**

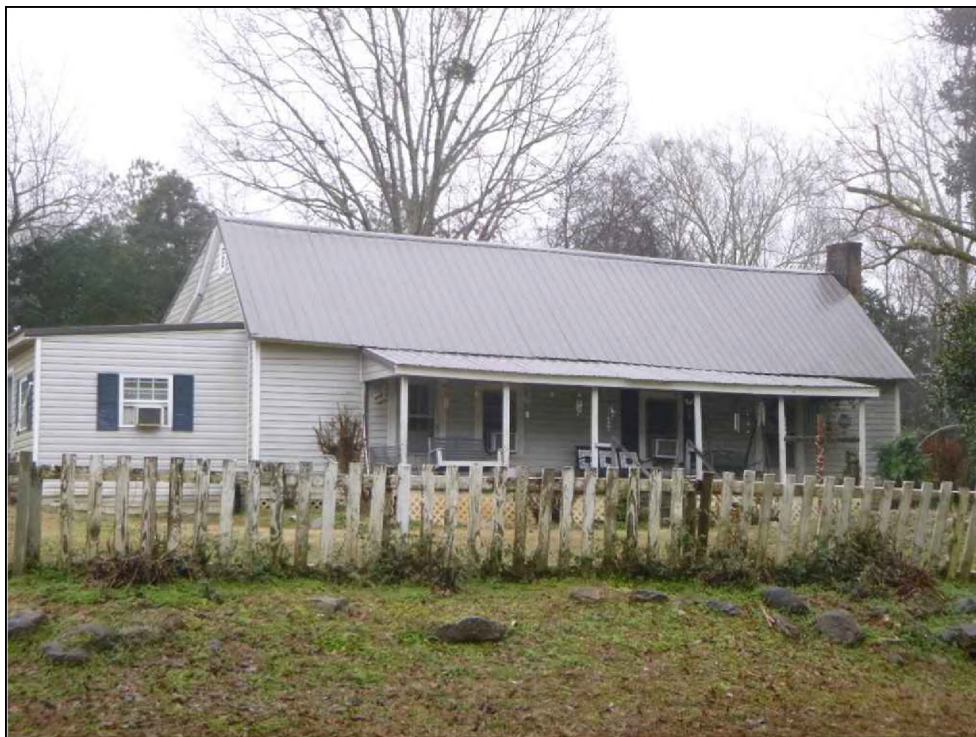
SHPO Survey Number 1651 is a circa 1900 one-story vernacular residence, located at 121 Ice House Road, approximately 0.15-mile southeast of the southern parcel (Figures 1.1 and 1.2). The house, which is currently a two-family residence and may have originally been constructed as a duplex, has a rectangular plan, with a four-bay façade and a side-gabled roof (Figure 5.27). The front elevation has a four-bay, shed-roofed porch that is supported by square wooden posts; the façade is symmetrical, with an entry door, two single two-over-two, double-hung, metal frame windows, and an entry door. The east elevation of the house has a single-story, shed-roofed addition, with one six-over-six, double-hung, vinyl sash window on its front elevation and a side entry door and single six-over-six, double-hung, vinyl sash window on the east side. The original rear of the house has a shed-roofed rear addition or porch that had been enclosed, but there is a visible change in the roofline created by an additional rear extension. The west elevation of the house has an exterior chimney that has been covered with stucco. The exterior of the house is covered with vinyl siding and the roof is standing-seam metal. A structure appears on historic maps at this location on the 1969 USGS 7.5-minute *Enoree* quadrangle (Figures 3.9). SHPO Survey Number 1651 is an example of an early twentieth century vernacular form of rural residence; this was a common residential type for this period. Although it retains its integrity of location, setting, and feeling, its integrity of design has been altered by the rear addition and the materials and workmanship have been compromised by modern siding and replacement windows. The house has no known historical associations. Therefore, S&ME recommends that SHPO Survey Number 1651 as ineligible for the NRHP.

**Figure 5.27. SHPO Survey Number 1651, facing southwest.**

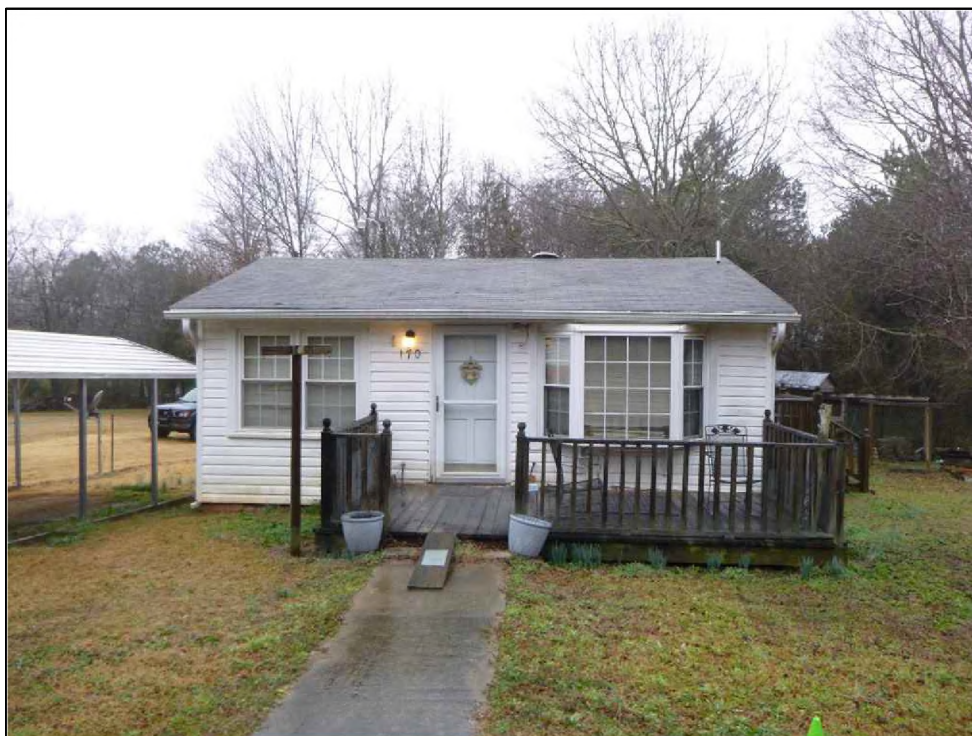
SHPO Survey Number 1652 is a circa 1949 one-story, Minimal Traditional-style residence, located at 170 Ice House Road, approximately 0.1-mile to the south of the southern parcel (Figures 1.1 and 1.2). The house has a rectangular plan, with a three-bay façade and a side-gabled roof; it rests on a concrete foundation (Figure 5.28). The front elevation consists of a central entry door, accessed by ramp to an uncovered wooden porch; to the west of the door is a paired six-over-six, double-hung, vinyl sash window and to the east is a three-bay projecting picture window, with a 16-pane vinyl window in front with four-over-four, double-hung, vinyl sash windows on the sides. The east elevation has a side entry door, accessed by a raised wooden porch; the west elevation has two single six-over-six, double-hung, vinyl sash windows. A single-story rear addition is visible along the north elevation. The exterior of the house is covered with vinyl siding and the roof is asphalt shingles. A structure appears on historic maps at this location on the 1969 USGS 7.5-minute *Enoree* quadrangle (Figures 3.9). SHPO Survey Number 1652 is an example of a mid-twentieth century Minimal Traditional-style residence; this was a common residential type for this period. Although it retains its integrity of location, setting, design, and feeling, its integrity of materials and workmanship have been compromised by replacement siding and windows. The house has no known historical associations. Therefore, S&ME recommends that SHPO Survey Number 1652 as ineligible for the NRHP.

**Figure 5.28. SHPO Survey Number 1652, facing north.**

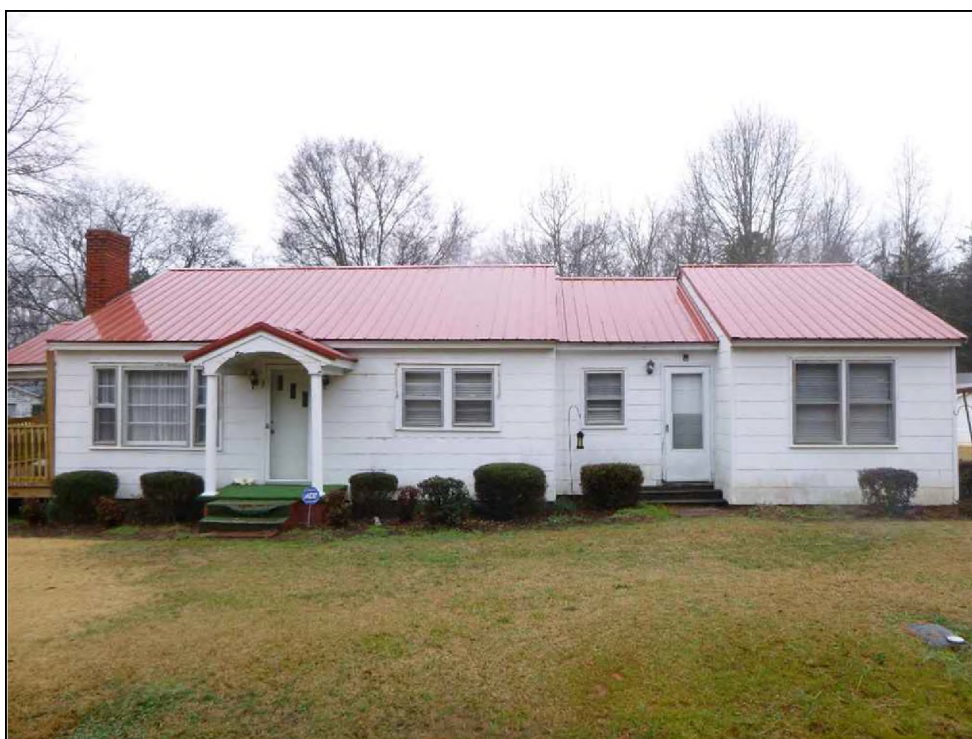
SHPO Survey Number 1653 is a circa 1955 one-story Minimal Traditional-style residence, located at 180 Ice House Road, approximately 0.1-mile south of the southern parcel (Figures 1.1 and 1.2). The house, which has had multiple additions since its original construction, has a side-gabled roof and it rests on a concrete foundation (Figure 5.29). On the original portion of the house, the central entry door is located beneath a gabled hood, with curved underside, supported by round columns; to the west is a metal frame, tripartite picture window and to the east is a small pair of two-over-two, double-hung, metal frame windows. The east elevation has a hyphen addition, with a single two-over-two, double-hung, metal frame window and an entry door, attaching to a one-story, side-gabled addition with a paired two-over-two, double-hung, metal frame window; the east elevation of the addition has two single two-over-two, double-hung, metal frame windows. The west elevation of the house has two single one-over-one, double-hung, metal frame windows flanking an exterior brick chimney; there is also a side entry door, located beneath a gabled side porch that is supported by square posts. The exterior of the house is covered with fiberboard siding and the roof is standing-seam metal. A structure appears on historic maps at this location on the 1969 USGS 7.5-minute *Enoree* quadrangle (Figures 3.9). SHPO Survey Number 1653 is an example of a mid-twentieth century Minimal Traditional-style rural residence; this was a common residential type for this period. Although it retains its integrity of location, setting, and feeling, its integrity of design has been altered by additions and the materials and workmanship have been compromised by modern siding and the replacement windows. The house has no known historical associations. Therefore, S&ME recommends that SHPO Survey Number 1653 as ineligible for the NRHP.

**Figure 5.29. SHPO Survey Number 1653, facing north.**

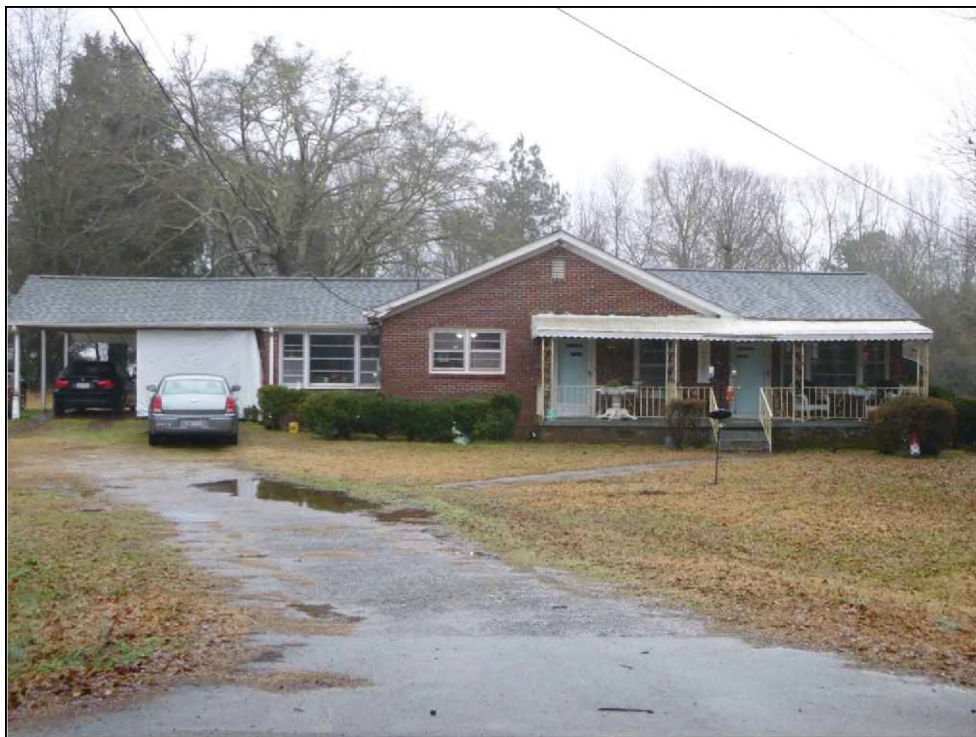
SHPO Survey Number 1655 is a circa 1940 one-story Minimal Traditional-style residence, located at 191 Ice House Road, located approximately 0.1-mile south of the southern parcel (Figures 1.1 and 1.2). The house, which appears to have been converted to a duplex, has a cross-gabled roofline and a five-bay façade (Figure 5.31). The eastern three bays, consisting of an entry door flanked by a paired and a single two-over-two, double-hung, metal frame window, are located on a front-gabled portion of the house, while the remaining two bays, consisting of an entry door and a metal-framed tripartite picture window, are on the side-gabled section; the western four bays are located beneath a shed-roofed metal awning that is supported by decorative metal posts. Along the east elevation of the house, a side-gabled carport, supported by metal posts, extends past the front-gabled section and is connected to the house with a hyphen addition, which appears to be a breezeway that has been enclosed and has a metal-framed, tripartite picture window. A single-story rear addition is located on the south elevation of the house. The exterior of the structure is covered with brick veneer and the roof is composition shingles; there are no visible chimneys on the house. A structure appears on historic maps at this location on the 1969 USGS 7.5-minute *Enoree* quadrangle (Figures 3.9). SHPO Survey Number 1655 is an example of an early to mid-twentieth century Minimal Traditional-style rural residence; this was a common residential type for this period. Although it retains its integrity of location, setting, and feeling, its integrity of design has been altered by the attachment of the carport and enclosure of the breezeway and the materials and workmanship have been replacement windows. The house has no known historical associations. Therefore, S&ME recommends that SHPO Survey Number 1655 as ineligible for the NRHP.

**Figure 5.31. SHPO Survey Number 1655, facing south.**

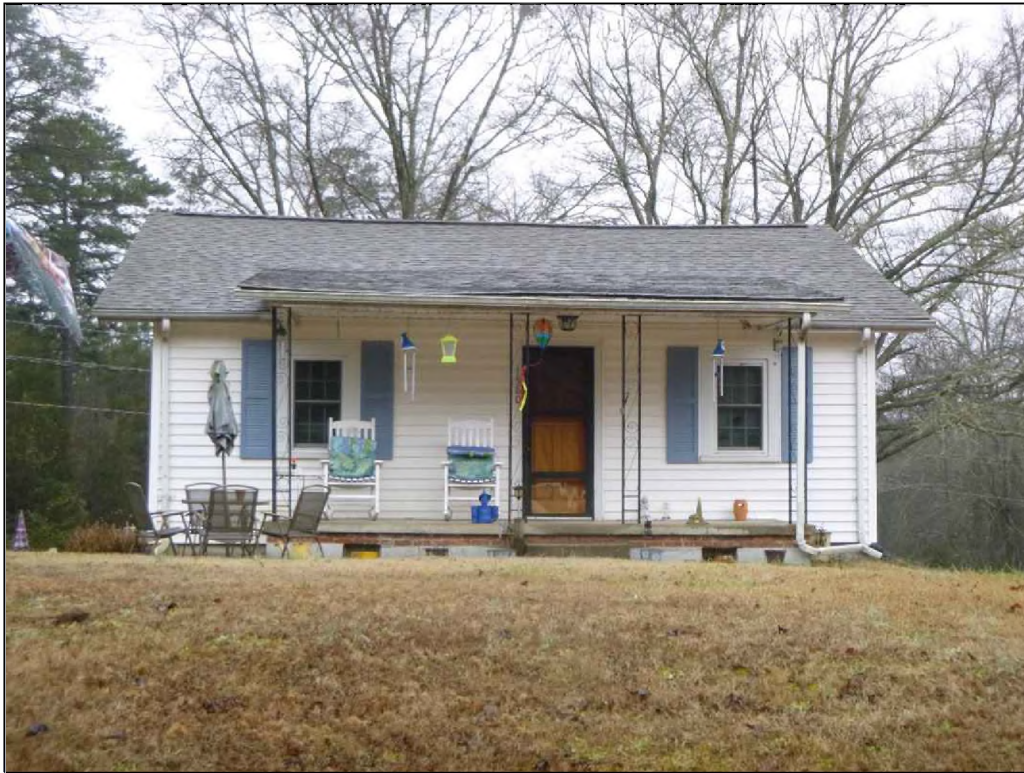
SHPO Survey Number 1658 is a circa 1948 one-story residence, located at 1580 Highway 92, approximately 0.15-mile southwest of the southern parcel (Figures 1.1 and 1.2). The house has a rectangular plan, with a side-gabled roofline; it rests on a concrete block foundation that creates a basement level as the lot slopes downward to the rear of the structure (Figure 5.34). The front elevation has an off-center entry door that is flanked by a single six-over-six, double-hung, vinyl sash window on either side; a three-bay, shed-roofed porch, which is supported by decorative metal posts, shades the door and windows. The east elevation of the house has a single and a paired six-over-six, double-hung, vinyl sash window; the west elevation that three single six-over-six, double-hung, vinyl sash windows on the main story and two single two-over-two, double-hung, metal frame windows on the

**Figure 5.34. SHPO Survey Number 1658, facing south.**

basement level. A shed-roofed addition spans the length of the rear elevation. The exterior of the house is covered with vinyl siding and the roof is composition shingles; there are no visible chimneys on the house. A structure appears on historic maps at this location on the 1969 USGS 7.5-minute *Enoree* quadrangle (Figures 3.9). SHPO Survey Number 1658 is an example of a mid-twentieth century vernacular form of rural residence; this was a common residential type for this period. Although it retains its integrity of location, setting, and feeling, its integrity of design has been compromised by an addition to the rear elevation and the materials and workmanship have been compromised by replacement windows and siding. The house has no known historical associations. Therefore, S&ME recommends that SHPO Survey Number 1658 as ineligible for the NRHP.

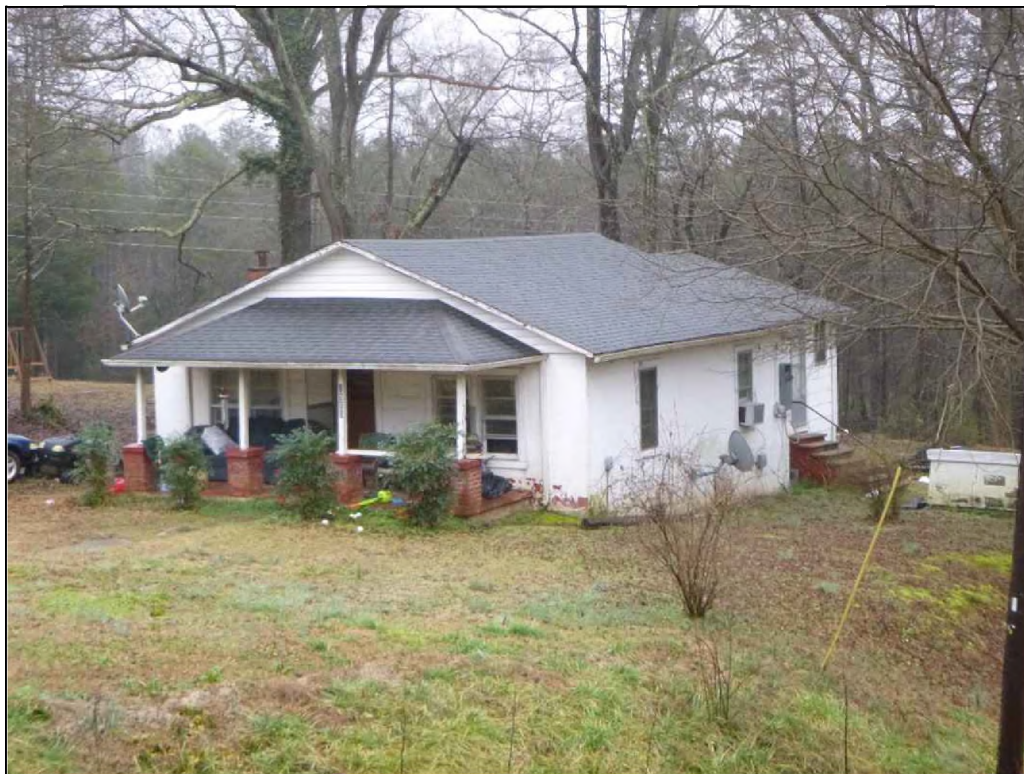
SHPO Survey Number 1659 is a circa 1954 one-story residence, located at 1560 Highway 92, approximately 0.15-mile southwest of the southern parcel (Figures 1.1 and 1.2). The house, which is of concrete block masonry construction with a partially stucco-covered exterior, has a rectangular plan, with a front-gabled roofline (Figure 5.35). The front elevation has a central entry door, flanked by paired two-over-two, double-hung, metal frame windows on either side; there is a full-width, hip-roofed porch that is supported by square posts that rest on brick piers. The west elevation of the house has two single two-over-two, double-hung, metal frame windows, as does the east elevation, which also has an exterior brick chimney. There is a single story, gabled rear addition, which has single one-over-one, double-hung, vinyl sash windows and is covered with fiberboard siding. The gable end of the house, above the concrete masonry walls, is covered with vinyl siding; roof of the house is covered with composition shingles. A structure appears on historic maps at this location on the 1969 USGS 7.5-minute *Enoree*

**Figure 5.35. SHPO Survey Number 1659, facing southeast.**

quadrangle (Figures 3.9). SHPO Survey Number 1659 is an example of a mid-twentieth century vernacular form of rural residence; this was a common residential type for this period. Although it retains its integrity of location, setting, and feeling, its integrity of design, materials, and workmanship have been compromised by the rear addition and replacement siding in the gable end. The house has no known historical associations. Therefore, S&ME recommends that SHPO Survey Number 1659 as ineligible for the NRHP.

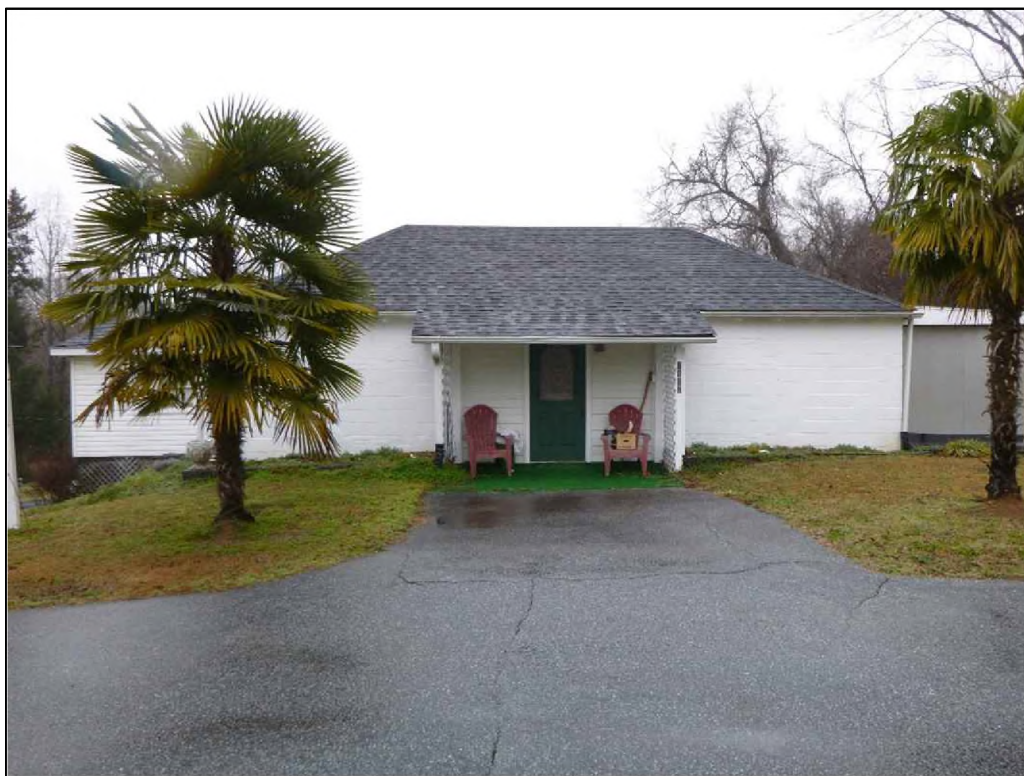
SHPO Survey Number 1660 is a circa 1950 one-story commercial structure, located at 1425 Highway 92, approximately 0.25-mile west of the southern parcel (Figures 1.1 and 1.2). The original building, which is of concrete block masonry construction, has a rectangular plan and hipped roof (Figure 5.36). The front elevation has a central entry door, located beneath a shed-roofed portico that is supported by square posts, with wooden lattice on the sides; the modern door is surrounded by vinyl siding, which covers the section under the porch. The main building has no other openings on the front elevation. On the west side, there are two single-pane, rectangular casement windows in the upper portion of the wall and a one-story, side-gabled addition that has a secondary entry door, single one-over-one, double-hung, vinyl sash window, and vinyl siding on its exterior. A structure appears on historic maps at this location on the 1969 USGS 7.5-minute *Enoree* quadrangle (Figures 3.9). SHPO Survey Number 1660 is an example of a mid-twentieth century commercial building. Although it retains its integrity of location, setting, and feeling, its integrity of design has been altered by multiple additions and alterations to the entryway and the materials and workmanship have been compromised by replacement windows and new siding on portions of the building. The structure has no known historical associations. Therefore, S&ME recommends that SHPO Survey Number 1660 as ineligible for the NRHP.

**Figure 5.36. SHPO Survey Number 1660, facing north.**

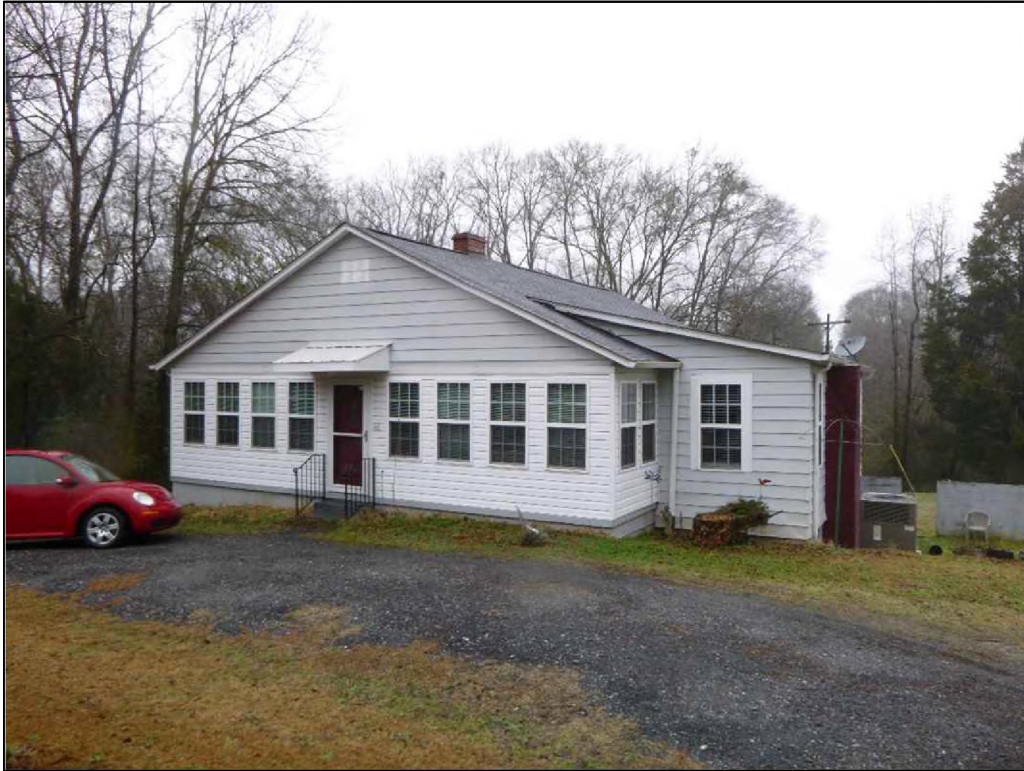
SHPO Survey Number 1661 is a circa 1900 one-story residence, located at 1421 Highway 92, approximately 0.25-mile west of the southern parcel (Figures 1.1 and 1.2). The house has a rectangular plan, with a front-gabled roofline; it rests on a concrete block foundation that creates a basement level on the rear of the structure (Figure 5.37). The front elevation has a central entry door, located beneath a shed-roofed metal awning; it is part of an enclosed porch that was an extension of the main gabled roofline, which now has six-over-six, double-hung, vinyl sash windows and vinyl siding. The west elevation has two single one-over-one, double-hung, vinyl sash windows. The east elevation has a shed-roofed side addition, which may have been an original side porch that was enclosed; it has two single six-over-six, double-hung, vinyl sash windows flanking a truncated exterior brick chimney, and a pair of small, six-over-six, double-hung, vinyl sash windows. The house is covered with vinyl siding and the roof is asphalt shingles; there is an interior brick chimney visible above the roof ridge. A structure appears on historic maps at this location on the 1969 USGS 7.5-minute *Enoree* quadrangle (Figures 3.9). SHPO Survey Number 1661 is an example of an early twentieth century vernacular form of rural residence; this was a common residential type for this period. Although it retains its integrity of location, setting, and feeling, its integrity of design, materials, and workmanship have been compromised by the enclosure of the front porch, the removal of the east elevation chimney top, and replacement siding and windows. The house has no known historical associations. Therefore, S&ME recommends that SHPO Survey Number 1661 as ineligible for the NRHP.

**Figure 5.37. SHPO Survey Number 1661, facing north.**
