ARCHAEOLOGICAL FIELD REPORT
SCDOT ENVIRONMENTAL SECTION

TITLE: Cultural Resources Survey for US 278 at SC 3 and SC 300 Intersection Improvements

PROJECT: US 278 at SC 3 and SC 300 Intersection Improvements

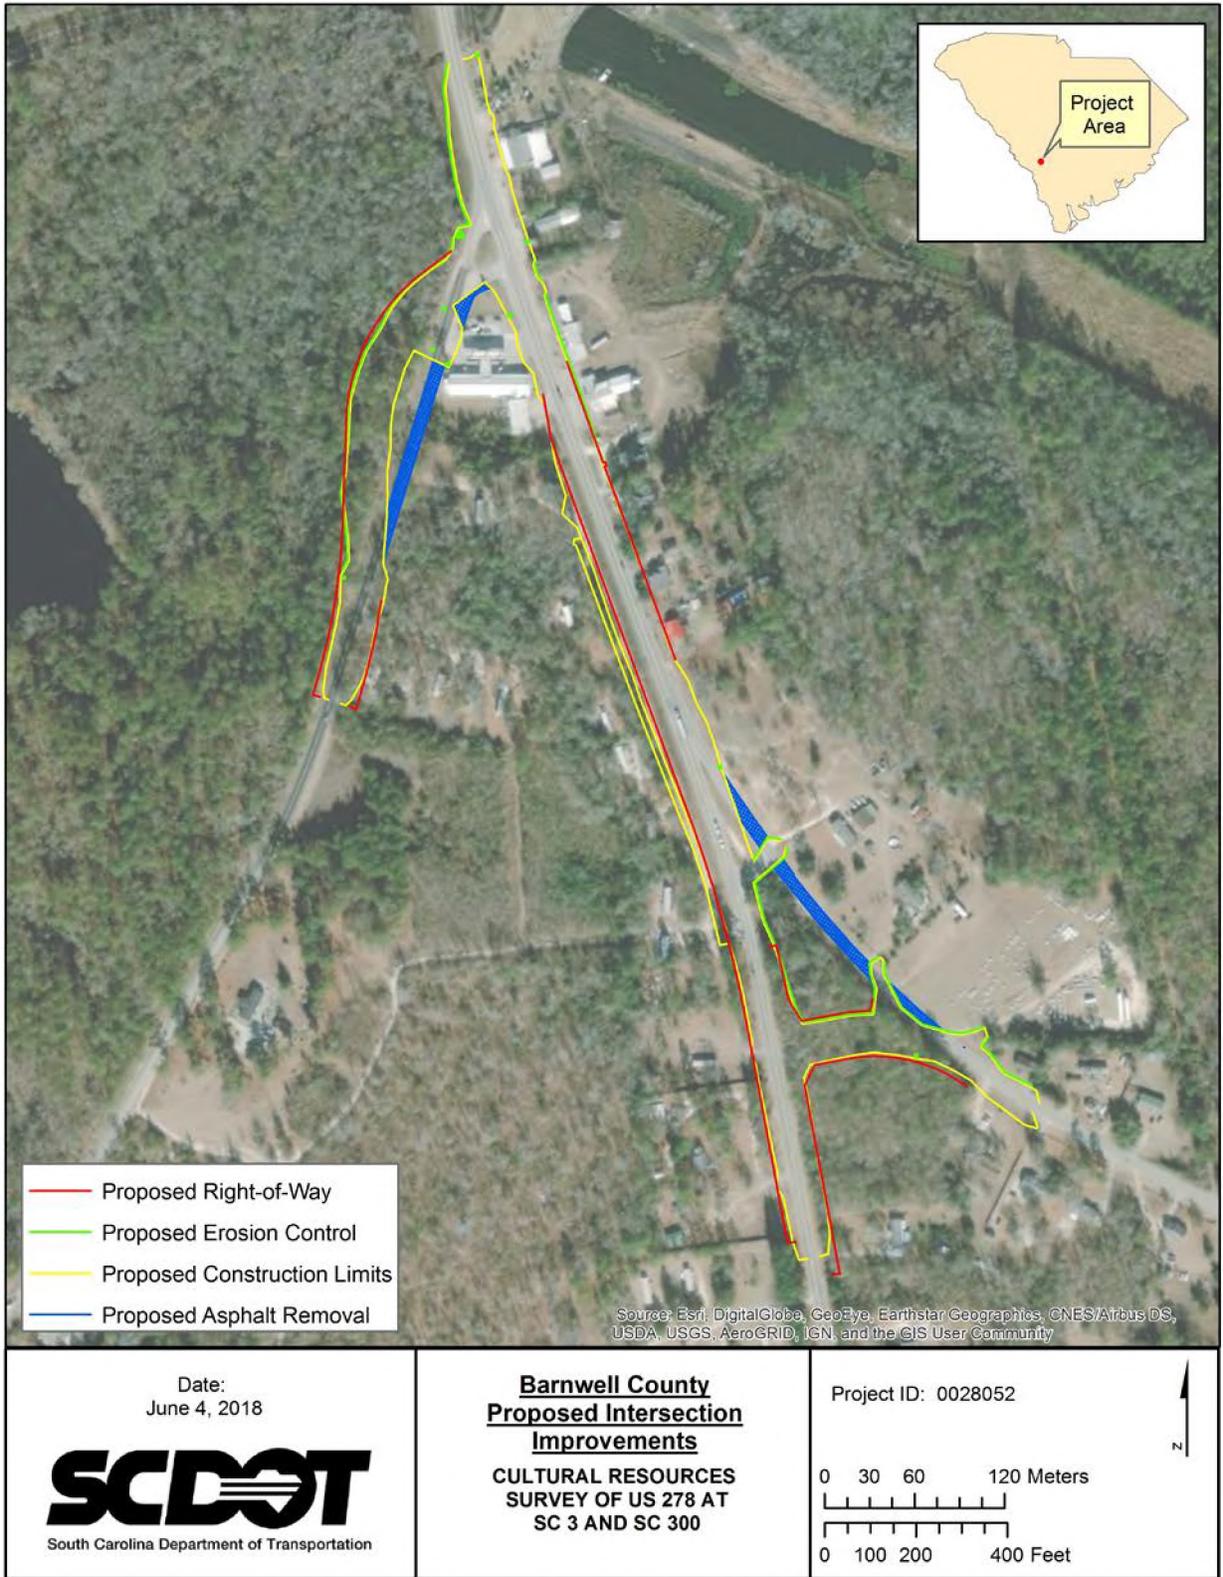
Figure 2. Intersection Improvement Plans for US 278 at SC 3 and SC 300.

DESCRIPTION: The Department proposes improvements to the intersections of US 278 with SC 3 and SC 300 in Barnwell County (**Figure 1**). The proposed plan will change the SC 3 and SC 300 intersections to make them perpendicular to US 278 (**Figure 2**). A small amount of new right of way will be required to complete the project. The APE (Area of Potential Effect) for archaeological resources for the project consists of land that will be acquired as new right of way as well as those areas within the existing right of way that might be affected by the undertaking. The APE for architectural resources consists of a 300 foot buffer around the archaeological APE (**Figure 3**).

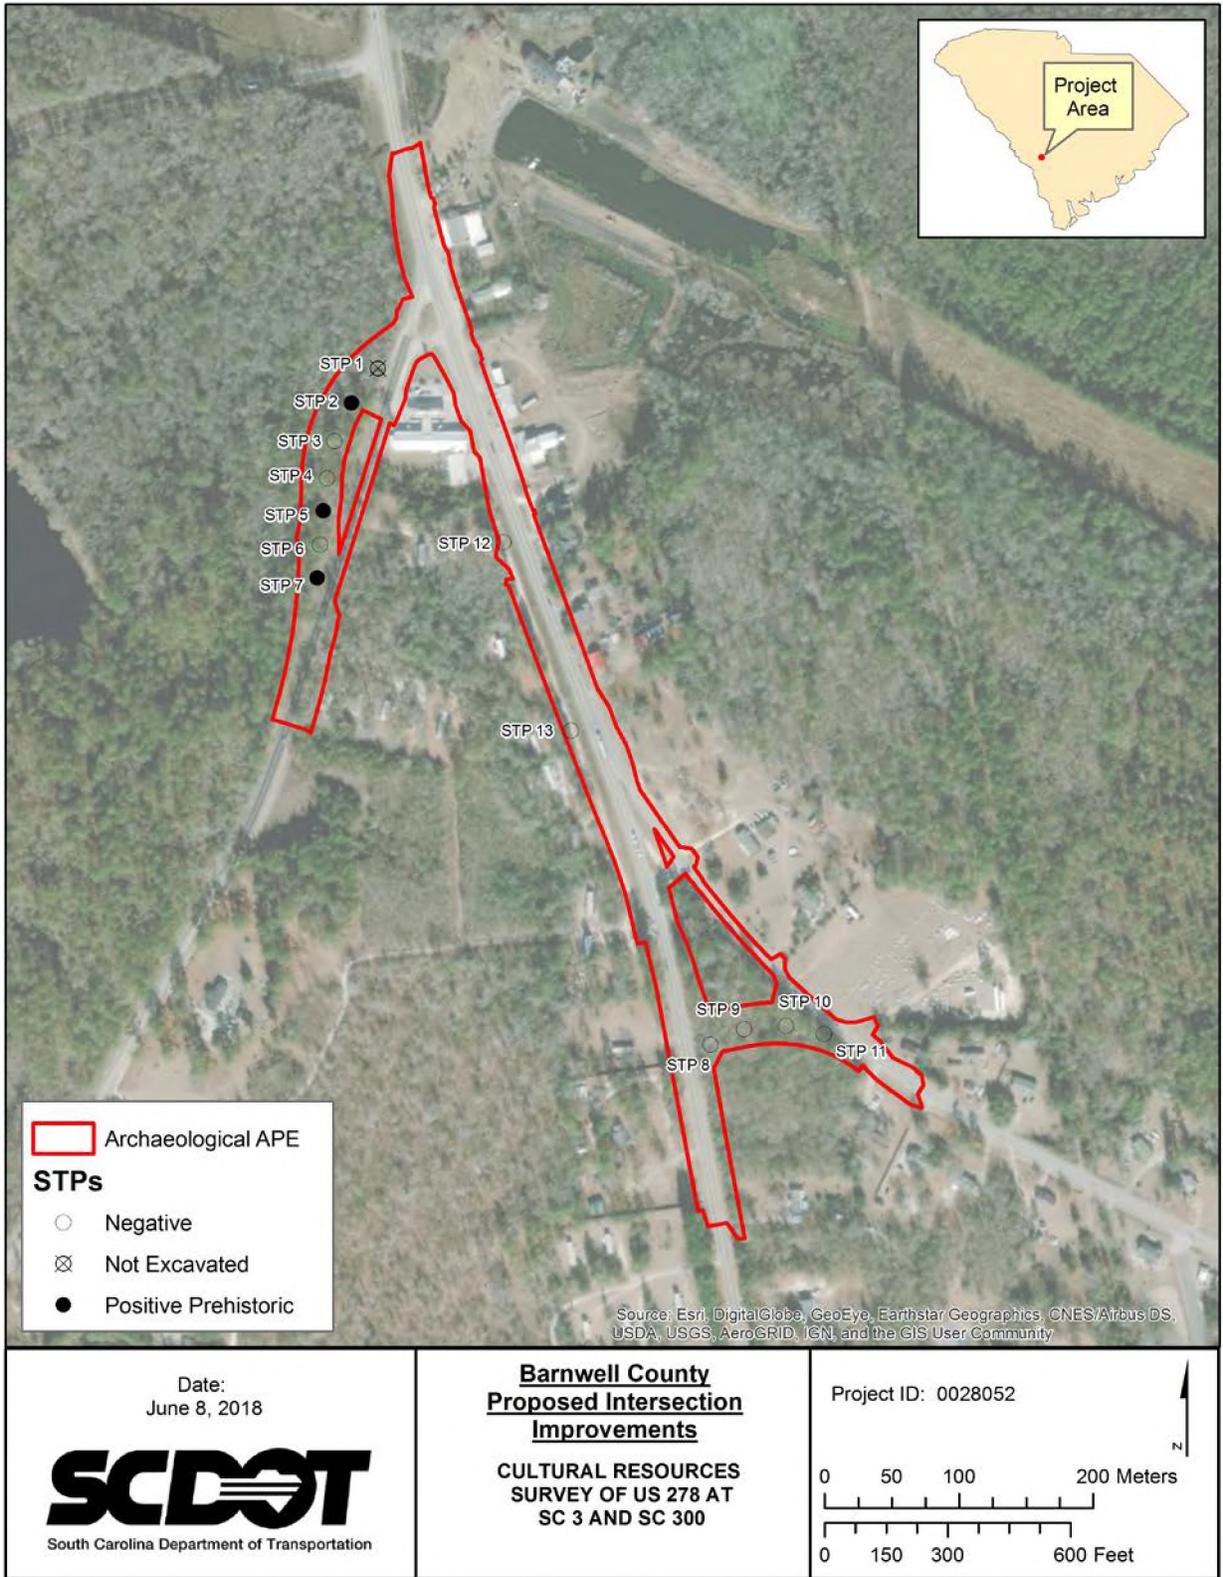
Figure 13. Transect Shovel Tests Within the APE.

ARCHAEOLOGICAL SURVEY RESULTS: There were two areas within the project area where new right-of-way completely left the original alignment and needed to be tested. The two areas of new right-of-way were shovel tested at 30 meter intervals while the rest of the project area was walked over and investigated with judgmental shovel test pits. Seven shovel test pits (STP) were excavated at the northern intersection improvement and four at the southern intersection improvement. Two additional shovel tests were excavated along the west side of US 278. Most of this area allowed for surface inspection because of the large amount of surface visibility. Transect shovel test pits are shown on **Figure 13**. Three transect shovel tests contained prehistoric material.

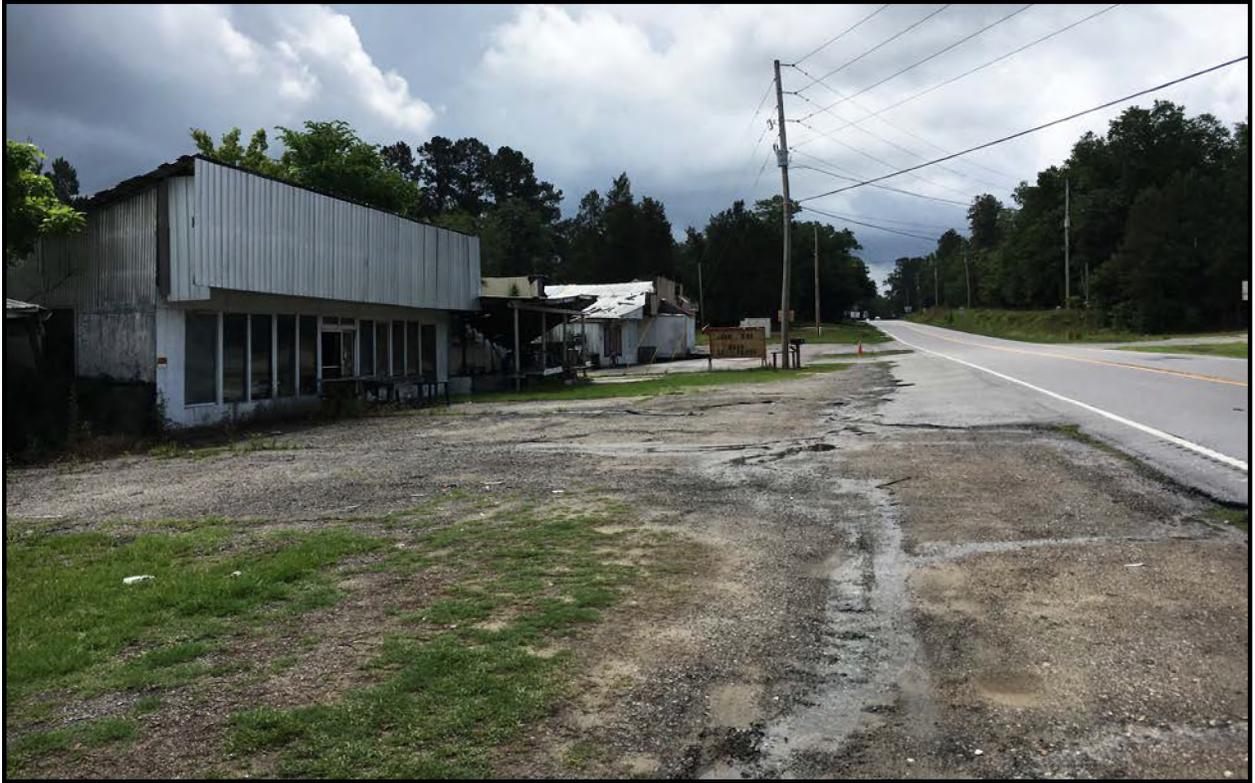
Much of the project area was found to exhibit significant disturbance from road construction, roadside ditches, road cuts, and buried and above ground utilities. **Figures 14 and 15** show the ground disturbance, buried utilities, and exposed ground surface within the project area.

Figure 14a. Paved and Graveled Disturbance Facing South Along US 278 at North End of APE.

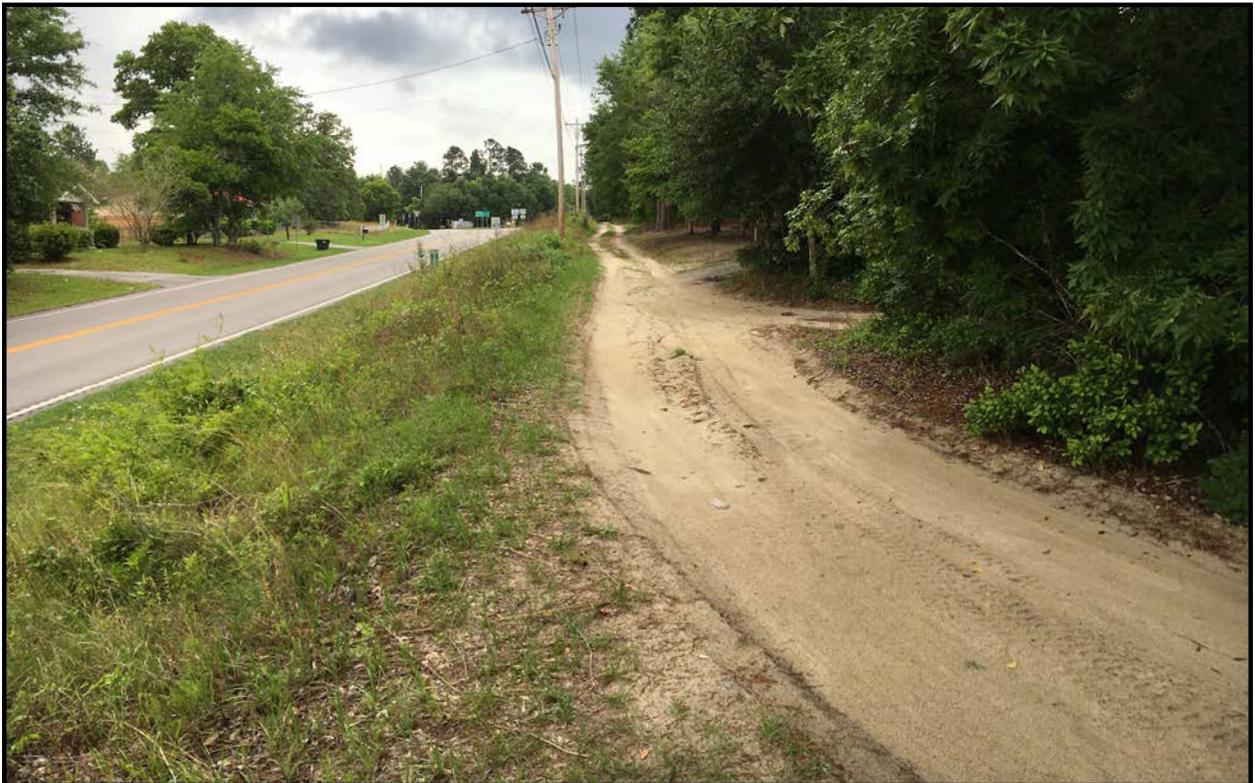
Figure 14b. Cut Bank and Exposed Ground Surface on West Side of US 278, Facing South.

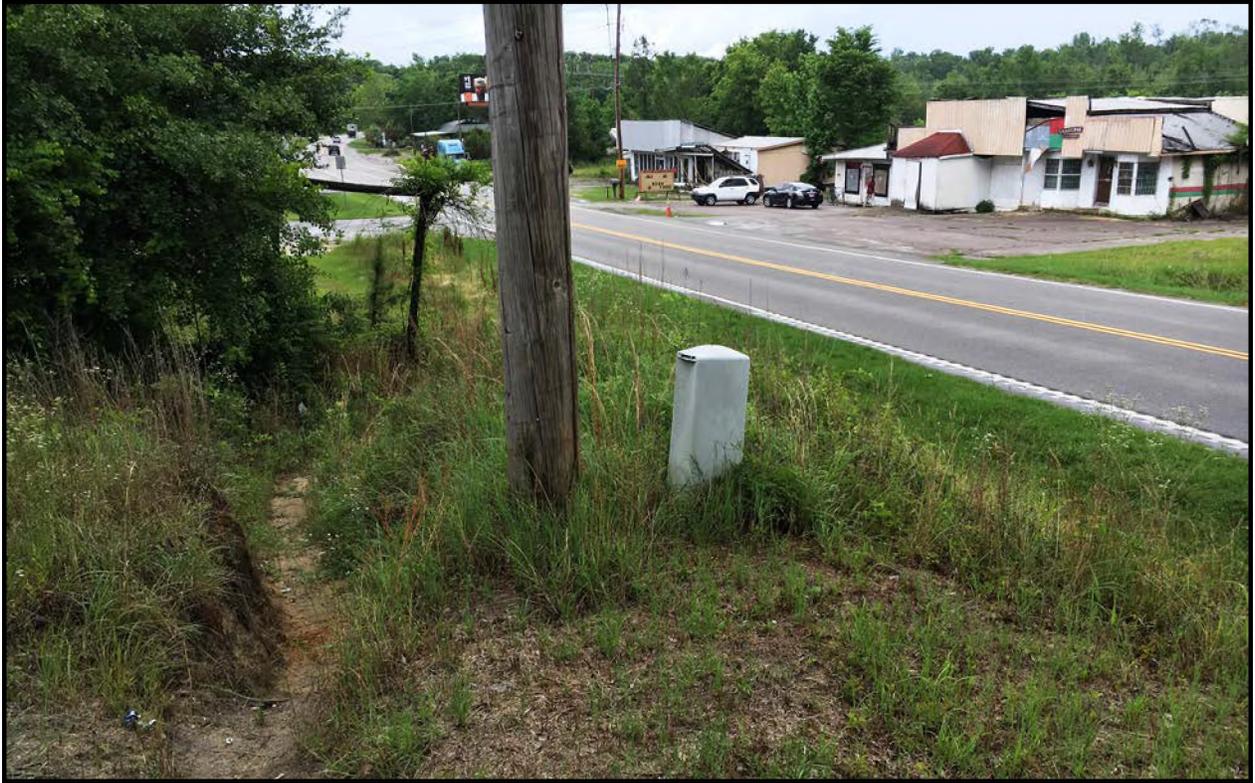
Figure 15a. View of Project Area Showing Cut Bank and Buried Utilities, Facing Northeast.

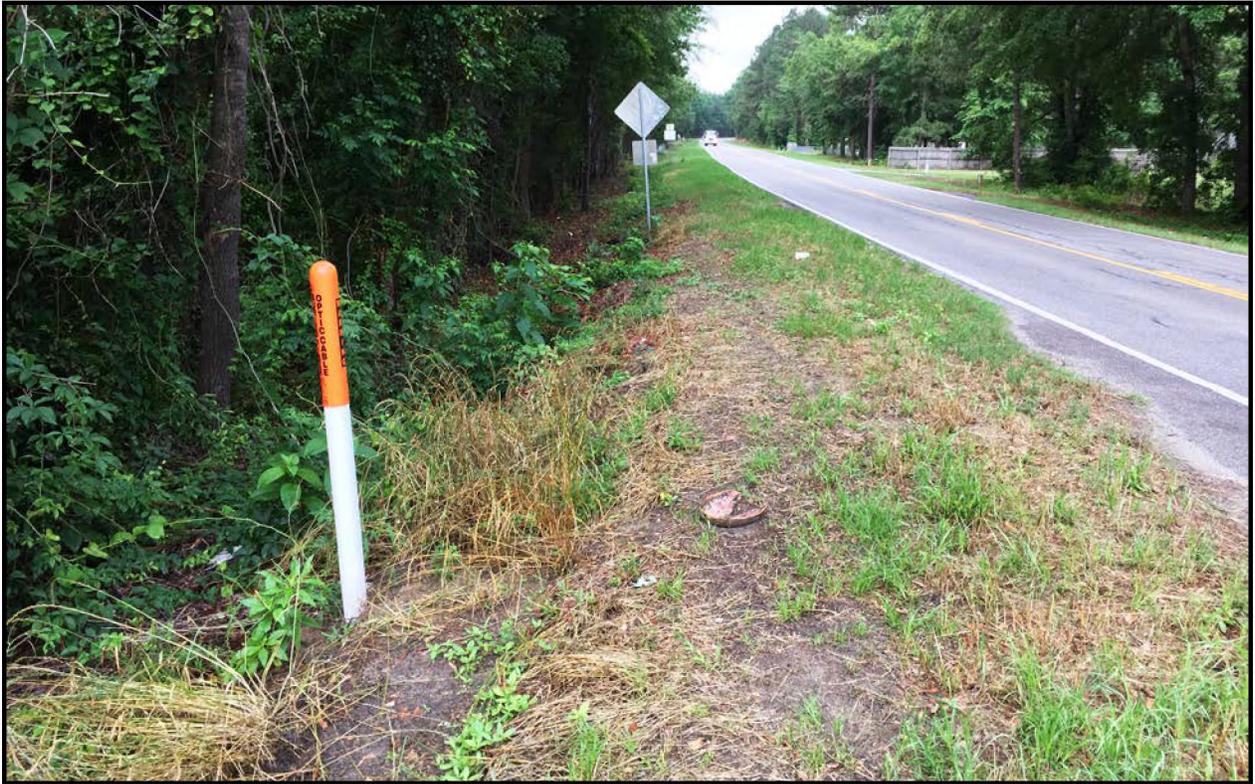
Figure 15b. View of Road Berm and Buried Utilities Disturbance Within Project Area, Facing South Along US 278.

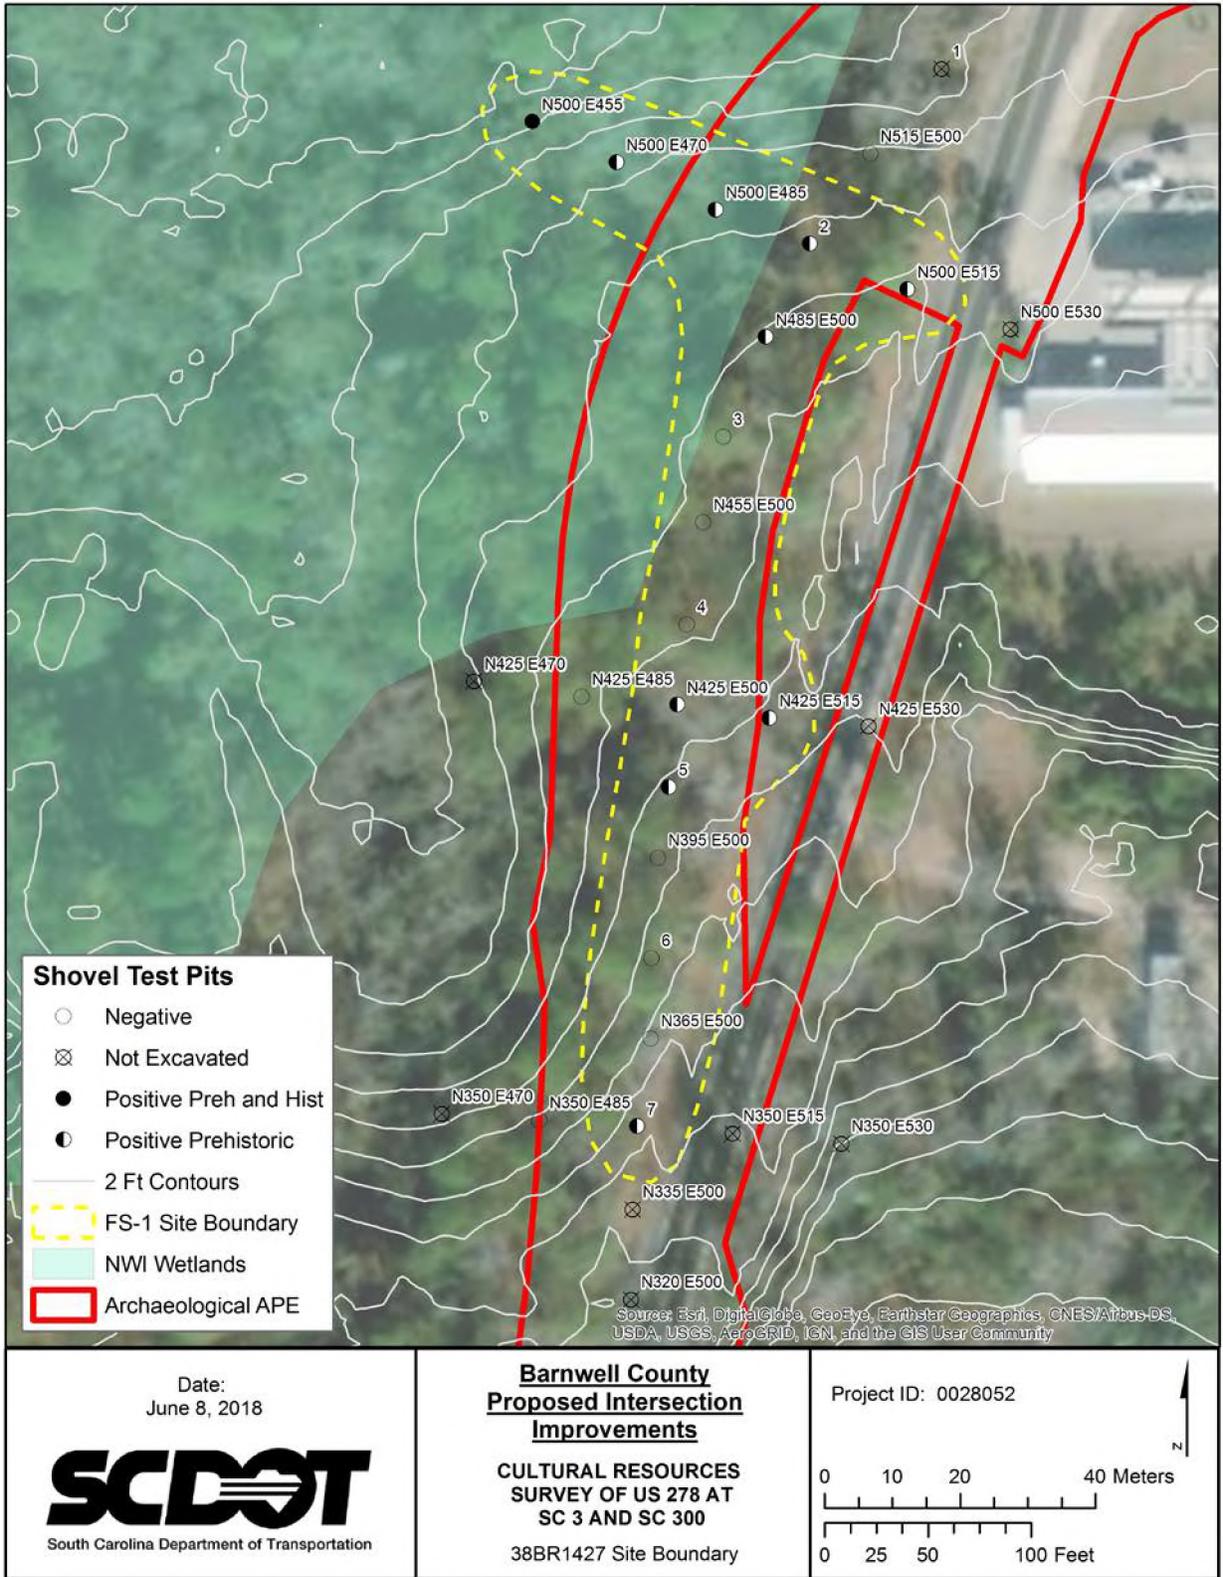
Figure 16. Map of Site 38BR1427.

Site 38BR1427 consists of a light scatter of prehistoric debitage along the west side of SC 3 (**see Figure 1**). The site overlooks marsh associated with Pen Branch to the west. It is situated on a northwest facing gentle ridge slope and was originally identified by three positive transect shovel test pits. The site was delineated at 15 meter intervals. It is bound to the north by a negative shovel test and disturbed slope, to the west by slope and wetland, and to the east and south by highway right-of-way and ground disturbance (**Figure 16**). Vegetation on the site consists of pine and hardwood with a light understory of saplings and briers. Disturbance to the site consists of highway right-of-way and erosion. Judging by the topography it is likely that the site originally extended to the east beyond what was documented in the current survey. This hypothesis was bolstered by a conversation with a local landowner who recalled finding numerous prehistoric artifacts behind (south) of the gas station located on the east side of SC 3 opposite the site. The landowner did not have access to the artifacts he reported finding and was not able to give a detailed description of the artifacts. **Figure 17** shows the site at the time of investigation.

A total of 58 artifacts were recovered at 38BR1427. These include 56 chert flakes and flake fragments, one chert biface fragment, and one wire nail. The majority of artifacts were recovered within the second stratum (n=50). At the fringes of the site, in STP N500 E455, six pieces of debitage and the wire nail were recovered in Stratum I, while in STP N350 E500 one flake was found in Stratum I. It is likely that these artifacts are the result of erosional deposition.

Site 38BR1427 is a moderate sized non-diagnostic prehistoric site consisting of a light scatter of debitage. Because of the limited size of the site, the lack of diagnostic artifacts, and because it has been heavily disturbed by erosion and construction and development, it is unlikely that additional work at the site will yield important information about the prehistory of the surrounding region. The site is recommended as not eligible for the NRHP and no further work is recommended.

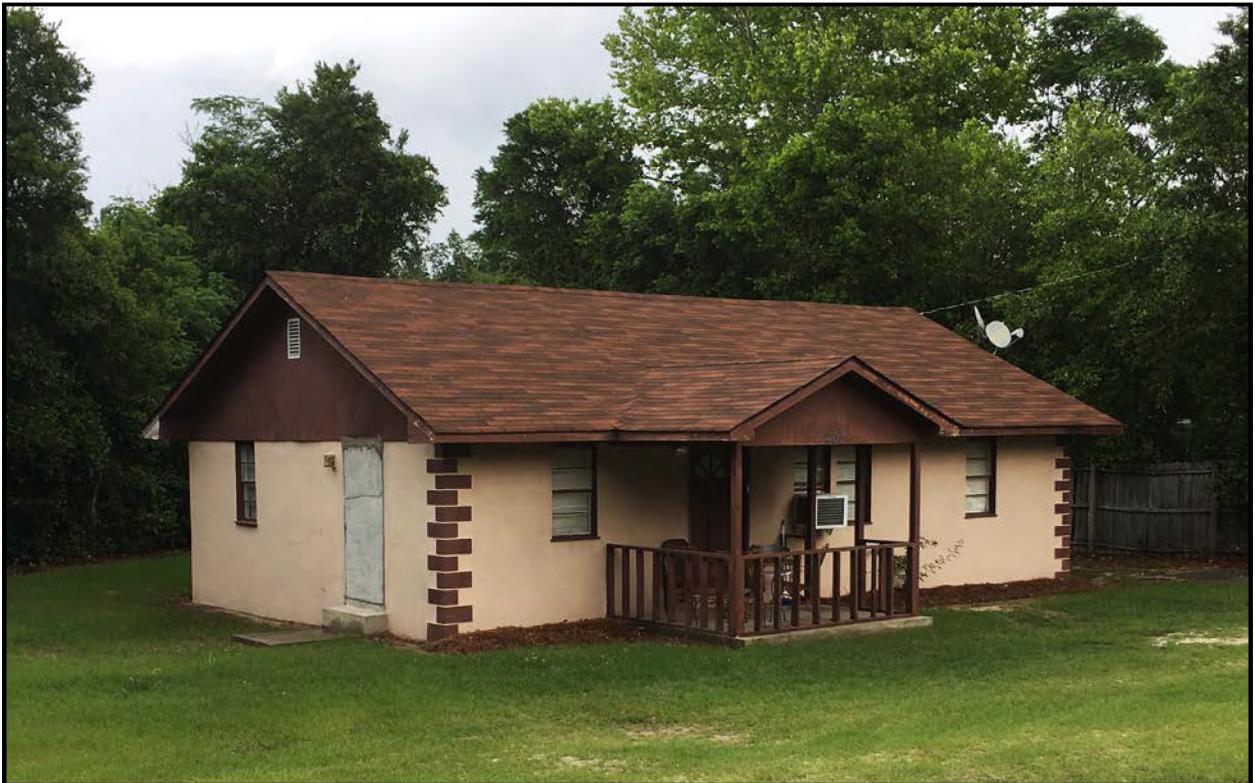
ARCHITECTURAL SURVEY RESULTS: Two (2) newly-identified structures (site #s 0494 & 0495) were identified within the Architectural APE. Site # 0494 is a circa 1940 store building (**Figure 19a**). Site # 0495 is a circa 1960 residence (**Figure 19b**). After consideration under all the criteria of the National Register of Historic Places (NRHP) neither site is recommended eligible for the NRHP.

Figure 19b. View of Site No 0495, Facing Southeast From SC 300.
