**Cultural Resource Survey of Proposed Recreation Facility Decommissioning
Enoree and Long Cane Ranger Districts, Sumter National Forest
Abbeville, Chester, Edgefield, Fairfield, Laurens, Newberry, and Union Counties, South Carolina**

**Francis Marion and Sumter National Forests
Cultural Resource Management Report No. 2018-17
SHPO Project Number 19-KL0361**

October 2019

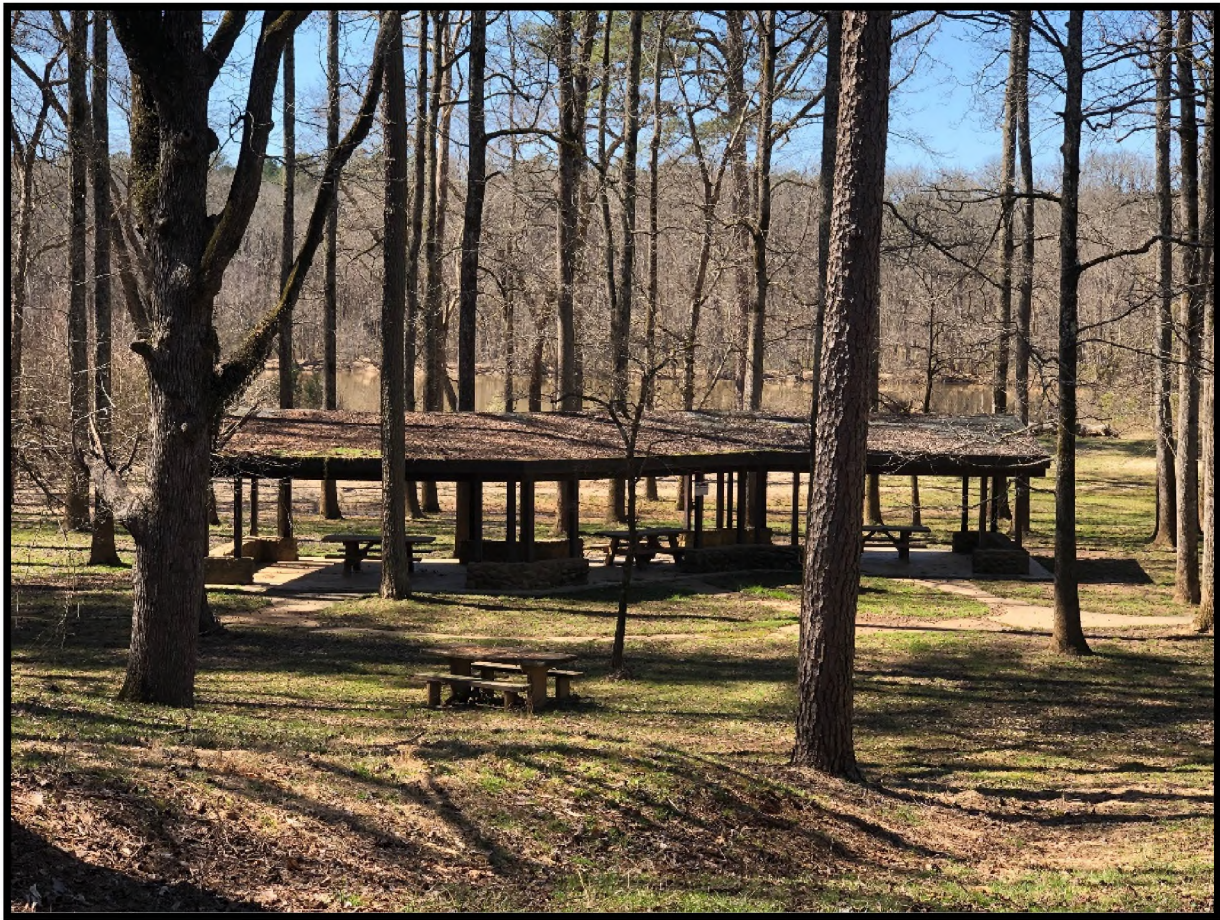
Figure 13. Overview of the Woods Ferry Picnic Structure.

construction. US Forest Service records indicate that the connected picnic structures were constructed in 1964 at the same time as the bathhouse in Loop B. Specific dimensions of the construction elements of the structure are presented in Figures 15 and 16. The Woods Ferry picnic shelter measures approximately 64 feet in length by 20 feet in width and is 12 feet in height to the top of the roof. The roof has a two-foot overhang and a three by ten-inch rafter. The building is a single-story open-air timber structure with masonry stone floor. Wood posts (6 by 6 inches) are sawn square and are joined with “U” flat iron plates and bolts to a concrete slab with masonry stones on the exterior. All timbers of the structure are painted brown and the metal plates were also stained brown to match the timber.

The Woods Ferry picnic shelter is recommended as not eligible to the NRHP. While the structure does reflect the broad patterns associated with Forest Service post-war recreation architecture it does not make a significant contribution to that broad pattern of history and likewise is not exemplary in that style. The structure is not associated with a significant person of our past and is unlikely to yield any further information potential to our history beyond what has been presented here. The current undertaking does not include the removal of the picnic shelters themselves but does propose to remove sections of the sidewalk leading to the structure. However, the removal of these sidewalk sections will not affect the picnic structures themselves and the picnic shelters will be avoided during that process. The current undertaking will have no effect to the historic structure. It is worth noting that due to seasonal flooding within the massive floodplain, the district may decide to propose the removal of the structure in the future due to risks to human health and safety.

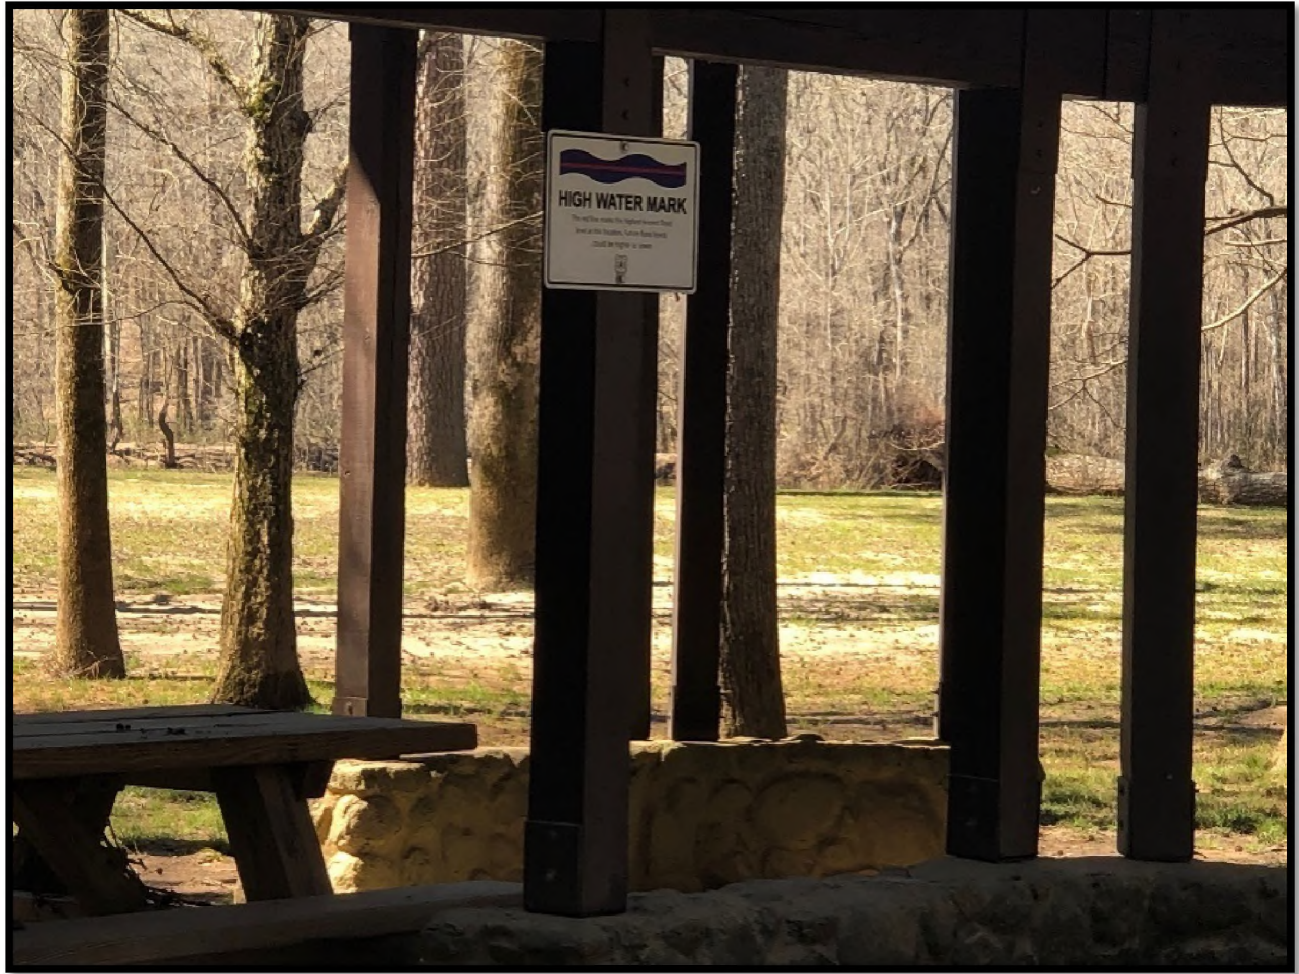
Figure 14. Photograph of the high-water mark indicating the picnic structure is within the flood zone.

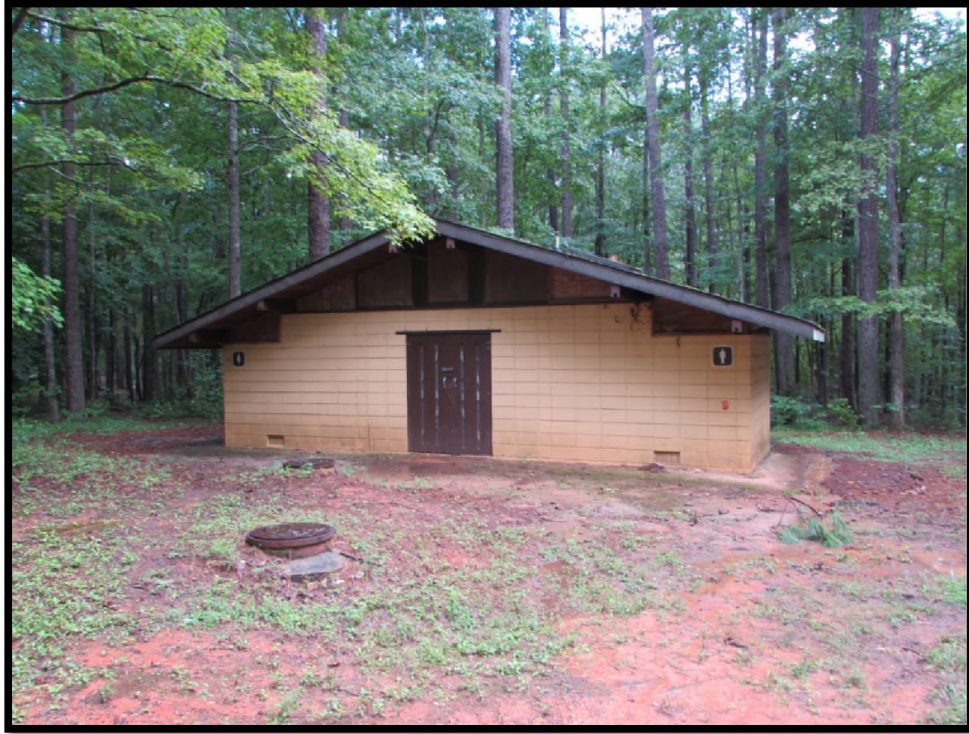
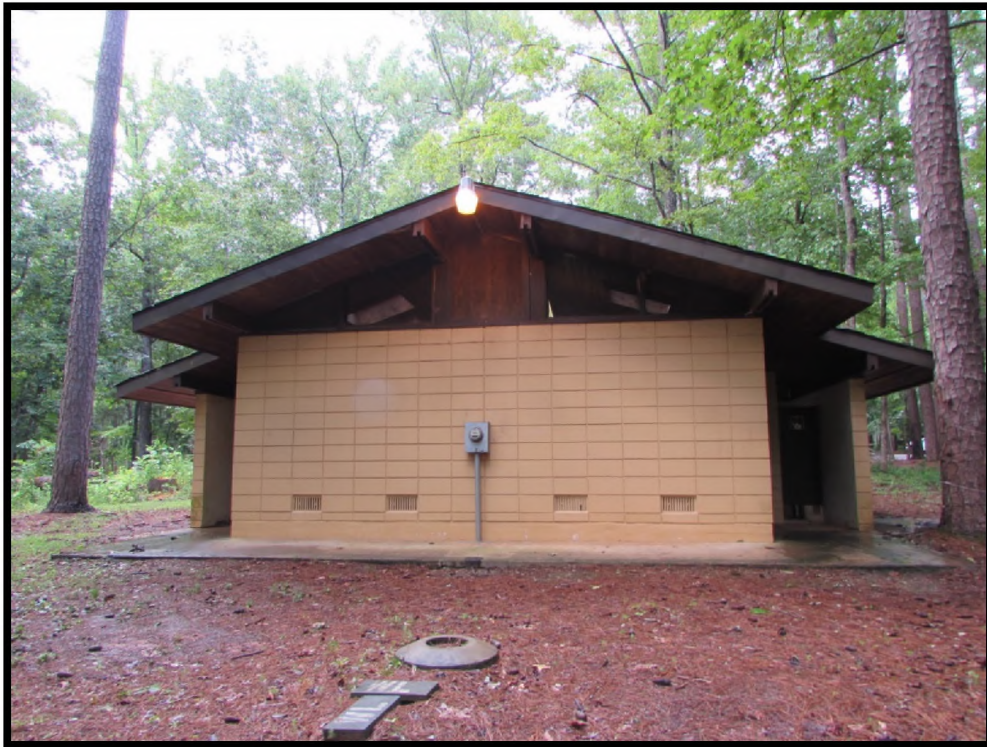
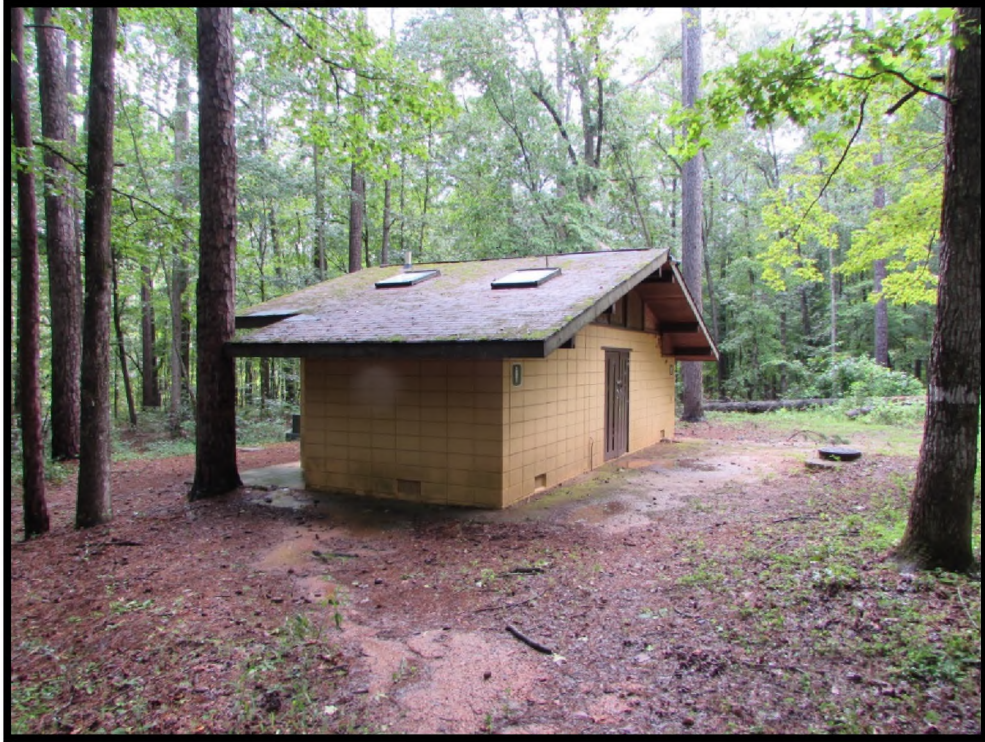
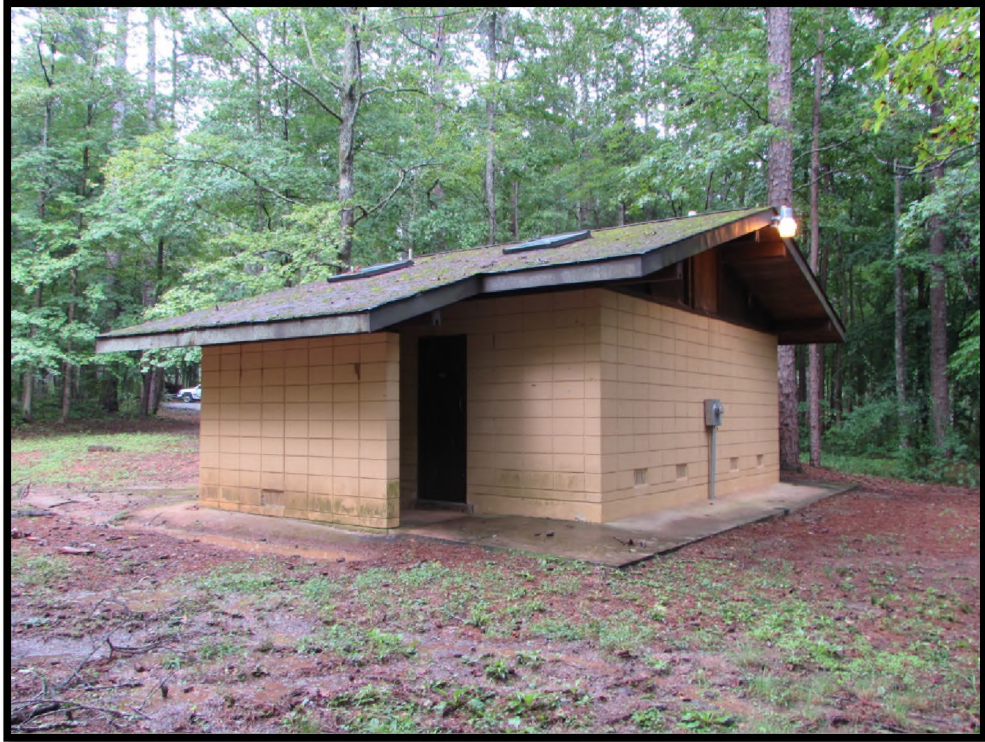
Figure 24. Parsons Mountain Campground Restroom and Bath House, front of the structure.

Figure 25. Parsons Mountain Campground Restroom and Bath House, back of the structure.

Figure 26. Parsons Mountain Campground Restroom and Bath House, side view of the front of the structure.

Figure 27. Parsons Mountain Campground Restroom and Bath House, side view of the back of the structure.

The structure is recommended not eligible for inclusion into the National Register of Historic Places. While the structure does reflect the broad patterns associated with Forest Service post-war recreation architecture it does not make a significant contribution to that broad pattern of history and likewise is not exemplary in that style. The structure is not associated with a significant person of our past and is unlikely to yield any further information potential to our history beyond what has been presented in this document. As part of the current undertaking, the Parsons Mountain Campground Bath house is proposed to be removed as are all the other features within the campground. The bathhouse is recommended as not eligible and the project will have no effect on heritage resources.

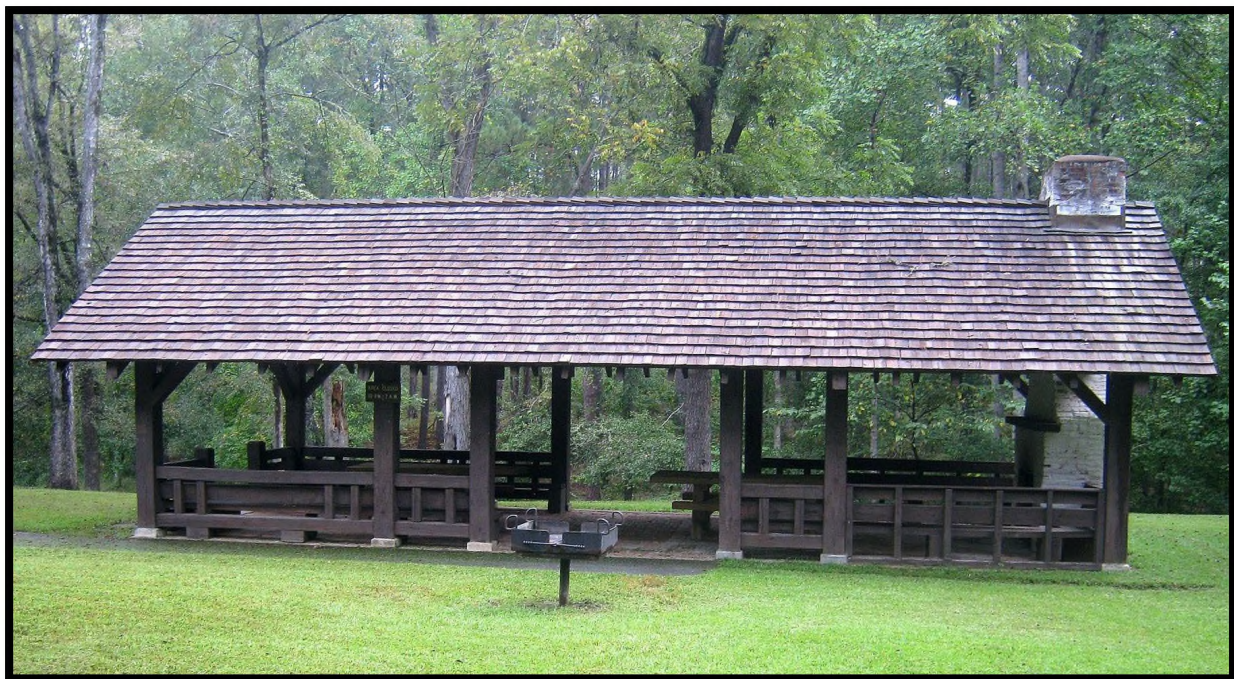
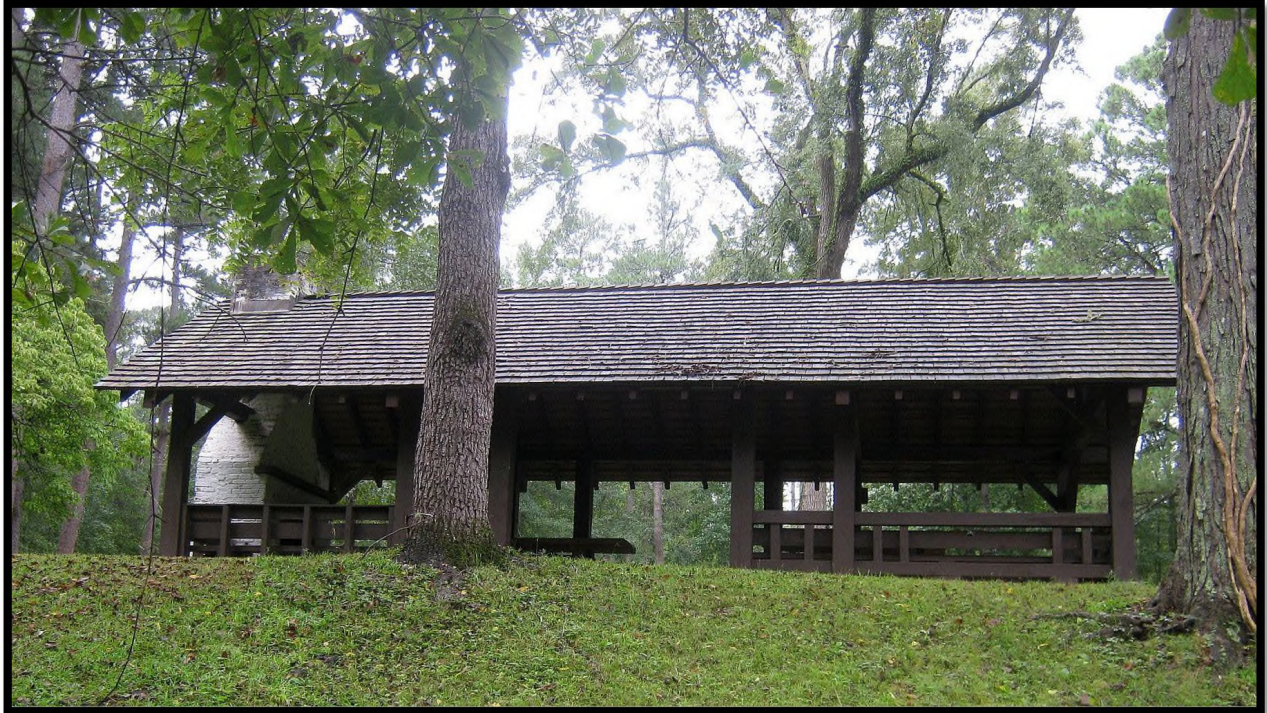
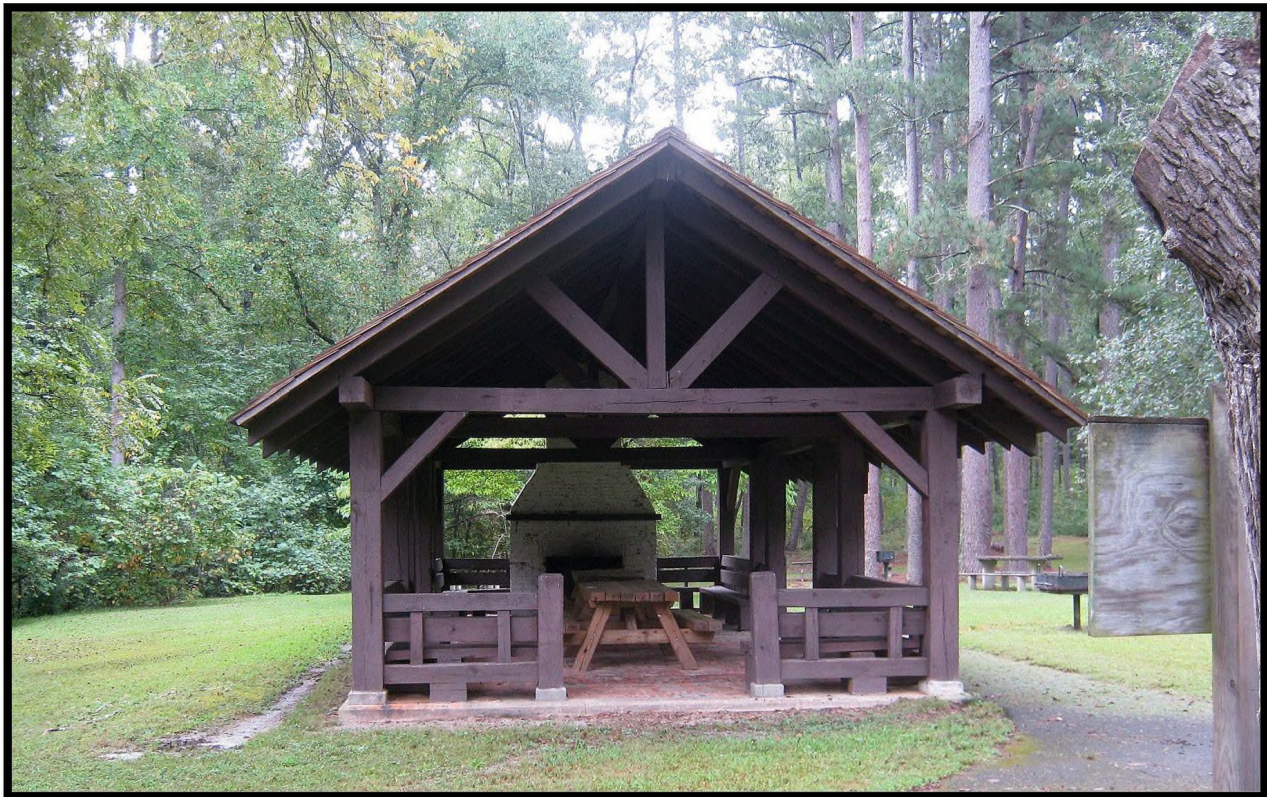
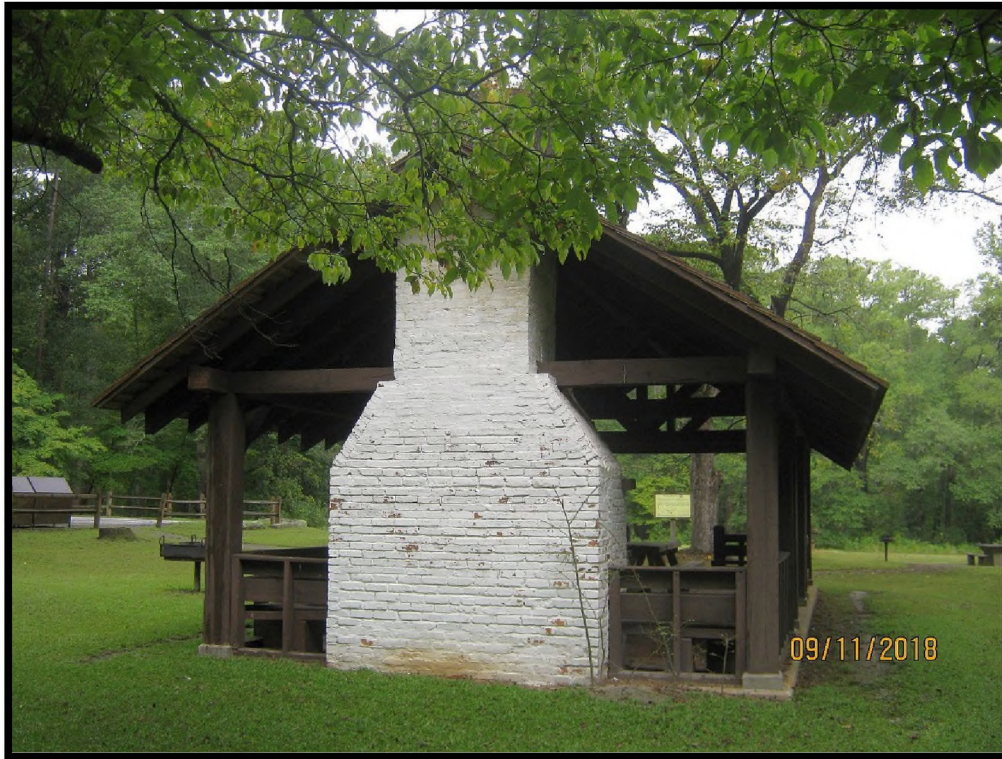
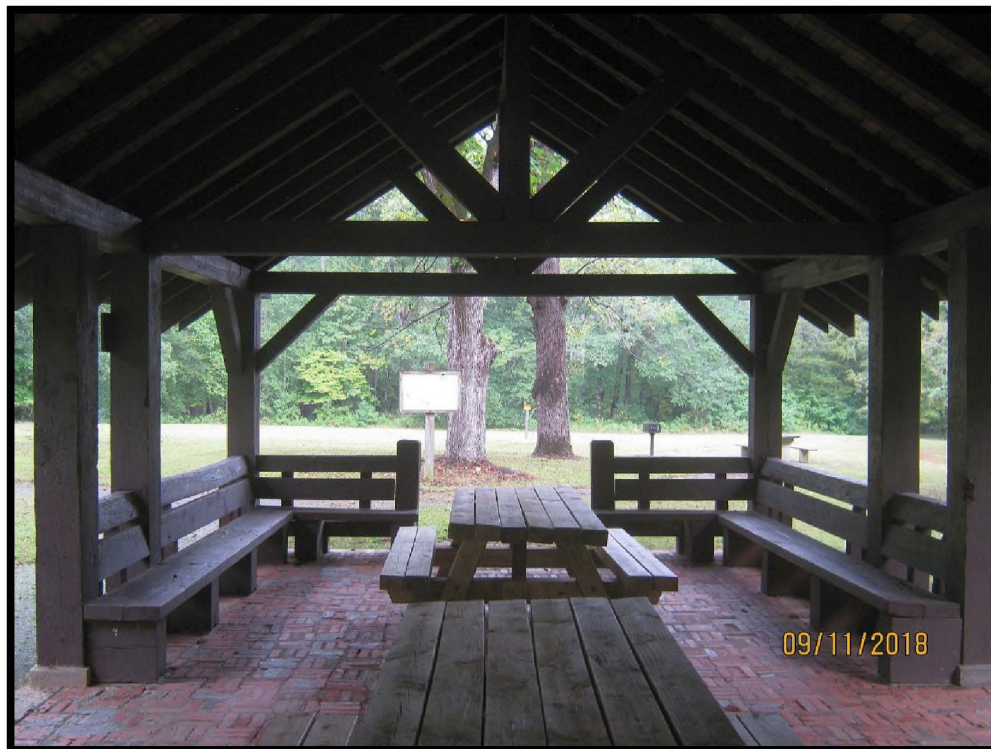
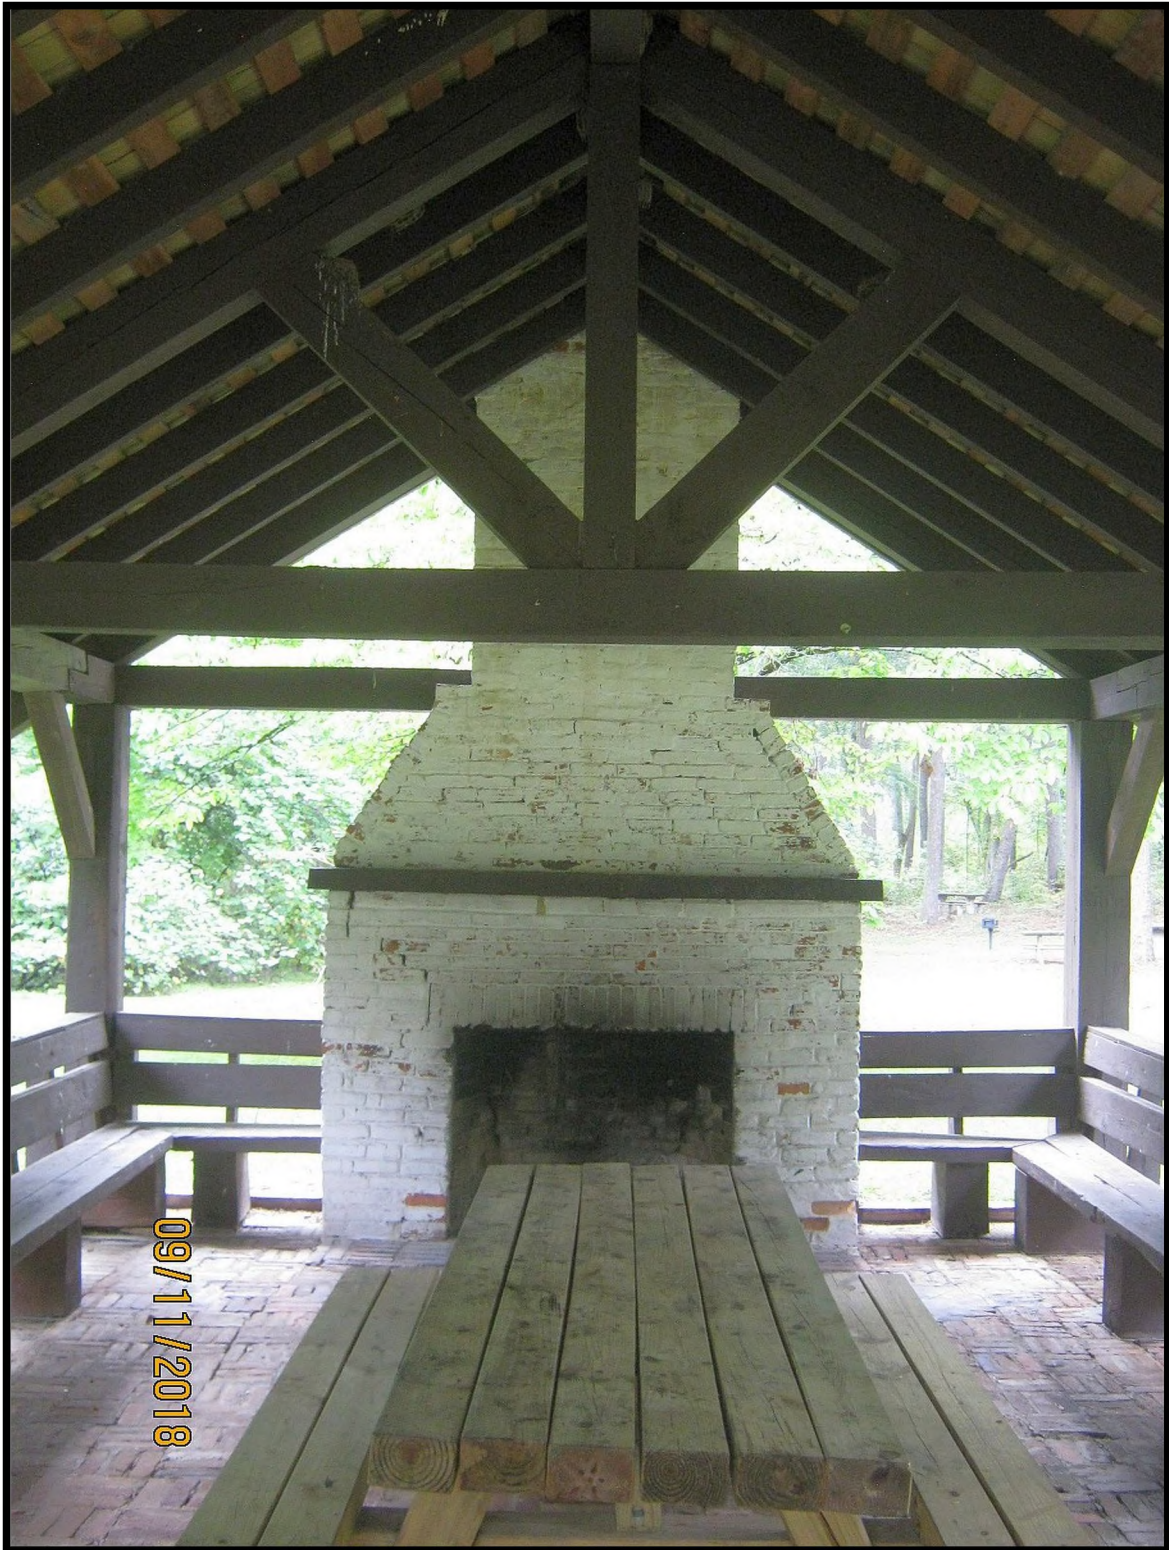
The Molly's Rock Picnic Shelter (Statewide Survey of Historic Properties Site No. 1976)(Figures 31-36) is located within the Suber Recreation area which is today known as the Molly's Rock Recreation Area. This recreation area was constructed by the Civilian Conservation Corps (C.C.C.) in 1936 (Figure 37). At the time, the recreation area contained roughly 20 acres and numerous improvements were planned for construction (a dam and pool; bath house; latrines; bridges; spring box, pumps, wells, and houses; fireplaces; garbage pits; incinerator; tables; benches; picnic shelter; and foot trails). W.D. Popham, a Forest Service architect, noted in a correspondence dated September 6, 1940 that "This area has never been the subject of any comprehensively planned program of developments; instead – first a few units were built, then from time to time other units were added, but so far as I know, the area has never been completely studied with relation to the completion of the area in accordance with both its original plan and its present needs..." Popham (1940) noted that the present shelter was "totally inadequate either to accommodate a crowd or to protect them from inclement weather and should be replaced." While few descriptions or documentation of the picnic shelter originally constructed at the Suber Recreation Area exist, those that do only describe the shelter as measuring 10 feet by 20 feet in maximum length and width.

Figure 31. Side Overview of Molly's Rock/Suber Recreation Area Picnic Structure, facing east.

Figure 32. Side Overview of Molly's Rock/Suber Recreation Area Picnic Structure, facing west.

Figure 33. Front Overview of Molly's Rock/Suber Recreation Area Picnic Structure, facing south.

Figure 34. Back View of Molly's Rock/Suber Recreation Area Picnic Structure, facing north.

Figure 35. View from interior of Molly's Rock/Suber Recreation Area Picnic Structure.

Figure 36. Interior view of Molly's Rock/Suber Recreation Area Picnic Structure, facing the fireplace.

At present, we are uncertain as to how much of the structure has been replaced since its construction in 1941. Because these renovations are difficult to discern, we believe that were in done "in-kind" with methods and materials similar to the original 1941 construction. However, the entirety of the structure, excluding the roof, was painted brown in the past. The original construction called for the structure to be stained with mixture of burnt umber, linseed oil, and turpentine. Once stained, the timbers would be allowed to weather naturally. In 2010, a condition assessment was conducted on the shelter (Sutphin and Shaw 2011). This condition assessment made the following recommendations:

- Replace missing bricks in floor in kind and repair where necessary with a lime based mortar.

- Replace bench bolster blocks with brick masonry supports and fasten seats to new supports. Refasten seats, bench rails, and seat backs where necessary.
- Posts should be borate treated for insects.
- Bracing should be added on the east end of the building to properly support the scarf joints. Braces should be joined with diminished housings to further strengthen the scarf joint construction.
- Replace the entire roof with appropriate wooden shingles installed according to the manufacturer's recommendations. Skip-sheathing should be first applied to the rafters followed by proper shingle weather exposure. Re-flash the chimney with proper roof flashing to the roof connection.
- Re-point the chimney where necessary using a soft mortar of lime and sand. Replace cracked bricks where needed.

These treatment recommendations were carried out between 2011 and 2013. While these and other earlier treatments represented changes from the original construction, these refurbishing/treatment episodes were conducted with like materials and in a manner like the original construction. They thus represent no significant departure in materials or workmanship from the original structure. As such, the Molly's Rock/Suber Recreation Area picnic shelter retains a high degree of integrity with respect to its location, setting, materials, workmanship, feeling, and association. The structure's design integrity is slightly diminished since the wane edge siding on the east side of the building was either removed or omitted from construction.

Based on the above information, we recommend that the structure be considered eligible for inclusion in the National Register of Historic Places under criteria A and C. The picnic shelter was constructed by the Civilian Conservation Corps in 1941. The C.C.C. represented one of President Roosevelt's New Deal Programs that sought to simultaneously provide economic assistance to families, provide training to youths across the Nation, and construct public works that provided services to the public. Because the country was still socially segregated, C.C.C. groups were organized into camps based on the race of the enrollees. While "mixed" camps existed, they were rare in the rural South. It is likely that the picnic shelter was constructed by a "colored" C.C.C. company (Company 4465). Much of the work conducted by this and other C.C.C. enrollees in the area focused on forestry and erosion control. As such, their tangible legacy is limited. However, the picnic shelter represents one of the few standing structures constructed by the C.C.C. on the Enoree Ranger District of the Sumter National Forest.
