ARCHAEOLOGICAL FIELD REPORT
SCDOT ENVIRONMENTAL SECTION

TITLE: Phase I Cultural Resources Survey of I-20 Westbound Bridge Replacement at North Augusta Greenway

PROJECT: I-20 Bridge Replacement N. Augusta Greenway

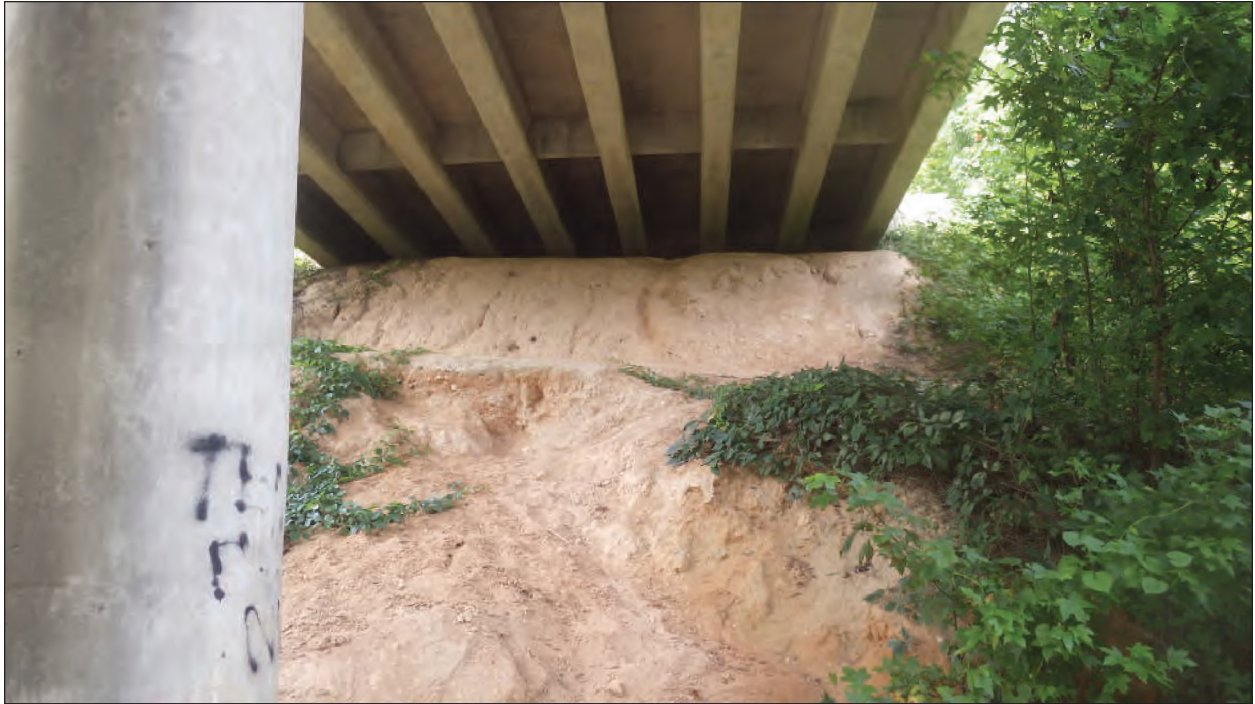
Figure 4.
Documentation of Fill Showing Artificial Elevation

The Phase I archaeological survey was conducted on August 13, 2018. As the entire length of I-20 within the APE was constructed on fill, there was little potential for finding intact archaeological resources (Figure 4). The entire survey area was inspected for areas that may have been intact, and shovel tests were excavated in various locations to confirm the presence of fill (Figure 5). Fill from all shovel tests were screened through 0.25-inch mesh hardware cloth to ensure systematic artifact recovery. One shovel test was excavated below the I-20 westbound bridge alongside the North Augusta Greenway, at the base of clear fill deposits underlying the interstate. This area consisted of dense, gravelly fill to 25 centimeters, at which point excavation could not continue. A second shovel test was excavated to 22 centimeters in the median between the westbound and eastbound lanes, which also confirmed the presence of fill in the APE. No additional shovel test locations were investigated along the 0.8 mile (1,287 m) of survey area. No archaeological sites were identified during the survey.

A. Exposed Fill Below I-20 Westbound Bridge

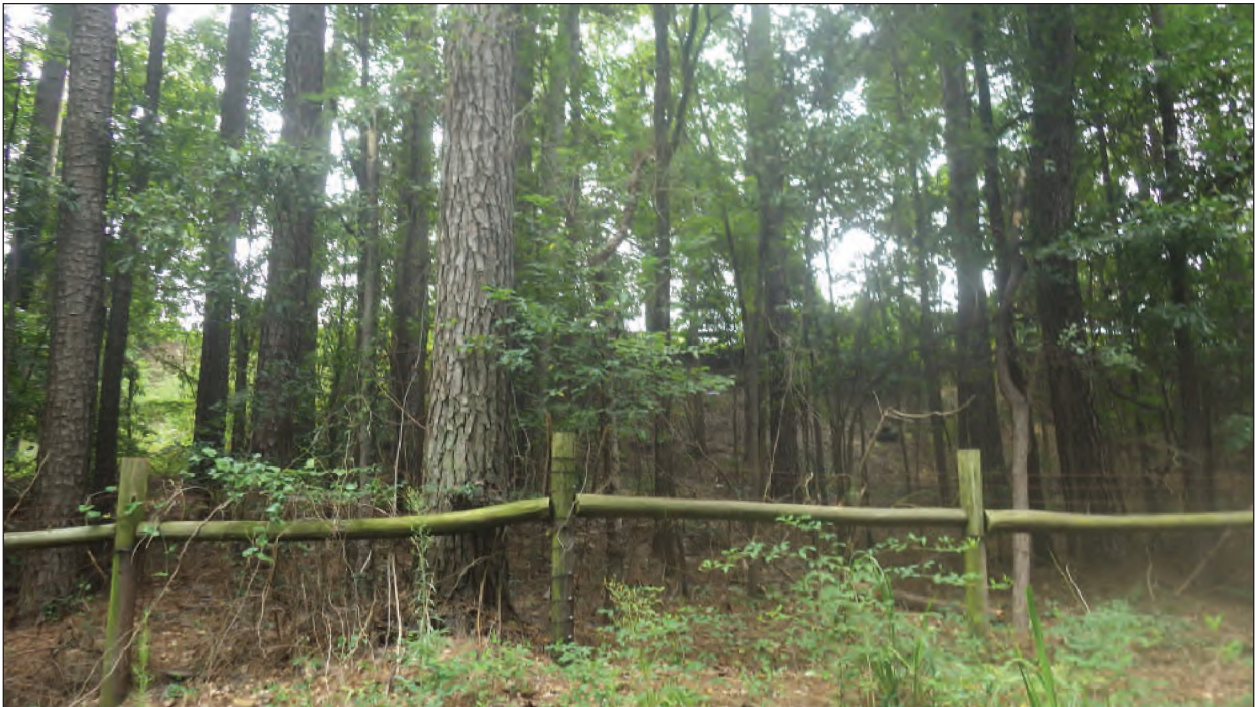
B. Grassy Fill Slope on North Side of I-20 Westbound, Facing Southwest

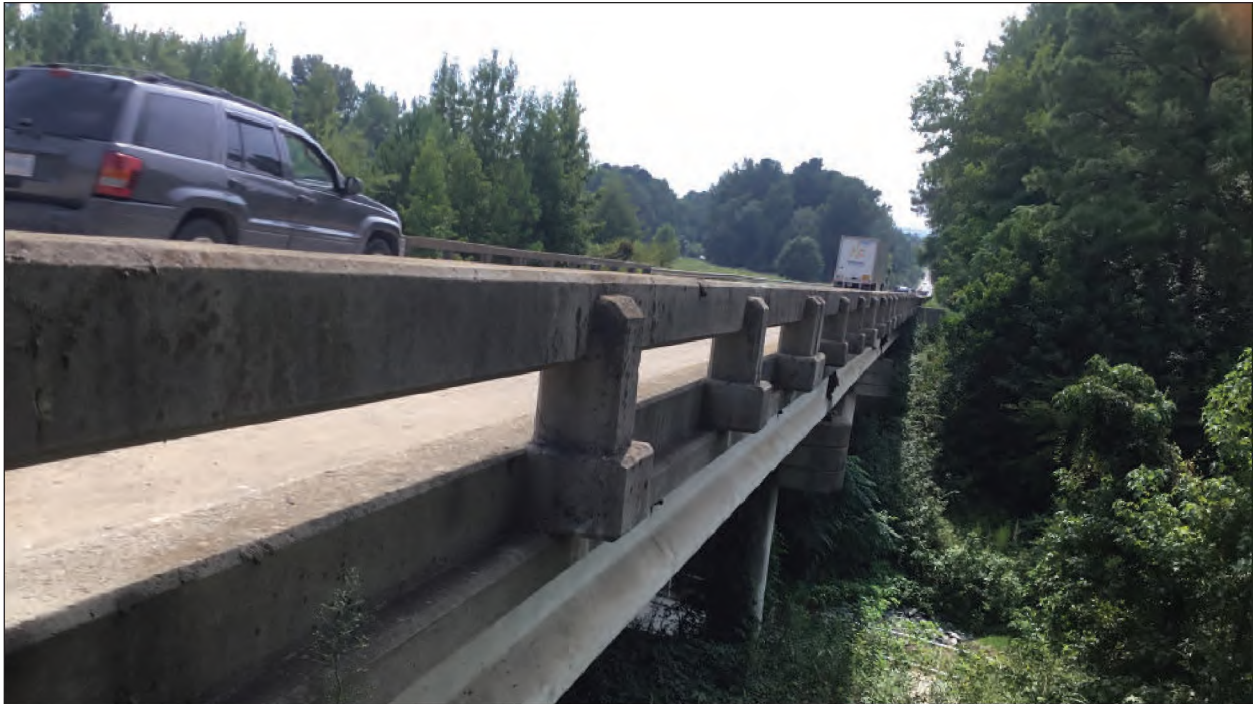
Figure 7.
Resource U/03/3502

Resource U/03/3502 is a circa 1965 four-span, prestressed concrete stringer bridge that carries two lanes of traffic on eastbound I-20 across the North Augusta Greenway. The bridge has prestressed concrete bents with rounded caps, a concrete deck, and I-shaped stringers (Figure 7). Per SCDOT guidance, a construction date of circa 1965 was used for this bridge evaluation. The bridge is of a common type constructed throughout the state. It is not architecturally or technologically significant and is not recommended as eligible under Criterion C. It is not known to be associated with events or persons significant in the past. Therefore, the resource is recommended as not individually eligible for the NRHP under Criterion A or B.

A. View Facing Northeast

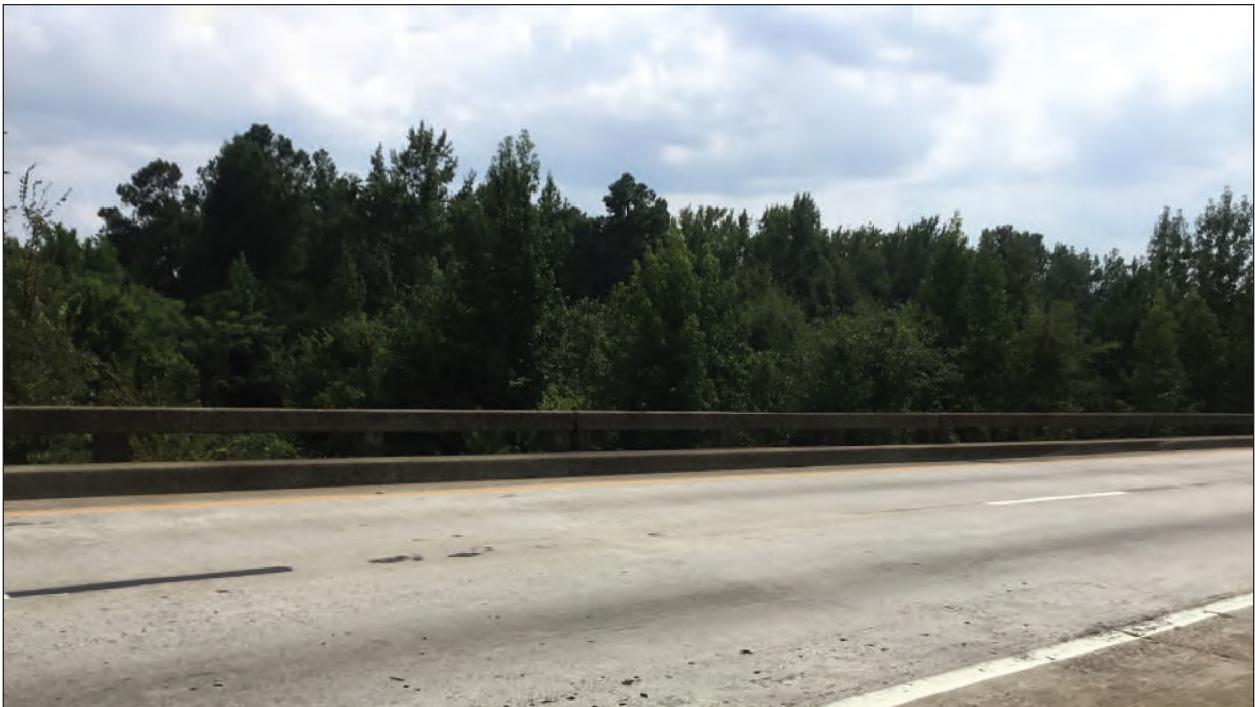
B. Deck and Rail, Facing North

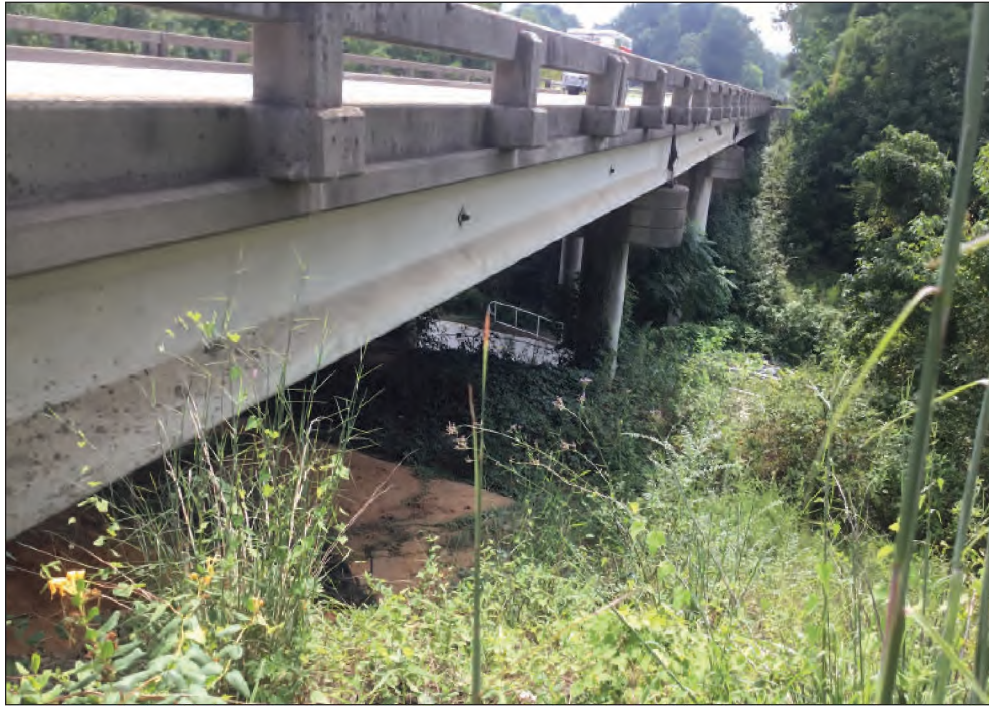
Figure 8.
Resource U/03/3503

Resource U/03/3503 is a circa 1965 four-span, prestressed concrete stringer bridge that carries two lanes of traffic on westbound I-20 across the North Augusta Greenway. The bridge has prestressed concrete bents with rounded caps, a concrete deck, and I-shaped stringers (Figure 8). Per SCDOT guidance, a construction date of circa 1965 was used for this bridge evaluation. The bridge is of a common type constructed throughout the state. It is not architecturally or technologically significant and is not recommended as eligible under Criterion C. It is not known to be associated with events or persons significant in the past. Therefore, the resource is recommended as not individually eligible for the NRHP under Criterion A or B.

A. View Facing Southeast

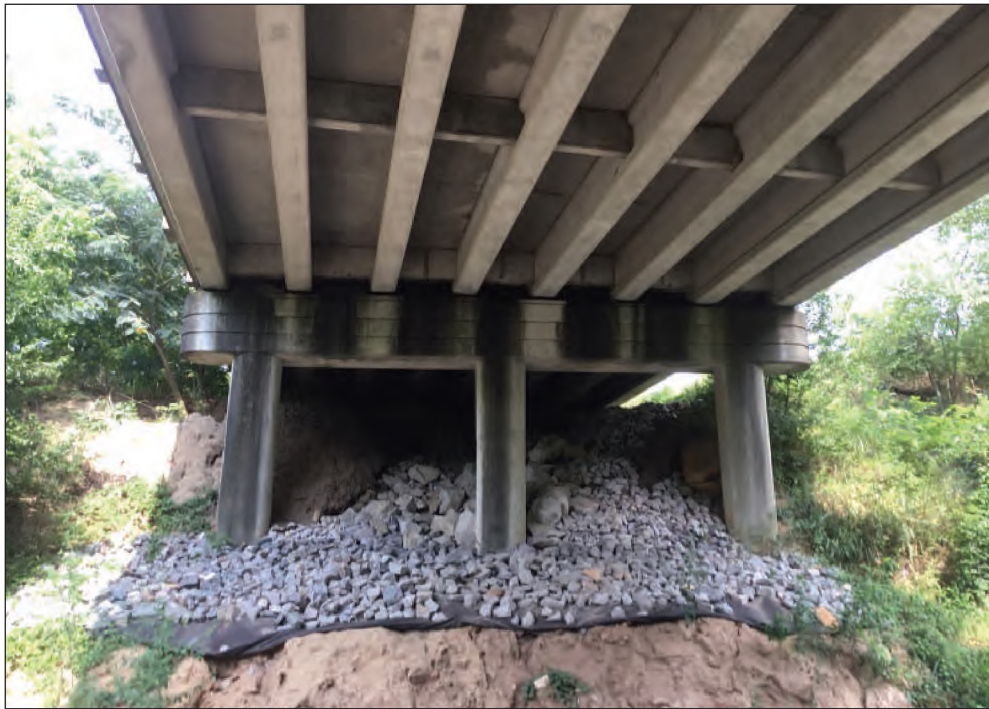
B. Substructure, Facing East
