ARCHAEOLOGICAL FIELD REPORT
SCDOT ENVIRONMENTAL SECTION

TITLE: Cultural Resources Survey for I-26 Rehabilitation from Mile Marker 74 to Mile Marker 85, Newberry County, South Carolina

PROJECT: I-26 Rehabilitation from Mile Marker
74 to Mile Marker 75

DESCRIPTION: The South Carolina Department of Transportation (SCDOT) has proposed improvements to the I-26 corridor from mile marker 74 to mile marker 85 in Newberry County, South Carolina (**Figure 1**). The proposed improvements include roadway rehabilitation, corridor improvements, and tree clearing along I-26, and jacking (raising) four bridges, that cross the highway in this segment. The bridges carrying S-38, S-82, S-99, and SC-773 over I-26 are to be raised (**Figure 2**). A small amount of new right-of-way (ROW) will be required to complete these undertakings. The area of potential effect (APE) for archaeological resources for the project consists of land that will be acquired as new right-of-way (ROW) as well as those areas within the existing ROW that might be affected by the undertaking. The APE for architectural resources consists of a 300 foot buffer around the archaeological APE. Architectural resources within the 300

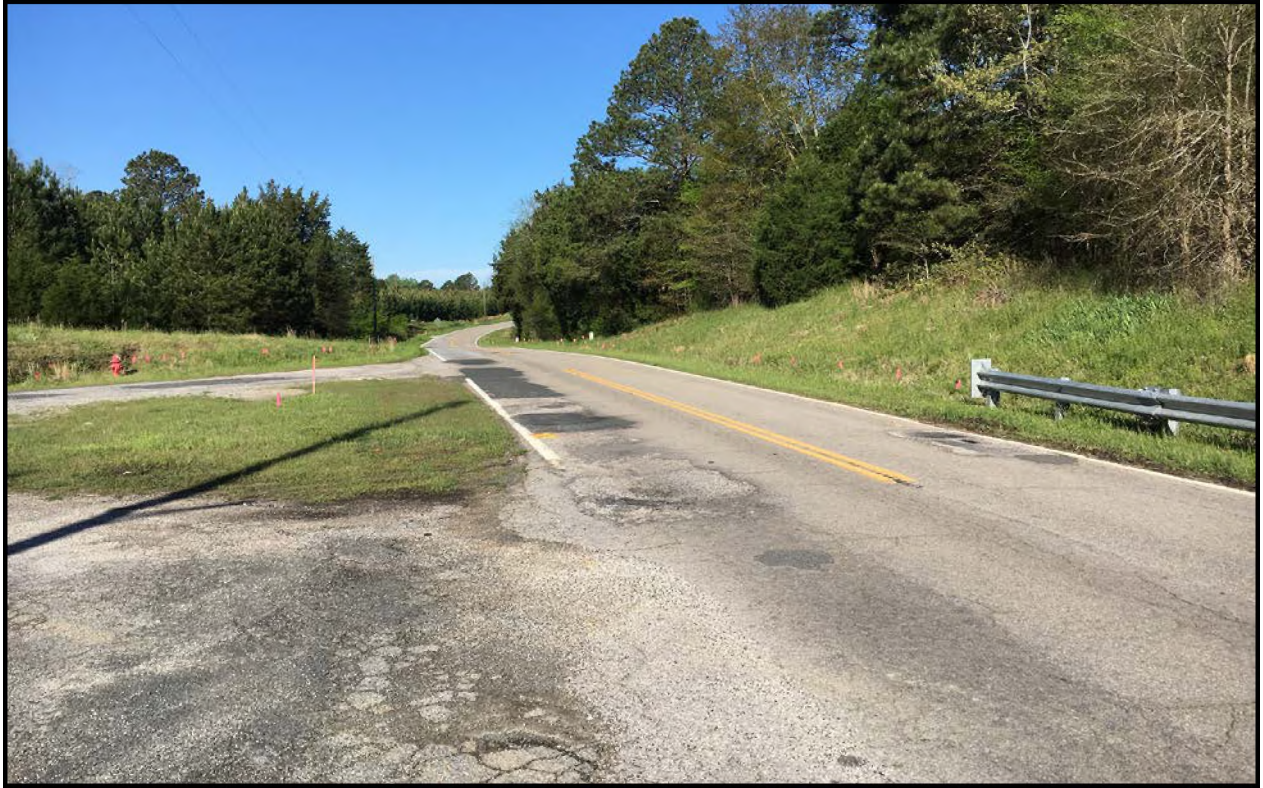
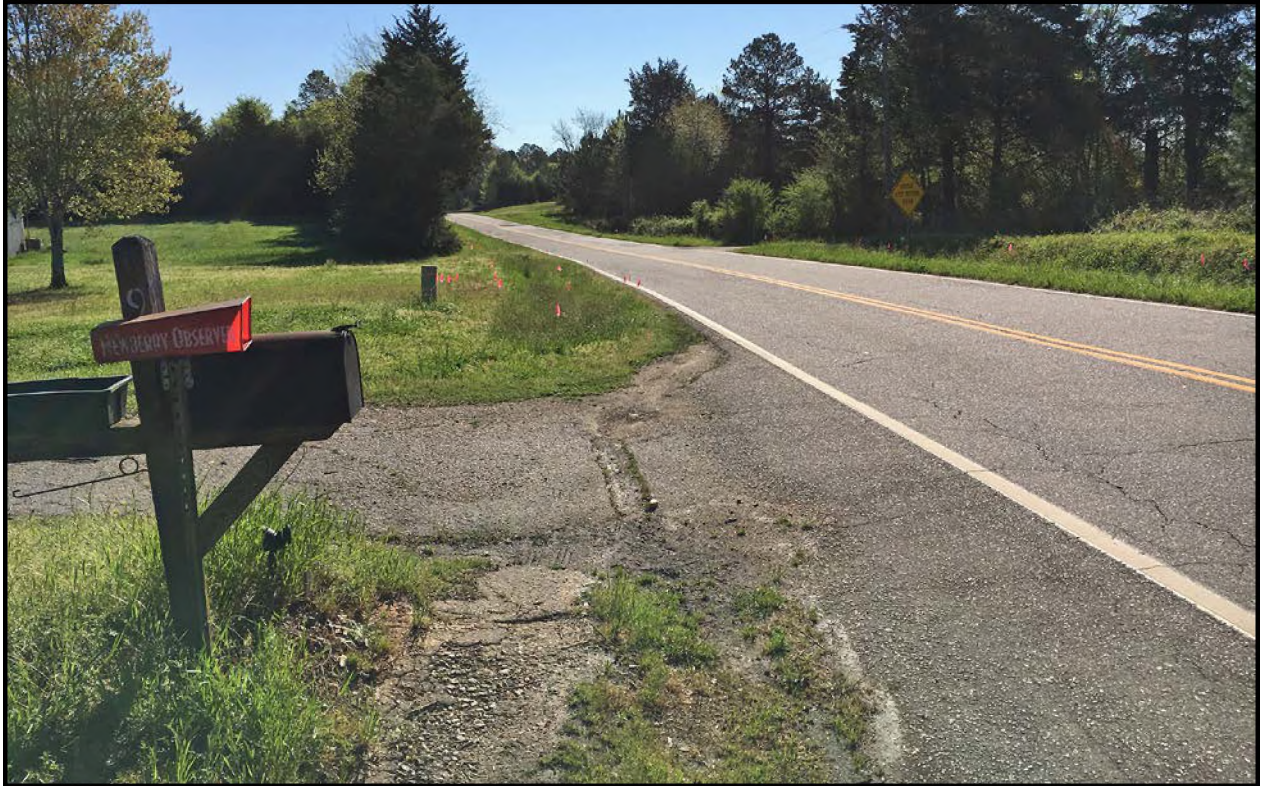
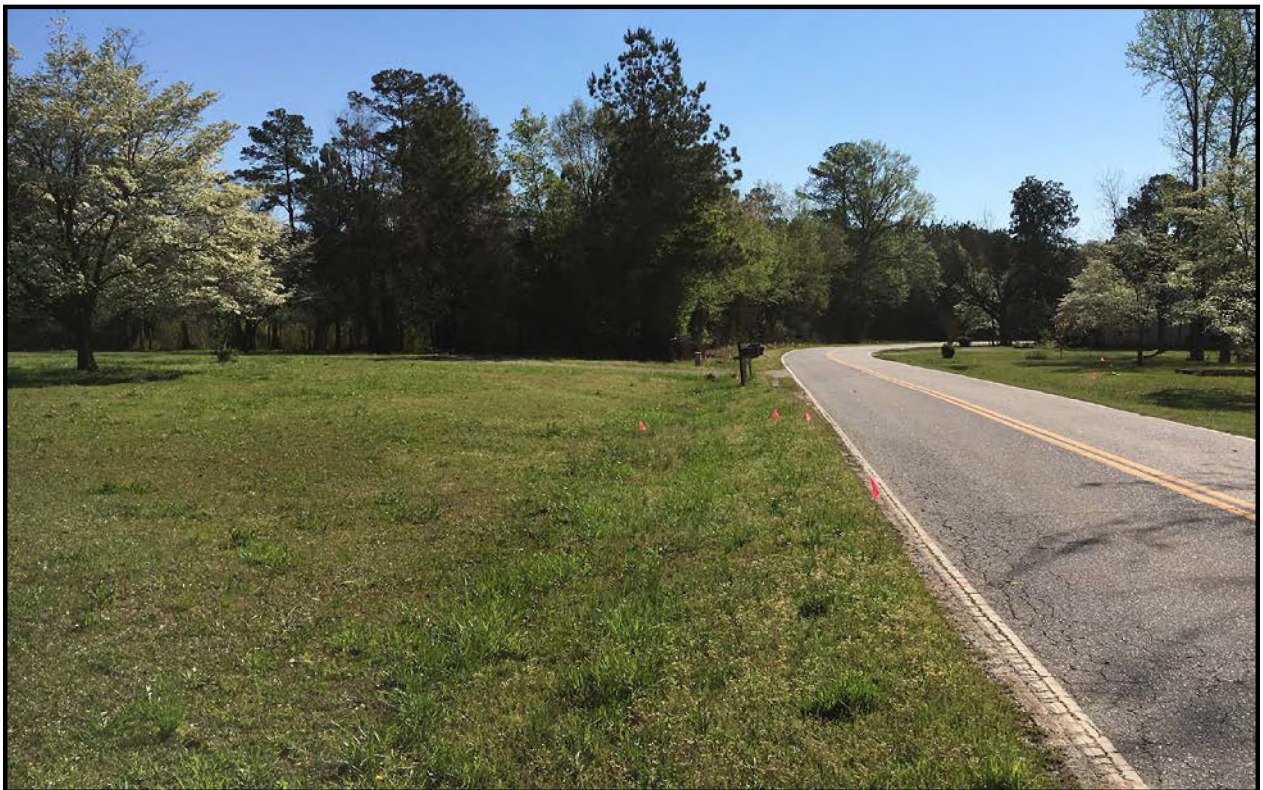
Figure 11. View of S-38 Showing Ground Disturbance, Facing West From STP 3-1.

Figure 12. View of S-38 Showing Ground Disturbance, Facing East From STP 1-1.

Figure 13. View of S-38 Ground Disturbance, From Eastern End of Project Area Facing West.

Figure 14. View of S-38 Showing Ground Disturbance, From STP 4-1 Facing East.

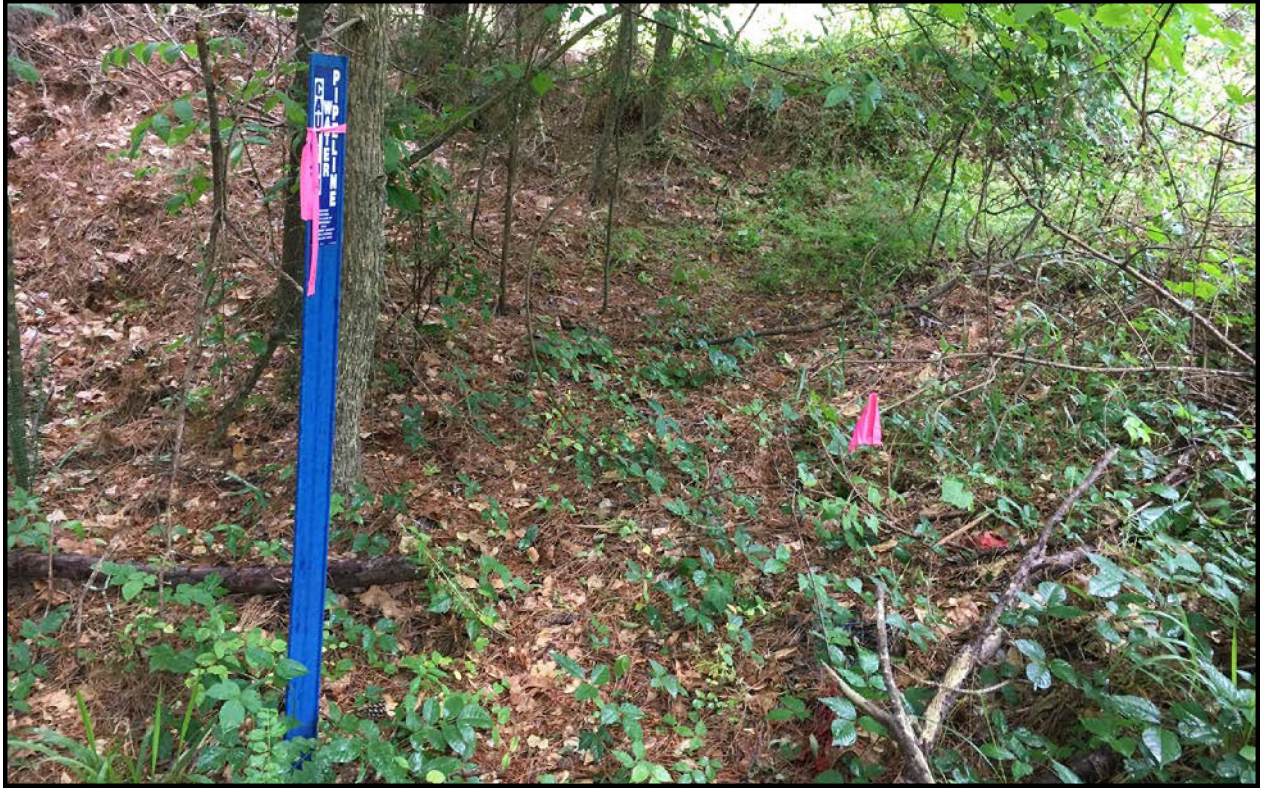
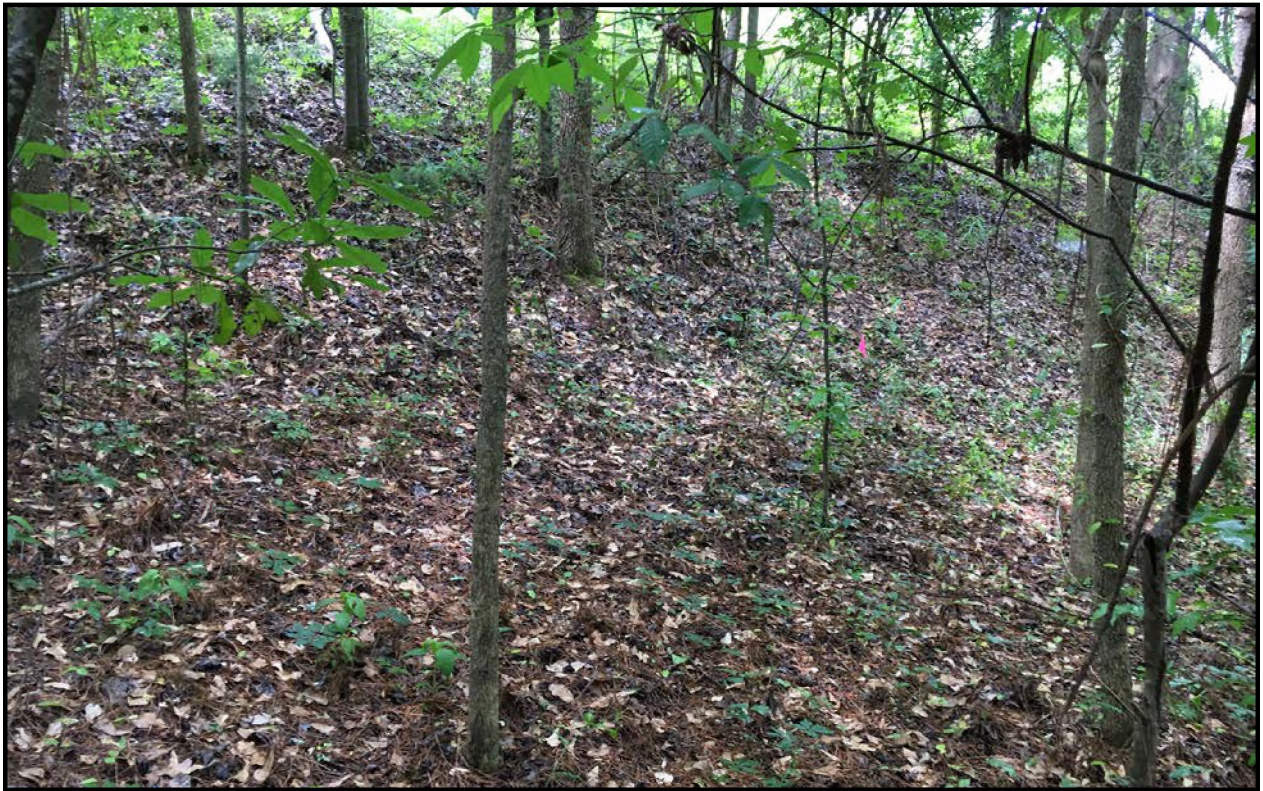
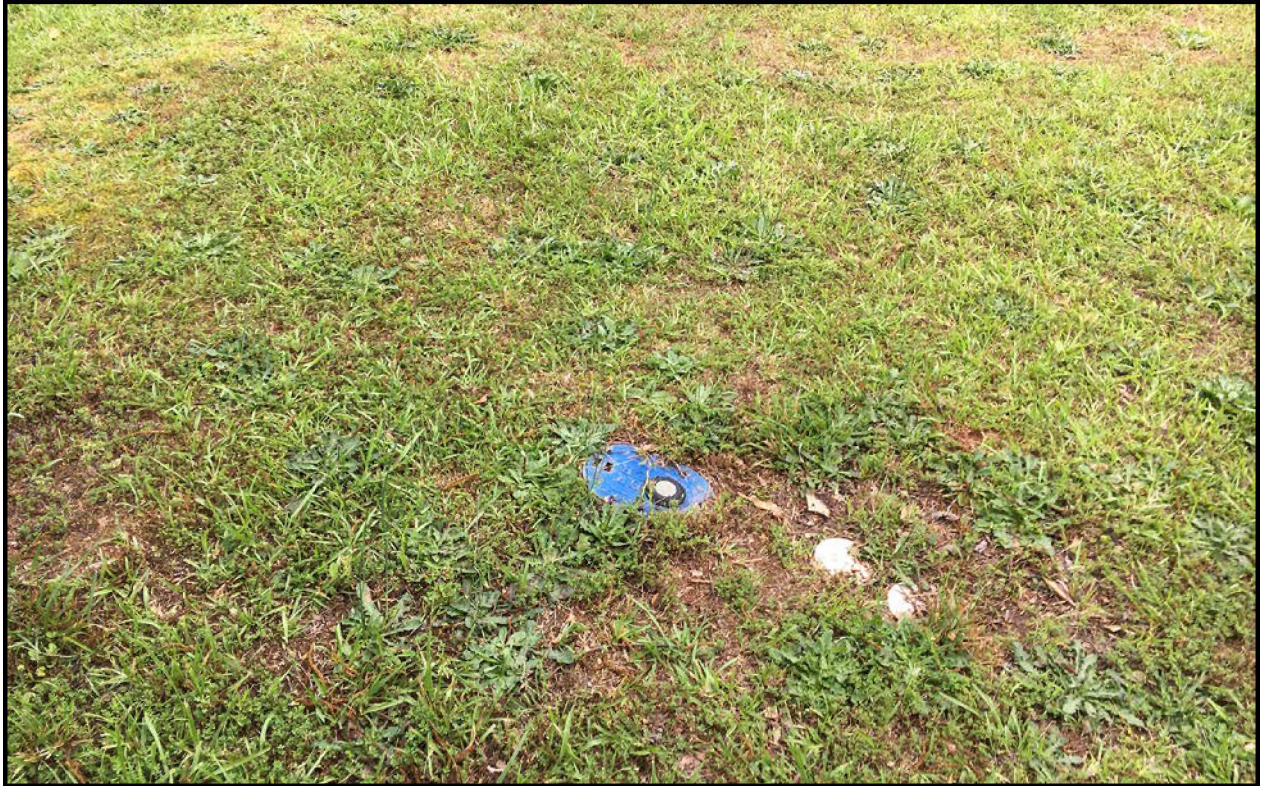
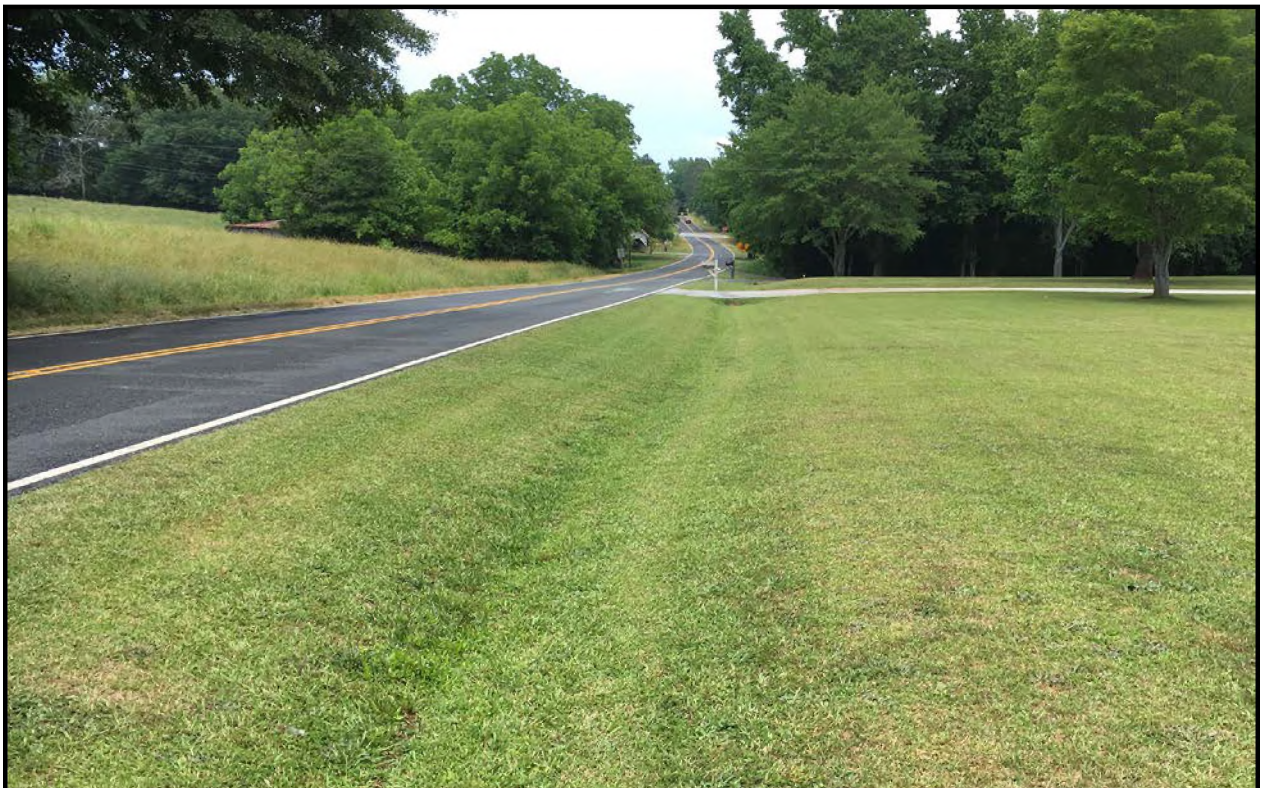
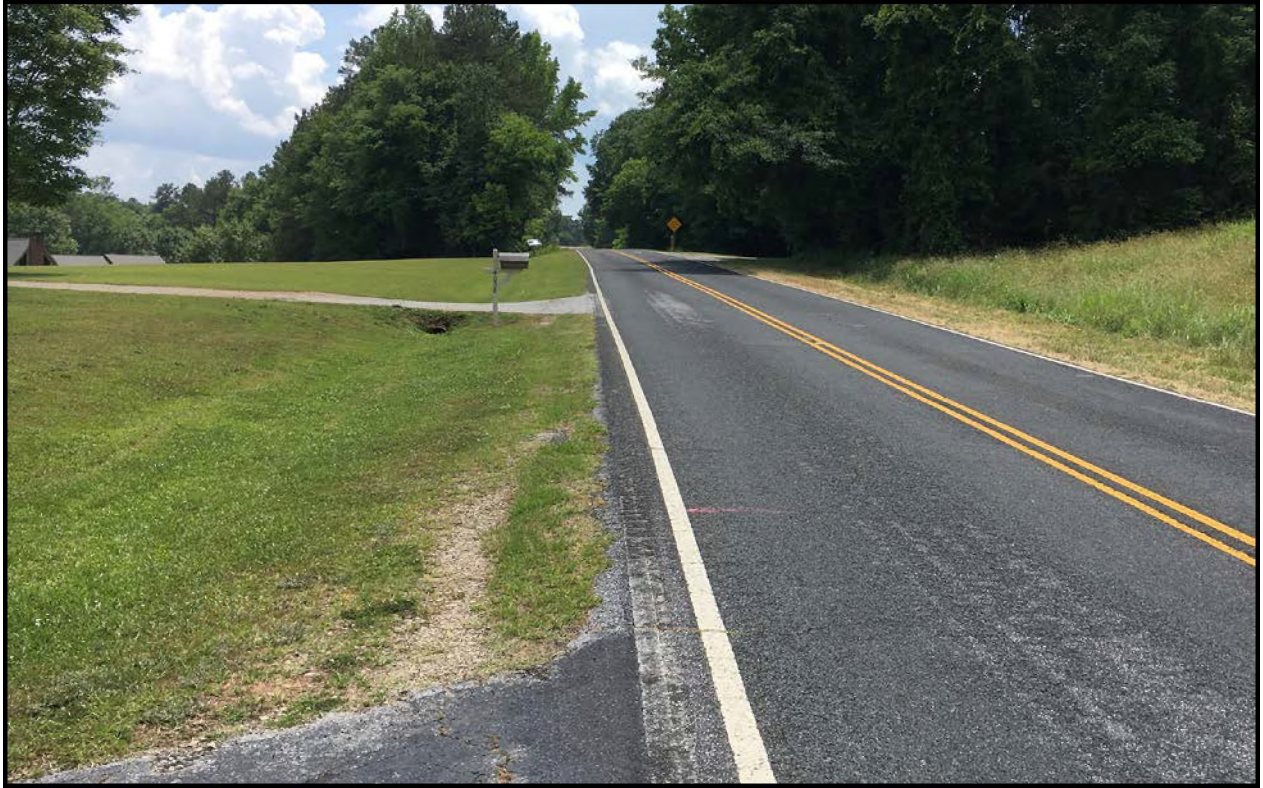
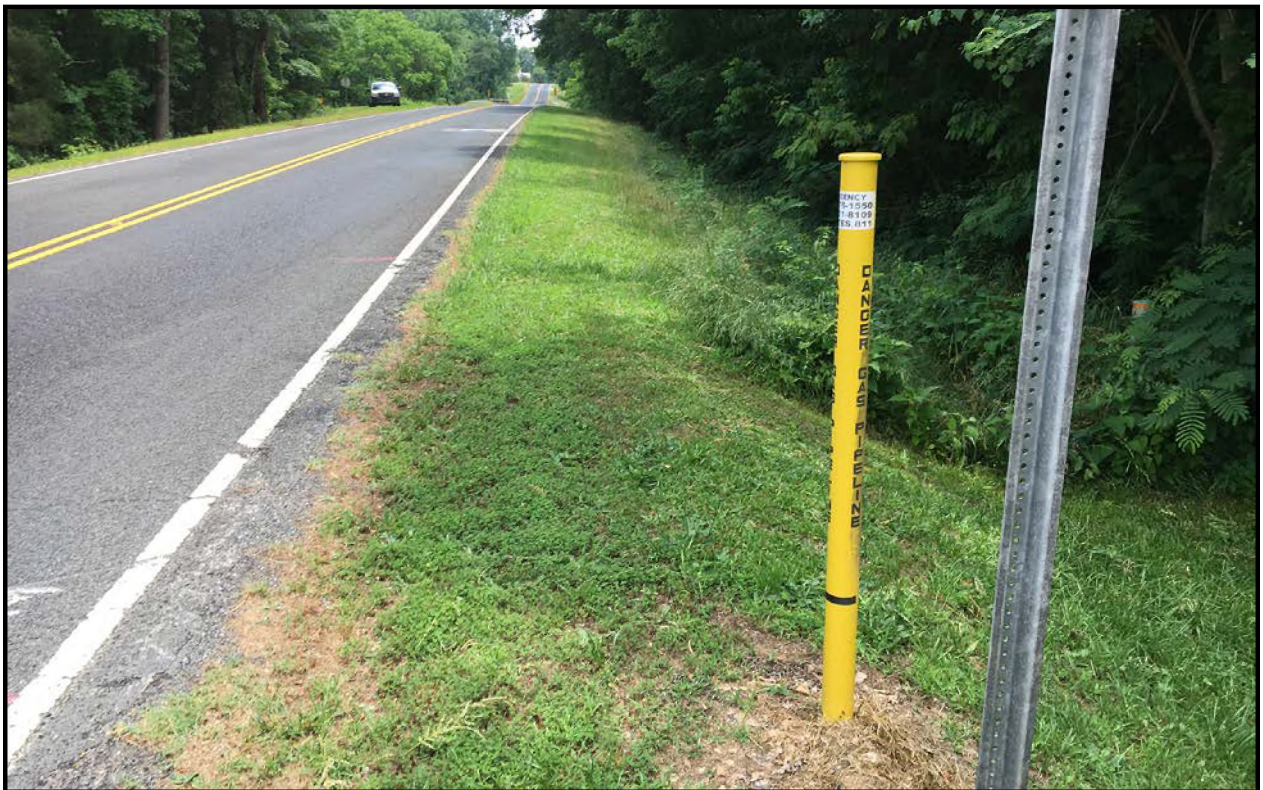
Figure 16. View of S-82 Showing Ground Disturbance, Facing Northeast From STP 2-3.

Figure 17. View of S-82 Showing Ground Disturbance, Facing Northeast From STP 2-4.

Figure 18. View of S-82 Showing Ground Disturbance, Facing Northeast From STP 1-2.

Figure 19. View of S-82 Showing Ground Disturbance, Facing Northeast From STP 1-3.

Figure 20. View of S-82 Showing Ground Disturbance, Facing Southwest From Northern End of Project Area.

Figure 21. View of S-82 Showing Ground Disturbance, Facing Southwest From Vicinity of STP 4-2.

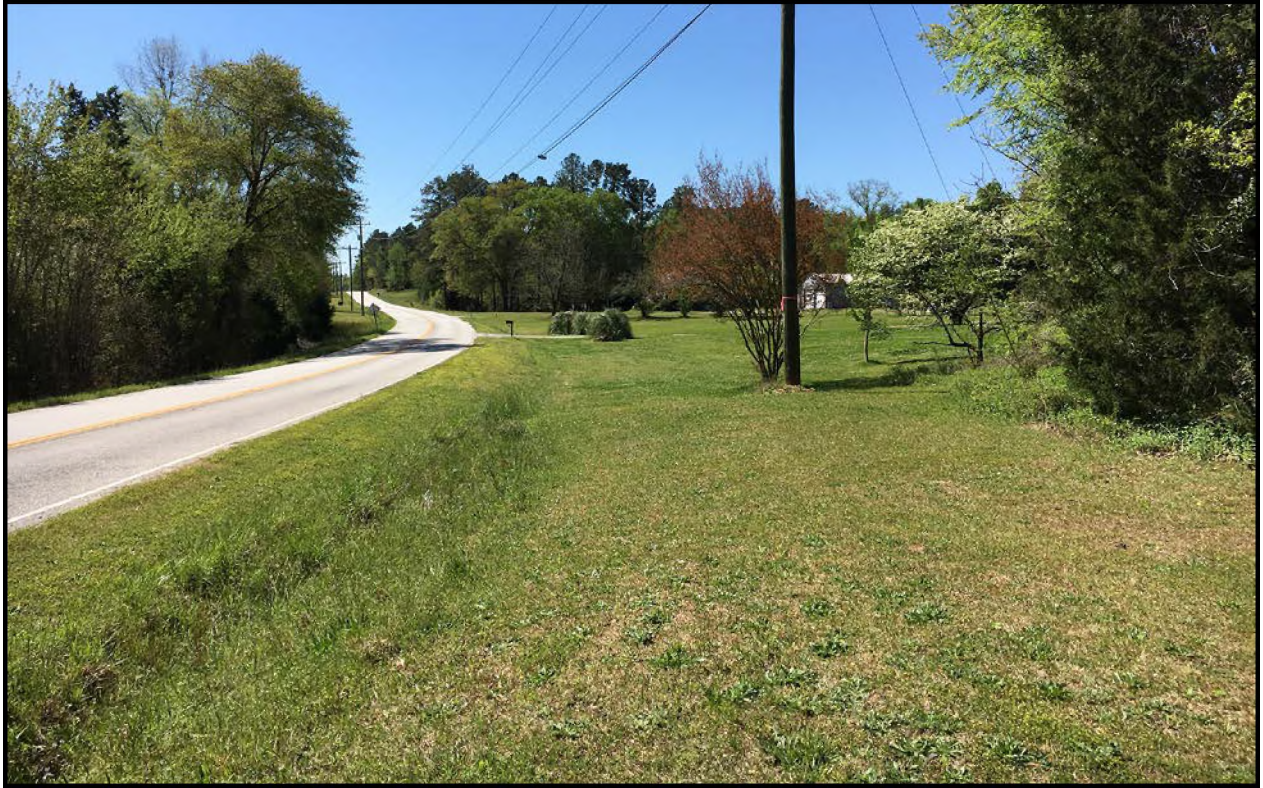
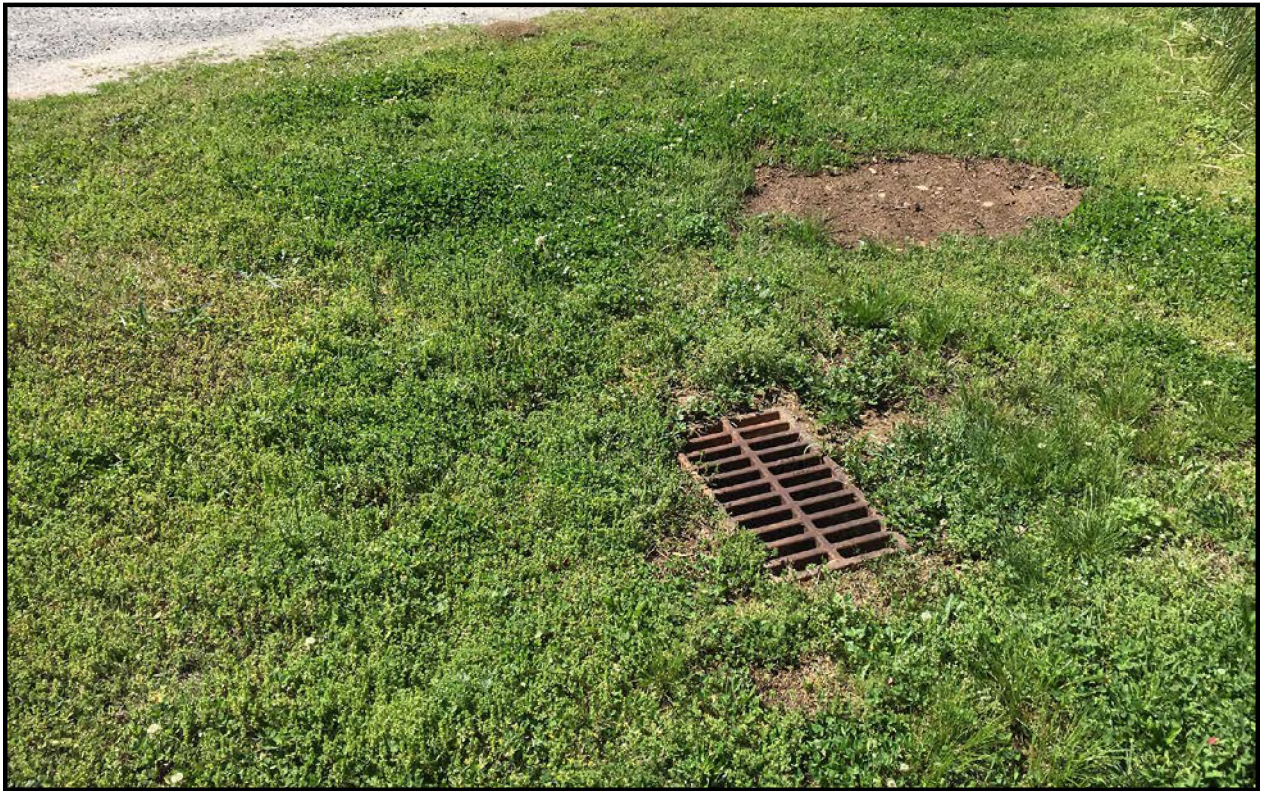
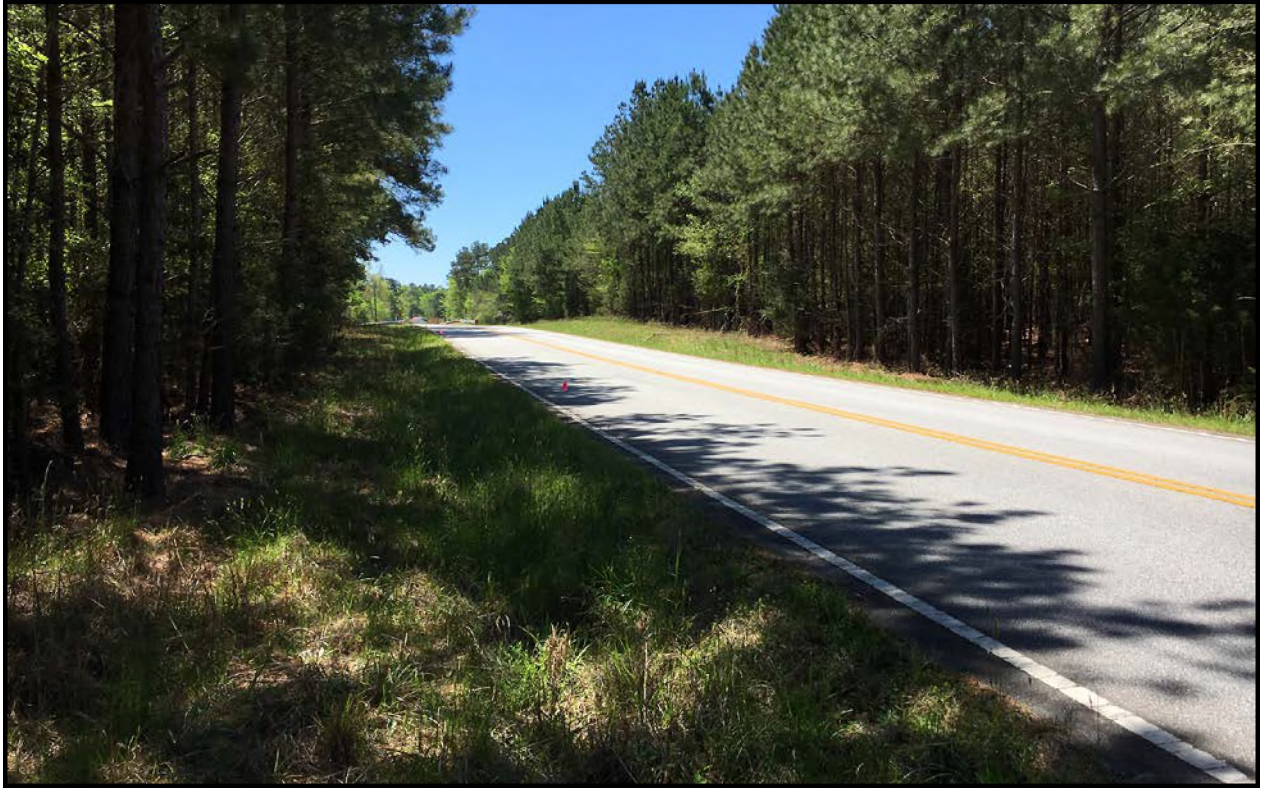
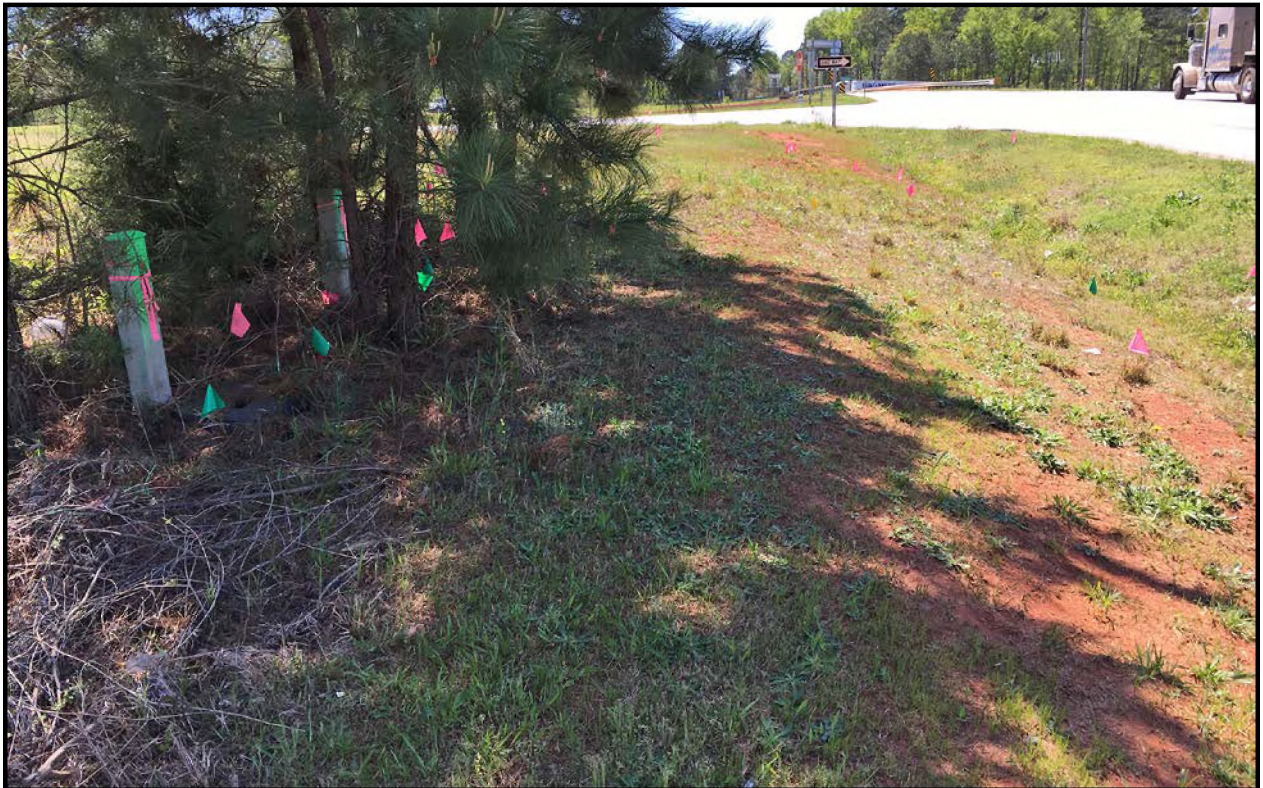
Figure 23. View of S-99 Showing Ground Disturbance, Facing South From STP 1-4.

Figure 24. View of S-99 Showing Ground Disturbance.

Figure 25. View of S-99 Showing Ground Disturbance, Facing South From STP 4-4.

Figure 26. View of S-99 Showing Ground Disturbance, Facing South From Vicinity of STP 3-3.

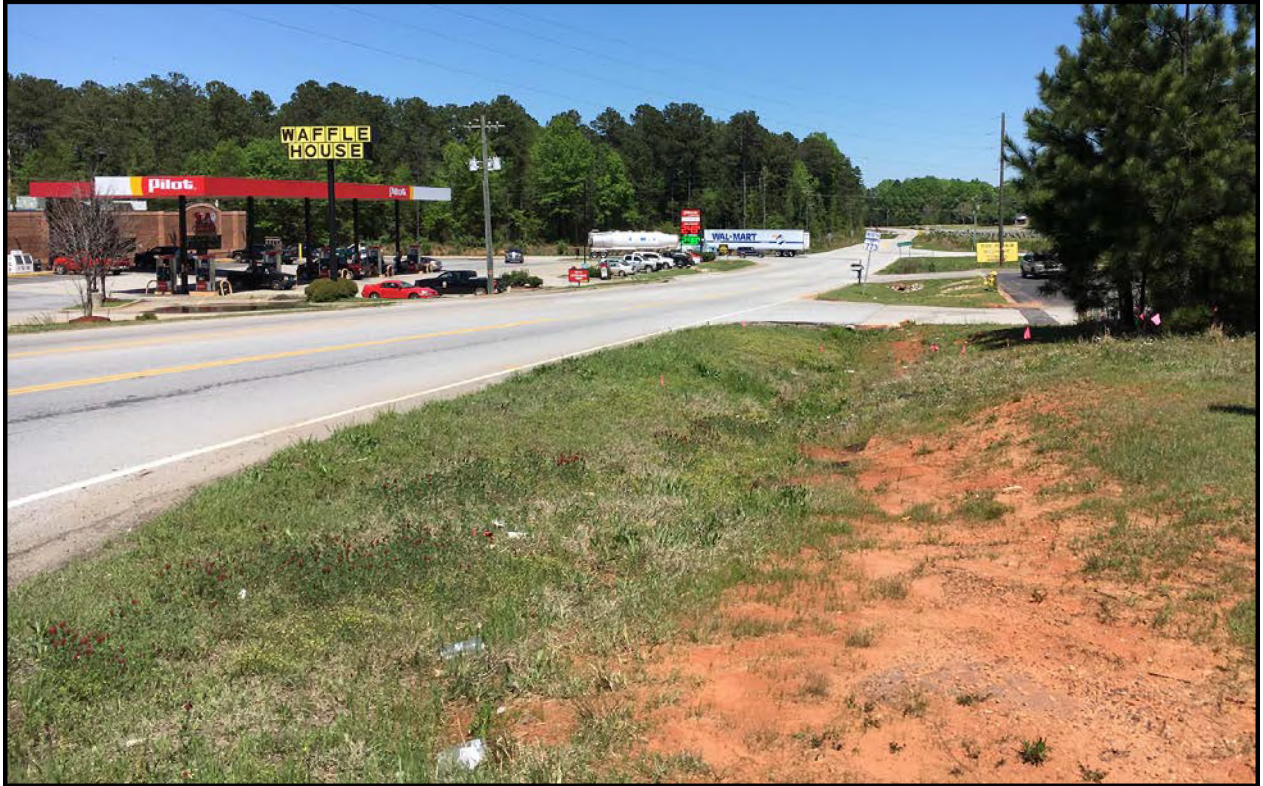
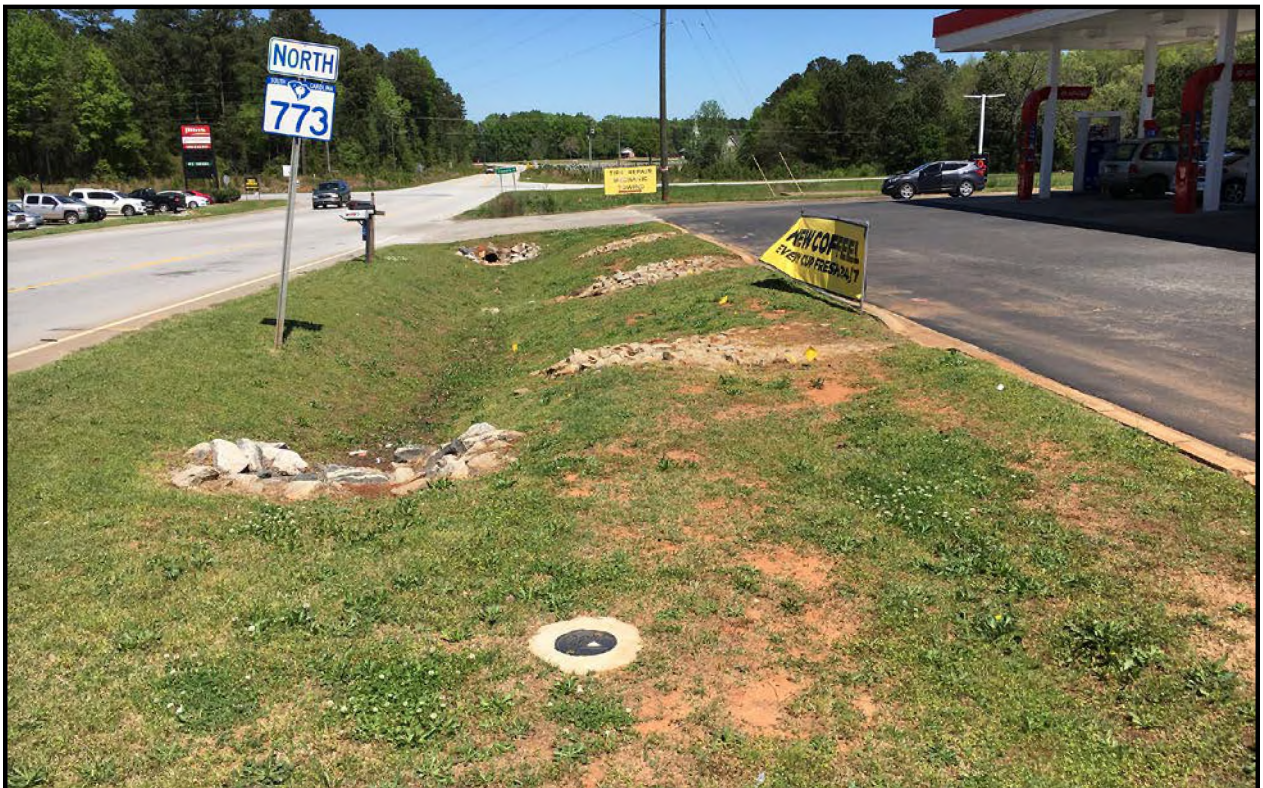
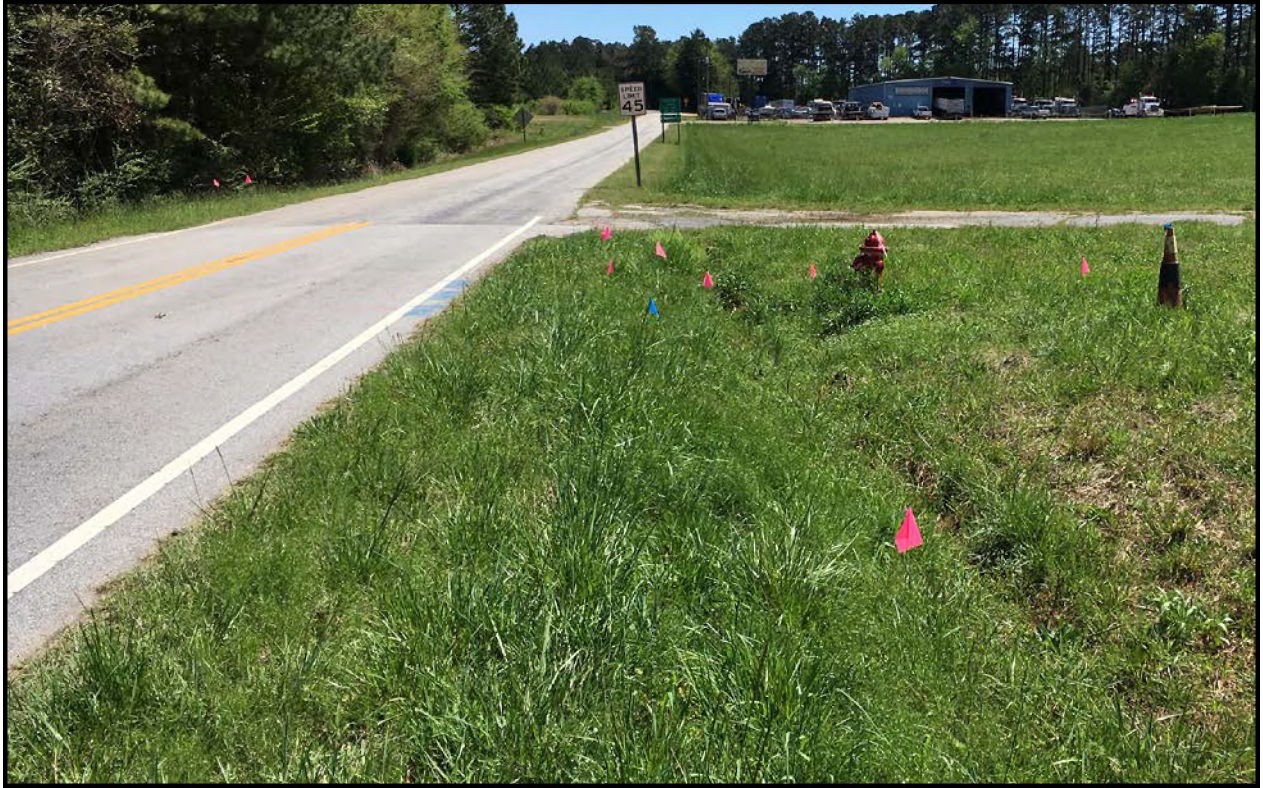
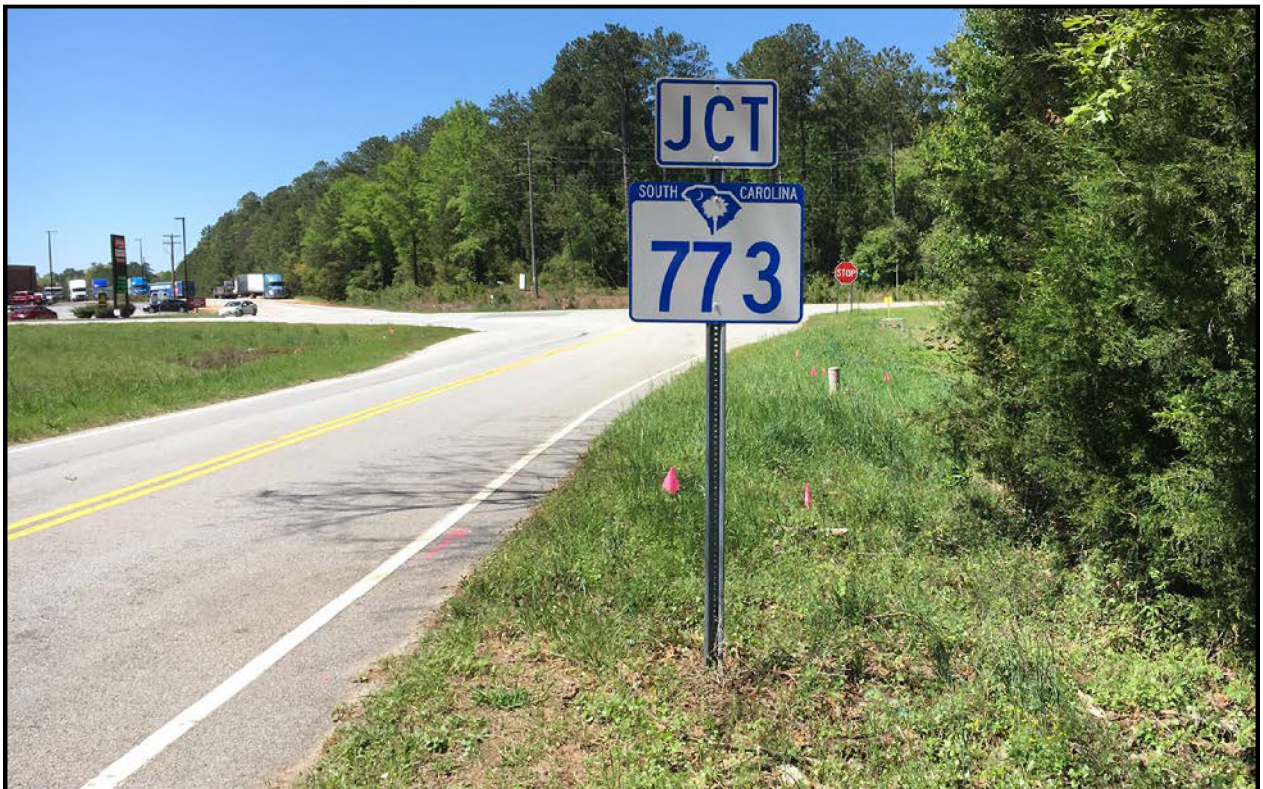
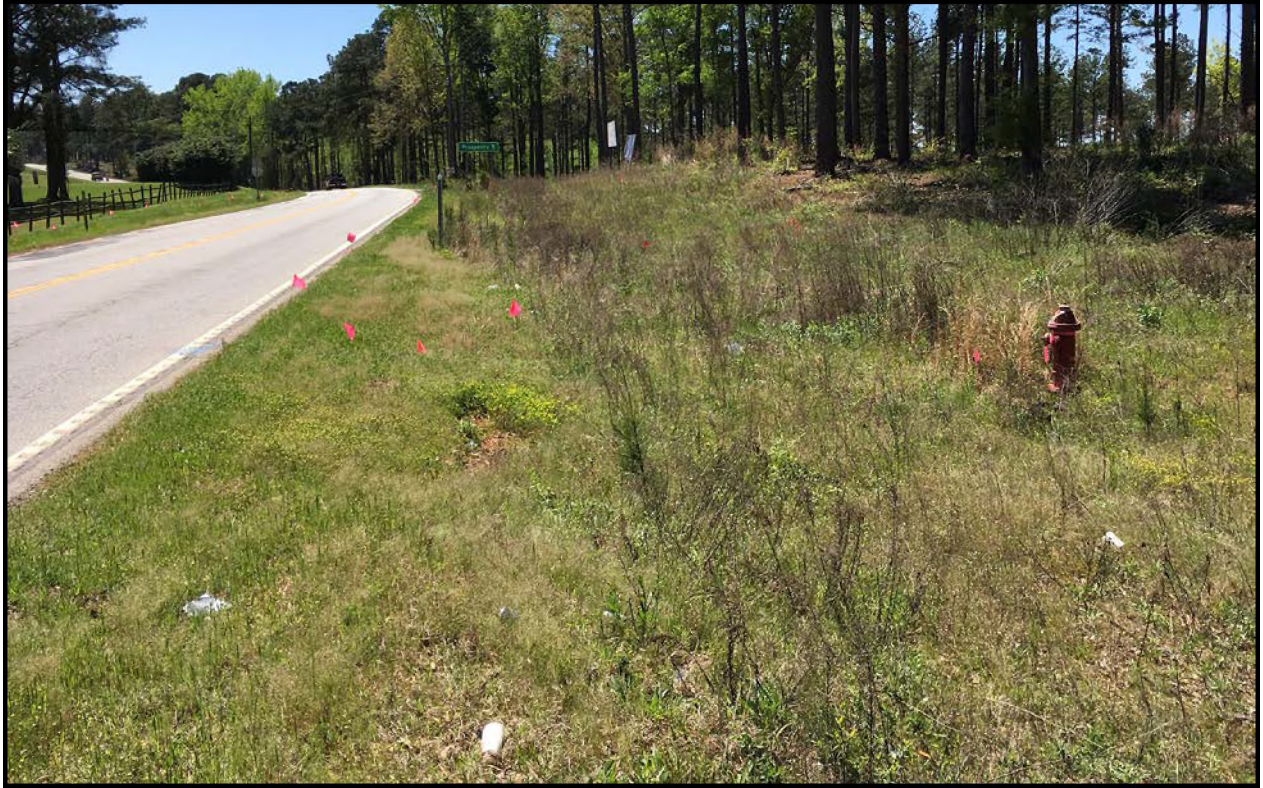
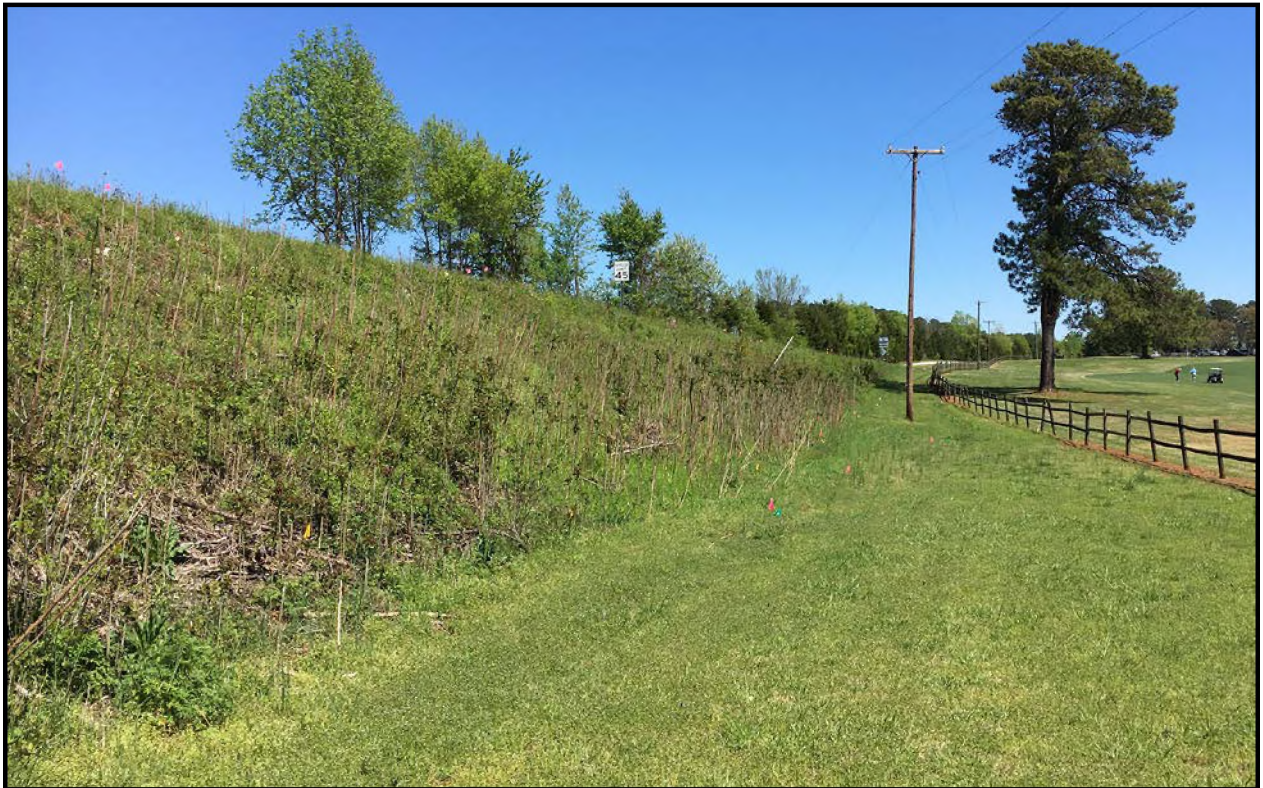
Figure 28. View of SC-773 Showing Ground Disturbance, Facing Northeast From Middle of Project Area.

Figure 29. View of SC-773 Showing Ground Disturbance, Facing Northeast From Middle of Project Area.

Figure 30. View of Koon Trestle Road Showing Ground Disturbance, Facing Southeast in Northern SC-773 Project Area.

Figure 31. View of Koon Trestle Road Showing Ground Disturbance, Facing Northwest in Northern SC-773 Project Area.

Figure 32. View of SC-773 Showing Ground Disturbance, Facing Southwest Towards STP 1-1.

Figure 33. View of SC-773 Showing Ground Disturbance, Facing Northeast From STP 2-2.
