CULTURAL RESOURCES FIELD REPORT

TITLE: Cultural resources survey for the Proposed Inland Port/BMW Lead Extension, Greer, Spartanburg County, South Carolina

CONSULTANT: Brockington and Associates, Inc. (Brockington)

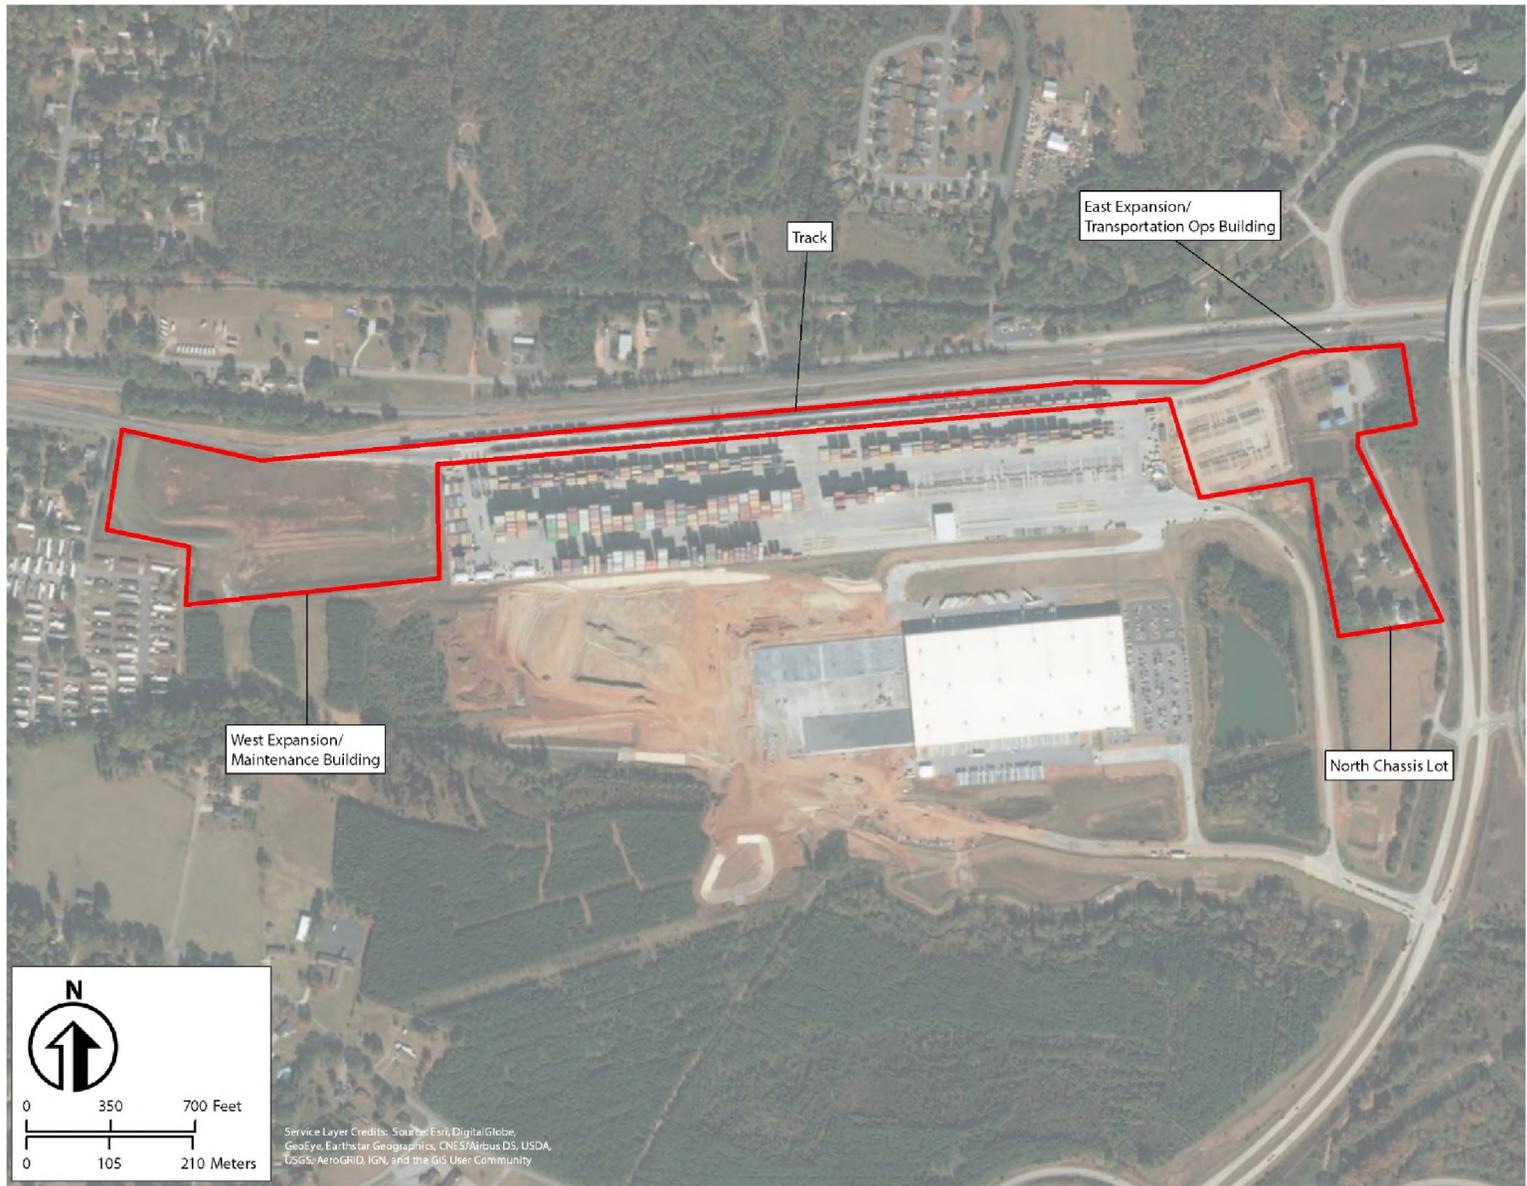
Figure 2. Aerial imagery of the APE at the existing IPG facilities.

DESCRIPTION: The South Carolina Ports Authority (SCPA) and the Norfolk Southern Railway Company (NSRC) are proposing to expand the Inland Port Greer (IPG) and the lead track east of the Port. The Area of Potential Effect (APE) is the sum of the NSRC lead track project and the SCPA IPG expansion. The IPG expansion project includes additional at-grade expansion of the rail yard on the north side of the IPG, and new container lots east and west of the IPG and adjacent to International Commerce Boulevard. The IPG expansion also includes a proposed transportation operations building. All of the IPG expansion work is to occur within existing IPG property that has been previously surveyed for cultural resources or is disturbed. Figure 1 displays the location of the IPG expansion and lead track project APE. Figure 2 displays recent aerial imagery of the IPG and the APE at that facility.

The portion of the APE at the western end of the existing facilities (West Expansion/Maintenance Building in Figure 2) was graded, filled, and leveled within the last five years. Figure 8 provides views of the West Expansion/Maintenance Building area. Aerial imagery on Google Earth®, presented in Figure 9, indicates that in February 1994 this area was farm fields and timberlands. In May 2005, it appears to be pasturage or fallow fields with one stand of timber; a second stand present in 1994 had been harvested. By April 2008, the remaining stand of timber had been harvested. By September 2010, trees were planted across the entire area as part of a commercial nursery operation, with furrows and lines of small trees visible throughout. By April 2014, the area was graded and large berms constructed along the western and southwestern edges; lower areas appear to have been filled creating a level surface inside the berms. Earlier successional vegetation is colonizing the area by June 2018.

The portion of the APE at the eastern end of the existing facilities (East Expansion/Transportation Ops Building in Figure 2) also witnessed demolition, grading, filling, and leveling within the last 15 years. Figure 10 provides views of the East Expansion/Transportation Ops Building area. Again, review of aerial imagery on Google Earth®, presented in Figure 11, indicates that in February 1994 a farm complex with at least eight buildings, some quite large, covered this area west of Dobson Shed Road; to the east of the road, another house or houses stood in the APE. By May 2005, all of the buildings have been removed except for a possible large barn adjacent to the railroad tracks and the areas where the buildings stood has been graded. By April 2008, this area is covered in planted trees with furrows visible throughout. Between November 2012 and April 2014, this area was graded (all vegetation was removed), fill placed over much of the area, and a detention pond excavated at its southern edge. In June of 2018, the western portion of this area was used for the storage of trailer chasses, while the eastern portion contained colonizing early successional vegetation.

The southeast portion of the APE (North Chassis Lot in Figure 2) contains four houses along its eastern margin (the three architectural resources described above and a modern modular house) and outbuildings and ancillary facilities (e.g., swimming pools) in the yard areas to the west of these houses. Between February 1994 and June 2018, the number of outbuildings and facilities vary, with some removed and new ones constructed. The degree of manipulation of these yards and the shallow nature of soils throughout the region indicates that there are few undisturbed areas in this portion of the APE. Also, during the documentation of the architectural resources within the North Chassis Lot of the APE, the project historian inspected surface exposures and observed no artifacts or other indications that extensive undisturbed areas are present in this portion of the APE.

The portion of the APE to the north of the existing facilities occupied by rail lines (Track in Figure 2) is disturbed by the construction and maintenance of the existing rail lines. Along the APE for the lead track to the east of the IPG proper (see Figure 12), all ground disturbance will occur within the existing ROW on the south side of the existing rail line; the ROW extends 100 feet to the south and north of the centerline of the existing track. Inspection of aerial photographs from 1957 (1957-1981 viewed at <https://www.historicaerials.com> on June 18, 2019) through 2018 (1994-2018 viewed on GoogleEarth®- see Figure 13) indicates that disturbance related to rail construction and maintenance extends 50-60 feet from the rail centerline at the eastern end of the APE (approximately 750 feet from Station 0+00 at Robinson Road to Station 7+50) and throughout the remaining portions of the APE/ROW related to rail construction/maintenance and commercial nursery operations (i.e., clear-cutting with stump removal and grading, mechanical preparation of beds, and mechanical planting and harvesting of live hardwood trees and pines). Nursery operations began by April 2008 with grading and planting in the western portion of the lead track APE and extended throughout the remainder of the lead track APE by October 2011. One possible exception is a narrow, wooded strip approximately 700 feet long and 20-30 feet wide near Stations 10+00 to 17+00. Here, the rail line cuts through a broad ridge creating a 20 to 22-foot-high cut bank to the south of the rail line. The narrow, wooded strip stands atop the cut bank. Also, a fiber optic cable extends along the southern edge of the ROW throughout the length of the APE.

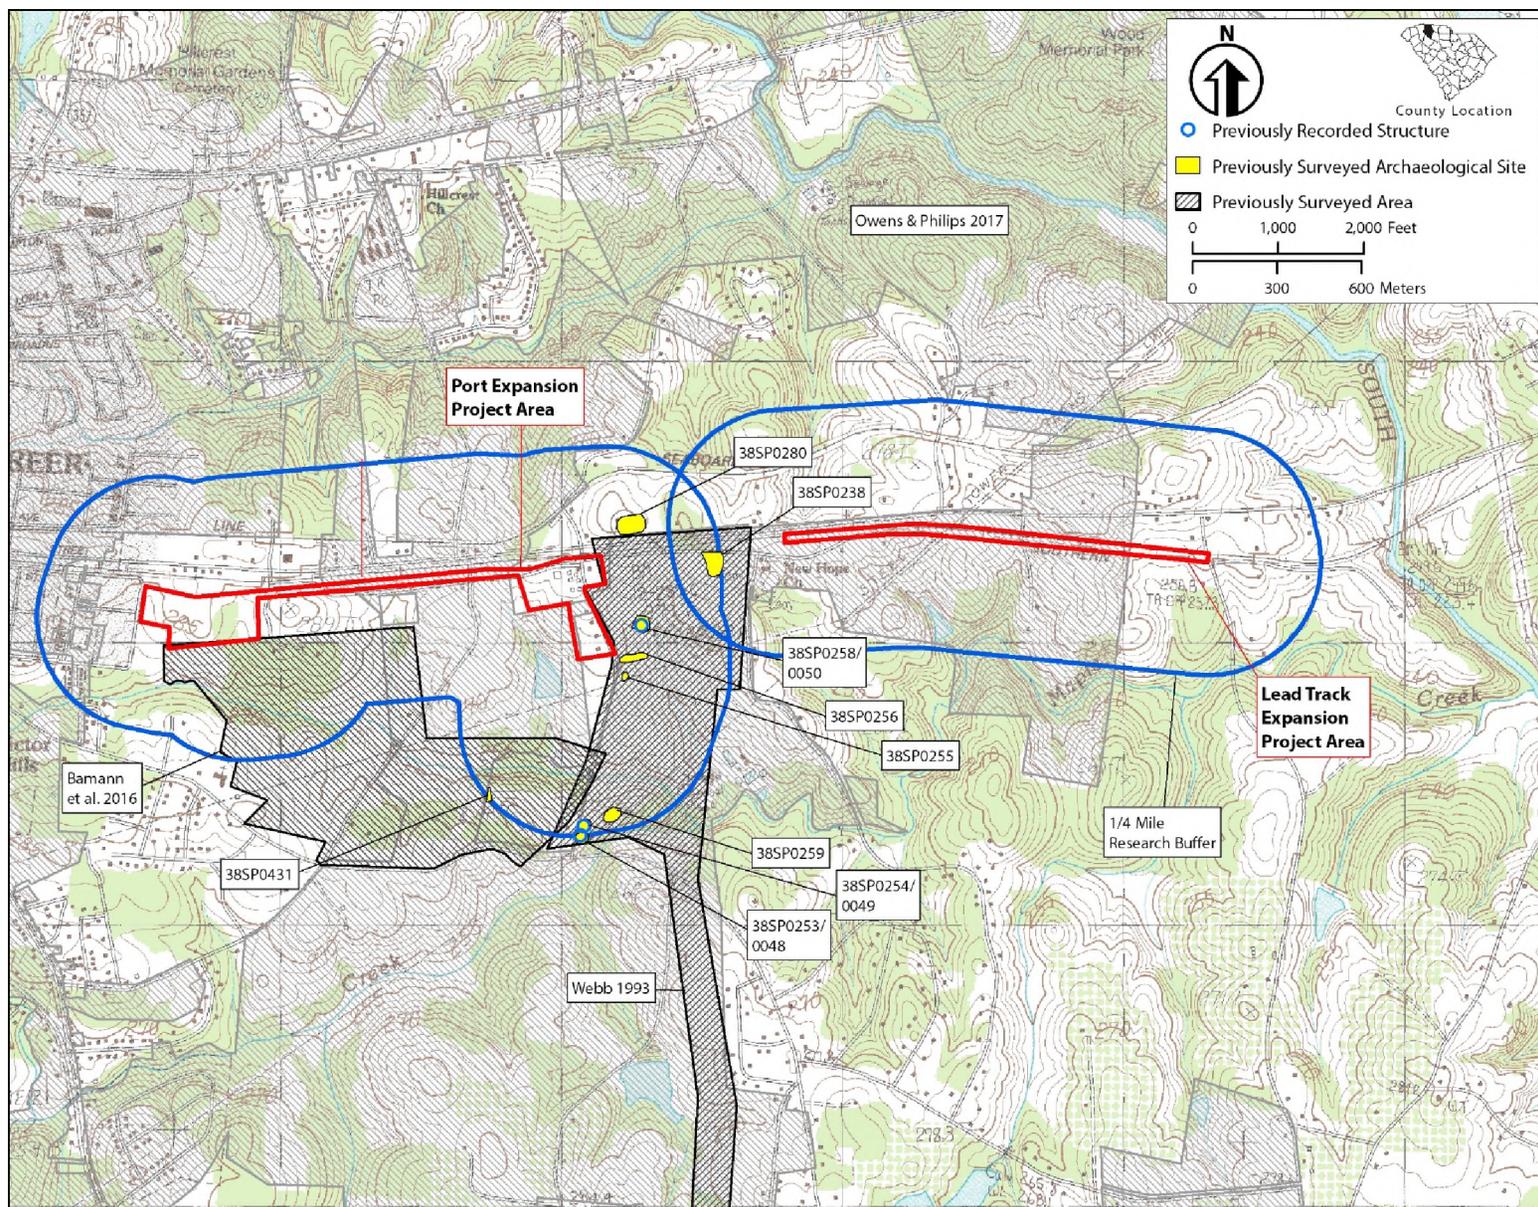
Figure 3. Previously recorded investigations and resources within 0.25 miles of the project areas.

Previously Identified Architectural Resources within ¼ mile of the Project Tract (see Figure 3)

Previously Identified Archaeological Sites Within ¼ Mile of the Project Tract (see Figure 3)

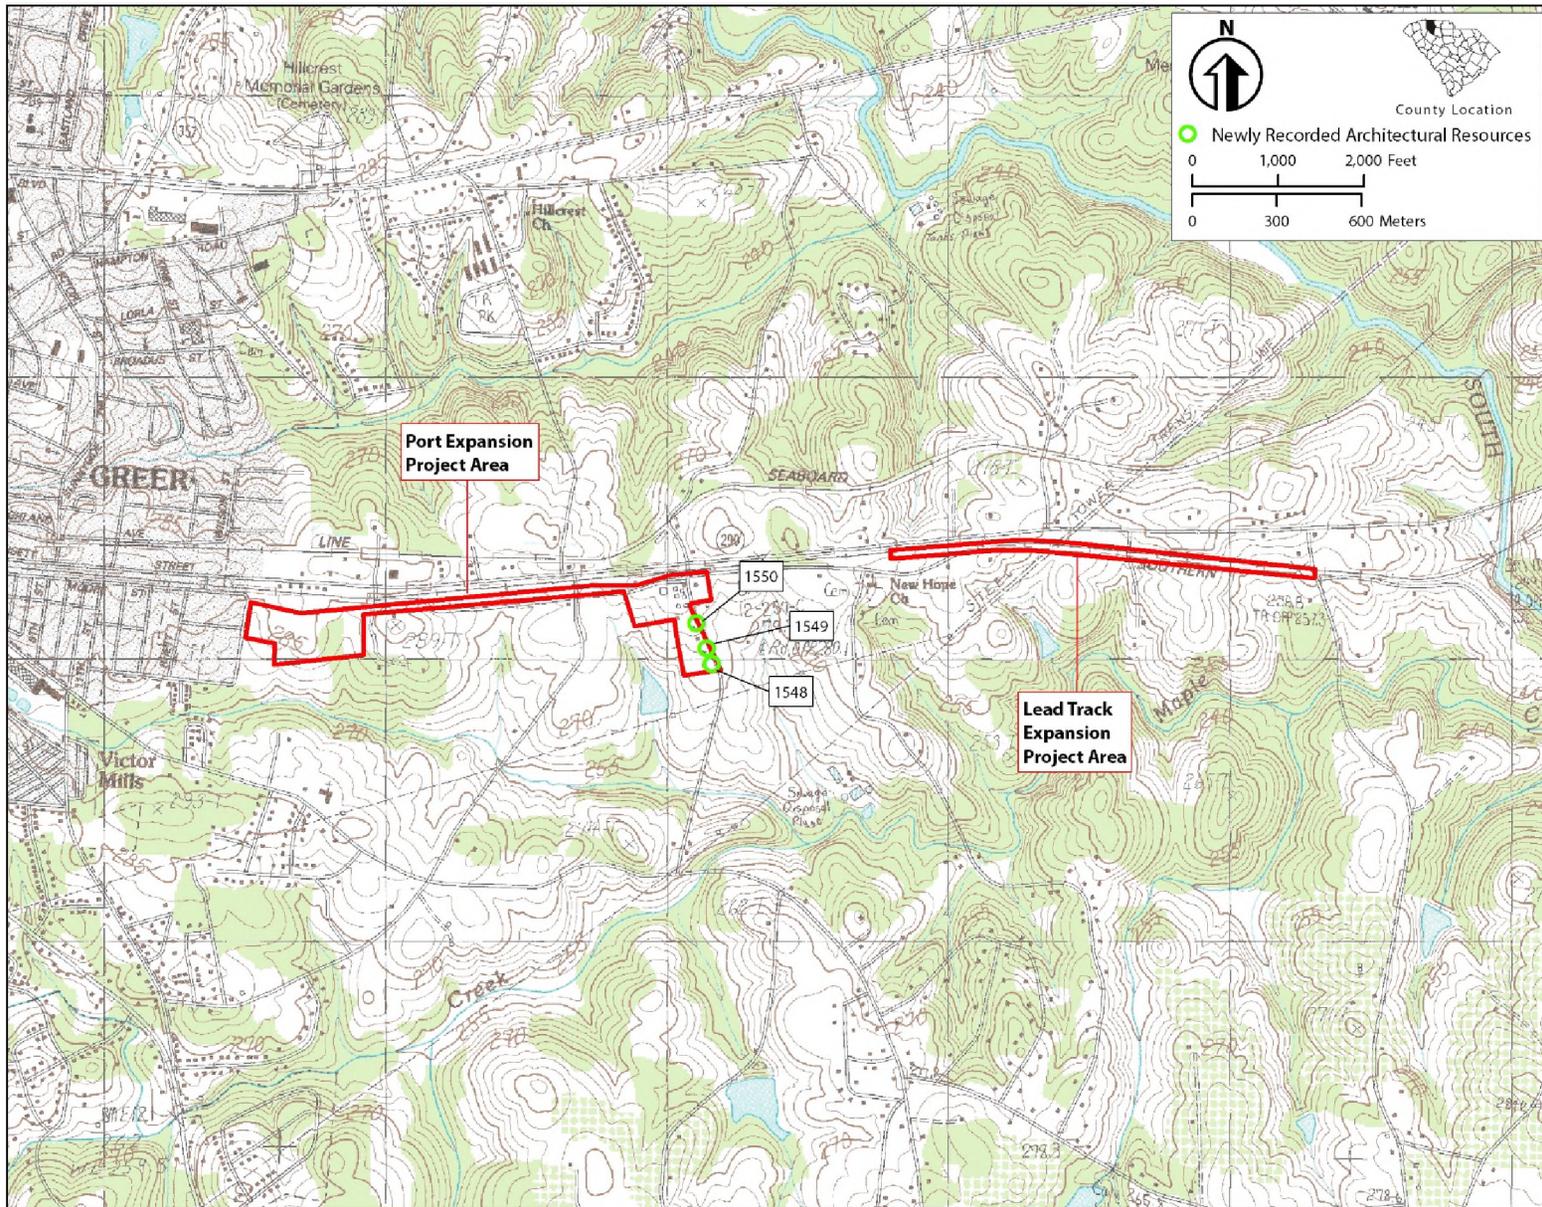
Figure 4. Newly identified architectural resources.

ARCHITECTURAL SURVEY: Brockington architectural historian David Dobbs recorded architectural properties within the survey universe on May 20, 2019. The project historian surveyed three architectural resources located on Dobson Shed Road (Survey numbers 1548, 1549, and 1550) that appeared to be 50 years of age and potentially retained sufficient architectural integrity to warrant evaluation for the National Register of Historic Places (NRHP). A fourth house was located within this cluster of residences, but it is a non-historic modular structure. Each historic house and any associated outbuildings were inspected, photographed, and notes taken as to original and altered components. None of the three resources qualify for listing on the NRHP. Each is summarized below. Figure 4 displays the location of these resources.

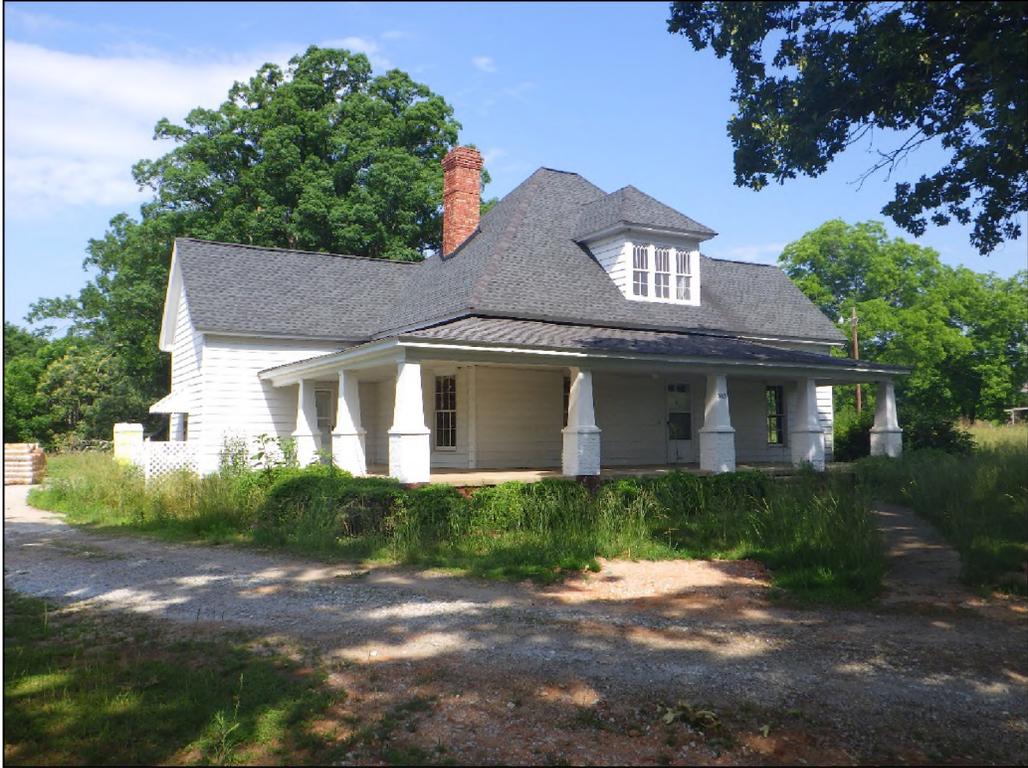
According to the Spartanburg County tax assessor, Resource 1548 was constructed circa 1900. Located at 363 Dobson Shed Road, this is a 1.5-story hipped roof residence with a porch that wraps around its east (façade) and south elevations (see Figure 5). The foundation is infilled brick, largely obscured with vegetation, and the wood-framed structure is clad in non-historic synthetic siding. Windows on the primary floor are wood-framed 6/6 double-hung

sash. Based on the materials, the wood windows do not appear to be the original units, but they may have been installed in the mid- to late-twentieth century. Other 6/6 windows on the rear of the house, as well as on the side and rear additions, are non-historic synthetic 6/6 double-hung units, and some of the windows include mid-twentieth century metal awnings. The hipped dormer on the façade roof is historic and contains the original window glazing of 4 arched lights over 4 grid lights. The front porch consists of replacement concrete steps and a non-historic concrete pad floor over what appears to be a rebuilt brick foundation. The brick piers and battered posts are original. The front door is a non-historic synthetic unit, but the side porch door (within the southern recess) appears to be original. The rear (west) elevation contains a sunroom or enclosed porch, consisting of all non-historic materials, as well as a non-historic hipped dormer. Another enclosed porch is present on the northwest elevation. Windows here are metal-framed 1/1 units. The property contains three historic outbuildings. Resource 1548.01, located north of the house, is a wood framed crib and chicken coop. Resource 1548.02, located behind the house, is a wood framed open carport with corrugated sheet metal siding. Resource 1548.03, also located behind the house, is a wood framed equipment shed, partially clad in wood and raised seam metal sheeting.

Archival research identified no historical events, persons, or research potential for Resource 1548 to qualify for the NRHP under Criteria A, B, or D. Resource 1548 has had several incompatible material and design alterations, including the replacement door, windows, siding, and additions. Due to these alterations, Resource 1548 lacks integrity in the areas of materials, design, workmanship, association, and feeling, and does not qualify for the NRHP under Criterion C for architecture.

Figure 5. Resource 1548, facing northwest.

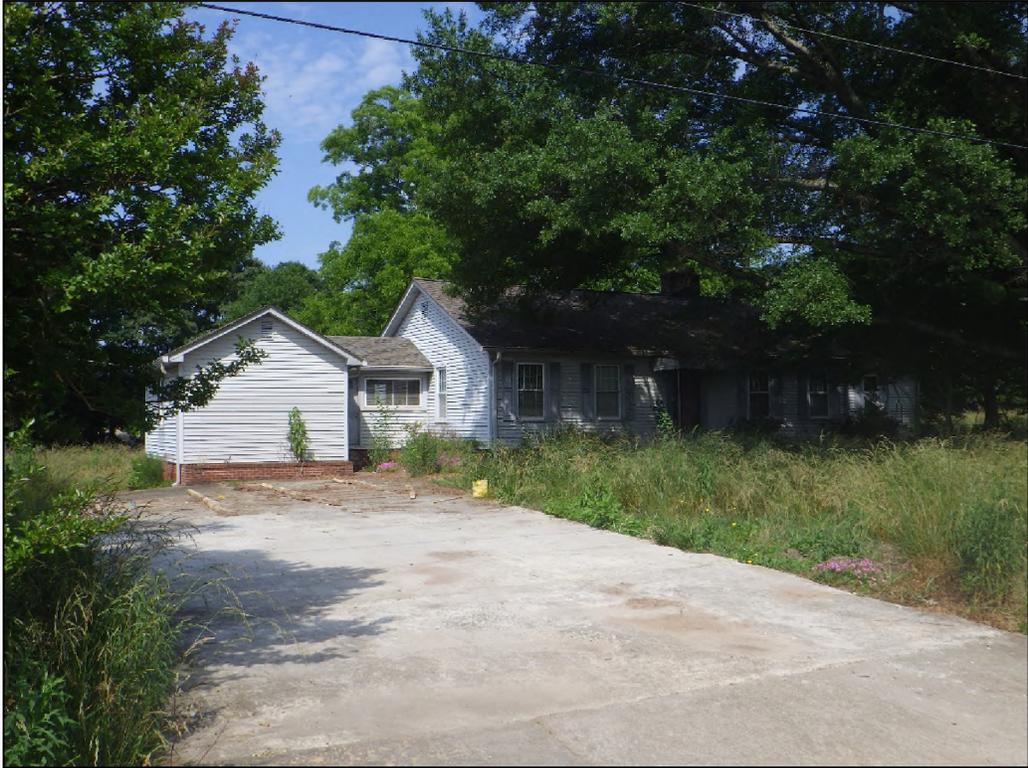
According to the tax assessor, Resource 1549 was constructed circa 1940. Located at 367 Dobson Road, this one-story wood-framed residence includes a rebuilt brick foundation, non-historic synthetic siding, non-historic 8/8 synthetic windows with vinyl shutters and additions/enclosures on the south and west (rear) elevations (see Figure 6). The south elevation includes a hyphen and enclosed room; these were likely a covered breezeway and carport when originally constructed. A secondary, non-historic door and synthetic windows are present on the connecting hyphen. The rear (west) elevation has an open carport, and a non-historic brick addition. The house is vacant and several windows have been broken. This property has a single outbuilding, Resource 1549.01, which is a detached three-car garage. The building consists of a concrete floor and concrete block walls, synthetic roll-up doors, and metal-framed 1/1 windows.

Archival research identified no historical events, persons, or research potential for Resource 1549 to qualify for the NRHP under Criteria A, B, or D. Resource 1549 has had several incompatible material and design alterations, including the replacement front door, windows, siding, foundation, enclosures and additions. Due to these alterations, Resource 1549 lacks integrity in the areas of materials, design, workmanship, association, and feeling, and does not qualify for the NRHP under Criterion C for architecture.

Figure 6. Resource 1549, facing northwest.

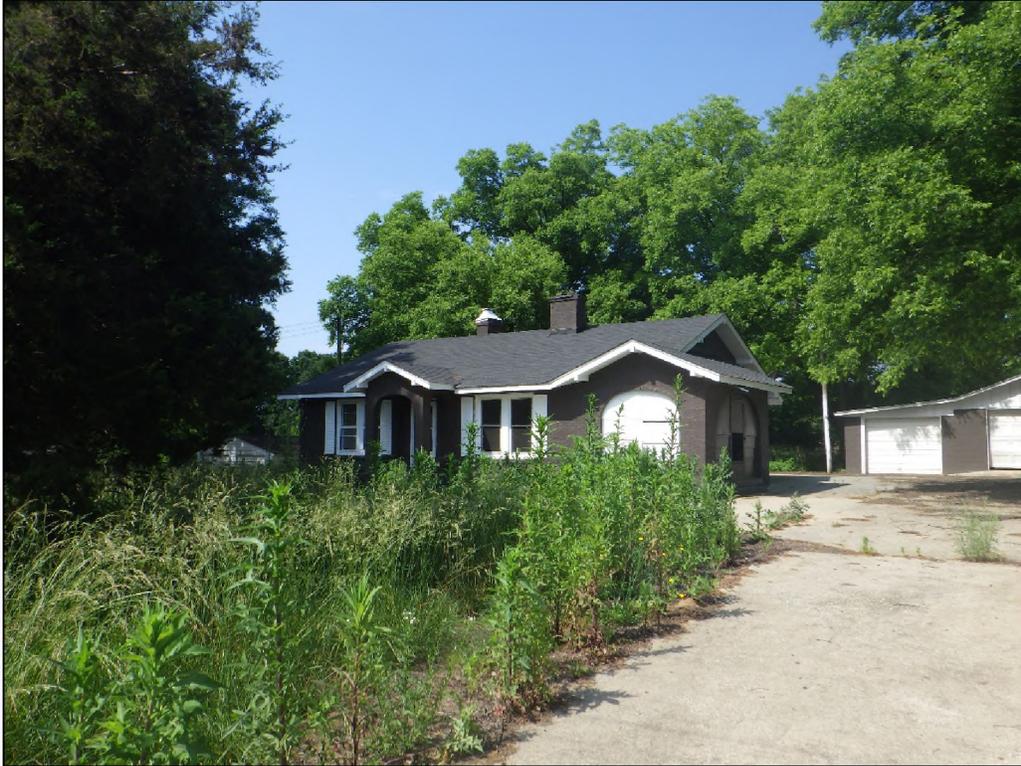
According to the tax assessor, Resource 1550 was constructed circa 1940. Located at 371 Dobson Shed Road, this minimal traditional house includes a masonry foundation, wood frame clad in brick, and a side-gabled roof (see Figure 7). In a review of tax assessor records, the brick has been painted a dark brown/gray within the last ten years. Windows on the façade are non-historic synthetic 1/1 double-hung windows flanked by applied shutters. The front porch has a brick arched entry with a front gable roof and decorative rafter tails. The front door is a non-historic, synthetic replacement with a fanlight. The north elevation porch originally included open archways on the east and north elevations, but these have been enclosed with plywood and vinyl window units, and a rear synthetic door installed. The rear (west) elevation includes a non-historic addition. The south side elevation contains the only remaining original windows, which are 4/1 double-hung sash. The property includes one outbuilding, Resource 1550.01. This is a concrete block, two-bay garage located immediately northwest of the house. Both roll-up doors have been replaced.

Archival research identified no historical events, persons, or research potential for Resource 1550 to qualify for the NRHP under Criteria A, B, or D. Resource 1550 has had several incompatible material and design alterations, including the replacement front door and windows, and the side porch enclosure. Due to these alterations, Resource 1550 lacks integrity in the areas of materials, design, workmanship, association, and feeling, and does not qualify for the NRHP under Criterion C for architecture.

Figure 7. Resource 1550, facing west.

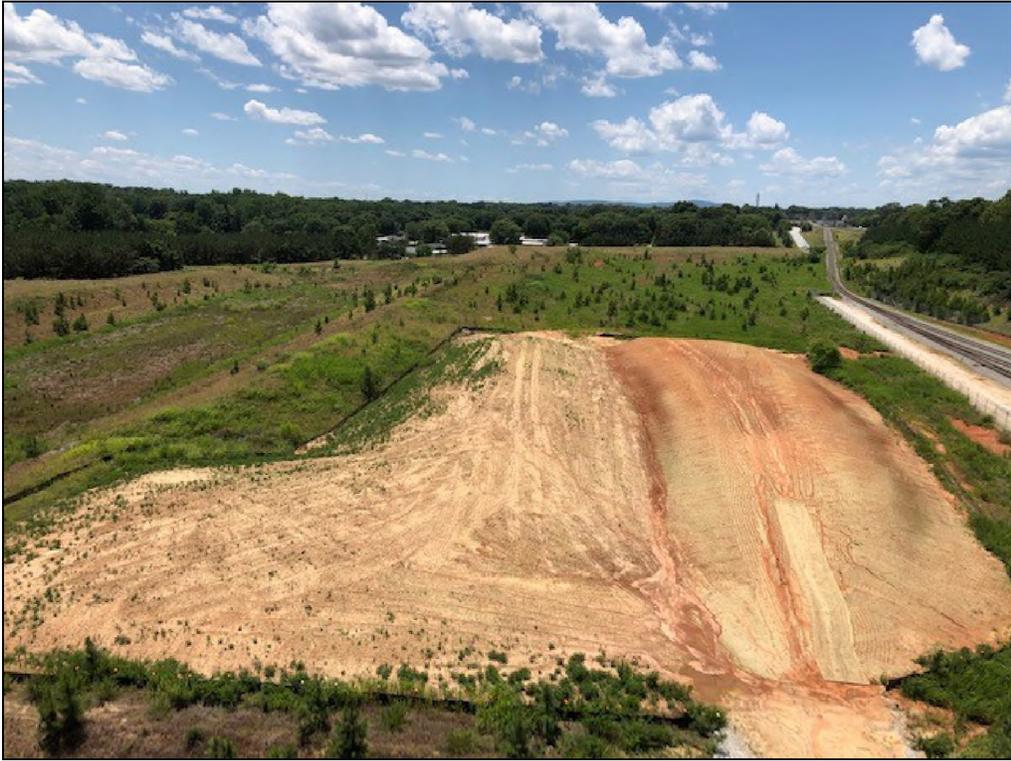
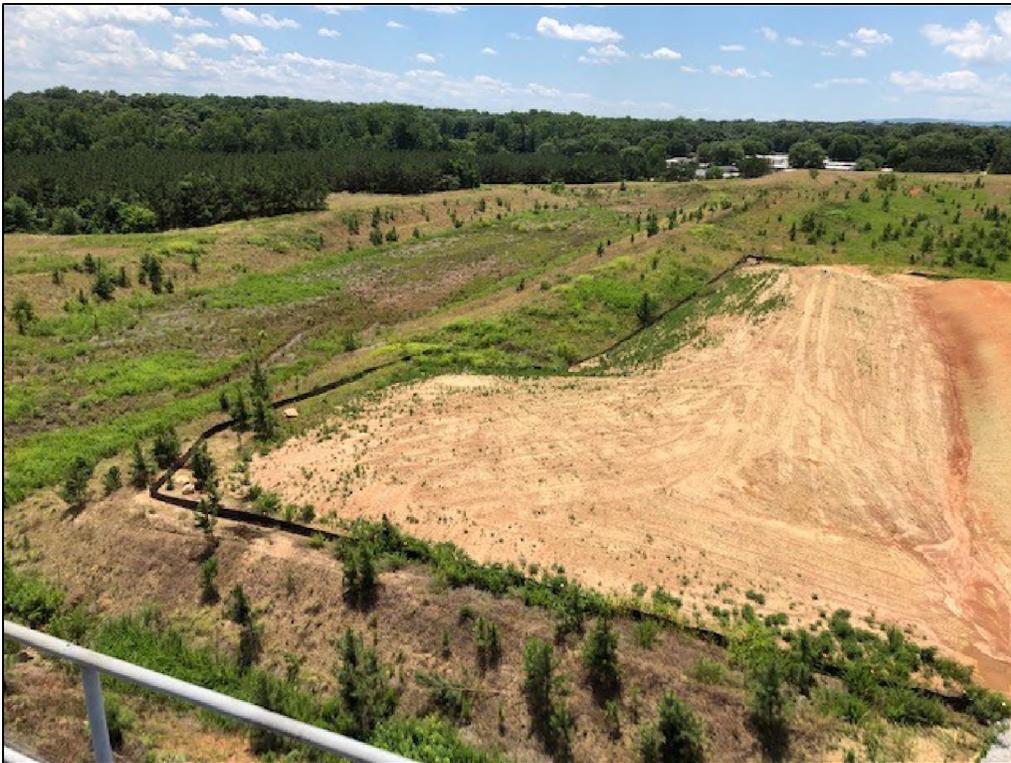
Figure 8. Views of the West Expansion area. Top: looking east. Bottom: looking southeast.

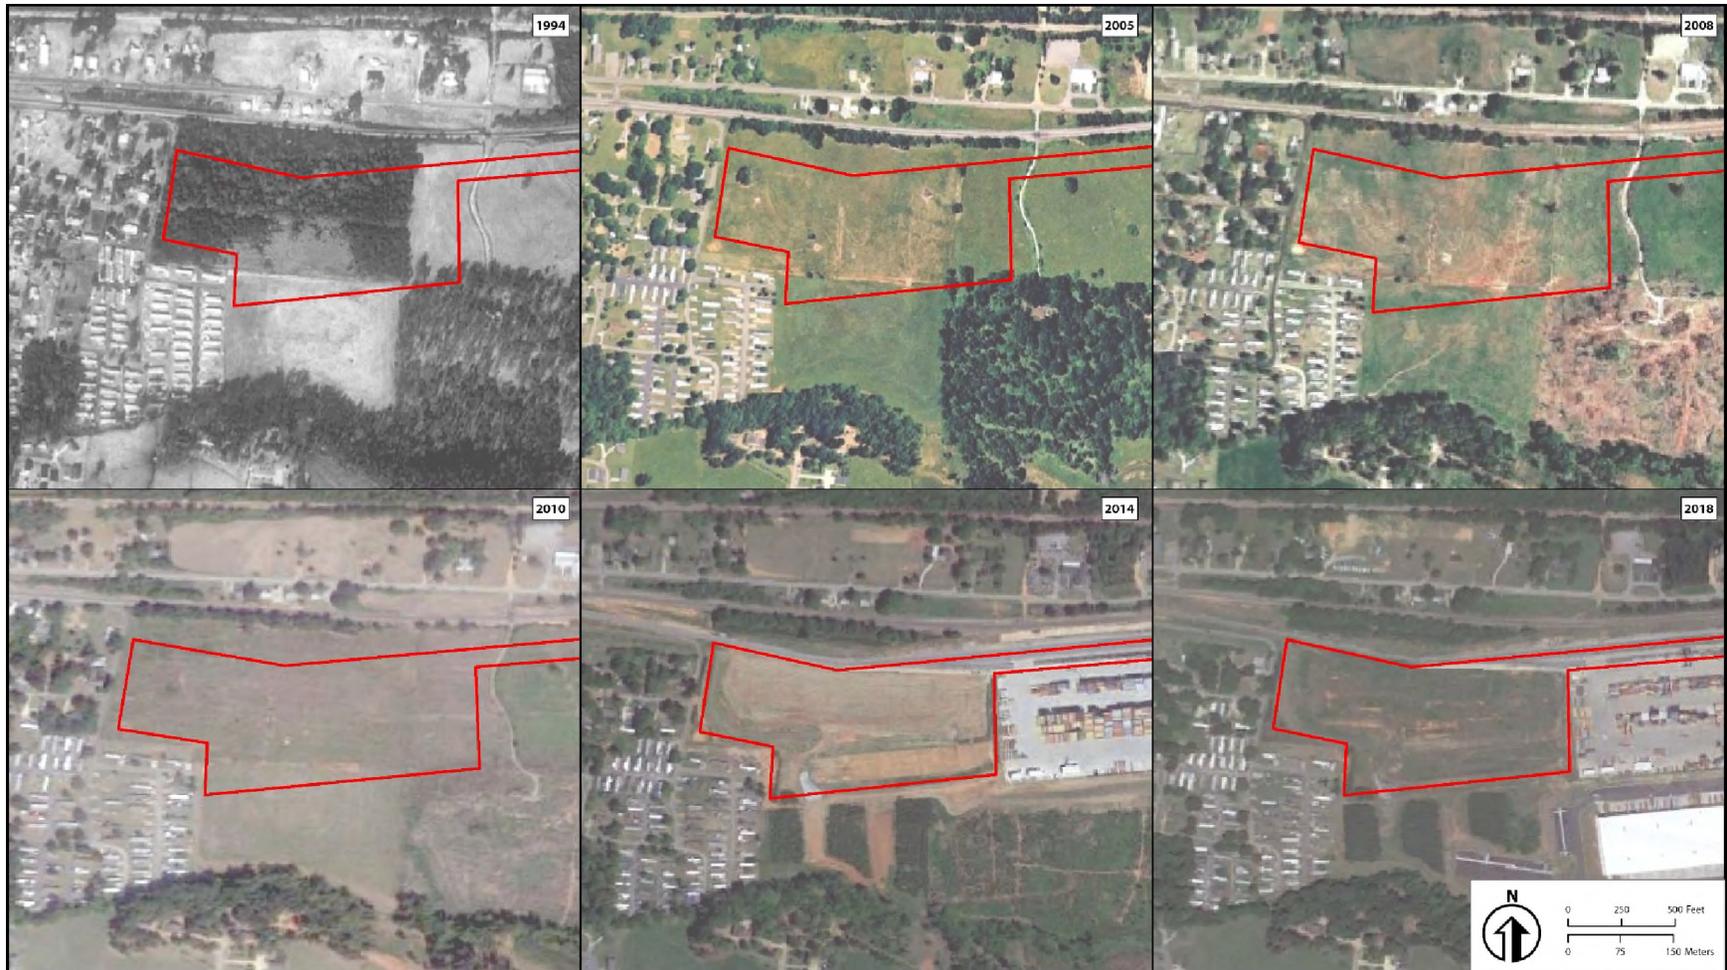
Figure 9. Aerial imagery showing land use and alterations of the West Expansion area since 1994 (from Google Earth®).

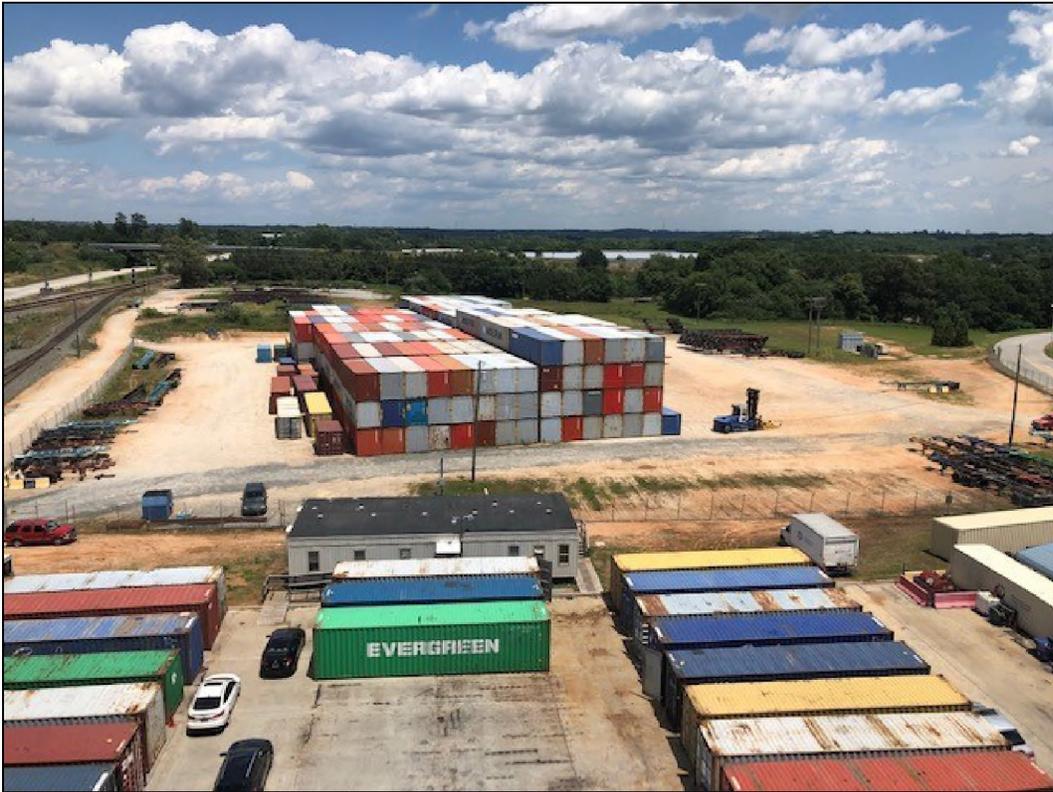
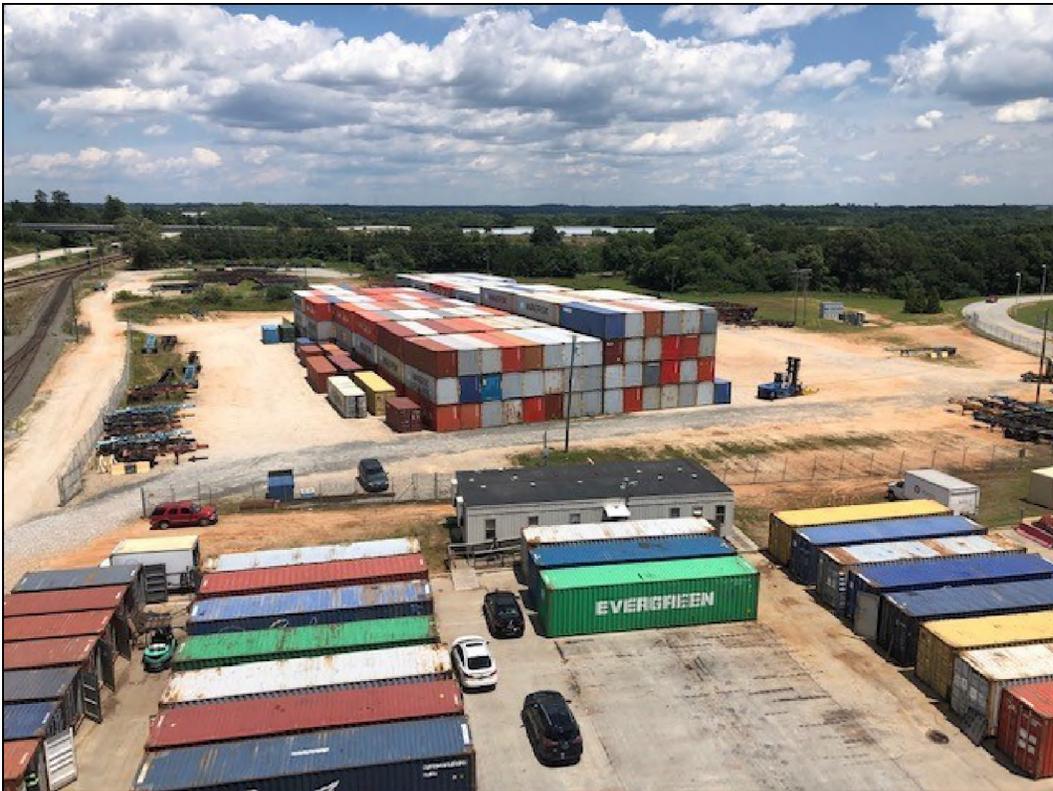
Figure 10. Views of the East Expansion area. Top: looking east. Bottom: looking southeast.

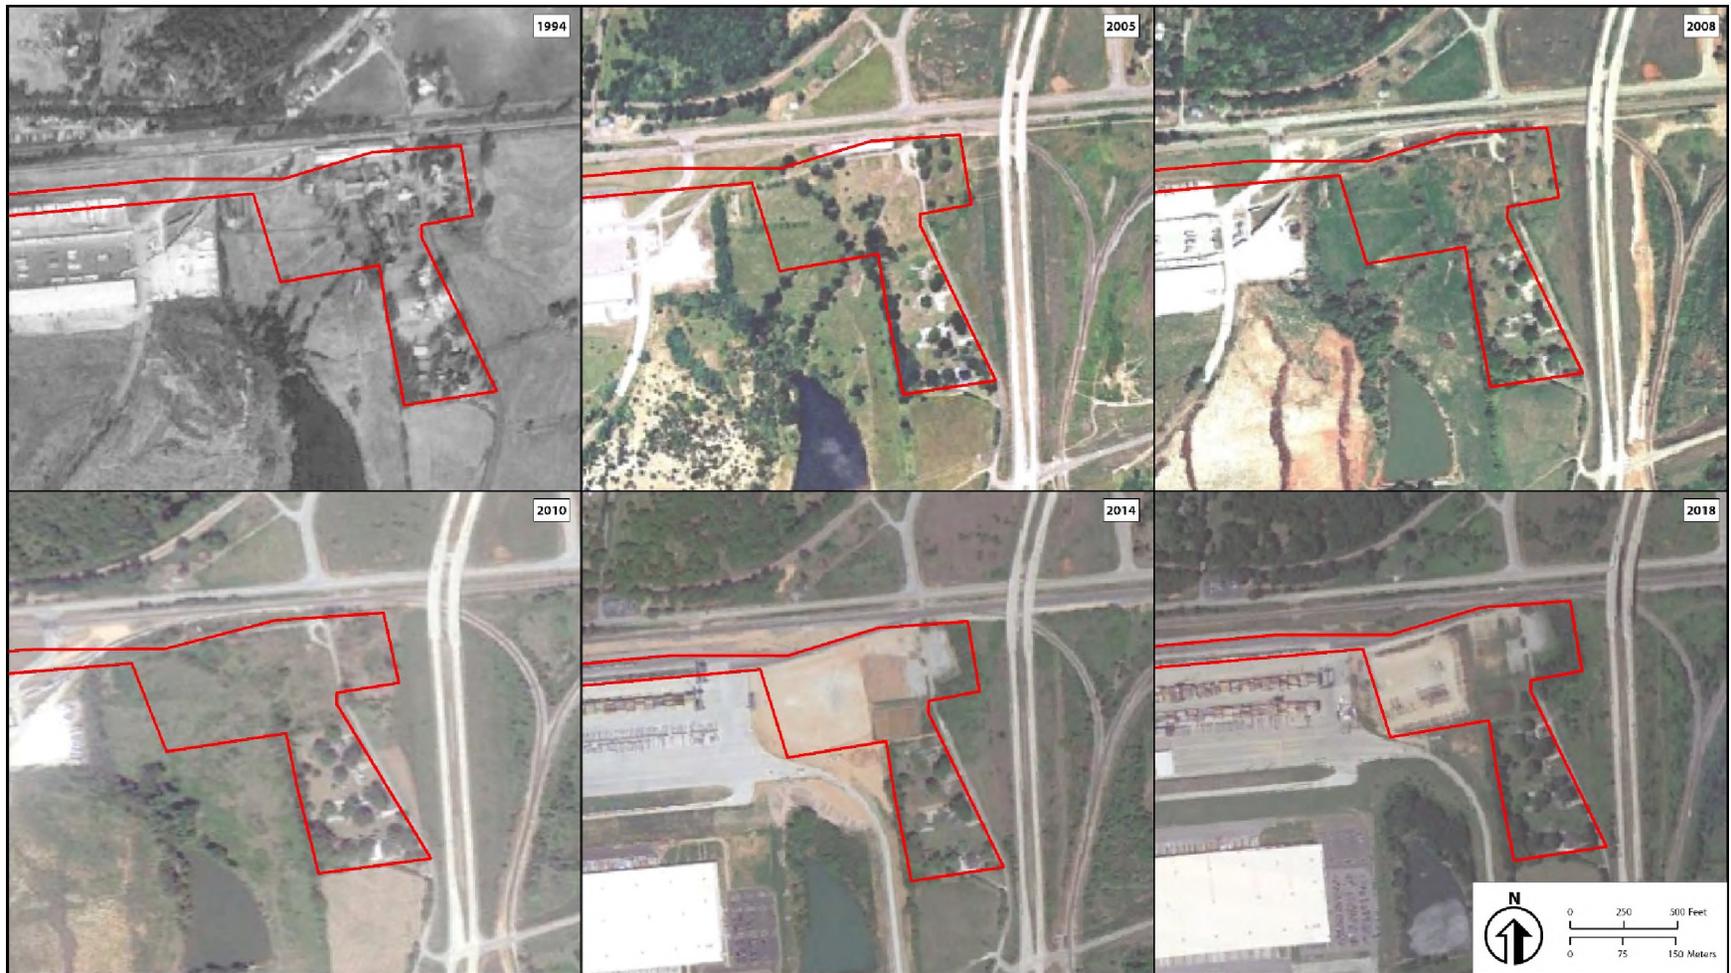
Figure 11. Aerial imagery showing land use and alterations of the East Expansion area since 1994 (from Google Earth®).

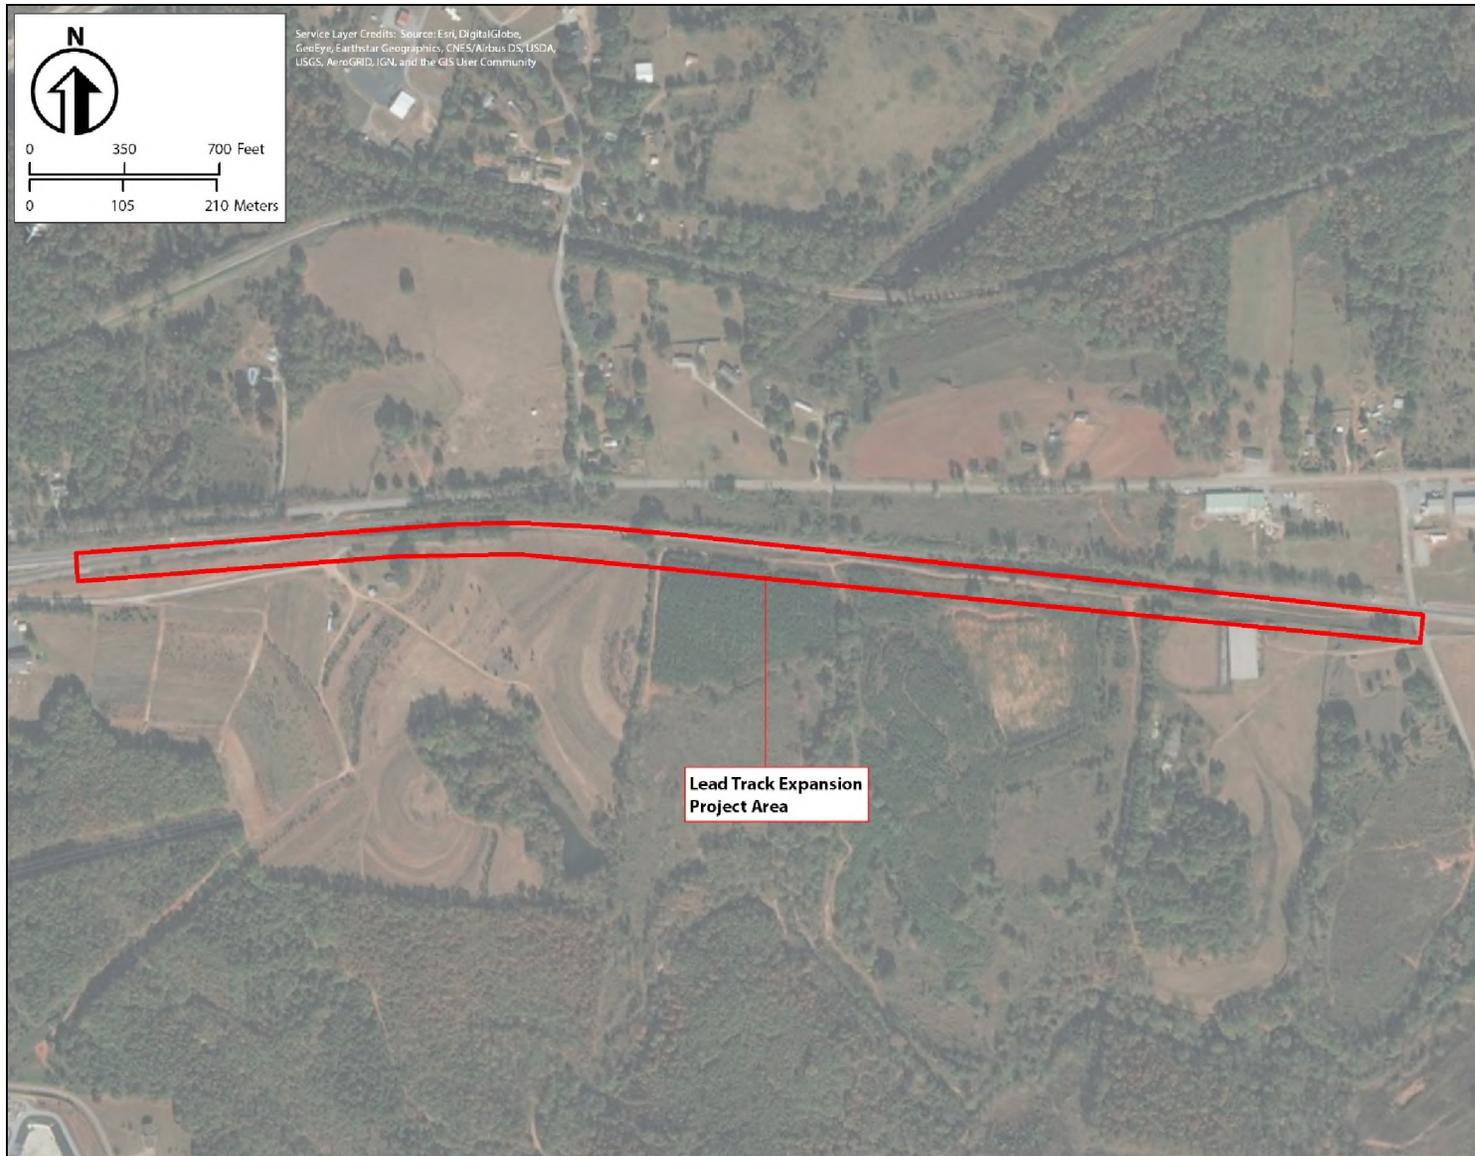
Disturbance related to the installation of the lead track will extend 40-50 feet from the centerline of the existing rail line throughout much of the APE, within existing disturbed areas; the centerline of the lead track will be 15 feet south of the existing rail line throughout the project. At the cut bank noted above, disturbance will extend 60-80 feet from the centerline of the existing rail line to create a more stable (less steep) slope for the cut bank. Approximately 20-30 feet of this area is disturbed by rail construction adjacent to the existing rail line with the remainder of the ROW disturbed by commercial nursery operations except for the narrow, wooded strip at the top of the cut bank noted above. Review of historic topographic maps from 1935 and 1938 (viewed at <https://www.historicaerials.com> on June 18, 2019) revealed no standing structures within 300 feet of the centerline of the existing rail line. Thus, previous ground disturbance related to rail construction/maintenance and commercial nursery operations extends throughout most of the lead track APE. There is little to no potential for the narrow, possibly undisturbed area near Stations 10+00 to 17+00 to contain archaeological deposits that can generate important information about the past and thus be eligible for the NRHP.

Figure 12. The Lead Track APE on modern aerial imagery.

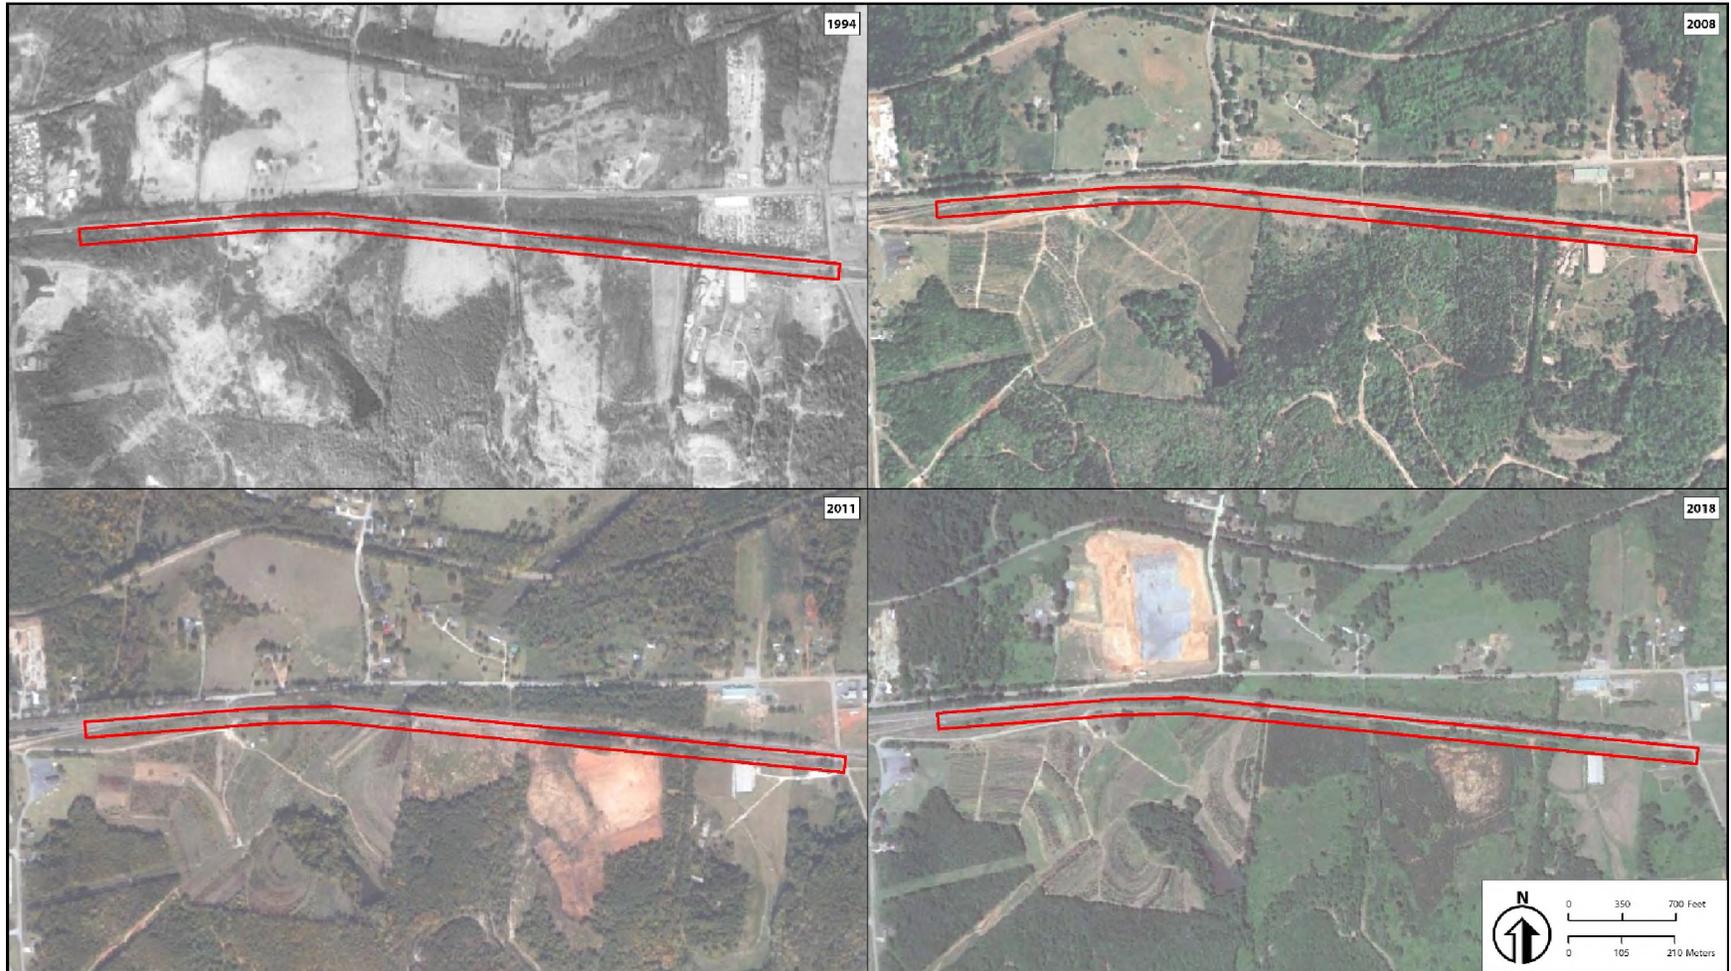
Figure 13. Aerial imagery showing land use and alterations of the Lead Track APE since 1994 (from Google Earth®).
