**ARCHAEOLOGICAL FIELD REPORT
SCDOT ENVIRONMENTAL SECTION**

TITLE: Cultural Resources Survey of the U.S. 301 Bridge over the North Edisto River

PROJECT: U.S. 301 Bridge over the North Edisto River

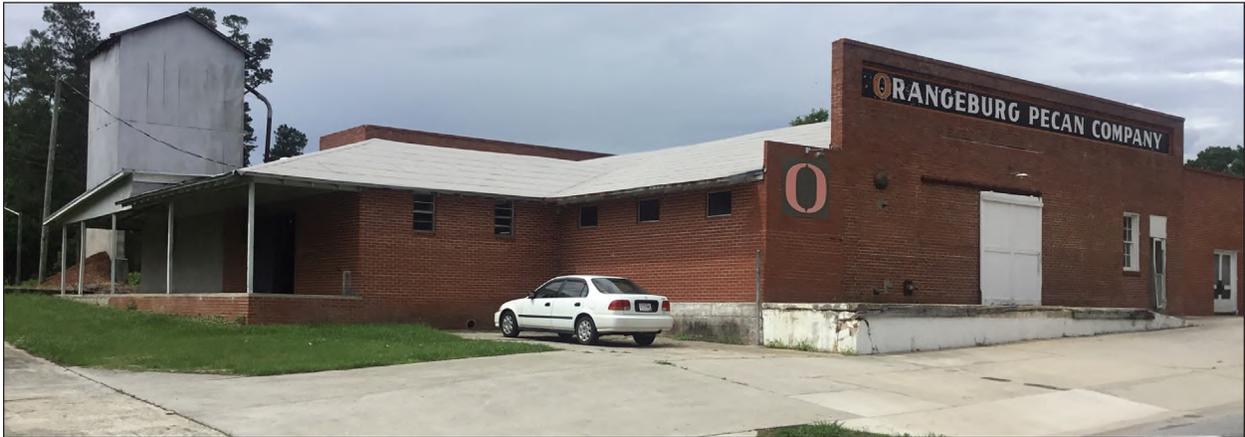
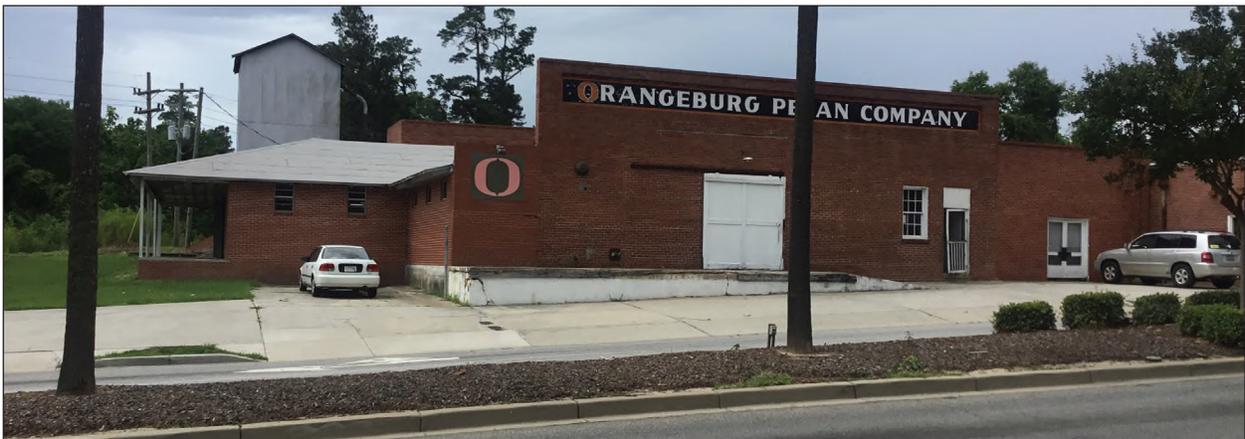
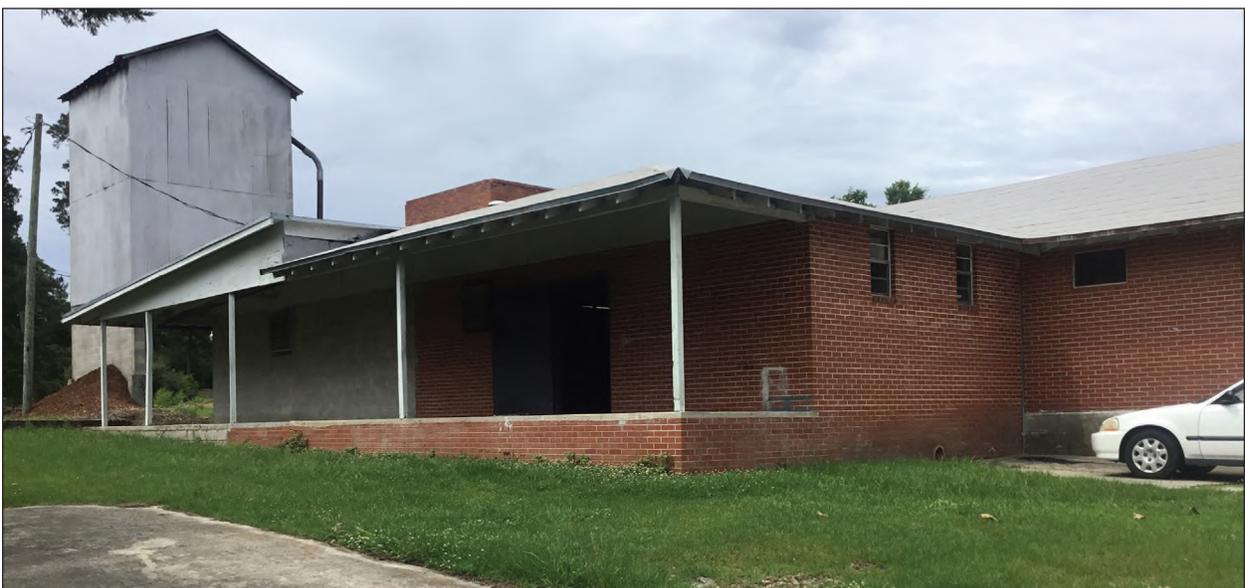
Figure 6.
Orangeburg Pecan Company – Main Building (Resource 0334)

The largest and oldest building in the complex is the main factory building, Resource 0334 (Figures 6-7). Resource 0334 was constructed in circa 1940 and is located at 751 Russell Street, on the northeast corner of Russell Street and Riverside Drive. It is the only building on the block that predates the Orangeburg Pecan Company. This building has undergone a number of additions and alterations, but the historic core is rectangular and one oversized story tall with a front-gabled asphalt roll roof. It is composed of five-to-one common bond brick and faces south towards Russell Street. The main elevation features a simple parapet with a brick cap and an inset portion where signage for the Orangeburg Pecan Company is painted. It is accessed via a wood panel barn door with a concrete loading ramp and a single wood panel personnel door with a blind transom. A single wood frame six-over-six double-hung sash window is located to the west of the door and a hyphen with double wood panel and glass doors has been added to connect Resource 0334 with Resource 0334.05 on the eastern side. The west and rear (south) elevations of the building have been added to multiple times. A shed roofed addition and a hipped addition with brick veneer are located on the west elevation.

A. Southwest Oblique

B. South Elevation

C. Southwest Oblique, Addition Detail

Resources 0334 through 0334.05 collectively form a unique extant example of a mid-twentieth-century agricultural business. The complex retains integrity of location, design, setting, materials, workmanship, and association. Some alterations have been made to the buildings, such as the variety of additions to Resource 0334. Additionally, many of the storefronts have been repurposed for use as storage facilities, which negatively affects integrity of feeling. The eastern portion of the block does not evoke the feeling of a mid-twentieth-century nut cracking business as effectively as the western portion of the block does. However, the complex as a whole still successfully conveys as a mid-twentieth-century nut cracking business, and it is particularly noteworthy that the business has retained the

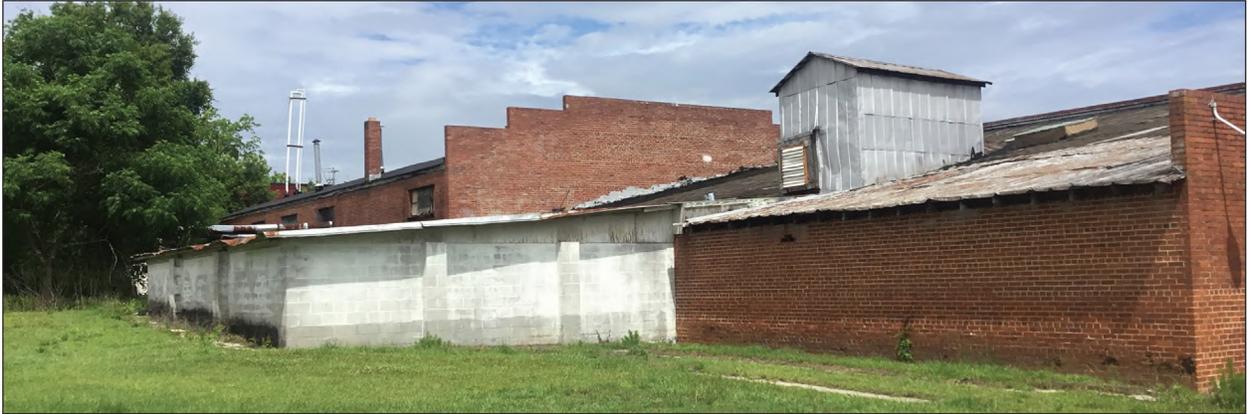
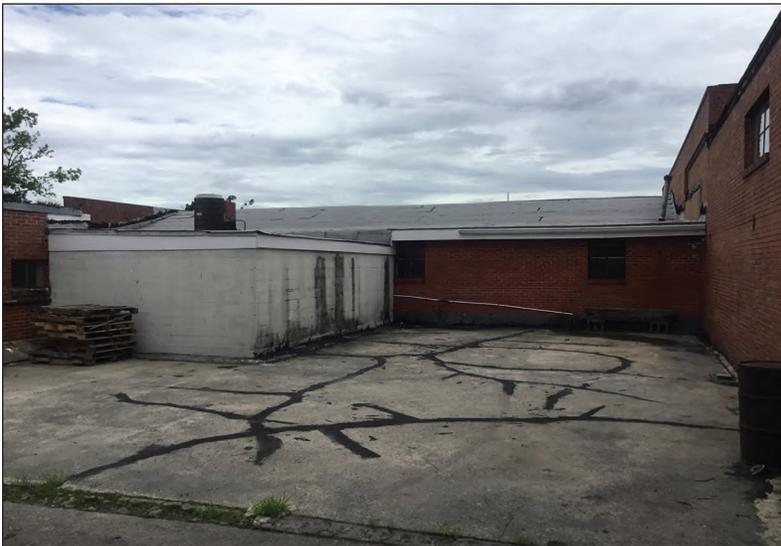
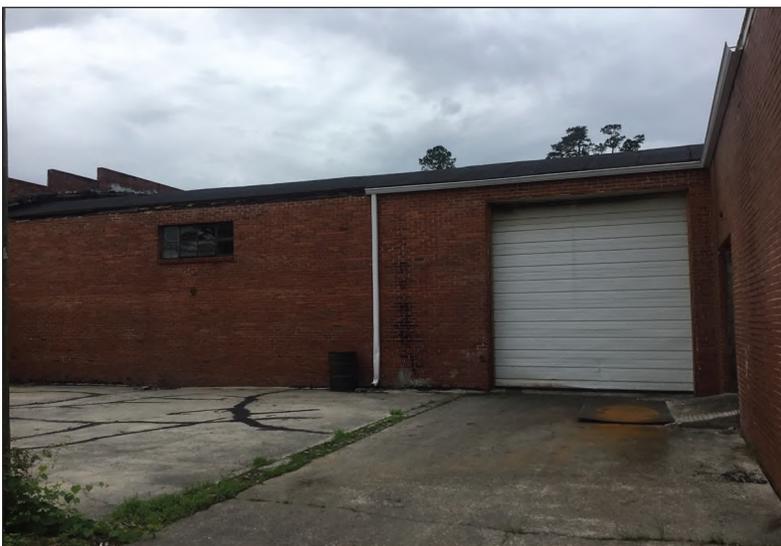
Figure 7.
Orangeburg Pecan Company – Main Building (Resource 0334)

This portion of the building features a partially engaged porch with square wooden supports and aluminum frame horizontal two-over-two double-hung sash windows. Further additions to the rear of the building include two concrete block portions with corrugated metal shed roofs and a corrugated metal-clad cupola to house tall equipment. A large five-to-one common bond brick portion with an arched asphalt roll roof extends to the rear and east of the building. Resource 0334 is connected to Resource 0334.02 via this rear extension.

A. Northwest Oblique

B. Rear L, View North

C. Courtyard Detail, View West

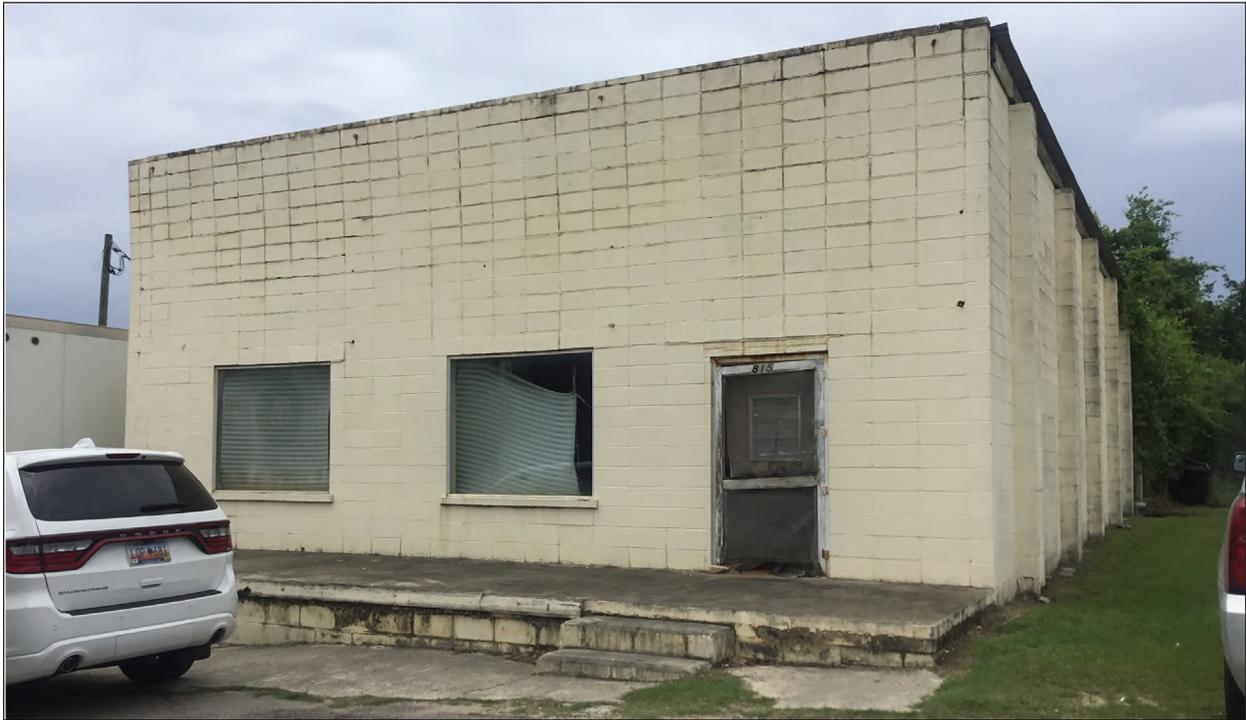
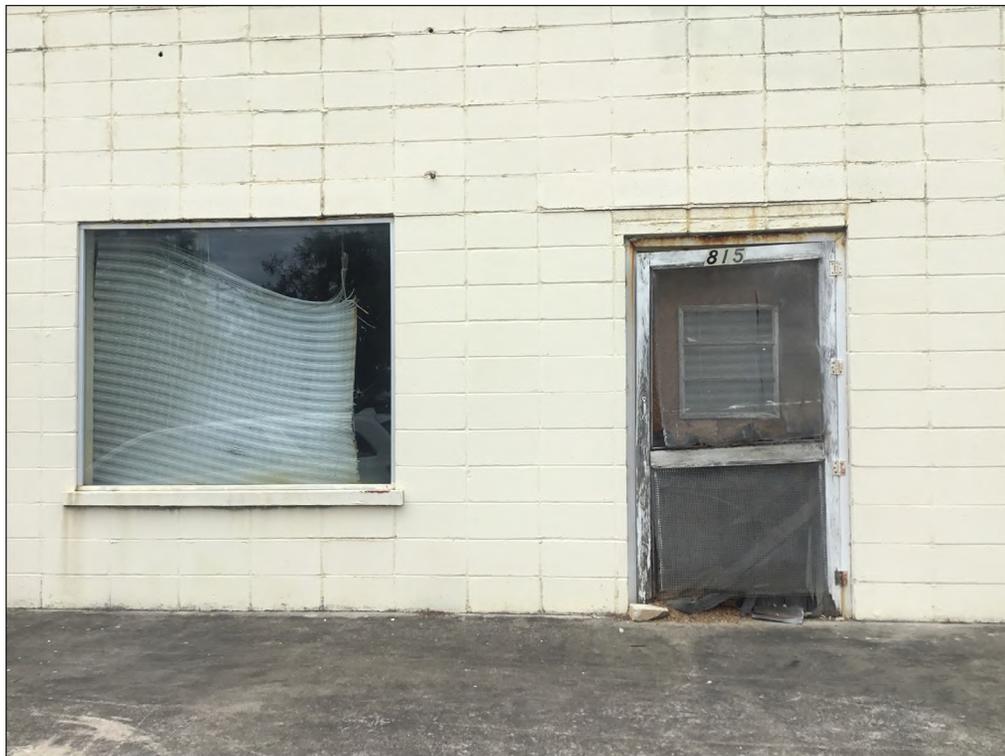
Figure 8.
Orangeburg Pecan Company – Concrete Block Building (Resource 0334.01)

Resource 0334.01 is located near the eastern end of the block and is the only freestanding building in the complex (Figure 8). Resource 0334.01 is plain single block commercial building. It is rectangular, one oversized story tall, and is composed of stack bond concrete blocks. It has a flat corrugated metal roof and simple attached buttresses on the east and west side elevations. It is accessed via a raised concrete block platform on the south elevation. The front door is historic wood with a three-pane wood frame window. To the west of the door lie two fixed aluminum frame picture windows. A loading dock is located on the west elevation with a concrete block ramp and a flat-roofed porch with round metal supports. The resource is surrounded by paved parking areas on the south, east, and west sides. This resource is used primarily for storage.

A. Southeast Oblique

B. South Elevation Detail

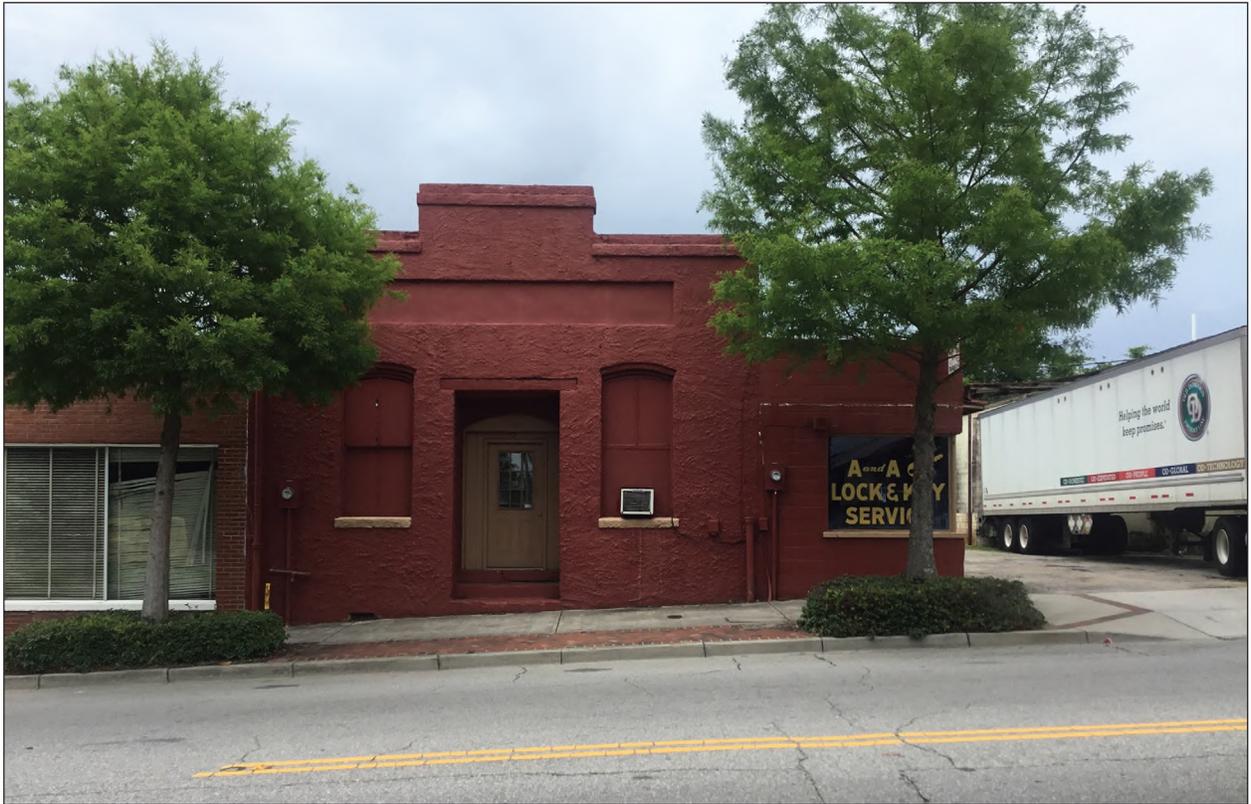
Figure 9.
Orangeburg Pecan Company – Stucco Storefront Building (Resource 0334.02), South Elevation

Resource 0334.02 is a single block commercial building located at 791 Russell Street (Figure 9). This circa 1945 building is rectangular in plan and is clad in rusticated stucco. It has a front-gabled corrugated metal roof that is concealed by a simple stepped parapet. There is an inset portion on the parapet for painted signage but it is currently not in use. The front elevation is symmetrical with a deeply inset front door. The door is a replacement and has an arched wood surround which appears to have once contained sidelights and a transom. Two arched windows flank the inset doorway. The windows are arched with vertical two-over-one double-hung sashes and stone sills. The glass panes of the windows have been painted over. This resource appears to be vacant or used for storage. It is attached to Resource 0035 on the east side and Resource 0034.03 on the west side.

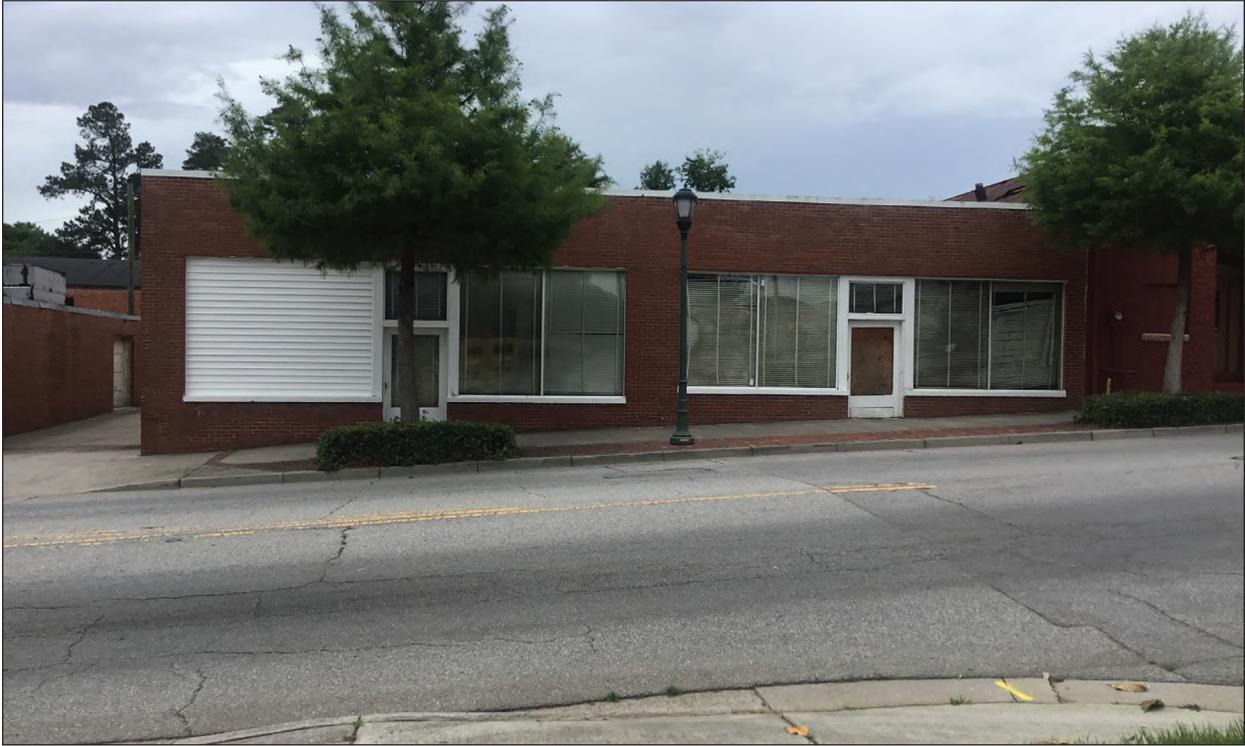
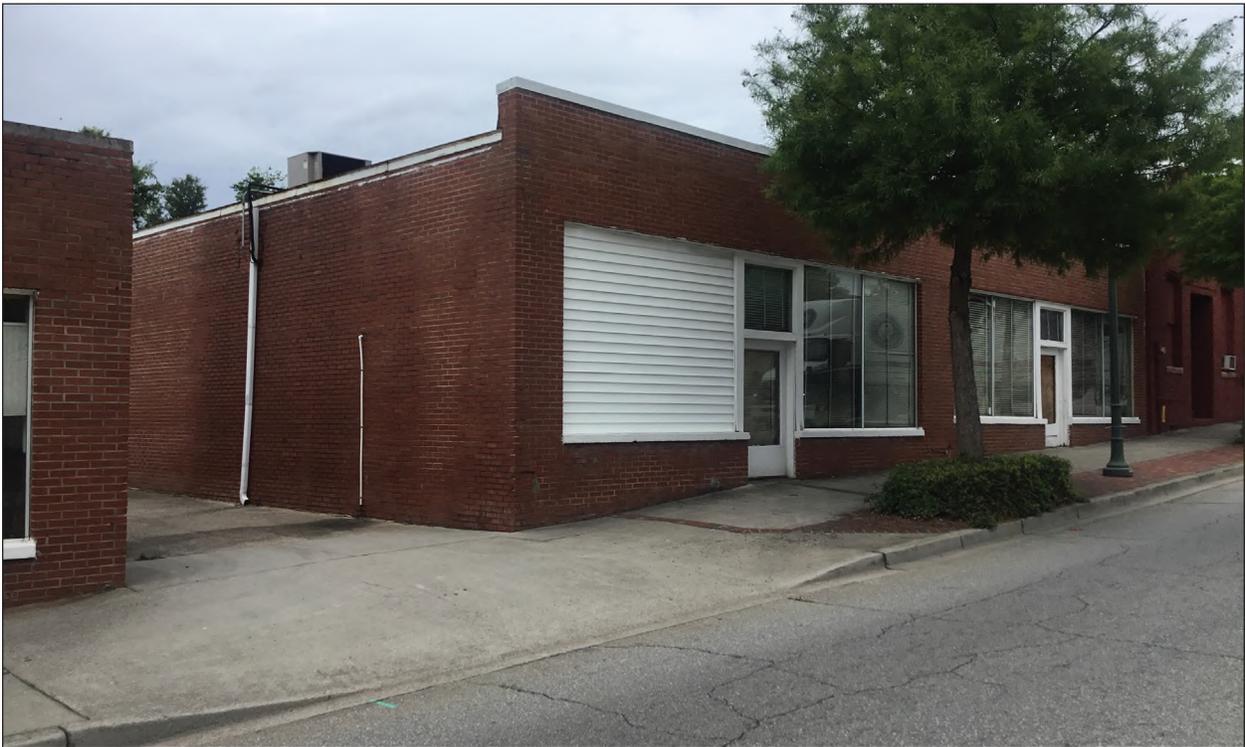
Figure 10.
Orangeburg Pecan Company – Double Storefront Building (Resource 0334.03)

Resource 0334.03 is a plain double block commercial building located at 781 Russell Street (Figure 10). This circa 1960 building is rectangular in plan and is one story tall. It is clad in brick veneer and has a flat asphalt roll roof that is concealed behind a low flat parapet with aluminum coping at the roofline. Both storefronts have full-light wood and glass doors with simple transoms flanked by fixed two-pane picture windows. The far west window has been replaced with synthetic siding. A wood panel loading door is located on the west elevation within a courtyard at the rear of the building. The foundation is concealed. This resource appears to be vacant or used for storage. Resource 0334.03 is connected to Resource 0334 at the rear of the building and 0334.02 on its east elevation.

A. South Elevation

B. Southwest Oblique

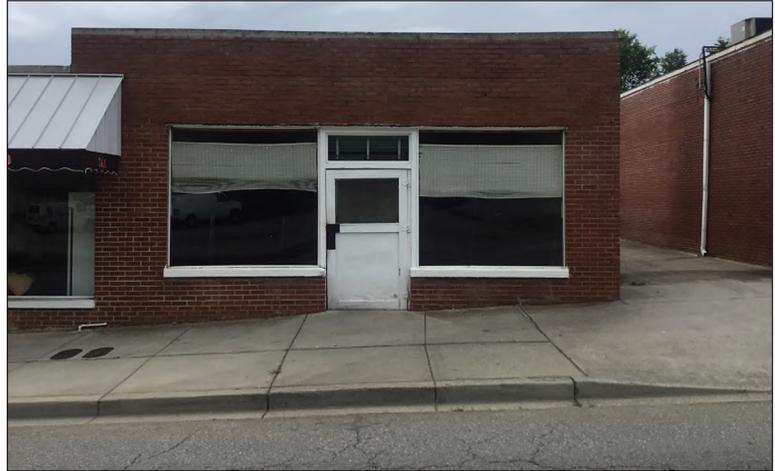
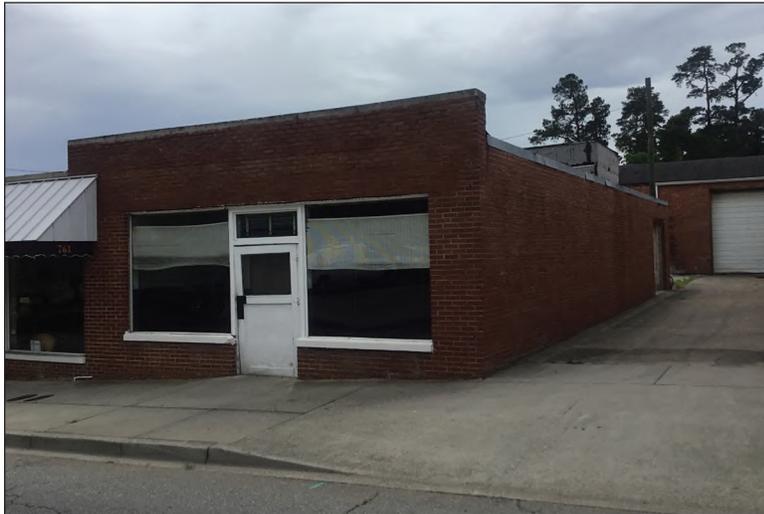
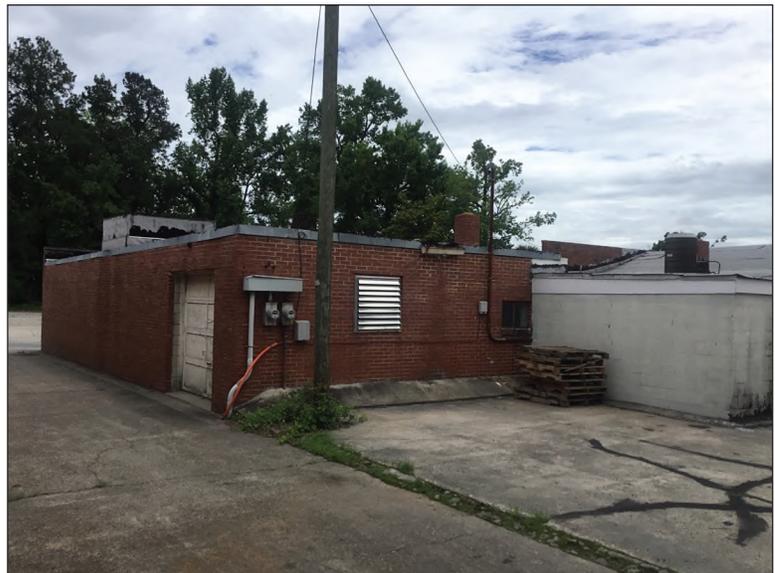
Figure 11.
Orangeburg Pecan Company – Single Storefront Building (Resource 0334.04)

Resource 0334.04 is a plain single block commercial building located at 771 Russell Street (Figure 11). This circa 1960 building is rectangular in plan and one story tall. It is clad in brick veneer and has a flat built-up roof concealed behind a flat parapet with a concrete cap. Fenestration on the symmetrical front elevation is similar to that of Resource 0334.03 and consists of a wide central wood and glass door with a simple transom flanked by large fixed picture windows. A wood panel garage door is located on the east elevation and faces into a rear courtyard. The foundation is concealed. This resource appears to be used for storage. Resource 0334.04 is attached to Resource 0334.05 on its east elevation.

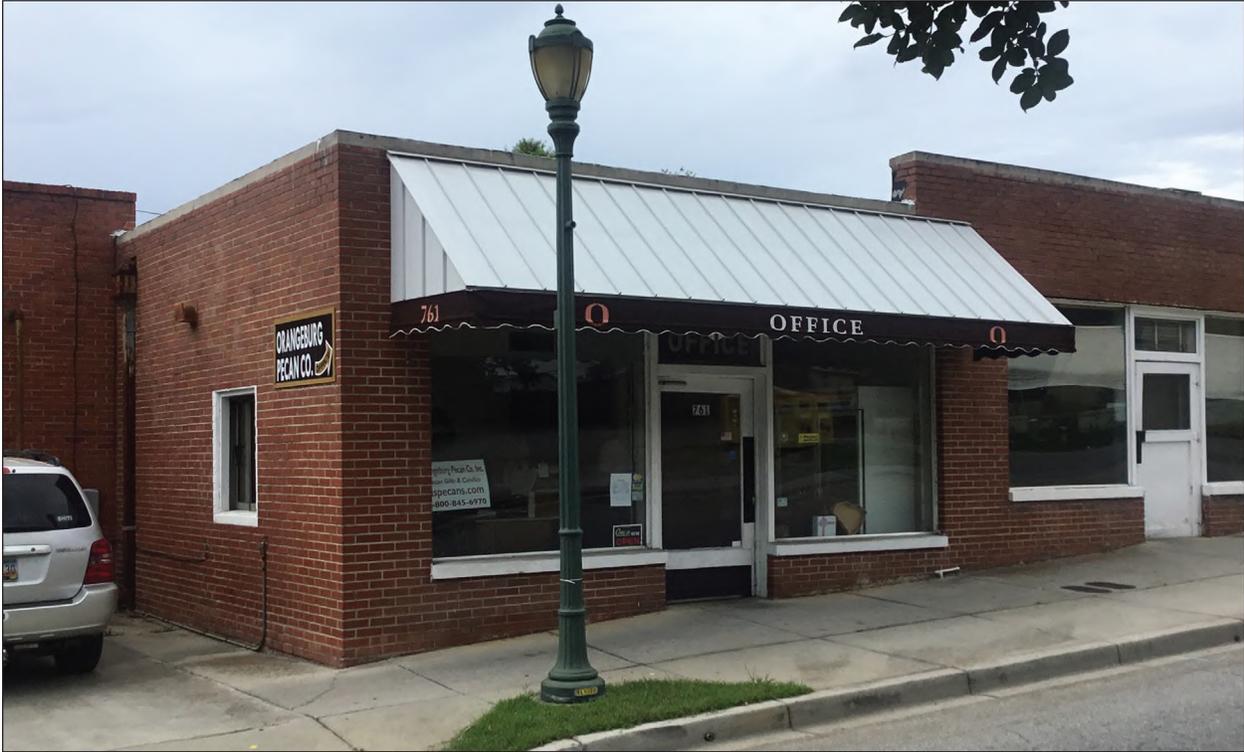
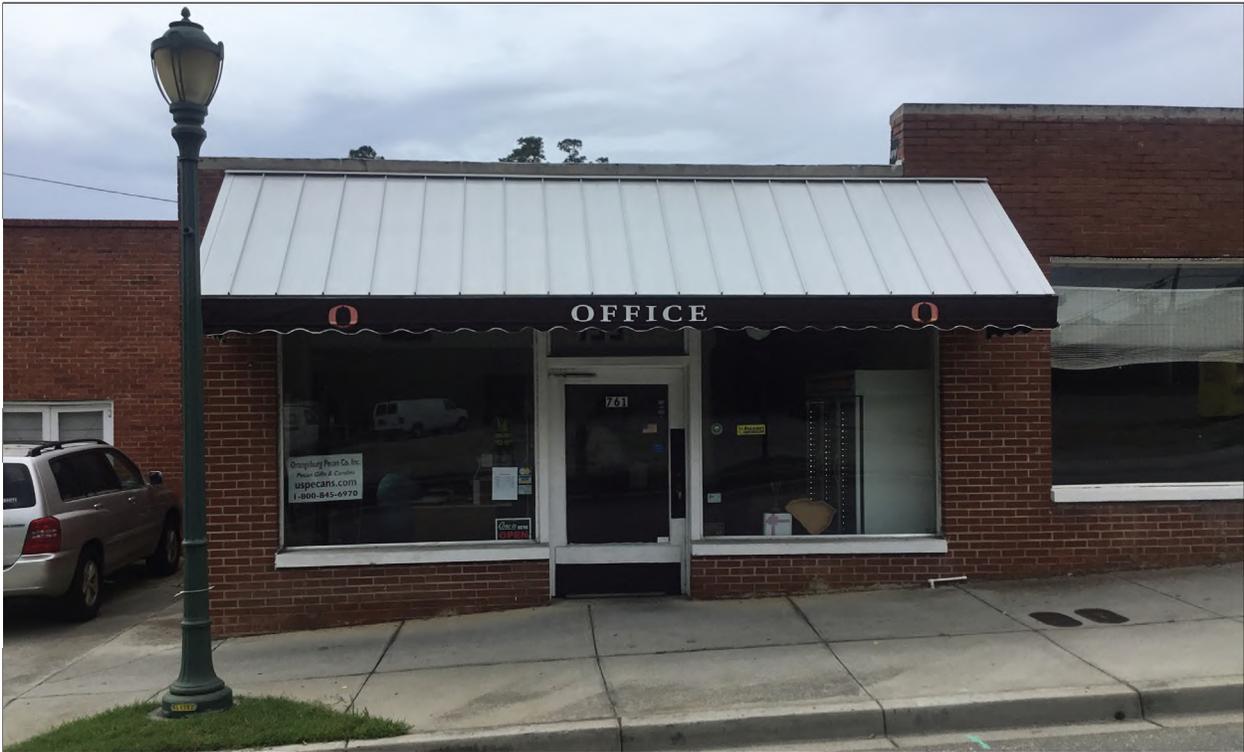
Figure 12.
Orangeburg Pecan Company – Office Building (Resource 0334.05)

Resource 0334.05 is a plain single block commercial building located at 761 Russell Street (Figure 12). This circa 1950 building is rectangular in plan and one story tall. It houses the sales office for the Orangeburg Pecan Company. It is clad in brick veneer and has a flat built-up roof concealed behind a flat parapet with a concrete cap. Fenestration on the symmetrical front elevation is similar to that of Resource 0034.04 and consists of a wide central wood and glass door with a simple transom flanked by large fixed picture windows. Resource 0334.05 is attached to Resource 0334 on its west side via a hyphen but has a smaller setback on Russell Street. There is a fixed wood frame window on the exposed portion of the west elevation. The foundation is concealed. Resource 0334.05 is attached to 0334 on the west and 0334.04 on the east.

A. Southwest Oblique

B. South Elevation

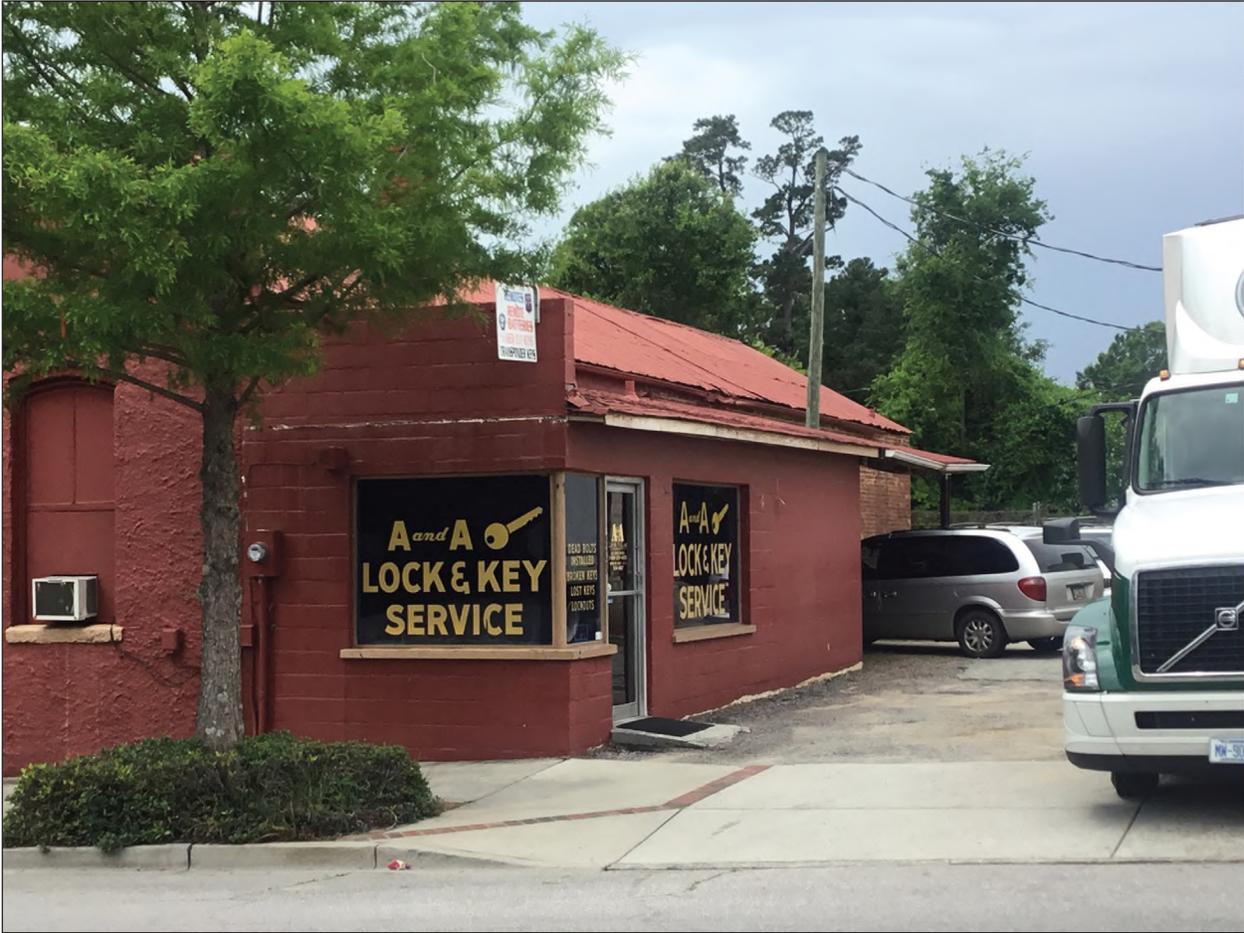
Figure 14.
A and A Lock and Key Service – 809 Russell Street (Resource 0335), Southeast Oblique

Resource 0335 is a small commercial building of no distinct style or type located at 809 Russell Street (Figure 14). According to Orangeburg County records, it was constructed in 1950. This one-story, concrete block building has a composition shingle shed roof and faces south towards Russell Street. The building is accessed via a metal and glass door on the east side elevation. A fixed picture corner window with heavy metal framing is located on the southeast corner of the building and an additional picture window is located on the east elevation. A flat parapet with simple brick trim conceals the roof from the front elevation of the building. Resource 0335 abuts Resource 0334.02 on the west side. The foundation is not visible.

Resource 0335 is located on Russell Street in the midst of a complex of buildings owned by the Orangeburg Pecan Company. The block is urban with sidewalks and relatively dense historic development, although most of the storefronts are used for storage rather than being open to the public. Resource 0335 is surrounded by pavement. Resource 0335 was not found to embody the distinctive characteristics of a type, period, or method of construction, and does not represent the work of a master or possess high artistic value. It is not known to be associated with events or persons significant in the past. Therefore, the resource is recommended as not individually eligible for the NRHP under Criterion A, B, or C.

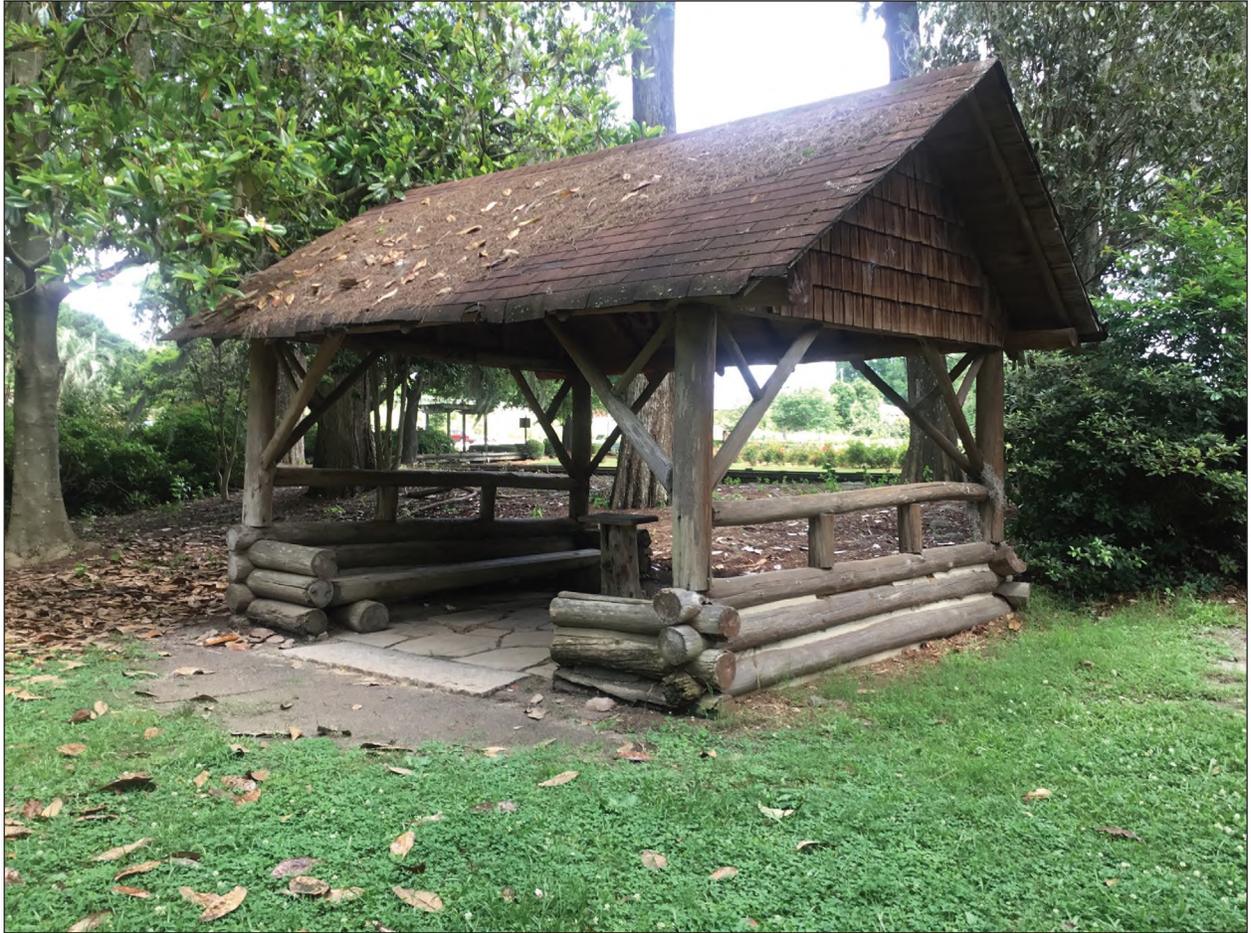
Figure 19.
Edisto Memorial Gardens – Picnic Shelter (Resource 0336.04), Northwest Oblique

Resource 0336.04 is a circa 1950 picnic shelter that is located on the pathway shown in Figure 18. The building is one story tall and rectangular in plan with a composition shingle gabled roof. It is constructed of logs and is open on all four sides. It has simple, rustic log brackets and wood shingles in the gable ends. The floor is paved with flagstones. A historic image of the picnic shelter can be seen in Figure 18 and Figure 19 shows the resource today.

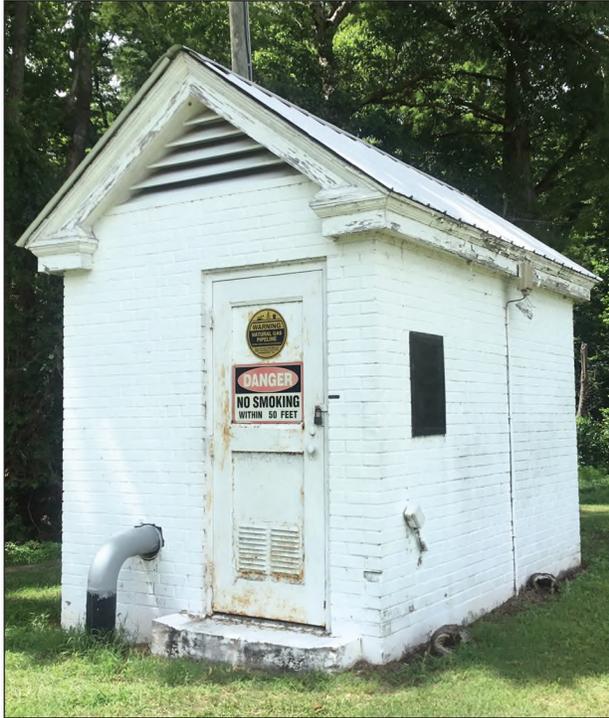
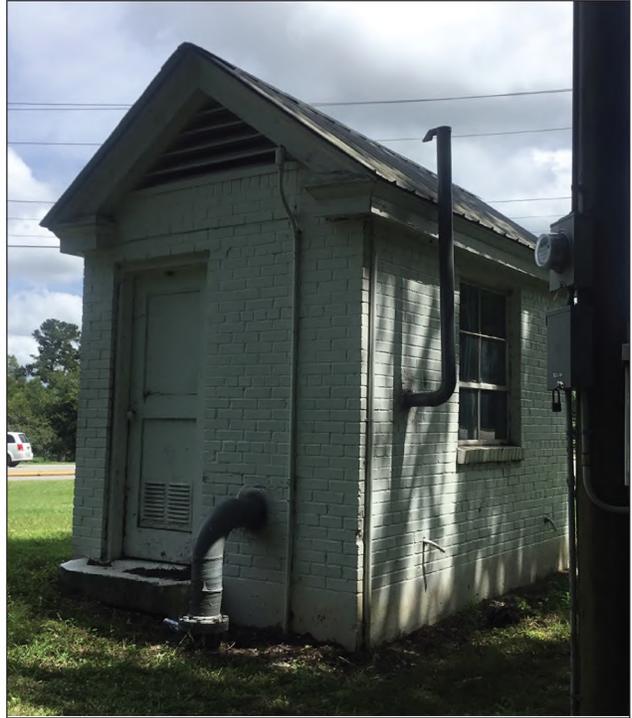
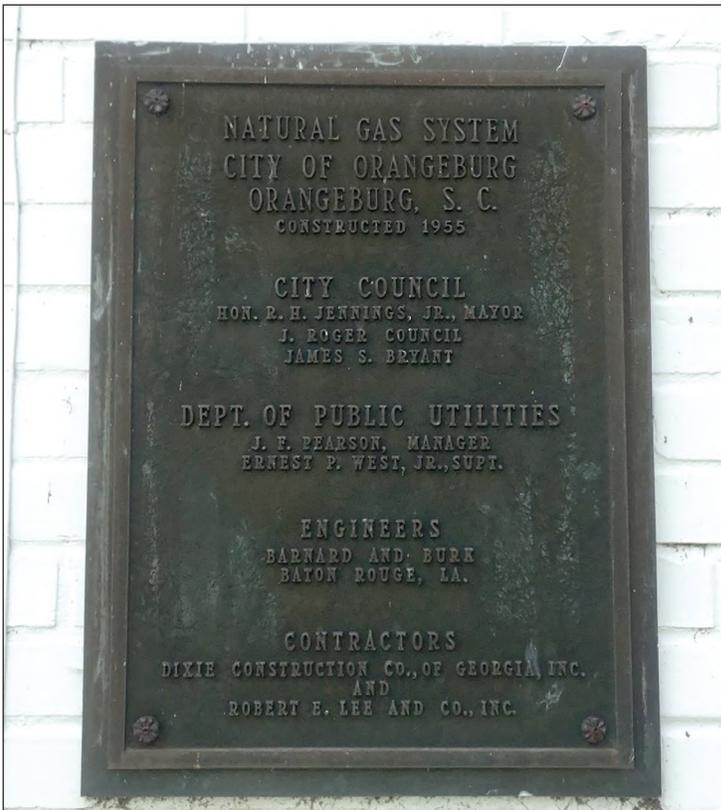
Figure 21.
Edisto Memorial Gardens – Natural Gas Building (Resource 0336.05)

Resource 0336.05 is a small utility building located approximately 300 feet southwest of the artificial lake. It is sited in a small grass clearing and is placed unobtrusively to avoid foot traffic within the park. It was constructed in 1955 and houses the natural gas system for the City of Edisto. It is rectangular in plan and one story tall with a front gabled V-crimp metal roof (Figure 21). It is composed of five-to-one common bond brick and has a fairly heavy wood cornice at the roofline that returns. It is accessed on the north and south elevations via slightly inset metal personnel doors. There are louvered metal windows in the gable ends. A steel frame four-over-two double-hung sash window is located on the west elevation. The foundation is slightly raised and is a continuous poured in place concrete slab.

A. Southeast Oblique

B. Northwest Oblique

C. Plaque Detail

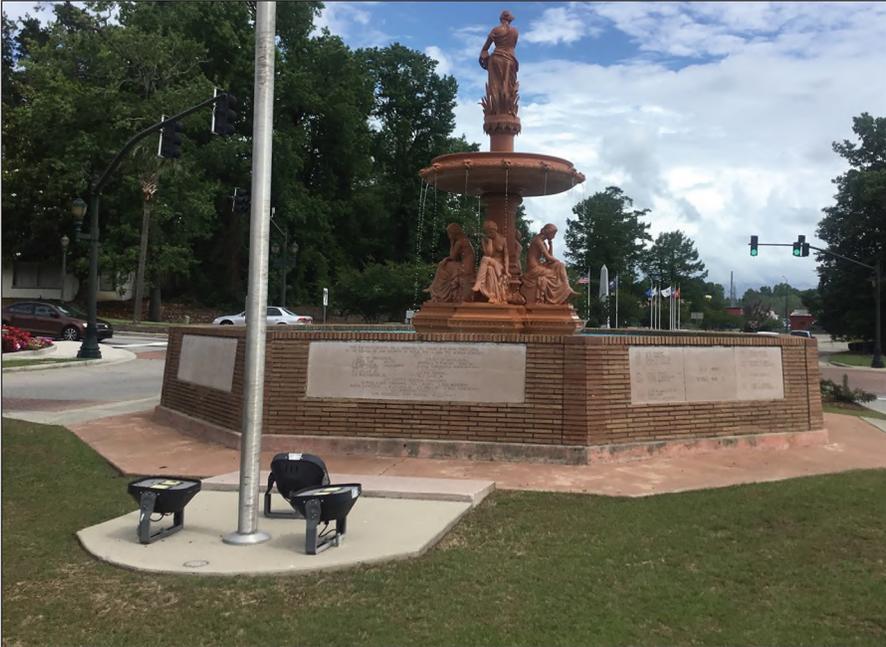
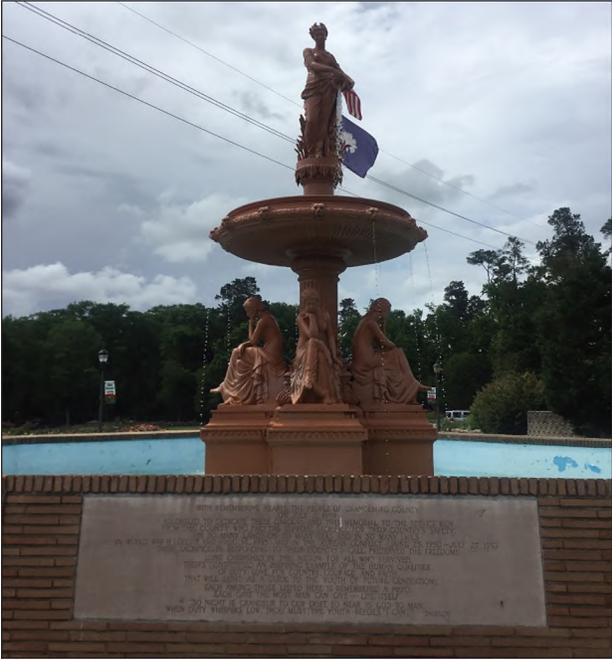
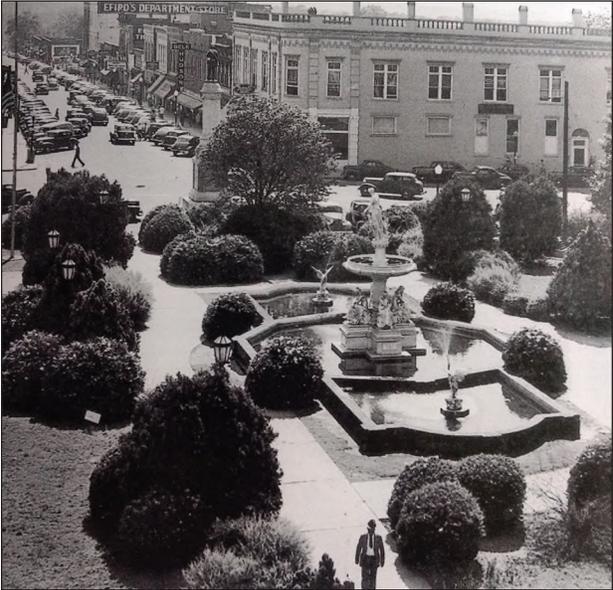
Figure 23.
Edisto Memorial Gardens – Lady Fountain (Resource 0336.01)

Resource 0336.01 is a circa 1928 fountain located at the northeast corner of Russell Street and Riverside Drive SW. The two directions of traffic on Riverside Drive SW split as they approach the intersection and the fountain is located in this grassy median. The fountain is directly adjacent to the southeastern corner of the rose garden. The central portion of the fountain is painted bronze and is Classically-inspired with four female figures (Figure 23). The central figure is raised on a pediment and is wearing a laurel leaf crown. Three kneeling figures encircle the round central pediment. All figures are clad in togas. This portion of the fountain dates to circa 1928 and was purchased in New York by City Councilman John Sifly to be placed in front of the new City Hall. Originally the fountain was surrounded by swan statues and two goldfish pools (see Figure 23C). The fountain was dismantled and placed in storage in circa 1948 but was resurrected in circa 1951 for use in the entrance to Edisto Memorial Gardens, this time as a memorial for local soldiers lost during the Second World and Korean Wars (Brown 2014). The fountain was reconstructed with a new hexagonal base of concrete and Roman brick veneer. Stone plaques are located on each side of the hexagonal base. The fountain was refurbished in 1992, although further research is necessary to determine what the refurbishment entailed.

A. View South

B. Detail

C. Original Location, Circa 1940
Courtesy: Louis Boone

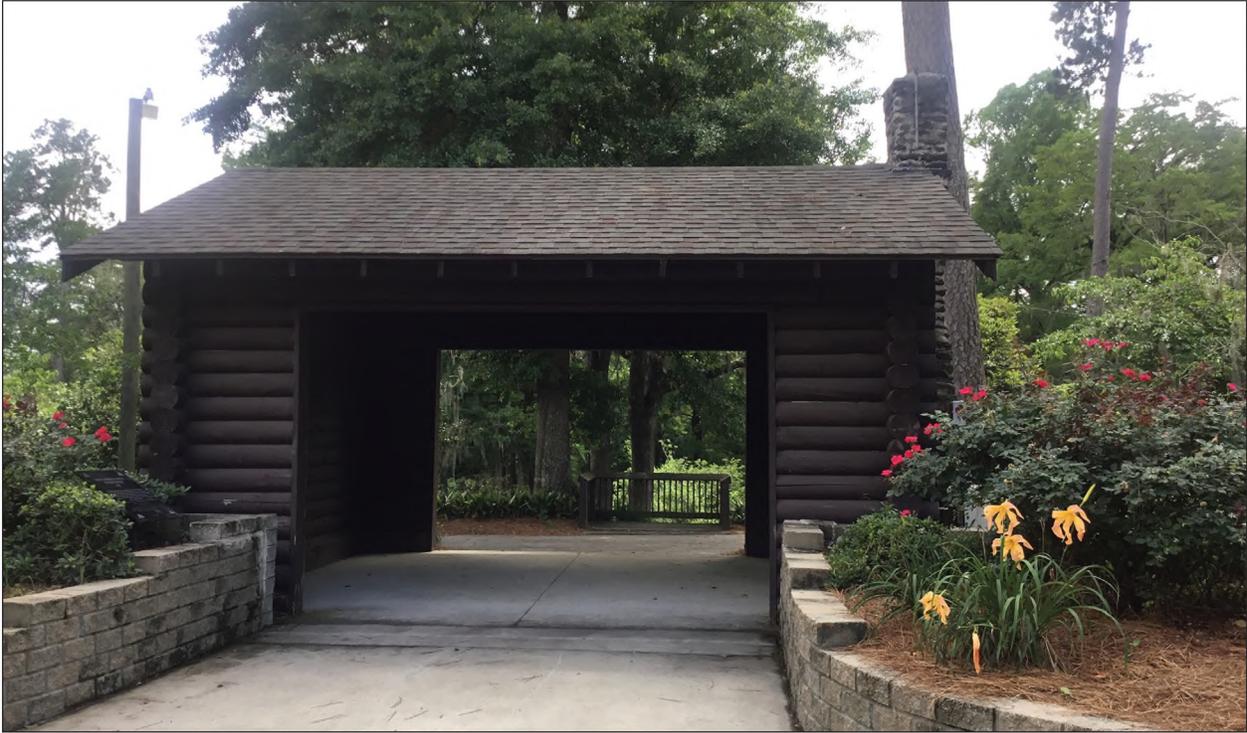
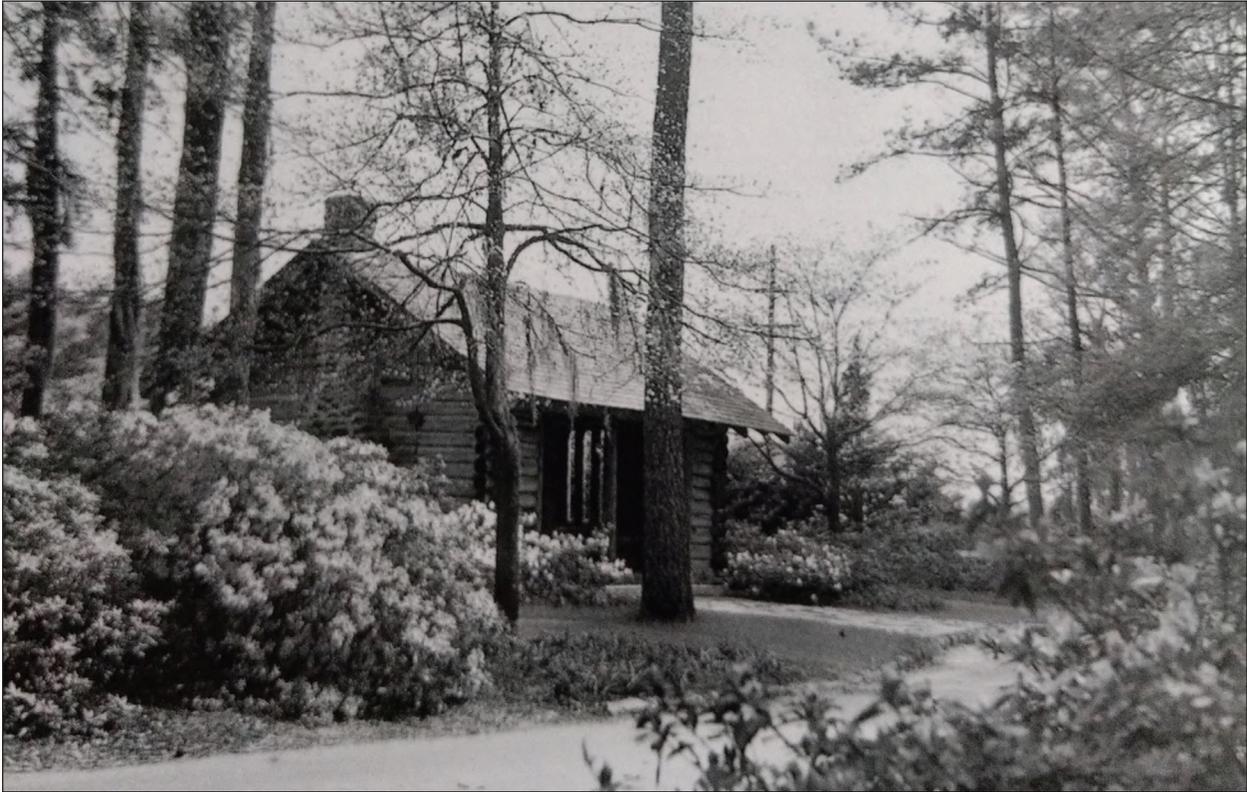
Figure 24.
Edisto Memorial Gardens – Park Office (Resource 0336)

Figure 24 depicts the circa 2011 park office. This building is located up a hill on the east side of Riverside Drive SW, approximately 350 feet northeast of the rose garden and directly across the street from the azaleas. The building is a partial reconstruction of a 1939 building that was destroyed in a fire in 2010. The original building was a rectangular one-story log cabin with a laterally gabled composition shingle roof and an open breezeway on the east and west side elevations (see Figure 24B). It had an exterior stone chimney on the north elevation and a series of vertical slats on the south. It was constructed with cypress wood harvested from the gardens and had exposed rafter tails. The modern reconstruction resembles the original building. The chimney on the modern building is decorative and does not pierce the roofline as it did on the historic building. The slats on the south elevation are missing and the building itself is constructed of commercial lumber. It is sited on a poured concrete slab.

A. View East

B. View Northwest Circa 1952

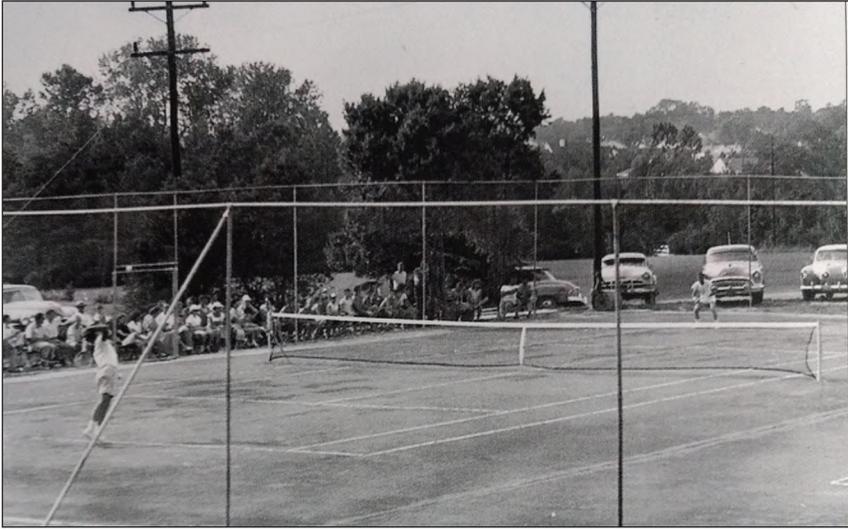
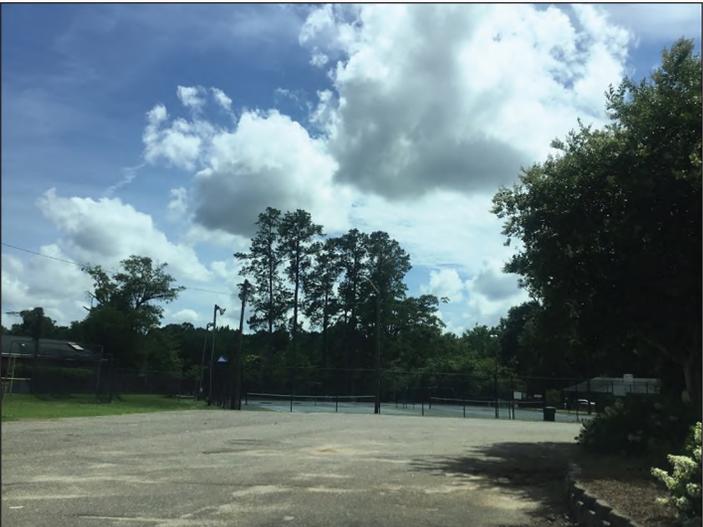
Figure 26.
Edisto Memorial Gardens – Albergotti Playground (Resource 0336.02)

Resource 0336.02 is the Albergotti Playground, which was originally constructed in 1922. The Albergotti Playground was the first playground in Orangeburg and was originally located where the rose garden currently is. The playground was moved to its current location approximately 0.3 mile to the northwest of the rose garden in 1950 (Atkinson 2001). It forms the northern leg of the horseshoe. While the 1950-era playground equipment no longer exists, the 1950 location of the playground remains. Additionally, tennis courts were installed as a component of the 1950 playground and remain today, although the fencing surrounding the court has been replaced. A plaque honoring the history of the playground was installed in 1965. The Albergotti Playground picnic shelter dates from 1950 and is discussed below as Resource 0336.03. The site is landscaped with mature pines, palms, and live oaks which likely are historic and date from the period of significance. Figure 26 shows a circa 1953 and modern image of Resource 0336.02.

A. Tennis Courts Circa 1953
Courtesy: City of Orangeburg

B. View East

C. View South with Plaque
