**ARCHAEOLOGICAL FIELD REPORT
SCDOT ENVIRONMENTAL SECTION**

TITLE: Cultural Resources Survey of the U.S. 301 Bridge over the North Edisto River

PROJECT: U.S. 301 Bridge over the North Edisto River

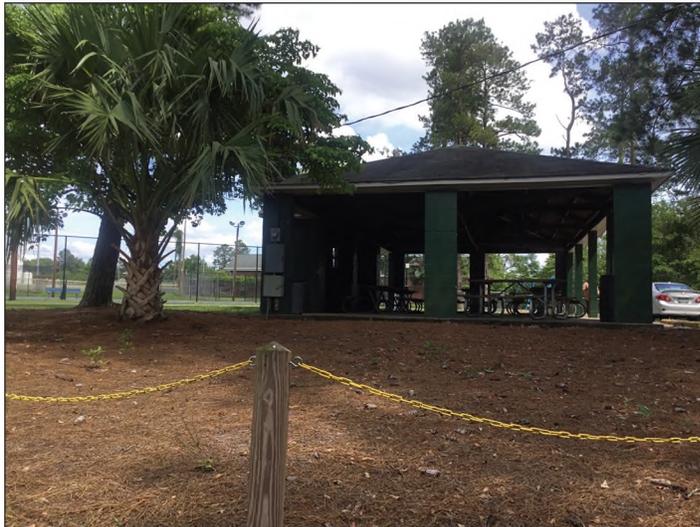
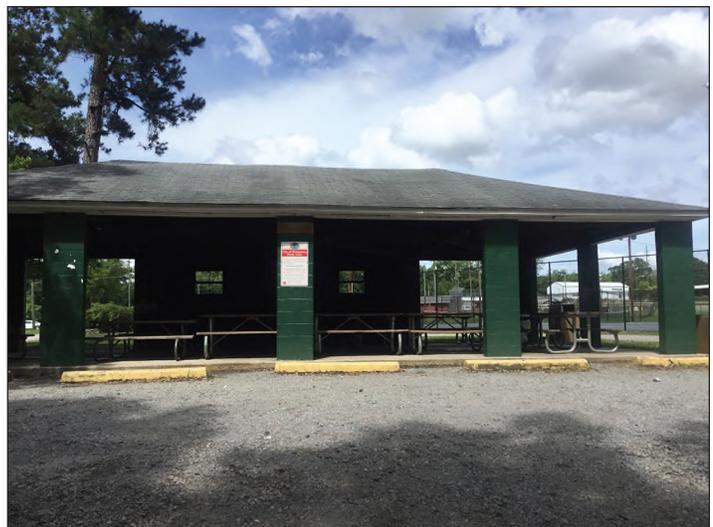
Figure 27.
Edisto Memorial Gardens – Albergotti Playground Picnic Shelter (Resource 0336.03)

Resource 0336.03 is a concrete block picnic shelter located within the Albergotti Playground. It is one story tall and rectangular in plan with a hipped composition shingle roof. It is open on the north, west, and south elevations with heavy concrete block supports. The east elevation is partially enclosed with two vertical two-over-two double-hung metal sash windows and two open doorways. Figure 27 shows a circa 1953 and modern image of Resource 0336.03.

B. South Elevation

C. West Elevation

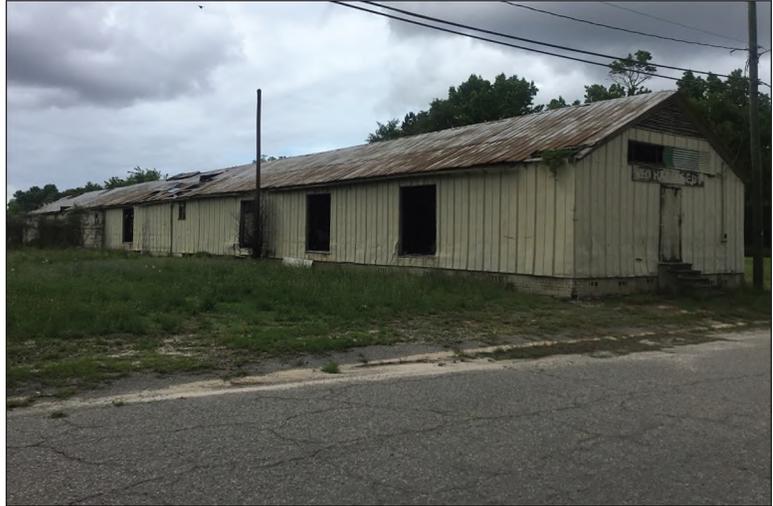
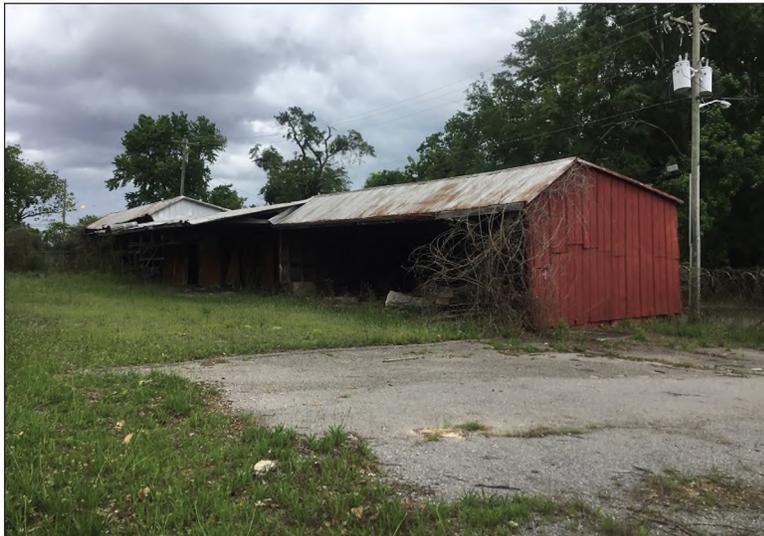
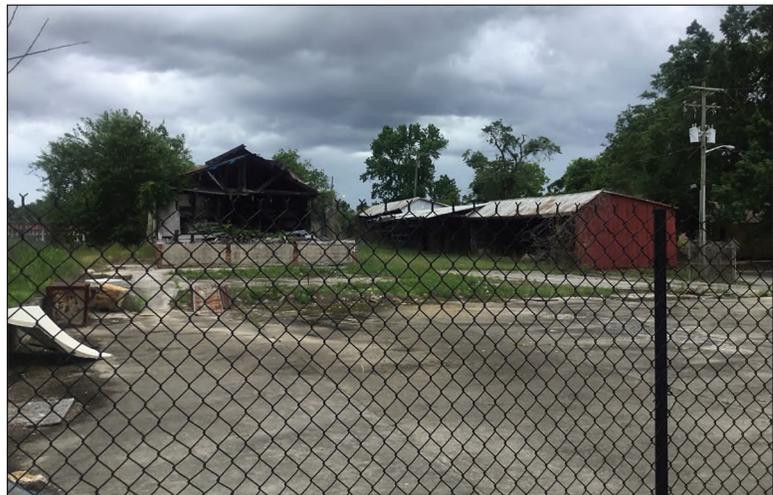
Figure 32.
812 Russell Street (Resource 0341 and 0341.01)

Resource 0341 is a circa 1960 vacant warehouse located at 812 Russell Street. It used to house Red Hat Feeds and signage for the company still remains. The resource is rectangular in plan and is one story tall with a front gabled V-crimp metal roof (Figure 32). It is clad in V-crimp metal siding. The foundation is a combination of concrete block piers, continuous brick, and continuous concrete block. The south end of the building is largely intact, with a metal door and louvered metal windows in the gable end. The long east and west side elevations contain fenestration for doors and windows which are missing. The north end of the building has sustained fire damage and is open to the elements. It appears that the roofline extended to create a front-gabled porch at this end of the building prior to the fire.

Resource 0341.01 is a circa 1960 vacant storage shed located at 812 Russell Street, approximately 30 feet southwest of Resource 0341. This building is one story tall, roughly rectangular in plan, and appears to have been constructed in three parts (see Figure 32). It has an asymmetrically pitched, laterally gabled V-crimp metal roof and is clad in sheet metal siding. The east elevation of all three portions is open to the air and the building is supported by a concrete block pier foundation. There is no fenestration with the exception of the open east elevation.

A. Resource 0341, Southwest Oblique

B. Resource 0341.01, Northeast Oblique

C. Contextual, View Southwest

Both resources are sited on a large lot which contains deteriorating paved parking areas and sparse grass lawn. It is encircled by a chain link fence. Resources 0341 and 0341.01 were not found to embody the distinctive characteristics of a type, period, or method of construction, and do not represent the work of a master or possess high artistic value. They are not known to be associated with events or persons significant in the past. Therefore, the resources are recommended as not collectively or individually eligible for the NRHP under Criterion A, B, or C.

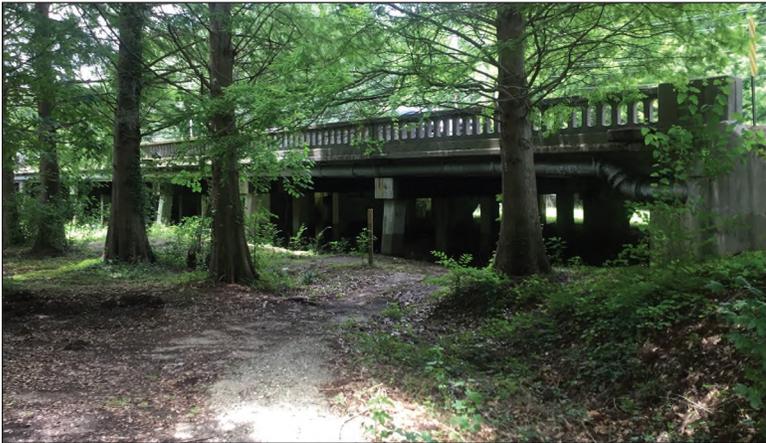
Figure 33.
U.S. 301 over North Edisto River Bridge (Resource 0342)

Resource 0342 is a nine-span T-beam bridge that carries U.S. 301 over the North Edisto River (Figure 33). The bridge was constructed in 1922 and is 293 feet long. The superstructure includes haunched beams and a state-standard concrete balustrade. The substructure includes concrete bents with arched caps. The bridge was widened on one side in 1954 when U.S. 301 was widened as it passes through Orangeburg. The new portion constructed in 1954 was designed to match the older section (Lichtenstein Consulting Services 2005).

A. View Northwest

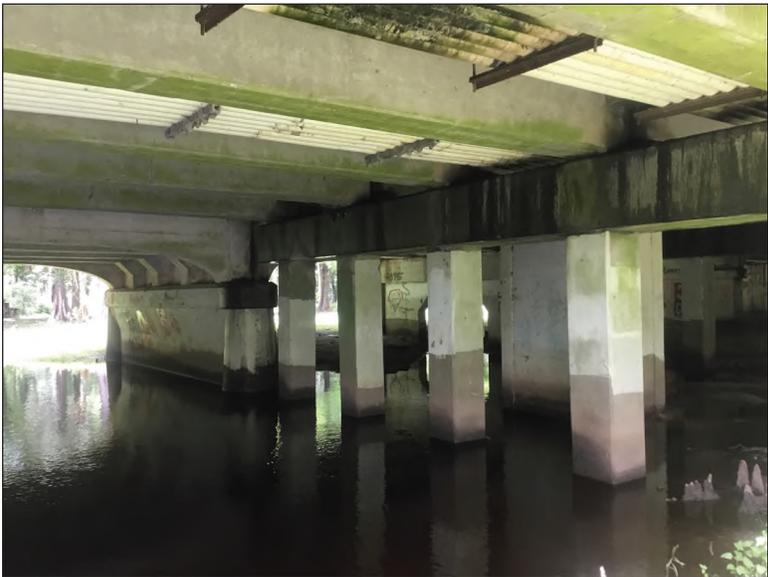
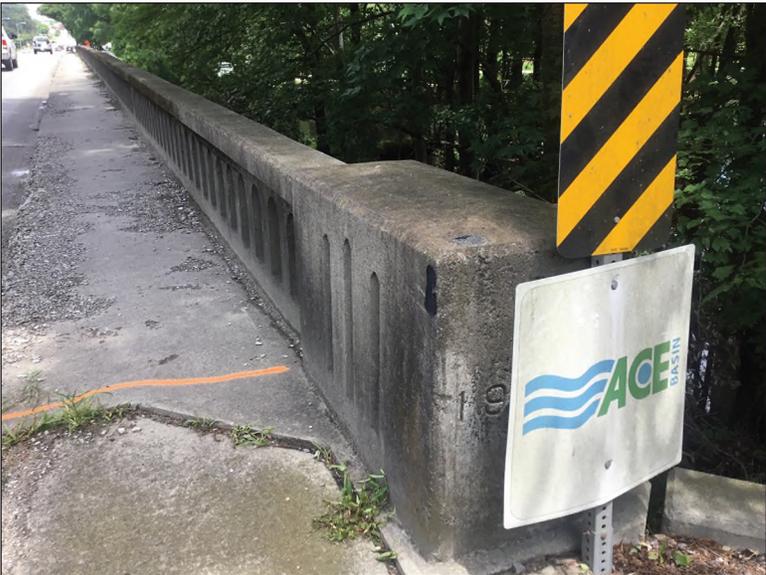
Resource 0342 was evaluated during the 2005 Lichtenstein Consulting Services *South Carolina State Bridge Survey* and was recommended as not eligible for the NRHP. This report concurs with that assessment. The bridge is of a common type constructed throughout the state. It is one of hundreds of similar bridges in South Carolina and its integrity has been negatively impacted by major alterations. It is not architecturally or technologically significant and is not recommended as eligible under Criterion C. It is not known to be associated with events or persons significant in the past. Therefore, the resource is recommended as not individually eligible for the NRHP under Criterion A or B.

B. Substructure Detail, Facing North

C. Balustrade Detail, Facing East

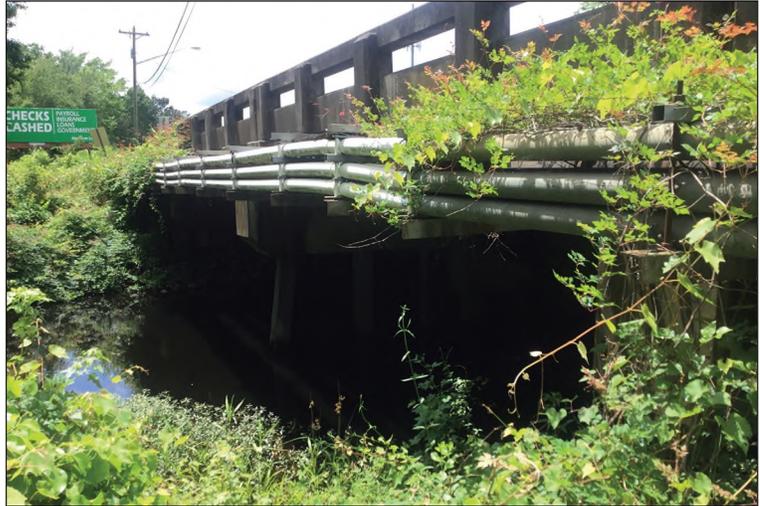
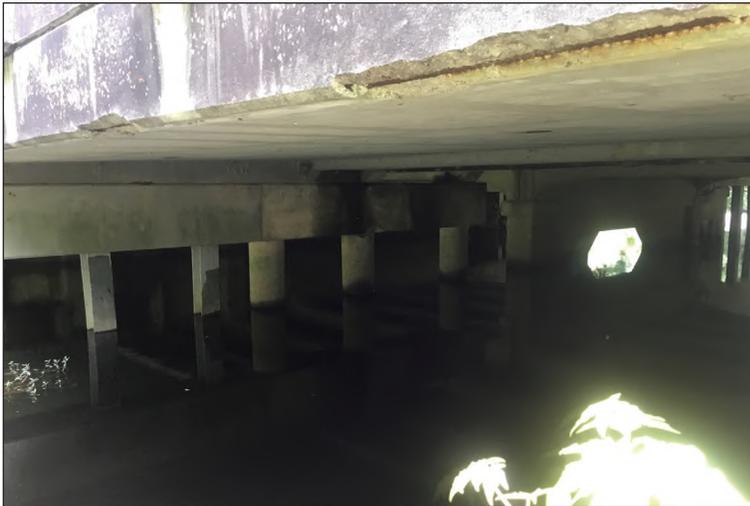
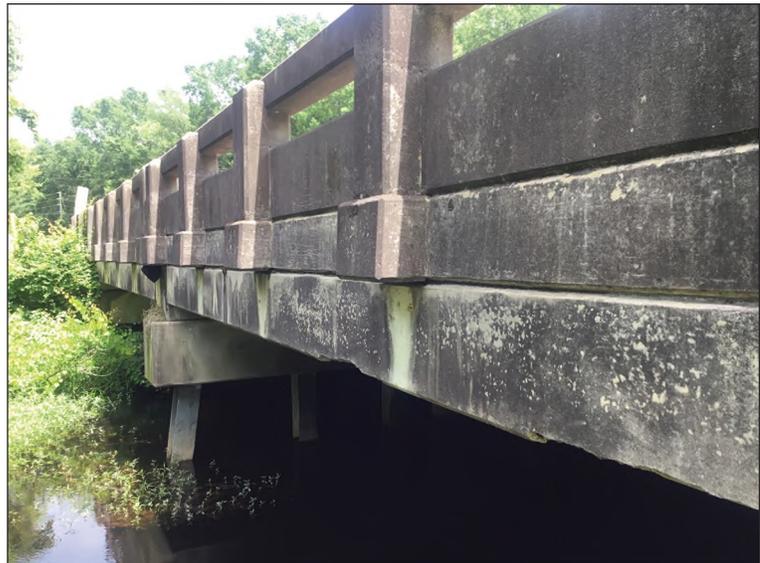
Figure 34.
U.S. 301 over North Edisto Swamp Bridge (Resource 0343)

Resource 0343 was evaluated during the 2005 Lichtenstein Consulting Services *South Carolina State Bridge Survey* and was recommended as not eligible for the NRHP. This report concurs with that assessment. The bridge is of a common type constructed throughout the state. It is one of hundreds of similar bridges in South Carolina and its integrity has been negatively impacted by major alterations which leave no historic fabric visible from the road. It is not architecturally or technologically significant and is not recommended as eligible under Criterion C. It is not known to be associated with events or persons significant in the past. Therefore, the resource is recommended as not individually eligible for the NRHP under Criterion A or B.

A. View Southeast

B. Substructure Detail, Facing South

C. Balustrade Detail, Facing East
