ARCHAEOLOGICAL FIELD REPORT  
SCDOT ENVIRONMENTAL SECTION

**TITLE:** Cultural Resources Survey for SC 72 (Saluda Road) and S-329 (McCandless Road) Intersection Improvement, Chester County, South Carolina (Second Addendum - Additional Research)

**PROJECT:** SC 72 and S-329 Intersection Improvement

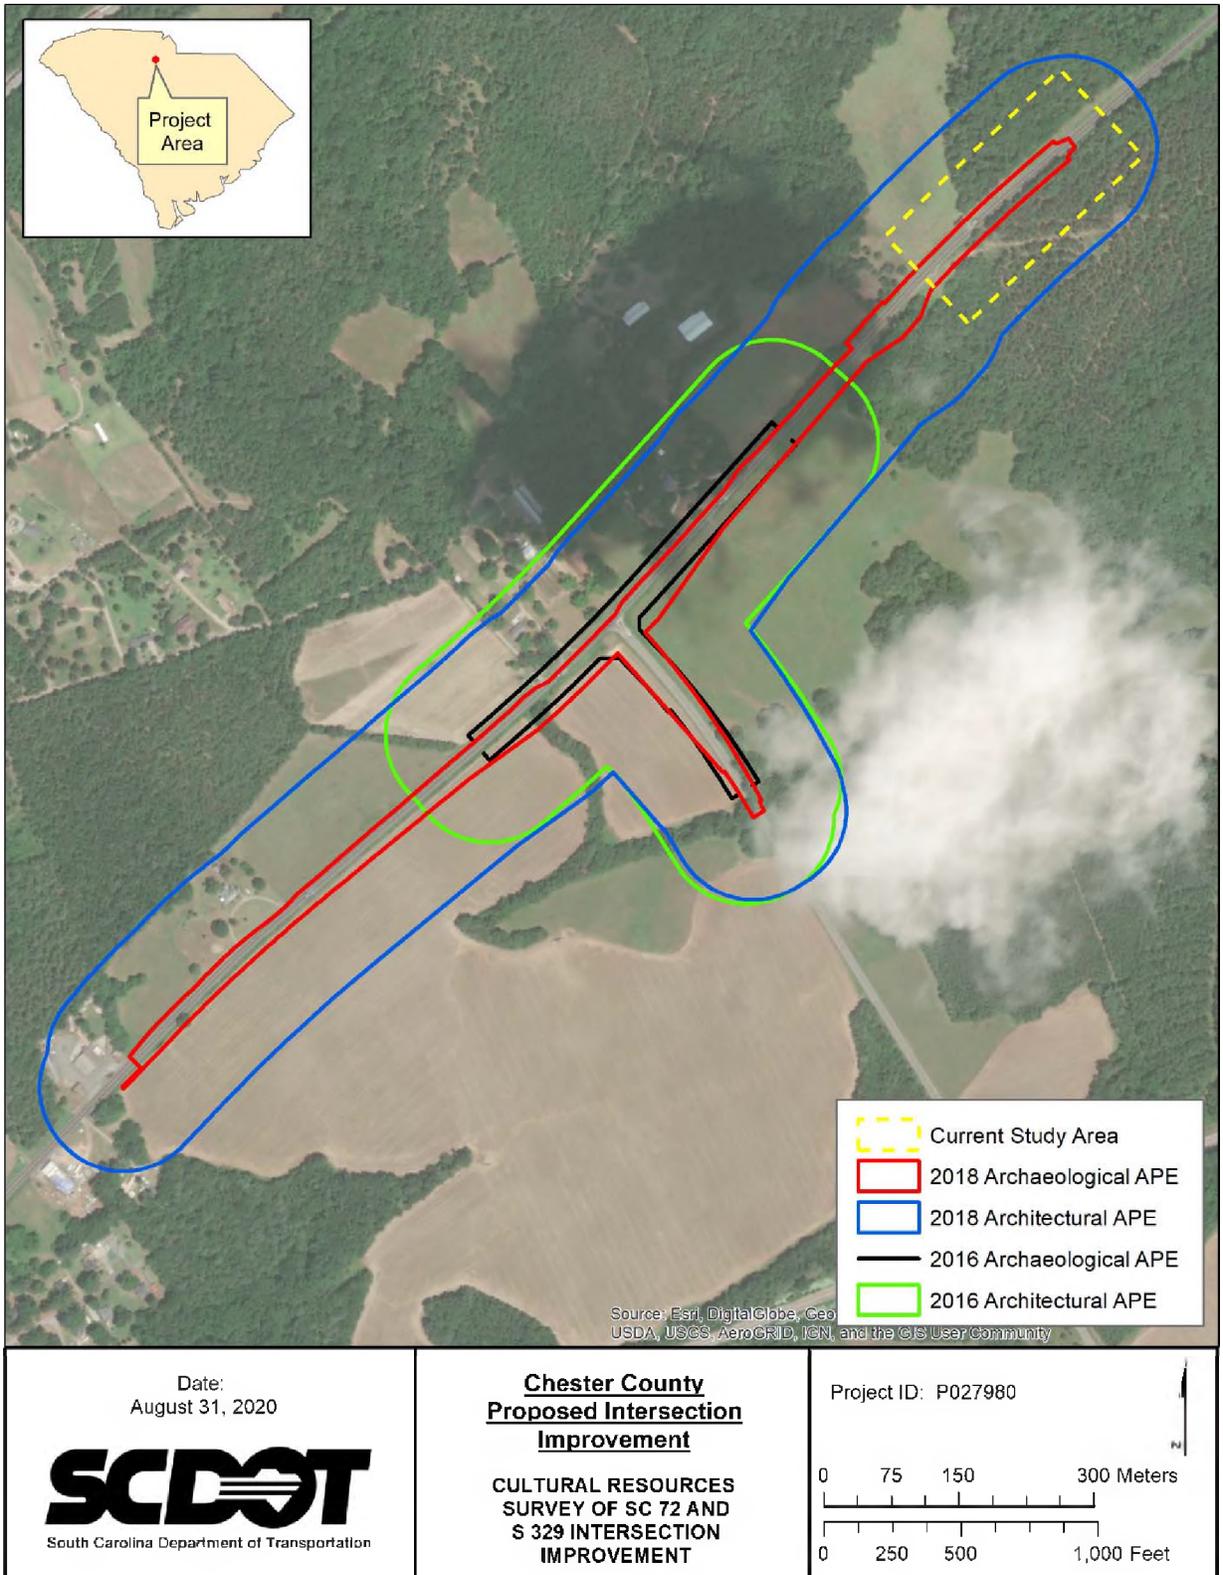
Figure 2. Intersection Improvement Plans for SC 72 and S-329.

**DESCRIPTION:** This report describes efforts by South Carolina Department of Transportation (SCDOT) archaeologists and consultants to locate and record an unmarked grave (Archaeological Site # 38CS420/Above-Ground Resource # 0303) and historic home site (38CS417) on the NW side of SC 72 (Saluda Rd.) NE of the town of Chester, in Chester County, SC (**Figure 1**). The possible presence of the grave and home site was reported to SCDOT right of way (ROW) agents by a landowner who owned land that was being acquired in order to make improvements to the intersection of SC 72 (Saluda Road) and S-329 (McCandless Road). The proposed improvements include adding a left turn lane to the northwest-bound lane of McCandless Rd at the SC 72 and S-329 intersection and a left turn lane to the southwest-bound lane of Saluda Rd at this intersection. Prior to the landowner notification SCDOT conducted two previous cultural resources investigations in conjunction with this project. An October 2016 survey covered areas that were initially projected to be impacted by the project, and resulted in the documentation of three above-ground resources, but no archaeological sites. Two of the above-ground resources, sites 0293 and 0294, were assessed as eligible for inclusion on the National Register of Historic Places (NRHP), but it was determined that these resources would not be adversely affected by the proposed undertaking (Jurgelski and Kelly 2016). Subsequent to the 2016 survey, SCDOT revised the plans for the project in response to landowner objections to the initial alignment. The revised alignment extended the project APE to the northeast and southwest of the initially proposed alignment. In June 2018, SCDOT archaeologists conducted a second cultural resources survey covering the portions of the new alignment that had not been examined in the initial survey. Two non-NRHP-eligible above-ground resources were recorded during this second survey, but no archaeological sites were documented (Martin and Jurgelski 2018). In September 2018, SCDOT right of way agents were told by a landowner, Ms. Margaret Hausman, that her Great-Great Uncle was buried in an unmarked grave on the NW side of SC 72 on land that would be impacted by the proposed project near the northeast end of the revised alignment. As a result, Ms. Hausman was reluctant to sell the land. Ms. Hausman's home and the surrounding landscape had been recorded as an NRHP-eligible above-ground resource (site # 0294), during the initial SCDOT cultural resources survey of the SC 72 and S-329 intersection project area, and the land on which the purported grave was located was part of the same legal land parcel. SCDOT archaeologists were informed of Ms. Hausman's account and asked to investigate. This report describes the results of that investigation, and comprises a second addendum to the 2016 survey report. Both the 2016 and 2018 survey reports are appended to this document. A report compiled by New South Associates describing the results of a December 2018 GPR survey and January 2019 backhoe testing at the unmarked grave location (Lowry et al. 2019) is also appended to this report. **Figure 2** shows the 2016 and 2018 survey areas, and the area that was the focus of the current investigation.

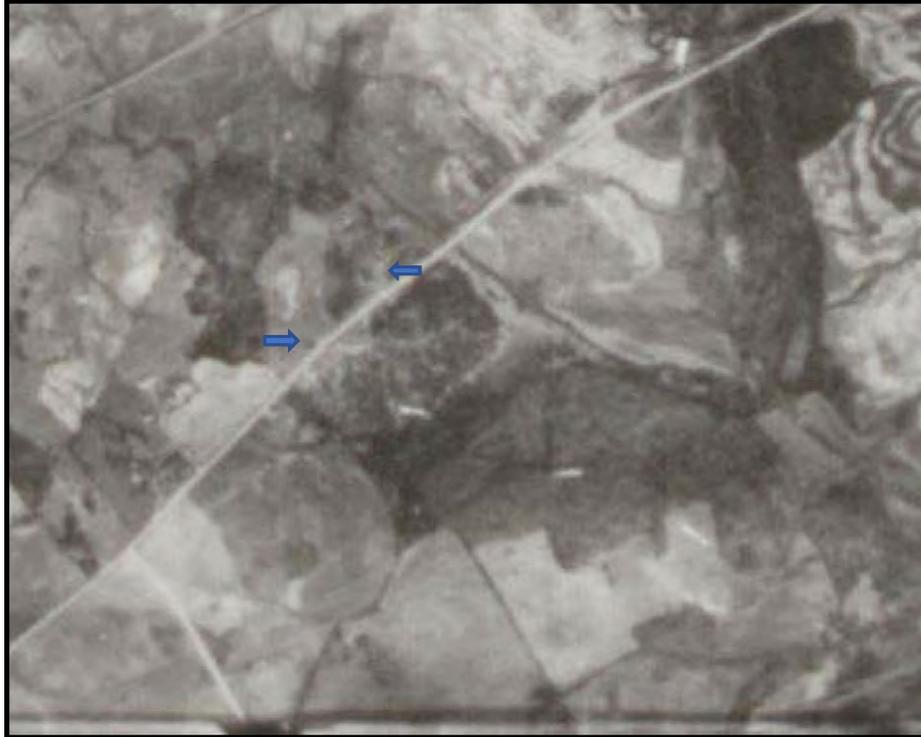
An examination of maps and aerial photographs of the project area did not yield definitive results. However, a 1941 aerial photograph showed an anomaly at the approximate grave location that may represent a tree or enclosure, and a second anomaly near the reported house location that that may represent a structure (**Figure 3**).

Figure 3. 1941 Aerial Photograph of Study Area. Arrows indicate anomalies that may represent the locations of the grave (lower arrow) and house site (upper arrow) documented during this investigation. Source: Courtesy of the University of South Carolina Map Library.

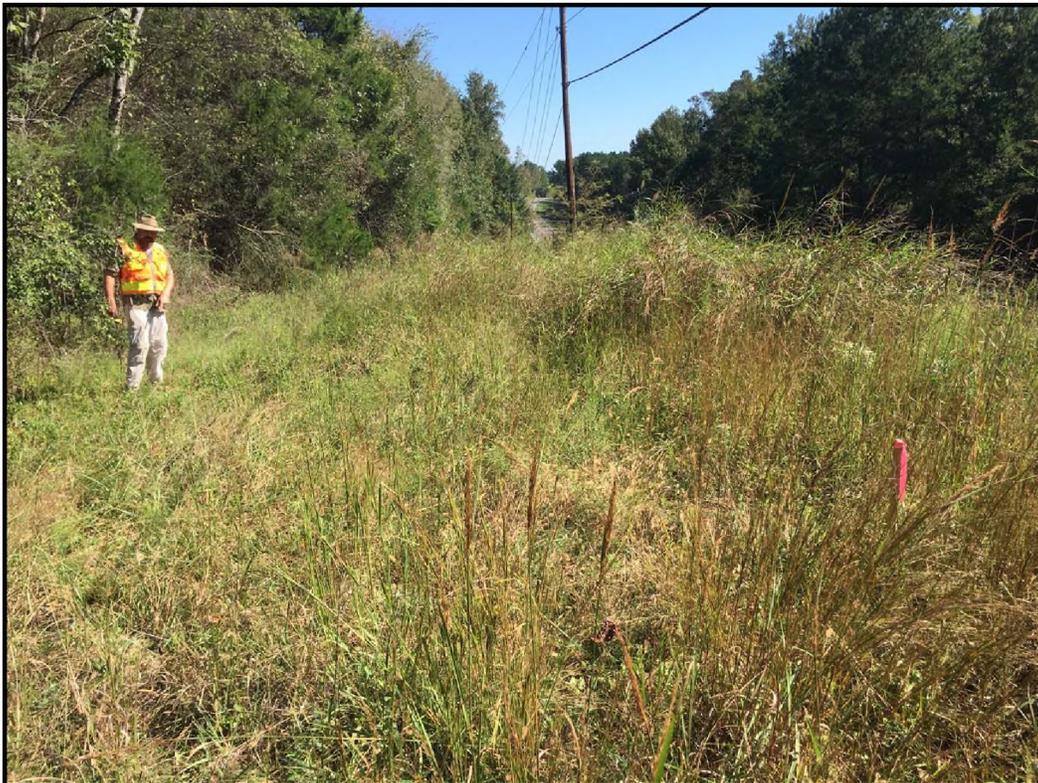
Figure 4. Site 38CS417 Probable House Location – View NE.

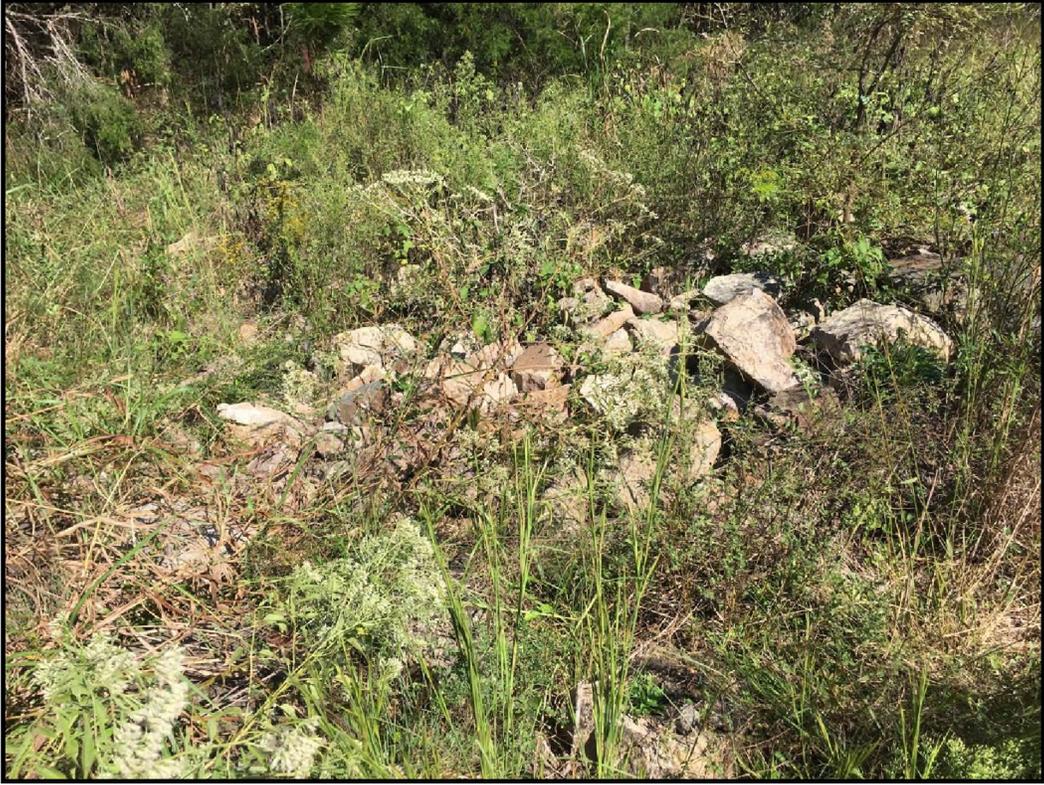
Figure 5. Site 38CS417 Rubble Pile– View N.

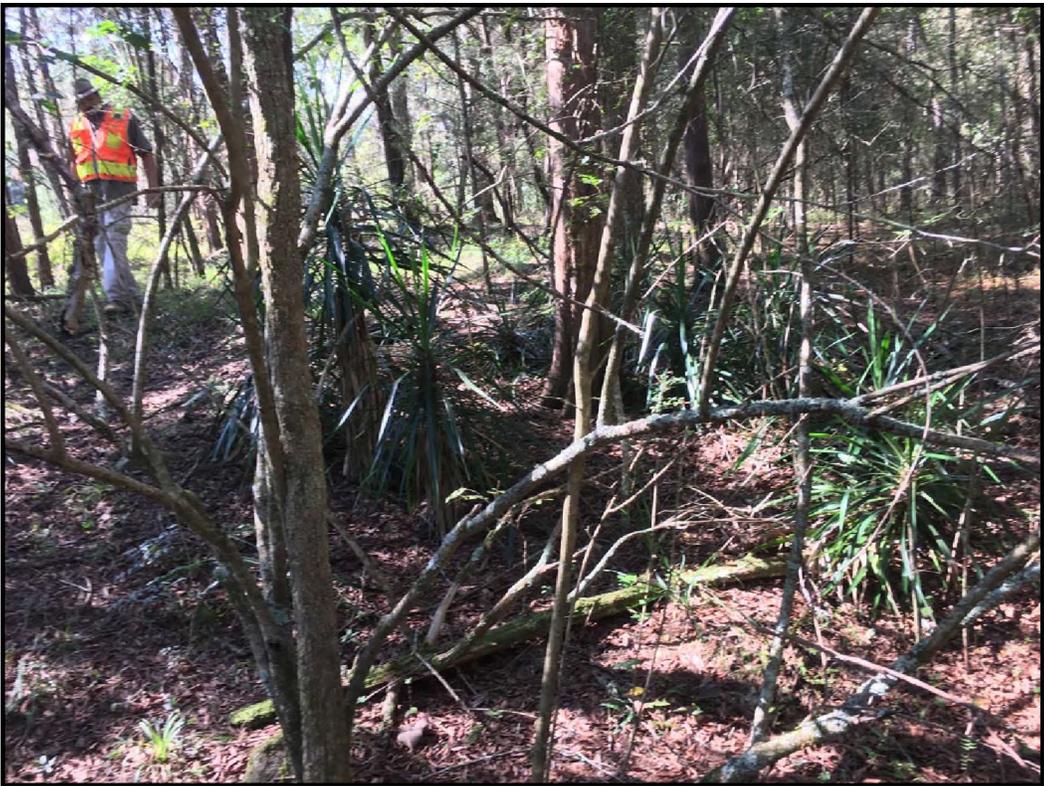
Figure 6. Site 38CS417 Yucca Plants – View S.

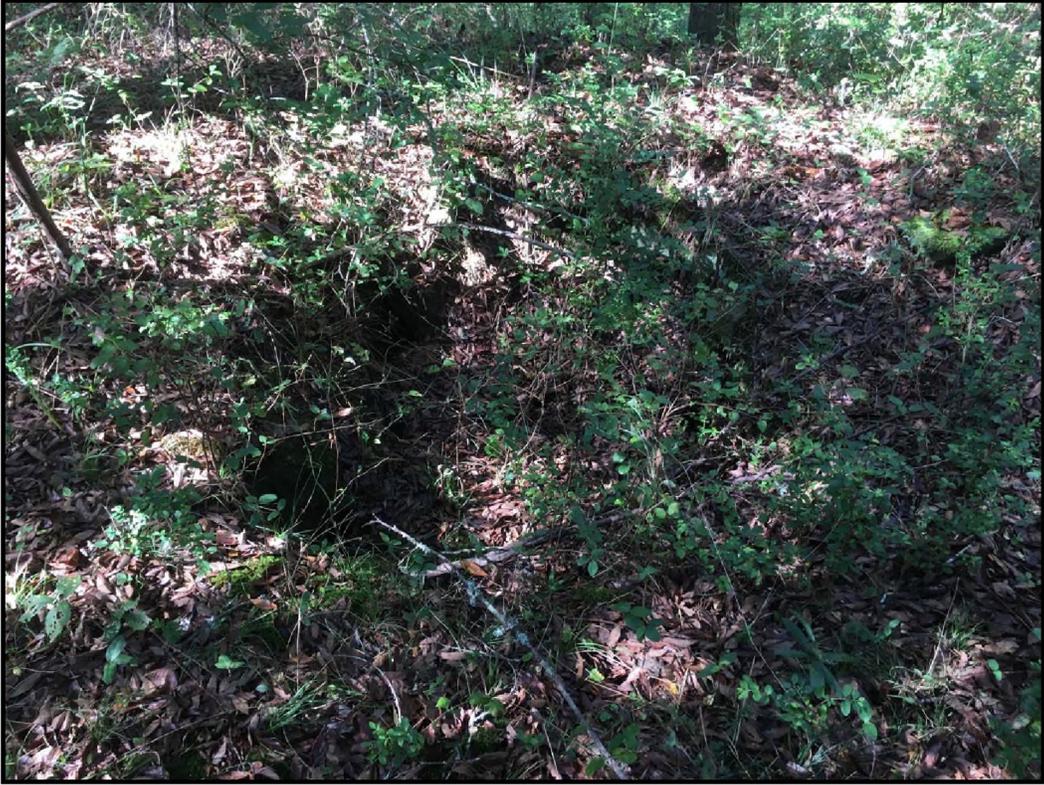
Figure 7. Site 38CS417 Stone Lined Well – View W.

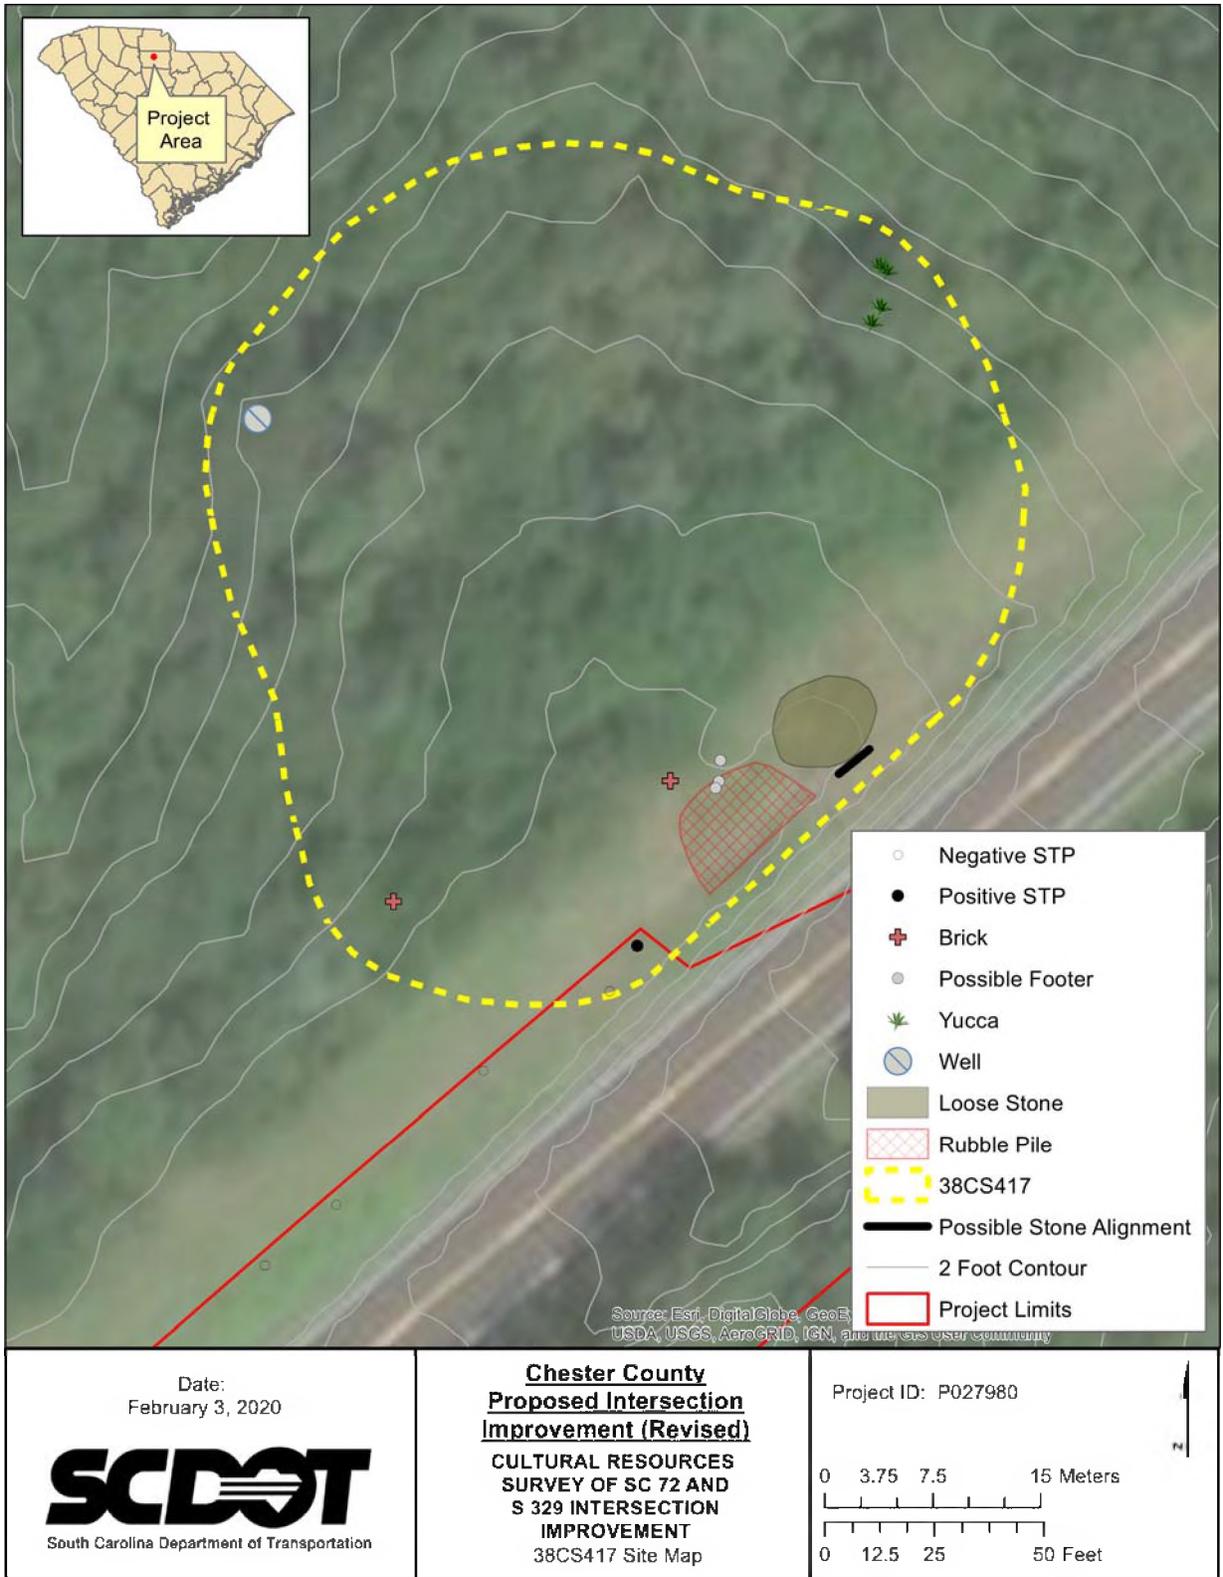
The archaeological reconnaissance conducted in the area suggested by Ms. Margaret Hausman and Ms. Erin Culp to be the location of William McCandless' home resulted in the identification of a badly disturbed historic house site (38CS417). Visible features suggestive of house remains included a substantial rubble pile that is likely the partial remnants of a collapsed or demolished chimney, possibly intermixed with rubble displaced from power line or roadway excavation; a possible stone alignment that may be the remnants of a wall or foundation; a few scattered bricks and shaped or cut stones that may comprise displaced foundation or chimney remains, and a partially backfilled stone lined well located approximately 30 meters to the northwest of the rubble pile/house location. In addition, yucca plants that may comprise remnant domestic vegetation were noted growing in the area to the north of the rubble pile (**Figures 4 – 7**). A total of four shovel test pits were excavated at approximately 10-meter intervals in a single transect to the southwest of the rubble pile. The shovel test pits were typically shallow, averaging about 25 centimeters in depth, with soils consisting of dark yellowish-brown (10YR 4/4) compact sandy loam overlying very compact yellowish-red (5YR 5/6) to dark yellowish-brown (10YR 4/6) sandy clay. One (1) shovel test yielded (1) artifact, a single cut nail fragment. In general, the site location appears to have been heavily disturbed by road and power line construction, and erosion/deflation (**Figure 8**).

Figure 8. Site 38CS417 Site Map Showing Project Limits, Shovel Test Pit Locations, and Locations of Documented Surface Features.

Project impacts to site 38CS417 are limited to a small portion of the southwestern portion of the site that has already been heavily disturbed by road and power line construction.

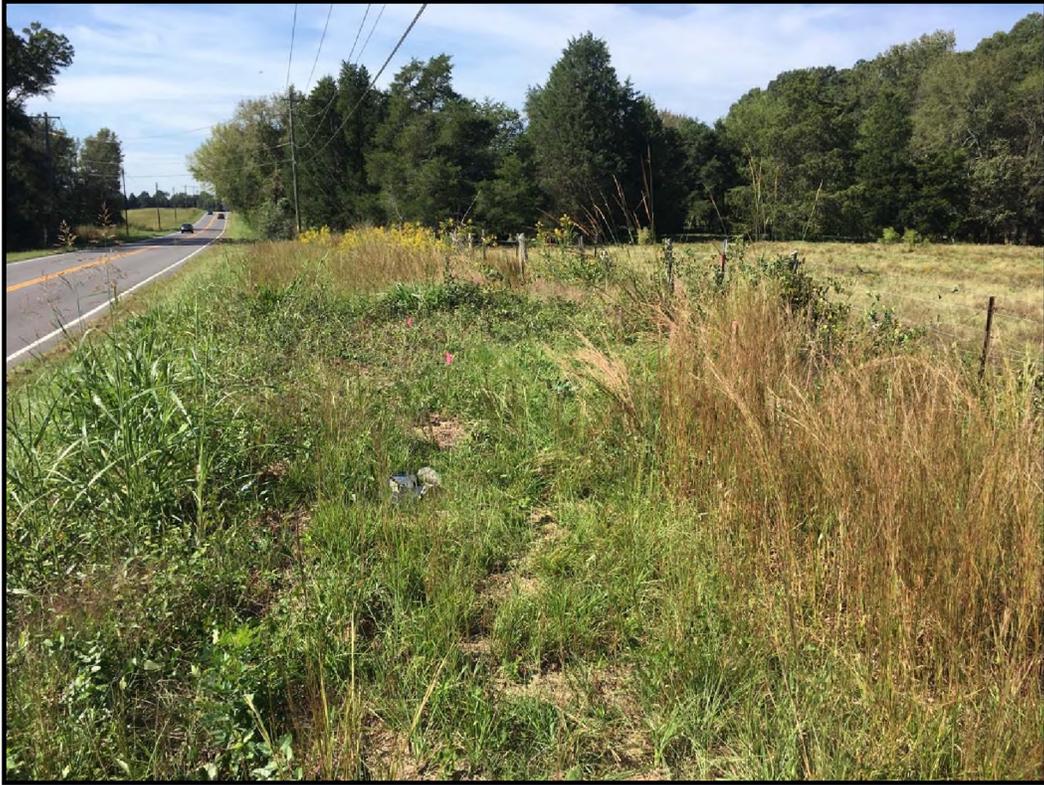
Figure 9. Location of Site 38CS420/0303

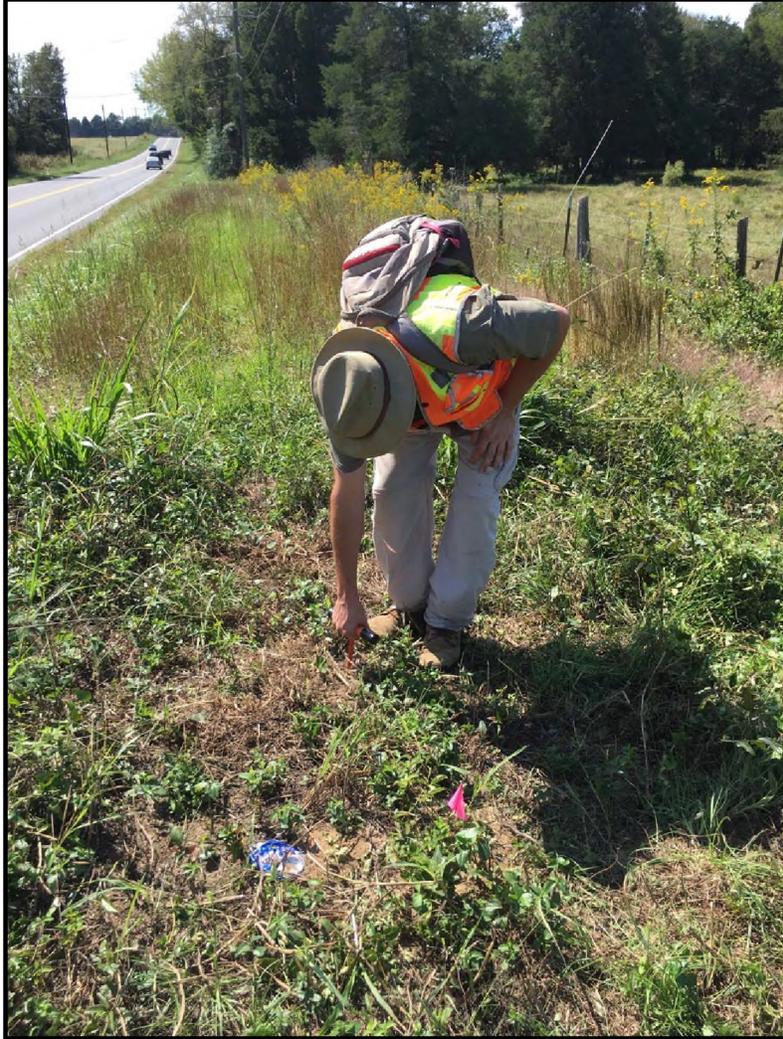
Reconnaissance of the William McCandless grave site (38CS420/0303) on 10-1-18 consisted of a surface inspection and limited probing (**Figure 9**). The probing was inconclusive but did detect an extremely soft area where the probe encountered little resistance up to its handle (about three feet) (**Figure 10**). This soft area apparently corresponded to the former location of a large cedar tree, as suggested by the oral history interviews and affirmed during the subsequent backhoe trenching. The surface inspection of the grave location also revealed several prickly pear plants, apparently corresponding to the cactuses referred to in the oral history interviews. No surface depressions, marker remnants, or the any remnants of rock or wire enclosures were found.

Figure 10. Probing at Site 38CS420/0303

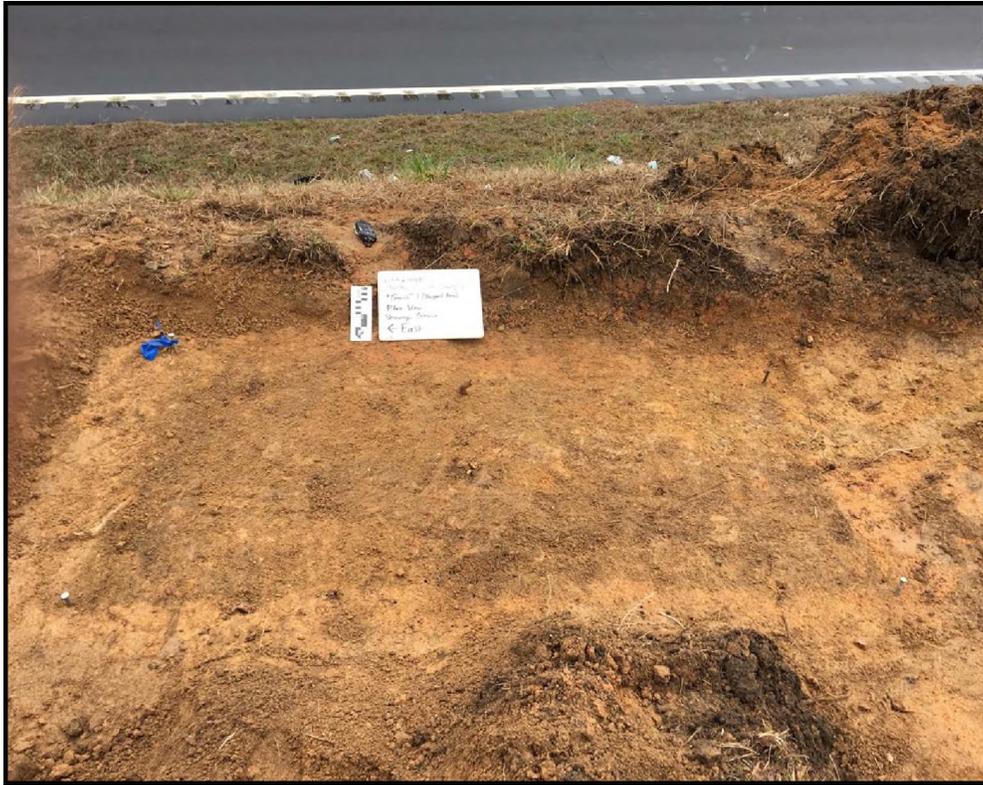
The GPR survey on 12-12-18 and subsequent backhoe trenching/ground truthing on 1-15-19 resulted in the discovery of a well-defined rectangular feature that is presumed to be the grave of William McCandless, as suggested in the oral history interviews (**Figure 11**). In keeping with current SHPO policy the grave was assigned both an above-ground resource number (0303) and an archaeological site number (38CS420). Full details of regarding the GPR study and subsequent backhoe trench excavation can be found in the New South Associates cultural resources report appended to the current document.

Figure 11. Site 38CS420/0303 – Grave Uncovered during Backhoe Excavation/Ground Truthing.

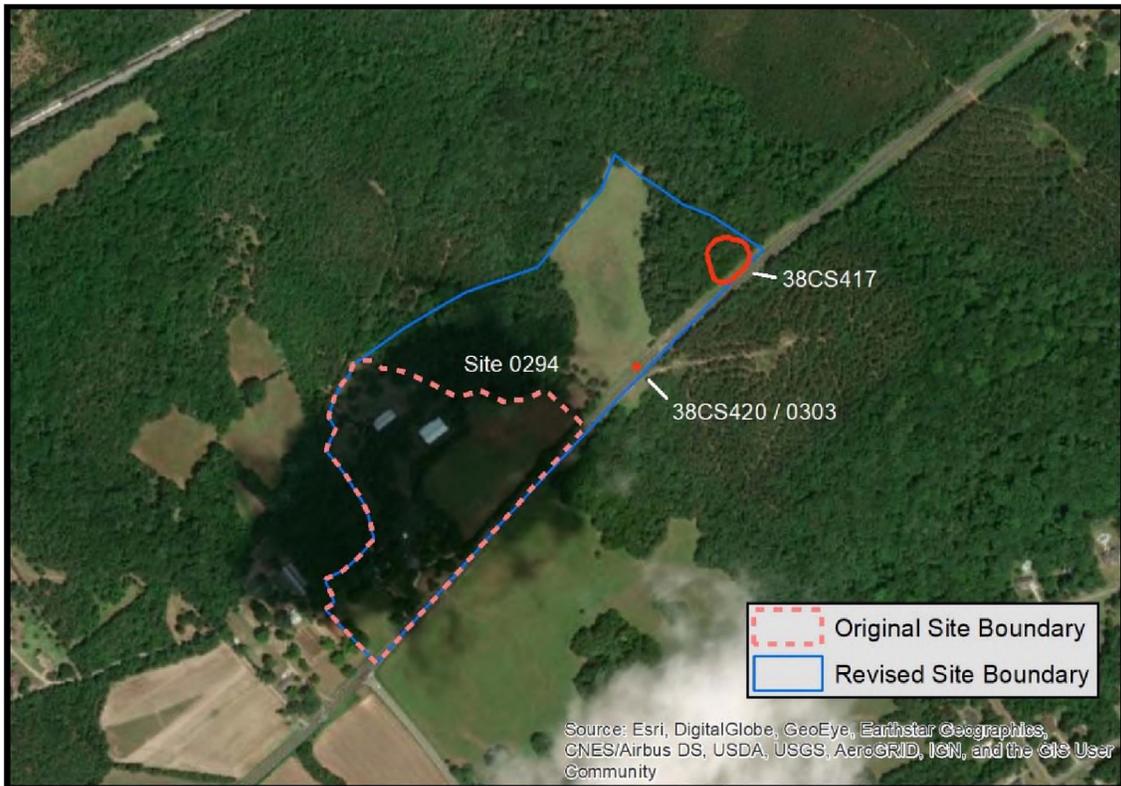
Figure 12. Original and Expanded Boundaries of Site 0294.

Although site 38CS420/0303 and the portion of site 38CS417 that extends into the SC 72 and S-329 project area are recommended as not individually eligible, per SHPO guidance both sites will be incorporated as contributing resources into the expanded boundaries of previously recorded site 0294, the McCandless House and associated landscape, which was recommended NRHP eligible under Criteria A and C when it was recorded during the initial SCDOT survey of the SC 72 and S-329 project area as then defined (see attached SCDOT survey report dated 11-18-16) (**Figure 12**). Therefore, project impacts to the newly recorded sites as contributing elements of site 0294 must be considered.

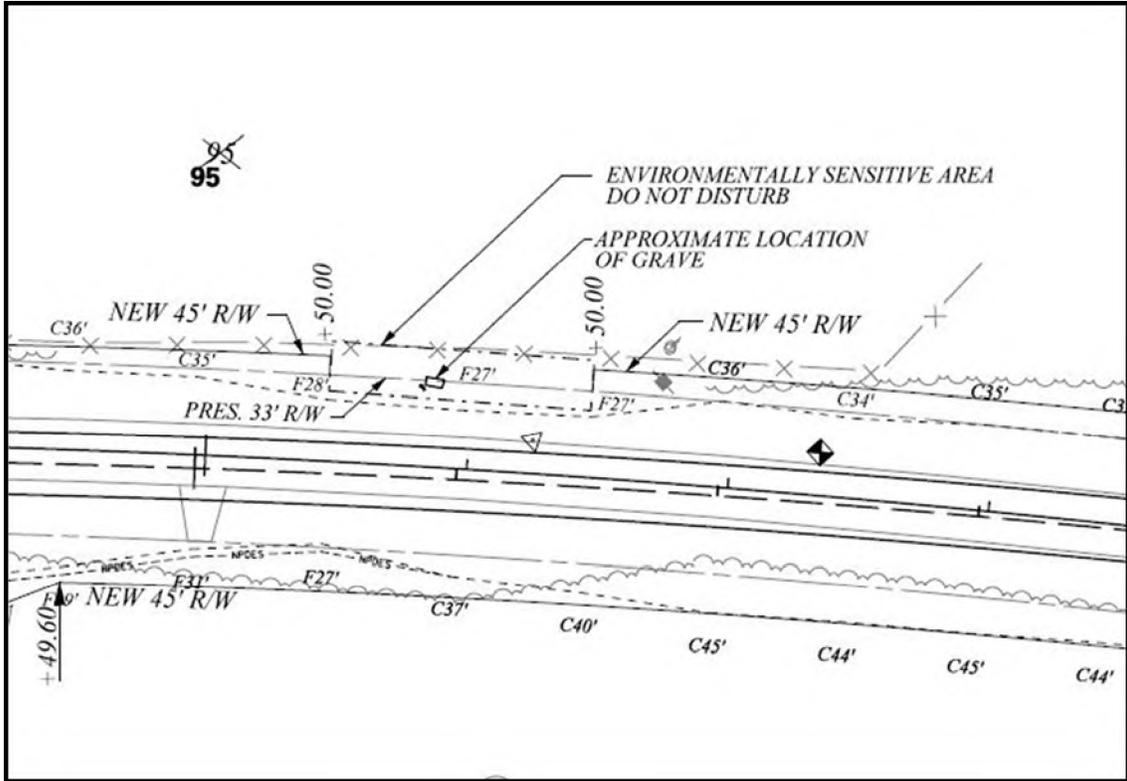
Figure 13. SCDOT Construction Plans Showing Provisions Made to Protect Site 38CS420/0303.

In order to avoid impacts to the McCandless grave, SCDOT engineers revised the limits of the SC 72 and S-329 intersection improvement project so that right of way acquisition in the grave vicinity would be avoided, and established a protective buffer around the grave to avoid construction-related impacts (**Figure 13**).
