PHASE I CULTURAL RESOURCES SURVEY OF INTERSECTION IMPROVEMENTS AT SC 9 (Boiling Springs Road) and 4th Street/Shoally Creek Road

SPARTANBURG COUNTY, SOUTH CAROLINA

April 10, 2019 • **Final Draft Report**
New South Associates Technical Report 2905

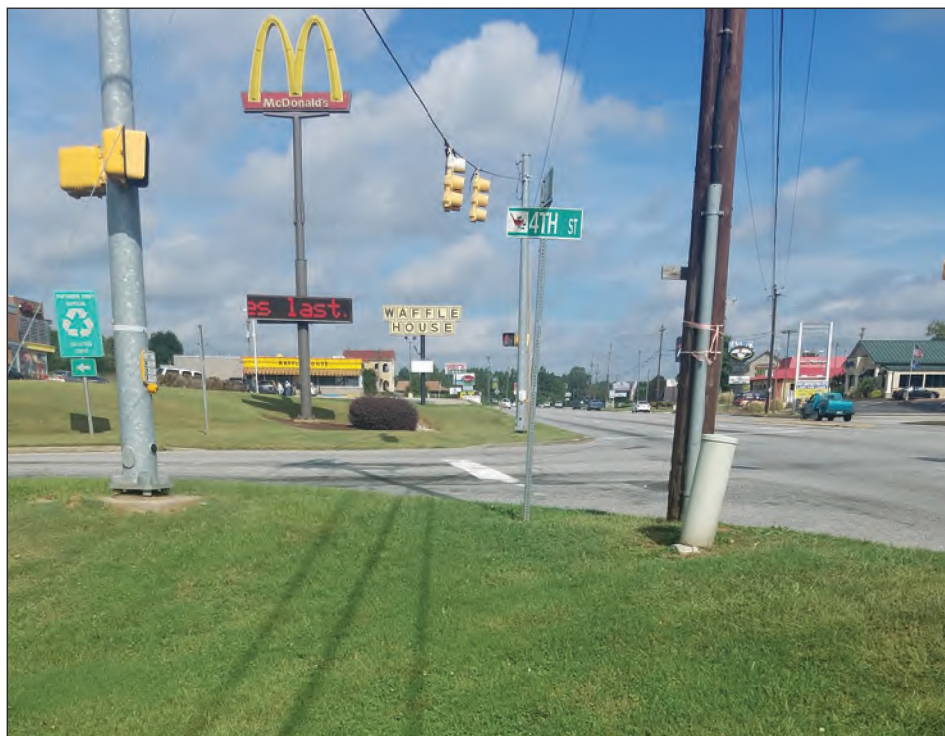
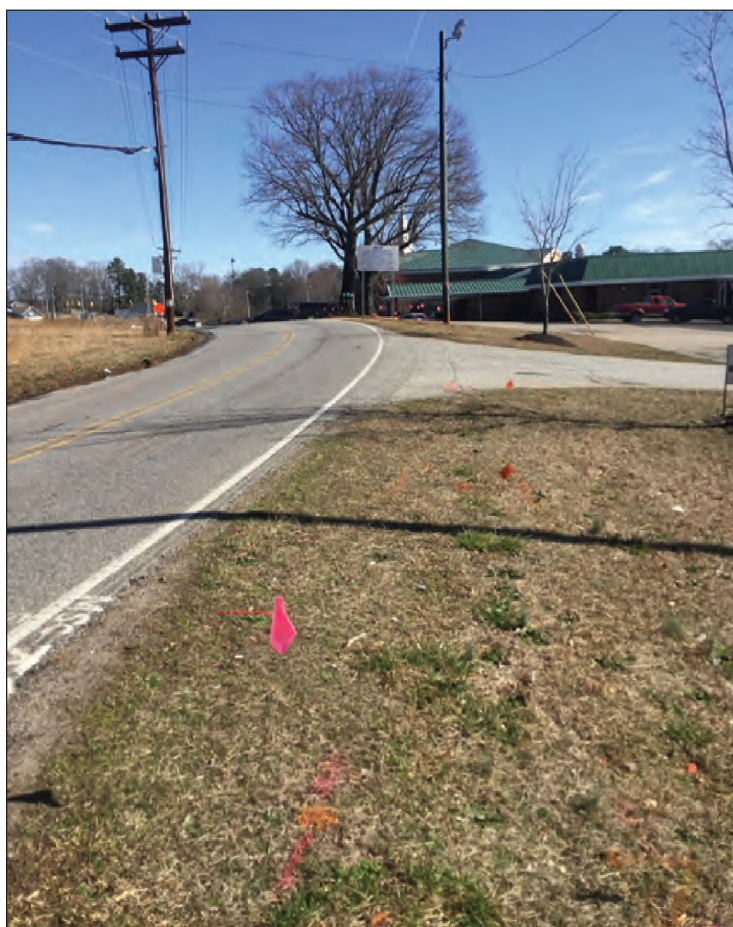
Figure 2.
Photographs of the Development in the APE, 1 of 2

Development was found along the SC 9 corridor and the intersecting streets (Figures 2 and 3). The APE is situated within an area of substantial commercial development north of the I-85 highway interchange, while there are residential areas located along the major intersecting roads. Most of the APE contains businesses, such as restaurants and gas stations, offices, and associated parking lots. Roadside settings along SC 9 and the intersecting roads exhibited significant disturbance from development and erosion. Residential areas also contributed to some ground disturbance in the project area (Figures 4 and 5). Much of the area of direct effects at all three intersections had been modified during development or contained underground utility lines.

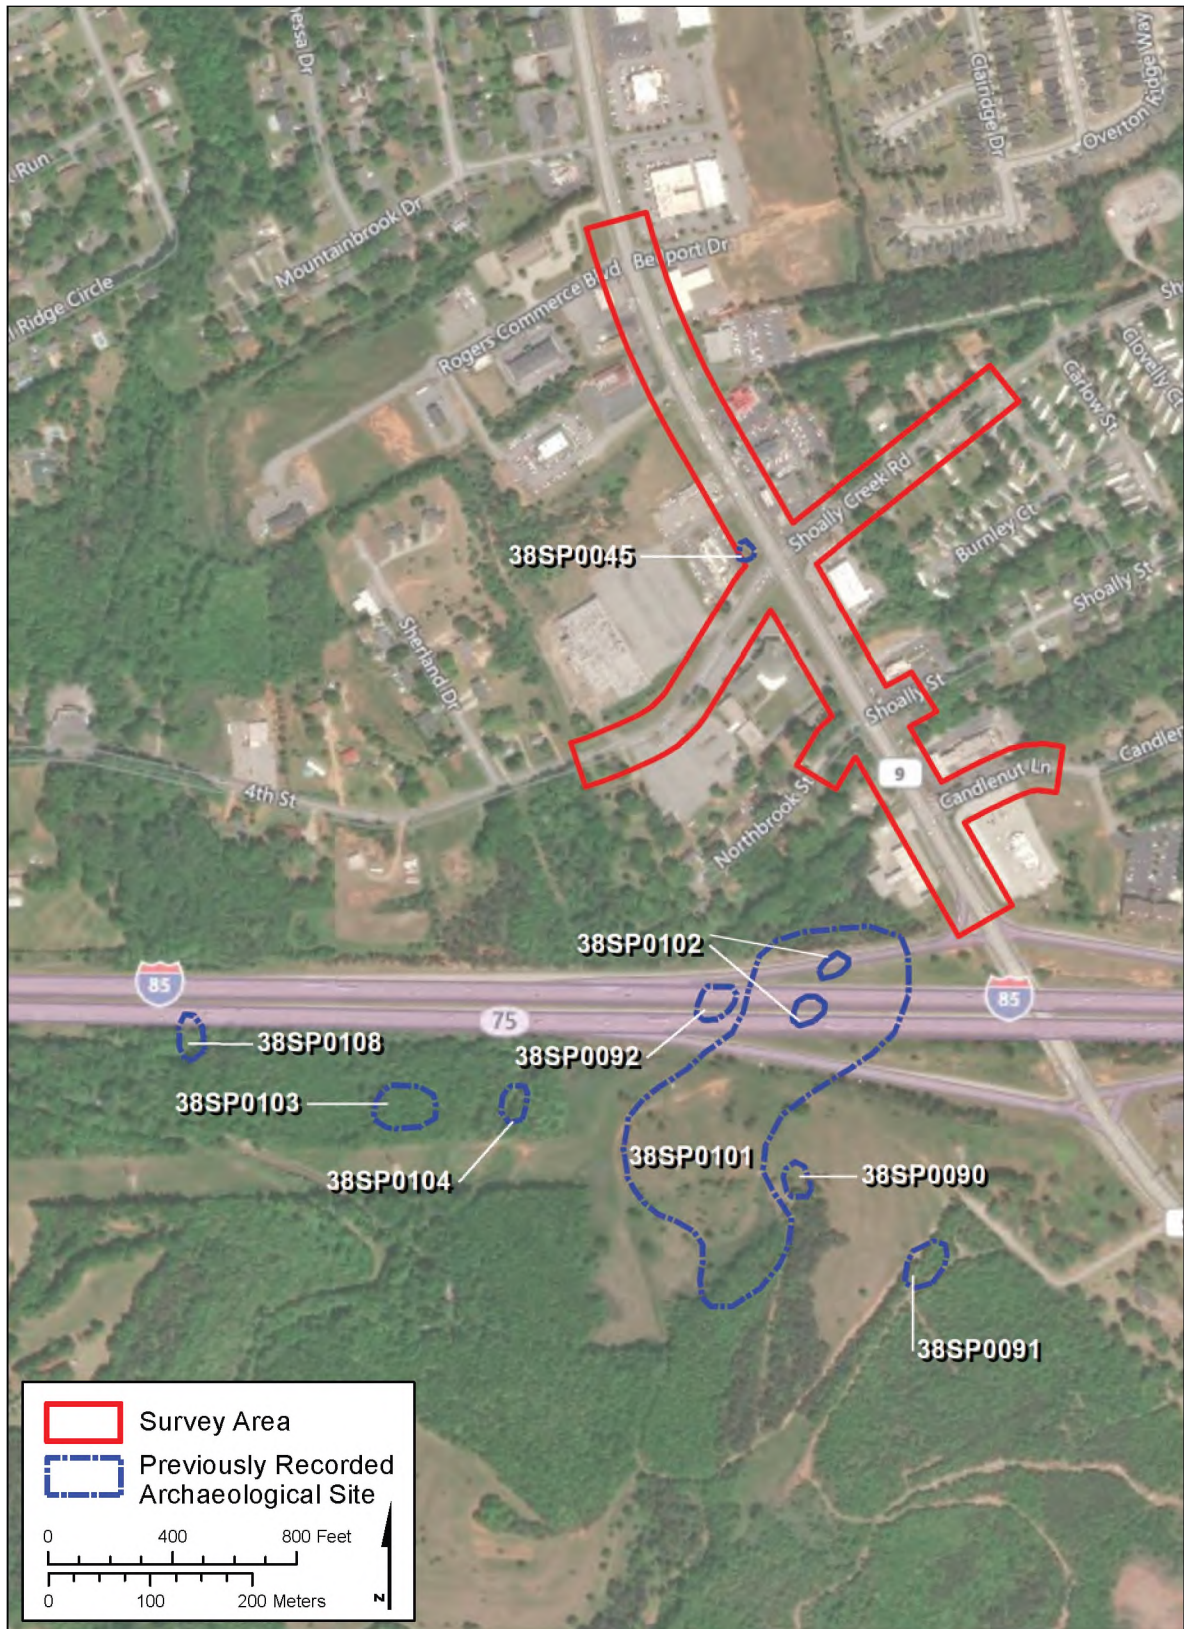
Figure 6.
Previously Recorded Resources Map

Background research was conducted through the ArchSite GIS database maintained by the University of South Carolina. There are nine previously recorded archaeological sites within 0.5 mile of the project area. Only one of the sites, 38SP0045 is within the APE. There are no previously recorded architectural resources within the APE (Figure 6, Table 1).

Artifacts consisted of a few quartzite flakes and ceramic sherds. Due to the disturbance at the time of discovery, the site was determined not eligible for the NRHP (Trinkley 1978). Based on the current survey conditions, it appears that the site was destroyed by commercial development and a retention pond.

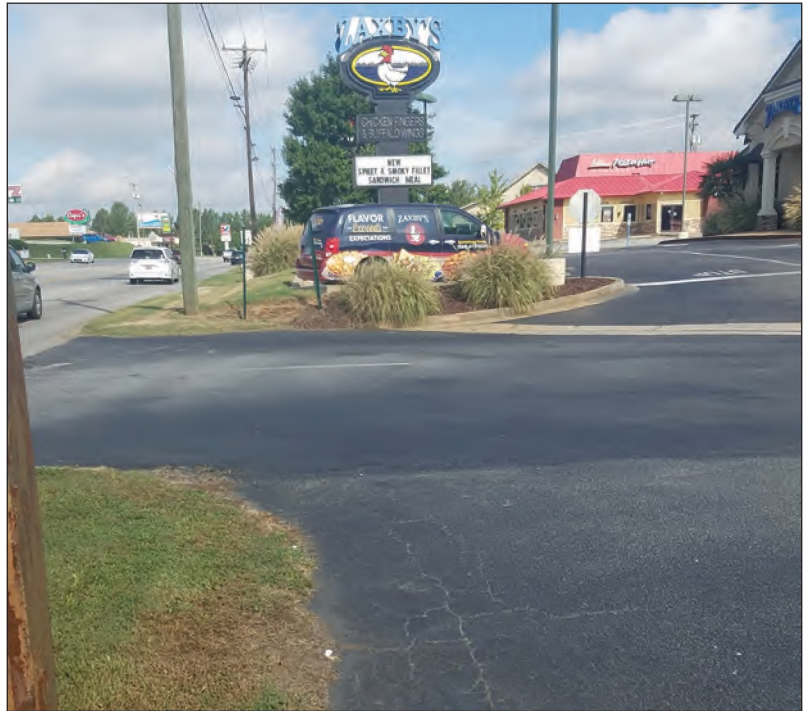
A. Transect 1, Facing North
from the East Side of SC 9

Transect 1 was located on the west side of SC 9 running 0.75 mile from the intersection with I-85 to the project terminus just north of Rogers Commerce Boulevard. This section of the project area was heavily developed by commercial properties. Buried utilities ran parallel to the road, indicating further disturbance. Shovel tests were also omitted along this transect because of buried utilities, driveways, parking lots, and intersections. Four shovel tests were excavated along this transect (Figures 7a and Figure 8).

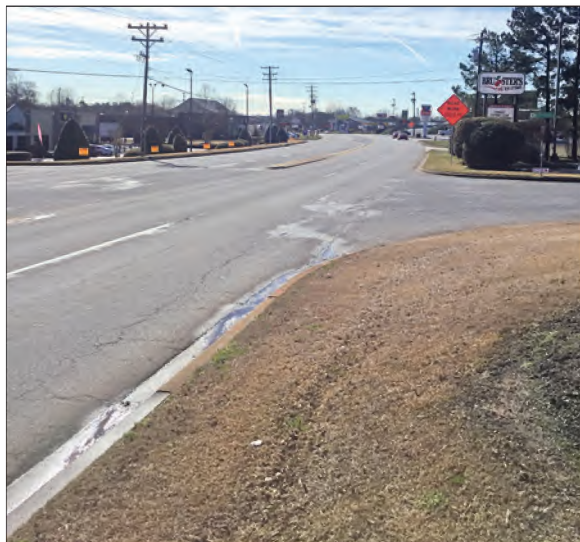
B. Transect 2, Facing South from Terminus

Transect 2 was located on the east side of SC 9 running 0.75 mile from the intersection with I-85 to the project terminus just north of Rogers Commerce Boulevard. This section of the project area was also heavily developed by commercial properties. Disturbances in the area were buried utilities, parking lots, paved driveways, and road berms (Figures 7b and Figure 8). Transect 2 bisected the previously recorded archaeological site 38SP0045. The location of the site was identified between the parking lot of the McDonald's and the western edge of SC 9 in a retention pond. The site has been completely eradicated by the construction of both the McDonald's and the retention pond. Two shovel tests were excavated along this transect.

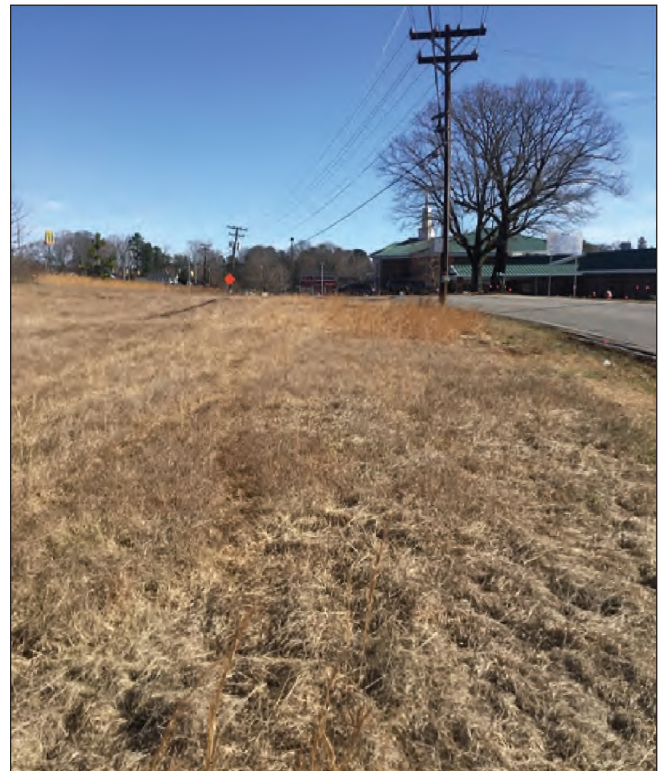
C. Transect 3, from
Terminus, Facing East

Transect 3 was located on the north side of 4th Street running 0.16 mile from the intersection with SC 9 to the project terminus just east of Sherland Drive. This section of the project area was disturbed by both buried utilities, road construction, commercial and residential development (Figures 7c and Figure 8). Two shovel tests were excavated along this transect.

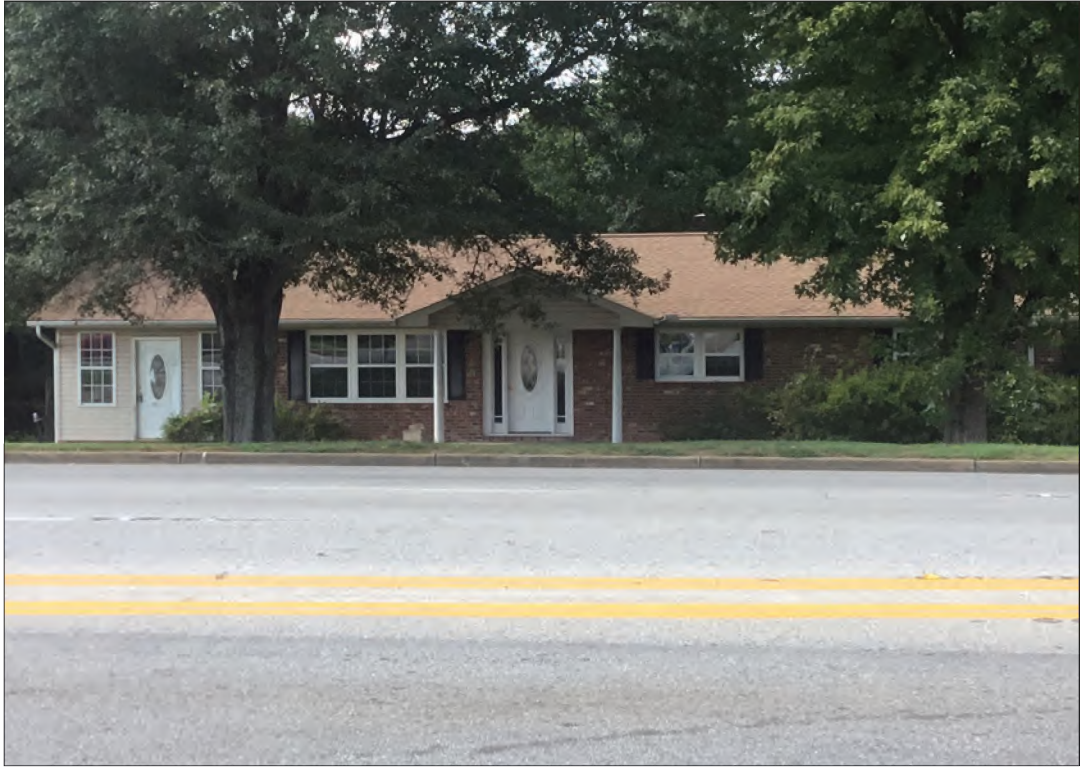
A. Resource No. 1356, Front Elevation

Resource Number 1356 is a Linear Ranch built in 1964 at 1707 Boiling Springs Road (Figure 9). It has a lateral gable roof covered in composition shingles with the gable ends clad in vinyl siding. The exterior is clad in brick veneer and the foundation was not visible. The front porch has a gable roof supported by plain columns. The front entrance is centrally located on the porch and has been updated with a new door flanked by side lights. The windows have been updated and replaced with six-over-six-light vinyl double-hung sashes. The attached carport has been enclosed and is clad with vinyl siding. The carport has a central entrance flanked by vinyl double-hung sash windows. The alterations to Resource Number 1356 have changed its original appearance.

The resource was not found to embody a distinctive characteristic of a type, period, or method of construction. It also does not represent the work of a master or possess high artistic value. It is not known to be associated with events or persons significant in the past. Therefore, the resource is recommended as not individually eligible for the NRHP under Criteria A, B, or C.

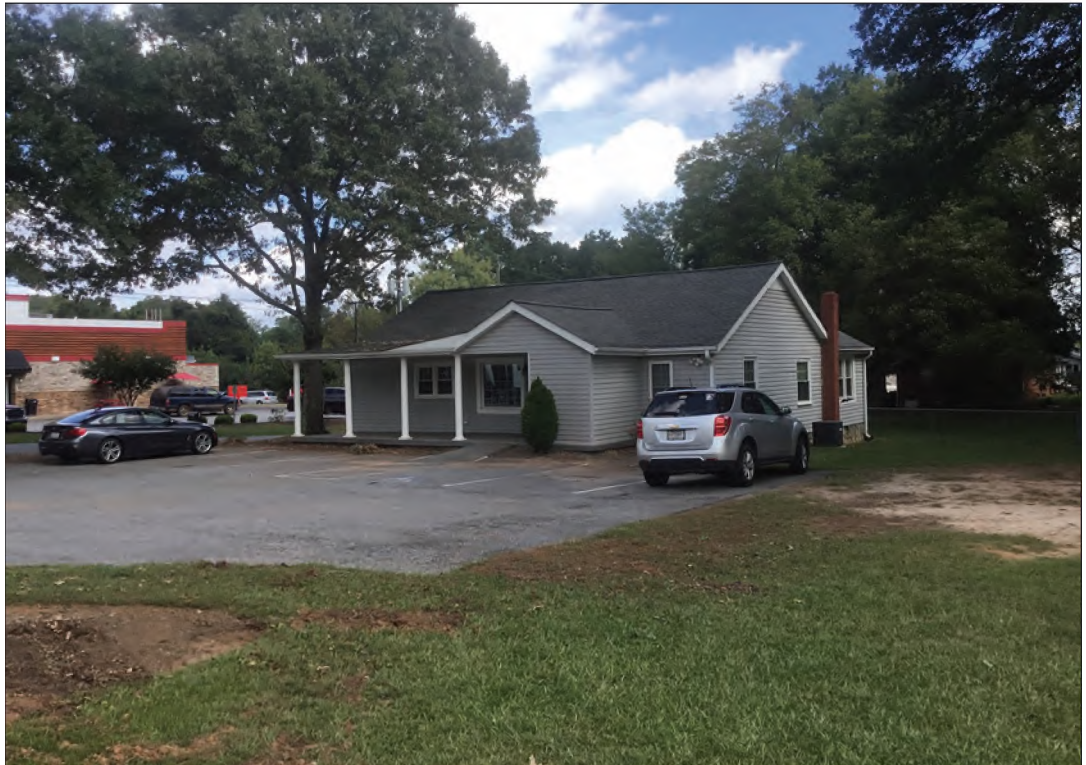
B. Resource No. 1357, Front Oblique

Resource Number 1357 is a residence constructed in 1945 with no identified type or style and located at 1714 Boiling Springs Road (see Figure 9). The resource is currently used as a commercial space. It is a one-story house with a rectangular core and irregular floor plan. The exterior is clad in vinyl siding and rests on a stone foundation. The resource has one exterior brick chimney located on its south elevation. The front porch has a shed roof that leads into a projecting front-gable section and is supported by plain columns that rest on a concrete slab floor. The front

entrance is accessed from the front-gable section of the porch and the door has been replaced with a non-historic wood panel door with an oval window. The windows along the front elevation have been rearranged and updated with vinyl windows. Replacement of the siding and windows, along with the additions to the building, have slightly altered the appearance of this resource.

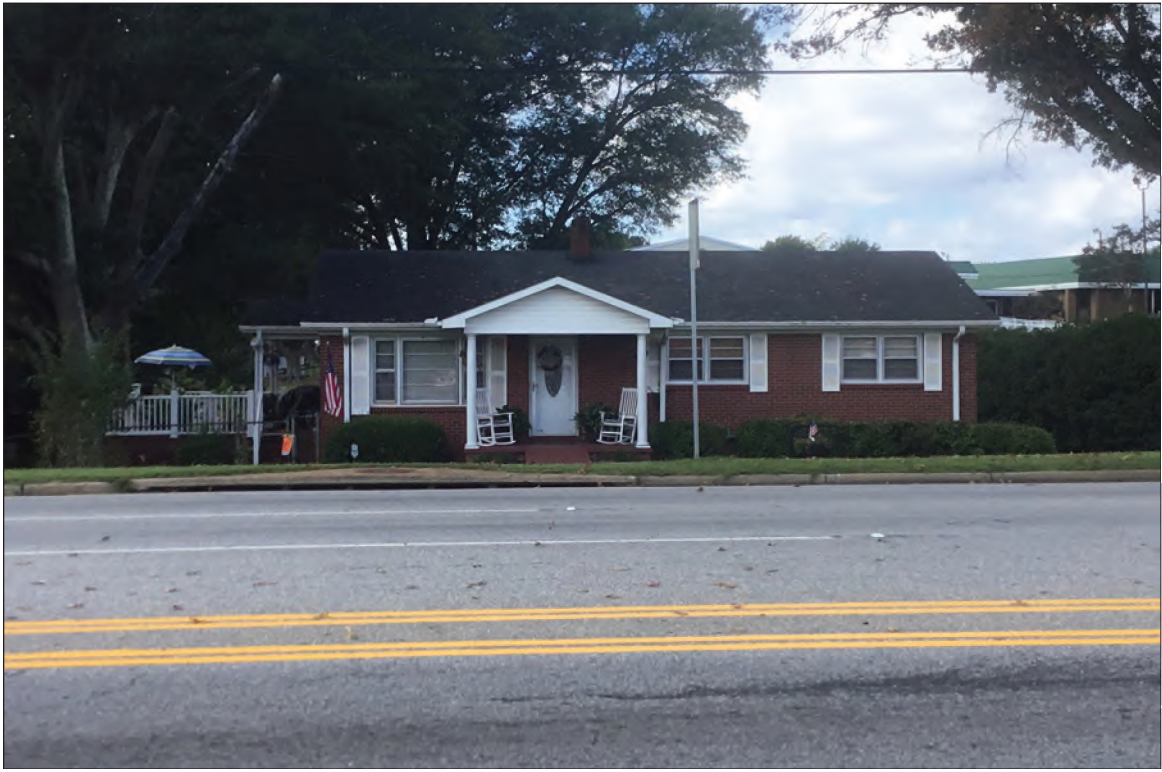
A. Resource No. 1358, Front Elevation

Resource Number 1358 is a Compact Ranch constructed in 1967 and is located at 1807 Boiling Springs Road (Figure 10). It has a linear massing and sits on a raised brick foundation. The exterior is clad in brick veneer and the lateral gable is clad with composition shingles. The gable ends are covered in vinyl siding. The front elevation has an asymmetrical appearance with an off-center entry porch covered by a cross-gable roof supported by plain columns. The front door is a replacement non-historic wood panel door with an oval window centrally located under the porch. The north bay has two sets of paired two-over-two-light wood double-hung sash windows. The south bay has a four-light picture window flanked by two-over-two double hung sash windows. The resource has a gabled entry porch on the left elevation which leads to a deck addition. The resource has one interior brick chimney. Alterations to the siding and windows, in combination with the additions to the building, have slightly changed the character of Resource Number 1358.

The rear of the lot has moderate vegetation and landscaping. Planted bushes line the façade of the resource. With the commercial development to the north of the resource, the view shed has been compromised.

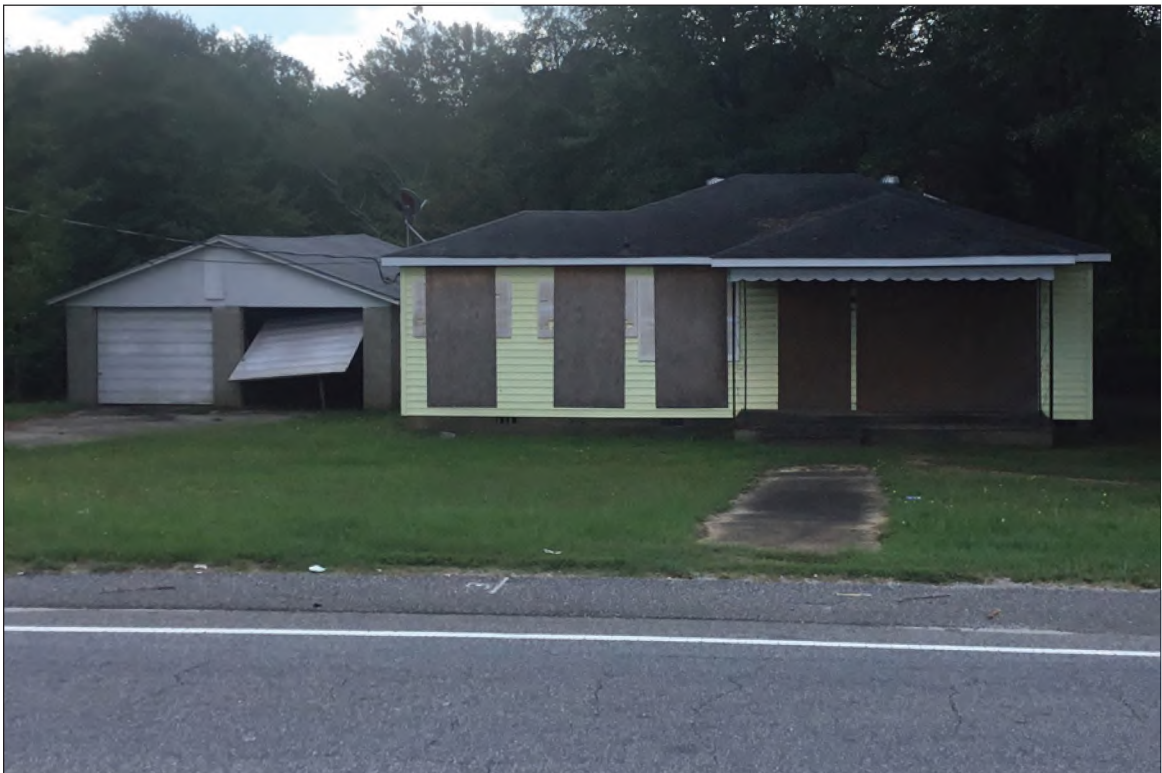
B. Resource No. 1359, Front Elevation

Resource Number 1359 is a Minimal Traditional house constructed in 1955 and is located at 1210 Shoally Creek Road (see Figure 10). The resource is a one-story vacant dwelling. It has a rectangular plan with a hip roof clad in composition shingles. The resource sits on a concrete block foundation and the exterior is covered in vinyl siding. It has an asymmetrical façade and the windows and doors are boarded over. The front porch has a hip roof supported by decorative metal posts on a concrete slab floor. Located on the west side of the building is a two-car garage built of concrete block. The gable ends of the garage roof are faced with pressboard and the garage doors are metal. Alterations have slightly affected the appearance of Resource Number 1359.

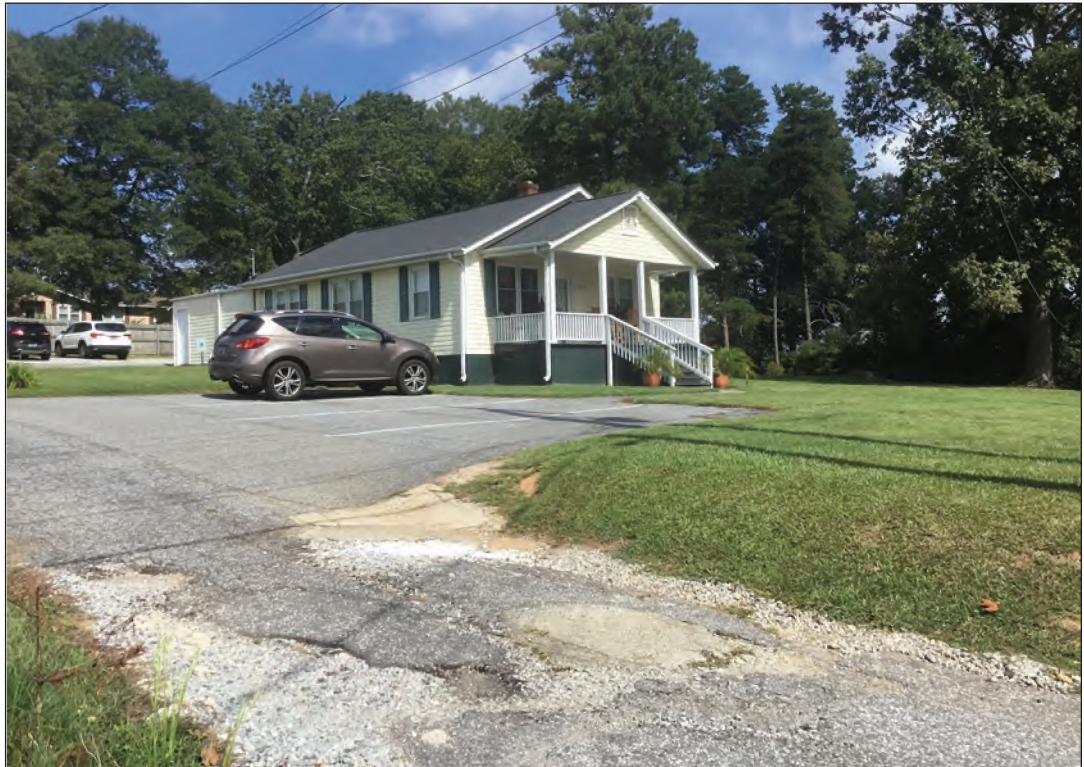
A. Resource No. 1360, Front Oblique

Resource Number 1360 is a Bungalow constructed in 1949 and located at 1223 Shoally Creek Road (Figure 11). Originally a residence, it is currently used as a commercial space. The resource is a one-story building with a front-gable roof. It has a rectangular massing that is situated perpendicular to the street. The exterior siding is vinyl and the building sits on a concrete block foundation. The front porch has a gable roof with plain wood posts and railings, along with concrete steps. The windows have been replaced with vinyl six-over-six-light double-hung sashes. The front entrance has been altered and sits off-center. The front entry has a multi-light door set in a vinyl frame. Located at the rear of the resource is a vinyl-clad addition. Replacement of the siding and windows, along with the additions to the building, have slightly altered the appearance of Resource Number 1360.

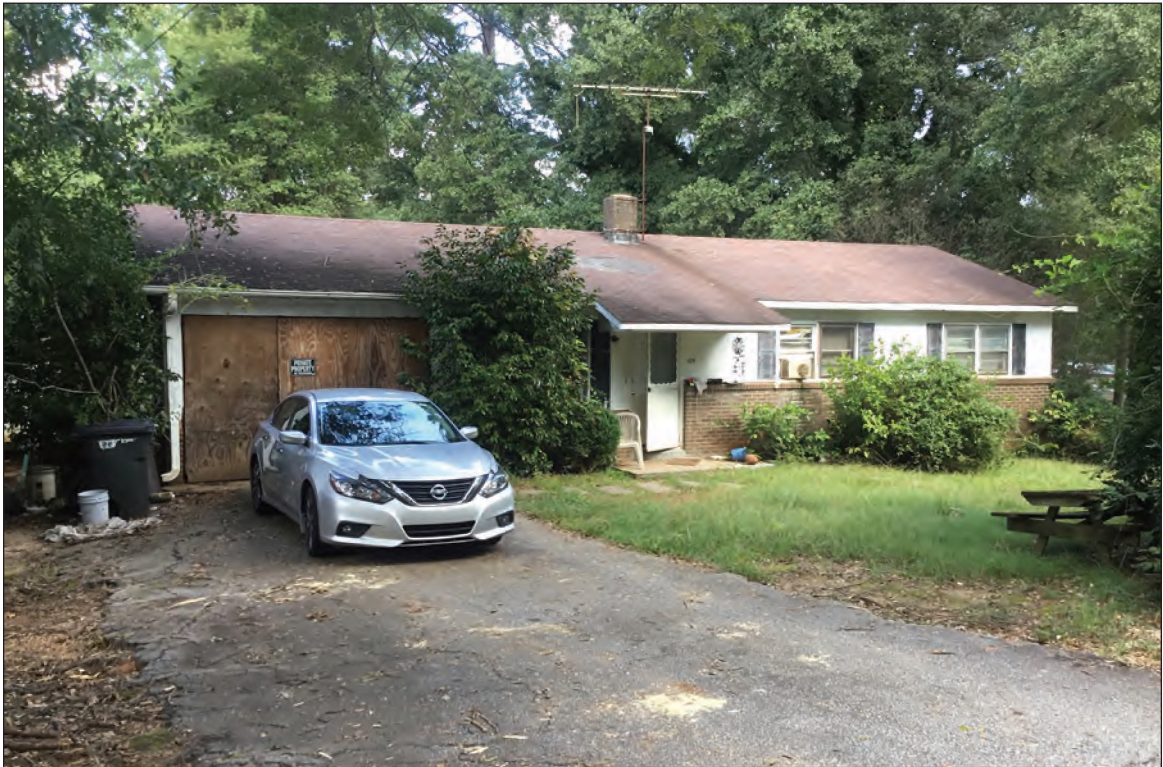
A. Resource No. 1362, Front Oblique

Resource Number 1362 is a Compact Ranch house constructed in 1967 at 105 Shoally Road (Figure 12). The front elevation has a brick skirt wall with vertical wood weatherboard above. The foundation is not visible. The front entrance is covered by a shed roof that projects from the main roof line and covers a small concrete slab floor. The front door is a replacement wood panel type but still retains its original screen door. The resource has an engaged carport on its west elevation which has been boarded up but not fully enclosed. The visible windows have wood two-over-two-light double-hung sashes. The resource has one interior brick chimney. The modifications to the resource are minimal and do not alter the appearance of Resource Number 1362.

It has moderate tree coverage on a grassy lot and some planted vegetation surrounding the building. A paved driveway leads to the carport. Resource Number 1362 is located within the same residential development as Resource Number 1361.

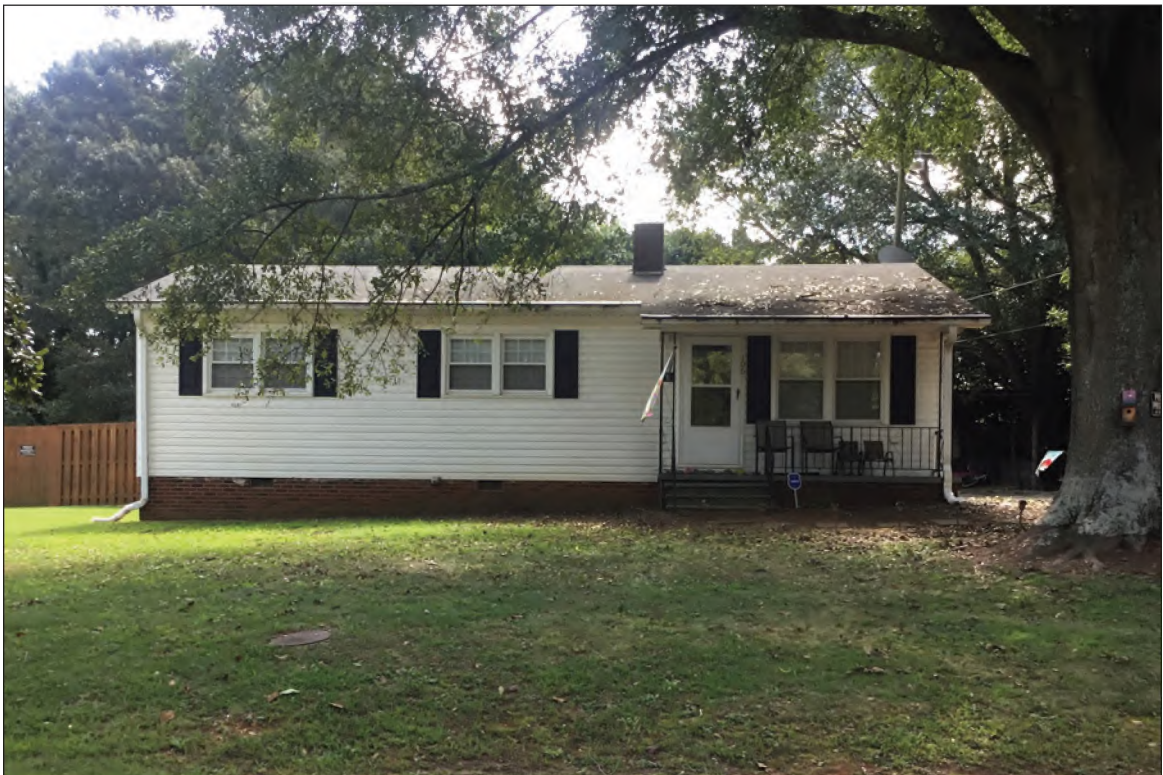
B. Resource No. 1363, Front Elevation

Resource Number 1363 is a Compact Ranch house built in 1962 and is located at 106 Shoally Road (see Figure 12). The resource is a one-story residence with a rectangular plan that rests on a brick foundation. It has a lateral gable roof covered with composition shingles and the exterior is clad in vinyl siding. The front porch has an engaged shed roof supported by decorative metal post and railings. The front elevation has an asymmetrical façade with an off-center door located under the porch line. The windows are replacement vinyl six-over-six double hung sash. The resource has one interior brick chimney. Alterations to the siding and windows have only slightly changed the appearance of Resource No. 1363.

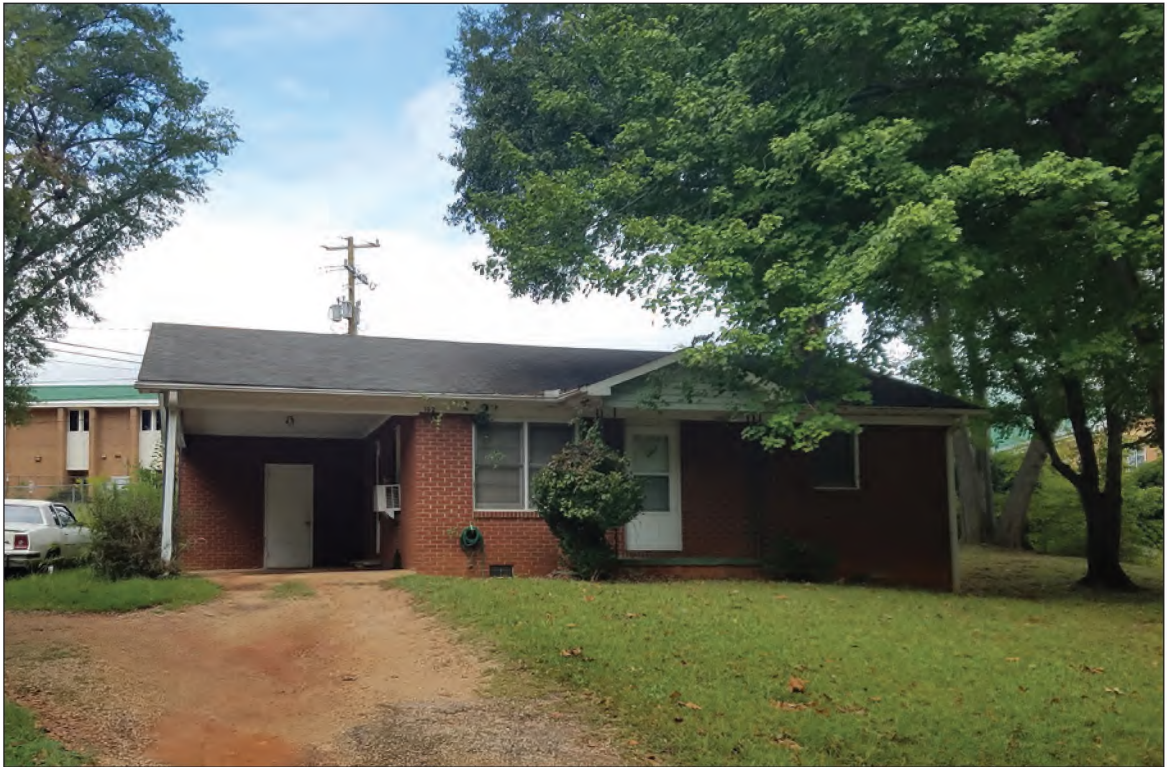
A. Resource No. 1364, Front Elevation

Resource Number 1364 is a Compact Ranch constructed in 1967 and is located at 102 Northbrook Street (Figure 13). The resource is a one-story residence with a rectangular plan and an engaged carport on the west elevation. The front elevation has an asymmetrical façade with wood two-over-two-light double-hung sash windows. The resource has a lateral gable roof covered with composition shingles and the gable ends are clad in vinyl siding. The exterior is clad in brick veneer and the foundation is not visible. The resource has a front entrance and a side entrance off the engaged carport. The front entrance is covered by the cross-gable porch supported on decorative metal posts. The front entry has the original aluminum door with a diamond window. The engaged carport is supported on its open side by decorative iron posts. Located to the rear of the carport is an enclosed storage closet typical of the style. Resource Number 1364 has undergone few modifications, none of which alter its appearance.

The resource was also assessed for its value to a district. Resource Number 1364 exhibits some characteristics that relate it to the surrounding residences. It is similar to the other Ranch Houses along the road in appearance and layout, suggesting a coordinated development dating to the 1960s. However, it is not recommended NRHP-eligible as it does not embody a distinctive characteristic of a type, period, or method of construction. It also does not represent the work of a master or possess high artistic value. It is not known to be associated with events or persons significant in the past. Therefore, the potential district appears to lack significance needed under Criteria A, B, or C for NRHP eligibility.

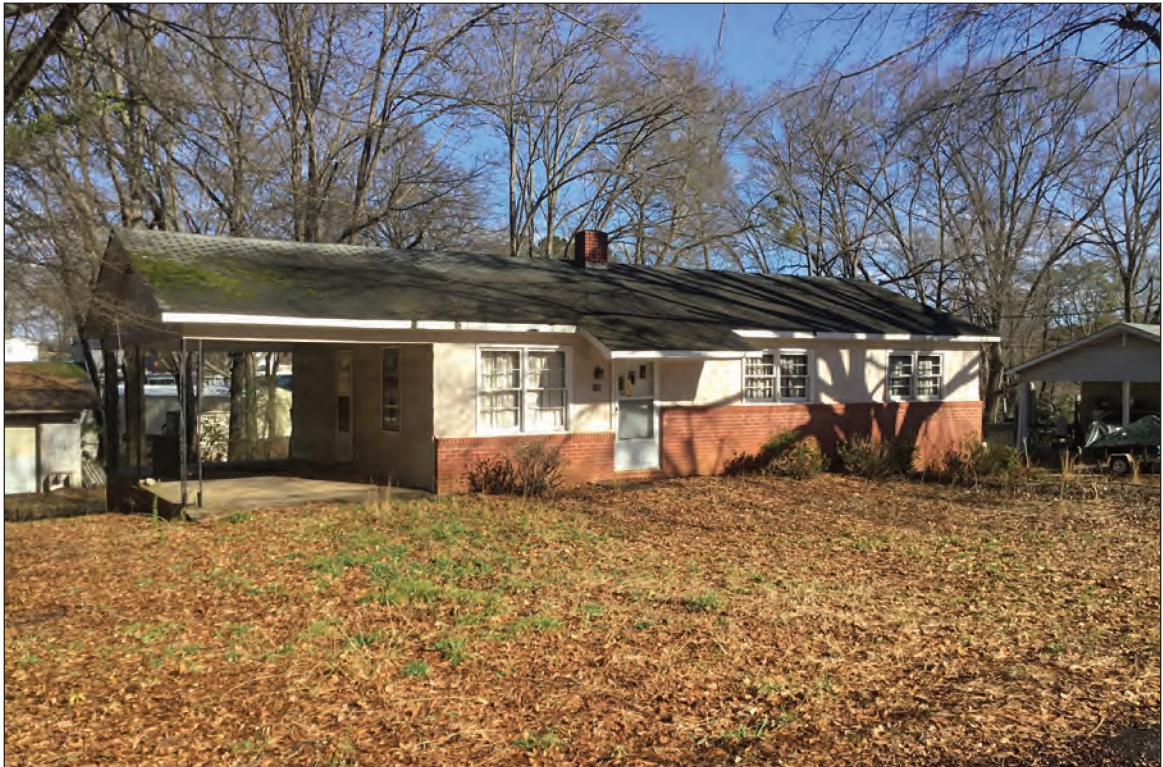
A. Resource No. 1401, Front Oblique

Resource Number 1401 is a Linear Ranch house built in 1964 and is located at 109 Shoally Road (Figure 14). It has a rectangular plan with a lateral gable roof. The roof is covered with composition shingle and the gable ends are clad in pressboard. The front elevation of the resource has a brick skirt wall with vertical shiplap siding above while the side elevations are clad in asbestos shingles. The resource has an engaged carport on its west elevation. The carport is open sided and supported by decorative metal posts. The front entrance is covered by a shed roof and concrete slab flooring. There is one visible interior brick chimney along the roof line. The windows have paired two-over-two-light double-hung wood sashes.

The resource has minimal tree coverage on a grassy lot and minimal planted vegetation along the front façade. A driveway is overgrown that leads to the engaged carport on the west elevation.

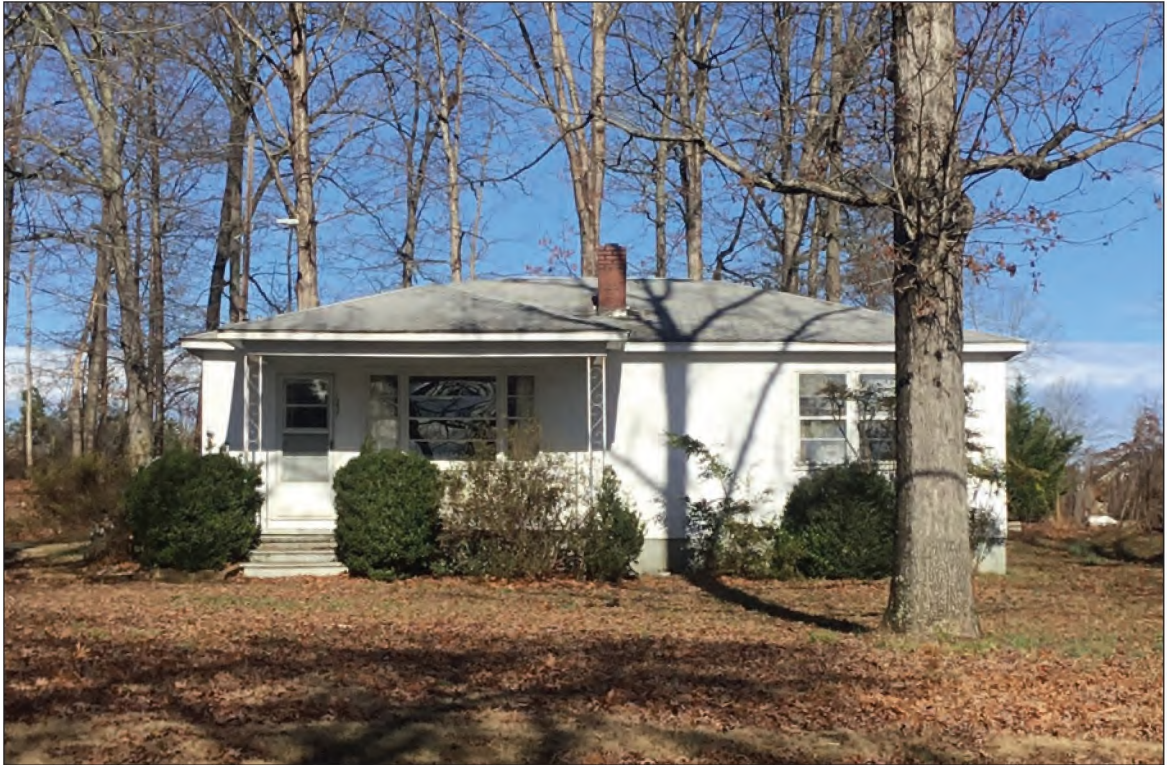
A. Resource No. 1403, Front Elevation

Resource Number 1403 is a Bungalow Style Ranch house, built in 1954 and is located at 1237 Shoally Creek Road (Figure 15). The resource has a slightly rectangular plan with a hip roof. The roof is clad in composition shingles and the exterior walls are faced with asbestos shingles. The front porch has a hip roof supported by decorative metal posts. The steps and porch flooring are constructed of concrete. The resource has two-over-two-light double-hung sash wood windows throughout. On the front elevation is a four-light picture window flanked by two-over-two-light windows. One interior brick chimney is visibly off-center of the roof line.

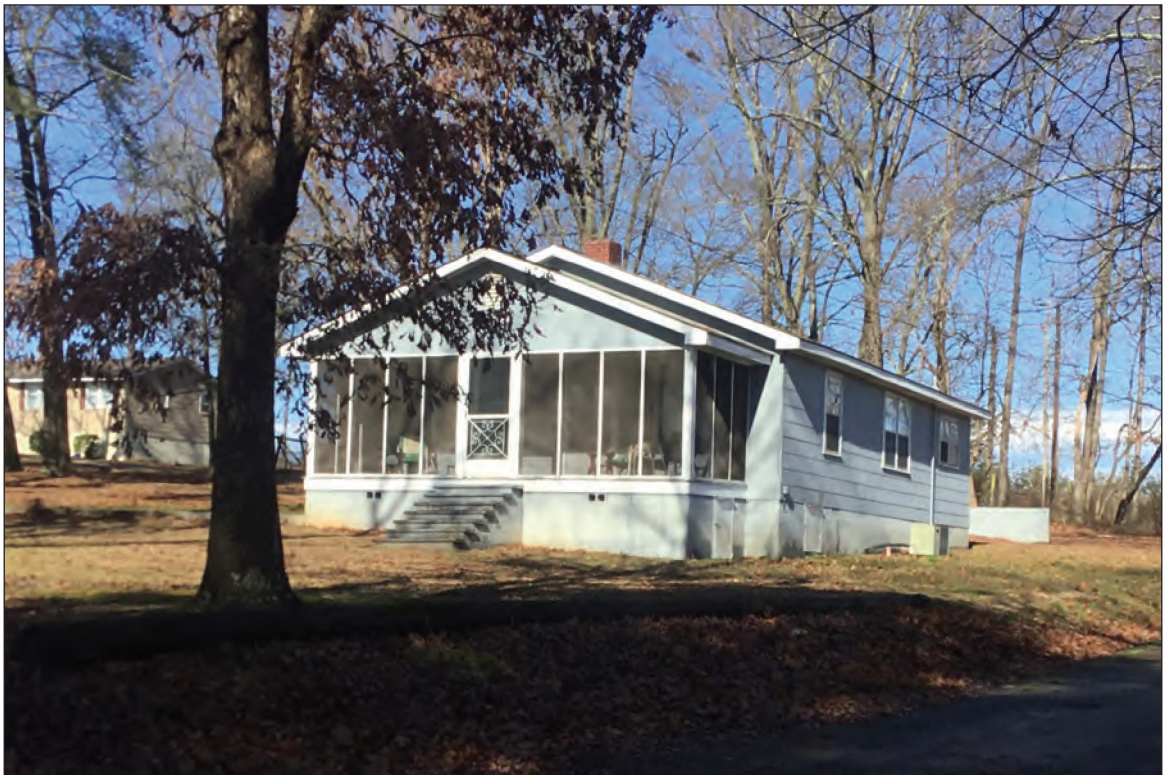
B. Resource No. 1404, Front Oblique

Resource Number 1404 is a Bungalow built in 1945 and is located at 1229 Shoally Creek Road (Figure 15). The resource has rectangular plan with a front-facing gable roof. The gable roof is clad in composition shingles and the gable ends have boxed returns. The exterior of the resource

is clad in asbestos shingles and the house sits on a concrete block foundation. The front porch has a gable roof that sits below the main roof line. The porch is enclosed with screens and sits on a concrete block foundation with concrete steps that lead to the entrance. There is one visible interior brick chimney located along the main roof line.

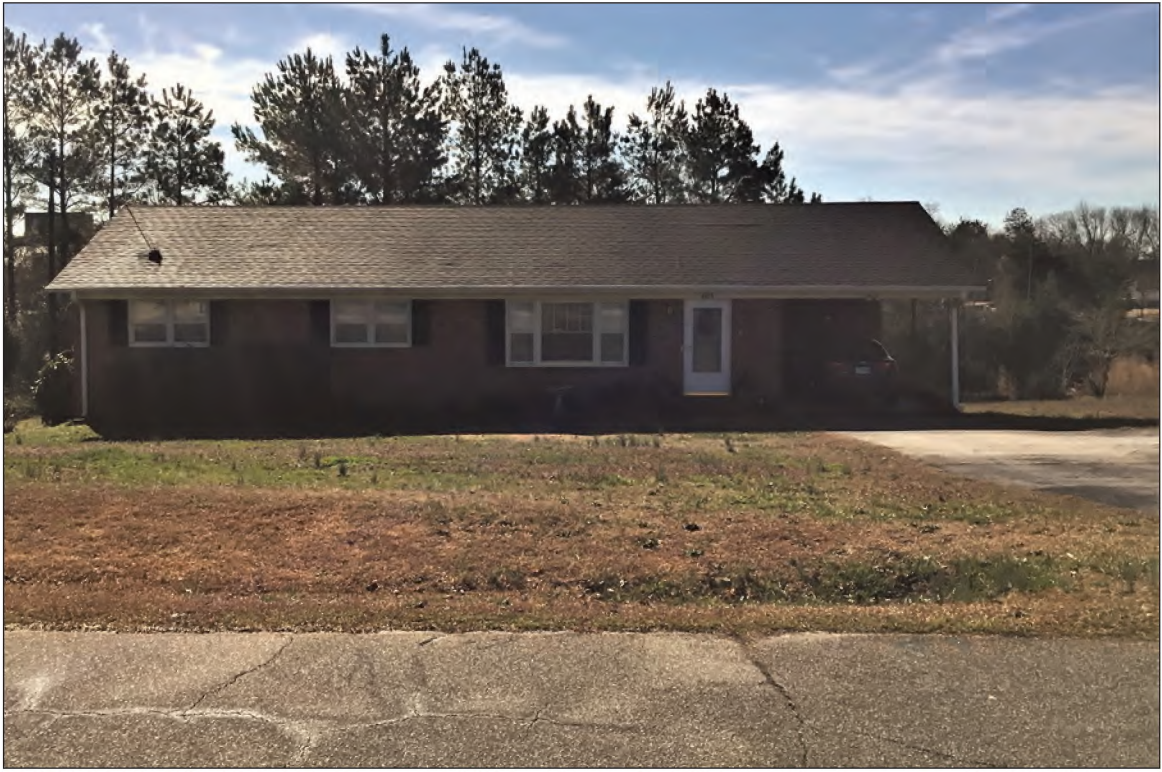
A. Resource No. 1405, Front Elevation

Resource Number 1405 is a Linear Ranch house built in 1968 and is located at 603 Mountainbrook Drive (Figure 16). The resource has a rectangular plan with a lateral gable roof. The gable roof is covered in composition shingles and the gable ends are clad in fiberboard. The exterior of the resource is faced in brick veneer and the foundation is not visible. The resource has an attached carport on the west elevation. The carport is open sided with a rear utility closet and is supported by decorative metal posts. The windows have replacement six-over-six-light double-hung vinyl sashes and the center bay has an eight-over-eight-light window flanked by four-over-four-light, double-hung sash windows.

The resource was not found to embody a distinctive characteristic of a type, period, or method of construction. It also does not represent the work of a master or possess high artistic value. It is not known to be associated with events or persons significant in the past. The resource has undergone some minor alterations to its façade. Therefore, the resource is recommended as not individually eligible for the NRHP under Criteria A, B, or C.

The resource was also assessed for its value to a district. No previously identified historic district currently exists in the community. Resource Number 1405 did not exhibit characteristics that would relate it to the surrounding structures. It also is not connected to the surrounding area based upon a plan or physical development. As no continuity or link to the other sites was found leading to a sense of time and place, the resource was not considered NRHP-eligible as part of a district.

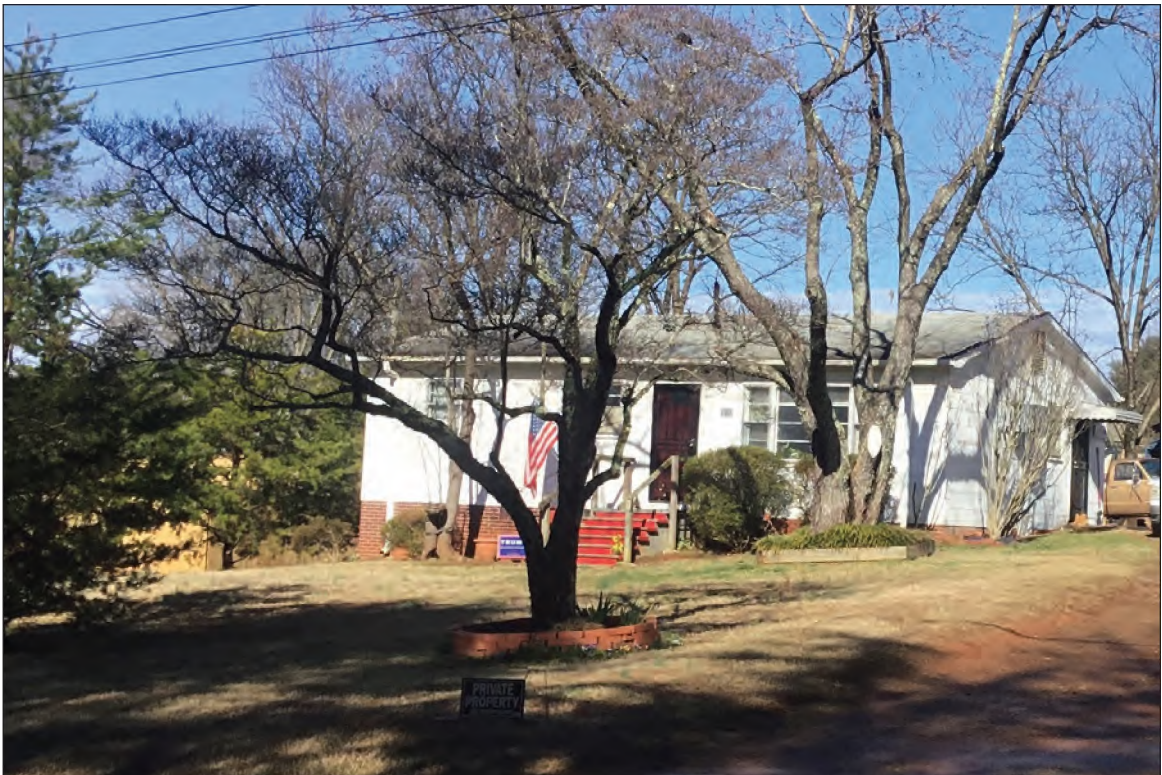
B. Resource No. 1406, Front Oblique

Resource Number 1406 is a Linear Ranch house built in 1968 and is located at 124 4th Street (Figure 16). The resource has a rectangular massing with a lateral gable roof. The roof is clad in composition shingles and the exterior is faced in asbestos shingles. The resource sits on a brick foundation on a slightly sloping lot. The front elevation is unadorned and has an uncovered front entry porch. The porch steps are concrete and have wood railings for supports. The windows have two-over-two-light double-hung wood sashes with a four-light fixed window flanked by two-over-two-light windows. There is a second entrance on the east elevation covered by an aluminum shed awning.

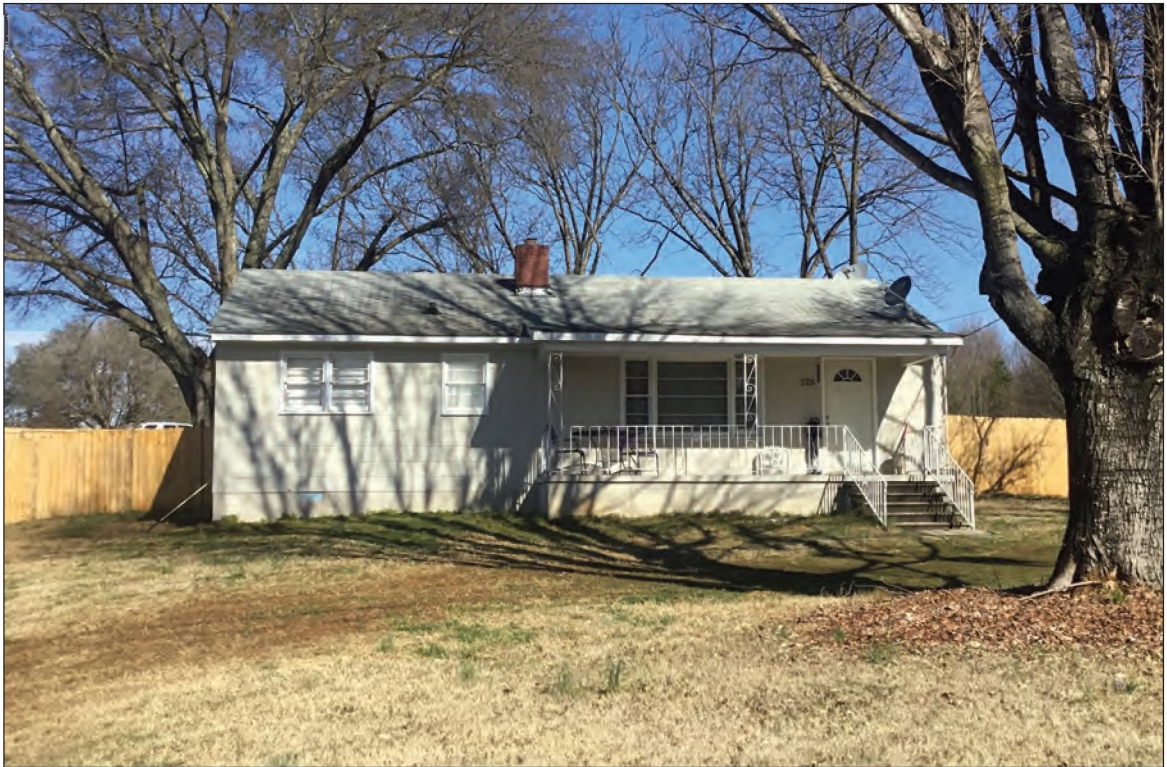
A. Resource No. 1407, Front Elevation

Resource Number 1407 is a Linear Ranch house built in 1957 and is located at 128 4th Street (Figure 17). The resource has a rectangular plan with a lateral gable roof and sits on a parged masonry foundation. The roof is clad in composition shingles and the exterior is faced with asbestos shingles. The front porch covers the entry and central bay with a shed roof supported by decorative metal posts. The windows have two-over-two-light double-hung wood sashes with a four-light fixed window flanked by two-over-two-light windows.

The resource has minimal tree coverage on a grassy lot and minimal planted vegetation along the façade.
