PHASE I CULTURAL RESOURCES SURVEY OF INTERSECTION IMPROVEMENTS AT SC 9 (Boiling Springs Road) and 4th Street/Shoally Creek Road

SPARTANBURG COUNTY, SOUTH CAROLINA

April 10, 2019 • **Final Draft Report**
New South Associates Technical Report 2905

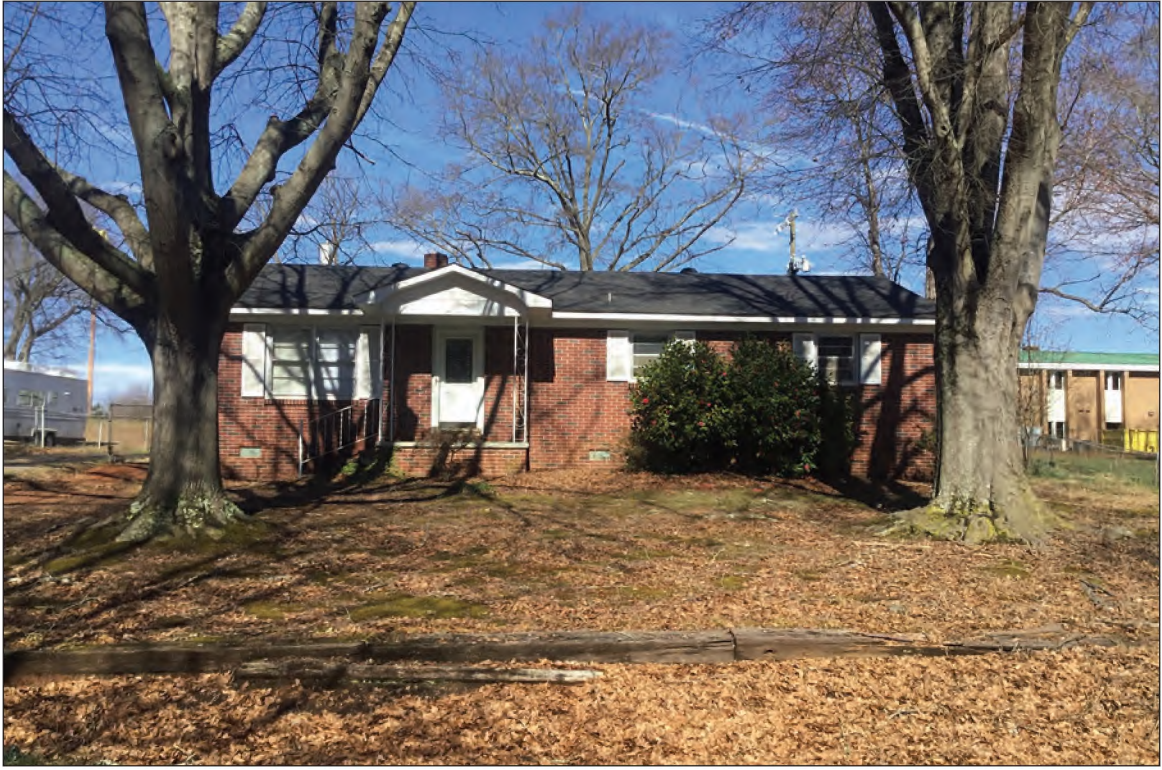
A. Resource No. 1409, Front Elevation

Resource Number 140 is a Linear Ranch house built in 1970 and is located at 111 Northbrook Street (Figure 18). The resource has rectangular plan with a lateral gable roof. The façade has six bays and the side elevations have two bays. The gable roof is covered with composition shingles and the gable ends are clad in vinyl siding. The exterior is faced with brick veneer and the foundation is obscured. The front porch covers the eastern three bays with a gable roof supported by plain wood posts. On the eastern elevation is an exterior brick slab chimney. The windows have two-over-two-light double-hung wood sashes.

The resource has moderate tree coverage on a grassy lot and some ornamental planted vegetation in the front yard. An asphalt driveway approaches the east side of the property through decorative wood fencing.
