Phase I Cultural Resource Survey for the North Main Street Corridor Revitalization Project

Sumter County, South Carolina

New South Associates, Inc.

November 5, 2018 • **Third Revised Draft Report**
New South Associates Technical Report 2768

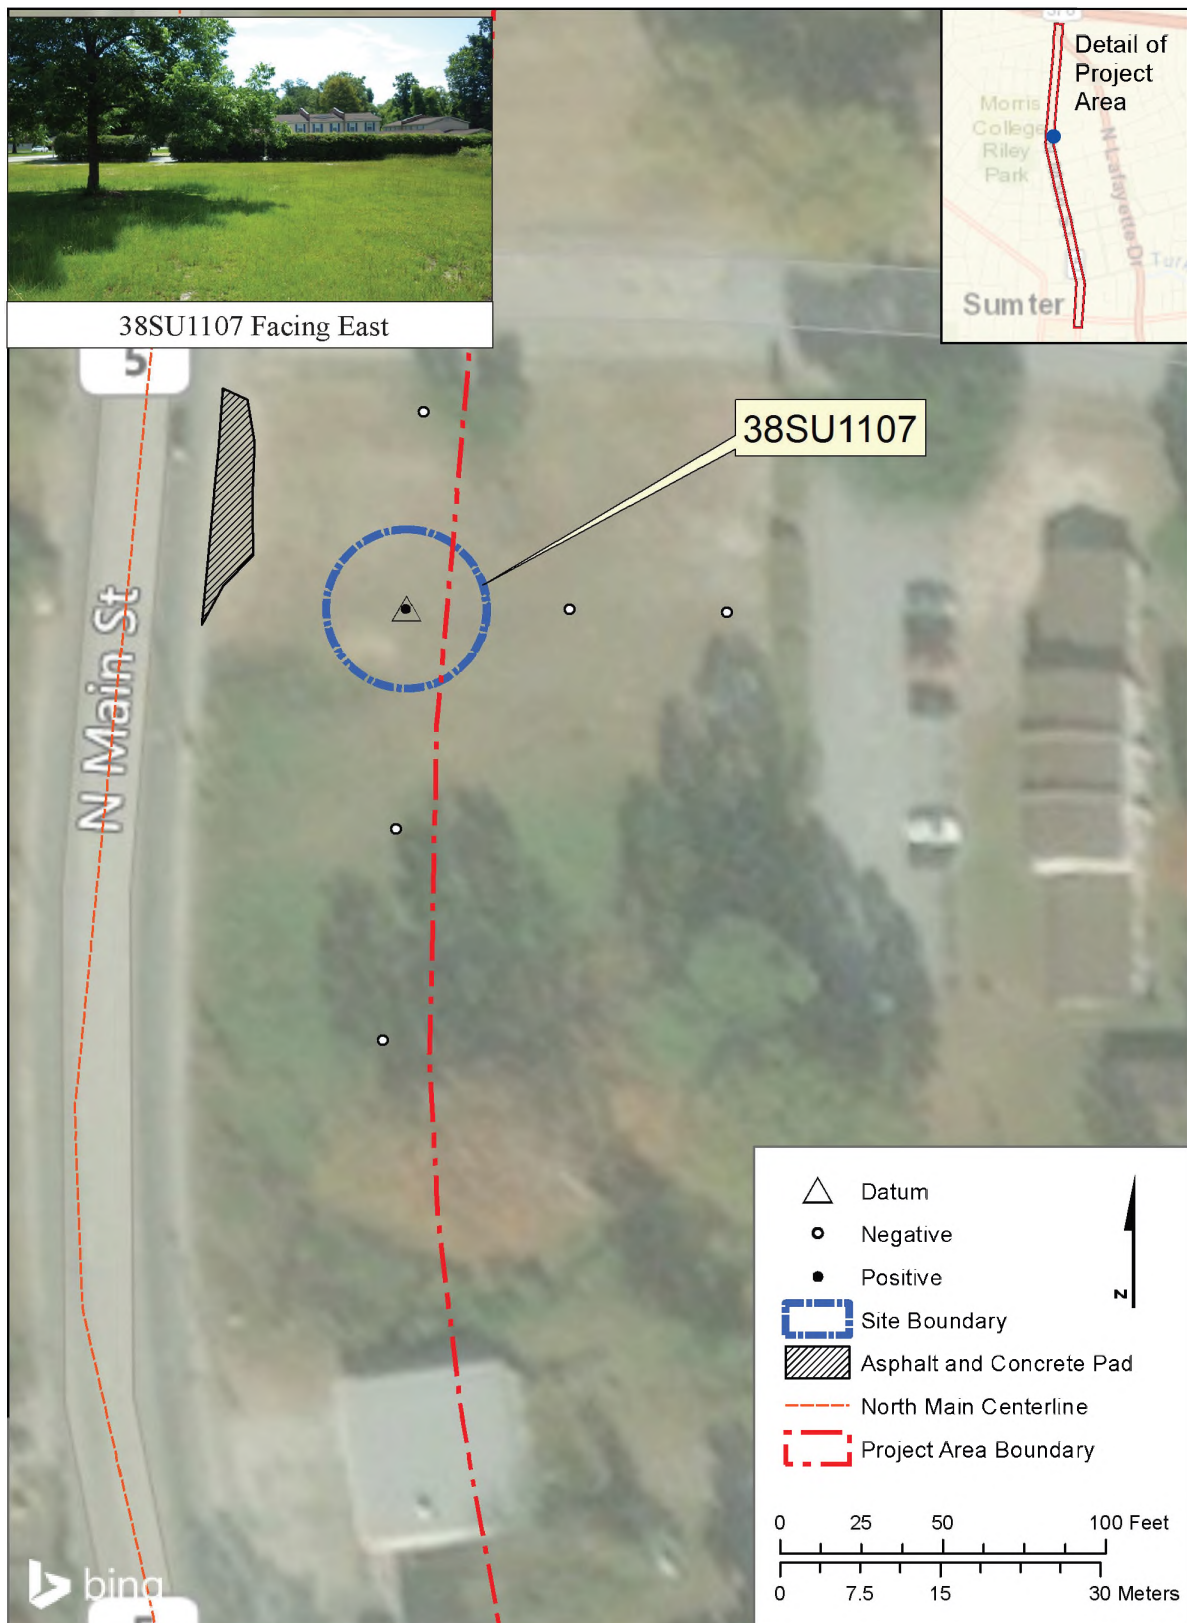
Figure 14.
Plan View and Photograph of 38SU1107

Cut nails have been manufactured since 1805 (Miller 2000). Wire nails post-date 1860 (Nelson 1968). Both types of nails were used as fasteners throughout the twentieth century. The presence of asphalt roofing shingles indicates the structure was constructed between 1917 and 1990 (Miller 2000).

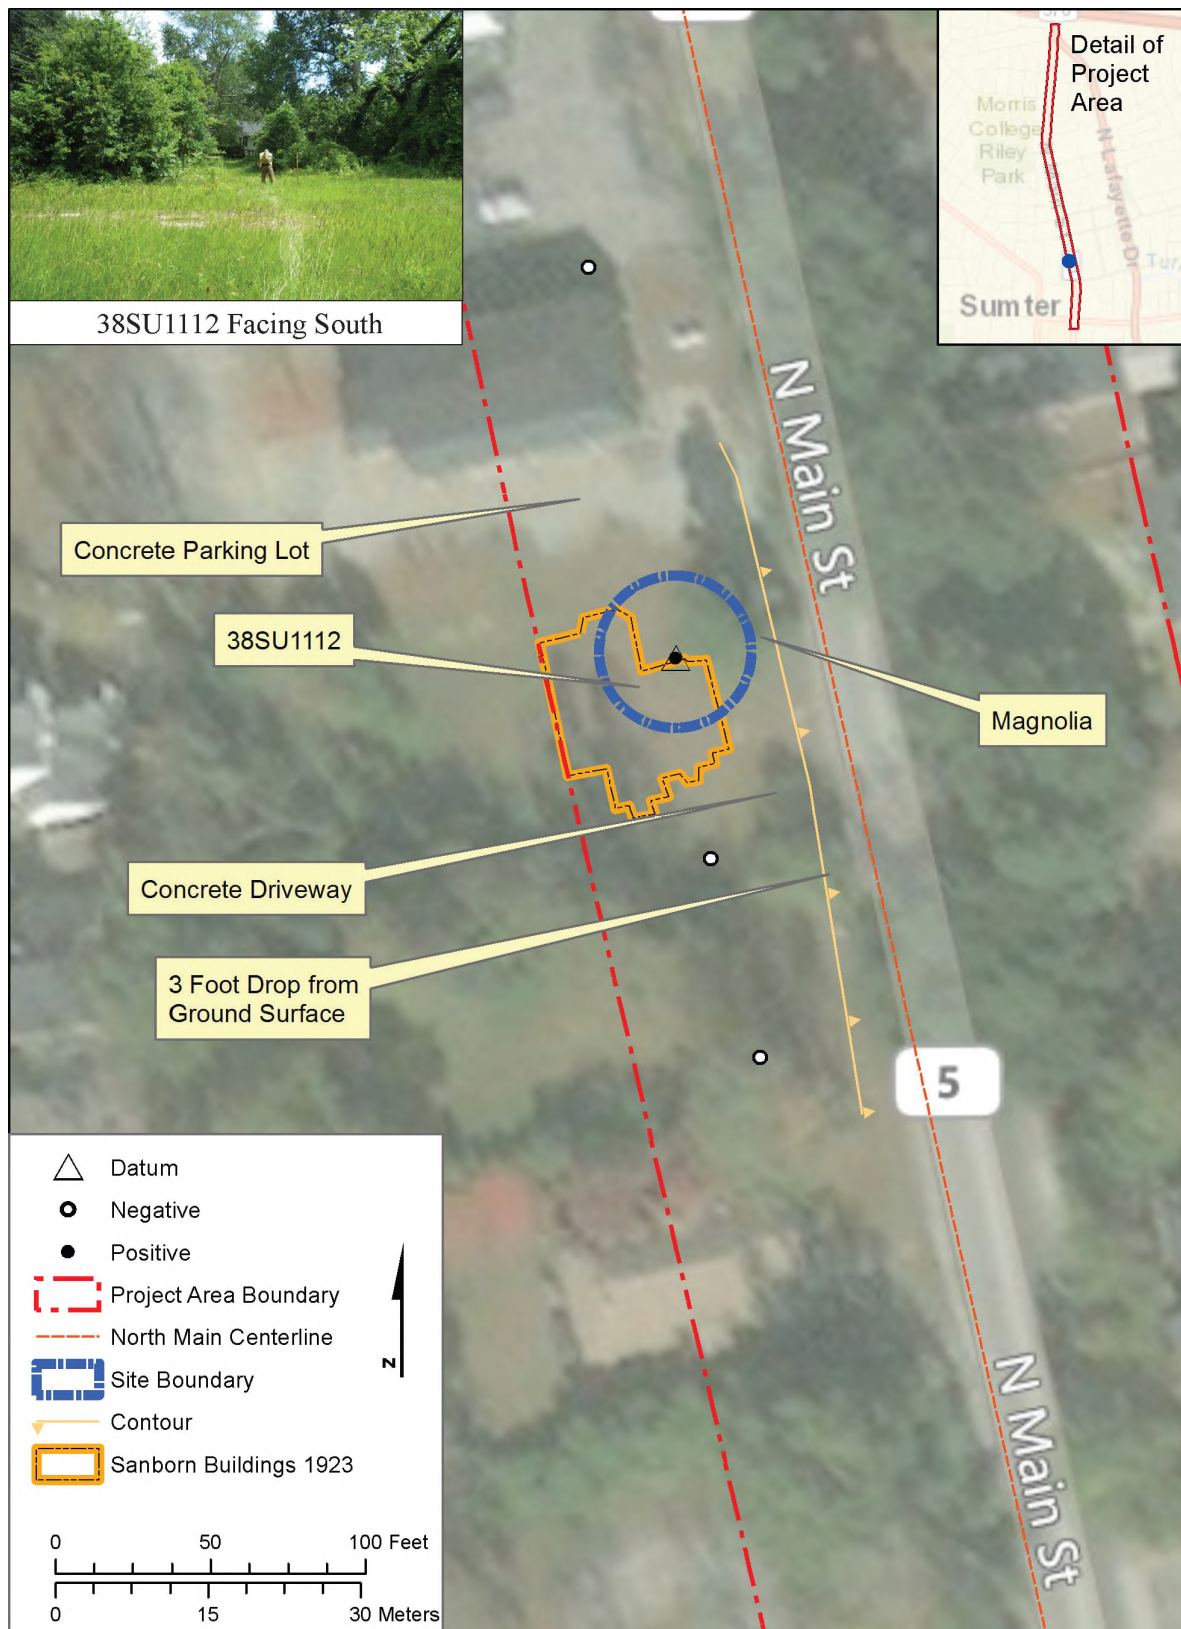
Figure 19.
Plan View and Photograph of 38SU1112

Five artifacts were collected from 38SU1112. This artifact collection includes four brick fragments and one piece of scallop-rimmed clear container glass. None of these artifacts assist in the dating of this artifact deposit.

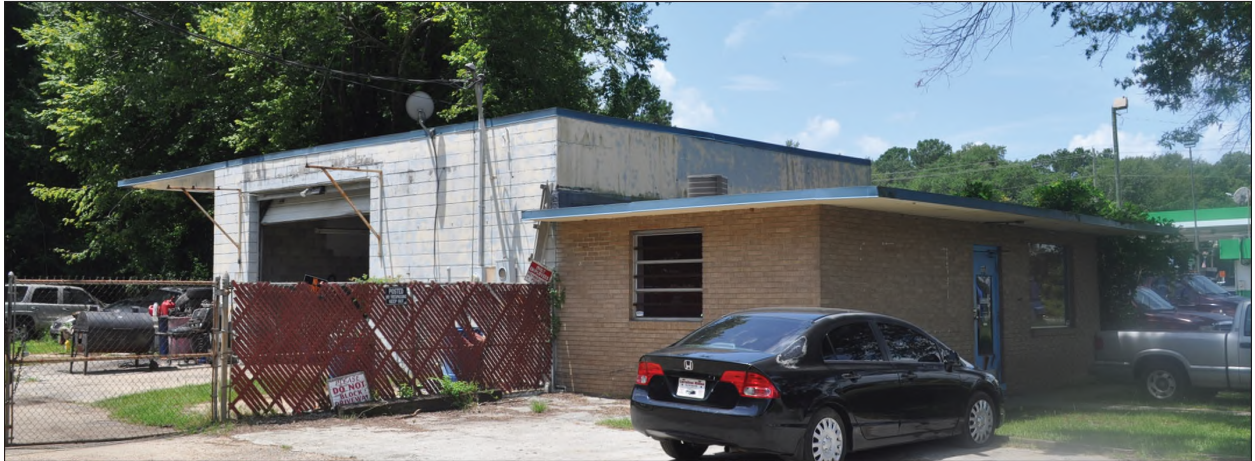
A. Northeast Oblique

Resource number U/85/2446 is located on the south side of South Pike East, east of the intersection with North Main Street (Figure 24). According to the tax assessor's record, this commercial building was constructed in 1963 and currently houses Isaac and Son Towing and Transportation. The one-story, rectangular office space is clad in brick veneer and features a flat roof with a wide overhang. The building has a metal-and-glass door and a fixed picture window on its façade, while each side elevation holds an aluminum awning window. A tall, concrete masonry unit (CMU) garage with a flat roof and wide rear elevation overhang covers the rear elevation of the office. The garage includes a single garage bay door on its east elevation.

Figure 24.
30 South Pike Street (U/85/2446)

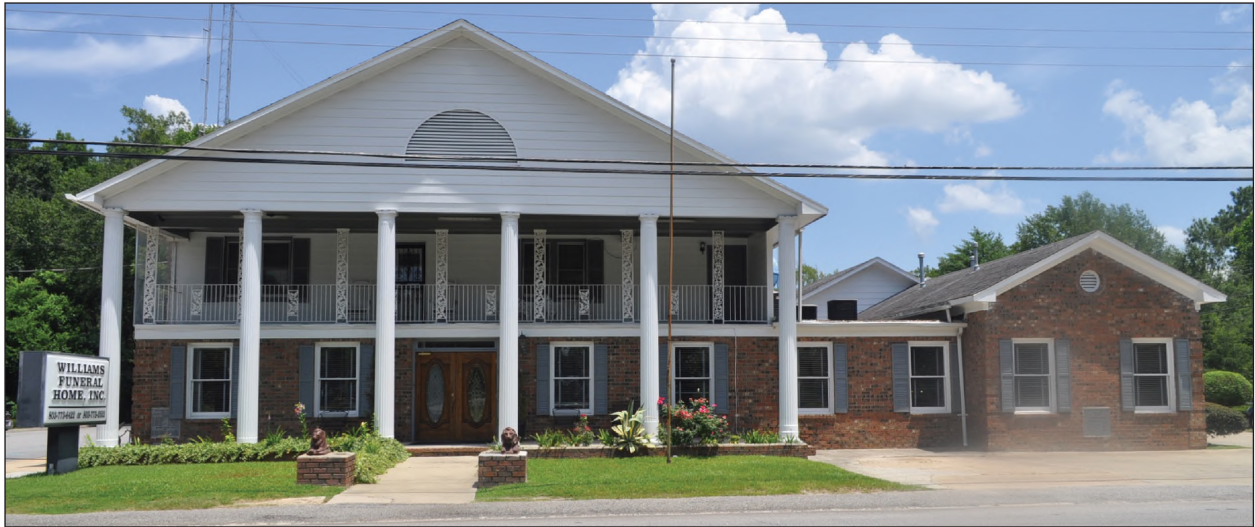
A. Façade (West Elevation)

Resource number U/85/2447 is located at 821 North Main Street, on the east side of the road, just north of the intersection with Phillips Street (Figures 25). According to the current owner, this two-story commercial building was constructed in 1945. It was originally organized as the Tribe Union Funeral Home. The home was established by a group of African American citizens of North Sumter to manage and carry out funereal requirements for their community's dead. It was the first such funeral home in North Sumter. The founding members included Reverend Robert Anderson, Reverend Richard Lloyd, Reverend R.M. Davis, Reverend Gable Tillman, Reverend M.J. Kirk, Deacon J.C. Capers, Reverend Frank E. Williams, Sr., Mr. Robert Anderson, Mrs. Addie Martin, Ms. Jenett Garner, and Mr. Murry Pinkney, Sr., under the leadership of Reverend John Wesley Williams, Sr. In 1947, the organization, then composed of Reverend John Wesley Williams, Sr., Reverend Frank E. Williams, Sr., Mrs. Clara P. Williams, Mrs. Annie M. Murray, Mrs. Katie S. Pinkney, Dr. L.W. Williams, Reverend Waddell A. Mack, and Reverend Richard Holliday, changed its name to Williams Funeral Home.. In 1970, Williams Funeral Home became the first African American business to join the Sumter Chamber of Commerce (Williams Funeral Home, Inc. 2008). The business remains in the Williams family and is owned today by the grandson of its founder.

The historic, two-story main massing is of masonry construction clad primarily in brick veneer on a concrete slab. The front-facing gable roof is covered in asphalt shingles, while the gable itself is covered in vinyl siding and a vinyl lunette gable vent. An engaged, two-story, full-façade porch carried by two-story fluted columns shields the entrance. Symmetrical, non-historic double doors flanked by two window bays each sit below a second-story, set back porch with a decorative wrought-iron railing and supports. The second-story façade and a portion of the south elevation are clad in vinyl. The north side elevation includes brick veneer-clad pilasters dividing window bays. Many windows on the main massing appear to be wood sash, but vary in one-over-one, six-over-six, and two-over-two horizontal. Fixed, wood, multi-light, stained-glass windows line the north elevation first floor. A single-story, non-historic gabled ell to the south extends via a hyphen from the main massing.

Figure 25.
Williams Funeral Home (U/85/2447 and U/85/2447.01)

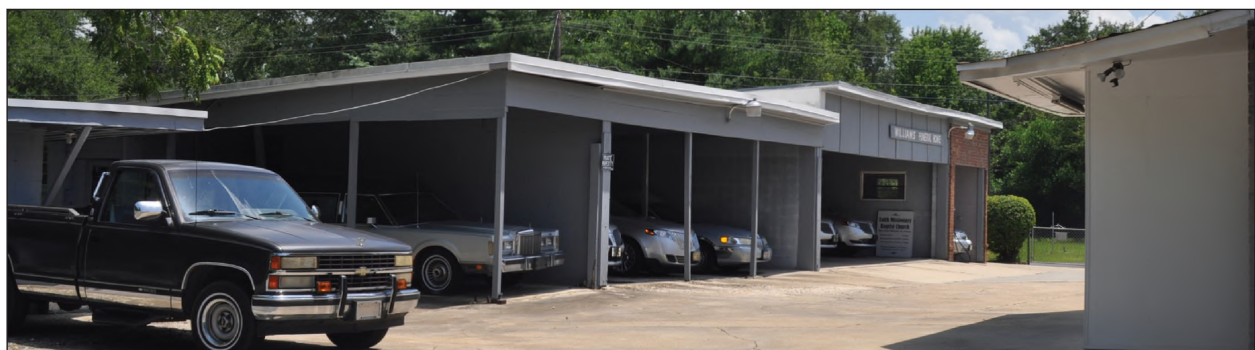
C. Northwest Oblique (U/85/2447.01)

The carport just east of the building includes six open bays, with one double bay to accommodate seven cars. CMU walls and slender metal poles support two shed roofs. To the south, a single and the double bay are partially enclosed in brick veneer and vertical plywood board.

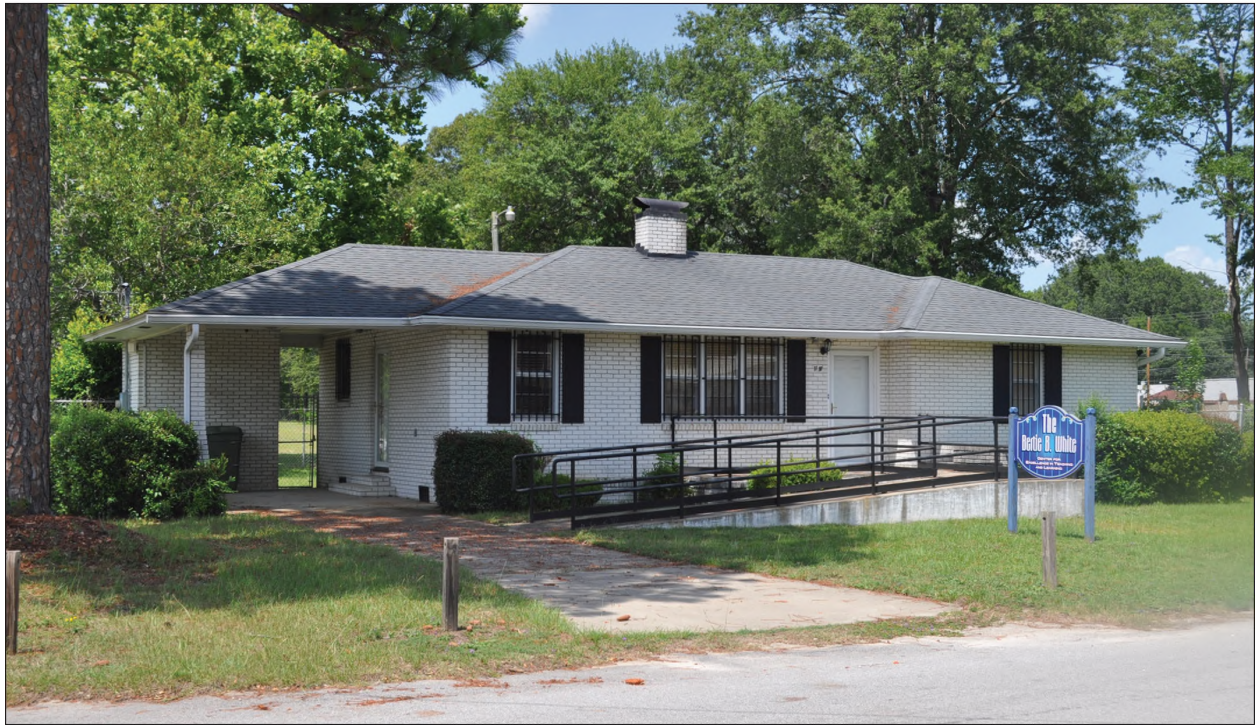
A. U/85/2448, Southwest Oblique

Resource number U/85/2448 is located on the north side of West College Street between North Main and Brown streets (Figure 26A). According to the tax assessor's record, this rectangular Linear-with-Clusters Ranch House was constructed in 1964. The former residence now serves as an educational building and houses the Bertie B. White Center for Excellence in Teaching and

Figure 26.
11 West College Street (U/85/2448) and 8 East Charlotte Avenue (U/85/2449)

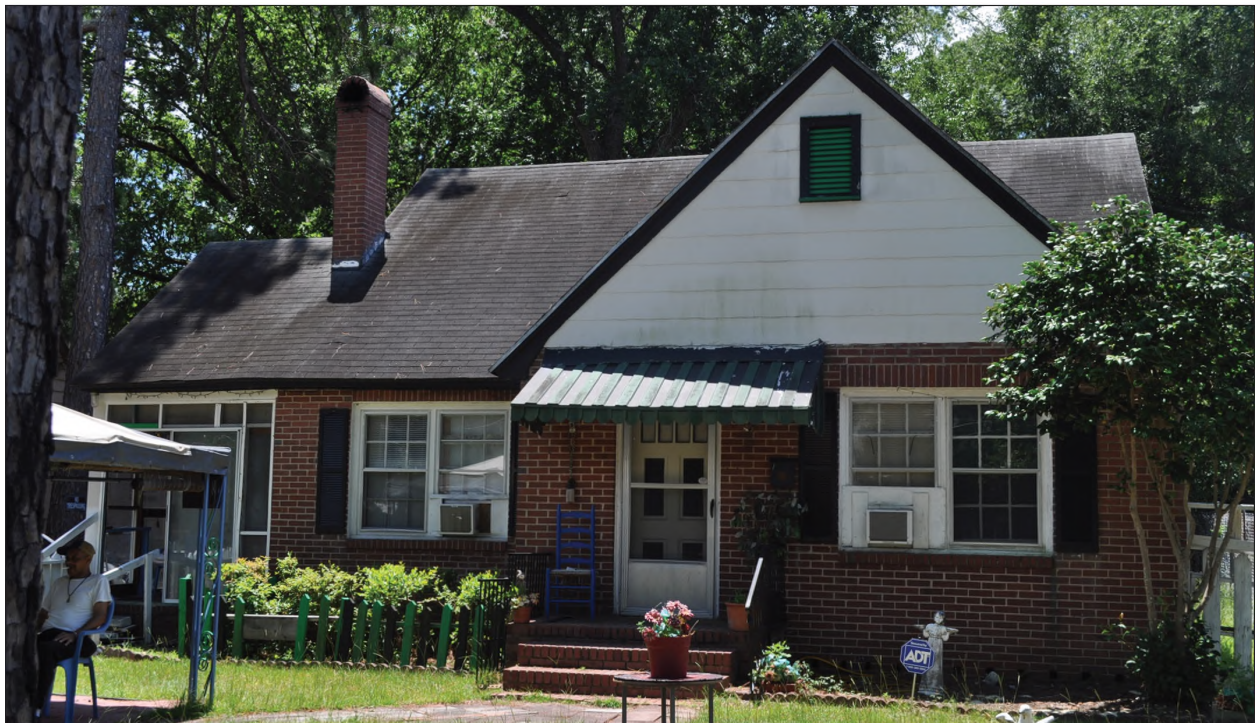
B. U/85/2449, Façade (North Elevation)

Resource number U/85/2449 is recommended not eligible for listing in the NRHP, as it was not found to be associated with any historic event or person of significance, nor is it an outstanding example of a Minimal Traditional residence. Therefore, the property is recommended not eligible under Criteria A, B, or C.

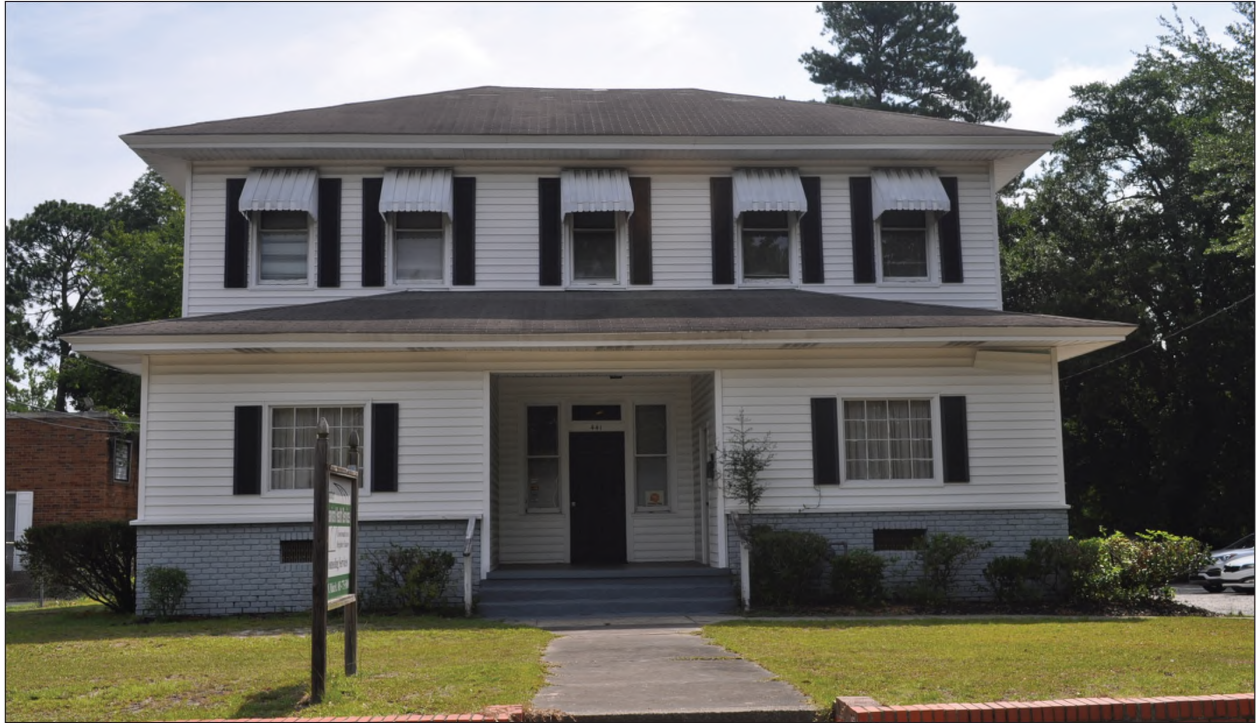
A. U/85/2450, Façade (West Elevation)

Figure 27.
441 North Main Street (U/85/2450) and 437 North Main Street (U/85/2451)

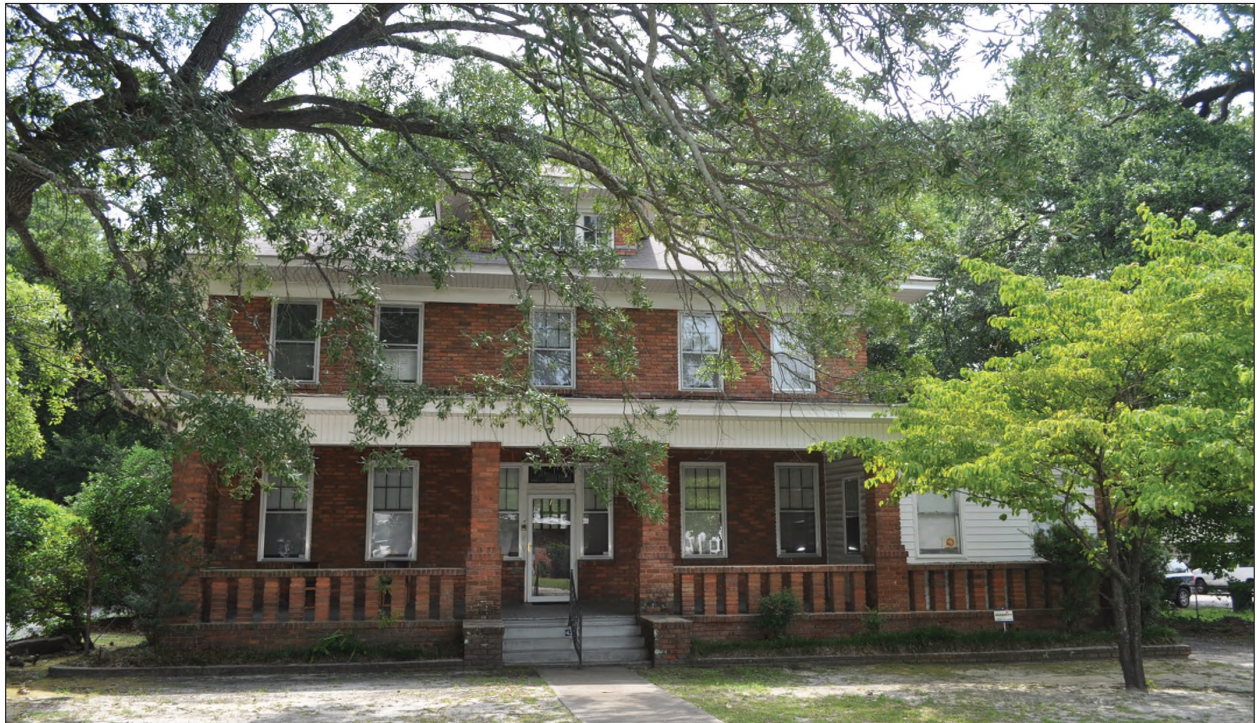
B. U/85/2451, Façade (West Elevation)

Resource number U/85/2451 is recommended not eligible for listing in the NRHP, as it was not found to be associated with any historic event or person of significance, nor is it an outstanding example of a Colonial Revival House. Therefore, the property is recommended not eligible under Criteria A, B, or C.

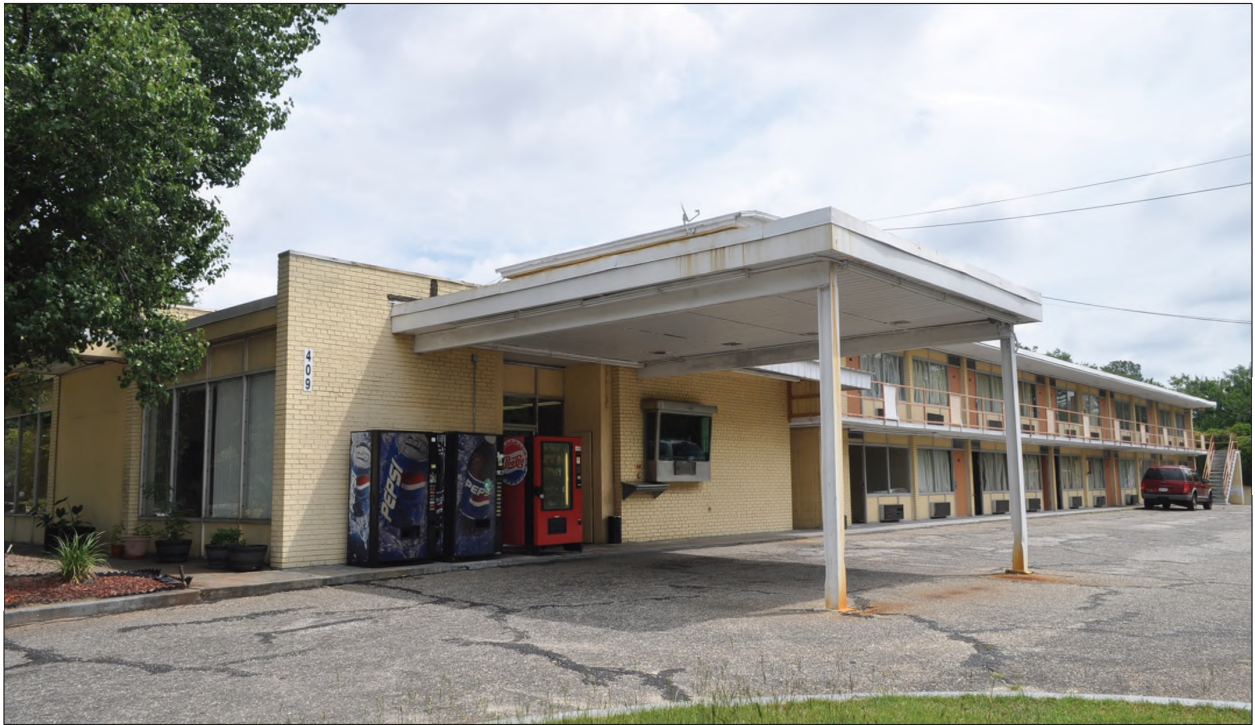
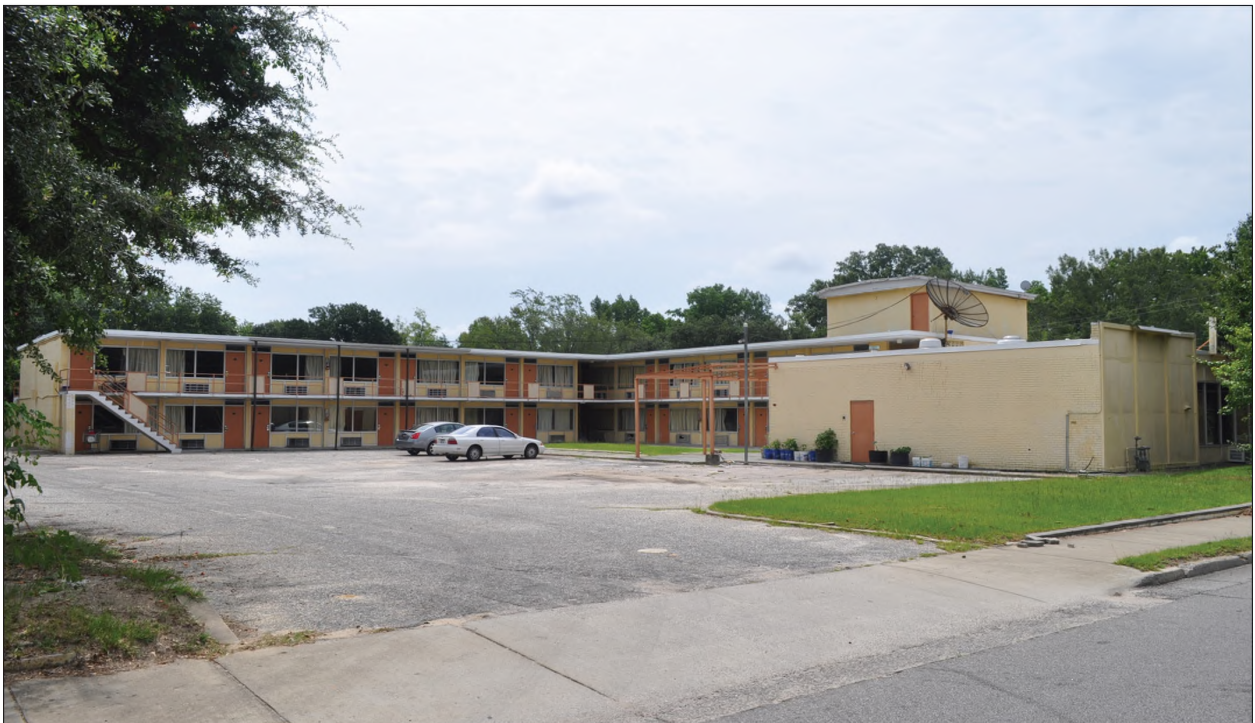
Figure 29.
409 North Main Street (U/85/2453)

A. Southwest Oblique

B. Northwest Oblique

Just north of this entrance is a metal night window. Guestrooms feature enameled metal panels, paired fixed aluminum windows, and metal doors below fixed aluminum transoms. The guestroom wing has a shallow-pitched gambrel roof addition covered in corrugated metal atop its roof that serves as a storage and equipment room.

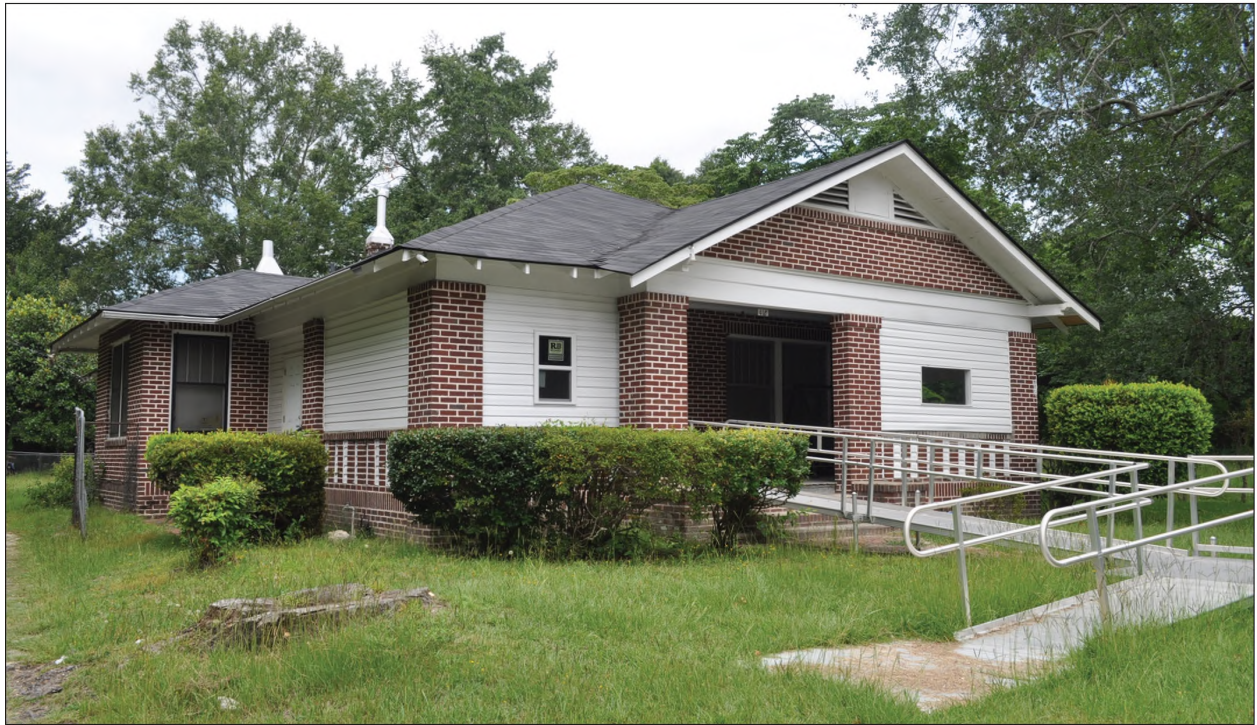
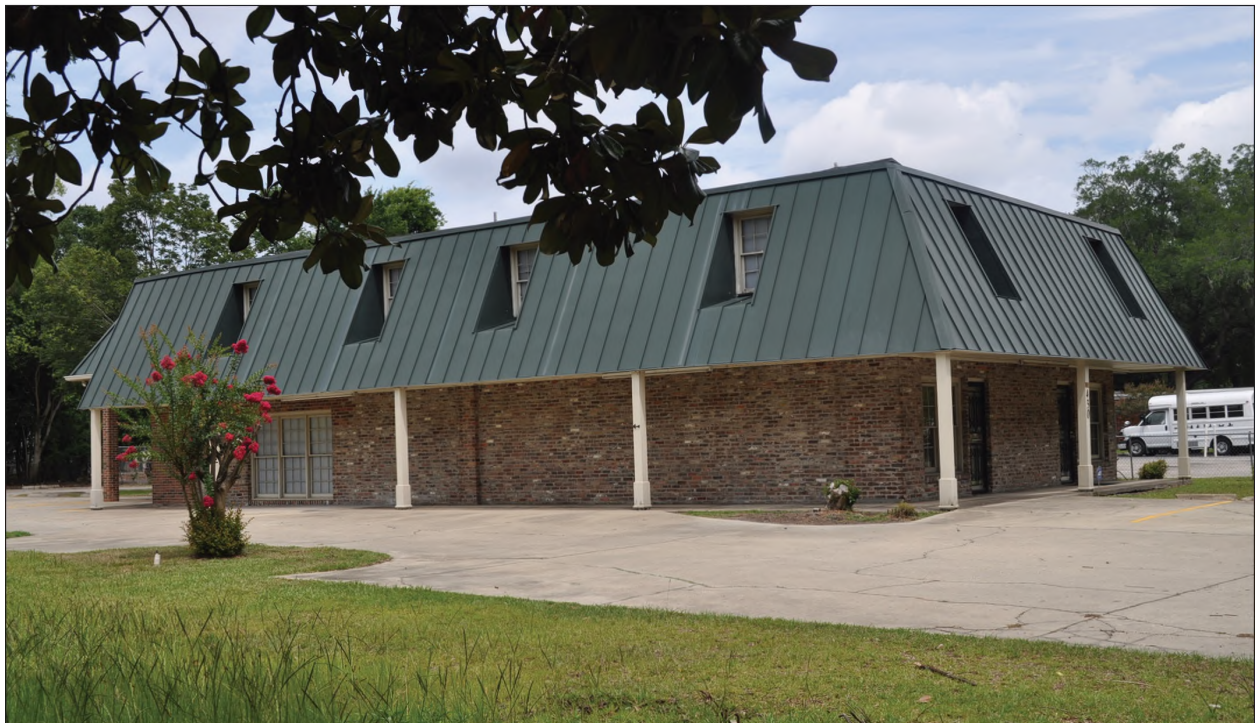
Figure 30.
418 North Main Street (U/85/2454) and 430 North Main Street (U/85/2455)

A. U/85/2454, Southeast Oblique

B. U/85/2455, Southeast Oblique

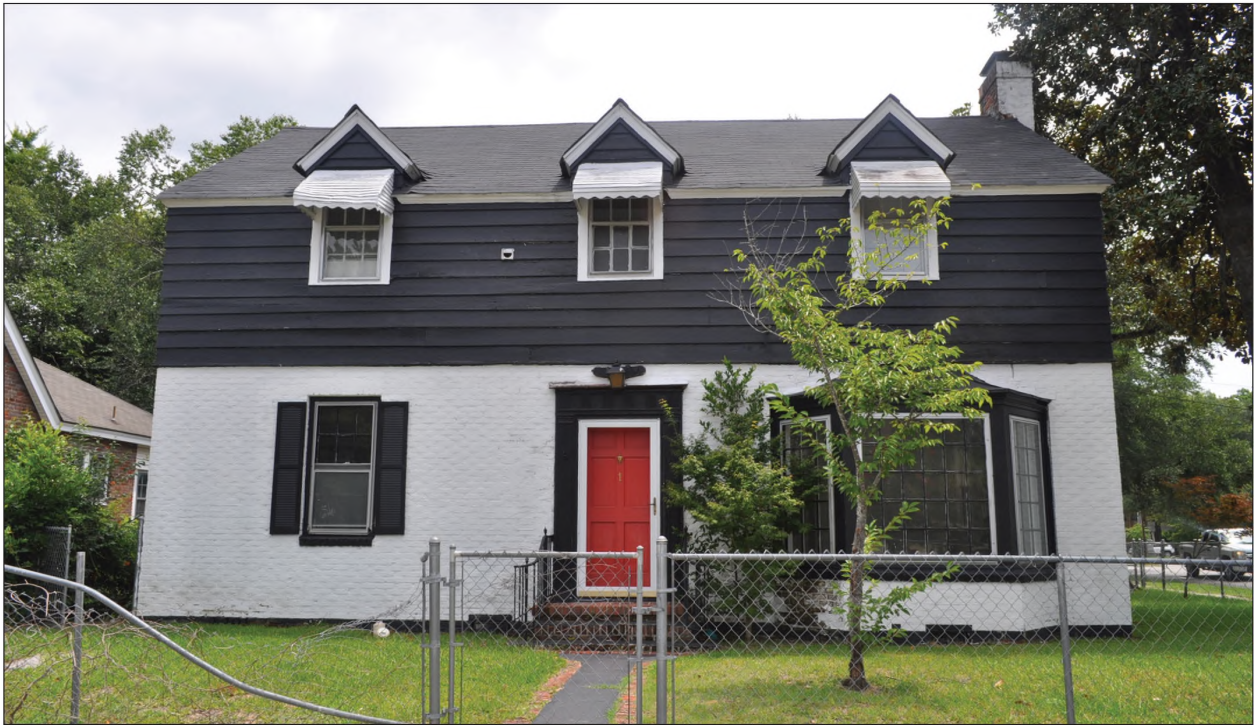
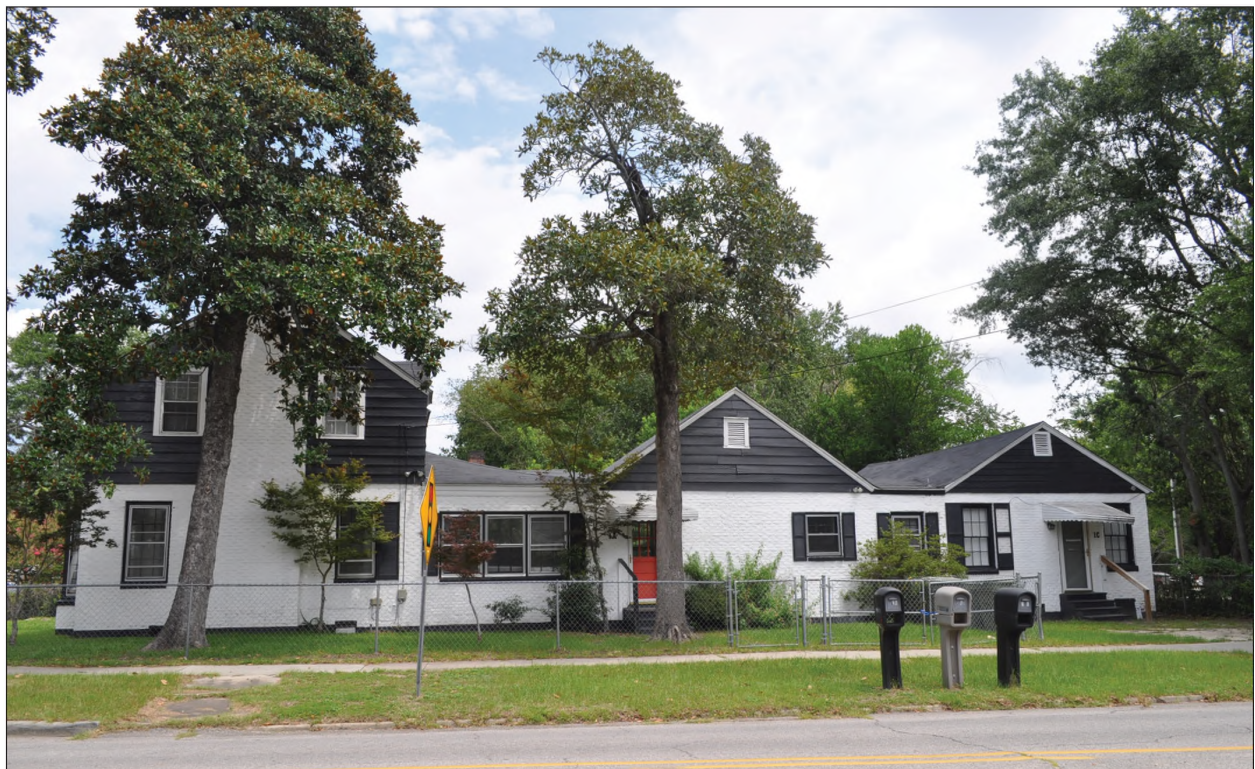
Figure 31.
1 Warren Street (U/85/2456)

A. West Elevation

Resource number U/85/2456 is recommended not eligible for listing in the NRHP, as it was not found to be associated with any historic event or person of significance, nor is it an outstanding example of a mid-twentieth century house. Therefore, the property is recommended not eligible under Criteria A, B, or C.

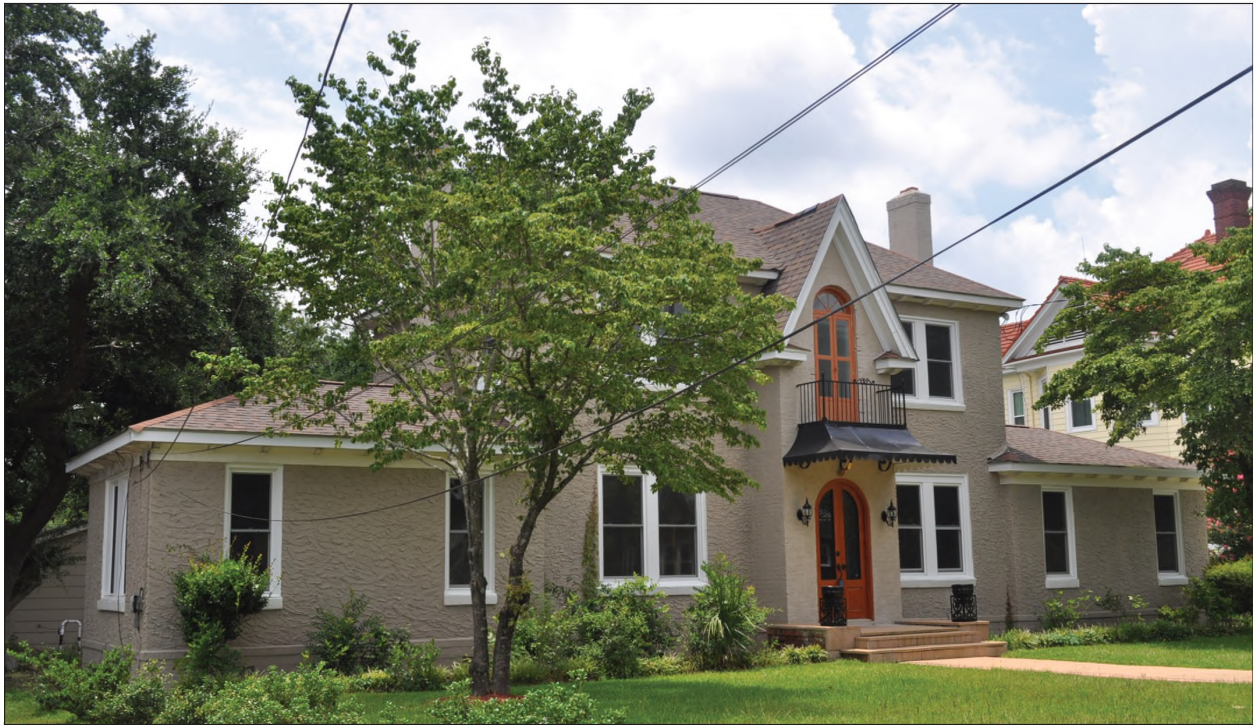
A. U/85/2457, Northeast Oblique

Figure 32.
16 Warren Street (U/85/2457) and 12 Warren Street (U/85/2458)

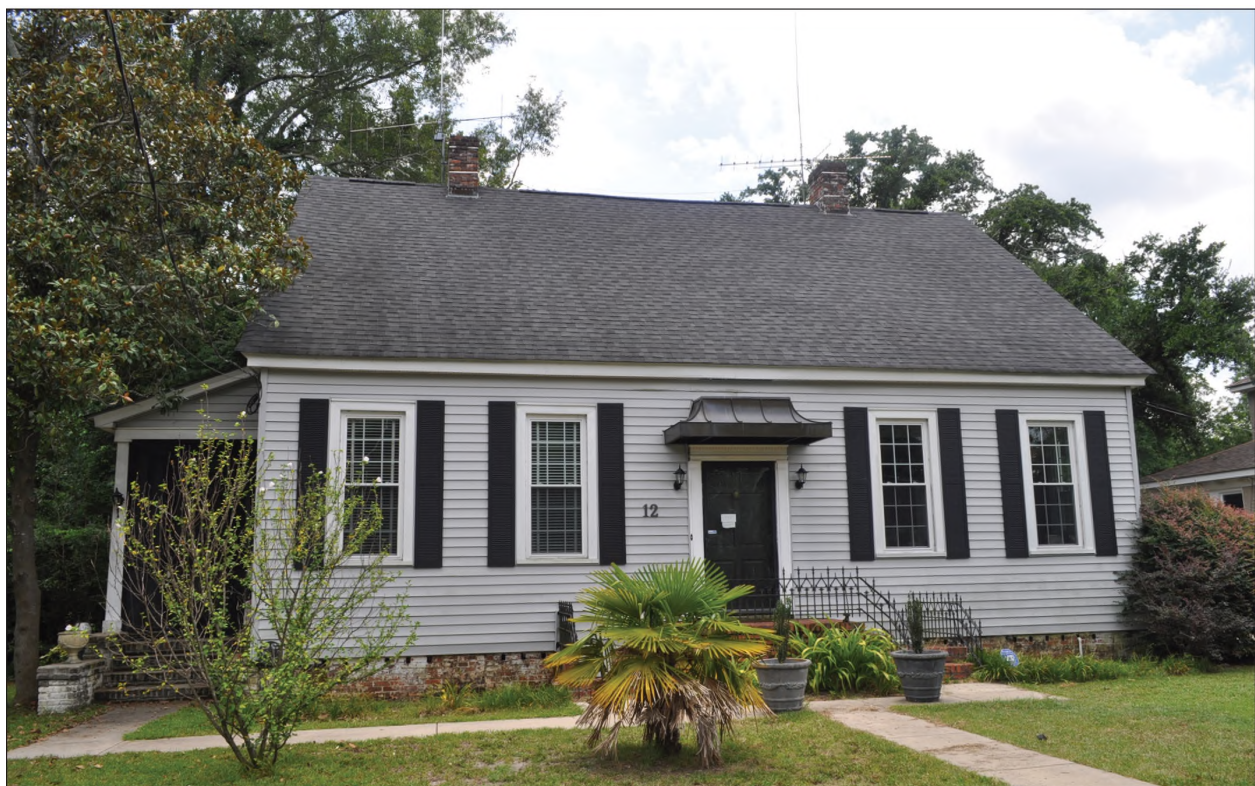
B. U/85/2458, Façade (North Elevation)

Resource number U/85/2458 is located on the south side of Warren Street, between North Main and North Washington streets (Figure 32B). According to the tax assessor's record, this one-story, rectangular, central hall Colonial Revival Cottage was constructed in 1930. The wood frame building is covered in vinyl siding and has a lateral gabled roof with gable returns where additions aren't present. The roof is clad in asphalt shingles and includes two symmetrically set brick chimneys in the ridgeline. The gable ends include large, rectangular vinyl vents.

The house is accessed via a gate in a historic cast-iron fence set atop a low brick wall with brick corner piers. A paved sidewalk leads to a straight double staircase stoop constructed of brick and lined by a low cast-iron railing. The centrally set wood panel door sits behind a vinyl storm door within a classical surround below a metal hood. The paved sidewalk continues to the east elevation of the house to a secondary entrance atop another brick stoop that is shielded by a shed roof with slender tapered supports. Flanking the main entrance are two sets of window bays, each with sash windows that have been replaced in vinyl. Matching windows are found throughout the building. Along the west elevation is bay window with a string of vinyl sash windows as well as a third entrance into the house set into a rear shed addition. This shed addition has its own exterior brick chimney on the rear elevation.

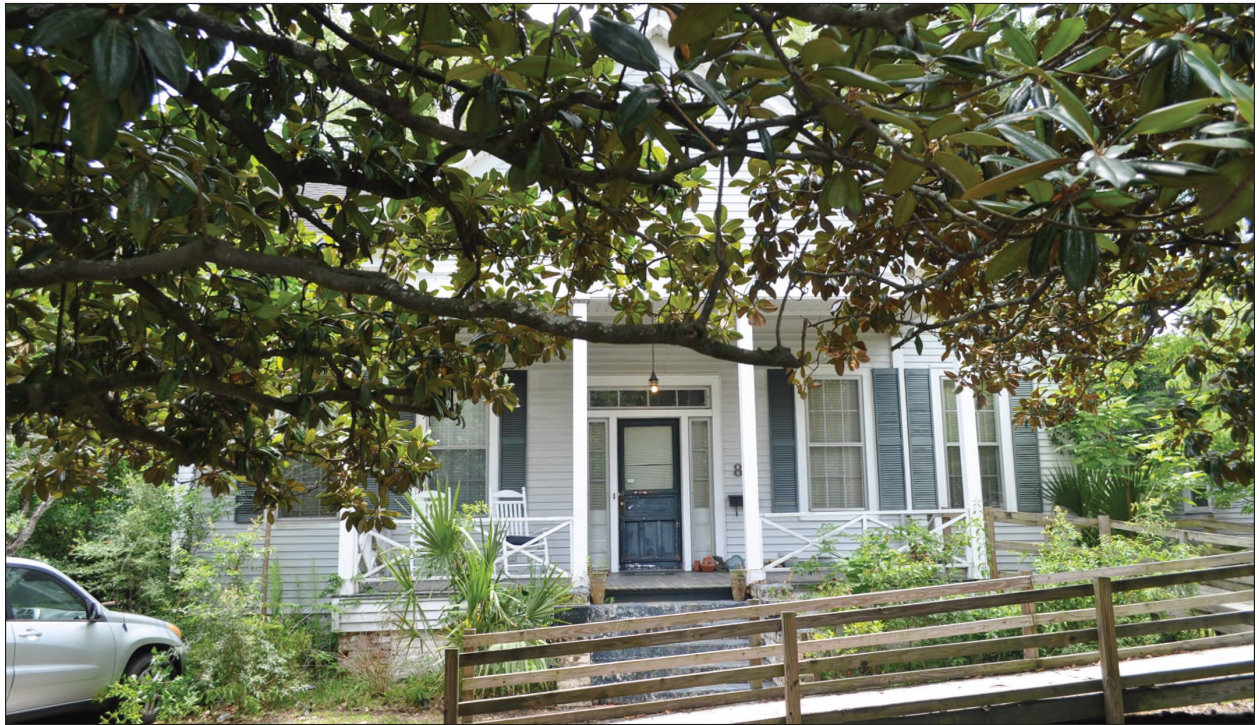
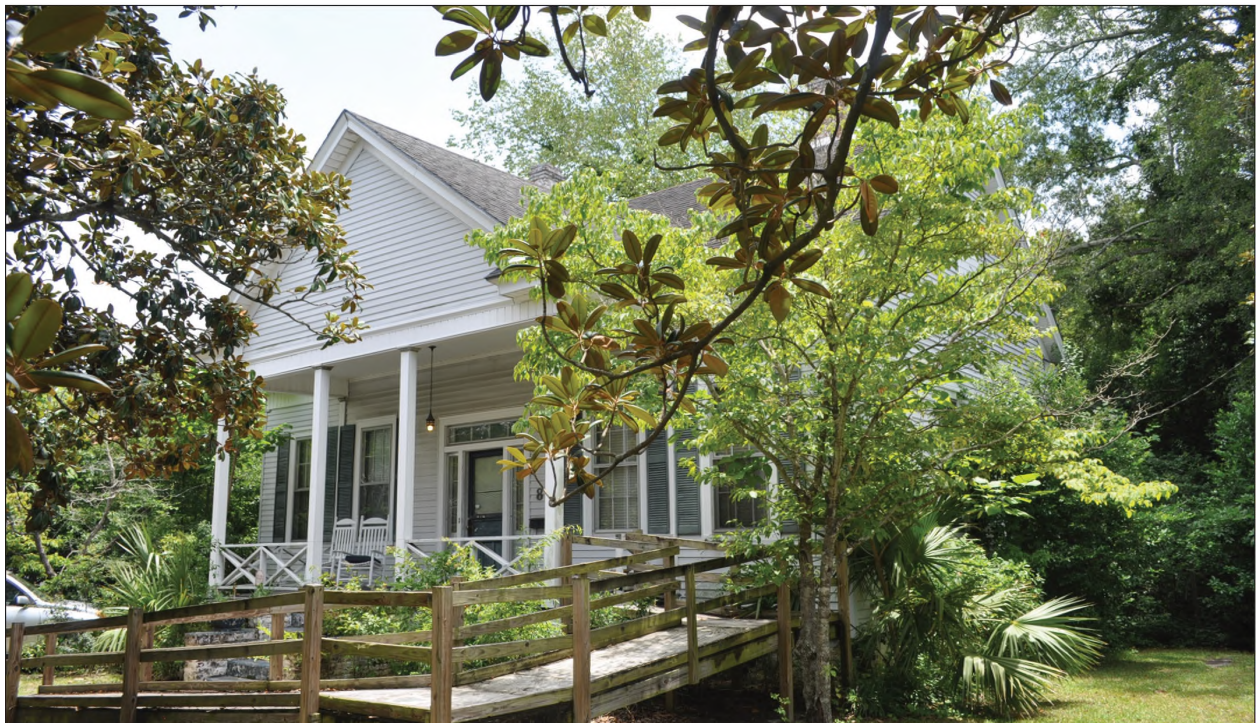
Figure 33.
8 Warren Street (U/85/2459)

A. Façade (North Elevation)

B. Northwest Oblique

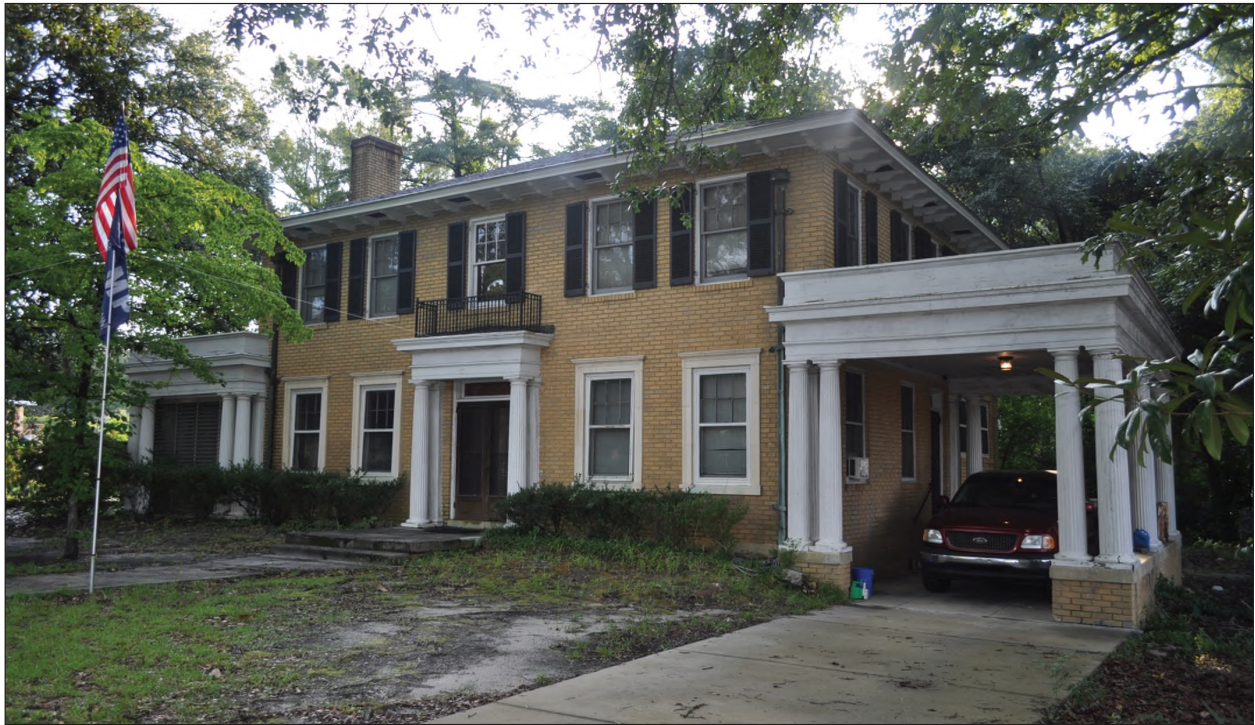
A. Northwest Oblique

Resource number U/85/2463 is located on the southeast corner of North Main Street and Loring Drive (Figure 36). According to the tax assessor's record, this two-story, T-shaped Colonial Revival House was constructed in 1935. The wood frame building is clad in brick veneer and the main massing has a hipped roof covered in slate tile shingles with wide overhangs lined in wood brackets. An exterior brick chimney is located on the east side elevation of the main massing and a second exterior brick chimney is attached to the rear elevation of what appears to be a very early rear, one-story, flat-roof addition or original extension.

A paved walkway leads from the sidewalk to a centrally set main entrance composed of double French doors behind double wood screen doors below a transom window. The door sits atop a shallow stoop with two low steps, within a classical surround with fluted columns that supports a Juliet balcony with a low iron railing. The symmetrical, five-bay façade includes six-over-one wood sash windows hung alone, with first-floor windows set in simple wood surrounds. Windows throughout the building match those on the façade and are hung both alone and in pairs. Working louvered wood shutters flank second-floor windows.

Figure 36.
331 North Main Street
