Phase I Cultural Resource Survey for the North Main Street Corridor Revitalization Project

Sumter County, South Carolina

New South Associates, Inc.

November 5, 2018 • **Third Revised Draft Report**
New South Associates Technical Report 2768

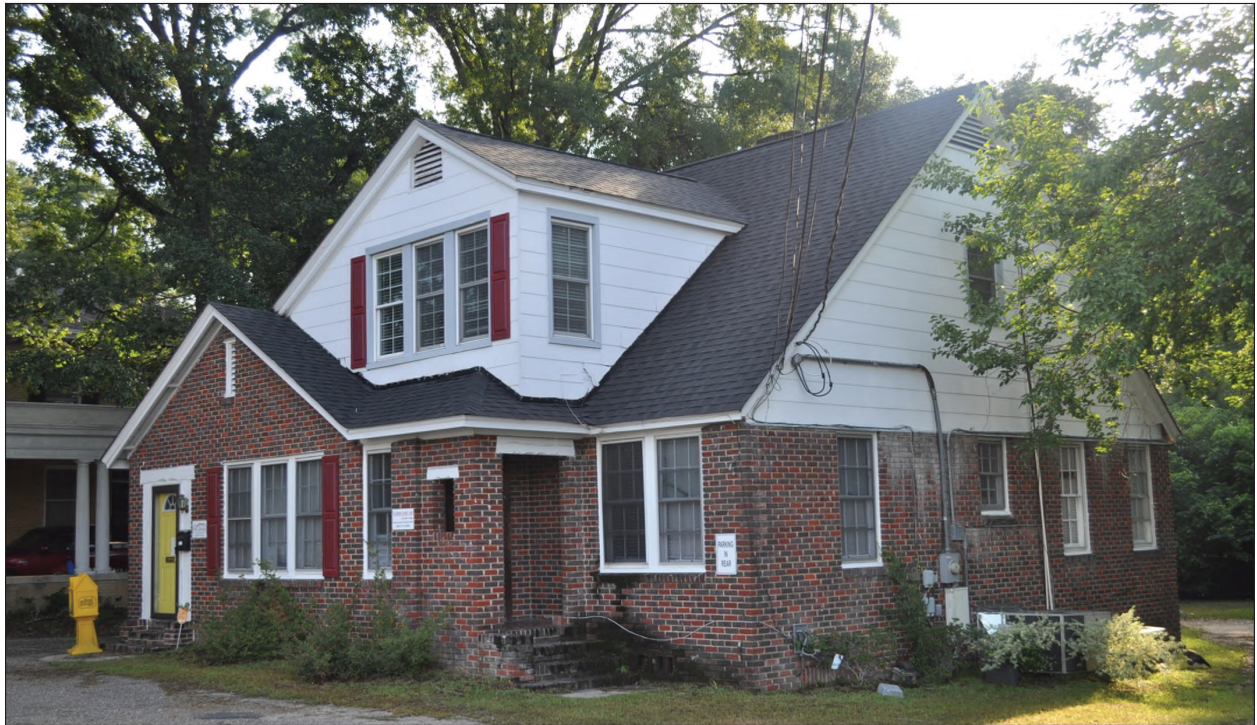
A. U/85/2464, Southwest Oblique

Resource number U/85/2464 is located on the east side of North Main Street, south of Loring Drive (Figure 37A). According to the tax assessor's record, this roughly rectangular, one-and-a-half-story Minimal Traditional house was constructed as a dwelling in 1960. The property is now an office building divided into two businesses. The wood frame resource is clad in brick veneer and sits below a cross-gabled, eaveless roof covered in asphalt shingles. A large, second front-facing gable has been added above the existing front-facing gable at the juncture of that gable and the main massing roof. The main massing gable ends and the gable addition are clad in aluminum siding.

Figure 37.
327 North Main Street (U/85/2464) and 323/325 North Main Street (U/85/2465)

The west-facing entrance sits in the front-facing cross gable and consists of a vinyl paneled front door behind a vinyl storm door set in a vinyl surround. The door is accessed by a low, shallow brick stoop. The north elevation of the cross gable is filled in with stucco and a single vinyl window, suggesting that this cross gable may have originally at least partially contained an open porch. A secondary entrance sits within a single-bay, engaged porch in the cross gable that faces south.

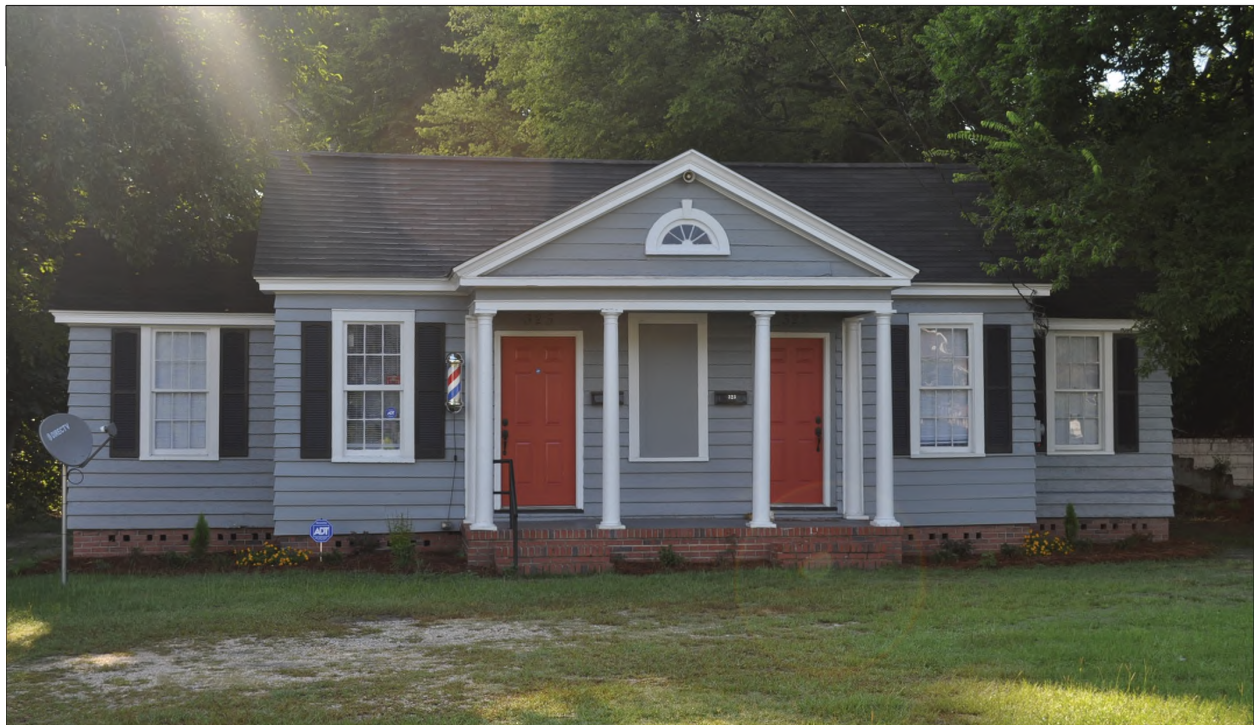
B. U/85/2465, Façade (West Elevation)

Resource number U/85/2465 is located on the east side of North Main Street, south of Loring Drive (see Figure 37B). According to the tax assessor's record, this historically rectangular, one-story building was constructed as a dwelling in 1960. The building may have been constructed as a duplex, but that possibility is unclear. The property now serves as a barbershop and houses a second address with an unknown use. The wood frame resource is clad in wood weatherboard and sits below a lateral gabled roof with gable ends that is covered in asphalt shingles. At each side elevation of the main massing is a gabled extension that was likely original to the building. Two gabled additions are attached to the rear elevation.

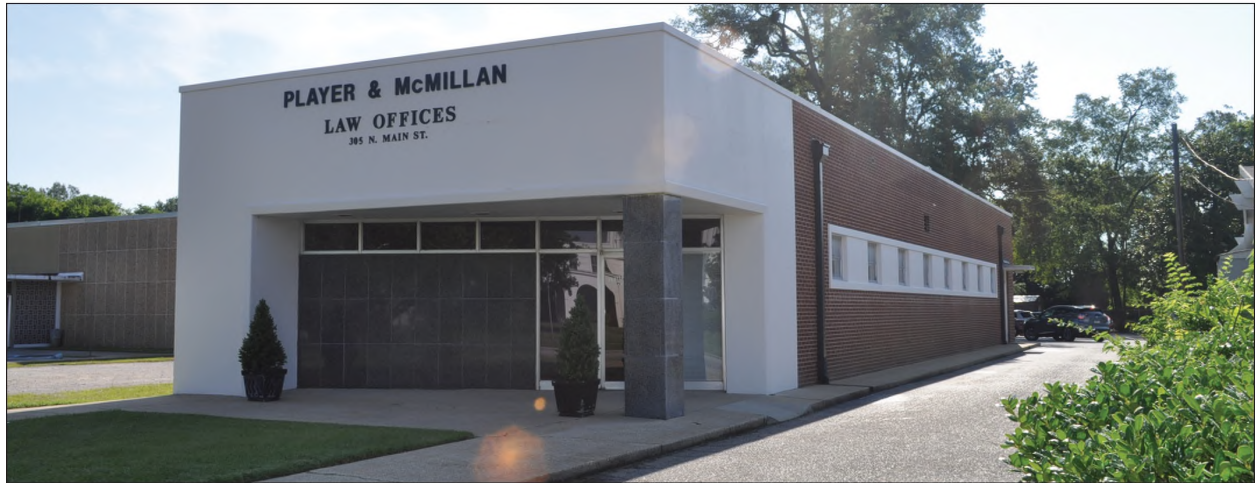
A. Southwest Oblique

Resource U/85/2469 is located on the east side of North Main Street between Ricker Lane and Calhoun Street (Figures 43-44). According to the tax assessor's record, this one-story, rectangular International Style building was constructed in 1960. It is currently in use as a law office. The resource has a flat parapet roof with a line of shallow coping both at the main massing roofline and framing the engaged porch. The CMU-framed building has a lightly scored stucco and black marble veneer façade, with secondary elevations clad in brick veneer. The asymmetrical façade features an offset entrance inset at an angle with a metal-and-glass door flanked by wide aluminum sidelights. A band of aluminum clerestory windows spans the full inset porch. Below the clerestory and north of the entrance bay is an unadorned wall of black marble veneer set in divided vertical panels. A single, heavy squared post covered in matching black marble carries the engaged porch. While the north elevation features an unadorned expanse of brick veneer, the south elevation hosts a string of aluminum awning windows inset within and divided by a line of stucco and a single secondary

Figure 43.
305 North Main Street (U/85/2469)

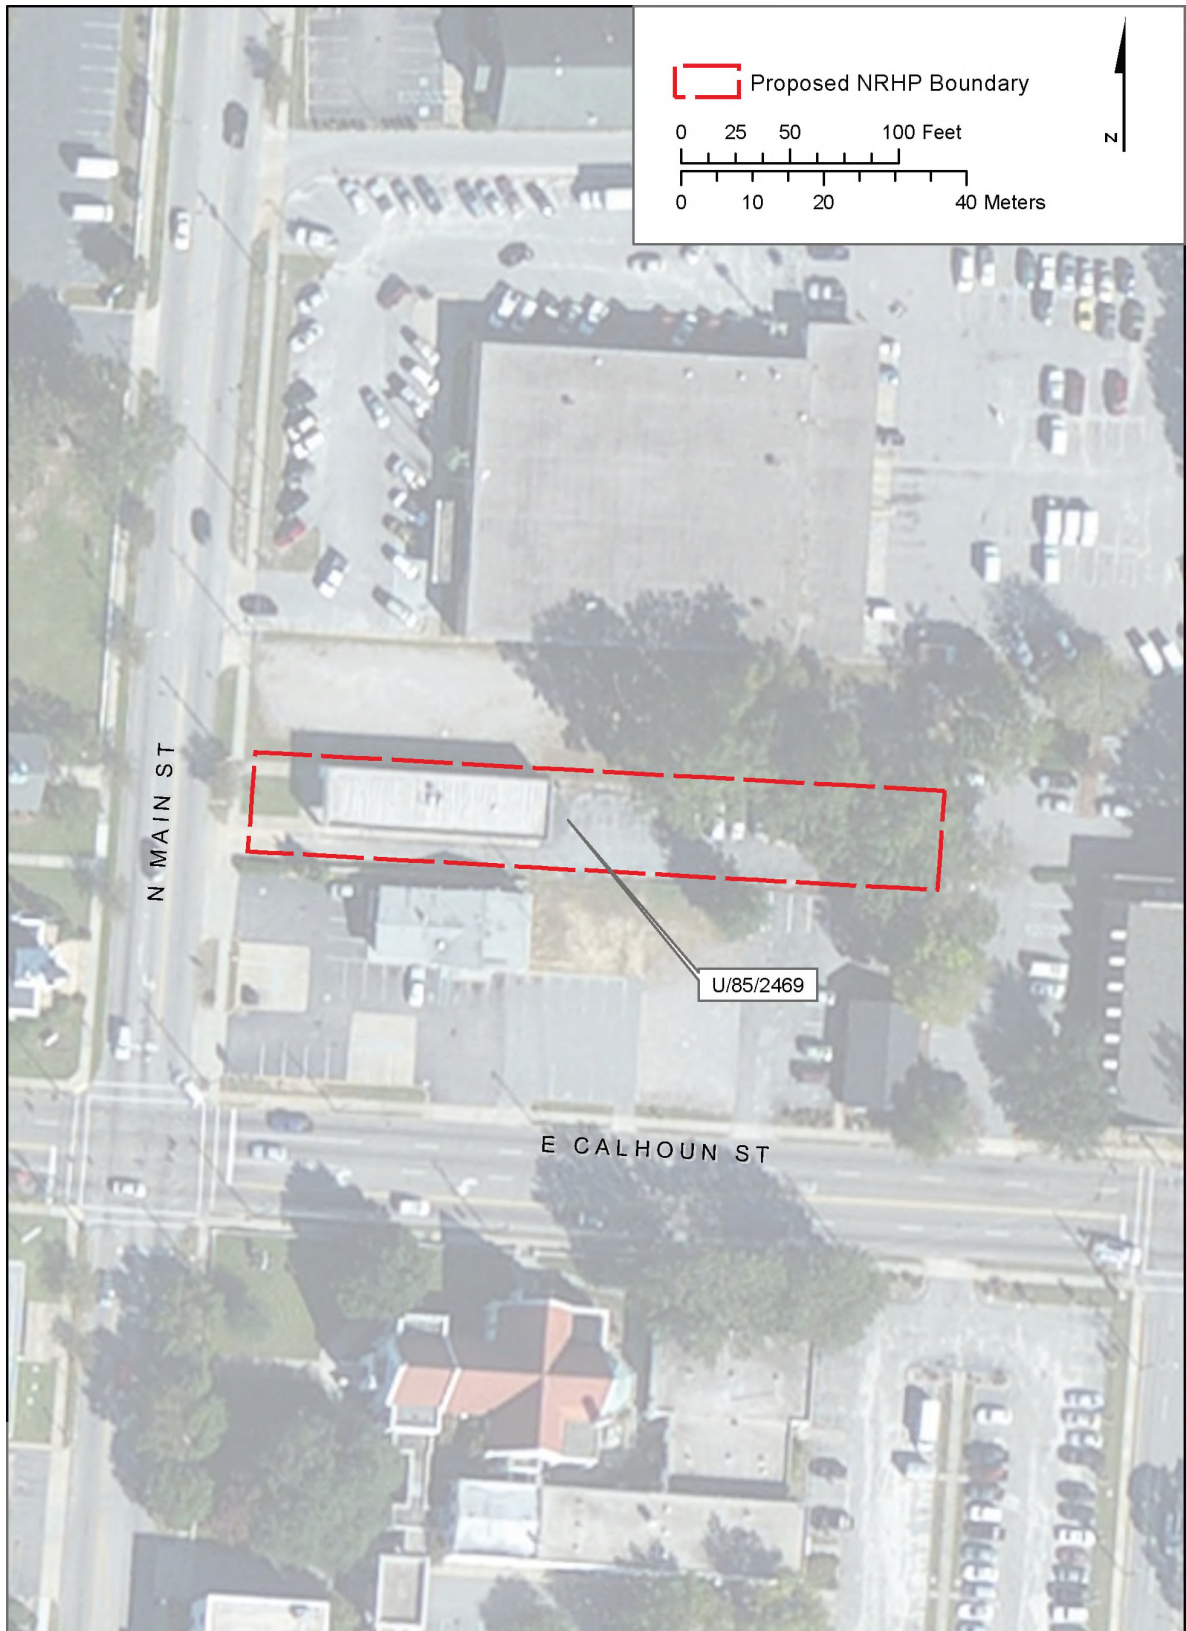
Figure 44.
Project Area and Proposed NRHP Boundary for 305 North Main Street (U/85/2469)

The proposed boundary for this property roughly conforms to the boundary of Sumter County Tax Parcel Number 2490803039 (Figure 44). The boundary includes roughly 0.33 acre and includes the office and its immediate landscape.

Avoidance of this resource is recommended during the proposed project work. If ROW were taken on the east side of North Main Street east of the sidewalk at this location, the proposed project would have an adverse effect on the recommended eligible property. Construction associated with the proposed project that requires removal of any contributing features of the proposed NRHP boundary would have an adverse effect on the setting and feeling of the property.

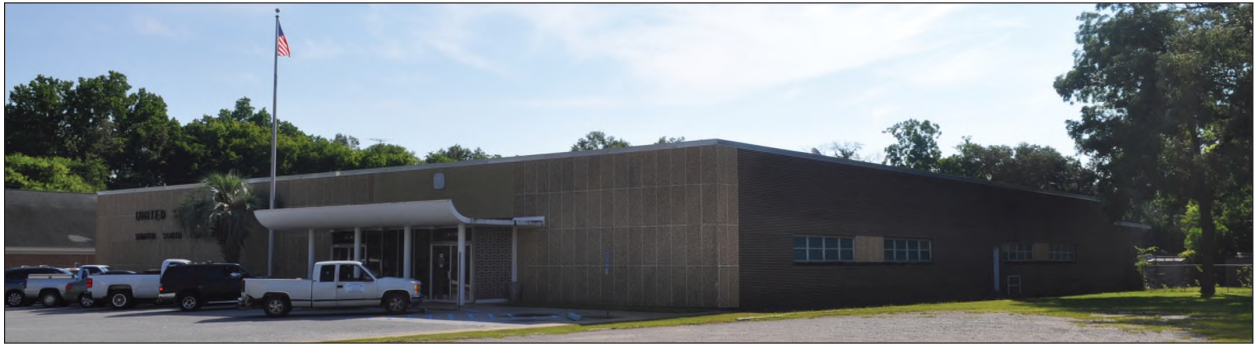
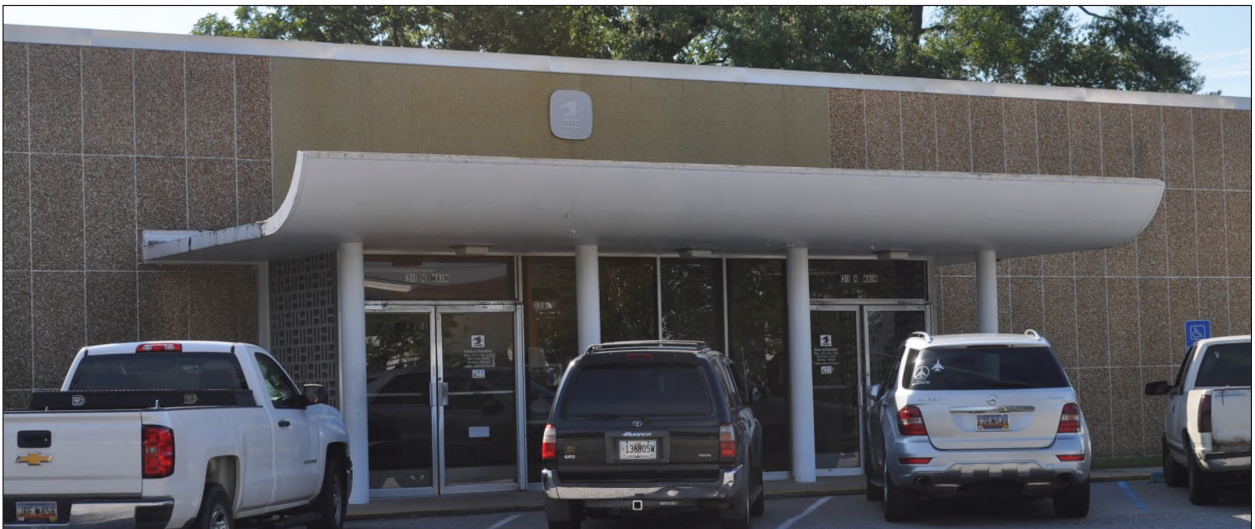
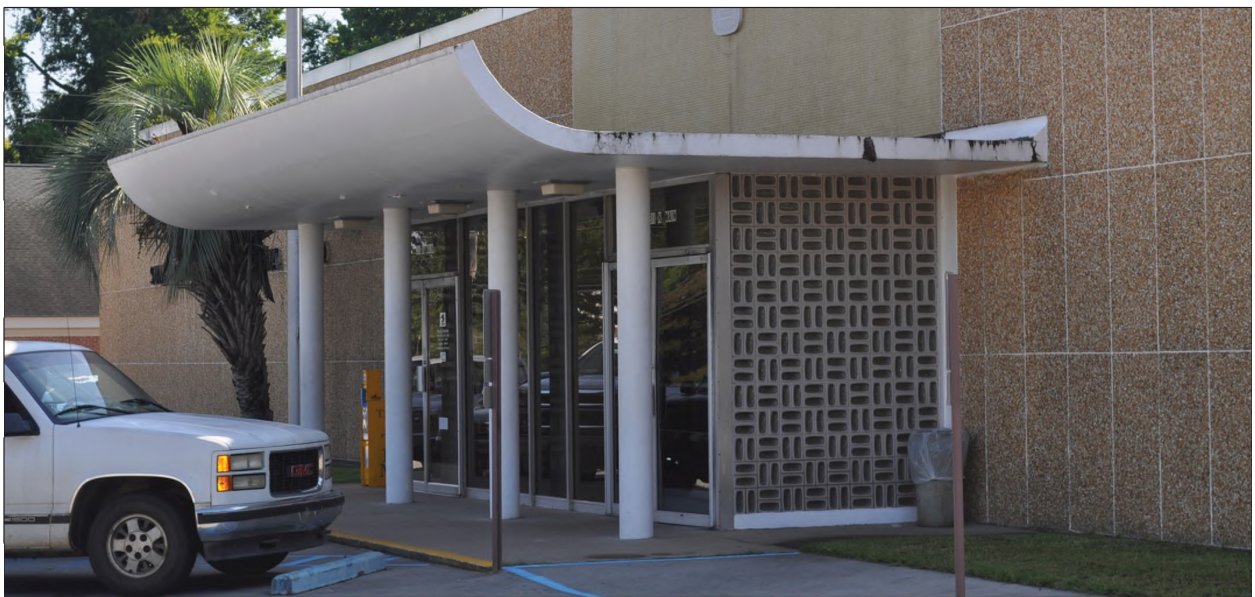
Figure 45.
United States Post Office (U/85/2470), 1 of 2

Resource U/85/2470 is located at 309 North Main Street, on the east side of the street between Ricker Lane and Calhoun Street (Figures 45-47). According to the tax assessor's record, this large, one-story, flat-roof, roughly rectangular-shaped International Style building was constructed in

1964. The CMU-framed building is covered in pebbledash stucco on the façade and brick veneer. The asymmetrical façade features an offset entrance marked by a concrete overhang that slopes upward at its edge. Rounded supports carry this roof above a vestibule with two sets of double metal-and-glass doors, transoms, and plate glass windows. CMU-and-glass screens mark the north and south ends of the vestibule. The remainder of the façade is clad in scored panels of vertical pebbledash and historic lettering indicating the building's use and location. The elevation is otherwise unadorned and includes no additional bays. Side elevations include bands of aluminum awning windows irregularly divided by bands of pebbledash panels. A shed wing across the rear elevation likely holds loading docks, but it was not fully visible during the field survey. Paved parking areas and driveways surround the building. The parcel also includes a narrow grass lawn framed by low curbing along its west boundary. Driveways on North Main Street access the property.

Resource number U/85/2470 is recommended eligible for listing in the NRHP under Criterion C for significance in architecture on the local level. The resource is an excellent example of an International Style building. The building includes typical International Style features such as a rectilinear form, flat roof, minimal decoration, windowless wall sections, bands of metal-framed windows, plain round porch supports, and an asymmetrical façade. The building's primary adornment—its sloped roof and CMU screened entrance—is its impressive example of a mid-century entrance vestibule. As this property appears to be almost completely unchanged since its construction, it is an excellent example of the International Style and is recommended eligible for listing in the NRHP. The period of significance is limited to 1964, the year of construction, as the building has undergone virtually no alterations since that time.

Avoidance of this resource is recommended during the proposed project work. If ROW were taken on the east side of North Main Street east of the sidewalk at this location, the proposed project would have an adverse effect on the recommended eligible property. Construction associated with the proposed project that requires removal of any contributing features of the proposed NRHP boundary would have an adverse effect on the setting and feeling of the property.

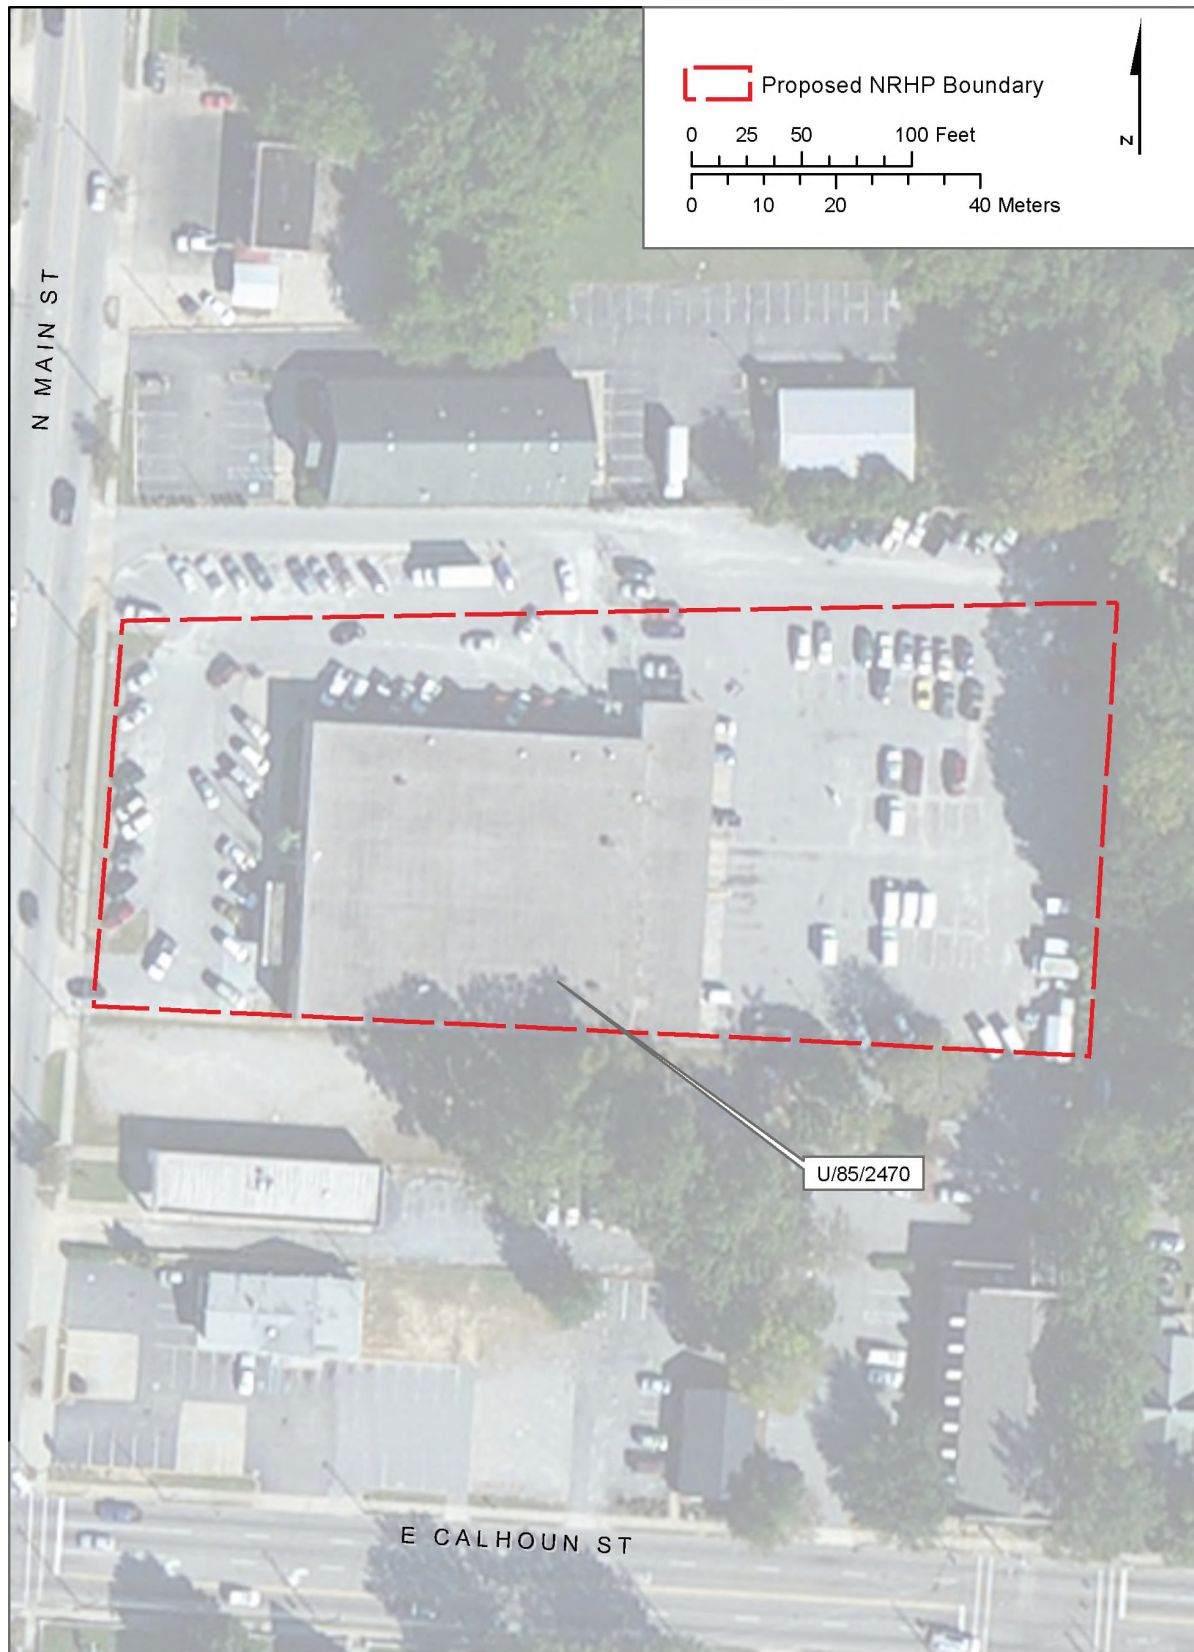
Project Area and Proposed NRHP Boundary for the United States Post Office (U/85/2470)

The proposed boundary for this property roughly conforms to the boundary of Sumter County Tax Parcel Number 2490803031 (see Figure 47). The boundary includes roughly 1.98 acres and includes the post office and the associated immediate landscape.

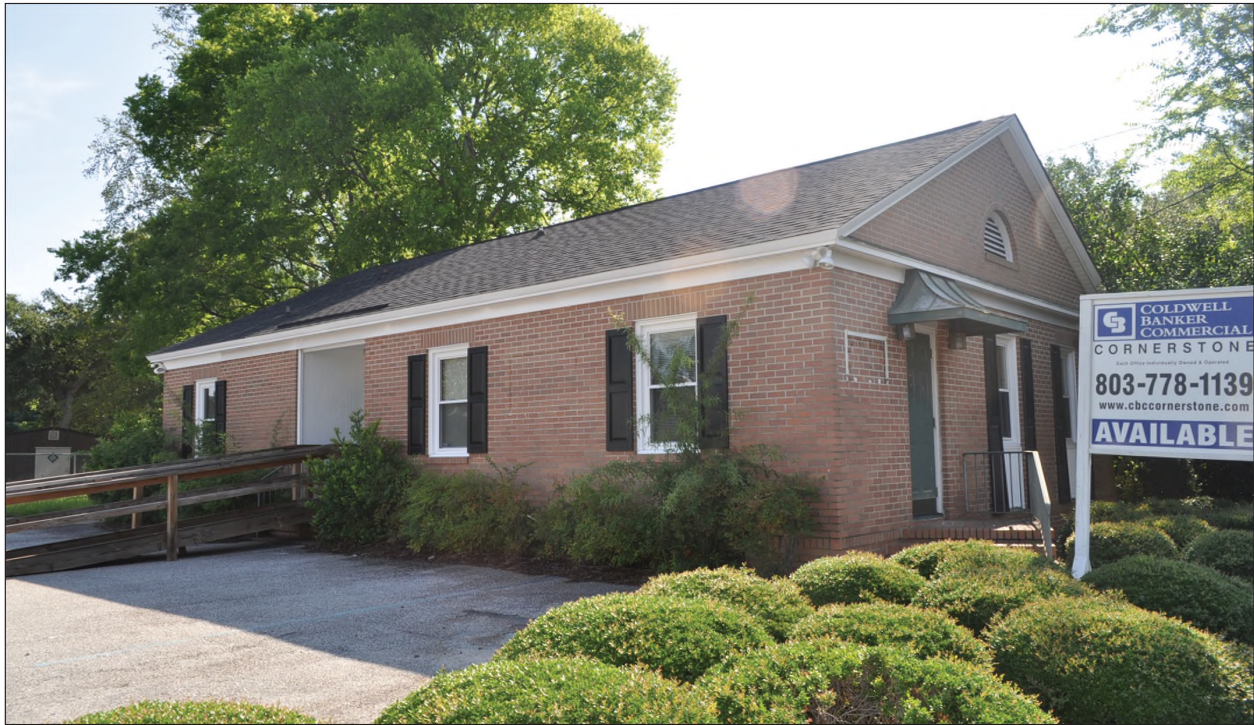
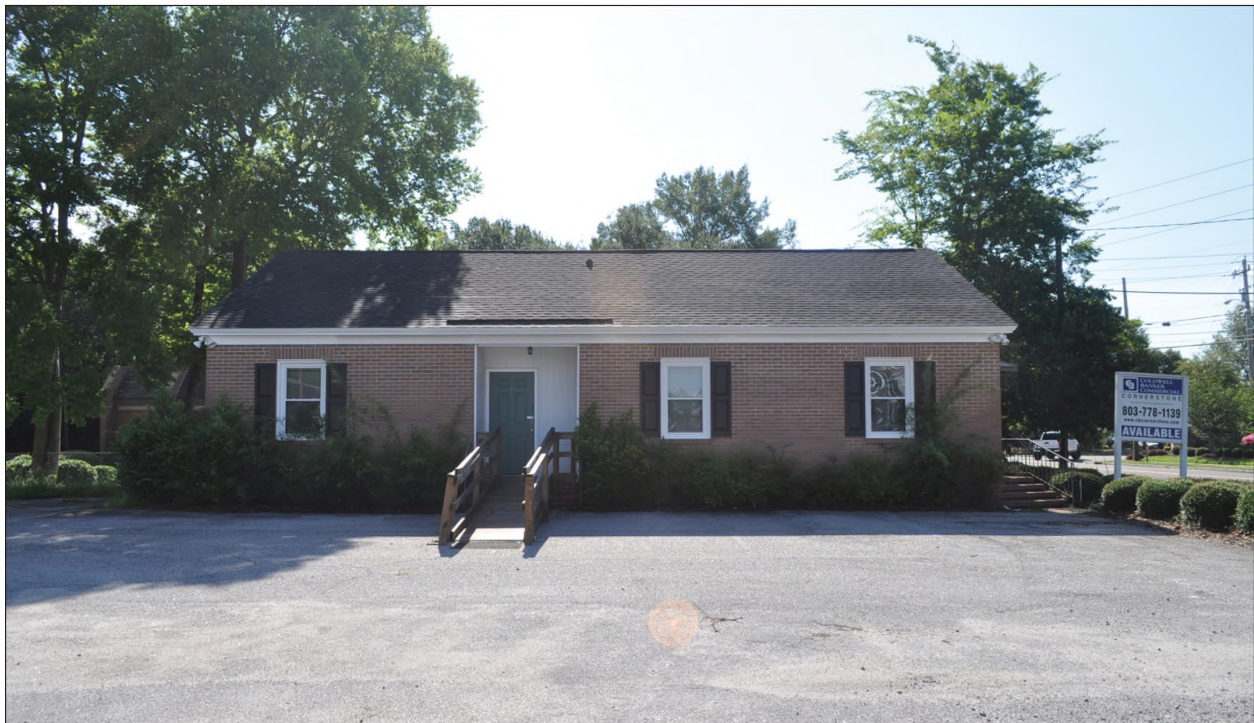
Figure 48.
11 East Calhoun Street (U/85/2471)

Resource number U/85/2471 is a commercial building located on the north side of East Calhoun Street, between North Main and Baker streets (Figure 48). According to the tax assessor's record, this building was constructed in 1966 and does not appear to be in use at the present time. The rectangular, one-story, frame building is clad in brick veneer and has a front-facing roof covered in asphalt shingles.

The building has two main entrances, one fronting Calhoun Street on the south elevation and another facing the building's parking lot on the west elevation. The south elevation entrance includes an offset metal paneled door atop a west-facing set of steps with a low iron railing. Above the door is a metal awning. East of the door are two window bays composed of vinyl sash above vinyl panels with faux shutters. The bay openings suggest that the original windows were much taller. Remaining windows throughout the building have shorter openings, and all windows have been replaced by vinyl sash and include faux shutters. Above the three bays, the gable end has a simple full pediment with a lunette louvered vent. A wood ramp leads from the property's parking lot to the secondary entrance on the west elevation. The ramp covers a set of low brick steps that lead onto a shallow, engaged porch. This metal paneled door is offset within the porch wall, which has been re-clad in vertical plywood board.

Resource number U/85/2471 is recommended not eligible for listing in the NRHP, as it was not found to be associated with any historic event or person of significance, nor is it an outstanding example of a mid-twentieth-century commercial building. Therefore, the property is recommended not eligible under Criteria A, B, or C.

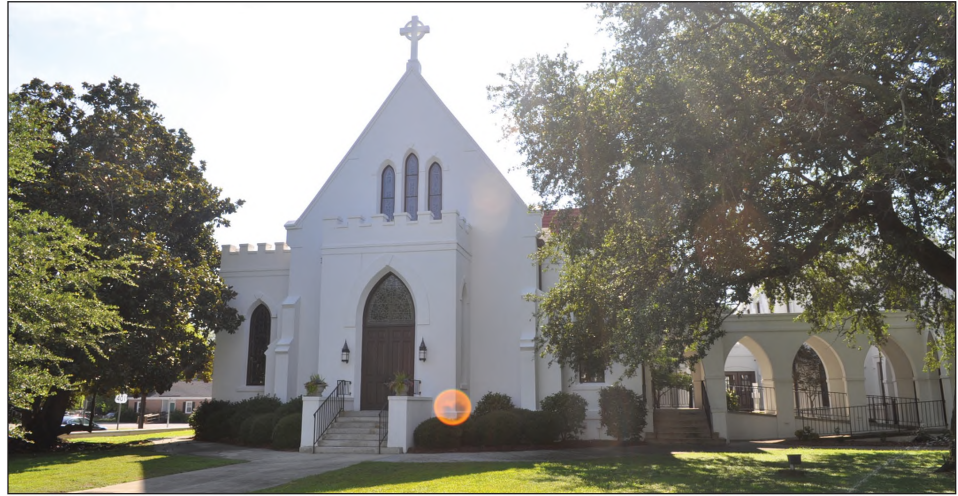
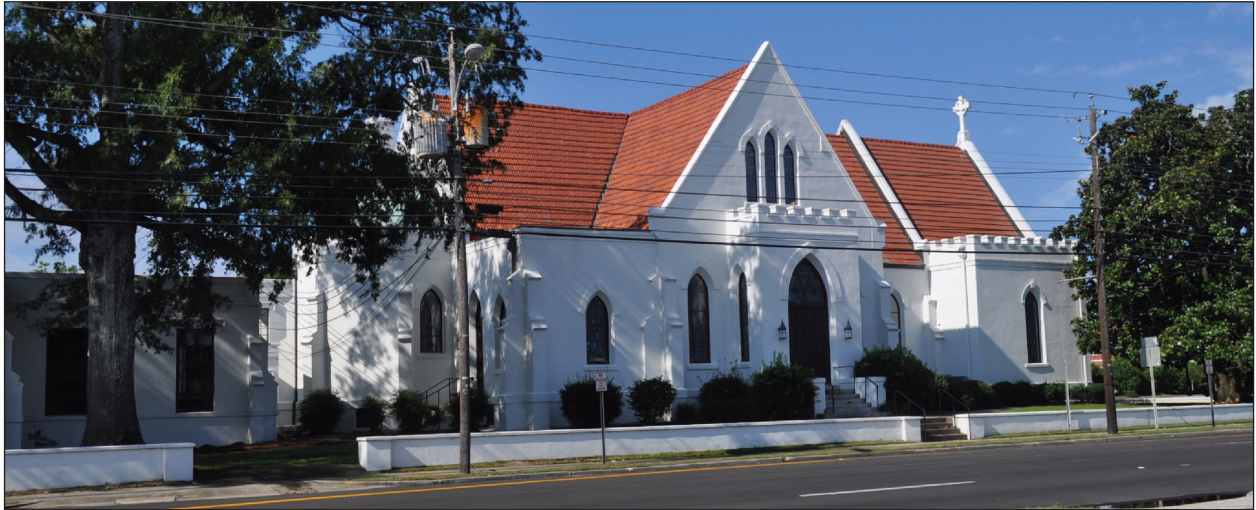
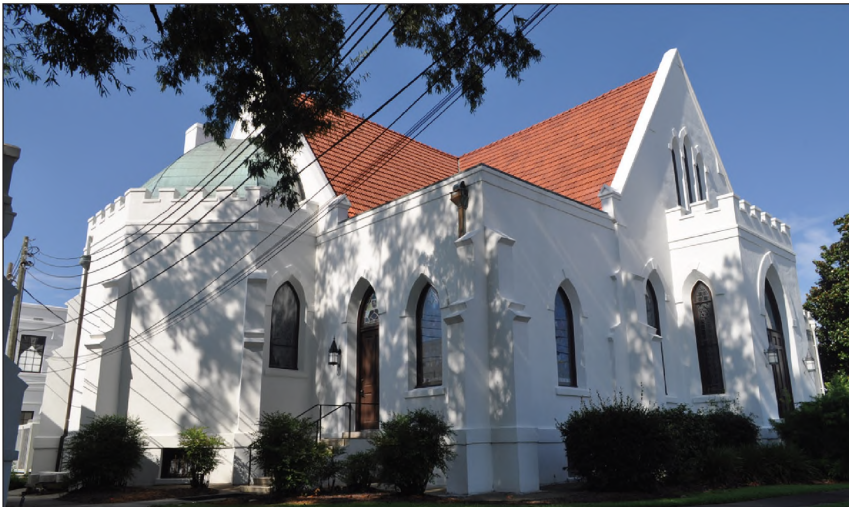
Figure 49.
Church of the Holy Comforter (U/85/2472, U/85/2472.01, U/85/2472.02), 1 of 2

The church at 213 North Main Street is situated at the southeast corner of North Main and East Calhoun streets (Figures 49-52). Constructed in 1909, the church serves a congregation founded in 1857 whose first building was erected in 1858. According to the Works Progress Administration (WPA) records, the current Gothic Revival sanctuary replaced the first sanctuary in 1900, when

The sanctuary has prominent entrances facing both North Main and East Calhoun streets, but the primary entrance reads as the one facing North Main. The Gothic Revival building has crenellated parapets above the entrance vestibules, as well as north and south of the main entrance marking the narthex. Both entrances have double wood paneled doors below gothic arched stained glass windows with window hoods. Gothic arched stained glass windows with window hoods are found throughout the sanctuary and above additional secondary wood paneled door entrances. The parapet gables are steeply pitched and marked by slender, tripartite gothic arched stained glass windows above the entrances. A Celtic cross marks the parapet gable ridgeline above the main entrance. Faux buttresses mark corners of the building. An arcade leading south from the sanctuary narthex connects the sanctuary to the secondary buildings via connecting arcades and a crenellated automobile canopy.

paneled main entrance wood doors sit below a gothic arched window with a window hood. A crenellated parapet marks the entrance vestibule and faux buttresses mark the corners of the one-story portion. The vestibule has gothic stained glass windows with window hoods, while eight-over-eight metal sash windows above four-light awning windows are found throughout the remainder of the one-story portion. These and all additional windows on this building feature drip mold crowns. Windows on the hyphen and two-story building wing are six-over-nine metal sash hung alone and in pairs. Secondary entrances found throughout the building are half-light paneled doors below flat overhangs and aluminum awnings. A fenced playground is located immediately south of this building.

Resource numbers U/85/2472 and U/85/2472.01 are recommended eligible for listing in the NRHP under Criterion C for significance in architecture on the local level. The church and support building are good examples of an early-to-mid twentieth-century Gothic Revival church complex. While some alterations have occurred to the building, most are historic or are alterations that are sympathetic to original Gothic Revival elements. The period of significance is defined as 1909, when Resource U/85/2472 was constructed, through 1958, when Resource U/85/2472.01 was completed. Resource U/85/2472.02 is recommended not eligible due to the extensive exterior renovations that have been made to the building; however, it does not detract from the ability of the complex as a whole to successfully convey as an early to mid-twentieth-century Gothic Revival church complex. The overall historic integrity of the property remains intact and resources U/85/2472 and U/85/2472.01 are recommended eligible for listing in the NRHP.

Avoidance of this resource is recommended during the proposed project work. If ROW were taken on the east side of North Main Street east of the sidewalk or the south side of East Calhoun Street south of the sidewalk at this location, the proposed project would have an adverse effect on the recommended eligible property. Construction associated with the proposed project that requires removal of any contributing features of the proposed NRHP boundary would have an adverse effect on the setting and feeling of the property.

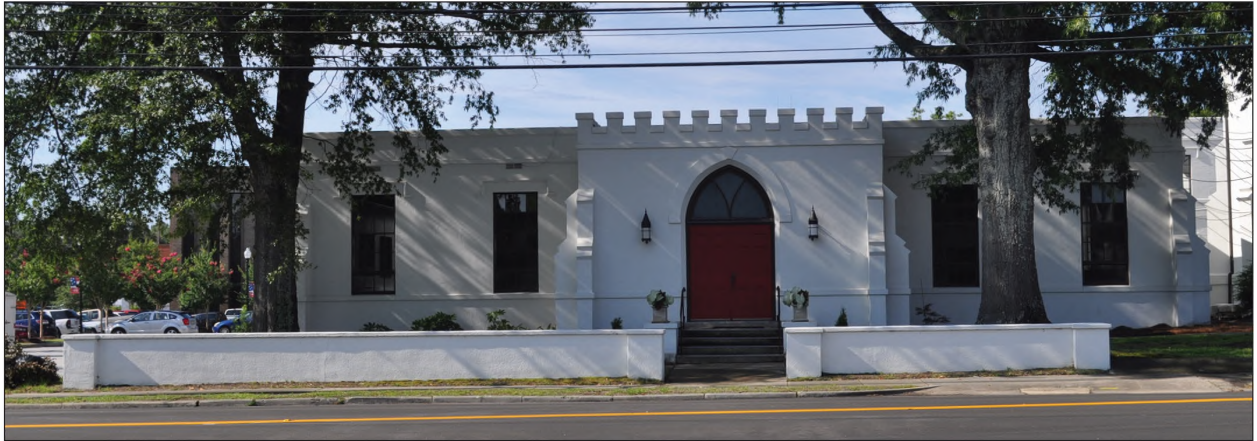
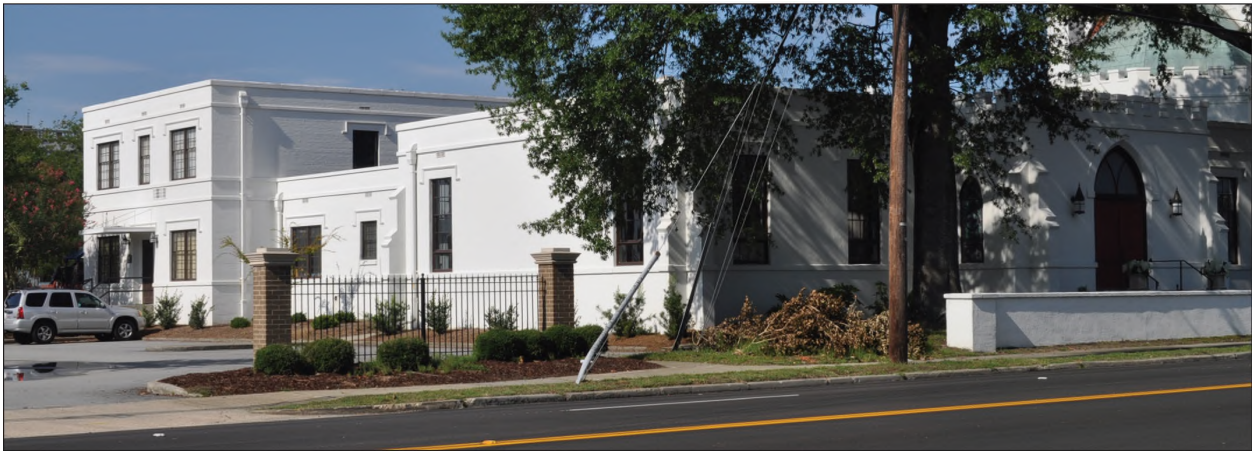
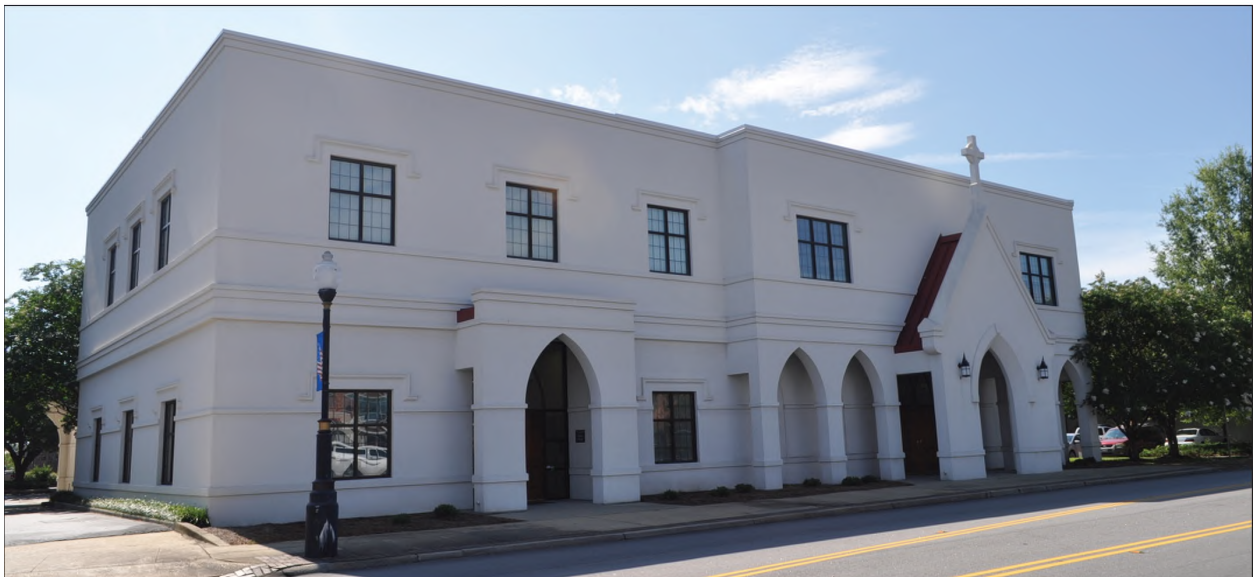
Figure 51.

the church relocated to this site from its previous location at South Main and Bartlette streets. The original wood frame sanctuary was moved to the present location and used as the Sunday School building through at least 1923 (Boykin 1936; see Figure 50). Sanborn maps prior to 1912, however, do not show the sanctuary. Therefore, the date of construction was likely slightly later. Architects William Augustus Edwards and Frank C. Walter apparently worked with contractor “Mr. Cain” to construct the sanctuary for the cost of \$18,500 in 1909 (Roots and Recall 2017). A wood frame rectory was also located just east of the sanctuary at this time. In 1950, the present Family Education Building and Walker Hall (U/85/2472.01) replaced these buildings (see Figure 51). In 1998, the circa 1956 National Bank of South Carolina building was purchased by the church and was renovated and repurposed as the Family Education Building (U/85/2472.02) (Monroe 2012).

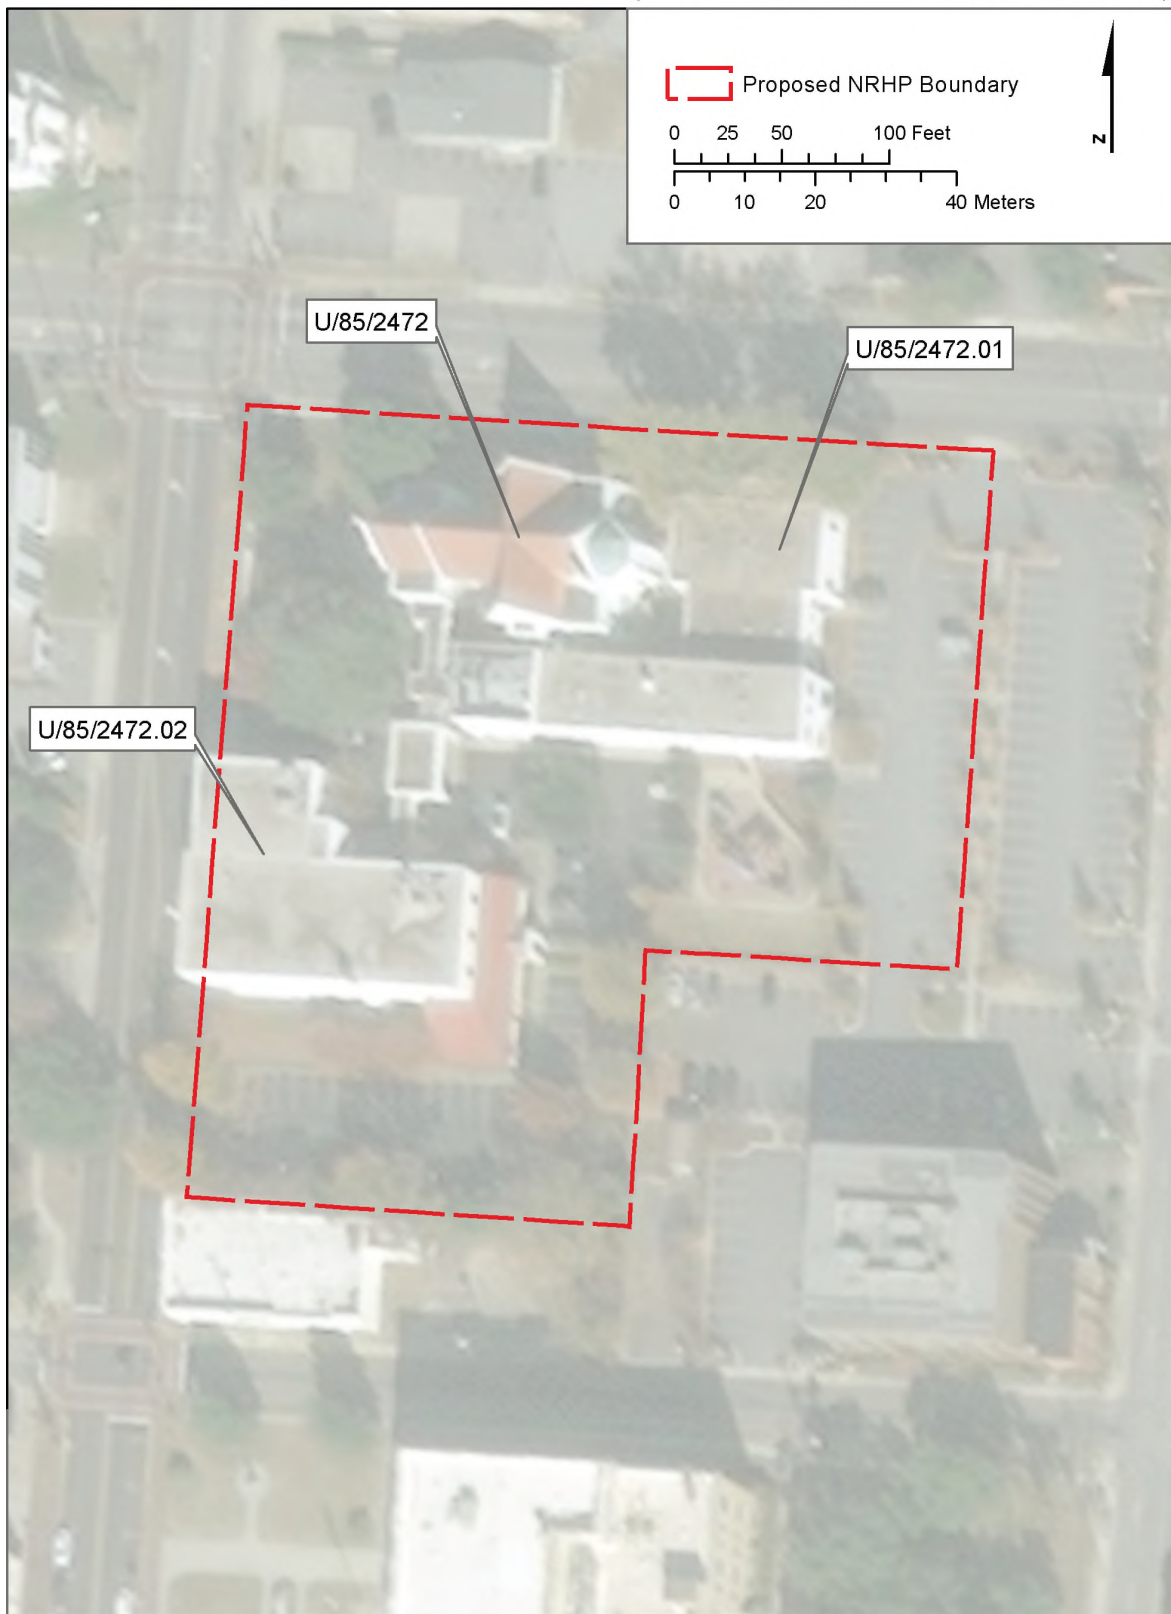
Figure 52.
Project Area and Proposed NRHP Boundary for Church of the Holy Comforter
(U/85/2472, U/85/2472.01, U/85/2472.02)

The proposed boundary for this property conforms only to the building and its surrounding grass lawns within the larger Sumter County Tax Parcel Numbers 2490901012 and 2490901006, and extends to the edge of the sidewalk along North Main and East Calhoun streets (see Figure 52). The boundary contains roughly 2.5 acres, and includes the buildings and the associated immediate landscape.

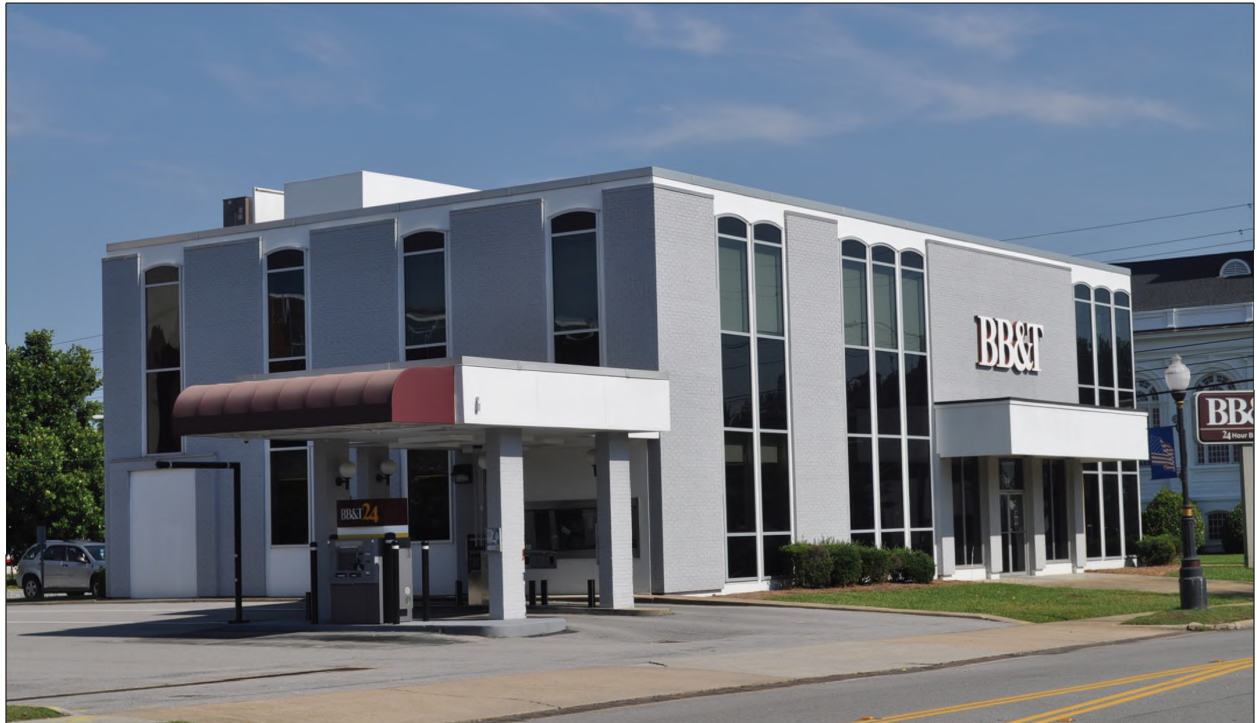
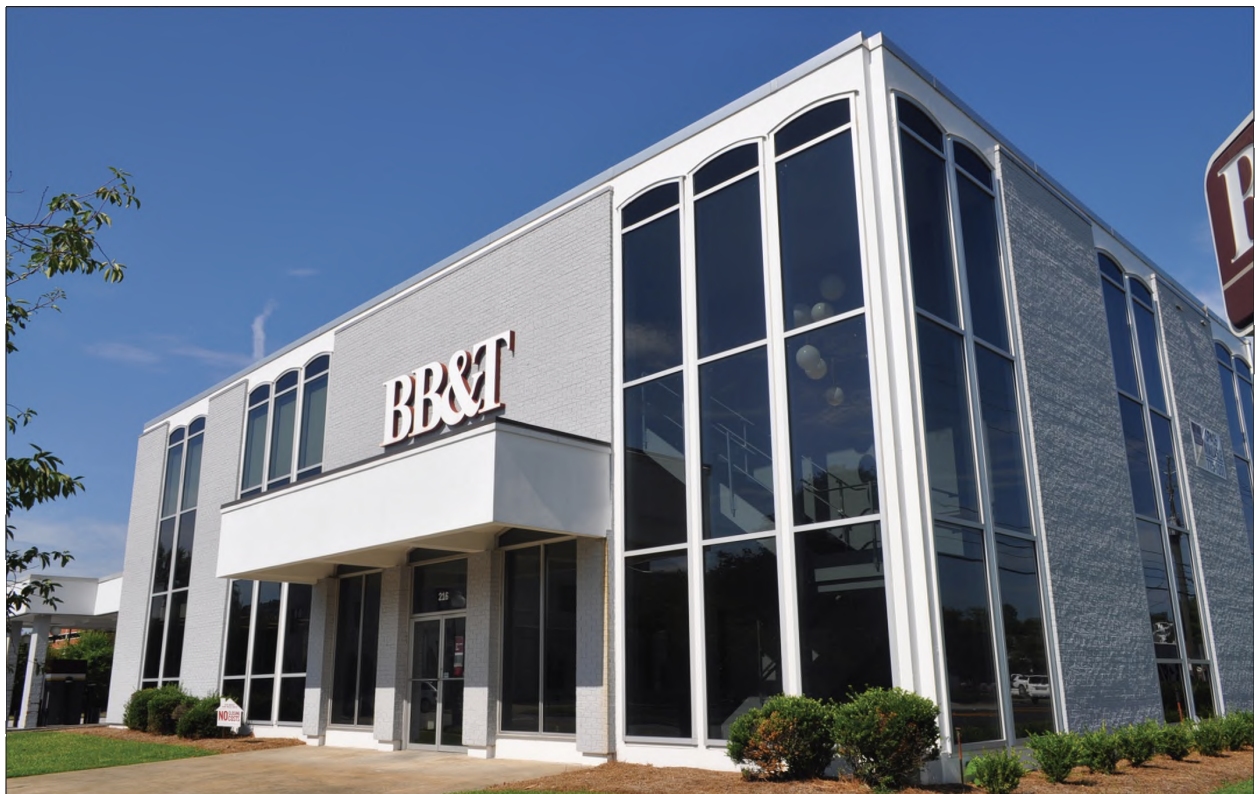
Figure 53.
214 North Main Street (U/85/2473)

Resource number U/85/2473 is a commercial building located at the southwest corner of North Main and West Calhoun streets (Figure 53). According to the tax assessor's record, this building was constructed in 1964 and appears to have been used as a bank since its construction. The large, two-story, rectangular, steel-frame building is clad in both painted brick veneer and stucco and has a flat, built-up roof. The building recalls the New Formalist style, with unadorned walls divided by soaring arched window bays in place of the style's more typical columnar supports. The two-story window bays are found alone, in pairs, and in triplet, and reach almost to the line of metal coping at the roofline. While these bays appear to be original, the glass looks replaced. An offset, cantilevered, flat canopy covers three single-story bays on the east elevation: a central metal-and-glass double door below a fixed transom with flanking paired fixed windows. Above the fixed windows and the transom are three arched fixed windows. The arched shape suggests that the walls of the canopy may have been originally arched. The current canopy wall does not appear to be original. On the south elevation of the building is a drive-through canopy that also appears to have been reworked since its construction. The canopy has a non-historic extension on its south end and the wall surrounding the primary drive-up window appears to have been reconfigured and

re-finished in stucco since the late 1960s. The bank building has a small grass lawn along its north and east elevations, while the remainder of the parcel to the west and south are paved for parking and driveways. The property is accessed from both West Calhoun and North Main streets.

Resource number U/85/2473 is recommended not eligible for listing in the NRHP, as it was not found to be associated with any historic event or person of significance. Due to its non-historic alterations, the building is not an outstanding example of a mid-twentieth-century bank. Therefore, the property is recommended not eligible under Criteria A, B, or C.
