Phase I Cultural Resource Survey for the North Main Street Corridor Revitalization Project

Sumter County, South Carolina

New South Associates, Inc.

November 5, 2018 • **Third Revised Draft Report**
New South Associates Technical Report 2768

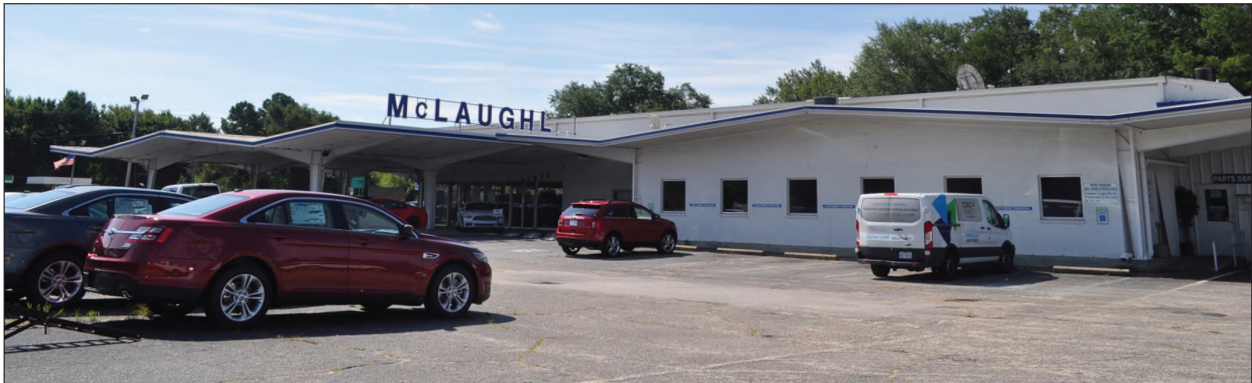
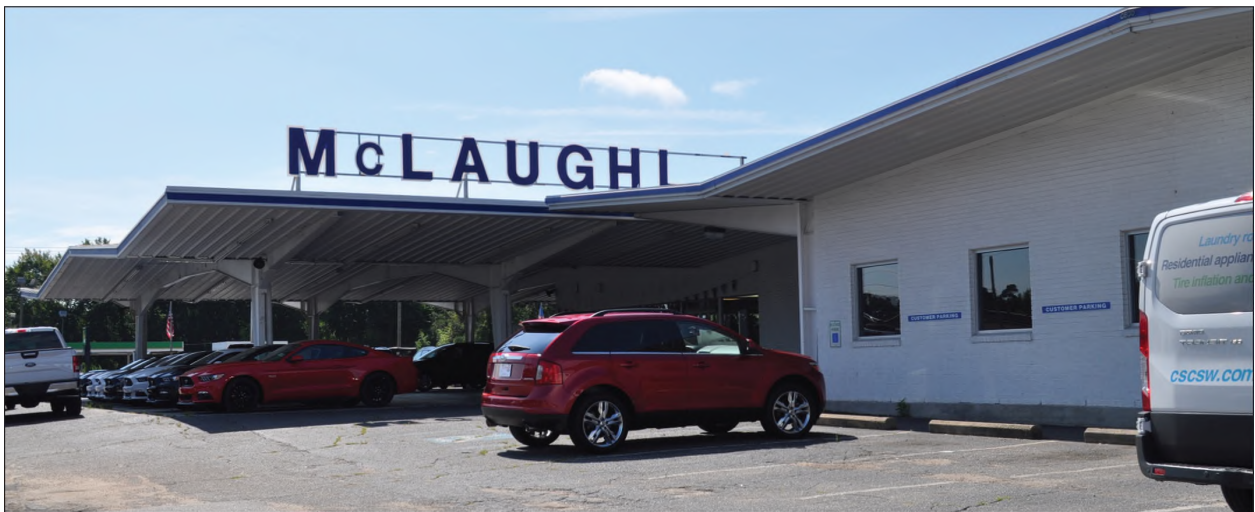
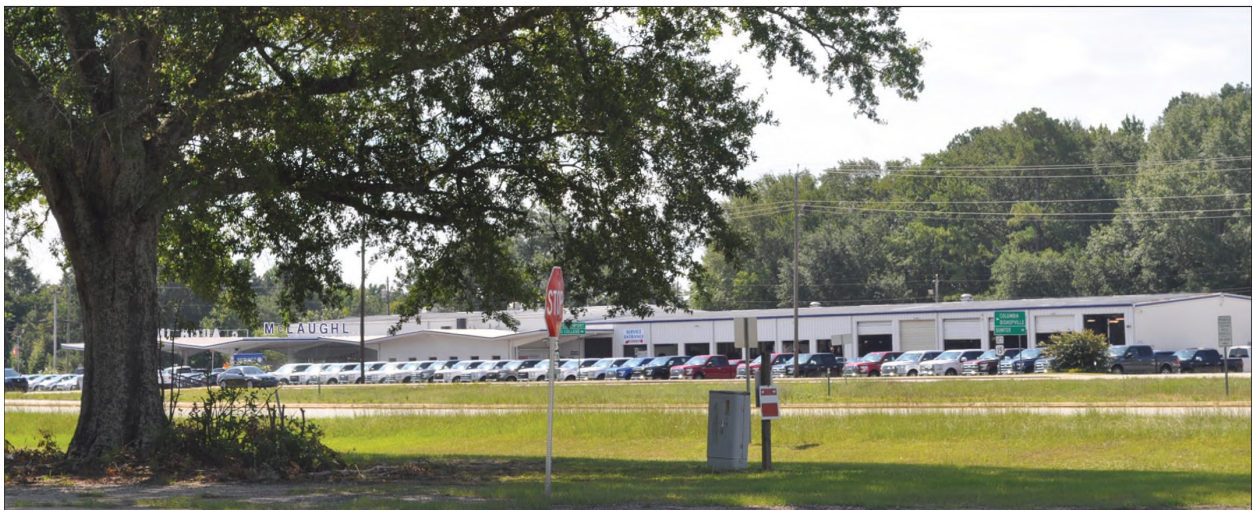
Figure 54.
950 North Main Street (U/85/2474)

Resource number U/85/2474 is a commercial building located at the southwest corner of North Main Street and South Pike West (Figure 54). According to the tax assessor's record, this building was constructed in 1967 and appears to have been used as a car dealership since its construction.

Resource number U/85/2474 is recommended not eligible for listing in the NRHP, as it was not found to be associated with any historic event or person of significance. Due to its non-historic additions, the building is not an outstanding example of a mid-twentieth century commercial building. Therefore, the property is recommended not eligible under Criteria A, B, or C.

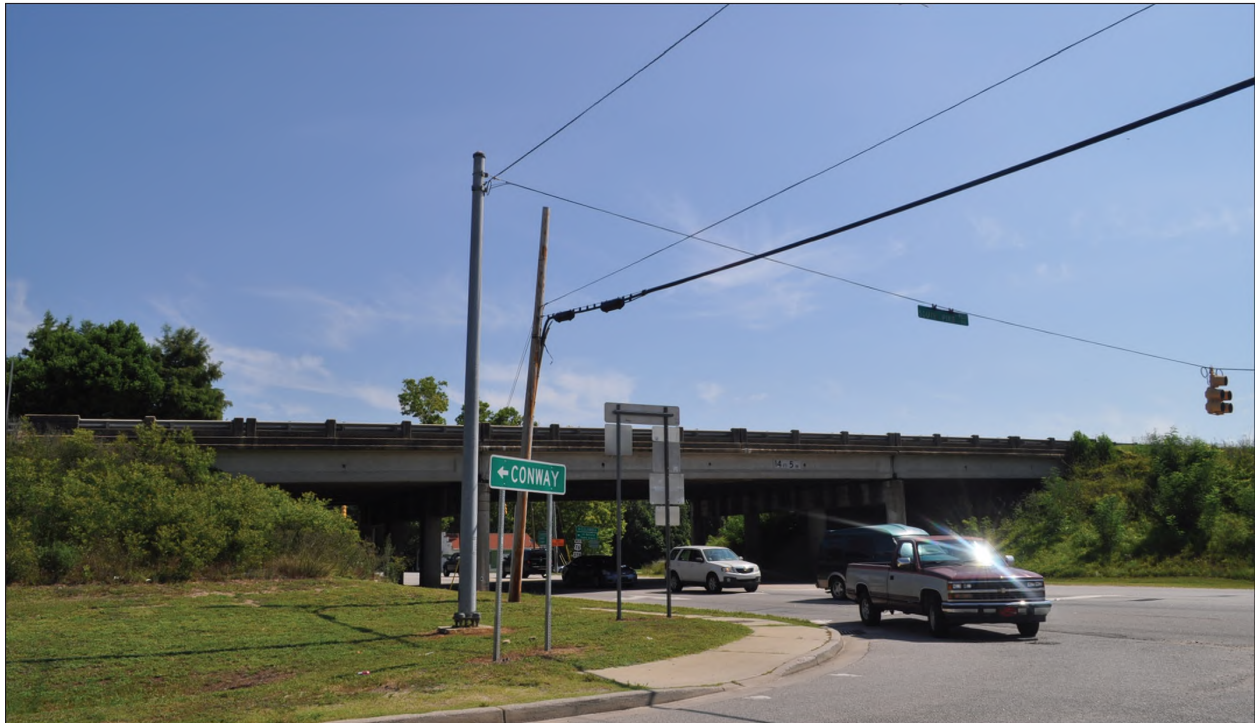
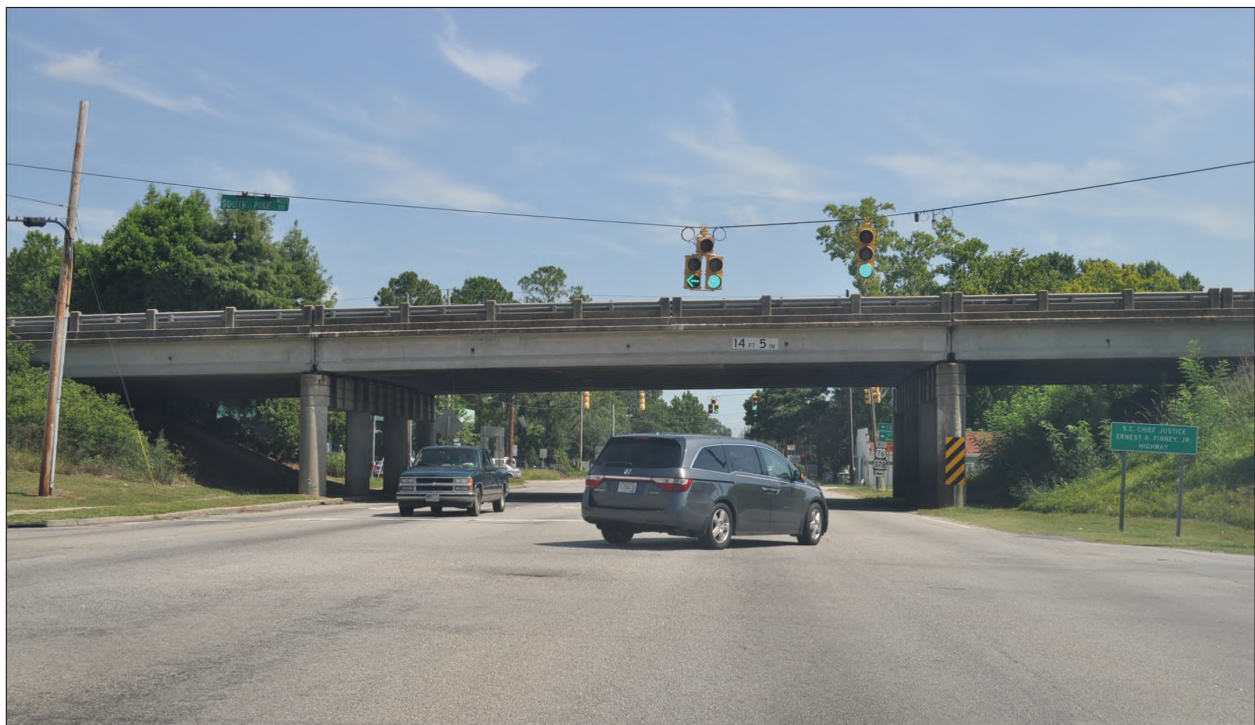
Figure 55.
Bridge at U.S. 76/U.S. 378 and North Main Street (U/85/2475)

A. Looking North

B. Looking Northeast
