# PHASE I CULTURAL RESOURCE SURVEY OF I-26 WIDENING PROJECT MM 187-194

Berkeley and Dorchester Counties,  
South Carolina

May 8, 2019 • **Revised Draft Report**  
New South Associates Technical Report 2877

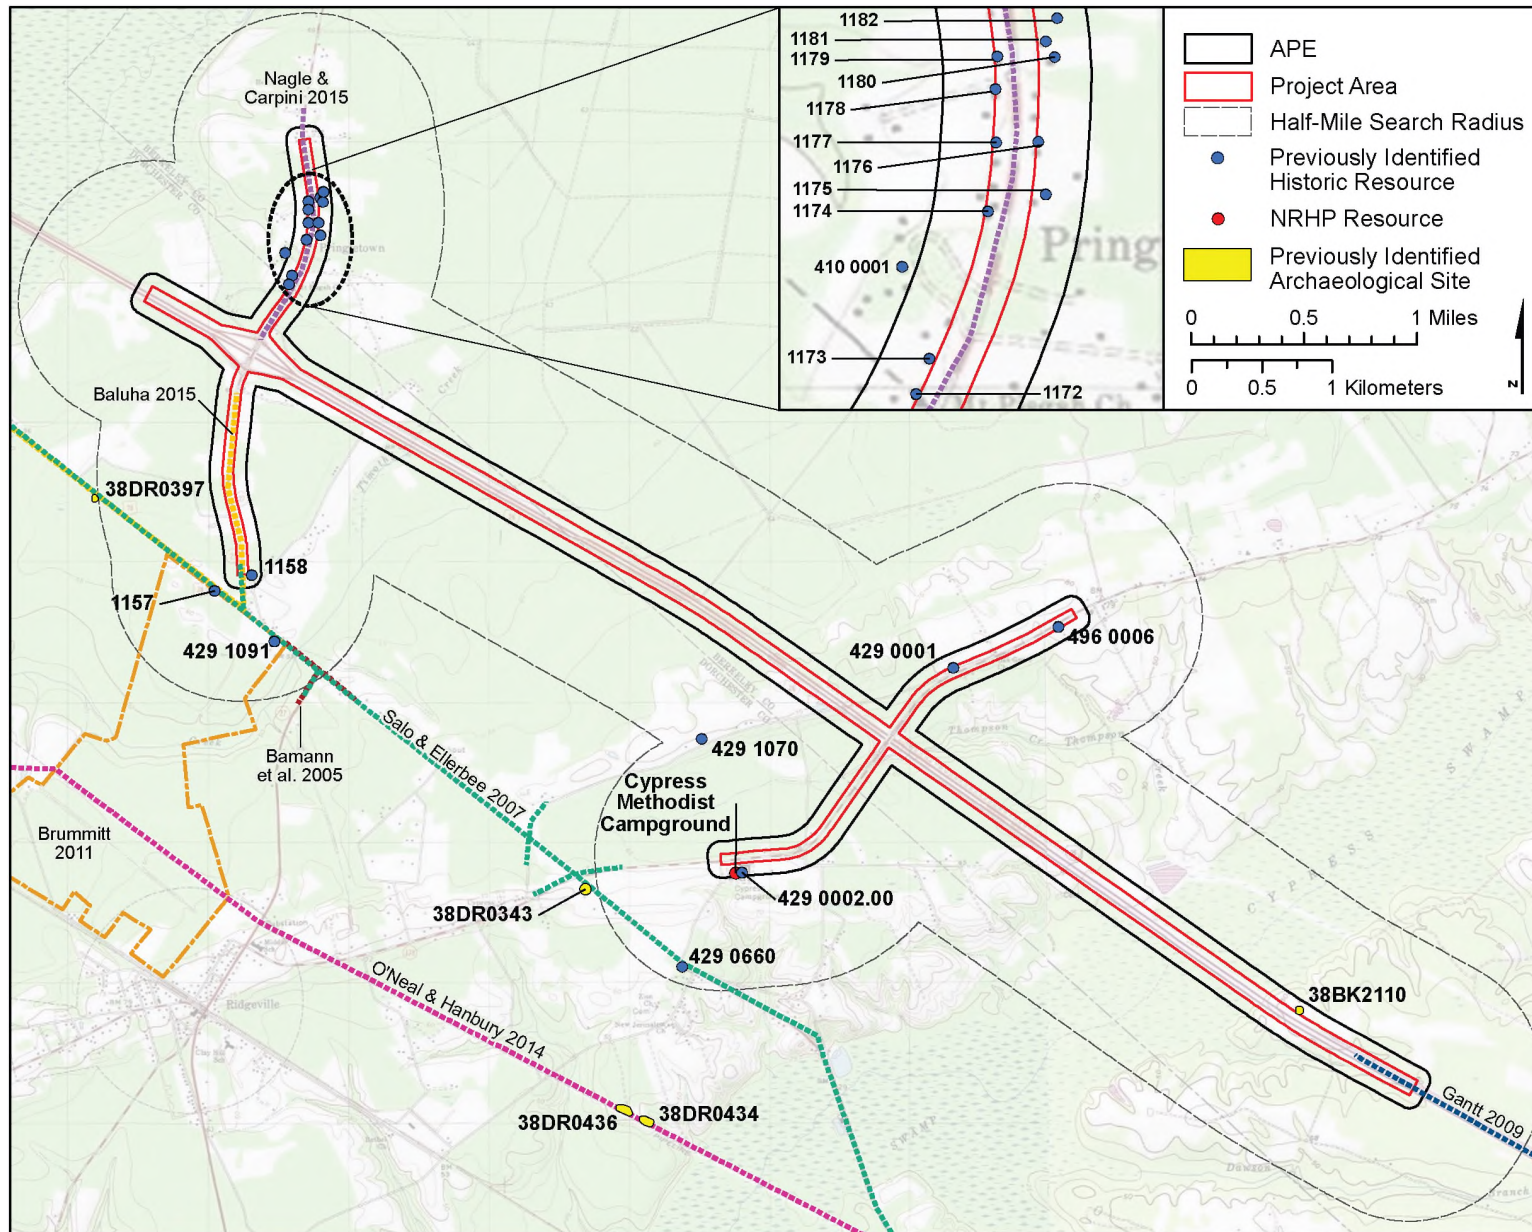
Figure 6. Sources: USGS Topographic Quadrangle Maps, Ridgeville, Summerville, and Pringletown, SC (1980)  
 Map Showing Previous Surveys, Previously Recorded Sites, and Previously Recorded Historic Resources within a Half Mile of the APE

The architectural resources within a half mile of the APE were identified during two comprehensive countywide surveys and two cultural resource surveys. Dorchester County conducted a countywide survey of architectural resources in 1997 (Fick and Davis 1997). Three resources that were recorded during this survey are within a half mile of the APE. Berkeley County also conducted a countywide survey of its architectural resources. (Preservation Consultants, Inc. 1989). The *Berkeley County Historical and Architectural Survey* was extensive and identified 809 sites, including newly surveyed resources, sites already listed on the NRHP, and sites identified during a 1972 Preservation Plan published by the Berkeley-Charleston-Dorchester County Regional Planning Council (Preservation Consultants, Inc. 1989). Three resources from this survey were within the APE and were revisited as a component of this report.

A 2015 cultural resources study conducted by S&ME for Berkeley County, *Cultural Resources Study for Project Sotor*, examined a portion of Old Gilliard Road as it passes through the project area, as well as a segment of Ridgeville Road (Nagle and Carpini 2015). Ten resources from this study were within a half mile of the APE, while nine were within the APE itself and were revisited. Additionally, two resources from the *Cultural Resources Survey of the Proposed US Highway 78 Improvement Project* conducted in 2007 and discussed above are located within one half mile of the APE (Salo et al. 2007). One of the two resources is located within the APE and was revisited.

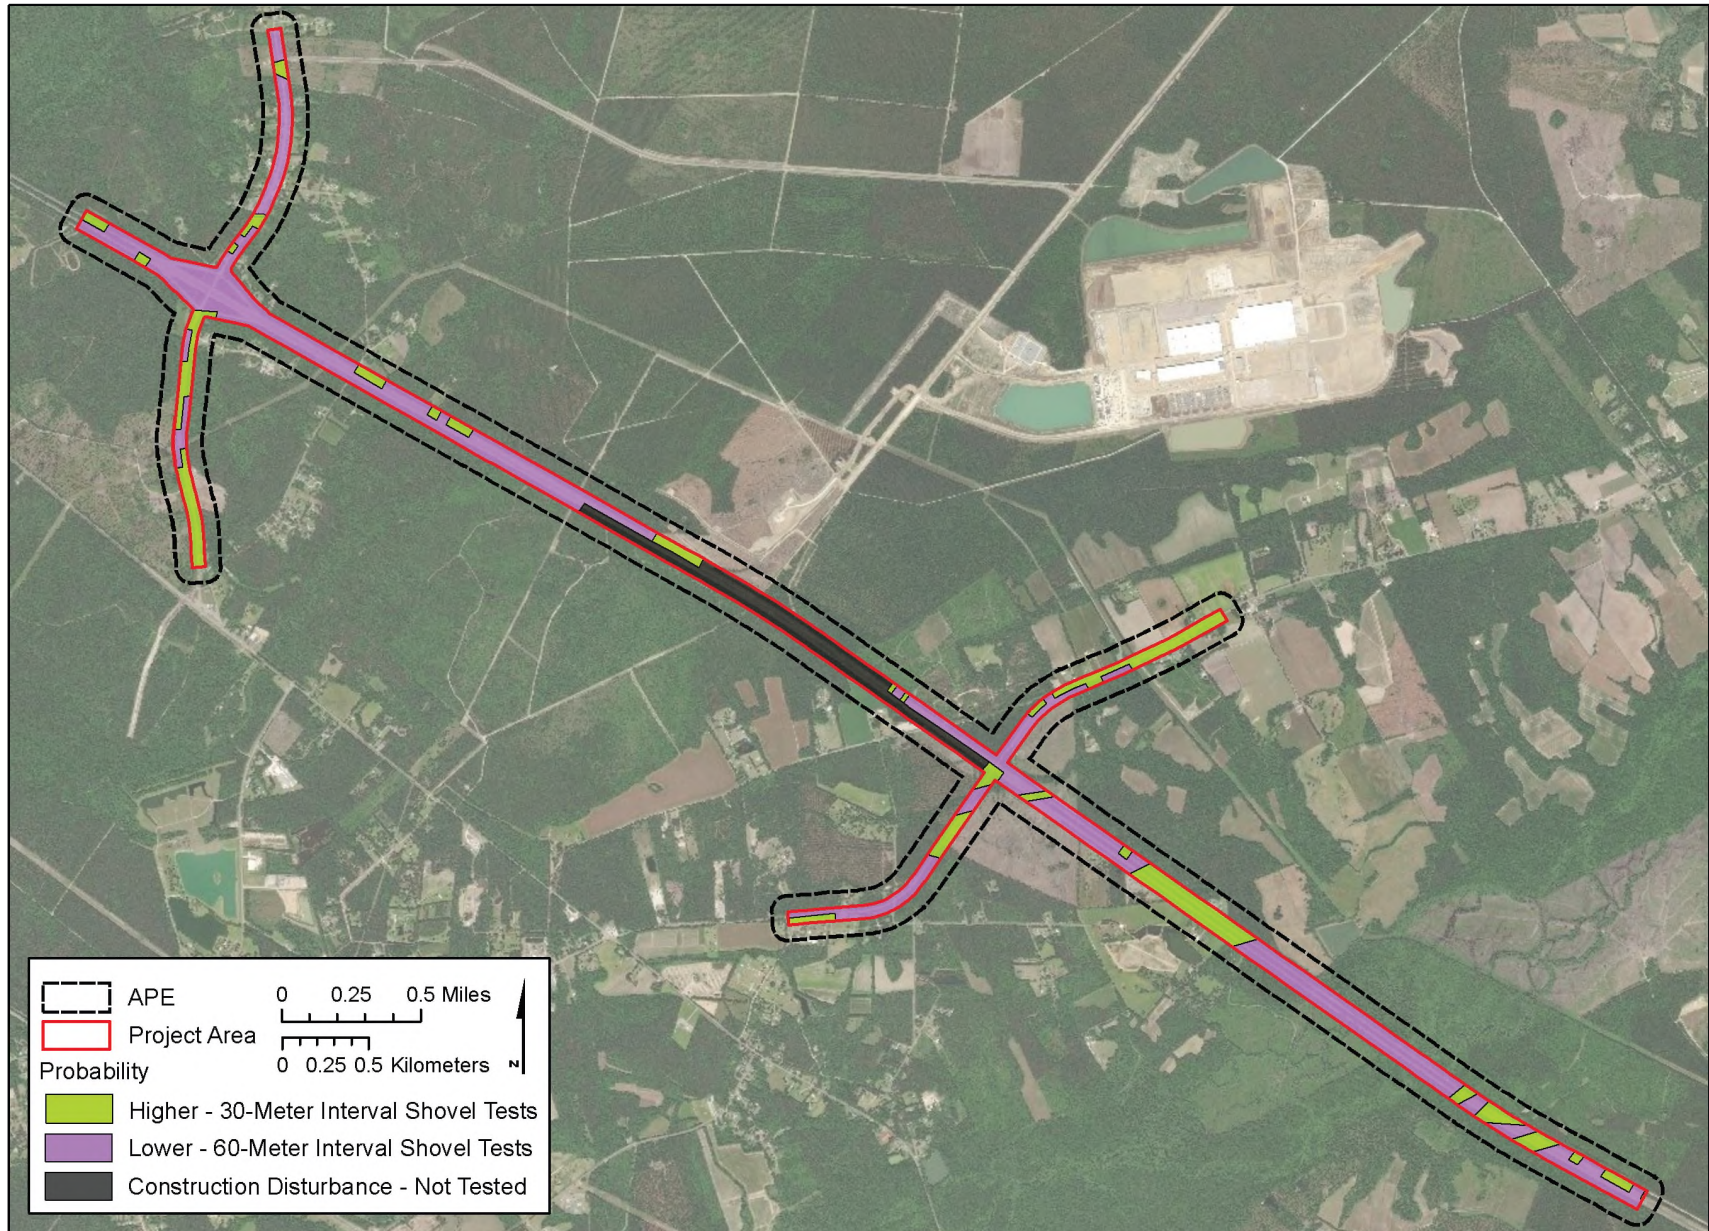
Figure 7.  
Archaeological Survey Coverage within the Project Area

The I-26 MM 187-194 project area was contiguous and included approximately seven miles of existing right of way (ROW) along the I-26 mainline corridor, as well as existing ROW at the SC 27 (Ridgeville Road) interchange and the S-18-182 (Myers Mayo Road [SC 182]/Cypress Campground Road) overpass. As described within Chapter IV, the project area was tested using 30- and 60-meter shovel test intervals, depending upon the potential of the location to contain archaeological deposits. Additionally, sections of the project area that exhibited significant disturbance were not subject to shovel testing. Figure 7 shows survey coverage within the project area.

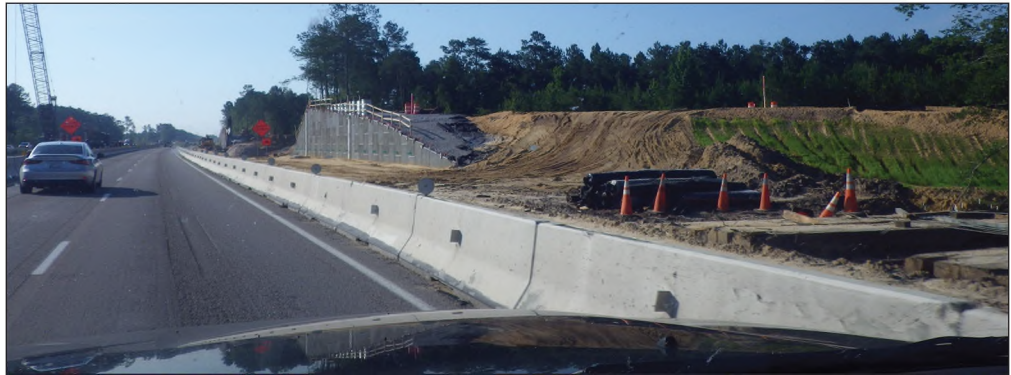
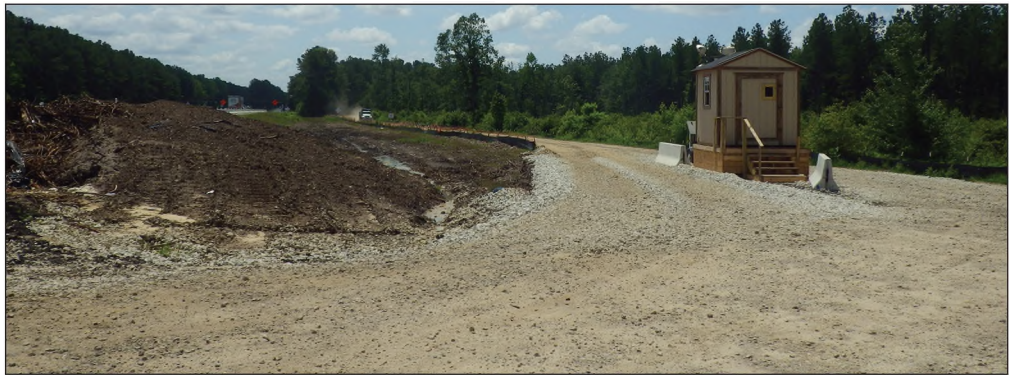
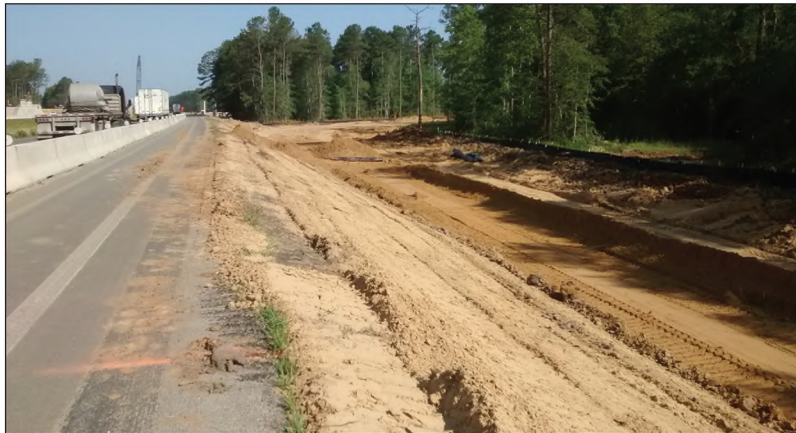
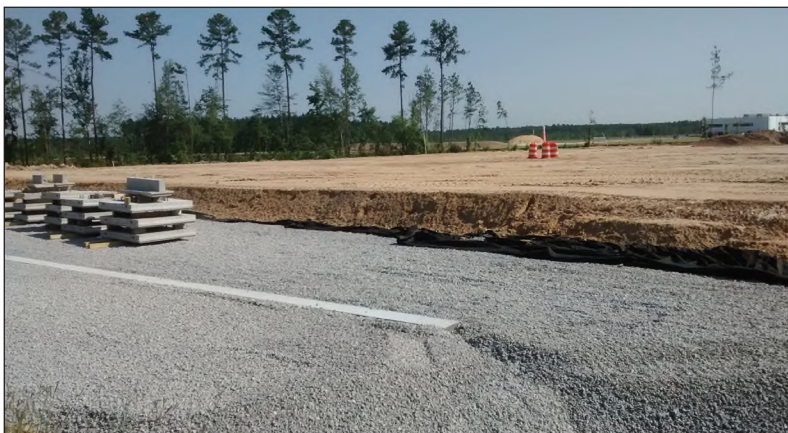
Figure 8.  
Construction Disturbance near Mile Marker 189

A. Eastbound  
Side of I-26

B. Westbound  
Side of I-26

The area surveyed during this project featured a great deal of variation among land-use, ground disturbance, and vegetation. A large swath of the project area on either side of I-26 near mile marker 189 exhibited a significant ground disturbance from current construction of an interchange for Volvo Car Drive (Figure 8). This area was not subject to shovel testing. The largest portion of the project area consisted of moderately to densely wooded forests of hardwood and pine trees with a moderate to heavy understory of saplings, briars, and vines. Wetlands were also common throughout the project area, both along I-26 and the connector roads, particularly in the sections near the Ashley River, Timothy Creek, Thompson Creek, and Four Hole Swamp. Graded or manicured lawns and commercial development were also common throughout the project area, particularly along the connector roads. Additionally, large sections of the ROW along I-26 were almost entirely encompassed by dirt or paved frontage roads. Other common land use types in the project area included fallow fields and recently logged (or logged within the last 20 years) forests with very deep furrows scarring the project area. Figures 9-11 show the various types of land use throughout the project area.

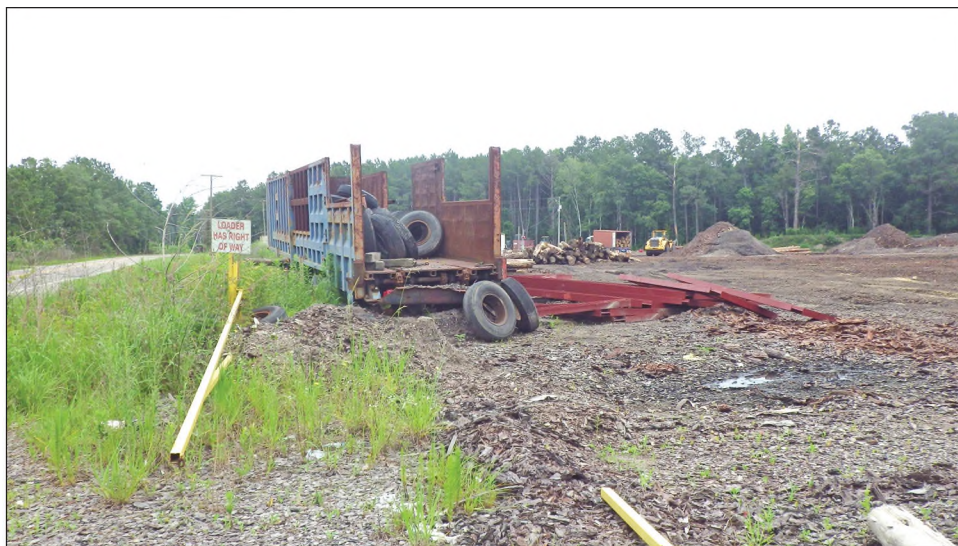
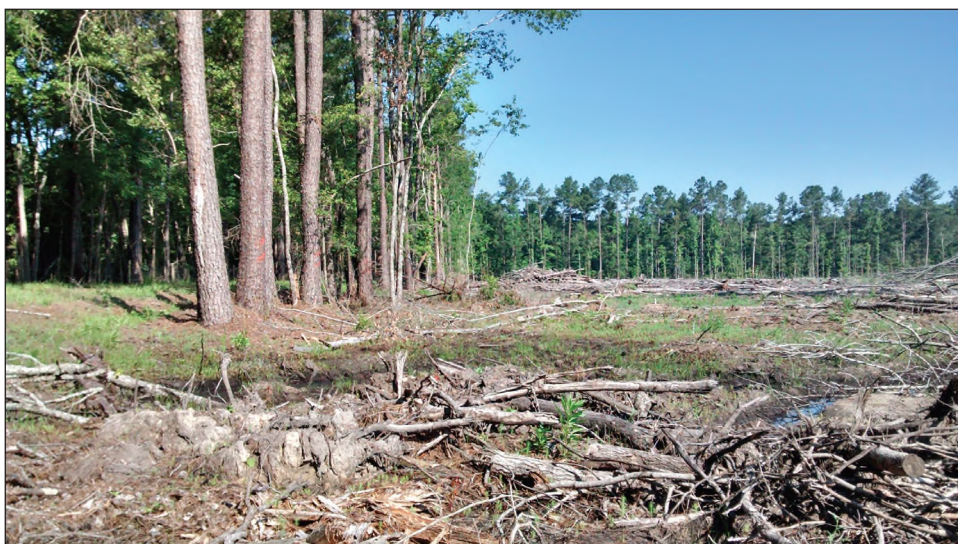
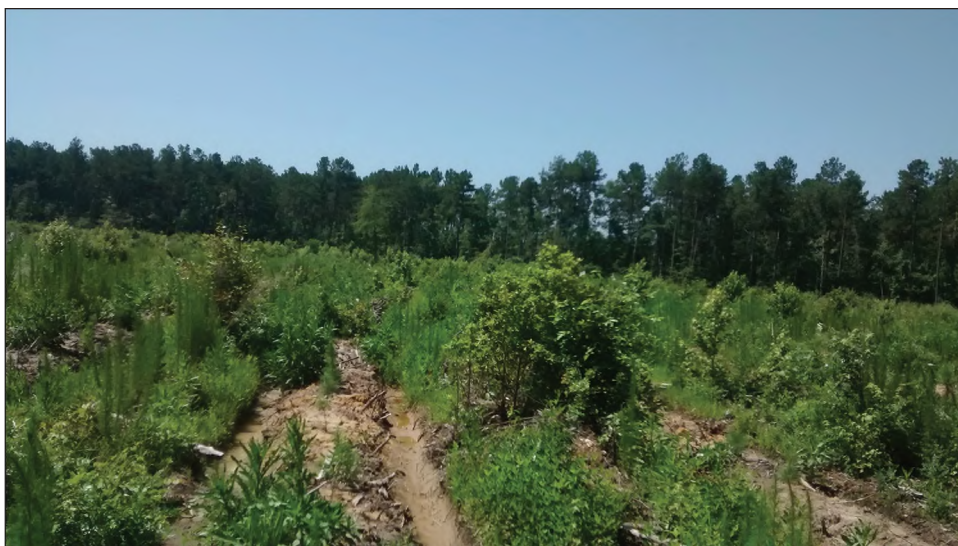
Figure 9.  
Examples of Logging within the Project Area

A. Processing Area

B. Recently  
Logged Area

C. Furrowed Land  
Resulting from Past  
Logging

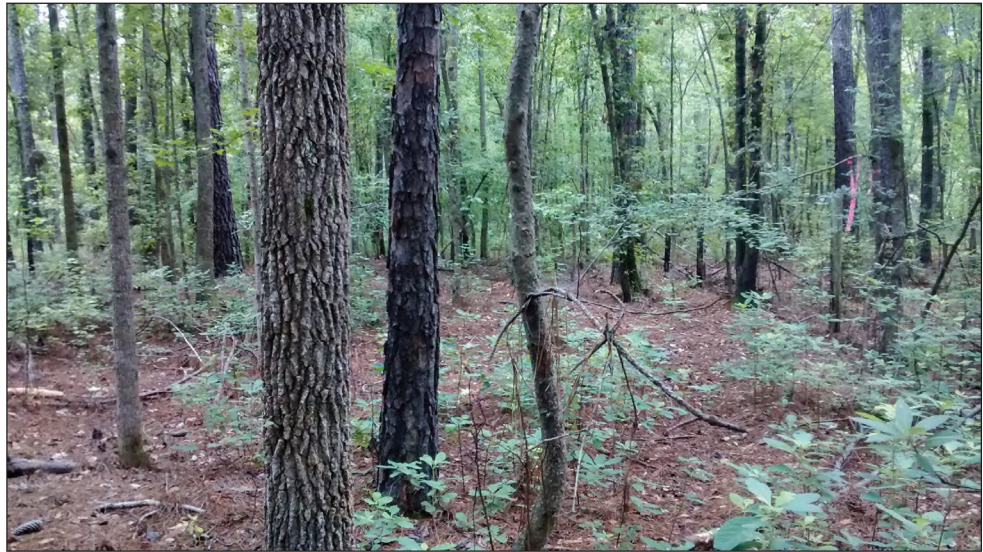
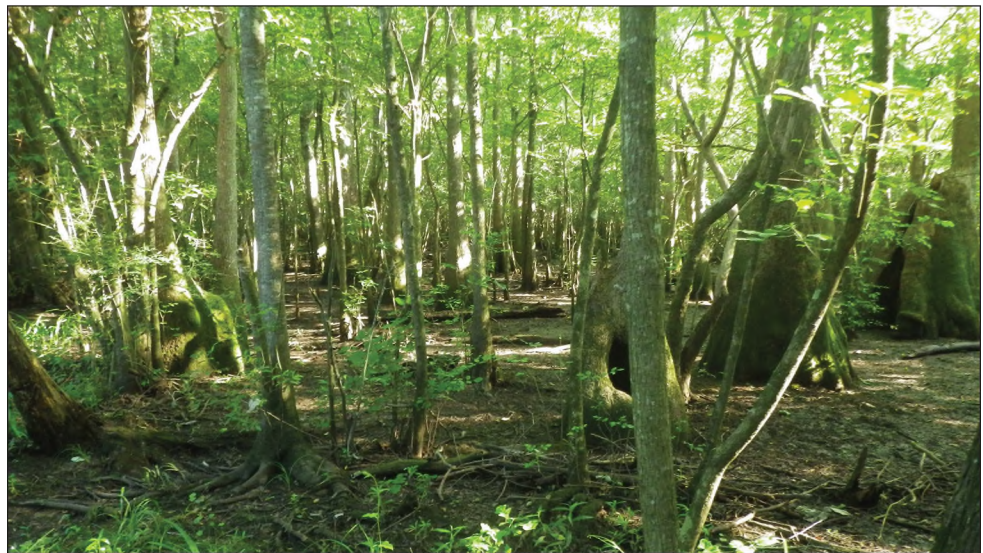
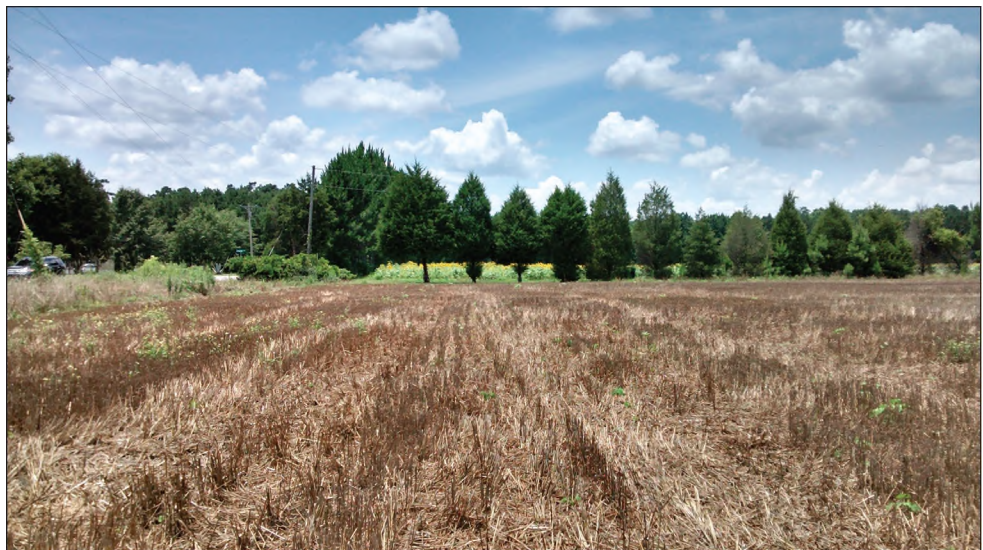
Figure 10.  
Examples of Typical Vegetation within the Project Area

A. Mixed Pine and  
Hardwood Forest

B. Wetland

C. Agricultural Field

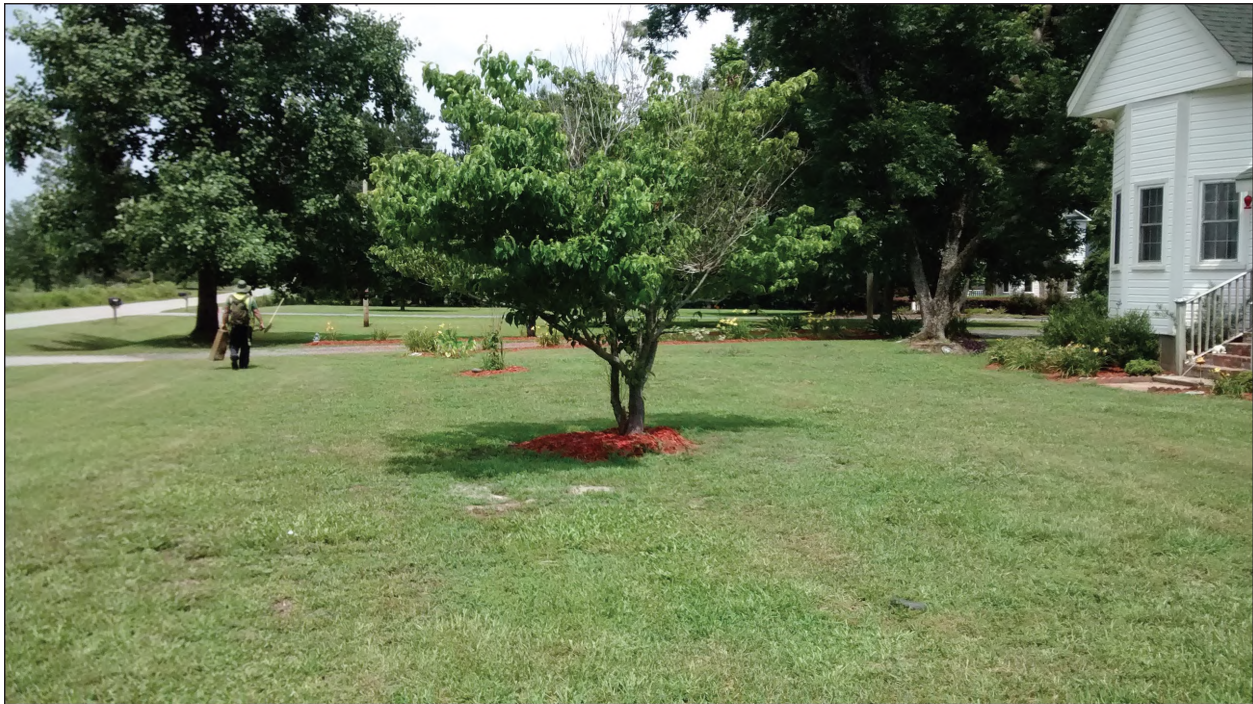
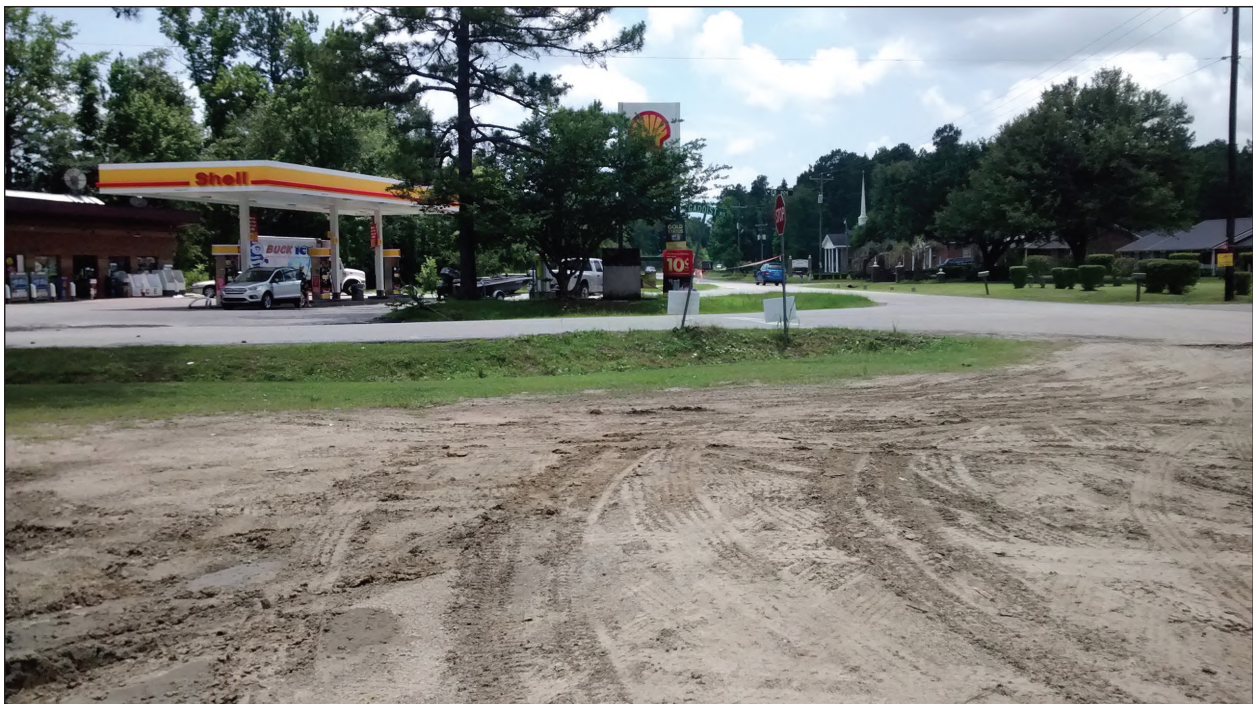
Figure 11.  
Examples of Residential and Commercial Development within the Project Area

A. Example of a Graded Lawn

B. Example of Commerical Development

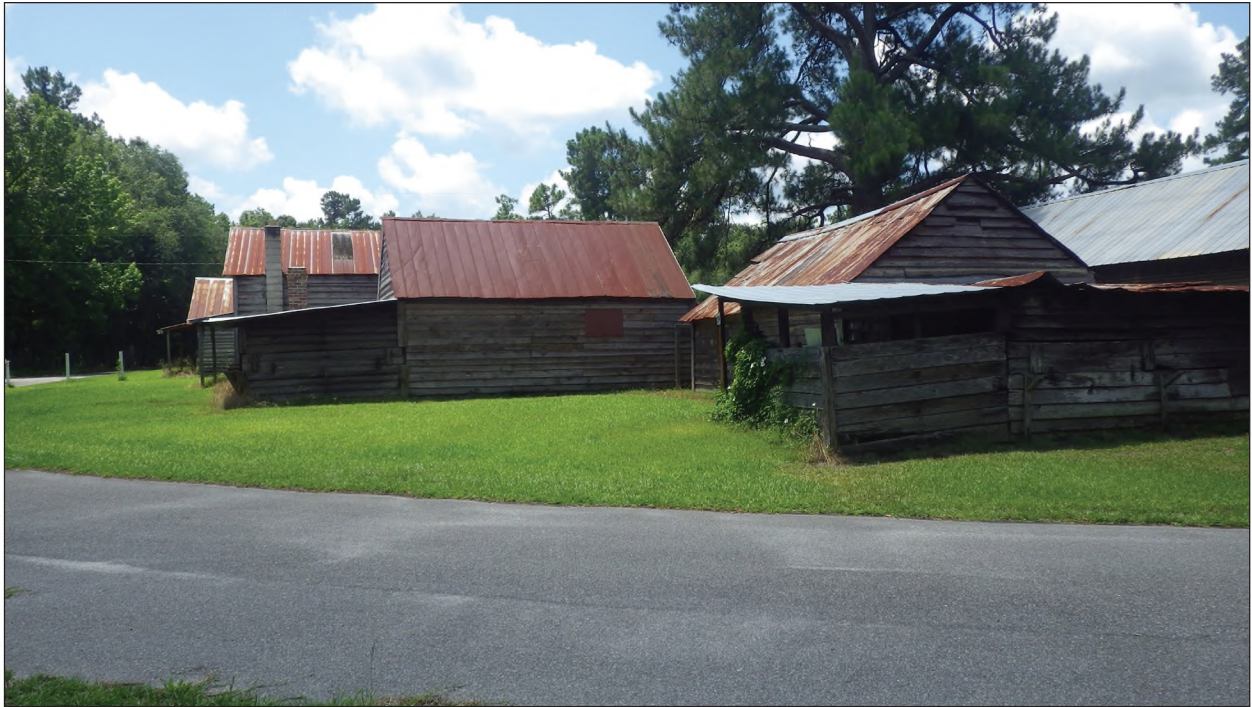
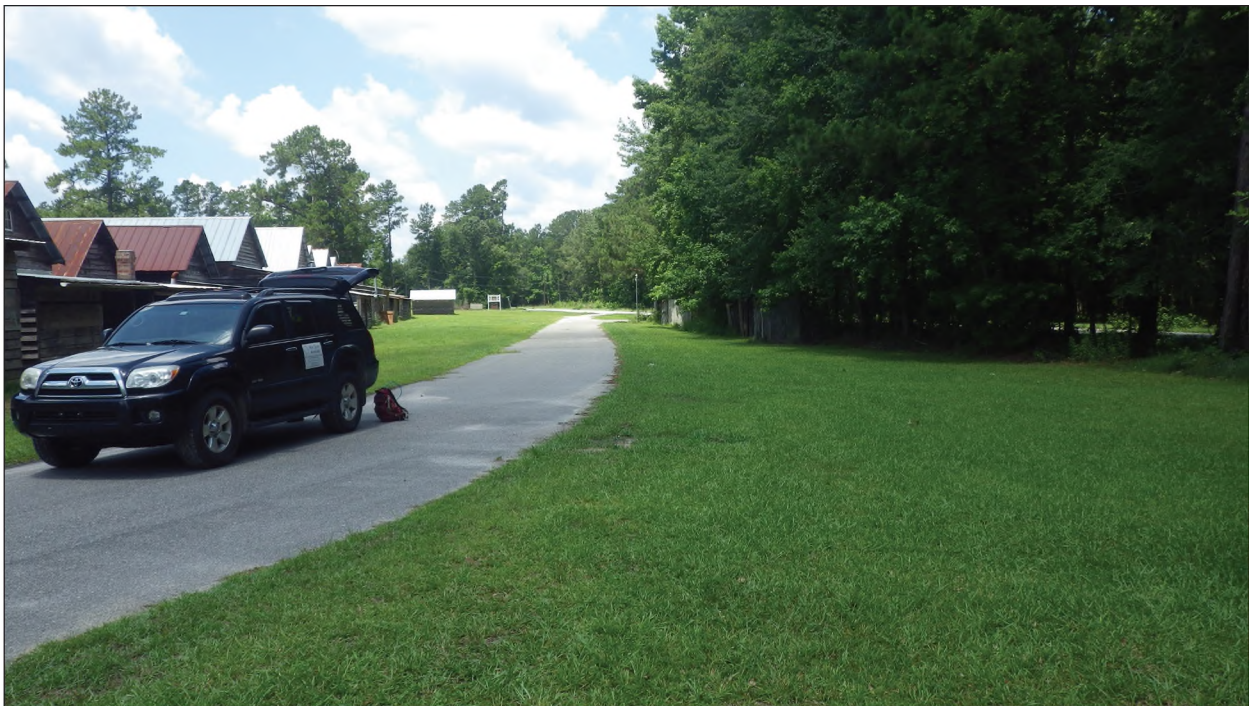
Figure 12.  
View of Site 38DR495

A. Looking South

B. Looking West

The site is located on an interior plain. The closest water source is Thompson Creek, located approximately 470 meters to the northwest. Vegetation at the site consists of a grassy lawn, with mixed pine and hardwoods along the edges of the campground (Figure 12). The archaeological component was first identified in a judgmental shovel test located in the northeastern portion of the campground between Campground Road and the row of outhouses that border Myers Mayo Road. Five shovel tests were excavated to determine the site boundaries and integrity. Of those, two were positive for artifacts, and four potential shovel tests locations were not excavated due to disturbance from Campground Road and Myers Mayo Road (Figure 13). Additionally, in order to adhere to signs posted around the site prohibiting ground disturbance, the site was not fully delineated beyond the southern boundary of the project area, which would have continued into the inner courtyard of the campground. Although only a small portion of the site was tested, the site boundary was drawn to encompass the entire built landscape of the campground and to match the proposed extension of the NRHP boundary (see Chapter VI).

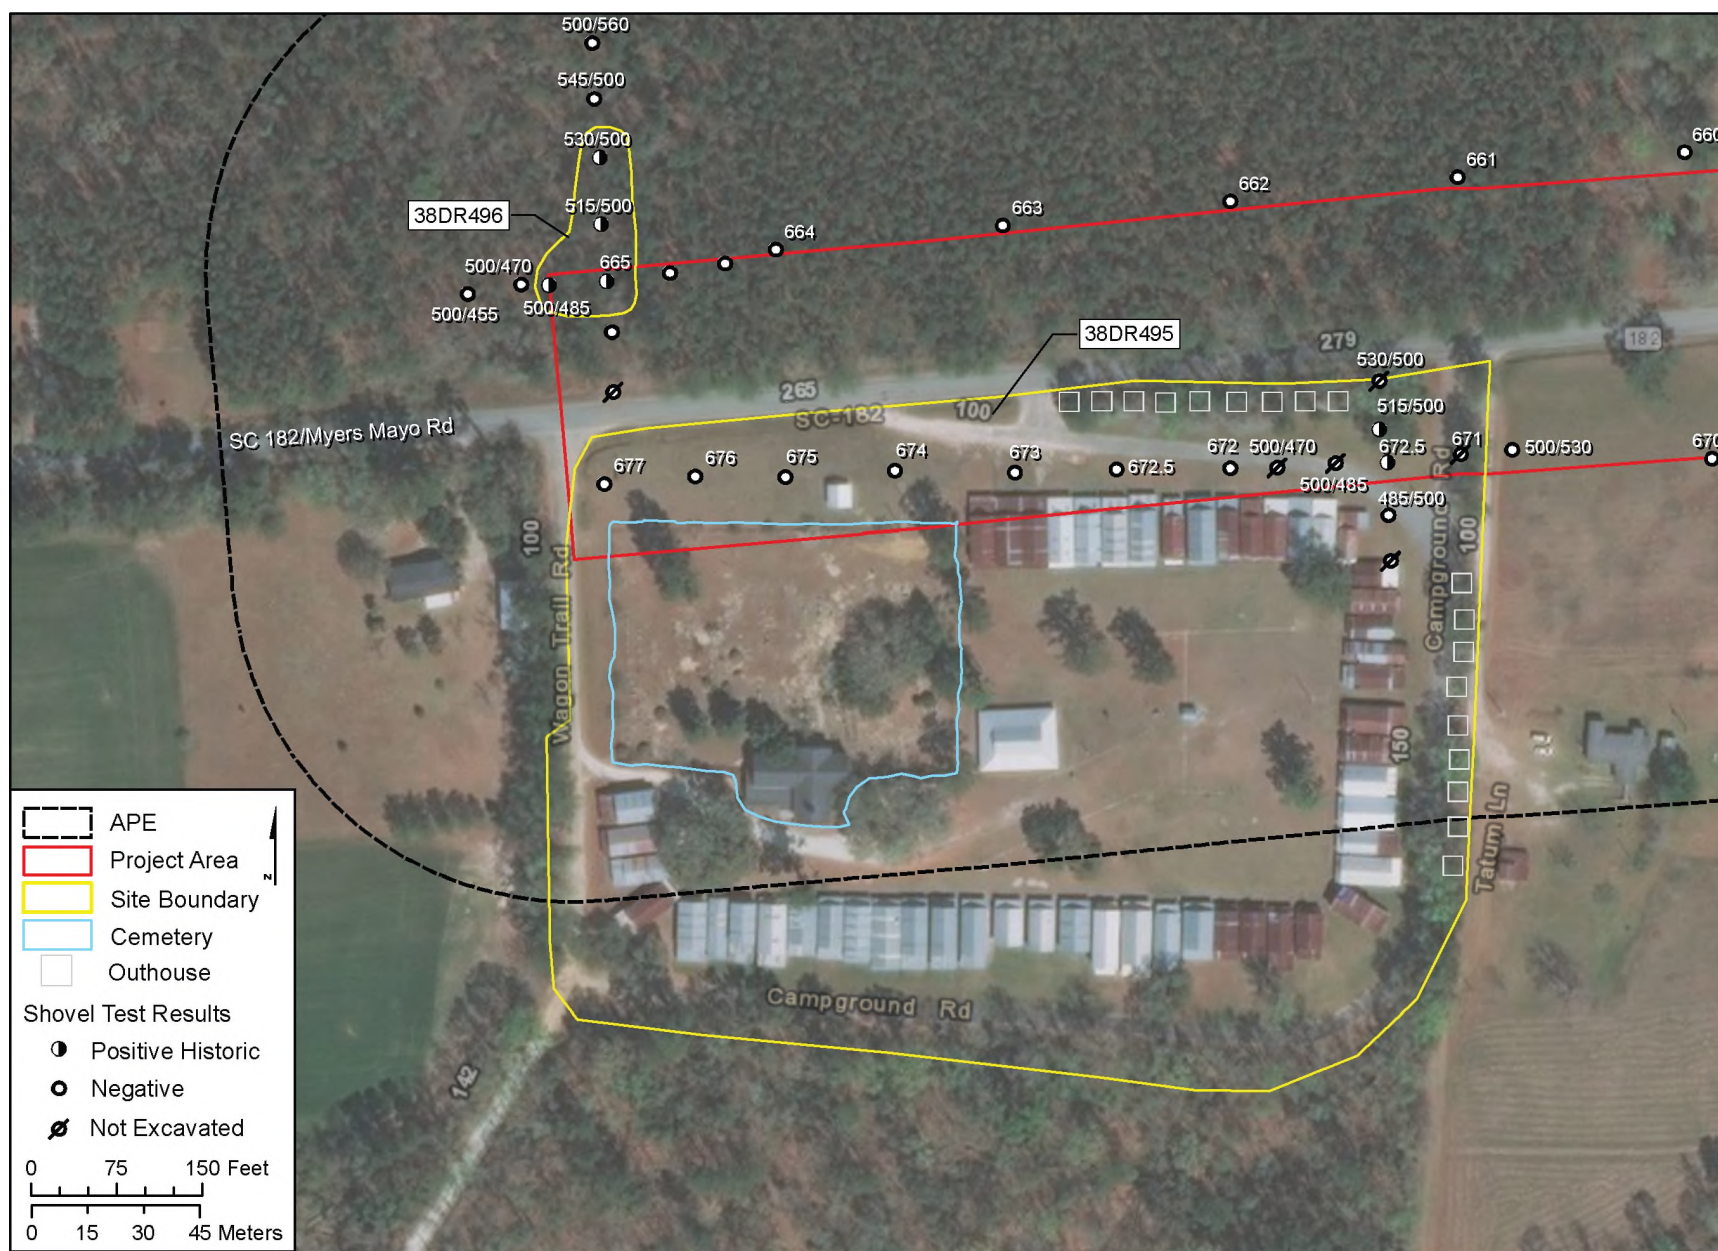
Figure 13.  
Map of 38DR495

There were 33 artifacts recovered from site 38DR495 (Table 3). All artifacts were recovered from Stratum I, within the first 30 cmbs. The majority of recovered artifacts were battery parts (n=19) and different types of container glass (n=11). Other artifacts included a cut or wrought nail fragment (n=1), a brick fragment (n=1), and a plastic fragment (n=1). Diagnostic artifacts include machine-made clear container glass with a Lauren’s Glass Works maker’s mark and a “Vat 69” Scotch Whiskey bottle. Laurens Glass Works operated out of Laurens, South Carolina from 1910 through 1996 (Lockhart et al. 2017). Vat 69 was a scotch whiskey first manufactured by Williams Sanderson & Son Ltd distillery in Leith, Scotland beginning in 1882 and is still manufactured today.

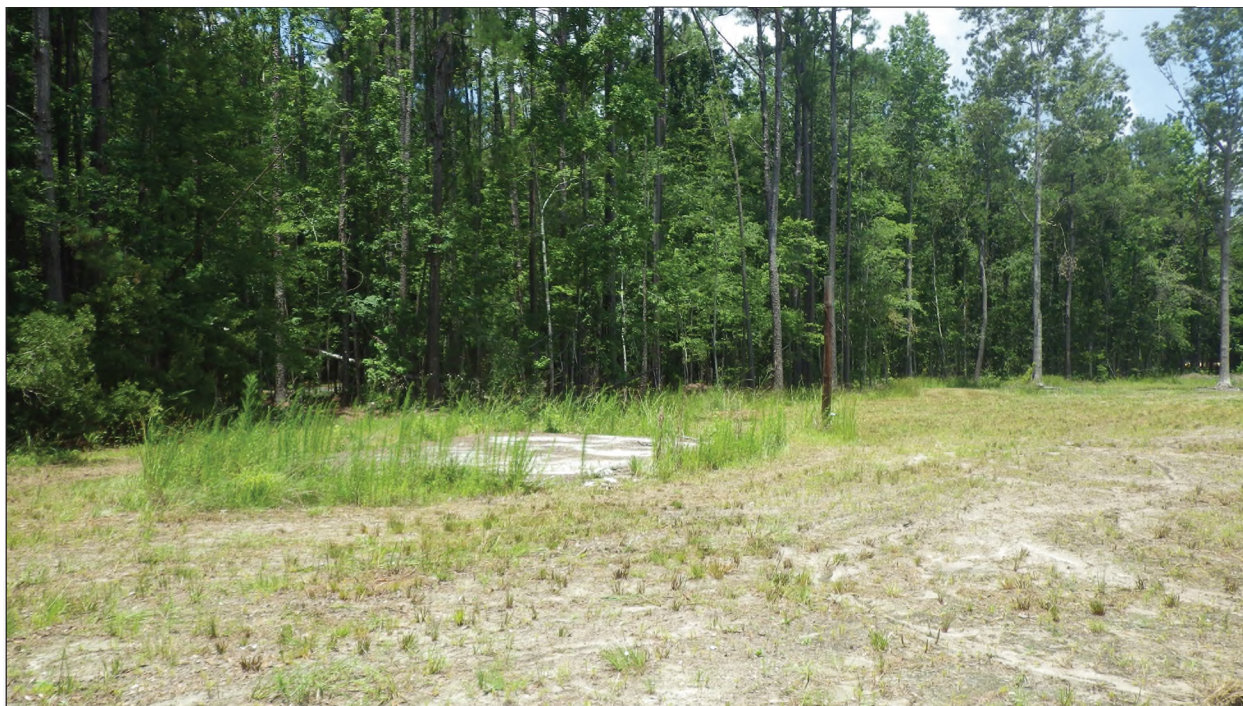
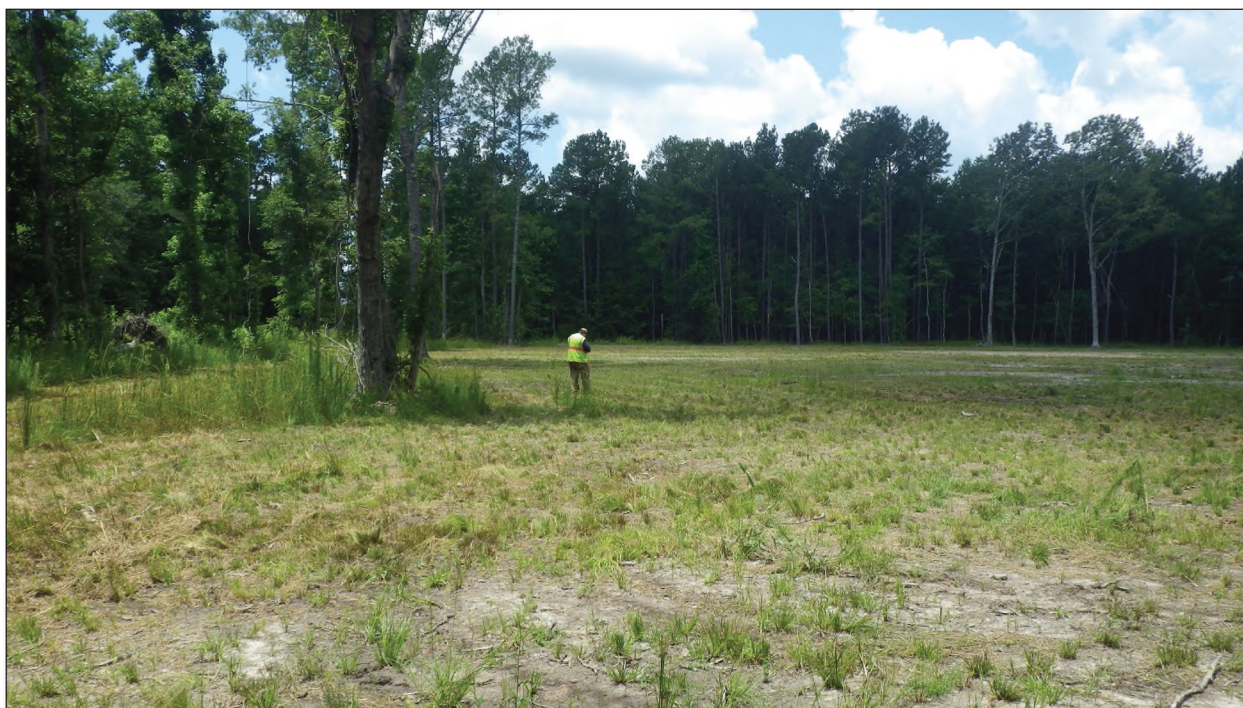
Figure 14.  
View of Site 38DR496

A. Looking North

B. Looking West

Site 38DR496 is a small historic artifact scatter identified as a surface scatter in a recently cleared field that offered 75 to 100 percent surface visibility. The site is located just north of Myers Mayo Road across from the intersection with Wagon Trail Road. The site is situated on an interior plain, and the closest water source is Thompson Creek, approximately 290 meters to the north. Vegetation at the site consisted of a very light ground cover of grasses and weeds. The cleared field in which the artifact scatter was located is surrounded by an open canopy of mixed pine and hardwood forest (Figure 14). Surface visibility within the forest was less than 25 percent. Significant disturbance from the recent clearing of the field, which shows as wooded on most aeriels, was evident at the site. Subsoil could be observed at the surface in many locations.

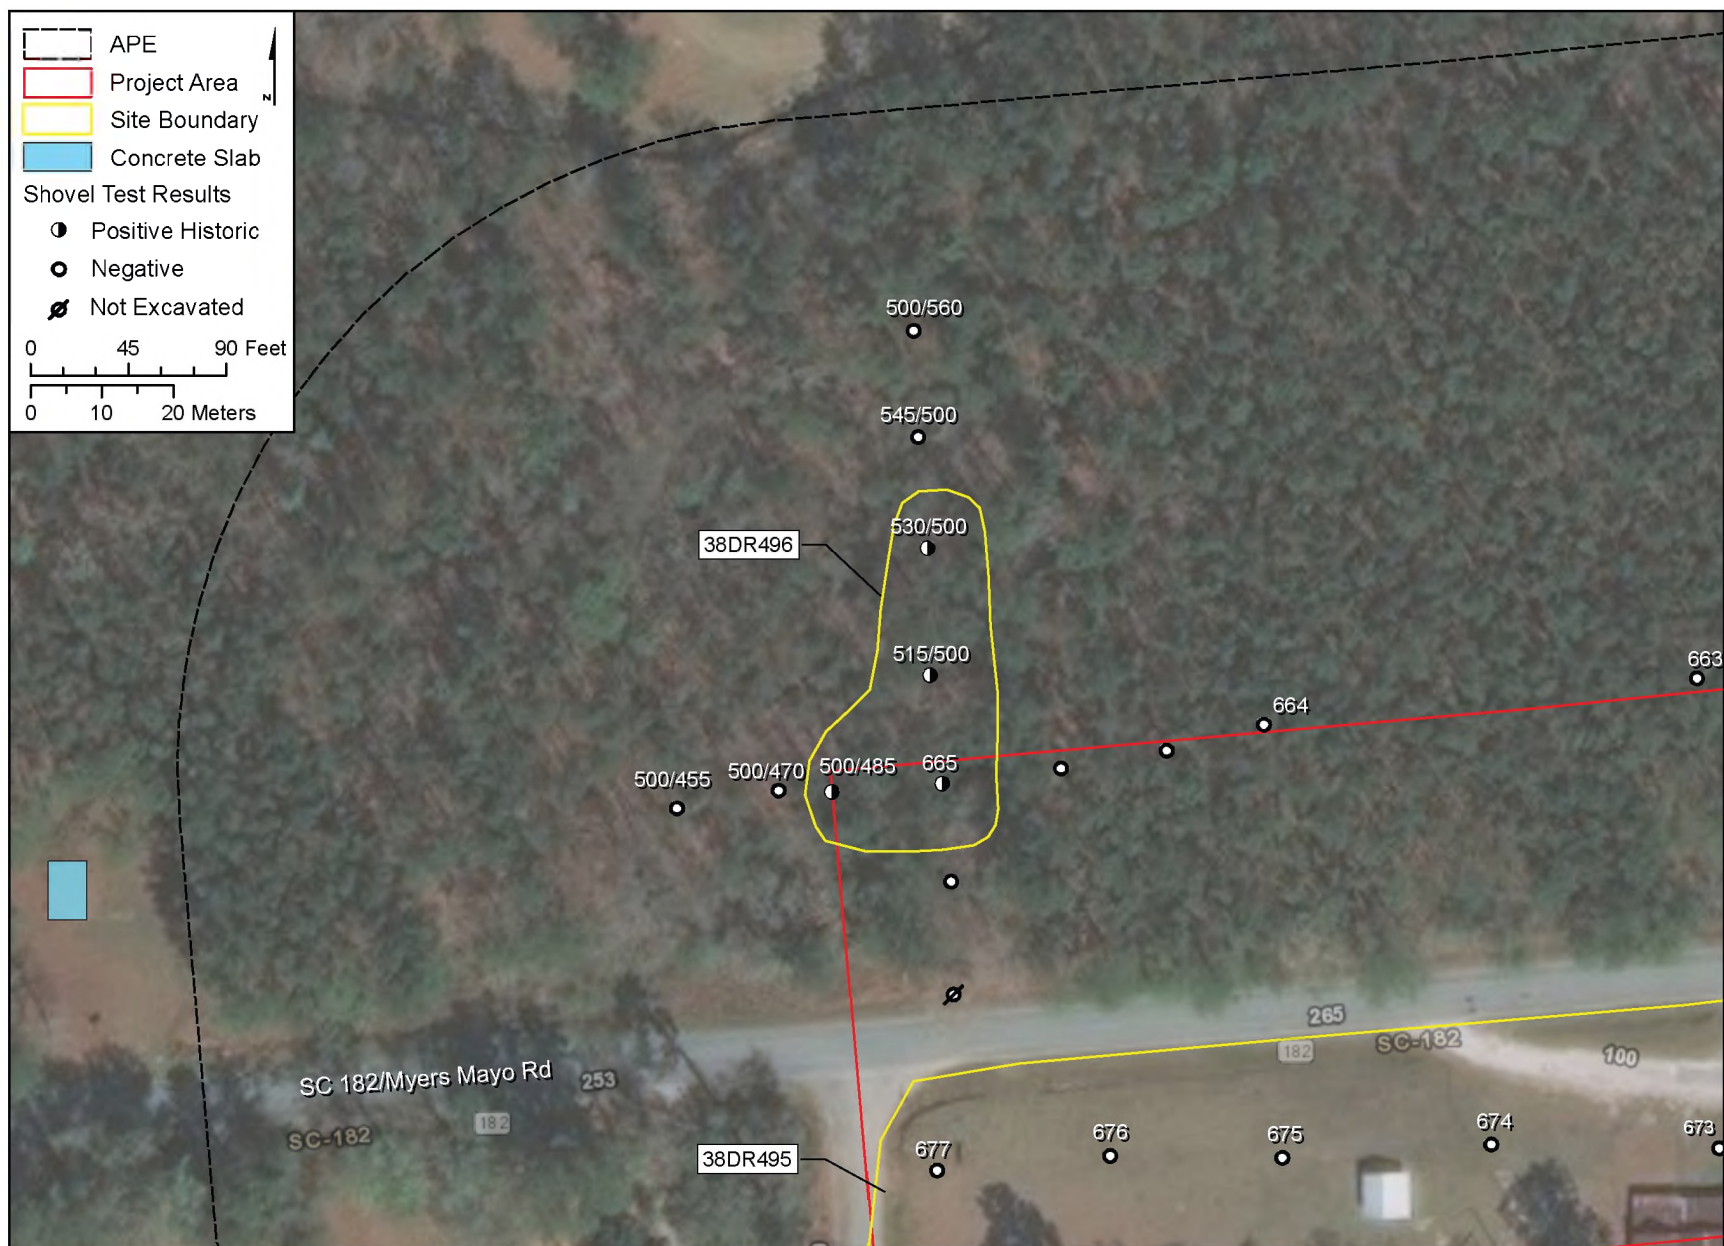
Figure 15.  
Map of 38DR496

Four artifacts were collected from 38DR496, including one fragment of clear glass, one fragment of milk glass, one plain whiteware sherd, and one unidentifiable fragment of iron or steel (Table 4). In addition to these artifacts, brick fragments and an unidentifiable fragment of iron were observed on the ground surface, but not collected. None of the artifacts collected or observed were temporally sensitive. The few artifacts that could be dated have long manufacture ranges that span hundreds of years. Milk glass has a manufacture start date of 1743 and is still produced today (Miller 2000). Similarly, whiteware has been in production continuously since 1830 (Miller 1991:5).

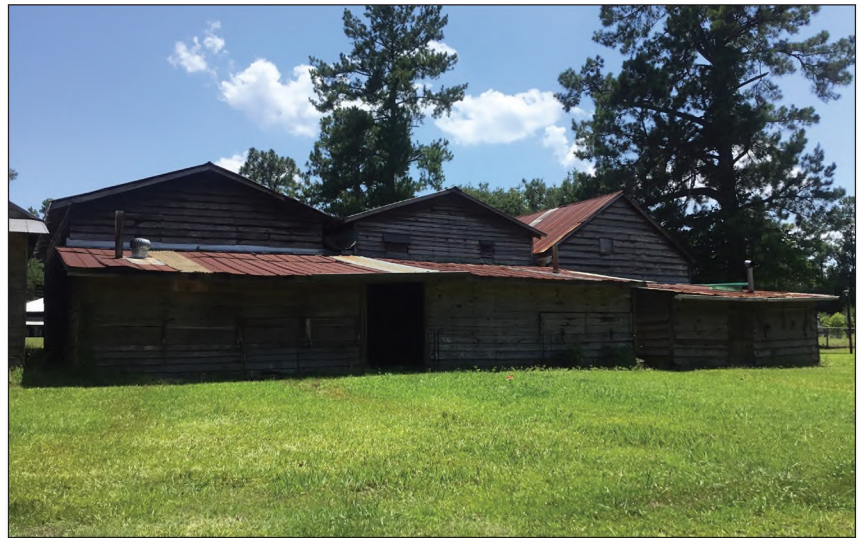
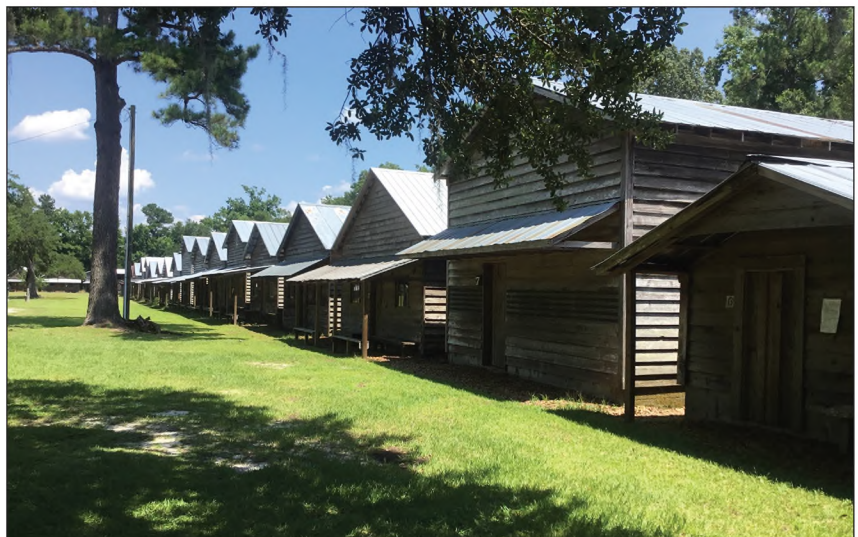
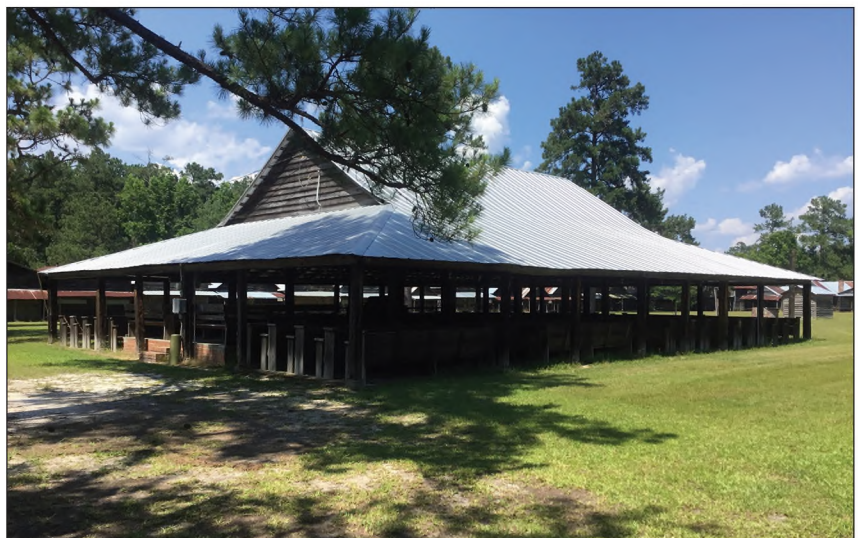
Figure 18.  
Cypress Methodist Campground Tents and Tabernacle

A. Tents, View  
Facing Southwest

B. Tents, View  
Facing West

C. Tabernacle,  
Southwest Oblique
