# PHASE I CULTURAL RESOURCE SURVEY OF I-26 WIDENING PROJECT MM 187-194

Berkeley and Dorchester Counties,  
South Carolina

May 8, 2019 • **Revised Draft Report**  
New South Associates Technical Report 2877

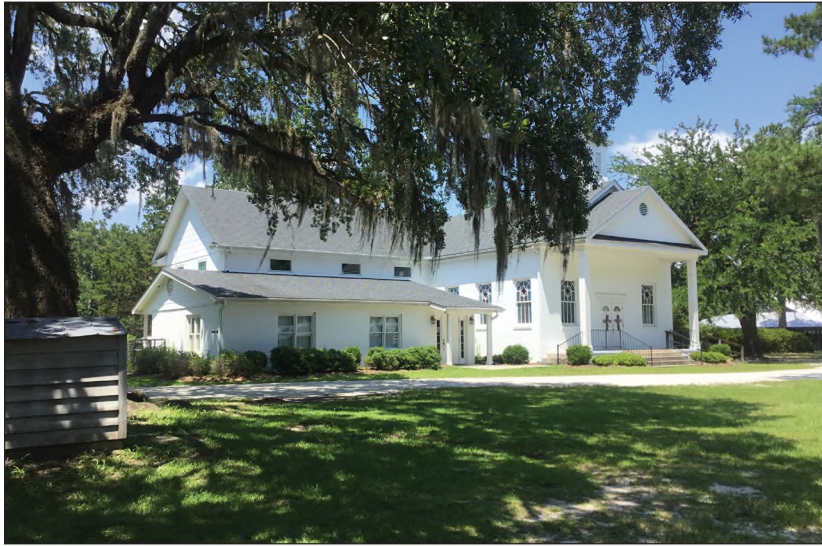
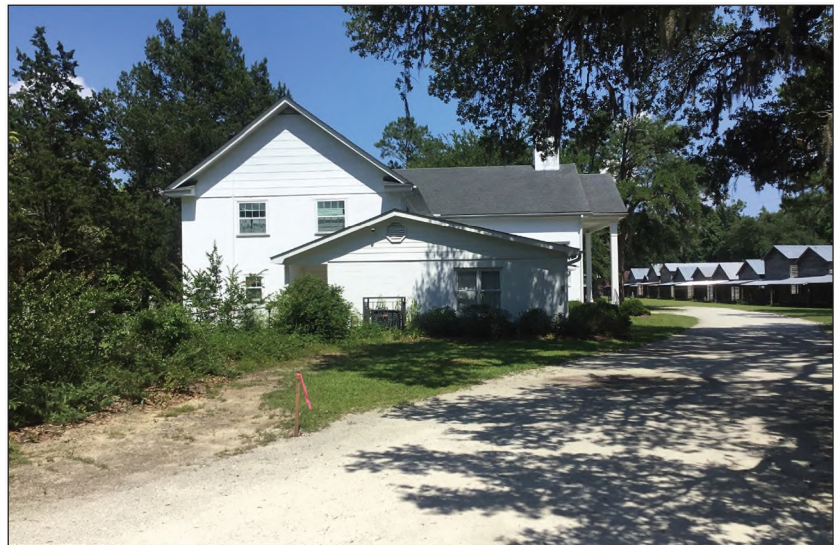
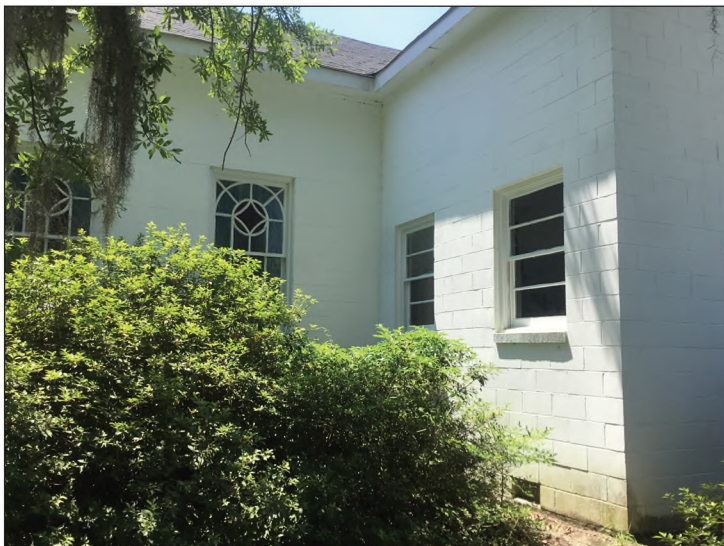
Figure 19.  
Cypress Methodist Campground Church

A. Southwest Oblique

B. West Elevation

C. Window Detail, Facing Northwest

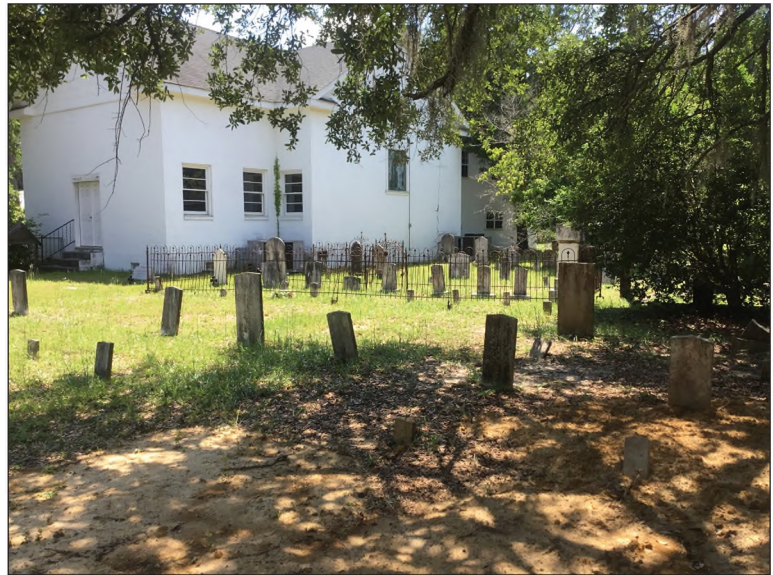
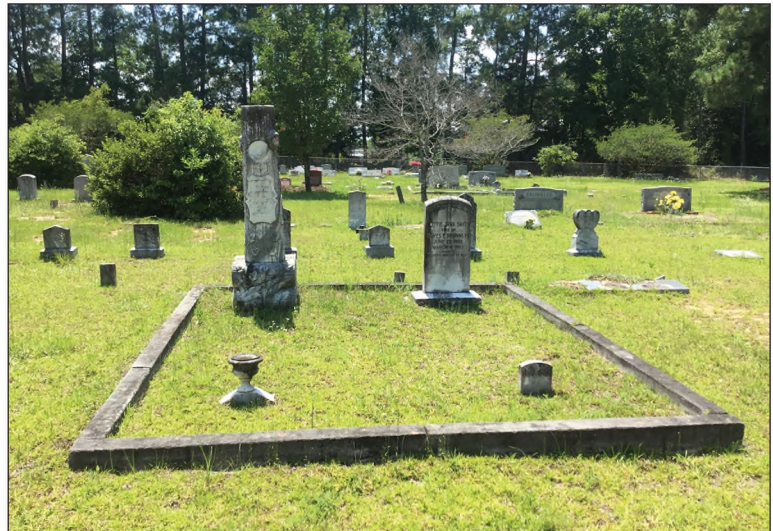
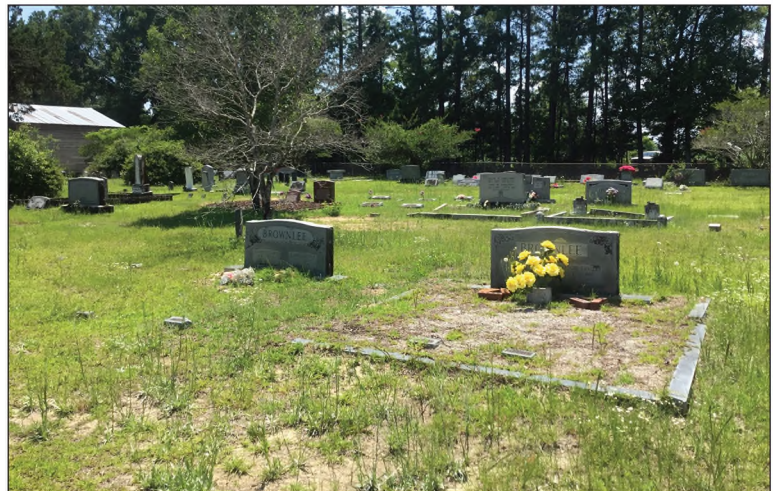
Figure 20.  
Cypress Methodist Campground Cemetery

A. Contextual,  
View Facing South

B. Family Plot,  
View Facing West

C. New Section,  
View Facing West

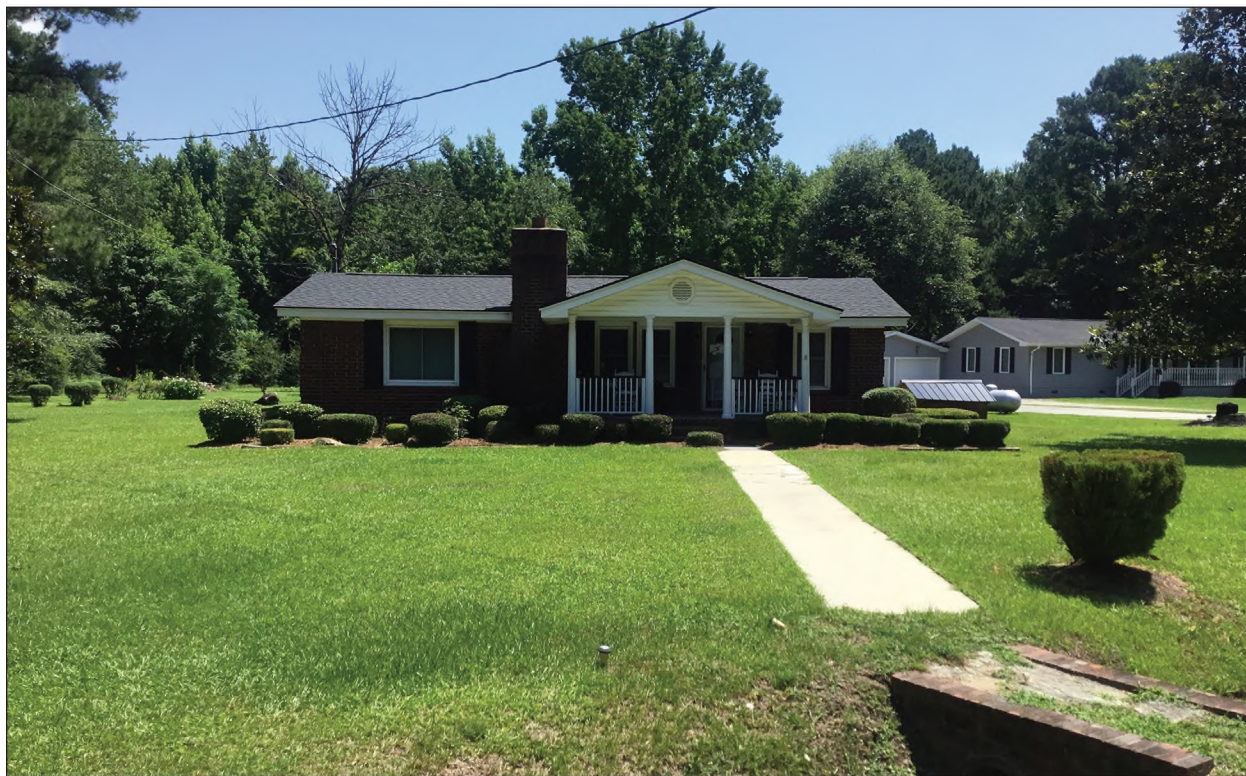
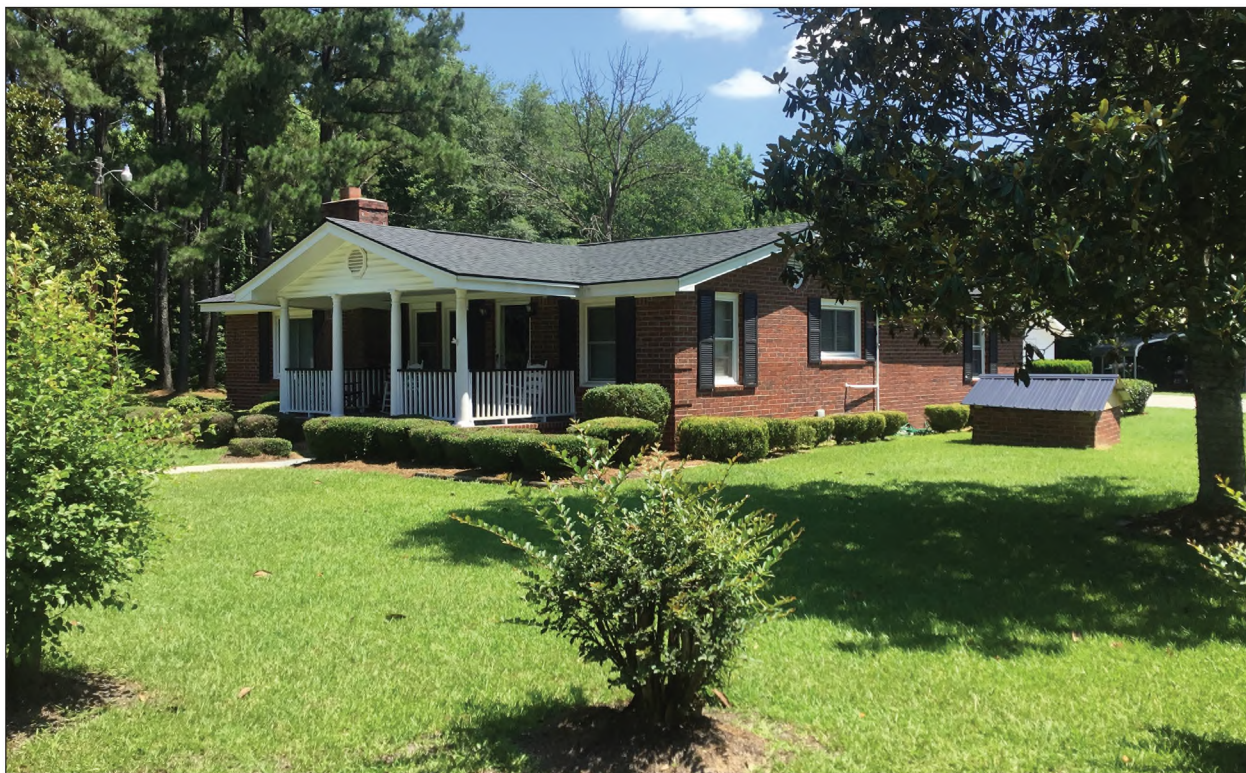
Figure 23.  
Resource 1316 (161 Jared Lane)

Resource 1316 and its outbuildings are located near the eastern terminus of Jared Lane, a one-lane residential road. It is sited on a fairly large lot with a generous setback and is landscaped with a grass lawn, manicured bushes, and a wooded buffer to the east and west. Although Resource 1316 is a Linear Ranch House, it is not a distinctive or noteworthy example of this house type that is common in South Carolina. Its integrity is further impacted by the replacement of its original windows. It was not found to embody the distinctive characteristics of a style, period, or method of construction, and does not possess significance for its engineering or materials. It is not known to be associated with events or persons significant in the past. Therefore, the resource is recommended as not individually or collectively eligible for the NRHP under Criterion A, B, or C. Resources 1316.01 and 1316.02 were not found to embody the distinctive characteristics of a type, period, or method of construction, and do not represent the work of a master or possess high artistic value. They are not known to be associated with events or persons significant in the past. Therefore, the resources are recommended as not individually or collectively eligible for the NRHP under Criterion A, B, or C.

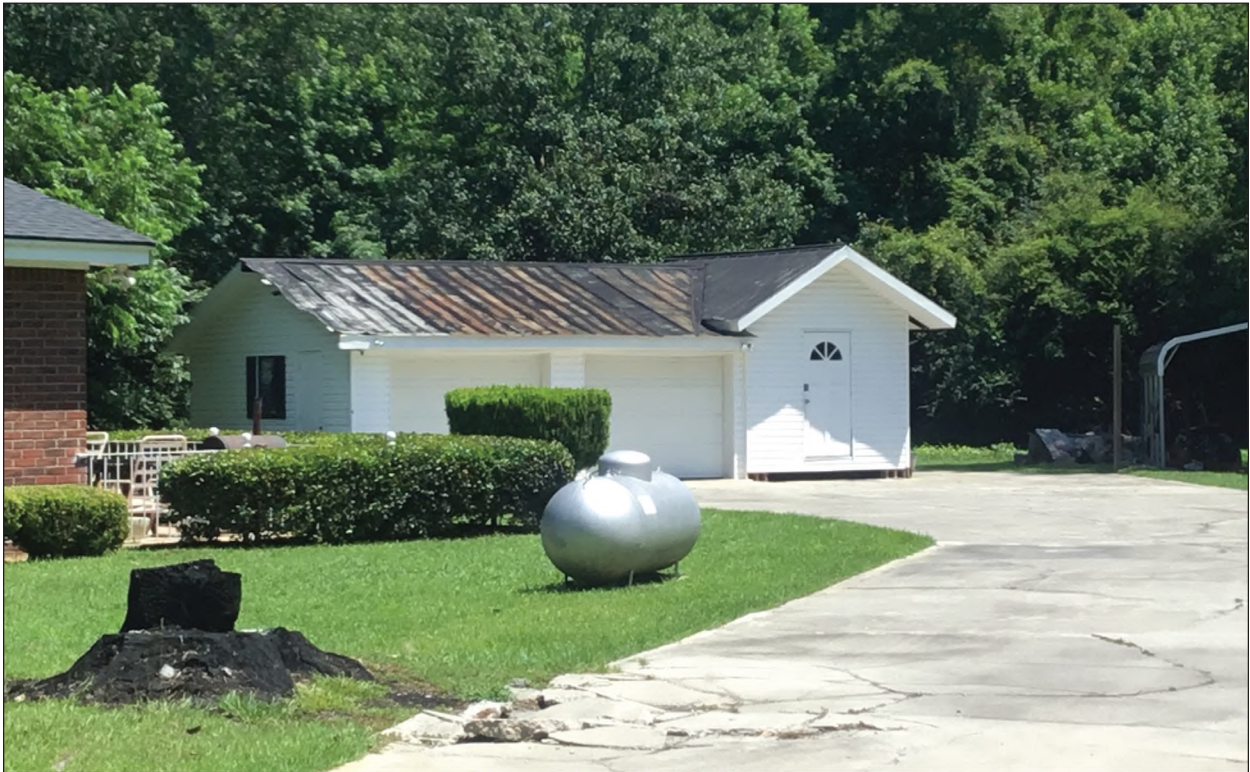
A. 1316.01 (Garage), Southeast Oblique

Resource 1316.01 is a circa 1967 garage located approximately 40 feet northeast of Resource 1316. This rectangular, two-car garage is one-story tall with weatherboard siding and a cross-gabled, V-crimp metal roof (Figure 24A). It is accessed by two rolling garage doors on the east elevation. A one-over-one, double-hung sash window is located on the south elevation. There is a front-gabled addition with concrete block pier foundation on the north elevation, accessed via a wood-panel door. The historic core has a concrete slab foundation.

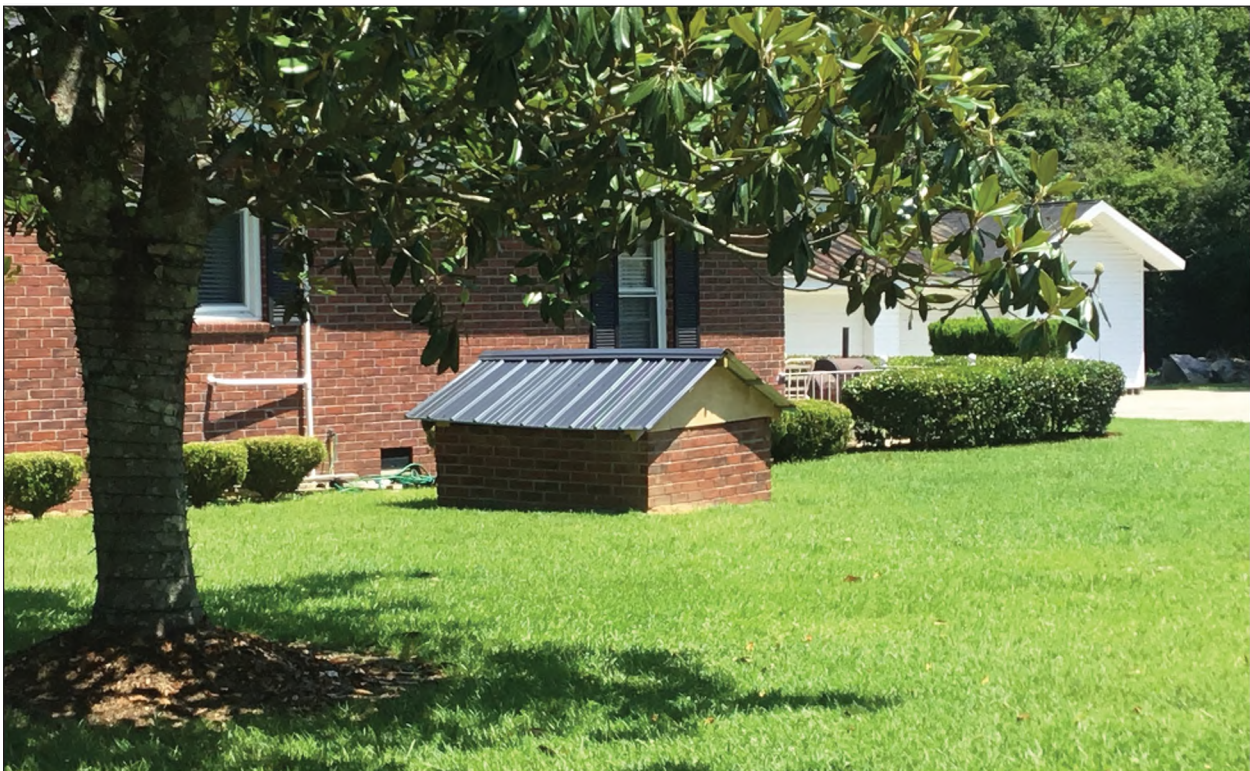
B. 1316.02 (Pump House), Southeast Oblique

Resource 1316.02 is a circa 1967 brick pump house located approximately 20 feet east of Resource 1316. The pump house is a small rectangular building with a gabled V-crimp metal roof (see Figure 24B). It is one undersized story tall, with vertical wood siding in the gable ends. The foundation is concealed.

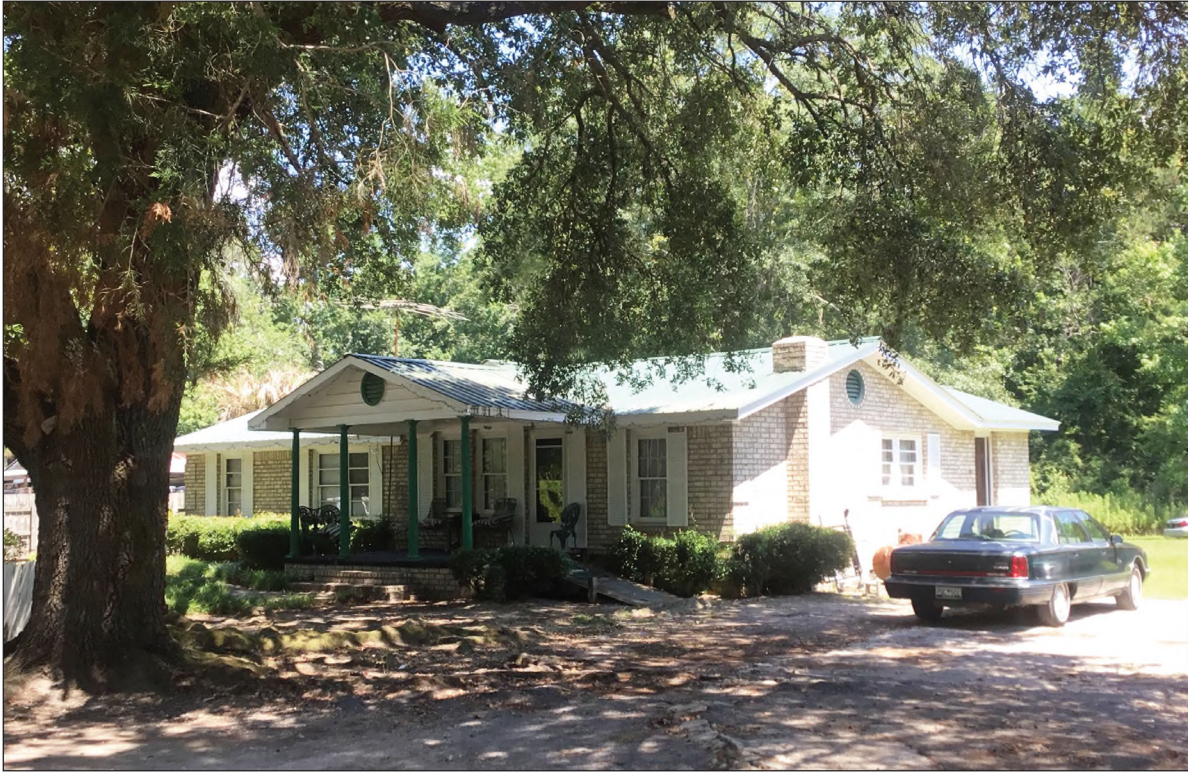
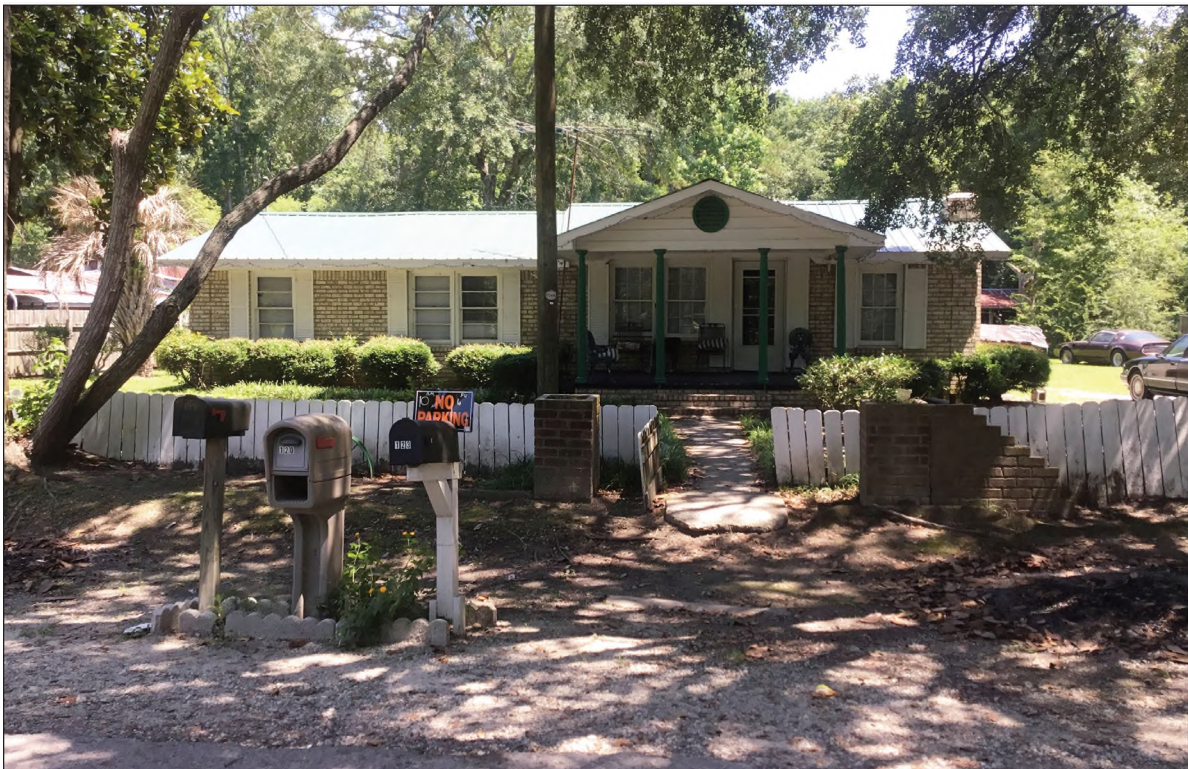
Figure 25.  
Resource 1317 (123 Jared Lane)

Resource 1317 and its outbuildings are located on the northern side of Jared Lane, a one-lane residential road. An auto repair business consisting of three buildings is also located on the property, but is not visible on a 1972 aerial photograph of the area. The lot is large enough to accommodate both buildings as well as parking for vehicles under repair. The house is surrounded by a grass lawn with manicured bushes, mature trees, and a white picket fence. Although Resource 1317 is a Linear Ranch House, it is not a distinctive or noteworthy example of this house type which is common in South Carolina. Its integrity is further impacted by the replacement of its original windows. It was not found to embody the distinctive characteristics of a style, period, or method of construction, and does not possess significance for its engineering or materials. It is not known to be associated with events or persons significant in the past. Therefore, the resource is recommended as not individually or collectively eligible for the NRHP under Criterion A, B, or C. Resources 1317.01 and 1317.02 were not found to embody the distinctive characteristics of a type, period, or method of construction, and do not represent the work of a master or possess high artistic value. They are not known to be associated with events or persons significant in the past. Therefore, the resources are recommended not individually or collectively eligible for the NRHP under Criterion A, B, or C.

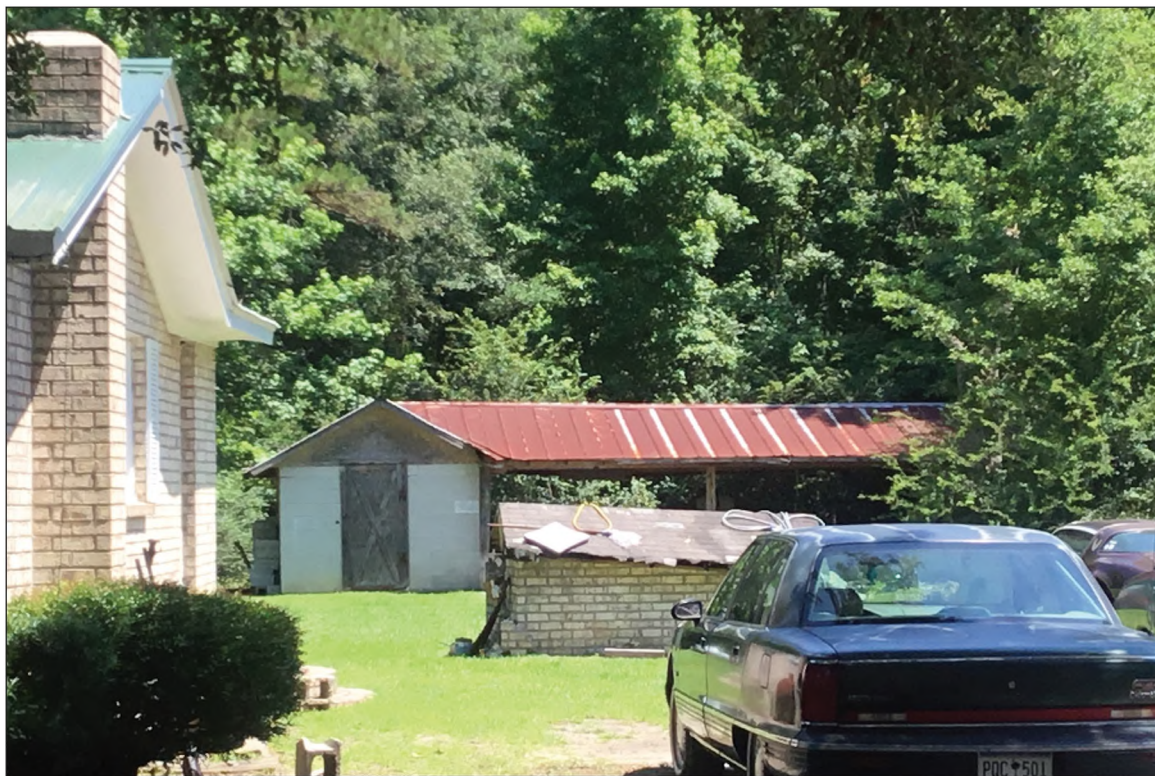
A. 1317.01 (Shed), South Elevation

Resource 1317.01 is a circa 1963 shed located approximately 80 feet north of Resource 1317. It is a rectangular frame building with a cross-gabled, standing seam metal roof. The laterally gabled eastern half is open to the air and has square wooden supports (Figure 26A). The western half is front-gabled with concrete block walls and a plywood door. There is plywood in the gable ends. The building has a slab foundation.

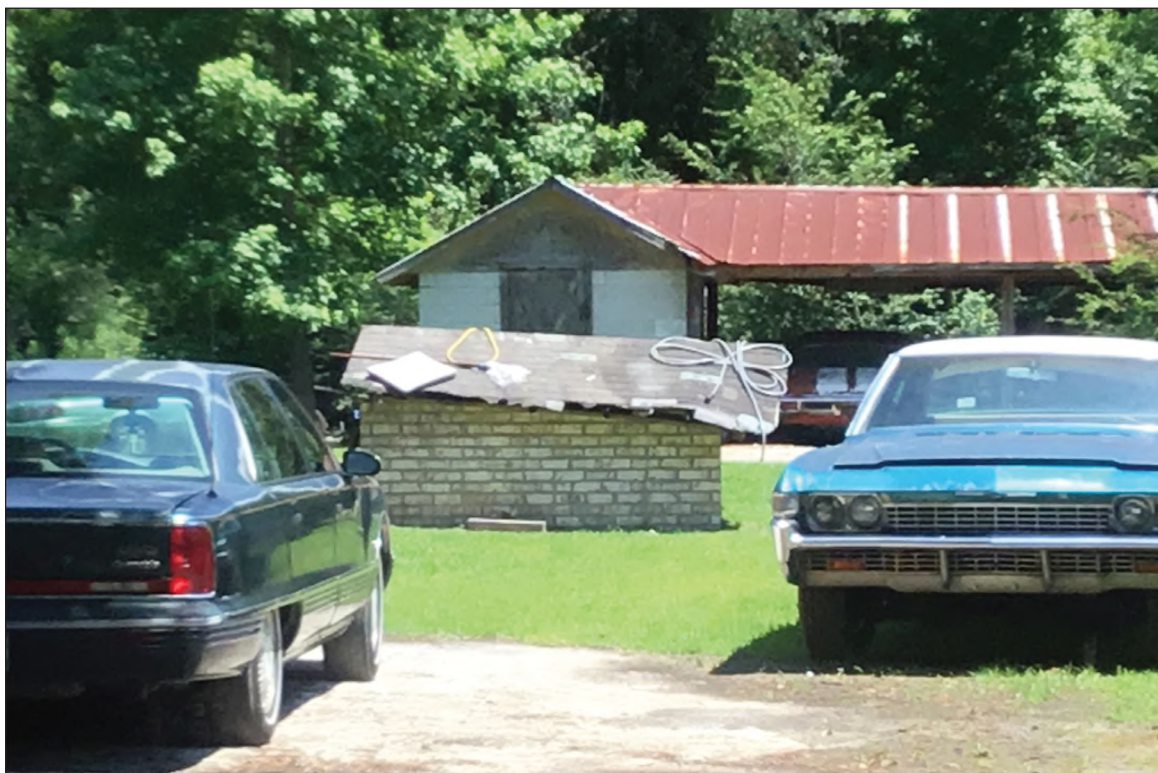
B. 1317.02 (Pump House), South Elevation

Resource 1317.02 is a circa 1963 pump house located approximately 15 feet northeast of Resource 1317. It is a small rectangular building with brick walls and a gabled asphalt roll roof (see Figure 26B). It is in a state of partial disrepair, and the foundation is not visible.

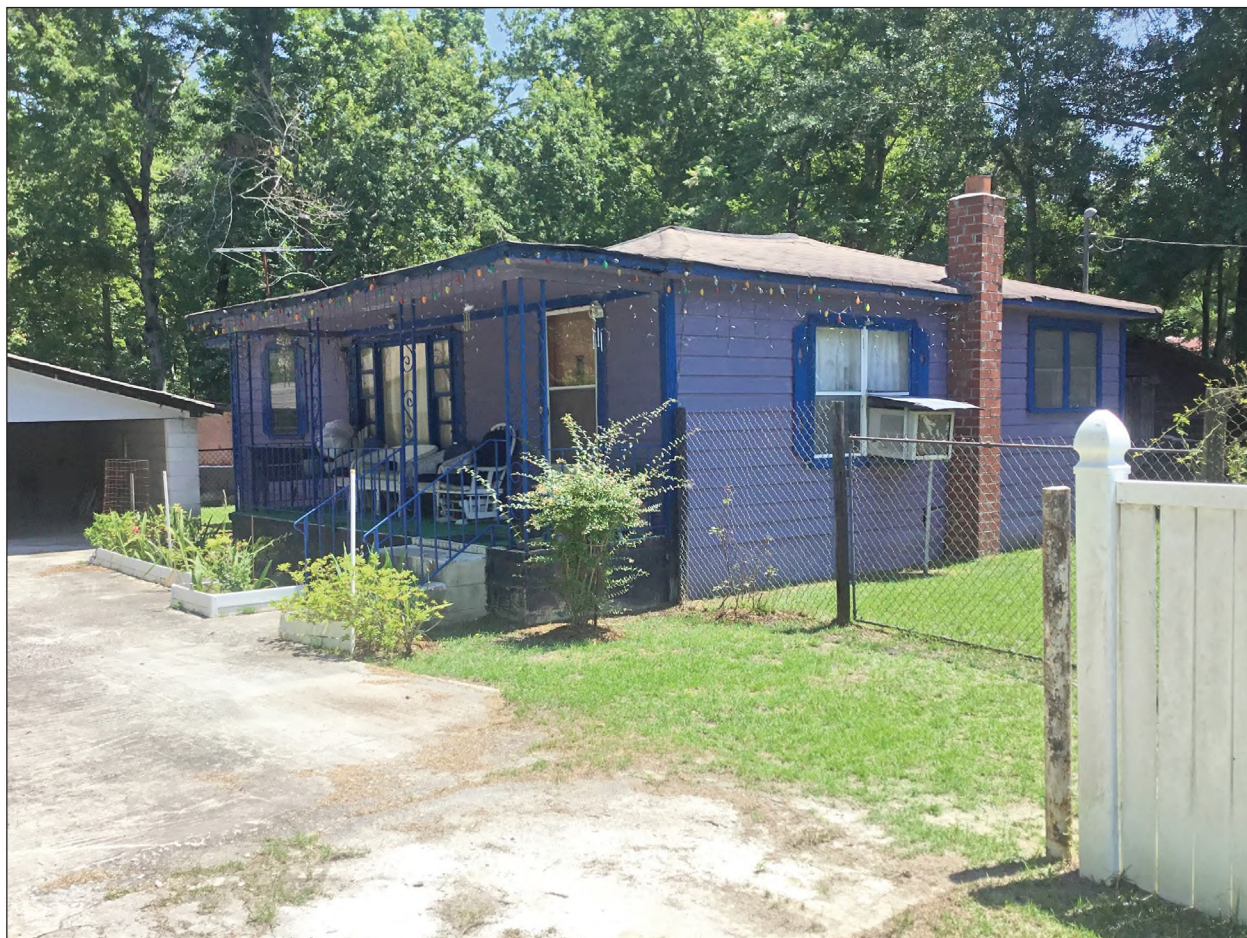
Figure 27.  
Resource 1318 (107 Jared Lane)

Resource 1318 is a circa 1950 American Small House located at 107 Jared Lane. Dorchester County tax records indicate that it was constructed in 1979, but it is visible on a 1972 aerial photograph of the area. The house is one story tall and rectangular in plan with a hipped, composition shingle roof and weatherboard siding (Figure 27). It faces west towards Ridgeville Road. A shed-roofed porch with wrought iron supports extends across the full front elevation of the historic core. A historic wood door with a small rectangular window is located on the south side of the front elevation, and a tripartite picture window is located to the north. The picture window is wood frame with horizontal two-over-two double-hung sash side pieces. Other windows on the house are one-over-one, aluminum frame, double-hung sash replacement windows. Windows on the side elevations are paired, and all windows have small, decorative wood shutters. An exterior brick chimney is located on the south elevation. A laterally gabled frame addition extends along the full north elevation. The house has a continuous concrete block foundation. A two-car concrete block garage is associated with the house but is not visible on historic aerial photographs.

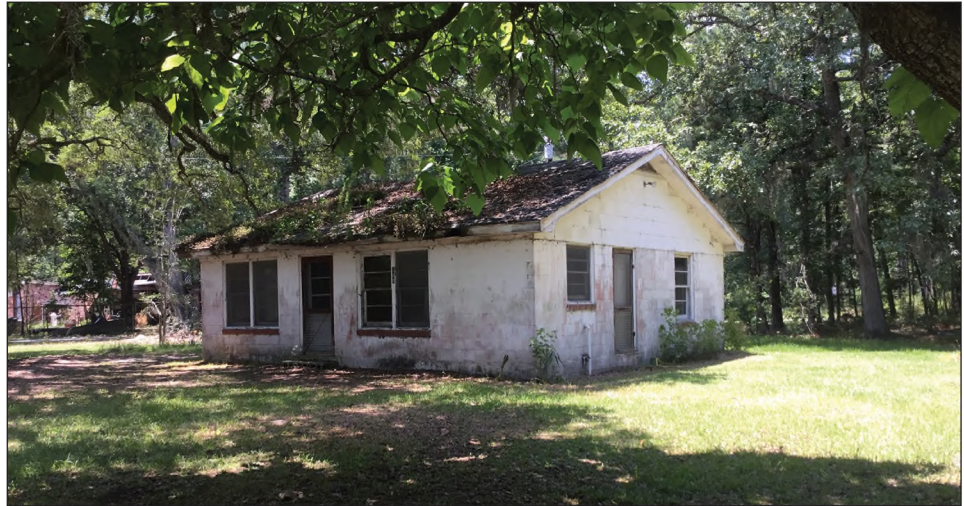
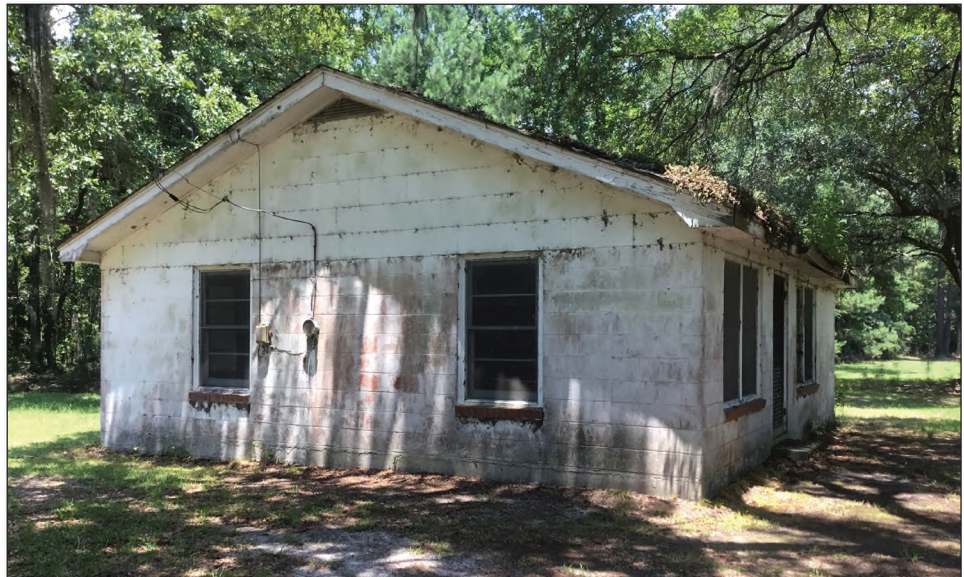
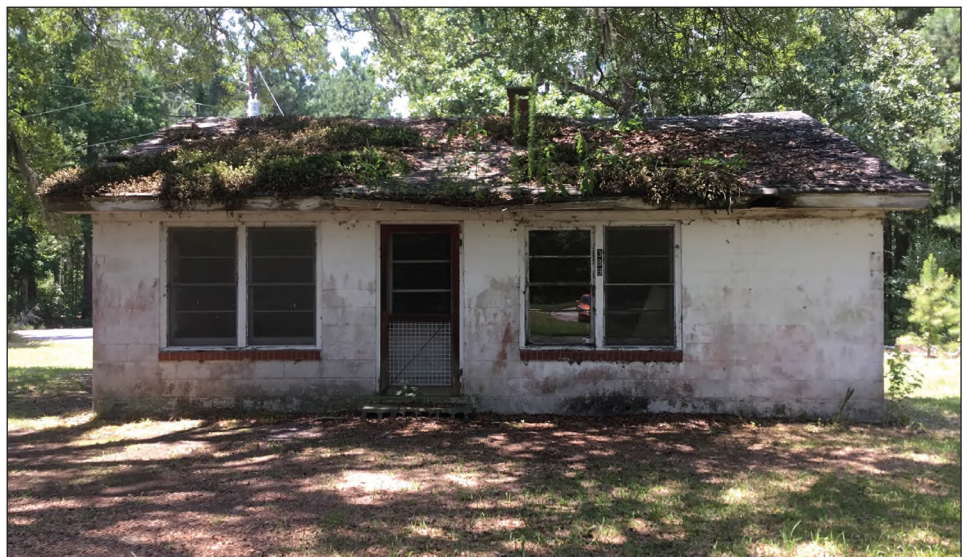
Figure 28.  
Resource 1319 (389 Myers Mayo Road)

west elevation simply contains two windows. The house has overhanging boxed eaves and is supported by a slightly raised concrete slab foundation. The house is vacant and shows signs of disrepair, including significant biogrowth.

Resource 1319 is located on the corner of Myers Mayo Road, a busy two-lane highway, and Sabb Drive, a two-lane residential road. This portion of the project area is fairly rural, and development consists of widely spaced single-family houses. Resource 1319 is sited on a large lot of approximately four acres and has a setback of approximately 140 feet. It is surrounded by a sparse grass lawn, and landscaping is overgrown. A large live oak tree is located on the lot near the resource. Although Resource 1319 is an American Small House, it is not a distinctive or noteworthy example of this house type, which is common in South Carolina. It was not found to embody the distinctive characteristics of a style, period, or method of construction, and does not possess significance for its engineering or materials. It is not known to be associated with events or persons significant in the past. Therefore, the resource is recommended as not individually eligible for the NRHP under Criterion A, B, or C.

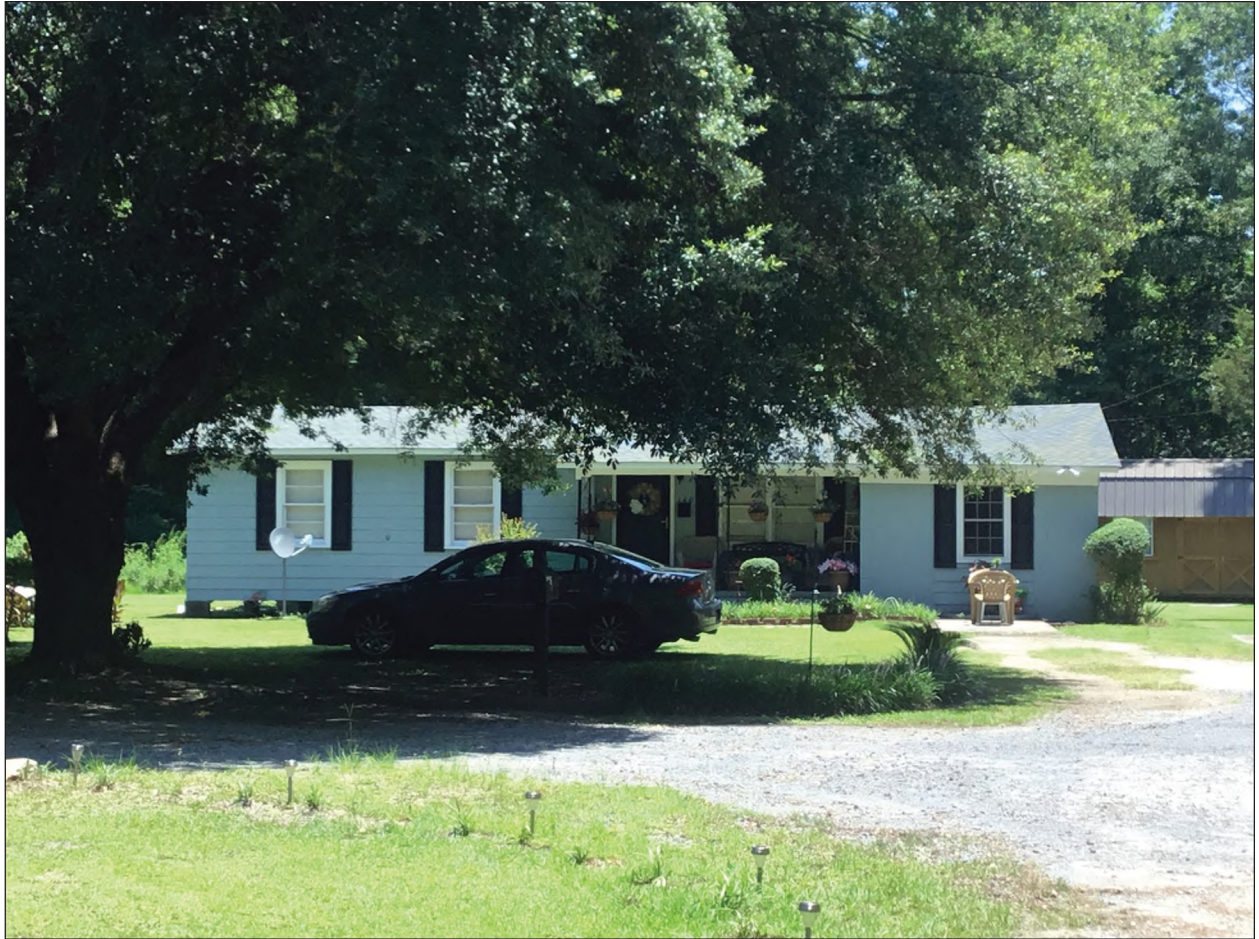
Figure 29.  
Resource 1277 (140 Emma Lane)

Resource 1277 is a circa 1965 Plain Compact Ranch House located at 140 Emma Lane. It is visible on a 1972 aerial photograph of the area. The historic core is one story tall and rectangular in plan with a laterally gabled, composition shingle roof (Figure 29). It is clad in weatherboard and faces roughly southwest. Windows on the historic core are horizontal, two-over-two, double-hung sashes with louvered shutters. A shed-roofed porch with wrought iron support shelters the wood-panel front door and a paired double-hung sash window. Two additional windows are located to the left of the porch. The historic core has a concrete block pier foundation. A laterally gabled concrete block addition has been made to the southern end of the house. The addition has a vinyl frame six-over-six double-hung sash window and a continuous, concrete block foundation. It extends to the width of the porch rather than the historic core, making the house L-shaped when considered in its entirety.

Resource 1277 is located near the terminus of Emma Lane, a one-lane unpaved drive with sparse, single-family, residential development. The resource is sited on a large lot with a circular driveway and landscaping that includes a grass lawn, flowerbeds, ornamental bushes, and mature trees. Two modern, prefabricated sheds are also located on the property. Although Resource 1277 is a Compact Ranch House, it is not a distinctive or noteworthy example of this house type that is common in South Carolina. Its integrity is further impacted by a large addition that is visible from the front elevation. It was not found to embody the distinctive characteristics of a style, period, or method of construction, and does not possess significance for its engineering or

materials. It is not known to be associated with events or persons significant in the past. Therefore, the resource is recommended as not individually eligible for the NRHP under Criterion A, B, or C.

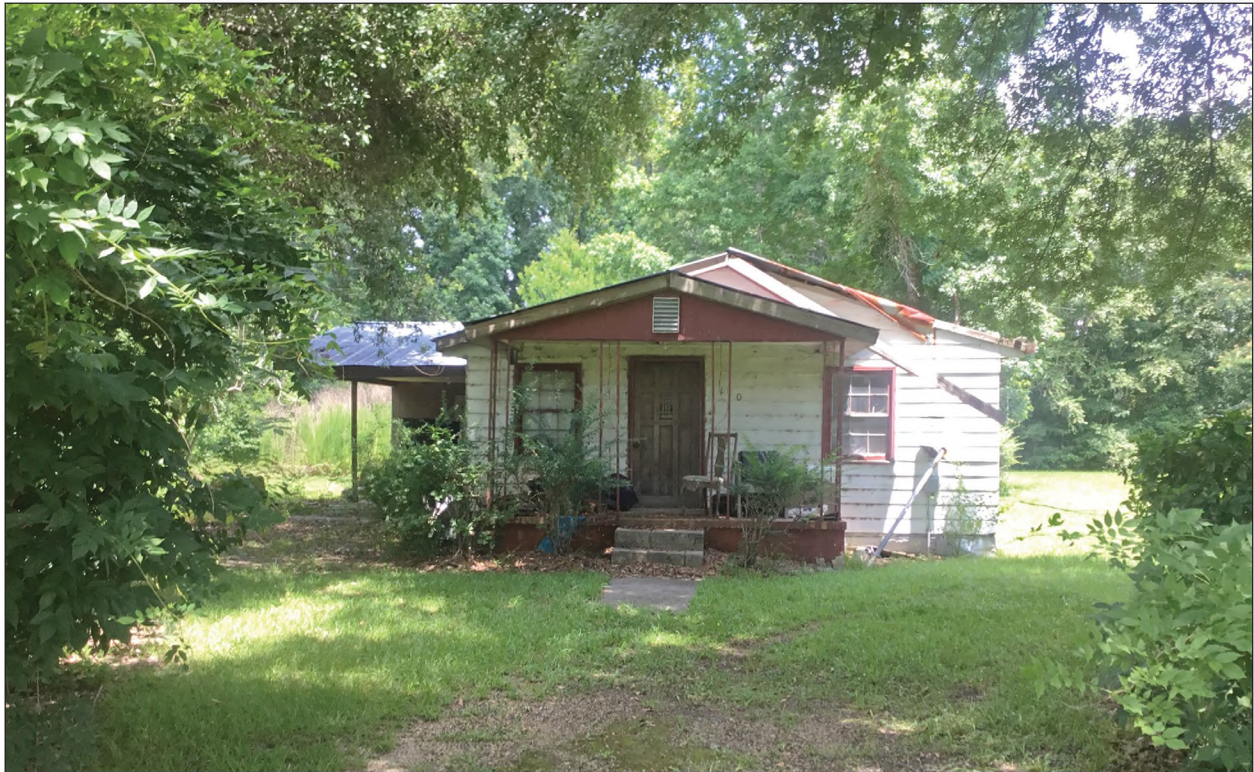
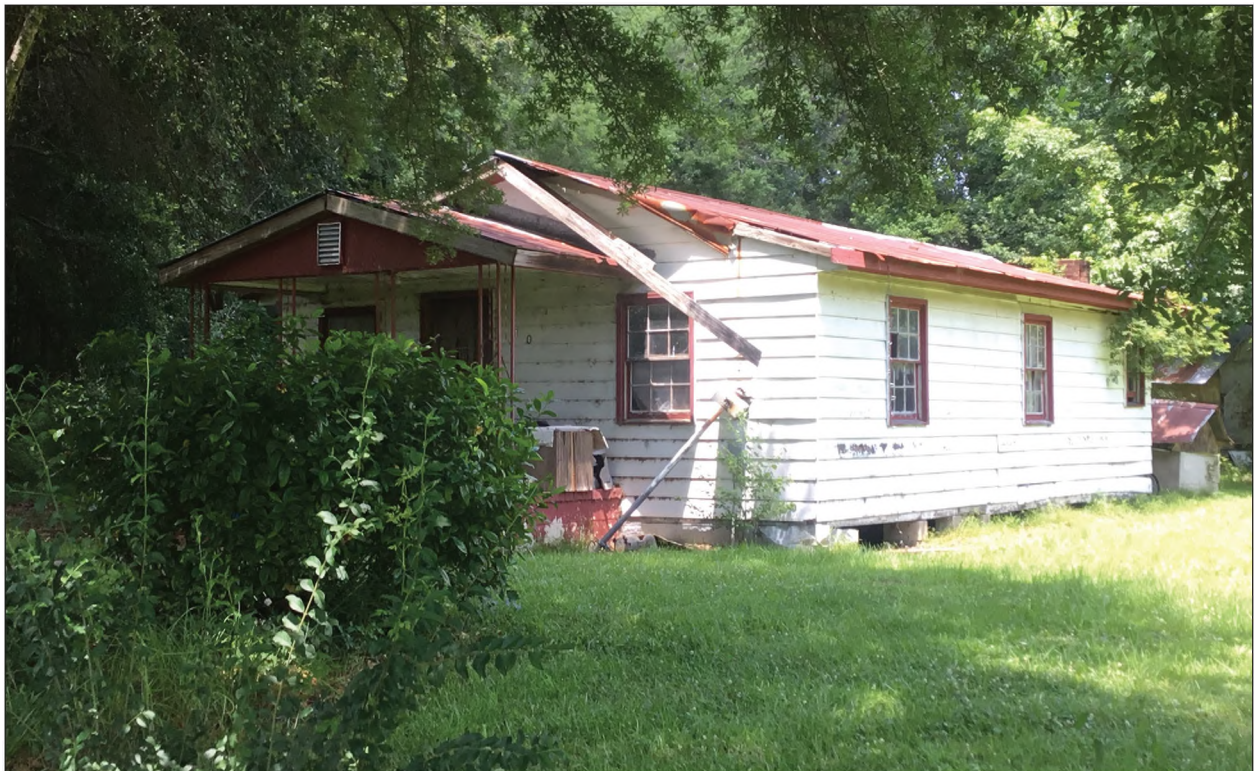
Figure 31.  
Resource 1279 and 1279.01 (113 Palacio Lane and Pump House)

Resource 1279.01 is a circa 1955 pump house located approximately five feet behind Resource 1279. It is a small, rectangular, concrete block building with a gabled, standing seam metal roof. There is plywood in the gable ends and the foundation is not visible.

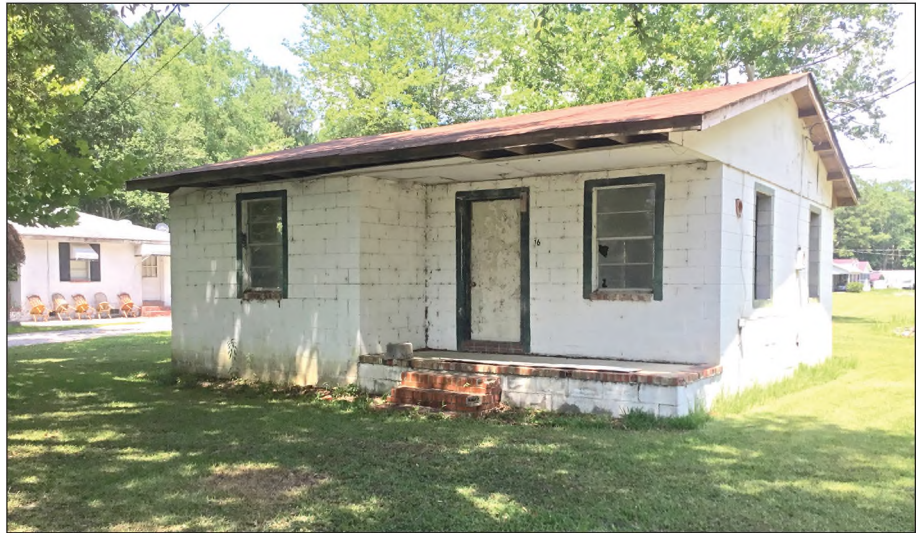
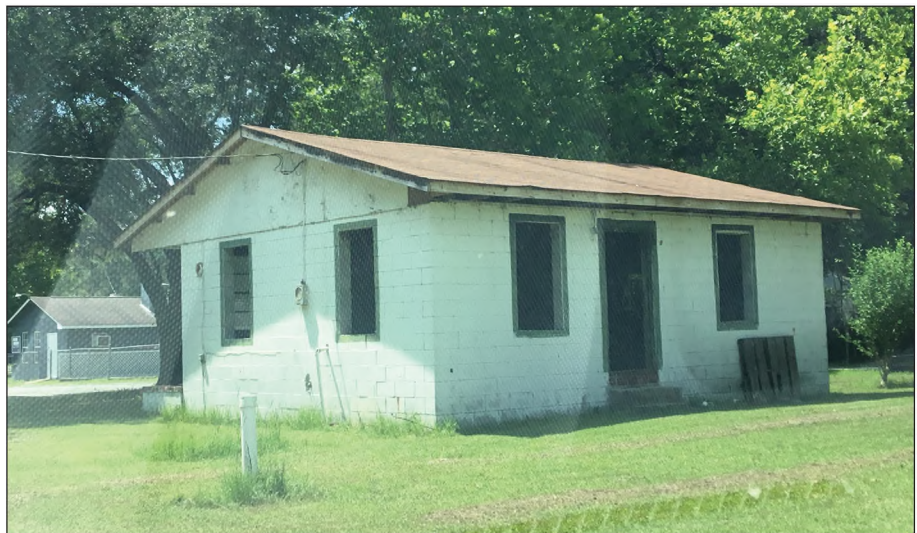
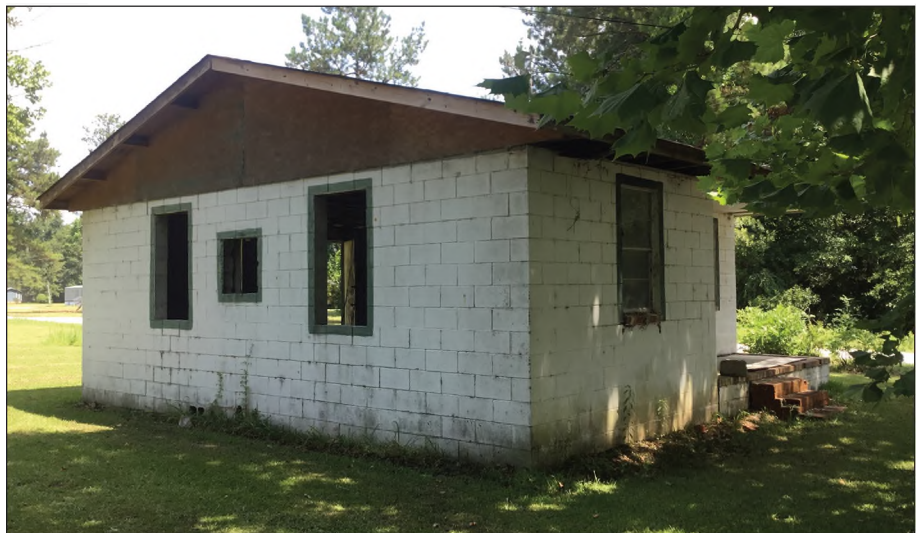
Figure 32.  
Resource 1280 (216 Garden Court)

same lot. Landscaping around Resource 1280 includes a grass lawn and a mature sycamore tree. Although Resource 1280 is an American Small House, it is not a distinctive or noteworthy example of this house type that is common in South Carolina. Its integrity is impacted by the loss of historic fabric, including window sashes on the side elevations, the back door, and boxing from the soffits. It was not found to embody the distinctive characteristics of a style, period, or method of construction, and does not possess significance for its engineering or materials. It is not known to be associated with events or persons significant in the past. Therefore, the resource is recommended as not individually eligible for the NRHP under Criterion A, B, or C.

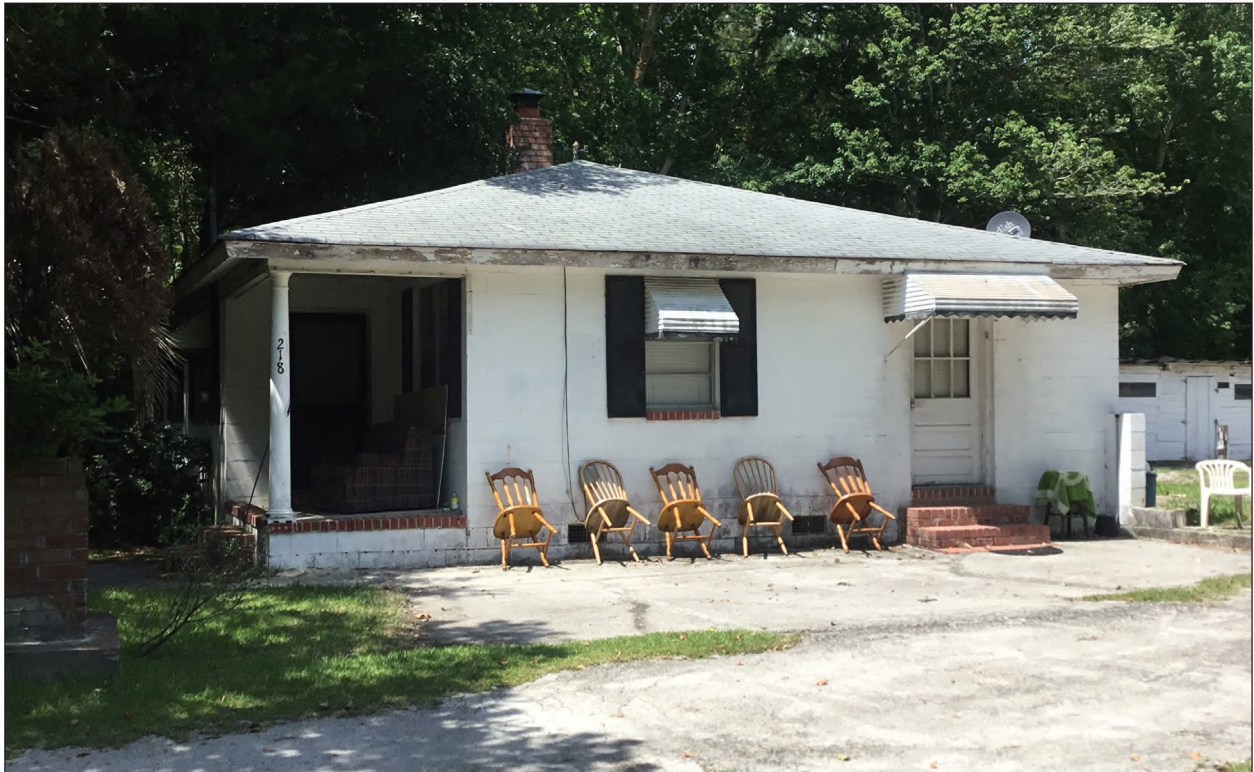
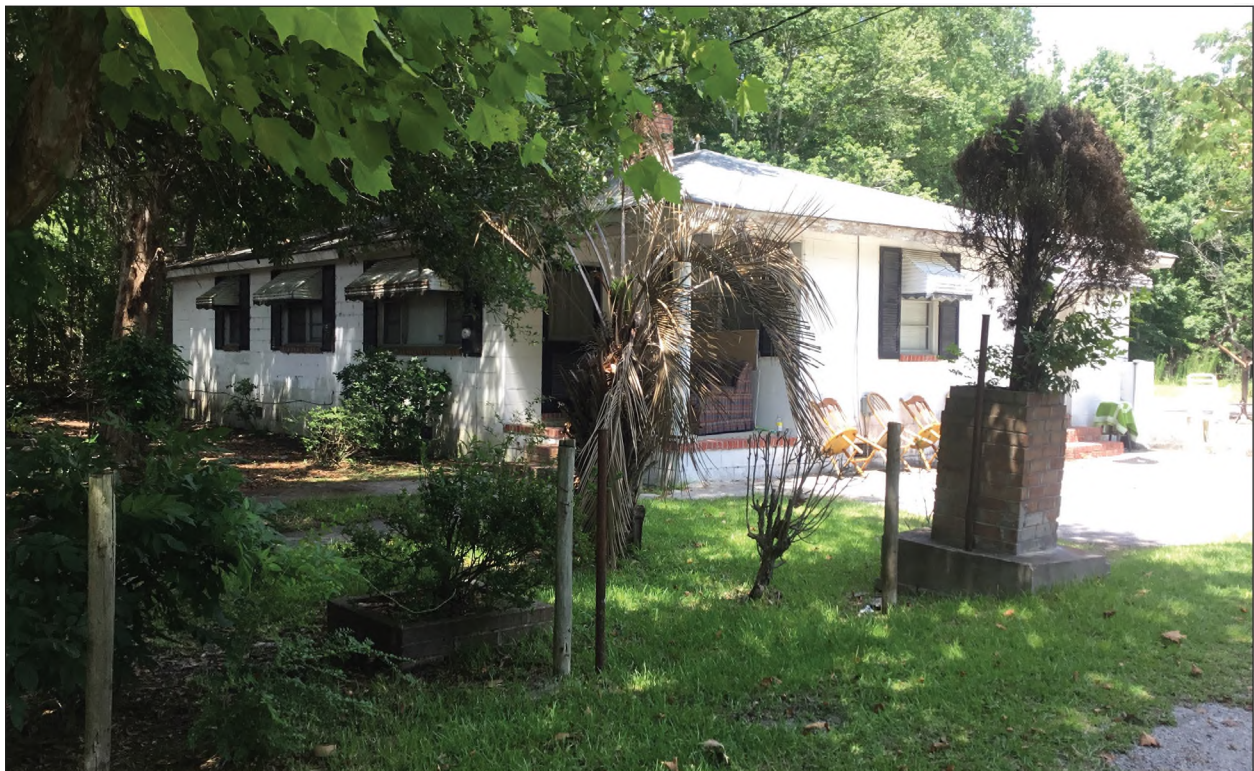
Figure 33.  
Resource 1281 (218 Garden Court)

Resource 1281 is located near the northeastern terminus of Garden Court, a meandering one-lane unpaved drive. Development along the road is primarily mid-twentieth-century and later single-family residential, often with multiple houses located on the same lot. Resource 1281 shares a lot with two additional houses and two sheds. None of the other buildings are visible on historic aerial photographs. The lot is large enough to accommodate all buildings while retaining traditionally sized yards for the houses. There is a wooded buffer to the north of the property, and much of the lot is landscaped with grass lawn and mature, deciduous trees. The area directly to the south of Resource 1281 is a swept yard. Although Resource 1281 is a Bungalow Ranch House, it is not a distinctive or noteworthy example of this house type, which is common in South Carolina. It was not found to embody the distinctive characteristics of a style, period, or method of construction, and does not possess significance for its engineering or materials. It is not known to be associated with events or persons significant in the past. Therefore, the resource is recommended as not individually eligible for the NRHP under Criterion A, B, or C.
