# PHASE I CULTURAL RESOURCE SURVEY OF I-26 WIDENING PROJECT MM 187-194

Berkeley and Dorchester Counties,  
South Carolina

May 8, 2019 • **Revised Draft Report**  
New South Associates Technical Report 2877

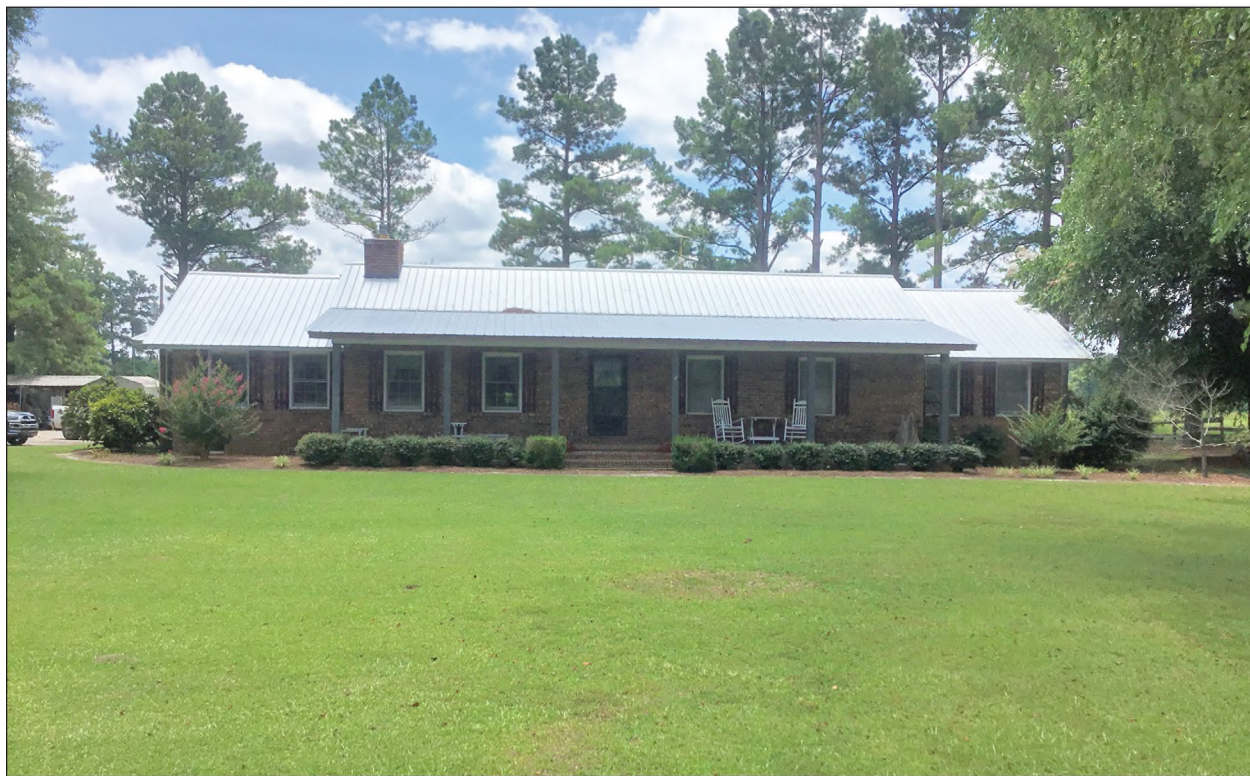
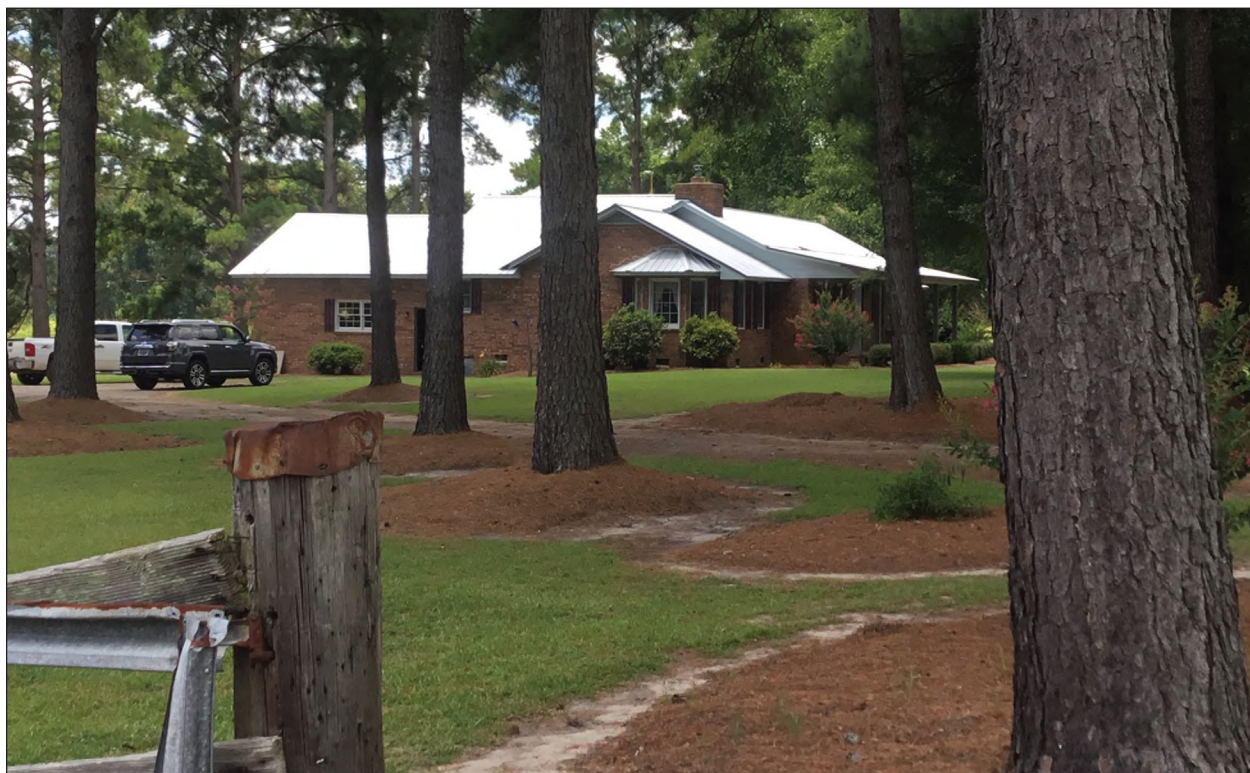
Figure 35.  
Resource 1283 (Hill Farm House— 1379 Cypress Campground Road)

Resource 1283 is a circa 1975 Plain Linear Ranch House located at 1379 Cypress Campground Road. It is one story tall with a rectangular historic core and a laterally gabled V-crimp metal roof (Figure 35). It is clad in brick veneer and faces north towards Cypress Campground Road. The house has a central core with two flanking wings and a symmetrical front elevation. All windows are six-over-six, wood frame, double-hung sashes with louvered shutters. A shed-roofed porch with square wooden supports covers the central portion of the house. The central half-light door is flanked by two windows to either side, and two additional windows are located on the east and west wings. A front-gabled addition is located on the rear of the house, and the foundation is concealed.

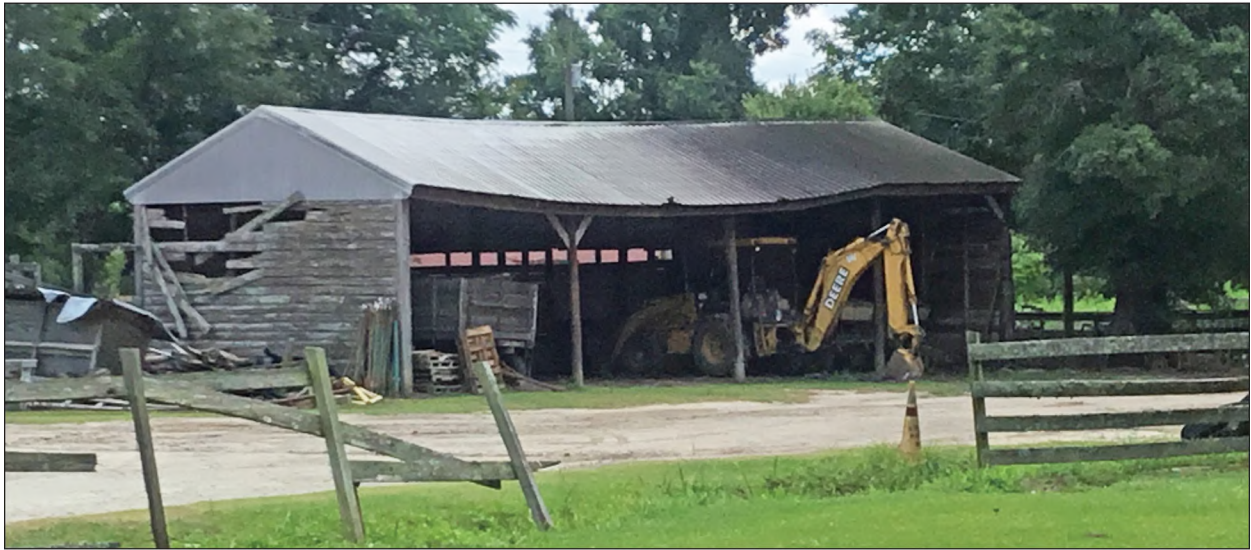
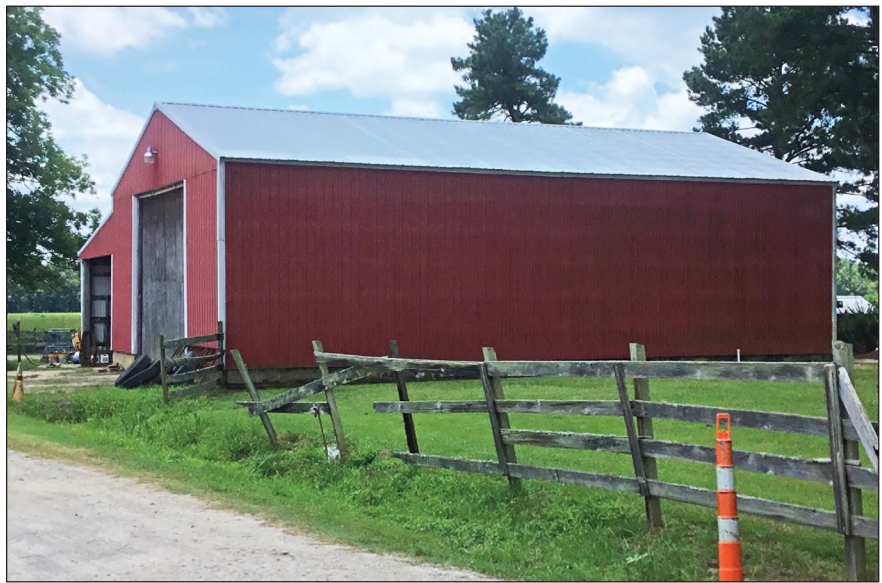
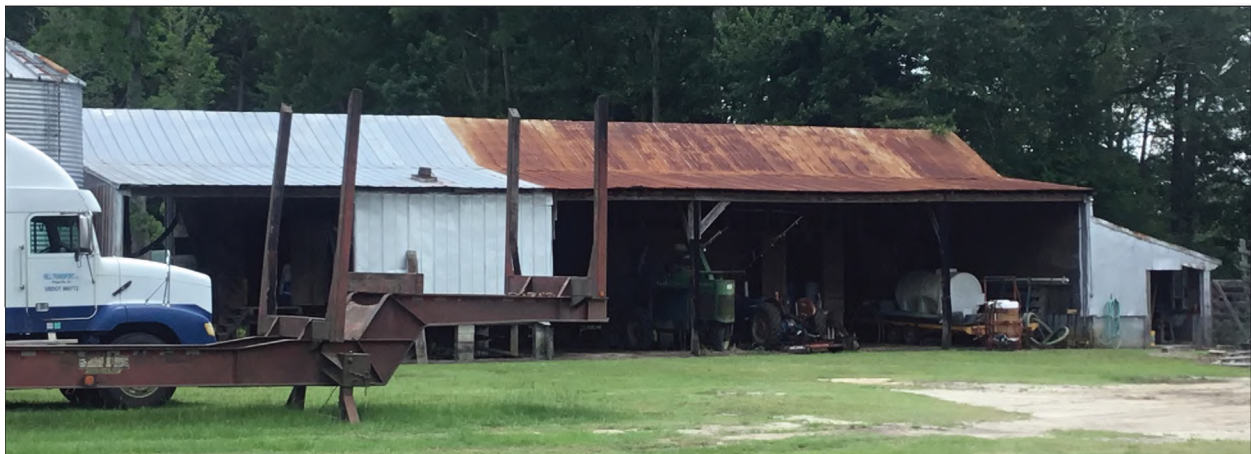
Resources 1283.01 – 1283.03 (Hill Farm – South Shed, Two-Story Barn, North Shed)

Of the 18 outbuildings on the property, seven are visible on a 1971 aerial photograph. Resource 1283.01 is a circa 1950 shed located approximately 240 feet east of the main house. It is a one-story tall, rectangular frame building with a laterally gabled, corrugated metal roof (Figure 36A). It is open on the west elevation with round wooden supports with simple brackets. The side and rear elevations are clad in deteriorating weatherboard. There is V-crimp metal siding in the gable ends. The shed has a post-in-hole foundation.

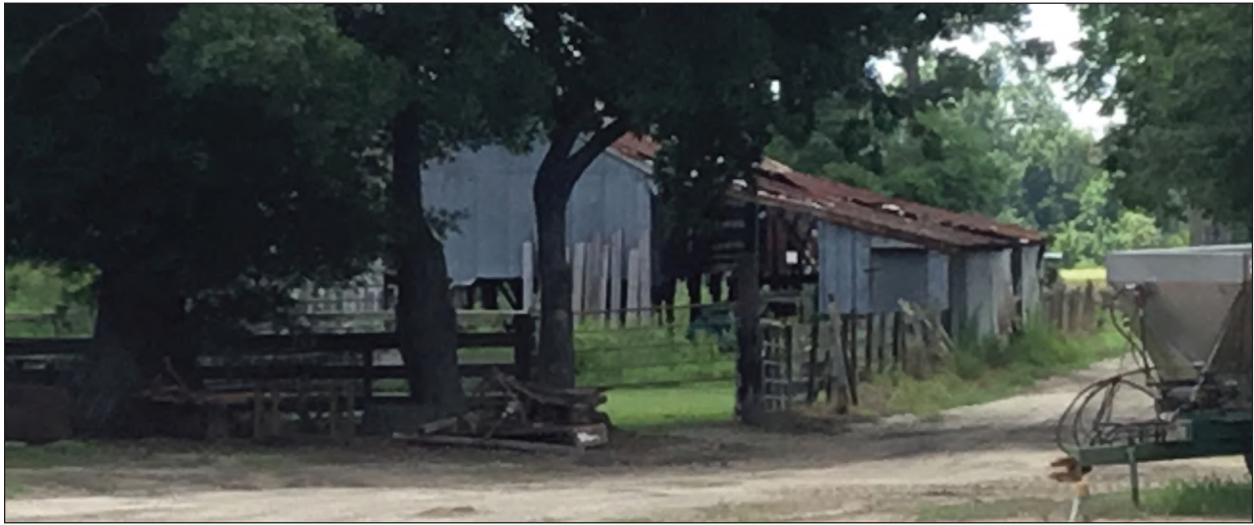
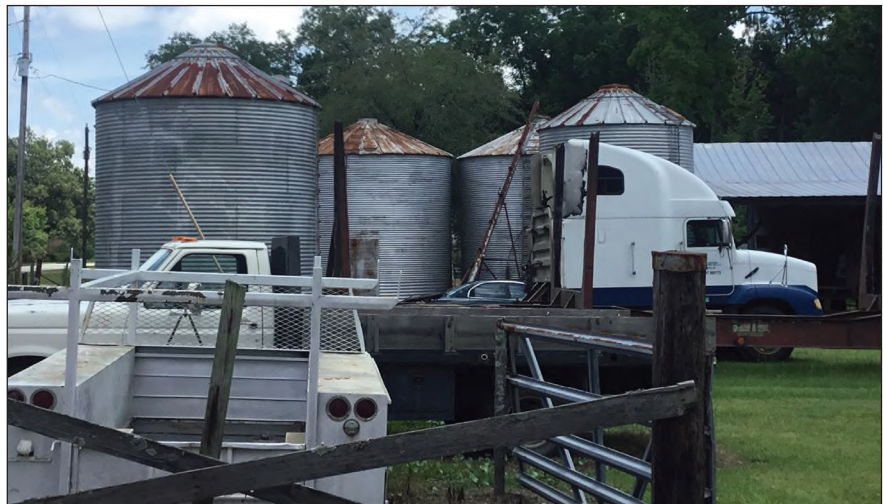
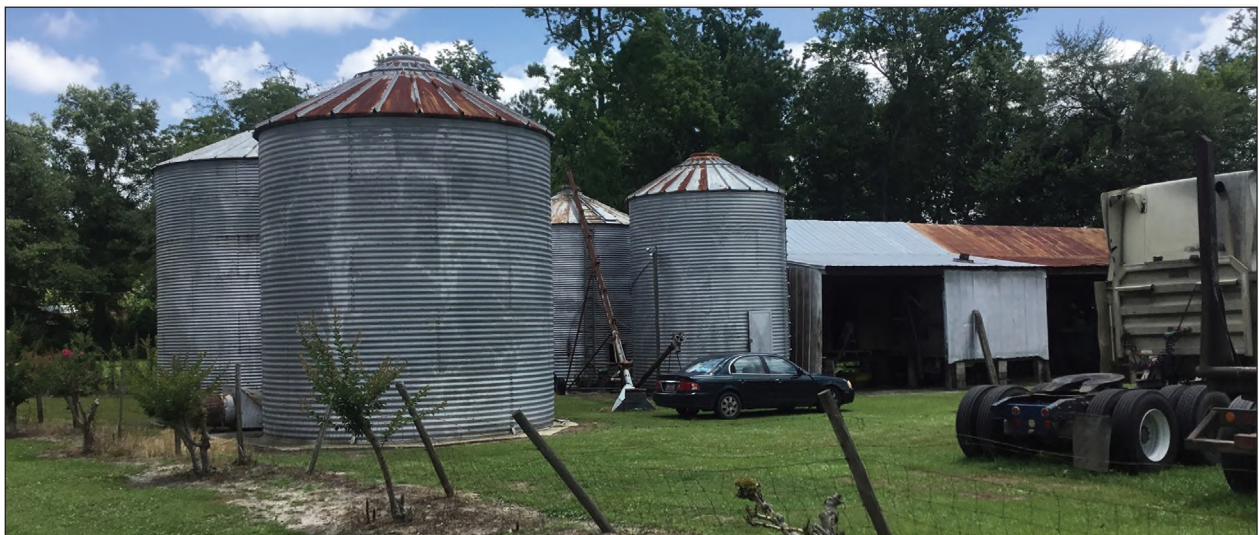
Figure 37.  
Resources 1283.04 – 1283.07 (Hill Farm – South Barn and Silos)

Resources 1283.05 through 1283.07 are three circa 1960 cylindrical storage silos located approximately 300 feet northeast of the main house and directly north of Resource 1283.03. While there are five such silos grouped together, only the southernmost three are visible in aerial photographs. Each building is one story tall and cylindrical with a conical V-crimp metal roof and corrugated metal siding (Figure 37B and C). They are fenestrated with one windowless metal door each, and the foundations are concealed.

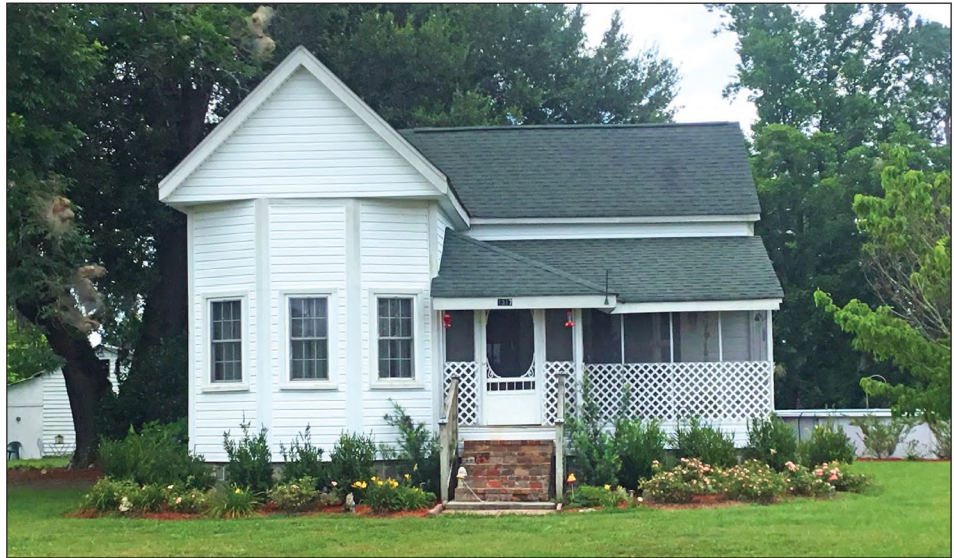
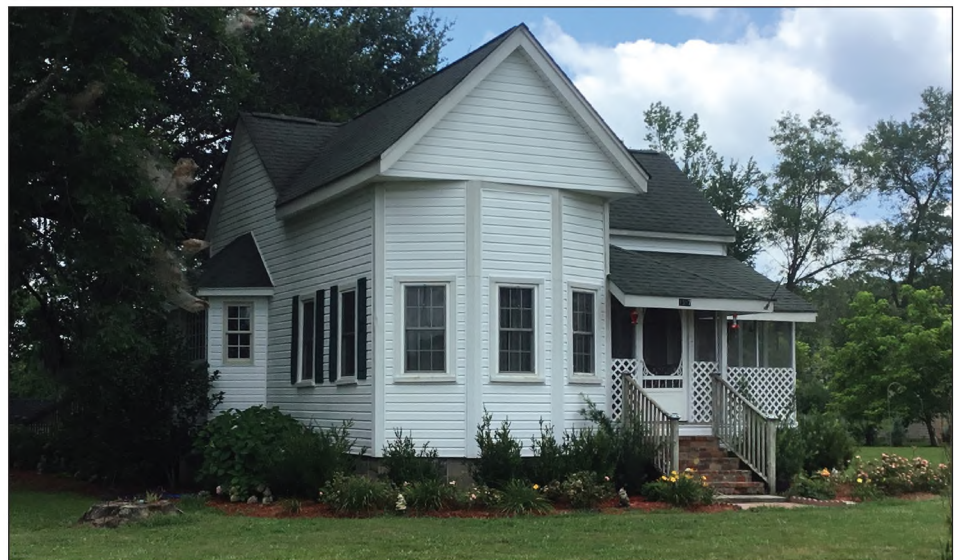
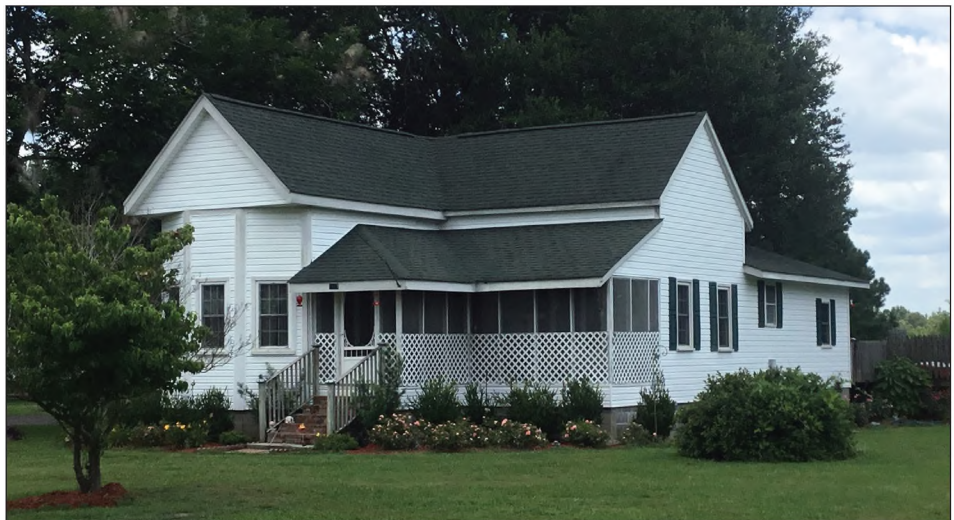
Figure 38.  
Resource 1284 (1317 Cypress Campground Road)

Resource 1284 is a circa 1910 Gabled Wing Cottage located at 1317 Cypress Campground Road. It is 1.5 stories tall and L-shaped in plan with a cross-gabled composition shingle roof (Figure 38). It is clad in synthetic siding and has replacement vinyl frame, six-over-six and four-over-four, double-hung sash windows. It faces north towards Cypress Campground Road. A gable with a bayed window is located on the east end of the front elevation. A porch wraps around the interior of the L, sheltering the rest of the fenestration. It has both shed and hipped roof

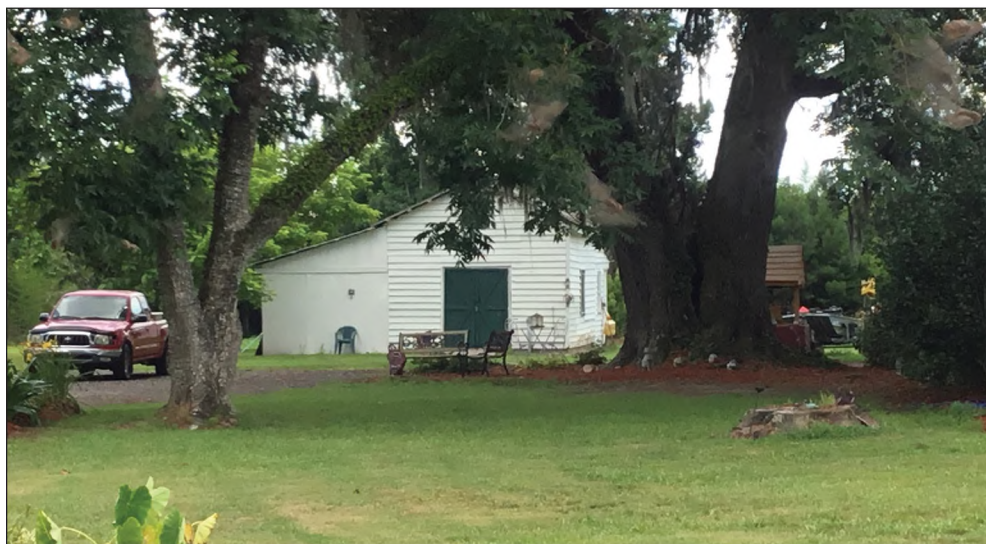
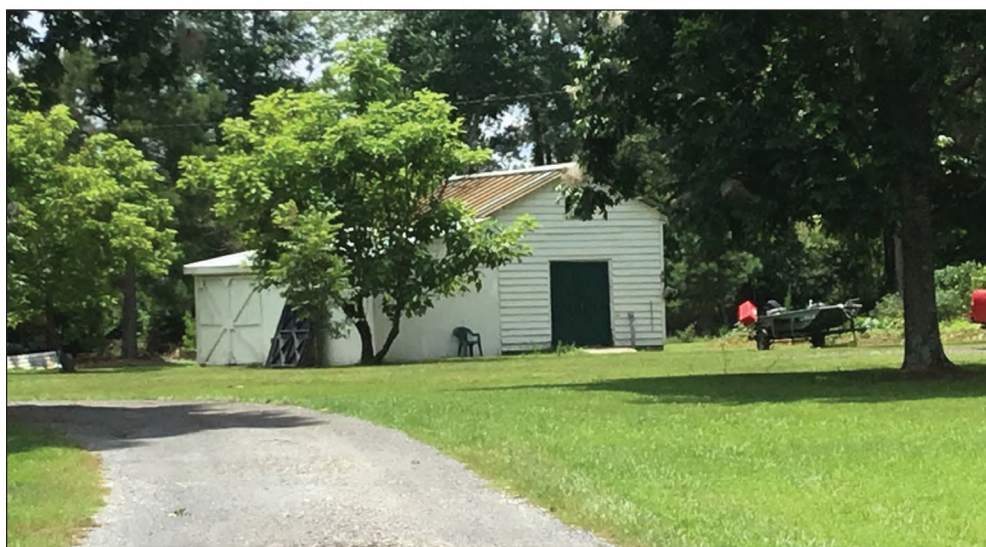
Resources 1284.01 and 1284.02 (1317 Cypress Campground Road – Garage and Pump House)

Resource 1284.01 is a circa 1910 garage located approximately 80 feet southeast of Resource 1284. The building is one story tall with a rectangular historic core and a front-gabled composition shingle roof (Figure 39A and B). It is clad in weatherboard. It is accessed on the north elevation by a set of wooden carriage doors which are large enough to admit only a small vehicle although the building itself is somewhat larger. Two wood frame double-hung sash windows are located on the west elevation and a shed roofed flushboard addition is located on the east elevation. The building has a slightly raised poured concrete foundation and overhanging eaves with exposed rafter tails. Resource 1284.02 is a circa 1950 pump house located approximately 25 feet southeast of Resource 1284. It is a small rectangular building and is one undersized story tall (see Figure 39C). It is of concrete block construction and has a front-gabled composition shingle roof. It faces east, and the only fenestration is a wood door.
