Phase I Cultural Resource Survey of Fred Nash Boulevard Widening Project

Horry County, South Carolina

May 2, 2019 • **Final Report**
New South Associates Technical Report 2951

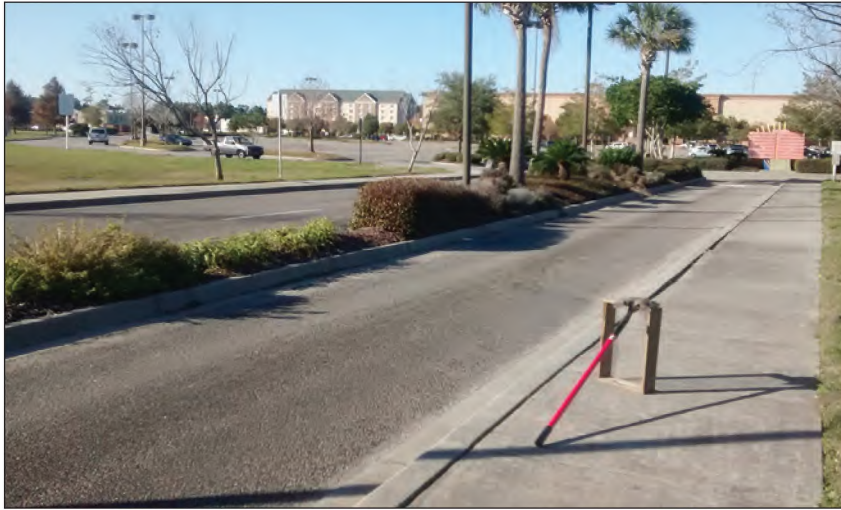
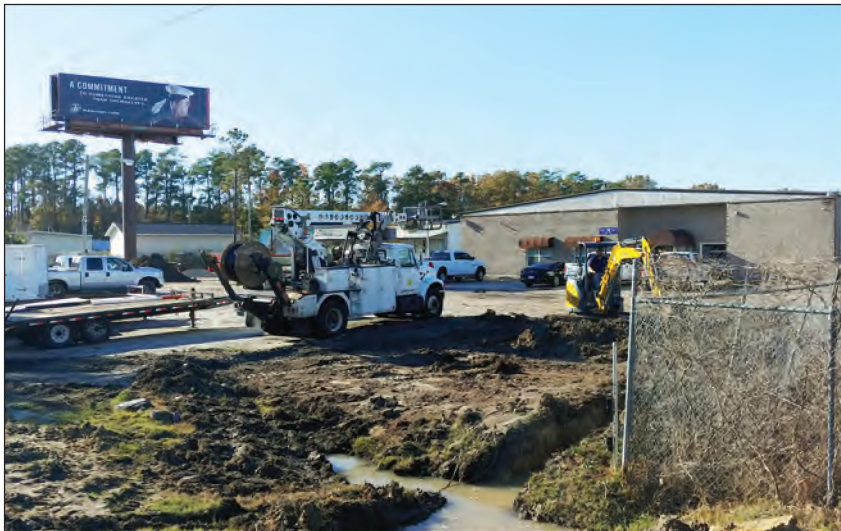
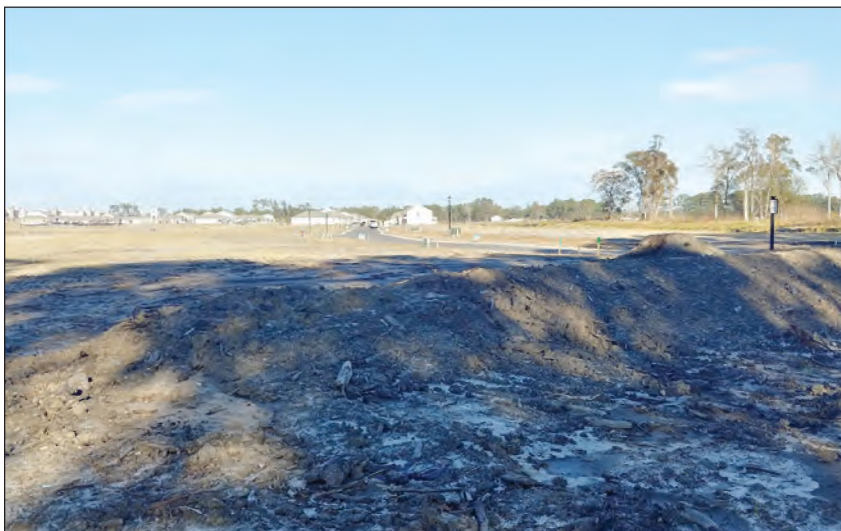
Figure 3.
Photographs of Field Conditions, 1 of 2

A. Paved Road Leading to
the Coastal Grand Mall, View
Northwest

B. Commercial Development in
the APE, View South

C. New Residential Construction
Activity in the APE, View North

A total of 854 shovel test locations were investigated during the survey. Of those, 600 could not be excavated due to disturbance, such as paved roadways, parking lots, recent construction, buried utilities, and standing water. Figure 5 illustrates areas omitted from shovel testing for these reasons. The remaining areas were subjected to shovel testing at 30-meter intervals.

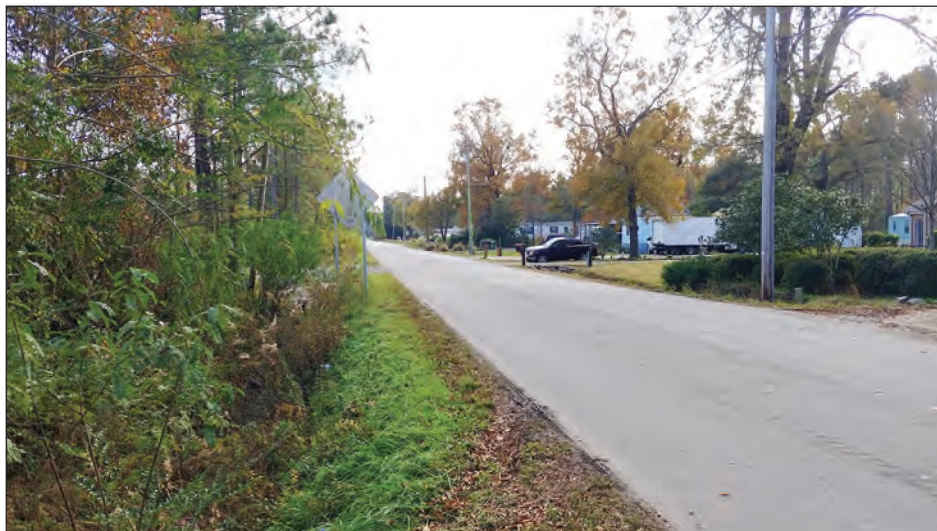
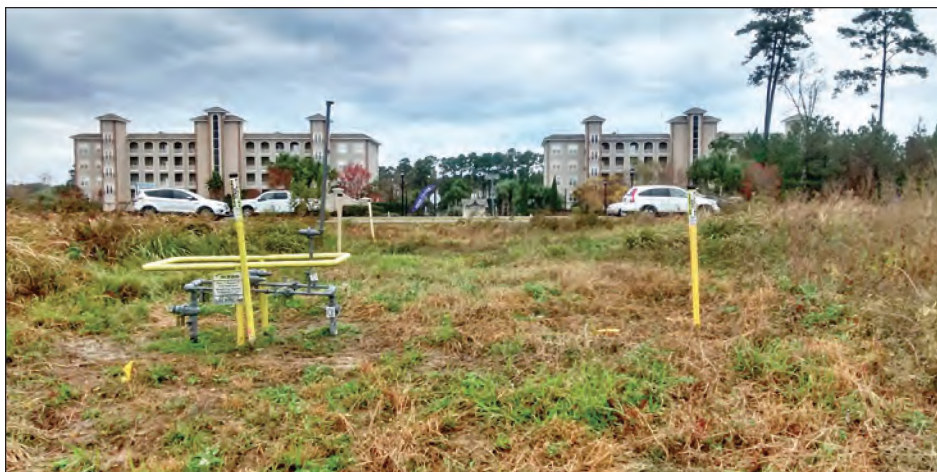
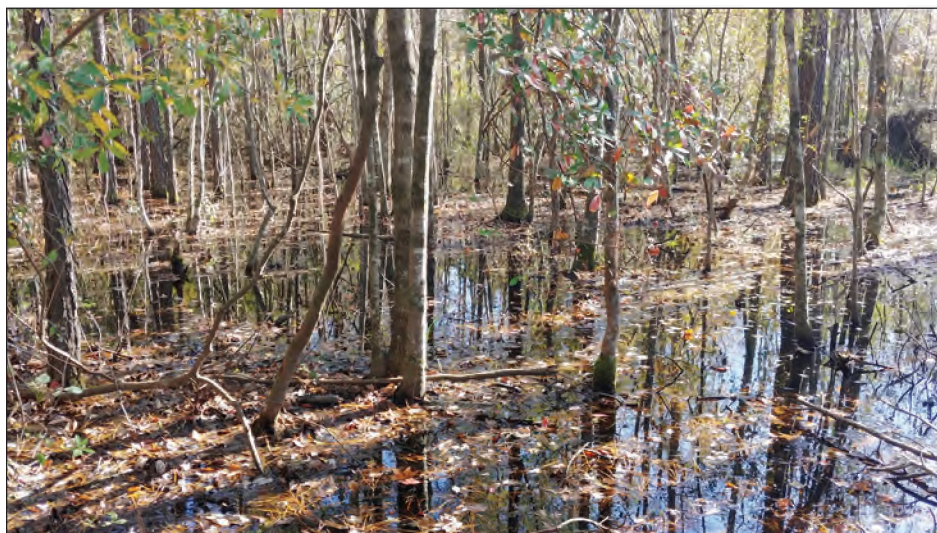
Figure 4.
Photographs of Field Conditions, 2 of 2

A. Late Nineteenth-Century Residential Area with Roadside Ditches, View East

B. Buried Utilities Along U.S. 17, View West

C. Inundated Portion of the APE, View Northeast

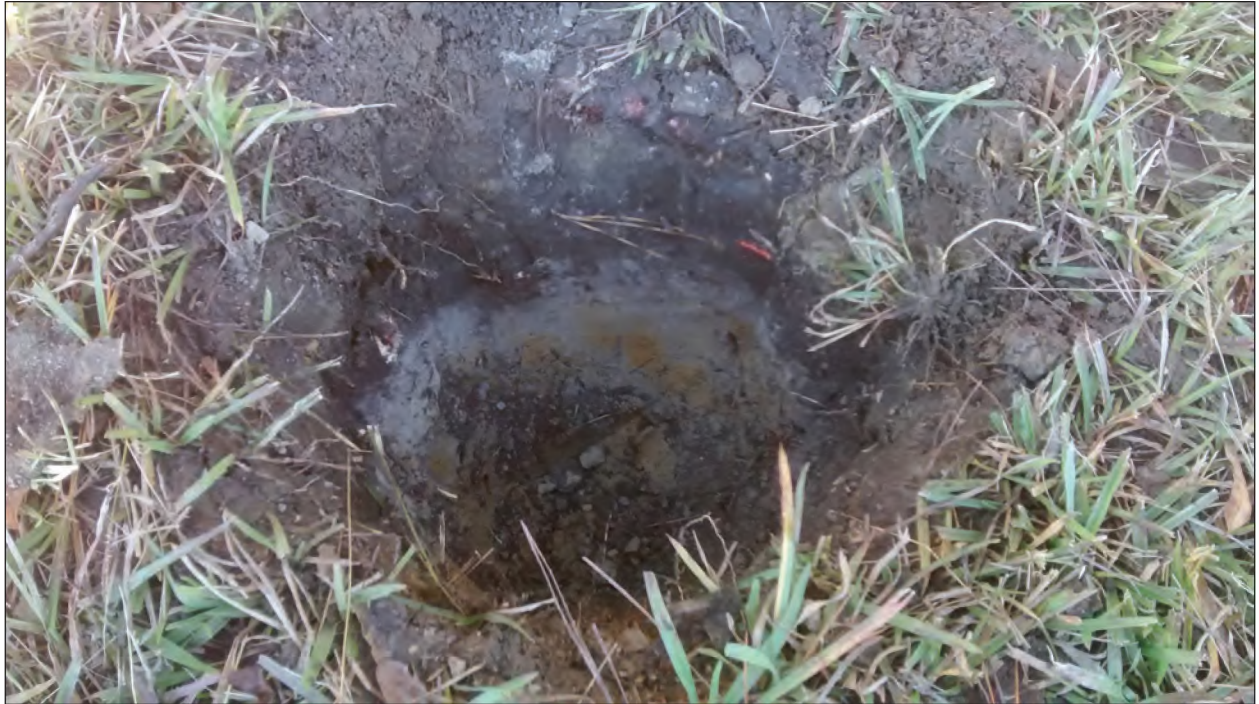
Figure 6.
Representative Undisturbed Soil Profile, View to the West

Soil profiles in the project area varied, but many of the excavated tests showed signs of substantial disturbance reflected by mottled soils and imported granite gravel. A typical disturbed soil profile consisted of dark brown (10YR 3/3) sandy clay loam from 0-30 centimeters below surface underlain by light gray (10YR 7/2) clay to the base of excavation at 40 centimeters below surface. This disturbance was caused by extensive landscape alteration that has taken place across the project area in recent years. In some areas, profiles showed undisturbed soils. These profiles included dark brown (10YR 3/3) loam to a depth of 15 centimeters. Below this was light gray (10YR 7/1) sand to a depth of 25 centimeters and very pale brown (10YR 7/3) clay to 40 centimeters (Figure 6).

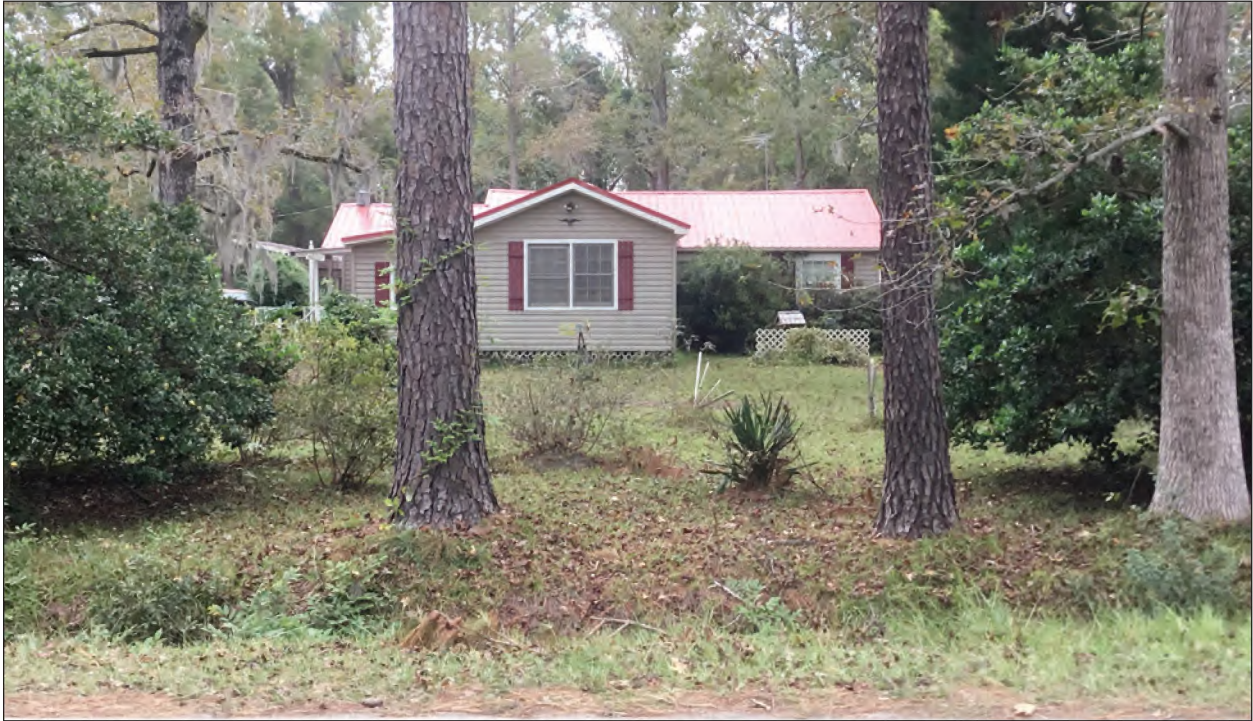
Resource 3884, located at 3000 Emory Road, is a one-story residence of no particular style or type, built circa 1940 (Figure 8a). It has a lateral gable roof with a front gable over the left bay. The roof is clad in raised seam metal and the exterior of the building is covered with vinyl siding. The foundation is obscured by lattice. The resource has a porch on the left elevation covered by a shed roof that is supported by plain wood posts. The front entrance is located off the side porch but is obscured from the right of way. The resource has undergone several alterations and additions. The windows are replacement vinyl, six-over-six double hung sash. The front left cross gable is an addition, as are the left elevation porch and rear additions. These modifications have altered the appearance of Resource 3884.

A. Resource 3884, Front Elevation

The building is located on a moderate size lot with some landscaping. There are planted bushes along the right bay façade and the lot has moderate tree coverage. The driveway approaches from the left side to a detached metal carport. The resource is located in a sparse rural residential development without plan or specific development. The viewshed of the resource has not been significantly compromised by commercial development and previous improvements to the roadways.

The resource was not found to embody a distinctive characteristic of a type, period, or method of construction. It also does not represent the work of a master or possess high artistic value. Alterations have changed the appearance of the resource. It is not known to be associated with events or persons significant in the past. Therefore, the resource is recommended as not individually eligible for the NRHP under Criteria A, B, or C.

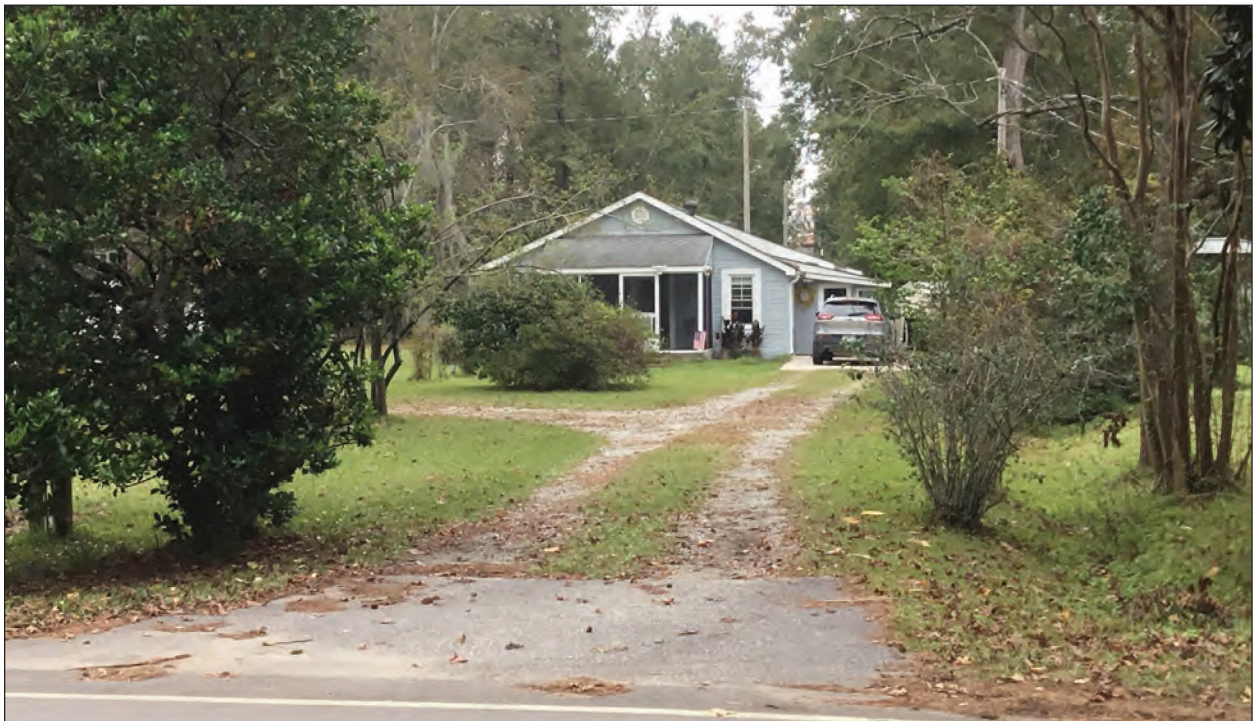
B. Resource 3885, Front Elevation

Located at 3004 Emory Road, Resource 3885 is a residence of no particular style or type built circa 1940 (see Figure 8b). The resource is a one-story residence with central massing. It has a front gable roof covered in composition shingles. The exterior is clad in vinyl siding. The foundation was not visible. The resource has a front porch covered by a shed roof. The porch roof is supported by plain wood posts and enclosed with screens. The front entrance is located on the porch but is concealed by the screen. The resource has undergone several alterations and additions. The windows are replacement vinyl four over four double hung sash. There are additions to the left and rear elevations that are visible by the extended roof line. These alterations have changed the appearance of Resource 3885.

The resource was not found to embody distinctive characteristics of a type, period, or method of construction. It also does not represent the work of a master or possess high artistic value. Alterations have modified the appearance of the resource. It is not known to be associated with events or persons significant in the past. Therefore, the resource is recommended as not individually eligible for the NRHP under Criteria A, B, or C.

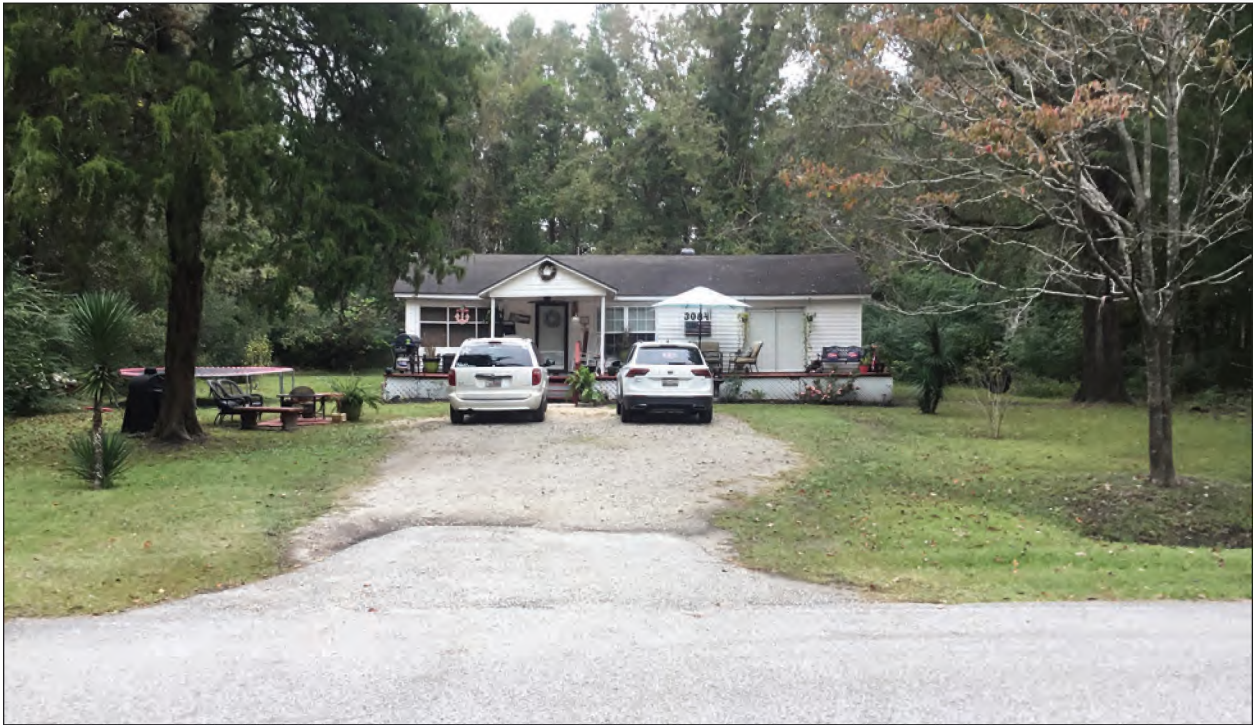
Resource 3886, sited at 3084 Emory Road, is a residence of no particular style or type, built about 1940 (Figure 9a). The resource is a one-story residence with a T-shaped massing. It has a cross gable roof with composition shingles. The exterior is clad in vinyl siding and rests on a brick foundation. The front porch has a concrete slab floor on a foundation obscured by lattice. The uncovered porch deck extends the length of the front elevation. Only the entrance bay is covered by a gable roof, which is supported by plain wood posts. The resource has an exterior brick chimney on its left elevation. The resource has undergone several alterations and additions. The windows on the central bay are replacement vinyl six-over-six double hung sash. Those on the right bay are French single pane doors and the left bay has three grouped one-over-one screened windows. There are additions to the left and rear elevations, which are visible by the extended roof line. These additions have altered the appearance of Resource 3885.

A. Resource 3886, Front Elevation

The resource was not found to embody the distinctive characteristics of a type, period, or method of construction, nor does it represent the work of a master or possess high artistic value. Its appearance has been altered. It is not known to be associated with events or persons significant in the past. Therefore, the resource is recommended as not individually eligible for the NRHP under Criteria A, B, or C.

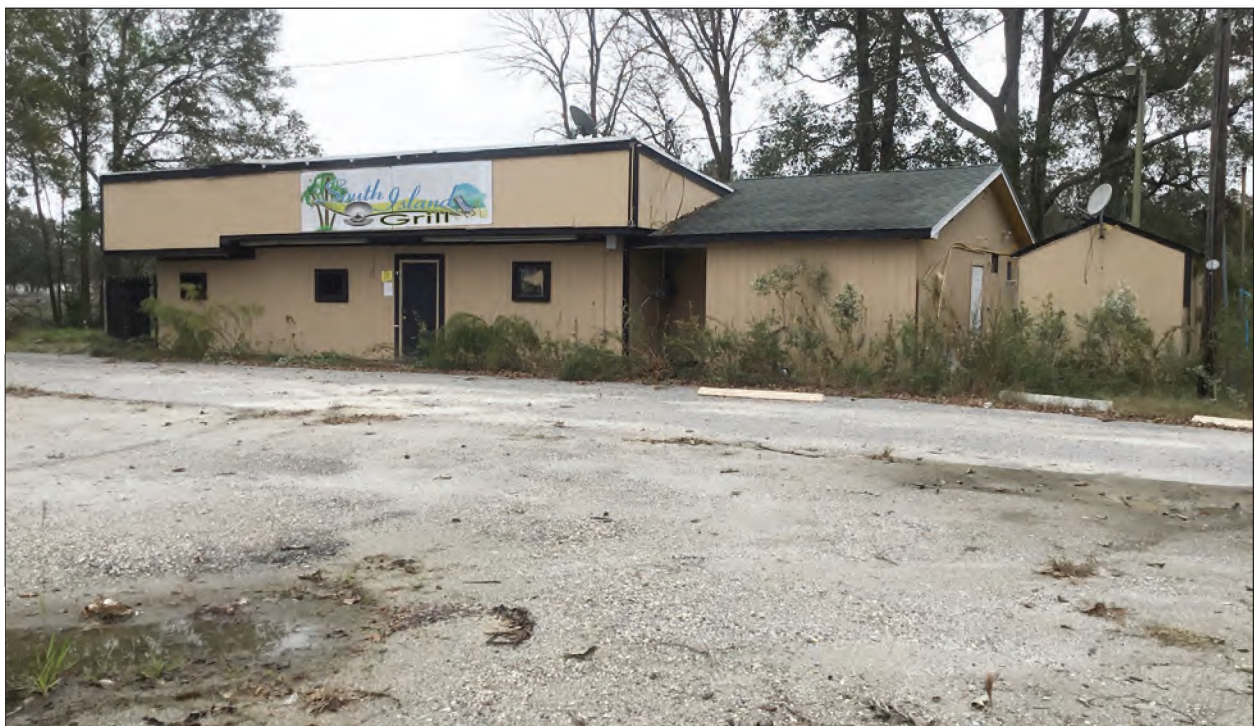
B. Resource 3887, Oblique

Resource #3887 is located at 2965 Fred Nash Boulevard. It consists of a commercial property of no particular style or type built around 1960 (see Figure 9b). The rectangular building has a flat roof with a hip parapet for signage. Its foundation is not visible. A right elevation addition has a gable roof clad in composition shingles. The exterior is clad in vertical weatherboard. Fenestration of the resource is minimal and mostly consists of windows that are small single panes encased in wood. The front entrance is a faux wood panel door that appears to be a replacement. Minor changes have altered the appearance of Resource 3887.

The resource was not found to embody distinctive characteristics of a type, period, or method of construction. It also does not represent the work of a master or possess high artistic value. Alterations have slightly altered the appearance of the resource. It is not known to be associated with events or persons significant in the past. Therefore, the resource is recommended as not individually eligible for the NRHP under Criteria A, B, or C.

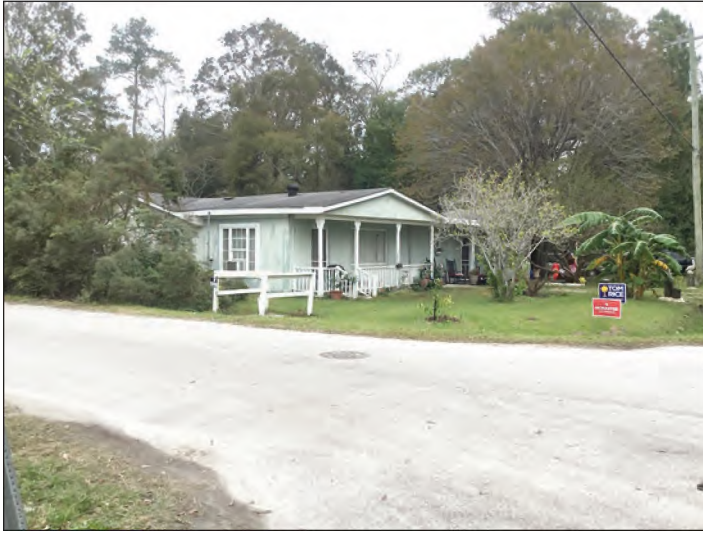
Resource 3888 is a circa 1950 dwelling of no particular style or type located at 3125 Shetland Lane (Figure 10a). The resource currently appears to be used as a duplex residence. It is a one-story multi-residence with a rectangular core. Its lateral gable roof has two front-facing gable porches. The roof is clad in composition shingles. The exterior of the resource exhibits two different siding materials. The left bay has brick veneer and the right bay vertical weatherboard.

A. Resource 3888, Left Oblique

The porch roofs cover two separate entrances and are supported by wood spindle posts. The foundation was not visible. The front elevation has casement windows and on the left elevation, there are wood six over six windows flanked by four-light side lights. There are additions to the right and rear elevations, which are visible in the extended roof line. These alterations have altered the appearance of Resource 3888.

The resource was not found to embody the distinctive characteristics of a type, period, or method of construction. It does not represent the work of a master or possess high artistic value. Further, alterations have slightly changed its appearance. The resource has no known association with events or persons significant in the past. Therefore, the resource is recommended as not individually eligible for the NRHP under Criteria A, B, or C.

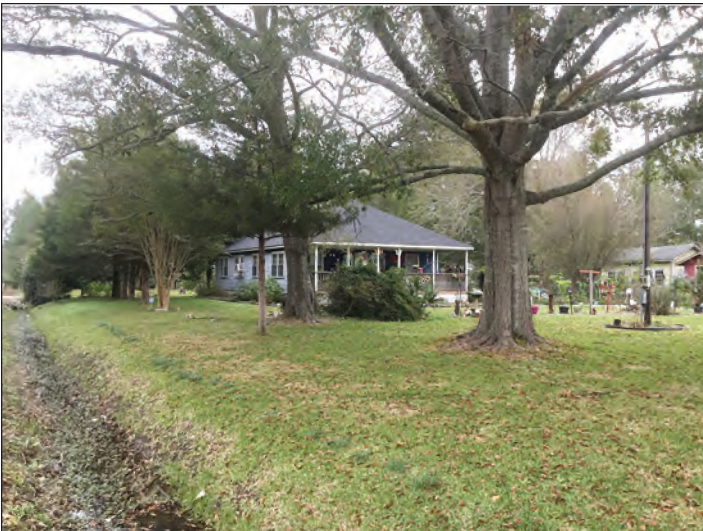
B. Resource 3889, Left Oblique

Resource 3889, located at 3140 Shetland Lane, is a circa 1940 Bungalow (see Figure 10b). The one-story residence is centrally massed. It has a hip roof with an engaged front porch. The roof is clad in composition shingles and the exterior in asbestos shingles. The building rests on a concrete block foundation that appears to be continuous. The front porch has plain wood posts and railings. The resource has an interior brick chimney. The windows are wood six-over-six double hung sash. There have been minor alterations to the appearance of Resource 3888.

The resource was not significantly altered but does not embody a distinctive representation of the Bungalow house type. It also does not represent the work of a master or possess high artistic value. Alterations have slightly affected the appearance of the resource. It is not known to be associated with events or persons significant in the past. Therefore, the resource is recommended as not individually eligible for the NRHP under Criteria A, B, or C.

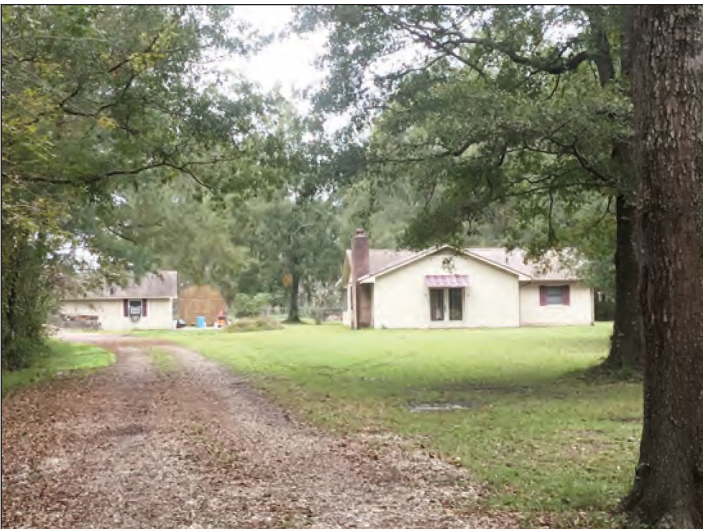
C. Resource 3890, Front Elevation

Built about 1940, Resource 3890, located at 3139 Shetland Lane, is a house of no particular style or type (see Figure 10c). The resource is one-story with a rectangular core and has a lateral gable roof with a left cross-gable. The roof is clad in composition shingles. The exterior is clad in vertical weatherboard and rests on a concrete block foundation. The resource has a left elevation exterior brick chimney. The windows are wood one-over-one double hung sash and the main entrance on the left bay has French doors. This entrance is covered by suspended plantation shutters. The resource has a rear addition covered by a shed roof. The additions have altered the appearance of Resource 3890.

Resource 3890.01 is an outbuilding associated with the main resource and is located to the left of the house (see Figure 10c). It has a rectangular massing with a lateral gable roof, which is clad in composition shingles. The exterior is clad in vertical weatherboard. It appears to have a single window that has been modified with an air-conditioning unit. This building does not add to the historical integrity of Resource 3890.

The resource was not found to embody distinctive characteristics of a type, period, or method of construction. It does not represent the work of a master or possess high artistic value. Alterations have modified its appearance. It is not known to be associated with events or persons significant in the past. Therefore, the resource is recommended as not individually eligible for the NRHP under Criteria A, B, or C.

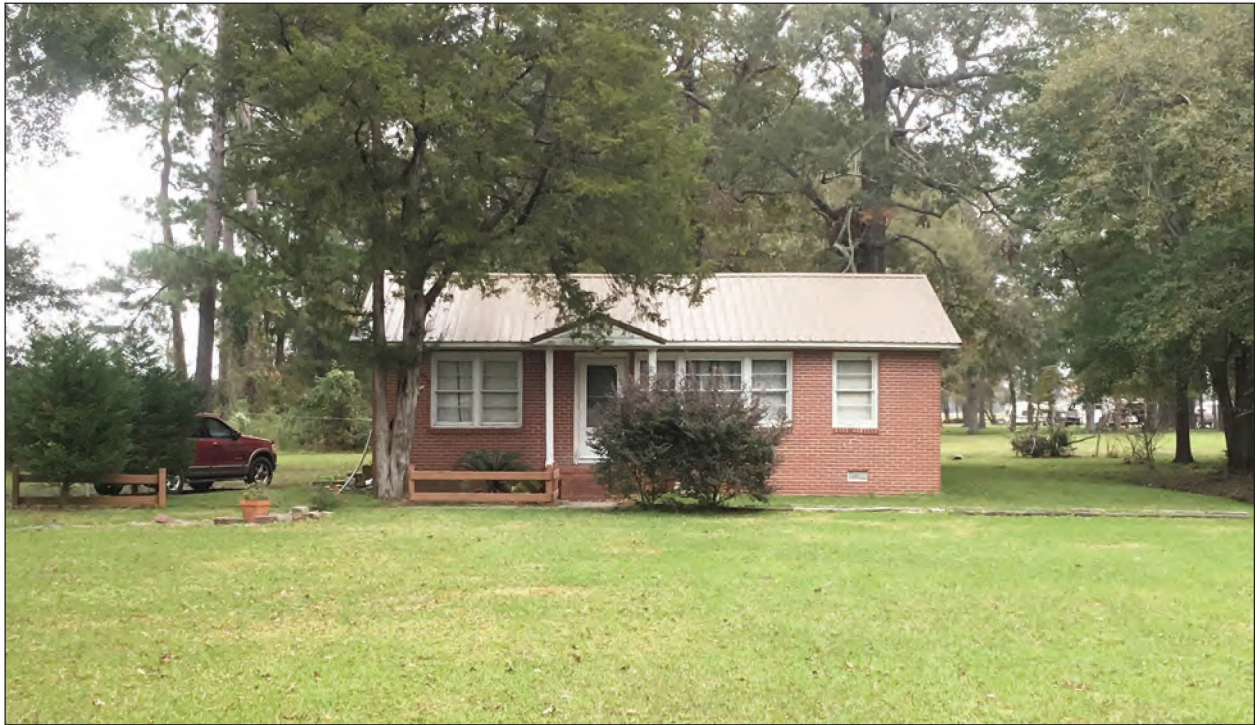
A. Resource 3891, Front Elevation

Resource 3891, located at 3144 Shetland Lane, is a Minimal Traditional, built circa 1950 (Figure 11a). The small one-story rectangular residence has a lateral gable roof covered in raised seam metal. The exterior is clad in brick veneer. The front entry porch has a gable roof supported by plain wood posts. The resource has wood windows that are two-over-two double hung sash. There have been minor alterations to the appearance of Resource 3891.

Its appearance has been slightly altered. It is not known to be associated with events or persons significant in the past. Therefore, the resource is recommended as not individually eligible for the NRHP under Criteria A, B, or C. The resource was also assessed for its value to a district. No previously identified historic district currently exists in the area and this survey did not identify a group of resources sharing construction dates, developmental histories, or layouts and features that could be construed as a historic district. Thus, Resource #3891 was not considered individually NRHP eligible or as contributing to a district.

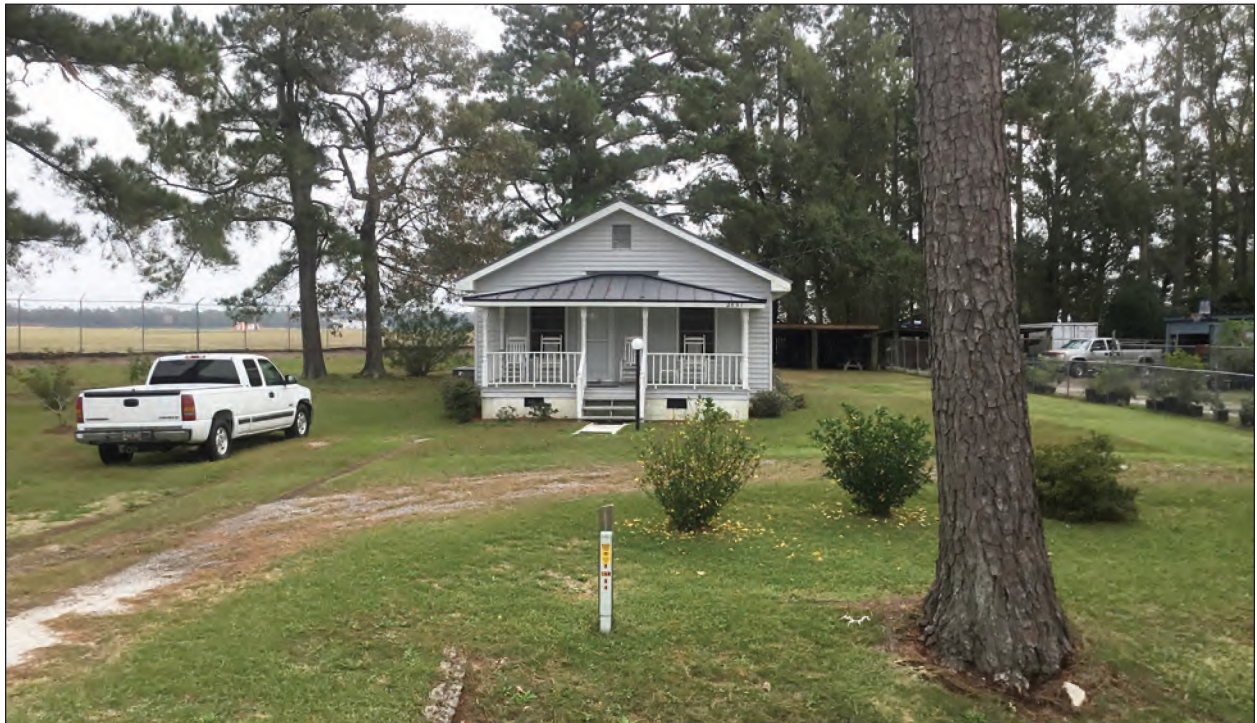
B. Resource 3892, Front Elevation

Resource 3892, located at 2839 Old Socastee Highway, is a Bungalow built about 1940 (Figure 11b). The one-story residence has a front gable roof clad in raised seam metal. The exterior is covered in vinyl siding and rests on a concrete block foundation. The front porch has a hip roof on wood spindle posts. The windows are replacement vinyl one-over-one double hung sash. These minor alterations have slightly affected the appearance of Resource 3891.

Alterations have slightly changed the appearance of the resource and, therefore, it does not embody a distinctive representation of a Bungalow House type. It also does not represent the work of a master or possess high artistic value. It is not known to be associated with events or persons significant in the past. Therefore, the resource is recommended as not individually eligible for the NRHP under Criteria A, B, or C.

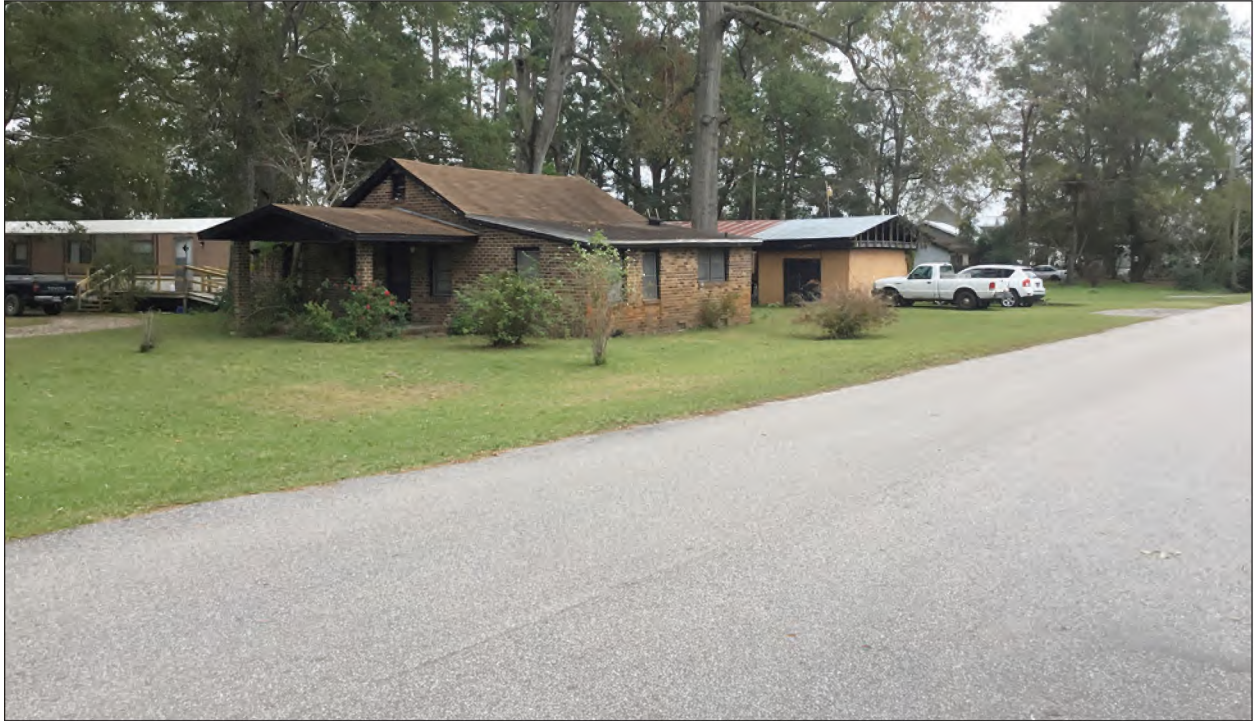
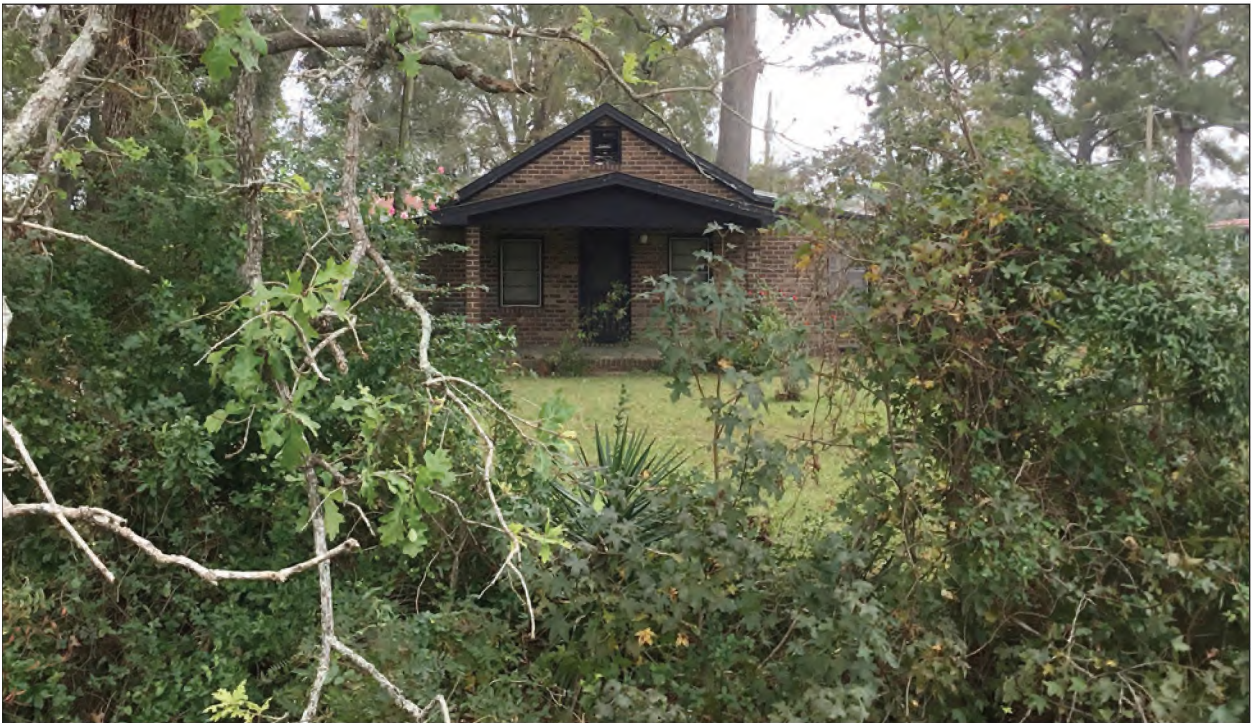
Figure 12.
Resources 3893 and 3893.01

Resource 3893 is a residence of no particular style or type built about 1960 and located at 1836 Stacey Street (Figure 12). The resource is a one-story residence with a rectangular core and side wings. It has a front gable roof that extends to a shed roof over the side wings. The roof is clad in composition shingles, while the exterior is covered in brick veneer. Brick veneer also obscures the foundation. The front porch has a gable roof supported on brick columns. The resource has wood windows that are two-over-two double hung sash. No major additions have altered the appearance of Resource 3893.

A. Resource 3893 and 3893.01, Oblique

B. Resource 3893, Front Elevation

Resource 3893.01 is an outbuilding located at the rear of the property. It has a rectangular core with a lateral gable roof. The building is constructed of concrete block and the roof is clad with metal. The building does not add to the historical integrity of the main resource.

The resource was not found to embody the distinctive characteristics of a type, period, or method of construction, nor does it represent the work of a master or possess high artistic value. Its appearance is slightly altered. It is not known to be associated with events or persons significant in the past. Thus, the resource is recommended as not individually eligible for the NRHP under Criteria A, B, or C.

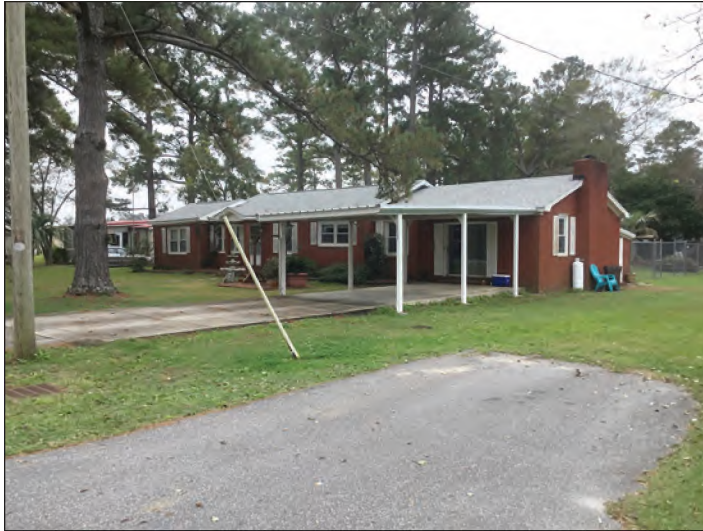
Resource 3894 is a Minimal Traditional, built ca. 1950, and is located at 1833 Stacey Street (Figure 13a). The resource is a one-story residence with a rectangular core. It has a lateral gable roof that is clad in composition shingles. The exterior is clad in brick veneer, and the foundation is masked. The front porch has a gable roof supported by brick columns. The resource has undergone several alterations and additions. The windows are replacement vinyl one-over-one double hung sash. The resource has additions to both side elevations and an attached carport. These alterations have altered the appearance of Resource 3884.

A. Resource 3894, Oblique

The resource is located on a moderate size lot with some landscaping. There are planted bushes along the right bay façade of the resource with moderate tree coverage. The driveway approaches from the right side to an attached carport. The resource is located in a rural residential development which is dominated by trailer parks and scattered commercial properties. The viewshed of the resource has been slightly compromised by commercial development and previous improvements to the roadways.

The resource is an example of a Minimal Traditional house type but is a modest example of its house type. It also does not represent the work of a master or possess high artistic value. Alterations have slightly altered the appearance of the resource. It is not known to be associated with events or persons significant in the past. Therefore, the resource is recommended as not individually eligible for the NRHP under Criteria A, B, or C.

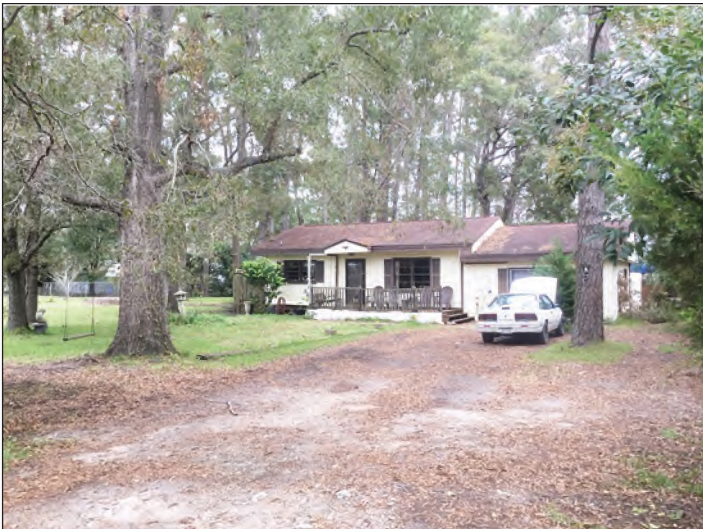
B. Resource 3895, Oblique

Resource 3895 is a Minimal Traditional, built ca. 1950, and is located at 1831 Stacey Street (Figure 13b). The resource is a one-story residence with a rectangular core. It has a lateral gable roof that is clad in composition shingles. The exterior is clad in vinyl siding, and the foundation is not visible. The front porch has a gable roof hood that covers the front entrance. The porch extends right, uncovered, to the end of the resource. The windows are wood two-over-two double hung sash. The resource has undergone some alterations and additions. The resource has an enclosed carport on the right elevation which has a glass pane sliding door entrance. The alterations to the resource have slightly altered its appearance.

This Minimal Traditional house is modestly constructed and was not found to embody a distinctive characteristic of the type, period, or method of construction. It also does not represent the work of a master or possess high artistic value. Alterations have slightly altered the appearance of the resource. It is not known to be associated with events or persons significant in the past. Therefore, the resource is recommended as not individually eligible for the NRHP under Criteria A, B, or C.

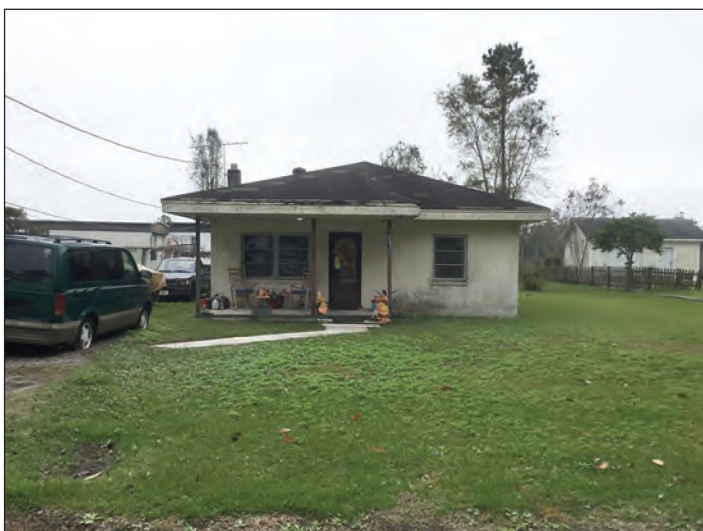
C. Resource 3896, Front Elevation

Resource 3896 is a dwelling of no particular style or type, built ca. 1950, and is located at 1816 Stacey Street (Figure 13c). The resource is a one-story residence with a square core. It has a hip roof that is clad in composition shingles and the exterior is faced with stucco. The foundation was not visible. The front porch has an extended roof line that covers the front entrance. The porch roof is supported by plain wood posts that rest on a concrete slab floor. The windows are wood three-grouped, vertical fixed panes. The resource has an exterior brick chimney on its left elevation. Minor alterations have slightly altered the appearance of Resource 3896.

The resource was not found to embody a distinctive characteristic of a type, period, or method of construction. It also does not represent the work of a master or possess high artistic value. Alterations have slightly altered the appearance of the resource. It is not known to be associated with events or persons significant in the past. Therefore, the resource is recommended as not individually eligible for the NRHP under Criteria A, B, or C.

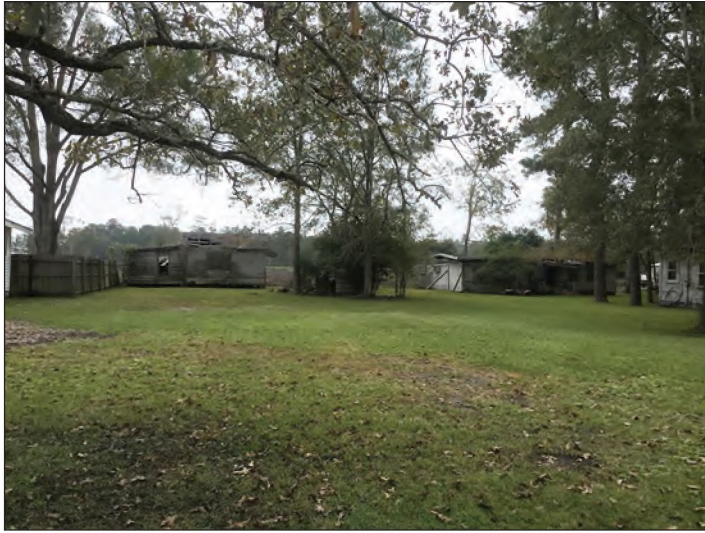
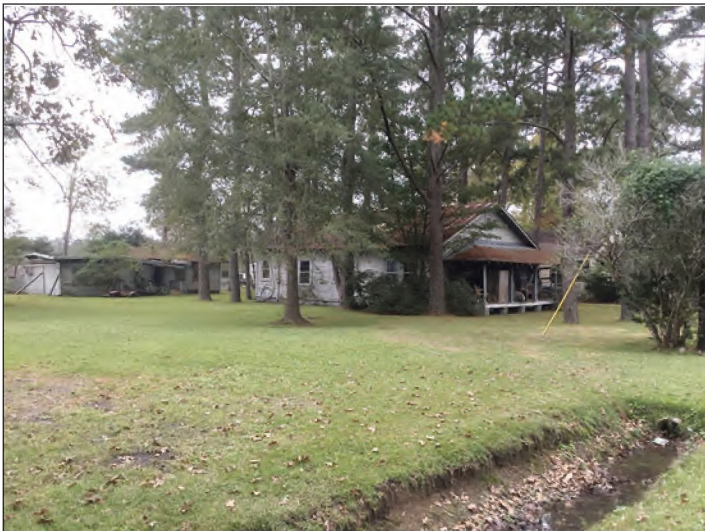
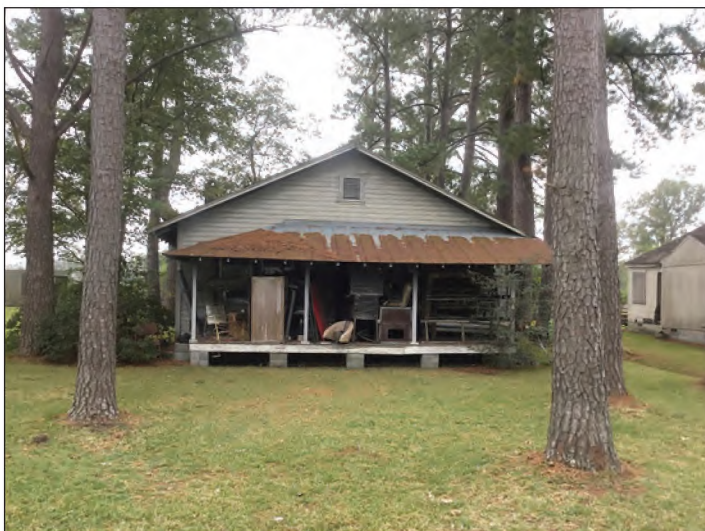
Figure 14.
Resources 3897, 3897.01, and 3897.02

Resource 3897 is a Bungalow, built ca. 1940, and is located at 1810 Stacey Street (Figure 14a). The resource is a one-story dwelling with a rectangular core. It has a front gable roof that is clad in raised seam metal. The exterior is clad in weatherboard and rests on concrete block foundation. The front porch has a hip roof that is supported by plain wood posts and rests on concrete block piers. The windows are wood six-over-six double hung sash. The resource appears to not have undergone major alterations.

Resources 3897.01 and 3897.02 are outbuildings located to the left and rear of the main resources, respectively (Figure 14b and c). They are both frame construction that rest on concrete block foundations. The exteriors are clad in wood weatherboard with metal clad gable roofs. They are both historical to the main resource and are in such a dilapidated state that their function is unknown.

A. Resources 3897.01 and 3897.02,
Setting Oblique

B. Resource 3897 and 3897.02,
Setting Oblique

C. Resource 3897, Front Elevation

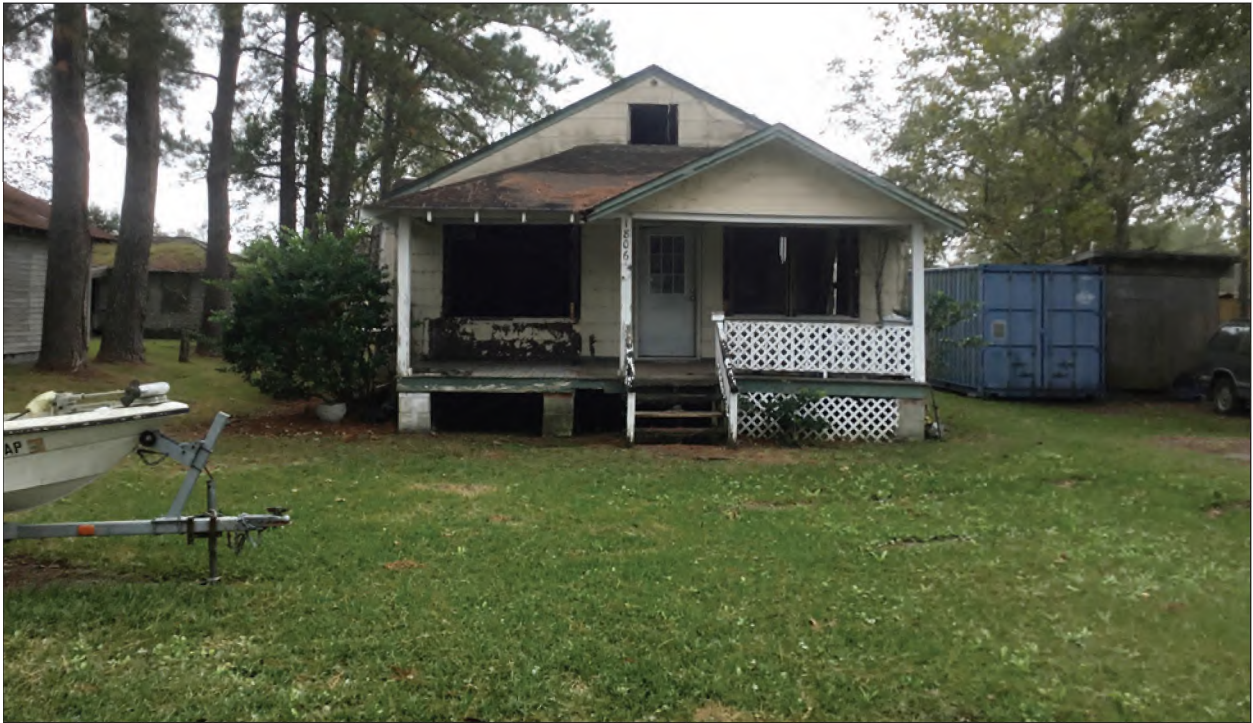
A. Resource 3898, Front Elevation

Resource 3898 is a Bungalow, built ca. 1940, and is located at 1806 Stacey Street (Figure 15a). The resource is a one-story residence with a rectangular core. It has a front gable roof that is clad in composition shingles. The exterior is clad in asbestos shingles and rests on concrete block foundation. The front porch has a hip roof with a front gable over the right bay. The roof of the porch is clad in composition shingles and is supported by plain wood posts. The porch rests on concrete block piers. On the left elevation is a side gable addition that projects outward. All windows on the resource have been removed. The front door, located on the front porch, is wood paneled with a nine-light window. The resource currently appears to be vacant.

The resource was also assessed for its value to a district. No previously identified historic district currently exists in the area and this survey did not identify a group of resources that have a shared date of construction, developmental history, or that share layouts and features that could be construed as a historic district. Thus, Resource 3898 was not considered individually NRHP eligible or contributing to a district.

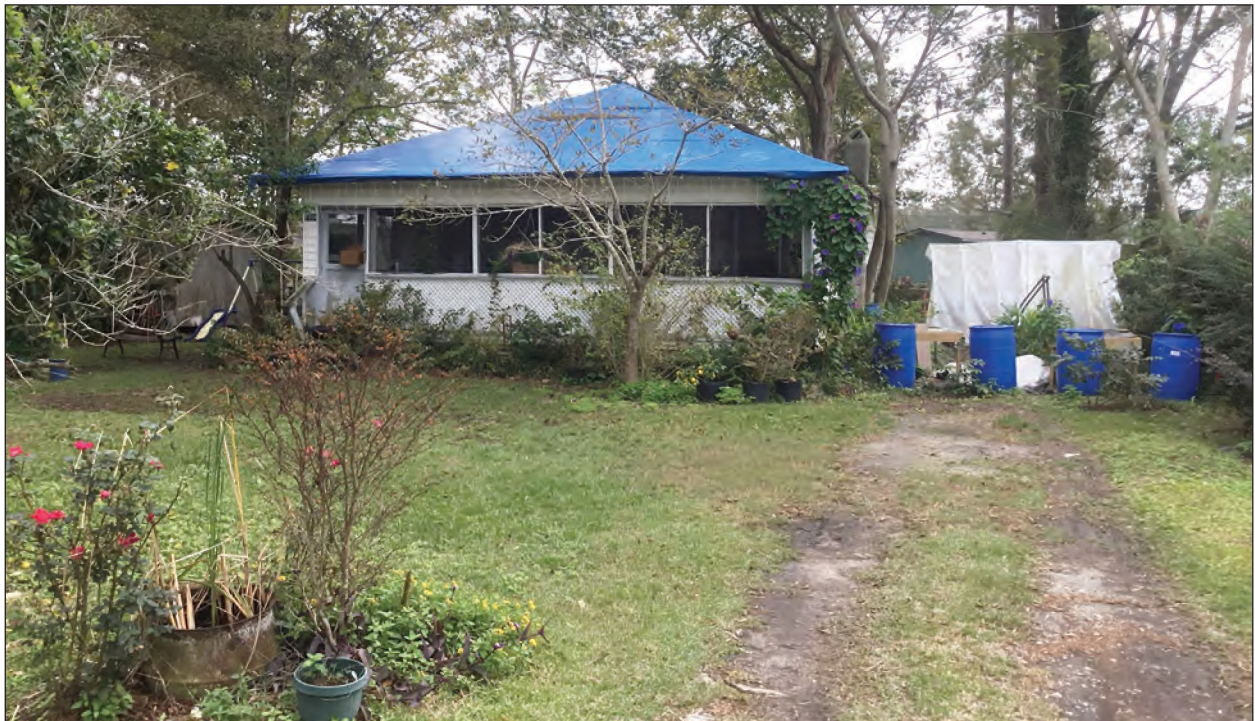
B. Resource 3899, Front Elevation

Resource 3899 is a dwelling of no particular style or type, built ca. 1950, and is located at 1804 Stacey Street (see Figure 15b). The resource is a one-story residence with a square core. It has a hip roof that is clad in composition shingles. Along the eaves of the roof are exposed rafter tails. The exterior is clad in vinyl siding and the foundation was obstructed by planted vegetation. The front porch is engaged, extending over the full façade porch. The roof is supported by plain wood posts that is enclosed with screen. The windows are wood six-over-six double hung sash. Minor alterations have slightly altered the appearance of Resource 3899.
