Phase I Cultural Resource Survey of Fred Nash Boulevard Widening Project

Horry County, South Carolina

May 2, 2019 • **Final Report**
New South Associates Technical Report 2951

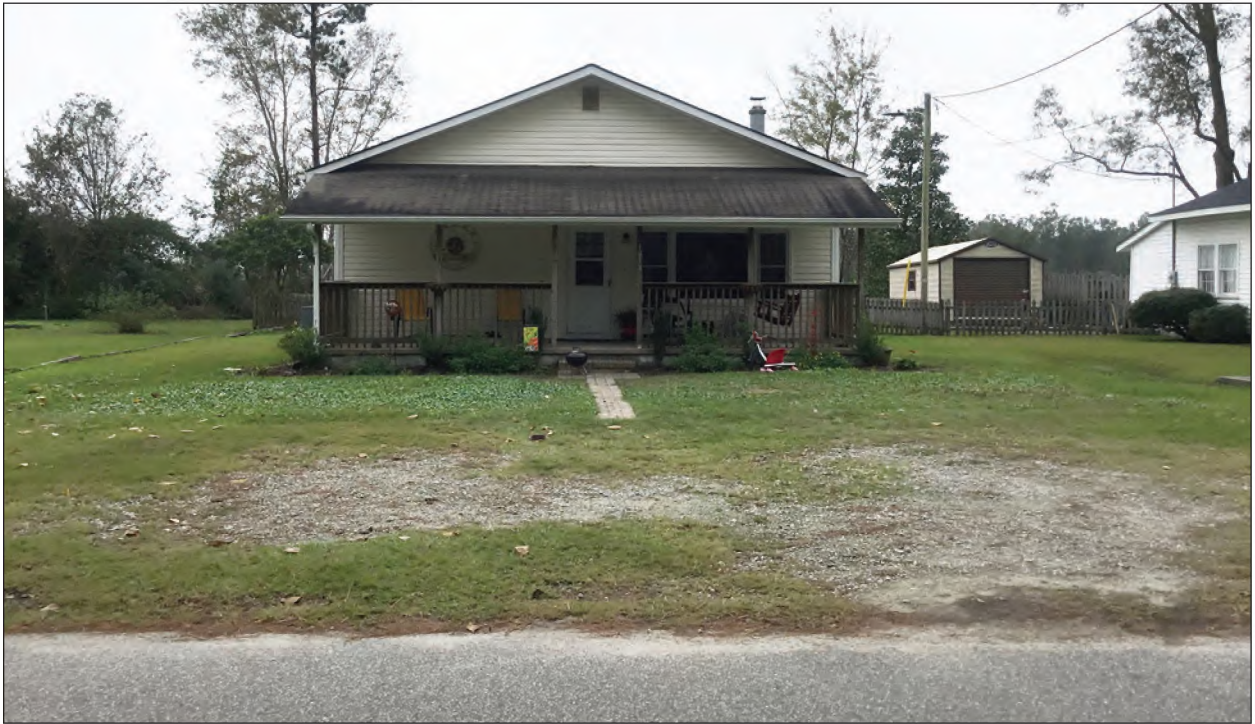
Resource 3900 is a Bungalow, built in 1930, and is located at 1814 Stacey Street (Figure 16a). The resource was built in 1930 according to the Horry County Land Records online. It is a one-story residence with a rectangular core. It has a gable roof that is clad in composition shingles. The exterior is clad in vinyl siding and rests on a concrete block foundation. The front porch has a shed roof that is supported by plain wood posts. The resource has an exterior brick chimney on the right elevation. The windows are vinyl one-over-one double hung sash throughout, with a picture window flanked by four-over-four windows on the right bay. The alterations have altered the appearance of Resource 3900.

A. Resource 3900, Front Elevation

The resource is located on a moderate size lot with some landscaping. There are planted bushes along the elevations of the resource. There is sparse tree coverage on the property with the rest of the lot having grass coverage. The resource is located in a rural residential development which is dominated by trailer parks and scattered commercial properties. The viewshed of the resource has been slightly compromised by commercial development and previous improvements to the roadways.

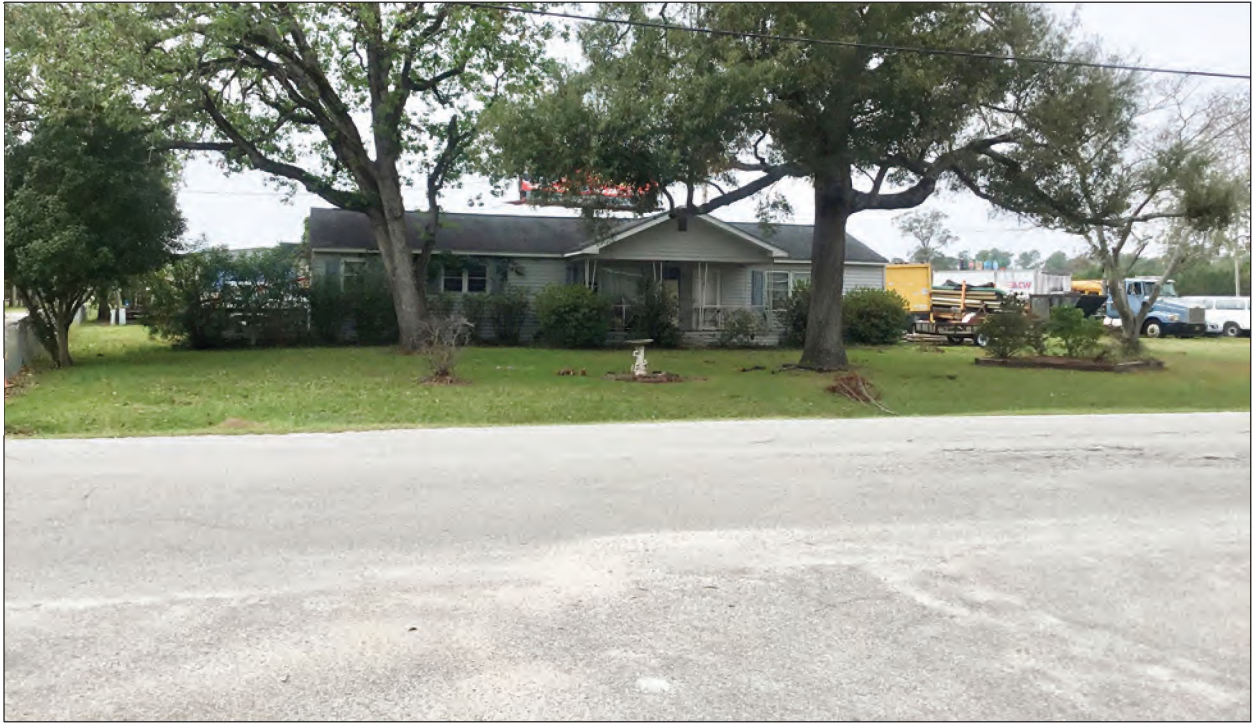
A. Resource 3902, Oblique

Resource 3902 is a residence of no particular type or style, built ca. 1950, is located at 3251 Shetland Lane (Figure 17a). The resource is a one-story with a rectangular core. It has a lateral gable roof that is clad in composition shingles. The exterior is clad in vinyl siding and the foundation was not visible. The front entry porch has a gable roof supported by plain metal posts. The windows are wood two-over-two double hung sash. There have been minor alterations to the appearance of Resource 3902.

The resource was also assessed for its value to a district. No previously identified historic district currently exists in the area and this survey did not identify a group of resources that have a shared date of construction, developmental history, or that share layouts and features that could be construed as a historic district. Thus, Resource 3902 was not considered individually NRHP eligible or contributing to a district.

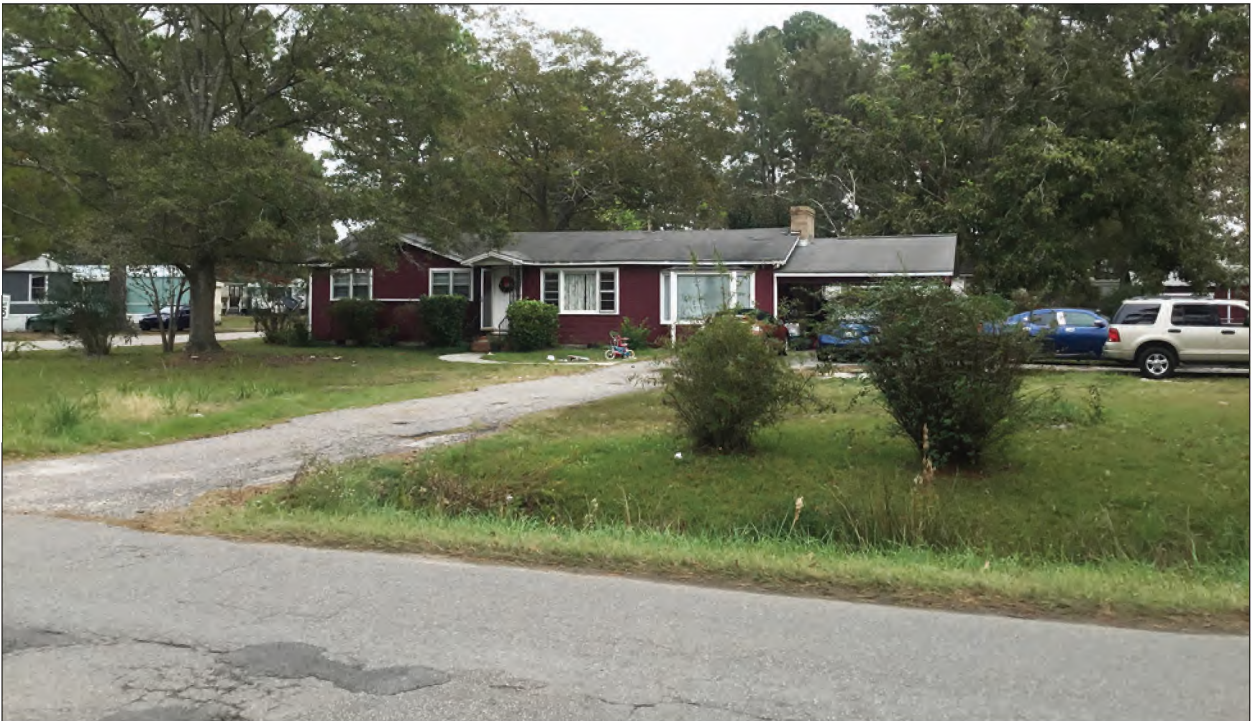
B. Resource 3903, Oblique

Resource 3903 is a Minimal Traditional dwelling, built ca. 1950, and is located at 3240 Shetland Lane (Figure 17b). The resource is a one-story residence with a rectangular core. It has a lateral gable roof with a left bay front gable that is clad in composition shingles. The exterior is clad in weatherboard and rests on a concrete block foundation. The front entry porch has a gable roof supported by decorative metal posts. The right most bay is clad in vertical weatherboard and has a bay window. Also, on the right elevation is an exterior brick chimney and an attached carport. The right bay next to the entrance has a picture window flanked by two-over-two double hung sash windows, all other windows are two-over-two. There have been minor alterations to the appearance of Resource 3903.

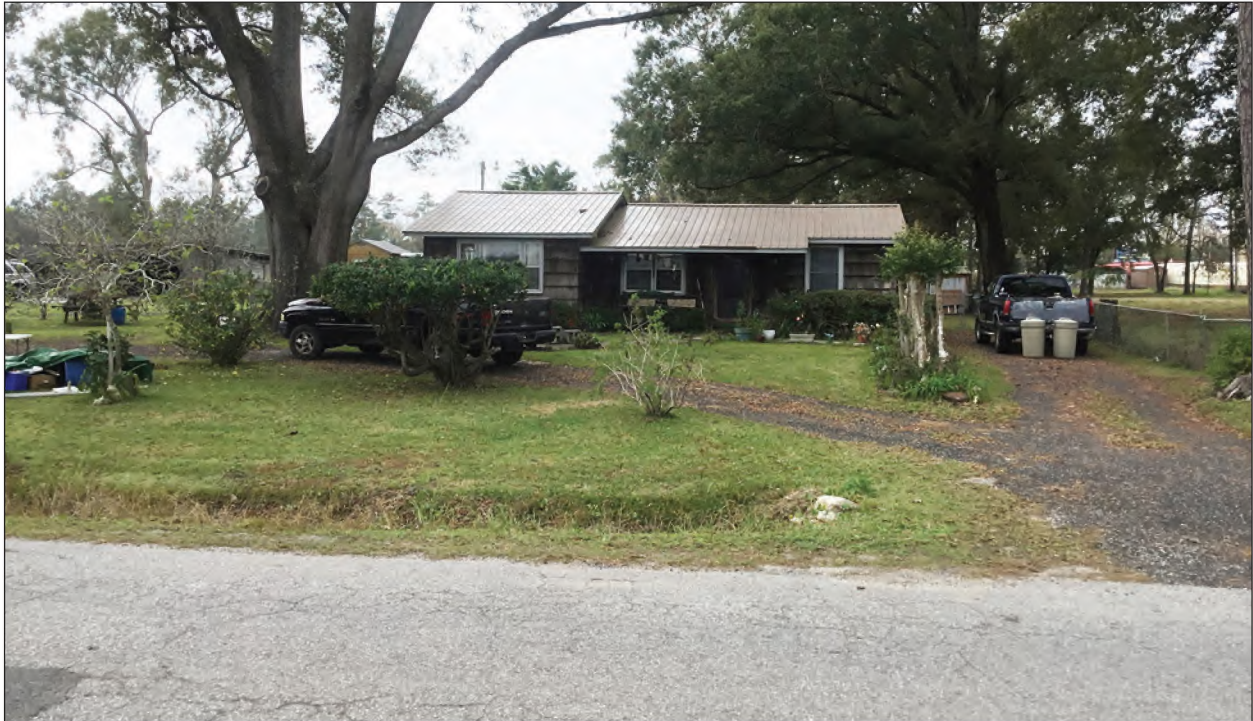
A. Resource 3904, Oblique

Resource 3904 is a residence with no particular type or style, built ca. 1960, is located at 3231 Shetland Lane (Figure 18a). The resource is a one-story with a rectangular core. It has a lateral gable roof. The roof is clad with raised seam metal and the exterior is clad in wood shingles. The foundation was not visible due to landscaping. The front entry porch is recessed under the main roof line and has brick steps. The windows are wood six-over-six double hung sash, with a picture window flanked by four-over-four windows on the left bay. There have been minor alterations to the appearance of Resource 3904.

The resource was also assessed for its value to a district. No previously identified historic district currently exists in the area and this survey did not identify a group of resources that have a shared date of construction, developmental history, or that share layouts and features that could be construed as a historic district. Thus, Resource 3904 was not considered individually NRHP eligible or contributing to a district.

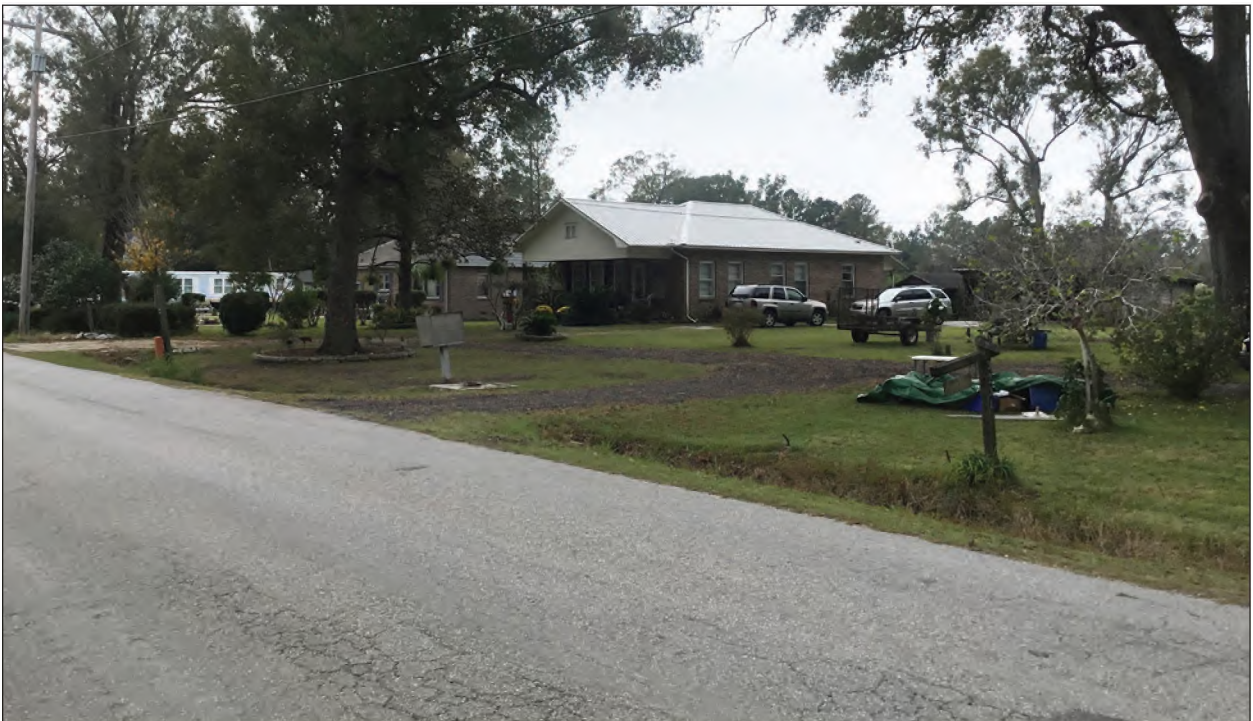
B. Resource 3905, Oblique

Resource 3905 is a Bungalow, built ca. 1940, is located at 3225 Shetland Lane (see Figure 18b). The resource is a one-story with a rectangular core. It has a front gable roof covering the porch which connects to the main hip roof. The roof is clad in raised seam metal. The exterior is clad in brick veneer and the foundation is masked. The porch roof is supported by decorative metal posts and the gable end is clad with pressboard. The windows are wood two-over-two. There have been minor alterations to the appearance of Resource 3905.

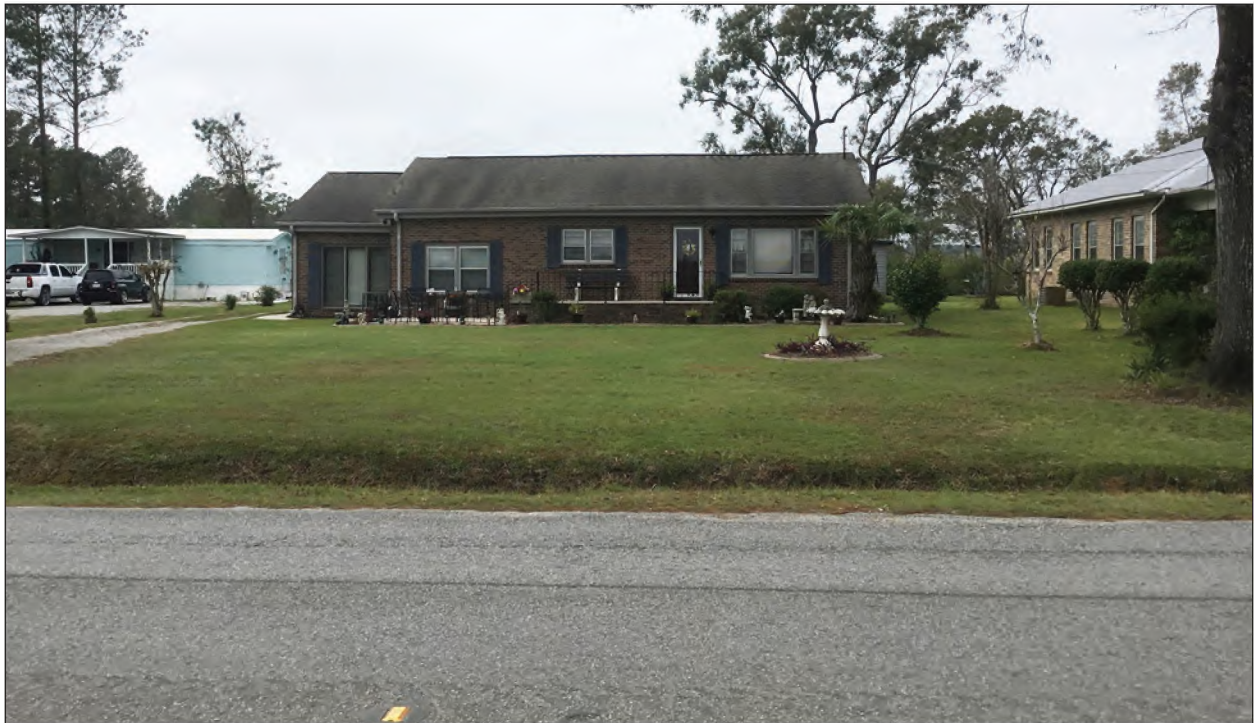
Resource 3906, a Minimal Traditional built ca. 1950, is located at 3221 Shetland Lane (Figure 19a). The resource is a one-story residence with a rectangular core. It has a lateral gable roof clad in composition shingles. The exterior is clad in brick veneer and the foundation is masked. The porch is slightly covered by the main roof. The porch extends from the front entrance to left bay onto a brick patio. The porch is lined with decorative metal railings. The windows are wood two-over-two double hung sash on the central bay and the left bay has one-over-one double hung sash. The left elevation addition has three-paired vertical fixed panes. There have been minor alterations to the appearance of Resource 3906.

A. Resource 3906, Front Elevation

The resource is located on a moderate size lot with some landscaping. There are planted bushes along elevations of the resource with minimal tree coverage. The driveway approaches the left side of the resource. The resource is located in a rural residential development which is dominated by trailer parks and scattered commercial properties. The viewshed of the resource has been slightly compromised by commercial development and previous improvements to the roadways.
