**ARCHAEOLOGICAL FIELD REPORT
SCDOT ENVIRONMENTAL SECTION**

TITLE: Phase I Archaeological Survey of the Proposed S-51 Over Gills Creek Bridge Replacement, Lancaster County, South Carolina

COUNTY: Lancaster **PROJECT:** SC 51 Over Gills Creek Bridge Replacement, Lancaster County, SC

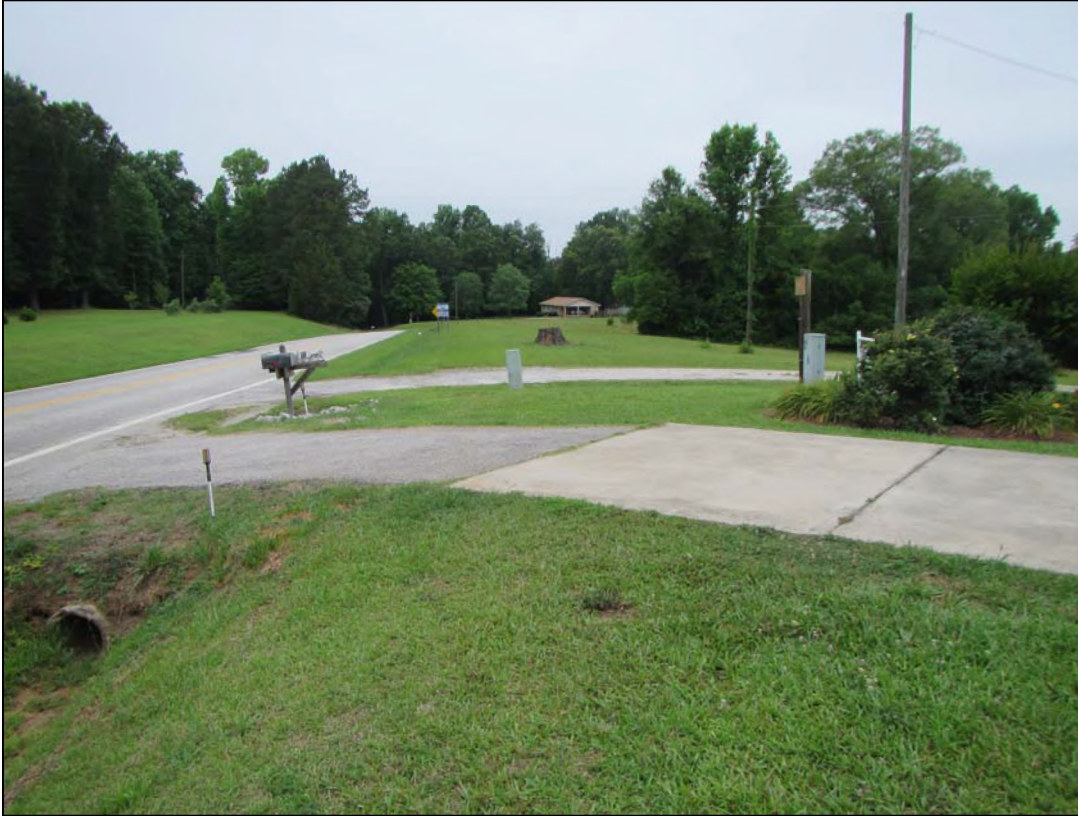
Figure 3: Representative Photo of the North Portion of the Survey Area, facing southwest.

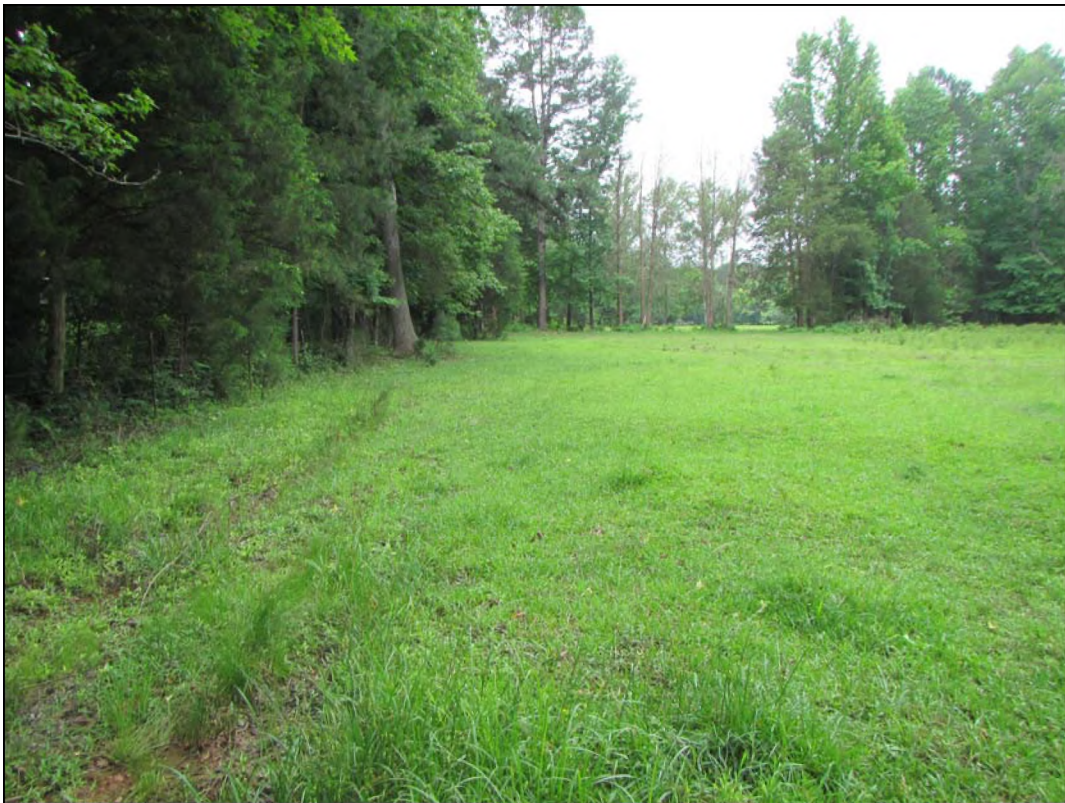
Figure 4: Representative Photo of the South Portion of the Project Area, facing southwest.

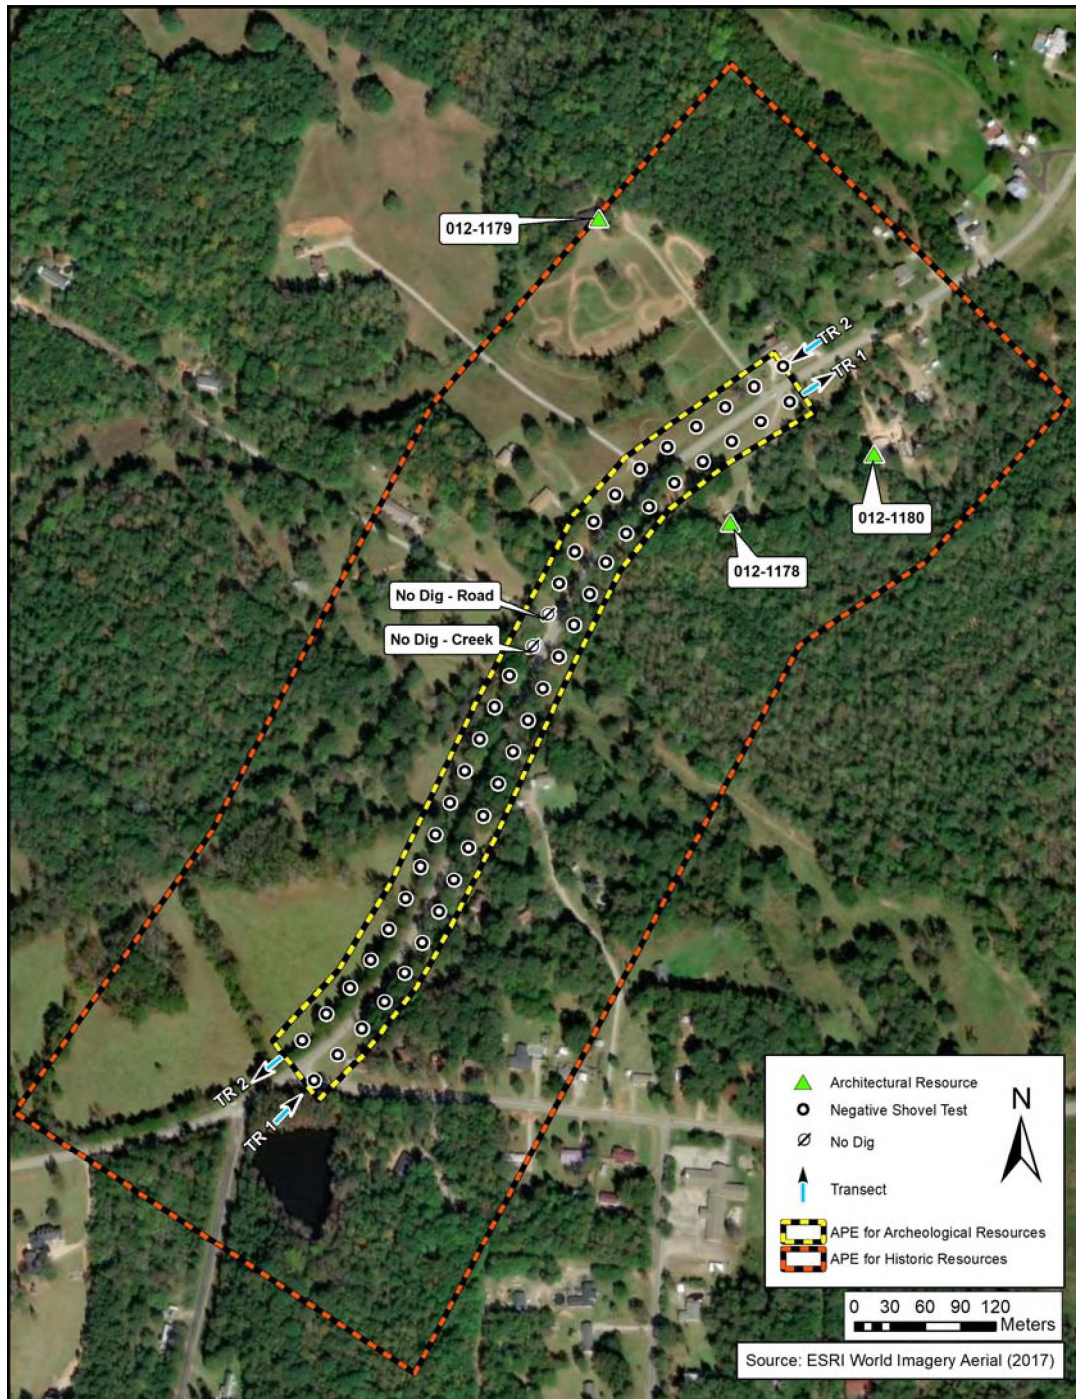
A total of 50 potential shovel test locations were examined, but only 48 shovel tests were excavated within the survey area. Two of the 50 potential shovel test locations were marked as no digs and were not dug due to placement on pavement or in the creek (Figure 5). All the shovel tests were negative for cultural material. Soil profiles were fairly shallow throughout the project area. A typical profile included two layers. The first layer extended from approximately 0-30 centimeters below surface (cmbs) and generally

consisted of some variation of the following three soils: 10YR 5/3 brown loam, 10YR 6/3 pale brown loam, or 10YR 5/6 yellowish brown loamy sand. The second layer was either a 10R 4/8 red clay or a 10YR 3/3 brown clay subsoil; the tests were terminated between 20-40 cmbs. Redeposited fill soils and mottled layers of clay subsoil were also found throughout the project area. No sites or isolated finds were discovered during the survey for this project.

Figure 5: Shovel Test Results and Location of the Newly Recorded Architectural Resources Discovered During the Survey.

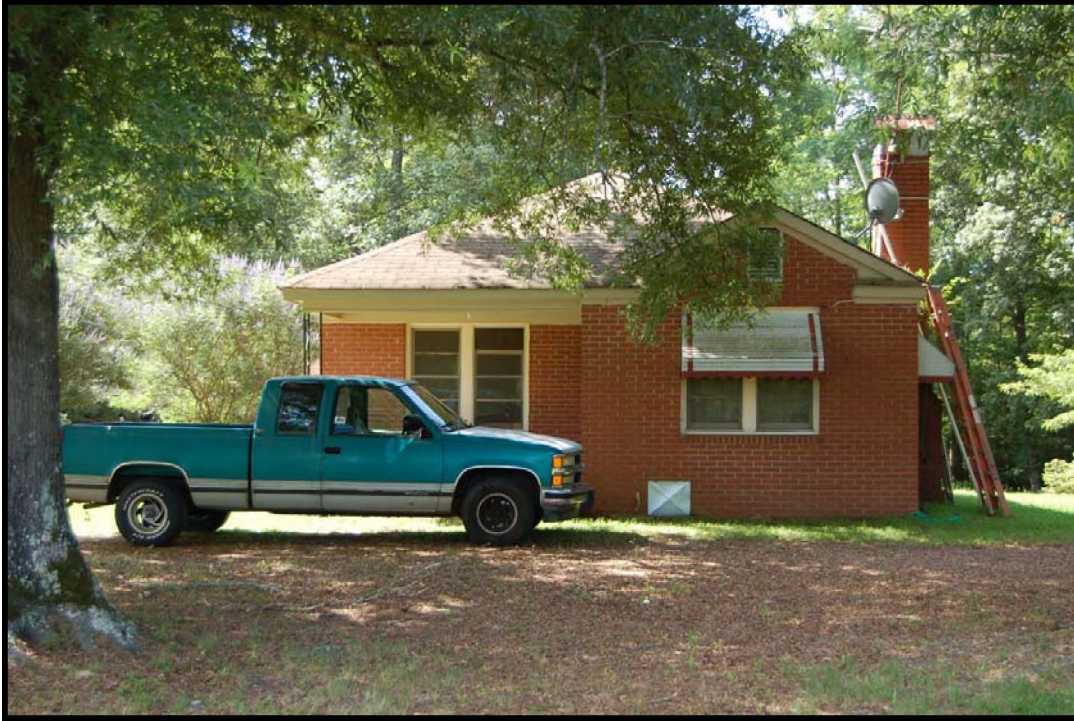
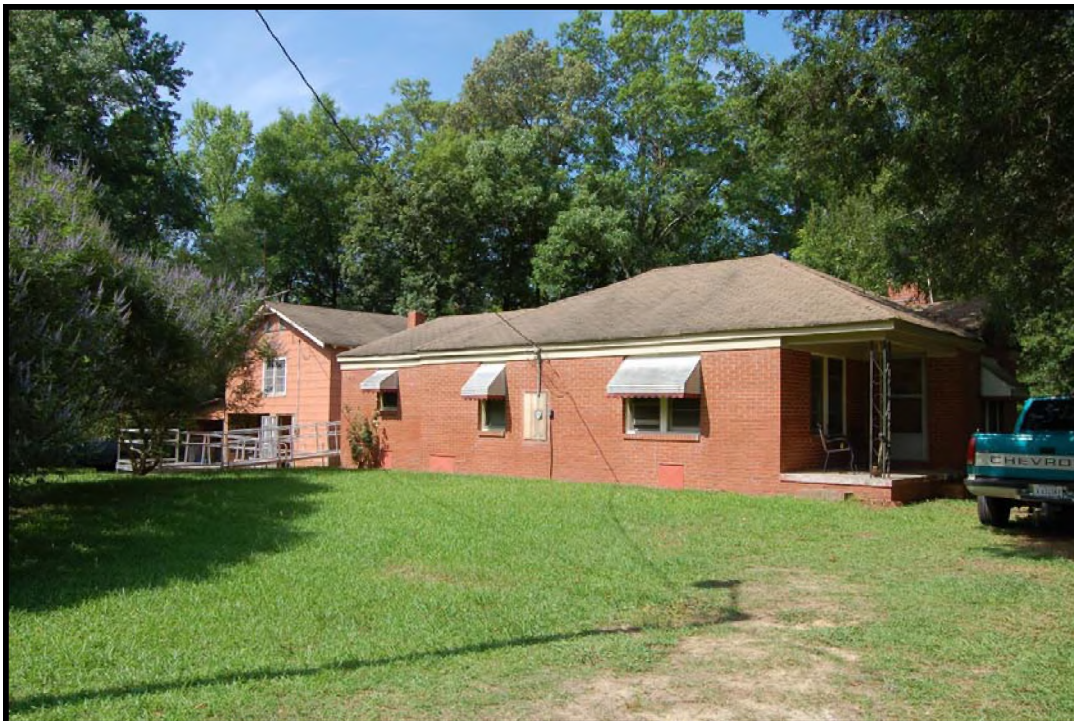
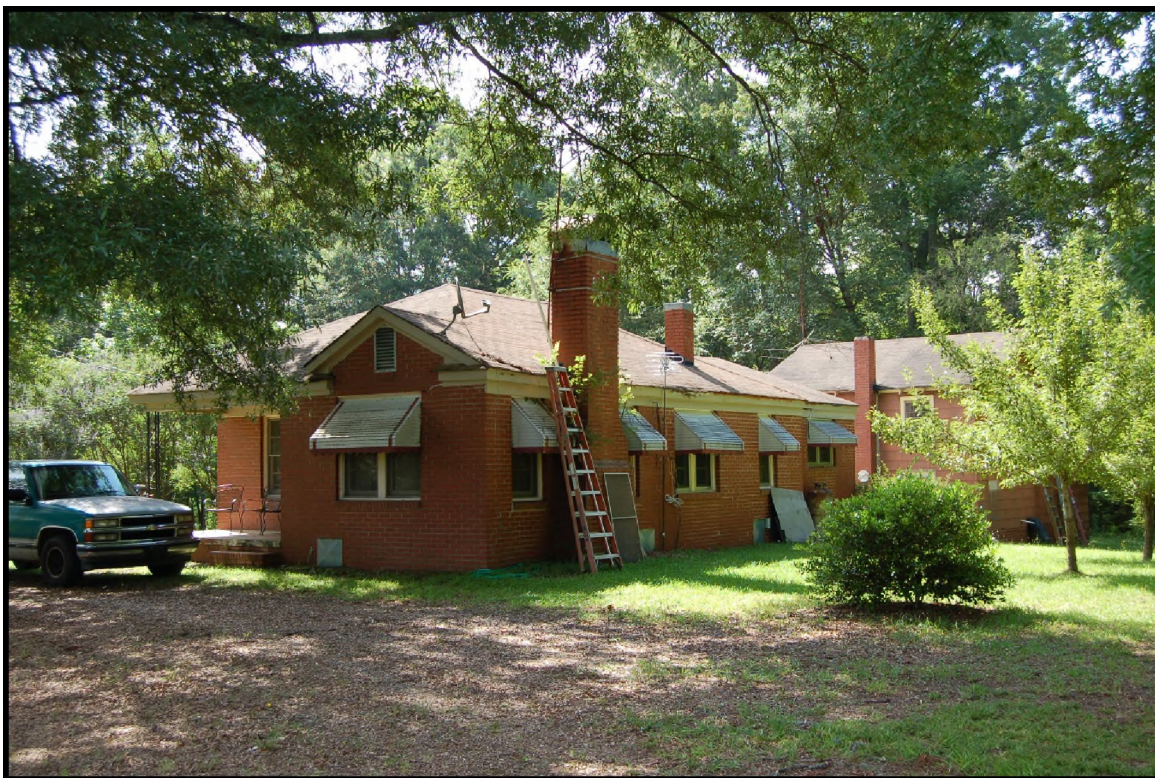
The resource is a one-story, asymmetric, hipped-roof bungalow of frame construction without stylistic features. The resource has a hipped asphalt shingle roof with little eave overhang; running bond brick veneer exterior; single and paired 2/2-light double-hung sash windows with metal canopy awnings; and a partial-width, integral porch on the façade supported by a single decorative metal post (see attached Figures 6-8). The front entrance accesses the porch and is perpendicular to the façade. It is suspected that the brick veneer is a later addition over original wooden exterior siding based on how deep the windows are recessed and the narrow eaves.

The resource is not known to be associated with a significant activity or event and there is not a known connection between the resource and any individual whose activities or achievements are historically significant. Therefore, there was no basis for evaluating the resource under Criterion A or B. Also, there is no indication that the resource is likely to yield information on important research questions in history or prehistory. The resource does not appear to have the potential to be the principal source of important information. Therefore, there was no basis for evaluating the resource under Criterion D. Whether or not the brick exterior is a later alteration that has affected the integrity of the resource in the areas of materials and workmanship, the resource is a plain and undistinguished example of a common architectural building type. Therefore, Resource 012-1178 is recommended **Not Eligible** for listing in the NRHP under Criterion C in the area of architecture.

Figure 6: Resource 012-1178 (1882 Camp Creek Road) - View of the façade facing southwest.

Figure 7: Resource 012-1178 (1882 Camp Creek Road) - View of the façade facing southwest.

Figure 8: Resource 012-1178 (1882 Camp Creek Road) - View of the façade facing southwest.

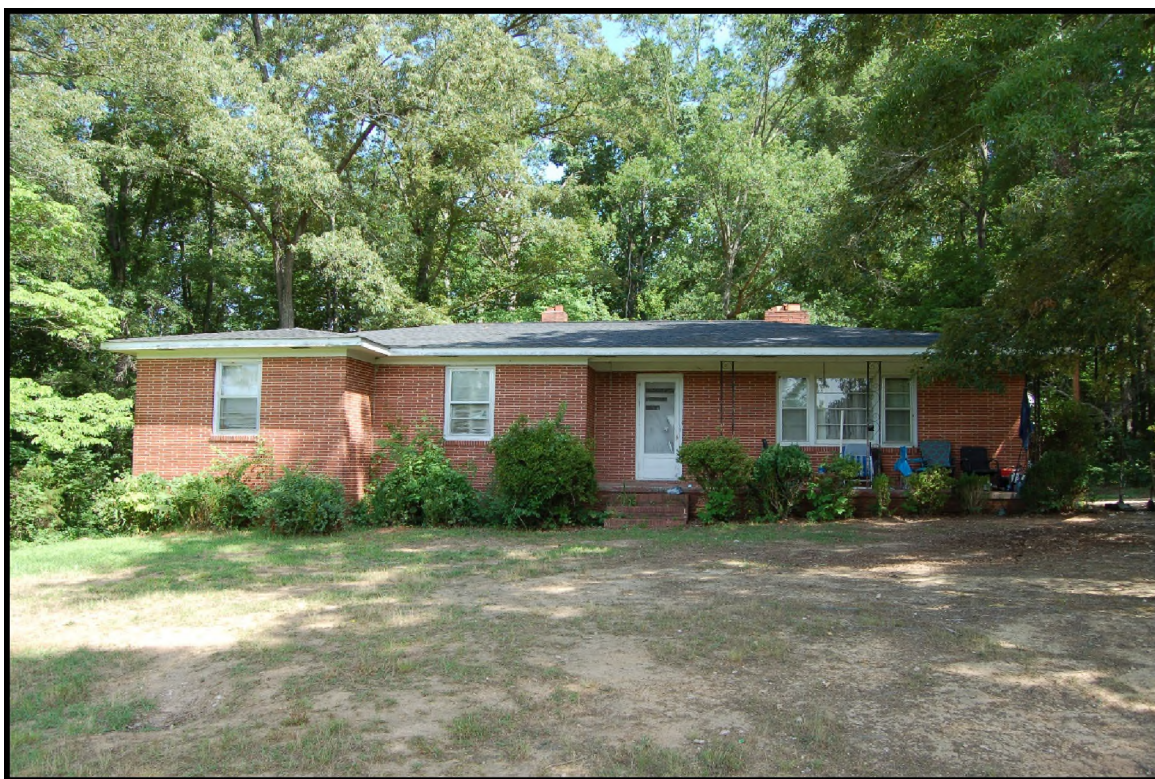
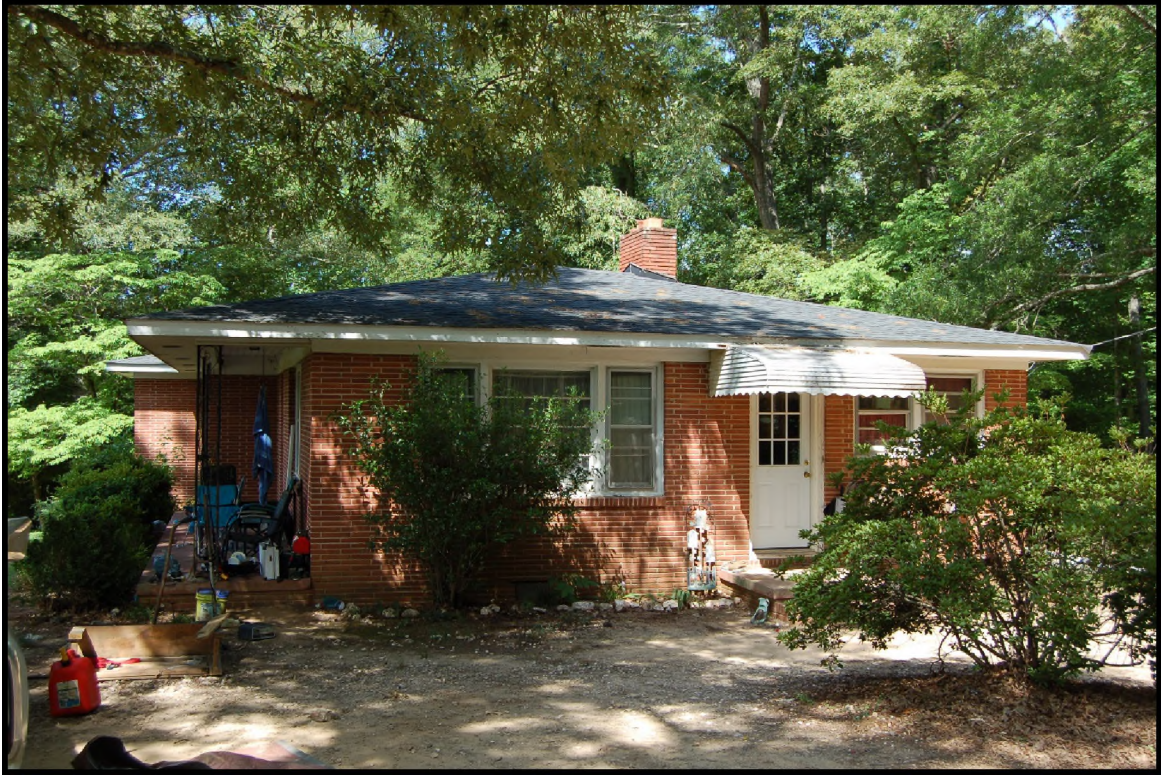
The resource is a one-story, asymmetric, Ranch without stylistic features. The resource has a low-pitched, hipped, asphalt shingle roof with wide eaves; running bond “Roman” brick exterior; a partial-width, integral porch on the façade supported by three decorative metal posts; a tripartite window on the façade comprised of a large, square, four-light fixed window flanked by smaller 2/2-light double-hung sash windows; a tripartite window on the east side elevation comprised of a large, square, four-light fixed window flanked by smaller 2/2-light double-hung sash windows; single and paired 2/2-light double-hung sash windows; and two brick interior chimneys on the rear roof slope (refer to Figures 9-10). There are no evident exterior alterations or additions to the resource.

The resource is not known to be associated with a significant activity or event and there is not a known connection between the resource and any individual whose activities or achievements are historically significant. Therefore, there was no basis for evaluating the resource under Criterion A or B. Also, there is no indication that the resource is likely to yield information on important research questions in history or prehistory. The resource does not appear to have the potential to be the principal source of important information. Therefore, there was no basis for evaluating the resource under Criterion D. The resource was evaluated under Criterion C in the area of architecture and is not considered to be a significant example of the Ranch type. While it retains a high degree of integrity in all aspects, the resource is a plain and undistinguished example of its architectural type. Also, the resource lacks an integral carport or garage and a variety of decorative window types, which are identified as significant characteristics and features of the Ranch type by the SC SHPO in their guidance entitled *Guidelines for Surveying Post-World War II Neighborhoods and Residences*. Therefore, Resource 012-1179 is recommended **Not Eligible** for listing in the NRHP under Criterion C in the area of architecture.

Figure 9: Resource 012-1179 (1897 Camp Creek Road) - View of the façade facing southwest.

Figure 10: Resource 012-1179 (1897 Camp Creek Road) - View of the façade facing southwest.

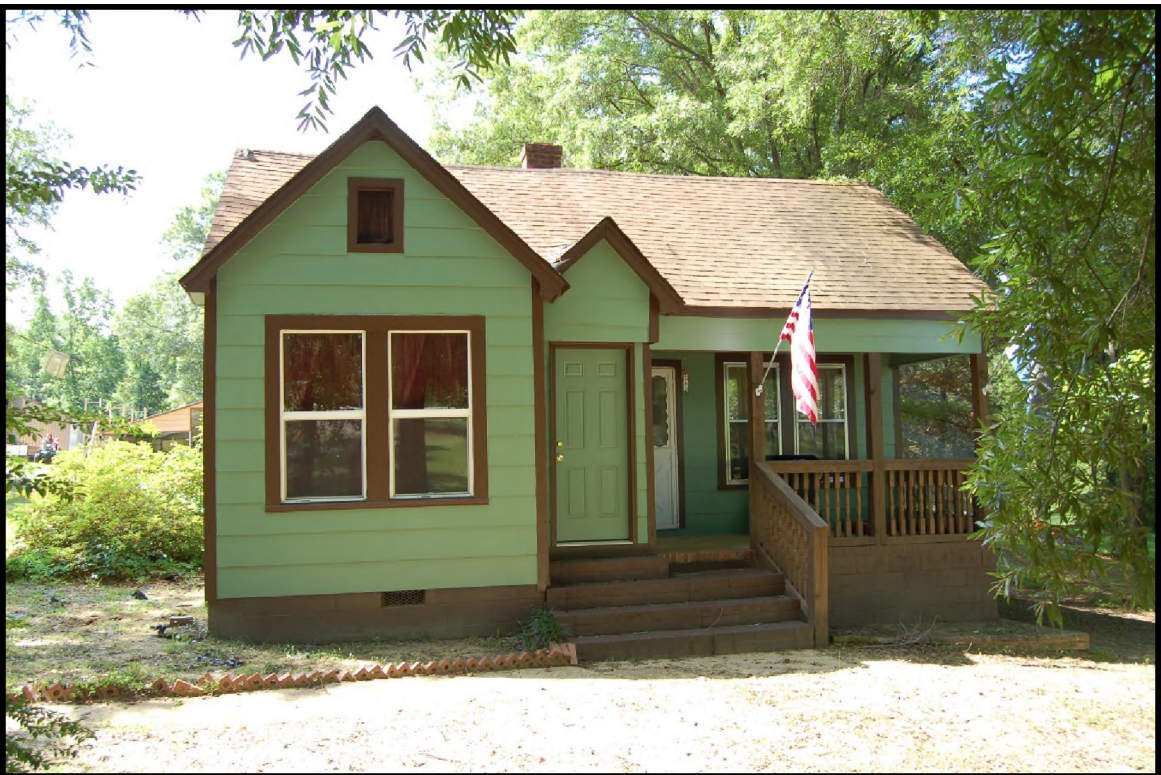
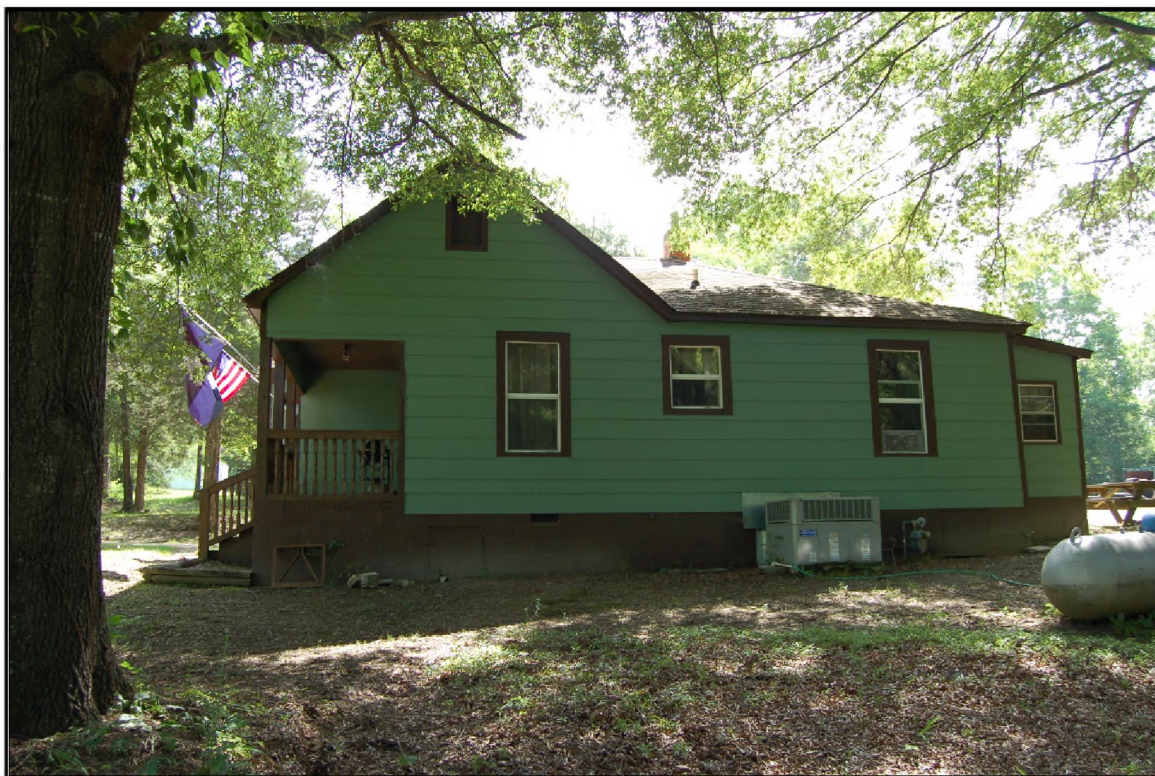
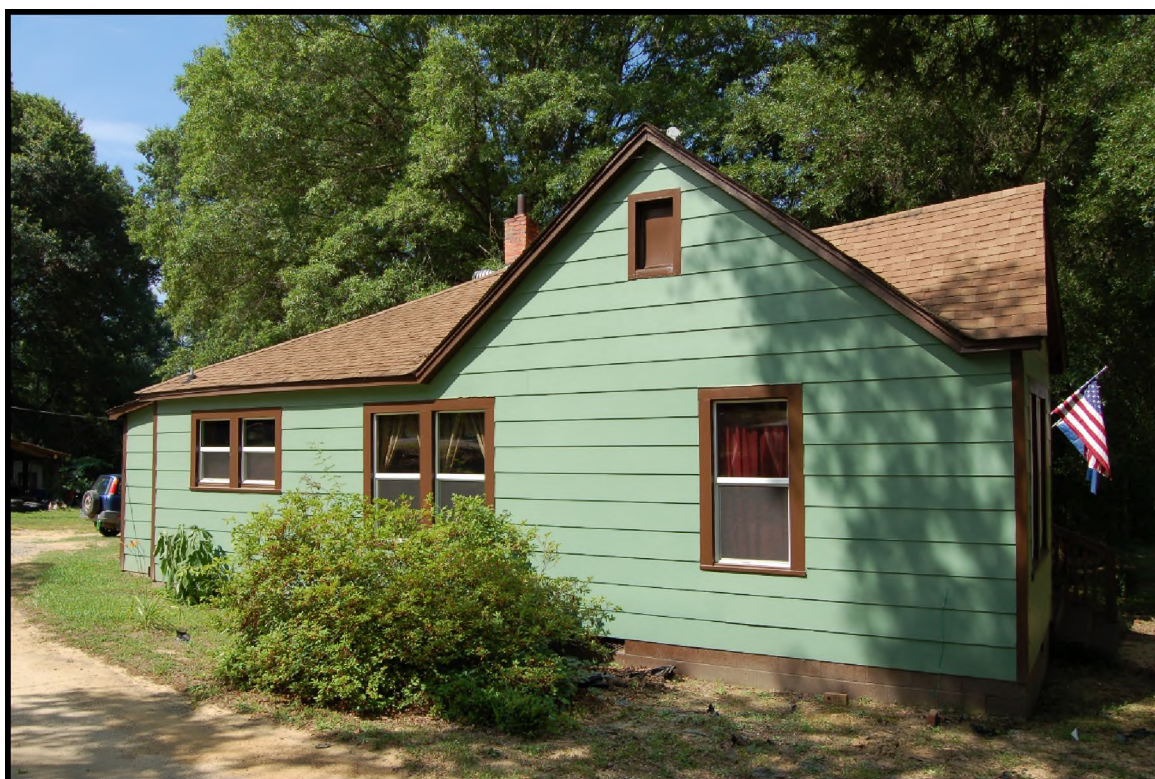
The resource is a one-story, asymmetric, cross-gabled residence of frame construction without stylistic features. The resource has a steeply-pitched, cross-gabled asphalt shingle roof; a continuous concrete block foundation; aluminum exterior siding; single and paired replacement metal-framed vinyl 1/1-light double-hung sash windows; a partial-width, integral porch on the façade supported by three wooden posts; a non-historic second entrance with a gabled roof on the façade; a near-full-width, shed-roofed addition on the rear elevation; and a brick interior chimney on the rear roof slope (refer to Figures 11-13).

The resource is not known to be associated with a significant activity or event and there is not a known connection between the resource and any individual whose activities or achievements are historically significant. Therefore, there was no basis for evaluating the resource under Criterion A or B. Also, there is no indication that the resource is likely to yield information on important research questions in history or prehistory. The resource does not appear to have the potential to be the principal source of important information. Therefore, there was no basis for evaluating the resource under Criterion D. Due to the

movement of the resource and significant exterior alterations, the resource has lost integrity in the areas of location, setting, design, materials, workmanship, and feeling and cannot convey significance in the area of architecture. Therefore, Resource 012-1180 is recommended **Not Eligible** for listing in the NRHP under Criterion C in the area of architecture.

Figure 11: Resource 012-1180 (1918 Camp Creek Road) - View of the façade facing southwest.

Figure 12: Resource 012-1180 (1918 Camp Creek Road) - View of the façade facing southwest.

Figure 13: Resource 012-1180 (1918 Camp Creek Road) - View of the façade facing southwest.
