Cultural Resources Survey of the US 701 North Widening Project

Horry County, South Carolina

SCDOT PIN P031789

Final Report

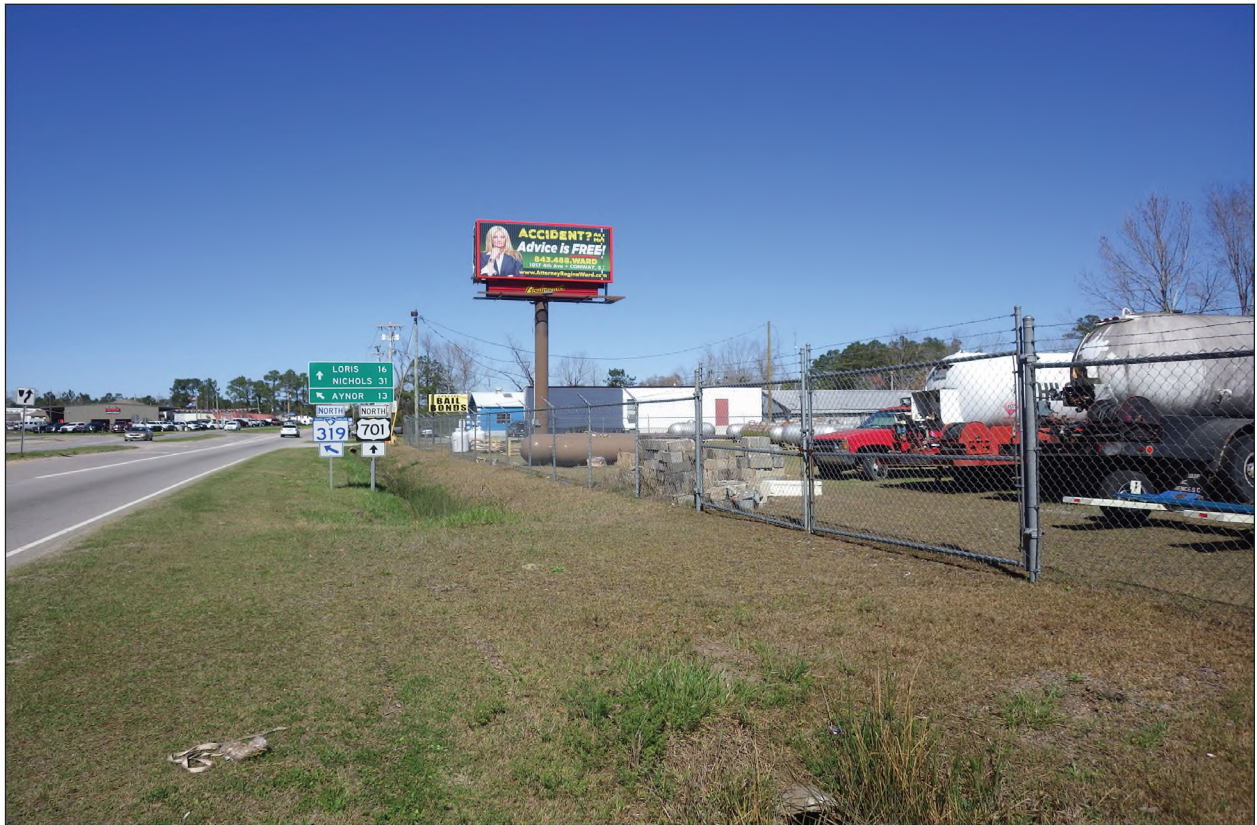
Figure 3.1 View of commercial/industrial disturbance along US 701 North in the southern portion of the Project Area, facing north near the SC 319 and US 701 intersection.

The project area has been substantially altered from its Pre-Contact and early Post-Contact settings. Today the Project Area is dominated by modern development (see Figures 3.1 and 3.2). Where the land remains undeveloped, stands of planted juvenile pine and agricultural crops are present. Some hardwoods also remain within wetland areas. In the past, hardwood swamp and upland forest expanded across the Project Area. During the Post-Contact era, upland forests were cleared for agricultural use as tobacco, cotton, and corn fields.

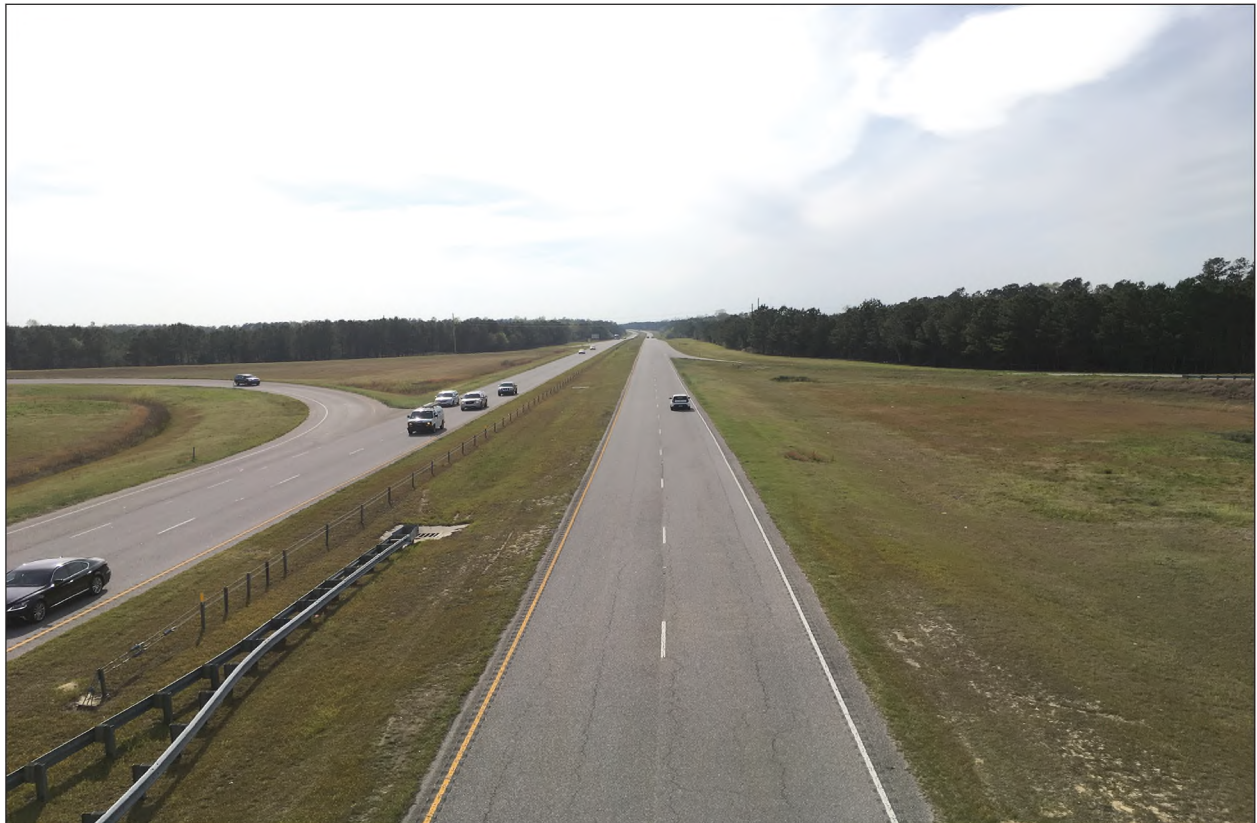
Figure 3.2 View of SC 22 (Veterans Highway) disturbance in the northern portion of the Project Area, facing west.

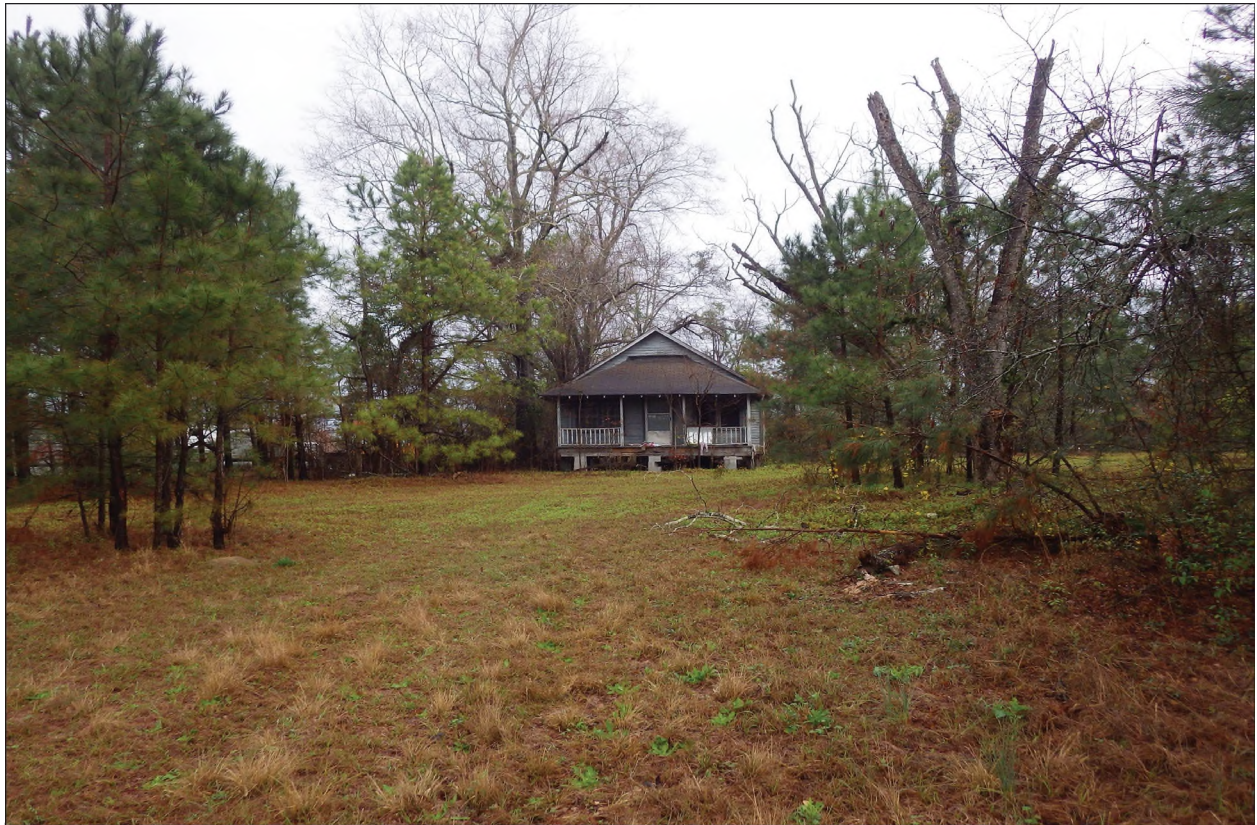
Figure 4.2 View of Resource 004 0215 at 38HR613, facing north.

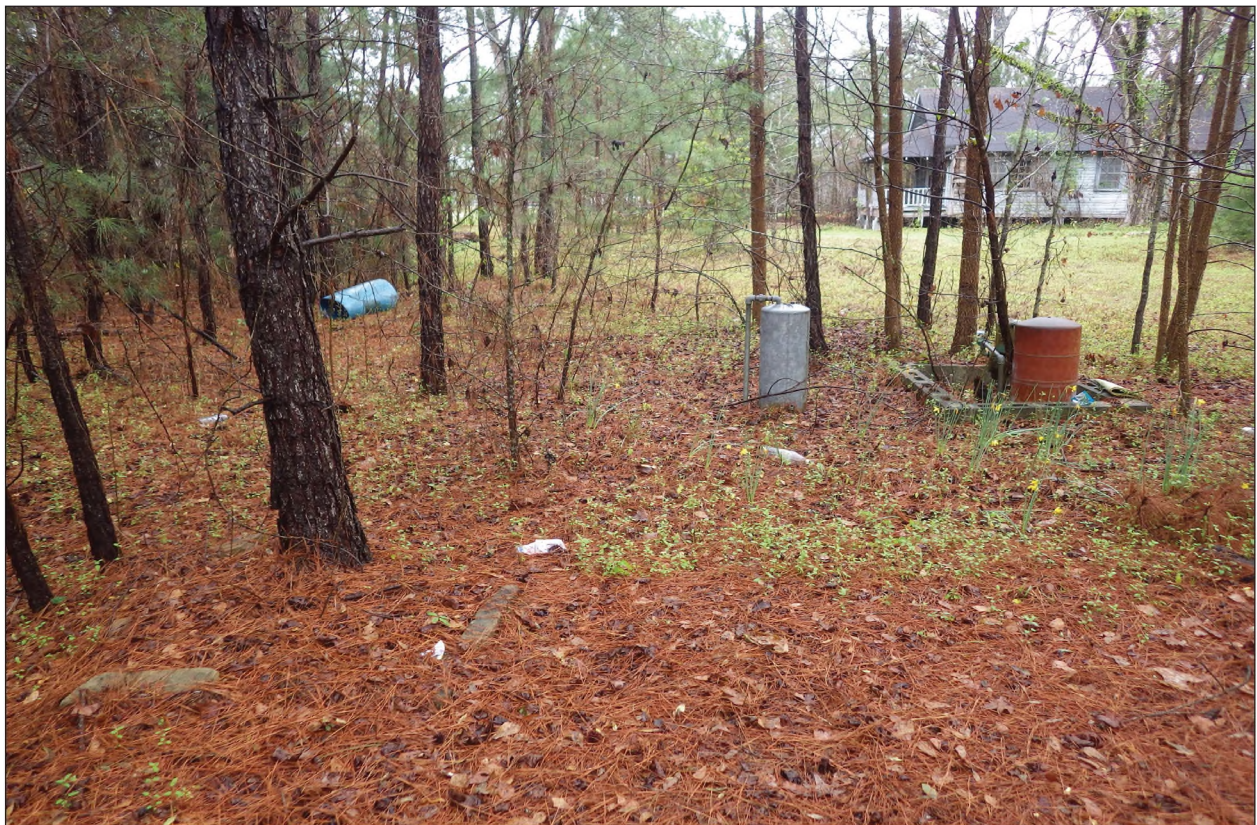
Figure 4.3 View of the water pump at 38HR613, facing northwest.

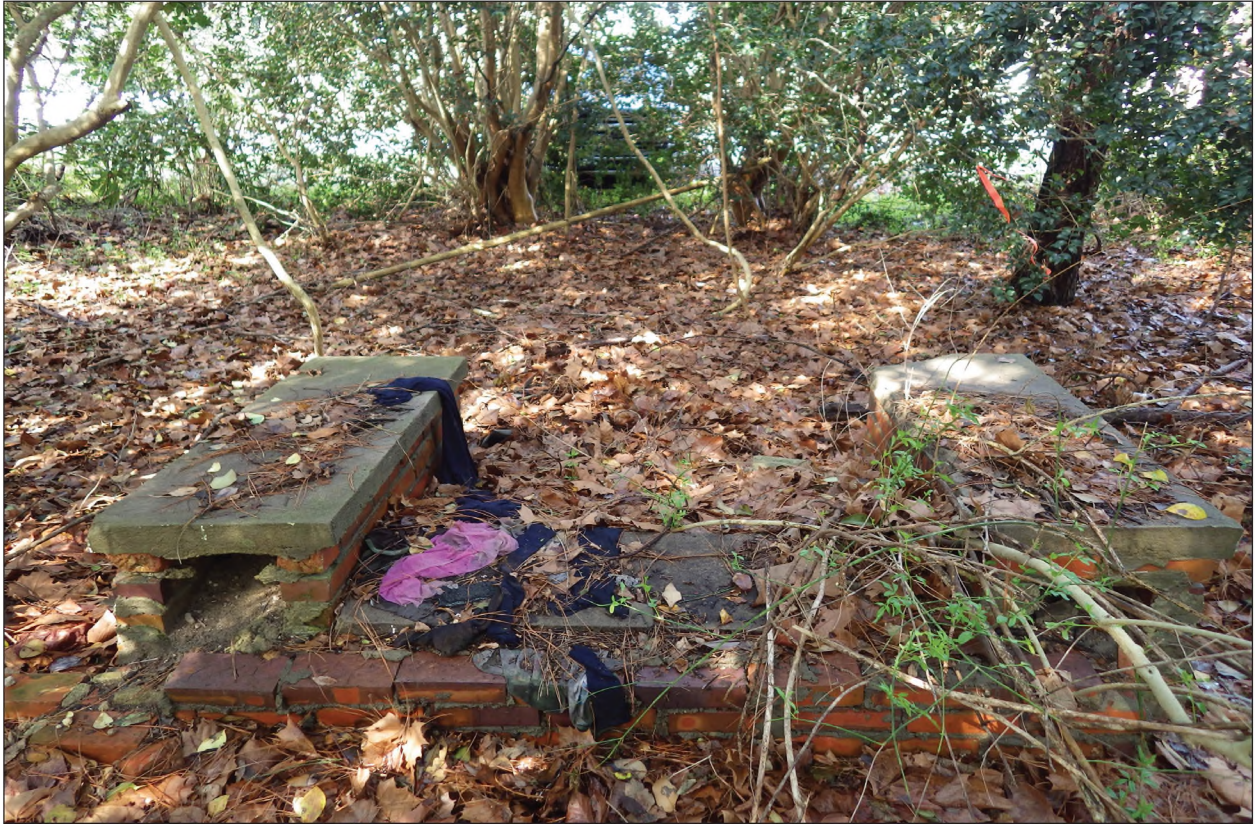
The site was identified when archaeologists observed a brick stair feature (see Figure 4.5) and several brick foundation or wall fragments associated with a general brick scatter, asphalt roof tiles, and pieces of sheet metal. We observed an iron pipe protruding from the ground east of the brick scatter. It is thought that this pipe would have originally

Figure 4.5 View of the brick stair feature at 38HR614, facing west along the gravel walkway flanked by two crape myrtles and beyond to US 701 North.

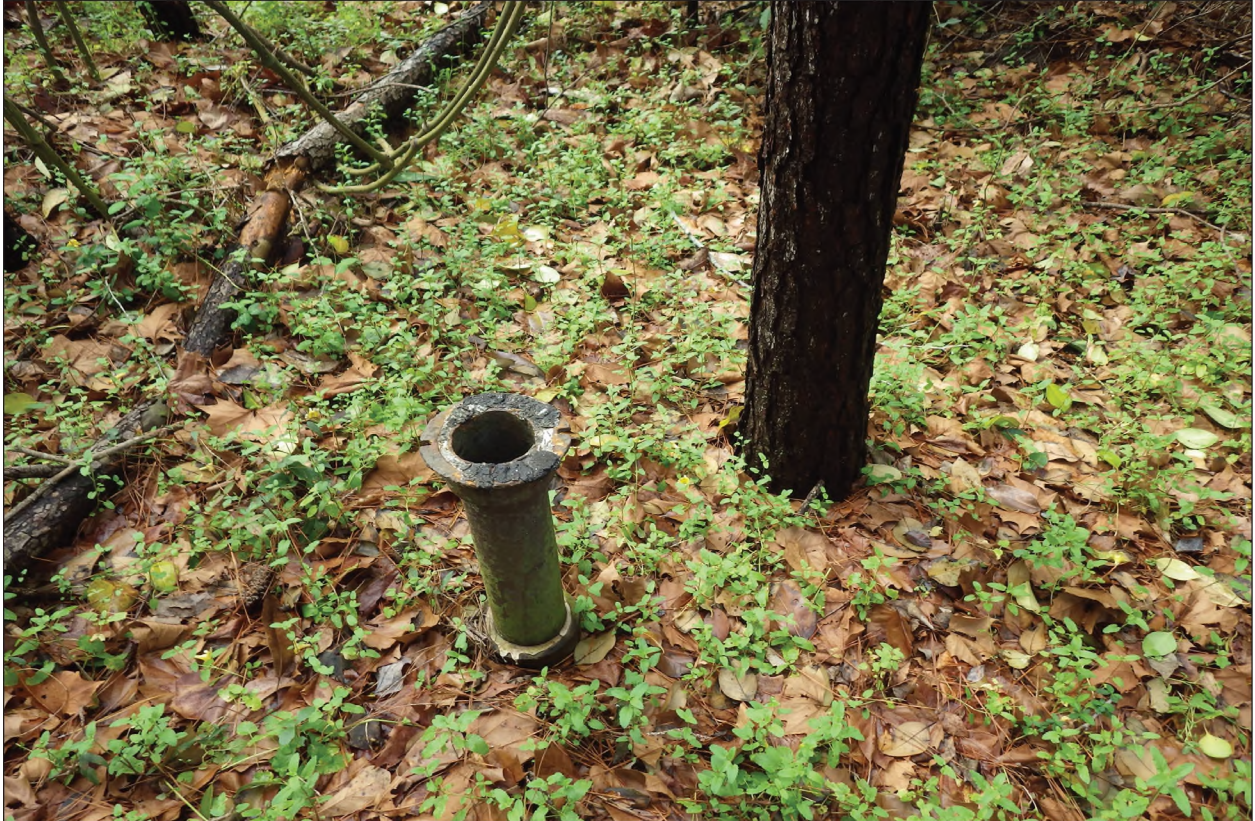
Figure 4.6 View of the iron pipe extending from the ground on the east side of 38HR614.

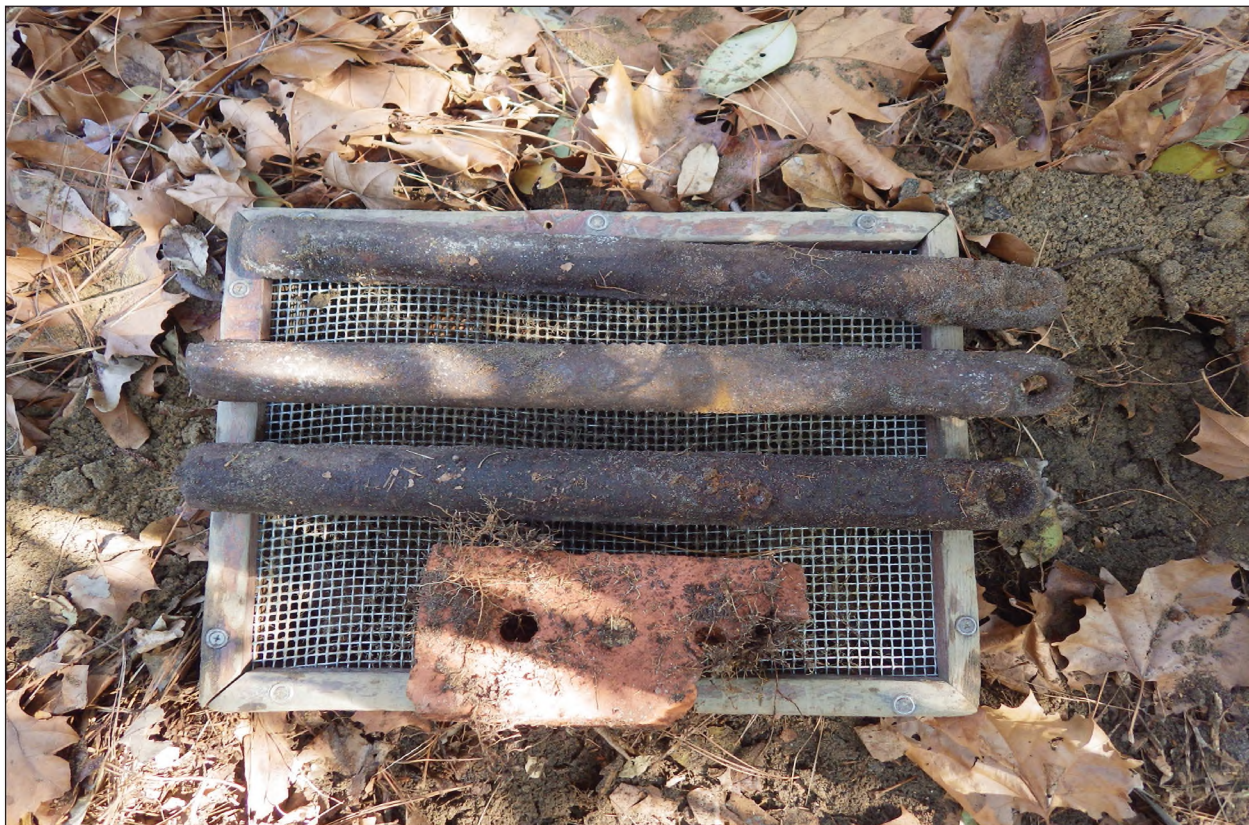
Figure 4.7 Artifacts (one brick and three iron window weights) observed on the ground surface near Provenience 2.0 at 38HR614.

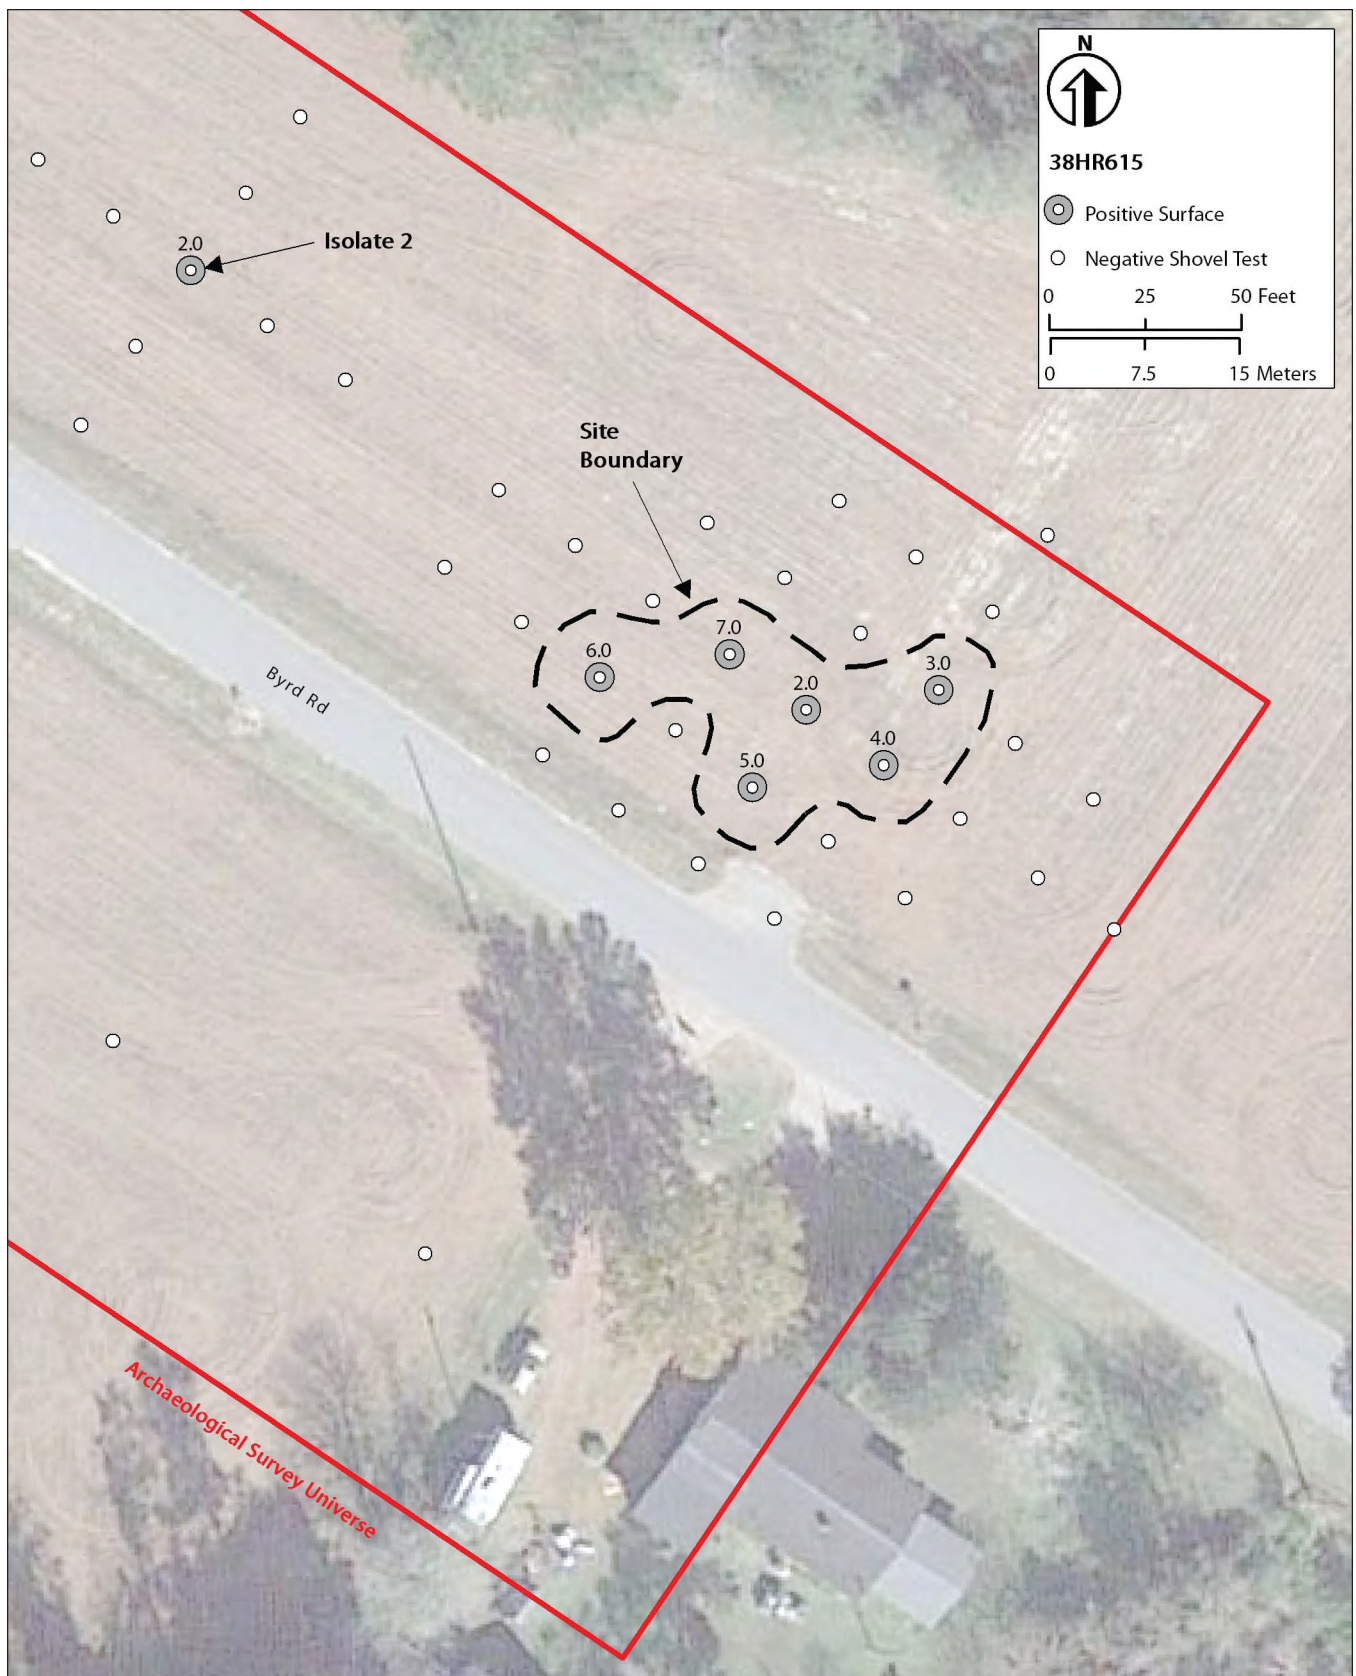
Figure 4.8 Site 38HR615 plan map.

We assessed 38HR615 for NRHP eligibility based on the criteria specified in Department of Interior Regulations 36 CFR Part 60: *National Register of Historic Places*. The site is not associated with events that have made a significant contribution to the broad pattern of history, or with significant persons or designs. Therefore, it is recommended ineligible under Criteria A, B, and C. We also assessed the site under Criterion D (*information potential*). Under Criterion D, an archaeological site must be able to generate data that can address specific research questions that are important in reconstructing or interpreting the past (Savage and Pope 1998). Late nineteenth- to early twentieth-century artifact scatters are common throughout the Southeast and this region of South Carolina. The low density of artifacts, lack of subsurface deposits, and overall disturbed nature of the site suggests that 38HR615 has limited potential to further contribute to our understanding of the history of Horry County. Therefore, it is recommended ineligible under Criterion D. Brockington recommends that

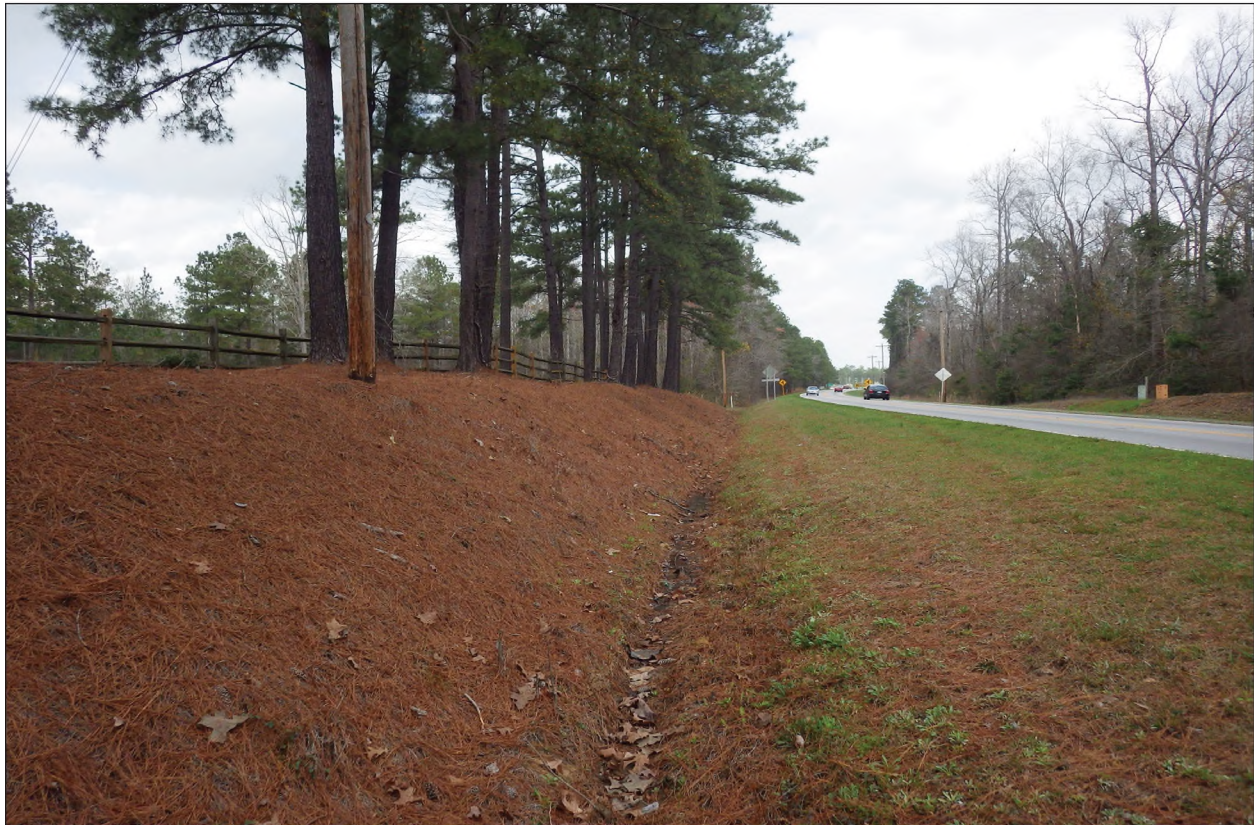
Figure 4.14 View of the steep grade between 38HR616 and US 701 North, facing northeast.

The site has been disturbed by agricultural use (e.g., plowing, mule pasture, etc.). Additionally, road construction and erosion have impacted the site. A steep grade to US 701 bounds the site to the east (see Figure 4.14). A scatter of broken, modern beer bottles was observed in the southwest portion of the site. This may indicate past or ongoing use of the

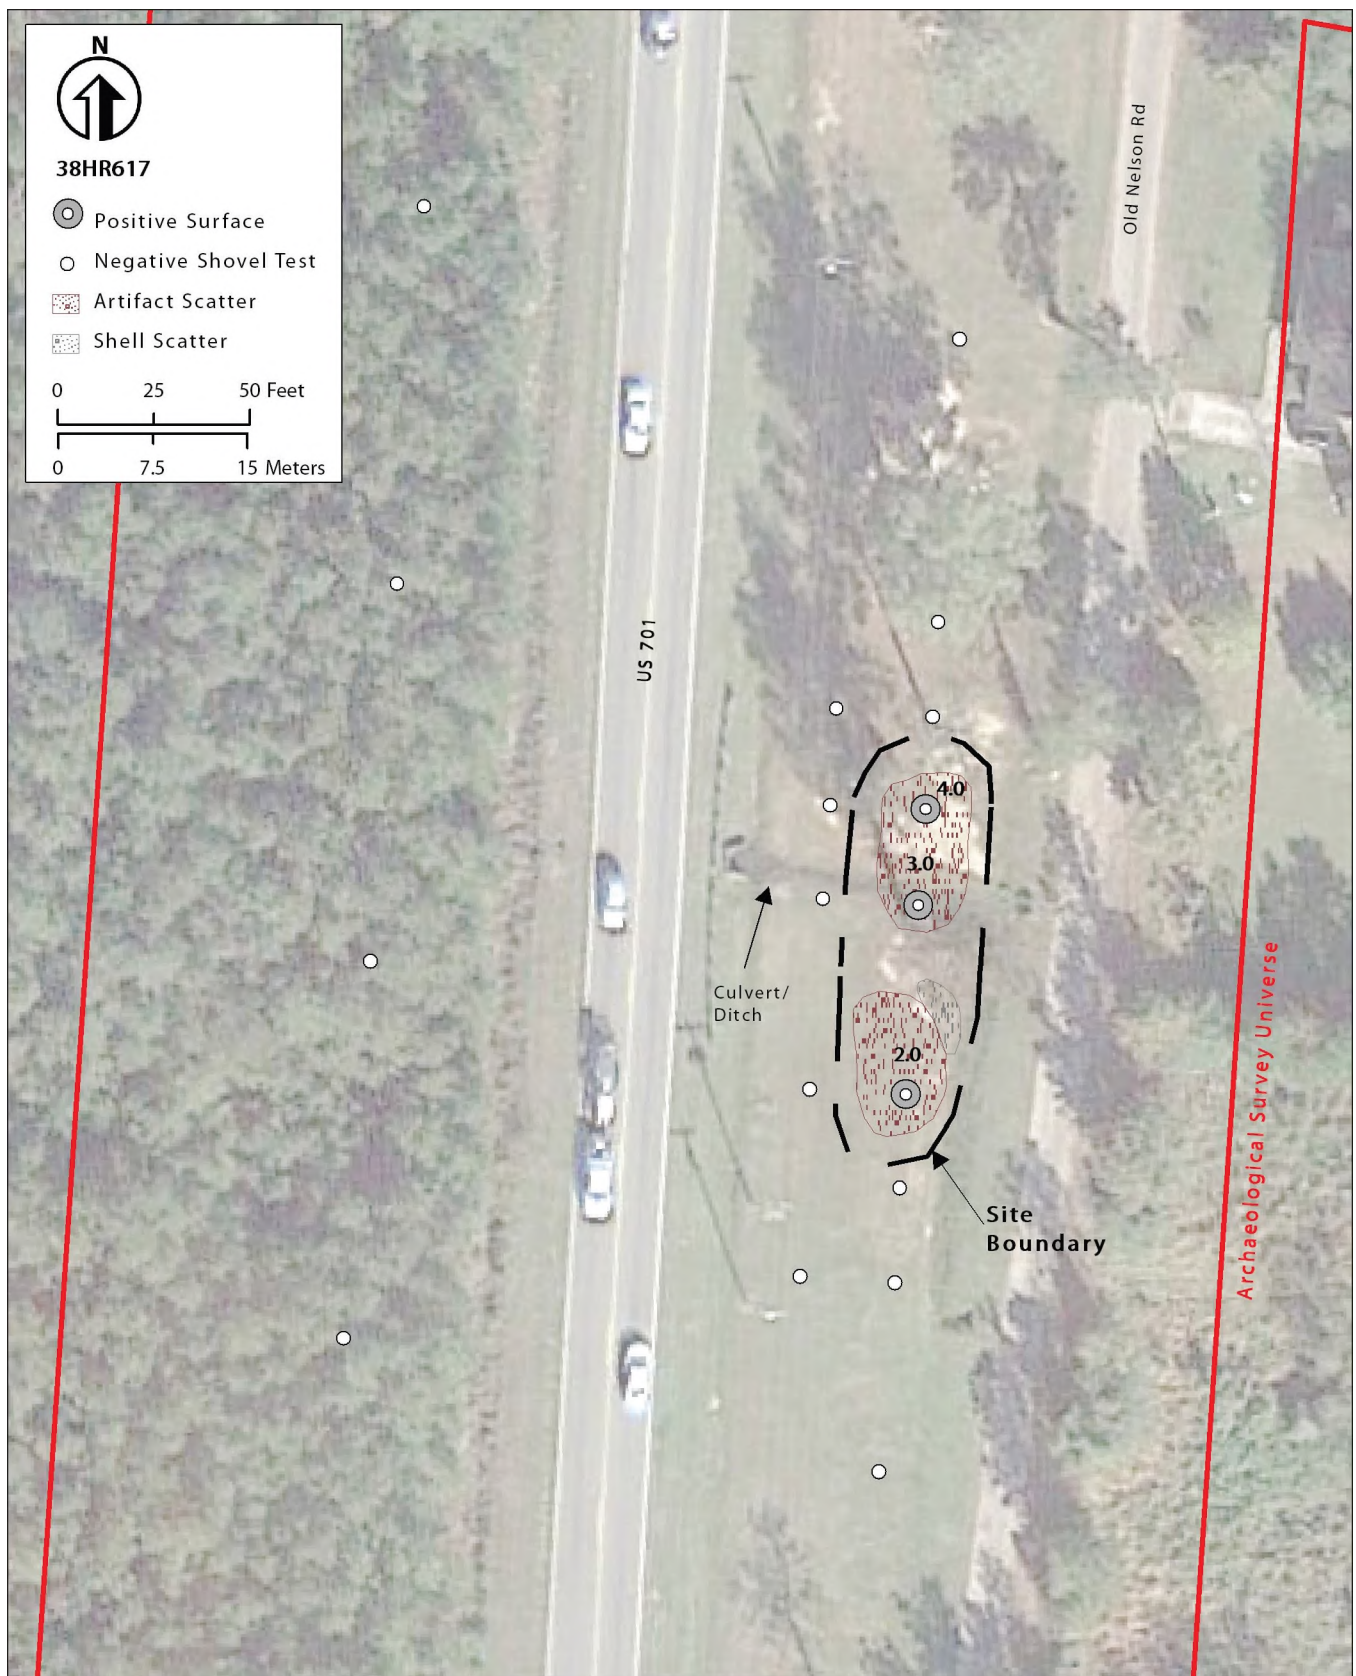
Figure 4.15 Site 38HR617 plan map.

Site 38HR617 consists of a surface scatter of Post-Contact artifacts located between US 701 and Old Nelson Road, just south of Hair Nook Road in Horry County (see Figures 1.2 and 2.4). The site is positioned on a modified terrace landform about 200 m northwest of an unnamed tributary of Grier Swamp. Nearby vegetation consists of grass and two hardwood trees; surface visibility is good (approximately 75 percent). Figure 4.15 presents a plan of 38HR617. Typical views of the site are shown in Figures 4.16 and 4.17.

The site contains two larger oak trees and a concentration of oyster shell. However, these features are likely coincidental. The site has been considerably disturbed by road construction and use, excavation of drainage ditches, and culvert construction. Soils are so disturbed that the artifacts were likely deposited in fill soil from an unknown location. The landform is also very eroded. We also observed some modern trash (i.e., plastic wrappers, aluminum can, modern beer bottles, etc.) across the surface of the site.

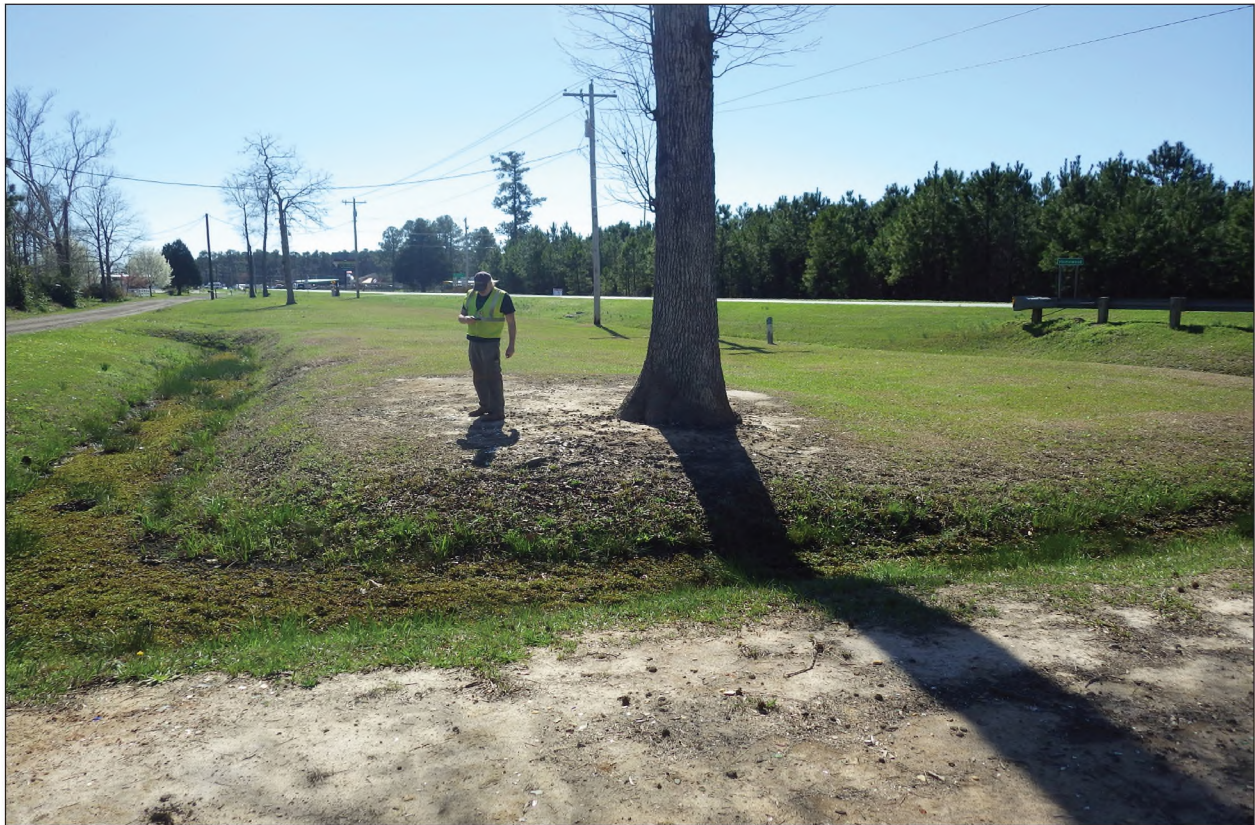
Figure 4.16 View of 38HR617, facing south across the drainage ditch. Brockington field archaeologist, John O'Donnell collects representative artifacts from the surface scatter.

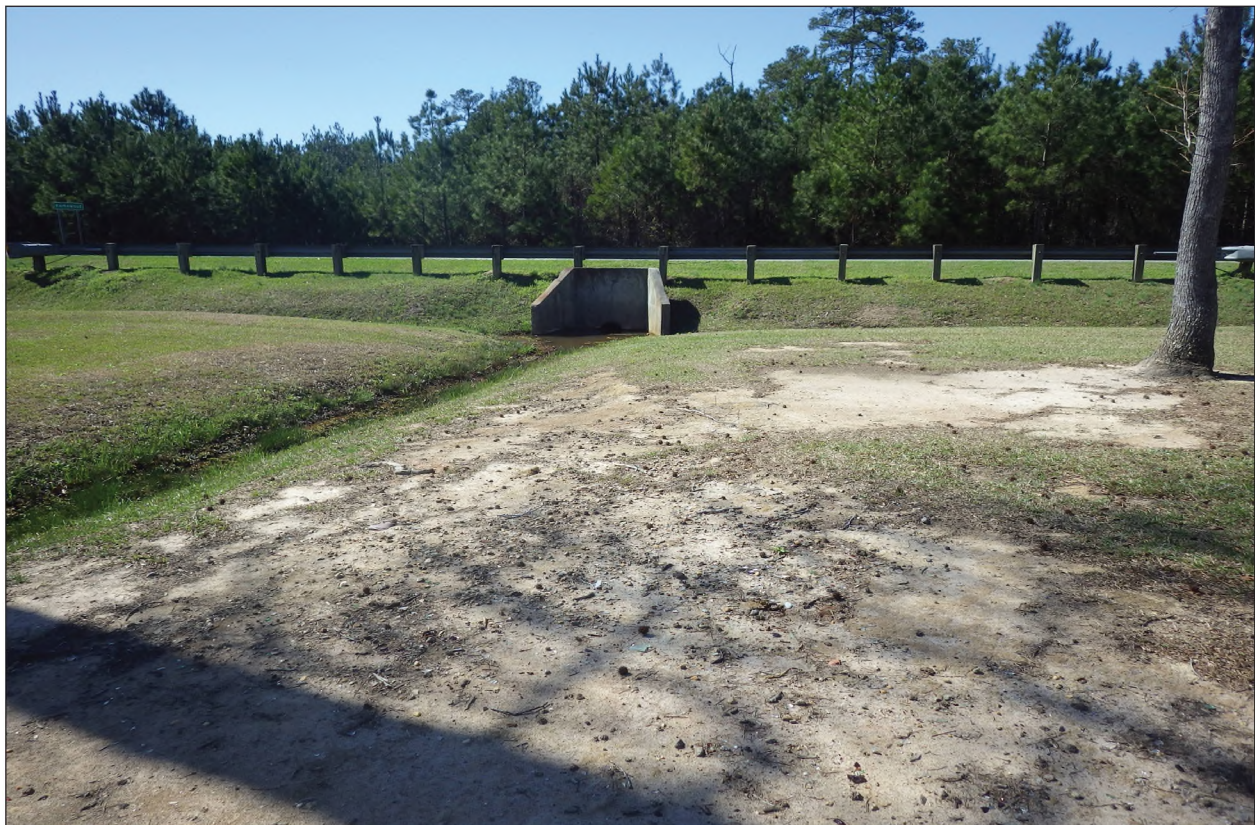
Figure 4.17 View from 38HR617, facing west southwest toward a culvert under US 701 North.

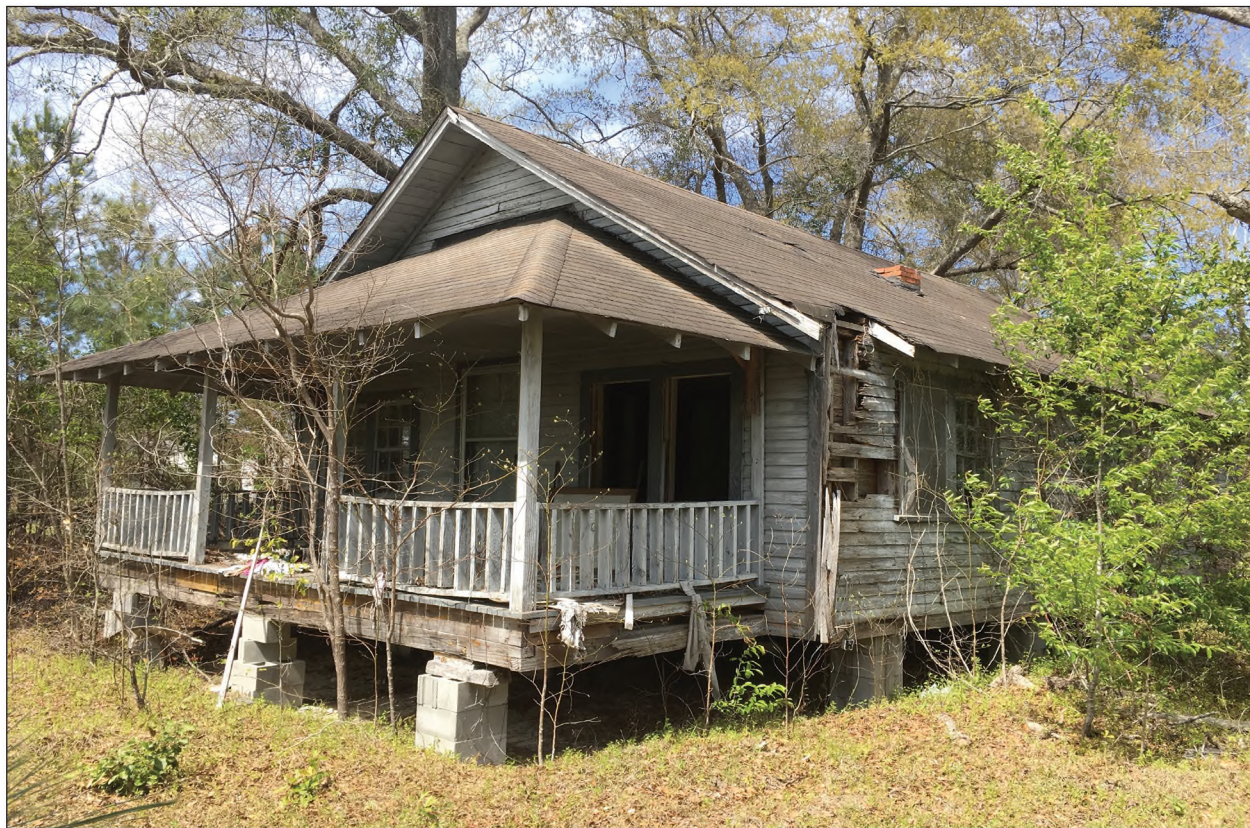
Carolina SHPO, the building is a typical example of early twentieth-century vernacular residential architecture in the area, and it is in poor structural condition. During background research, we identified no events or people that would qualify the resource for inclusion under Criteria A (*events*) or B (*people*). Due to the absence and poor condition of architectural materials, the resource exhibits a low level of integrity and does not embody the distinctive characteristics of its type, period, or method of construction, and thus does not qualify under Criterion C (*architecture*). There is no known potential for the resource to qualify under Criterion D (*information potential*). Resource 004 0215 remains ineligible for the NRHP.

Figure 4.22 Resource 004 0215, facing northwest.

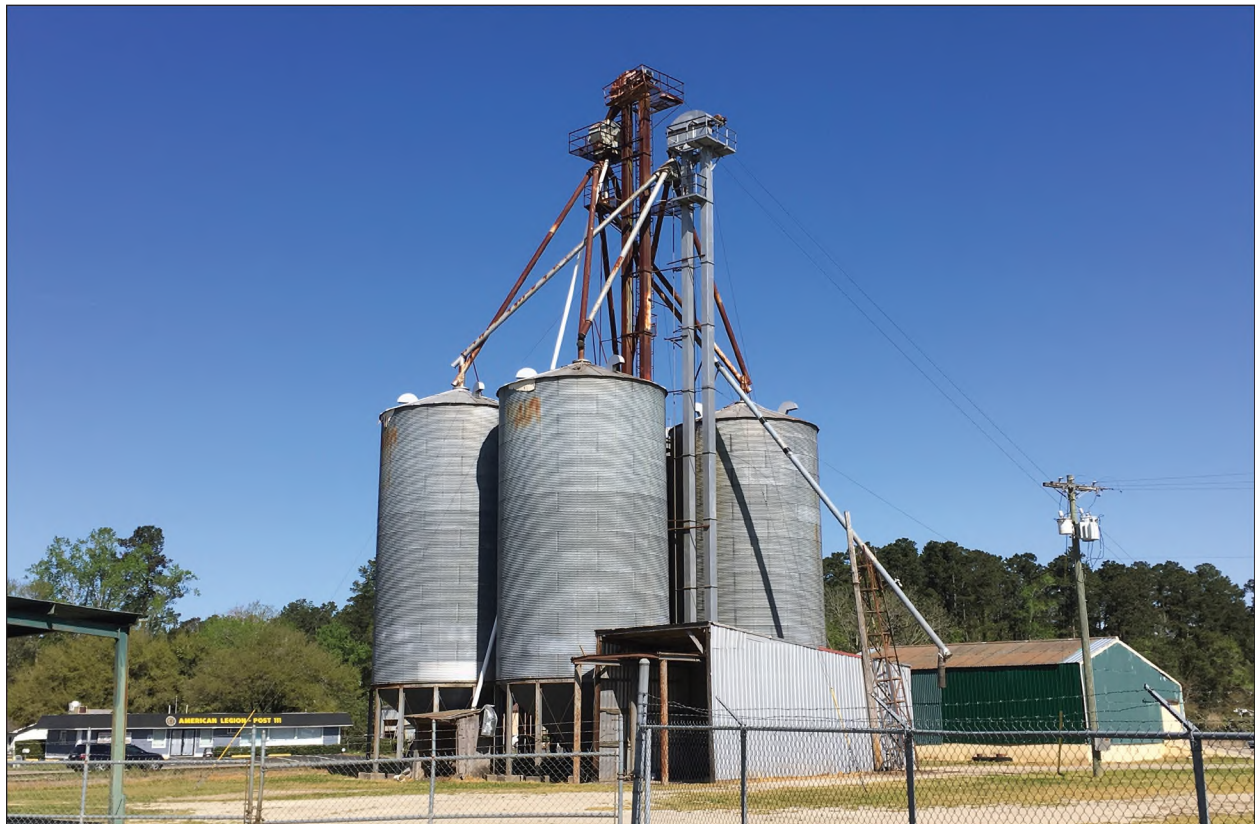
not qualify under Criterion C (*architecture*). There is no known potential for the resource to qualify under Criterion D (*information potential*). Resource 3313 remains ineligible for the NRHP.

Figure 4.23 Resource 3313, facing east.

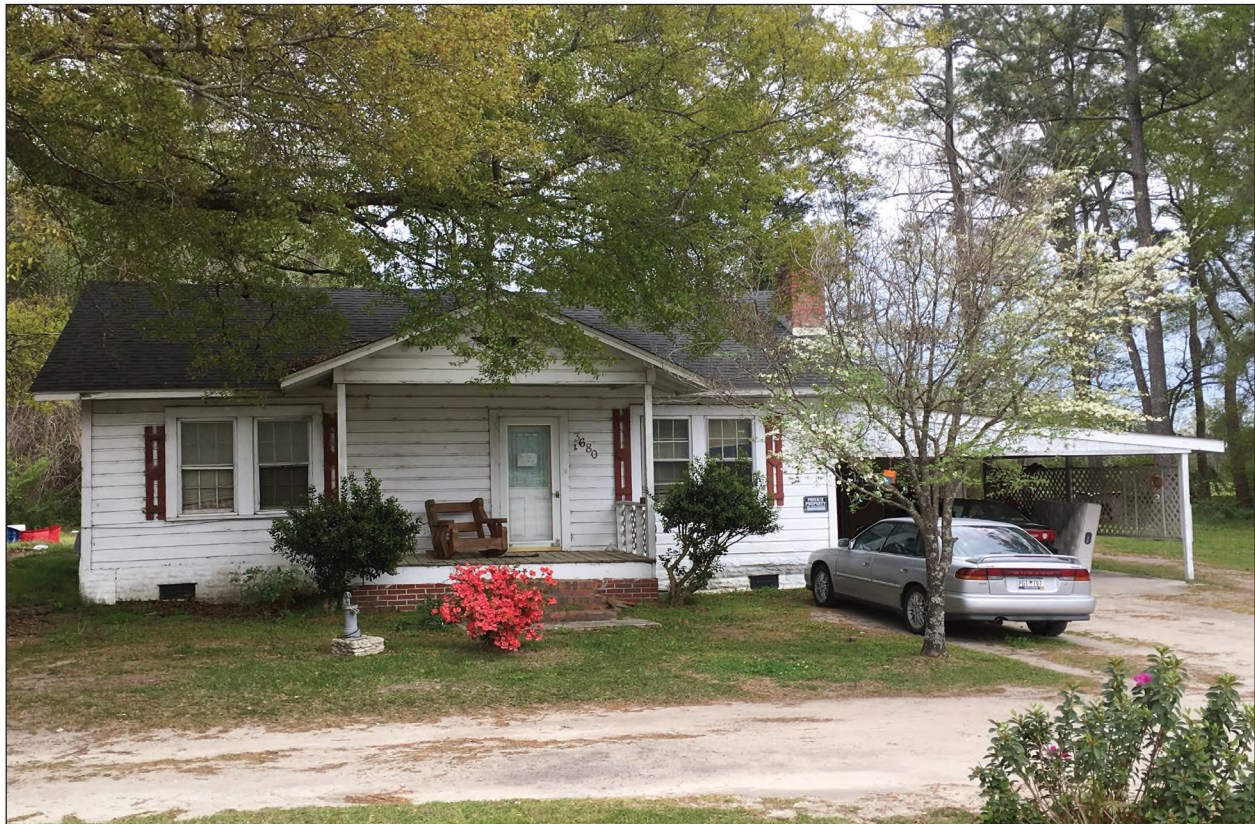
area and it is in poor structural condition. During background research, we identified no events or people that would qualify the resource for inclusion under Criteria A (*events*) or B (*people*). The resource exhibits a moderate degree of integrity and does not embody the distinctive characteristics of its type, period, or method of construction. It does not qualify under Criterion C (*architecture*). There is no known potential for the resource to qualify under Criterion D (*information potential*). Resource 3315 remains ineligible for the NRHP.

Figure 4.24 Resource 3315, facing east.

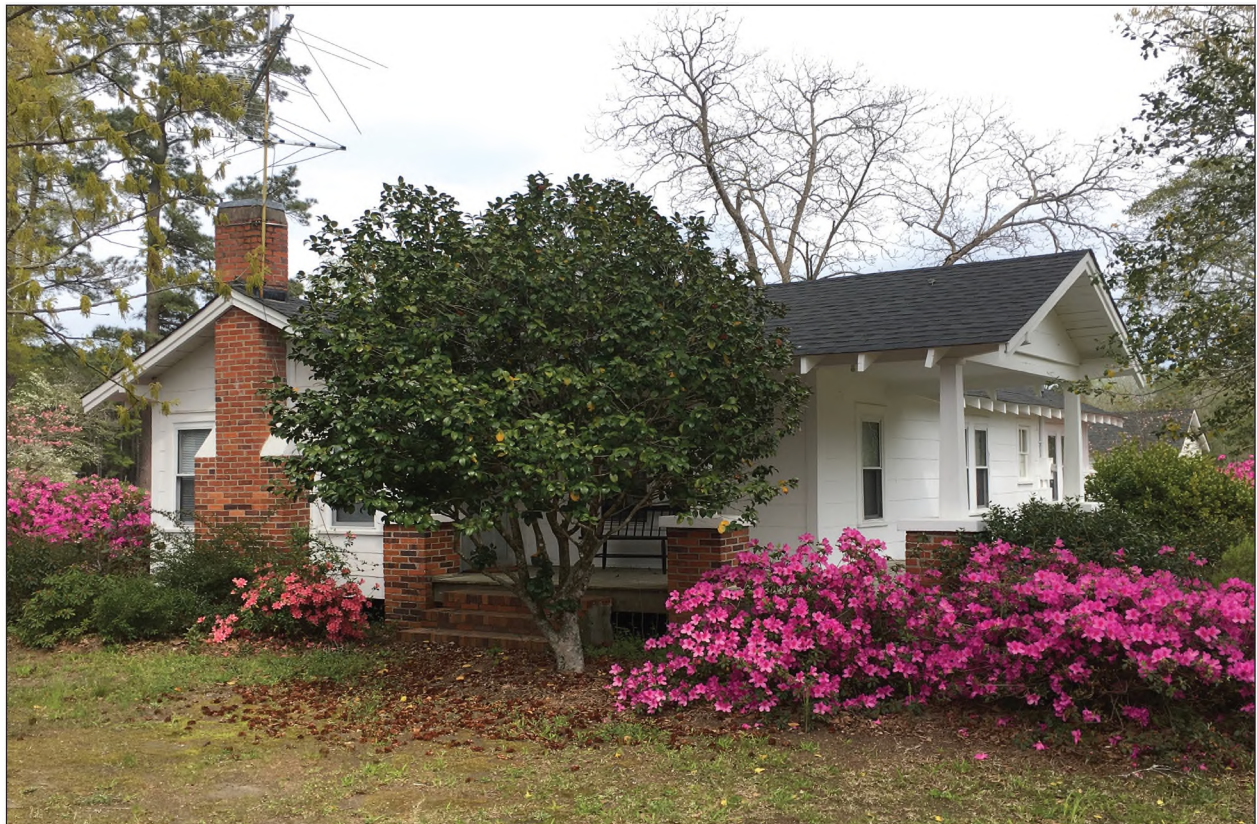
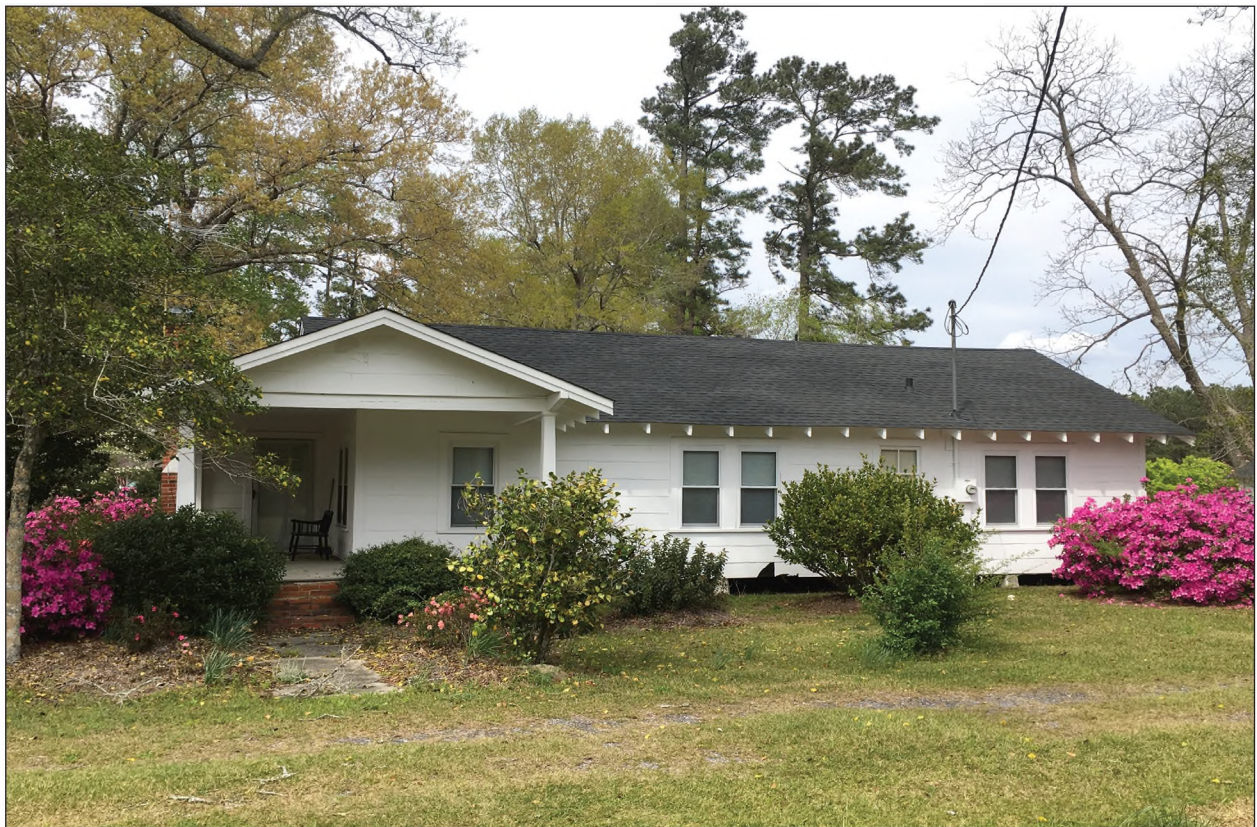
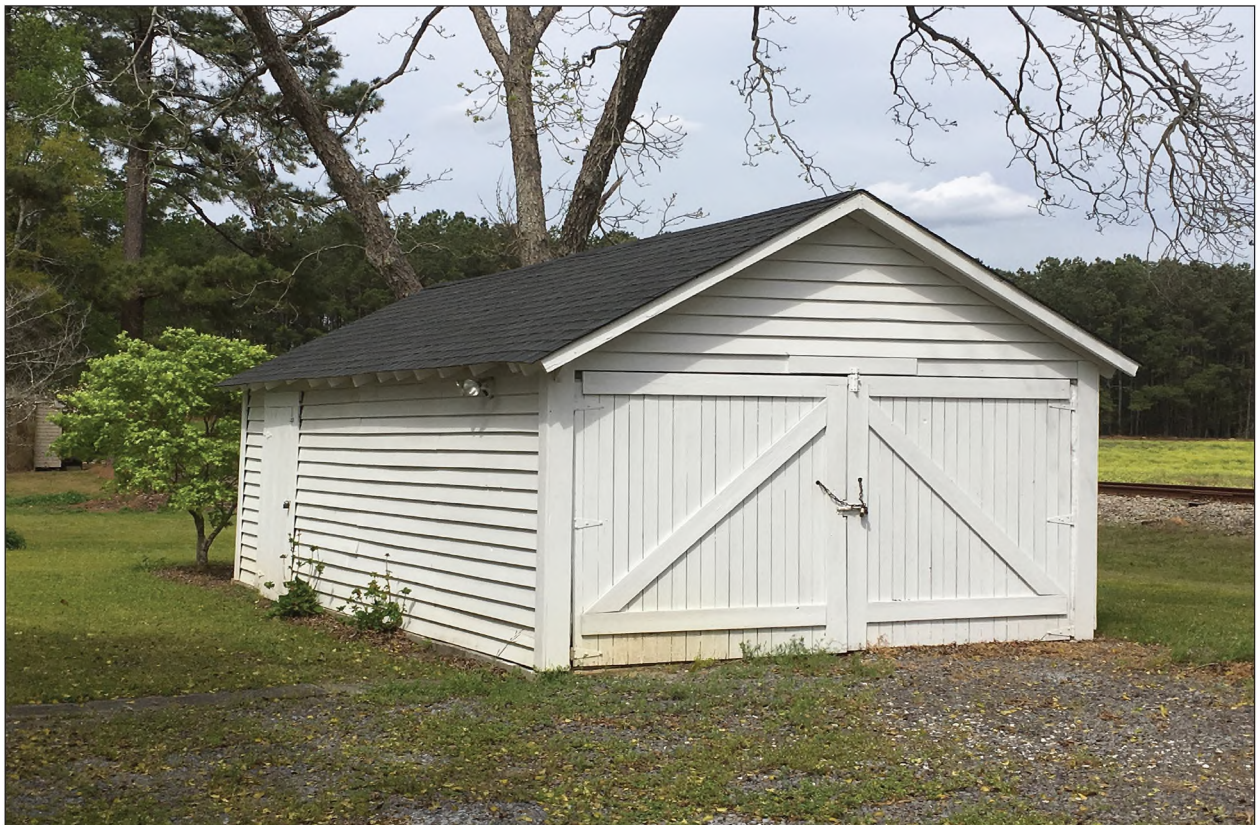
We reviewed the NRHP eligibility of Resources 3316 and 3316.01 with respect to Criteria A-D (see Section 2.6). Originally determined ineligible by the South Carolina SHPO, the property is a typical example of early twentieth-century vernacular residential architecture in the area. During background research, we identified no events or people that would qualify the resource for inclusion under Criteria A (*events*) or B (*people*). The resource lacks integrity due to alterations, such as the replacement of original windows with incompatible replacements. The building represents a common architectural type that does not possess historical or architectural significance and thus does not qualify under Criterion C (*architecture*). There is no known potential for the resource to qualify under Criterion D (*information potential*). Resources 3316 and 3316.01 are not eligible for the NRHP.

Figure 4.25 Resource 3316, front oblique, facing northeast.

Figure 4.26 Resource 3316, side elevation, facing north.

Figure 4.27 Resource 3316.01, garage, facing northeast.
