Cultural Resources Survey of the US 701 North Widening Project

Horry County, South Carolina

SCDOT PIN P031789

Final Report

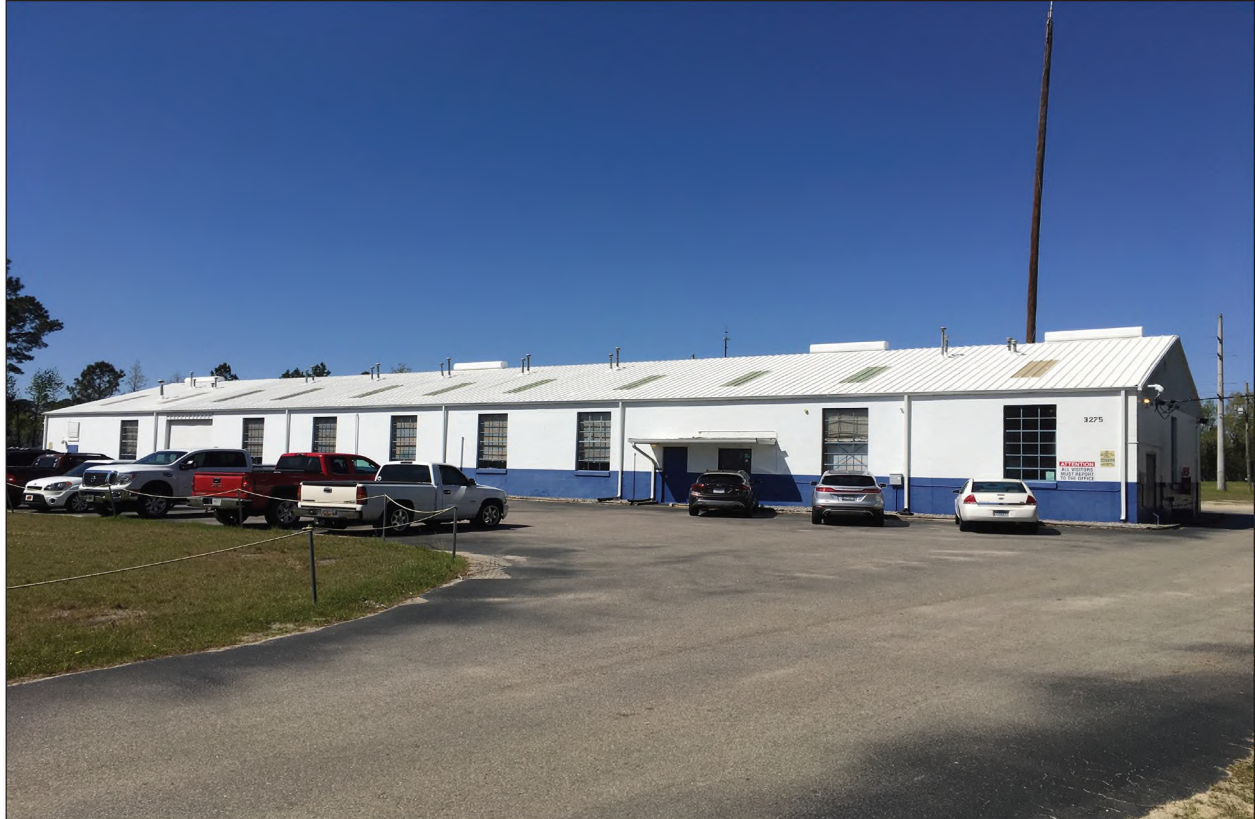
Figure 4.28 Resource 3318, facing west.

We reviewed the NRHP eligibility of Resource 3318 with respect to Criteria A-D (see Section 2.6). Originally determined ineligible by the South Carolina SHPO, the building is an example of mid-twentieth-century utilitarian architecture and was designed for functionality. During background research, we identified no events or people that would qualify the resource for inclusion under Criteria A (*events*) or B (*people*). It does not embody

the distinctive characteristics of its type, period, or method of construction, and thus does not qualify under Criterion C (*architecture*). There is no known potential for the resource to qualify under Criterion D (*information potential*). Resource 3318 remains ineligible for the NRHP.

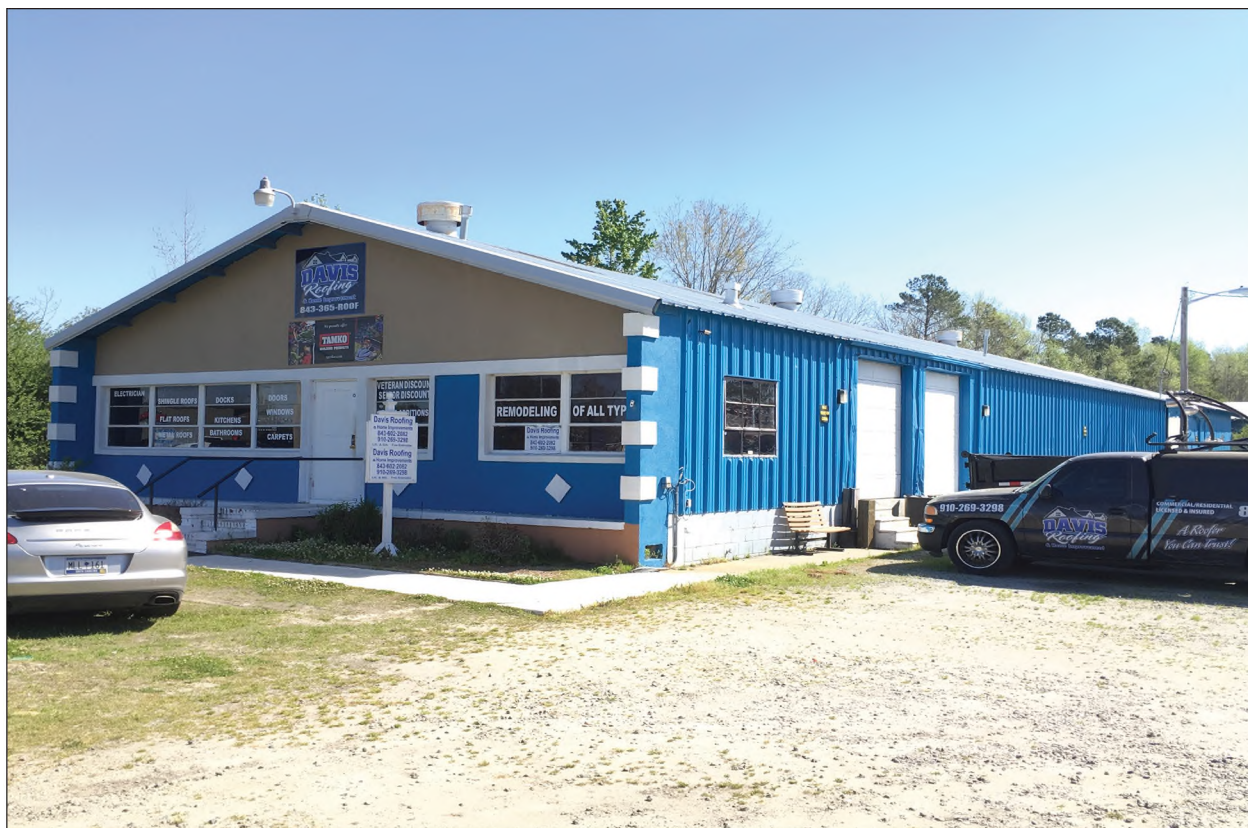
research, we identified no events or people that would qualify the resource for inclusion under Criteria A (*events*) or B (*people*). It does not embody the distinctive characteristics of its type, period, or method of construction and has been altered by the application of stucco on the façade, and thus does not qualify under Criterion C (*architecture*). There is no known potential for the resource to qualify under Criterion D (*information potential*). Resource 3319 remains ineligible for the NRHP.

Figure 4.29 Resource 3319, facing east.

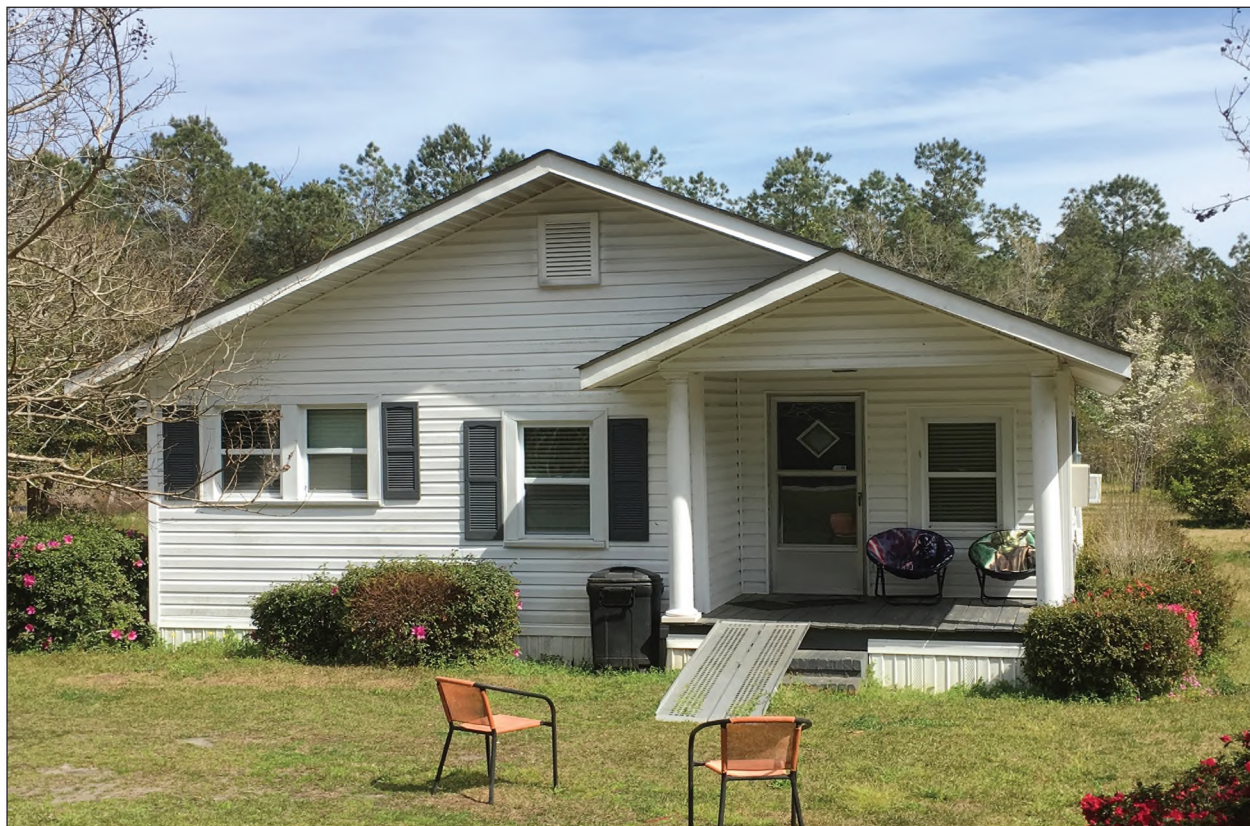
century vernacular residential architecture in the area. During background research, we identified no events or people that would qualify the resource for inclusion under Criteria A (*events*) or B (*people*). The resource exhibits a low level of integrity and does not embody the distinctive characteristics of its type, period, or method of construction, and thus does not qualify under Criterion C (*architecture*). There is no known potential for the resource to qualify under Criterion D (*information potential*). We recommend Resource 3801 not eligible for the NRHP.

Figure 4.30 Resource 3801, facing east.

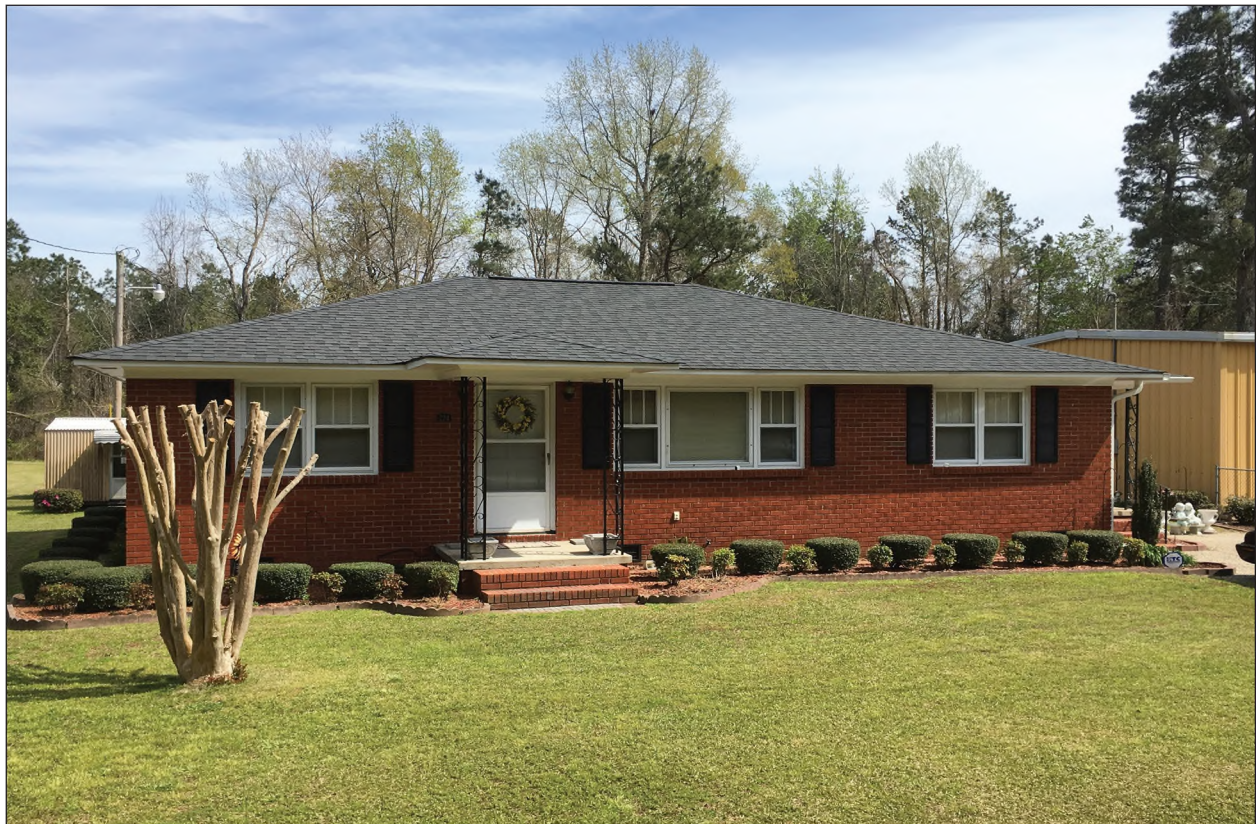
Although the resource maintains a high level of integrity, it represents a common form of mid-twentieth-century architecture and does not possess architectural significance and does not qualify under Criterion C (*architecture*). There is no known potential for the resource to qualify under Criterion D (*information potential*). We recommend Resource 3802 not eligible for the NRHP.

Figure 4.31 Resource 3802, facing east.

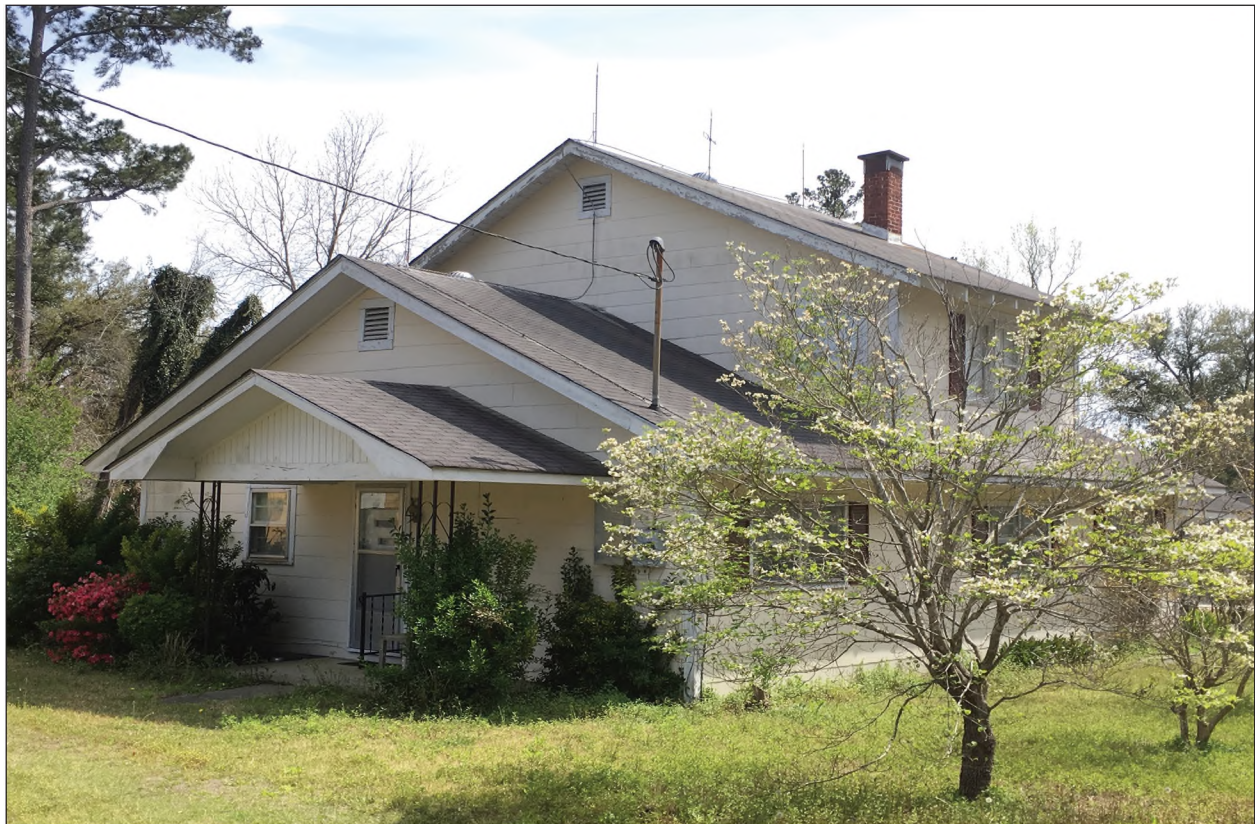
under Criteria A (*events*) or B (*people*). Although the resource maintains a moderate level of integrity, it does not possess architectural significance and does not qualify under Criterion C (*architecture*). There is no known potential for the resource to qualify under Criterion D (*information potential*). We recommend Resource 3803 not eligible for the NRHP.

Figure 4.32 Resource 3803, facing east.

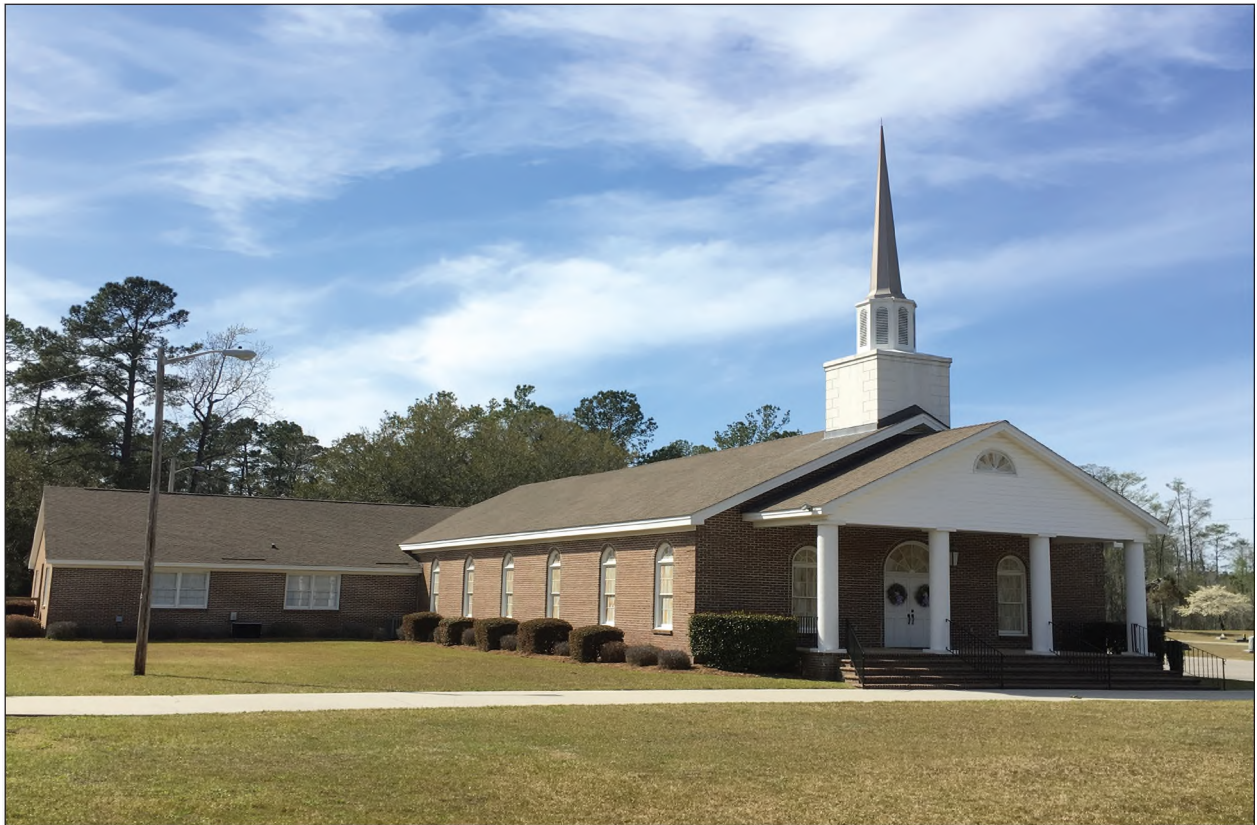
The present Poplar United Methodist Church (Resource 3805) replaced an earlier structure that dated to about 1905. This c1965 building features a temple-front design typical of mid-twentieth-century religious architecture, which is highlighted by the classical bell tower and steeple (Figure 4.33). The façade includes a front-facing gable sheathed in vinyl siding along with a stained-glass lunette. The porch consists of a masonry floor, steps, simple Doric columns, and an iron railing. The paired doors are set symmetrically to the façade and are capped with a lunette. Each of the stained glass eight-over-eight double-hung windows, present throughout the sanctuary, are also topped with lunettes and brick arches. Simple brick quoining decorates the building's front corners. Based on the appearance of the brickwork, the rear fellowship hall likely post-dates the sanctuary. This wing is set perpendicular to the sanctuary and includes a side-gabled roof and six-over-six wood windows.

Figure 4.33 Resource 3805, Poplar United Methodist Church, facing north.

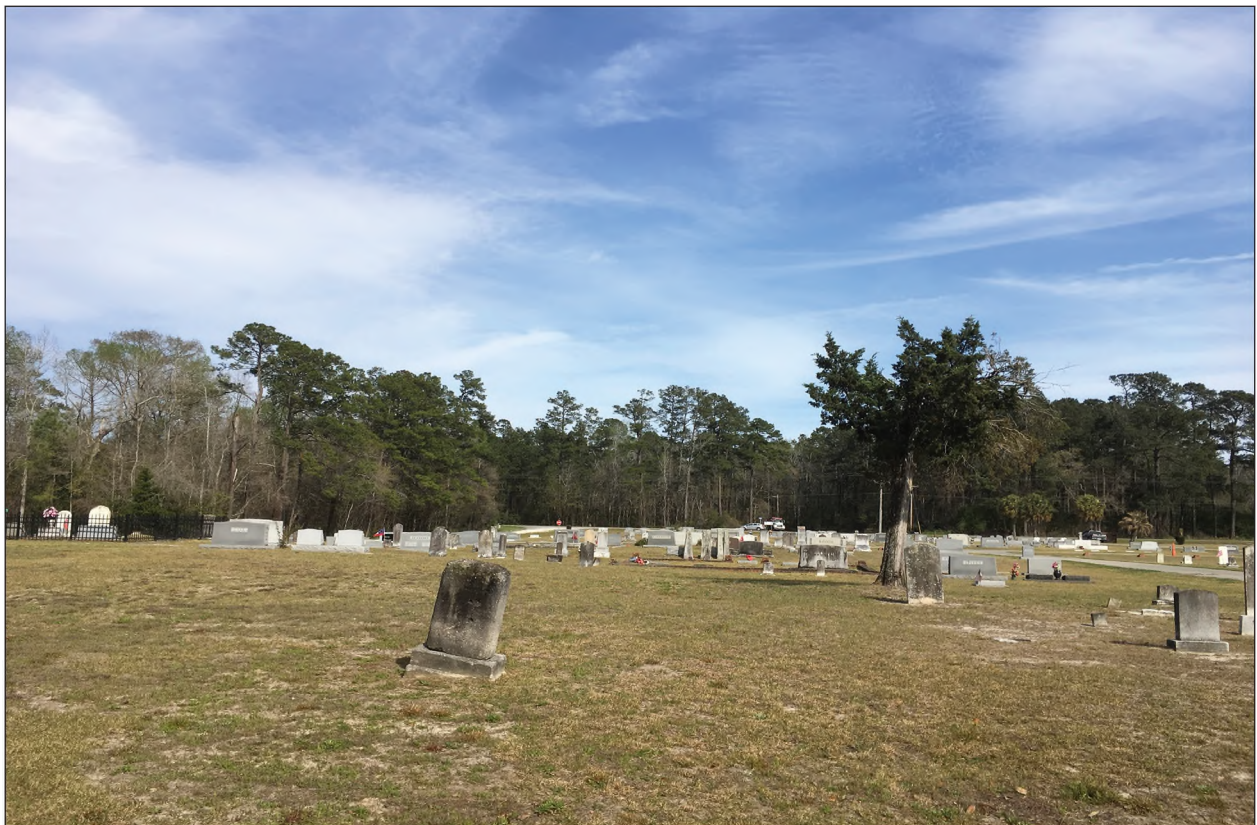
Figure 4.34 Resource 3804, Poplar Methodist Church Cemetery.

However, cemeteries are protected from disturbance and desecration under South Carolina state law (South Carolina Code of Laws 16-17-600). Resource 3804 should be preserved in place. The proposed project should be designed to avoid Resource 3804.

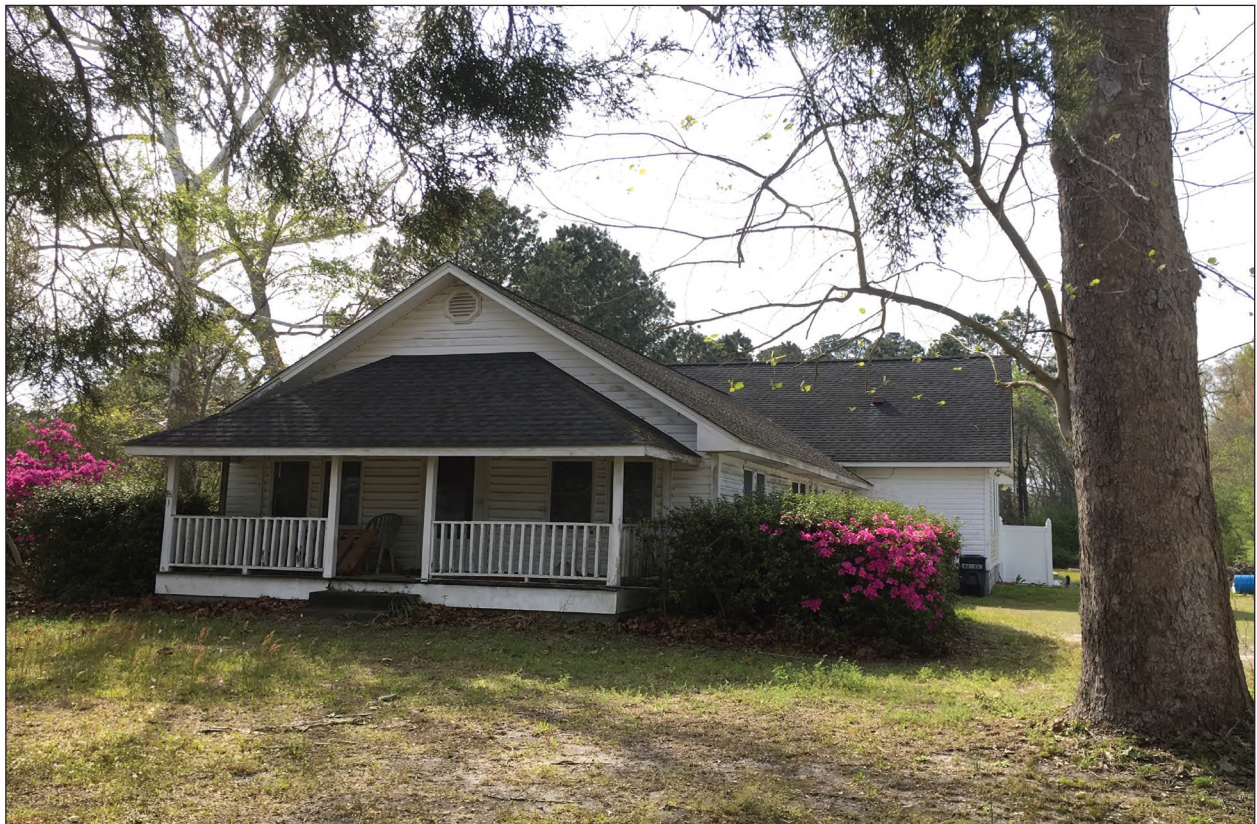
little of its historic fabric is visible. It does not possess architectural significance and does not qualify under Criterion C (*architecture*). There is no known potential for the resource to qualify under Criterion D (*information potential*). We recommend Resource 3806 not eligible for the NRHP.

Figure 4.35 Resource 3806, facing west.

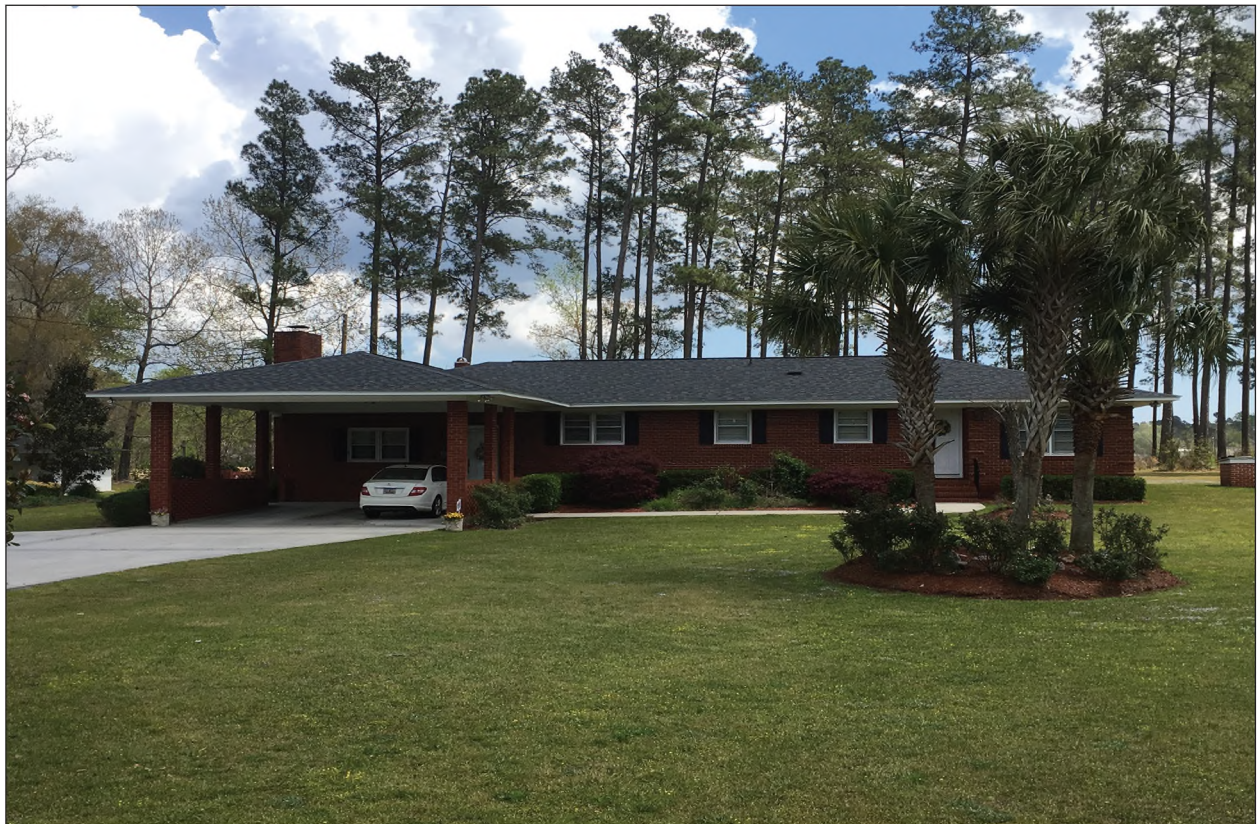
the resource maintains a high level of integrity, not unusual for mid-twentieth-century brick ranches, it represents a common form residential architecture and does not possess the architectural significance to qualify under Criterion C (*architecture*). There is no known potential for the resource to qualify under Criterion D (*information potential*). We recommend Resource 3807 not eligible for the NRHP.

Figure 4.36 Resource 3807, facing west.

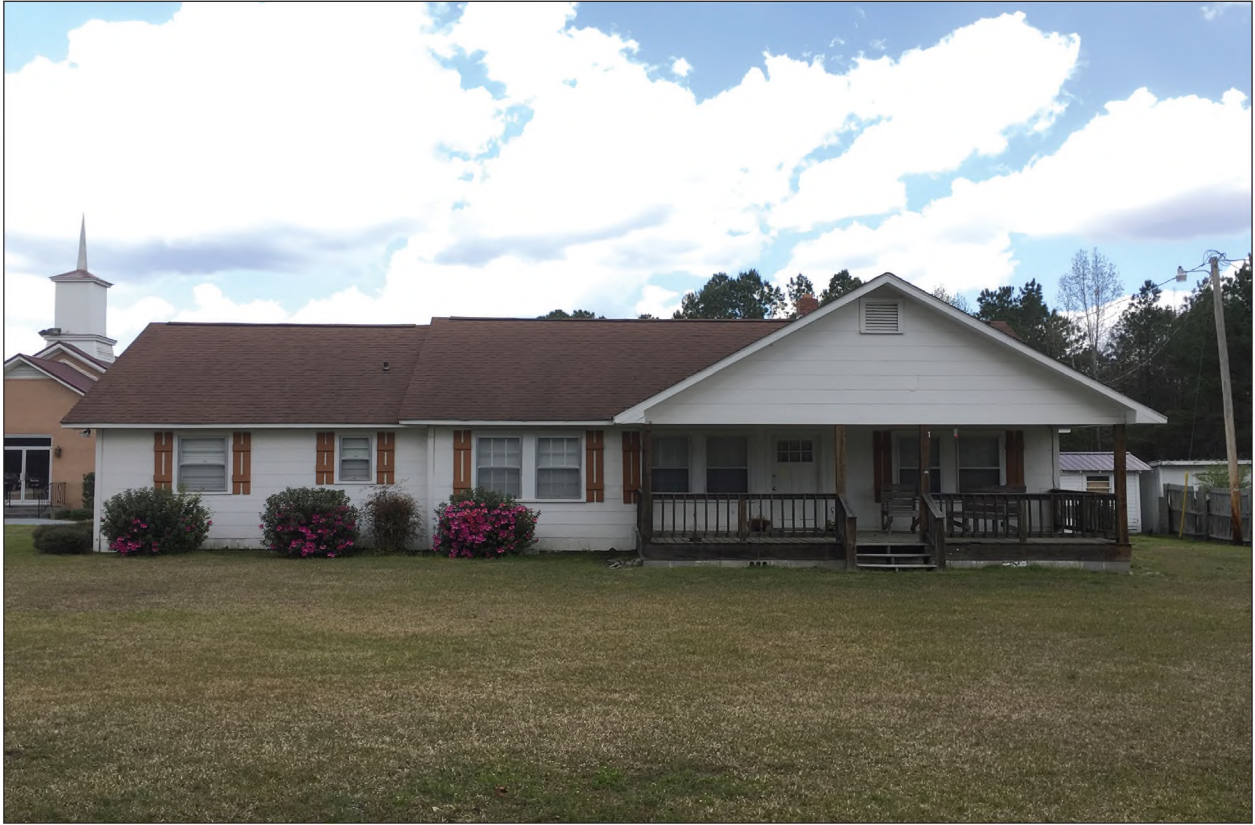
We assessed the NRHP eligibility of Resource 3808 with respect to Criteria A-D (see Section 2.6). The building is a typical vernacular example of the mid-twentieth-century residential architecture in the area. During background research, we identified no events or people that would qualify the resource for inclusion under Criteria A (*events*) or B (*people*). The resource retains a moderate level of integrity but does not represent a significant type of architecture and does not qualify under Criterion C (*architecture*). There is no known potential for the resource to qualify under Criterion D (*information potential*). We recommend Resource 3808 not eligible for the NRHP.

Figure 4.37 Resource 3808, facing west.

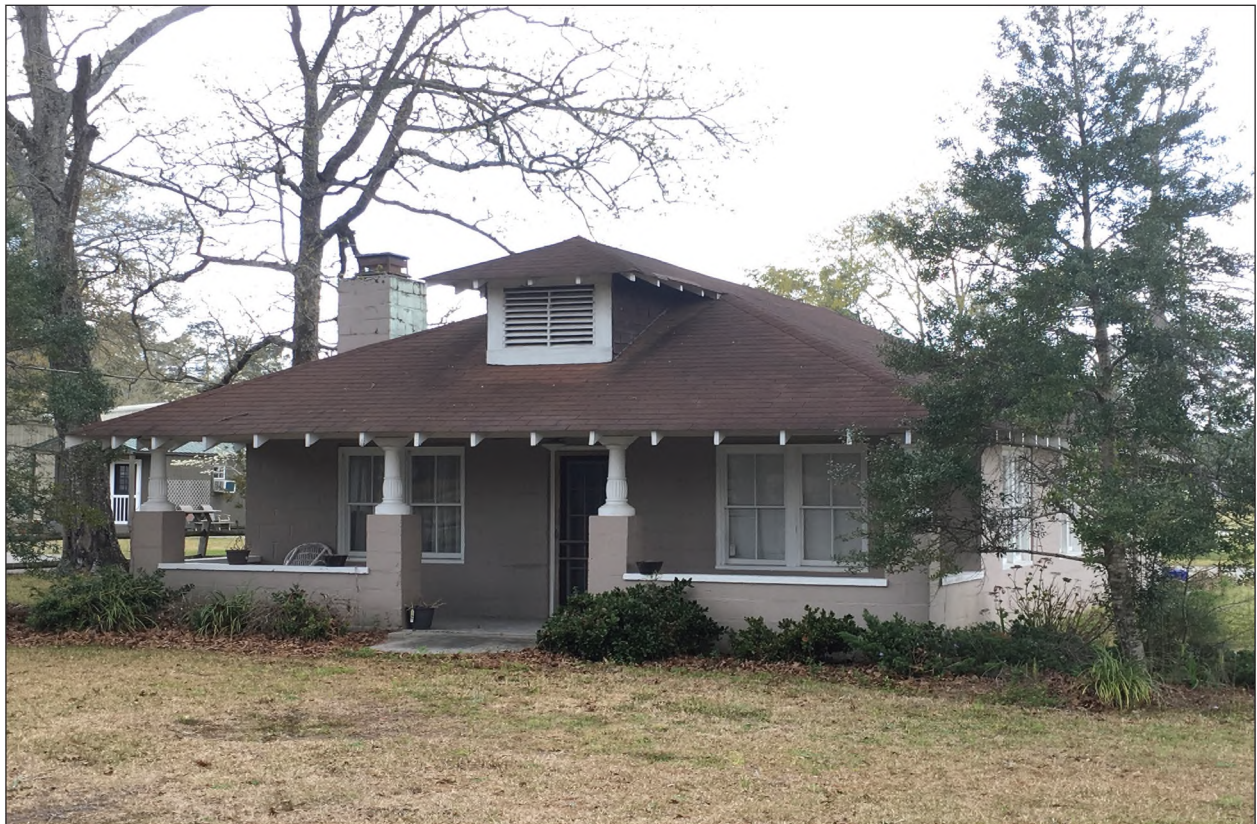
We assessed the NRHP eligibility of Resource 3809 with respect to Criteria A-D (see Section 2.6). The building is a typical example of the mid-twentieth-century residential architecture in the area. During background research, we identified no events or people that would qualify the resource for inclusion under Criteria A (*events*) or B (*people*). Although the resource maintains a high level of integrity, it represents a common form of mid-twentieth-century architecture and does not possess architectural significance. It does not qualify under Criterion C (*architecture*). There is no known potential for the resource to qualify under Criterion D (*information potential*). We recommend Resource 3809 not eligible for the NRHP.

Figure 4.39 Resource 3809, facing west.

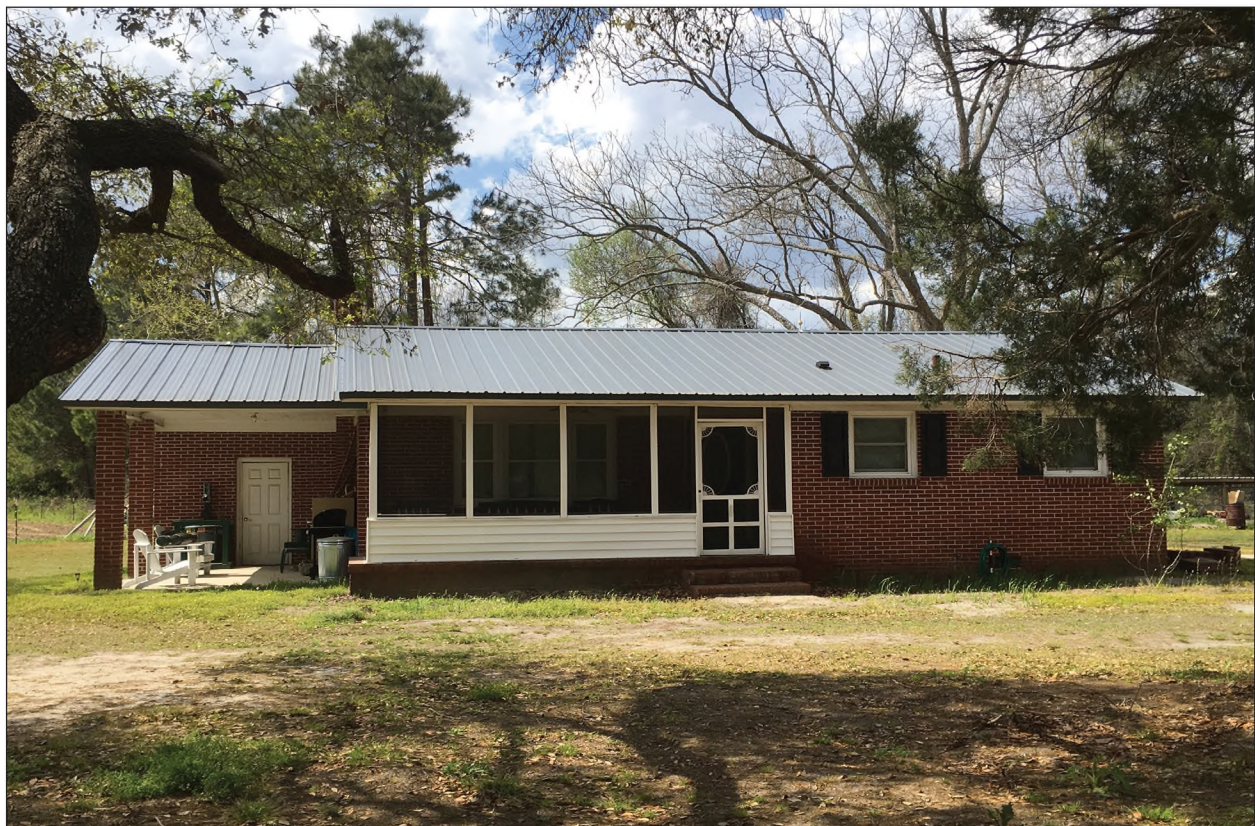
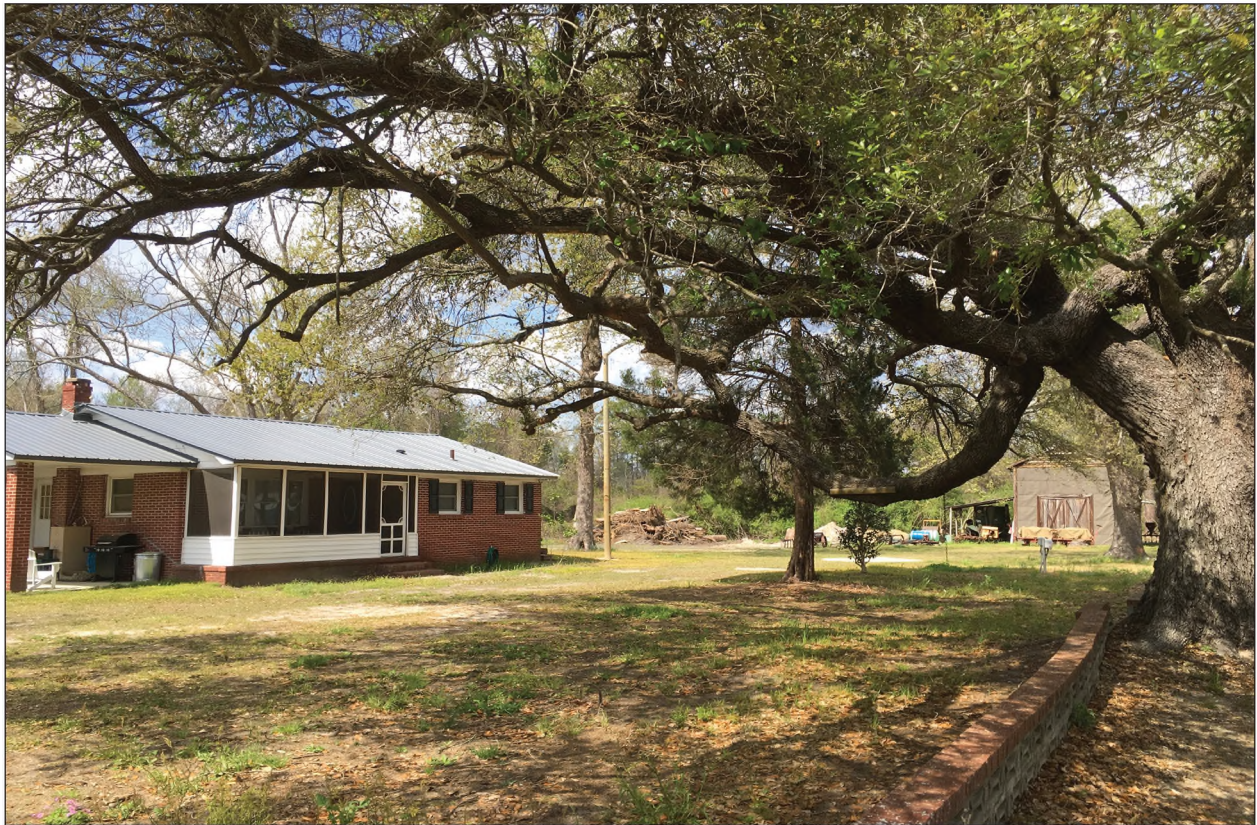
We assessed the NRHP eligibility of Resource 3810 with respect to Criteria A-D (see Section 2.6). The building is a typical example of the mid-twentieth-century residential ranch architecture in the area. During background research, we identified no events or people that would qualify the resource for inclusion under Criteria A (*events*) or B (*people*). Although the resource maintains a moderate level of integrity, it represents a common form of mid-twentieth-century architecture and does not possess architectural significance and does not qualify under Criterion C (*architecture*). There is no known potential for the resource to qualify under Criterion D (*information potential*). We recommend Resource 3810 not eligible for the NRHP.

Figure 4.40 Resource 3810, facing west.

Figure 4.41 Resource 3810 and yard, facing northwest.

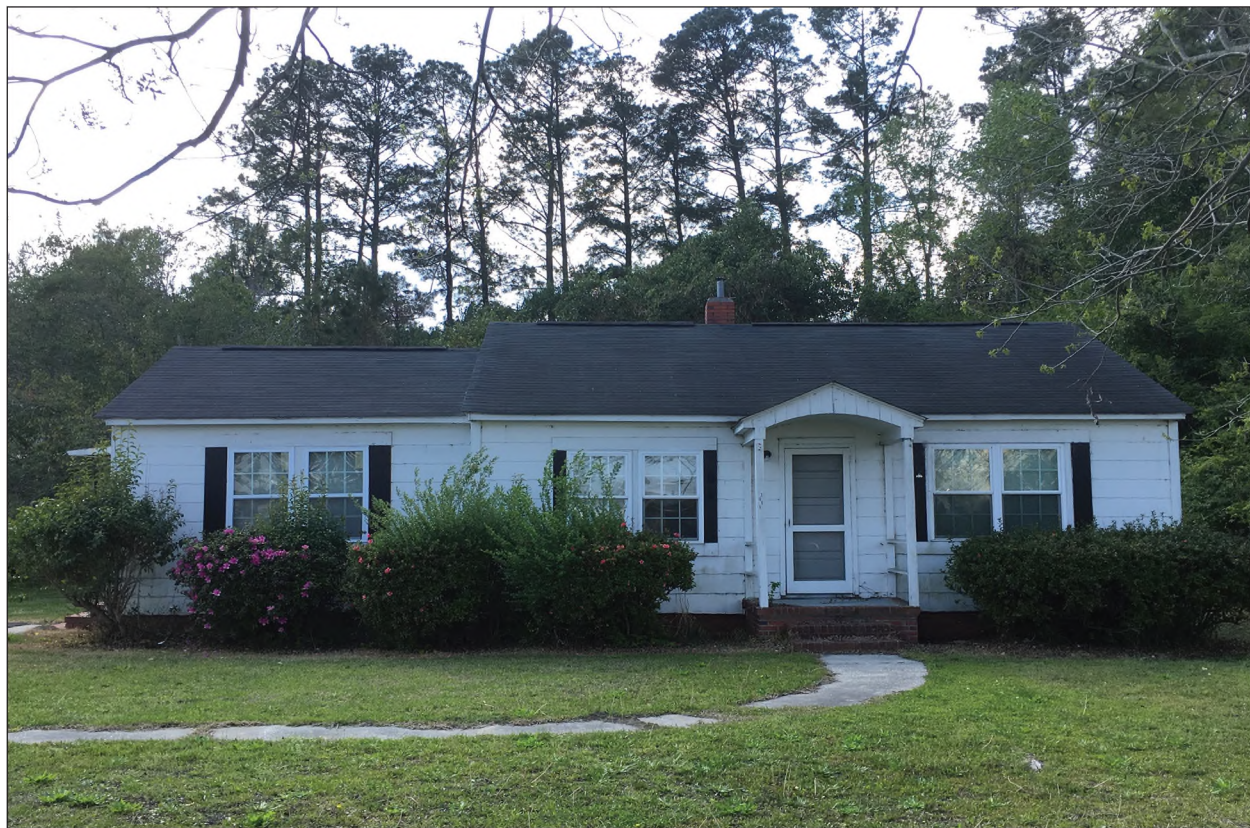
Figure 4.43 Resource 3811, facing west.

We assessed the NRHP eligibility of Resource 3811 with respect to Criteria A-D (see Section 2.6). The building is a typical example of the mid-twentieth-century residential ranch architecture in the area. During background research, we identified no events or people that would qualify the resource

for inclusion under Criteria A (*events*) or B (*people*). Although the resource maintains a moderate level of integrity, it represents a common form of mid-twentieth-century architecture. It does not possess architectural significance and does not qualify under Criterion C (*architecture*). There is no known potential for the resource to qualify under Criterion D (*information potential*). We recommend Resource 3811 not eligible for the NRHP.

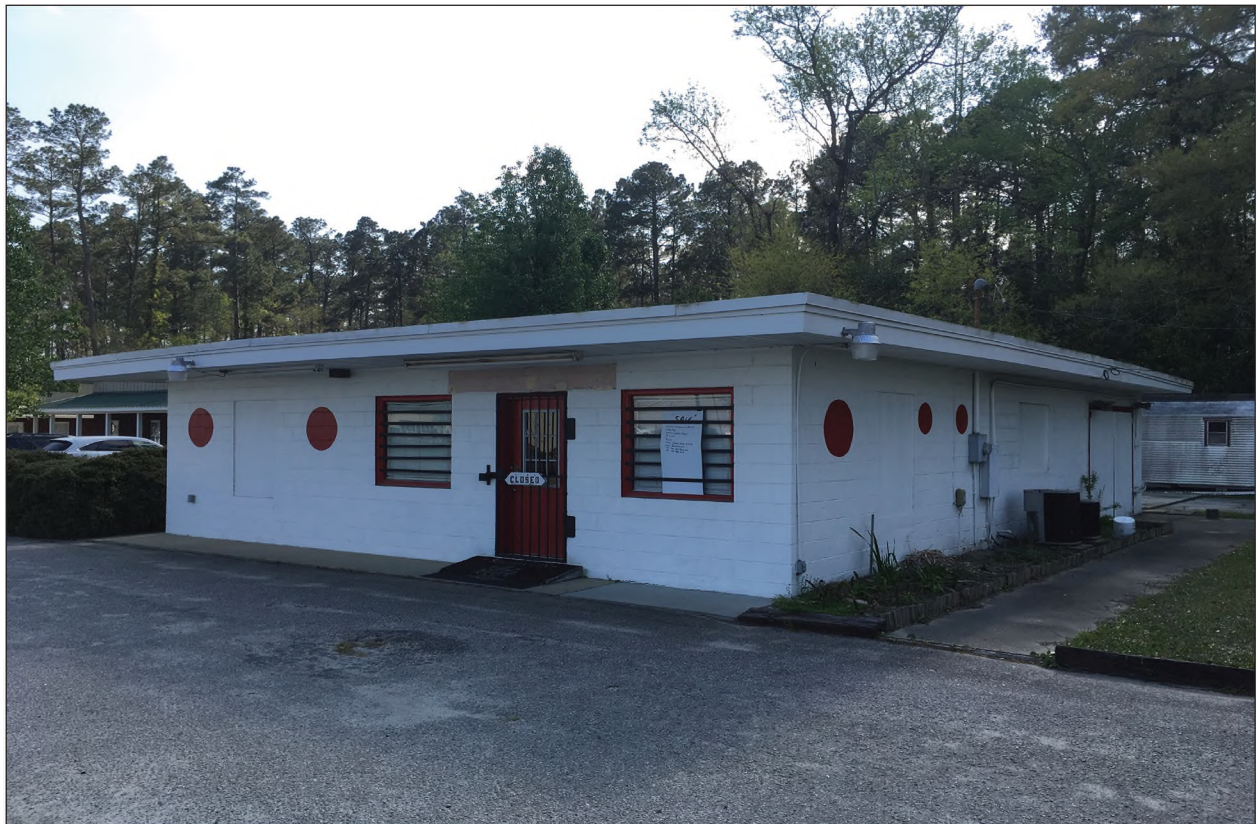
Figure 4.44 Resource 3812, facing southwest.

We assessed the NRHP eligibility of Resource 3812 with respect to Criteria A-D (see Section 2.6). The building is an example of mid-twentieth-century roadside commercial architecture commonly found throughout the region. During background research, we identified no events or people that would qualify the resource for inclusion under Criteria A (*events*) or B (*people*). Due to alterations, specifically the replace-

ment or enclosure of doors and windows, the building retains a low level of architectural integrity. Therefore, it conveys no architectural significance and does not qualify under Criterion C (*architecture*). There is no known potential for the resource to qualify under Criterion D (*information potential*). We recommend Resource 3812 not eligible for the NRHP.

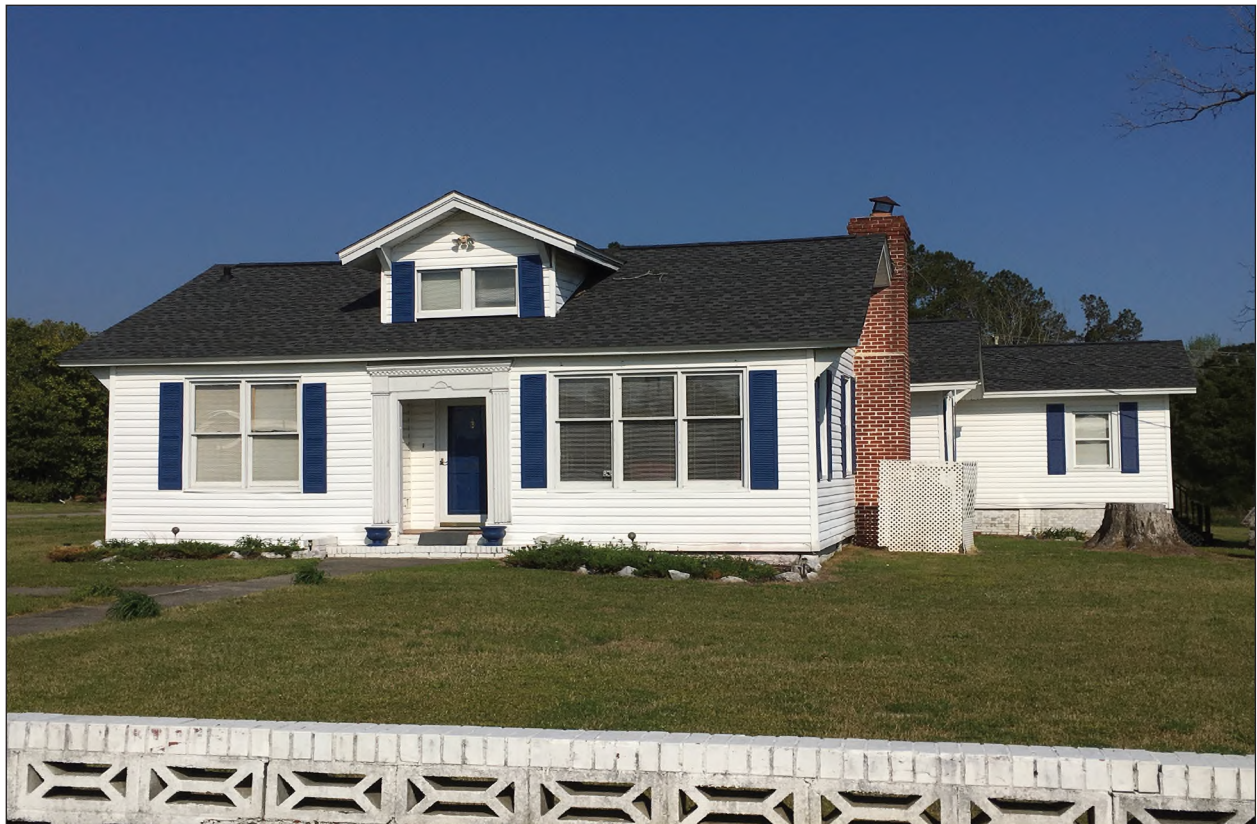
Figure 4.45 Resource 3813, facing east.

We assessed the NRHP eligibility of Resource 3813 with respect to Criteria A-D (see Section 2.6). The building represents a poor example of a common form of mid-twentieth-century residential ar-

chitecture in the area. During background research, we identified no events or people that would qualify the resource for inclusion under Criteria A (*events*) or B (*people*). The resource possesses very little of its historic fabric, does not possess architectural significance, and does not qualify under Criterion C (*architecture*). There is no known potential for the resource to qualify under Criterion D (*information potential*). We recommend Resource 3813 not eligible for the NRHP.

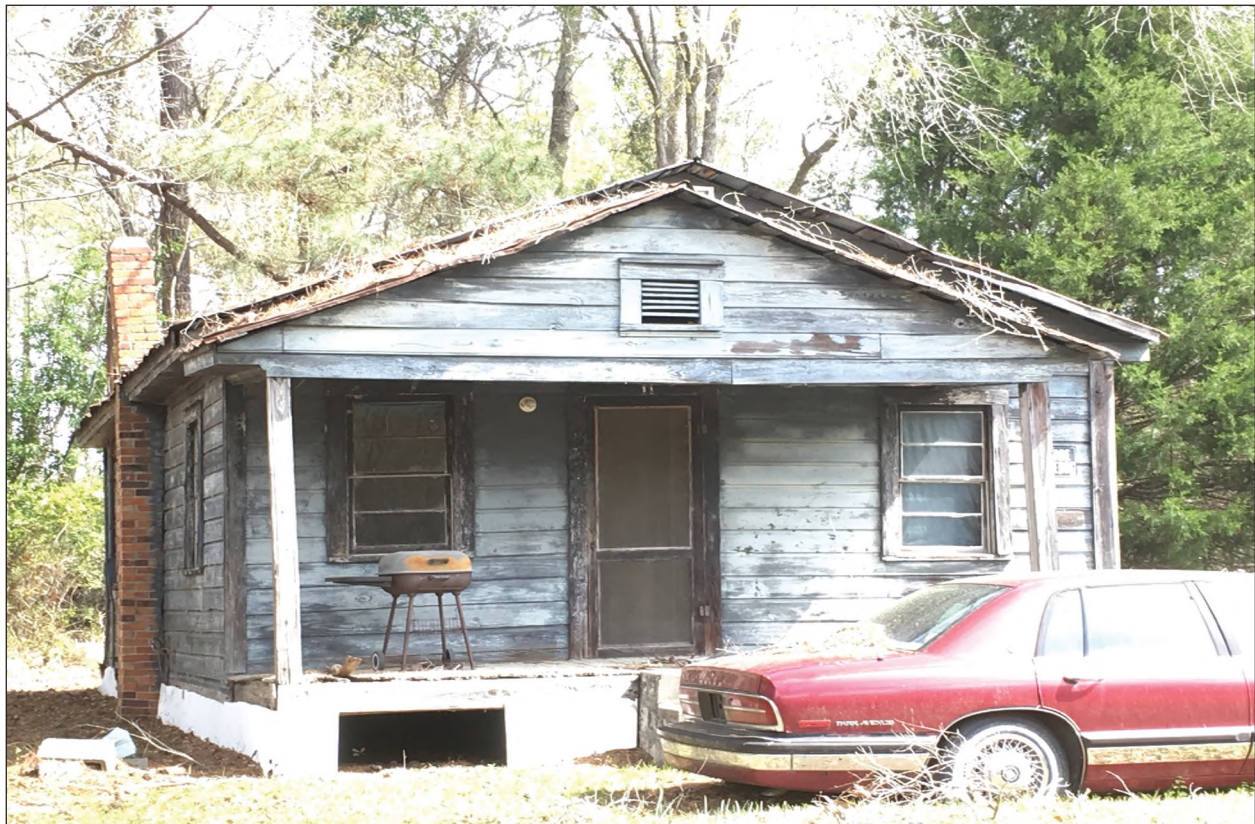
Figure 4.46 Resource 3814, facing north.

We assessed the NRHP eligibility of Resource 3814 with respect to Criteria A-D (see Section 2.6). The building is a typical example of the early to mid-twentieth-century residential architecture in the area. During background research, we identified no events or people that would qualify the resource for inclusion under Criteria A (*events*) or B (*people*). Although the resource maintains a moderate level of integrity, it represents a common form of period architecture and does not possess architectural

significance and, therefore, does not qualify under Criterion C (*architecture*). There is no known potential for the resource to qualify under Criterion D (*information potential*). We recommend Resource 3814 not eligible for the NRHP.
