Cultural Resources Survey of the US 701 North Widening Project

Horry County, South Carolina

SCDOT PIN P031789

Final Report

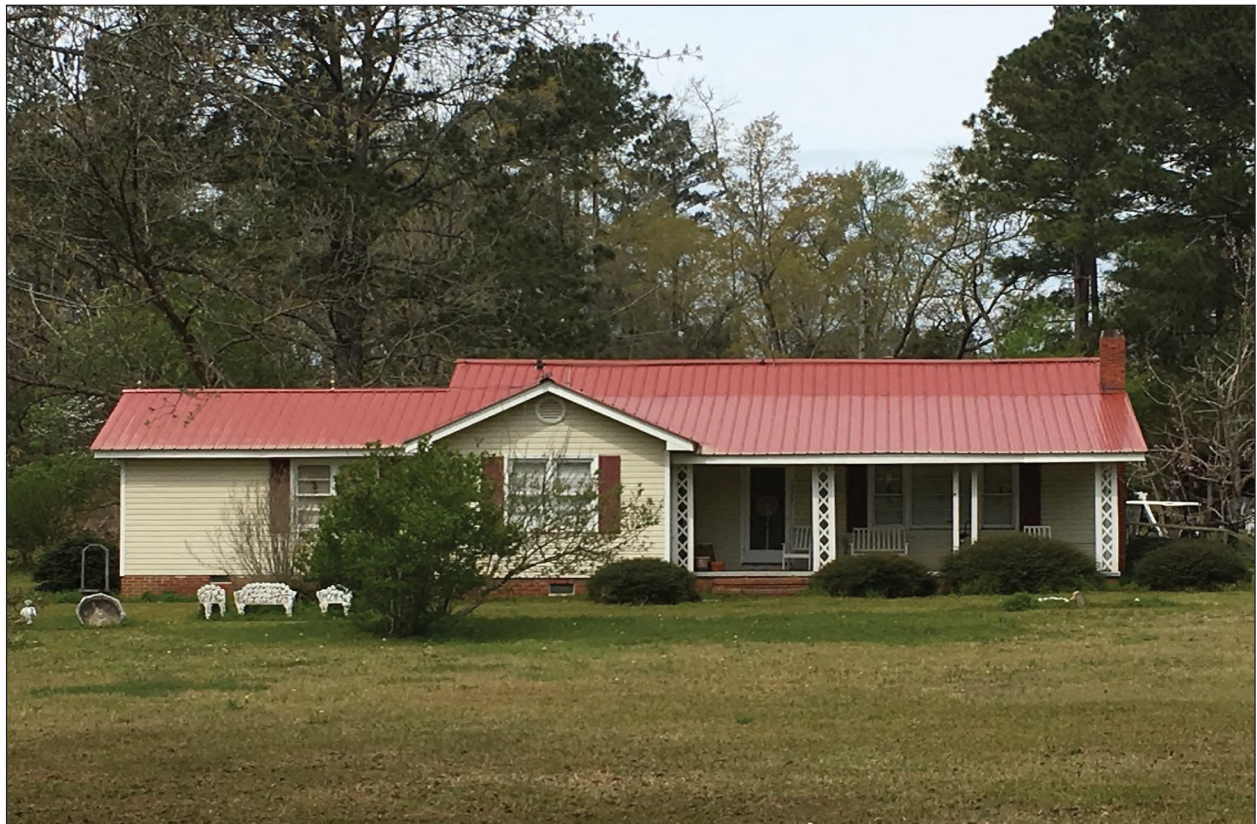
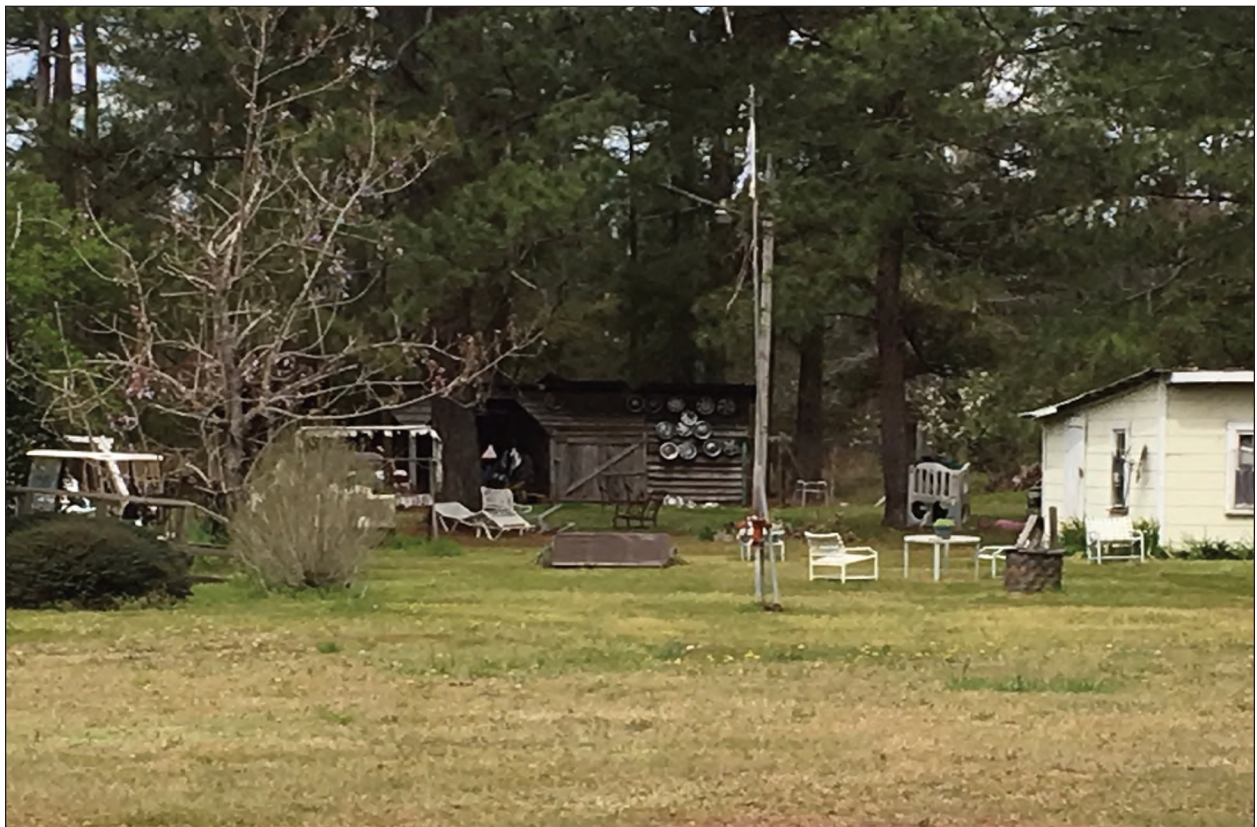
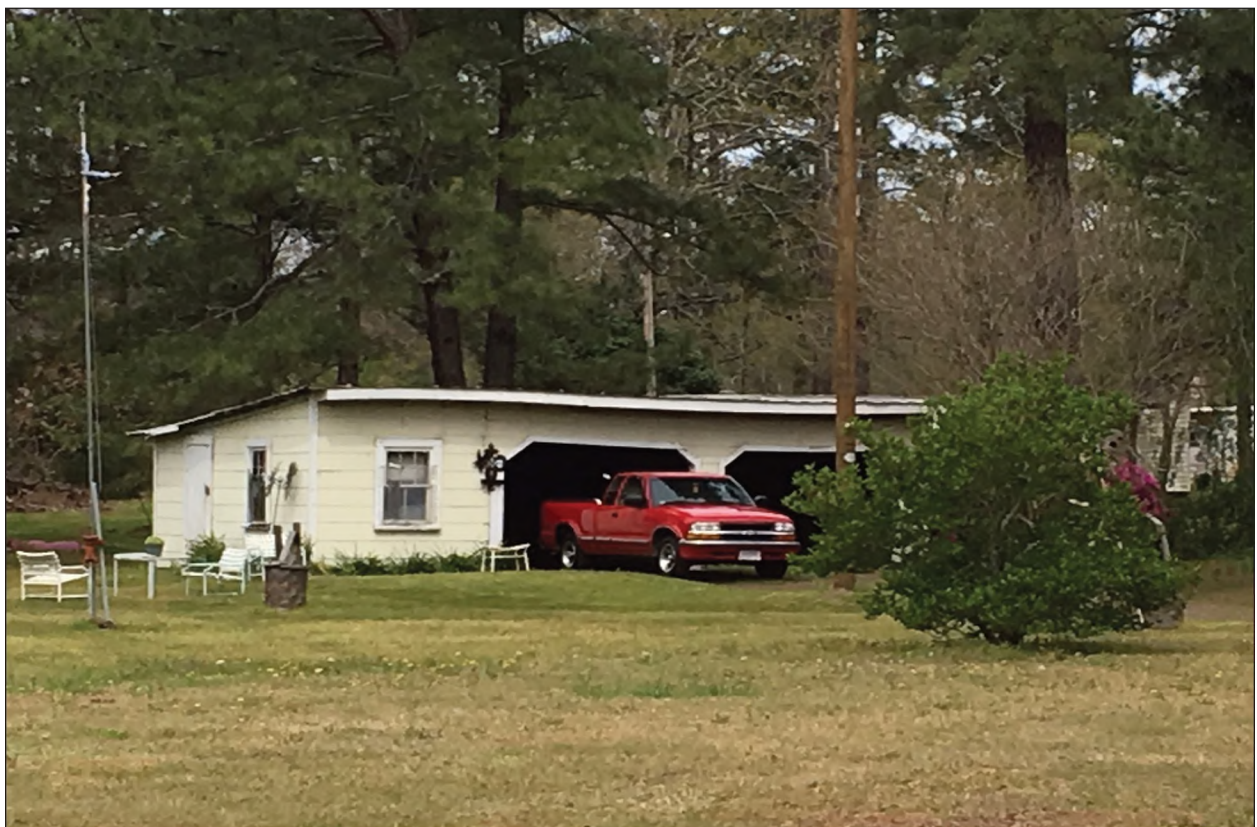
Resource 3815 is a c1955 vernacular house located at 4324 US 701 (see Figure 4.19; Figures 4.47-4.49). Set back from the highway, the house rises a single story from a brick foundation and its wood frame is sheathed in synthetic siding. The windows are primarily paired across the façade and include wood-framed, double-hung sash units. The inset front porch includes a tri-partite picture window composed of double-hung sash units flanking four horizontal fixed lights. Three of the paired square wood porch supports include diamond patterns with a fourth containing no decorative embellishment. There is a north end exterior brick chimney, and a historic south side addition. The side gabled roof is covered in raised seam metal. The property also contains small outbuildings (Resources 3815.01 and 3815.02). Building 3815.01 (see Figure 4.48) is a wood-framed shed with an open port for equipment storage. Building 3815.02 (see Figure 4.49), is a wood-framed garage with two open ports and a utility unit with six-over-six double hung windows. The framed structure is covered in asphalt shingles.

We assessed the NRHP eligibility of Resource 3815 with respect to Criteria A-D (see Section 2.6). The building is a typical example of the early to mid-twentieth-century residential architecture in the area. During background research, we identified no events or people that would qualify the resource for inclusion under Criteria A (*events*) or B (*people*). Due to alterations, such as the synthetic siding, the house possesses a low level of integrity. It is a poor example of a common form of period architecture and does not possess architectural significance. Therefore, it does not qualify under Criterion C (*architecture*). There is no known potential for the resource to qualify under Criterion D (*information potential*). We recommend Resource 3815 not eligible for the NRHP.

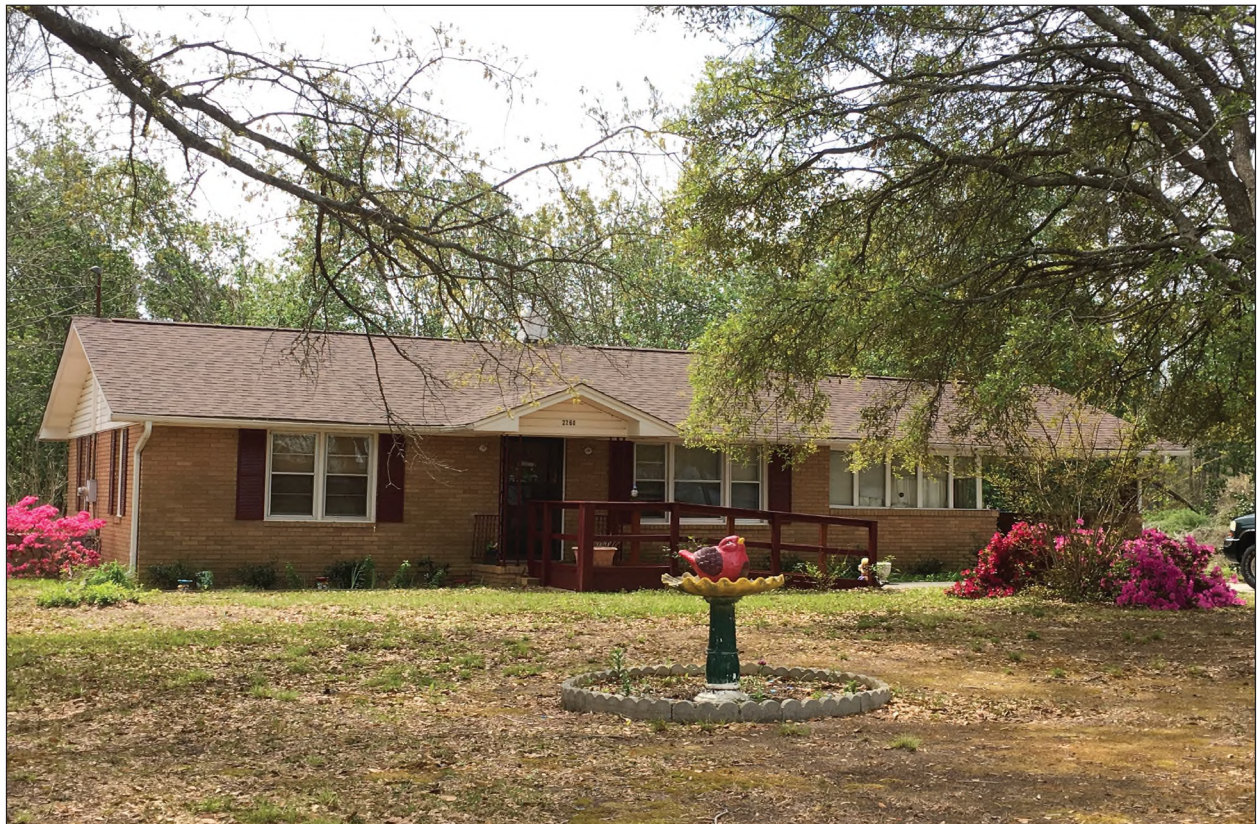
Figure 4.50 Resource 3816, facing south.

We assessed the NRHP eligibility of Resource 3816 with respect to Criteria A-D (see Section 2.6). The building is a typical example of the mid-twentieth-century residential architecture in the area. During background research, we identified no events or

people that would qualify the resource for inclusion under Criteria A (*events*) or B (*people*). Although the resource maintains a high level of integrity, not atypical for brick ranches, it represents a common form of mid-twentieth-century architecture. It does not possess architectural significance and does not qualify under Criterion C (*architecture*). There is no known potential for the resource to qualify under Criterion D (*information potential*). We recommend Resource 3816 not eligible for the NRHP.

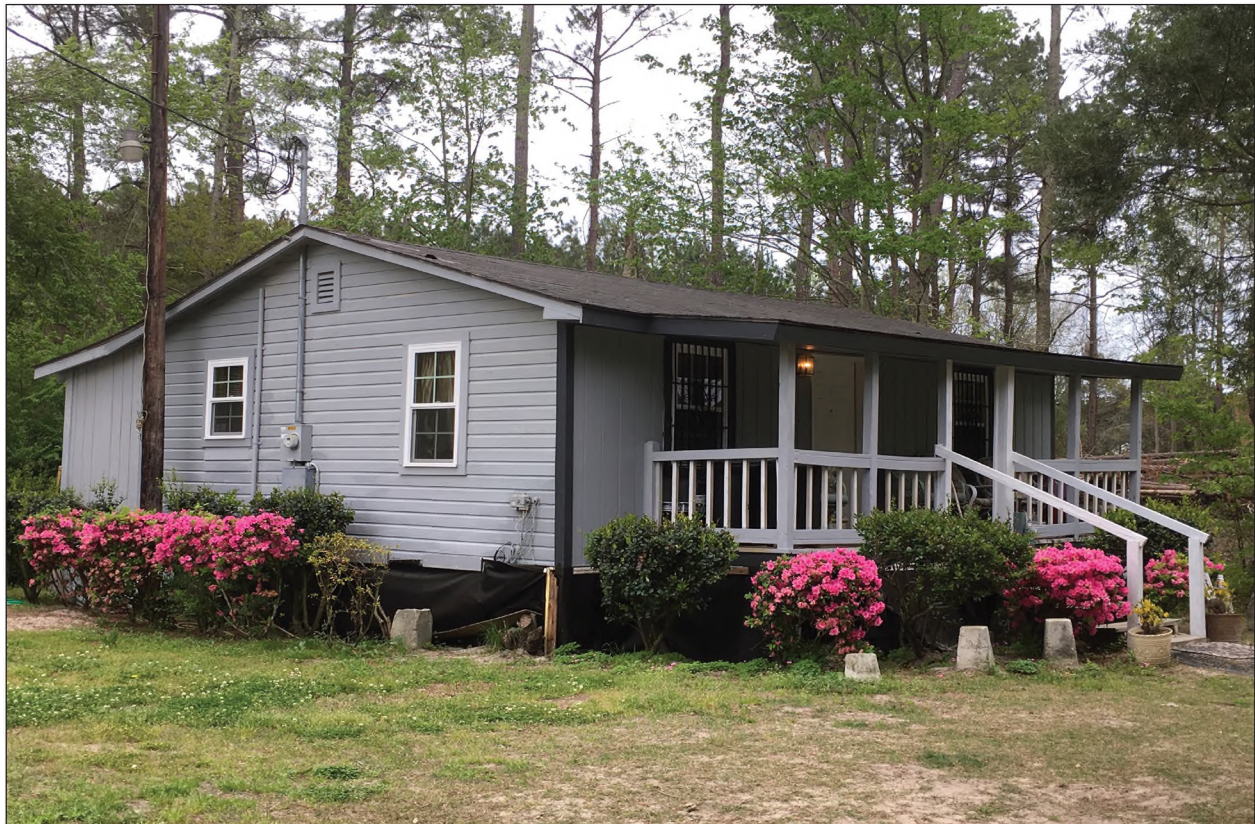
Figure 4.51 Resource 3817, facing southeast.

We assessed the NRHP eligibility of Resource 3817 with respect to Criteria A-D (see Section 2.6). The building is a typical and poor example of the mid-twentieth-century residential architecture in the area. During background research, we identified no events or people that would qualify the resource for inclusion under Criteria A (*events*) or B (*people*). The resource retains little historic fabric except for

its overall form, which represents a common mid-twentieth-century vernacular architecture. It does not possess architectural significance and does not qualify under Criterion C (*architecture*). There is no known potential for the resource to qualify under Criterion D (*information potential*). We recommend Resource 3817 not eligible for the NRHP.

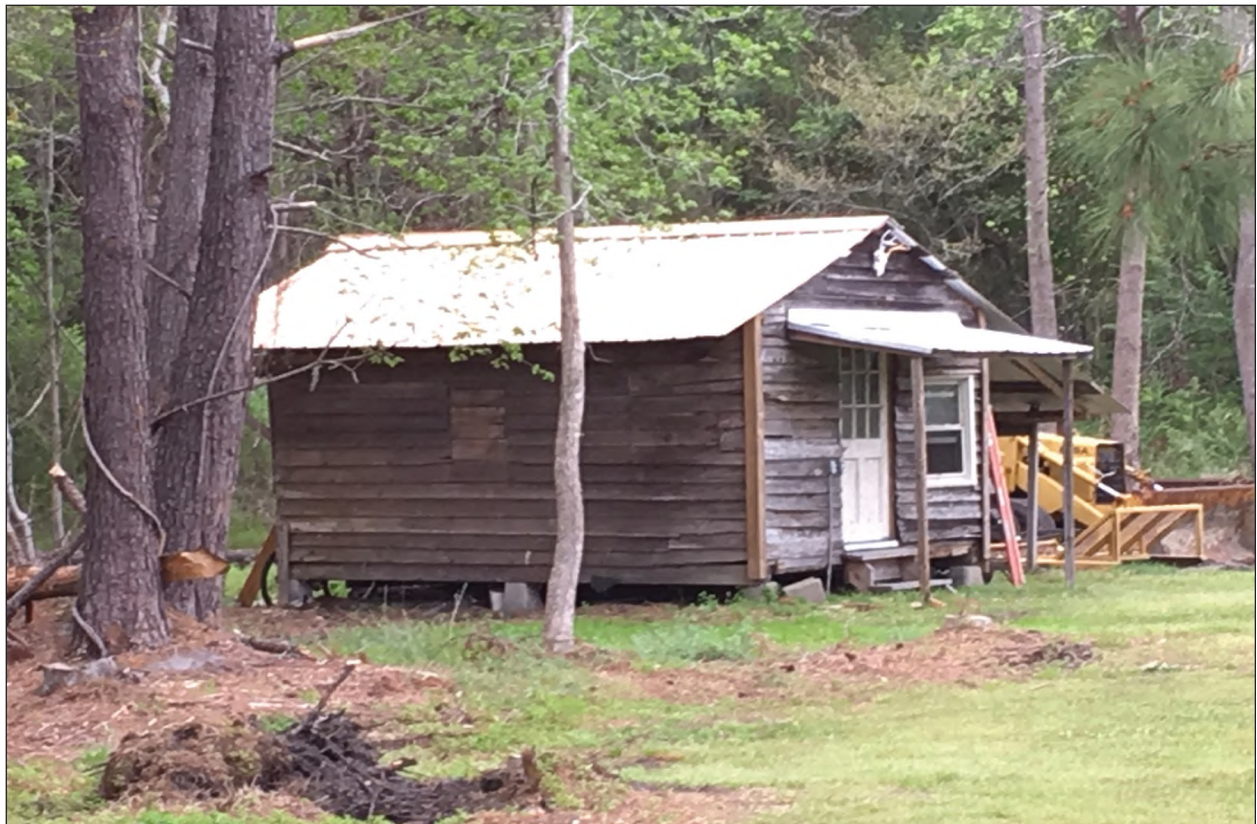
Figure 4.52 Resource 3818, facing east.

We assessed the NRHP eligibility of Resource 3818 with respect to Criteria A-D (see Section 2.6). The building is a typical example of the early to mid-twentieth-century residential architecture in the area. During background research, we identified no events or people that would qualify the resource for inclusion under Criteria A (*events*) or B (*people*). The resource possesses poor overall architectural integrity and represents a typical mid-twentieth-century vernacular type of architecture. It does not possess architectural significance and does not qualify under Criterion C (*architecture*). There is no

known potential for the resource to qualify under Criterion D (*information potential*). We recommend Resource 3818 not eligible for the NRHP.

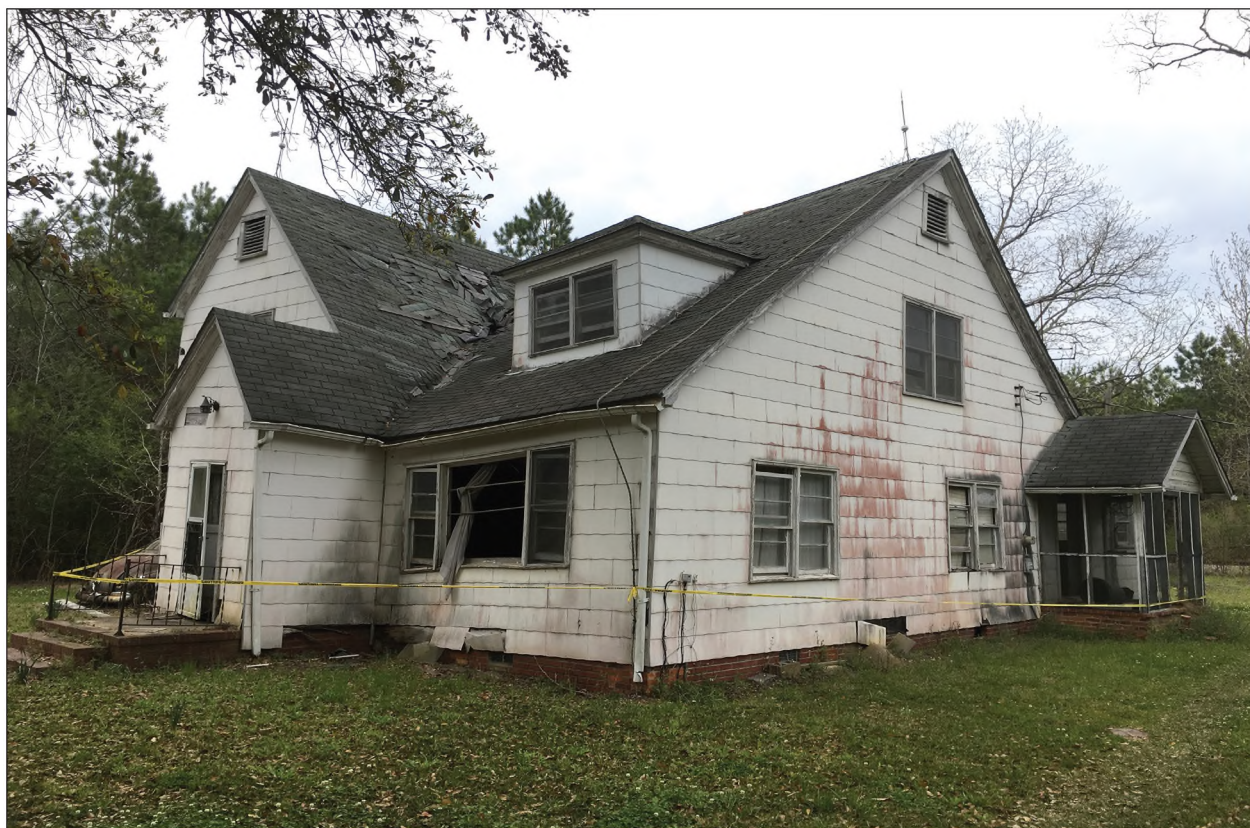
Figure 4.53 Resource 3819, facing northeast.

We assessed the NRHP eligibility of Resource 3819 with respect to Criteria A-D (see Section 2.6). The building typifies early to mid-twentieth-century residential architecture in the area. During background research, we identified no events or people that would qualify the resource for inclusion under

Criteria A (*events*) or B (*people*). Due to deterioration, the resource possesses poor overall architectural integrity and is a poor example of a common type of mid-twentieth-century architecture. It does not possess architectural significance and does not qualify under Criterion C (*architecture*). There is no known potential for the resource to qualify under Criterion D (*information potential*). We recommend Resource 3819 not eligible for the NRHP.

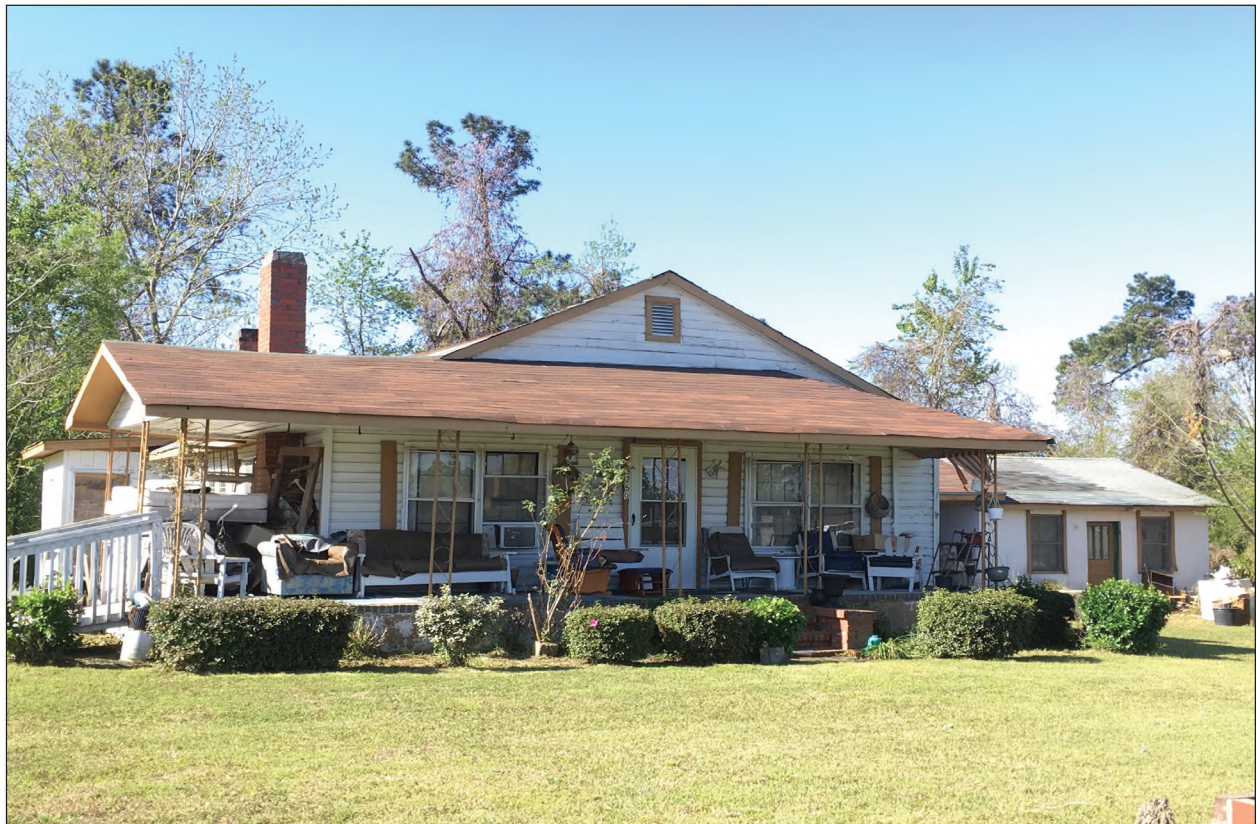
Figure 4.54 Resource 3820, facing south.

Constructed c1945, Resource 3820 faces north on Hair Nook Road (Figure 4.21). Originally constructed as a front-gabled bungalow, the house now includes several west elevation additions (Figure 4.54). The original house rises one story from a stuccoed masonry foundation and features a central paneled front door flanked by paired double-hung, six-over-six windows. Non-historic false shutters flank the façade windows and decorative iron posts support the front shed porch, which is a non-historic alteration. Clapboard siding covers the exterior of the wood-framed structure and the roof is sheathed in asphalt shingles. The east elevation includes a brick exterior chimney and two concrete block additions extend from the west elevation. The first addition is an attached carport with an integrated utility room. The second addition includes a wood paneled door with vertical lights, and two double-hung wood-framed windows.

We assessed the NRHP eligibility of Resource 3820 with respect to Criteria A-D (see Section 2.6). The building represents an altered example of a typi-

cal early to mid-twentieth-century residence in the area. During background research, we identified no events or people that would qualify the resource for inclusion under Criteria A (*events*) or B (*people*). Due to alterations, such as the side and porch additions, the resource possesses poor overall architectural integrity and is a poor example of a common type of mid-twentieth-century vernacular architecture. It does not possess architectural significance and does not qualify under Criterion C (*architecture*). There is no known potential for the resource to qualify under Criterion D (*information potential*). We recommend Resource 3820 not eligible for the NRHP.

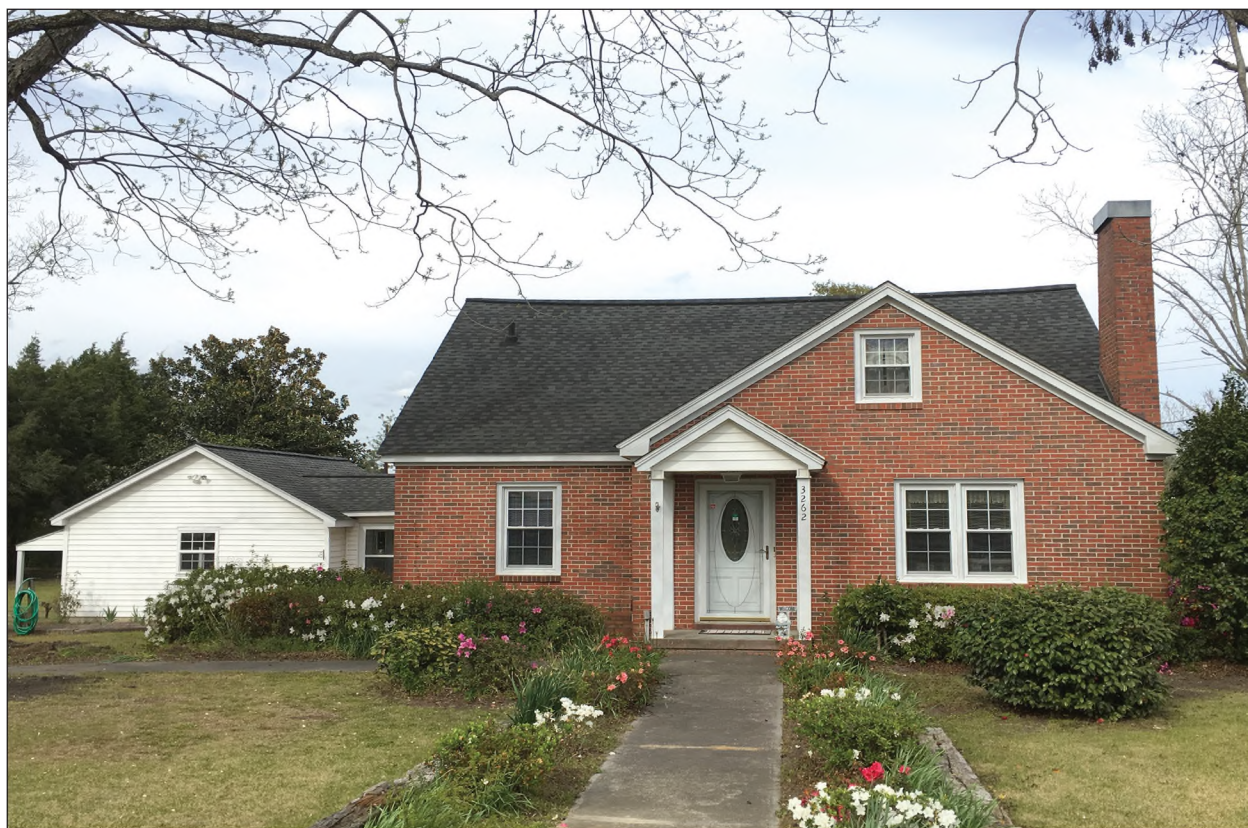
Figure 4.55 Resource 3821, facing northeast.

Constructed about 1950 in the Minimal Traditional style, Resource 3821 faces southwest on SC 319 (see Figure 4.20; Figure 4.55). The house rises one and one-half stories from a masonry foundation and has a cross-gabled roof covered in asphalt shingles and bonded brick exterior. Typical of this type of architecture, the façade features minimal architectural detail, with a small entry bay porch set beneath a front-gabled hood supported by wood posts, and an exterior end chimney. The doors and windows (synthetic six-over-six) are non-historic replacements and a non-historic addition extends from the northwest elevation. The addition includes a wood-framed hyphen and garage, all sheathed in vinyl siding.

We assessed the NRHP eligibility of Resource 3821 with respect to Criteria A-D (see Section 2.6). The building represents an altered example of a common mid-twentieth-century style prevalent throughout the region. During background research, we identified no events or people that would qualify the resource for inclusion under Criteria A (*events*) or B (*people*). Due to alterations, such as

the window and door replacements, the resource possesses poor overall architectural integrity. It does not possess architectural significance and does not qualify under Criterion C (*architecture*). There is no known potential for the resource to qualify under Criterion D (*information potential*). We recommend Resource 3821 not eligible for the NRHP.

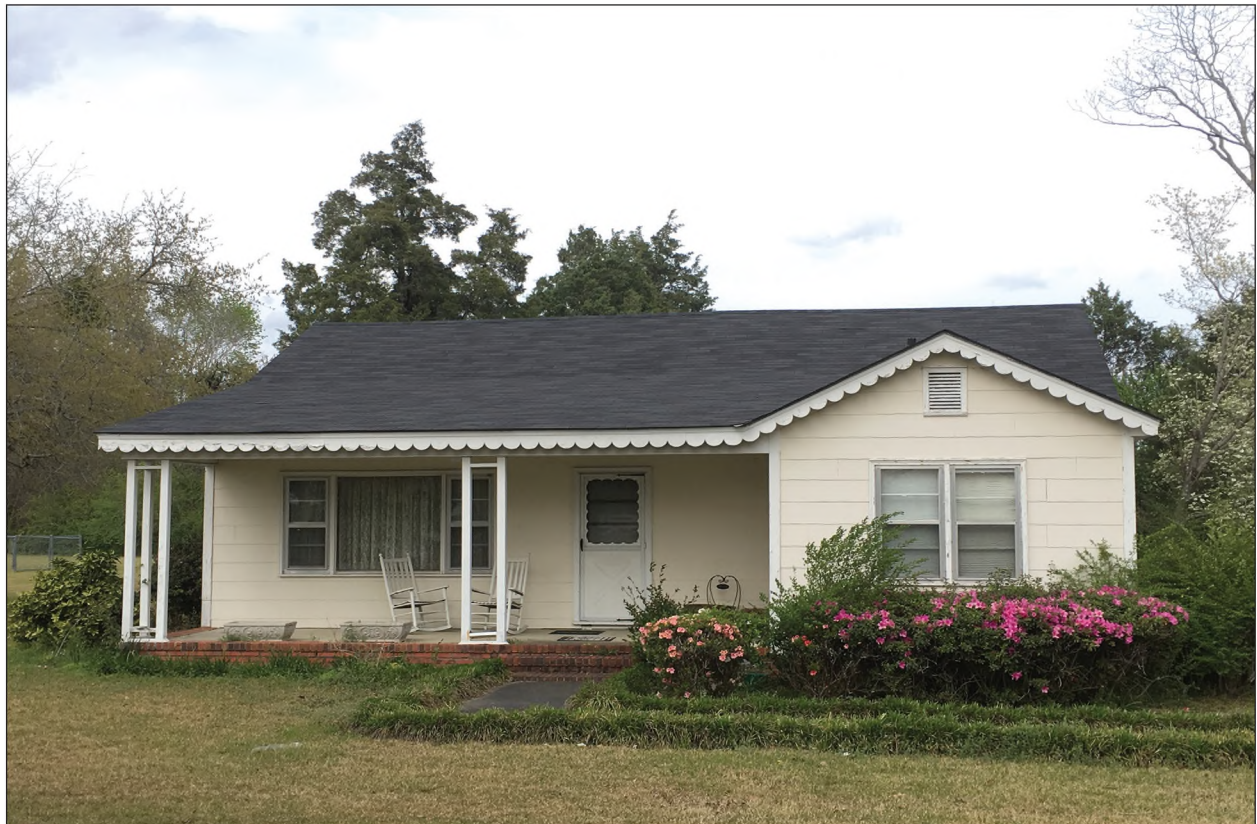
Figure 4.56 Resource 3822, facing northeast.

Constructed about 1945, Resource 3822 faces southwest on SC 319 (see Figure 4.20). The house rises one story from a masonry foundation and has a side-gabled roof covered in asphalt shingles and an exterior covered in asbestos shingles (Figure 4.56). The façade features a front-gabled projection with paired two-over-two double-hung windows and a three-quarter-length porch set beneath a shed roof. The porch is supported by paired wood posts set on a brick and concrete foundation. The door is original with three horizontal lights in the upper portion and the flanking tri-partite window consists of a single fixed light set between small two-over-two double-hung windows. The roofline is decorated with scalloped woodwork.

We assessed the NRHP eligibility of Resource 3822 with respect to Criteria A-D (see Section 2.6). The building represents a typical example of mid-twentieth-century architecture prevalent throughout the region. During background research, we identified no events or people that would qualify the resource for inclusion under Criteria A (*events*) or B

(*people*). While retaining a high degree of integrity, the building is a common architectural type, does not possess architectural significance, and does not qualify under Criterion C (*architecture*). There is no known potential for the resource to qualify under Criterion D (*information potential*). We recommend Resource 3822 not eligible for the NRHP.

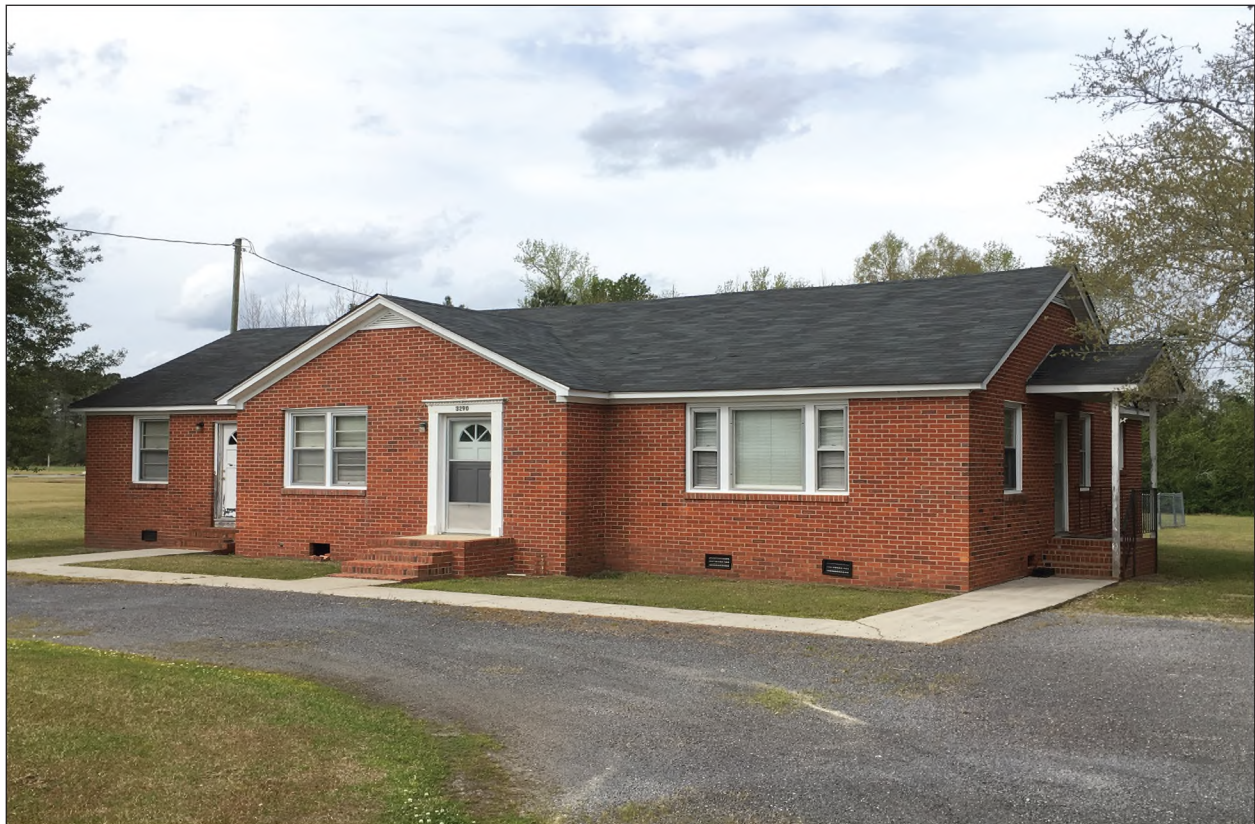
Figure 4.57 Resource 3823, facing northeast.

Constructed about 1950 in the Minimal Traditional style, Resource 3823 faces southwest on SC 319 (see Figure 4.20). The house rises one story from a masonry foundation, has a bonded brick exterior, and a cross-gabled roof covered in asphalt shingles (Figure 4.57). Typical of this type of architecture, the façade features minimal architectural detail, with a small entry stoop and a decorative door surround. Both doors on the façade are non-historic replacements, although all the windows appear to be original two-over-two double-hung sash. There is another entry bay on the southeast elevation and given the number of entries, the house may have been modified for multi-family living.

We assessed the NRHP eligibility of Resource 3823 with respect to Criteria A-D (see Section 2.6). The building represents an altered example of a common mid-twentieth-century style prevalent throughout the region. During background research, we identified no events or people that would qualify the resource for inclusion under Criteria A (*events*) or B (*people*). Due to the door replacements and likely

living space reconfiguration, the resource possesses a moderate level overall architectural integrity. It does not possess architectural significance and does not qualify under Criterion C (*architecture*). There is no known potential for the resource to qualify under Criterion D (*information potential*). We recommend Resource 3823 not eligible for the NRHP.
