ARCHAEOLOGICAL FIELD REPORT  
SCDOT ENVIRONMENTAL SECTION  
**SCDOT**

**TITLE:** Phase I Archaeological Survey of the Proposed SC 72 Over Stony Fork Creek Bridge Replacement, York County, South Carolina

**DATE OF RESEARCH:** June 11 – 12, 2018

**COUNTY:** York      **PROJECT:** SC 72 Over Stony Fork Creek Bridge Replacement, York County, SC

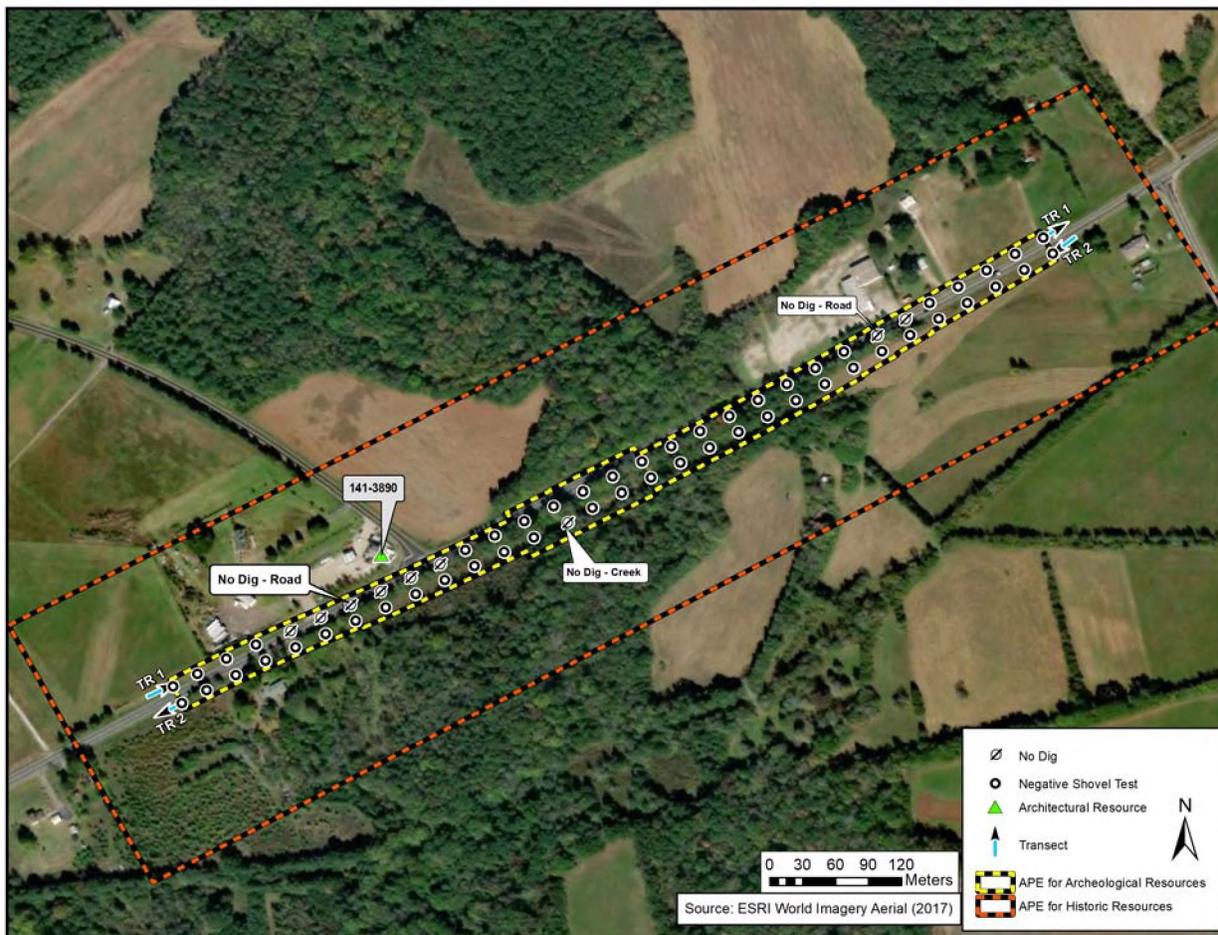
A total of 62 potential shovel tests locations were examined within the survey area. Of that number 53 were excavated and 9 were not dug due to placement on pavement or in the creek (Figure 7). All of the shovel tests were negative for cultural material. Soil profiles were fairly shallow throughout the project area. A typical profile included an approximately 0-20 centimeters below surface (cmbs) layer of 10YR 5/3 brown or 2.5YR 5/3 reddish brown loamy sand, overlying 10R 4/8 red clay subsoil. Most tests were terminated between 30 and 50 cmbs. Redeposited fill soils and dolomitic gravel were encountered as well throughout the project area. No sites or isolated finds were discovered during the survey for this project.

**Figure 7:** Shovel Test Results and Location of the Newly Recorded Architectural Resource Discovered During the Survey.

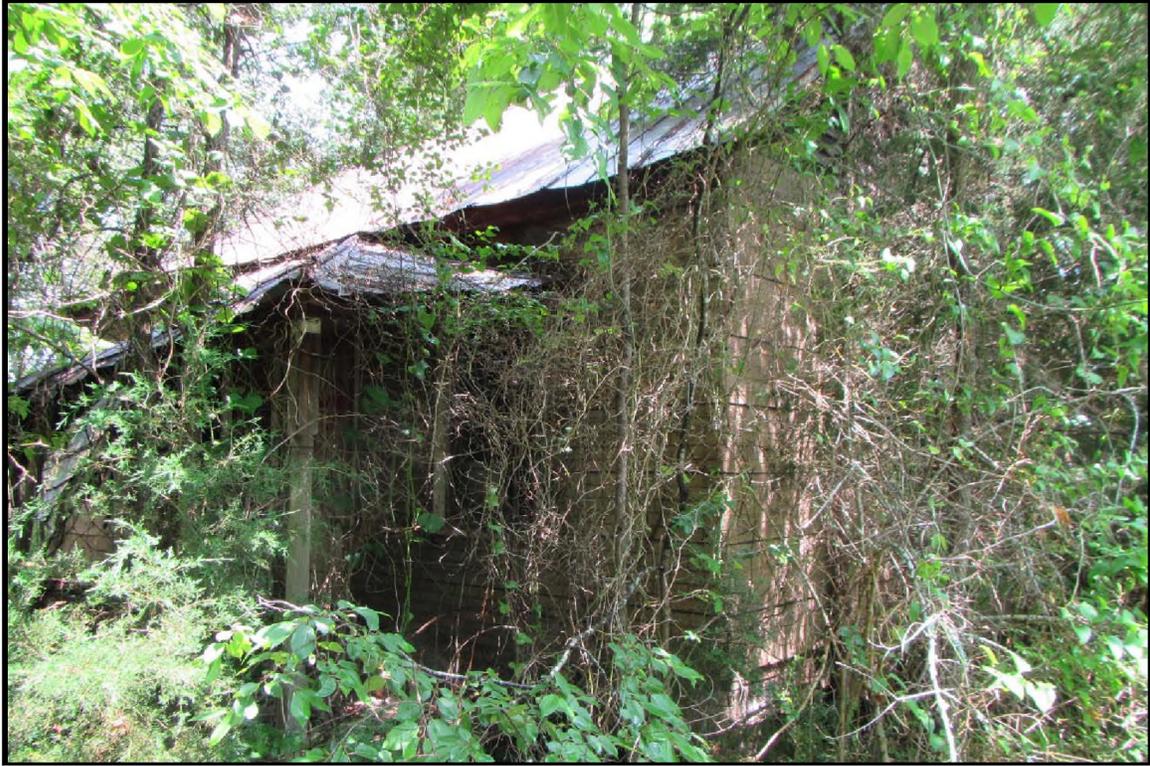
The resource consists of a vacant one-story, side-gabled residence identified as site 141-1410; a large gambrel-roofed barn of frame construction identified as site 141-1410.01; and a front-gabled outbuilding of unknown original use identified as site 141-1410.02. The buildings and structures are overgrown with vegetation on all sides and have been vacant and unused for many years. The house is of frame construction with a side-gabled metal roof; rolled asphalt exterior siding; a partially-collapsed, partial-width, hipped-roofed porch supported by turned posts on the façade; a six-panel entry door; and wood-framed 6/6-light double-hung sash windows (see Figures 8-11). The porch floor is rotted away and most of the window glass and many of the window frames have been removed due to lack of maintenance, neglect, and vandalism. The large barn has a gambrel metal roof, hayloft opening on the upper level of the façade, and weatherboard exterior (see Figure 10). The second outbuilding of unknown original use has a gabled metal roof, metal sheet exterior siding, and a full-width shed-roofed shelter on the east side elevation.

**Figure 8: Resource 141-1410 (South side of Saluda Road 0.21 mile SW of Strait Road) – Oblique view of the façade and west side elevation facing southeast.**

information. Therefore, there was no basis for evaluating the resource under Criterion D. The resource was evaluated in the 1992-1993 York County survey of historic and architectural resources and was determined to be Not Eligible for inclusion in the NRHP. The integrity of the resources in the areas of setting, design, materials, and workmanship has further deteriorated in the approximately 25 years since that survey due to lack of maintenance and neglect and vandalism and the resource cannot convey significance in the areas of agriculture or architecture. Therefore, the previous determination that Resource 141-1410 was **Not Eligible** for listing in the NRHP is considered still accurate.

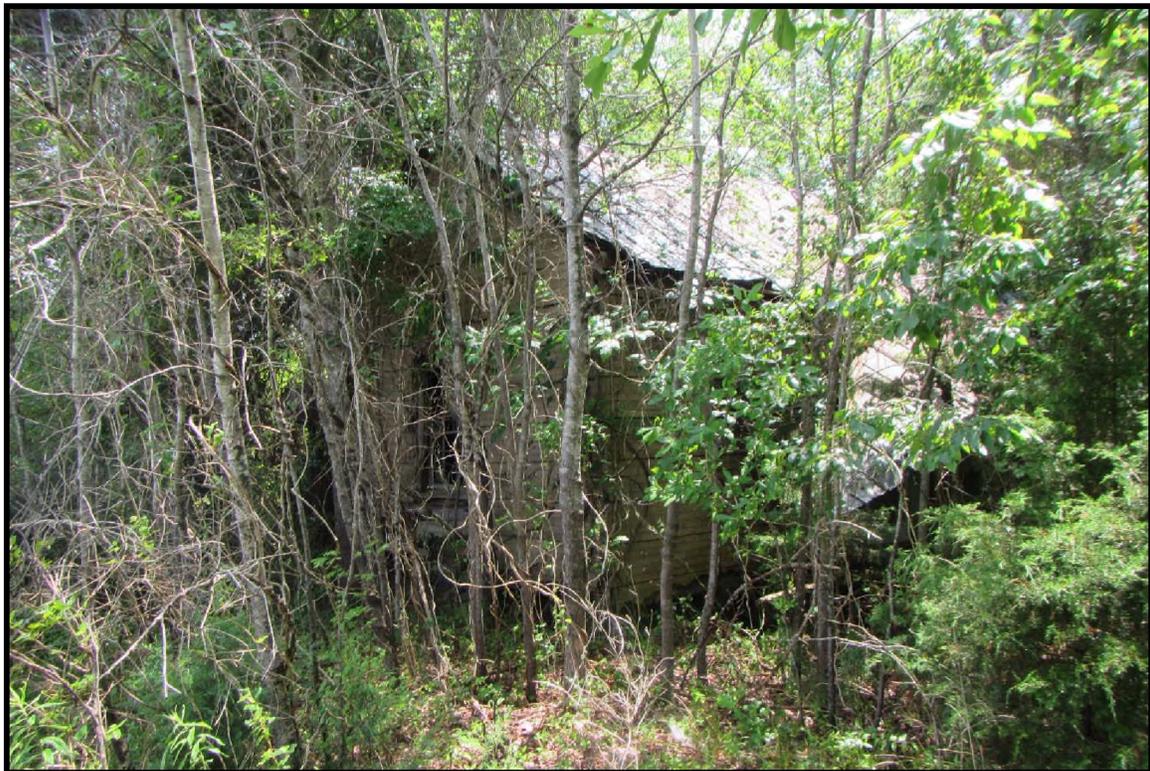
**Figure 9: Resource 141-1410 (South side of Saluda Road 0.21 mile SW of Strait Road) – Oblique view of the façade and east side elevation, facing southeast.**

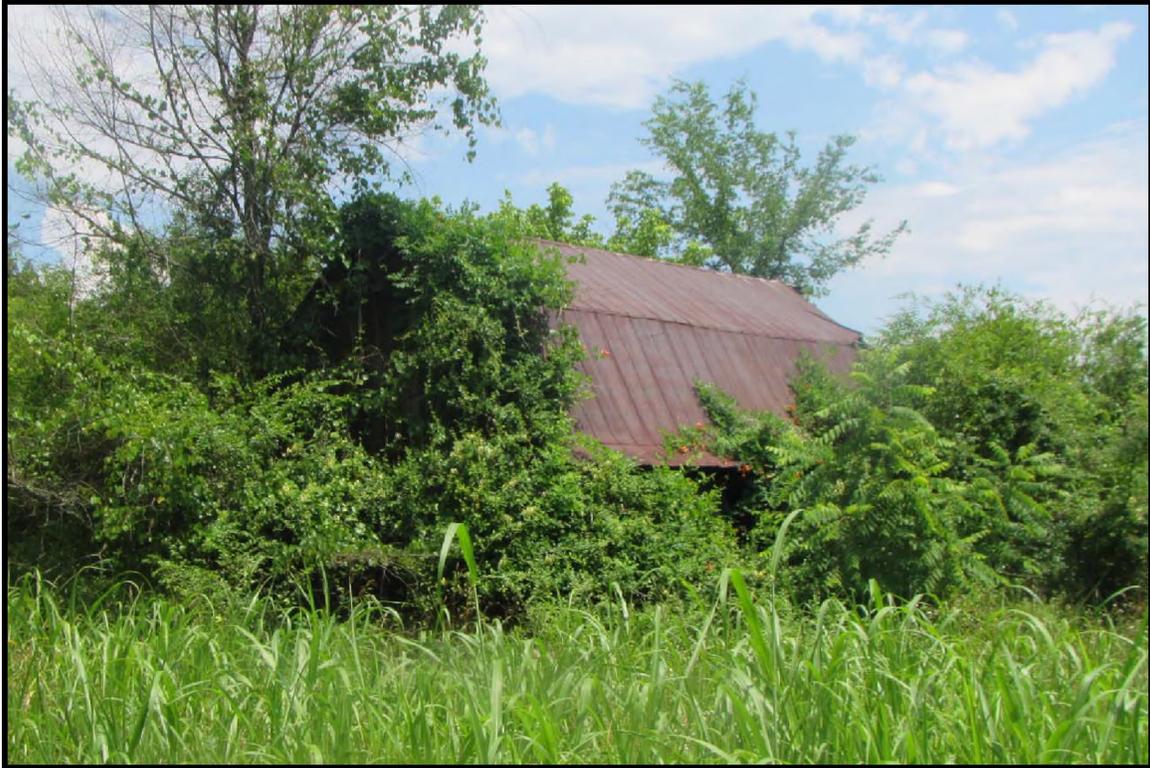
**Figure 10: Resource 141-1410.01 (South side of Saluda Road 0.21 mile SW of Strait Road) - Oblique view of façade and west side elevation, facing southeast.**

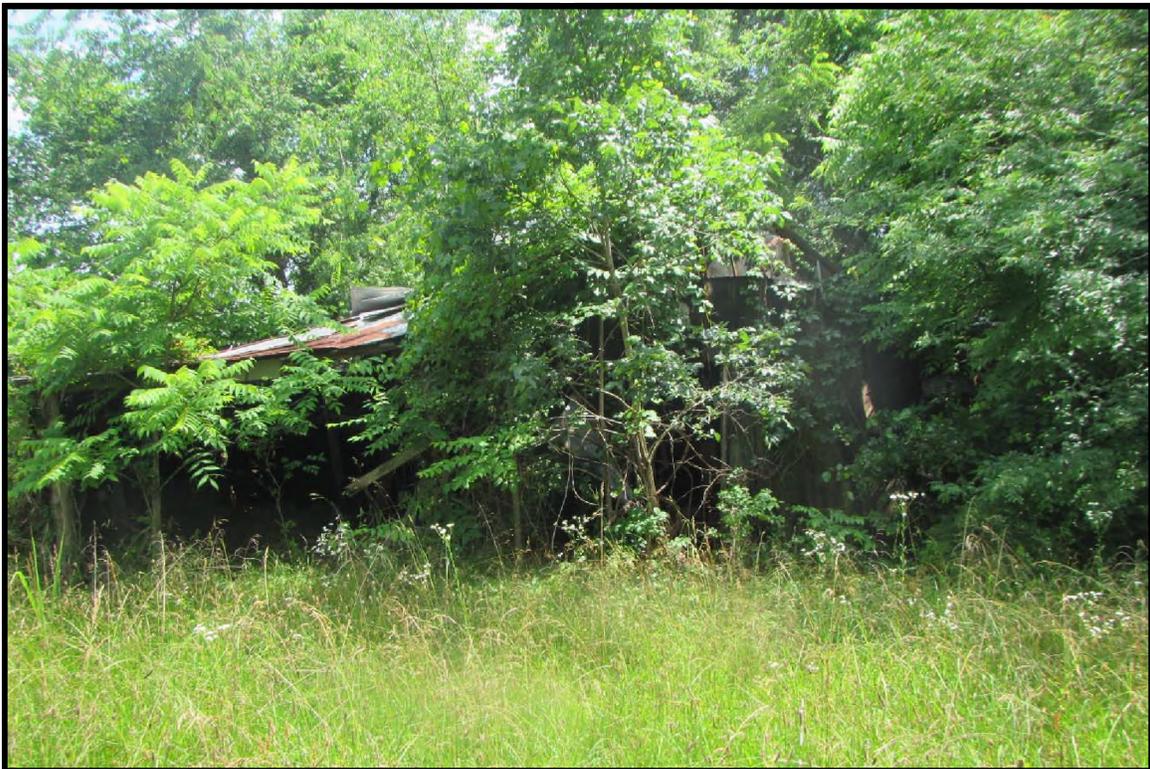
**Figure 11: Resource 141-1410.02 (South side of Saluda Road 0.21 mile SW of Strait Road) – Oblique view of the façade and east side elevation, facing southwest.**

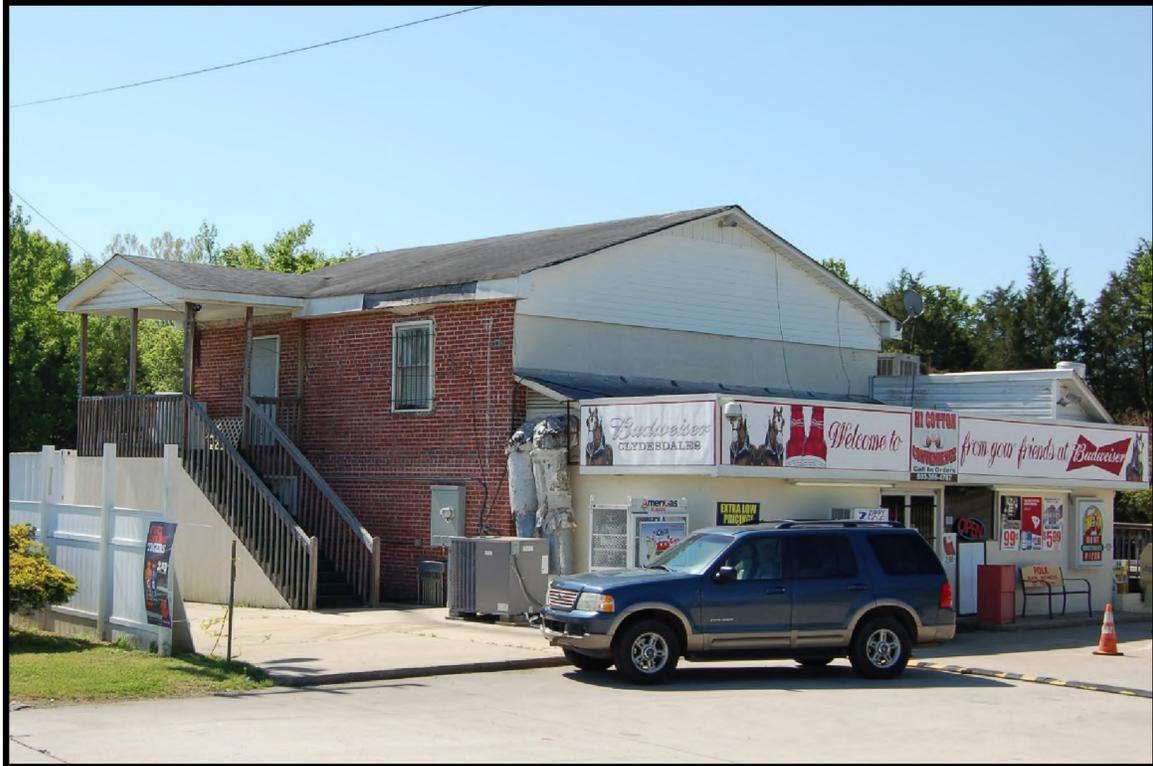
The resource is a two-story, asymmetric, two-part community store building of masonry construction with a non-historic, wrap-around, shed-roofed addition on the north and east side elevations. The primary façade appears to have been changed from the south elevation (which faces SR 72/Saluda Road), to the north elevation (which faces the gas pumps and paved parking area). The resource has a front-gabled asphalt shingle roof; an unusual variation in the common bond brick exterior with a seemingly random number of stretcher courses between the header courses; the original windows have been replaced with non-historic 1/1-light windows with metal frames; and shed-roofed additions have been constructed on the south and east side elevations (see Figures 12-14). Vinyl exterior siding has been applied in the gables. A former window opening on the second story of the east side elevation has been converted to a doorway and an external stairway and projecting gabled roof has been constructed over the landing. Additional window openings on the east and west side elevations have been covered with plywood sheet. No evidence of historic pump islands or store signage was observed.

Figure 12: Resource 141-3890 (3622 Saluda Road) - View of the façade facing southwest.

The resource was evaluated for NRHP eligibility in accordance with the guidance in *Rural Commerce in Context: South Carolina's Country Stores, 1850-1950*. There is not a known connection between the resource and any individual whose activities or achievements are historically significant. Therefore, there was no basis for evaluating the resource under Criterion B. Also, there is no indication that the resource is likely to yield information on important research questions in history or prehistory. The resource does not appear to have the potential to be the principal source of important information. Therefore, there was no basis for evaluating the resource under Criterion D. The resource is located at the intersection of SC 72 (Saluda Road) and SC 324 in an unincorporated community identified as Smith on topographic maps. The community appears to be comprised of widely dispersed historic and non-historic residential properties, and does not contain any other commercial or institutional buildings. Therefore, the resource does not appear to have been the impetus for further development of the local area. The resource lacks many of the fundamental and defining characteristics of the two-part store type identified in the country store context. The primary façade appears to have been changed from the south to the north elevation, there is not a clearly defined entrance, no display windows, and no entrance porch. In addition, the integrity of the resource in the areas of setting, design, materials, workmanship, and feeling has also been diminished by the construction of the non-historic, wrap-around, shed-roofed addition on the north and east side elevations; and by the large area of concrete paving, large concrete parking lot, and the non-historic, large, canopied, multi-pump fuel islands to the north and northwest of the resource. Therefore, Resource 141-3890 is recommended **Not Eligible** for listing in the NRHP under Criterion A in the area of commerce, and under Criterion C in the area of architecture.

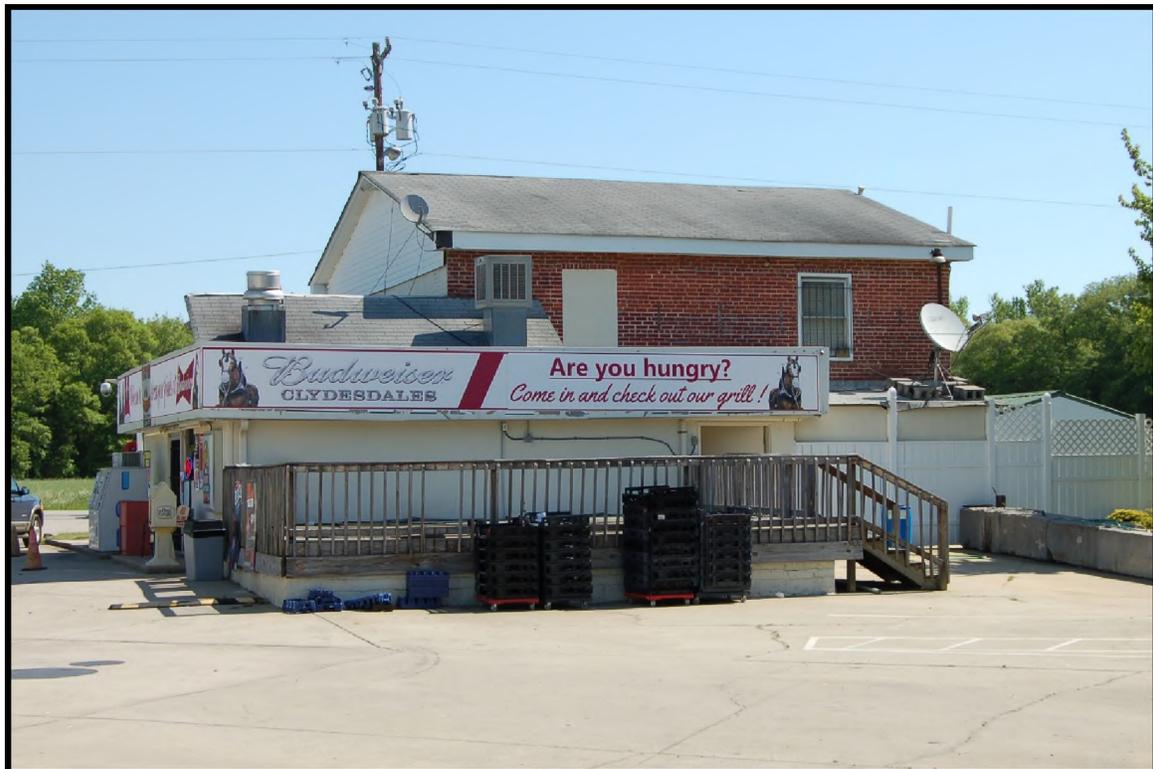
Figure 13: Resource 141-3890 (3622 Saluda Road) - View of the east side elevation facing southeast.

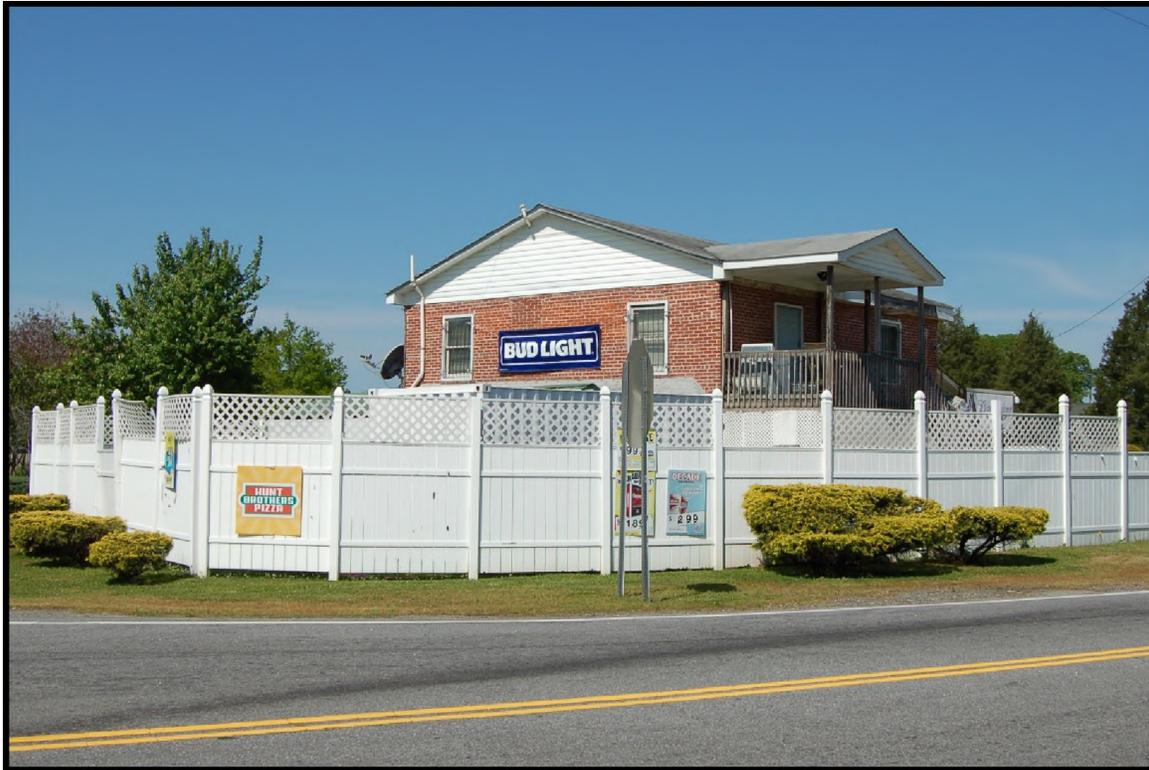
Figure 14: Resource 141-3890 (3622 Saluda Road) – Oblique view of west side elevation facing northwest.
