ARCHAEOLOGICAL FIELD REPORT
SCDOT ENVIRONMENTAL SECTION
SCDOT

TITLE: Phase I Cultural Resources Survey of the S-45 (Tomahawk Street) over Tributary to Boser Swamp Bridge Replacement

PROJECT: S-45 over Tributary to Boser Swamp Bridge Replacement

PIN: P037638

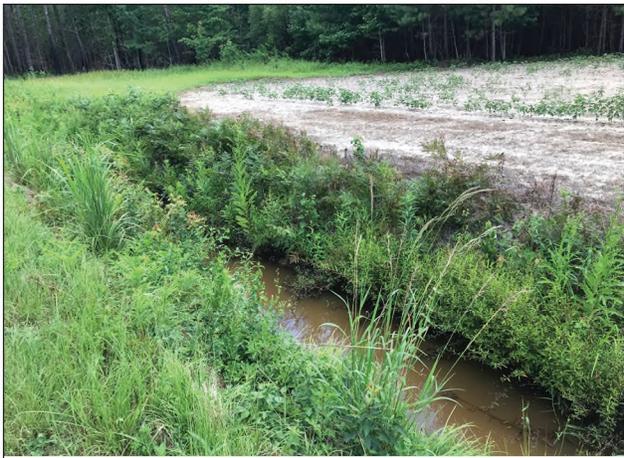
The project area is mostly covered by wetlands and agricultural fields. Residential lawns and a small pine wood were on the northeast side of Tomahawk Street (see Figures 2 and 3). Extensive surface exposures were present in agricultural field rows and ditches.

B. Agricultural Field and Ditch

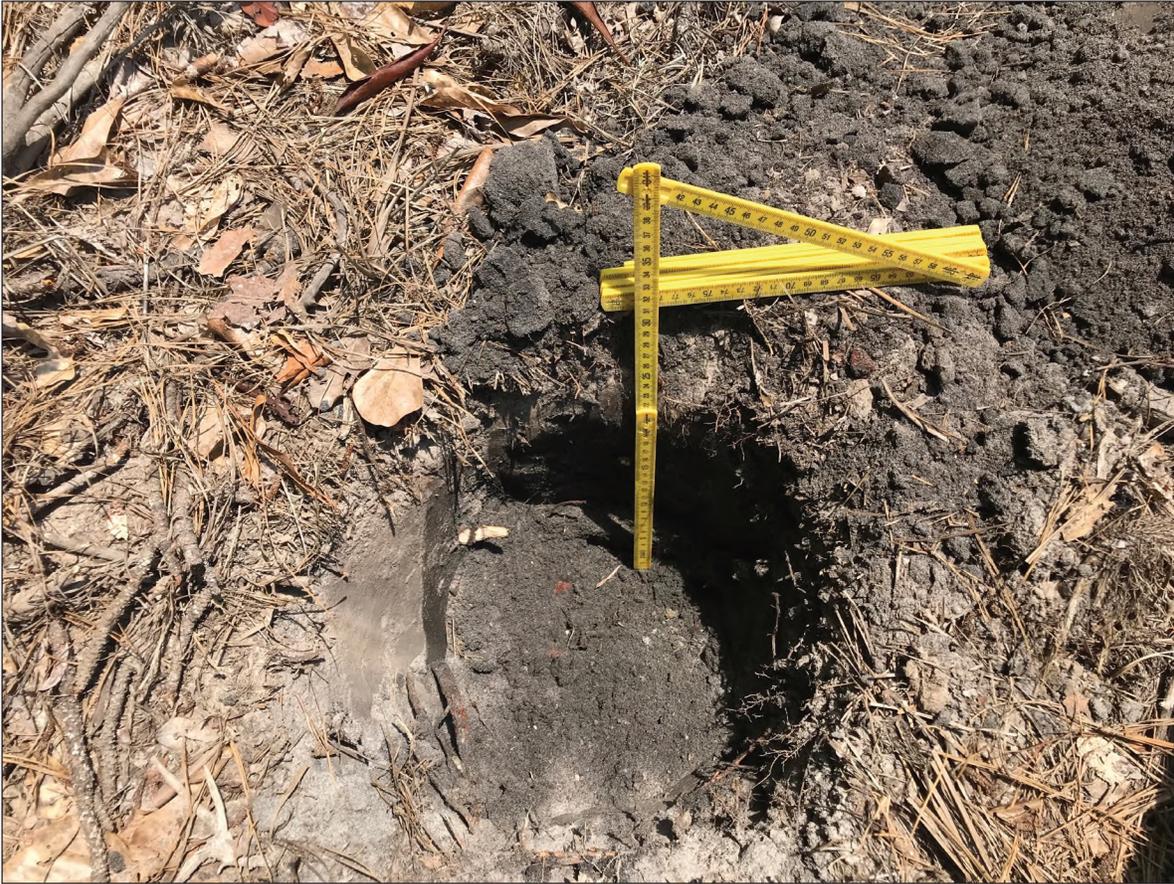
Figure 5.
Typical Shovel Test Profile

The archaeological survey was conducted July 2, 2019. Although soils data suggested that moderately well-drained soils were present in the project area, visual inspection and shovel-testing indicated that project area water table was lowered through artificial means. Ditches located in the northern half of the study area were in excess of six feet deep. Pedestrian walkover of the agricultural fields in the northwestern and southwestern quadrants, and visual inspection of surface exposures in the northeastern and southeastern quadrants identified one artifact scatter (38GE680) on the upland located at the southeastern end of the project area. Eleven shovel tests were excavated in the project area (Figure 2). Of these, the five judgmental tests that extended from the periphery of the delineated wetland and encountered 35 centimeters of gray (10YR 6/1) silty loam overlying very dark grayish brown (10YR 3/2) silty clay (Figure 5). These hydric sediments were observed along the drainage bank profiles throughout the northwestern portion of the project area. Six tests were excavated in the upland area southeast of the stream crossing. They encountered 10 centimeters of disturbed light gray (10YR 7/1) silty loam overlying 15 centimeters of yellowish brown (10YR 5/4) sand and yellowish brown (10YR 5/4) sandy clay. As these tests were located along a drainage ditch, it is assumed that the soils in this location were deposited during ditch clearing activity.

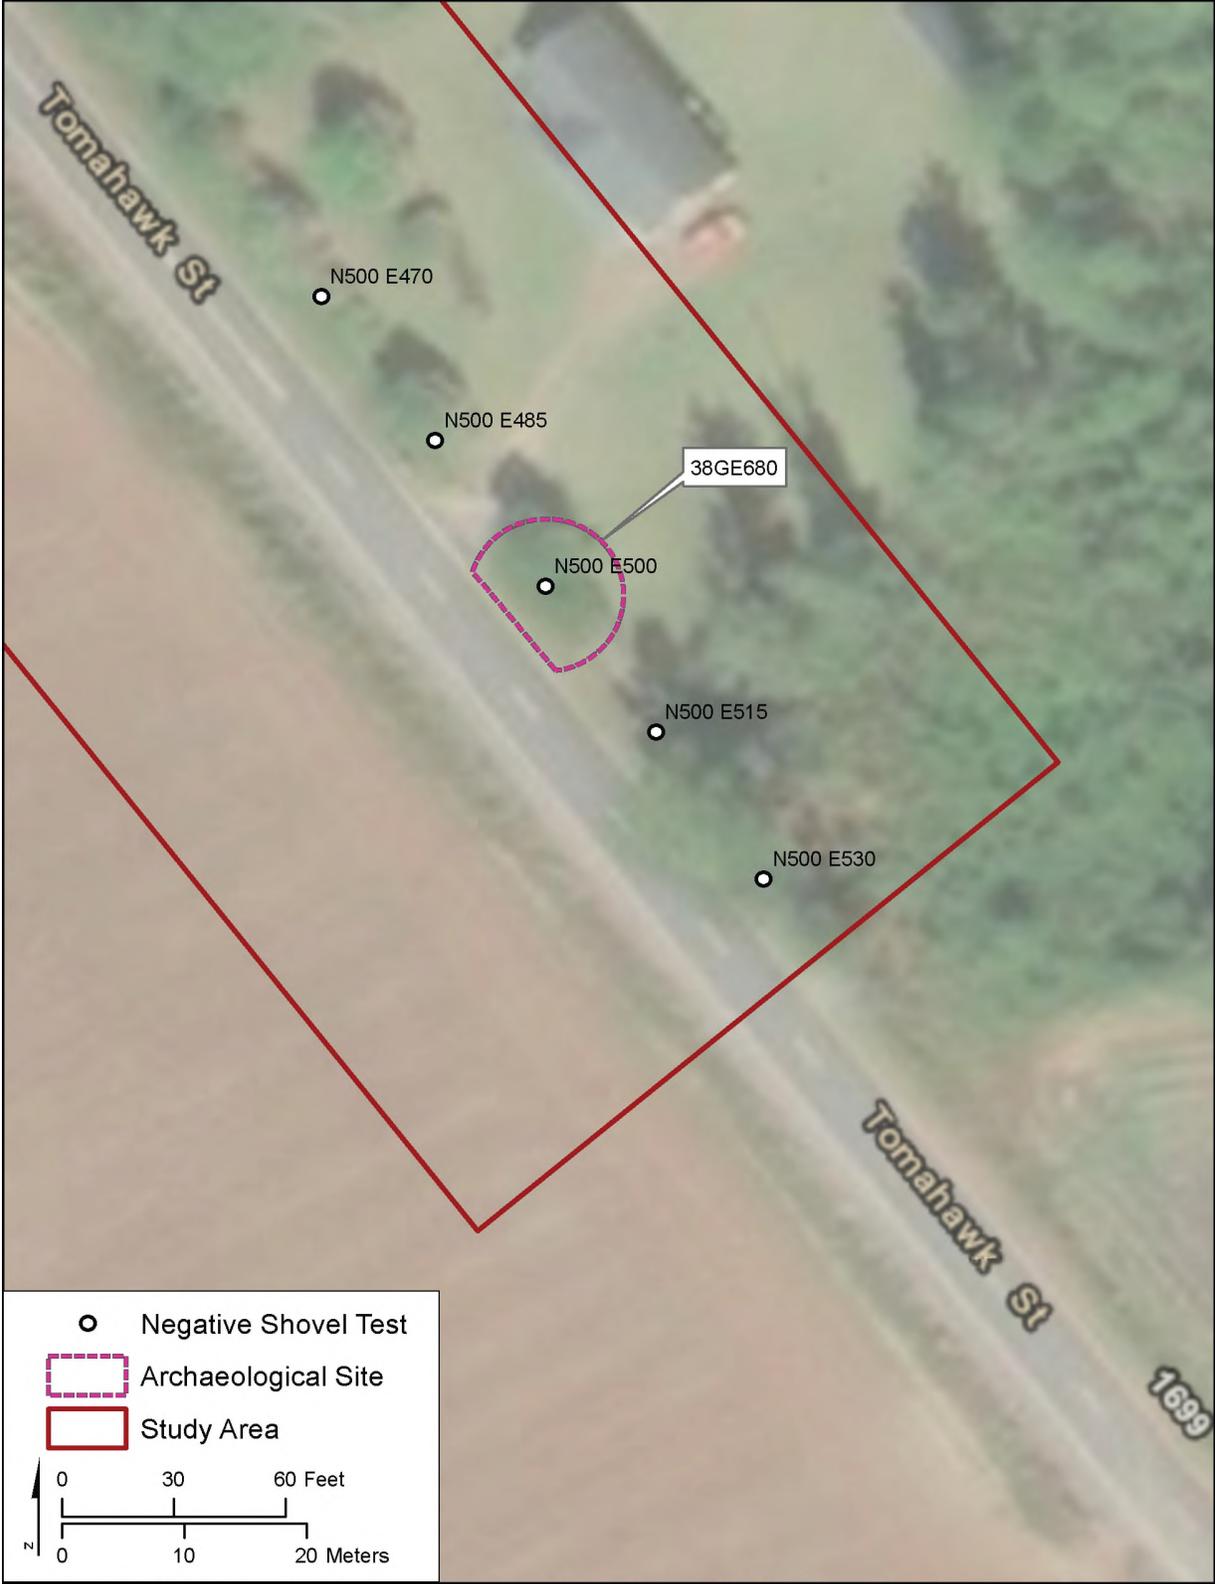
Figure 6.
Site 38GE680 Site Map

The location of the site relative to Tomahawk Street and the results of walkover and shovel testing indicated that the artifact scatter measured 9x13 meters (see Figure 6). The few artifacts found at site 38GE680 resulted from casual discard since they only consisted of a handful of historic sherds. As the surface finds lack context, are sparse, and cannot be related to a specific occupation, the site has no integrity or research potential. Site 38GE680 is recommended not eligible for the NRHP under Criterion D. The artifact scatter cannot be associated with any significant individuals, events or broad historical patterns, and it does not convey associations with any significant design elements or workmanship. Thus, site 38GE680 is also recommended not eligible under NRHP Criteria A, B, and C. No further work is recommended for this site.

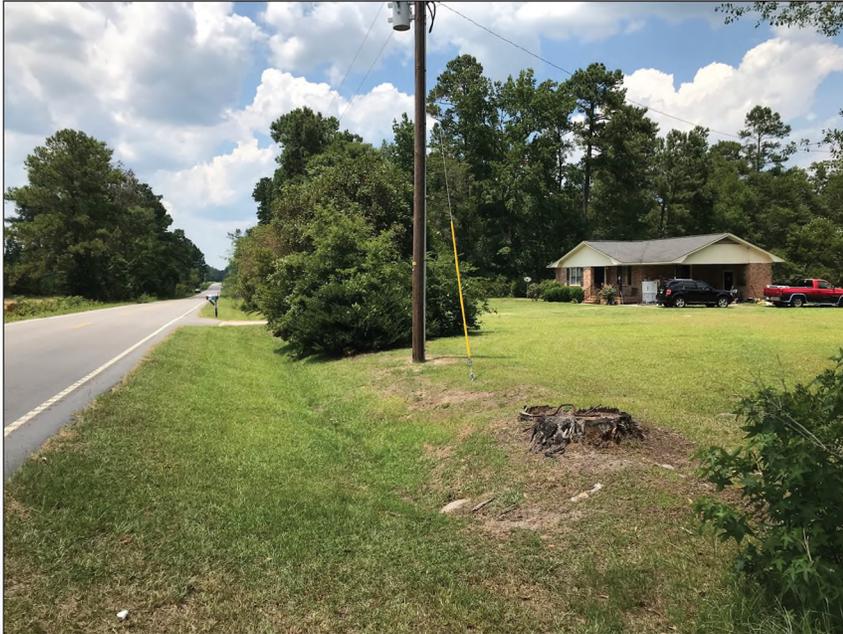
Figure 7.
Site 38GE680

A nineteenth-or-twentieth century artifact scatter was identified 45 meters from the southern edge of the project area, on the northeastern side of the road. Local vegetation included a lawn and a young pine wood. The wood extended over a concentration of pushpiles representative of land-clearing activity. Surface exposures were present along the cut bank while the adjoining lawn had 25 percent surface visibility. Pedestrian walkover of these areas identified five historic sherds at the base of a utility pole near the upper cut bank edge. These sherds were identified as nineteenth-or-twentieth-century plain whiteware (n=4) and yellow ware (n=1) (Miller et al. 2000). Five 15-meter interval shovel tests were excavated in the area surrounding the surface scatter. None contained subsurface artefact deposits. No tests were excavated east of the initial positive due to the disturbed condition of this area (Figure 6). Observed soils included 15 centimeters of yellowish brown (10YR 5/4) sand and yellowish brown (10YR 5/4) sandy clay subsoil (Figure 7).

A. Setting, Facing Northeast

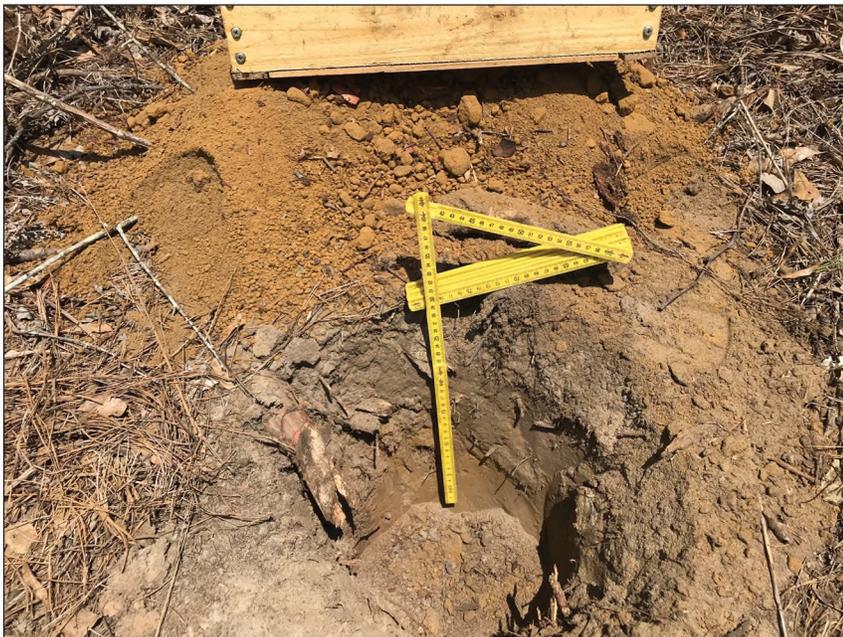
B. Shovel Test Profile

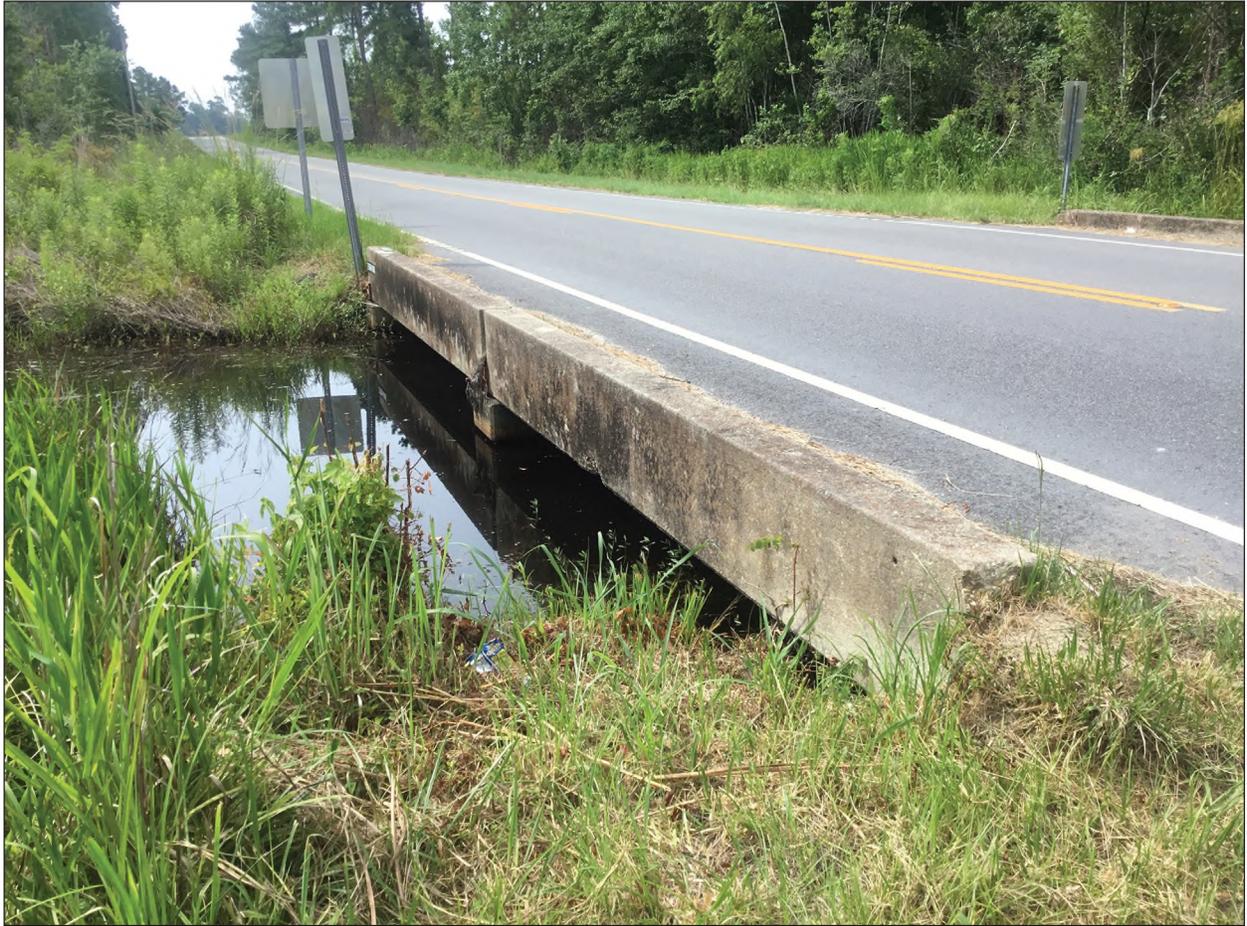
Figure 8.
Resource 1139, View South

Resource 1139 is a 35-foot-(10.6-m) long bridge built in 1959. The structure is a concrete slab bridge that was constructed of precast concrete panels (Figure 8). Short concrete railings line the bridge along the road elevation. Within the past ten years, minor general maintenance repairs have been made to the bridge. Resource 1139 is an example of a common South Carolina bridge type. While the bridge’s integrity has not been significantly impacted by alterations, it does not possess any significant architectural or technological attributes. Thus, the resource is not recommended as eligible under Criterion C. The bridge is also not known to be associated with events or persons significant in the past and is also recommended not individually eligible for the NRHP under Criterion A or B.

One archaeological site (38GE680) and one architectural resource (1139) were identified during this investigation. The nineteenth or twentieth century surface scatter has no integrity or research potential. The bridge represents a common South Carolina type and is considered not individually significant. Site 38GE680 and Resource 1139 are both recommended not eligible for the NRHP. No further work is recommended for this undertaking.
